Wear and Friction Modelling on Lifeboat Launch Systems

B. Thomas^{*a}, M. Hadfield^a, S. Austen^b.

Royal National Lifeboat Institution, Poole, UK^b

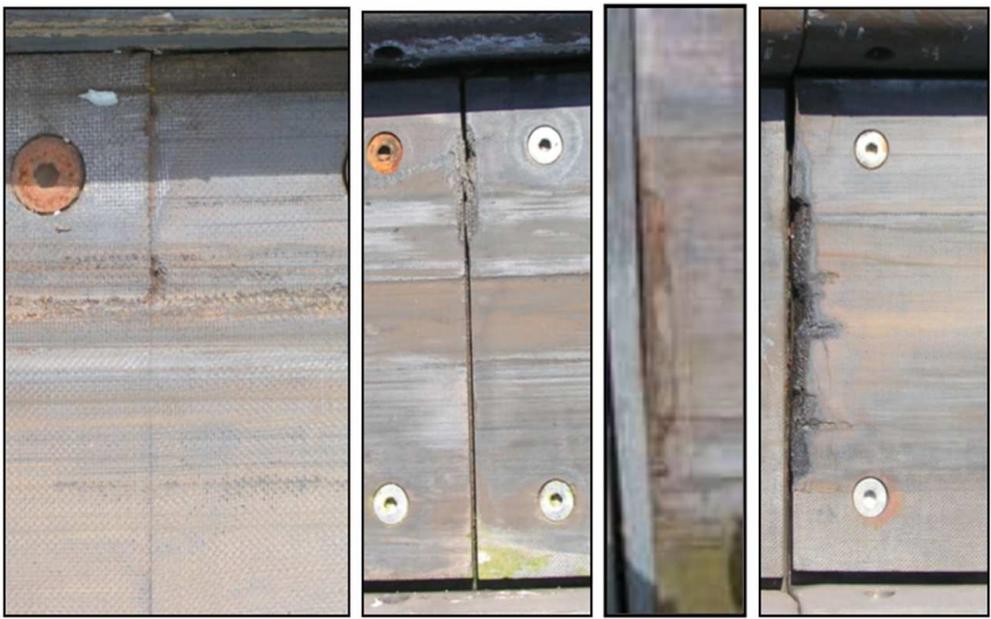
1
2
3 This is the most common form of panel end wear observed from the slipway surveys; it represents
4 the case where abrasive wear has resulted in a relatively even and graded wear scar, as opposed to
5
6 the larger scale panel cracking effects observed elsewhere.
7
8
9

13
14
15
16
17 Fig. 2 above shows the typical progression of an abrasive wear scar on a misaligned panel. Initially
18 panel end stresses cause a small region of the composite to deteriorate and fail, this initial
19
20 imperfection develops until it is the width of the lifeboat keel on the panel. Further slipway operation
21
22 causes this wear scar to progress into the composite panel until it reaches the level of the fixing bolts,
23
24 at this point the panel is considered to have failed as it is no longer sufficiently attached to the
25
26 slipway superstructure.
27
28
29
30
31
32
33

Fig. 2: Abrasive panel end wear: typical wear progression (left to right)
247x135mm (132 x 150 DPI)

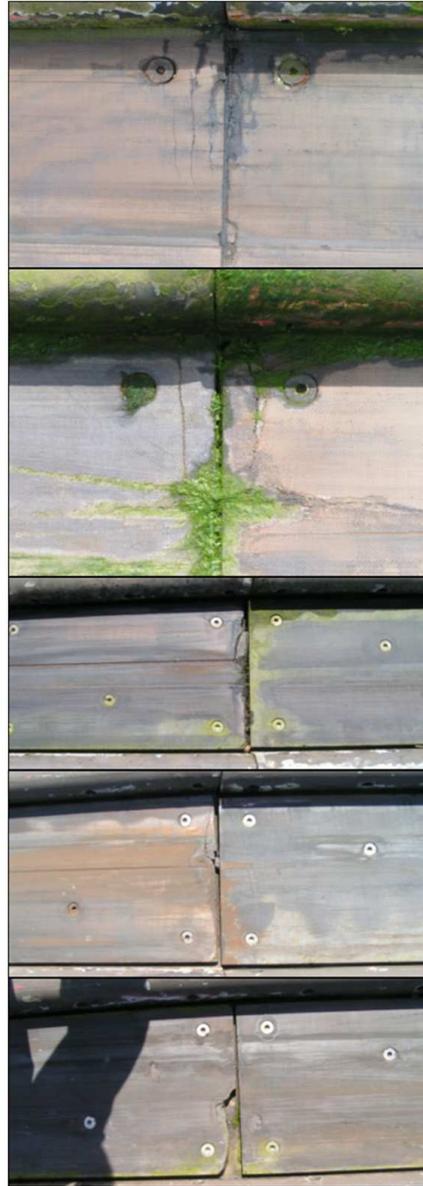
35
36 Panel end stresses can also result in the formation of deep cracks in the phenolic resin of the
37
38 composite, these can progress to form panel 'islands' where the phenolic resin has cracked but the
39
40 jute fibre mesh retains the cracked section in place. The jute fibres eventually fail leaving the
41
42 cracked material to break loose of the main panel, this results in distinctive large scale missing
43
44 'chunks' on the panel ends. This effect is noted to be more pronounced on misaligned panels and is
45
46 suspected to be caused by the same stress concentration effects. Fig. 3 shows the progression of this
47
48 process on different panels.
49
50
51
52
53
54
55
56
57
58
59
60

Fig. 3: Cracking panel end wear: wear scar progression: Initially high contact stresses due to panel misalignment cause a surface crack to develop in the phenolic resin bulk of the composite, this then develops until it reaches the other side of the slipway panel, at this point the cracked area is held in place solely by the jute fibre matrix. The jute fibres subsequently fail, allowing a large section of slipway panel to break free
96x268mm (150 x 150 DPI)

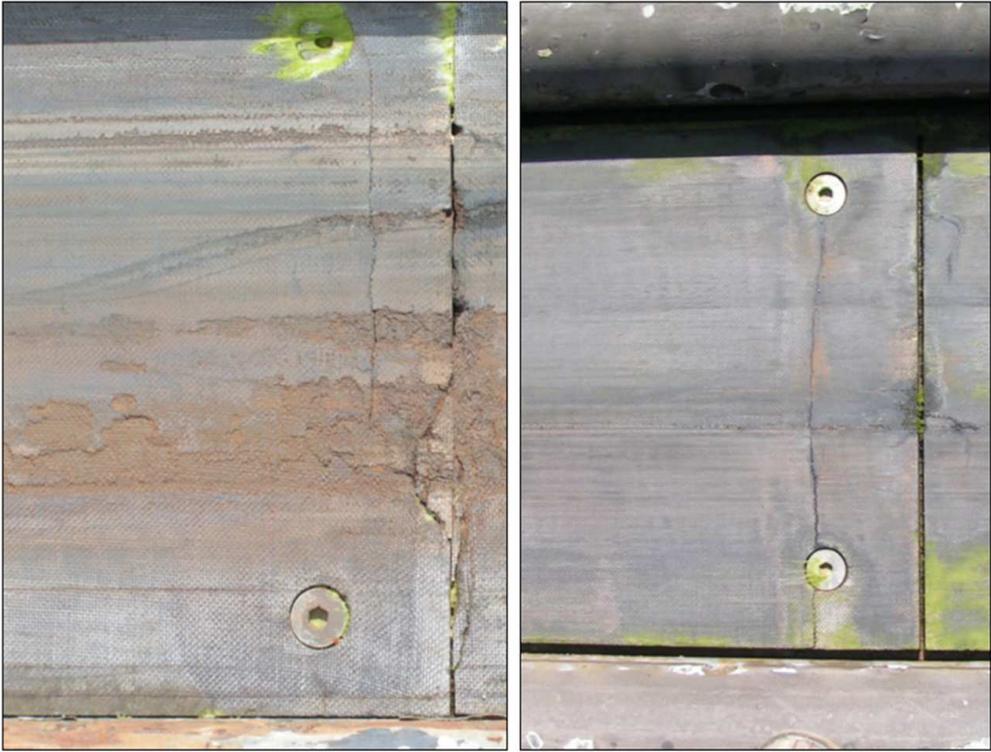
1
2
3 A subset of the cracking to leave panel 'islands' case is where cantilever effects (where the panel is
4 not adequately supported after the final fixing bolts) can result in cracking of the phenolic bulk
5 materials between the fixing bolts as show below in fig. 4. This type of wear is severe as once the
6 cracked section separates from the main panel the holes for the fixing bolts are broken also and the
7 panel can be considered to have failed as it is not adequately fixed to the underlying slipway
8 structure.
9
10
11
12
13
14
15
16
17
18
19

Fig. 4: Panel end wear: cracking between fixing bolts
227x165mm (143 x 150 DPI)

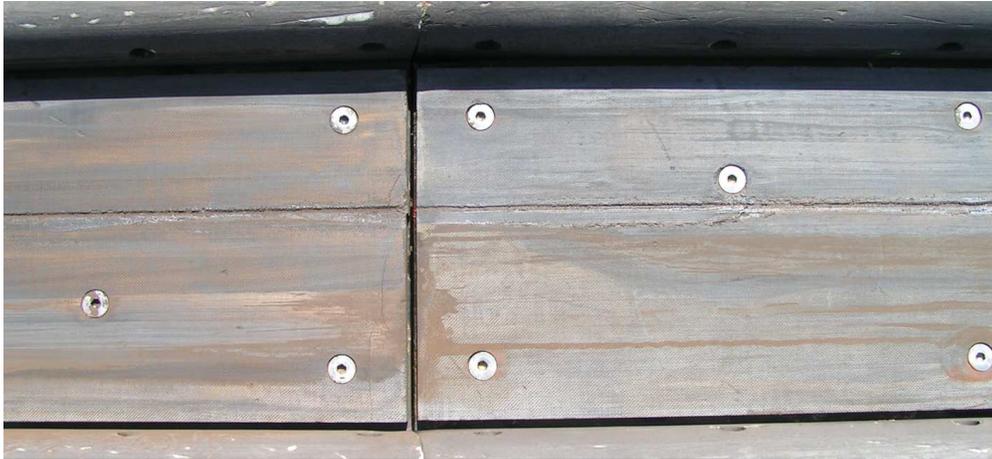
30
31 Deep, parallel gouging wear scars are observed at the new Tamar equipped Padstow and Tenby
32 slipways. These are subsequently attributed to an imperfection in the keel of the prototype Tamar
33 class lifeboat, used for initial slipway hauling trials at both slipways.
34
35
36
37
38
39
40

Fig. 5: Gouging wear from Tamar prototype
238x109mm (150 x 150 DPI)

42
43
44
45
46 This issue has since been rectified and the absence of other significant gouging wear scars on the
47 Tamar slipways and general slipway friction performance better than that expected from ploughing
48 friction calculations indicate that once the prototype Tamar keel was repaired no other major
49 gouging wear was encountered here. This is supported by the other slipway inspections at Selsey and
50 Bembridge where some light gouging wear is present, though not to the severity that would be
51
52
53
54
55
56
57
58
59
60

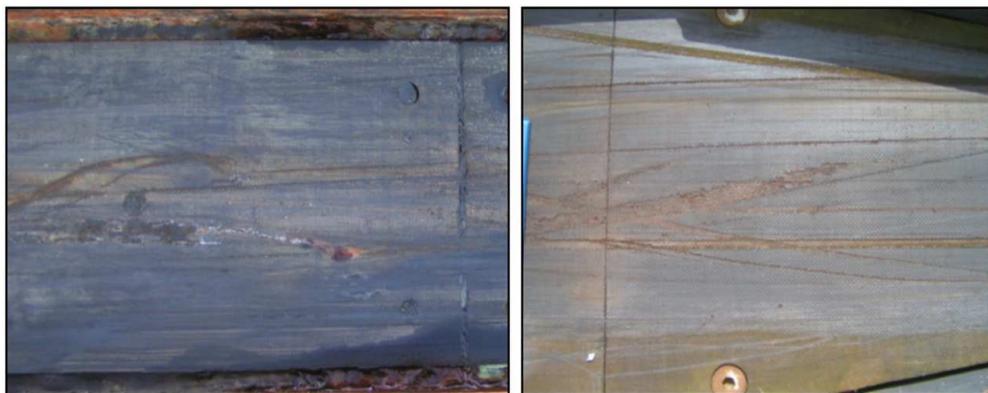
1
2
3 expected for the large number of launches and recoveries conducted on these slipways. This supports
4
5 the proposition that significant, persistent keel damage not a common occurrence on slipways and
6
7 raises the possibility that the lighter gouging wear scars on Selsey and Bembridge slipways are
8
9 caused by 3rd party wear particles trapped between the contact. This is supported by the presence of
10
11 diagonal and wavy gouging scars on panels, if the scars were caused solely by keel imperfections
12
13 these would be expected to run along the length of the slipway lining as the lifeboat does not move
14
15 laterally as it proceeds along the slipway, this is shown in fig. 6 below:
16
17
18
19

23
24
25
26
27 Overall the impact of gouging wear on the slipway is unlikely to have a significant systemic effect
28
29 on slipway function, the presence of straight gouging grooves on the slipway panels is an early
30
31 indicator of keel damage and this should be identified and remedied before further slipway lining
32
33 damage occurs. However, the low number of gouging wear scars on other composite slipways
34
35 indicates that this is likely to be an infrequent problem. The presence of wavy or diagonal wear scars
36
37 on the slipway indicates the presence of 3rd body particles between the keel and slipway lining, as
38
39 these are not attached to either contact face they are likely to be removed from the slipway by the
40
41 process of lifeboat launch and recovery. Similarly the low incidence of this type of gouging wear on
42
43 the slipways surveyed indicates that this is likely to be an infrequent problem, however if these wear

Fig. 6: 3rd body gouging wear
239x87mm (136 x 150 DPI)

44
45 scars are noted to appear regularly on a specific slipway it may be necessary to inspect the slipway
46
47 for debris before use. Interestingly, the diagonal wear scars indicating 3rd body wear are also present
48
49 on the water lubricated Tamar slipways at Padstow and Tenby, it had been thought that a by-product
50
51
52
53
54
55
56
57
58
59
60

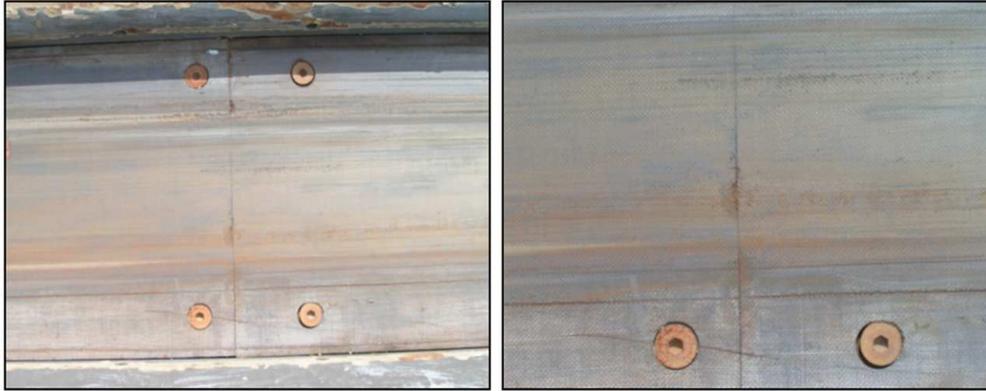
11
12 Plane abrasive wear occurs when the slipway panel is well aligned and the contact with the keel is
13
14 even and planar, in this case the contact pressures are relatively evenly distributed along the panel
15
16 and the resulting wear is light and even. This typically results in the phenolic bulk of the composite
17
18 material eroding to expose the underlying jute fibres.
19
20
21

25
26
27
28
29 The incidence of plane abrasive wear on a panel is a sign that the panel is performing well and that
30
31 the keel contact is well aligned. Under these contact conditions wear will be very light, approaching
32
33 the wear rates observed during the aligned contact tribometer testing.
34
35
36

Fig. 7: Plane abrasive wear: exposed jute fibres
230x86mm (141 x 150 DPI)

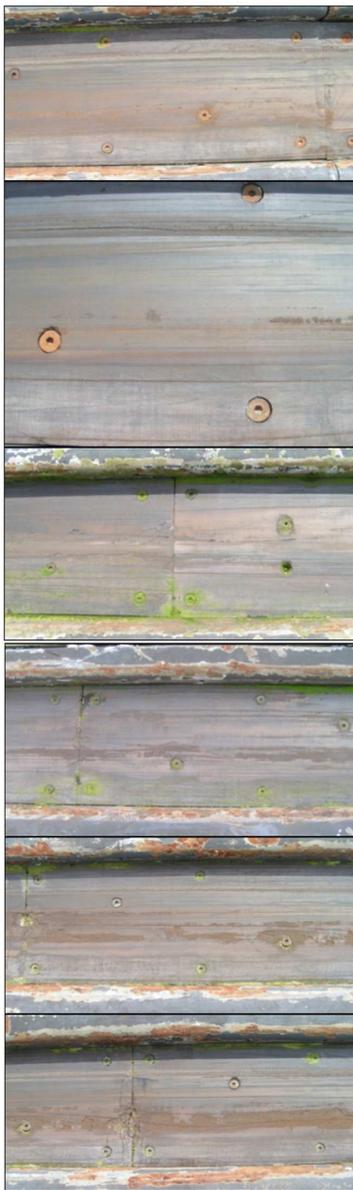
47
48 This kind of wear is noted at both of the new Tamar equipped slipways at Tenby and Padstow. The
49
50 progression of delamination wear is shown in fig. 8. Here the wear is shown to develop initially as
51
52 small pits the depth of a composite layer, before the pits widen and join to form large areas of
53
54 delamination along the slipway.
55
56
57
58
59
60

Delamination of the composite slipway panels implies that there are high shear stresses present in the composite bulk around the contact area, and this in turn implies that friction forces and friction coefficients are high in these regions. This leads to the conclusion that the presence of delamination on slipway panels indicates well aligned contact conditions, but high frictional forces on the panel. The presence of delamination wear on the new Tamar equipped slipways may be due to a breakdown of the lubrication regime to allow unlubricated contact or a consequence of running the slipway dry.

Fig. 8: Delamination wear: wear scar progression
112x375mm (150 x 150 DPI)

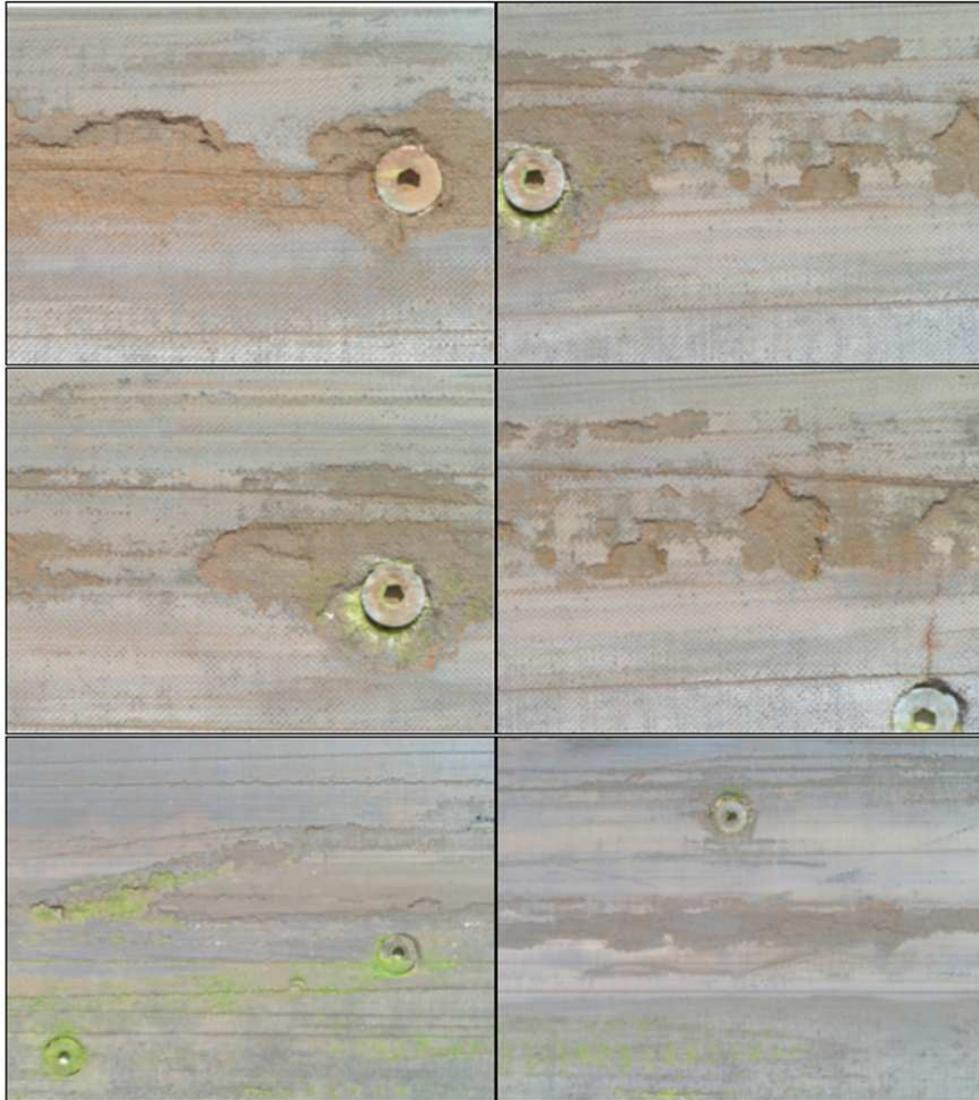
Close up images of delamination wear on the composite slipway lining material are shown in fig. 9.

Fig. 9: Delamination wear: detail
149x167mm (150 x 150 DPI)

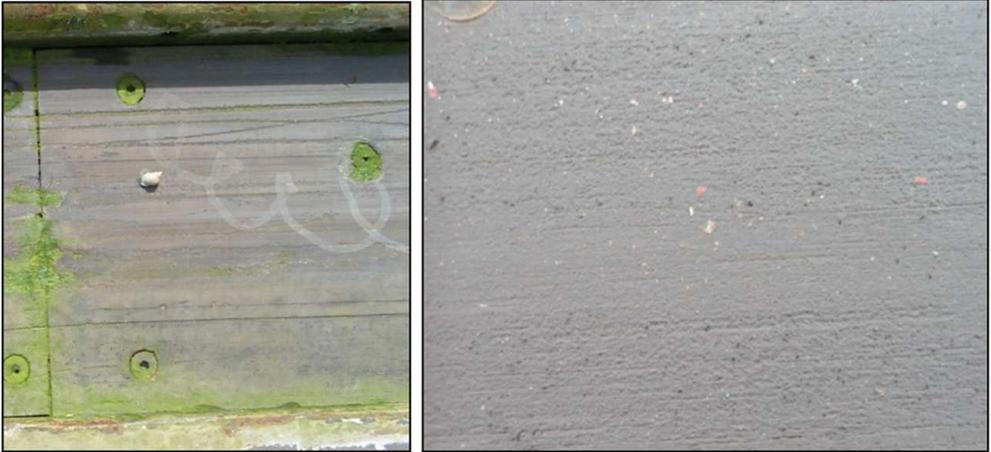
1
2
3 Embedded debris is noted at Selsey slipway, conversations with the coxswain indicate that this is
4
5 likely to be animal shells, this is confirmed by observation of snails and snail trails on slipway
6
7 panels.
8
9

Fig. 10: Embedded Debris
230x102mm (141 x 150 DPI)

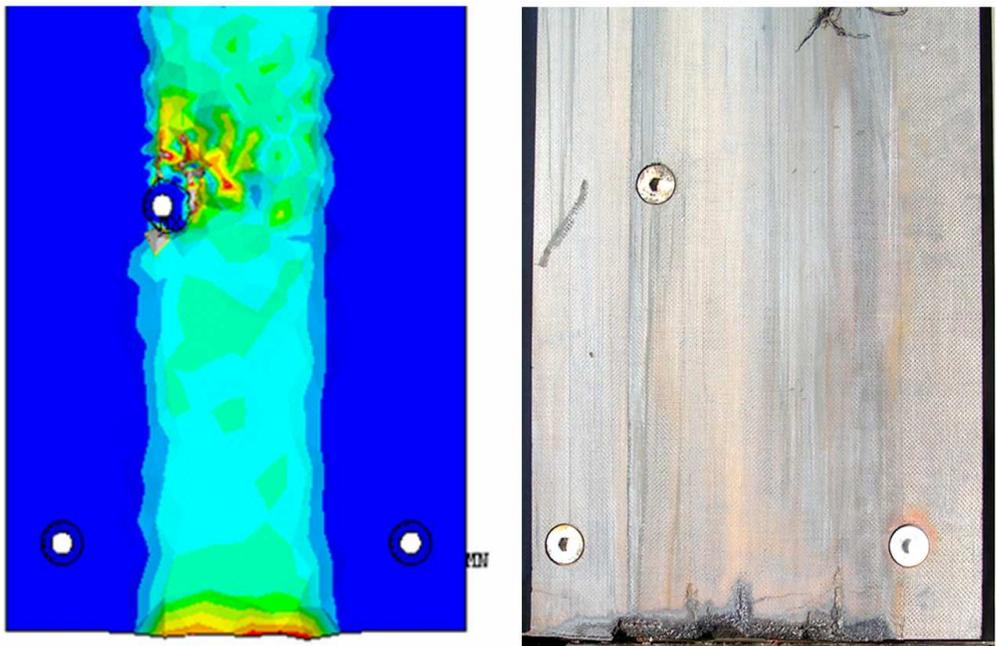
1
2
3 It is found that the areas of high stress concentrations correlate well with the worn regions observed
4 on composite panels during slipway surveys and on the damaged slipway panel recovered from Tenby
5
6 slipway station as shown in fig 12.
7
8
9

Fig. 12: FEA simulation vs. typical worn composite panel section from Tenby slipway 245x141mm (133 x 150 DPI)
