East Stoke: The Archaeology of the Old Church of St Mary

This is the second of two reports relating to research and fieldwork at the site of the Old Church of St Mary, East Stoke (see Hewitt, Russell and Manley 2009). These investigations were undertaken in conjunction with the East Stoke Heritage and Archaeological Group. This paper presents the results of limited non-intrusive archaeological fieldwork.

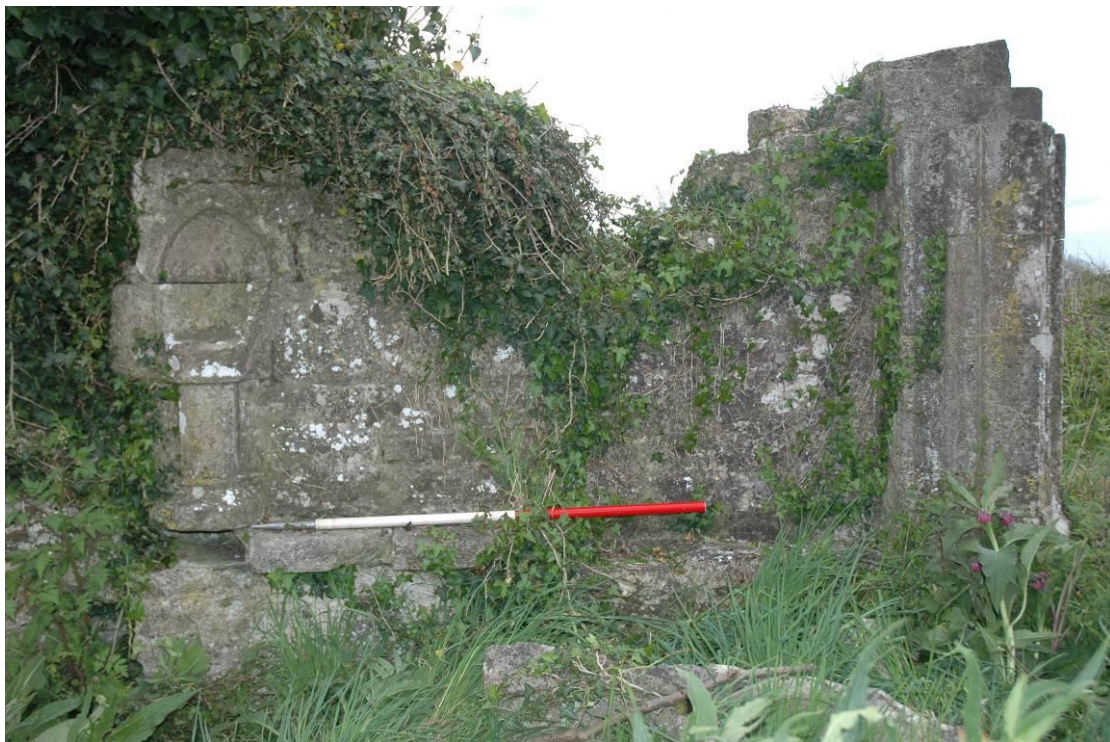
In common with other church porches of the 15th or 16th centuries, the south-east interior of the porch contains a holy water stoup at the point where the latch of the nave door would have been. This example is constructed from three limestone blocks, of the same geological origin as the porch. It has a chamfered arched head with an octagonal base underneath which a flat stone has been removed. The central pillar is cylindrical and has annulets at either end. The bowl is incomplete, about 50% of it having been broken away.

However, sufficient of the bowl remains as to suggest that originally it was circular and of ca 250mm depth.

The porch also contains stone bench-seating. On the east wall this feature remains almost complete but there are traces of it on the west side too. This seating would have been for the use of the Church Wardens and other parochial worthies (Figure 4). Above and centre, the remaining wall dips downwards. This was the position of a quatrefoil window that has vanished since it was recorded by the Royal Commission (1970, 274-5). The creeping incursion ivy is self-evident.

Figure 4: *Interior east wall of the south porch showing the relative locations of the stoup (left) and the stone bench. The dip in wall above indicates the former position of the quatrefoil window. Ivy (Hedera helix) is firmly rooted into the top of the fabric.*
