Survey of the standing remains of the Old Church of St Mary, East Stoke, Dorset.

Document date: June 2010

The East Stoke Heritage and Archaeological Group
June 2010

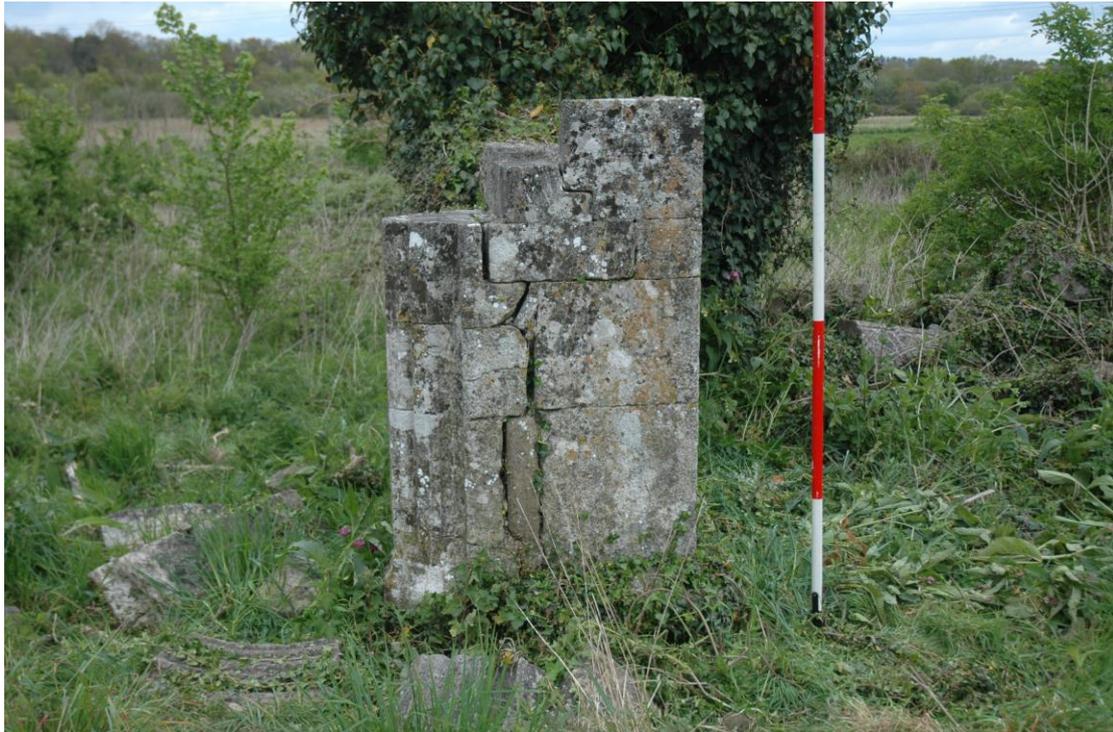
4.2.3 The survey did demonstrate a curious feature of the porch: the south elevation, east of the entry arch, betrays signs of reconstruction (Figure 4). Close to the ground is visible a slab-like stone that seems to be out of place in this vertical position. Furthermore, it is a limestone of a slightly different hue to other component stones of the porch. It is out of place, and this, together with apparent re-cutting lines of the blocks immediately above it, suggests that the porch had been re-assembled having formerly graced a previous site. A date after the Dissolution of the monastic houses of nearby Bindon Abbey and east Holme Priory (1539) would make sense.

Figure 2 *The south-east corner of the porch showing the anomalous slab stone close to the ground and the dog-leg cutting of the three stones immediately above.*

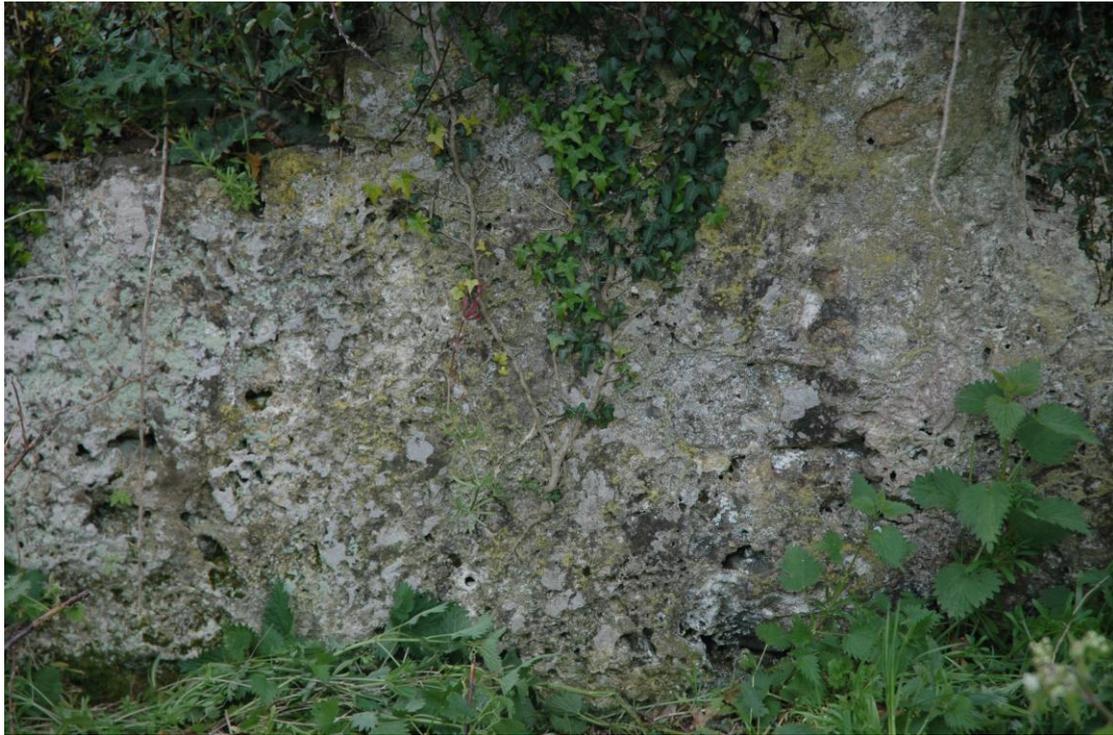
4.2.2 The remaining south wall stands at ca 3.0m maximum height though precision of measurement was prevented by ivy cover. The wall is of rubble construction, a material that was probably accessed locally from the Bagshott Beds and which certainly includes fragments of Carstone (Heathstone). Examination of the interior suggests that this was finished with a lime plaster (Figures 3 and 8). However the porch

Figure 3 *The interior of the south wall showing the surviving traces of the lime plaster that conceal the rubble wall.*

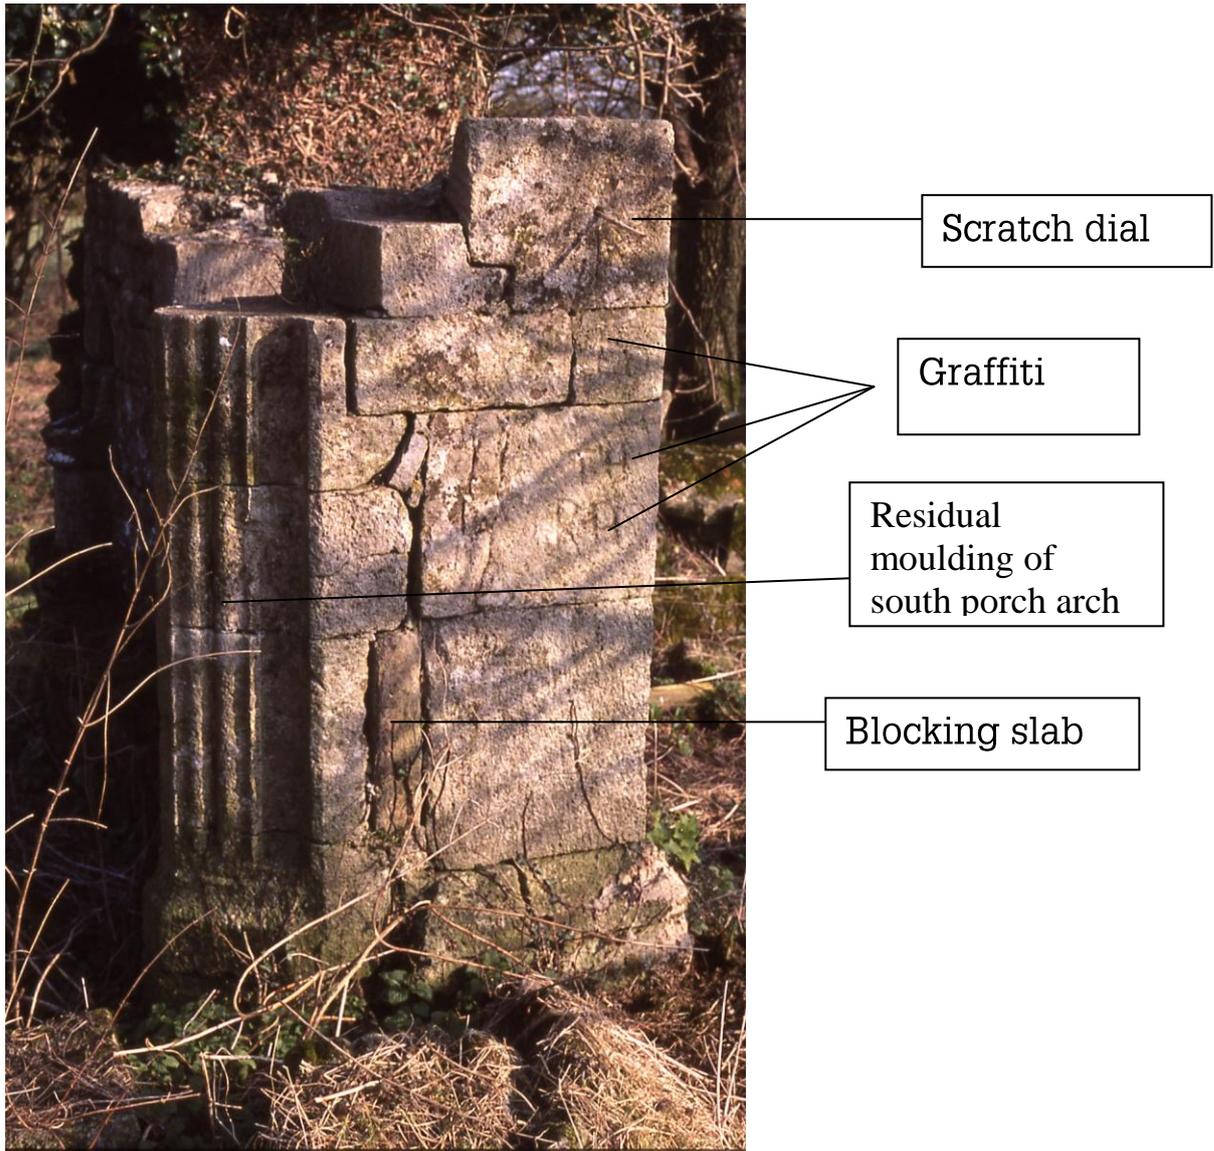
4.3.2 The scratch dial is incised into a single limestone block (see Figure 4). In common with many dials of its type, the East Stoke example comprises an incised horizontal line (220mm) that passes through a central hole (*ca* 25mm diameter) that also served as the location point for the gnomon. The gnomon point acts as the starting point for 6 (possibly 8) radiates arranged in protractor fashion and spaced at approximately 15 degree intervals. Each radiate is of *ca* 110mm length. At a point roughly midway between the fourth and fifth radiates from the left, and *ca* 600mm beneath them, a peg hole has been impressed into the mortar between two stone blocks. Clearly, this peg hole is part of the dial and probably indicates the time at which mass was to be performed.

4.3.3 Carved into the stone block immediately below the scratch dial are the letters ED, the largest of the letters being 75mm in height. The incisions are of both letters are approximately 15mm in width. One block further down, has been incised with two further sets of letters: TH and (immediately beneath) RH. The style and size of engraving is much the same as the ED above which suggests that all three may be contemporary. However, the letter R is by far the most pronounced at 120mm in length. A date cannot be indicated with certainty but all of the letters are indicative of an amateur style that would not be out of place from the late 19th through to the late twentieth centuries.

Figure 4 *Southeast wall of south porch showing features as described. The porch sits on a plinth finished in a single sunken chamfer (Child 2008: 39).*

in 5.1 above. It is advisable that the remaining structure should be inspected on a regular basis as part of an ongoing conservation plan. Any perceived need for re-pointing should take into account that lime mortar should be used in accord with the original construction materials. Re-pointing in the vicinity of the scratch dial would need to be applied with great sensitivity and must avoid concealment of the 'mass peg' location at the base of the dial (see 4.3.1).

5.2.4 More contentious are the feature stones of the Old Church that remain within the surviving fabric. The comparatively recent loss of the quatrefoil window from the east wall of the porch indicates that feature stones of this type are attractive and therefore vulnerable to theft. The scratch dial is particularly vulnerable to a fate of this kind but its save removal to any proposed village hall site would rob it of its very specific astronomical context and is not advocated here. It is therefore suggested that the best course of action in the case of the scratch dial

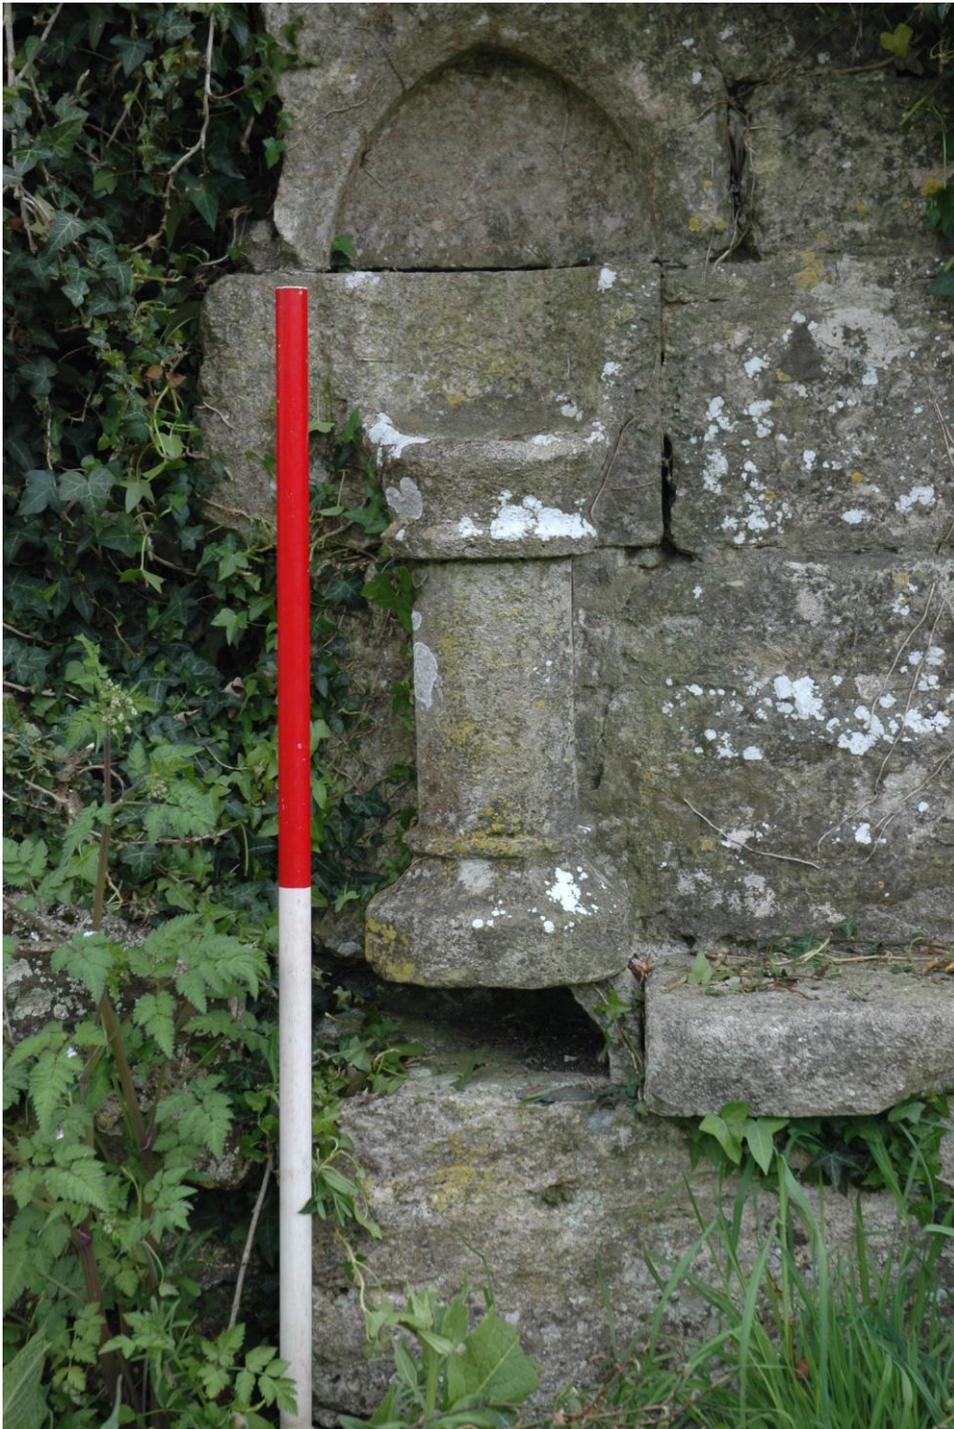
In common with other church porches of the 15th or 16th centuries, the south-east interior of the porch contains a Holy Water stoup at the point where the latch of the nave door would have been. This example is constructed from three limestone blocks, of the same geological origin as the porch. It has a chamfered arched head with an octagonal base underneath which a flat stone has been removed. The central pillar is

cylindrical and has annulets at either end. The bowl is incomplete, about 50% of it having been broken away. However, sufficient of the bowl remains as to suggest that originally it was circular and of ca 250mm depth.

Figure 5 *The stoop in the south porch at the point where it abbotts the ivy-clad remains of the south wall of the nave.*

and the stoup is that they remain where they are but are subject to regular inspection.

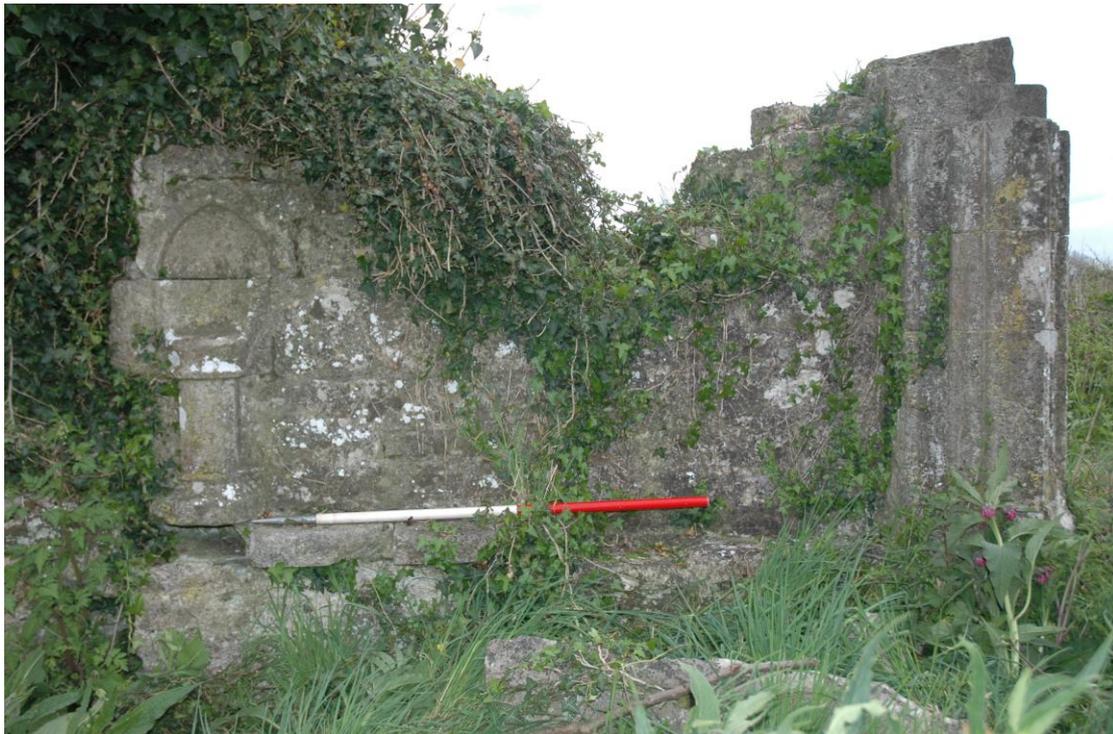
The porch also contains stone bench-seating. On the east wall this feature remains almost complete but there are traces of it on the west side too. This seating would have been for the use of the Church Wardens and other parochial worthies. Figure 6 shows this feature adjacent to the stoup (left). Above and centre, the remaining wall dips downwards. This was the position of a quatrefoil window that has vanished since it was recorded by the Royal Commission (1970, 274-5). The creeping incursion ivy is self-evident.

Figure 6 *The interior east wall of the south porch showing the relative locations of the stoup (left) and the stone bench. The dip in wall above indicates the former position of the quatrefoil window.*

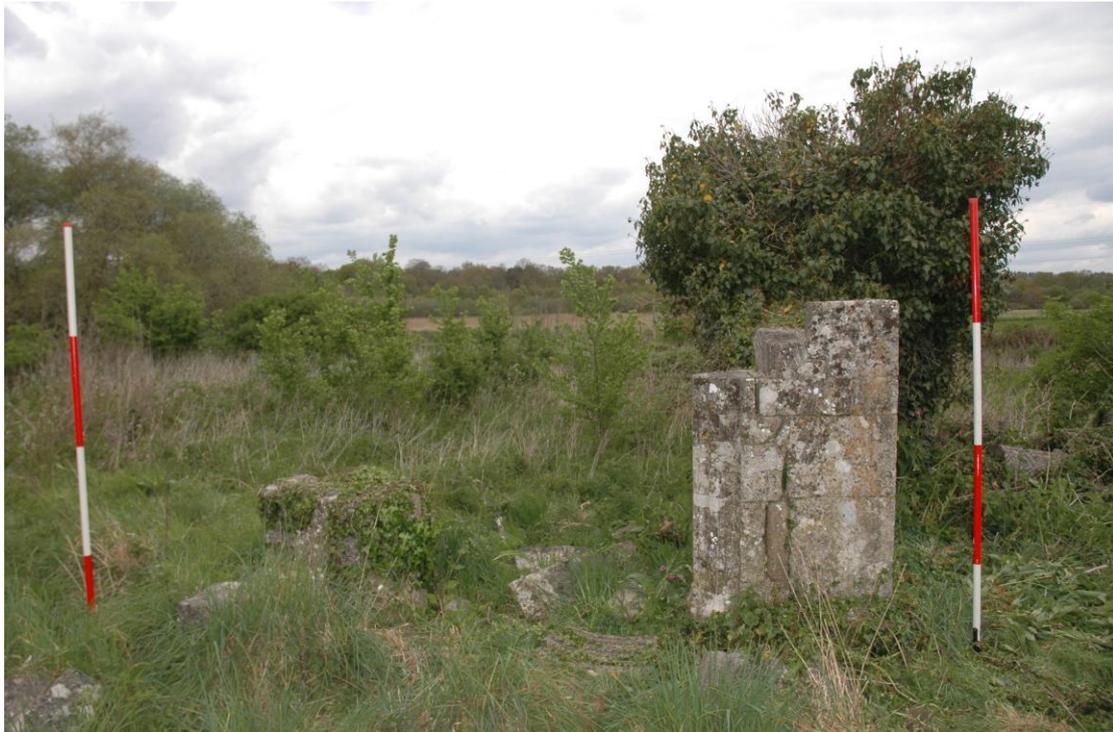
Only the lowest levels of the south porch arch survive in position (Figure 4 and 7). Other component stones lie scattered around the site of the arch with no indication that any are missing.

Figure 7 *The in situ stones of the south porch arch. Former component stones lie scattered as they fell.*

The architectural stone fragments include the sections of the fallen arch Of the south porch, and the decorated end slabs of the chest tomb that was formerly sited close to the south porch. Re-erection of the south porch arch would require a major constructional project that would have to include new structural elements such as buttressing. Foundations for such a feature would in turn require considerable disturbance to the site and produce a finish that would be out of keeping with the monument as stands.

5.2.3 An alternative approach to the problem would be to consider removal of the worked elements of the former arch from the site where they might be included as a feature in the proposed new village hall. Here they would be secure and available for public access. Scheduled Monument Consent would be required for such a venture.

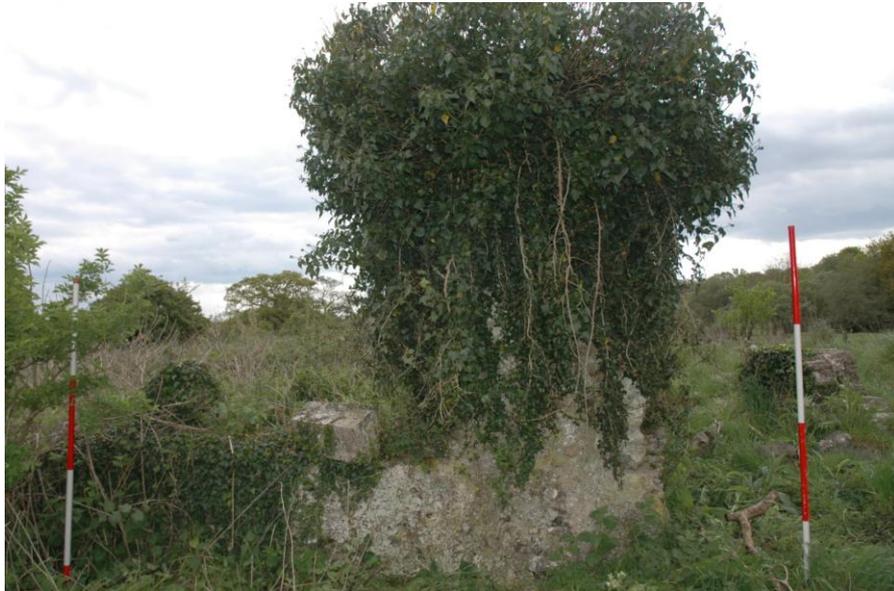
Consideration has been given to the matter of ivy cover that is particularly prevalent on the south wall of the church. This seems to be well established and the roots of this vegetation are firmly established within the upper regions of the fabric rather than in the ground (Figure 8). The surviving fragment of south wall is of rubble construction and any attempt at the removal of the ivy roots would constitute a serious threat to the fabric. It is therefore recommended that the ivy be left in place where it may act as a bonding agent for a potentially fragile wall.

To the left of Figure 8 ivy cover can be seen to have spread to the much lower surviving window sill of the south wall. Here the situation is different for the ivy is ground rooted and removal might be considered. If this option is preferred, then a sacrificial cap of locally cut turf is recommended.

Figure 8 The internal elevation of the surviving south wall showing ivy (*Hedera helix*) firmly rooted into the top of the rubble fabric.

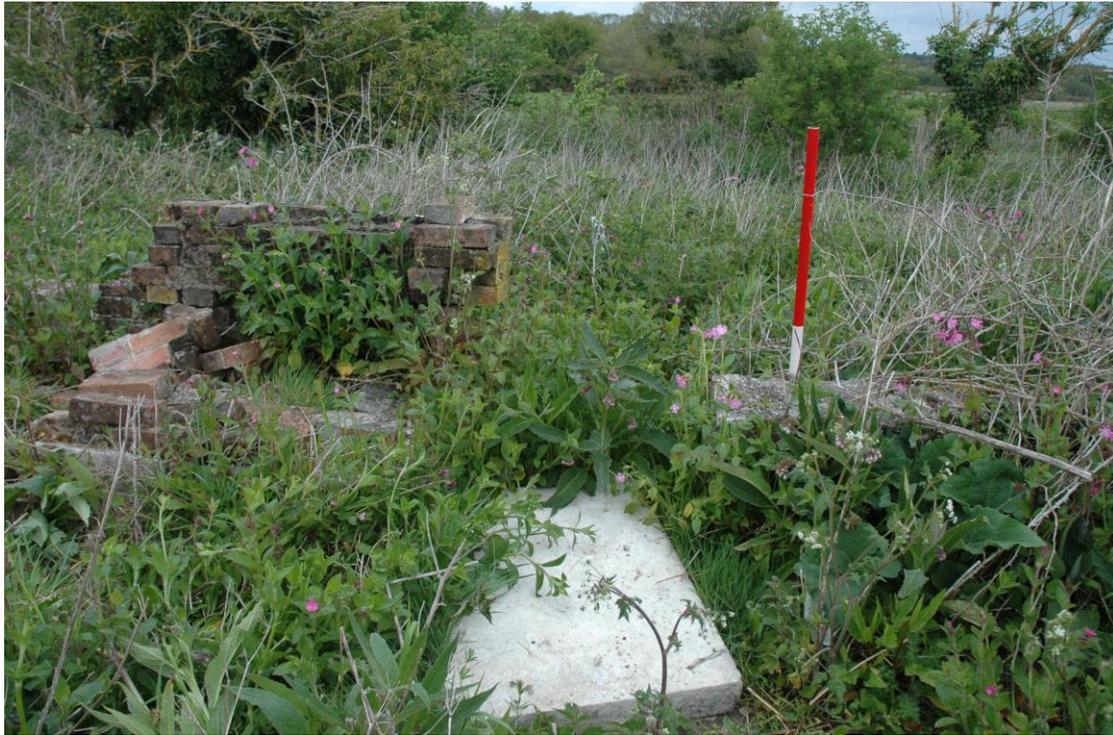
Figure 9 *The remains of two chest tombs to the north of the church. To the left is the brick-built example, to the right, limestone blocks. In both cases the dedicatory upper slabs have been displaced.*

5.3.1 Of the three tombs, the brick-built example to the north of the church has the potential to be reconstructed provided that the dedicatory top-slab and the (probably plain) end slabs can be identified (Figure 9). However, some of the bricks might be missing and these would have to be replaced by modern substitutes. A similar case might be made for the adjacent limestone specimen. The problem of matching the parts to the whole could prove to be intractable. Identity may remain uncertain or impossible to ascertain. In the case of these two monuments, the expense of reconstruction could be justified only if the appropriate components can be located.
