Scuttled in the Morning: the discoveries and surveys of HMS *Warrior* and HMS *Sparrowhawk*, the Battle of Jutland's last missing shipwrecks

Innes McCartney

Due to the circumstances of the loss of HMS *Warrior* and HMS *Sparrowhawk* in 1916, in which subsequent to disablement both had drifted and been towed unknown distances from the Jutland battlefield, they were not located in the 2015 Jutland survey. In August 2016 both ships were located and HMS *Warrior* was revealed to be a pristine warship wreck, the only example in this condition of the 25 ships sunk in the battle. HMS *Sparrowhawk* had a similar pattern of disturbance as seven of the other Battle of Jutland destroyer wrecks. The survey of these wrecks draws to a conclusion a long period of discovery at Jutland and raises questions as to how these important cultural artefacts should be treated in the future.

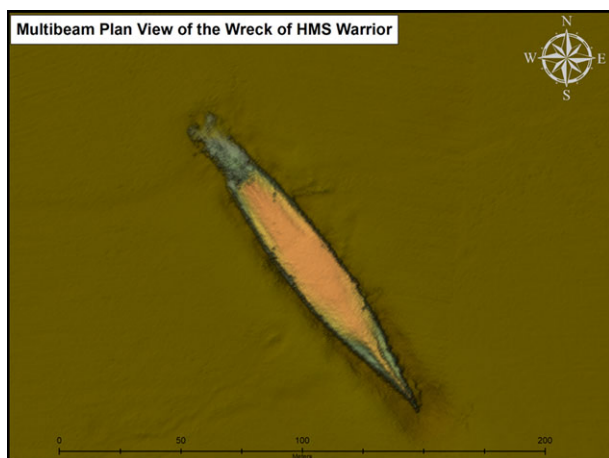
Figure 4. The digital terrain model of HMS *Warrior* as located on multibeam in the evening of 24 August 2016. The wreck appeared to be completely upside-down (Innes McCartney/Sea War Museum Jutland).

late evening of 24 August 2016 at a position recorded in Danish records held by Sea War Museum Jutland as a net snag (Fig. 4). The wreck points to the south-east and was measured at the correct length and width for HMS *Warrior*. On the digital terrain model (DTM) it

looked as if the wreck was completely upside-down and therefore few of the readily identifiable features could be seen. Inspection by ROV was required to ascertain for certain that the wreck was HMS *Warrior*, but also to attempt to discern the manner of its sinking. The ROV was deployed at 23:00 and aside from the ROV's lighting the wreck was in complete darkness throughout the inspection, explaining the dark character of the images.

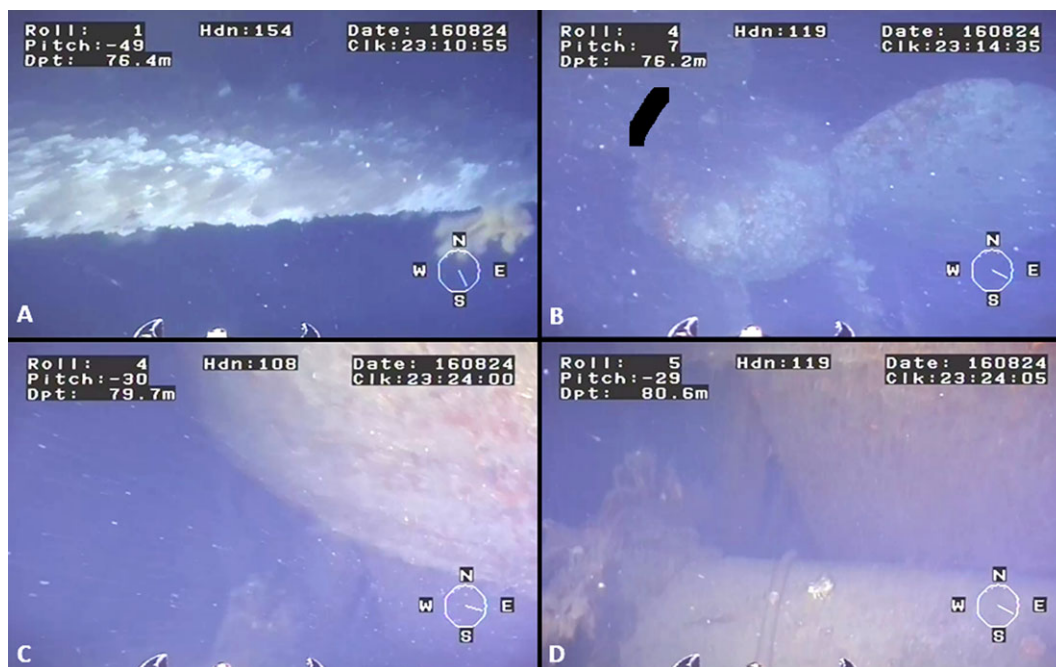
The ROV passed from the northerly end of the wreck down the north side and around the bow. In the stern area the rudder was seen to have been flattened into a near horizontal position (Fig. 5A). Both propellers were present and one is visible in Figure 5B. Both propeller shafts and the rudder were observed to have been bent so that they lay with a bias to the starboard side of the wreck. The ROV then moved to the level of the upper deck and the curved overhanging structure of the after starboard side 9.2-inch gun barbette could be seen (Fig. 5C). The turret itself is mainly buried and there is no clearance under the wreck. The armoured wall of this turret was seen to have split along a join in the armoured plate (Fig. 5D), probably because it is one of the structures supporting the entire weight of the ship. In the foreground of Figure 5D is a section of the mainmast, which was observed to be running out from under the body of the wreck at this point.

Figure 5. ROV images of the stern and after port side of the wreck of HMS *Warrior* (Innes McCartney/Sea War Museum Jutland).

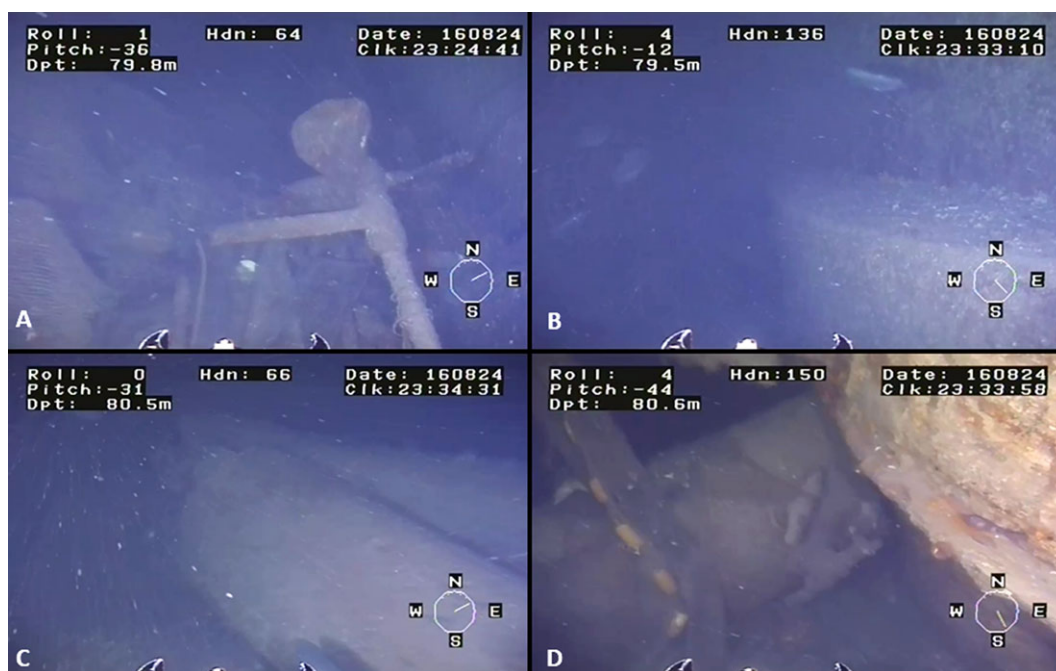
The ROV continued along the starboard side of the ship at the seabed level (Fig. 6). The remains of a pinnacle with its distinctive propeller was seen just forward of the visible portion of the mainmast (Fig. 6A). The underside of the overhanging barbette (now inverted) of the forward of the 9.2-inch gun turret on that side of the ship was visible (Fig. 6B). Under it, a portion of the foremast could be seen poking out (Fig. 6C). This has folded back on itself and the top is buried under the wreck. The foremast passes out from under the wreck just forward of the turret (Fig. 6D). It must have fallen over the gun barrel as the ship sunk.

Figure 6. ROV images of the central portion of the port side of the wreck of HMS *Warrior* (Innes McCartney/Sea War Museum Jutland).

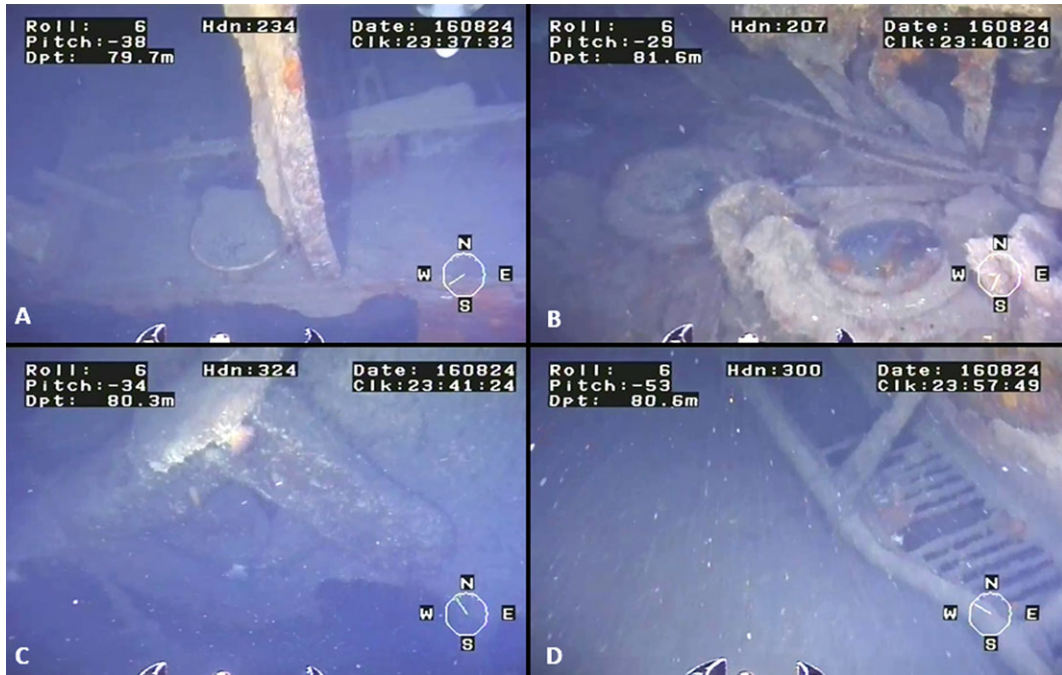
The bow area of the wreck was observed to be the most degraded (Fig. 7). The exposed frames at the forward end of the ship, approximately in line with 'A' turret, were recorded (Fig. 7A) beyond the forward end of the armoured citadel, at a point where at the upper-deck level no armour was fitted (Parkes, 1966: 443). Here, the thinner metal of the hull has entirely corroded, leaving a porthole to lie on the underside of the upper deck. Further forward, more portholes could be seen lying on the seabed and the frames themselves have buckled (Fig. 7B). The probable reason for this is visible in Figure 7C, as it is the sheer weight of the anchor, its hawse, and cables that is forcing this area downwards. The distinctive outer walkway of these armoured cruisers was also seen (Fig. 7D). The area shown is on the port side of the wreck, in line with 'A' turret.

Figure 7. ROV images of the fore section of the wreck of HMS *Warrior* (Innes McCartney/Sea War Museum Jutland).

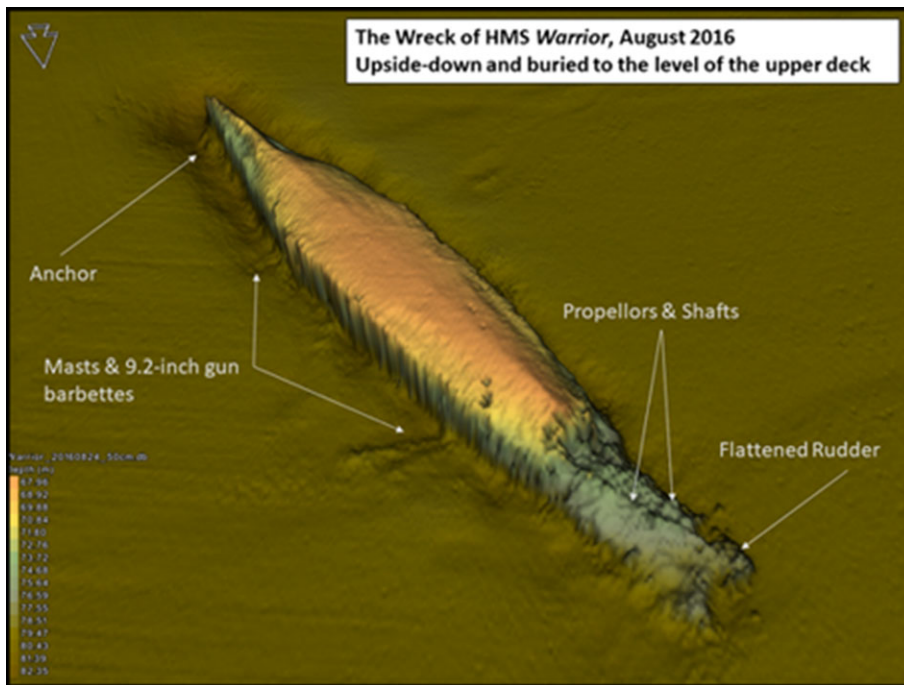
The wreck lies at a general depth of 80m but the scouring around it goes down to beyond 82m (Fig. 8).

The wreck is almost entirely upside-down. Its SE/NW orientation is consistent with a vessel that had drifted beam on to the prevailing weather as reported at the time. The noticeable holes in the DTM line with the engine room were not examined by ROV. They may well turn out to be the exit holes of the rounds which sunk

The survey of the wreck shows that it must have sunk stern first. It was last seen heavily down by the stern. It seems probable that the stern may have temporarily embedded itself in the seabed when the ship hit bottom.

Figure 8. How features observed on the wreck of HMS *Warrior* are located as shown on a multibeam rendering of the wreck (Innes McCartney/Sea War Museum Jutland).

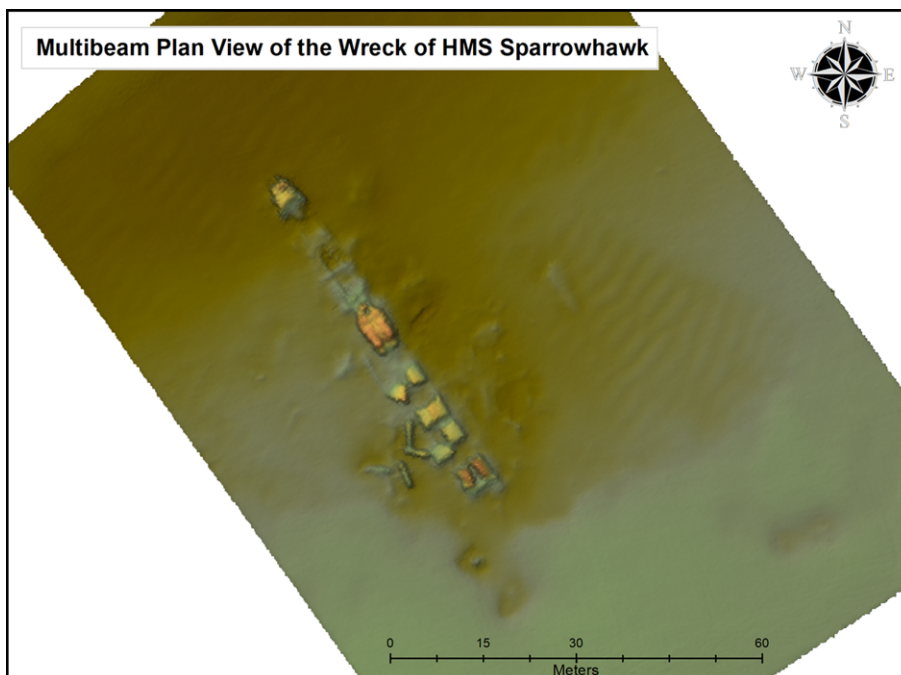
The DTMs of the two wrecks examined in 2016 showed wrecks that are dimensionally consistent with WW1-era destroyers. Site A looked dispersed in a similar way to that seen on several other Jutland destroyer sites (Fig. 10). The wreck at Site B appeared to be a lot more intact and seemed to have features suggesting it was of German origin (Fig. 11). This was confirmed by ROV inspection.

Figure 10. Multibeam plan view of the wreck of HMS *Sparrowhawk* (Innes McCartney/Sea War Museum Jutland).

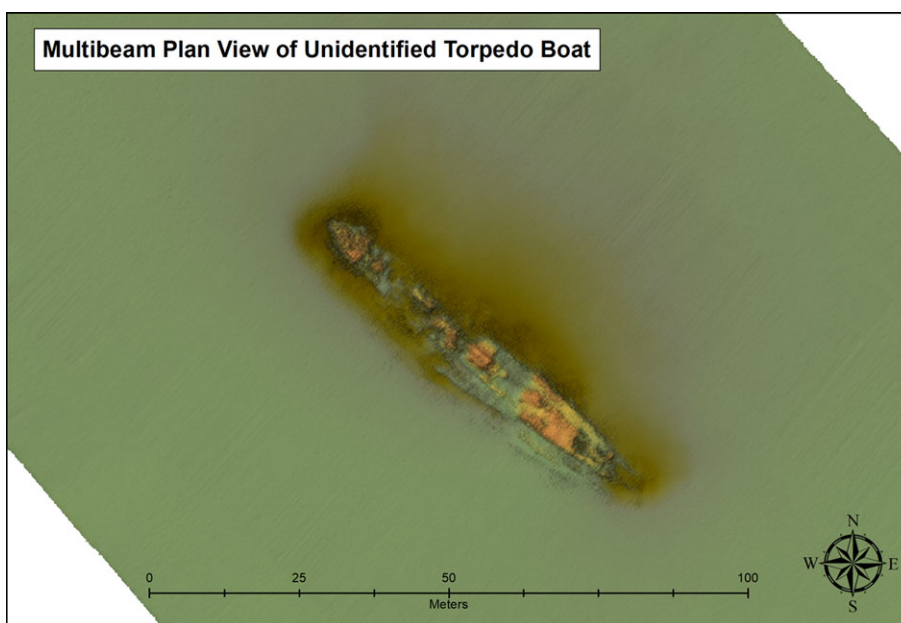
Figure 11. Multibeam plan view of the wreck of an unknown German-built torpedo boat (Innes McCartney/Sea War Museum Jutland).

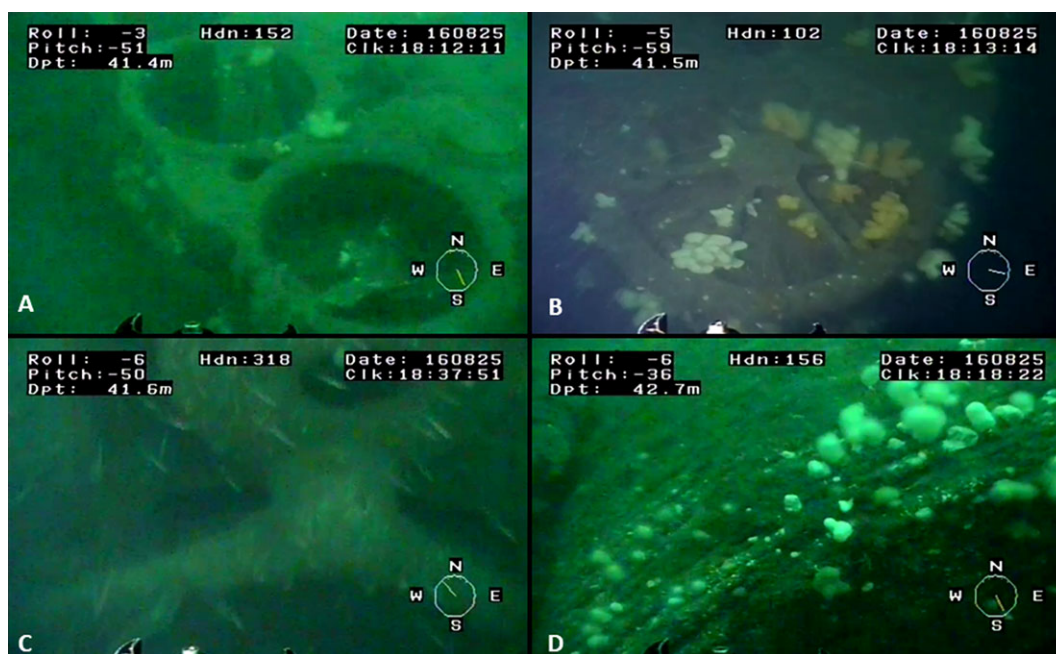
Both sites were examined by ROV. The visual inspection of Site B quickly established that the wreck could not be HMS *Sparrowhawk*. It was eliminated because the wreck was equipped with triple expansion engines (Fig. 12A and B), whereas *Sparrowhawk* was turbine powered (March, 1966: 124–132). Figure 12A shows the top of the portside engine. It can be seen that the cylinders are empty and the engine appears

to have been decommissioned, or was being serviced when the ship sunk. Figure 12B shows the top of the starboard engine with the cylinder intact with a circular covering grate in place. This engine looks as if it was operational at the time of the ship’s loss.

Figure 12. Images from the ROV survey of the wreck of the German torpedo boat (Innes McCartney/Sea War Museum Jutland).

examined. Figure 12C shows the downcomer pipe seen at the apex of one of the three boilers present, at the end of the steam drum. This carried water back down to both water traps, hence the Y shape. This feature is not seen on the Yarrow-type boilers fitted to HMS *Sparrowhawk* and is generally associated with the Schulz-Thornycroft design adopted by the High Seas Fleet. The curved water tubes seen in image D also conform to the German type. Yarrow water tubes were straight (McCartney, 2016: 26).

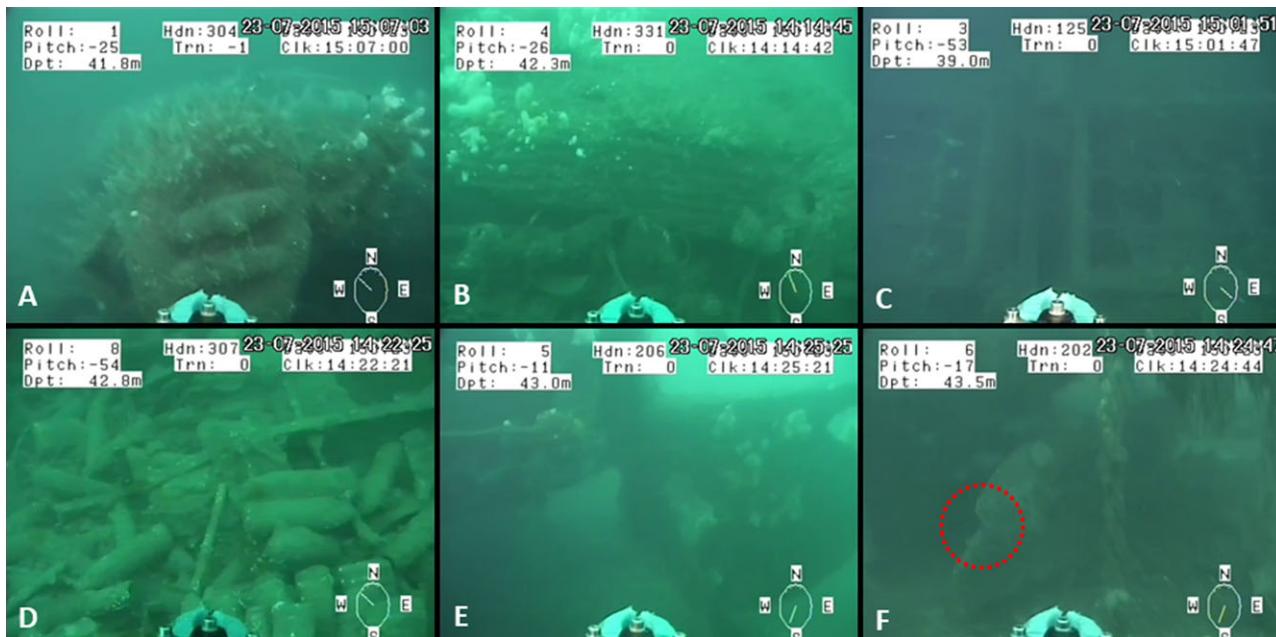
The ROV inspection of Site A showed features that confirmed the wreck is to be HMS *Sparrowhawk*. The images here are from the 2015 visit to the site when the underwater visibility was much better than in 2016. The water traps seen on the boilers are oval (Fig. 13A), which is consistent with the Yarrow type (McCartney, 2016: 26). The tubes are straight (Fig. 13B) and therefore also of Yarrow type. The turbines, seen from above, had square steam uptakes, side by side (Fig. 13C). From these steam progressed to the condensers. A large amount of ammunition was seen in the stern area (Fig. 13D). It is of British 4-inch type, as were the brass cordite containers seen on the wreck. At the extreme north-east of the wreck the rudder sticks out as the final intact part of the wreck (Fig. 13E). Finally, a chain was seen hanging down to the seabed (Fig. 13F). There are in fact two present on the wreck. These may have been part of the towing yoke used while trying to save *Sparrowhawk*. The port side propeller is partially buried in the seabed (Fig. 13F, it is notched where circled in red).

Figure 13. Images from the ROV survey of the wreck of HMS *Sparrowhawk* (Innes McCartney/Sea War Museum Jutland).

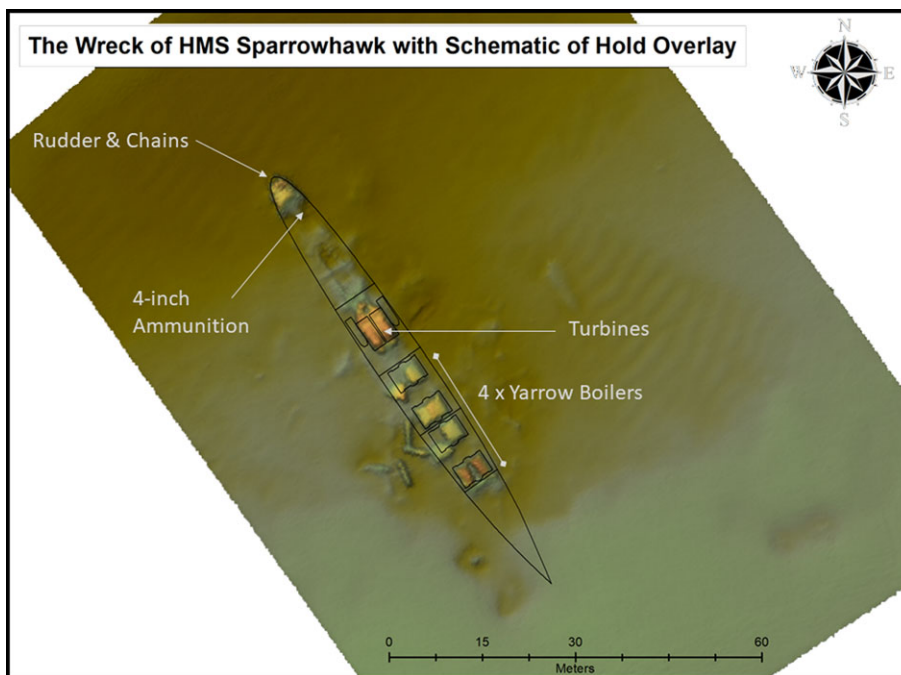
By a process of elimination this site has to be HMS *Sparrowhawk*. The established methodology of overlaying the class-correct hull plan over the

multibeam DTM (McCartney, 2016: 25) showed an exact match, proving the wreck was an *Acasta*-class destroyer (Fig. 14). No other *Acasta*-class destroyer was lost nearby that has not previously been found.

Figure 14. Multibeam plan view of the wreck of HMS *Sparrowhawk* with a schematic overlay of the hold layout of the *Acasta*-Class of destroyer (Innes McCartney/Sea War Museum Jutland).

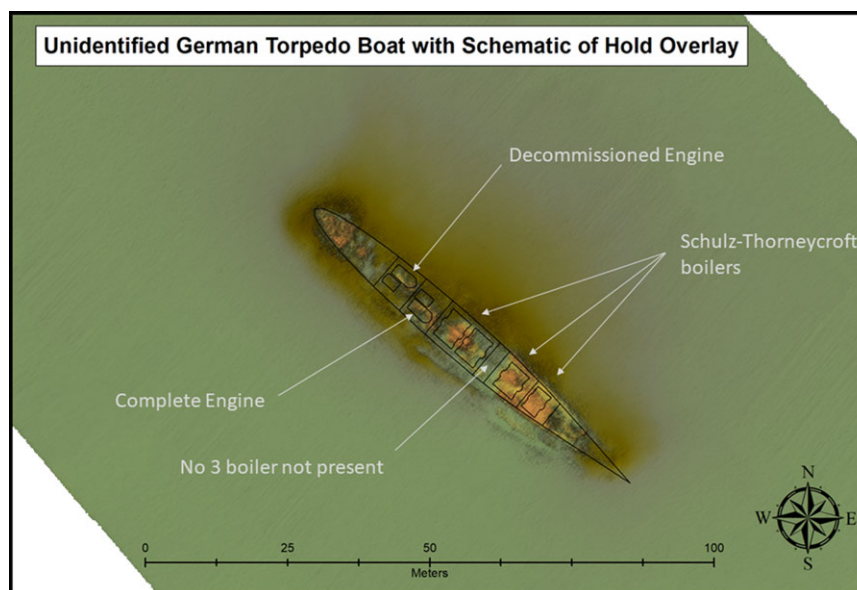
engines were laid out in the typical German fashion of the period, in two separate compartments, with the port side engine to the rear (McCartney, 2016: 24–25). The class particulars were checked against the class drawings and a schematic of the hold layout was made and overlaid on the DTM of the wreck-site (Fig. 15).

Figure 15. Multibeam plan view of the wreck of an unknown German-built Torpedo boat with a schematic overlay of the hold layout of the S138-class of German torpedo boat (Innes McCartney/Sea War Museum Jutland).

The overlay matches in most regards, with the engines and overall dimensions fitting perfectly. However, as can be seen on the DTM and on the ROV tape of the wreck, there are only three boilers present, with one appearing to be absent from the central boiler room. So in order for this to be *T-156*, or similar, some form of modification had to have taken place during the ship's life. At present, no information confirming this has been found. But it is plausible that during its conversion to a torpedo-recovery vessel a boiler was removed to make room for a hold, or similar. It is known that others of the S138-class were modified to take three boilers (Gröner, 1990: 173).
