FRICTION AND WEAR PERFORMANCE OF LIFEBOAT LAUNCH SLIPWAYS

A thesis submitted in partial fulfilment of the requirements of Bournemouth University for the degree of Doctor of Philosophy

July 2009

Bournemouth University In collaboration with the Engineering and Physical Sciences Research Council and the Royal National Lifeboat Institution

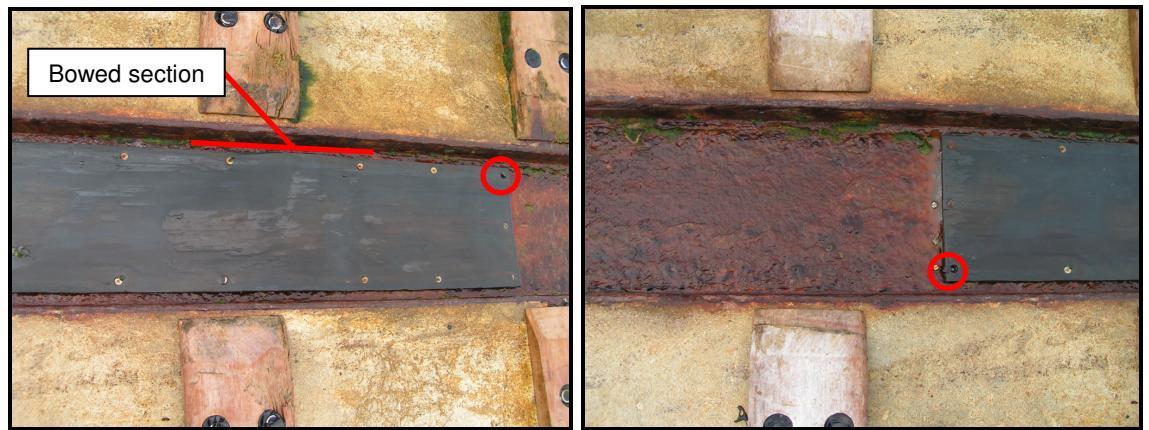
Fig. 3.25: Sennen Cove Slipway Inspection – Lower lined section
The low end of the slipway has a small section of composite below the image in fig. 3.25. This section exhibited little wear apart from a couple of missing bolts (ringed) but it did show a good degree of bowing (indicated) that is likely to be from expansion due to water absorbtion. This problem has not been observed on slipway stations fitted with the thicker 19mm composite panels and may be in part due to the lower lateral stiffness of the thinner 6mm sections used at Sennen Cove. This section of slipway is rarely used as it is below water during high tide when recovery is most commonly attempted.

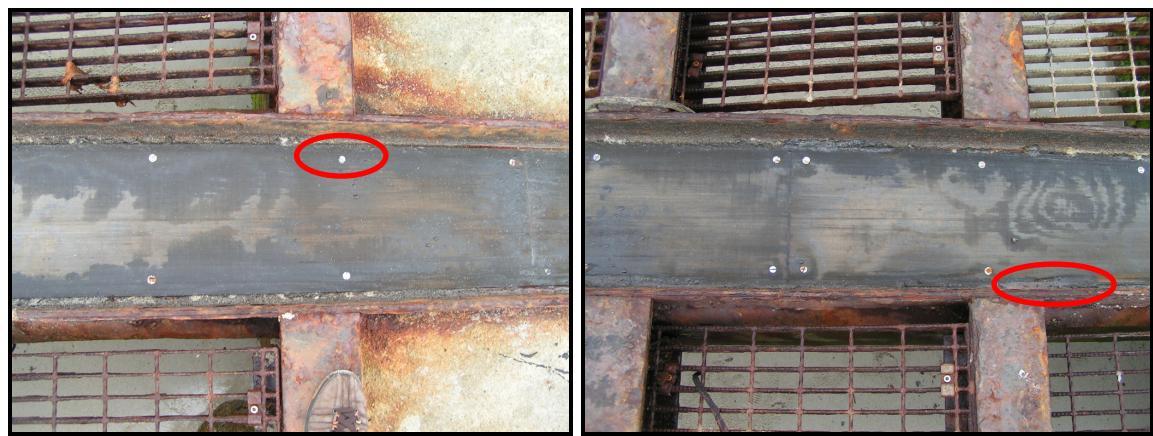
The second stage of slipway lining bears the weight of the lifeboat as it is drawn up the slipway by the winch. Again, this section is in relatively good condition with no prominent wear scar. The start of the slipway lining shows wear where an inclined section intended to smooth the step up from the unlined steel channel has worn away. Without this section the end of the slipway lining is beginning to wear in a similar fashion to the worn slipway panels observed at Selsey and Bembridge. The second slipway panel is almost unscathed with only some damage to one of the fixings observed. Wear on this section from the lifeboat keel is light and evenly distributed with the phenolic resin having worn away evenly in places to reveal the underlying jute fibre mesh in a similar way to the distributed plane sliding wear observed at Bembridge. This wear again represents the ideal case where contact is near planar and there are no stress concentrations present.

Fig. 3.27: Sennen Cove Slipway Inspection - Upper lined section, scoring and light panel edge wear

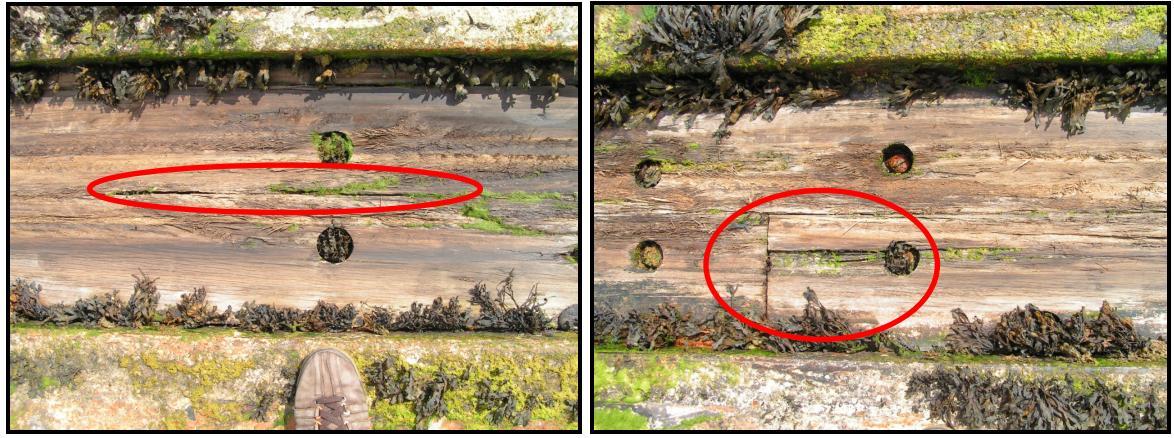
Fig. 3.35: The Lizard Slipway Inspection: Greenheart wood section

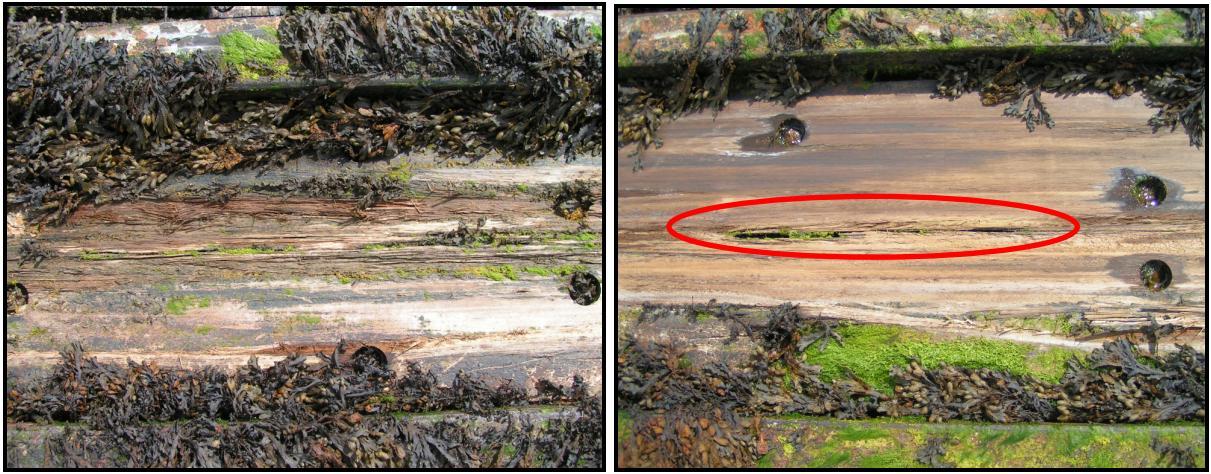
This section uses Greenheart treated wood as a bearing surface. Discussions with the crew indicate that there is a problem with high friction on this section of the slipway with the lifeboat exhibiting stick/slide characteristics as it is brought up the slipway. Seaweed and algae is left in place here as it acts as a natural lubricant and reduces the friction along the slipway. Wear on this section appears to be high, with the wood featuring cracks and heavy wear over the keel diameter.

Fig. 3.36: The Lizard Slipway Inspection: Greenheart wood section

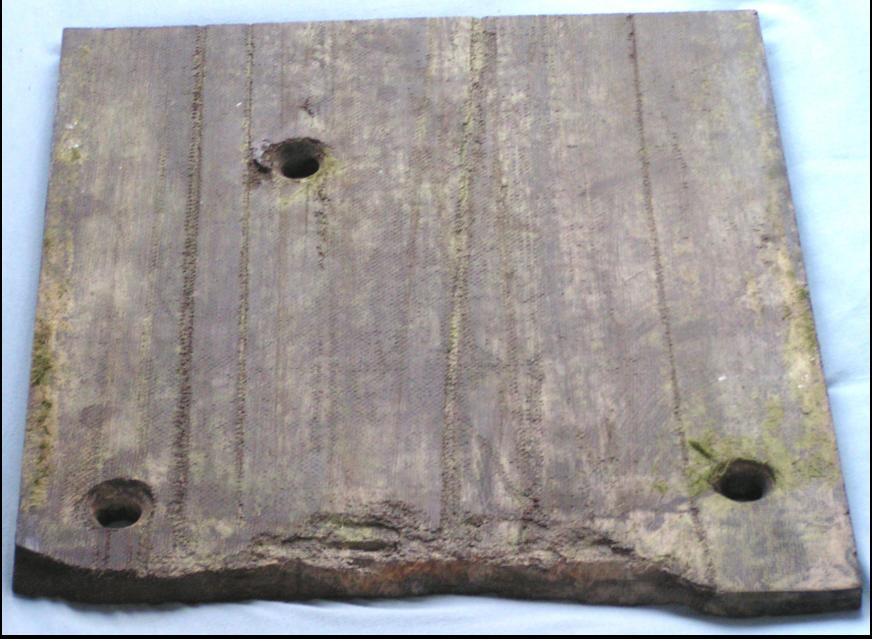
The recovered section shows three distinct wear types, the most obvious is the deep scores left in the panel as a result of gouging wear by a raised keel section or 3rd body trapped between the keel- composite slipway lining contact. The second wear type present on the recovered panel is the abrasive wear present at the panel end; this is thought to be a result of panel misalignment as similar wear on real life slipway linings is noted to be far more pronounced in panels exhibiting vertical misalignment with respect to their neighbours. The third type of wear present is termed plane sliding wear and represents the abrasive wear resulting from the distributed lifeboat load under plane sliding, this wear is very light and represents the idealised sliding scenario. Plane sliding wear is also observed on other slipway panels and is characterised by an even erosion of the phenolic resin bulk of the composite material exposing the jute fibres, this is visible on slipway panels as areas of lighter colour. Algae is also present in places which may have some effect on the local friction.

Fig. 3.41: Worn composite slipway section; Abrasive wear at the panel end is clearly visible, the deep scores running along the panel are the result of gouging wear from a protruding keel section or similar and the lighter sections show plane abrasive wear where the phenolic material has been abraded away to show the lighter underlying jute fibre matrix

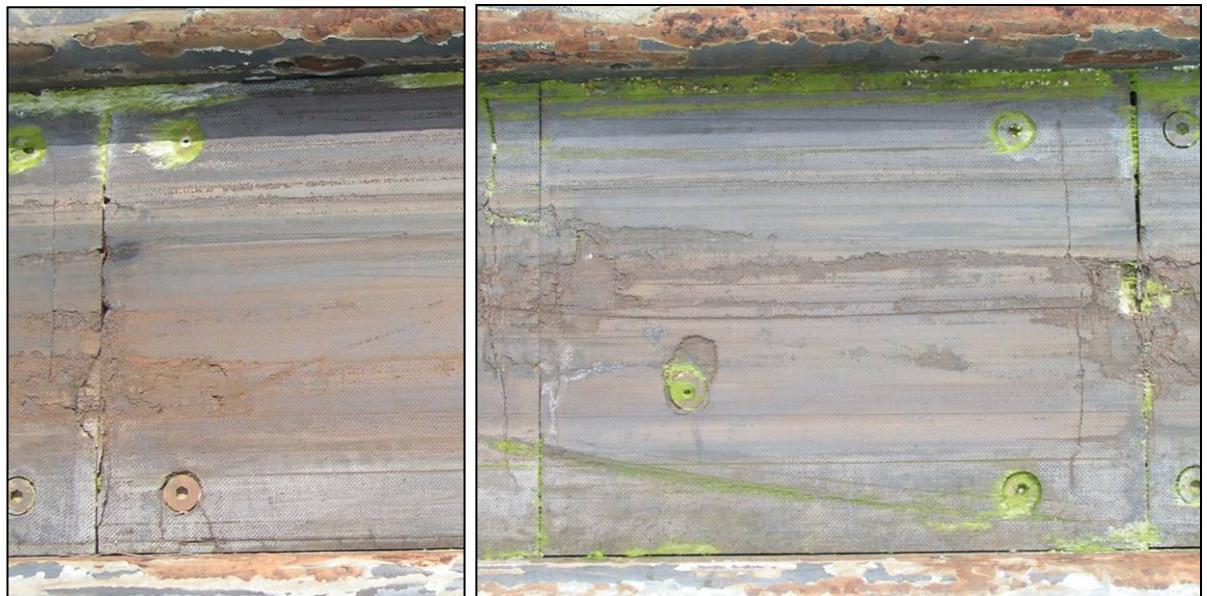
As in the recovered worn slipway panel it is noted that wear is most apparent at the ends of slipway panels. It is also noted that the panels exhibiting the most severe end wear show significant height misalignment with the adjacent panel. It is thought that this will have a significant effect on the stress distribution over the panel and that this may be a major contributor to wear. To further investigate this effect a panel alignment survey is conducted as described later in this section.

Fig. 3.42: Tenby Slipway Inspection: Panel End Wear

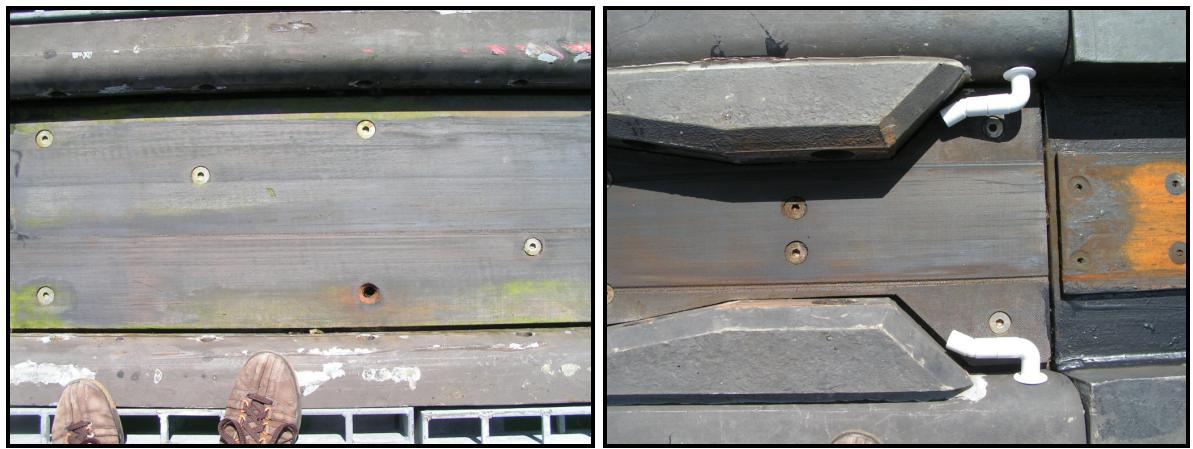
Plane abrasive wear is noted on the well aligned slipway panels, this is characterised by a noticeable smoothing effect along the centre of the panel where the keel passes. The wear volume is very small and this can be seen to represent the wear that would be expected from the ideally aligned contact case.

Fig. 3.54: Padstow Slipway Inspection: plane abrasive wear

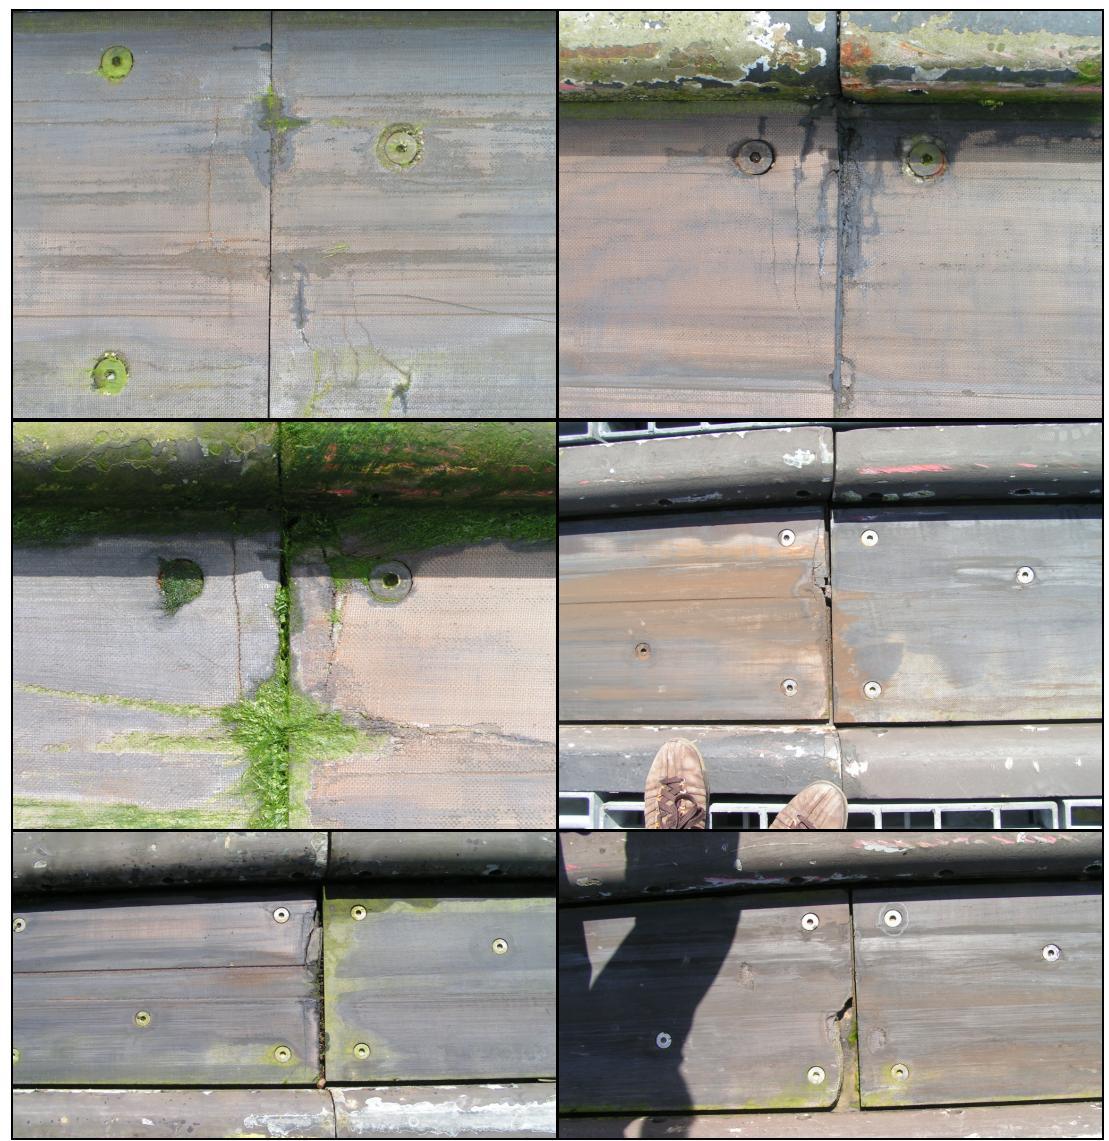
Panel end stresses can also result in the formation of deep cracks in the phenolic resin of the composite, these can progress to form panel 'islands' where the phenolic resin has cracked but the jute fibre mesh retains the cracked section in place. The jute fibres eventually fail leaving the cracked material to break loose of the main panel, this results in distinctive large scale missing 'chunks' on the panel ends. This effect is noted to be more pronounced on misaligned panels and is suspected to be caused by the same stress concentration effects. Fig. 3.56 shows this process at different progressions on different panels.

Fig. 3.56: Cracking panel end wear: wear scar progression: *Initially high contact stresses due to panel misalignment cause a surface crack to develop in the phenolic resin bulk of the composite, this then develops until it reaches the other side of the slipway panel, at this point the cracked area is held in place solely by the jute fibre matrix. The jute fibres subsequently fail, allowing a large section of slipway panel to break free*

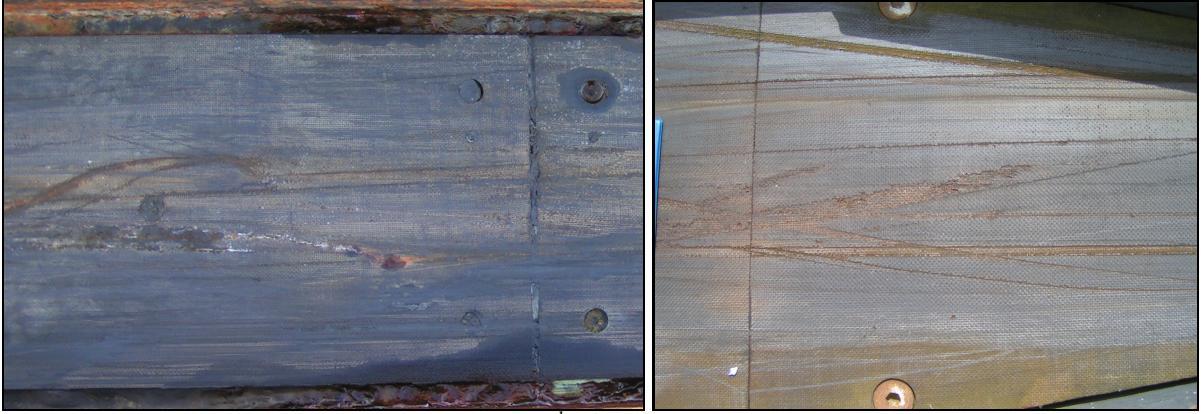
The absence of other significant gouging wear scars on the Tamar slipways and general slipway friction performance better than that expected from ploughing indicate that once the prototype Tamar keel was repaired no other major gouging wear was encountered here. This is supported by the other slipway inspections at Selsey and Bembridge where some light gouging wear is present, though not to the severity that would be expected for the large number of launches and recoveries conducted on these slipways. This supports the proposition that significant, persistent keel damage not a common occurrence on slipways and raises the possibility that the lighter gouging wear scars on Selsey and Bembridge slipways are caused by 3rd party wear particles trapped between the contact. This is supported by the presence of diagonal and wavy gouging scars on panels, if the scars were caused solely by keel imperfections these would be expected to be in straight lines as the lifeboat does not move laterally as it proceeds along the slipway, this is shown in fig. 3.59 below:

Fig. 3.59: 3rd body gouging wear

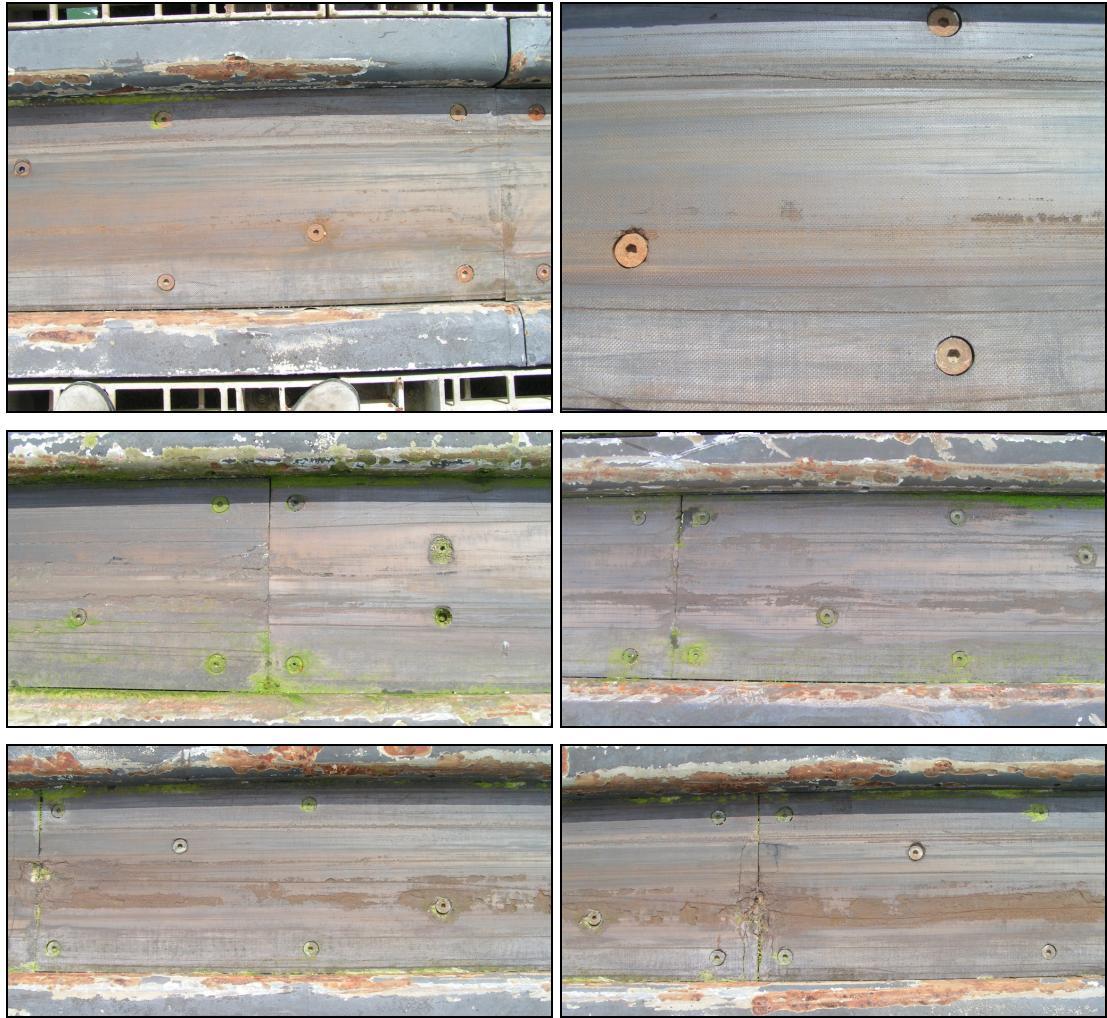
A further wear mechanism noted is the incidence of delamination, here the upper layer of the composite has separated and worn away leaving an uneven bearing surface. This kind of wear is particularly noted at Tenby. The progression of delamination wear is shown in fig. 3.61. Here the wear is shown to develop initially as small pits the depth of a composite layer, before the pits widen and join to form large areas of delamination along the slipway.

Fig. 3.61: Delamination wear: wear scar progression

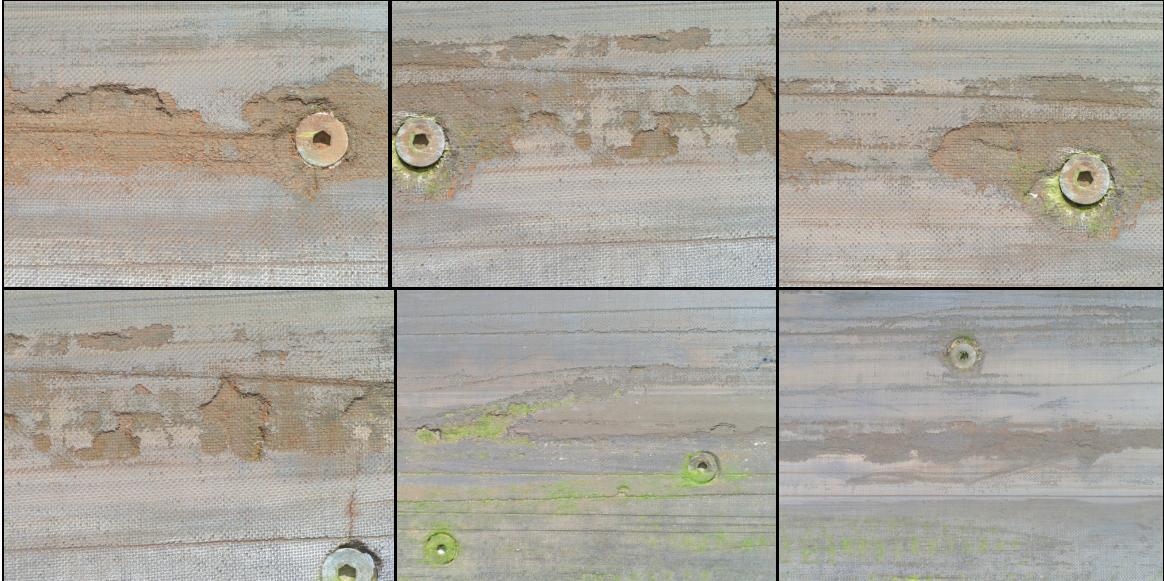
Fig. 3.62: Delamination wear: detail

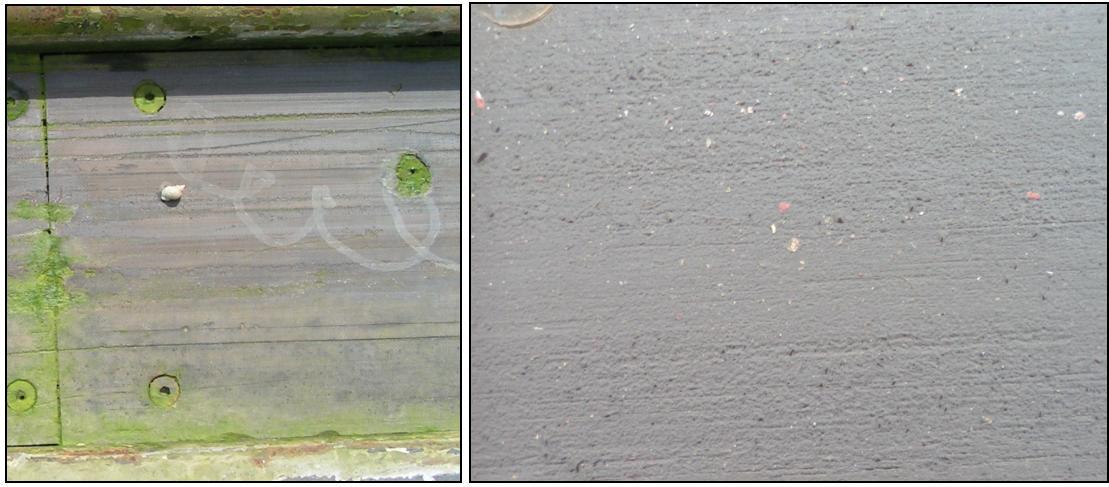
Embedded debris is noted at Selsey slipway, conversations with the coxswain indicate that this is likely to be animal shells, this is confirmed by observation of snails and snail trails on slipway panels.

Fig. 3.63: Embedded Debris

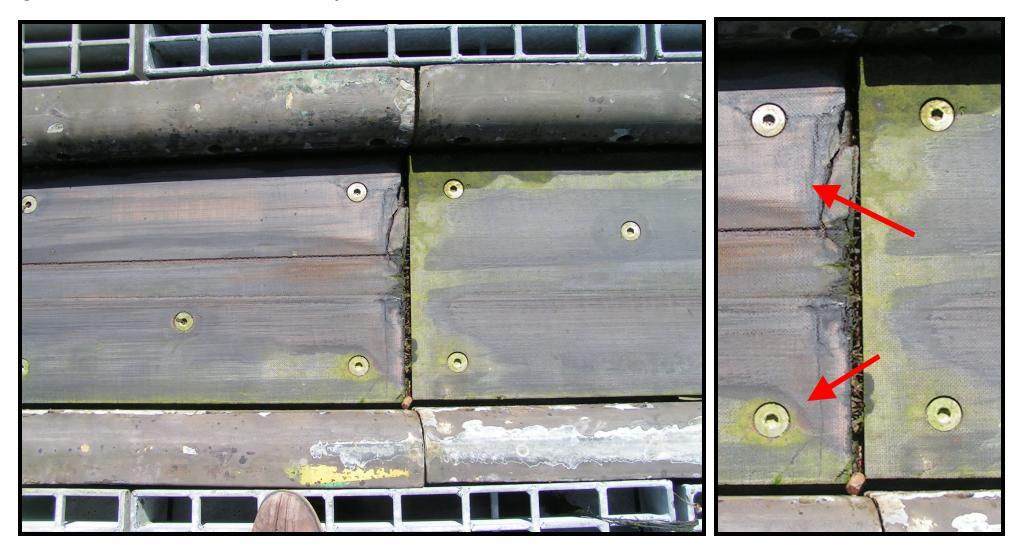
Fig 9.11: Worn Panel Failure Criteria - Islands shown on slipway panels from Padstow

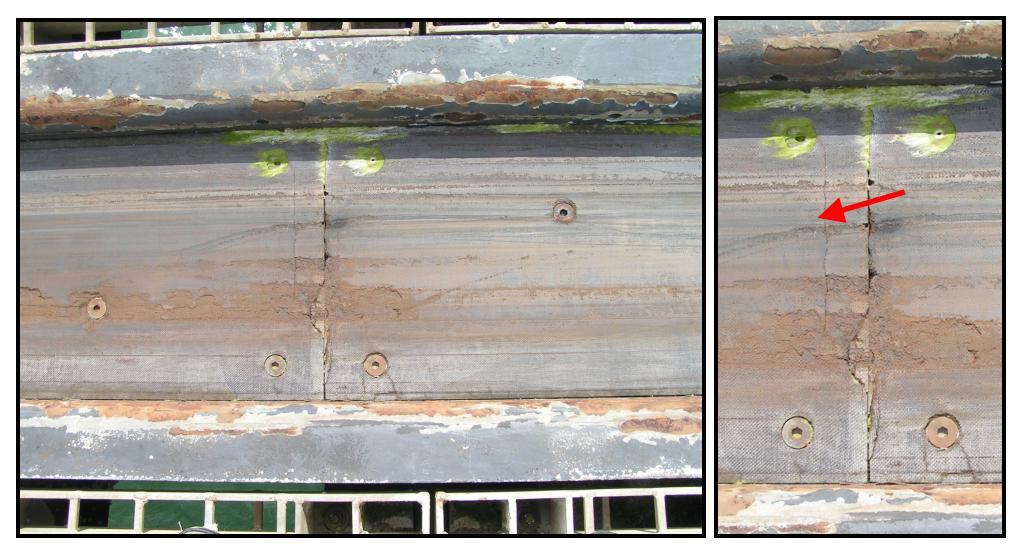
Fig 9.12: Worn Panel Failure Criteria - Islands shown on slipway panels from Tenby

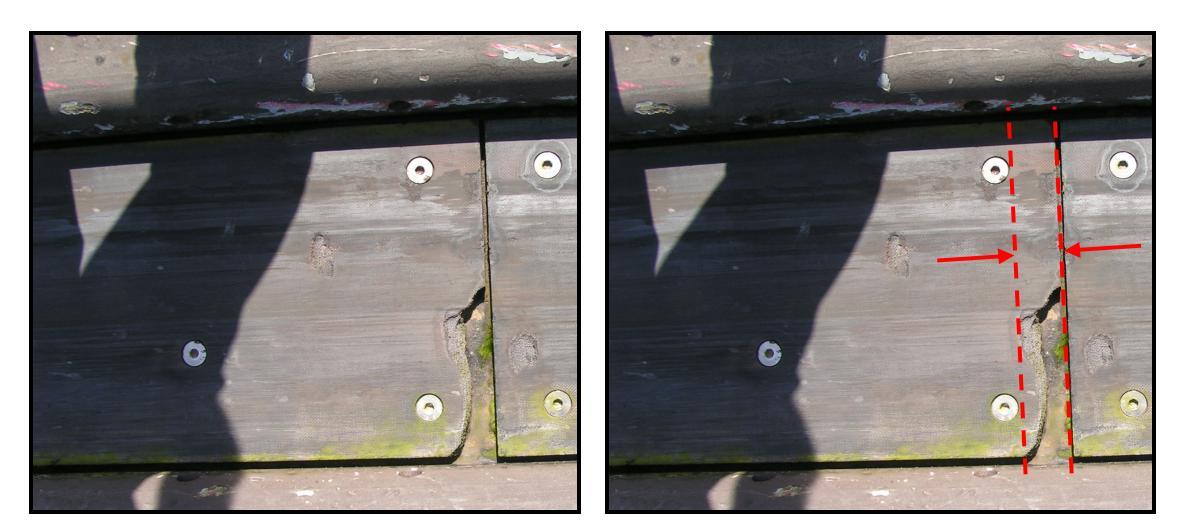
Fig 9.13: Worn Panel Failure Criteria - Uneven panel end wear from Padstow
