Wear Mechanisms applied to Lifeboat Slipway Launches

B. Thomas^{*a}, M. Hadfield^a, S. Austen^b

Sustainable Product Engineering Research Centre,
Bournemouth University,
UK

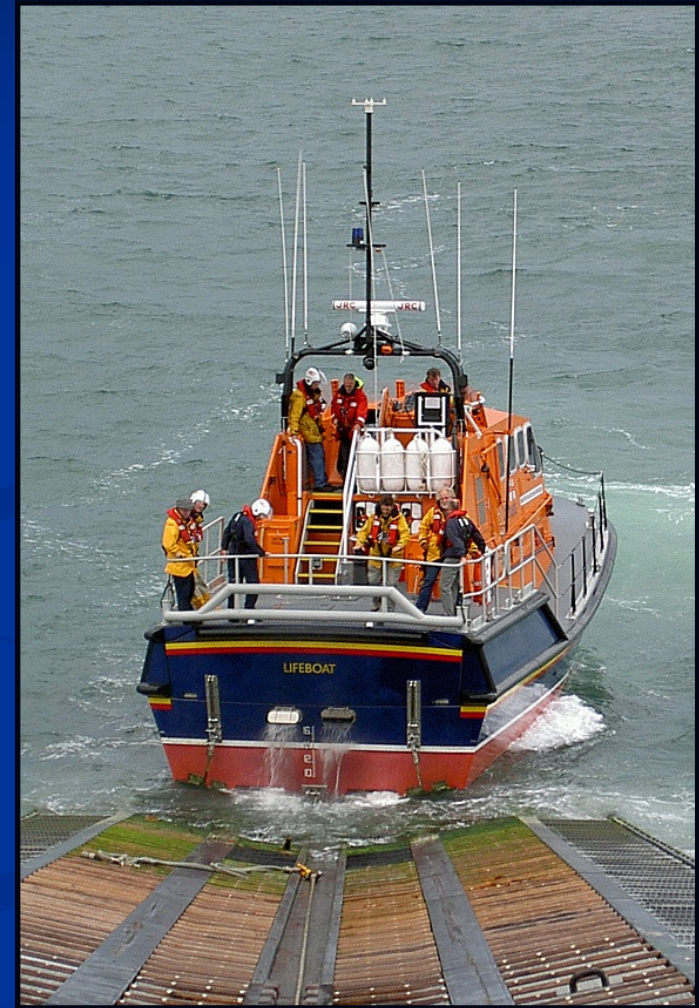
Tamar Class Lifeboat

- The Tamar slip-launched lifeboat is designed as a replacement to the Tyne class lifeboat. It is significantly larger and heavier than the Tyne and this has meant new slipways and boathouses have had to be built to accommodate it.
- The Tamar currently operates from new boathouses and slipways at Tenby, Padstow and Cromer

Slip-launched Lifeboats	Tyne	Tamar
Year Introduced	1982	2006
Length	14.3m	16m
Beam	4.48m	5m
Draught	1.26m	1.35m
Speed	17.6 knots	25 knots
Displacement	26 - 27 tonnes	~ 35 tonnes
Construction	Steel	FRP
Range	240n. miles	250n. miles
Crew	7	6

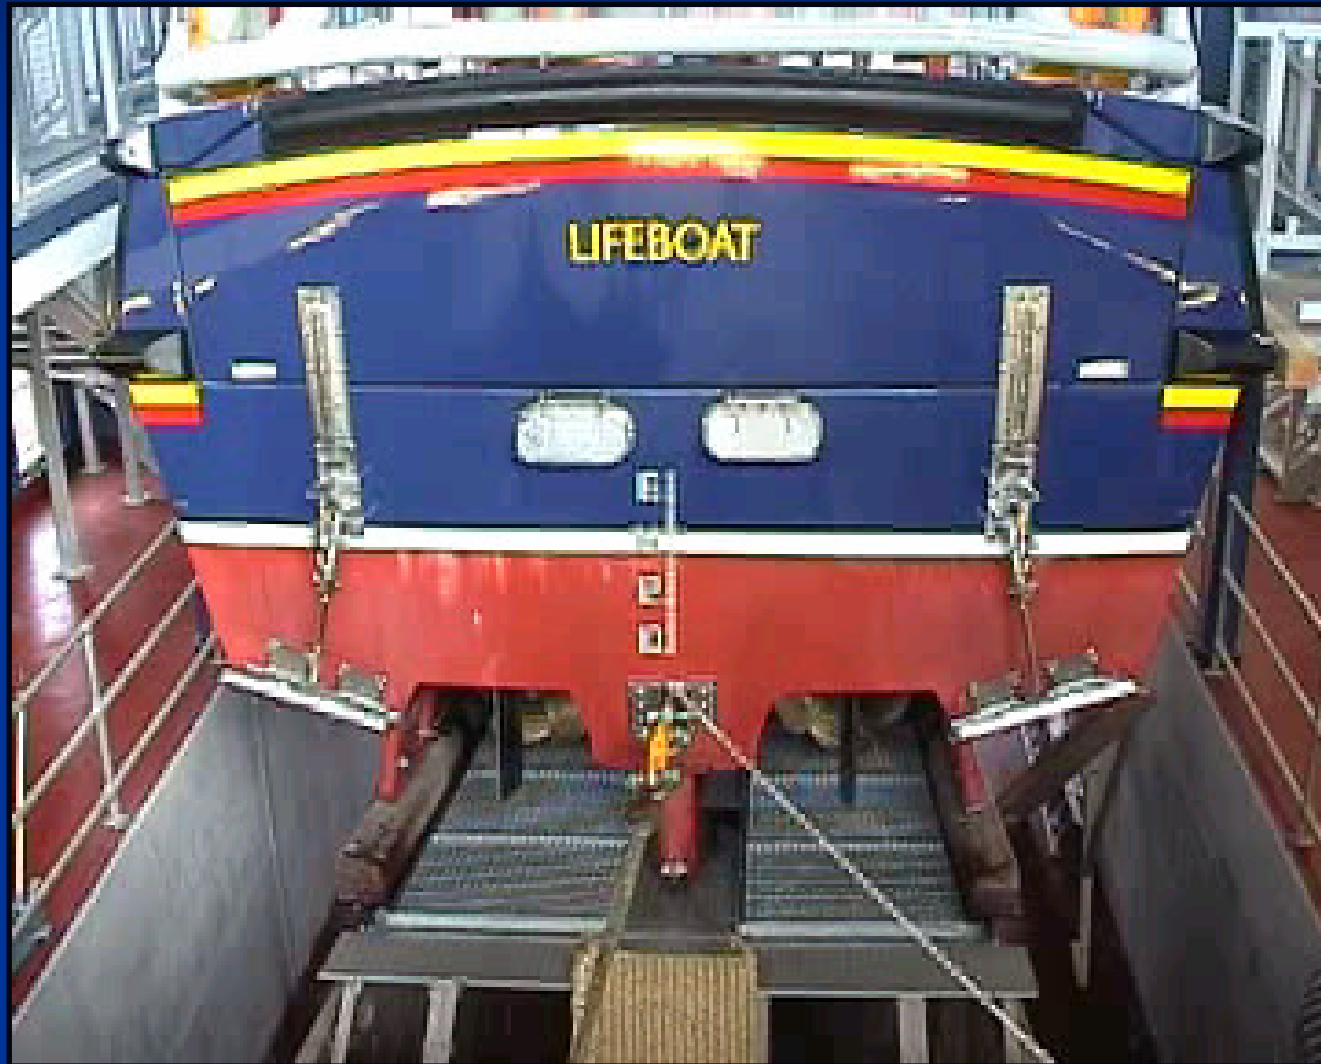
Lifeboat Slipway Launch

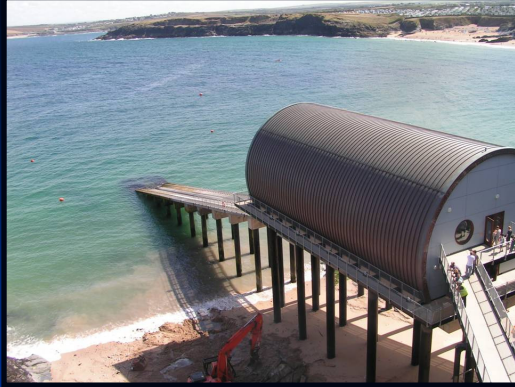
Typical Slipway - Padstow

- Padstow has recently received a new boathouse in order to accommodate the new Tamar class slip-launched lifeboat
- The slipway layout is typical of the next generation boathouses and slipways being built for the Tamar
- The slipway consists of an upper section of steel rollers and a lower section lined with low-friction 19mm thick Jute/Graphite infused Phenolic resin Composite panels

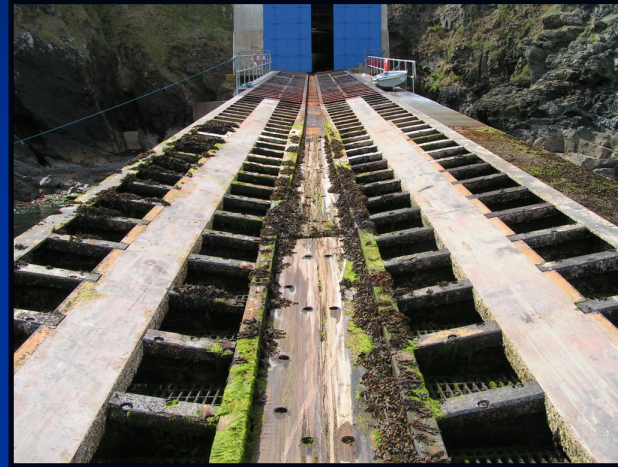
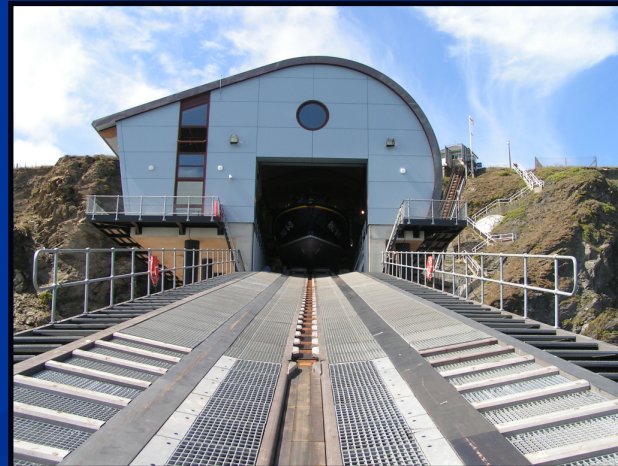
Jute/Graphite Infused Phenolic Resin Composite

- Weather Treated Wood – Traditional
c.1850
- Nickel/Chromium carbide coated Steel
– c.1980
- Jute/Graphite Infused Phenolic Resin Composite – c.1996

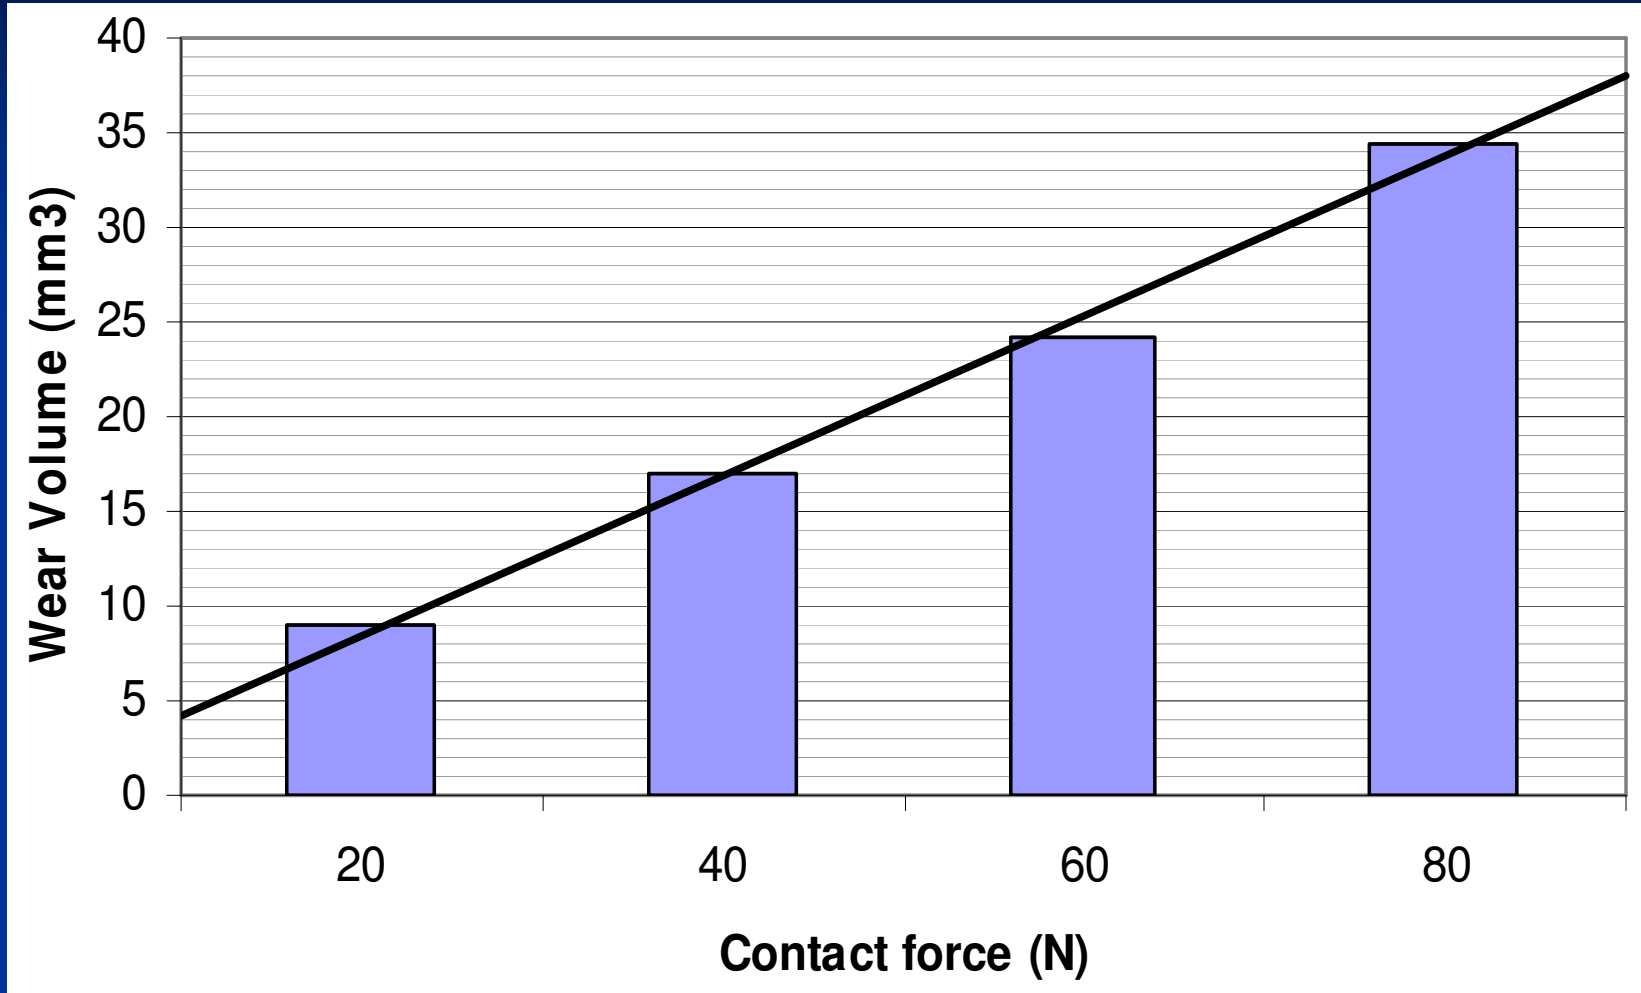
TE92 Jute/Phenolic Composite: Wear Volume vs. Contact Pressure

- Under ideal conditions the wear coefficients between slipway panels and lifeboat keel are not sufficient to cause failure during the expected 2-year lifespan of the panel.

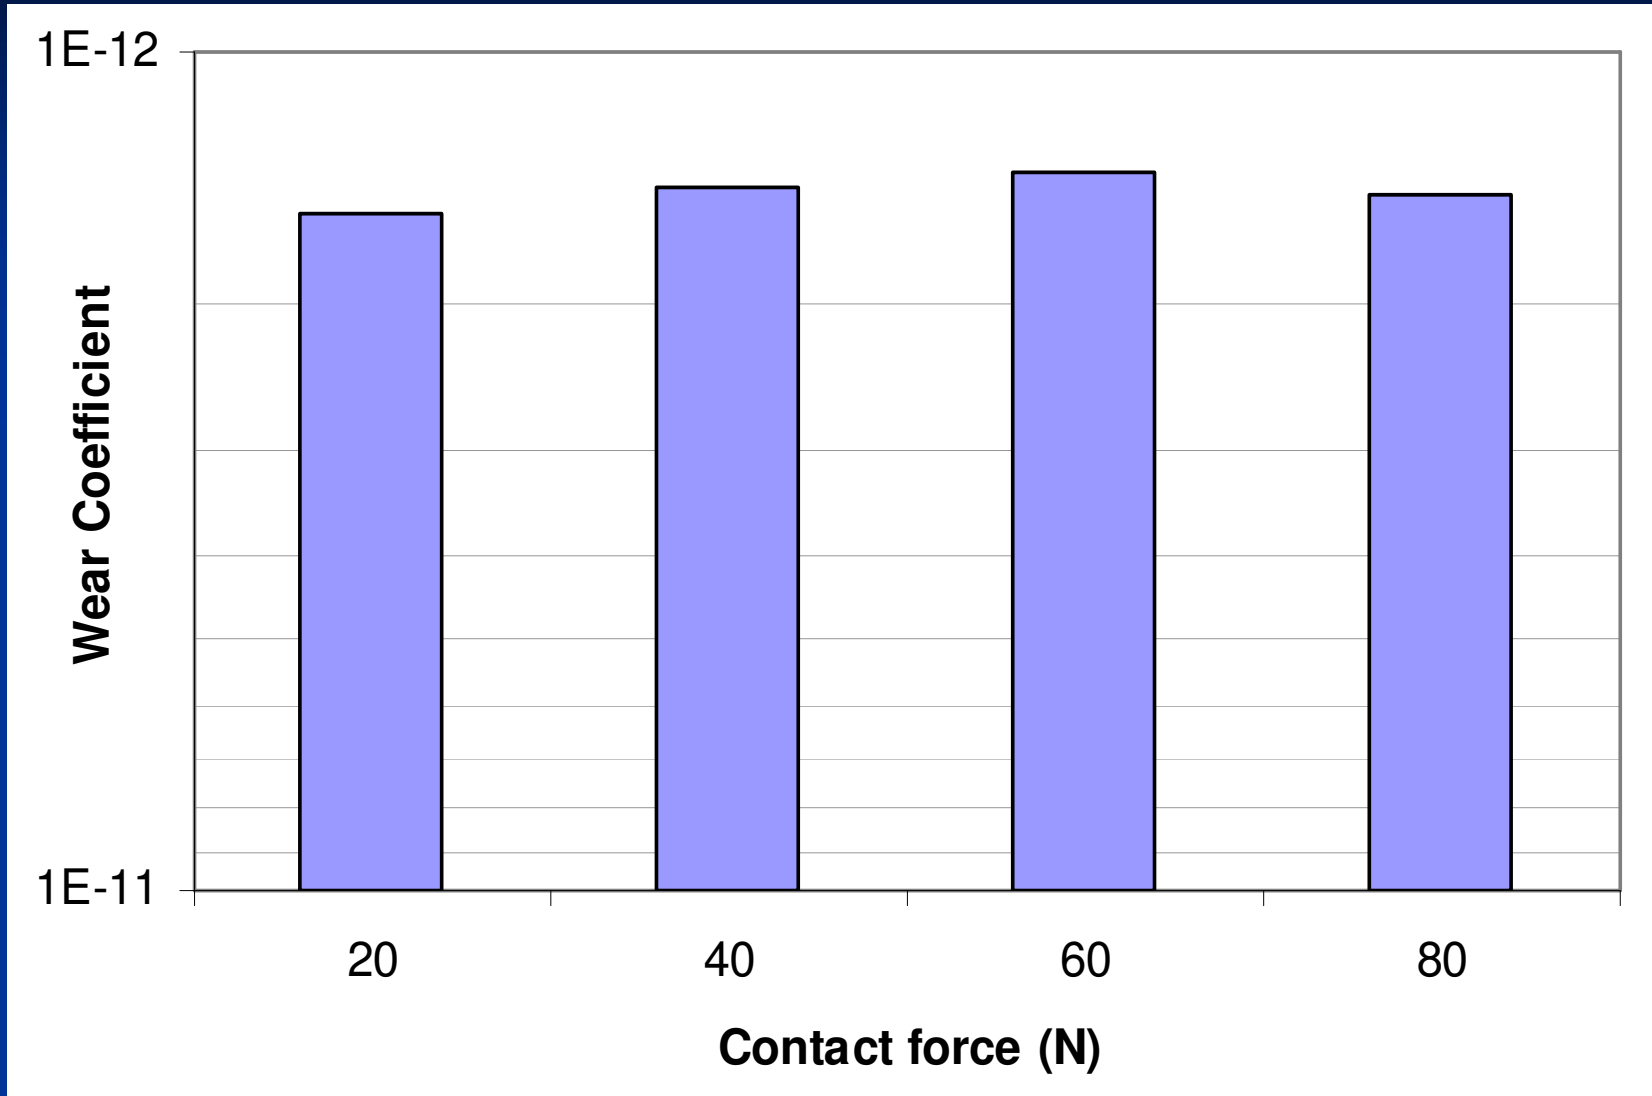
TE92 Jute/Phenolic Composite: Wear Coefficient vs. Contact Pressure

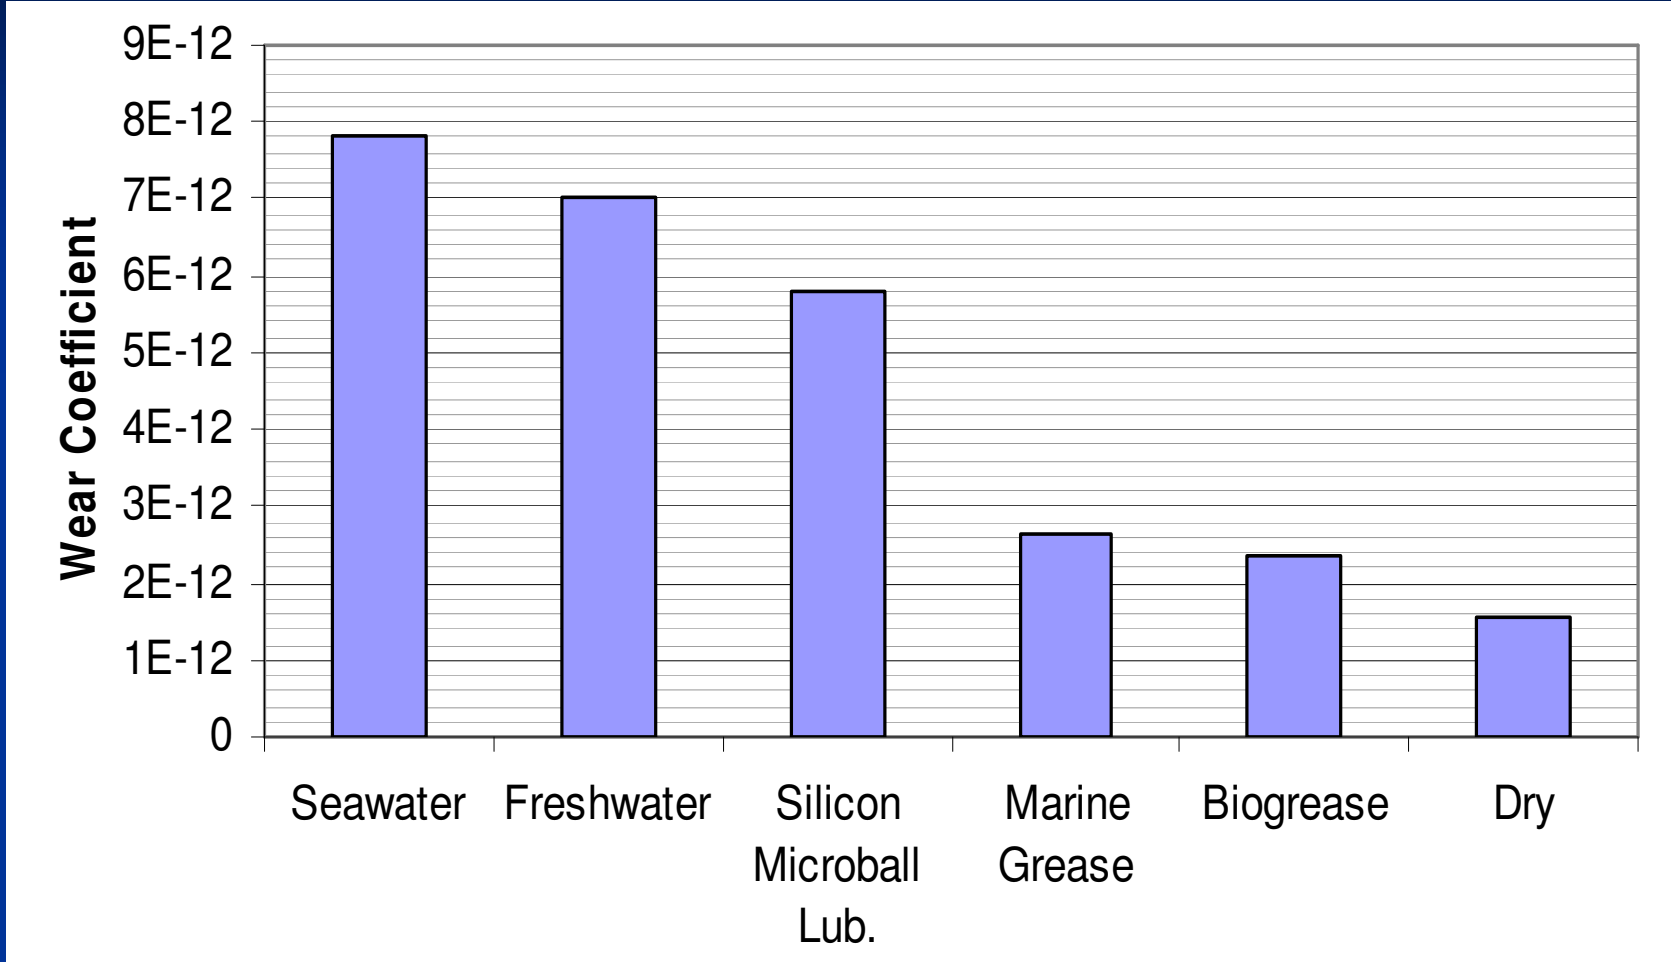
TE92 Jute/Phenolic Composite: Wear Coefficient vs. Lubricant Regime

- This increase in wear due to stress concentrations is sufficient to explain the high wear observed at Tenby and Padstow.
- The use of lubricants along the slipway should again have little effect under ideal conditions according to the test data. However, with panel misalignment included the choice of lubricant may become more significant.

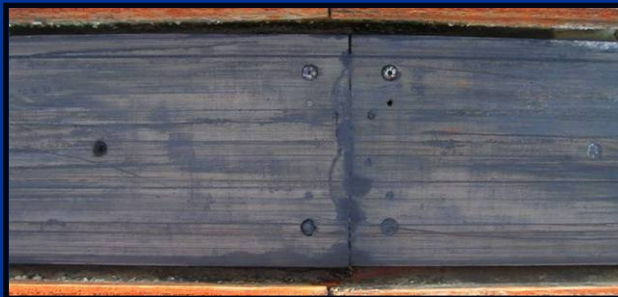
Bembridge

- Slipways were examined at Selsey, Tenby, Swanage, Padstow, Bembridge, Sennen Cove and The Lizard
- Jute/Phenolic composite sections at Selsey, Bembridge, Padstow, Tenby and Sennen Cove were all found to have similar wear patterns

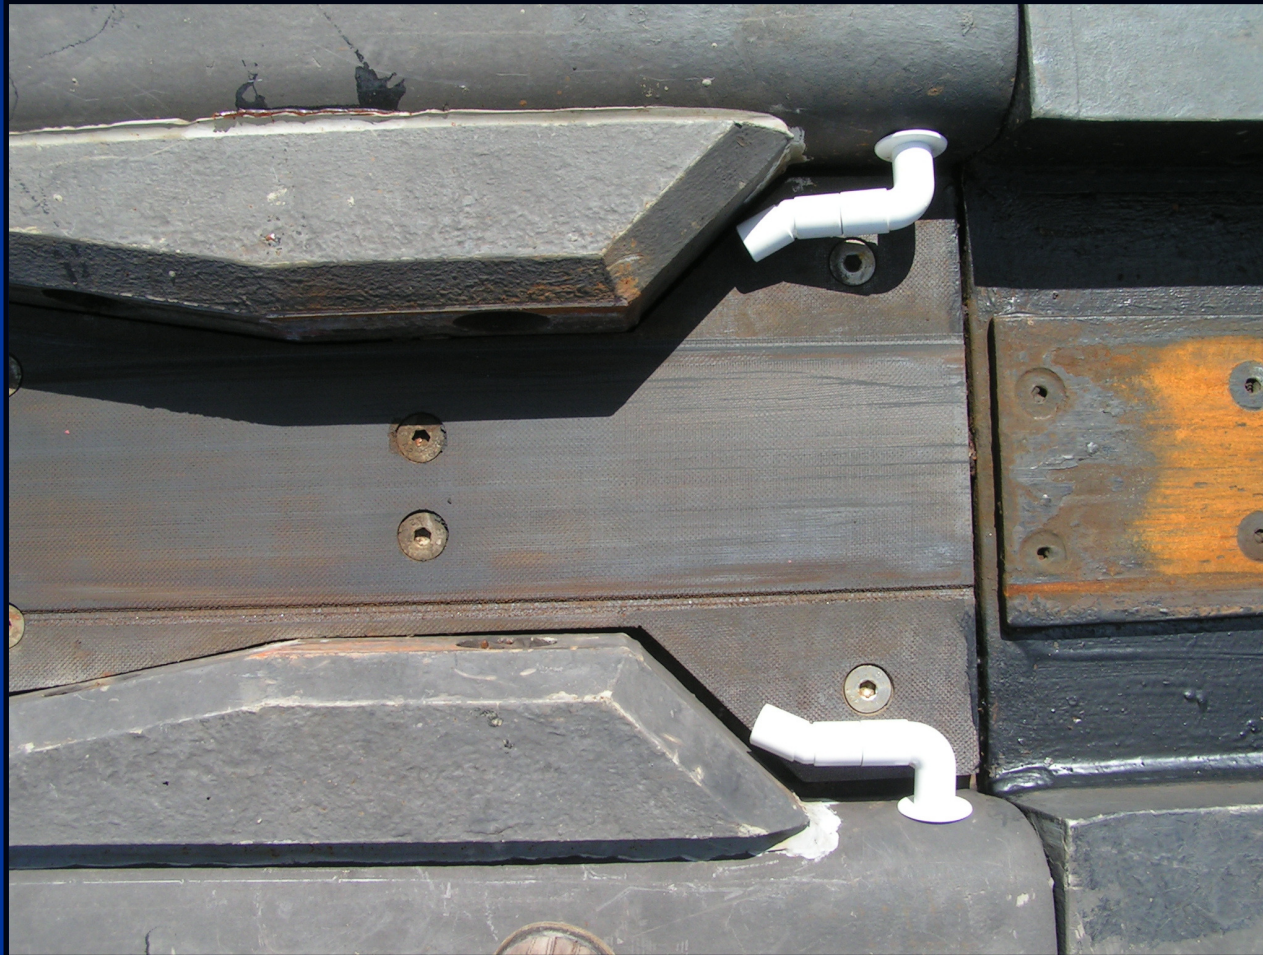
Water Jet Adoption - Padstow
