*Sustainable design and durability of  
domestic micro combined heat and  
power scroll expander systems*

*Thesis submitted in a partial fulfilment of the  
requirements of Bournemouth University for  
the degree of Doctor of Philosophy*

*by Iakovos Tzanakis*

*Bournemouth University  
in collaboration with the  
Energetix Group Ltd.*

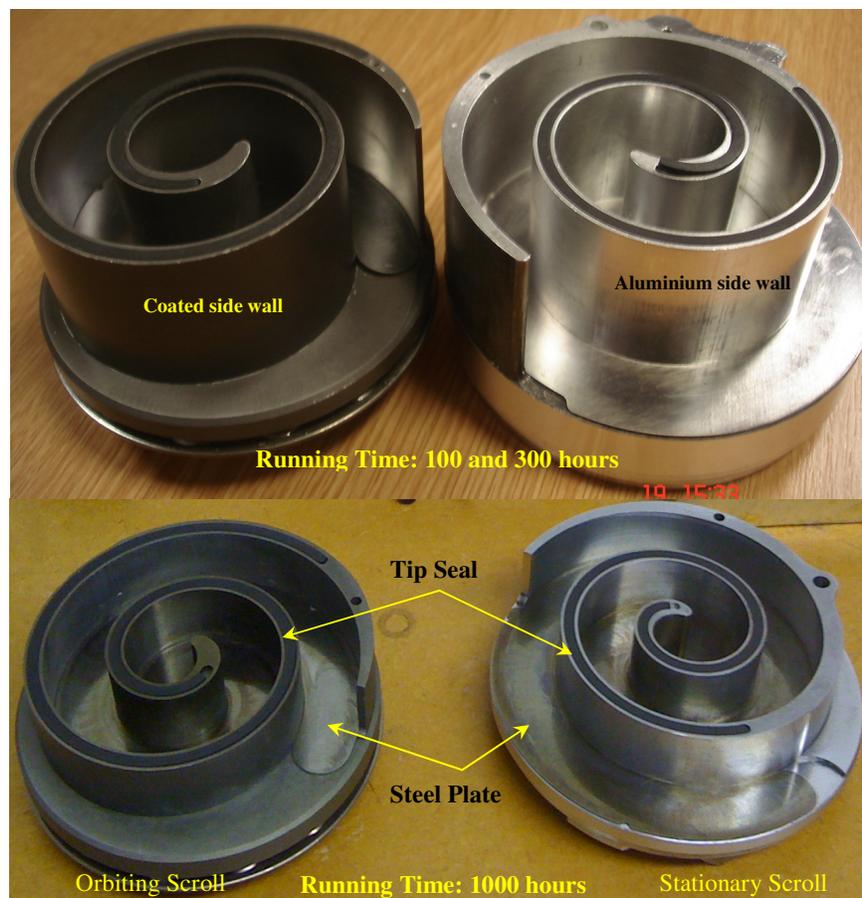
**Figure 13: Main parts of the scroll expander used for tribological tests**

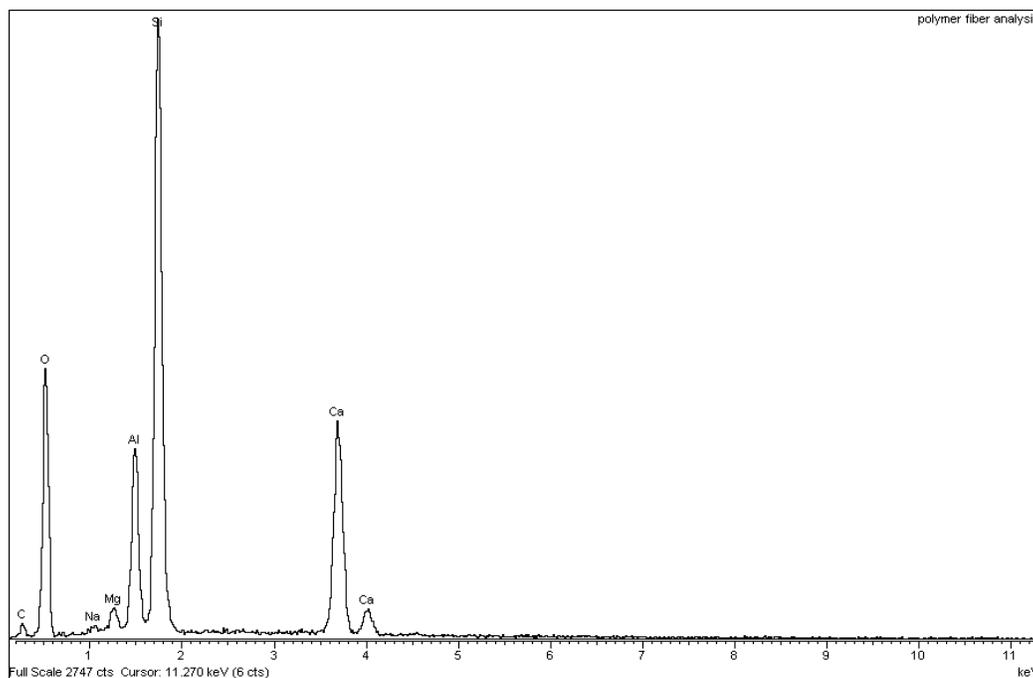
**Figure 16: EPMA analysis of isolated fibres within the matrix of the fluoroelastomer tip seal**

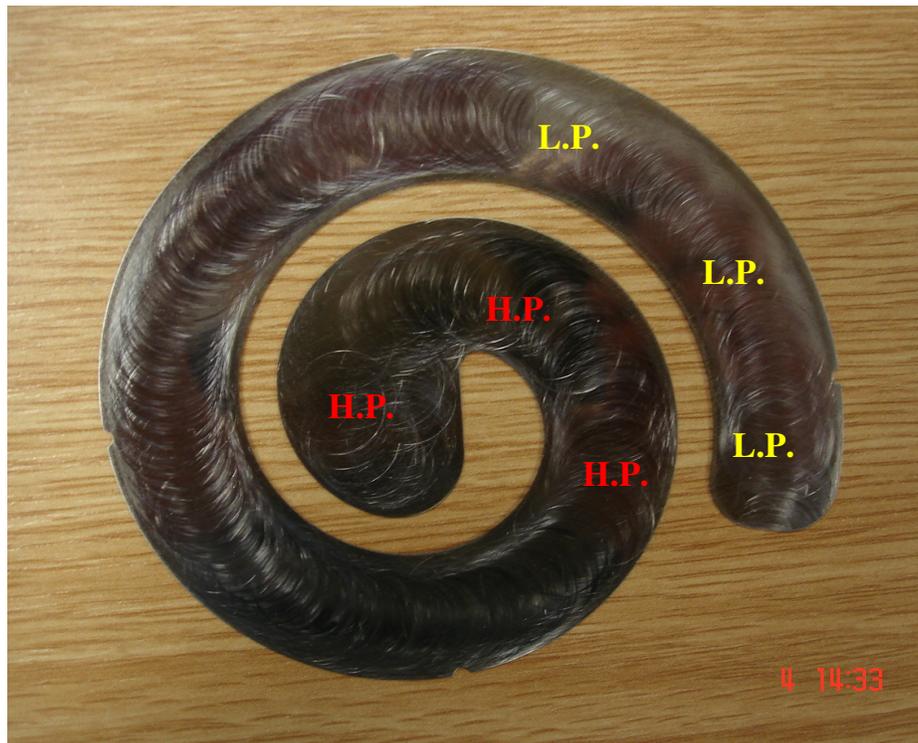
**Figure 17: Circular wear marks on the high and low pressure regions of the scroll's steel plate**

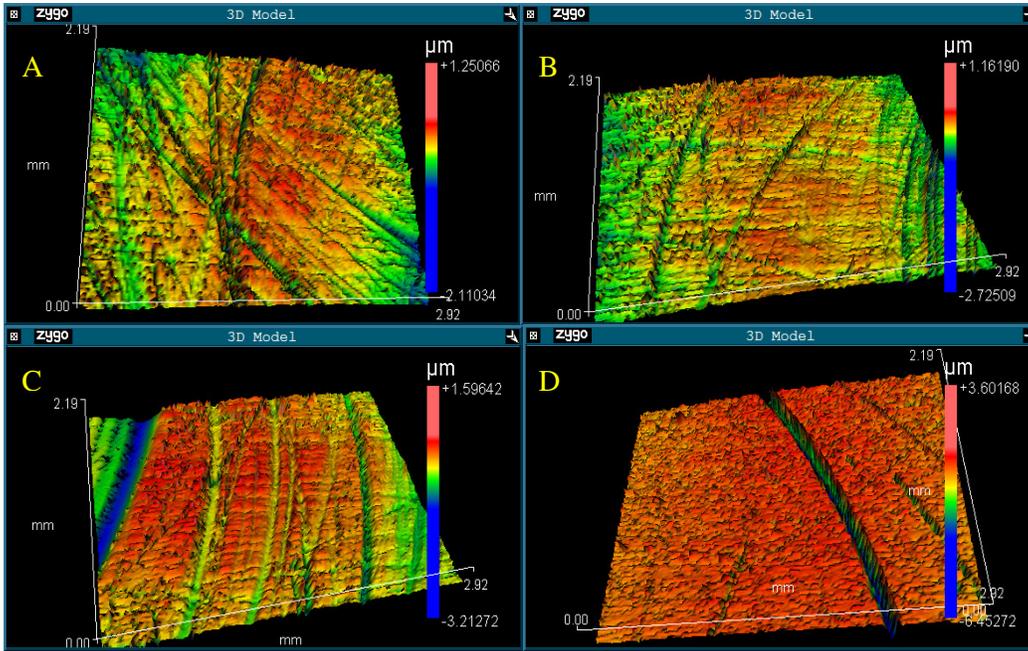
**Figure 18: Different wear regions across the scroll's steel plate after 300 hours of continuous operation: A&B) Low pressure region, average depth of the wear marks 0.5-1  $\mu\text{m}$ . C&D) High pressure region average depth of the wear marks 2-4  $\mu\text{m}$**

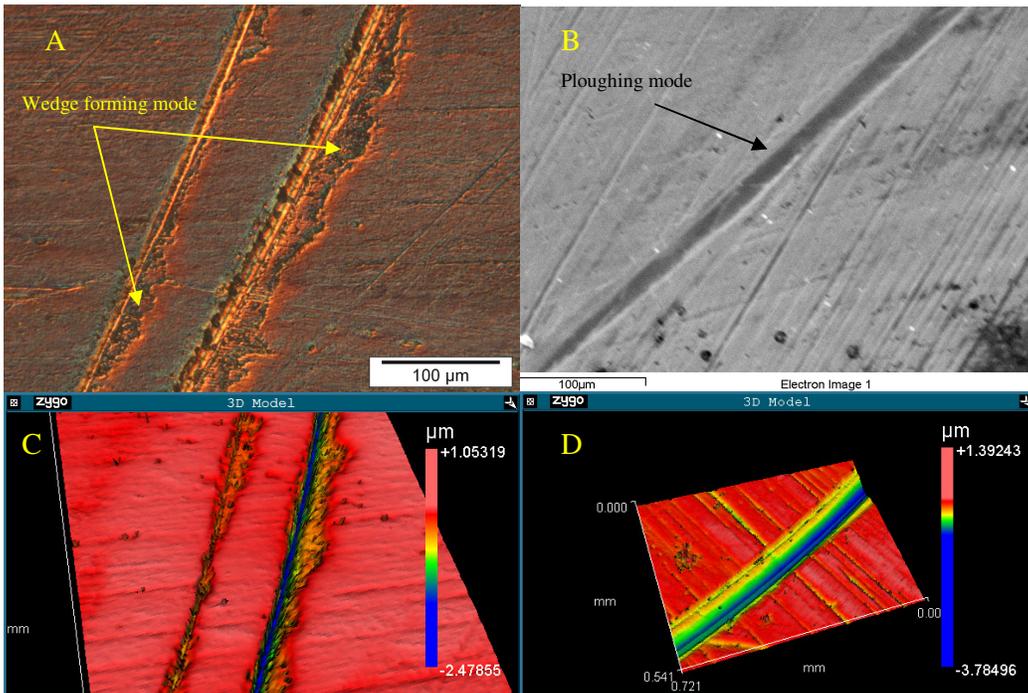
**Figure 19: The different wear modes formed by two-body abrasive wear on the 1000 working hours scroll expander A-C) Wedge forming mechanism B-D) Ploughing wear mode**

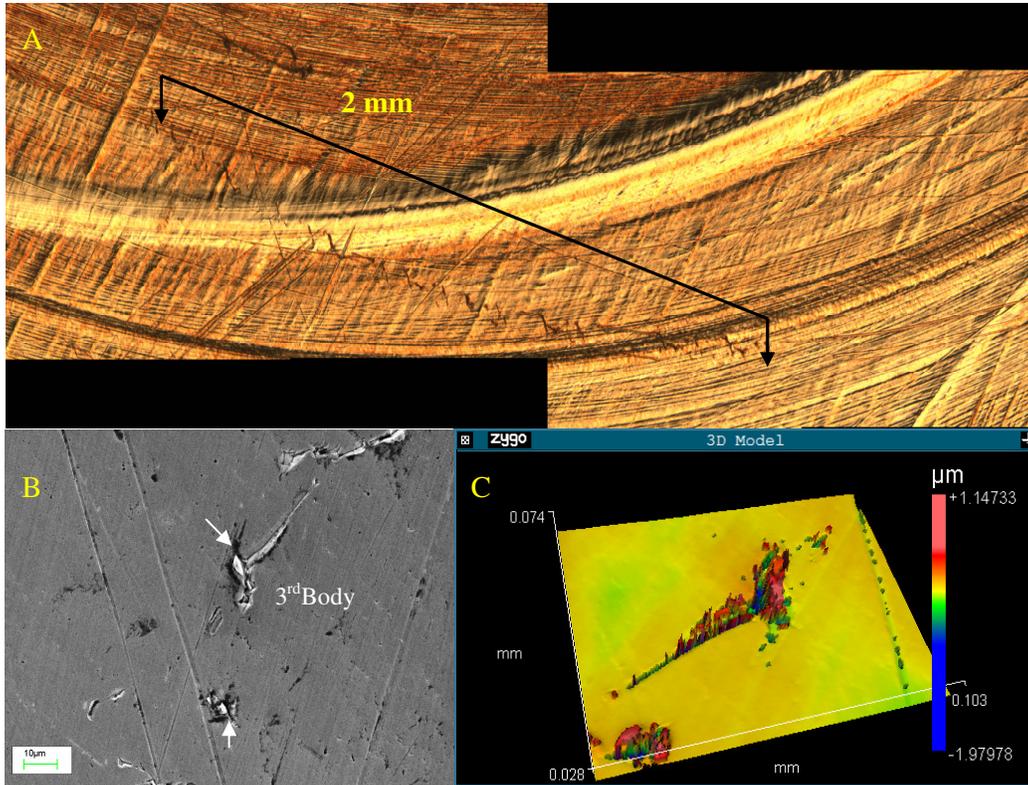
**Figure 20: A) Overview of the river marks formed across the steel plate B) A close up of an individual river mark C) Surface profile of the river marks**

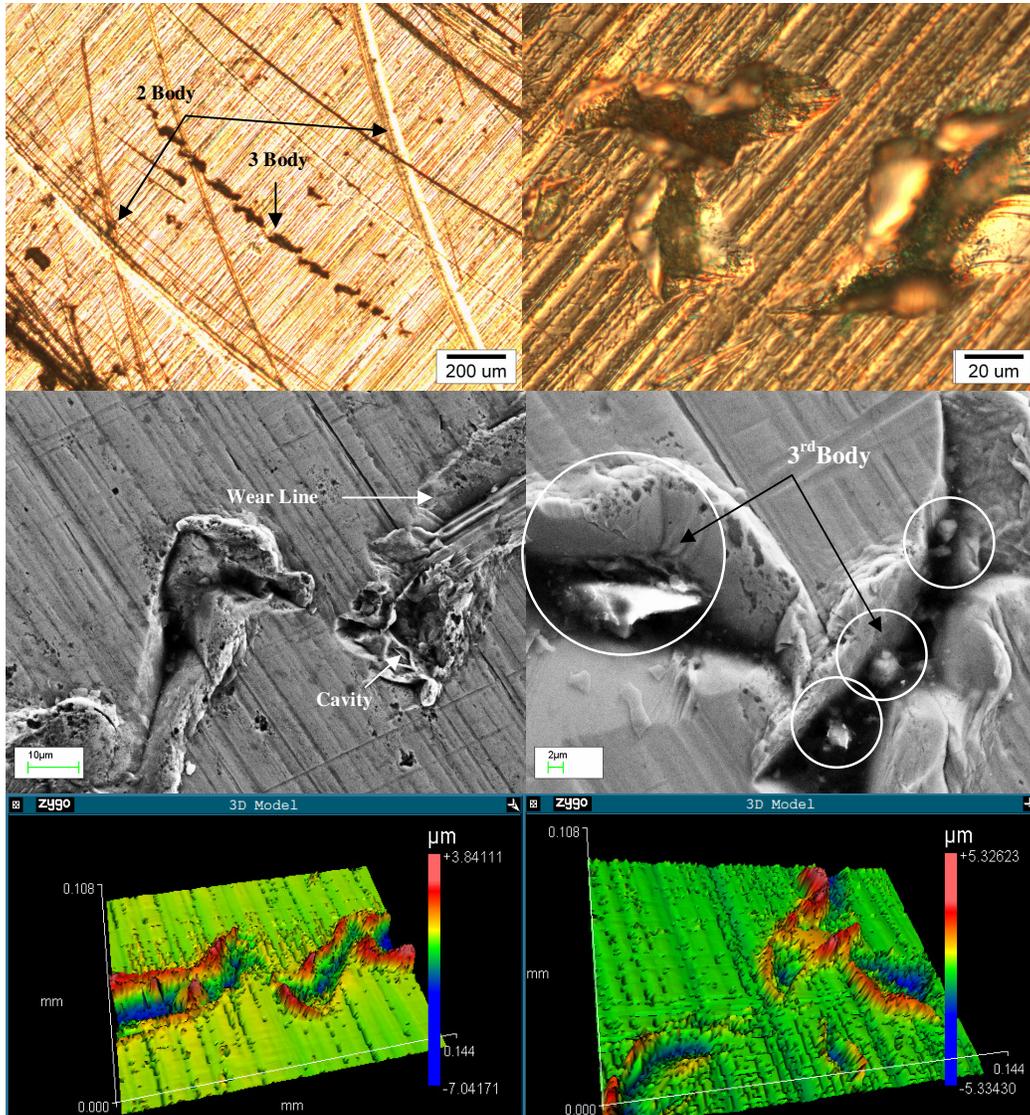
**Figure 21: Two different groups A&B with accumulated three-body wear marks found across the high pressure regions of the scroll's steel plate. The wear marks initially detected with the optical microscope, analysed in detail with the SEM and finally their morphology is thoroughly investigated by ZYGO interferometer.**

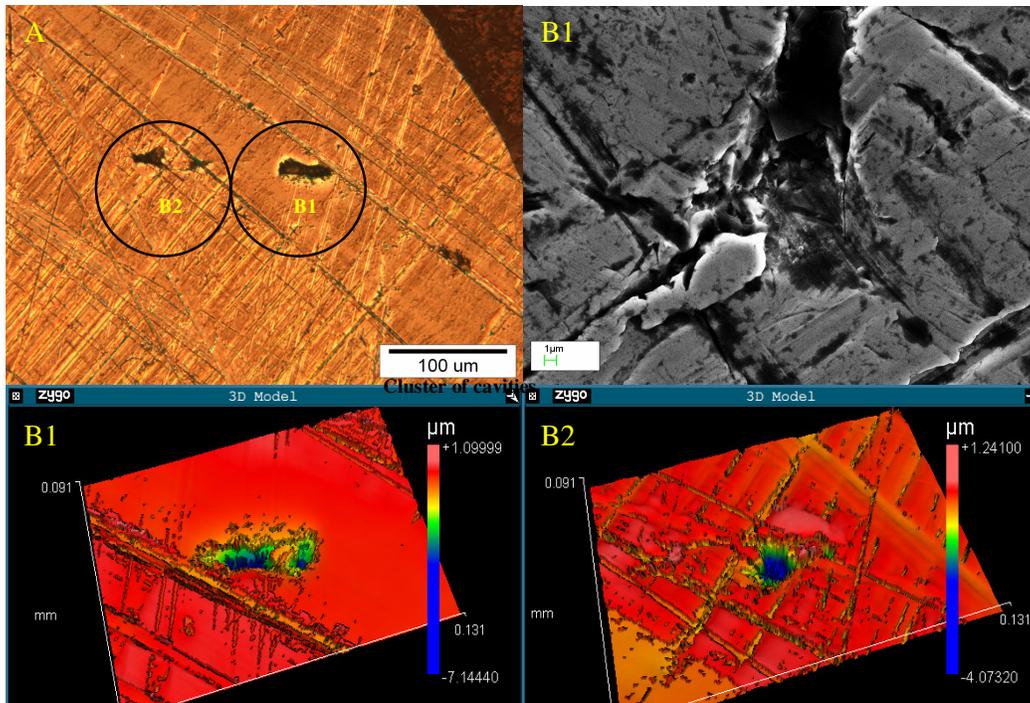
**Figure 24: Cavities across the surface of the steel plate of the SE<sub>300</sub>. A) Cluster of small size cavities B) SEM micrograph of the B1 cavity. B1-B2) Isolated cavities surface profile taken by ZYGO interferometer microscope**

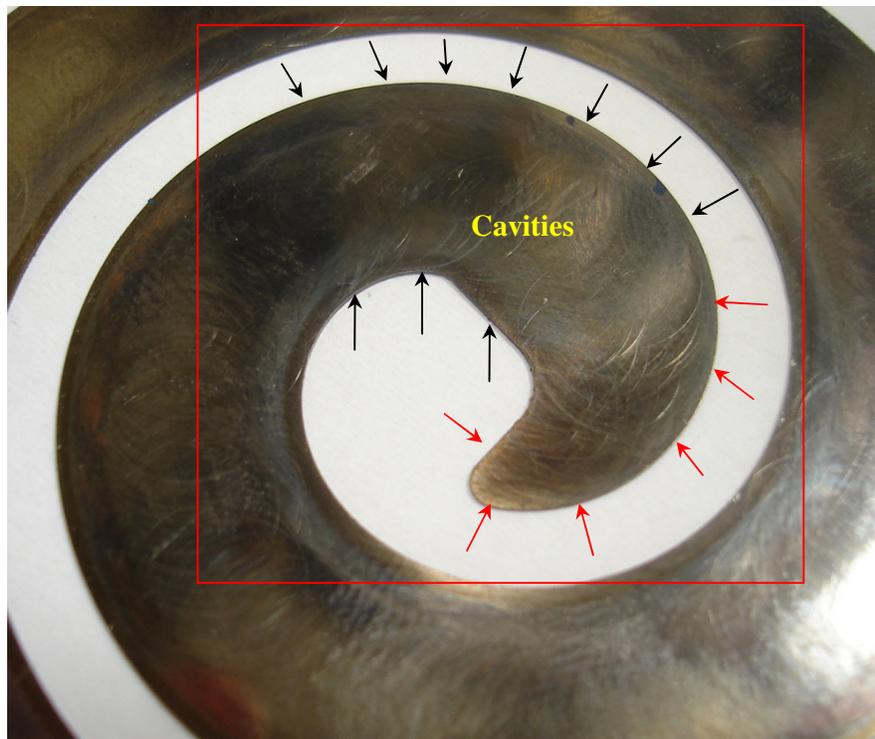
**Figure 25: The high pressure area of the scroll expander  $SE_{1000}$ . Cluster of cavities formed across the edges of the steel plate. Red arrows depict the most severe region damaged by cavitation impact.**

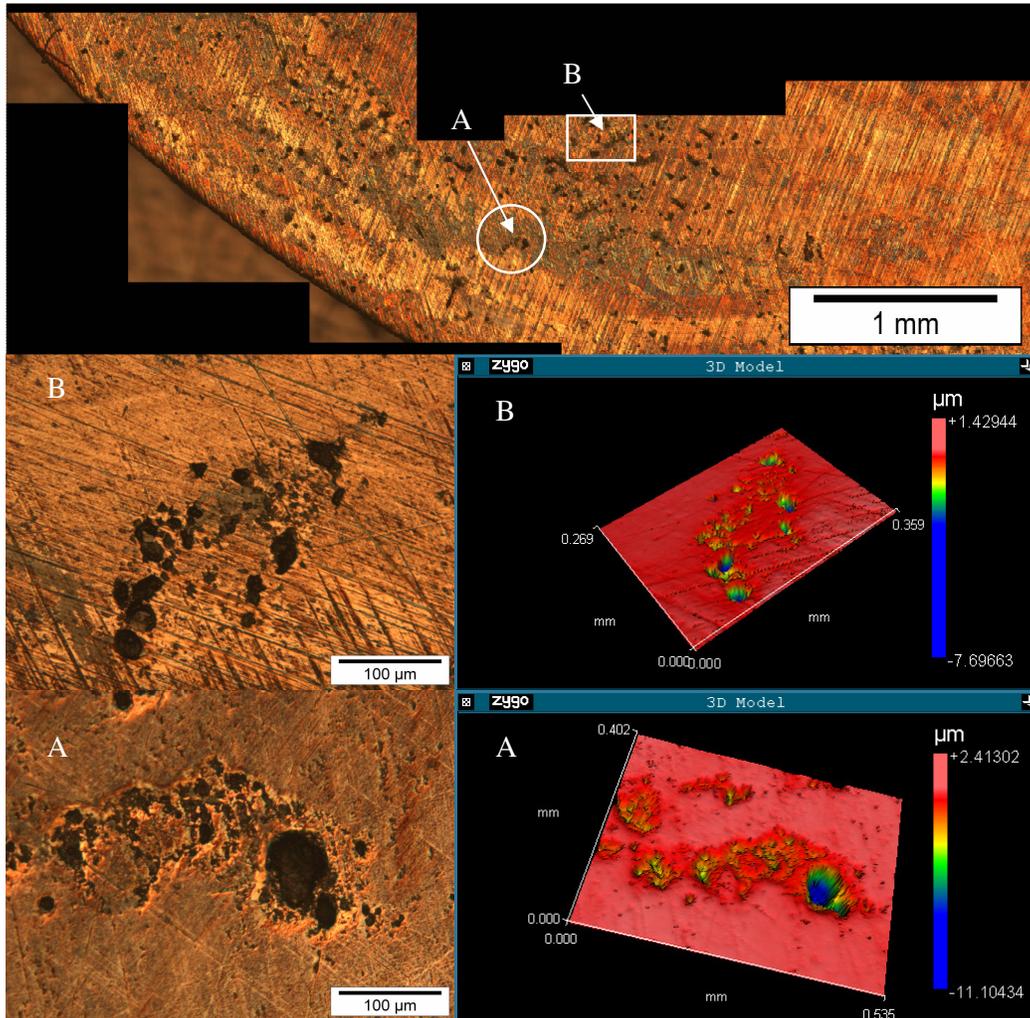
**Figure 26: Cluster of cavities across the high pressure region of the scroll expander SE<sub>1000</sub>. Close-up observation of the cavities with the use of the optical microscope and the ZYGO surface interferometer.**

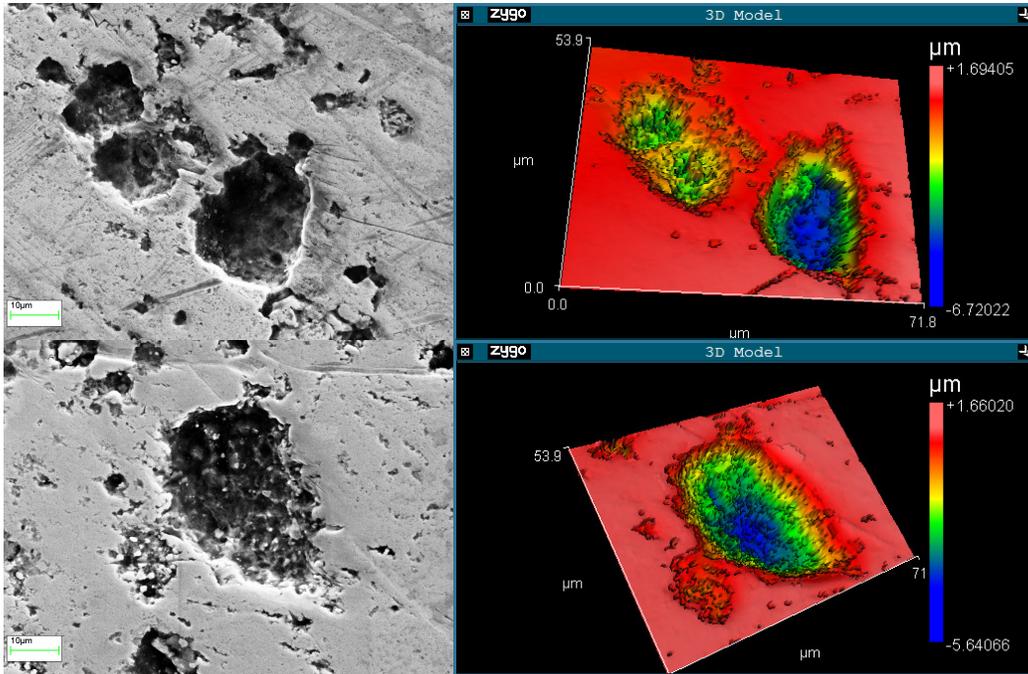
**Figure 27: Characteristic detailed SEM micrographs of the cavities profile. Surface analysis of the specific cavities using ZYGO interferometer microscope.**

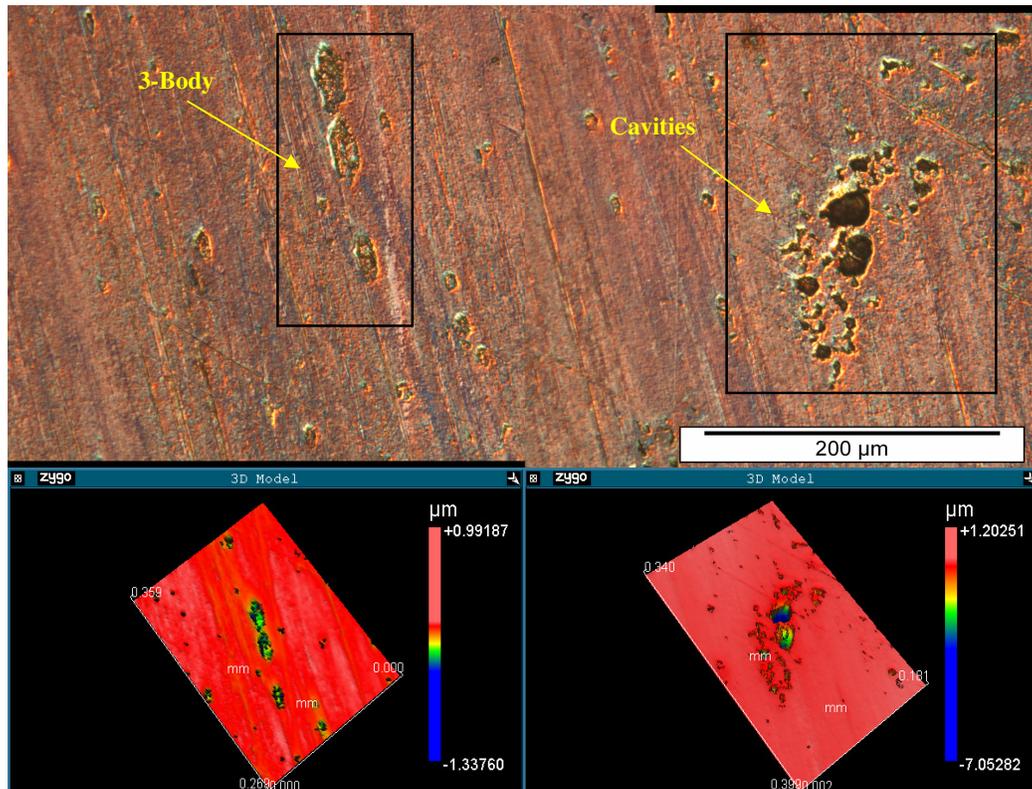
**Figure 29:** Combination of wear mechanisms on the SE<sub>1000</sub> steel plate. Surface analysis of a random area in the high pressure region a) Three-body abrasive wear b) Cluster of cavities

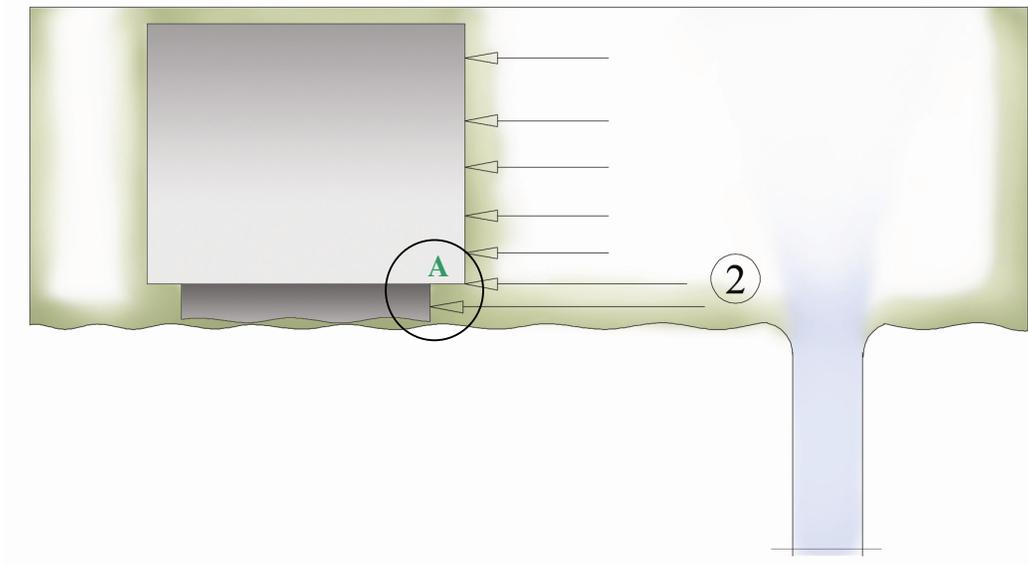
**Figure 31: The second step of the expansion process where the side walls of the scroll pushed by the working fluid. The critical area “A” is presented.**

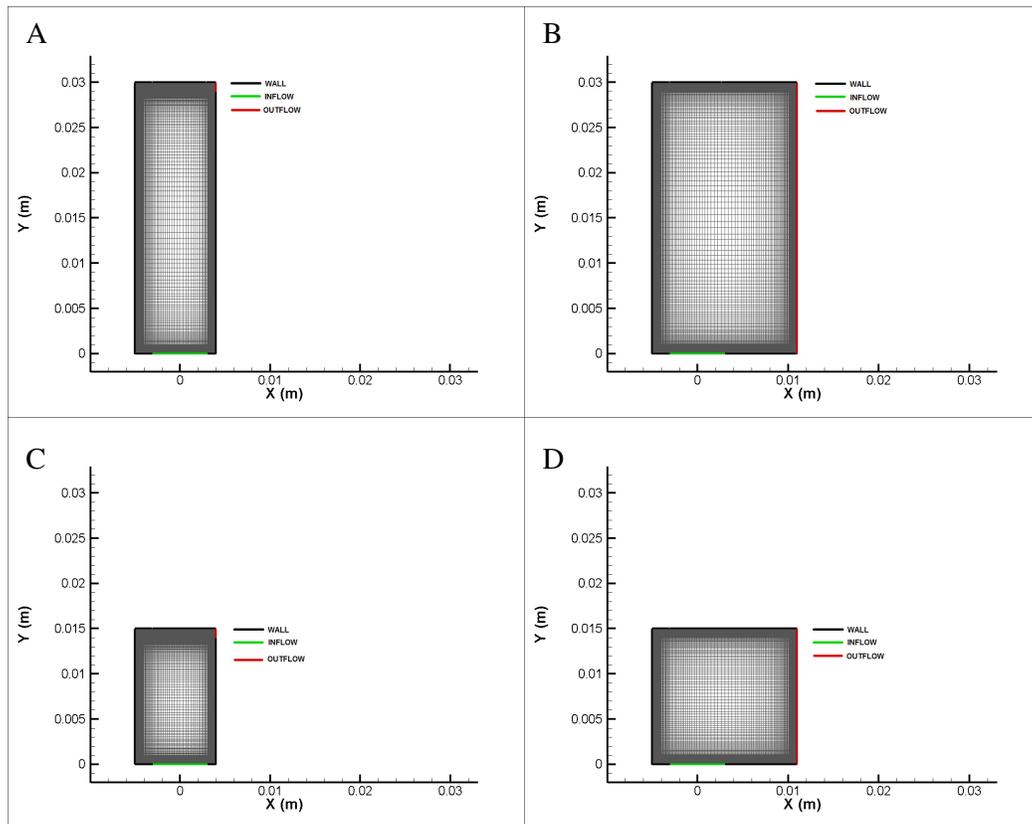
**Figure 37: Geometry, computational mesh and boundary conditions of the first expansion pocket of the: SE<sub>300</sub> A) Initial position B) Final position and SE<sub>1000</sub> C) Initial position D) Final position**

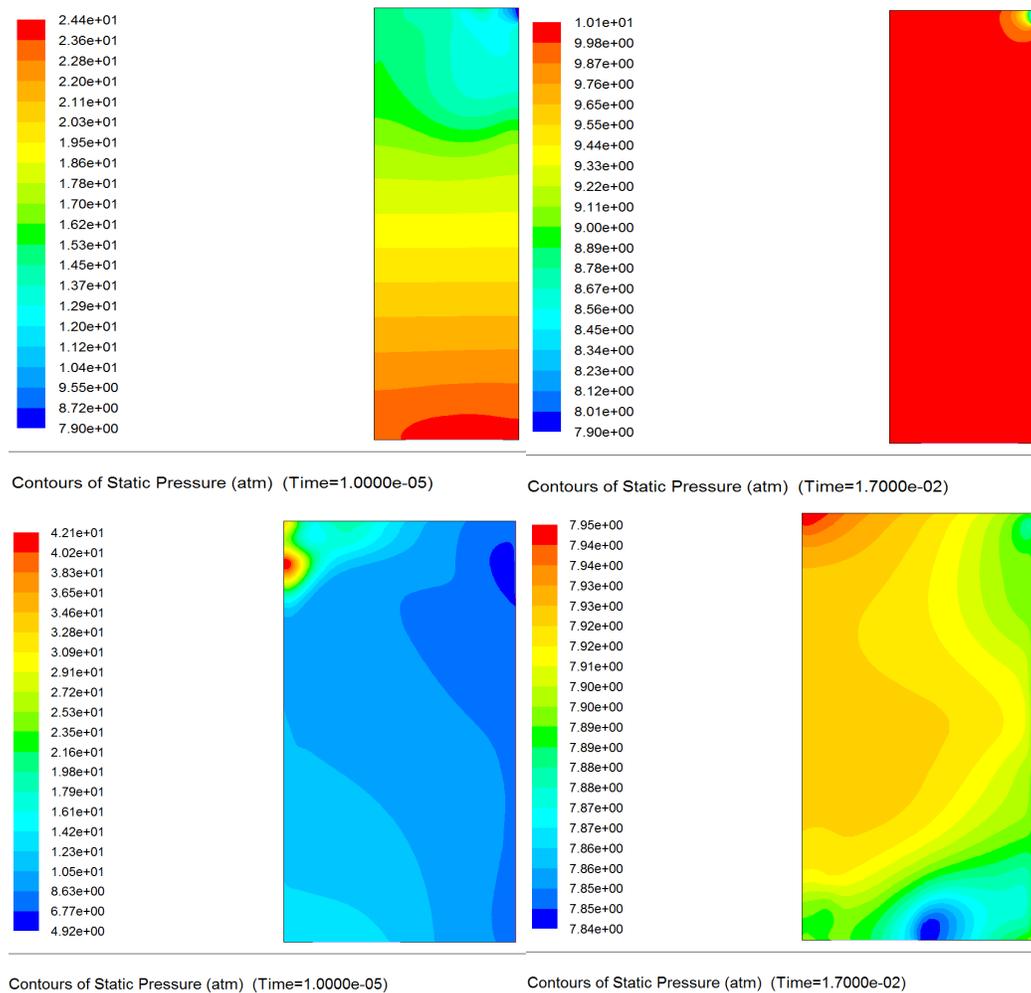
**Figure 39: Distribution of the static pressure in the initial and the final position of the moving part for SE<sub>100</sub>&SE<sub>300</sub>**

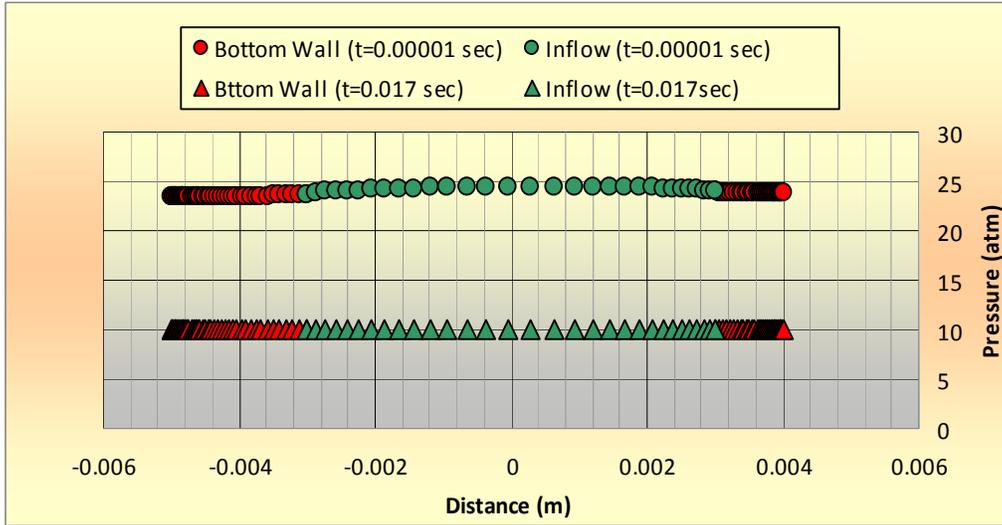
**Figure 40: Pressure distribution along bottom boundary for  $SE_{100}$  and  $SE_{300}$  (Initial position of the moving wall)**

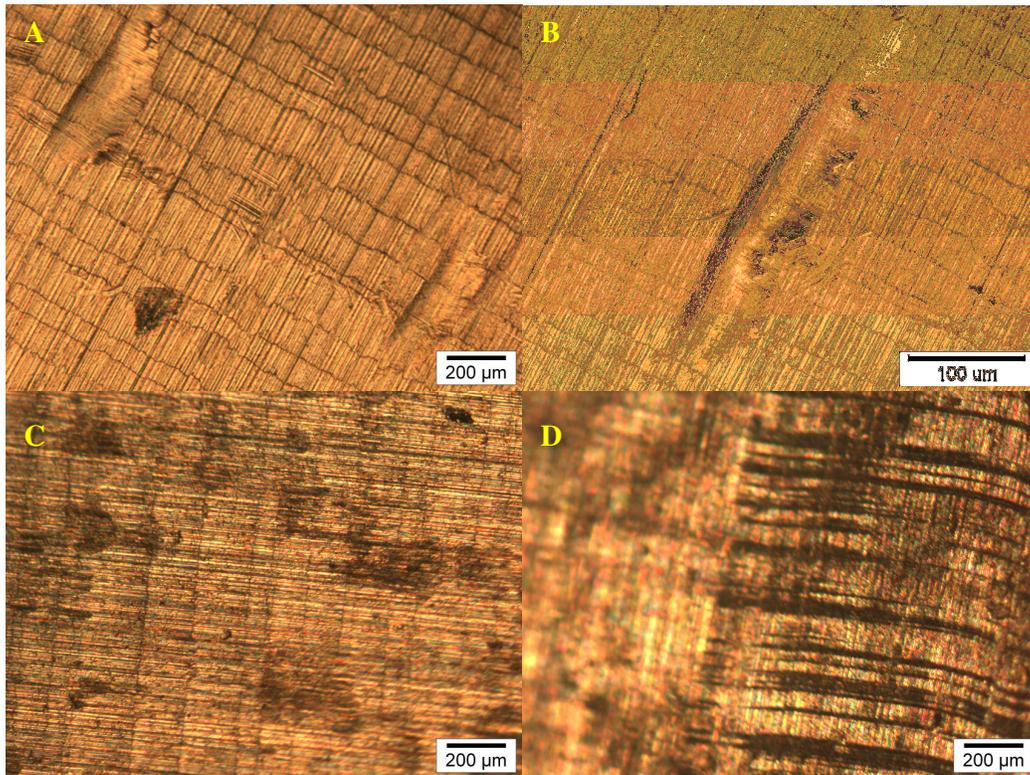
**Figure 45: Wear across the surface of the aluminium scroll A-B) Combination abrasive-adhesive wear C-D) Abrasive wear formed by the orbiting coating scroll**

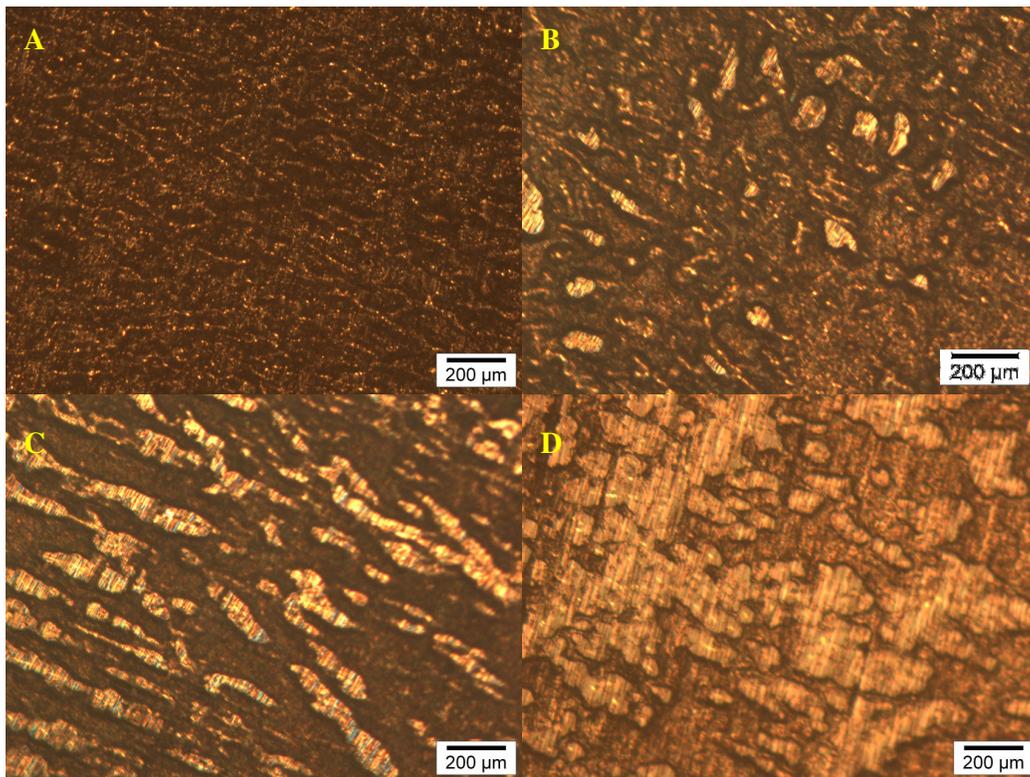
**Figure 46: Adhesive wear on the coating scroll A) Original surface B) Adhesion appears as aluminium particles welded on the coating surface C) The quantity of the aluminium particles is increased D) A major part of the coating scroll is covered by aluminium particles**

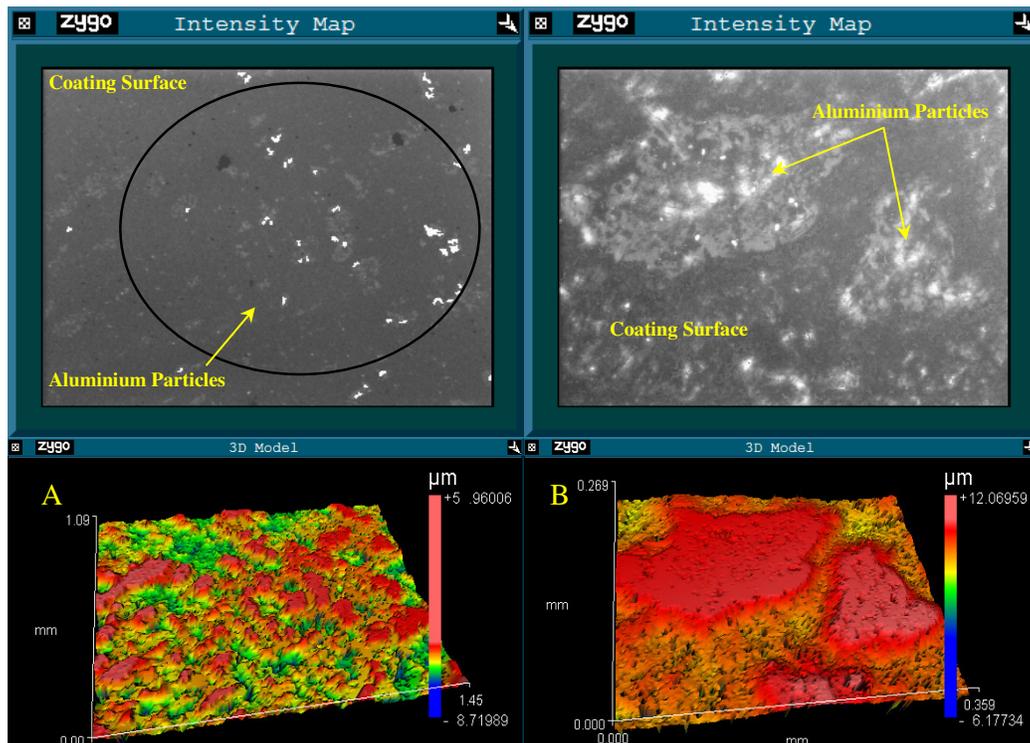
**Figure 47: ZYGO micrographs show the features of the embedded aluminium particles onto the surface of the coating scroll A) Overview of the area with the aluminium particles B) Close up investigation of the aluminium particles morphology**

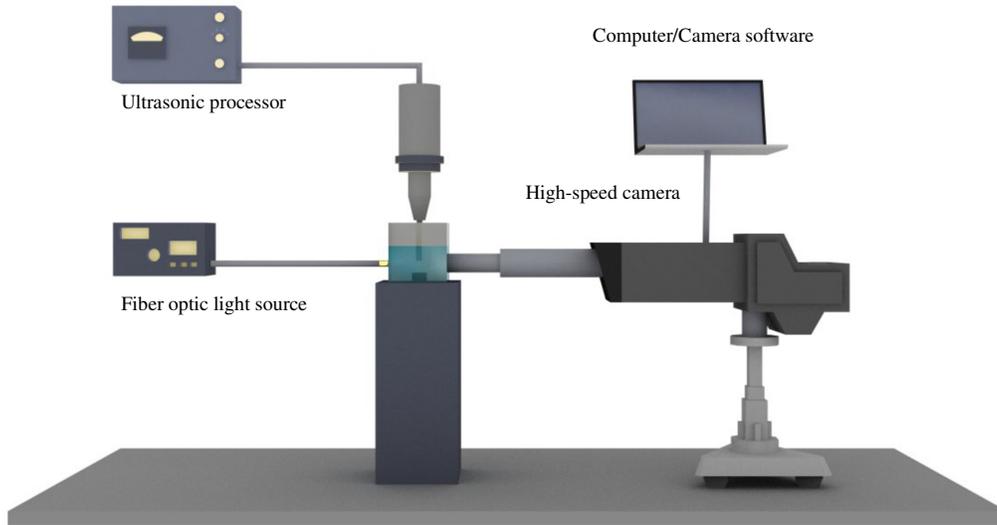
**Figure 51: Schematic of the cavitation experimental set up**

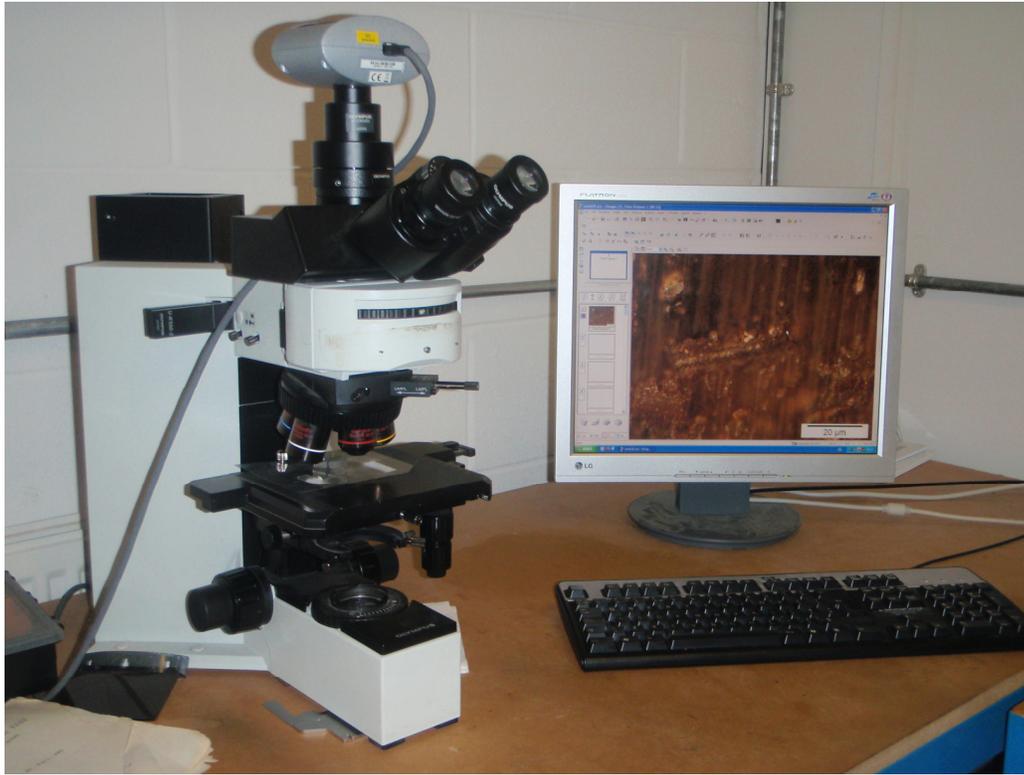
The optical microscope utilised for this project was the Olympus BX 60 figure 52. This microscope was the first tool used for inspection. The optical microscope is simple to use and provides quick and representative results. It uses visible light and a collection of microscope lenses of 5, 10, 20, 50 and 100x magnification for intensive surface observations. Apart from the traditional system of eyepiece, the microscope is fitted with a digital camera to monitor and capture images. These images are then displayed on a monitor via a computer link.

**Figure 52: Olympus BX 60 Optical microscope**

A quality analysis of an image requires the use of various combinations of polarizing filters in order that the mountain (peaks) and the valleys (troughs) can be revealed. In addition, the effective measurements of the size and the depth of the wear mark, found in this image, using appropriate commands of the software and further microscopy techniques can be well estimated. Finally, in some cases stitching of an image is essential. With stitching a broader image of the sample in the desirable magnification is available for a thorough optical investigation.

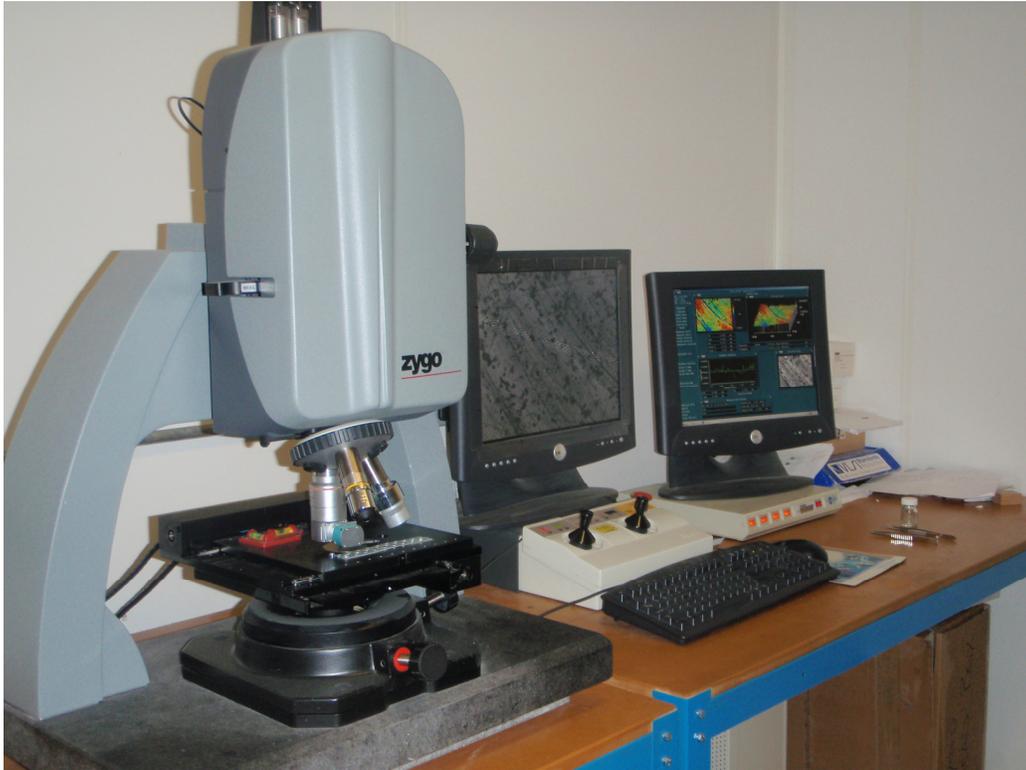
The ZYGO surface interferometer is a very powerful tool in the field of materials surface analysis figure 53. Its operating principle is based on the white light scanning interferometry and is capable of mapping an area of a few millimetres wide in a single measurement with sub-nanometres resolution, providing instantaneous information about surface roughness, shape and waviness. The surface finish of the original surface can be measured and compared with the surface morphology after the test. The three-dimensional surface mapping profilometer can accurately measure the surface roughness, the depth of cavitation pits and wear grooves, the size and periphery of the cracks, the step heights and the volume loss.

**Figure 53: ZYGO surface scanning interferometer**

Initially the sample was carefully set onto the moving platform of this advanced equipment. Then light focus is adjusted on the sample surface by moving the instrument head. The fringes have to be revealed in the monitor and extended as wide as possible across the screen for a superior analysis. After setting the height and the focus point, light intensity is the next parameter to be adjusted. Thereafter measurements take place using the appropriate

Finally stitching is another parameter of the software which can be proved useful in many measurements. After a number of detailed scans across the surface with specific magnification, the generated images can be stitched together to create a full 3D profile of the surface and the wear scars. This technique was enabled the author to accurately determine the size parameters, the roughness, the wear erosion rate and the volume loss from all the tested samples.

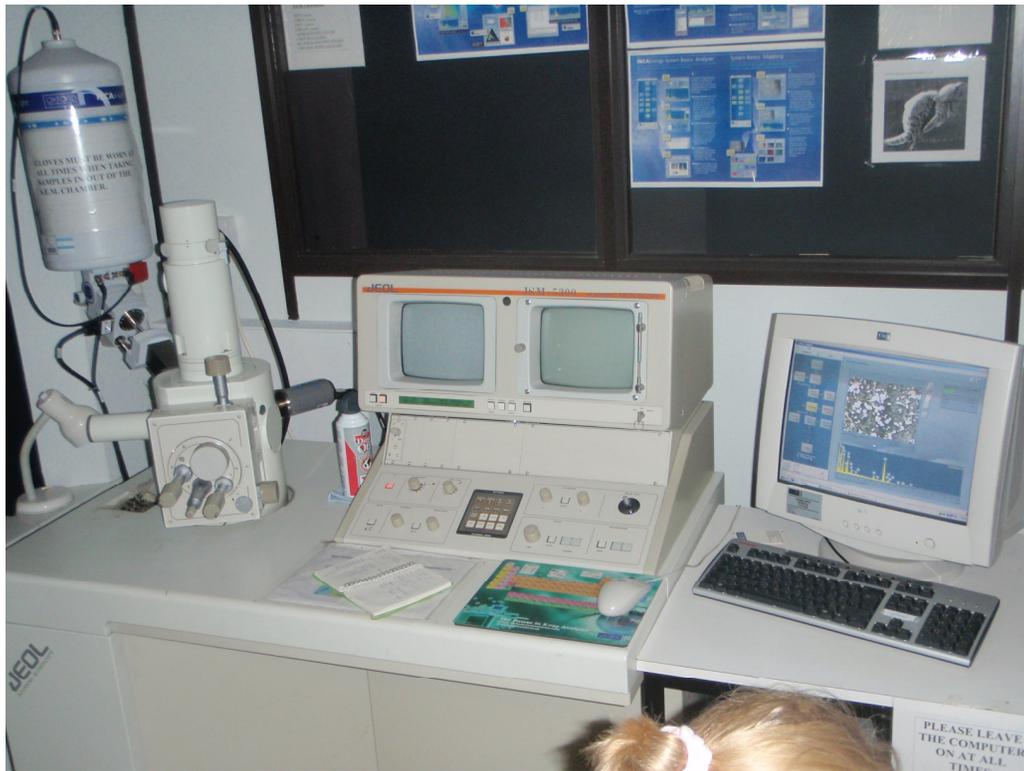
Scanning electron microscopy is widely used for providing high quality micro-structure images and obtaining chemical composition of the material samples. Its advanced technology is making it one of the most versatile instruments for surface investigations. In this project two different SEM systems were used: a typical SEM found at Bournemouth University (figure 54) and a technologically superior model, the Zeiss Supra 35 VP, used by the author at Brunel University.

**Figure 54: Scanning electronic microscope (SEM)**

The sample was entered into the vacuum chamber and was placed in position. The chamber is vacuumed in order to avoid any electron dispersal or scatter due to collisions with other molecules. The electron gun was adjusted to a desirable working distance (WD) for the highest possible definition images. The system generates an illuminating beam of electrons (kV) controlled by the SEM operating console. The higher the voltage the better the image resolution but the greater the heat that is generated on the specimen. Thus, lower voltages (10 kV) may have to be used for delicate samples like the elastomer tip seal. Higher voltages (20 kV) can be used for non biological specimens like metals [179].

The SEM proved to be extremely useful for the interpretation of the wear mechanisms on the elastomer surface because the black surface colour of the tip seal did not allow ZYGO to create proper 3D images or the optical microscope to generate fine images. Moreover SEM was used for element analysis in order that the debris found on the surface of both samples after test could be indentified to show the nature of the wear regime.

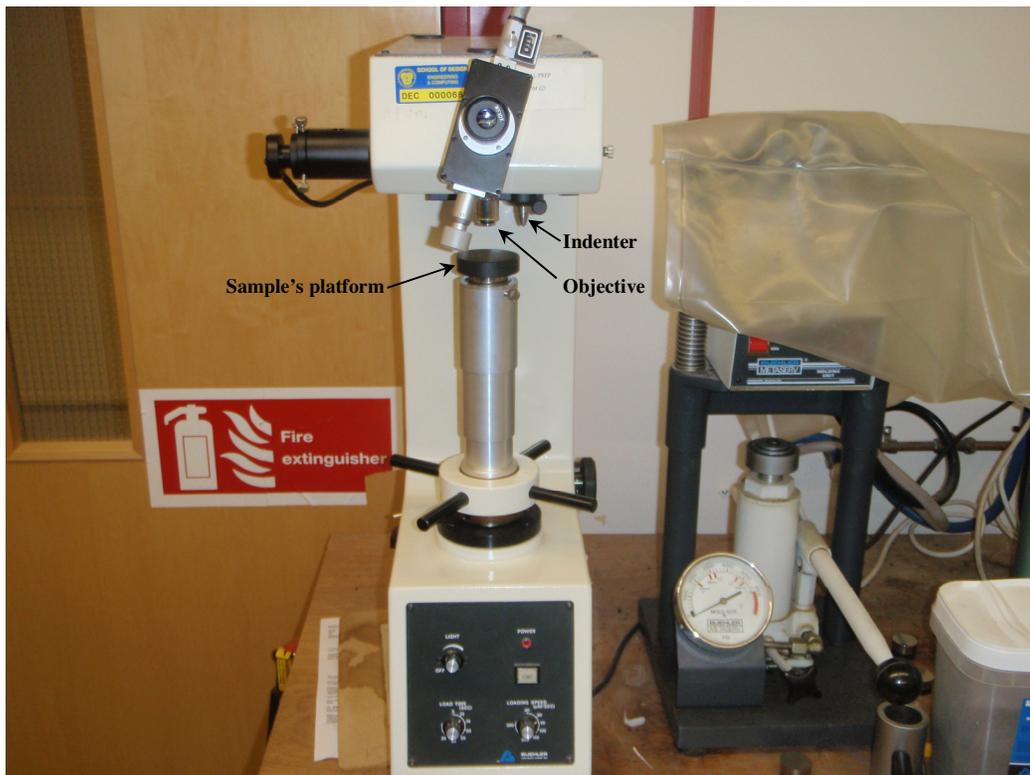
With the hardness test, the mechanical hardness of all the tested samples was effectively measured (figure 55). With the micro-hardness test, the transition of the mechanical hardness across the cavitation samples was calculated. Specifically, the fluctuation of hardness values across the main crater, formed by cavitation impact, and its outside periphery were evaluated and plotted into graphs.

Figure 55: Hardness test machine

Prior to cavitation tests, the sample was positioned on the base of the hardness machine. Then the applied load and the downward speed were adjusted. The load used varied from 50 to 100 N. The speed was adjusted according to the hardness standards. The hardness values of the samples were successfully interpreted. After the completion of the cavitation tests, micro-hardness tests were performed using 8.825 N applied load. Subsequently, the tested samples

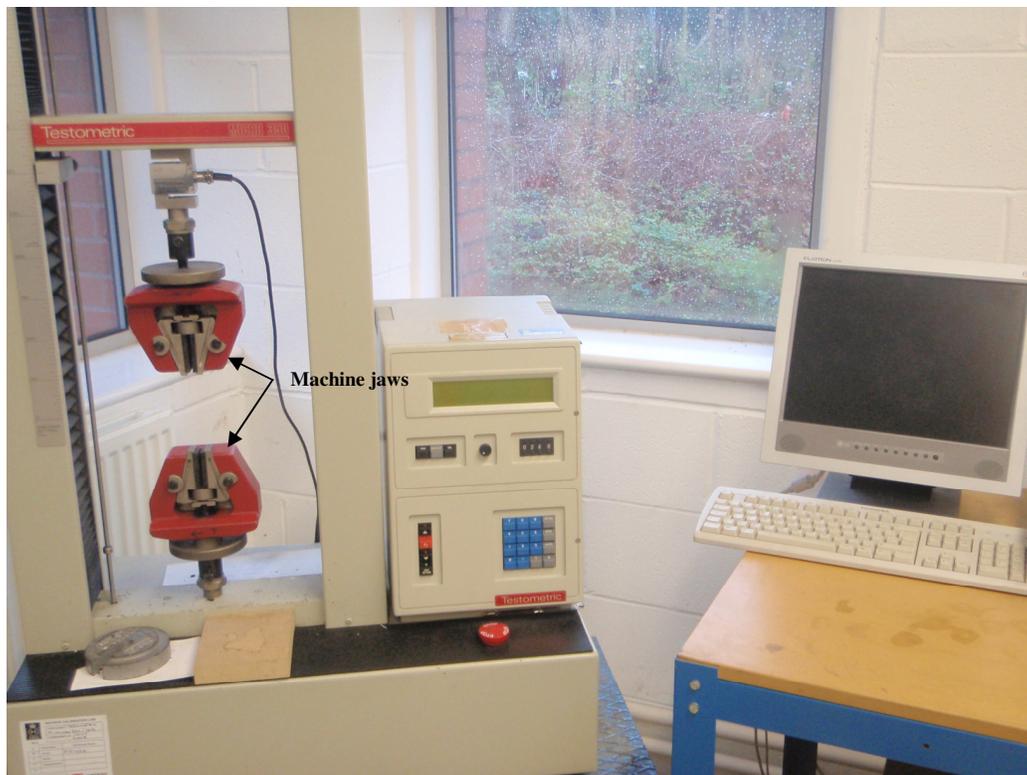
With the help of the Testometric machine (figure 56) the material properties of the scroll's steel plate were successfully determined. The sample was properly modified to obtain the bone shape required for this test and was gripped by the edges within the machine jaws. Then the software parameters were entered in the interface console and the tension process was started. The data was obtained in plotted graphs (Appendix C).

Figure 56: Testometric machine for performing tension and compression mechanical tests

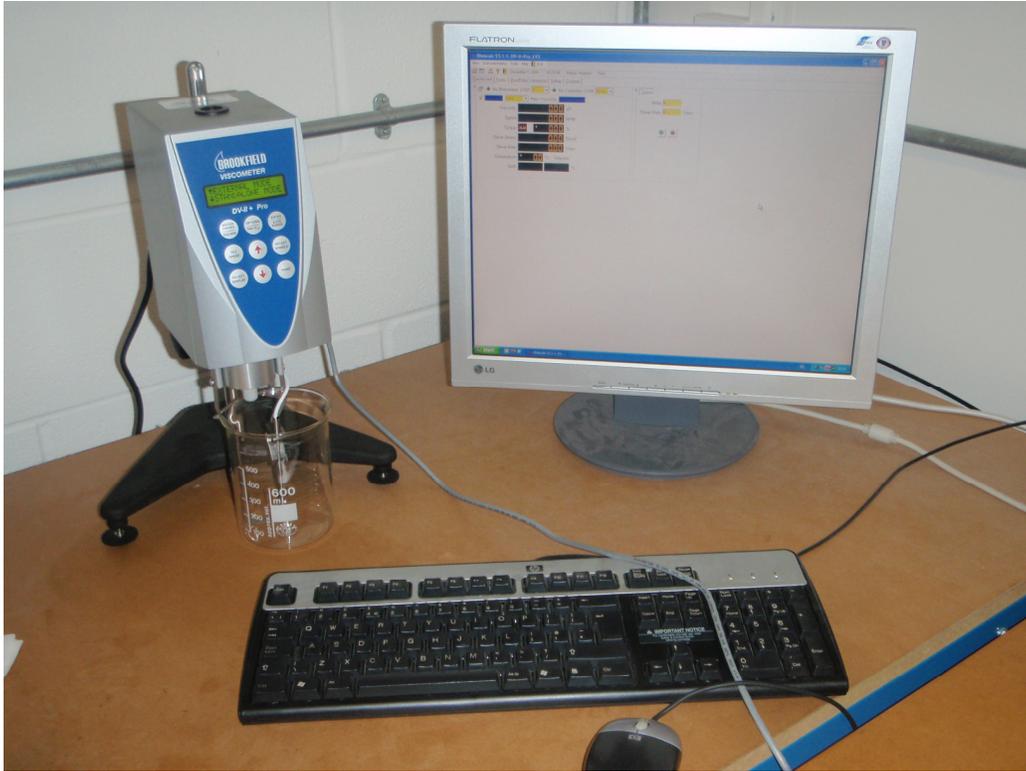
With the use of the DV-II+ PRO Digital Viscometer (figure 57) the viscosity of the lubricant used in the cavitation tests was properly measured. Then, a correlation of the viscosity values with other parameters from the cavitation tests was conducted.

**Figure 57: DV-II+ PRO Digital Viscometer**

Initially a calibration of the system was made using water liquid. The operation of the viscometer is based on the fluid resistance the spindle experiences as it rotates. A minimum quantity of 300 ml of lubricant was poured into a glass beaker and the appropriate spindle attached to the viscometer was immersed into the liquid. The deeper the spindle was immersed into the fluid the higher the measurement accuracy was achieved. Special stainless steel low viscosity spindles can measure a wide range of viscosities from 15 to 6,000,000 mPa·s with 1% of full scale range torque measurements accuracy. The speed can be varied from 0.01 to 200 rev/min. Temperature measurements and data outputs are gathered by the Rheocalc software and are automatically displayed on a PC monitor.
