*Sustainable design and durability of  
domestic micro combined heat and  
power scroll expander systems*

*Thesis submitted in a partial fulfilment of the  
requirements of Bournemouth University for  
the degree of Doctor of Philosophy*

*by Iakovos Tzanakis*

*Bournemouth University  
in collaboration with the  
Energetix Group Ltd.*

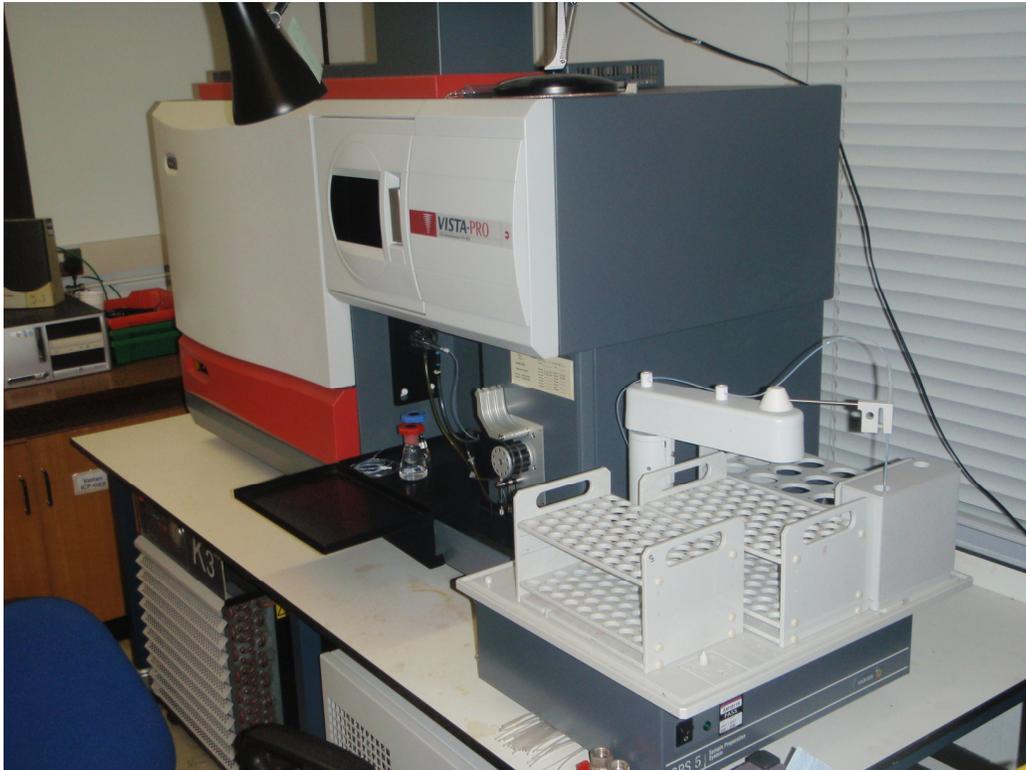
A comprehensive oil analysis was also conducted with the use of an optical emission spectrometry system (figure 60). The oil samples after the end of the sliding tests were drawn off and placed into plastic bottles. The plastic bottles with four different types of oil at 40 °C, 100 °C and 150 °C and a bottle with fresh oil were sent for analysis to the Inductively Coupled Plasma Optical Emission Spectrometry (ICP-OES).

**Figure 60: Inductively Coupled Plasma Optical Emission Spectrometry (ICP-OES) for liquid analysis**

The first step in the procedure is the conversion of the molecules in the sample to individual atoms and ions using a high temperature radio frequency induced by ionized (typically argon)

plasma. Then, the sample solution is introduced to the ICP instrument by free aspiration or an optional peristaltic pump. Finally, ICP-OES utilizes ultraviolet light (UV) and visible spectrometry to image the plasma at the exact wavelength of ionic excitation of the element of interest. In other words by comparing emission intensities of elements in the test sample with emissions intensities measured with the standards, the concentrations of elements in the test sample are calculated [180].

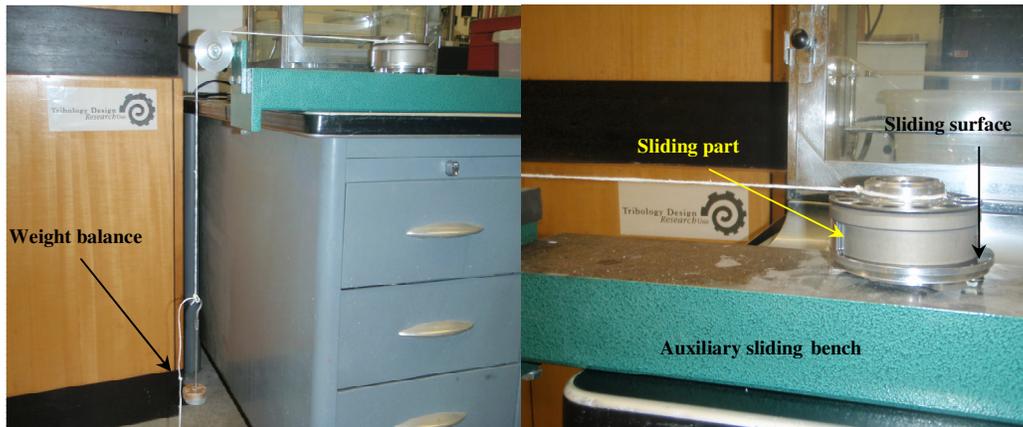
The friction coefficient of the upper scroll material when is in sliding contact with the lower bottom one was measured. The friction coefficient of the tip seal against the steel plate was measured during the start up conditions of the scroll, when the scrolls were in close contact. This was performed using a sliding friction bench figure 62. The friction coefficient after several dozen measurements was effectively estimated to be among 0.2 and 0.25. This number correlates well with the experiments made with the TE 57 micro-friction machine when low loads between the tip seal and the steel plate were applied. Through the friction

**Figure 62: Measuring the friction coefficient of the two involute scroll parts with the use of a sliding friction bench**

where  $r$  (m) is the radius of eccentricity and  $\mu$  is the dimensionless static coefficient between the scrolls (tip seal/steel plate). The contact load was found to be between 800 and 1000 N. The contact parameters of the scroll had to be matched to those of the samples and the contact stress of the scroll correlated with that of the samples in the TE 57 in order that the contact load calculations made sense.

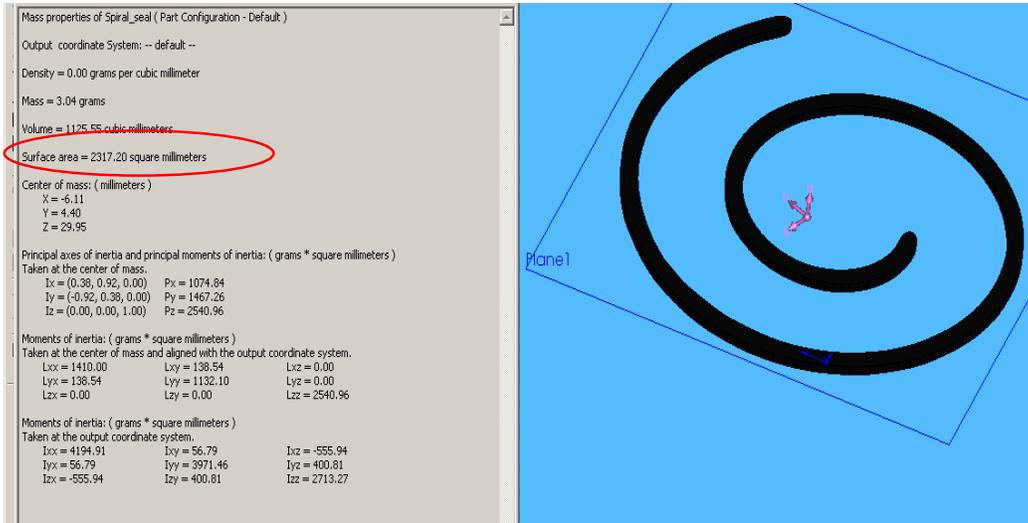
**Figure 63: Calculation of the tip seal surface area with the use of SolidWorks software**

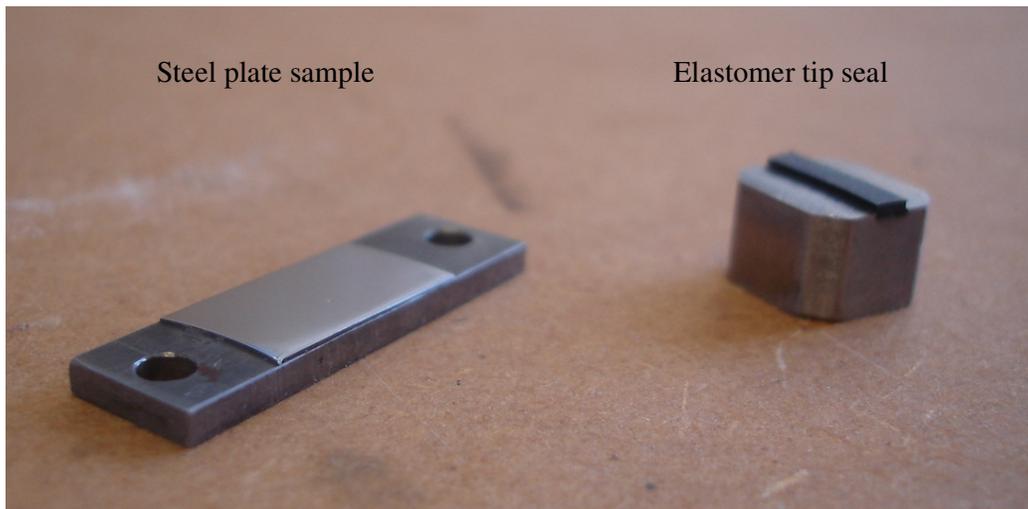
**Figure 65: The implementation of the testing samples used for sliding wear tests**

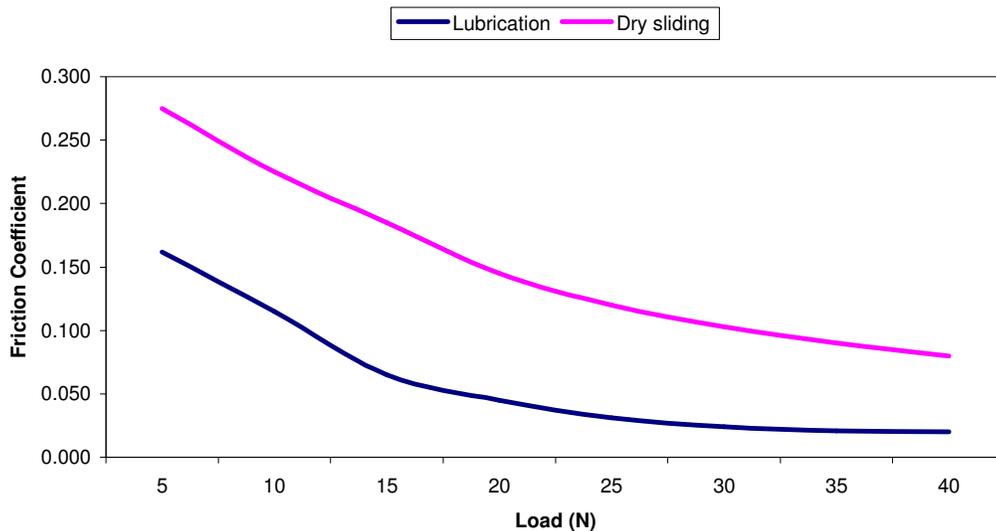
**Figure 66: Variation of friction coefficient with the applied load for different contact regimes**

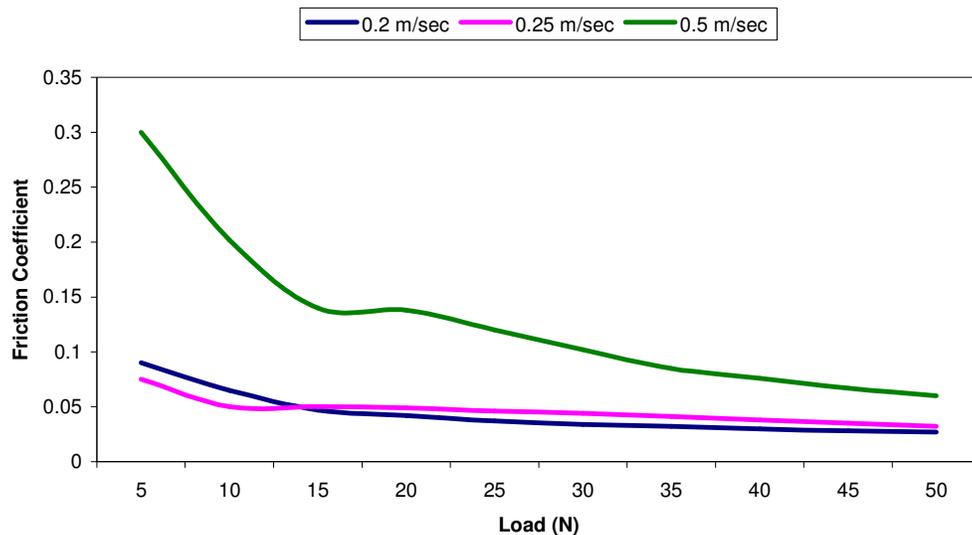
**Figure 67: Variation of friction coefficient with the applied load for different velocity conditions**

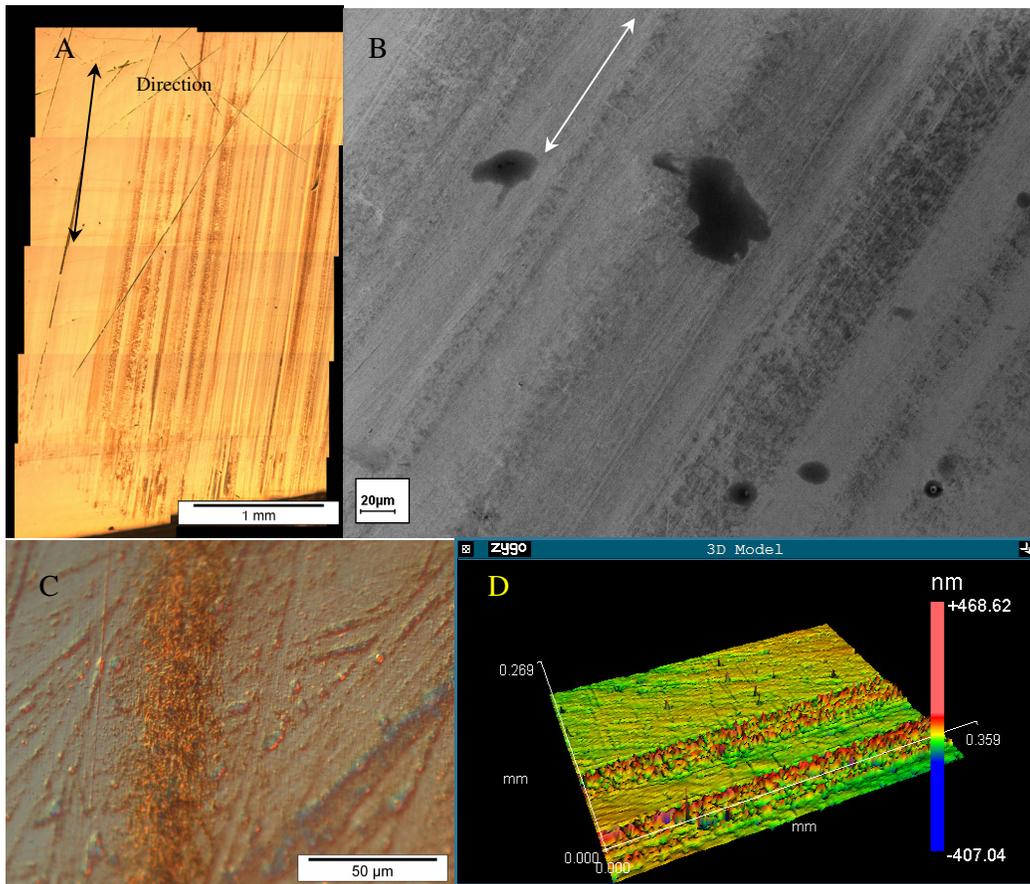
**Figure 69: A) Optical photograph of transfer films of the elastomer formed on the surface of the steel plate after 10 min test duration. B) SEM micrograph C) Optical micrograph D) ZYGO interferometer micrograph of the film deposition. (Load 40 N, sliding speed 0.5 m/sec)**

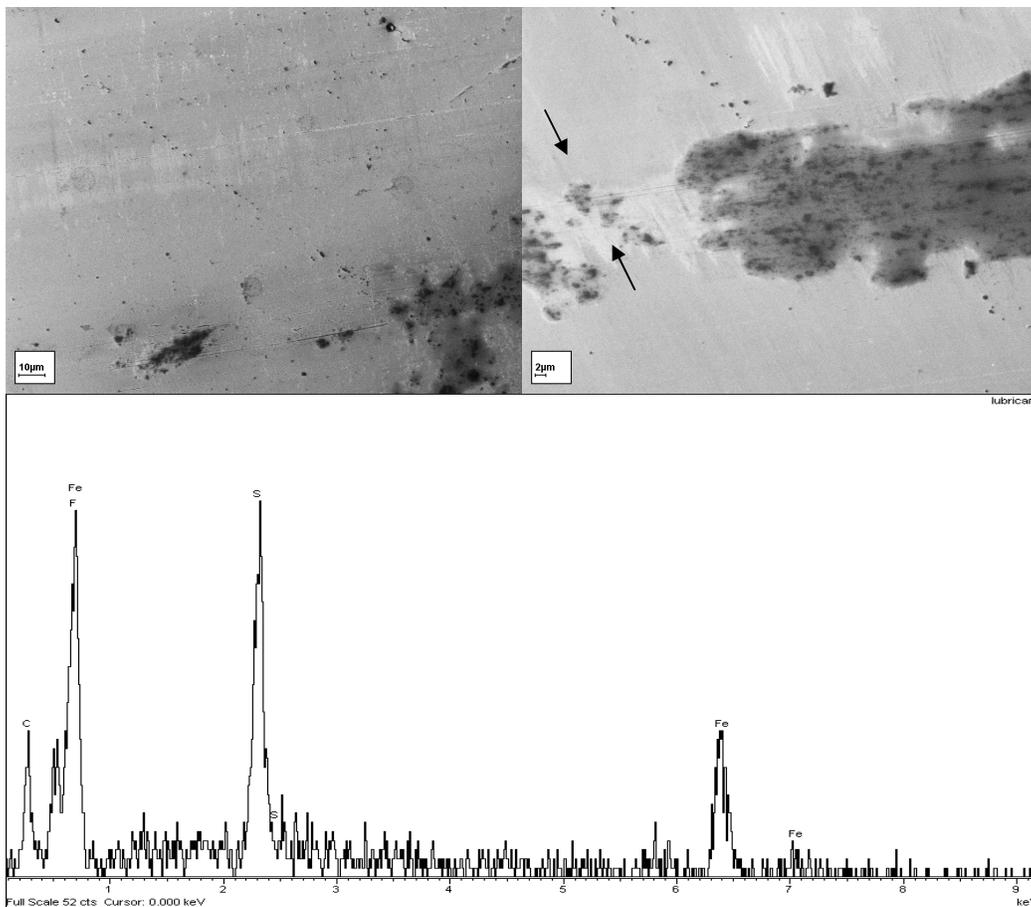
**Figure 70: Transfer films of the elastomer material detected on the surface of the steel plate after the completion of lubricated contact experiments. EPMA analysis graph reveals the presence of fluorine and sulphur, indicating the adhesive mechanism of the elastomer within a lubricant environment. Lubricant adhesion mechanism is highlighted.**

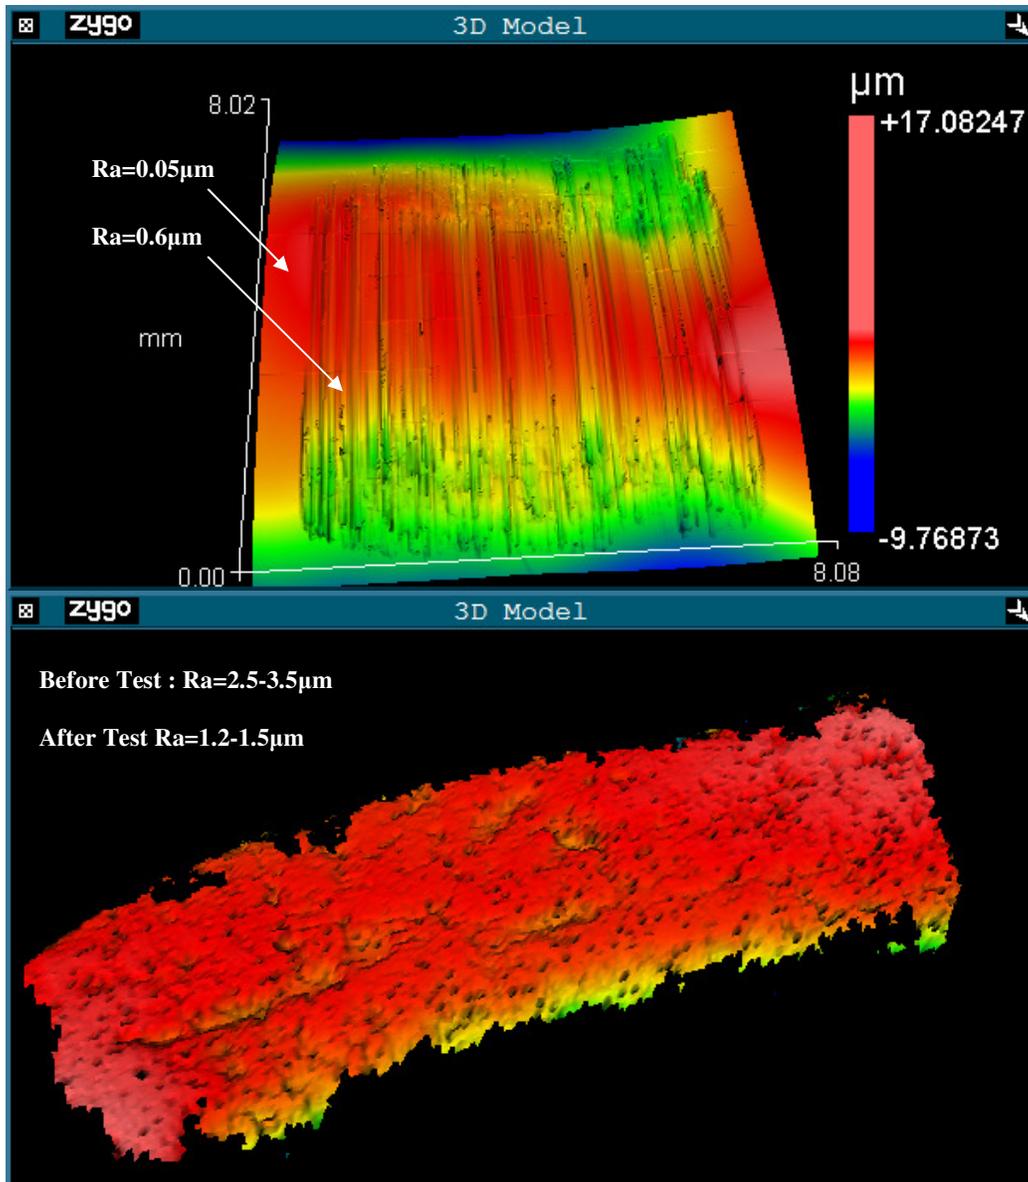
**Figure 91: Surface profile of the worn regions across the steel and the elastomer surfaces. The experimental conditions were 0.5m/sec, 0.8MPa, 100C, 20hours.**

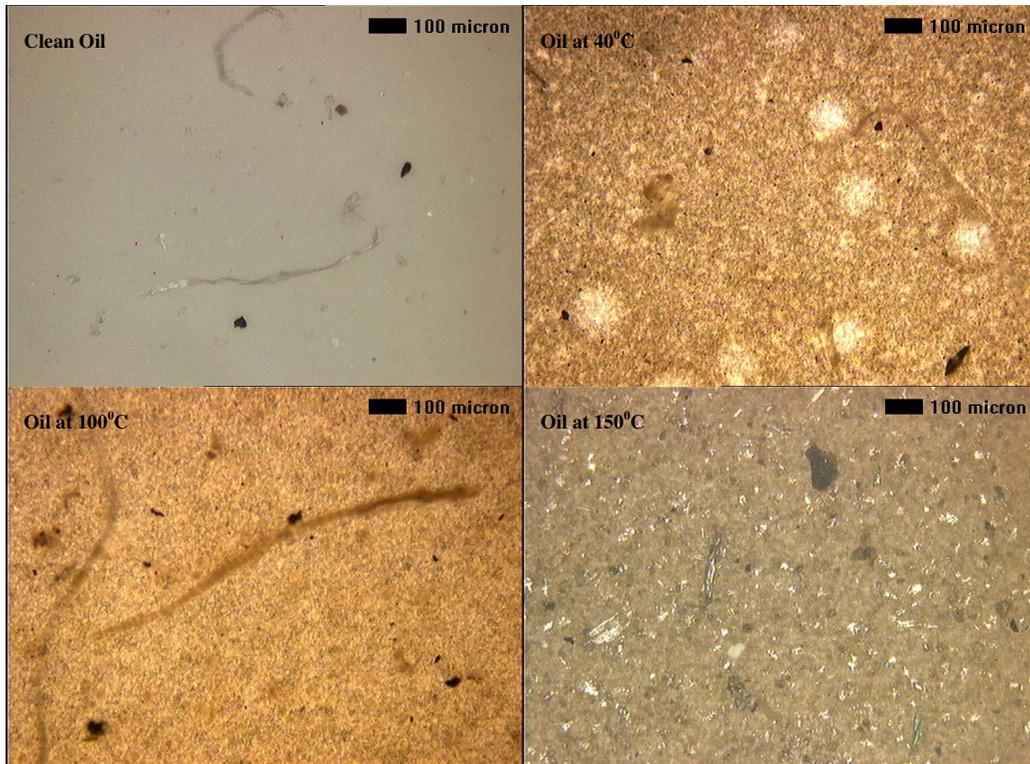
**Figure 94: Optical examination of the after test lubricant samples at 40 °C, 100 °C and 150 °C**

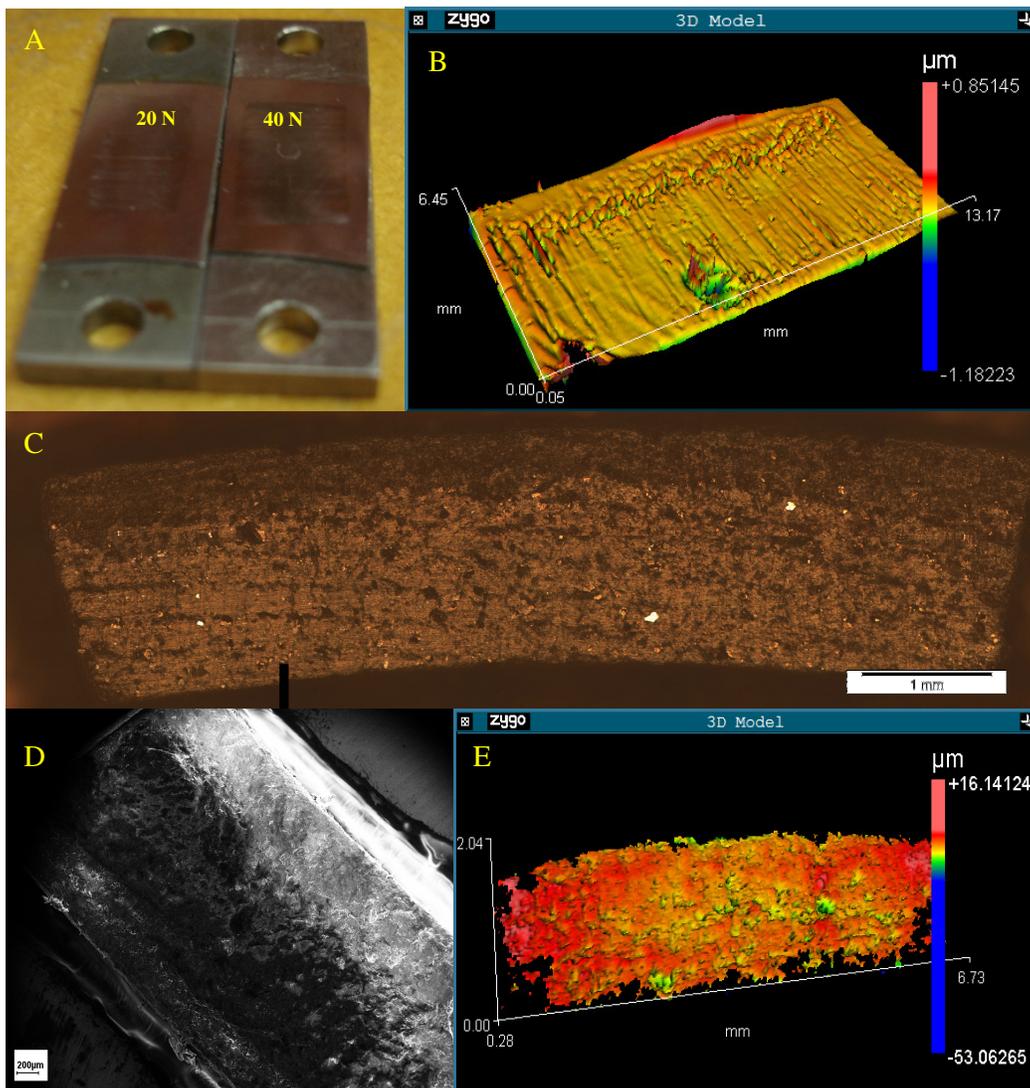
**Figure 95: An overview of the wear pattern formed due to sliding wear on the surface of the steel samples: A) Photo image of the steel samples for different applied loads, at 20N and 40N respectively. B) ZYGO interferometer image of the steel plate at 100°C-20N-50Hz-20hours. Overview micrographs, of the reinforced elastomer tip seal sample after the completion of the test at 100°C-20N-50Hz-20hours, taken with C) Optical microscope D) SEM E) ZYGO interferometer**

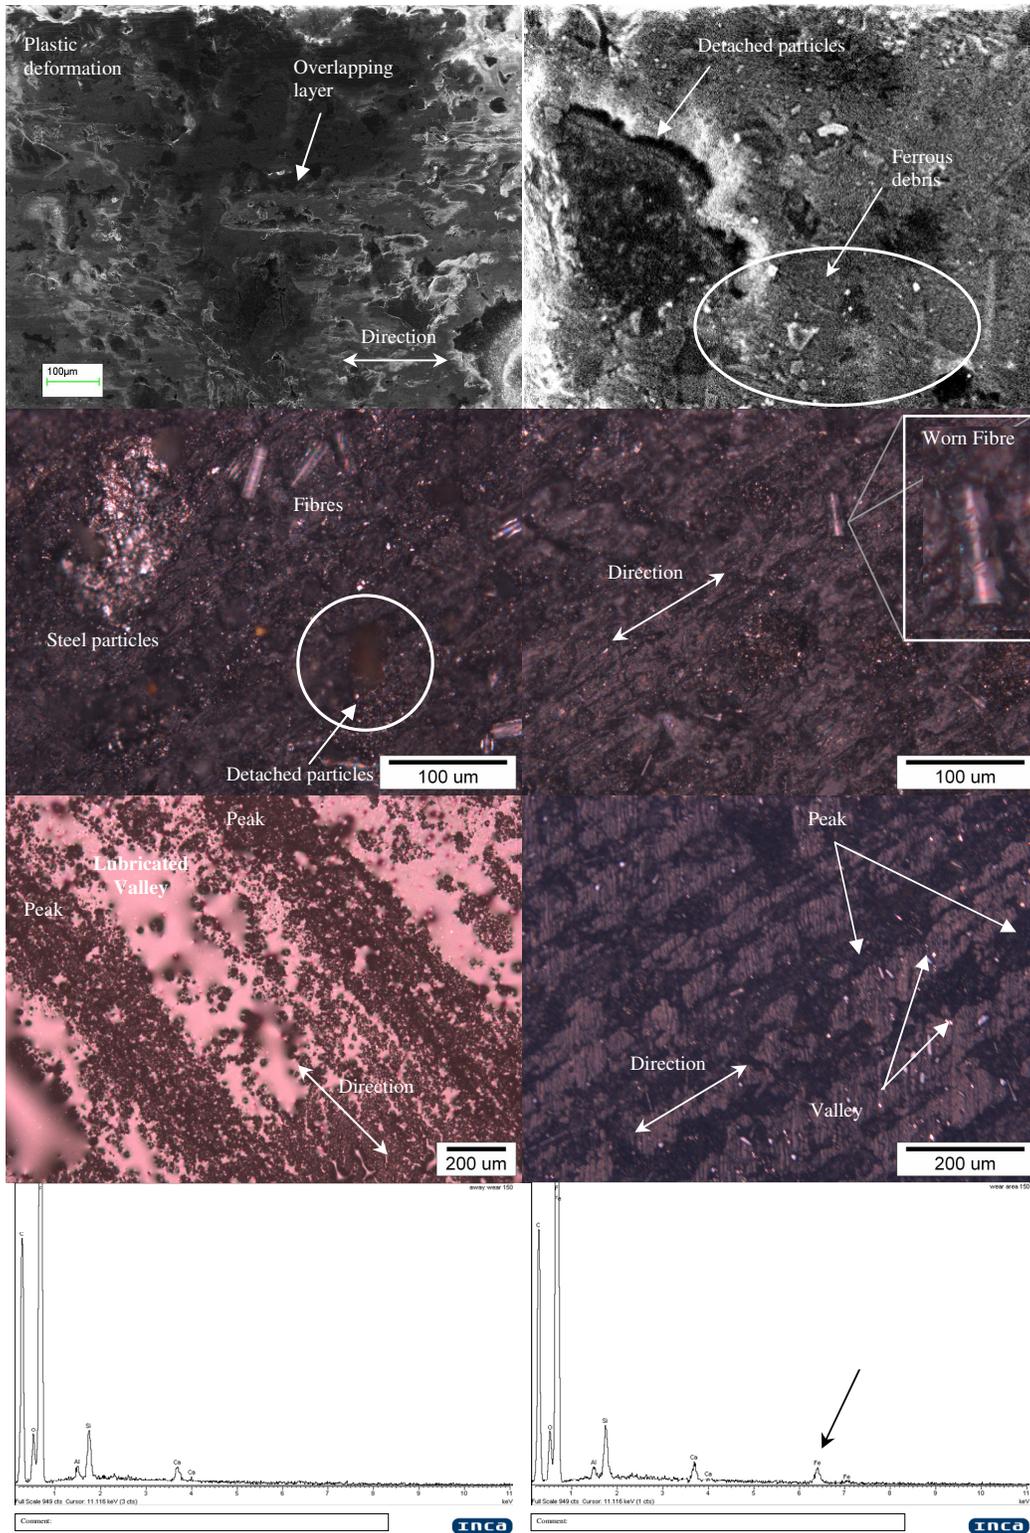
**Figure 96: Fluoroelastomer sample after the end of 20 hours sliding test (40N/0.5msec<sup>-1</sup>/100<sup>0</sup>C). The plastic deformation of the surface, overlapping layers due to thermal/melting effects, the deterioration of the substrate, the worn fibres disorientation, the detached particles, the embedded steel particles, the formation of peaks and lubricated valleys, is shown.**

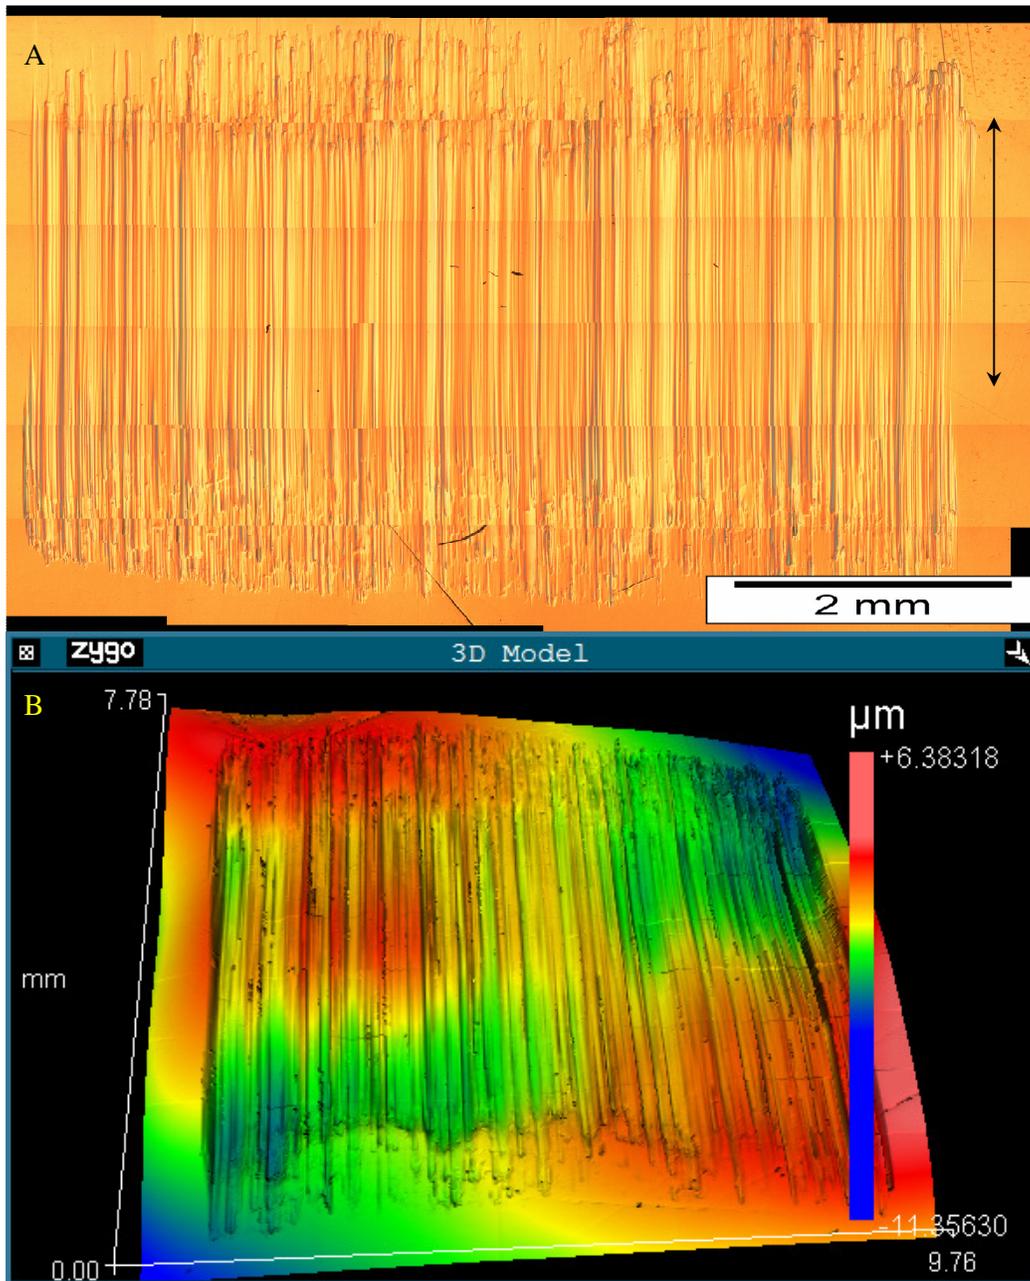
**Figure 97: A typical pattern of the wear damage formed on the surface of the steel plate sample after the completion of the experimental process with the following conditions: 100<sup>0</sup>C-50Hz-60hours-20N. A) Optical microscope B) ZYGO interferometer**

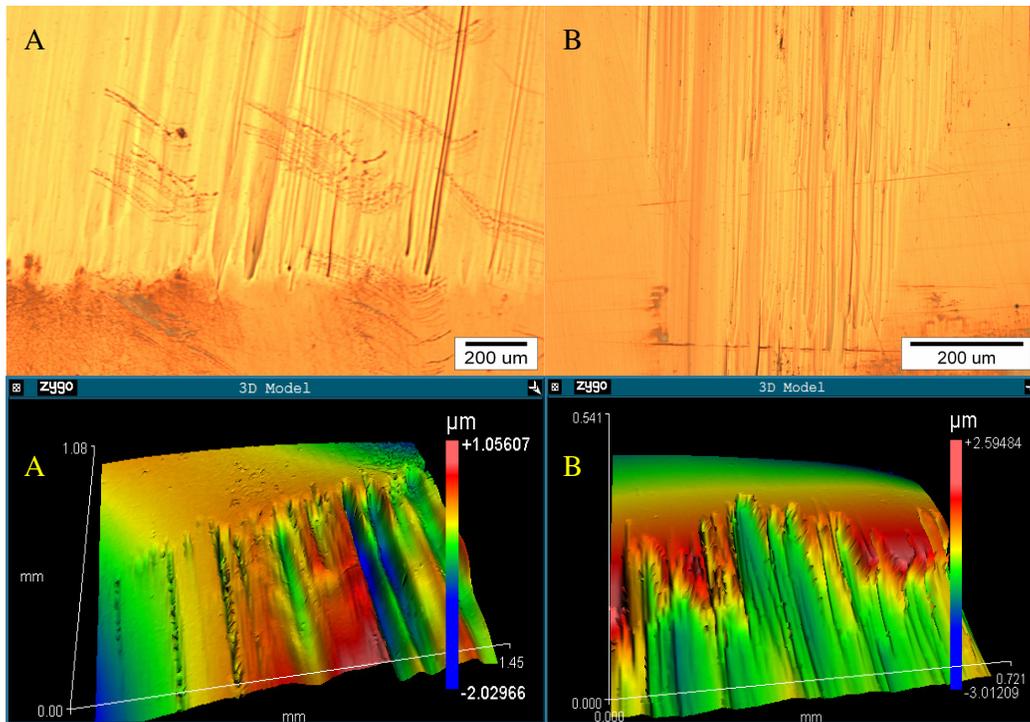
**Figure 98: Surface morphology of the wear lines distributed on the steel counterpart surface A) 0.8MPa, 0.5m/sec, 150<sup>0</sup>C, 20hours and B) 0.8MPa, 0.5m/sec, 100<sup>0</sup>C, 20hours**

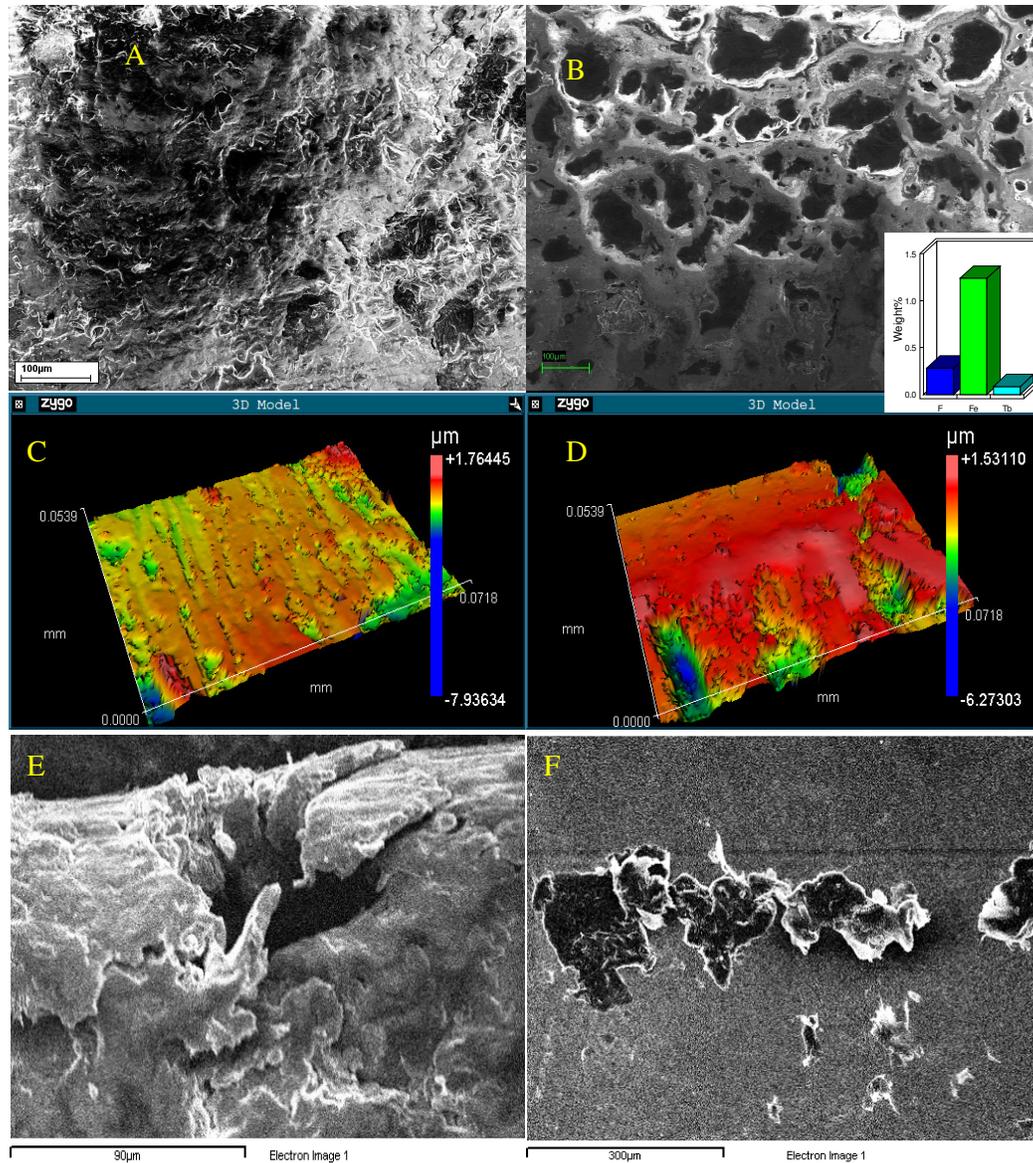
**Figure 100: Fluoroelastomer surface after A) 20h-100°C-20N-25Hz, B) 20h-100°C-20N-50Hz. Surface morphology for C) 25Hz reciprocating frequency, D) 50Hz reciprocating frequency. SEM micrograph of a E) detached particle, F) elastomer particles found on the steel plate/chemical analysis**

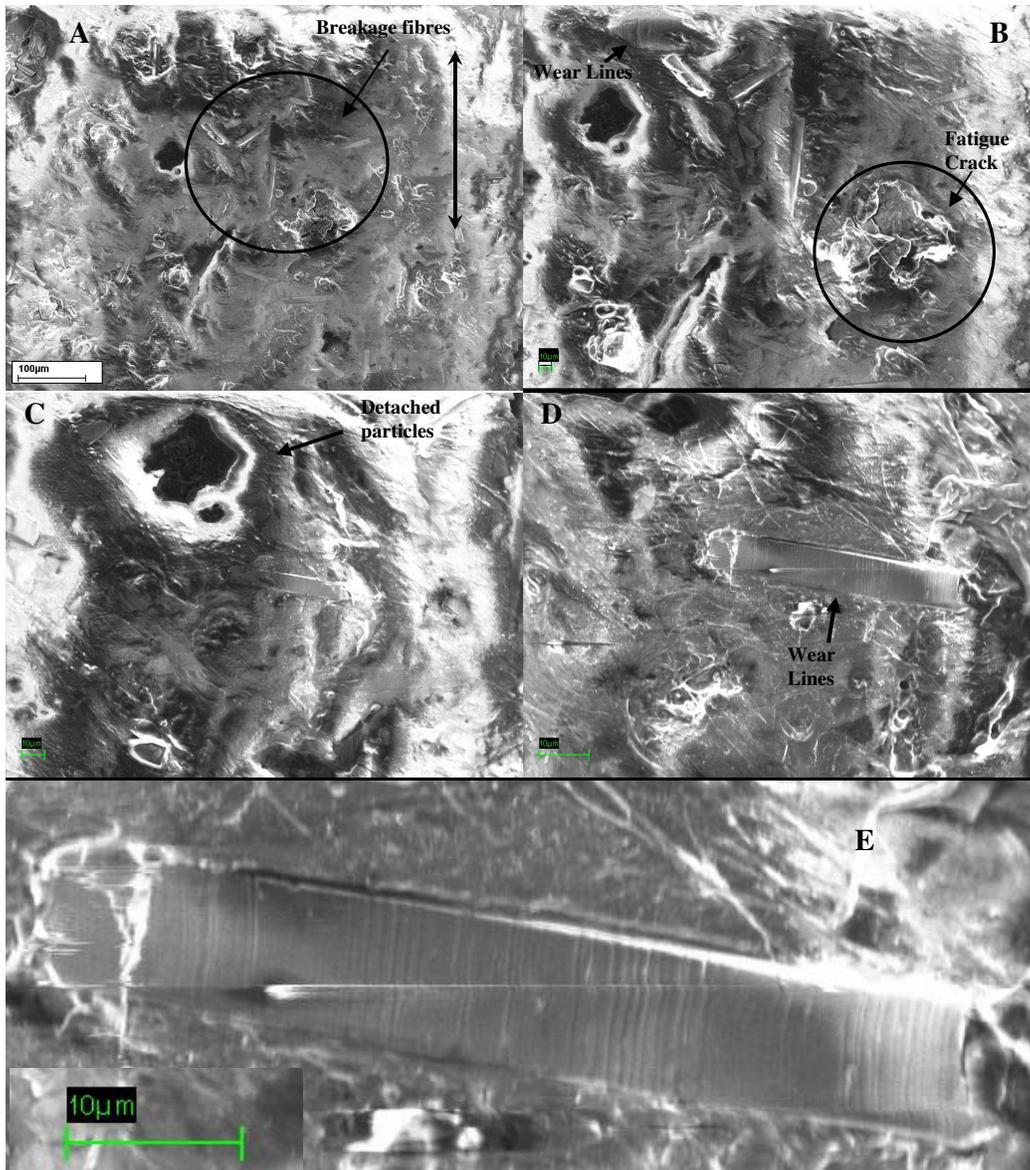
**Figure 102: SEM micrograph of an elastomer surface after the completion of sliding test A-C) Broken fibres, fatigue cracks and detached particles are depicted D-E) Wear linear scratches found on the surface of a fibre are illustrated**

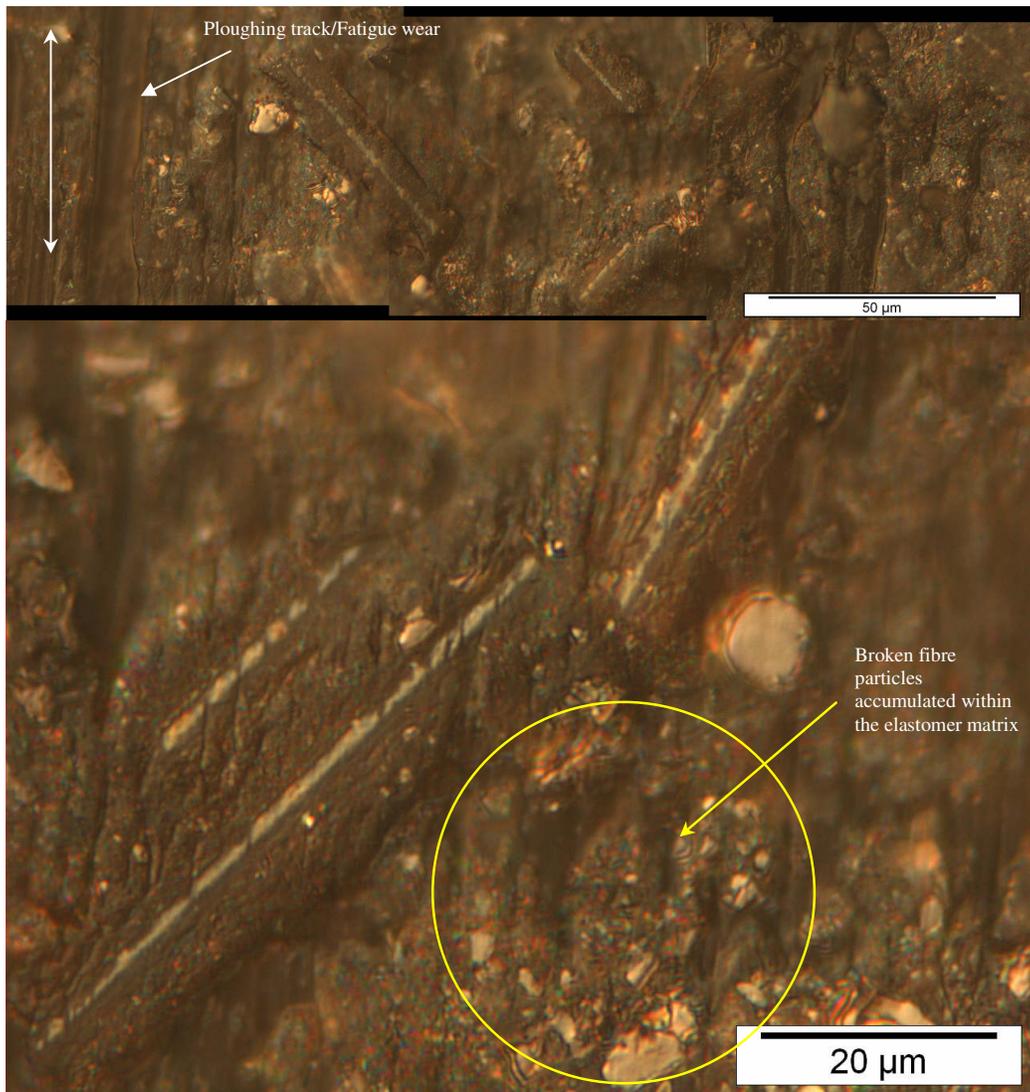
**Figure 103: Optical micrograph of A) accumulated fibres within the elastomer matrix B) detailed representation of the damage surface of the fibres**

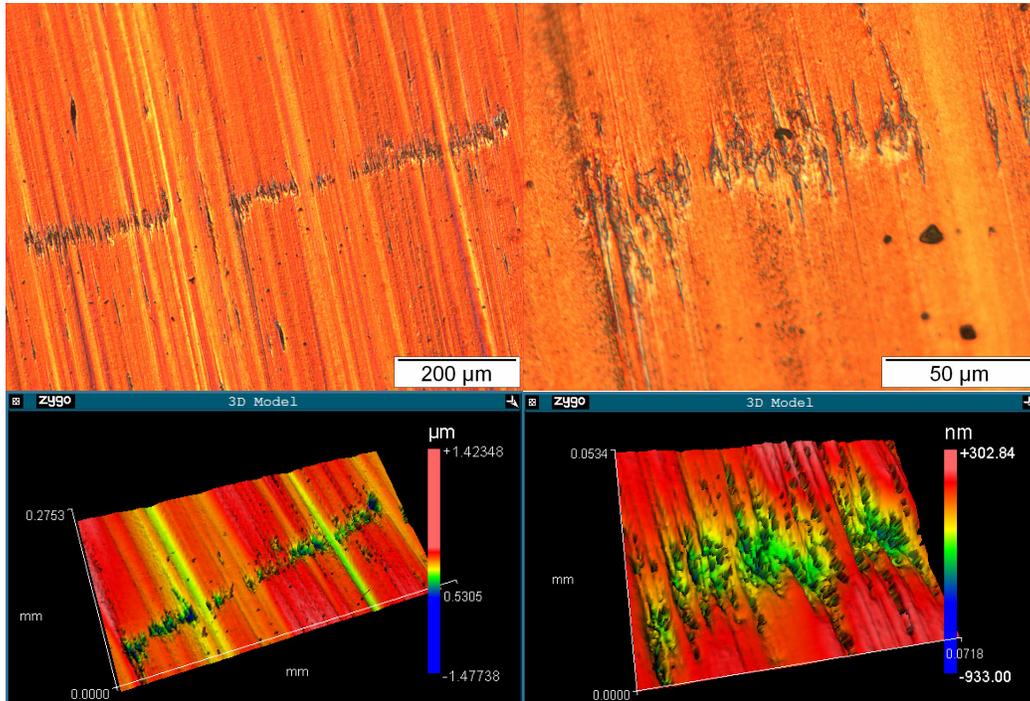
**Figure 104: Optical microscope images of the fatigue crack developed by three-body abrasion particles. Zygo interferometer microscope reveals the size and the depth of this track.**

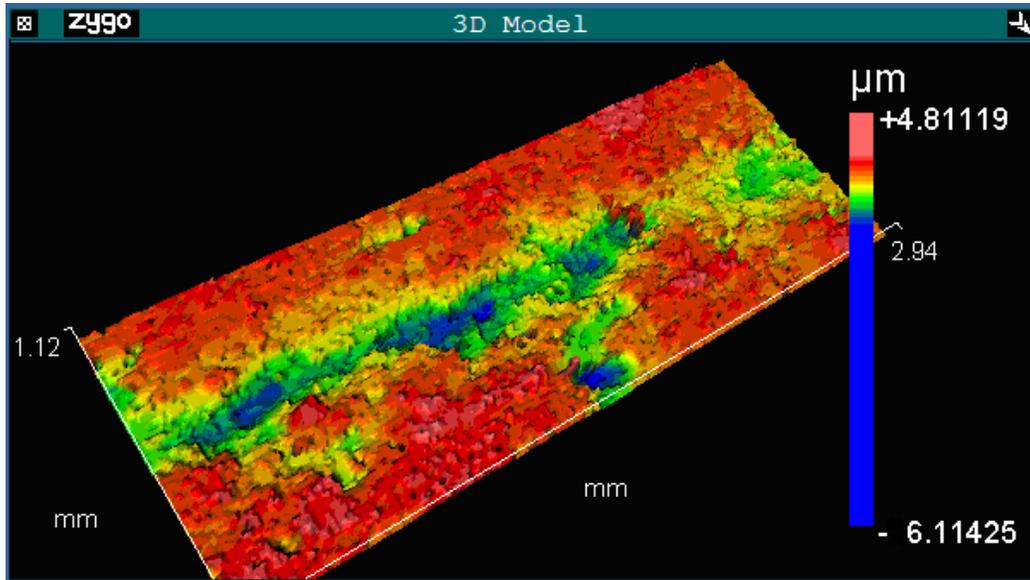
**Figure 106: ZYGO interferometer image shows the morphology of the inside folds of fatigue track.**

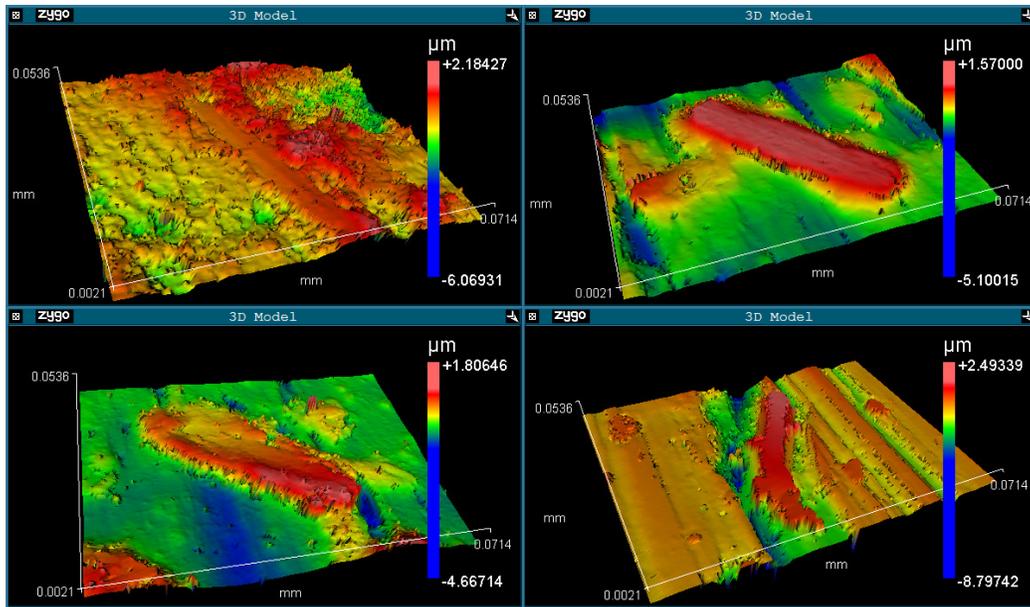
**Figure 107: Fibre analysis on the surface of the fluoroelastomer. a) position of the fibre within the original surface (before test) b) fibre revealed on the surface (after test) c) fibre damaged “oblate shape” d) fibre between a micro-crack and a micro-ploughing wear mark**

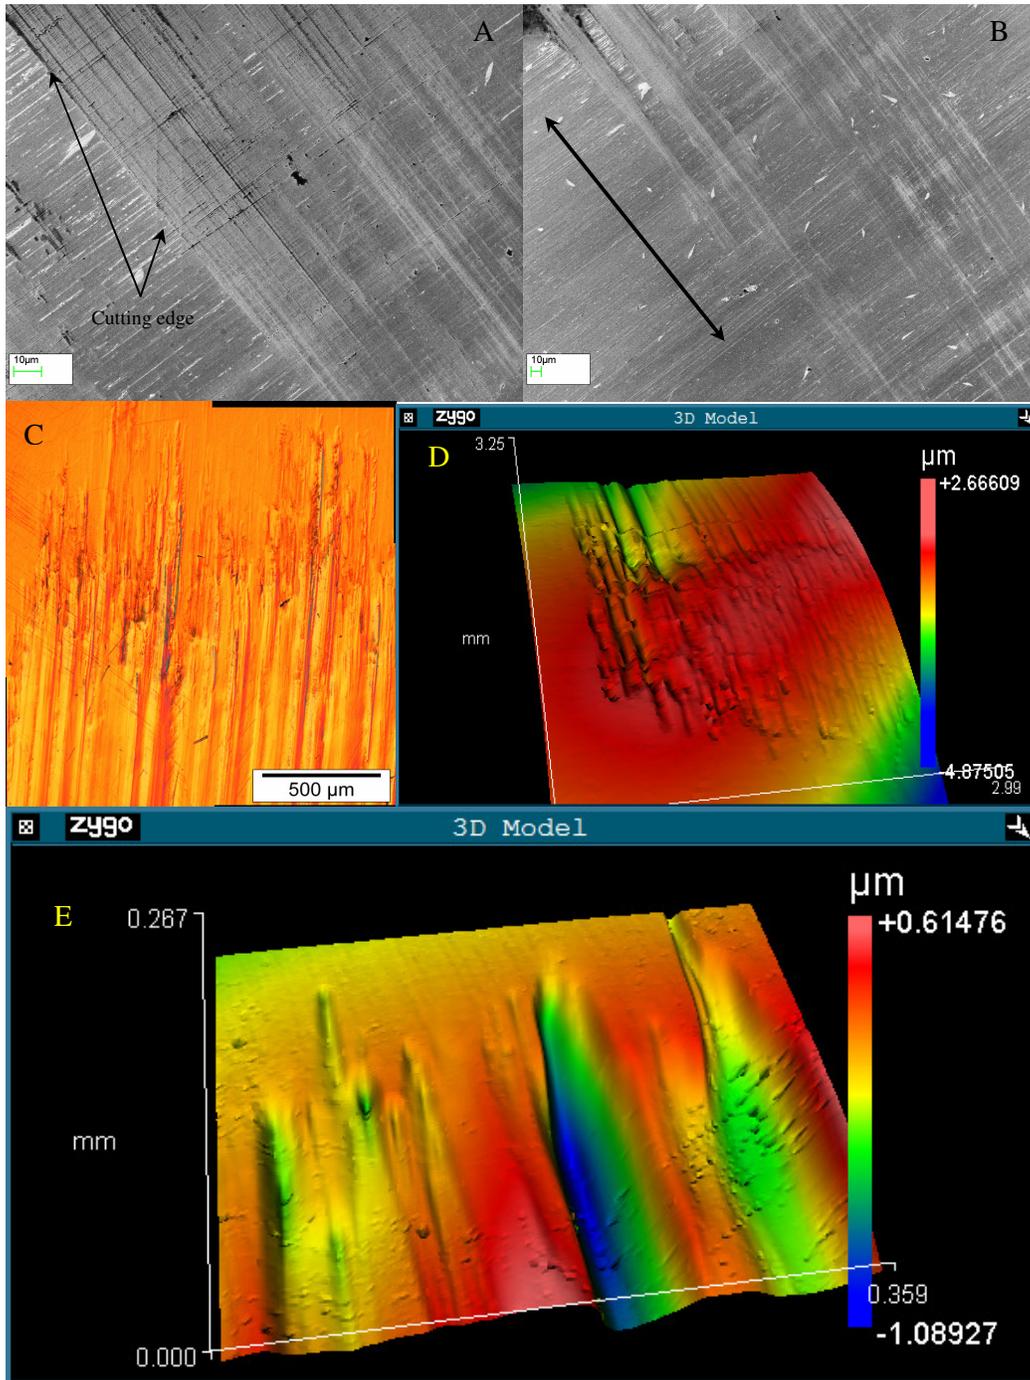
Figure 108: Typical steel plate wear damage. Test conditions were adjusted at 150<sup>0</sup>C-60hours-20N-50Hz. A-B) Precise fine perpendicular cut across the edge of the steel surface by the reciprocating movement of the reinforced elastomer is observed. C-D) The main body of wear is governed by wear linear marks. E) A detailed representation of the steel edge ploughing mechanism is depicted

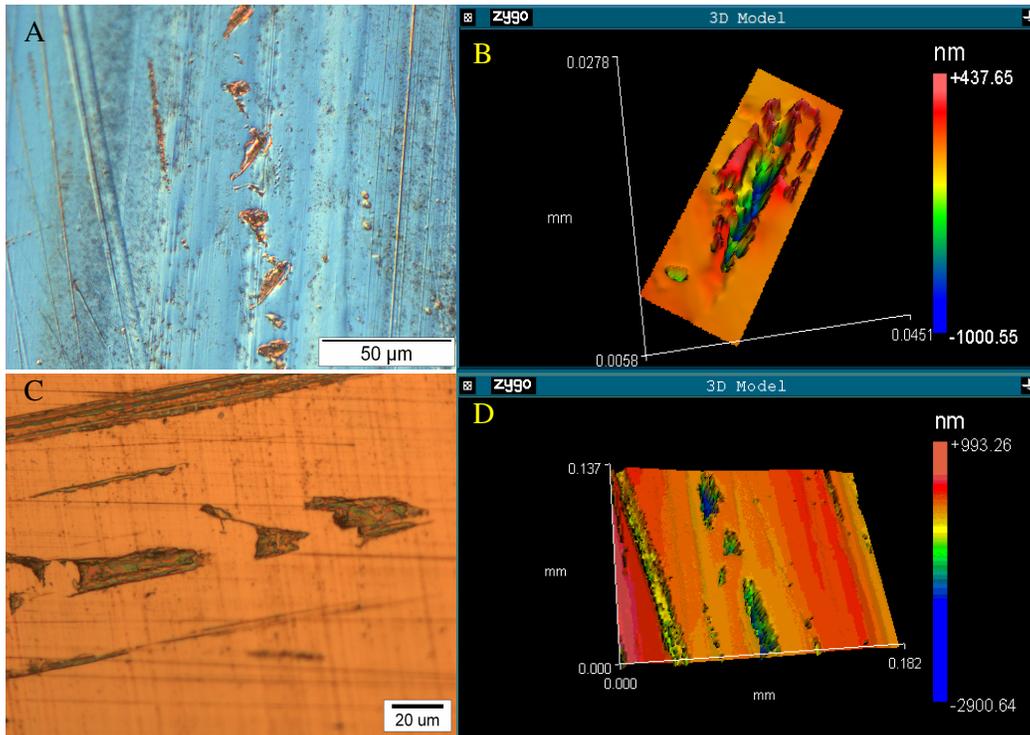
**Figure 110: Three-body wear abrasion cracks formed at 100°C on the surface of the steel plate a) average depth b) maximum depth**

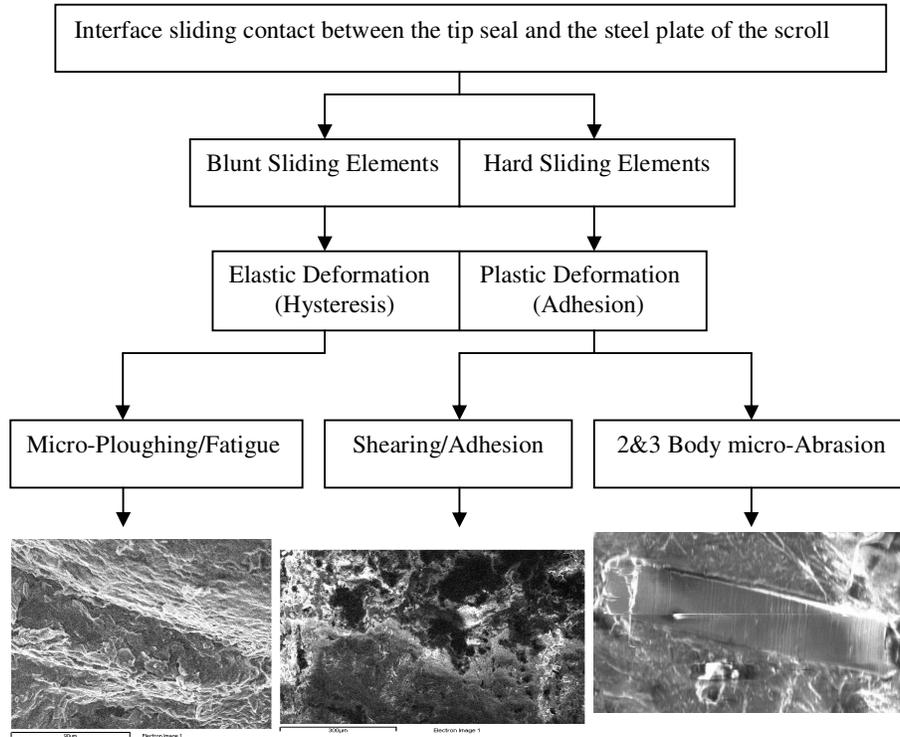
**Figure 113: Classification of the sliding friction process leading to wear of the elastomer tip seal.**

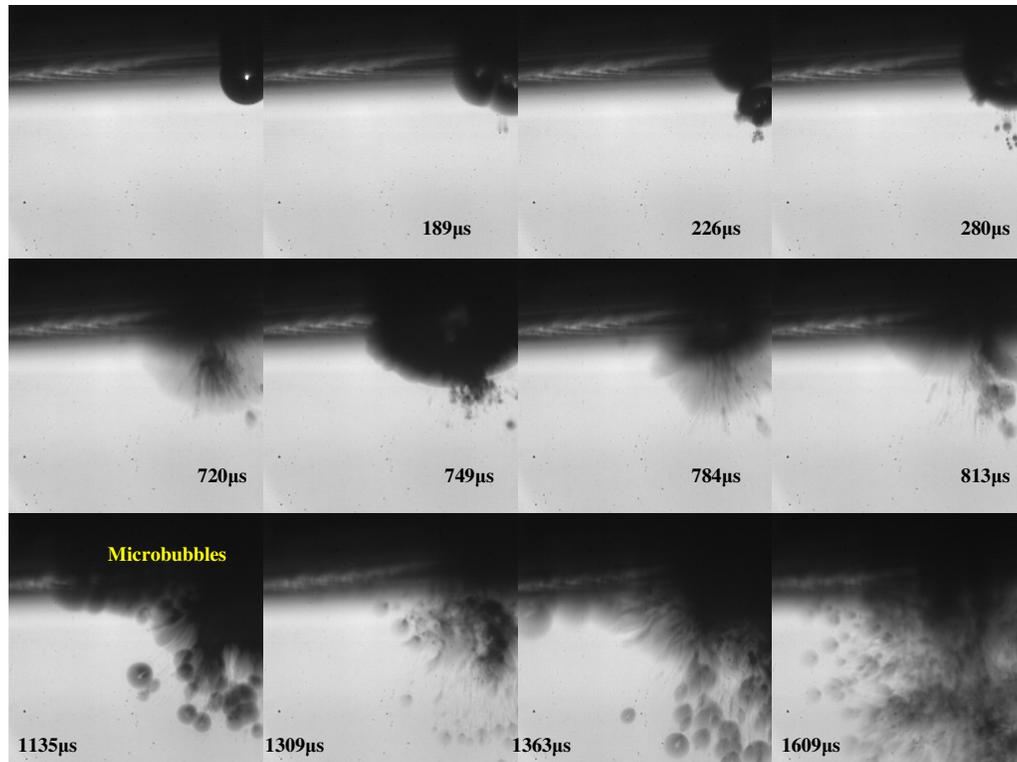
Figure 115: Expansion mode of an acoustic cavitation water bubble at its incubation stage onto the lower surface of the horn. The frame size is 0.5×0.5 mm.
