*Sustainable design and durability of  
domestic micro combined heat and  
power scroll expander systems*

*Thesis submitted in a partial fulfilment of the  
requirements of Bournemouth University for  
the degree of Doctor of Philosophy*

*by Iakovos Tzanakis*

*Bournemouth University  
in collaboration with the  
Energetix Group Ltd.*

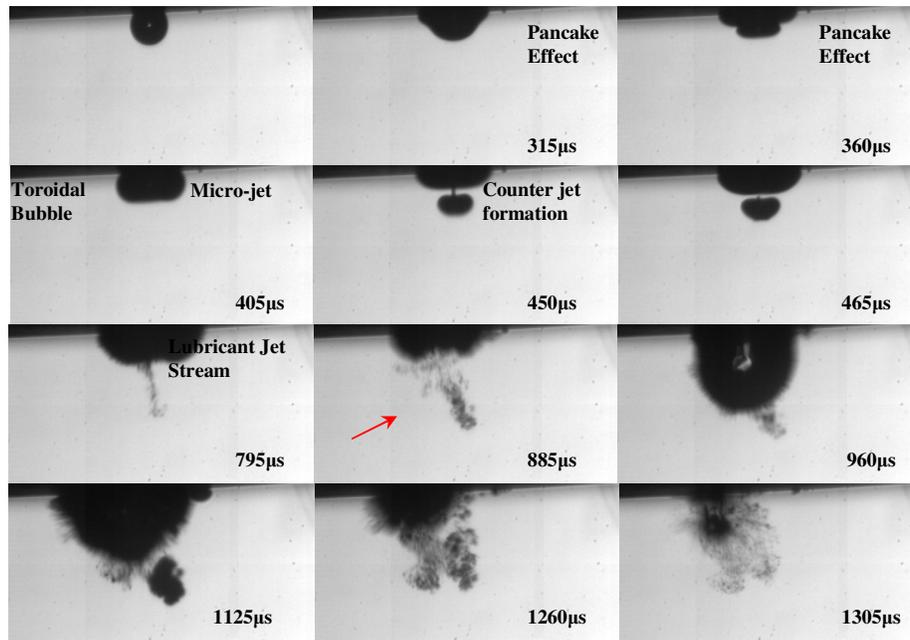
**Figure 116: Expansion mode of an acoustic cavitation lubricant bubble on the tip of the horn. The frame size is 1 x 0.5 mm.**

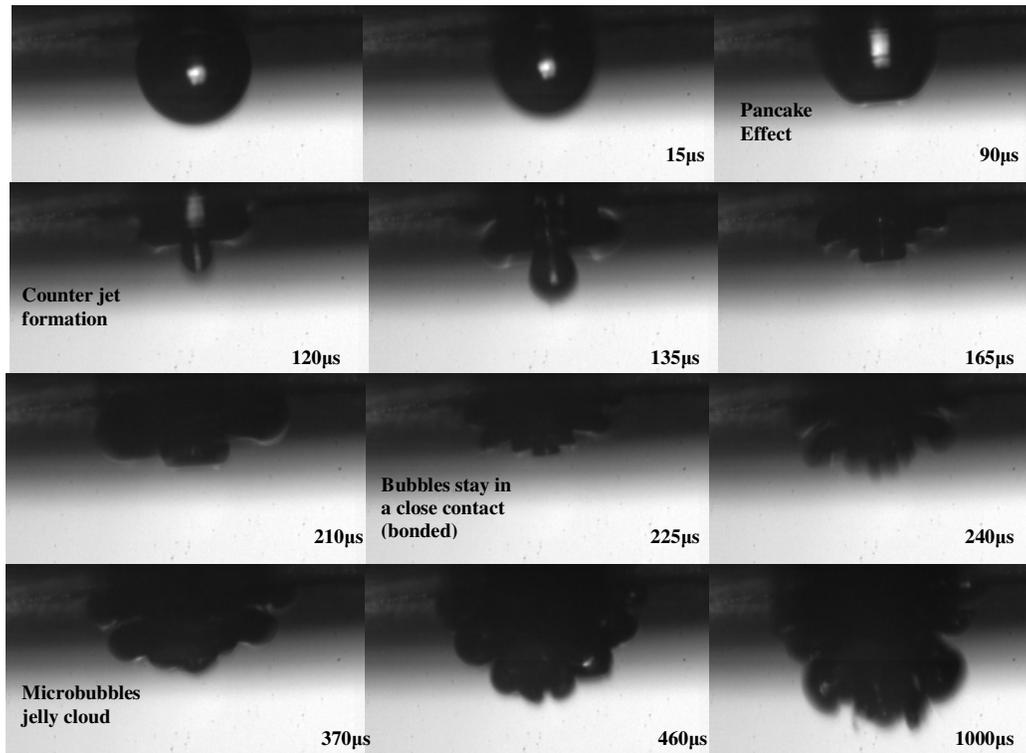
**Figure 117: Expansion mode of an acoustic cavitation refrigerant bubble on the tip of the horn. The “jelly” cloud shape is shown. The frame size is 1×0.5 mm.**

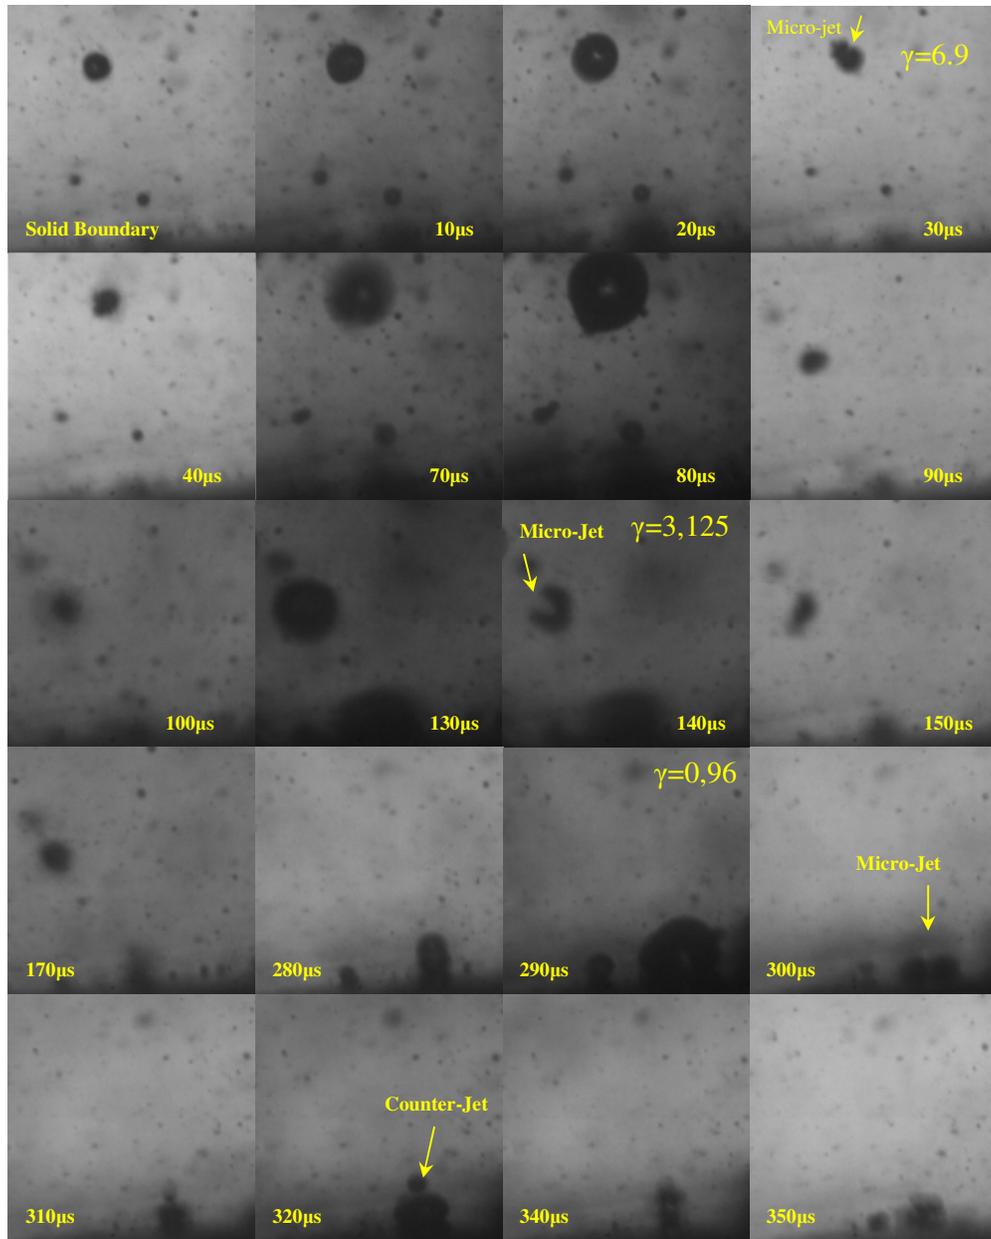
**Figure 120: Behaviour of an acoustic cavitation water bubble in correlation to the normalized distance as it approaches the rigid boundary. The frame size is 0.5×0.5 mm.**

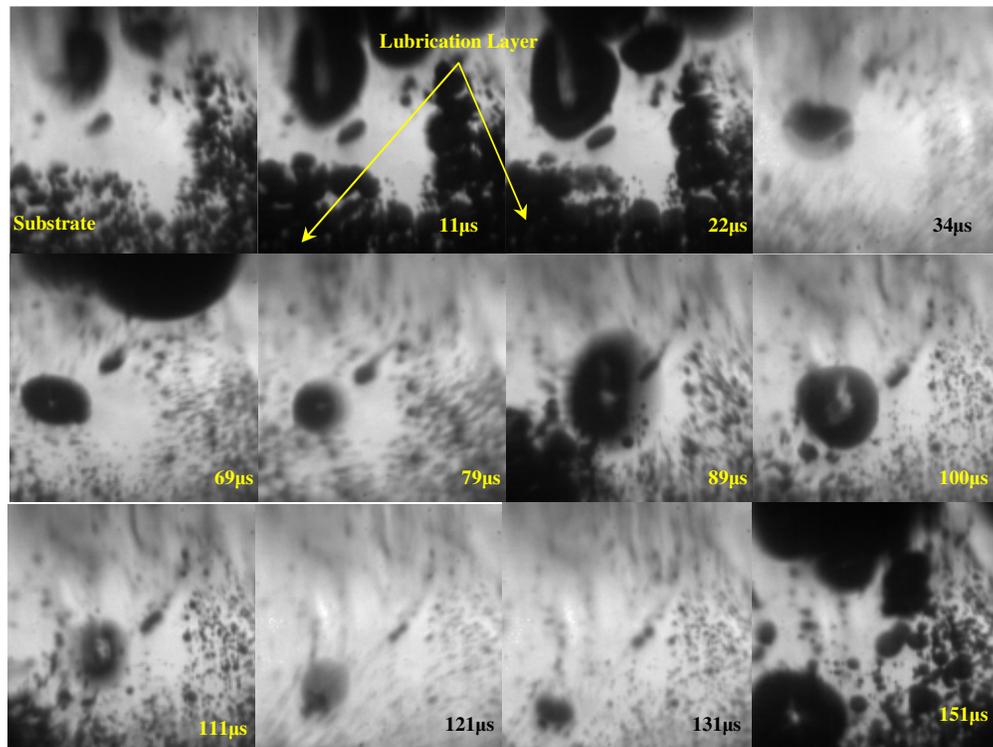
**Figure 122: Collapse of an acoustic cavitation lubricant bubble near the solid boundary. A lubrication layer is formed. The frame size is 0.5×0.5 mm.**

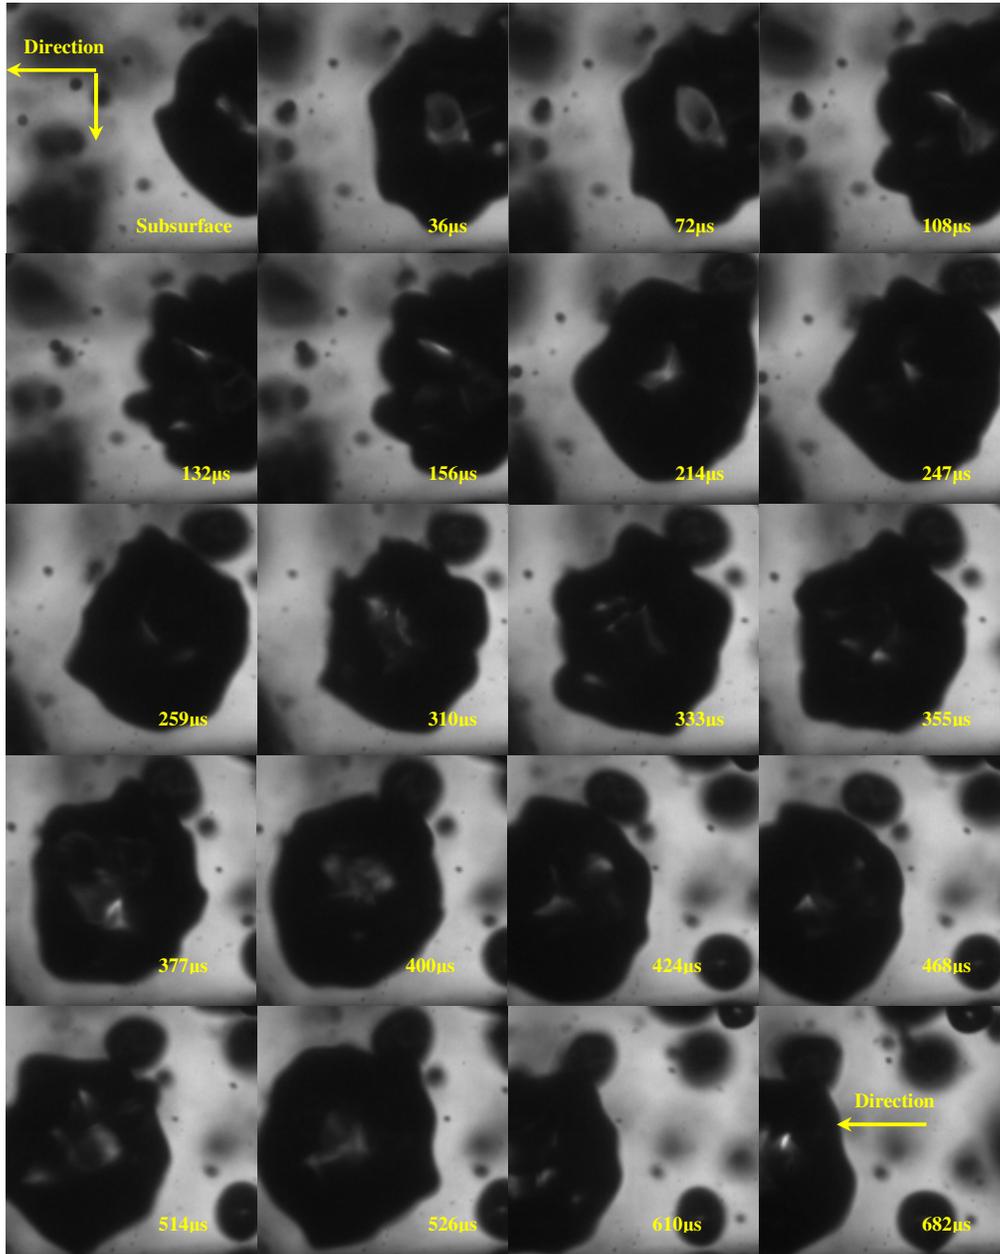
**Figure 125: The ceaselessly wobbling movement of an acoustic cavitation refrigerant bubble near the solid boundary. The frame size is 0.5×0.5 mm.**

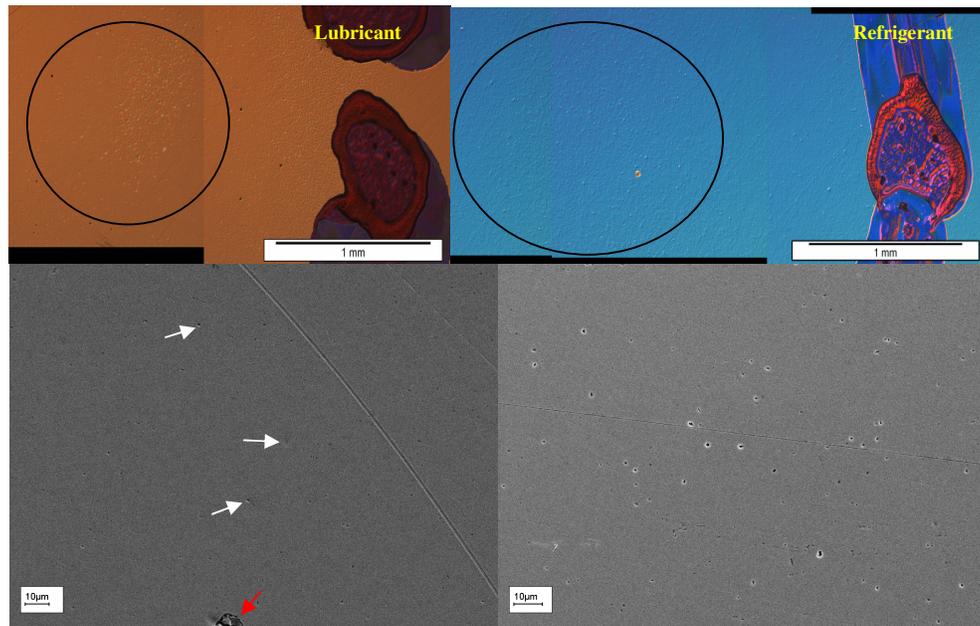
**Figure 133: Cluster of cavities formation on steel plate surface after 10 minutes of testing. Optical micrographs showing the cavities formation: in lubricant and refrigerant environment. High magnification SEM micrographs showing the cavitation pits formed in these areas.**

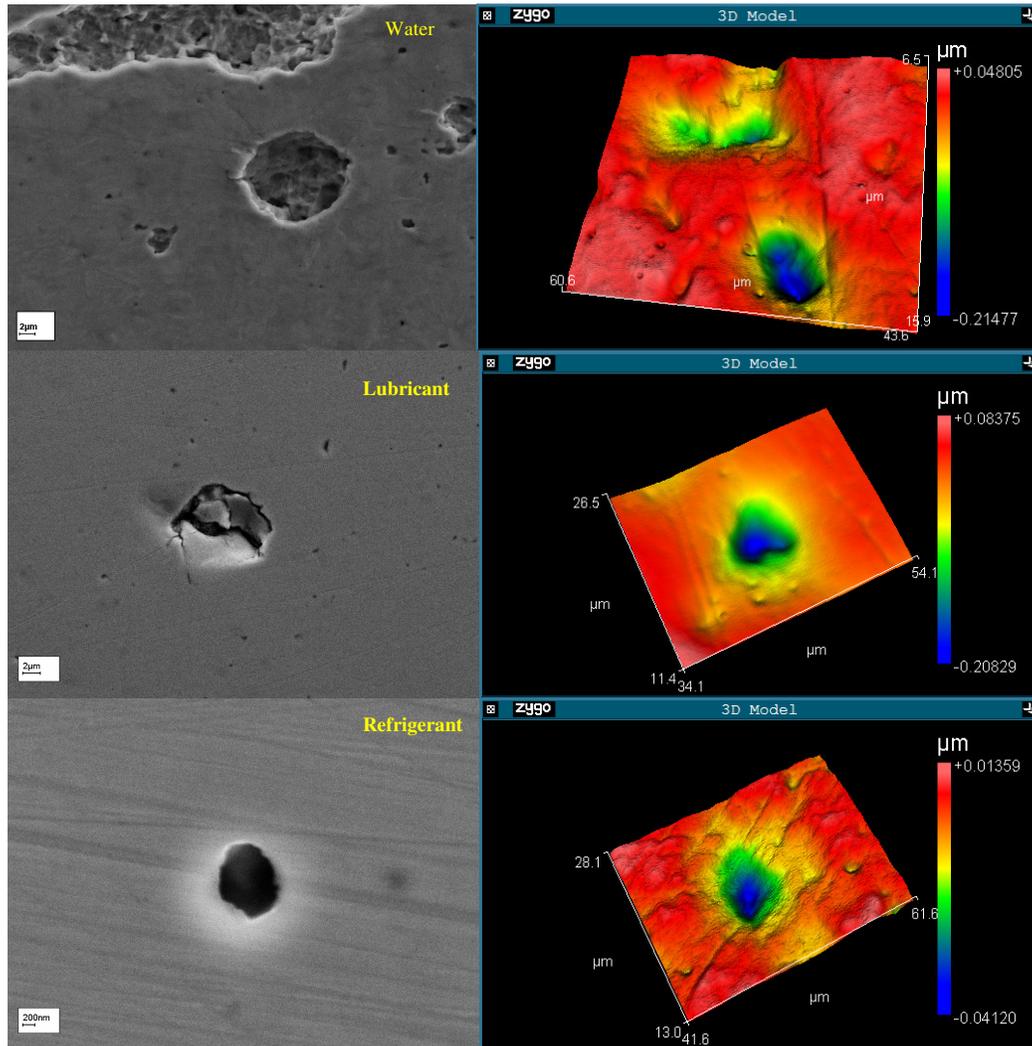
**Figure 134: SEM and high magnification ZYGO micrographs showing a typical cavitation erosion pit formed in water, lubricant and refrigerant solution.**

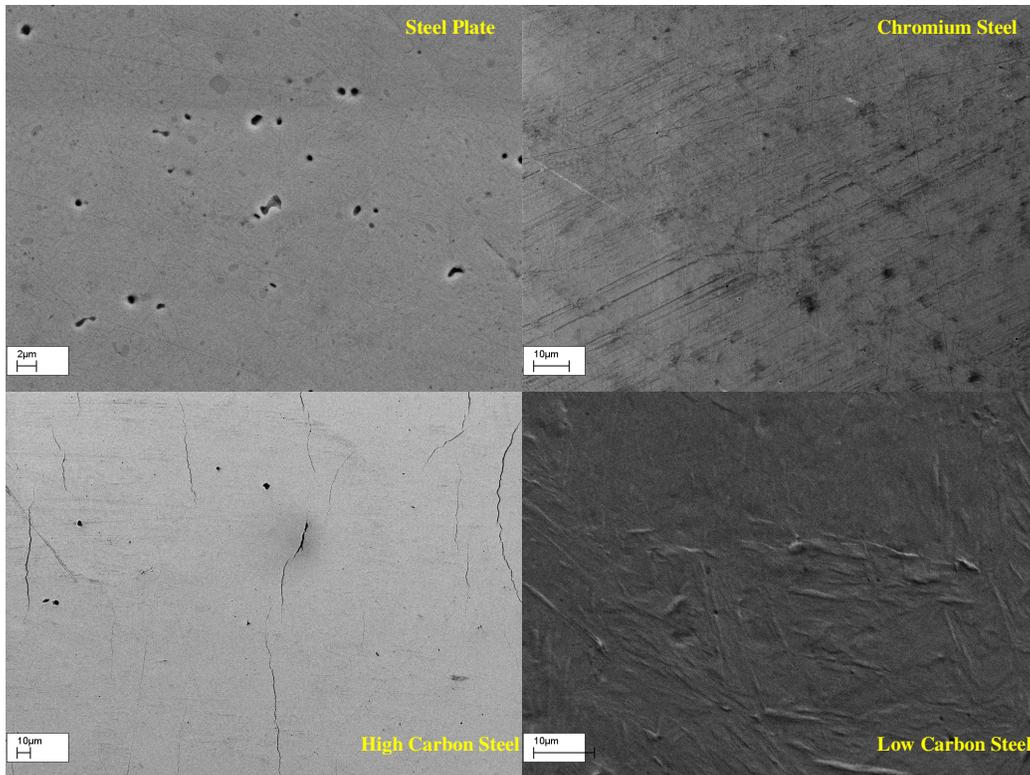
**Figure 135: SEM micrographs showing the deformation of the tested steel types after 10 minutes of exposure to cavitation in a water solution.**

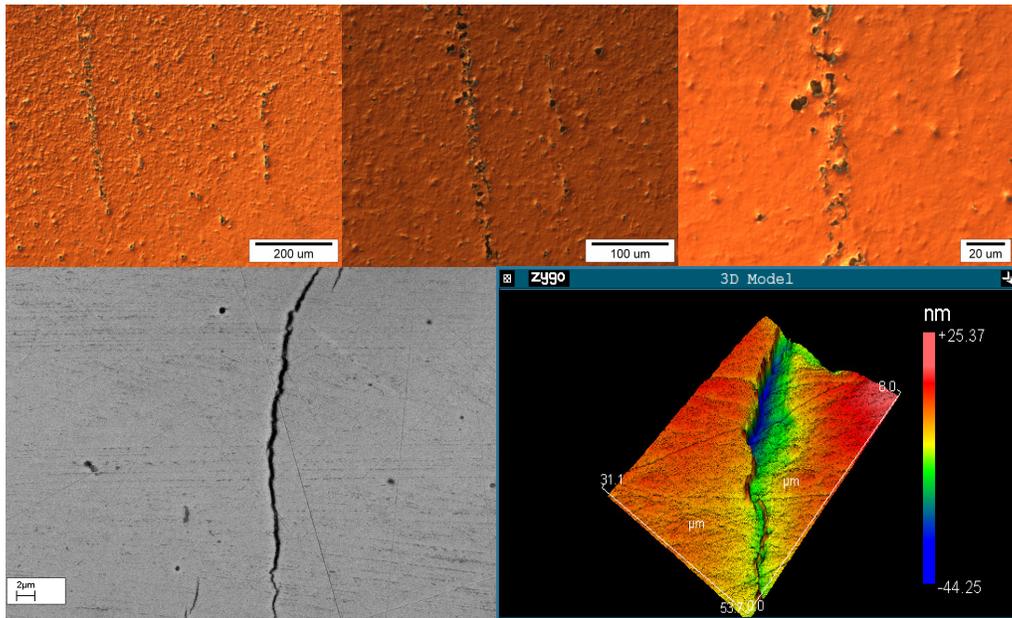
**Figure 137: Optical microscope images showing the accumulation of cavities along the cracks of the High Carbon steel. SEM micrograph shows the morphology of the crack. High magnification ZYGO interferometer image shows the step of the crack.**

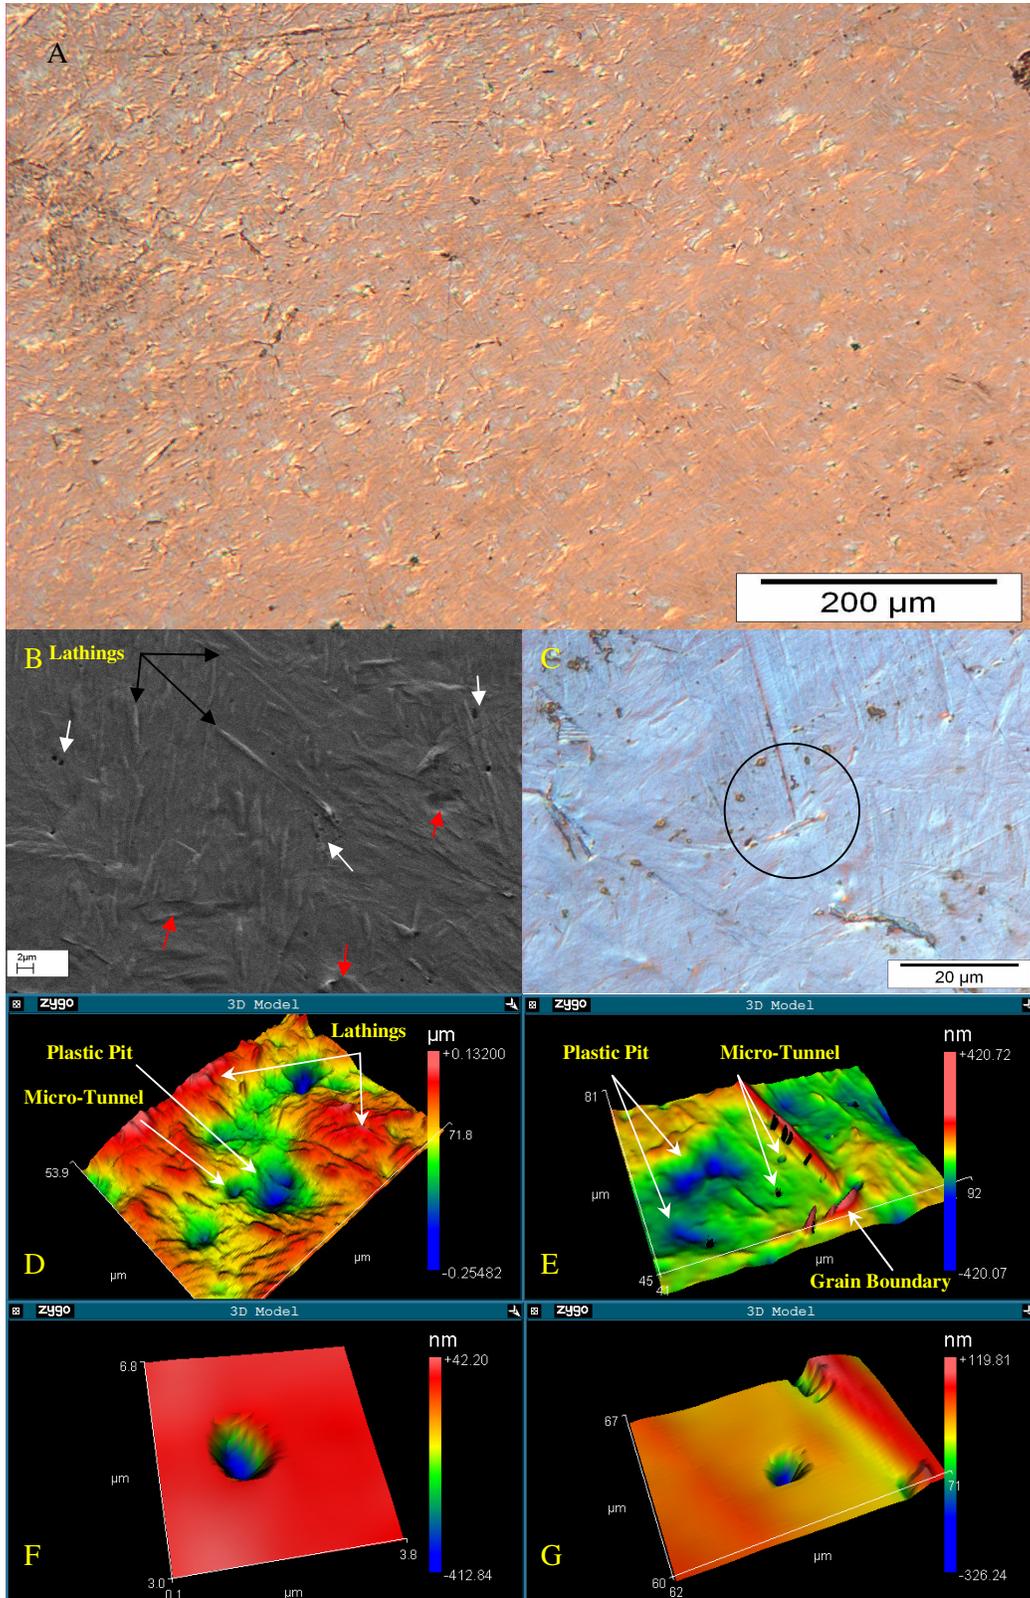
**Figure 138: Optical and SEM images of cavitation damage arisen on Low Carbon steel surface after 10 min of exposure to cavitation. A-C) Martensitic lathings and intergranular fracture revealed. ZYGO interferometer image shows a typical eroded area surface. D-G) Micro-tunnel and deformation pits are depicted.**

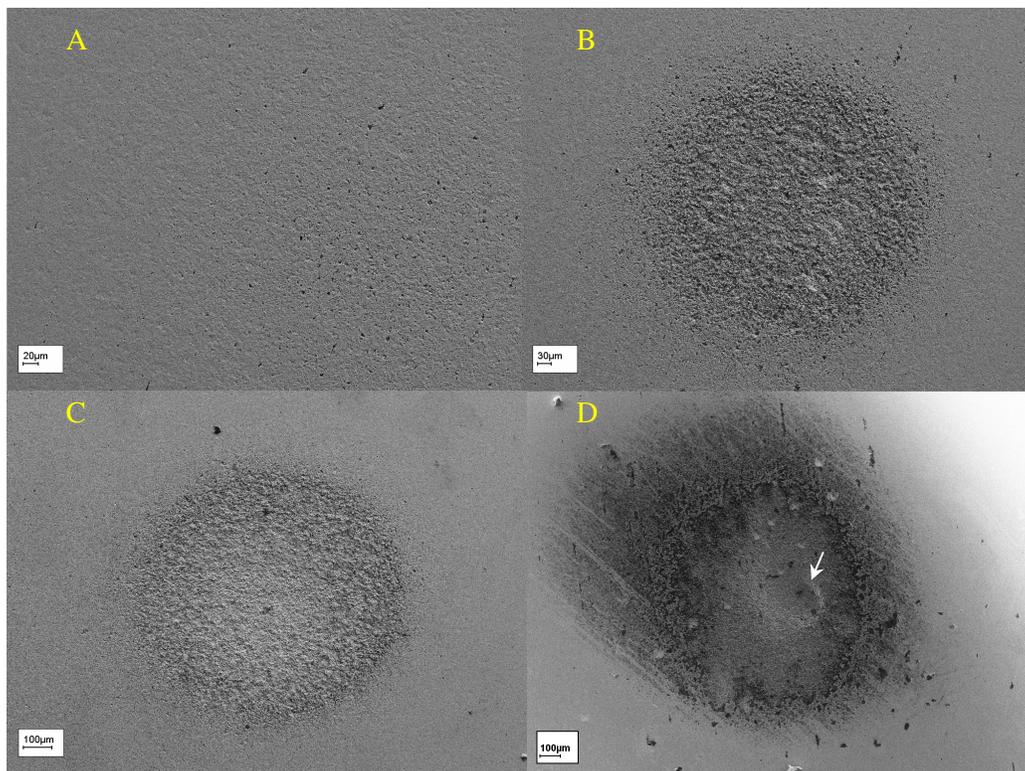
**Figure 142: SEM images of eroded areas at different stages: A) 1 h B) 3 h C) 5 h D) 8 h**

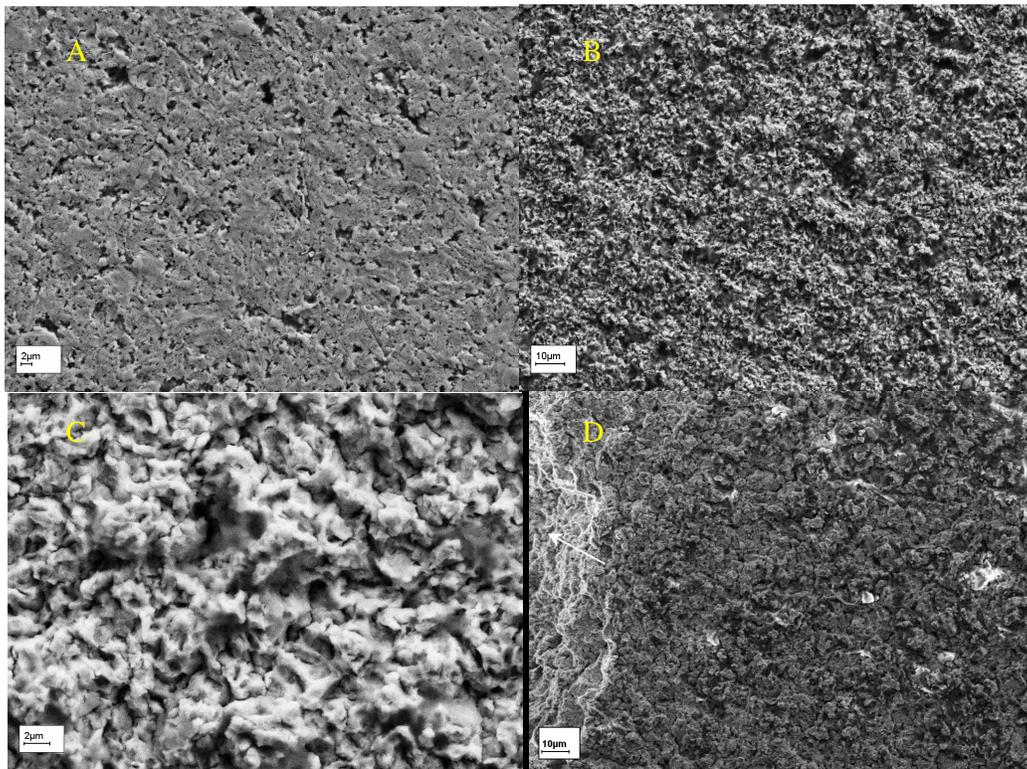
**Figure 143: A close up series of SEM micrographs showing the damage by cavitation erosion impact at different stages: A) 1 h B) 3 h C) 5 h D) 8 h**

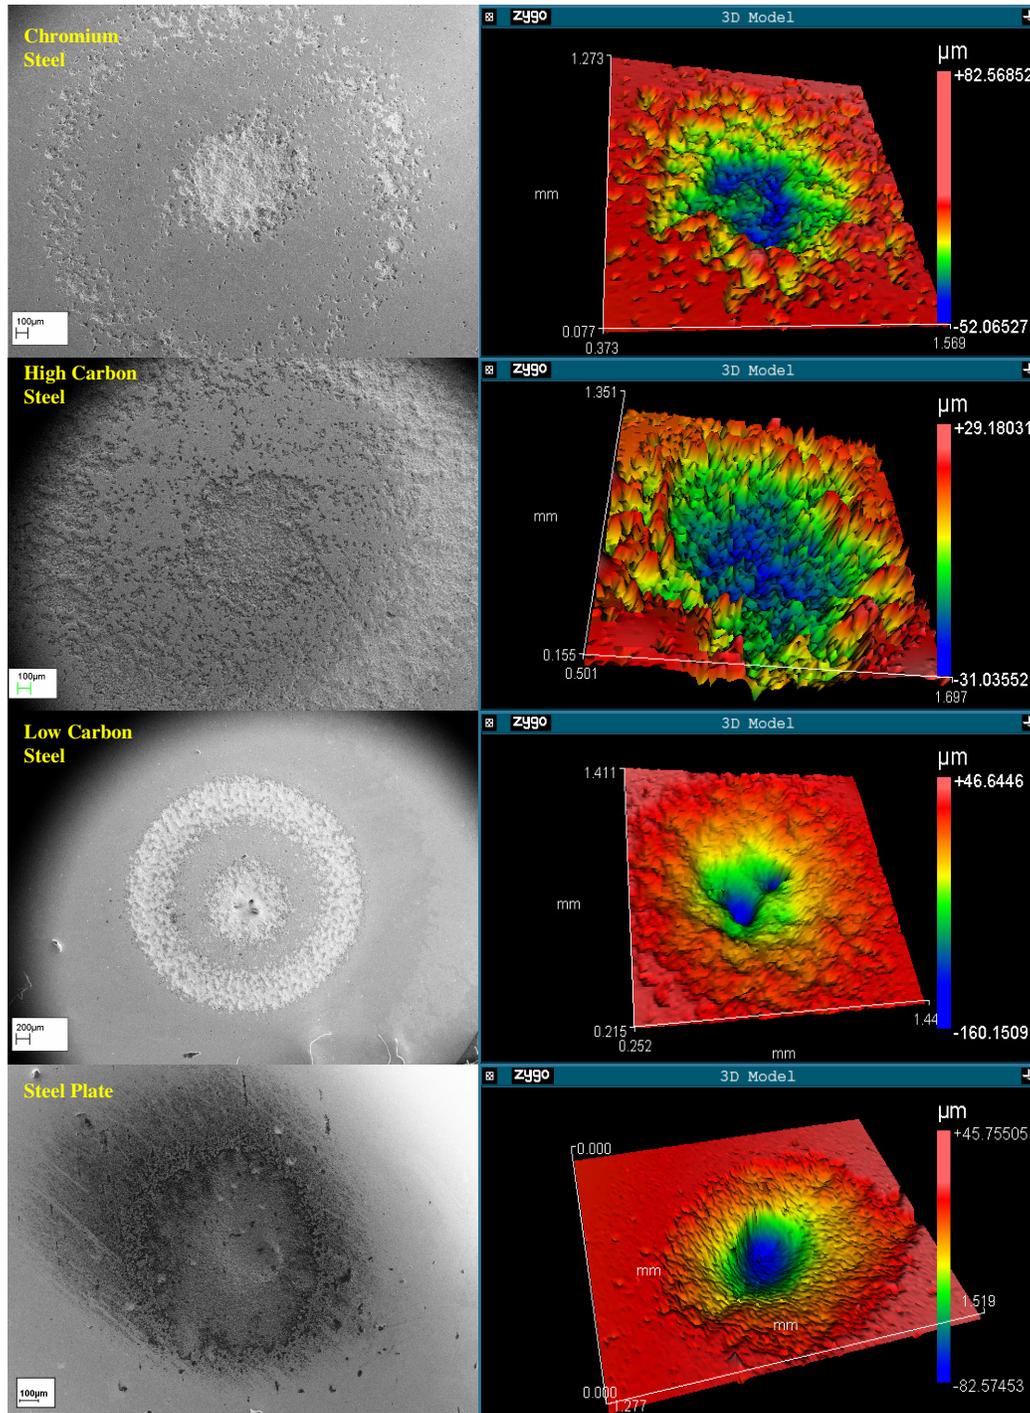
**Figure 144: Morphologies of the steel samples after 8 hours exposure to cavitation erosion.**

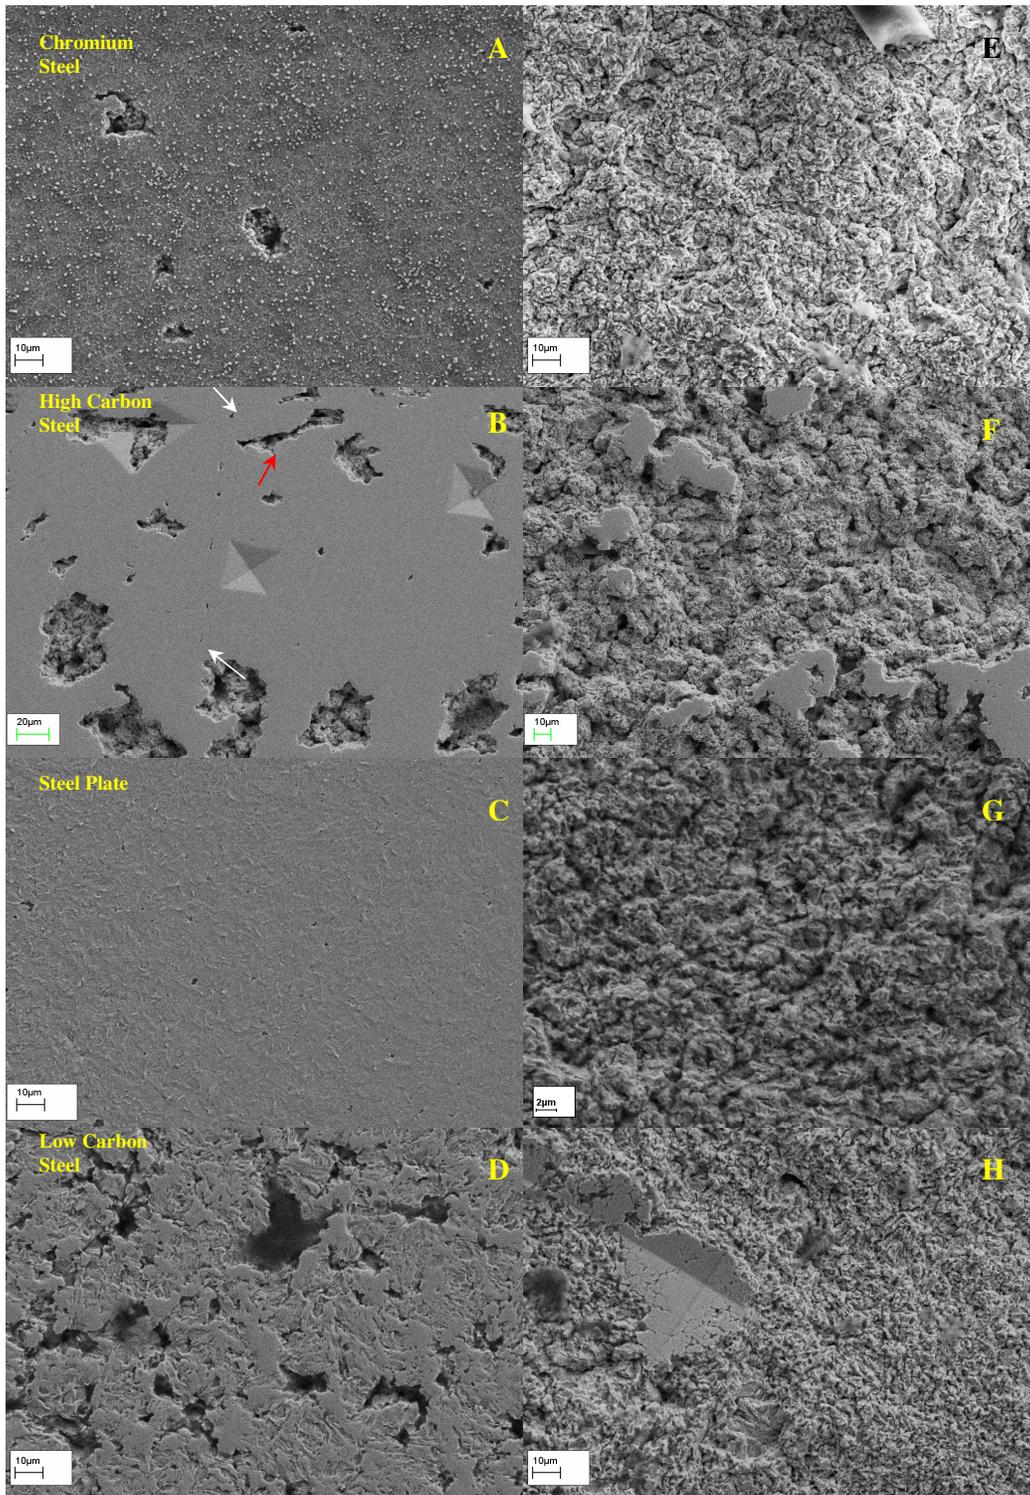
**Figure 145: Cavitation erosion damage: in the low intensity area in between the crater and the outer annulus (A-D) and in the high intensity area in the centre of the ultrasonic source (E-H).**

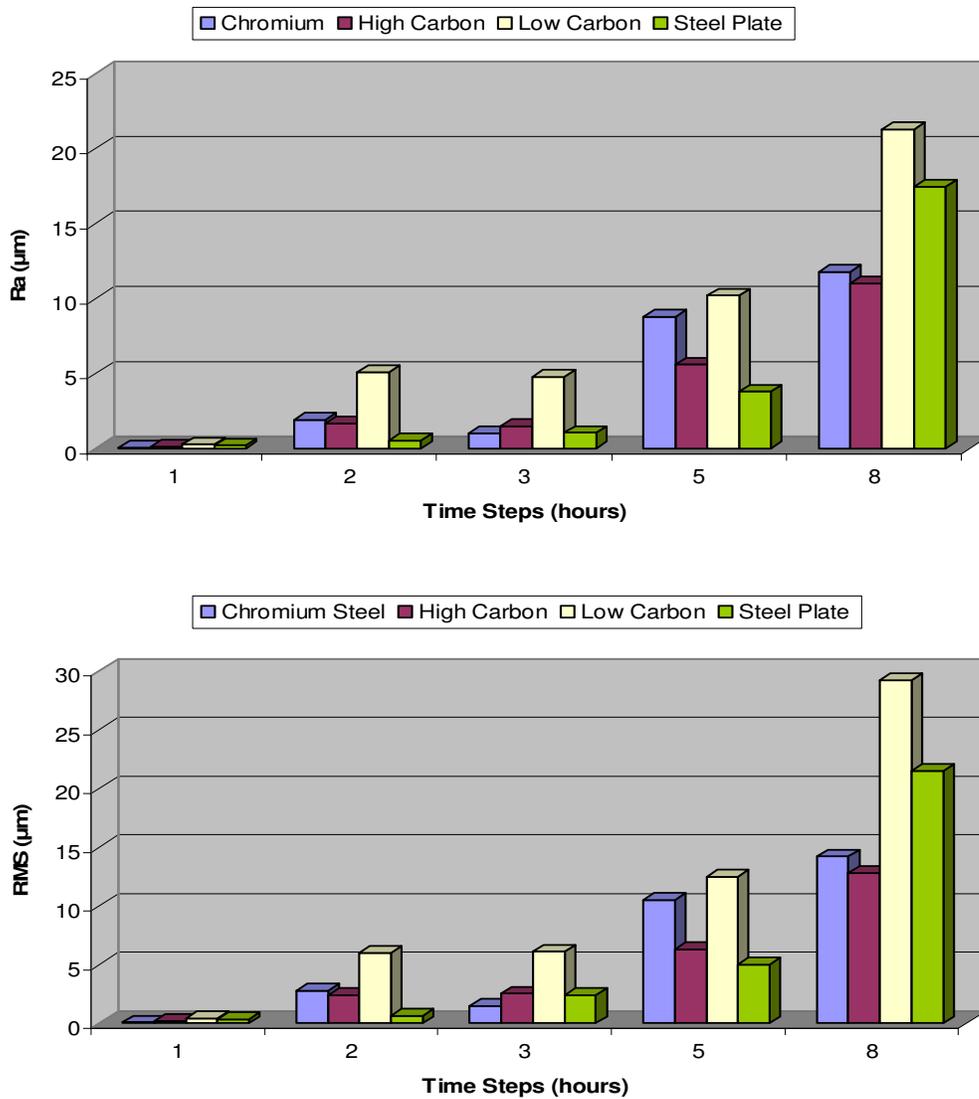
Figure 150: Evolution of the roughness parameters (Ra and RMS) in cavitation erosion tests.

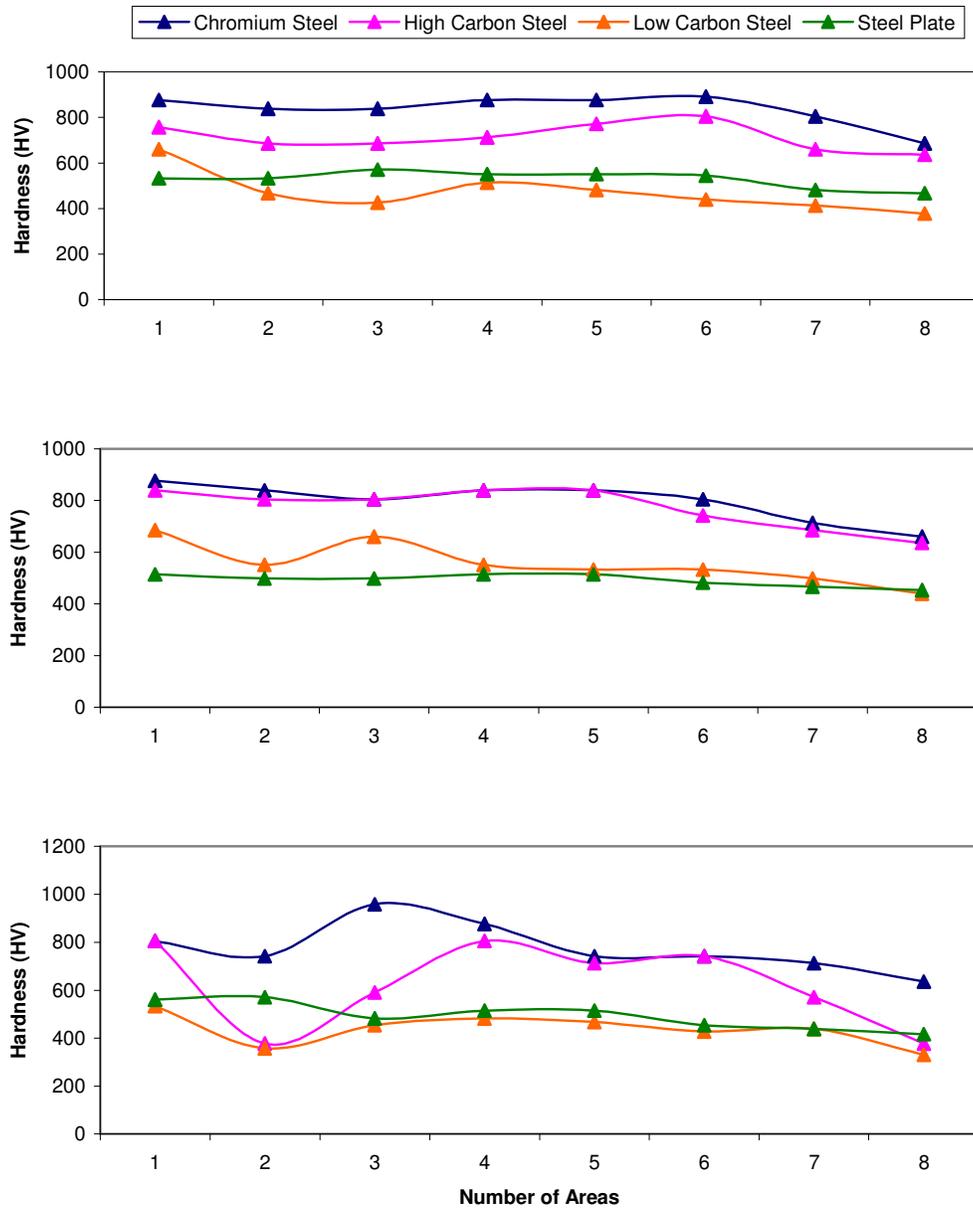
Figure 154: Hardness measurements after 3, 5 and 8 hours of exposure to cavitation. The number of areas is in accordance to figure 153.

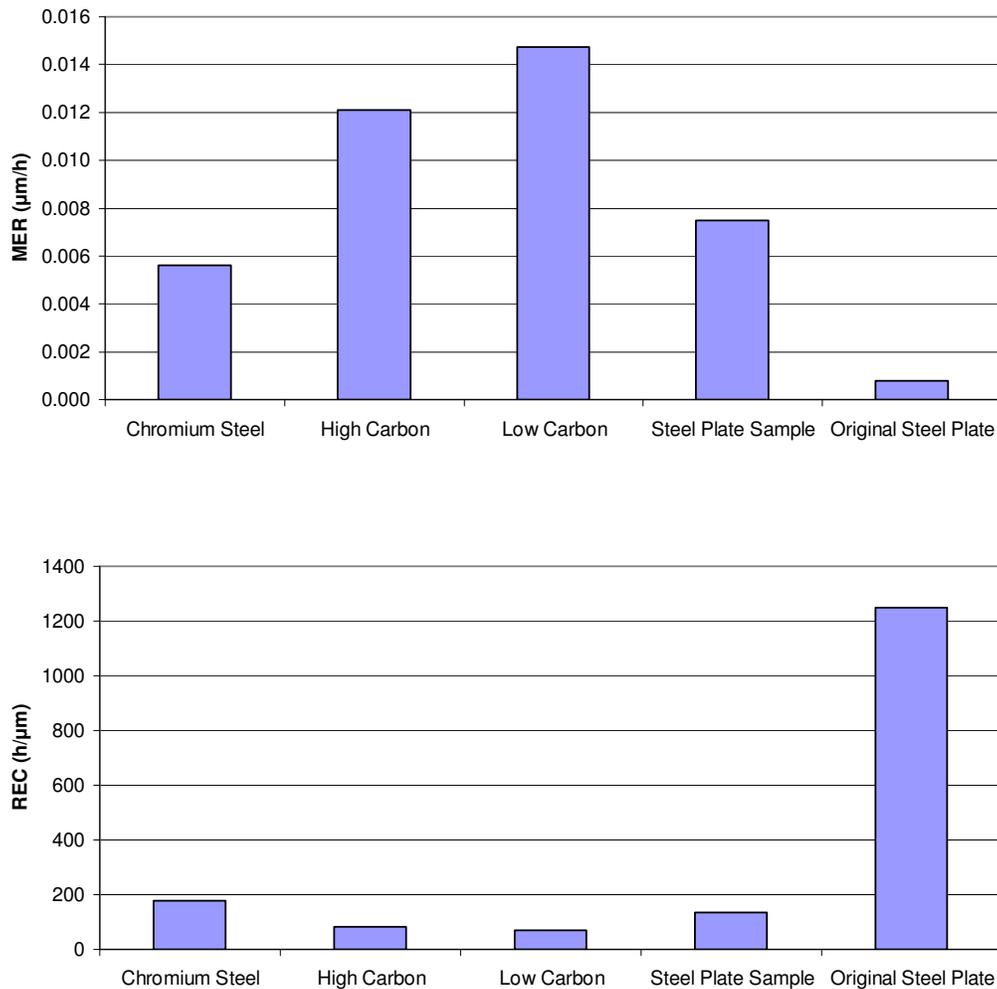
**Figure 155: Correlation of the mean erosion rate and the cavitation erosion resistance of the tested steels against the original steel plate of the scroll expander. The testing time was 1 hour for the steel samples overlying in a water liquid and 1000 hours for the actual steel plate of the scroll exposed to its extreme operational environment.**

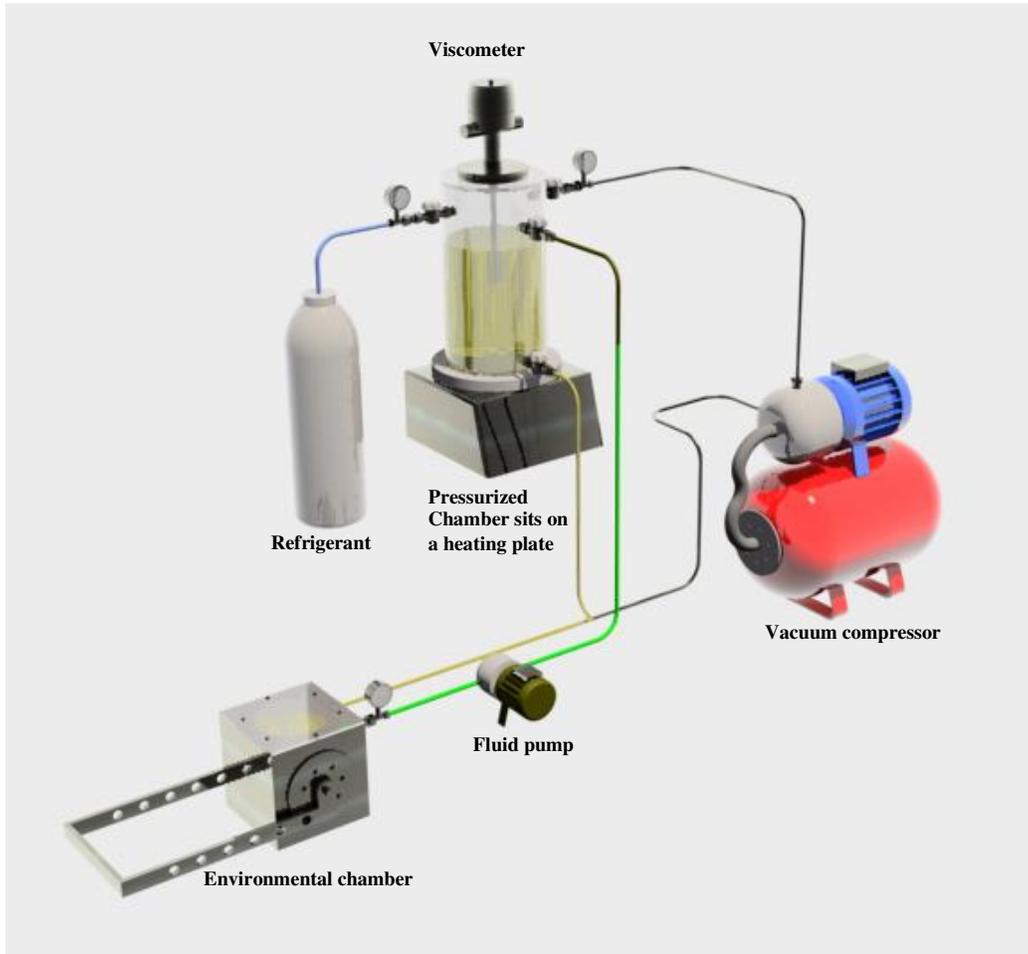
**Figure 156: Schematic representation of the modified TE 57 test rig**

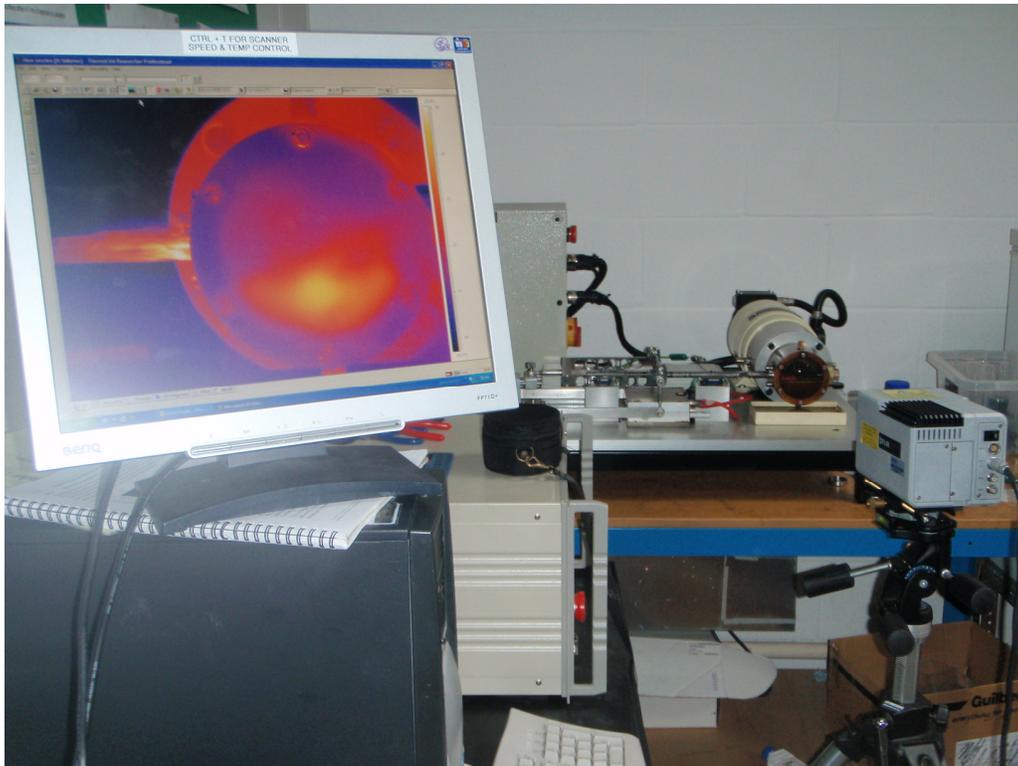
**Figure 157:** The thermal imaging system FLIR ThermoCAM SC3000 integrated to the TE 57 sliding micro-friction machine.

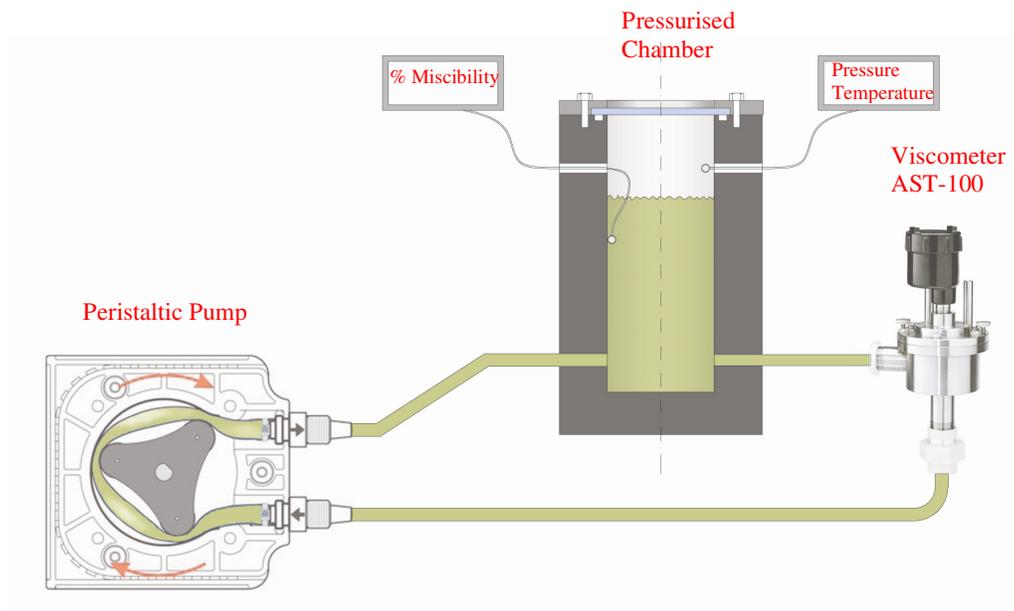
**Figure 158: Schematic representation of the viscosity test rig.**

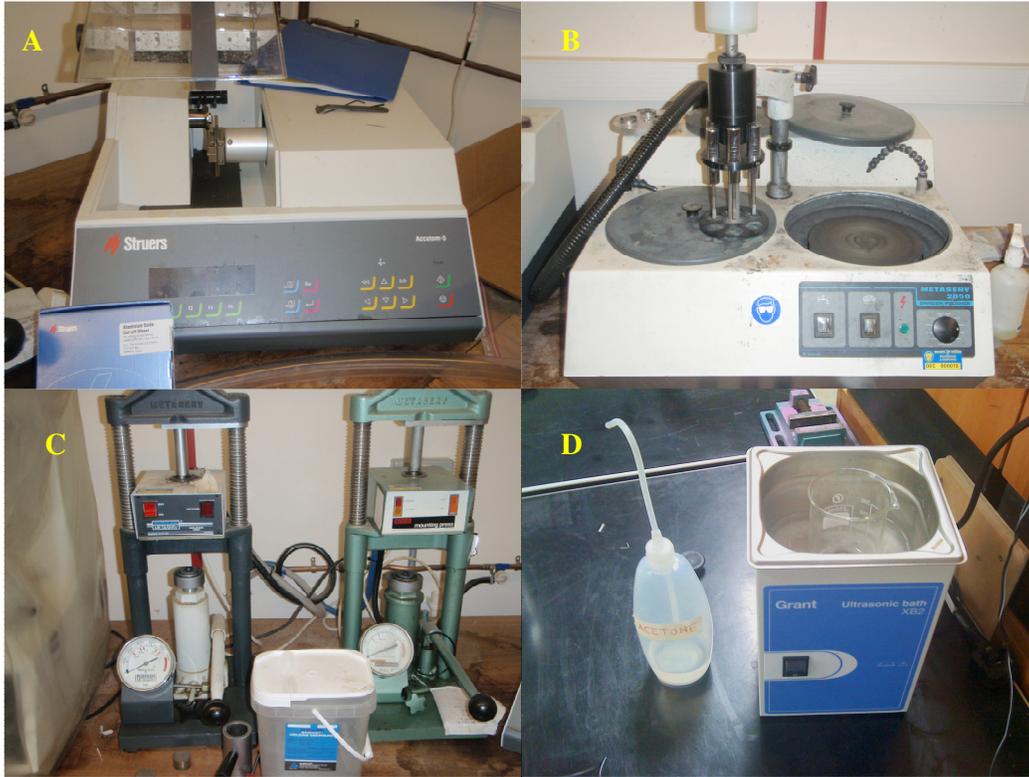
**Figure 159: A) Mounting press B) Polishing wheels C) Cutting machine D) Ultrasonic bath**

The sample was initially cut in appropriate shape and dimensions by the cutting machine and then was installed into the chamber of the mounting press where Bakelite powder was added. The sample when mounted on the Bakelite base sample was sent for grinding and polishing. Special polishing pastes and lubricants were used. Finally the steel sample was send into an ultrasonic bath for thorough cleaning. This same cleaning process was also used after the end of the some of the experiments.

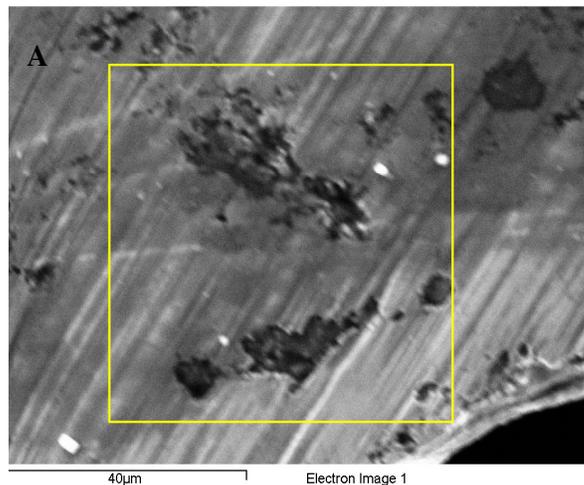
## Appendix E: Evidence of corrosion within the cavities of the steel plate of the SE<sub>1000</sub>

Element	Weight%	Atomic%
P K	1.03	1.84
S K	0.44	0.76
K K	0.62	0.88
Fe K	95.83	94.93
Cu K	0.88	0.76
Br L	1.2	0.83
Totals	100
