**NATURAL PROCESSES IN THE DEGRADATION OF OPEN-
AIR ROCK-ART SITES: AN URGENCY INTERVENTION
SCALE TO INFORM CONSERVATION**

A thesis submitted in partial fulfillment of the requirements of Bournemouth
University for the degree of Doctor of Philosophy

July 2012
Bournemouth University

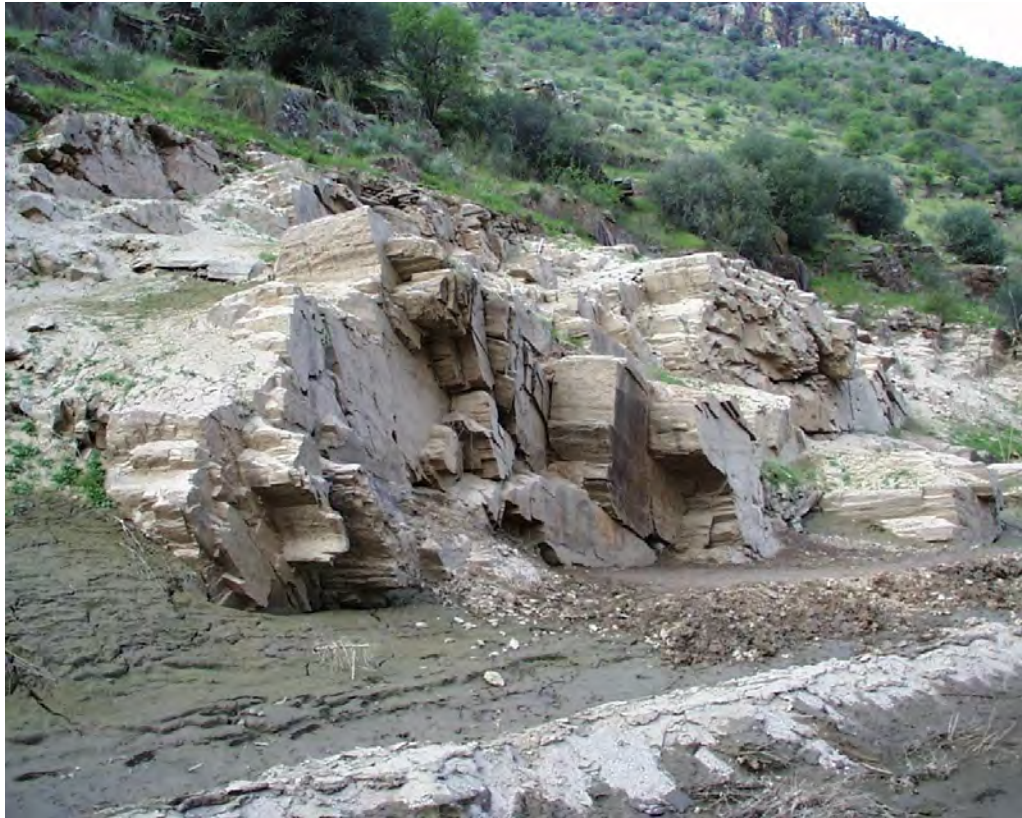
Figure 45. Ribeira de Piscos Rock 1 after flooding. Note that the soil platform area in front of the panel with the tangling horses results from deposition by a flooding episode.

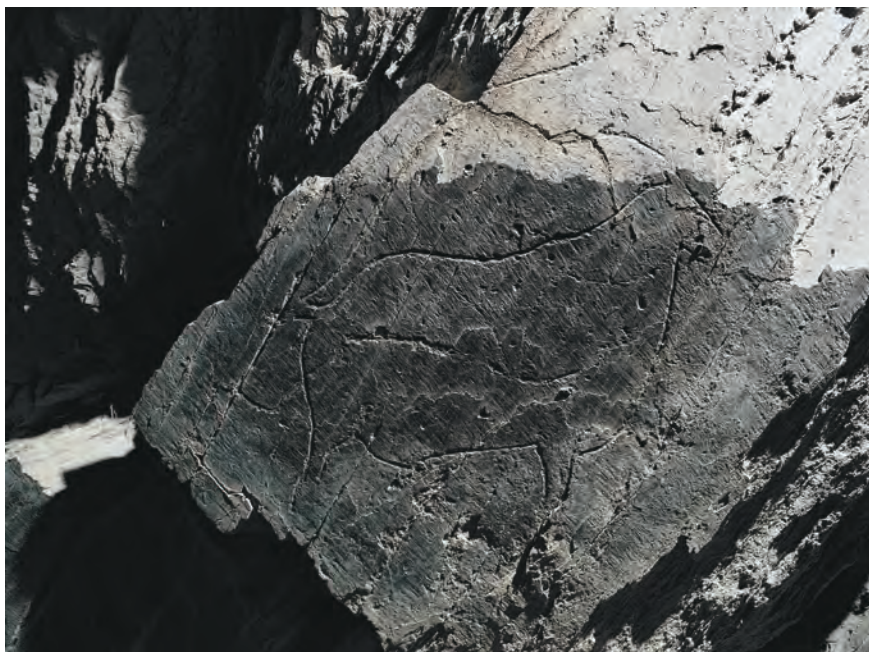
Figure 46. Goat in Penascosa Rock 5. The posterior line that makes part of the animal's front leg is not engraved but is rather a natural fracture of the rock. Photo in Baptista (1999, 106-7).

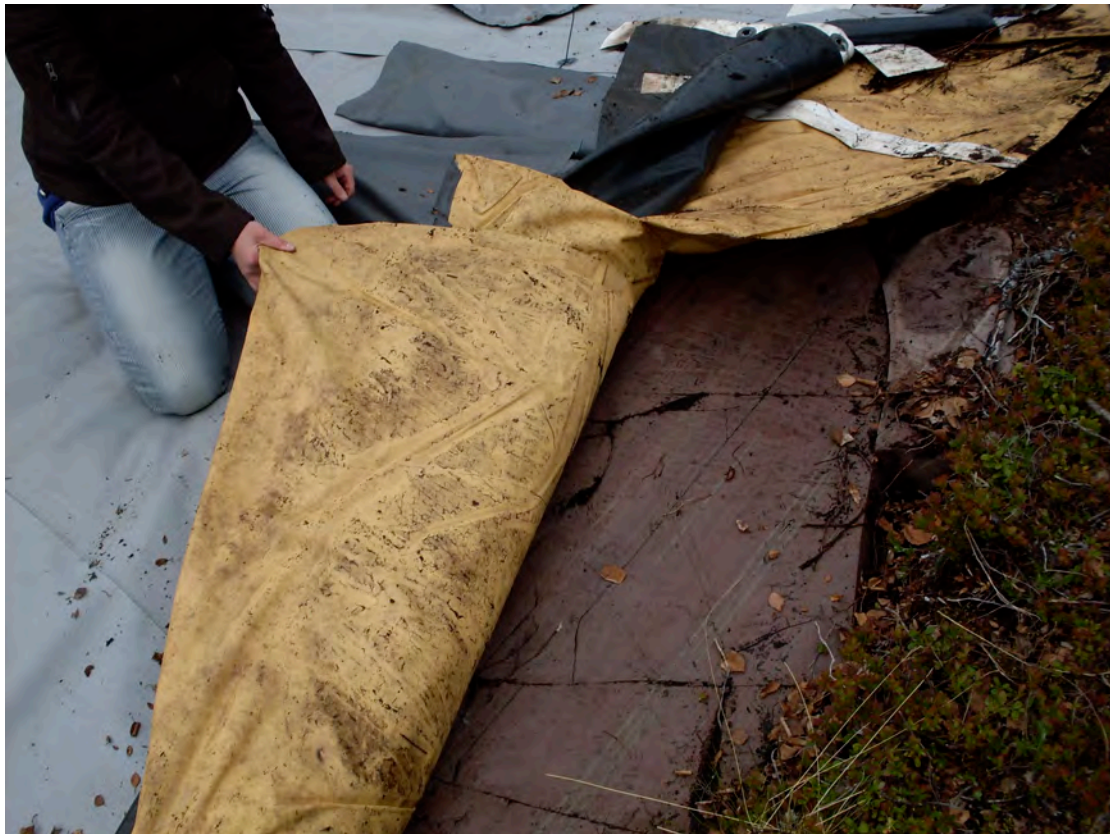
Figure 61. Condition in which the panels in Alta remain when covered: humid and affected by organic matter.

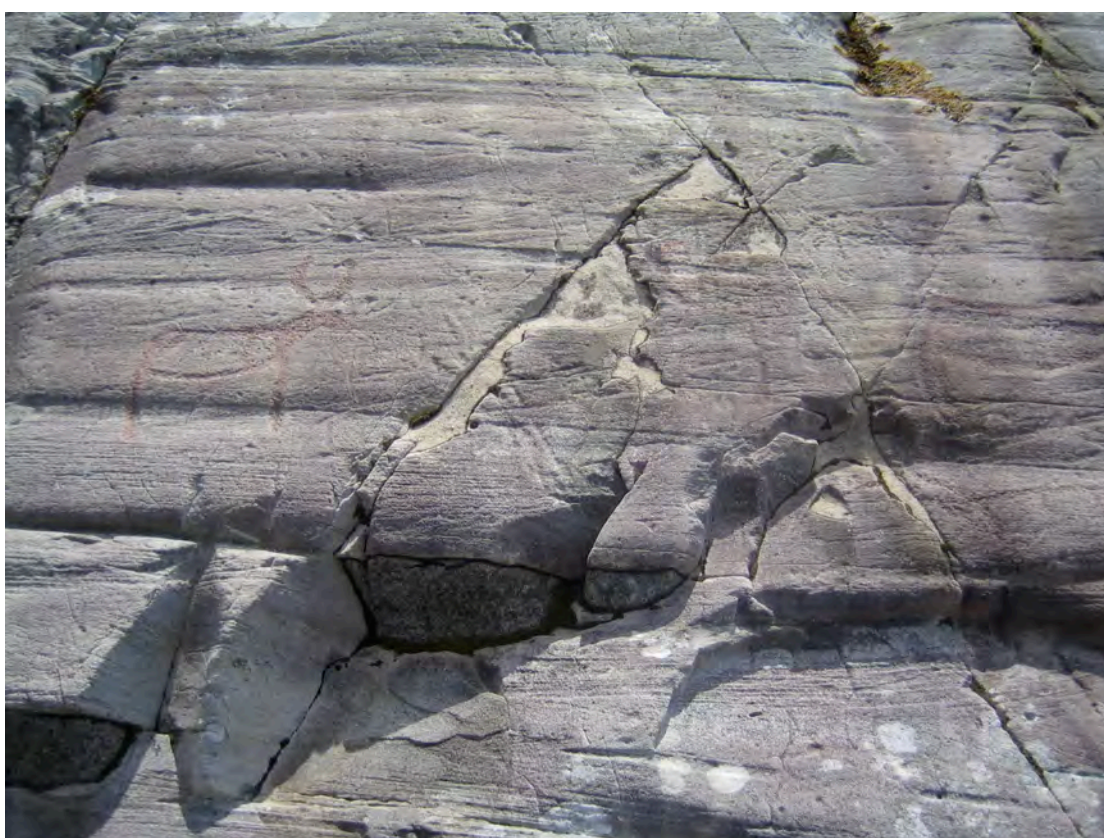
Figure 64. Filling of fractures and gaps of a panel in Vingen.

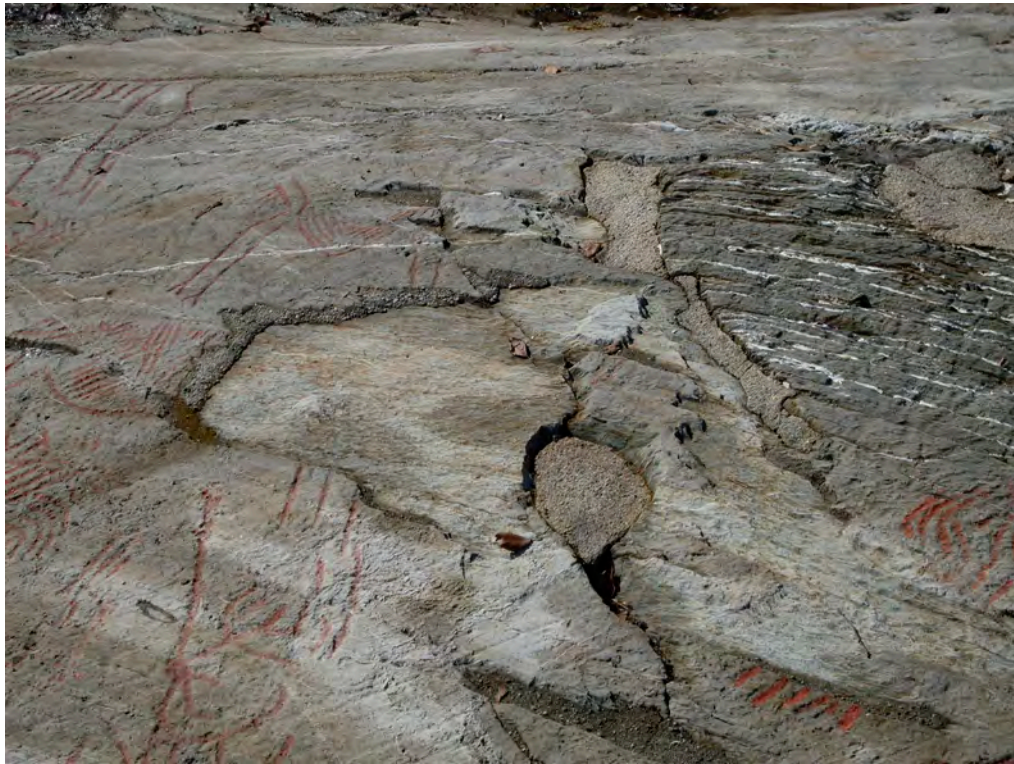
Figure 65. 'Patchwork' condition of areas of the Ausevik outcrop. Note how cement-based mortars applied in different interventions cure differently.

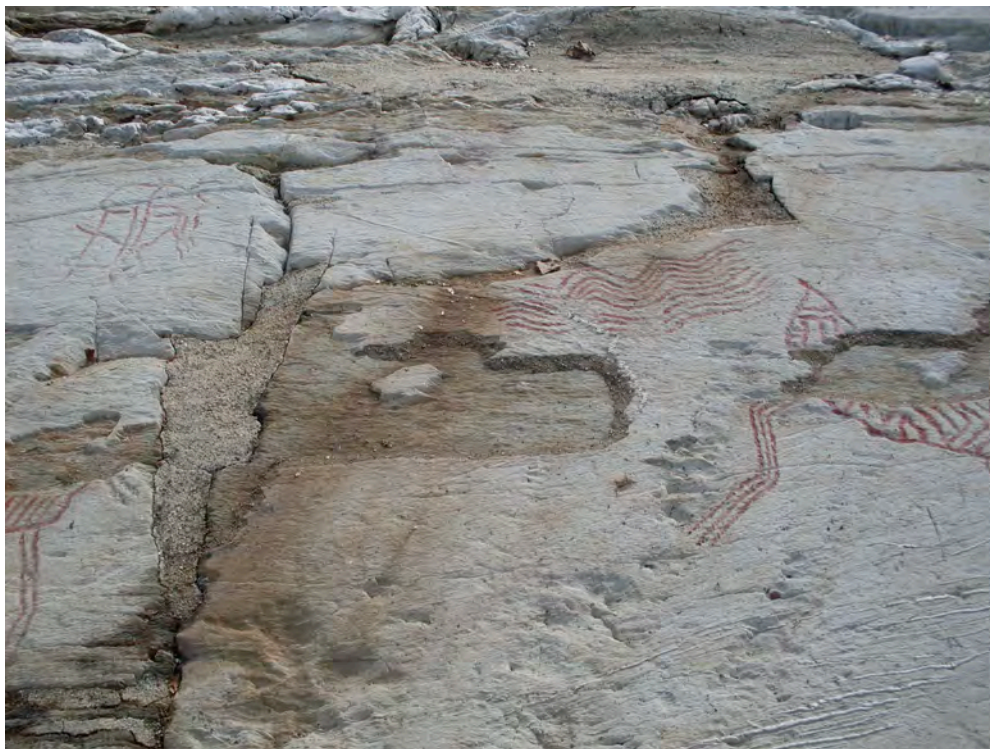
Figure 66. Another perspective of the 'patchwork' condition at Ausevik featuring more recent and older cement-based mortar interventions.

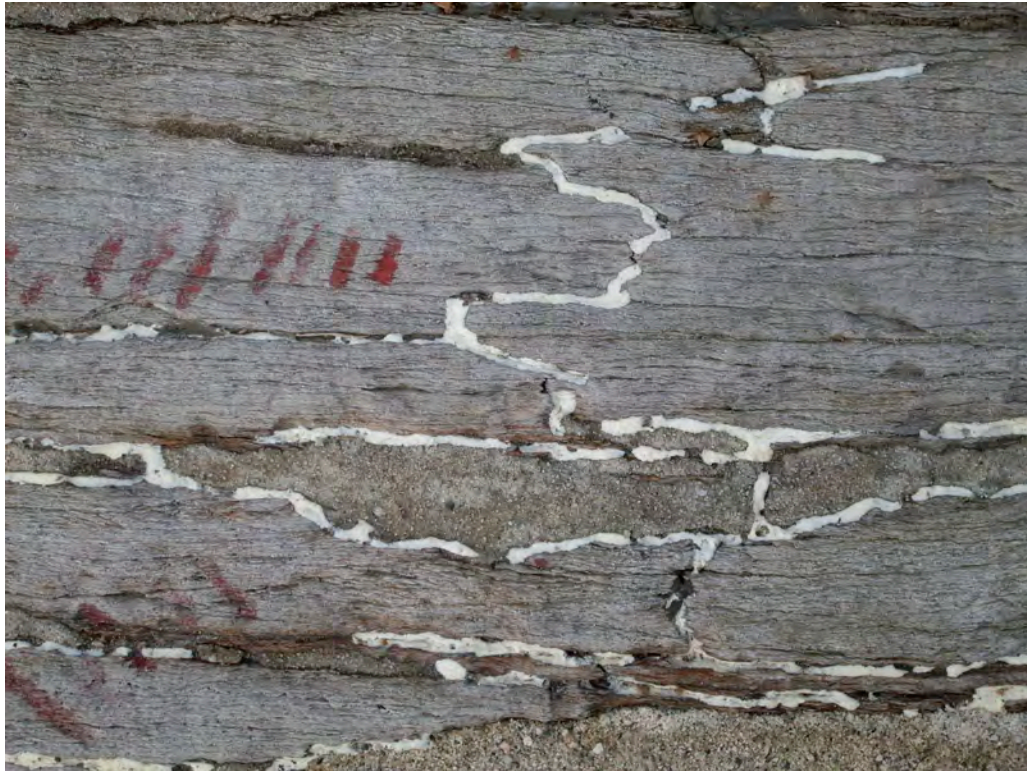
Figure 67. Fractures filled and sealed with cement-based mortar and Mowilith DM 123 S binder (white material) in previous interventions in Ausevik.

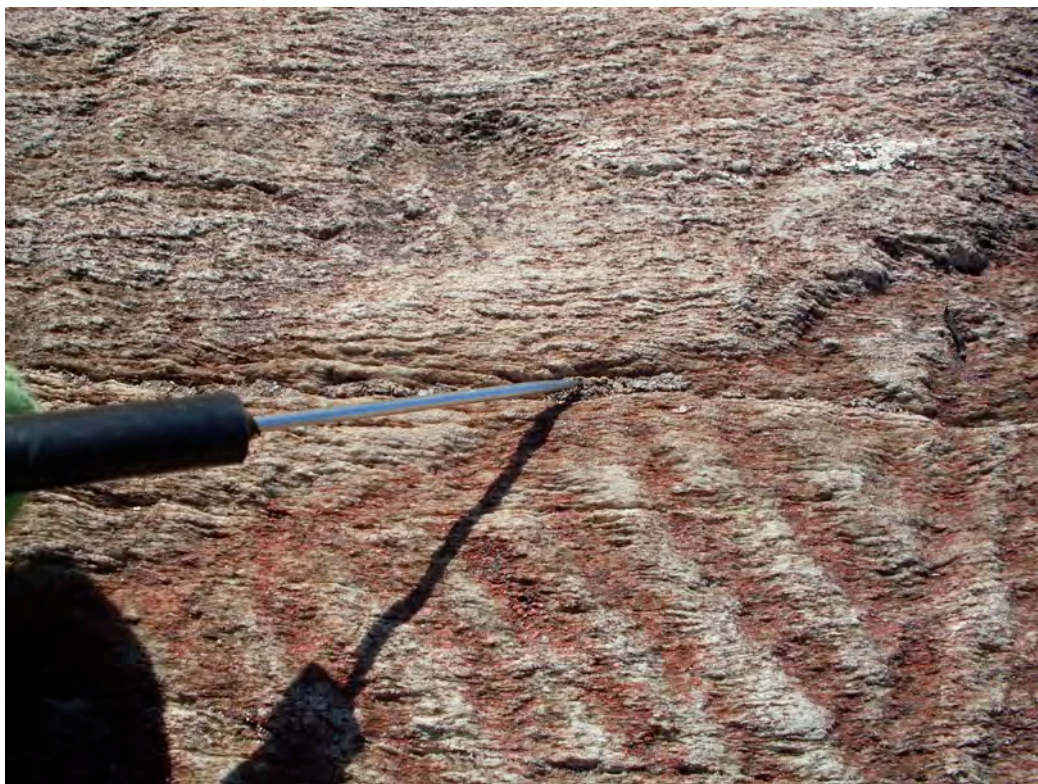
Figure 68. Small fracture sealed with cement-based mortar in a past interventions at Ausevik.

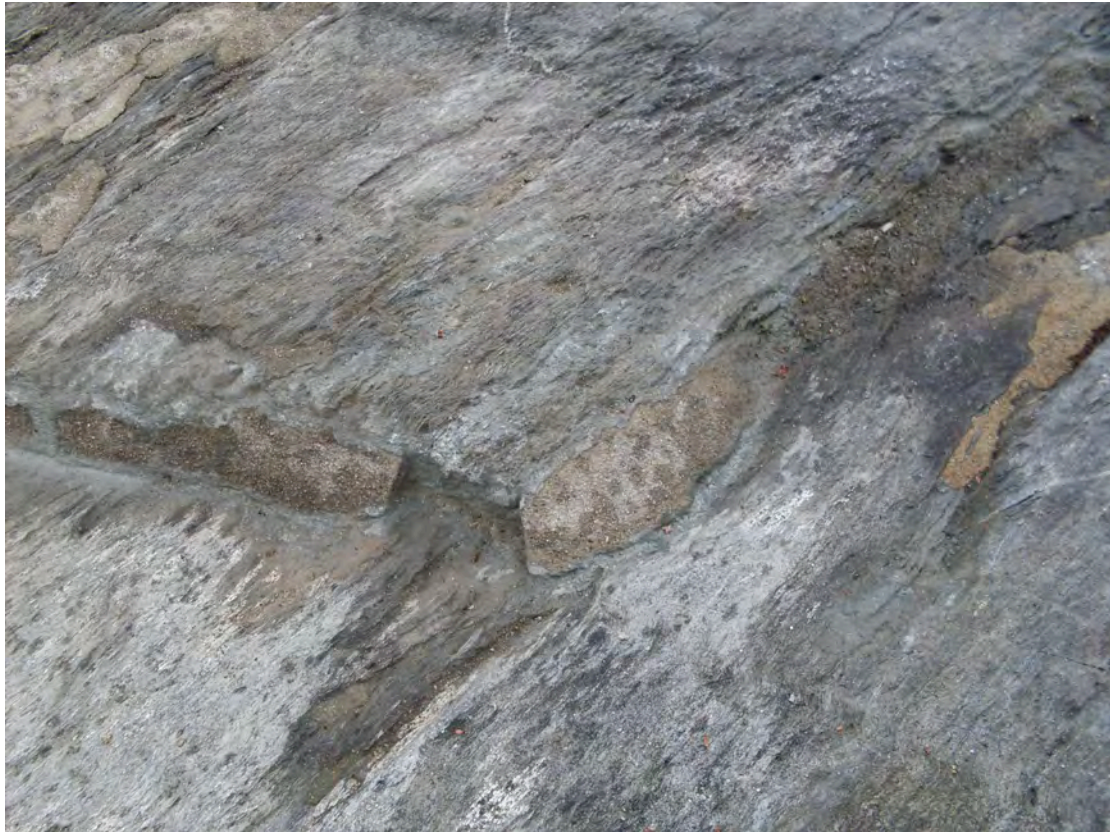
Figure 69. Area at the Ausevik outcrop in which previous cement-based mortar filling and sealing of less cohesive areas had to undergo maintenance work with the resealing of the cement/parent rock interface.

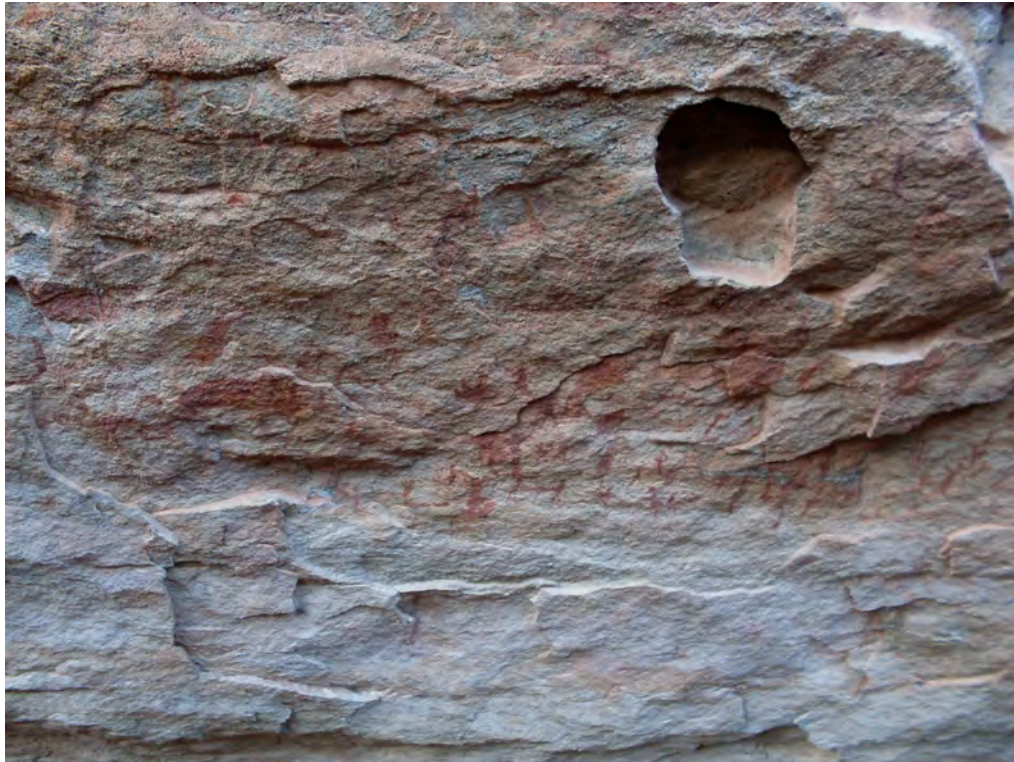
Figure 81. Surface detachment. It is visible though that the paintings are located on different superficial planes. Hence, the panel was probably in the present-day condition (or in a quite similar condition) when these paintings were produced.

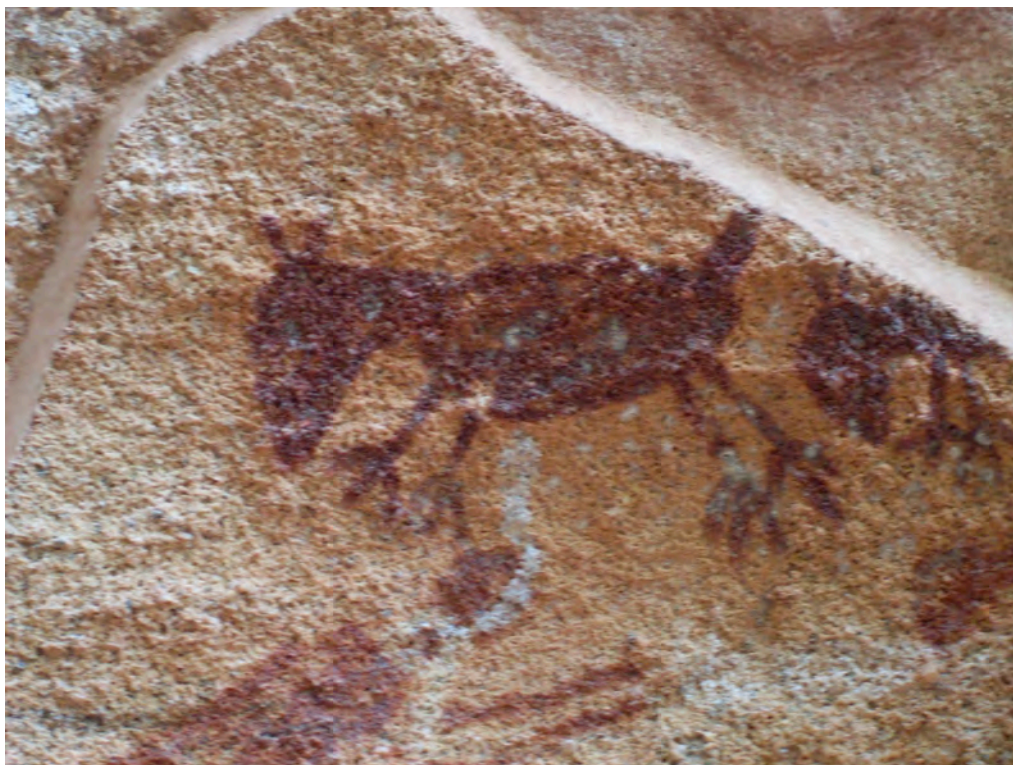
Figure 83. Consolidation of a panel in risk of detachment at Toca da Ema do Sítio do Brás I following the same methodology developed for Toca da Entrada do Pajaú.

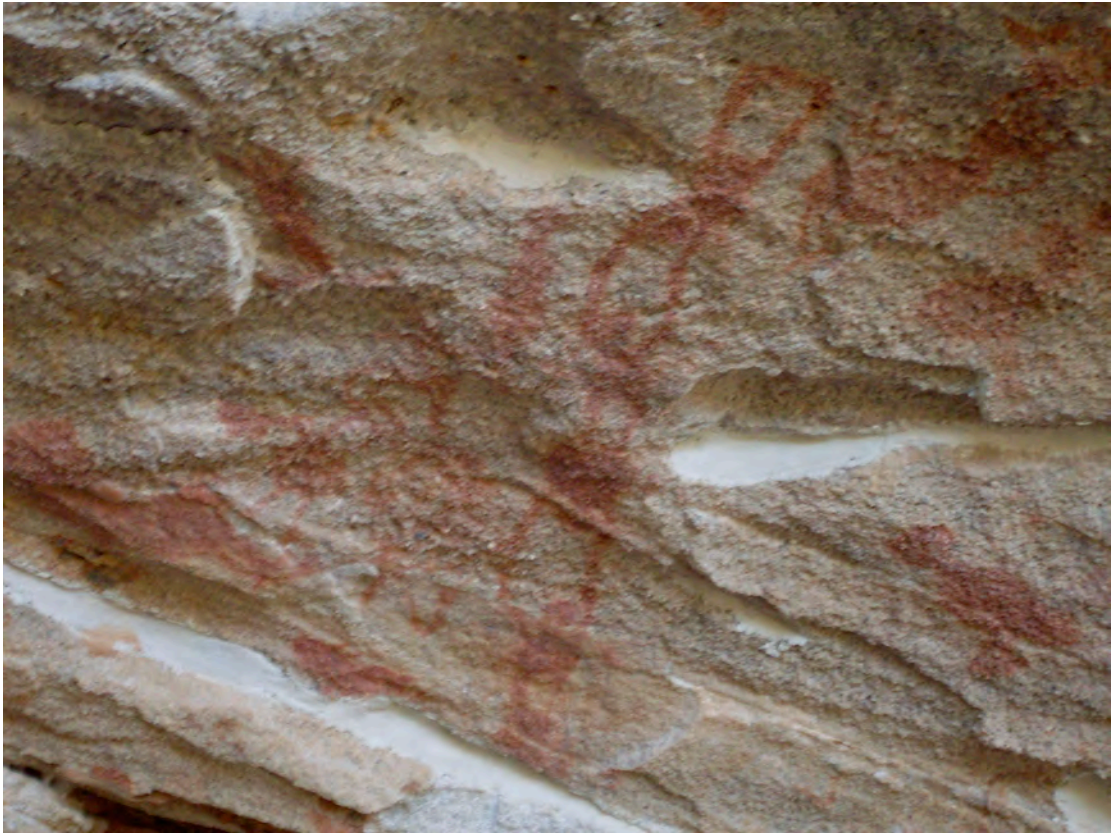
Figure 85. Filling of gaps and fractures.

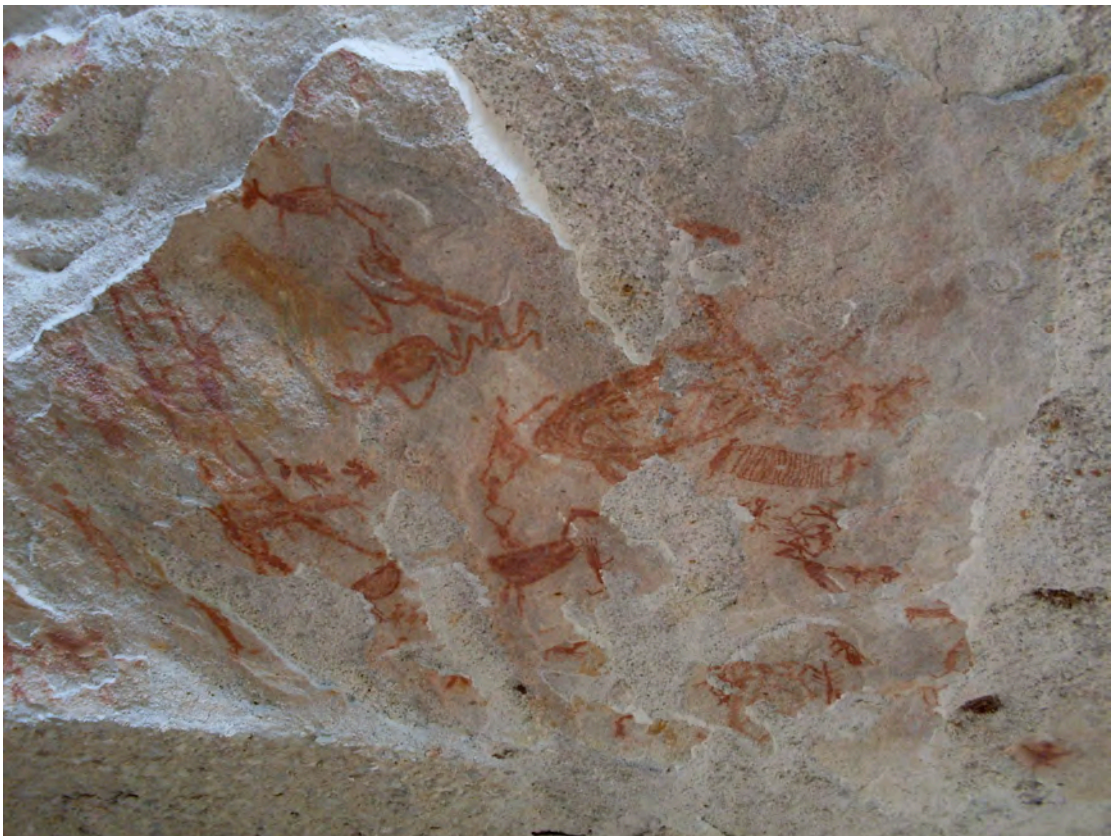
Figure 86. Sealed panel that was in risk of detachment.

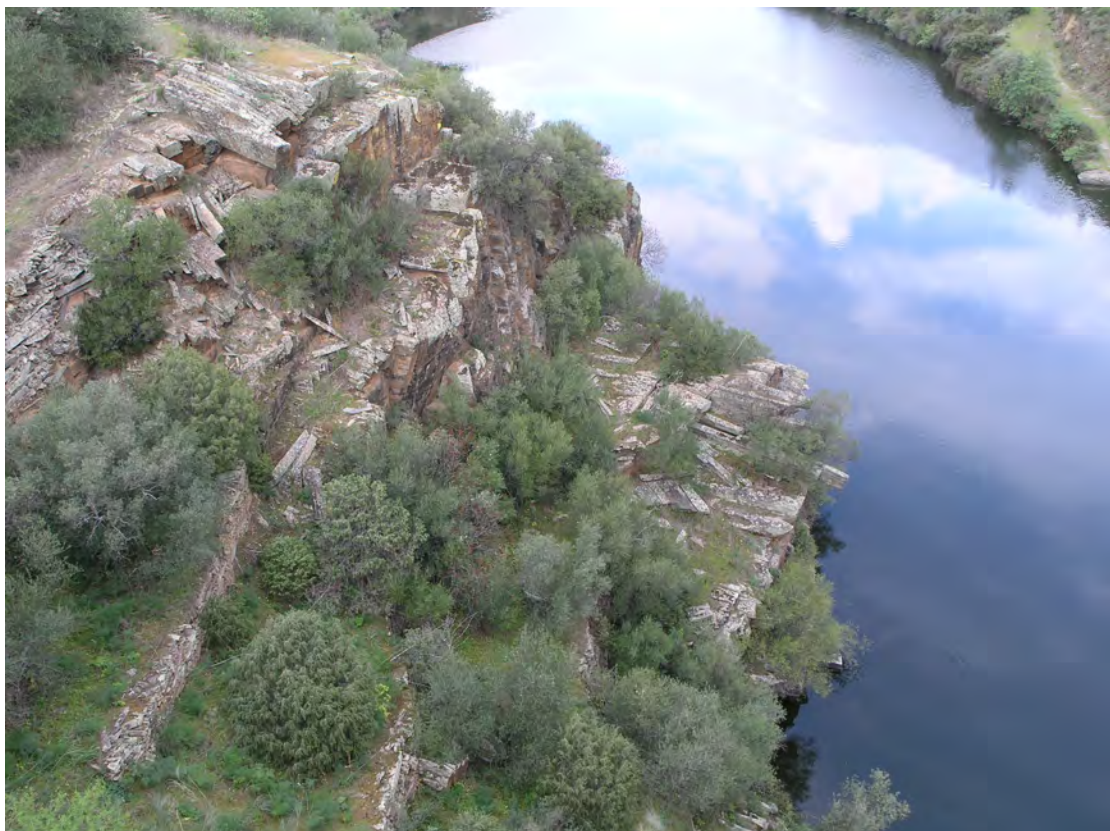
Figure 121. Outcrops in the Foz do Côa rock-art site. Note the 'steps' that each outcrops constitutes, a result of the river down-cutting process exposing the bedrock following the orientation of previously existing regional fracture families.

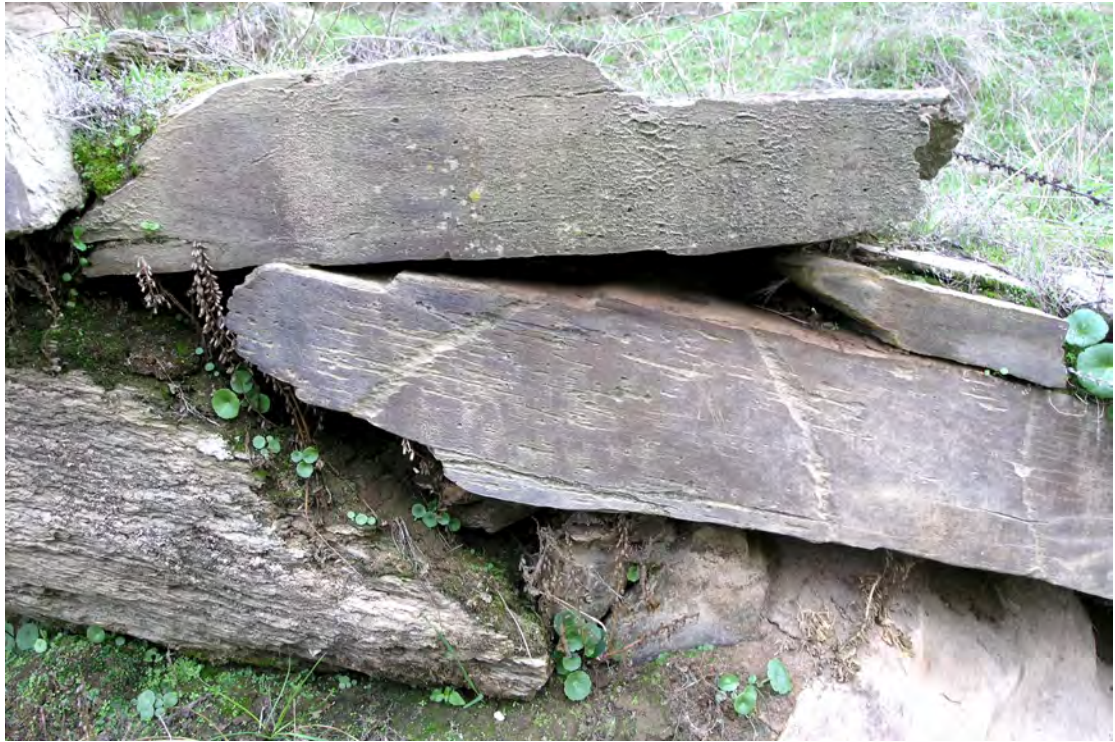
Figure 174. This engraved block at Penascosa has broken and fallen from an engraved block (probably Penascosa Rock 7 located directly above) and was used to construct a dry stonewall.

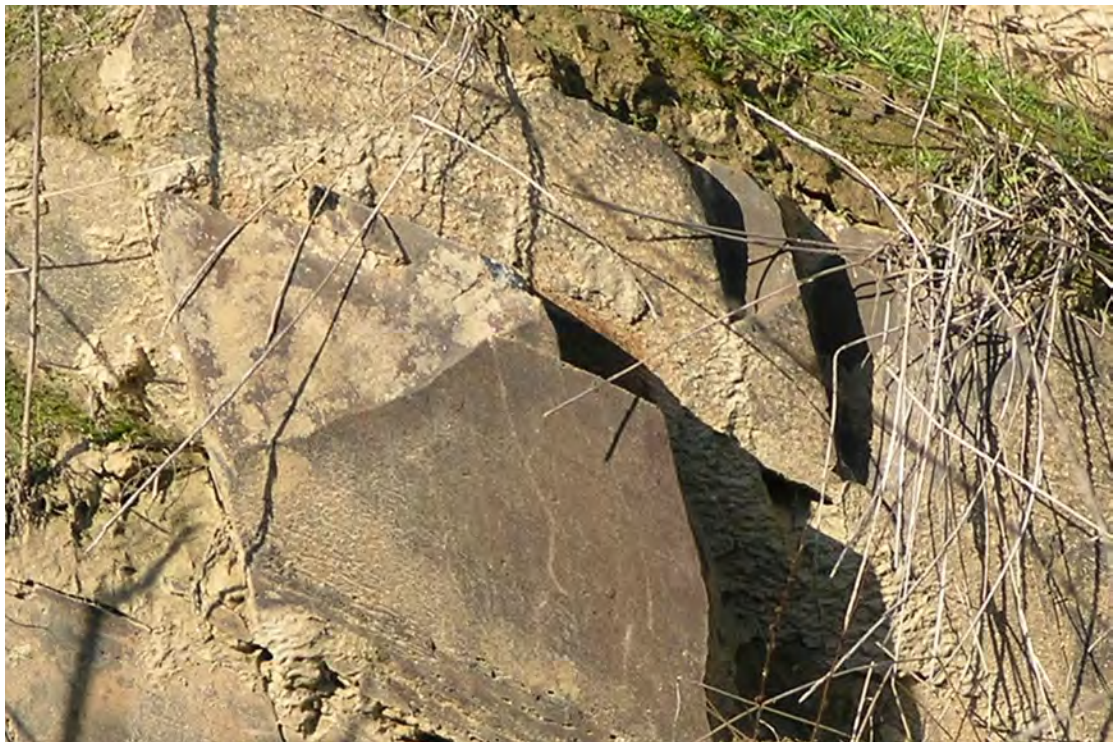
Figure 175. Concretions and deposits of other type at an un-engraved outcrop in Ribeira de Piscos rock-art site

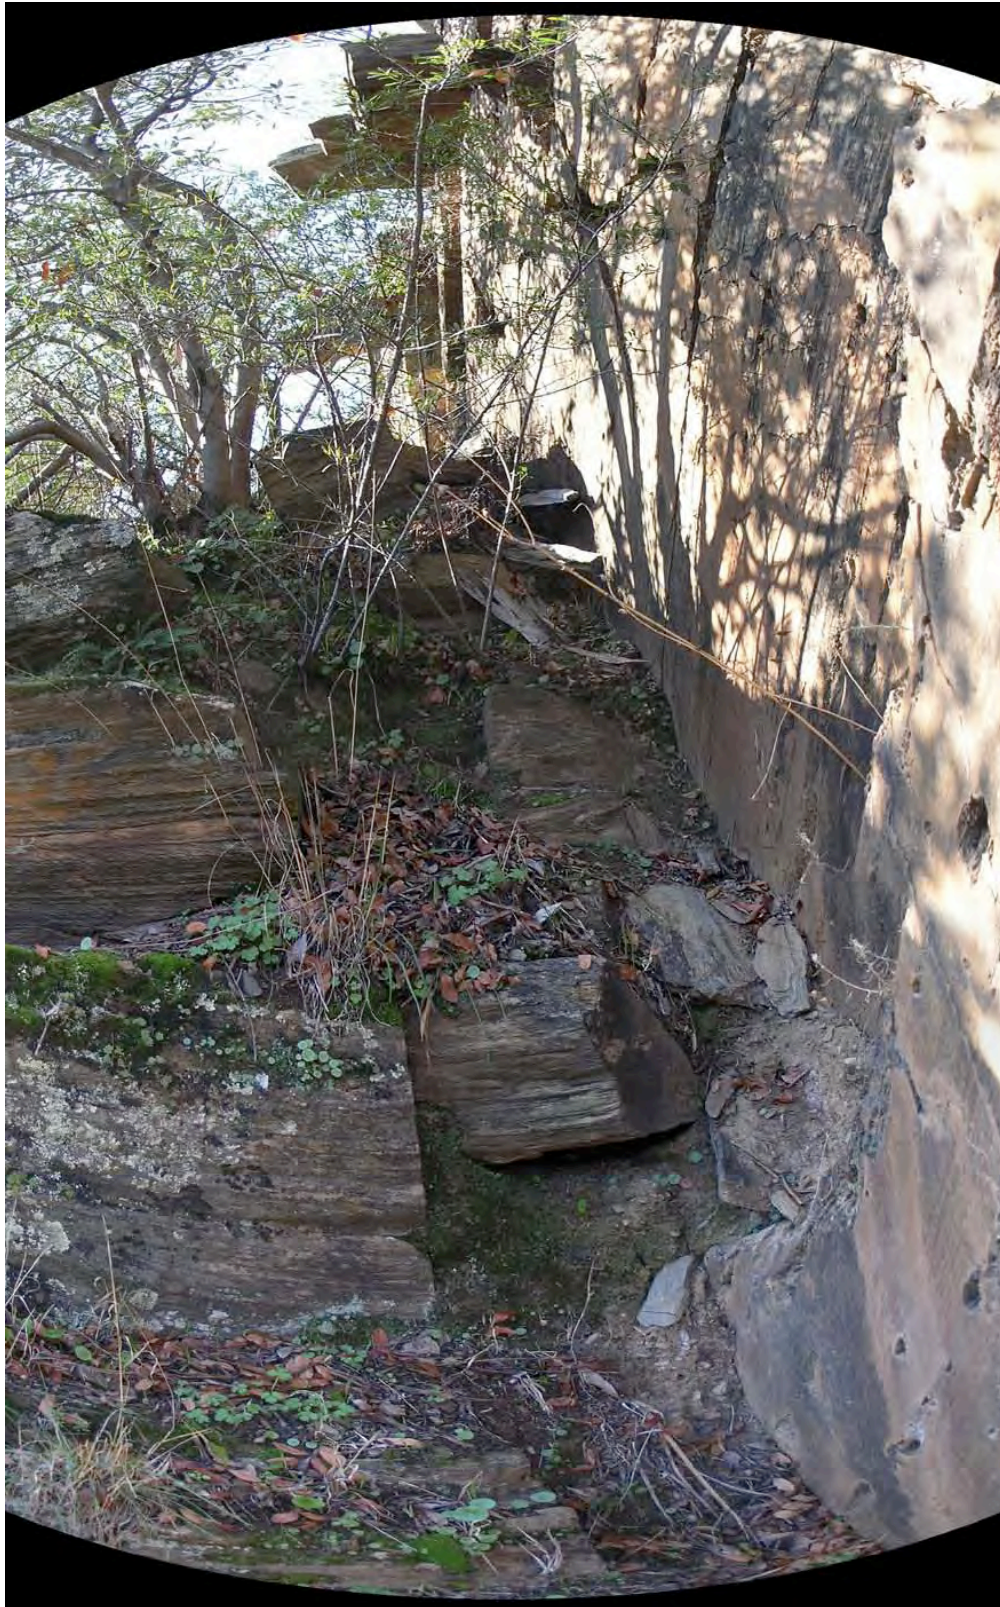
Figure 176. Diaclase behind the Canada do Inferno 13 outcrop. Notice infilling with soil, vegetation and loose blocks fallen from above.

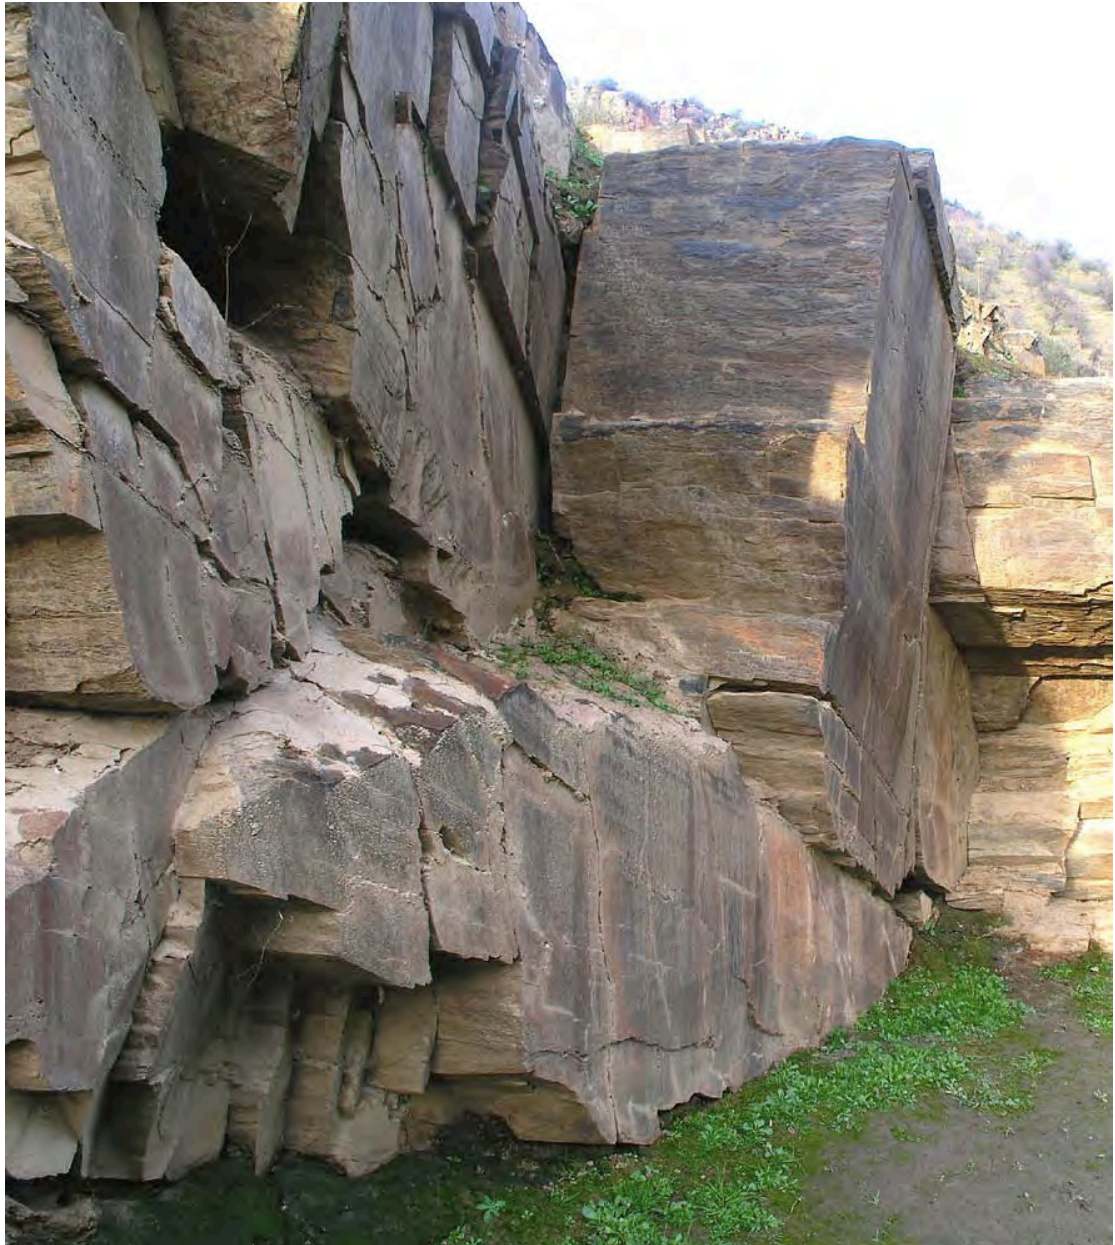
Figure 177. Ribeira de Piscos Rock 1. Note the diaclyse and forward tilting of the block that contains the tangled horses motif.

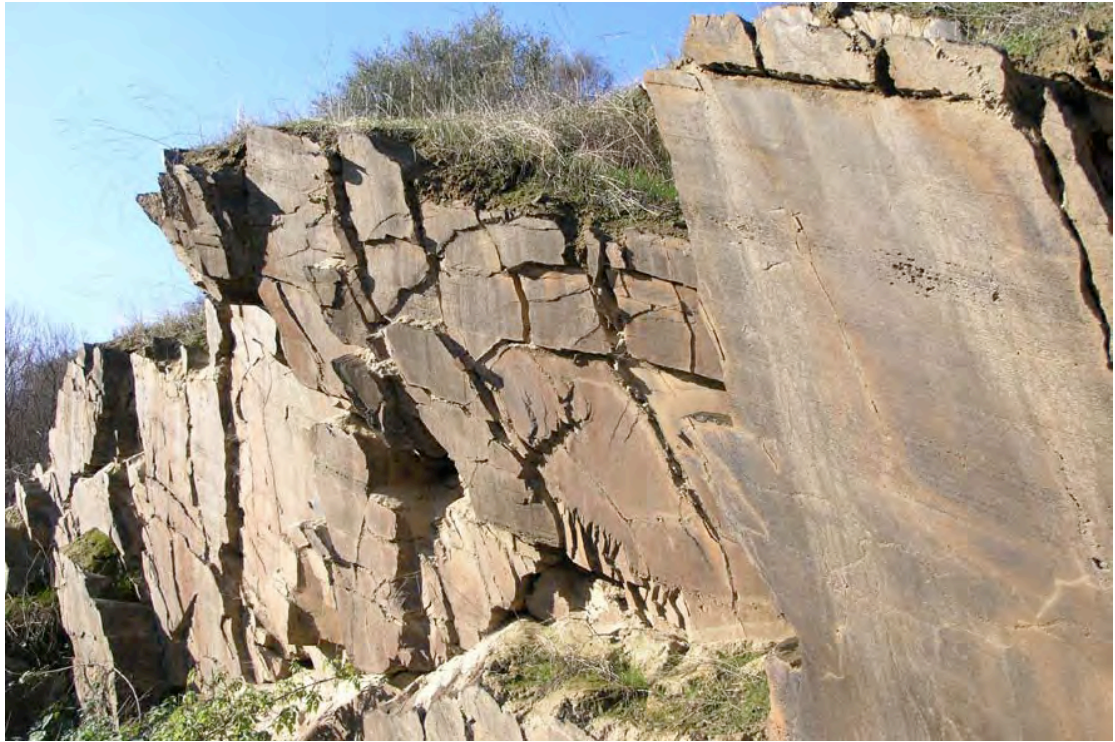
Figure 181. Fractures and loose blocks in Ribeira de Piscos Rock 1 outcrop.

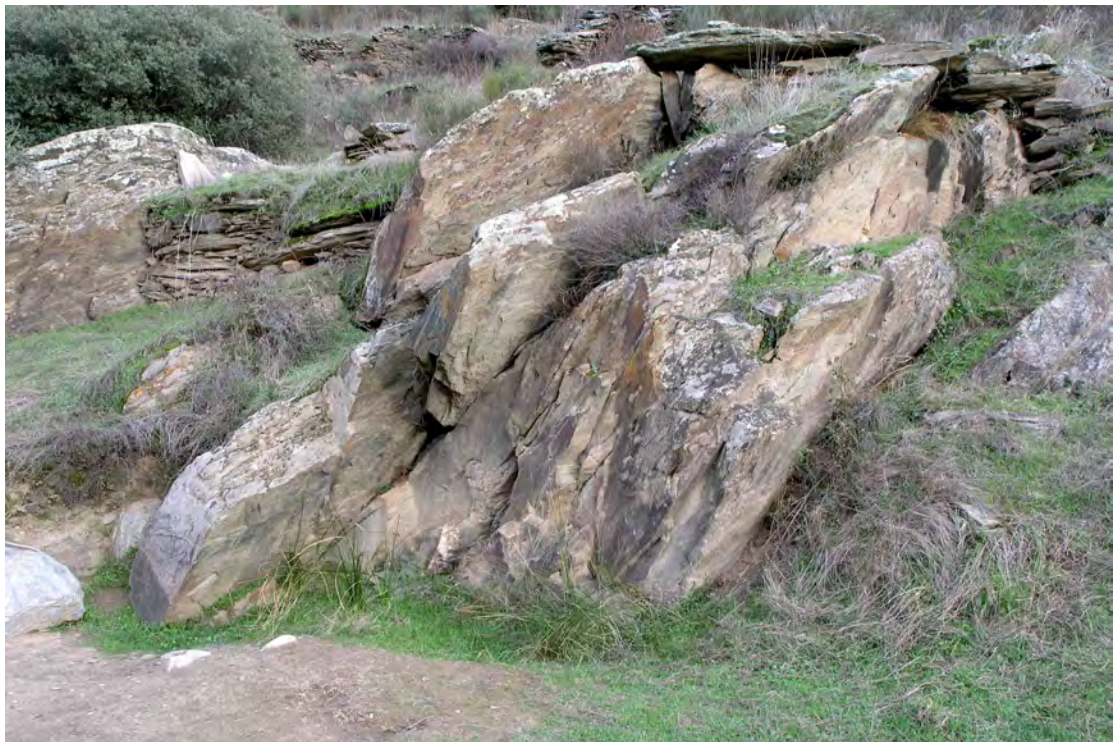
Figure 182. Fractures and loose blocks in Penascosa 4 outcrop.

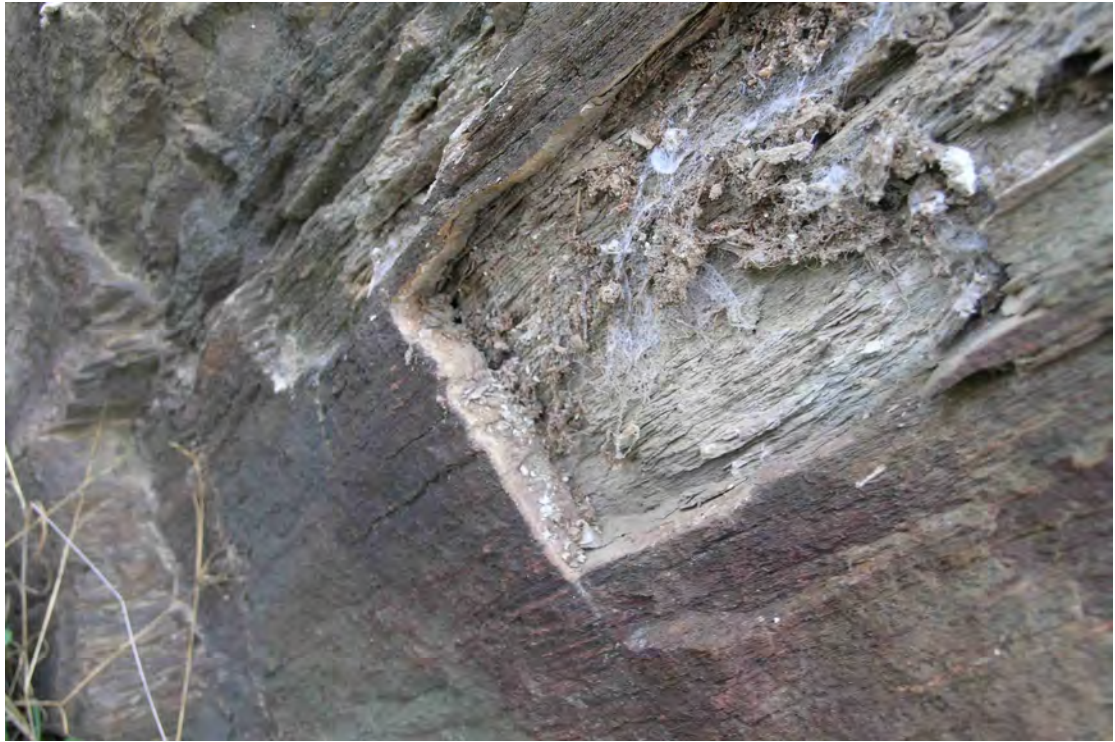
Figure 183. Weak area of an un-engraved outcrops at the Penascosa rock-art site

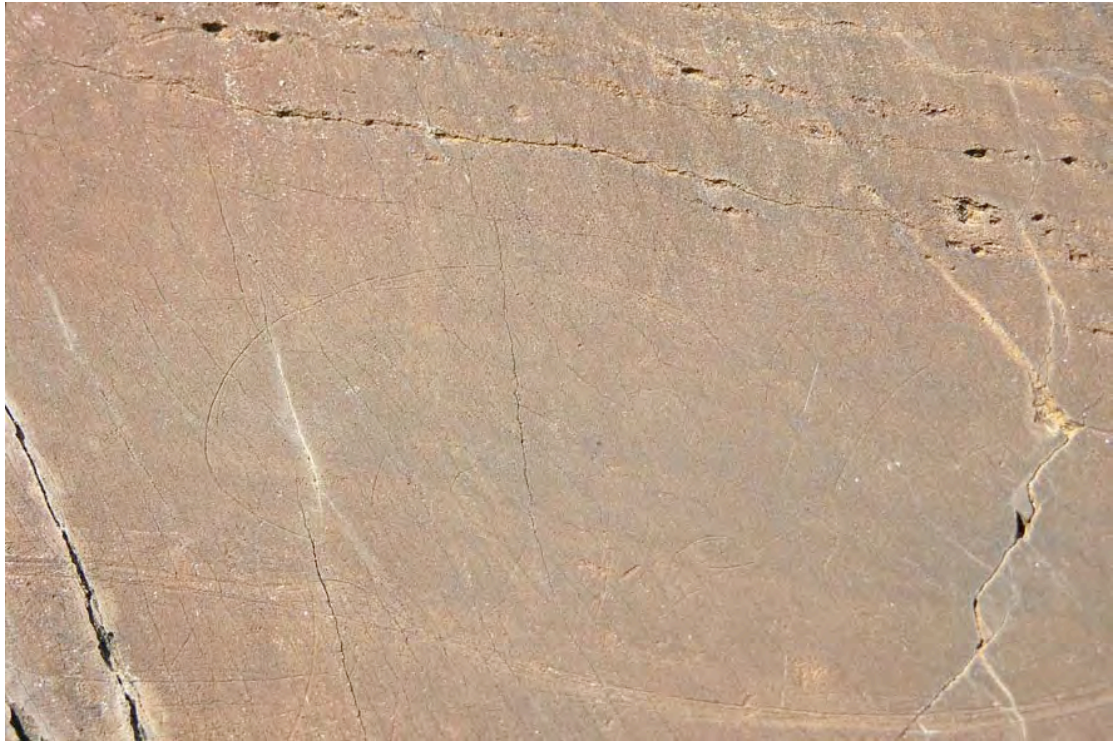
Figure 187. Engraved area of Ribeira de Piscos Rock 2. Note both vertical and horizontally orientated fissures.

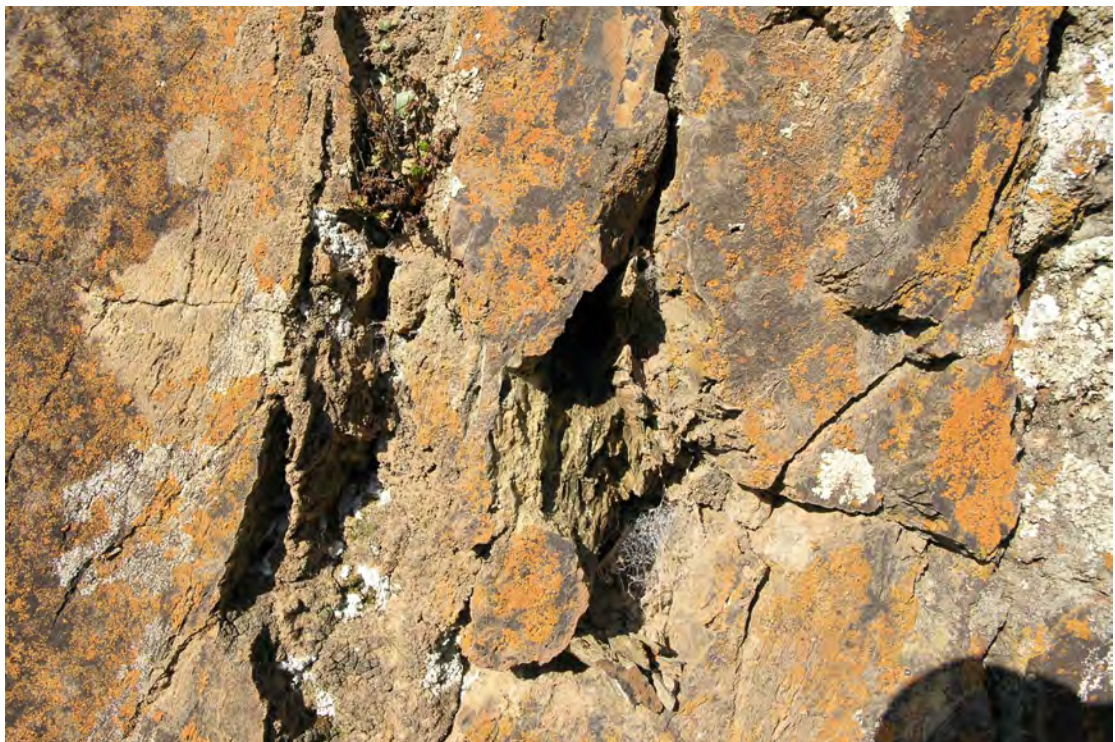
Figure 188. Different types of fractures.

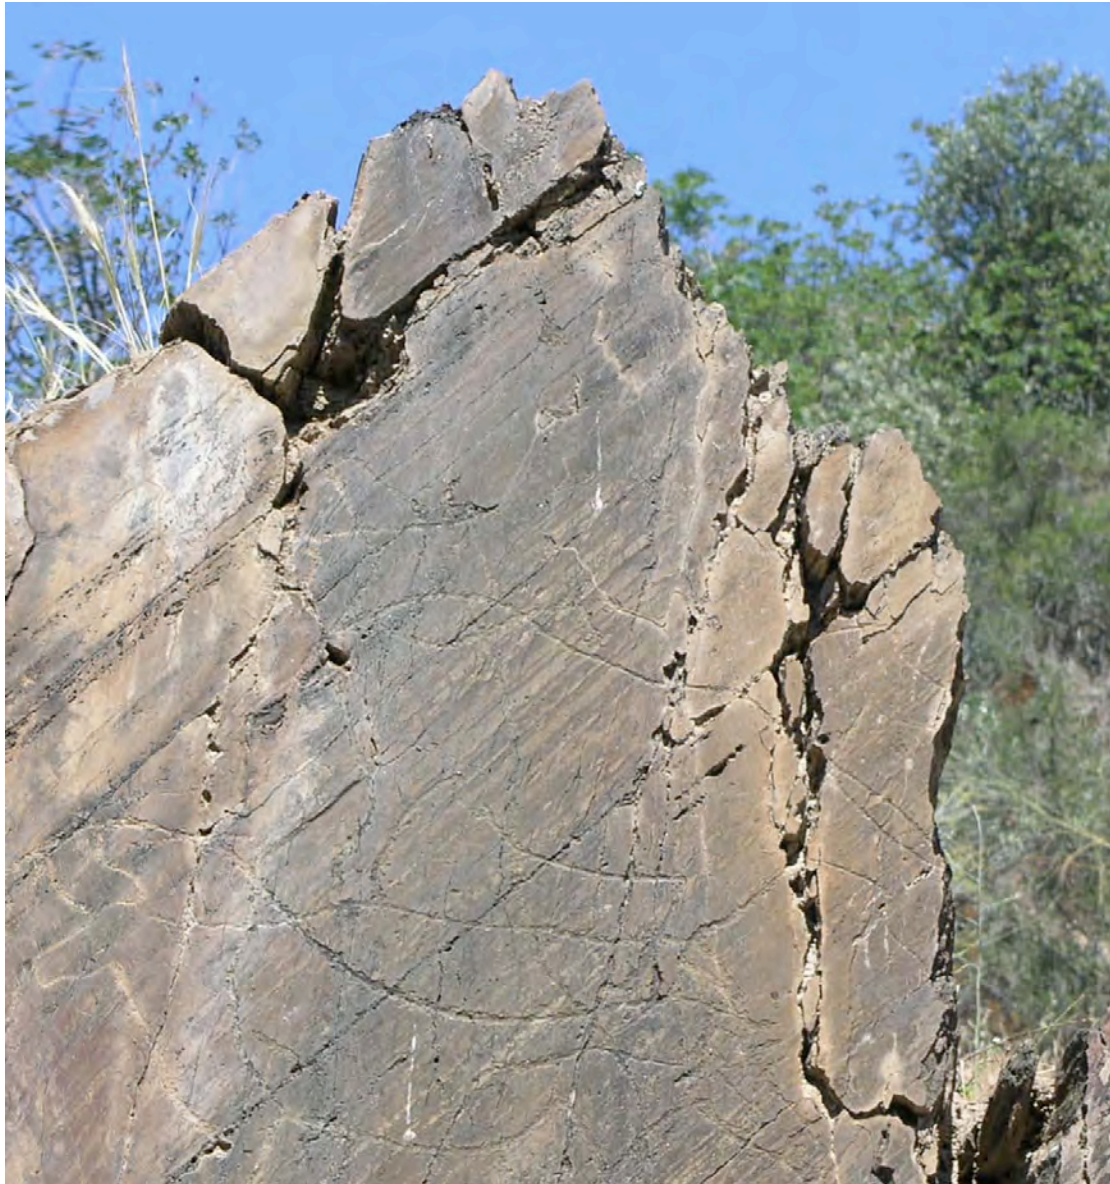
Figure 189. Engraved area of Canada do Inferno Rock 1. Note to the right the fracture that delimitates a minor dimension loose block. This fracture also interrupts the engraved lines that compose a two-headed horse. Bird's droppings can also be seen.
