**NATURAL PROCESSES IN THE DEGRADATION OF OPEN-
AIR ROCK-ART SITES: AN URGENCY INTERVENTION
SCALE TO INFORM CONSERVATION**

A thesis submitted in partial fulfillment of the requirements of Bournemouth
University for the degree of Doctor of Philosophy

July 2012
Bournemouth University

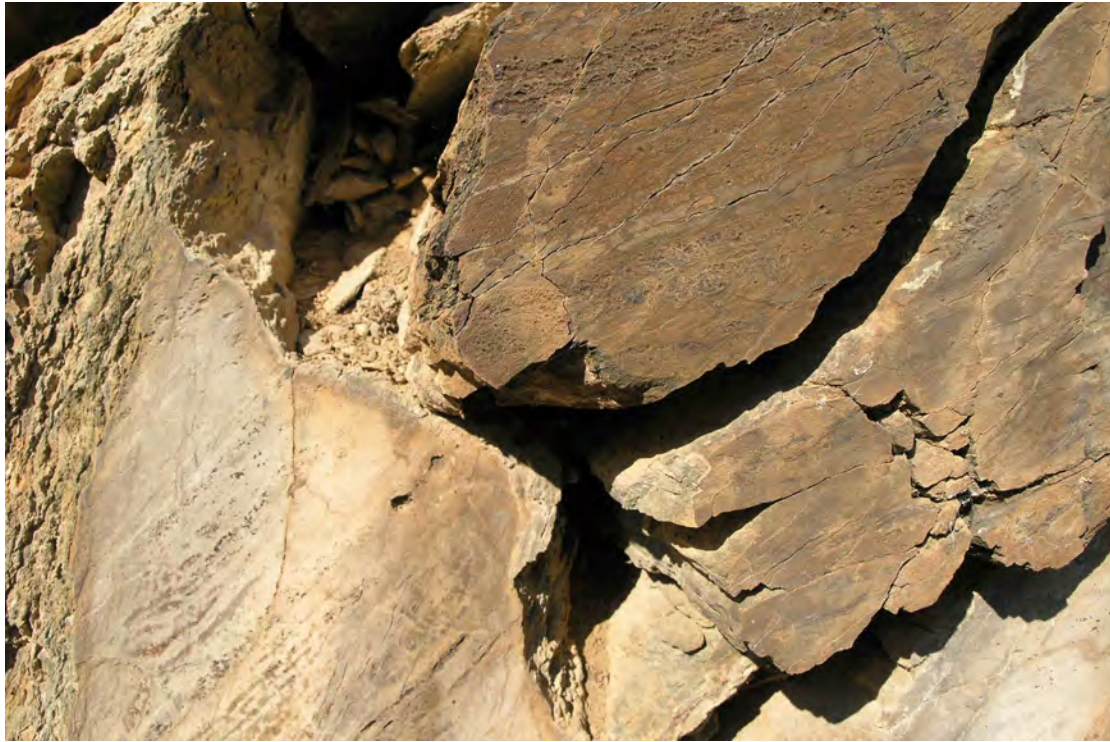
Figure 190. Open fractures.

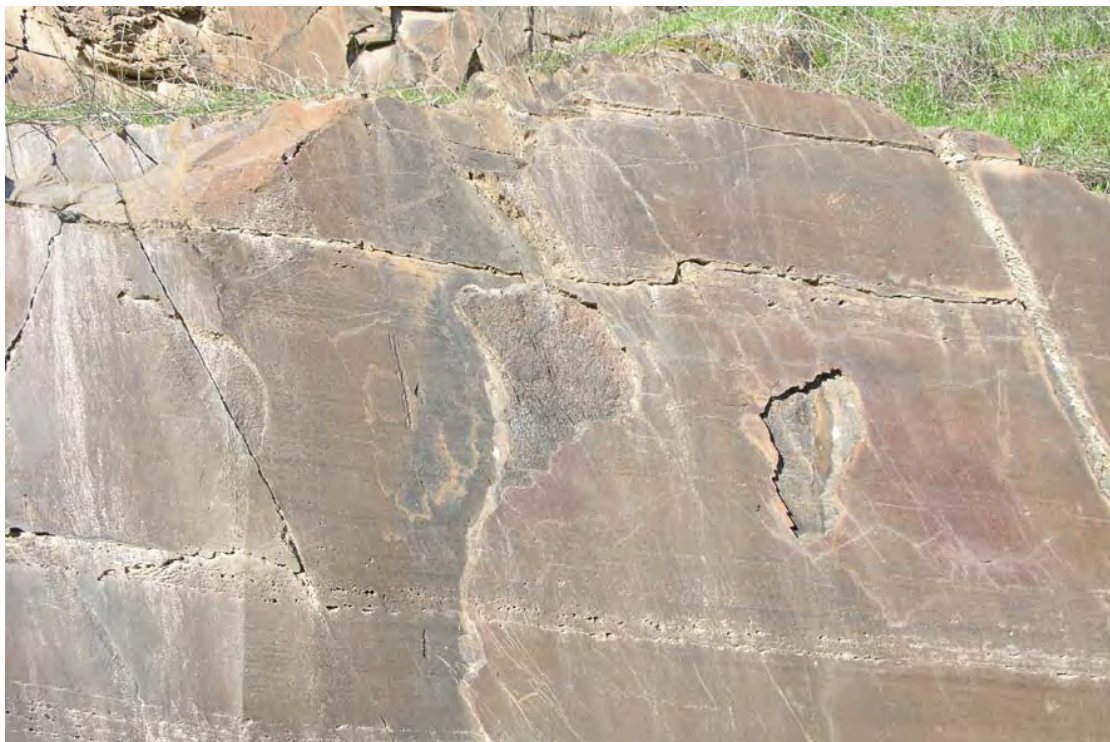
Figure 191. Gaping in Ribeira de Piscos Rock 2 fortunately in an un-engraved area of the outcrop. Note also superficial chromatic alterations. Note also splintering.

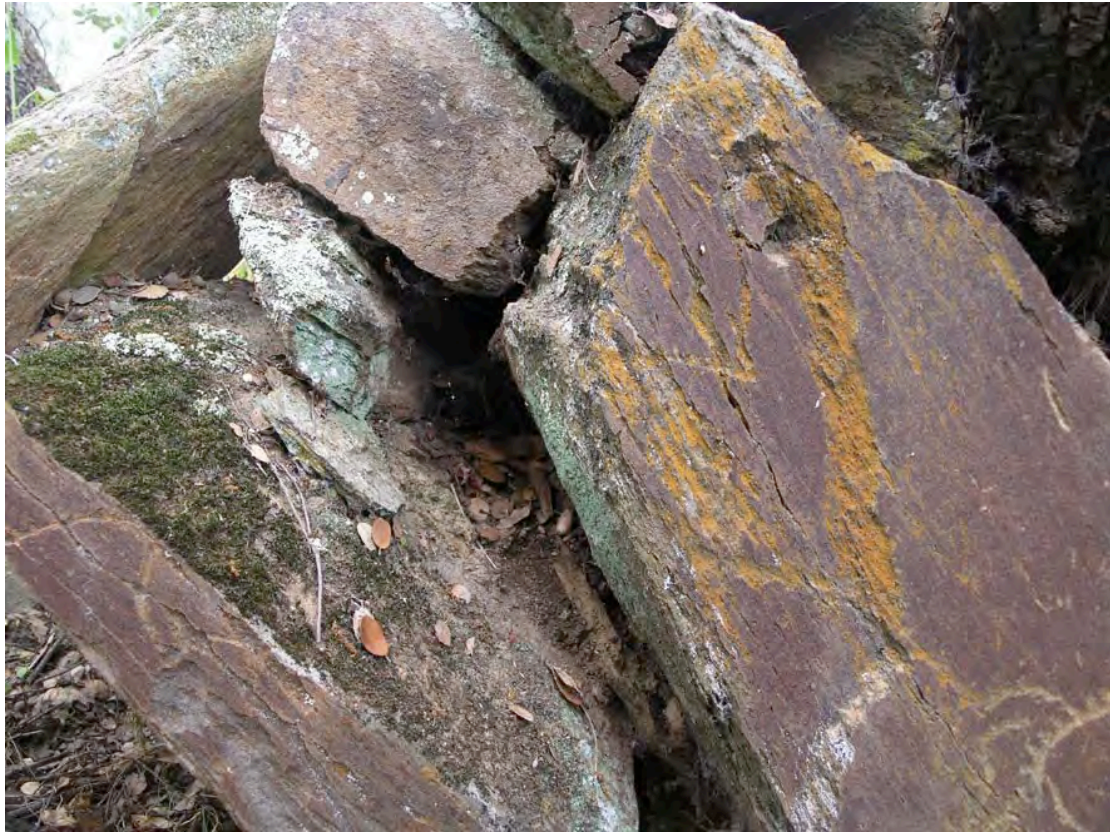
Figure 196. Lichen colonization at Quinta da Barca Rock 3. Note that these colonies settle preferentially in more 'cosy' areas, namely the ones provided by holes, fractures and concave portions of the rock surface (and also the engraved grooves). This has been one of the panels in which lichens have been removed for documentation purposes. In less than 20 years, re-colonization of the lines that make the rear part of the incomplete motif seems to be well on the way (compare with Figure 169).

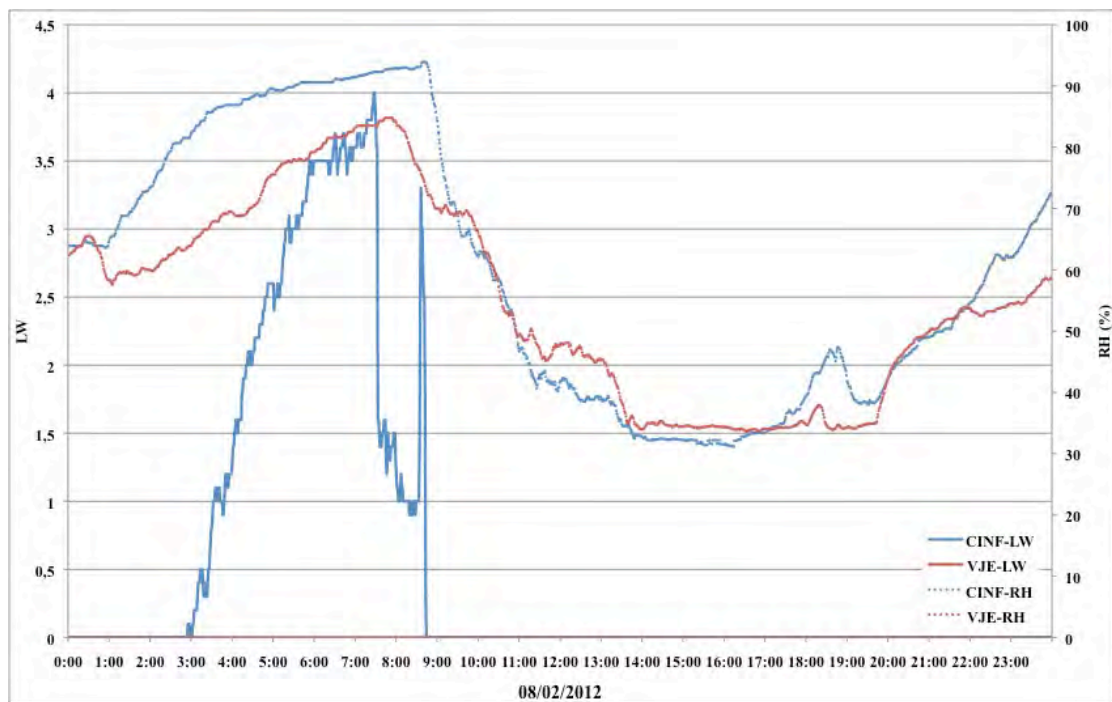
Figure 233. Leaf wetness and relative humidity values for the 8th of February 2012.

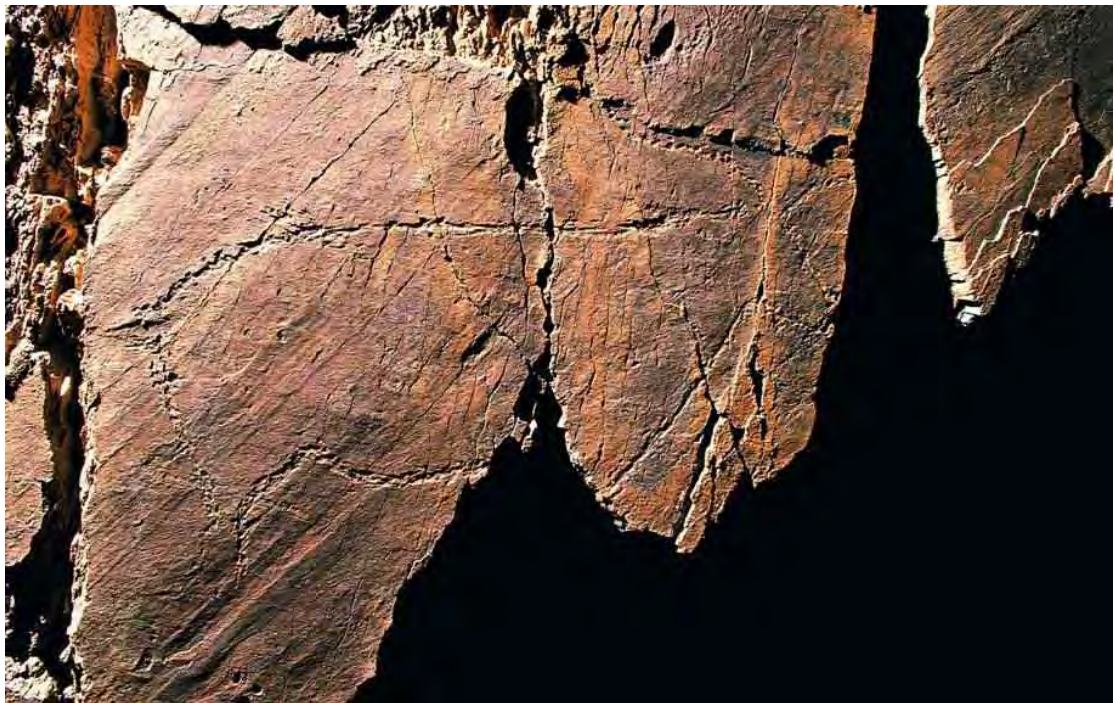
Figure 242. Canada do Inferno Rock 2. Note the open eroding fracture is affecting the integrity of the goat motif. Photo in Baptista (1999, 80).
