Article

An Optimised Approach of Protecting and Sustaining Large Vehicle System

Adil Saeed *, Zulfiqar A. Khan and Main H. Nazir

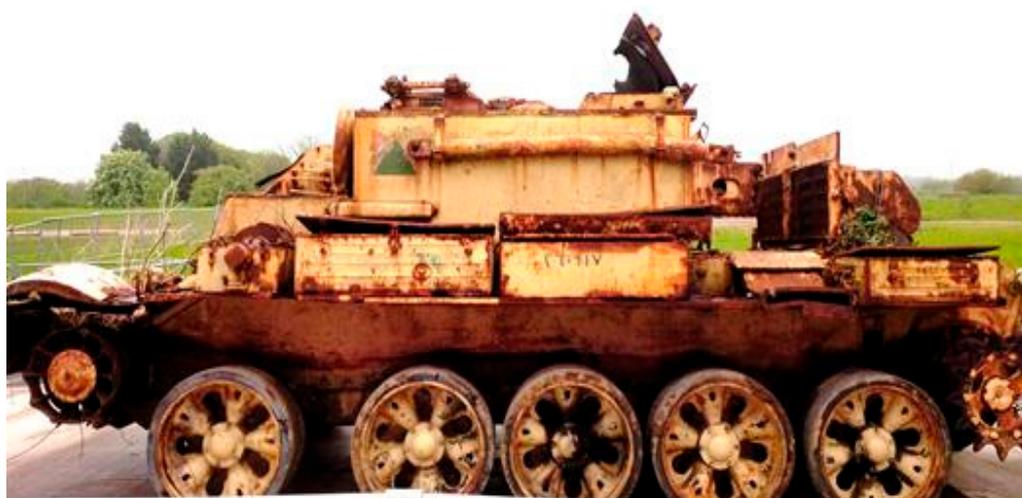
Figure 1. Corrosion damage in Russian T 55 IMR recovery vehicle stationed outside the shelter.

In this article, the term large vehicles refers to military tanks, one such example is shown in Figure 1, and only considers research conducted on such vehicles. These large vehicles are complex objects with a wide variety of interacting components, materials, designs and are manufactured for a specific life span. However, during and beyond their service life, these vehicles start to endure structural ageing, mainly attributed to materials and component degradation through corrosion and wear.

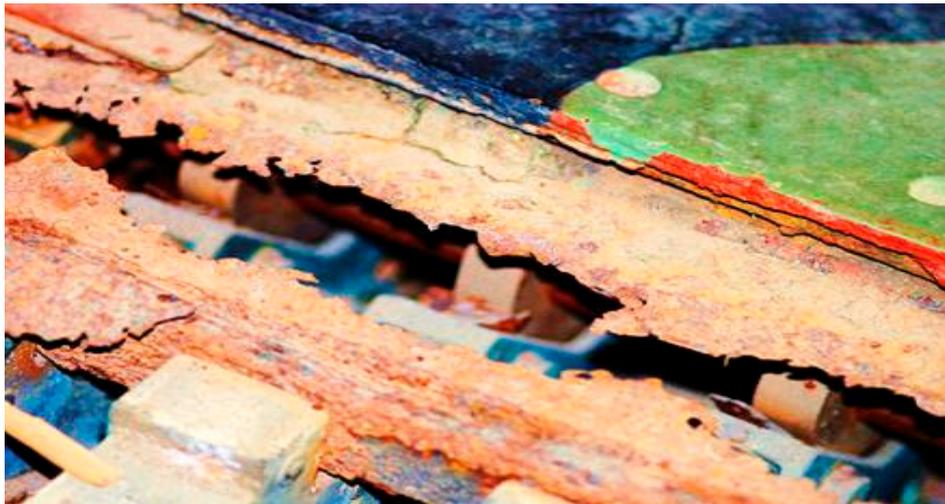
Figure 2. Corrosion damage to Tog II vehicle stationed inside the shelter.

Risks of failures due to corrosion are high and pose significant danger to the structural integrity of large vehicles considered in our research. The magnitude of corrosion is different in every vehicle, which could be the result of their operating environment in different terrains and/or the current environmental/operating conditions. The overwhelming phenomenon of corrosion is shown in Figures 1 and 2. Figure 1 is of a Russian T55 IMR that is stationed outside the shelter and is structurally corroding. Figure 2 shows the severity of the corrosion problem in Togg II, a vehicle stationed inside the shelter. The mechanism of structural degradation was dictated by various modes of corrosion working alone and/or together. In this article, damage due to surface corrosion has been reported briefly. Results of other forms of corrosion, *i.e.*, stress corrosion cracking and pitting, are published elsewhere [2,4,5].

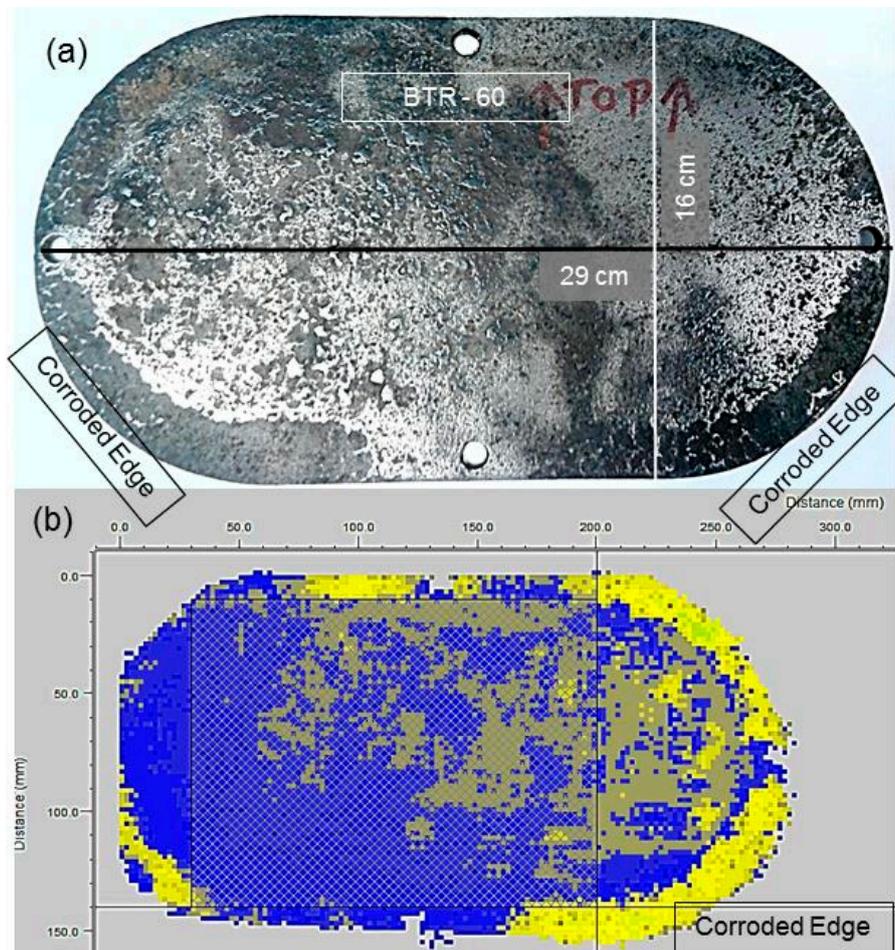
Figure 3. BTR-60 (a) sample's image and (b) ultrasonic scan.

Brone-transporter 60 (BTR-60) was manufactured by Gorkovsky Avtomobilny Zavod in the former USSR during 1960–1976. It is one of the most widely used personnel carriers. It remained in production till 1976 [18]. This vehicle was captured during the First Gulf War. This vehicle is parked outside the shelter currently and is exposed to an uncontrolled environment. This vehicle is severely corroding; a sample of the compartment cover was collected for corrosion mapping shown in Figure 3 with the corresponding ultrasonic scan.

Corrosion mapping results of the five lowest and highest remaining thicknesses' are provided in Table 1. A difference of 1 mm material loss was recorded on the sample selected for the corrosion mapping between the maximum and minimum remaining thicknesses. A consistent decrease in the component thickness was observed.

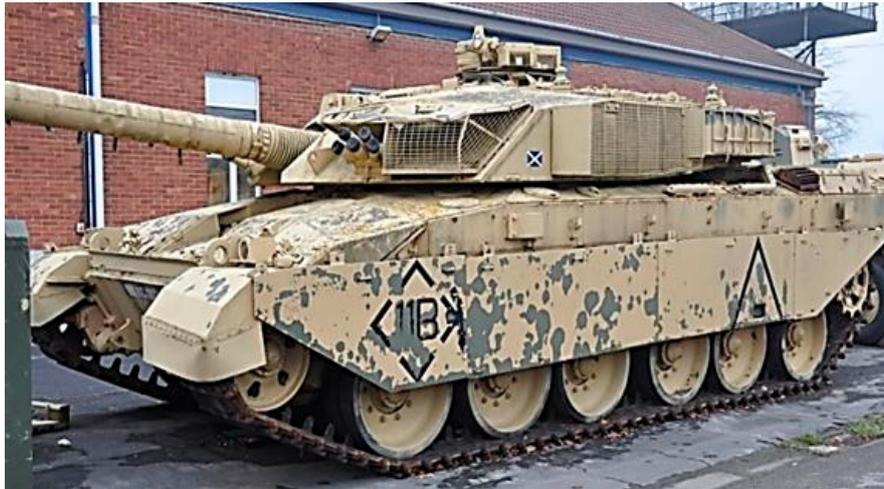
Figure 4. Challenger 1 failures in surface protection.

The most common and effective methods of protection against corrosion is the application of paint system on metal surfaces. However, there are conditions under which the paint system starts to degrade, although failures in the paint system do not cause structural failures, they are, however, linked indirectly to the promotion of component failures through corrosion. When the paint system starts to fail, it allows the permeation of moisture to the substrate, which as a result causes corrosion, one of the major causes of structural degradation. Paint system failure was observed in many vehicles, as shown in Figures 4 and 5.

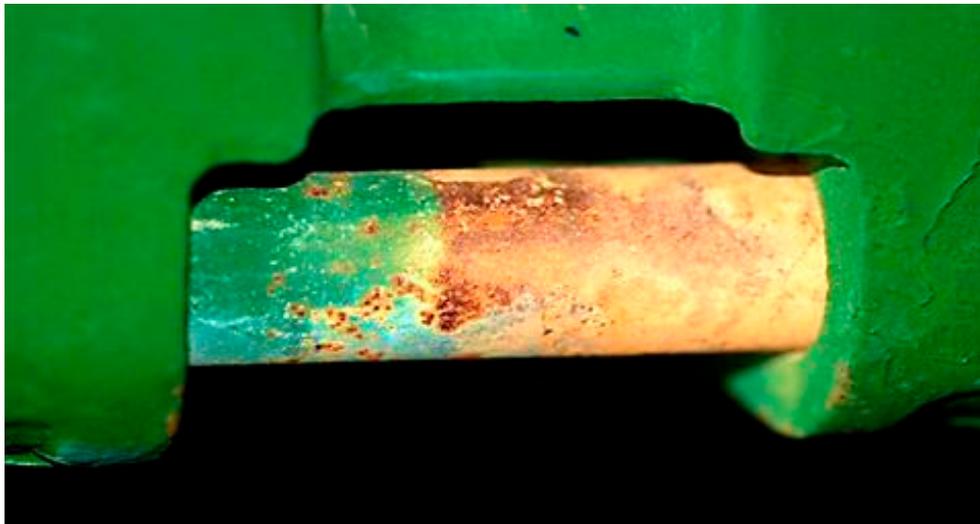
Figure 5. Centurion-stridsvagn 104 paint system following a corrosion attack.

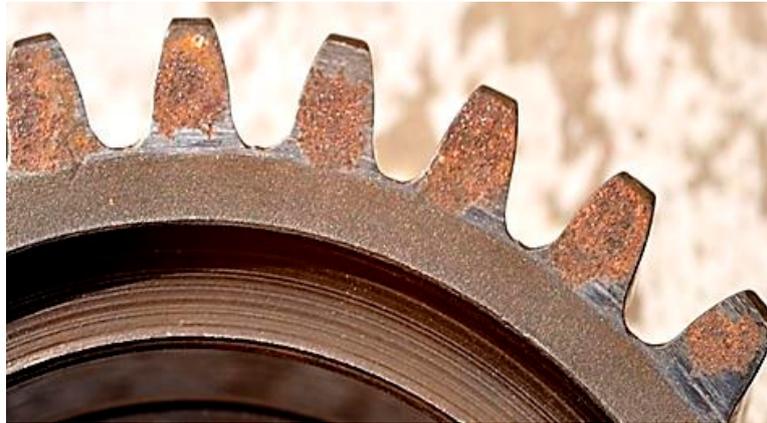
Figure 6. Corrosion problem in King Tiger's Gear Box Planet Gear.

The Gear Box of the King Tiger was disassembled after almost fifty years for corrosion investigation, as shown in Figure 6. The gearbox showed various types of corrosion in many of its components. Although the King Tiger does not operate anymore, it is, however, structurally degrading due to corrosion.

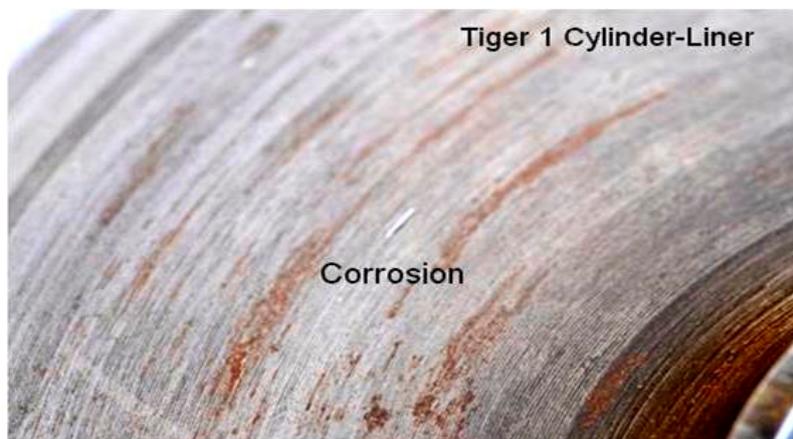
Figure 7. Tiger 1 corrosion build-up in the cylinder liner.

Tiger 1 operates occasionally; when it is stationary, there is the possibility of corrosion build-up in the engine, such an example is shown in Figure 7. Corrosive-wear has a detrimental impact on the engine performance in particular and on the Tiger 1 as a whole.

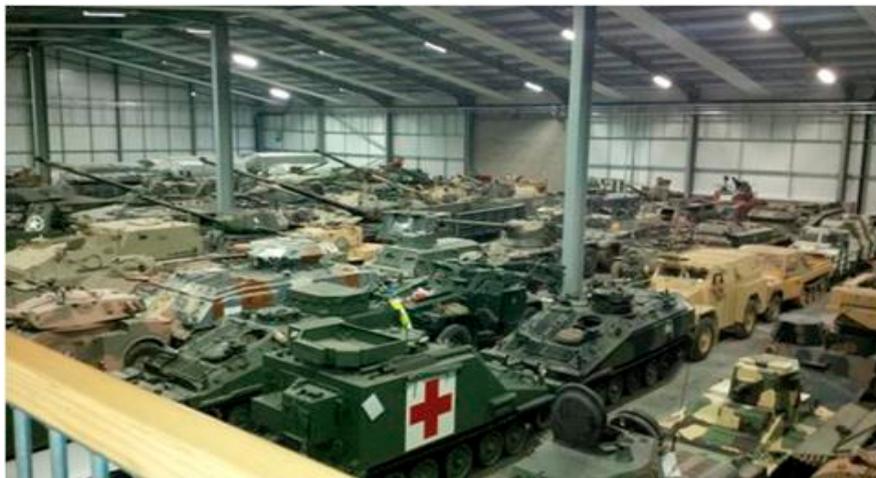
Figure 8. Collection of large vehicles that are now stored within a controlled environment in a new facility.

Relative humidity and temperature monitoring sensors are now installed in the shelter at 10 locations, where the relative humidity and temperatures are constantly monitored. In addition to this, based upon the recommendations from this research, a new conservation facility shown in Figure 8 was recently built where temperature and relative humidity variations are kept to a minimum.

Keeping the occurrences of sharp rises and falls in relative humidity to a minimum, and ideally achieving an optimum level (35%–45%), is an important factor with respect to keeping the vehicles protected. This can be achieved through better ventilation, dehumidification and air conditioning. Optimum scale of relative humidity and temperature will help mitigate corrosion, thus achieving extended life for large vehicles and effectively retarding environmental assisted damage.

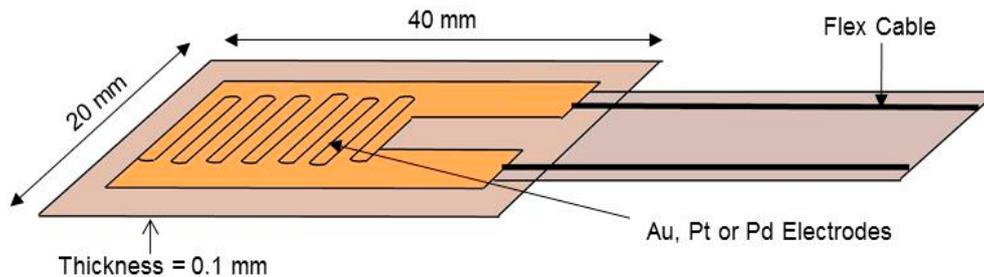
Figure 9. Three electrode corrosion sensors.

A framework of *in-situ* condition corrosion monitoring based upon micro-linear polarisation resistors [29,30] shown in Figure 9 is developed and installed on the vehicles. This framework is able to detect materials degradation through corrosion in large vehicles in its early stages. This is one of the novel systems to provide the opportunity to detect material degradation through corrosion in its early stages cost effectively and non-intrusively. It can be defined as condition-based maintenance (CBM), rather than scheduled-based maintenance (SBM), for corrosion mitigation before it becomes an unnecessary burden [31].

In the initial stage, sensors are installed on two valentine vehicles. One of the valentines is permanently stationed inside the shelter, whereas the other operates sporadically. Data are collected regularly in order to monitor the structural degradation of these two vehicles in real time. The data acquired enables delivery of a critical evaluation of the structural health, which is useful in terms of predicting corrosion failures. This framework provides an opportunity to protect the vehicles sustainably [32].

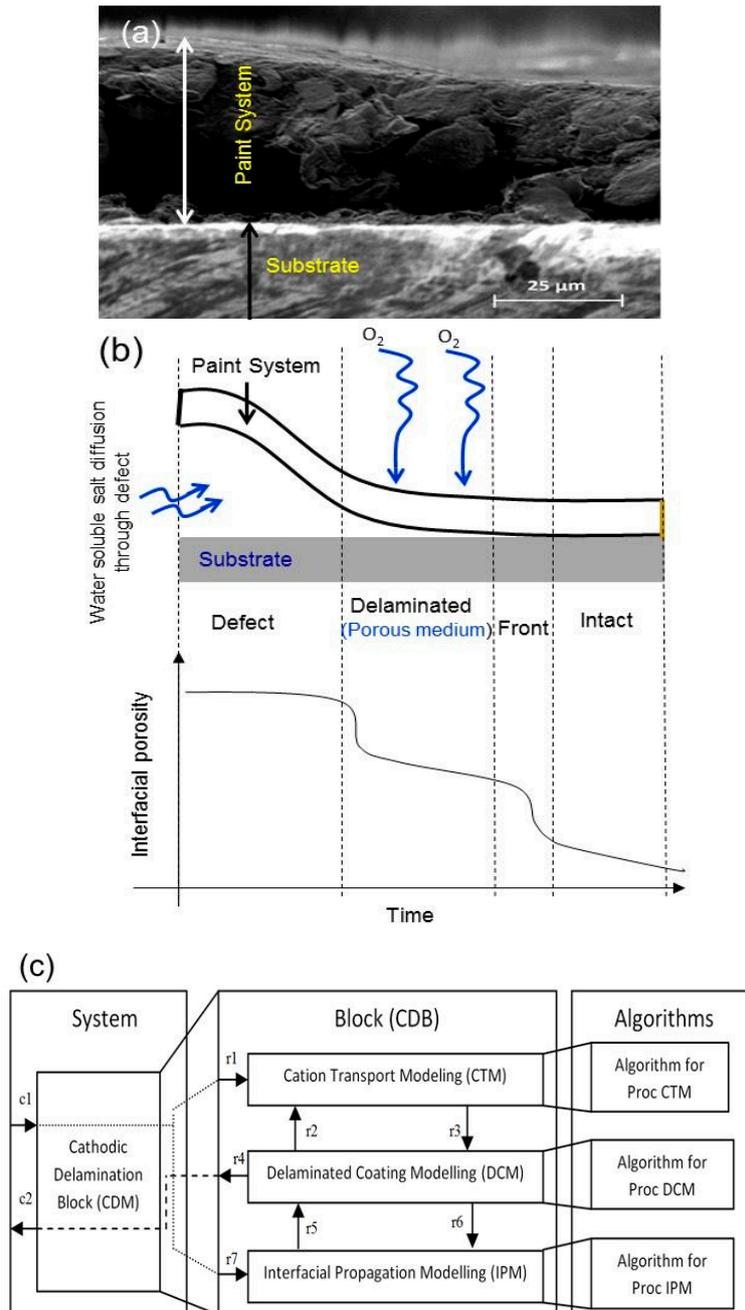
Figure 10. (a) Process of actual paint system failure. (b) Schematic representation of paint system failure. (c) Representation of cathodic delamination mechanism-modelling methodology.

One of the main reasons for paint system failures in large military vehicles is edge delamination or the gradual removal of paint system from the metal surface in time. This phenomenon is shown in Figure 10a. Research was conducted to develop a holistic model [12] for paint system failure predictions because of edge delamination as shown in Figure 10b. An advanced model to understand the cathodic delamination mechanism was developed. The model contains system and blocks, inside the blocks there are three interdependent parallel processes; Process of Cation Transport Modelling (Proc. CTM), Process of Delaminated Coating Modelling [Proc. DCM] and Process of Interfacial Propagation Modelling (Proc. IPM) as shown in Figure 10c. These processes represent (a) cation formation (b) reduction of oxygen and (c) mechanism of cation transportation. Every process in the model is a discrete algorithms with an ability of inter-communication. This communication is facilitated through duplex channels transmitting signals r_2 , r_3 , r_5 and r_6 , which represents a discrete delamination parameter. The interdependency of several parallel processes makes the study and understanding of quantitative agreement among delamination parameters easier. The obtained results are in close agreement with the experimental data, its interpretation and numerical analyses which have been reported recently [12]. The proposed delamination prediction model will be a useful resource for future research.

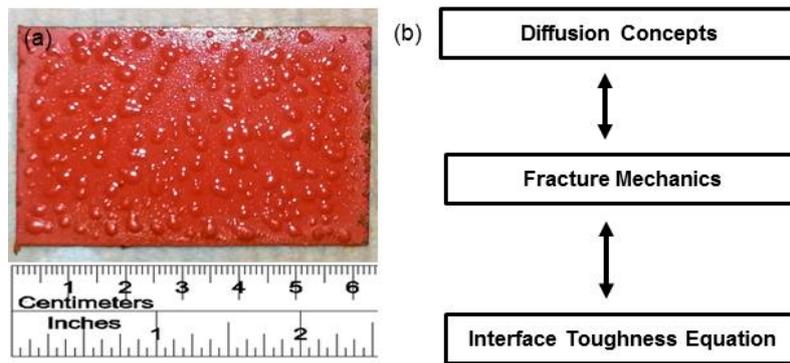
Figure 11. (a) Blisters on steel sample; and (b) modelling methodology for blistering.

Blistering is another reason why paint systems degrade in large vehicle that are in continuous operation in severe environmental conditions. An example of blistering in the paint system of a large vehicle is shown in Figure 11a. Research has been conducted to develop, model and predict initial paint system failure linked to blistering [8,9,14]. Both fracture mechanics classical theory approach and diffusion concepts have been incorporated through a generalised meso-mechanics modelling techniques to analyse blister initiation and propagation in two distinct stages. Diffusion concept have been deployed to represent the transport of corrosive species towards the interface of paint system and substrate, and fracture mechanics concept to show blister growth in the form of circular crack propagation. A simple criterion is identified by using a developed interfacial toughness equation, which however does not include blister propagation on wider scale. The model has been validated using experimental methods showing a good qualitative agreement between the two.

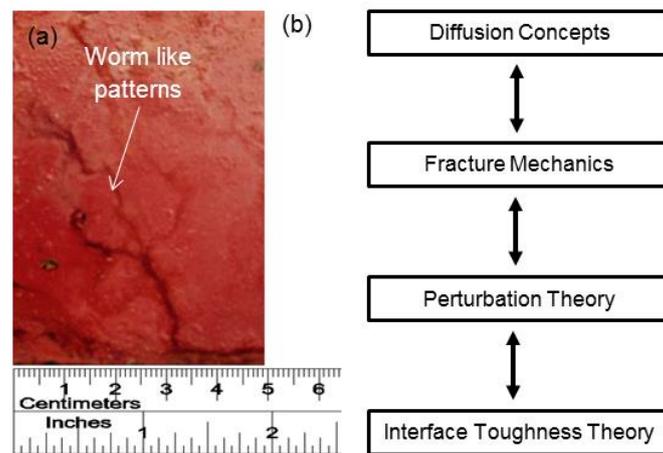
Figure 12. (a) Sample showing the propagation of blister in to worm like pattern under increasing resultant coupling stress (residual stress coupled with diffusion induced stress). (b) Modelling methodology for unstable blister propagation.

The previously mentioned blistering model was further modified in order to predict paint system failures due to unstable propagation of circular blisters in the form of worm-like patterns as a result of the development of compression and diffusion induced stress in harsh environments, as shown in Figure 12a. Paint system de-bonds from the substrate due to sufficiently large delamination, giving rise to blister, which consecutively induces the driving force on crack tip at interface. The crack tip

driving force decides the interface toughness, higher driving force account for low interface toughness and *vice versa*. The predictive model shown in Figure 12b presents non-axisymmetric perturbation of blister in to branching, which eventually results in worm-like pattern. The model was validated using detailed experimental study on a palladium-coated steel substrate, which allows the visualisation of delamination of paint system under the influence of both compression and diffusion of species. The investigation suggests that non-axisymmetric instabilities would develop at the crack tip during the propagation of blister, which eventually results in worm-like patterns, the patterns often observed in the delamination of thin paint systems.
