The Opening and Closing Sequences of the Battle of Jutland 1916 Re-examined: archaeological investigations of the wrecks of HMS *Indefatigable* and SMS *V4*

Innes McCartney

This paper presents the findings from surveys carried out in 2016 of two wrecks sunk during the Battle of Jutland. The remains of HMS *Indefatigable* had previously only been partially understood. SMS *V4*, was found and surveyed for the first time. They represent the first and last ships sunk and allow the timings of the opening and closing of the battle to be established. In the case of HMS *Indefatigable*, the discovery that the ship broke in two, seemingly unnoticed, substantially revises the narrative of the opening minutes of the battle.

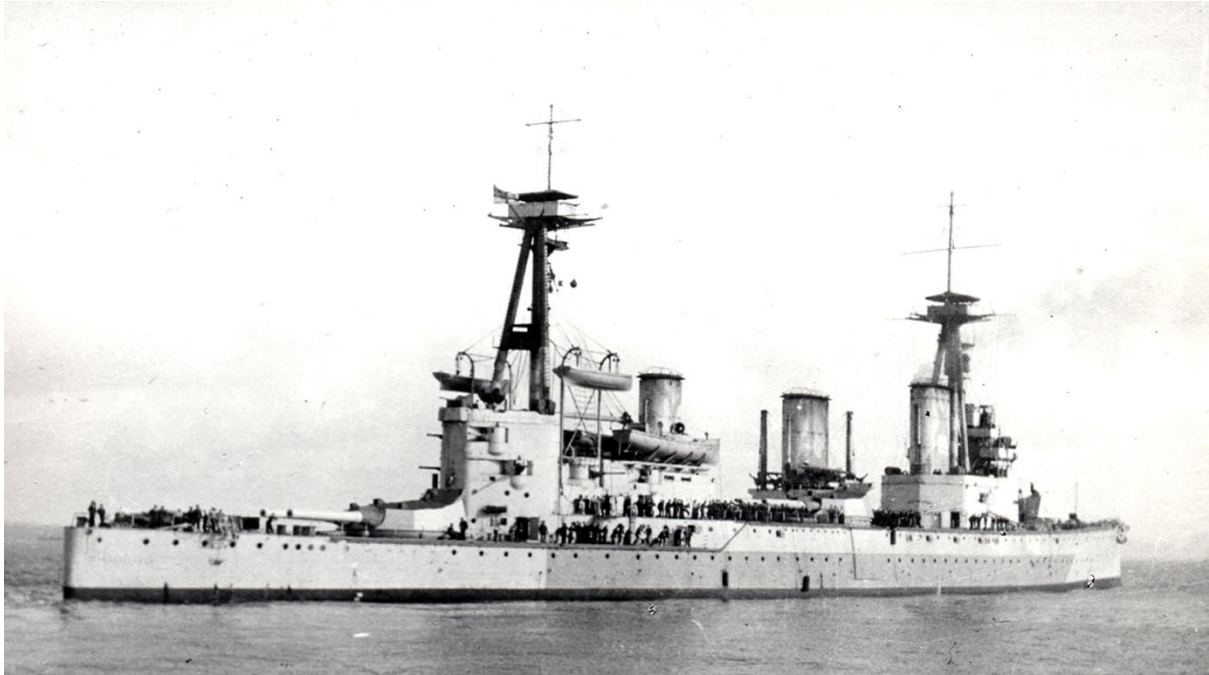
Figure 2. HMS *Indefatigable*: Displacement: 18,500 tons, Length: 180m, eight 12-inch guns, sixteen 4-inch guns (with permission, World Ship Society collection).

HMS *Indefatigable* was the lead ship of the class and represented a stretched version of the first generation of British battlecruisers, the *Invincible* Class (Fig. 2). The ship was constructed at Devonport and launched in 1909. After service in the Mediterranean, HMS *Indefatigable* joined Admiral Beatty's Battlecruiser Fleet (BCF) based in Rosyth in early 1915, from whence it sortied for the Battle of Jutland the following year. The BCF, operating as an independent reconnaissance force of the main British Fleet, encountered the German all-battlecruiser First Scouting Group (1SG) in the late afternoon on 31 May.

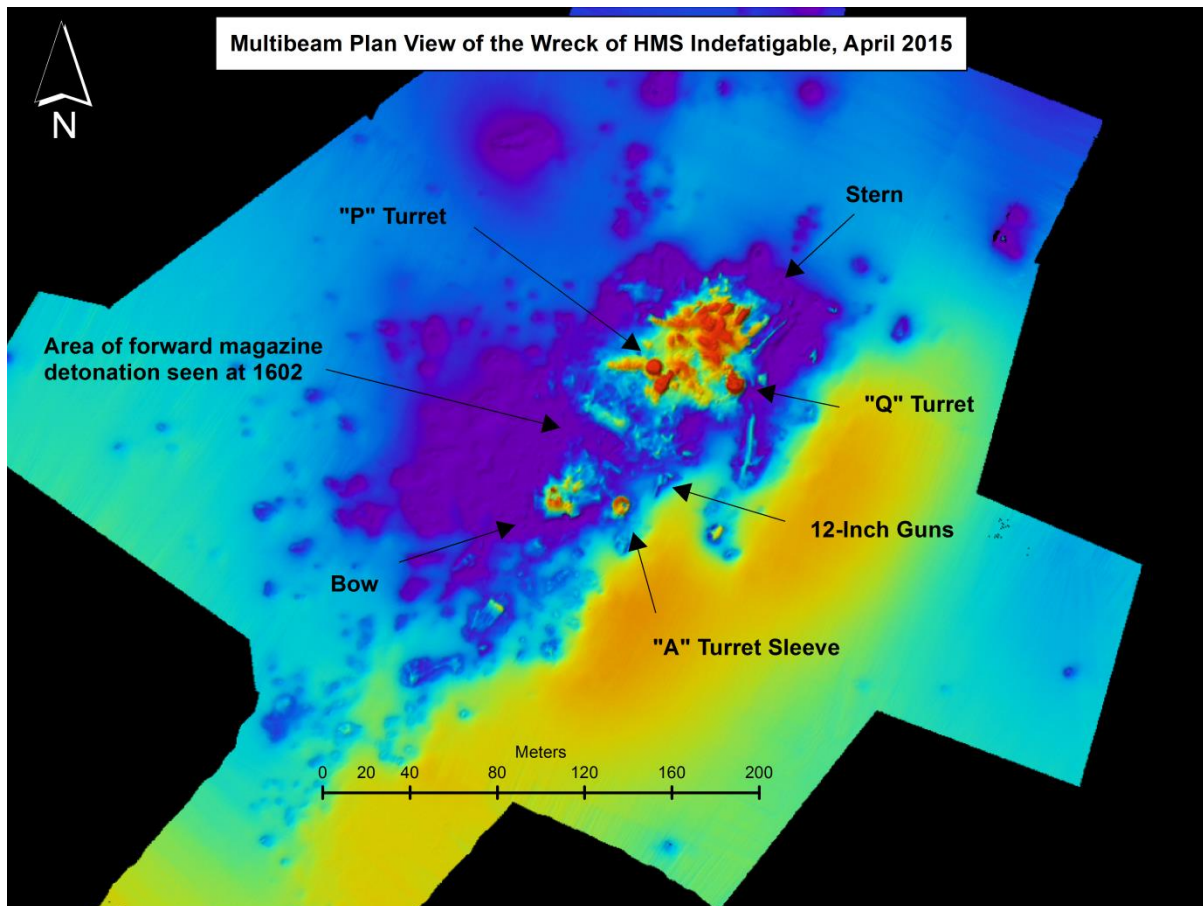
Figure 3. Multibeam plan view of the wreck of HMS *Indefatigable* as seen in April 2015 (Innes McCartney/JD-Contractor).

The wreck of HMS *Indefatigable* remained undiscovered until located and dived by the author in 2001 when the site was photographed and recorded on video (McCartney, 2016: 37–41). The wreck was seen to be very broken down and dispersed, possibly upside down. At the time there were no practical means by which an accurate map of the wreck-site could be derived, because it was too large and too deep (48m) to be measured using traditional diver-deployed techniques. What was needed was a geophysical survey. This finally occurred in 2015 when, in conjunction with underwater specialists JD-Contractor and its owner, Gert Normann Andersen, all the known wrecks of the Battle of Jutland, including HMS *Indefatigable*, were surveyed with high-grade swath bathymetry (multibeam) (Fig. 3).

The 2015 survey revealed that the wreck was violently dispersed over an even wider area than the 2001 dives had shown. An ROV was used to examine some of the outlying features uncovered by the multibeam and to confirm that the bow was pointing to the south-west. Three turrets were observed among the wreckage, with the fourth not identified. It was something of a revelation to see that craters made in the seabed by pieces of debris flying out of the ship when it exploded could still be seen 100 years after the event. The survey clearly demonstrated that, in accordance with the both Harper (1927: 20) and Groos (TNA ADM 186/626: 41), the fore part of the ship had exploded violently, seemingly leading to its destruction.

The BCF's track was broadly to the south-east (Fig. 4). It has been known since the 2015 survey that the wreck points to the south-west (Fig. 3), but it is particularly interesting to note the dispersal of pieces of wreckage seen on the wide-area multibeam survey of the wreck taken in 2016 (Fig. 5). This seems to show the course of the fore part of the ship as it turned and rolled to starboard before sinking. It appears that it turned sharply at around the time it sunk.

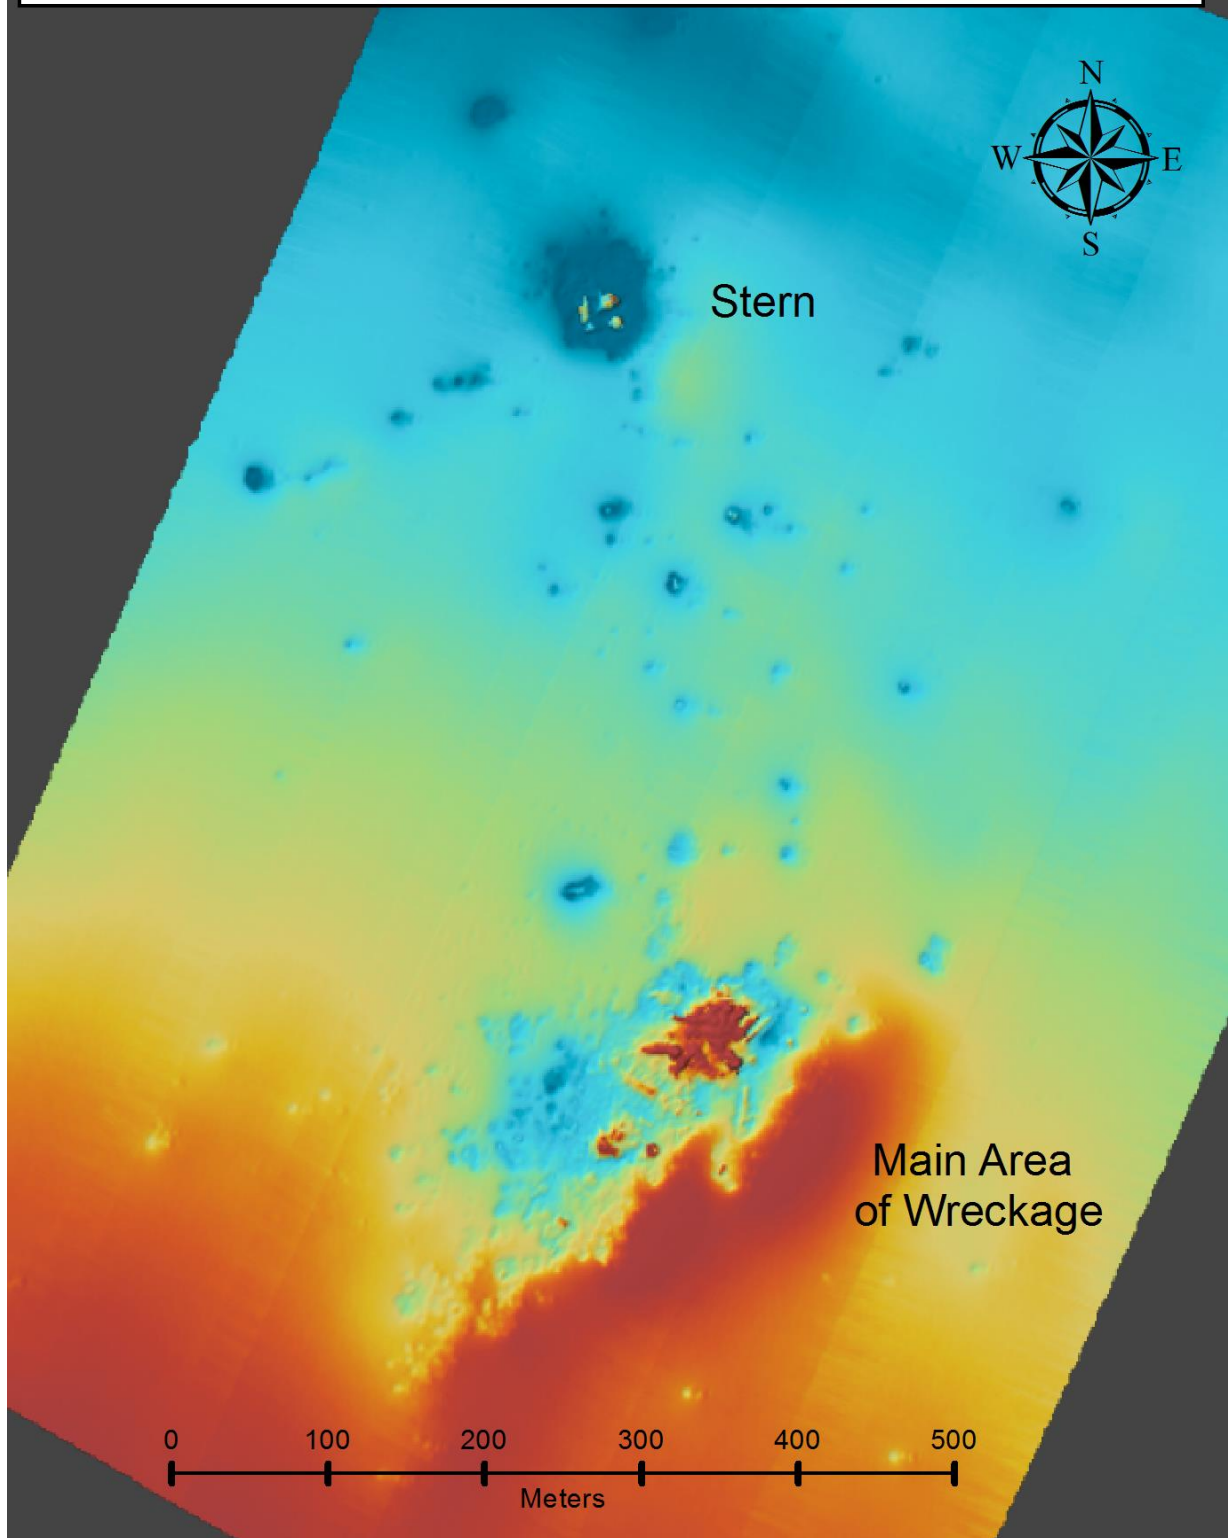
Multibeam Plan View of the Wide Area Survey of HMS *Indefatigable*, March 2016

Figure 5. The results of the wide-area multibeam survey around the wreck of HMS *Indefatigable* (Innes McCartney/JD-Contractor).

On 15 March a wide-area survey using multibeam was conducted around the wreck-site and to the north of HMS *Indefatigable*. The multibeam scan took around three hours to complete and it was not until near the end that the remarkable image of what appeared to be HMS *Indefatigable*'s entire stern appeared on the monitors in *Vina*'s survey station. The results of the survey show the previously known main wreck-site and a large piece of new wreckage detected 500m to the north (Fig. 5). The new piece of wreckage was investigated by ROV and confirmed to be the stern of HMS *Indefatigable*, upside down on the seabed (Fig. 6). Visible features included: the upside-down base of the counter balance at the rear of 'X' turret, with the open escape hatch clearly visible (Fig. 7A); the upper side of 'X' turret's armoured barbette, which is upside down and orientated at a 45° angle (Fig. 7B); three of the ship's propellers (Fig. 7C); and the pair of rudders, completely vertical, as the uppermost point of the stern of the ship (Fig. 7D). The propellers looked as if they had been pulled

out of the wreckage as they lay some distance away from where they would have originally been situated. All these features clearly demonstrated that the stern of the ill-fated battlecruiser, as far forward as the after end of 'X' turret had been located, 500m from the main wreck-site.

The results of the 2015 and 2016 multibeam surveys, backed up by visual inspections of the wreck, clearly show that *Indefatigable* suffered two devastating explosions, significantly revising what is known of how the ship sunk. The stern portion was blown off along a line just aft of 'X' turret and must have been caused by a detonation of the cordite magazine under 'X' turret (Fig. 8). Similarly, the multibeam shows that the fore part of the ship was destroyed by a major explosive source that must have been the magazine under 'A' turret.

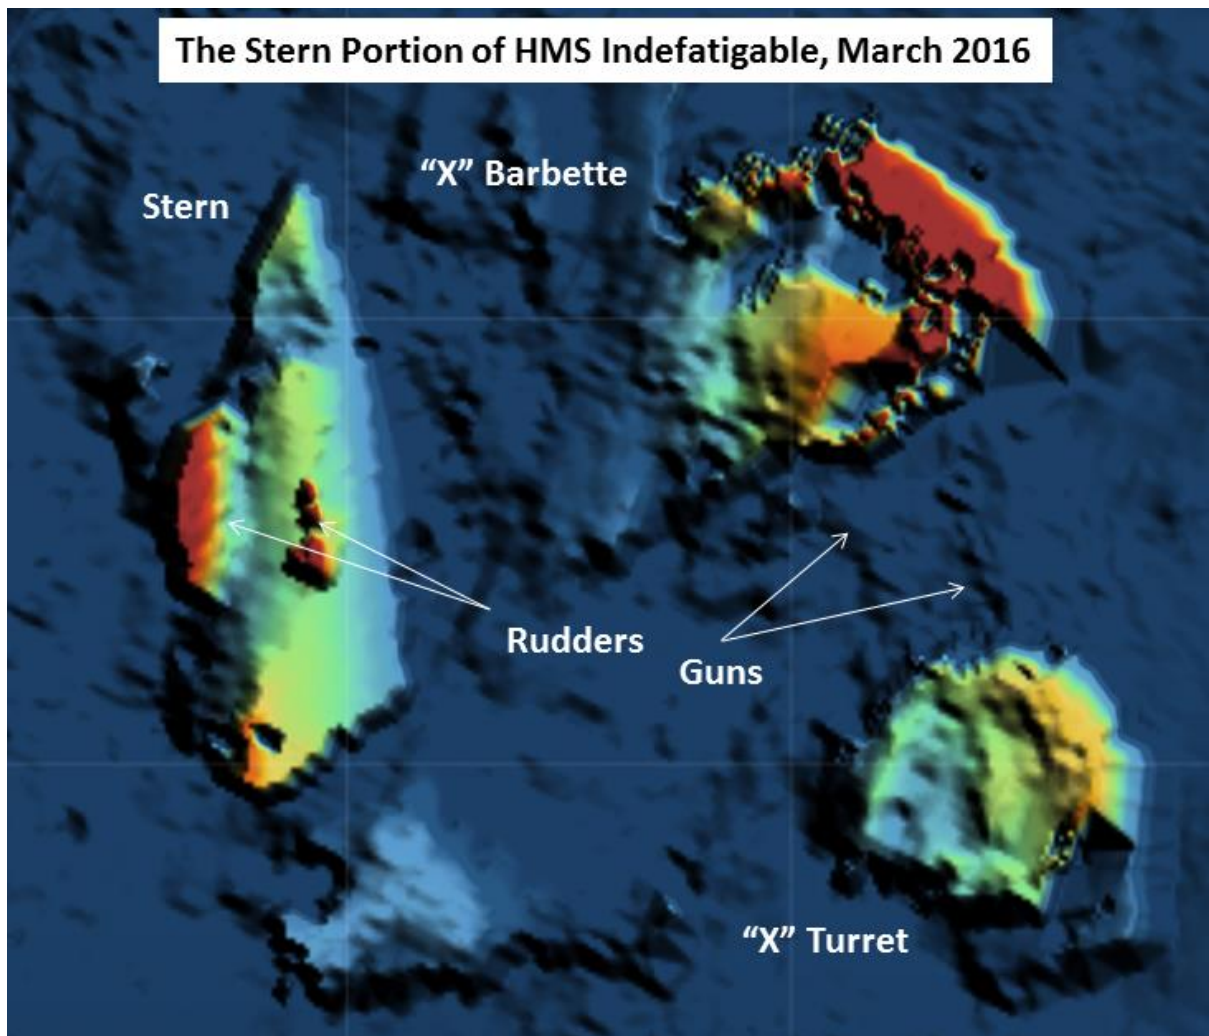
Figure 6. A close-up of the multibeam scan of the stern portion of HMS *Indefatigable* as discovered in March 2016 showing the upside-down stern with its twin rudders, the armoured barbette lying aft of the upside-down 'X' turret (Innes McCartney/JDContractor/MSP).

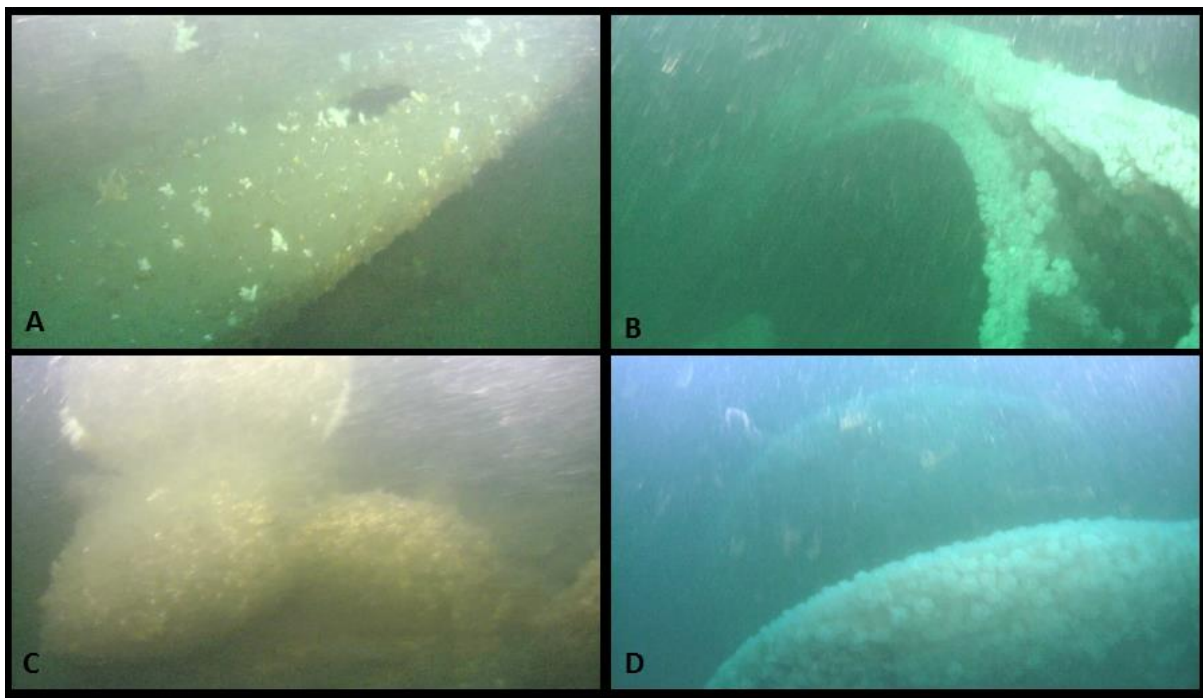
Figure 7. Images from the ROV survey of the newly discovered stern of HMS *Indefatigable*, March 2016: A) base of the counterbalance at the rear of the 'X' turret, with escape hatch; B) upper side of 'X' turret's armoured barrette; C) three of the ship's propellers; D) pair of rudders, (Innes McCartney/JD-Contractor).

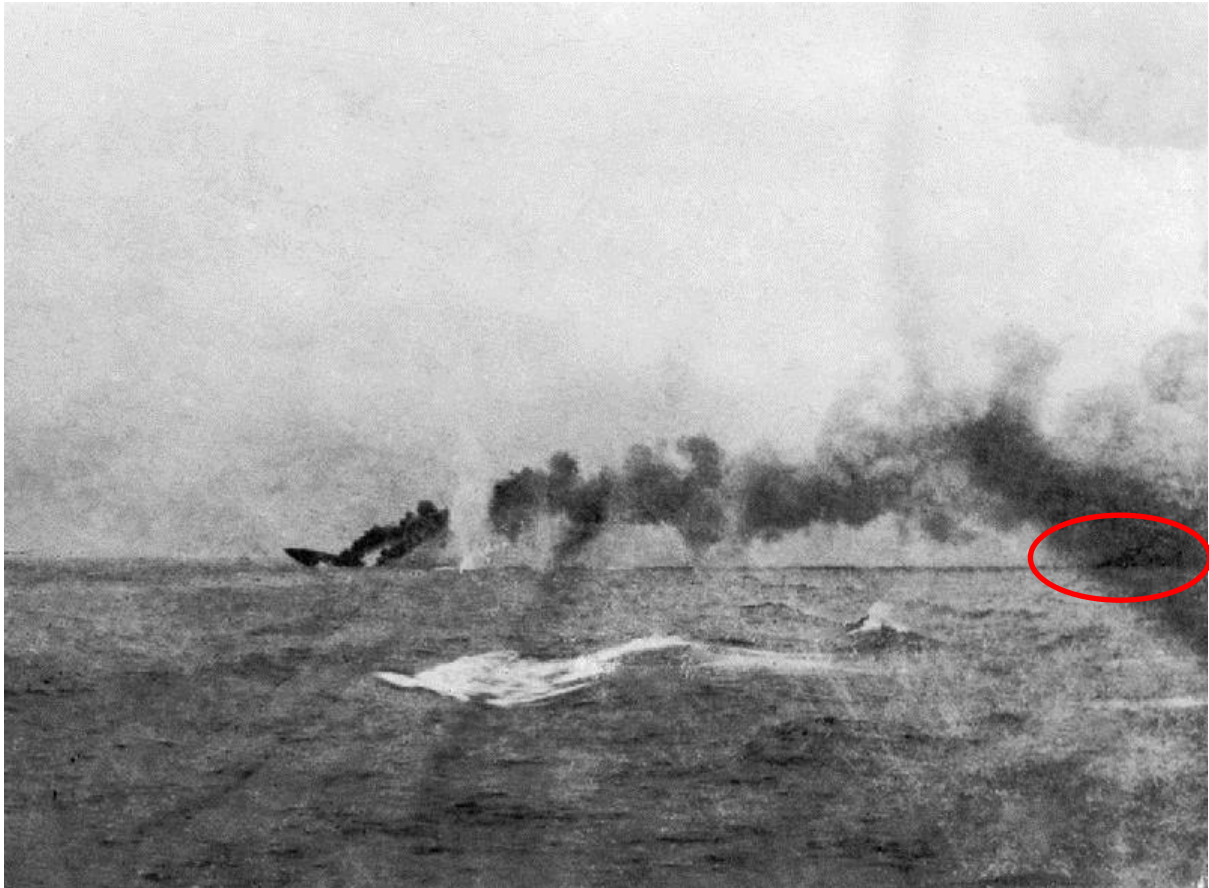
Figure 9. HMS *Indefatigable* on its side and sinking by the stern, as seen from HMS *New Zealand*. The area circled in red seems to show a pall of smoke where the stern had already sunk to the seabed (Imperial War Museum Q64302).

A photograph showing HMS *Indefatigable* sinking was re-examined in the light of the discovery of the stern section of the wreck (Fig. 9). The photograph was taken by Midshipman W. P. Carne from a position in the after torpedo control station on HMS *New Zealand*. It shows HMS *Indefatigable*, leaning very heavily to port and sinking by the stern. The notable absence of *New Zealand's* wake attests to several eyewitness accounts that *Indefatigable* hauled off to starboard, out of line, and on *New Zealand's* starboard quarter after it was hit aft. We now know the ship would have been completely out of control, having lost all means of steering and propulsion.

In the light of the discovery of the stern of the ship in 2016, it seems the photograph held a previously unnoticed surprise: a pall of smoke clearly emanating from the surface of the sea, some distance aft of the sinking fore part of the ship. In all probability this represents the aftermath of the explosion of 'X' magazine; an innocuous detail of no significance until the stern was discovered. This one photograph seems then to capture the entire sinking process sometime between the two magazine explosions.

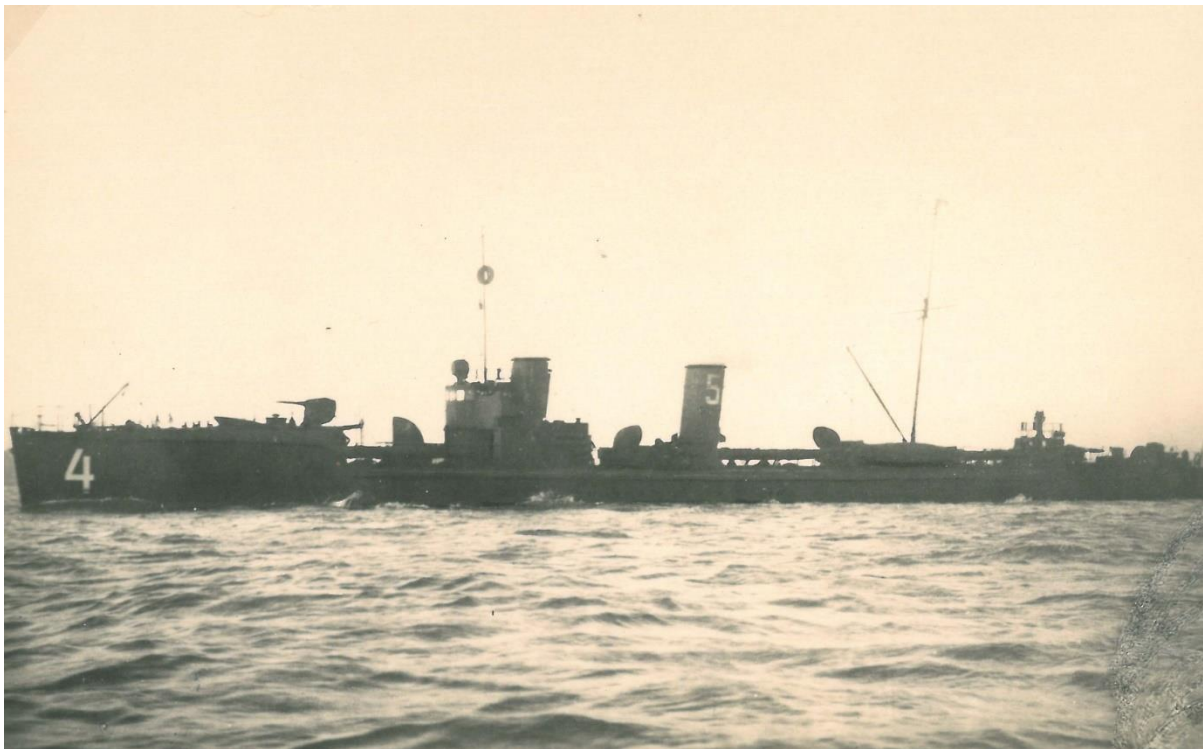
Figure 10. The torpedo boat SMS V4, length: 233ft, displacement: 689 tons, two 3.46-inch (88mm) guns of 30 calibre, one forward and one aft in single mounts, four 19.7-inch torpedo tubes with two mounted singly aft of the forecastle, one amidships on the centreline and one aft (Archiv Deutscher Marinebund).

SMS V4 was one of six torpedo boats built for the 1911–1912 construction programme by the Vulcan yard at Stettin, hence the 'V' prefix to the ship's name (Fig. 10). They were not considered to be a successful design, suffering from poor seakeeping, and by 1913 the German navy had adopted an alternative design (Gröner, 1990: 178). Nevertheless, one single flotilla, the 5th, was entirely of this class of vessel and was present at Jutland. The 5th Flotilla was made up of two half flotillas, the 10th and the 9th, in which SMS V4 was serving. During the close of the night phase of the battle the 5th Flotilla had been stationed towards the van of the German battle-fleet as it made its way back to Germany.

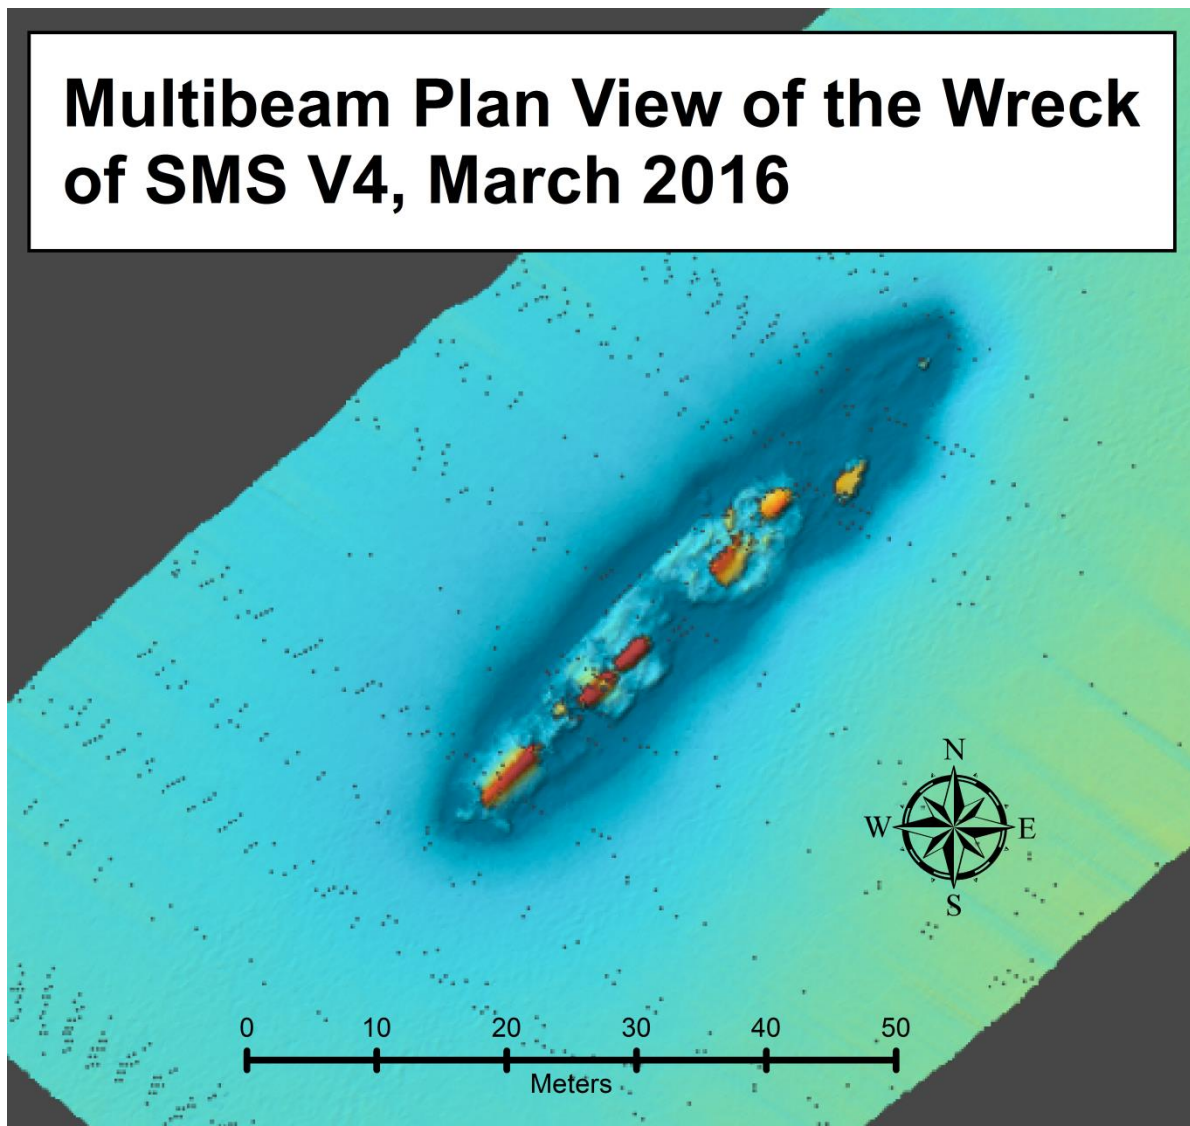
Figure 11. Multibeam plan view of the wreck of SMS V4 as found in March 2016 (Innes McCartney/JD-Contractor).

A further examination of known fishing snags in the area revealed a very small snag that was close to Harper's position. On the morning of 14 March 2016 *Vina's* multibeam system surveyed this position and the unmistakable signature image of a small warship, as seen during surveys of 11 similar ships in the previous years, was revealed (Fig. 11). In nearly every case only the heavy machinery now remains. Time and the hostile marine environment of the North Sea have contributed to reducing these smaller wrecks to a broken-down state.

One interesting element of the survey of this site was that it revealed that the bows pointed around 90 degrees out of line with the known path the ship was taking. The wreck points to the south-west, whereas SMS V4 was heading south-east when the ship exploded. Perhaps the circumstances by which the crew were rescued from the floating remains of the ship had some bearing on how it is orientated. It is known that the sea state was rising (TNA ADM 186/626: 203) and the weather report from the nearest weather station, Blaavunds Huk, Denmark, shows the wind to be from the south (Metrological Office, 1916: 153), aiding which may have aided in swinging the floating portion of the ship around.

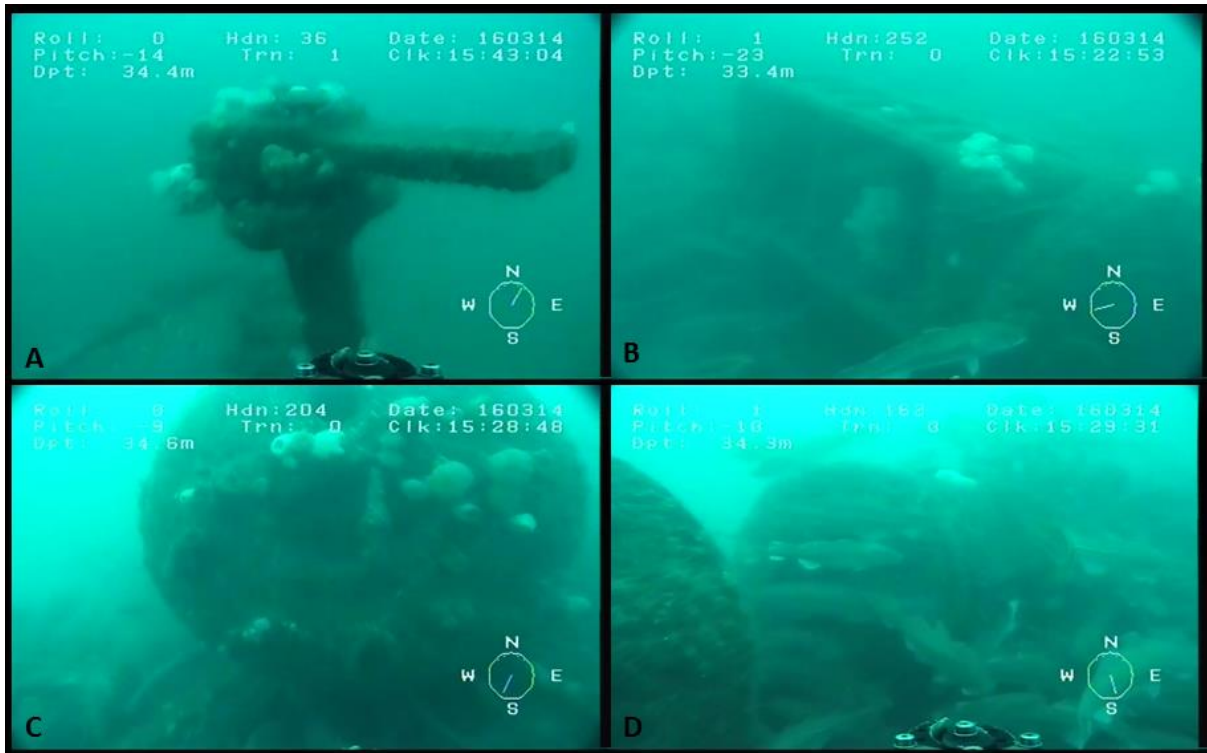
Figure 12. Images from the ROV survey of the wreck of SMS V4 on the day it was discovered: A) rudder post; B) turbine; C) Thorneycroft forward boiler; D) the two boilers. (Innes McCartney/JD-Contractor).

The site was inspected by ROV and also by *Vina's* divers, Toni Andersen and Denis Normann Andersen. All of the data gathered confirmed that this was the wreck of a Kaiserliche Marine torpedo boat. The highest feature showing on the wreck was at the extreme stern and is the ship's rudder post (Fig. 12A). It is not unusual for this feature to be seen on German torpedo boats of this era. They also featured twin engine rooms, each fitted with a single turbine and condenser. In this case the turbine can be seen, but the condenser is no longer present, leaving a rectangular void visible where it would have been fitted (Fig. 12B). The boilers present on the wreck were of the Thornycroft type extensively fitted to German vessels of this period (McCartney, 2016: 26). In this case the forward boiler was double length, the after end of which can be seen in Figure 12C. The two boilers in the centre of the ship faced each other, where they would be loaded with coal. The conjunction between these boilers was clearly visible (Fig. 12D).

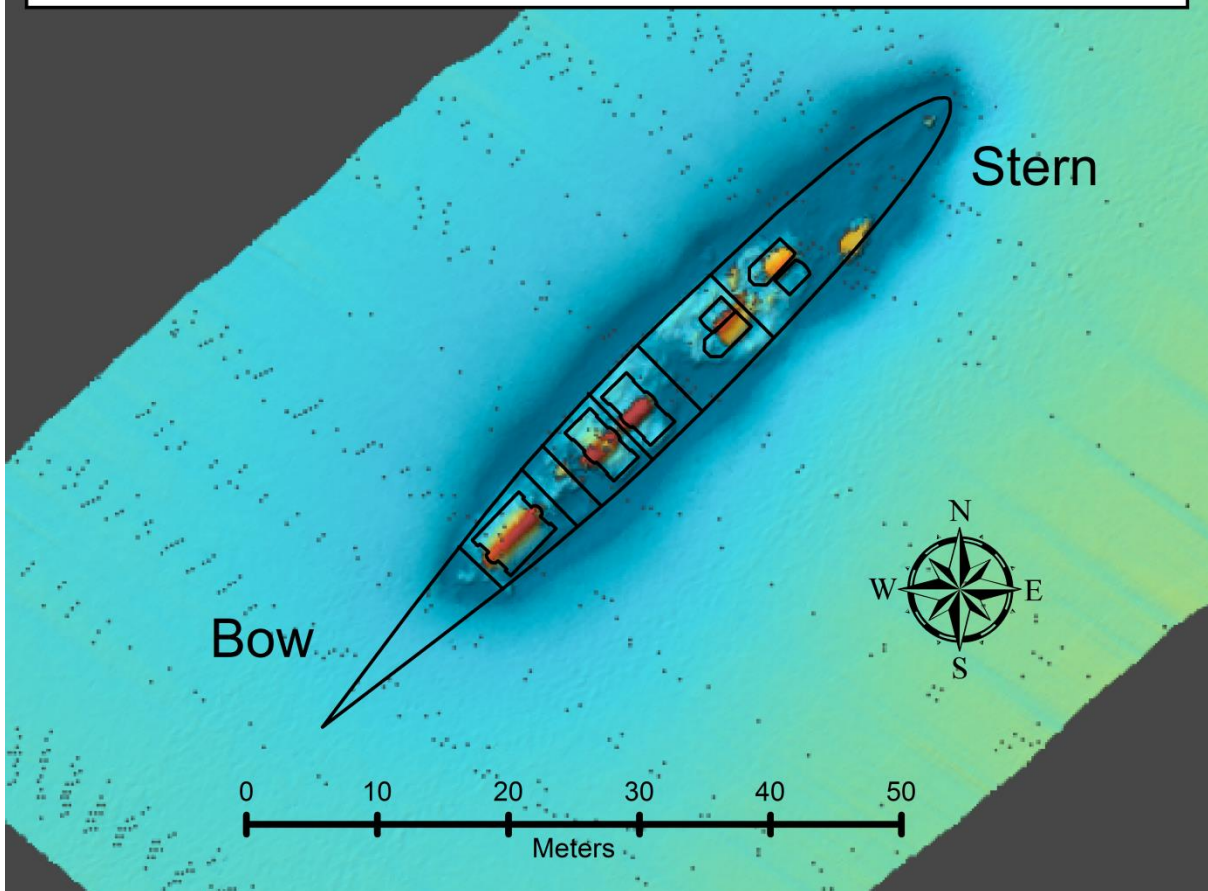
The Wreck of SMS V4, March 2016

Figure 13. The hull form and machinery distribution plan for SMS V4 laid over the multibeam plan view (Innes McCartney/JD-Contractor).

It was recognized in the 2015 survey data that, in nearly every case, all that remains of the destroyers and torpedo boats sunk at Jutland is the heavy machinery and occasionally some dispersed wreckage on the seabed. So a useful tool was devised, using a typology based on the construction drawings of the holds of each class of small warship. Drawings were laid over the multibeam scans of the wrecks and were instrumental in identifying each wreck-site (McCartney, 2016: 25). For example, this methodology was used on the multibeam plan view of SMS *V4* and the main features of boilers and turbines line up very well (Fig. 13). SMS *V4* was the only torpedo boat of the 1911–1912 order to be sunk at Jutland. These facts likely prove that the wreck is SMS *V4*. Its proximity to the position calculated by Harper (1927) is additional proof of the accuracy of his records both in terms of time and place.

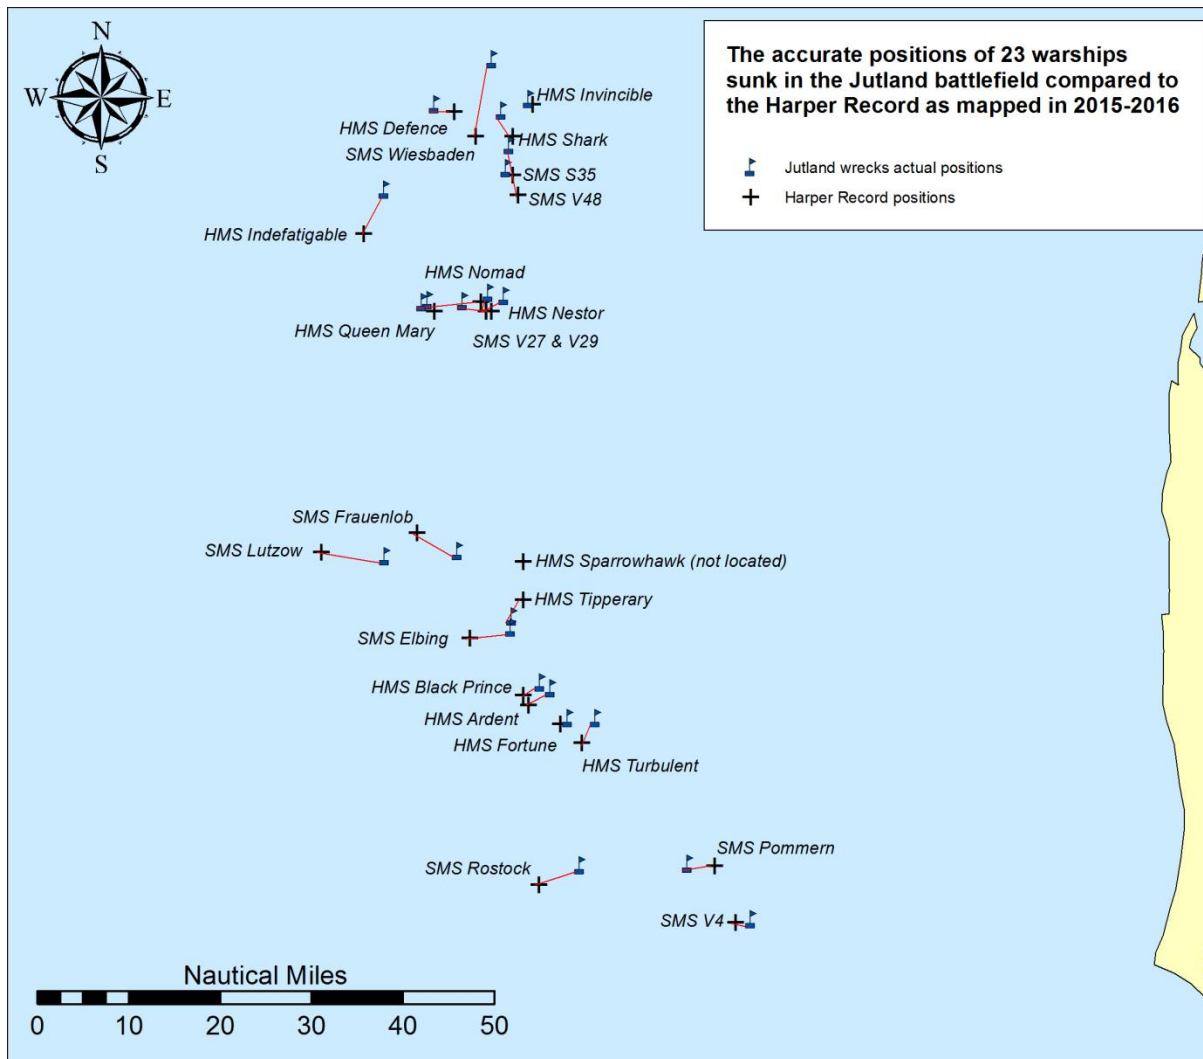
Figure 14. The Jutland battlefield as known in March 2016 showing the actual positions of each wreck-site compared the positions given in the Harper Record. The red lines show the difference between Harper’s estimations and the actual wrecks (Innes McCartney).

In the case of *V4* it has been shown that its proximity to the position outlined by Harper (1927) confirms the timing and location where the last ship sunk in the battle. This supports the established premise that the Harper Record is a broadly correct chronology of the battle, with an average positional discrepancy of less than 3.5 miles (McCartney 2016, 244-245) (Fig 14).
