# Material characterisation to understand various modes of corrosion failures in large military vehicles of historical importance

A. Saeed<sup>1</sup>, Z. Khan<sup>1</sup>, N. Garland<sup>1</sup> & R. Smith<sup>2</sup>

<sup>2</sup>*The Tank Museum, Bovington, UK*

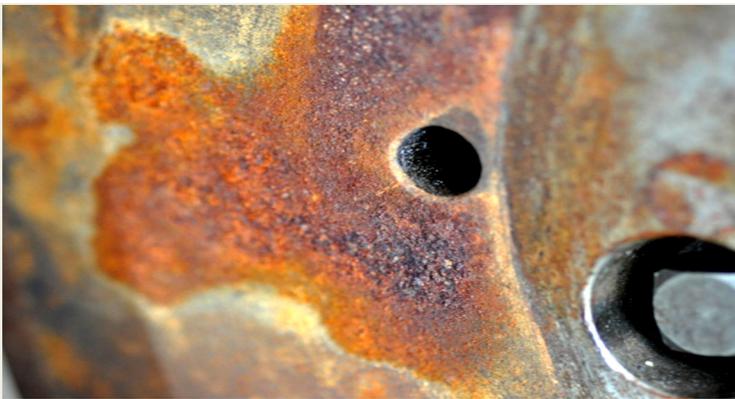
Figure 1: King tiger flywheel.

With uniform corrosion, a direct chemical attack affects the surface of the metal and then spreads out evenly across the entire surface; the results are not usually fatal and it is not classified as one of the severe forms [9]. Fig. 1 of the King Tiger's flywheel shows uniform corrosion spreading across the surface. Uniform corrosion was also found in Tog II and FT 17 on considerably larger surface areas. Uniform corrosion, if left to continue, could lead to general thinning of the surface and may transform into another form of corrosion [10].

The modes of corrosion identified above can be retarded by using protective measures such as coatings and paint for uniform corrosion, application of lubrication and exclusion of air in the fretting corrosion, alleviating the stress in stress corrosion cracking, using same metal types in galvanic corrosion or applying insulation between two different metals.

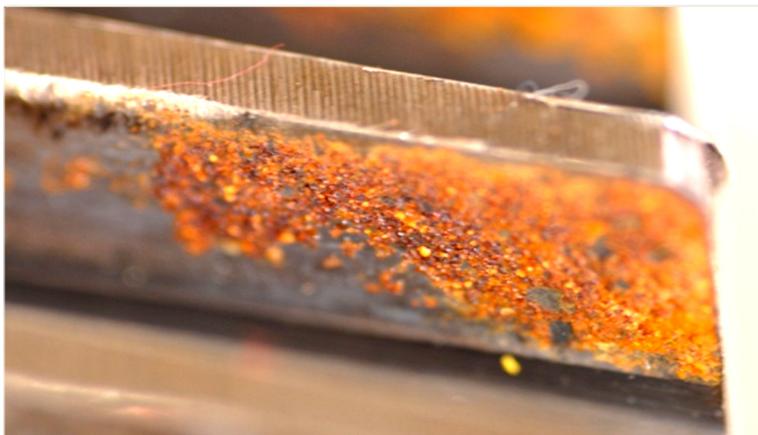
Figure 2: King tiger planetary gears.

Fretting corrosion occurs at the interface of the interacting surfaces which are subject to relative motions. The King Tiger planetary gears (Fig. 2) are a classic example of this form. Interacting mechanical wear leads to the removal of material particles, followed by the oxidation of the material debris and the newly exposed surface [11]. The oxidised debris would act as an abrasive media leading to further wear and fatigue failures could occur [9, 12].

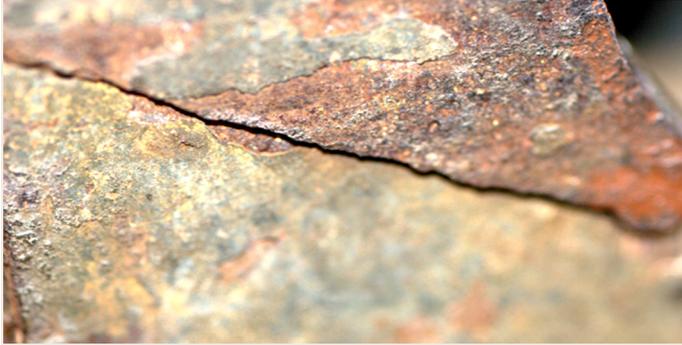
Figure 3: Mark II glasis plate.

Stress corrosion cracking is considered one of the severe types of corrosion; it could cause a partial or complete failure of a structure especially in the presence of dynamic or static loading and initiation of a stress corrosion crack [13]. The Mark-II Tank glasis plate in Fig. 3 shows stress corrosion cracking where a crack is initiated and penetrating through the surface with no significant material loss on the surface. Stress corrosion is difficult to detect, hard to predict and unexpected failure can occur [13, 14].

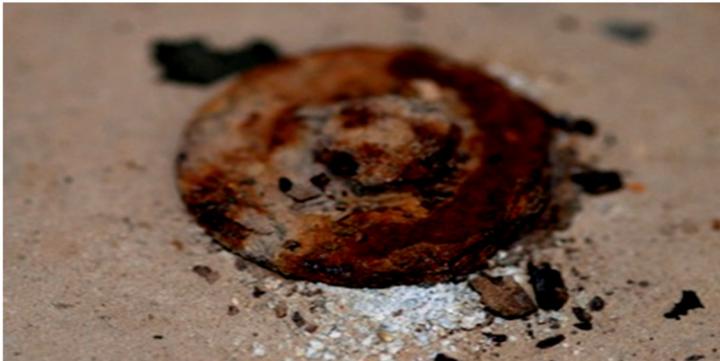
Figure 4: Galvanic corrosion in Scorpion.

Galvanic corrosion is the electrochemical reaction between two dissimilar metals in the presence of electron conductive path and the preferential corrosion of one metal more than the other [15, 16]. This mode of corrosion was identified in the Scorpion, see Fig. 4. The presence of moisture among the bolt, washer and the armoured skirt has caused this type of corrosion.

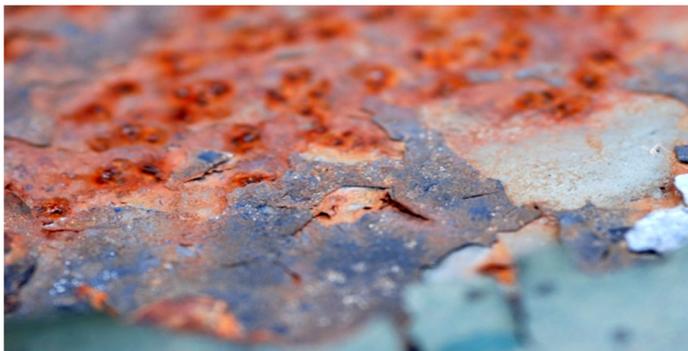
Figure 5: Pitting in Centurion.

Centurion in Fig. 5 shows signs of pitting corrosion. In this case, the corrosion is confined to a small point with resulting cavities in the metal. The localised phenomenon of corrosion creates holes in the metal and then penetrates inwards, deteriorating the metal from the inside. The corrosion products cover the pit and create a small hole with no significant material loss on the surface leading to a catastrophic malfunction; it is one of the severe forms of corrosion, which is very difficult to detect and hard to predict the result [14, 17, 18].

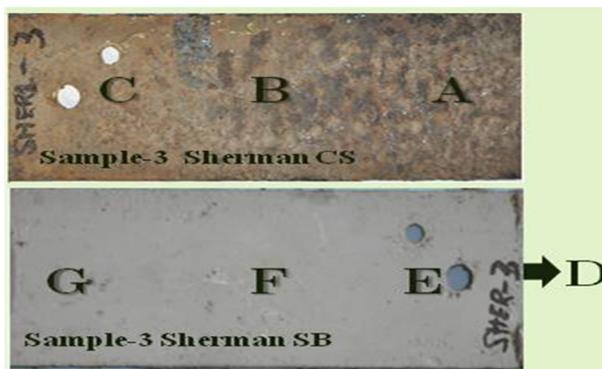
Figure 6: XRF points on Sherman.

X-Ray fluoresce (XRF) was conducted on three points A, B, C on corroded, E, F, and G on sand blasted surfaces and point D on the cross section of the sample, see Fig. 6. Table 2 shows the results from points A, B and C. On averages, Fe at 92.07% is the highest, second highest is the Si at 5.39%, Mn at 0.91% was the third highest and the lowest was Cu with a trace of 0.04%.

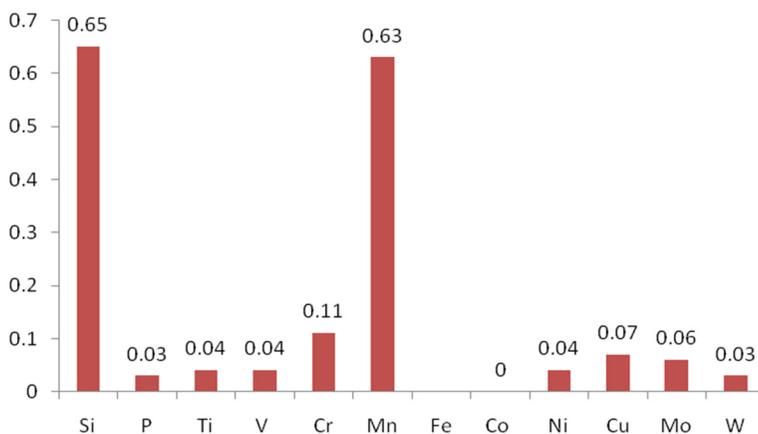
Figure 7: XRF analysis of point D, No Fe (98.30%) included.

Fig. 7 shows the graphical representation of the XRF conducted at point D where Fe at 98.30% is the highest, second highest is Si at 0.65%, Mn at 0.63% the third highest and no traces of Ti, V, Co and Mo were identified.

The alloying elements such as Mn, Cr, V, W and Mo identified though XRF are used as hardening agents to improve hardness, ductility and tensile strength [19]. Also Mo, Mn and P are used for the rust and corrosion prevention. Mo is used in high strength alloys and super alloys for strength and wear resistance [20].

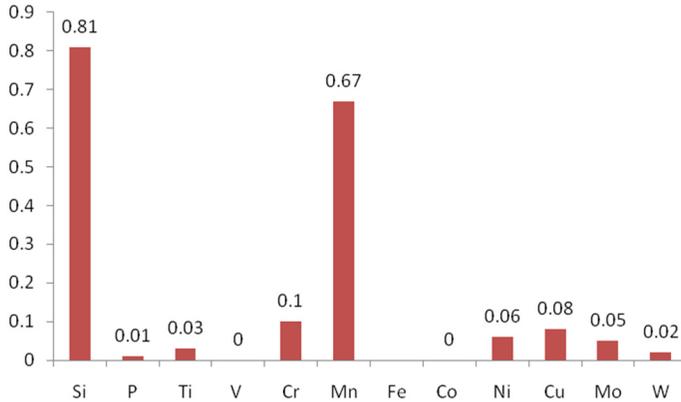
Figure 8: XRF analysis of point G, No Fe (98.09%) included.

XRF conducted at points E, F and G on the sandblasted surface shown on averages Fe at 98.12% the highest, Mn at 0.66% second highest, Si at 0.59% the third highest while W at 0.02% the lowest and no traces of Co or V were identified. Fig. 8 shows the graphical representation of the XRF analysis at point G.

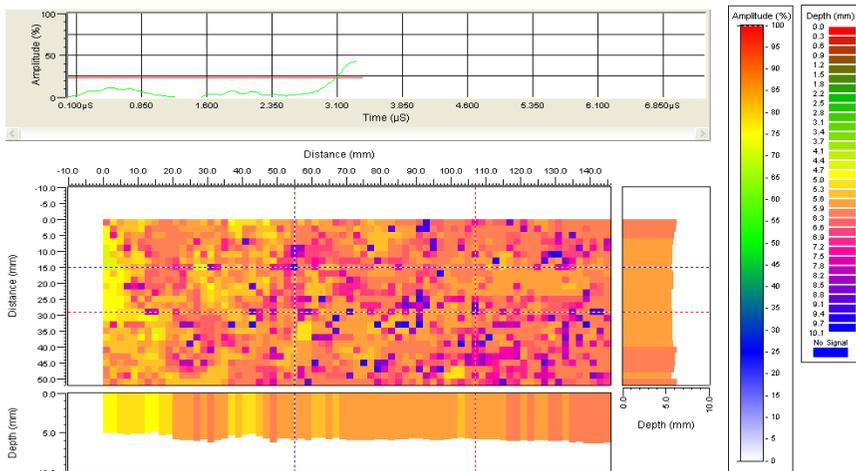
Figure 9: Pulse echo scan of M4A1.

Pulse Echo scanning was conducted on the Sherman M4A1 with a probe of 4.00 MHz twin crystal and 10.00 mm diameter using 0.25 MHz Hi pass filter and 10.00 MHz low pass filter frequencies with a probe delay of 7.630  $\mu$ S. Compression waves with a velocity of 5903.00 m/s are used to scan a total area of 174.00 mm length with 6.040 pulses/mm and 68.00 mm width with 3.580 pulses/mm mapping material loss every 2.00 mm on the sample.

Fig. 9 shows the end views and the c-scan of the sample with implementation of colour coding Red for 0.00 mm and Blue for 10.00 mm. Two cursors Red and Blue show the *x*-axis, *y*-axis location and the corresponding depths of the particular points on the sample.

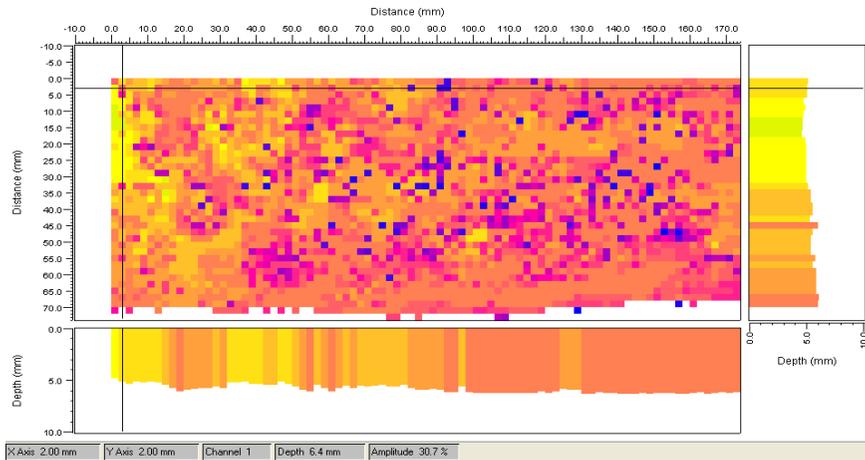
Figure 10: User defined area starting at 2.00 mm on  $x$ -axis and at 2.00 mm on  $y$ -axis.

A user defined area is taken for finding the maximum and minimum thicknesses starting at 2.00 mm on the *x*-axis, 2.00 mm on the *y*-axis in Fig. 10 and finishing at 172.00 mm on the *x*-axis and 66.00 mm at the *y*-axis in Fig. 11 respectively to avoid any distortion in signals at the edges. The scan detected maximum remaining thickness of 9.80 mm at horizontal position of 150.00 mm and vertical position of 26.00 mm with a drastic loss in material to a minimum of

4.60 mm at horizontal position of 28.00 mm and vertical position of 8.00 mm. The maximum thickness of 9.80 mm is recorded at two different points. The second lowest depth is 4.70 mm and is detected at seven different positions; third lowest of 4.80 mm at six various points and the remaining thickness of 4.90 mm is recorded at four different points in the samples. The minimum remaining thickness of 4.60 mm is recorded at three different points.

Sherman M4A1 was designed by Lima Locomotive Works in the United States. At the time of manufacture, the armoured thickness range was kept between a maximum of 62.00 mm and a minimum of 12.00 mm [21, 22]. However it is not practical to follow any possible modification in the armour thickness and, for this reason, the highest thickness recorded in the scan is considered the maximum thickness. During the service life, exposure to extreme environments has led to the deterioration and material loss. The ultrasonic scan has shown a remarkable material loss of 5.20 mm between the maximum remaining thickness of 9.80 mm and the minimum remaining thickness of 4.60 mm. Currently in the museum collection, the Sherman travels between two controlled and uncontrolled environments. Varying environments and the likelihood of failing protective measures, temperature fluctuations, humidity ratio variations, rain water and the extent of chemical reaction etc will influence the rate of corrosion and, in the controlled environment, corrosion residues may result in indoor atmospheric corrosion [23, 24].
