A Novel Non-Destructive Sensing Technology for On-Site Corrosion Failure Evaluation of Coatings

ABSTRACT The quality of coating and the resulting rate of corrosion of the underlying metal substrate can be measured by a variety of corrosion measurements (Tafel, electrochemical impedance spectroscopy) by using standard laboratory electrochemical cells. However, there is always a need of low cost, portable, and non-destructive electrochemical cells, which can be used on-site field for condition monitoring of large structures for example bridges and large infrastructures, complex operating systems as aircrafts, precision machines, petrochemical processes, automotive, and locomotives. This research has developed state of the art cells fabricated by using a special magnetic aluminum compound (Al_nX_n), which is highly electrically conductive and corrosion resistive. The research has commissioned for deploying this novel sensing technology for micro-defects detection, corrosion rate measurement, and condition assessment of the defected coatings. Tafel measurement facilitated by these non-destructive cells is used to detect micro-defects and corrosion rate measurement while electrochemica

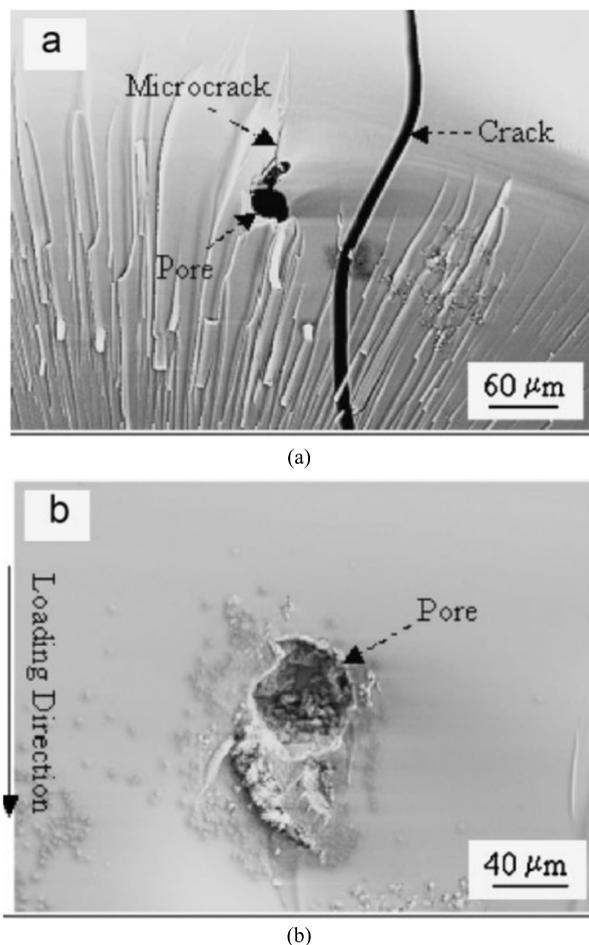
FIGURE 1. SEM fractographs demonstrating (a) a pore-like flaw, micro-crack, and crack on the fracture surface, and (b) a pore-like flaw, which resulted in macroscopic splitting failure under compression [3].

loading subsequently propagate and expose substrate to atmospheric moisture and oxygen as shown in Fig. 1. This action results in accelerated dis-bonding of the paint and flake formation from the coating-substrate interface [2]. Fig. 1 shows the pore-like defect in a polymeric coating. In Fig. 1 (a), a micro-crack can be seen that initiated from a pore and propagated a short distance [3]. These cracks typically propagate roughly parallel to the loading direction. Thus, macroscopic splitting failure under compression likely result from pores (Fig. 1 (b)). For practical applications, it is desirable to deposit continuous, defect-free coatings to achieve optimal performance.

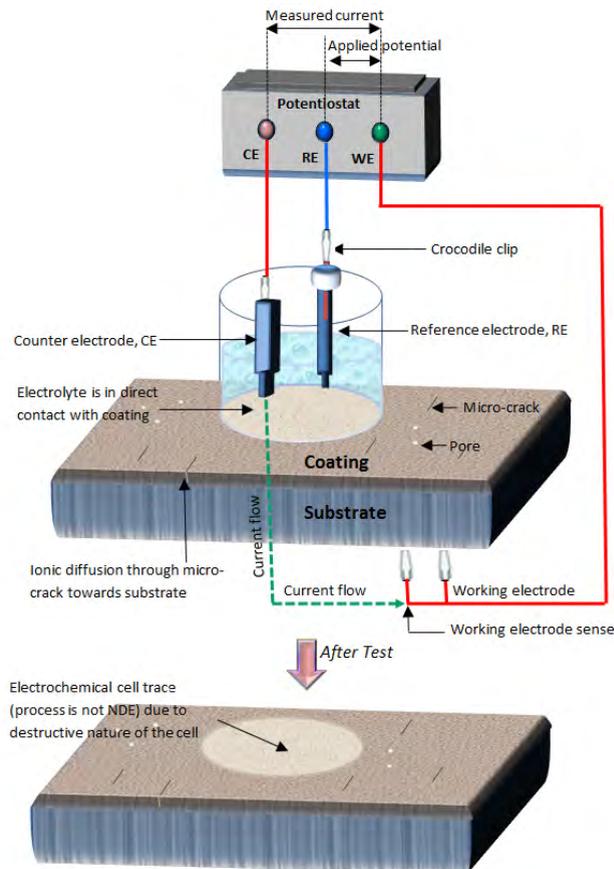
FIGURE 2. Schematic diagram for standard electrochemical cell setup for performing the electrochemical analysis of coating.

A typical electrochemical setup for coatings consists of an electrochemical cell and a potentiostat. In testing practice, a standard electrolytic cell (the system under investigation) is setup consisting of an electrolyte, a reference electrode (RE), a counter electrode (CE), working electrode sense (WES) and the coated sample of interest as shown in Fig. 2. The coated sample is called the working electrode (WE) and can be seen to possess micro defects providing the pathways

The most basic form of the cell has two electrodes (2-electrode configuration) as shown in Fig. 3 (a). The potentiostat cell cables WE+WES leads are connected together to working electrode and cell cable CE+RE leads are connected to counter electrode as there is no reference electrode. It is also used in measurements of electrochemical measurements at high frequencies (>100 kHz), especially when the thickness of coating is very large or coating is in very good condition (defect free - ideal) [20]. A three-electrode configuration for an electrochemical cell is most common for typical electrochemical applications. The cell cables WE+WES leads are connected together to working electrode however due to the addition of reference electrode cell cable CE connects to counter electrode and cable RE connects to reference electrode. A third additional electrode (the reference electrode) is used to determine the potential across the electrochemical interface accurately as shown in Fig. 3 (b). Such setup gives reliable results for damaged coatings which poses large defects [20]. Cell schematic in Fig. 2 is a three electrode configuration [20].

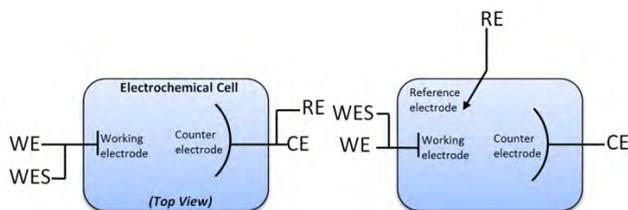
FIGURE 3. Schematic overview of the (a) 2-electrode setup (b) 3-electrode setup.

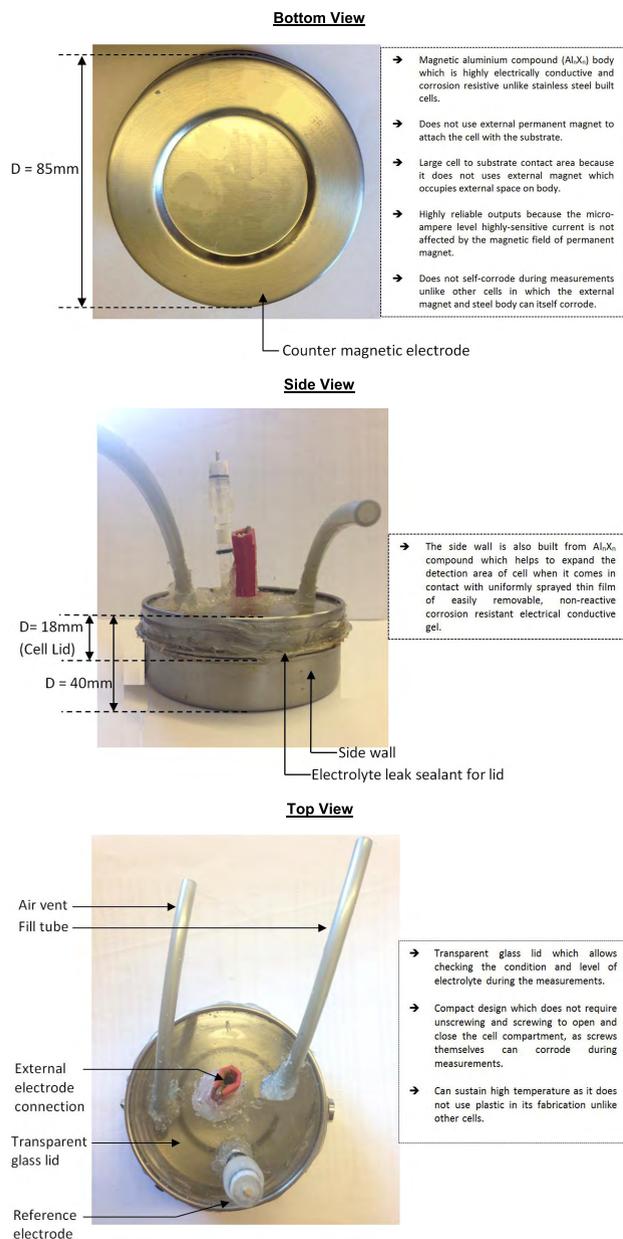
FIGURE 4. Bottom view, side view and top views of portable electrochemical cell (PEC).

The PEC system unlike standard electrochemical cell is a portable cell with a magnetic body which can be attached to any horizontal, vertical and upside down metal object. In this way the object constitutes the bottom of the PEC and the object itself can be used as an electrode. The cell can be filled with the electrolyte (3.5% NaCl solution) by using a tube that leads directly into the cell. A similar tube allows air to escape to ensure a completely filled cell in order to prevent air pockets inside the cell compartment. The inlet filling tube is positioned in a way such that it is always lower in level compared to outlet/ air vent tube. Another purpose of inlet and outlet tubes is for cleaning the cell by flushing the used electrolyte out and filling it with fresh electrolyte. PEC design does not allow the electrolyte to come in direct contact with the coating due to magnetic aluminium compound Al_nX_n

base of cell which ensures non-destructive monitoring of coating condition. Al_nX_n has been specifically chosen for fabricating PEC to obtain optimum corrosion monitoring data due to its exceptional electrical-conductive and corrosion resistance properties. Al_nX_n is prepared by doping aluminum with ferrite nanoparticles [35].

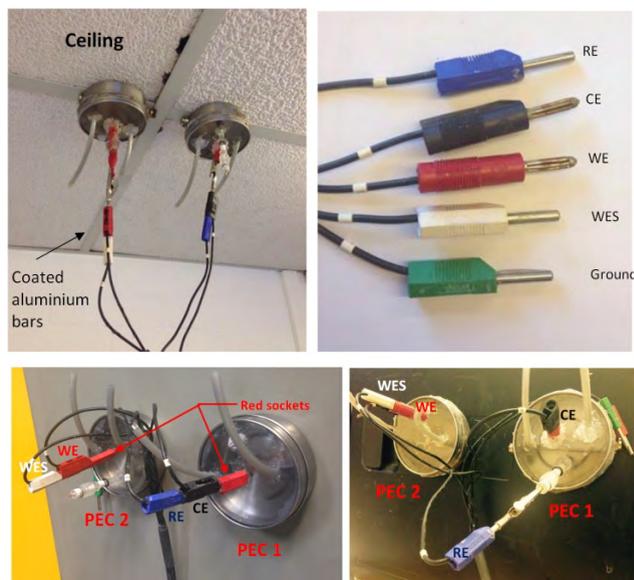
FIGURE 5. The top left image shows the corrosion monitoring of steel coated ceiling bar. The top right image shows the type of leads. Two PEC are being used together for analysing the condition of coating in a two electrode configuration in top right and three electrode configuration in bottom left. This non-destructive system is able to detect the micro-defects over the large surface area of coating.

PEC has an advantage over standard electrochemical cell that because of its completely sealed design it can be attached to metal objects with any orientation (vertical, horizontal, upside down) which allows its restriction free use in the laboratory as well as on the field as shown in Fig. 5 (top left). The object it has been attached to can be used as counter (or working) electrode. This object can be both coated and an uncoated structure. For non-destructive testing of coated object (without damaging the coating), an additional PEC is used as a second electrode which works in combination with the first PEC. This combination allows the condition monitoring of large coated structures with no possibility to reach the metal substrate. The two PECs in combination can work both in 2-electrode and 3-electrode configuration by using the leads shown in Fig. 5 (top right).

Fig. 5 (bottom left) shows the two electrode configuration in which the base metal cannot be accessed, the potentiostat cell cable CE+RE leads are connected together to the stainless steel electrode of PEC1 (red socket). The potentiostat cell cable WE+WES leads are connected together to the stainless steel electrode of PEC2 (red socket). In the shown 2-electrode

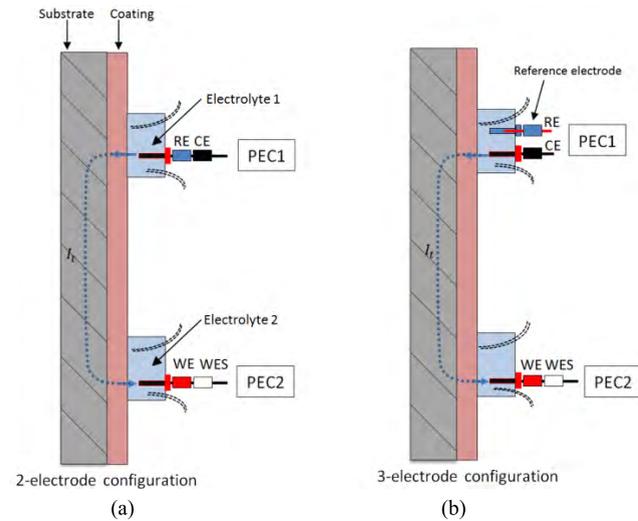
FIGURE 6. Schematic representations of (a) 2- electrode configuration PECs and (b) 3- electrode configuration PECs.

When both PEC's are attached to the polymeric coated steel an electrochemical cell is formed between the Al_nX_n electrodes in the back of both PEC's. Connecting the potentiostat cell cable WE+WES leads to the Al_nX_n electrode of PEC2, and the potentiostat cell cable leads CE+RE to the Al_nX_n electrode of PEC1, a 2- electrode configuration is formed. If reference electrode is connected to cell cable lead RE, a 3-electrode cell is formed. Schematic representations of both the 2- and 3- electrode configurations are shown in Fig. 6 (a-b) below. Like standard cell, in PECs, the current also flows between working and counter electrode. However, unlike standard cell it has to pass through the coating twice.

Using two PEC's results in a the path of current I_t that flows from electrode PEC 1 → electrolyte1 → coating → substrate → coating → electrolyte 2 → electrode PEC 2.

The above setup shown in Fig. 6 and 7 can only monitor the condition and detect pores in the coating area which is directly under the PEC. This is because that only the coating area which is directly under the PEC acts as a conductive region for the current I_t between the counter electrode and metal substrate. The pores which are not located under the PEC will not be detected. In order to detect such pores an alternative conductive path (path 2) is needed between the

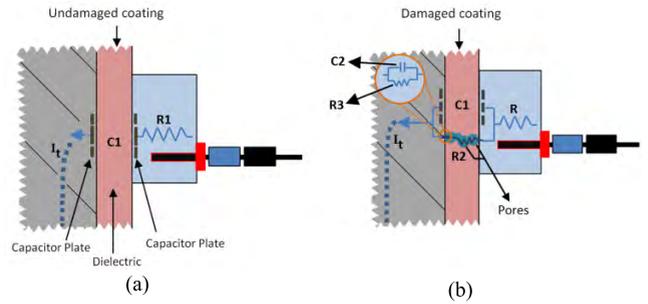
FIGURE 7. Equivalent circuit in 2-electrode configuration (a) undamaged coating (b) damaged coating.

A metal covered with an undamaged coating generally has very high impedance resulting in negligible current I_t flow mostly in PicoAmp as shown in the equivalent circuit in Fig. 7 (a). The model includes a very high resistor R1 (due to electrolyte resistance) and a very low coating capacitance C1 in series. In the case of a coated metal in contact with the electrolyte through PEC's counter electrode (at bottom), the substrate metal is one plate, the coating is the dielectric, and the electrolyte in PEC is the second plate as shown in Fig. 7 (a). The coating capacitance relationship is given by

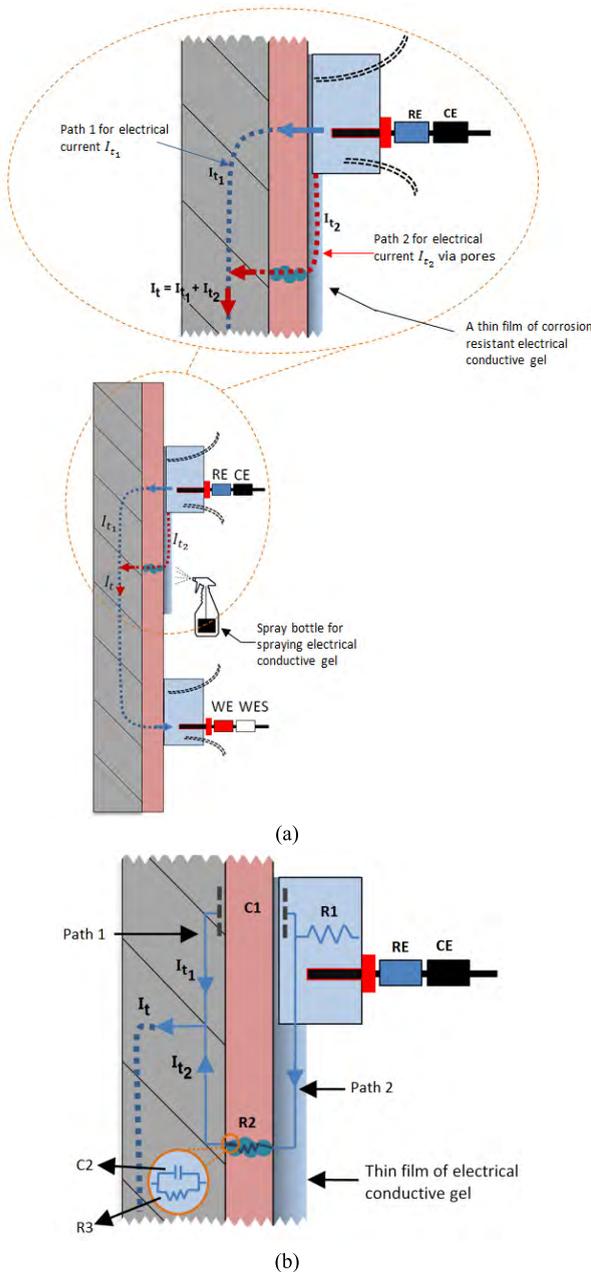
FIGURE 8. (a). Schematic showing that the (a) large sized pores have smaller R_2 which accounts for large current I_{t2} . (b) the magnitude of current I_{t2} through path 2 increases with the number of pores 'n' in this path.

electrode of PEC and the substrate such that the current can flow from electrode to pore and then from pore to substrate via path 2 as shown in Fig. 8 (a). Path 2 is created by uniformly spraying a thin film of easily removable, non-reactive corrosion resistant electrical conductive gel on coating, which comes in contact with the pores forming a closed path between counter electrode and substrate. After the gel has been sprayed, there will be two parallel paths: path 1 and path 2. Path 1 is via undamaged coating region therefore it has very high impedance resulting in negligible current flow I_{t1} while path 2 contains pores causing low impedance which results in large current flow I_{t2} as shown in Fig. 8 (b). The net current I_t which flows between PEC 1 and PEC 2 is given as: $I_t = I_{t1} + I_{t2}$.

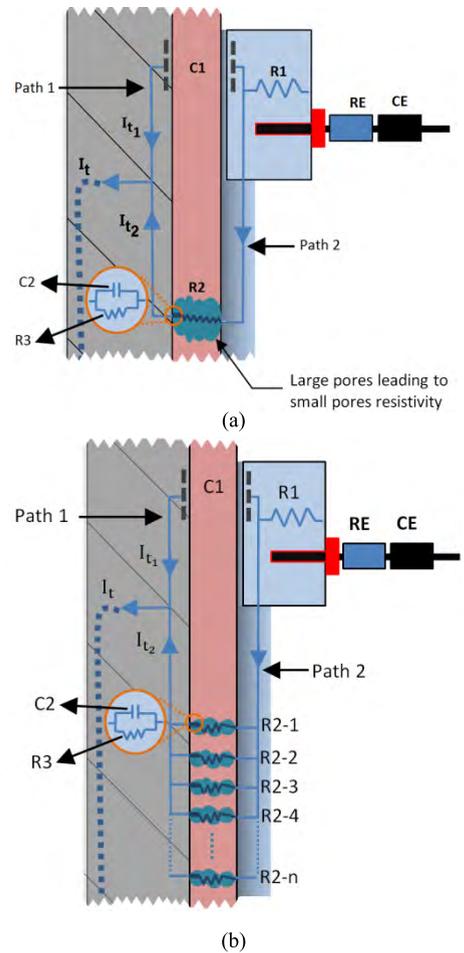
FIGURE 9. (a) Schematic showing that the (a) large sized pores have smaller R_2 which accounts for large current I_{t2} . (b) the magnitude of current I_{t2} through path 2 increases with the number of pores 'n' in this path.

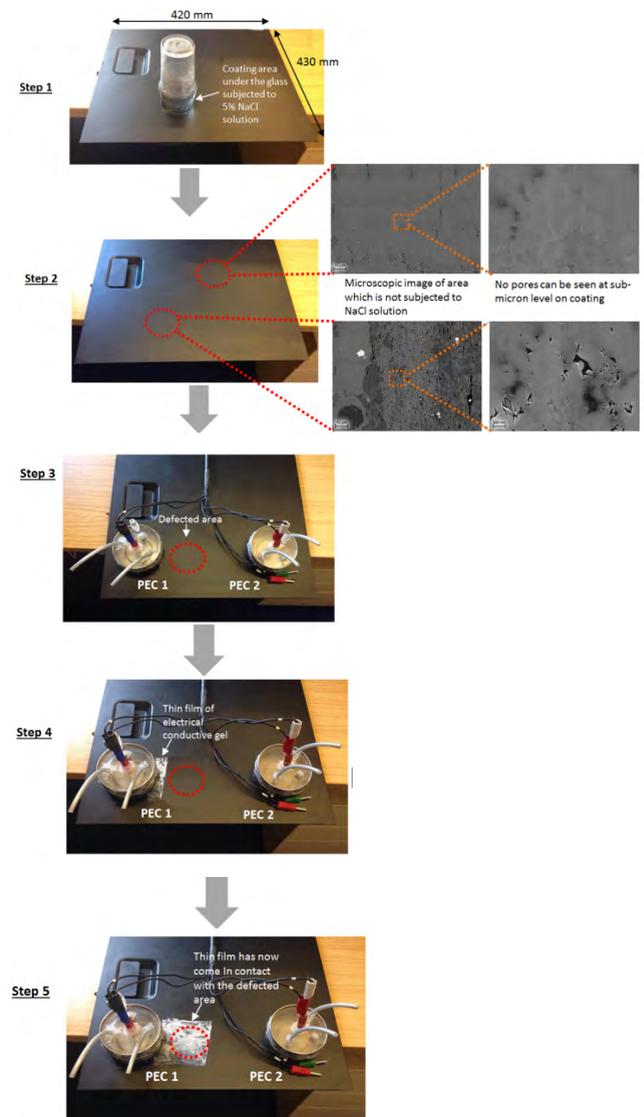
FIGURE 10. The five step experimental study performed to analyse the working of PECs.

A five step experimental study was performed by using a 420mm × 430mm aluminium sample coated with polymeric epoxy resin in black as shown in Fig. 10. The equivalent weight and density of aluminium are 26.9g and 2.7 g/cm³ respectively. For the most part, epoxy coatings are used as functional coatings for substrate protection where corrosion resistance, impact resistance, and adhesion are essential. This coating is normally used in industrial equipment, automotive components, metal furniture and appliances [38]. The objective of this experiment was to detect invisible micron and sub-micron level defects (pores) and to determine the condition of defected coating by using a custom developed PEC.

In the first step, a selected area on the coated sample was subjected to 5% NaCl solution for 72 hours as shown in Fig. 10 (step 1). This process was performed to degrade the specific area of coating under the glass which resulted in the opening of pores in the coating. In step 2, the microscopic

analysis of the subjected area was performed which was compared with the microscopic images taken from the non-subjected area of coated sample. In step 3, the two PECs were installed on the sample in 2-electrode configuration. In next step 4, a thin film of corrosion resistant electrical conductive gel was sprayed on coating by using a precise gel coat spray gun. The gel is non-corrosive, non-reactive and can easily be removed by using a dry wipe. The gel was sprayed in a stepwise manner such that the coverage area of gel was slowly increased until it incorporated the degraded area beneath it. At the same time the Tafel scan was also performed, in which the potential on counter electrode was increased from –3 V (E start) to +3 V (E end) which resulted in the corresponding change in net current I_t . The scan rate (from –3 to +3V) was set to a low value of 20 mV/sec which resulted in large scan duration giving enough time to increase the coverage area of gel gradually. In step 5, as the conductive gel came in contact

with the degraded area it resulted in the formation of a closed path (path 2) between the counter electrode of PEC 1 and the substrate. It is at this specific instance that the sudden rise in I_t is observed in the form of large trough in I - E graph indicating the location of defected area on coating.

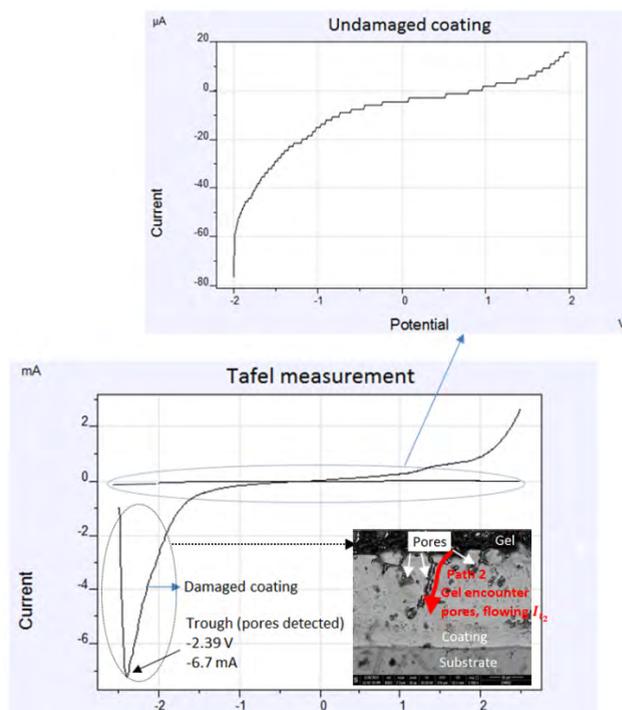
FIGURE 11. Tafel measurements for both the damaged (bottom graph) and undamaged (top graph) coatings. The graph for the damaged coating shows the trough which indicates the detection point of pores on damaged coating during Tafel scanning.

From the above experimental setup, the results are shown in Fig. 11 below. It can also be seen from the trend of damaged coating that the Tafel scanning was performed from -3 V to $+3\text{ V}$ at the same time when the coverage area of gel was increased by spraying (as depicted in steps 4 and 5 of Fig. 10). As the coverage area was increased during scan, the gel encountered the pores at $E = -2.39\text{ V}$ which resulted in the sudden drop in net current I_t to a level -6.7 mA and then the subsequent exponential rise in I_t . This sudden drop and rise in I_t was observed in the form of a trough, indicating the detection point of pores. The exponential rise in I_t is associated with the formation of low impedance conductive path 2 through pores resulting in large current flow I_{t2} . The cross-sectional microscopic image of coating-substrate interface on the right of graph shows the instance when the gel encountered the pores and resulted in the formation of a trough due to development of path 2 causing large current flow I_{t2} .

Comparison between the Tafel measurements from damaged (after NaCl exposure) and the undamaged (prior to NaCl exposure) coating can also be seen in the graph. Undamaged coating possesses only one high impedance path (path 1) for current flow I_{t1} , therefore the magnitude of net current I_t is extremely small, mainly in μA 's as can be seen in Fig. 11. However, damaged coating possesses two paths (path 1 +

path 2), therefore, the magnitude of net current I_t is high because of the formation additional low impedance path 2 (due to presence of pores) eventually adding more current: $I_t = I_{t1} + I_{t2}$, mainly in mA's. It can also be seen that for damaged coating the current reached to maximum peak current of 2.4 mA which is certainly very high current indicating the presence of low resistive large sized pores within the damaged area.

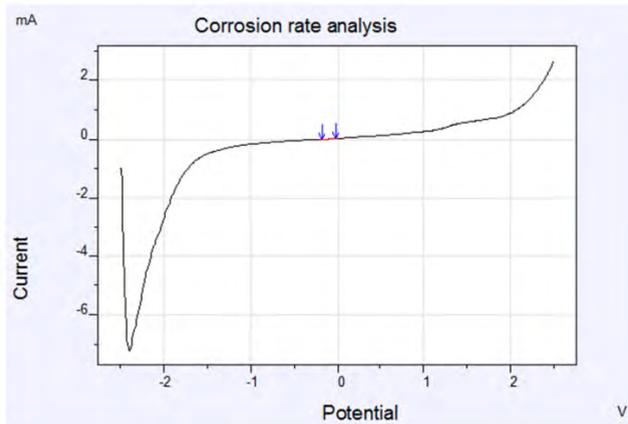
FIGURE 12. Measurement of corrosion rate by using 'slope analysis' approach.

At first, the ‘slope analysis’ was performed as shown in Fig. 12. Slope analysis identifies the corrosion potential and the polarisation resistance R_p at the zero current intersection point. The calculated quantitative results (E_{corr} , I_{corr} , R_p and C Rate) from slope analysis can be seen under the ‘Pol Res’ column of table in Fig. 13.

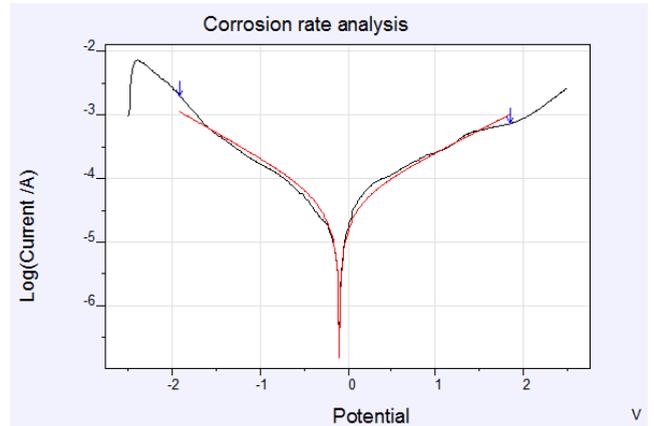
FIGURE 15. Calculation of corrosion rate by using 'Model analysis' approach.

'Model analysis' as shown in Fig. 15. Model analysis utilises the material constants i.e. surface area, equivalent weight and density (already identified in previous section) to calculate the corrosion data. The Model analysis is expected to yield the best results in most cases, because it applies complete Butler-Volmer to full data range therefore model data results are most reliable compared to slope analysis and Tafel analysis.

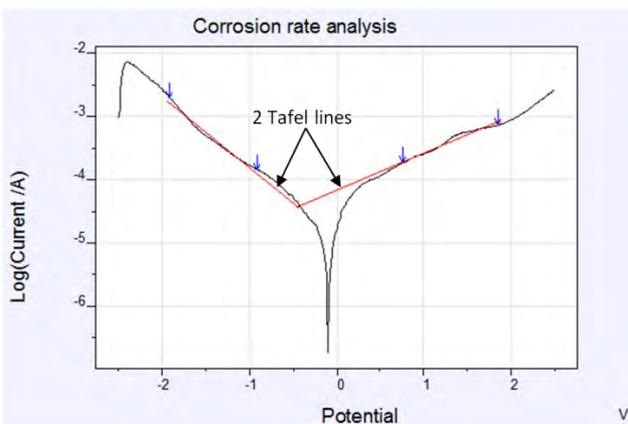
FIGURE 14. Measurement of corrosion rate by using 'tafel analysis' approach.

The ‘Tafel analysis’ was performed on the damaged coating to calculate the corrosion parameters from the 2 Tafel lines as shown in Fig. 14. The calculated quantitative results

from Tafel analysis are shown in the second column of table 'Tafel data'. Further the corrosion parameters were calculated with a numerical analysis of the available data by using

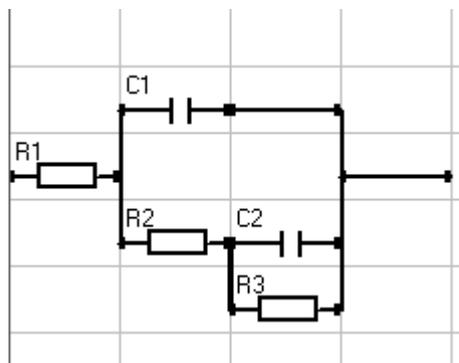
FIGURE 16. Equivalent circuit for the damaged coating.

Once the defected area and the corrosion rate of the damaged coating sample has been determined by using Tafel measurement (after performing all five steps), an EIS measurement was done on the same damaged sample in a 2-electrode configuration. The EIS scan was performed between 0.06 Hz start and 1MHz end frequency with 20mV amplitude and E = 0V vs. OCP (Open Circuit Potential). EIS measurement was performed to determine the parametric values (R1, C1, R2, C2 and R3) in the equivalent circuit shown below (Fig. 16) by using various plots for example Bode, Nyquist plots. Fig. 16 shows the circuit for the damaged coating accepted by most coating researchers.

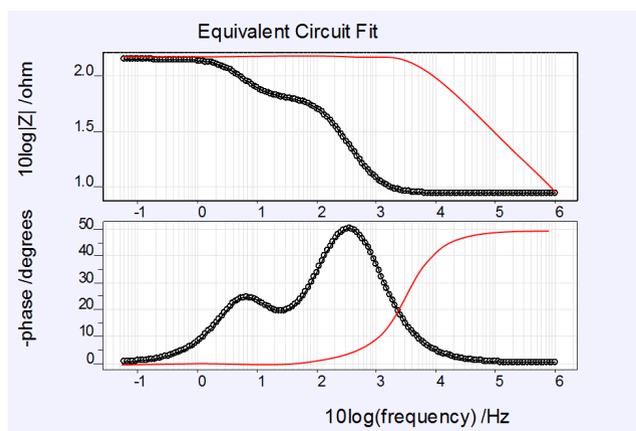
FIGURE 17. Bode plot for the damaged and undamaged coating.

The bode plot for both damaged and undamaged coating samples are plotted in the same graph in Fig. 17. It can be seen that initially at low frequency i.e. 0.06Hz (10log(f)/Hz = -1), the corresponding impedance (10log |Z|/Hz) for both damaged and undamaged coating stayed high till 10log(f)/Hz = 0.2. After this point the impedance for damaged coating drastically decreased while for the undamaged coating it still sustained to the same level as before till 10log(f)/Hz = 3.8 was achieved which

is very high frequency. Similarly, for damaged coating the corresponding phase angle reached to a high level just after start while the corresponding phase angle for undamaged coating remained low till it reached a high frequency of $10\log(f)/\text{Hz} \approx 2$. Therefore it can be concluded that the undamaged coating has greater ability to sustain higher frequencies compared to the damaged coating. Bode plots is Fig. 17 works in accordance with the relation shown in eq. 3.

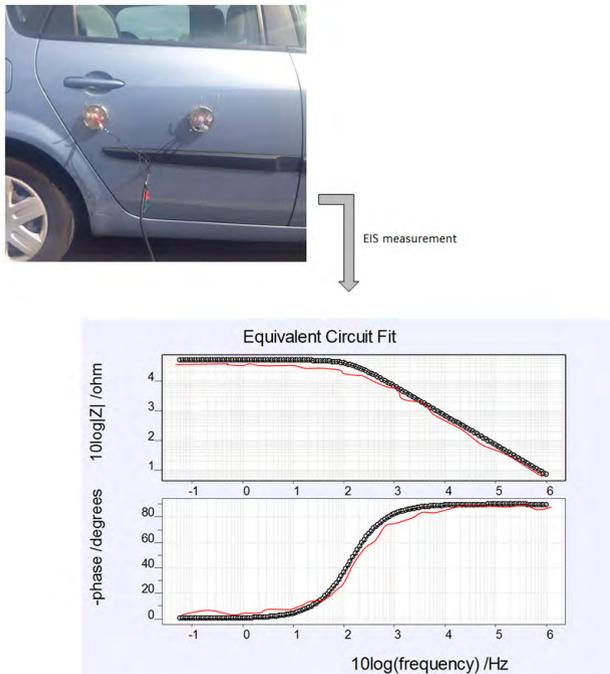
FIGURE 20. EIS measurement of automotive coating taken by using PEC and standard electrochemical cell (red trend).

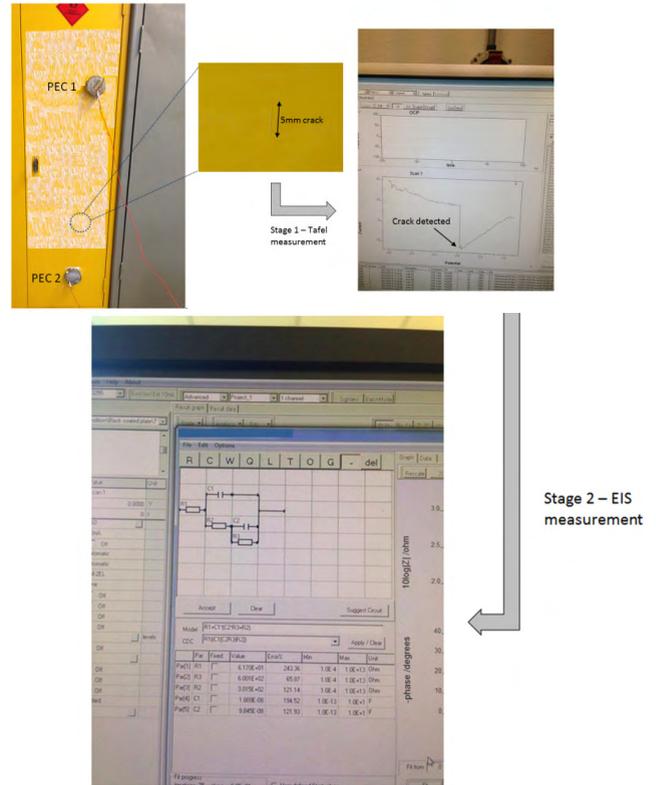
FIGURE 22. Tafel scanning performed by using PEC to detect the invisible crack on hazardous compartment coating (Stage 1). EIS measurement is used for calculating the parametric values of the equivalent circuit (Stage 2).

In the second example, PECs were installed on hazardous compartment. Two stage analyses was performed in which the defect in coating was detected by using Tafel measurement in stage 1 and then the coating condition was identified in stage 2 by using EIS measurement as shown in Fig. 22.

The stage 2 measurement shows a low pore resistance R2 (3.015 E+02) which indicates that the coating is defected but at the same time it also shows a high coating capacitance C1 (9.845 E-08) which points out that the defect is not significant and the overall condition of coating is good. If both C1 and R2 would have been simultaneously low, then this would have been an indication of a degraded coating.

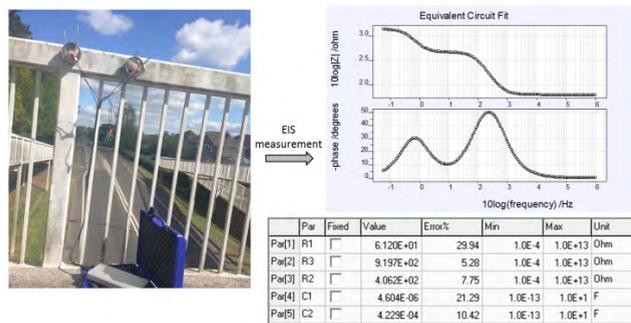
FIGURE 23. EIS measurement and result of overhead pedestrian bridge coating taken by using PEC.

PECs were installed on overhead bridge to measure the condition of coating as shown in Fig. 23. Visual inspection showed that the coating of bridge was significantly damaged. Non-destructive EIS measurement was performed to cal-

culate the parametric values of equivalent circuit which showed considerable low pore resistance R2 (4.062 E+02) and high coating capacitance C1 (4.604 E-06).

The results clearly show that the coating of overhead bridge is significantly degraded as both pore resistance R2 (4.062 E+02) and coating capacitance C1 (4.229 E-04) are low.
