Nasty, Brutish and Short?; The Life Cycle of an Iron Age Roundhouse at Black Loch of Myrton, SW Scotland

Excavations at Black Loch of Myrton, Dumfries & Galloway are revealing the very well-preserved remains of an Iron Age settlement, the wetland context ensuring that the timber structures have remained intact and that the detritus of daily occupation survives for us to pick apart and understand. One of the structures in this settlement is an exceptionally well-preserved roundhouse, the material remains of which have been subjected to a barrage of analyses encompassing the insect, macroplant, bone and wood assemblages, soil micromorphology, faecal steroids, radiocarbon-dating and dendrochronology. These will enable us to address some of the key issues regarding the life cycles of Iron Age roundhouses, from conception and construction, use of internal space, nature of occupation and likely function, through to abandonment. Critically, we are now able to view that life cycle through the lens of a tightly-defined chronology bringing us close to the ‘... short-term timescales of lived reality’ [Foxhall, L. 2000. “The Running Sands of Time: Archaeology and the Short-Term.” *World Archa

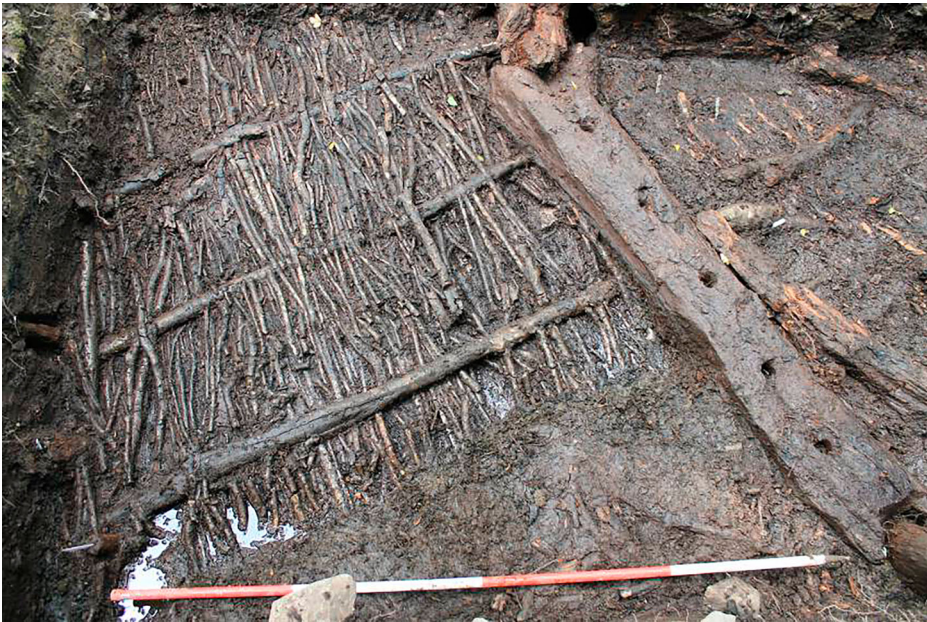
Figure 5. Sillbeam 223/1 *in situ* displaying stake holes and jointing around the posts. The stakes of the outer wall are visible to the left. The wickerwork screens formed the sub-floor of the Phase 1 building.

Associated Surfaces (Figures 5 and 6)

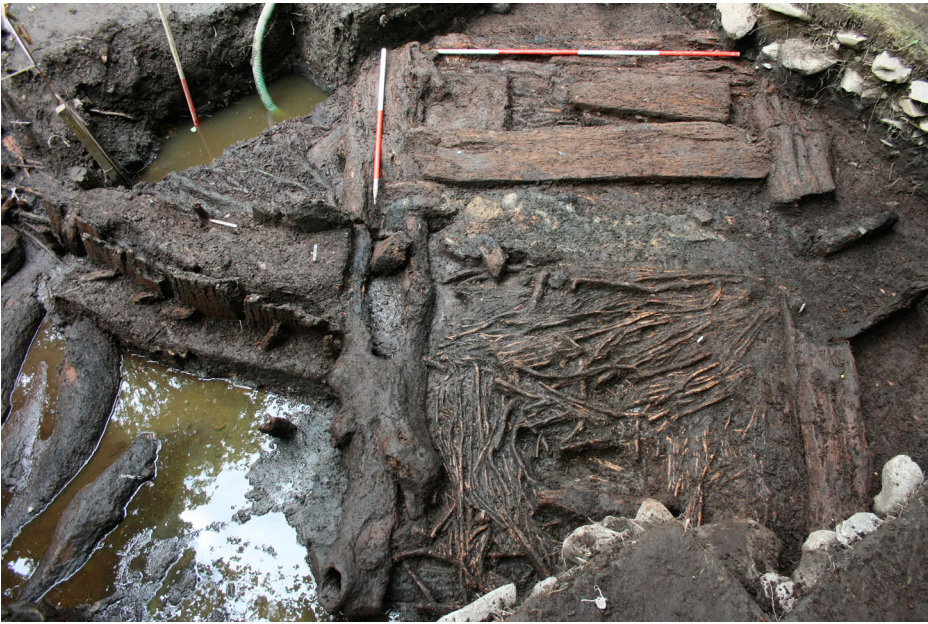
Figure 11. The Phase 2 entrance structure, looking into the building.

This framework was much more shoddily built than the Phase 1 entrance. New radial logs were laid directly over the Phase 1 logs (Figure 11). These radials were fashioned from undressed half-logs of alder, the curved surface of the log uppermost; it is possible that they are the two halves of the same log.
