INNES MCCARTNEY

# ECHOES FROM THE DEEP

*Inventorising shipwrecks at the national  
scale by the application of marine  
geophysics and the historical text*

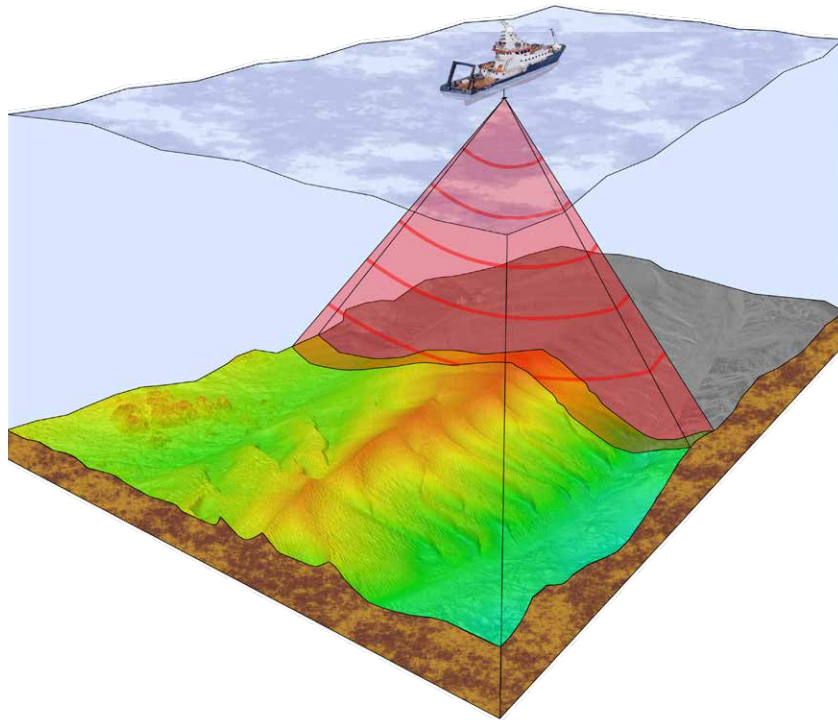
Figure 1.1. Swathe Bathymetry or Multibeam Echo Sounder (MBES) creates a fan of acoustic pulses which create a 3D model of the seabed (Bangor University).

By measuring the time taken for each pulse of sound to travel from and to the sonar system after reflecting off the seabed and knowing the speed of sound in the column of water being surveyed, the distance from the sonar to the seabed can be accurately calculated. This process is constantly repeated as the vessel transits along a defined survey track and the results form a collection of points referred to as a pointcloud. The sonar returns are corrected post-survey to compensate for factors such as movement of the survey vessel by wave action, tidal height changes during the survey and the effect of salinity on sound velocity. Each data point is assigned a coordinate value by utilising an accurate position fixing and reference system on the survey vessel. This is the stage in the survey process when the data can be handed over for archaeological study.

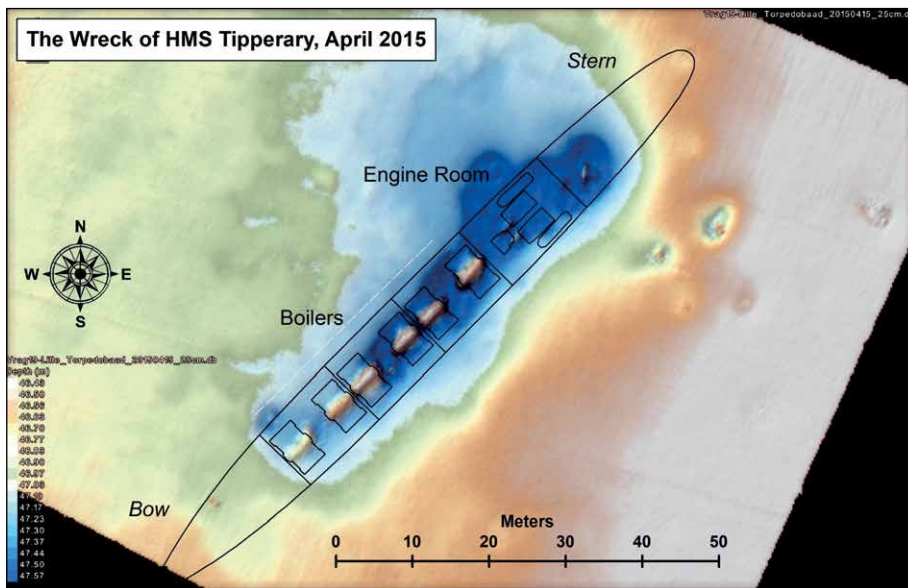
Figure 1.2. The DTM of the wreck of the large destroyer HMS *Tipperary*. The wreck was identified from this site plan. Amongst the destroyers sunk at Jutland, *Tipperary* uniquely had six boilers situated in a single row. These could easily be discerned in the DTM, when an outline of the ships machinery spaces was correctly scaled and overlaid onto it (Innes McCartney).

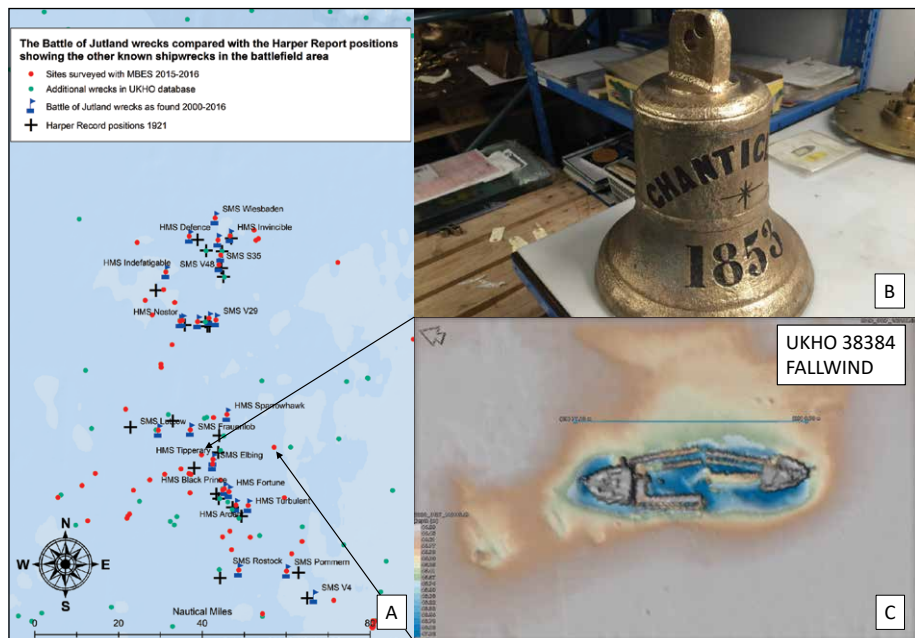
Figure 1.3. The Jutland battlefield with surrounding shipwrecks (A), the bell of the steamer *Chanticleer* which disappeared in 1889 (B) and the DTM of *MV Fallwind*, which sank nearby a century later (A&C Innes McCartney & B Sea War Museum Jutland).

area, miles off course was unexpected. Another nearby shipwreck is a modern loss, which was recorded at the time. This is the wreck of the MV *Fallwind* which foundered in heavy seas in 1988 when its cargo shifted. The wreck is recorded by the UK Hydrographic Office (UKHO) as UKHO 38384.

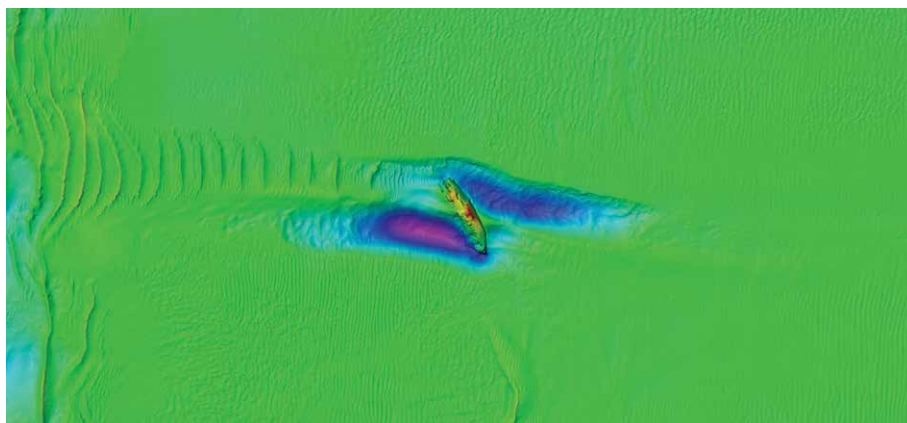
Figure 1.4. The scour pits and seabed ripples created by the ebb and flood tides circulating around the wreck of the 7,832 ton cargo-liner *SS Apapa* (UKHO 7332) which sank in 1917 off Anglesey. These have accumulated over time. But how long did it take to occur? Has this effect stabilised? The questions are being addressed by SEACAMS2. Dating the wrecks is crucial to understanding the temporal and spatial scale of the effect observed (Bangor University).

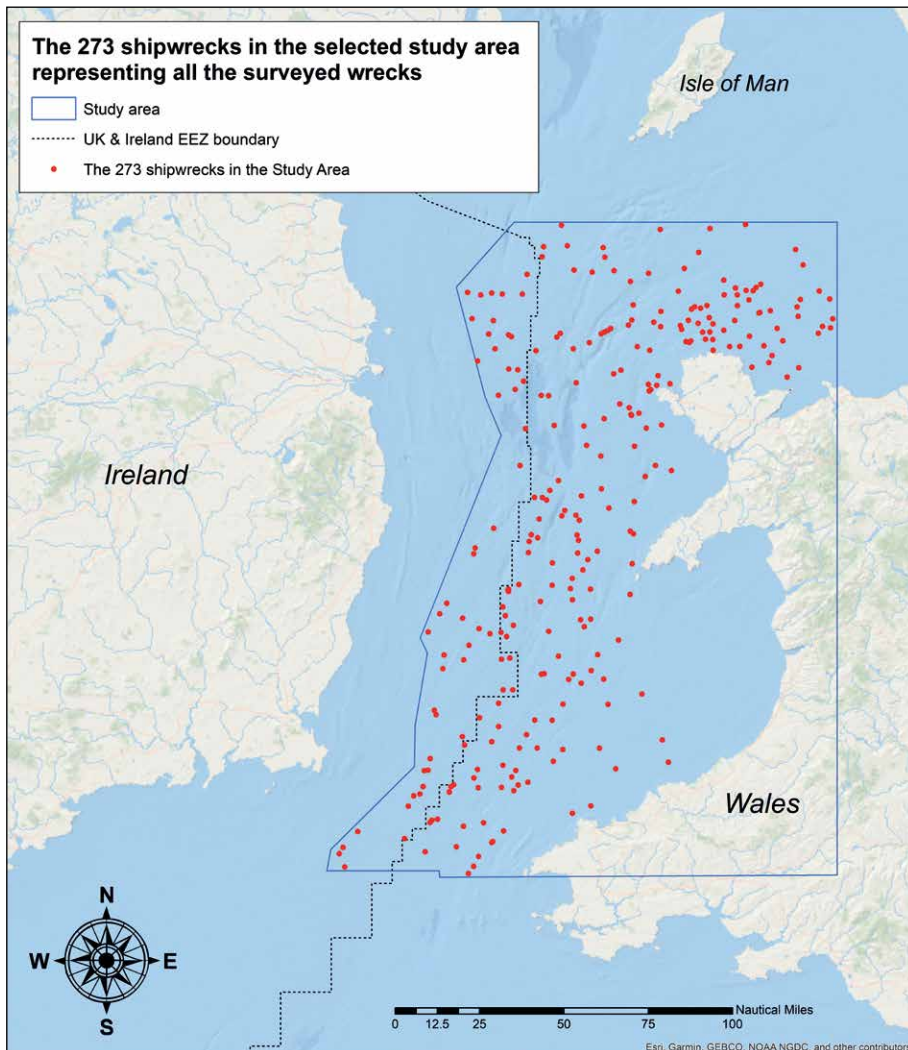
Figure 1.5. The distribution of the 273 accessible charted shipwrecks in the study area, forming the archaeological basis of the research undertaken. This represents full coverage of the offshore shipwrecks in the area (Innes McCartney).

Figure 1.5 shows the extent of the area of Bangor University's School of Ocean Sciences surveys in which 100% of the wrecks have been surveyed. This became the study area of the research. However, it must be noted that the western border does not extend to the Irish coast, this is because Irish regulations forbid marine survey inside its 12 mile limit.

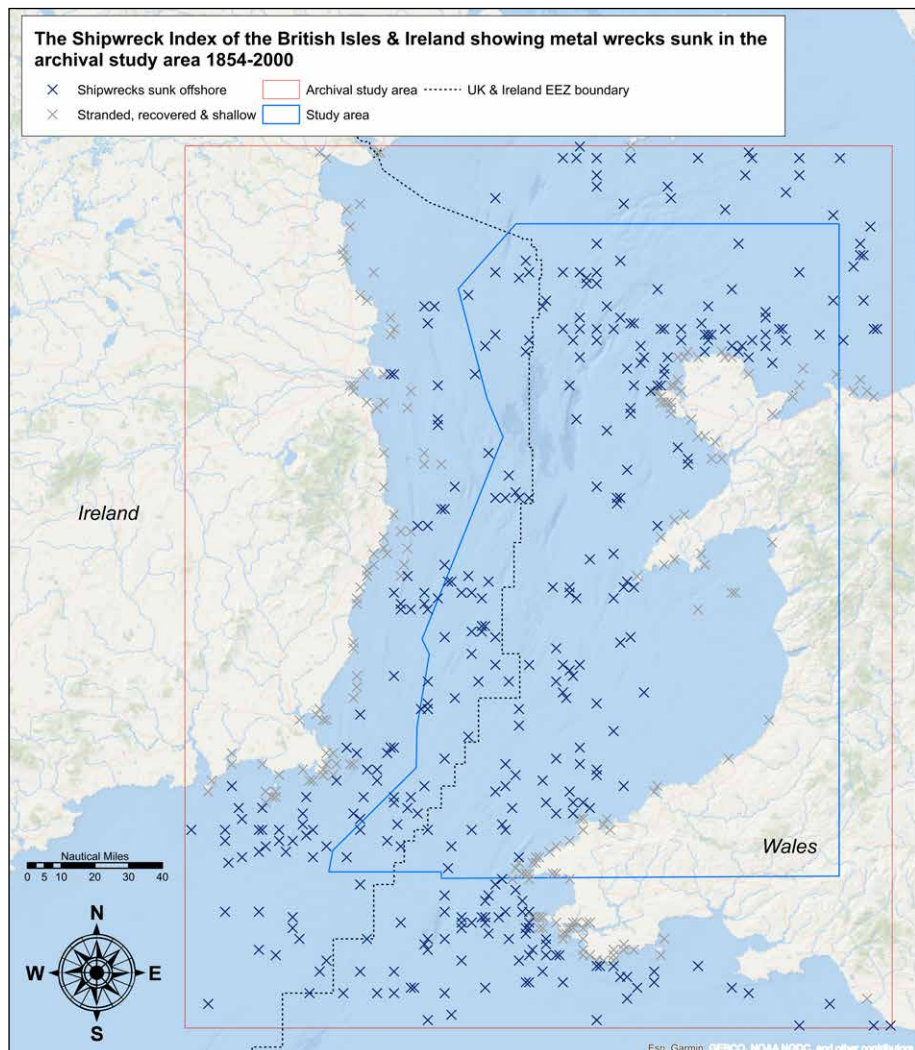
Figure 2.1. The positions of the 724 shipwrecks listed in the Shipwreck Index of British Isles, which plot in the archival study area, separated into the 298 inshore and 426 offshore cases (Innes McCartney).

Due to the relative inaccuracy of navigation prior to 1944, when electronic means began to be used, it was necessary capture positional data which plotted close to as well as inside the study area boundary. In some cases, such as Larn & Larn (2000 & 2002) it meant capturing the entire chapters which only partially intersected the study area. Whereas with other published indices it meant plotting the results which in lat/long were within a few minutes of the study area boundary or given in range and bearing to plot in the periphery of the study area. See Figure 2.1 for the extent of the archival study area.

Further analysis of these shipwrecks shows that 298 of the losses are recorded as strandings or sank in water too shallow to survey. As such, they were not likely to be detected within the MBES dataset, because, as described in Chapter 1, *Prince Madog* did not, as a rule operate inside the 20m line. The extent and distribution of the 724 cases is shown in Figure 2.1. It shows that Larn & Larn (2000 & 2002) list a total 426 shipwrecks sunk offshore in the archive study area. Up to 273 of these cases would be expected to be among the shipwrecks surveyed during the fieldwork for this research. These would be cases within the study area and potentially some of the outliers in the archival study area.

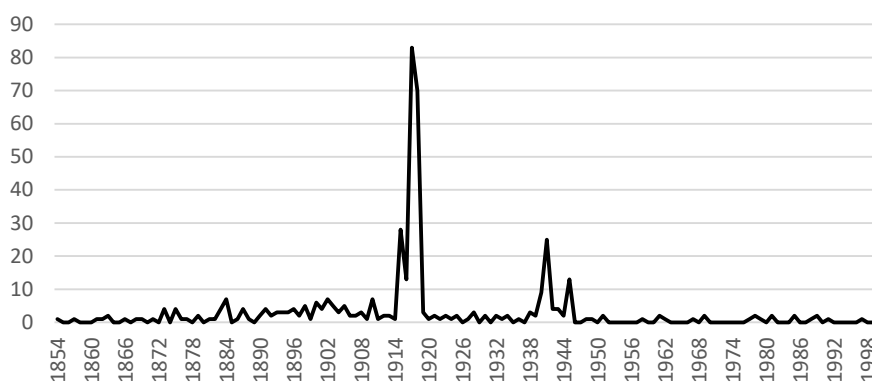
**The 426 offshore shipping losses in the archival study area 1854-2000 shown by year**

Figure 2.2. The 426 offshore shipping losses in the archival study area analysed by year and historical period of loss. The two world wars are the dominant cause of these losses (Innes McCartney).

Focusing on the 426 offshore shipping losses, the data can be broken down by year to give an insight into the numbers of ships sunk throughout the period since the first recorded loss in 1854. The results are shown in Figure 2.2. It becomes immediately apparent that the dataset is dominated by ships sunk during WW1. This accounts for 195 (46%) of the wrecks. The losses in WW2 account for a further 59 (14%) of the wrecks. In total 254 ships sunk offshore were sunk in wartime. This amounts to 60% of the total.

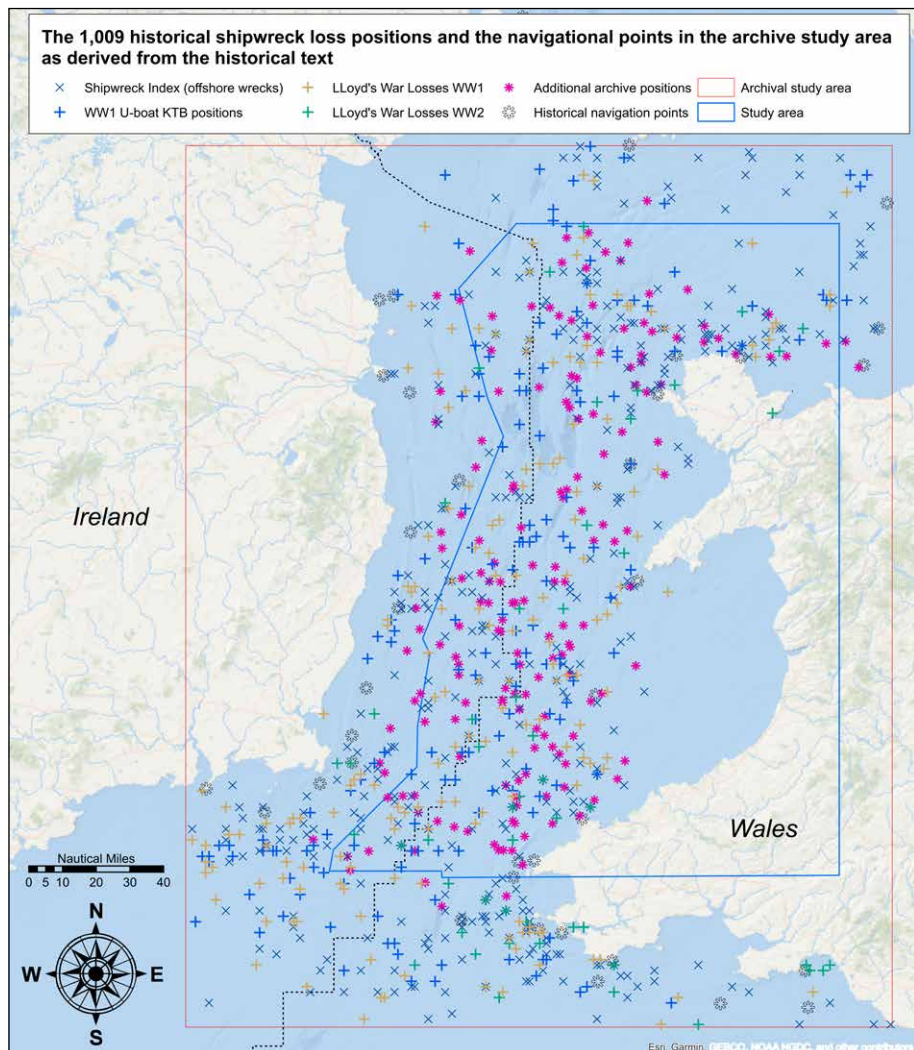
Figure 2.4. The final extent of datapoints for shipping losses which were plotted in the GIS. Also included are the historical navigational points from which range and bearing positions were plotted. The final total was 1,009 historical positions plotted in GIS (Innes McCartney).

In reality there were a wide range of other positional sources consulted as and when required. This necessitated the development of a further shapefile into which additional positions from Admiralty files, contemporary newspapers, official inquiries etc. could be added to provide evidence during Phase 2 of the research. The sources used are cited in the relevant shipwreck datasheets given in Appendix 2. This final shapefile of “Additional archive positions” contained a further 166 datapoints once Phase 2 had been completed. The final, full extent of the plotted datapoints collated during the research is shown in Figure 2.4.

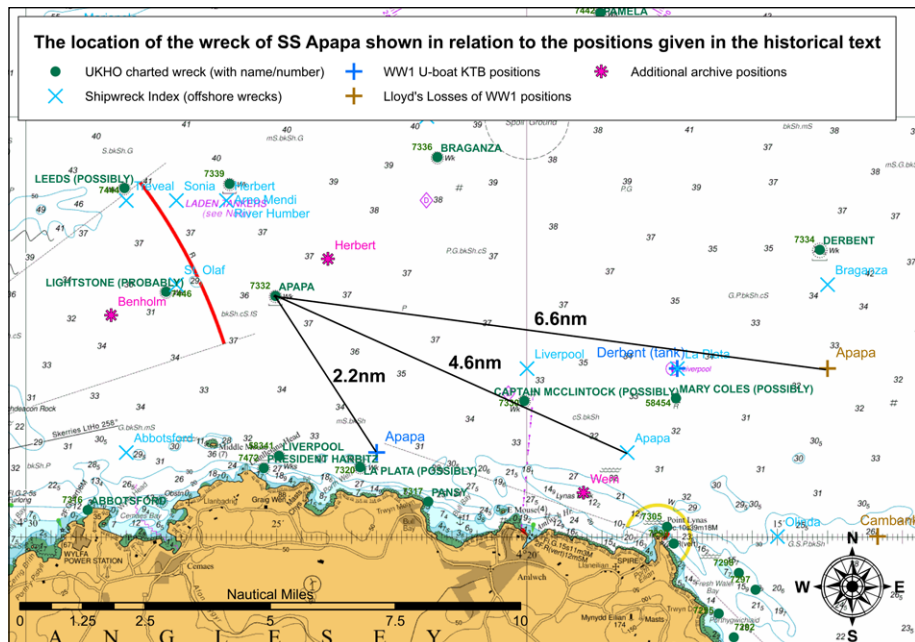
Figure 2.5. The wreck of SS *Apapa* shown in relation to the historical positions as plotted in the shapefiles. (Innes McCartney).

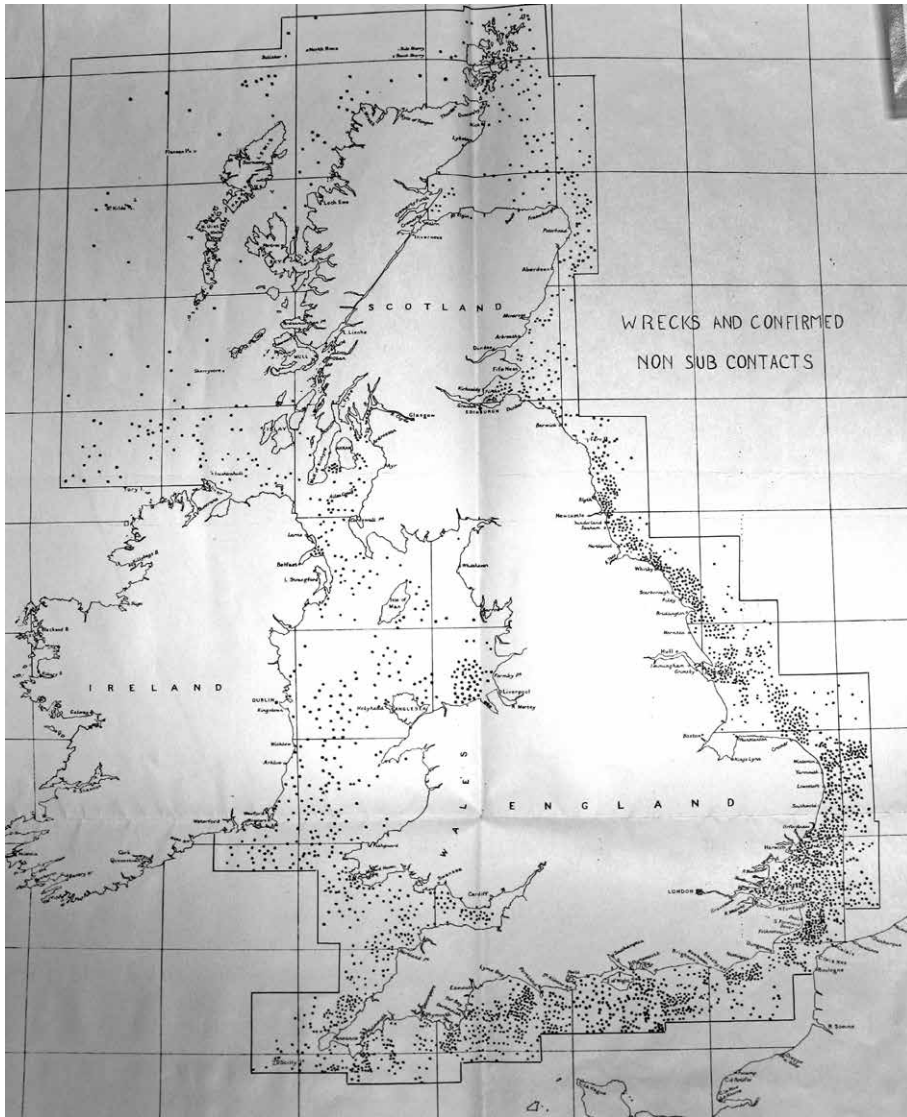
Figure 3.1. A summary chart from December 1944 showing the extent of the 3,200 known “non-sub” contacts in UK waters at that time (Admiralty).

Research visits to the UKHO archive at Taunton have been unsuccessful in finding the original Plymouth List and despite wider searches, it is still unconfirmed whether a copy survives in the UK now. However, the extent to which the Plymouth List was developed is evidenced in a report issued by The Directorate of Naval Operational Studies in December 1944. It stated that there were 3,200 “non-sub” contacts in UK waters and around 2,800 of those were known to be shipwrecks, see Figure 3.1 (TNA ADM 219/166).

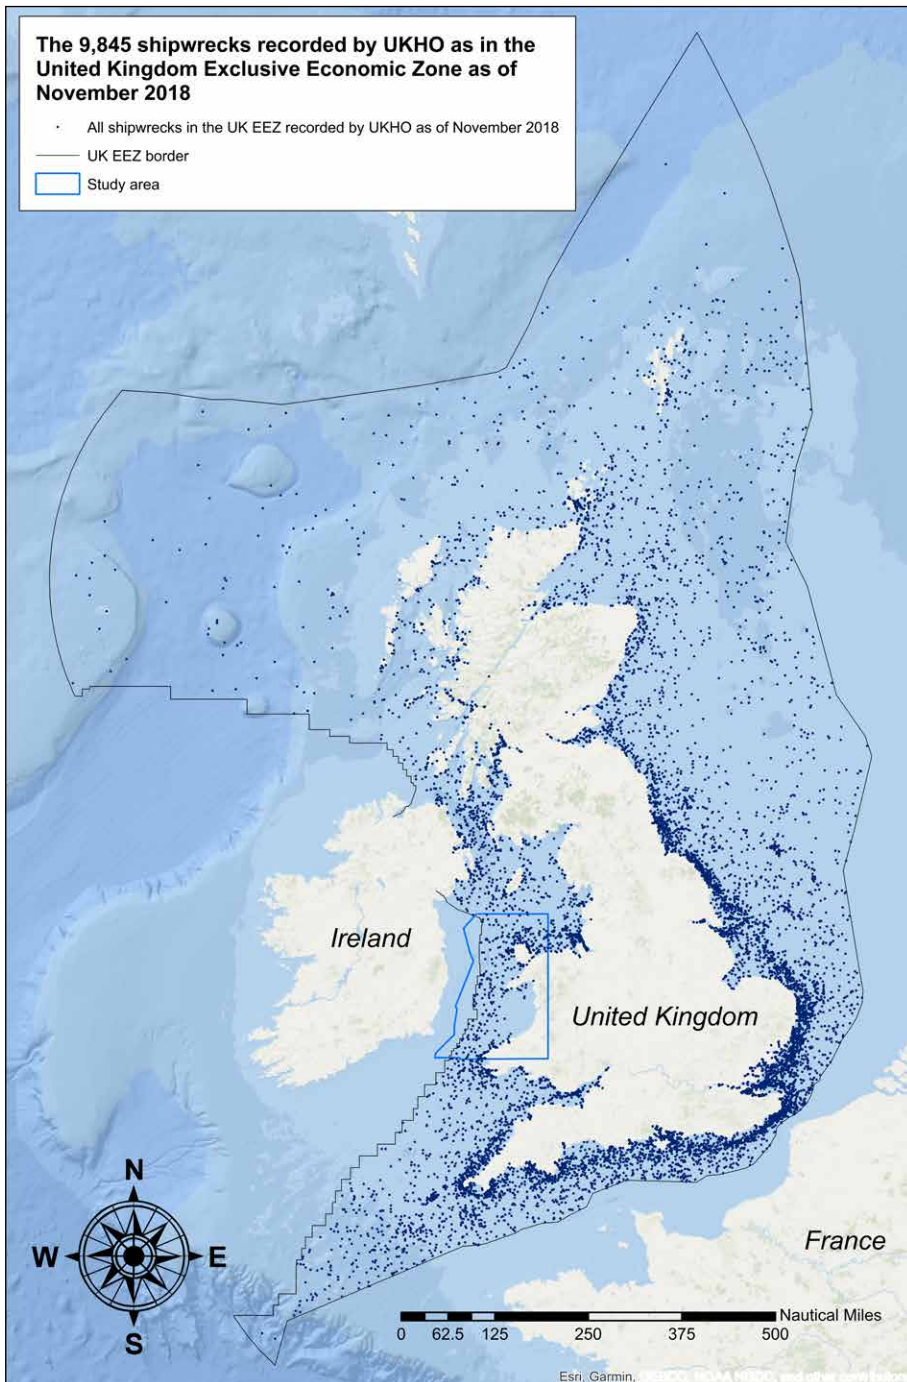
Figure 3.2. The distribution of the 9,845 shipwrecks in the UKHO database in the UK EEZ as of November 2018, showing the research study area (Innes McCartney. Contains public sector information, licenced under Open Government Licence v3.0 from UKHO).

Today the UKHO database for the entire UK Exclusive Economic Zone (EEZ) records 9,845 shipwrecks, as depicted in Figure 3.2. This is a far greater number than were recorded during WW2 (the 3,200 “non sub” sites on the Plymouth List shown in Figure 3.1)

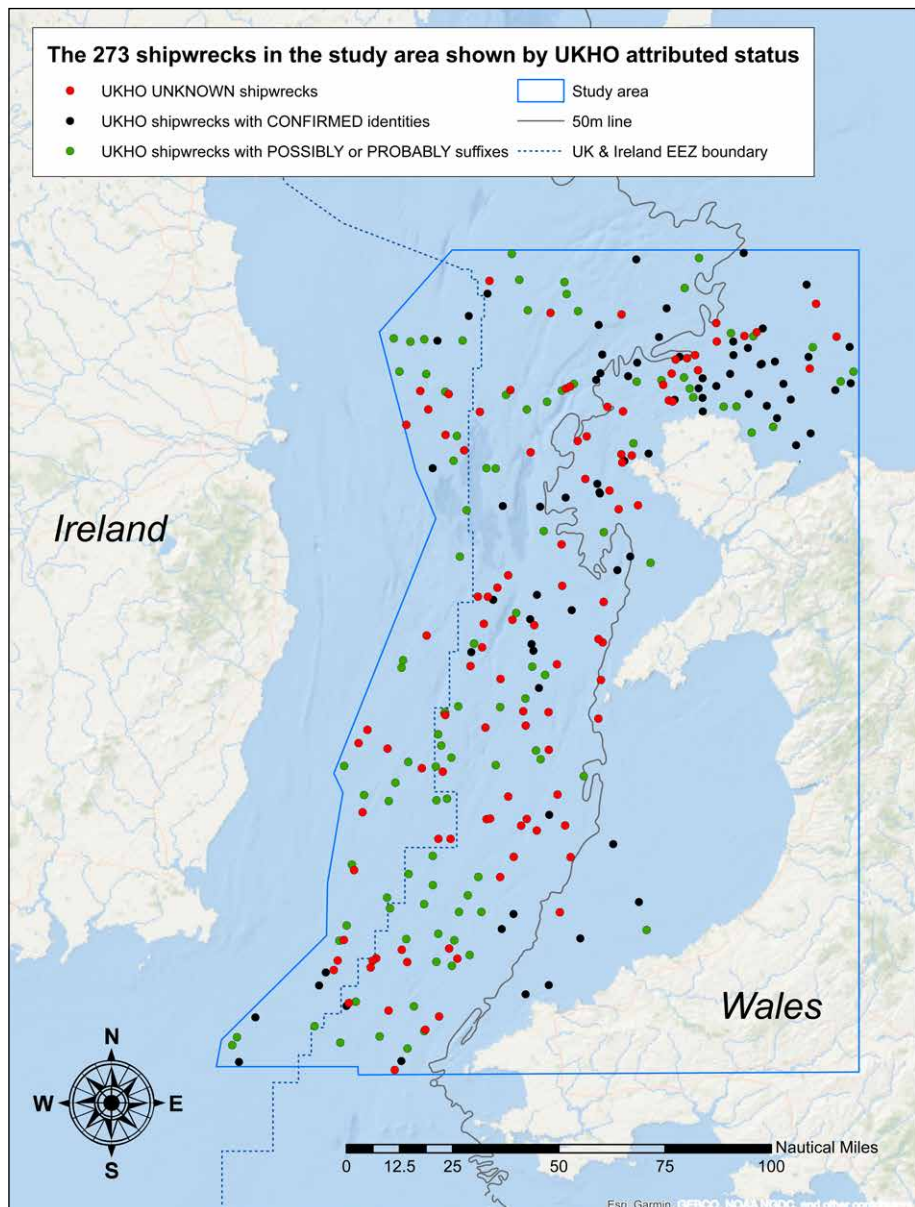
Figure 3.3. The 273 shipwrecks listed by UKHO in the study area shown by the attributed status of the wrecks (Innes McCartney. Contains public sector information, licenced under Open Government Licence v3.0 from UKHO).

Figure 3.3 shows the 273 surveyed wrecks which feature in this research. They are all listed in the UKHO database specifically as shipwrecks. There are 101 UNKNOWN, 99 (POSSIBLY) and (PROBABLY) and 73 wrecks with CONFIRMED identities. There is a high concentration of CONFIRMED cases to the east of the 50m depth contour line, especially in the north. This undoubtedly due the activities of recreational divers and their reporting of discoveries to UKHO in the past. This has made a significant difference to the accurate identification of wreck sites in shallower waters. The CONFIRMED wrecks in deeper waters are mainly made up of sites commercially salvaged, sites discovered by salvage companies, recent shipwrecks and ships sunk when the identity and location of the wreck was accurately fixed at the time.

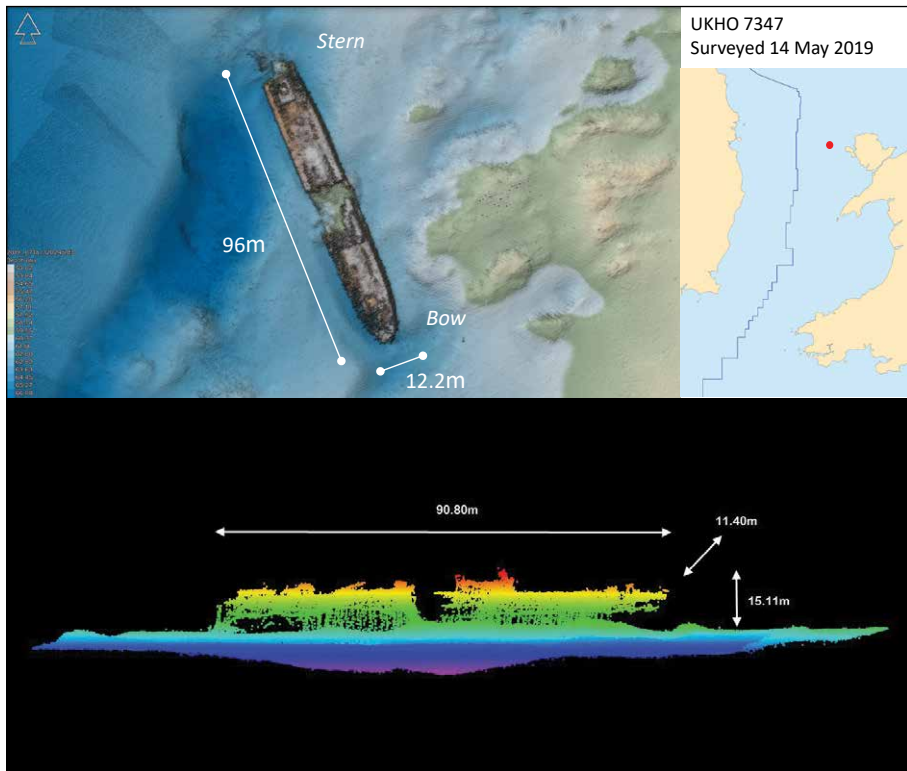
Figure 3.4. Above, the DTM of UKHO 7347 as surveyed by Bangor University's School of Ocean Sciences in May 2019. The stern appears to have collapsed to the seabed, but is present, making the overall length of the wreck approximately 96m. Compare this with the UKHO measurements shown below. In this instance it is the extant portion of the wreck which has been measured, accounting for the difference in lengths (Above: Innes McCartney, Below: UKHO which contains public sector information, licenced under Open Government Licence v3.0 from UKHO).

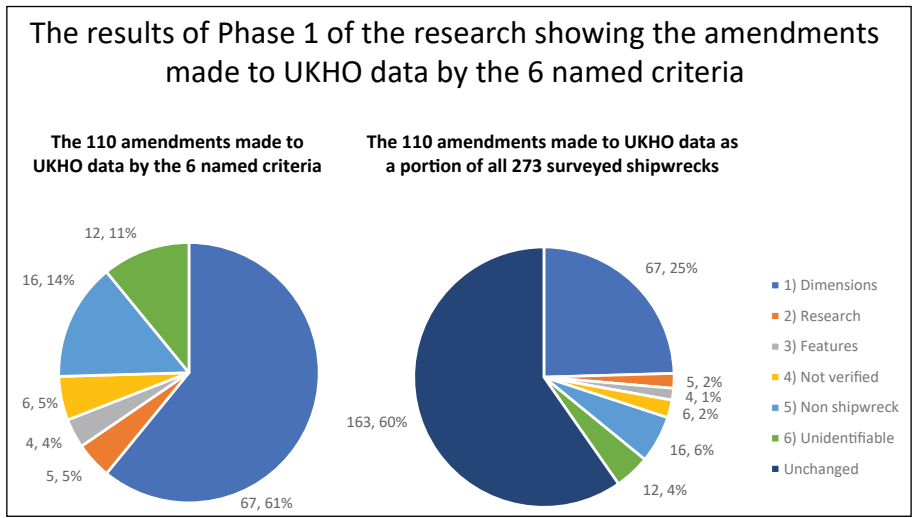
Figure 3.5. The 110 amendments made to the UKHO wreck cards shown by the six criteria used to segment the results. The impact of the results on the full 273 wreck dataset is shown on the right (Innes McCartney).

When each of the 273 shipwrecks in the study area was processed and assessed against its UKHO wreck card as described, a total of 110 shipwreck sites required amendments to be made. These were based on the six criteria given above. The results are shown in Table 3.2 and in Figure 3.5. For the individual outcomes for each specific shipwreck, see Appendix 1.

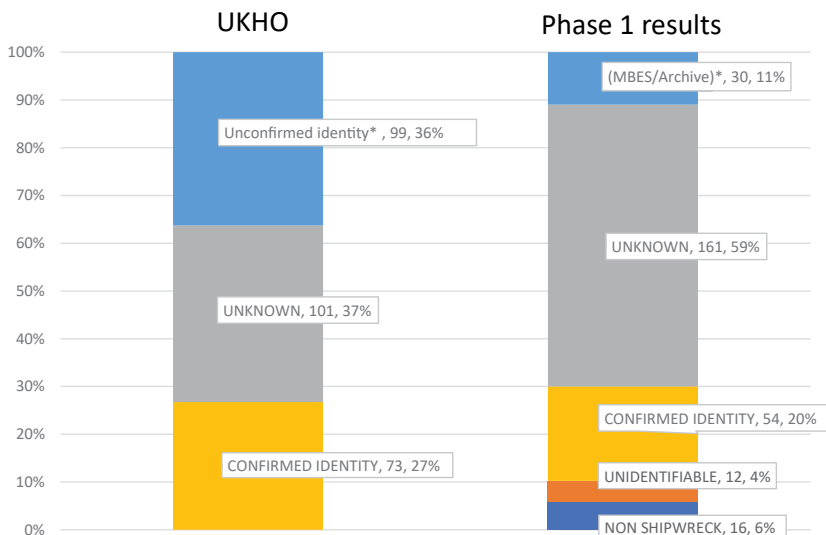
### The results of Phase 1 of the research in establishing the actual UNKNOWN status of the 273 shipwrecks in the study area

\*UKHO use both (PROBABLY) and (POSSIBLY) to signify unconfirmed shipwreck names. This research uses the single criterion of (MBES/Archive) as a replacement.

Figure 3.6. The attribution changes made during Phase 1 compared to the original UKHO wreck cards shown by number and percentage. The number of UNKNOWN sites grew by 60 to 161 of the overall total of 273 wrecks, accounting for the majority (Innes McCartney).

shown in Table 3.3 and in Figure 3.6. The number of sites which were CONFIRMED fell by 19. Unconfirmed cases fell by 69, (25% of the 273 wrecks), UNIDENTIFIABLE and NON SHIPWRECK increased by 12 and 16 respectively, where there were of course none beforehand.

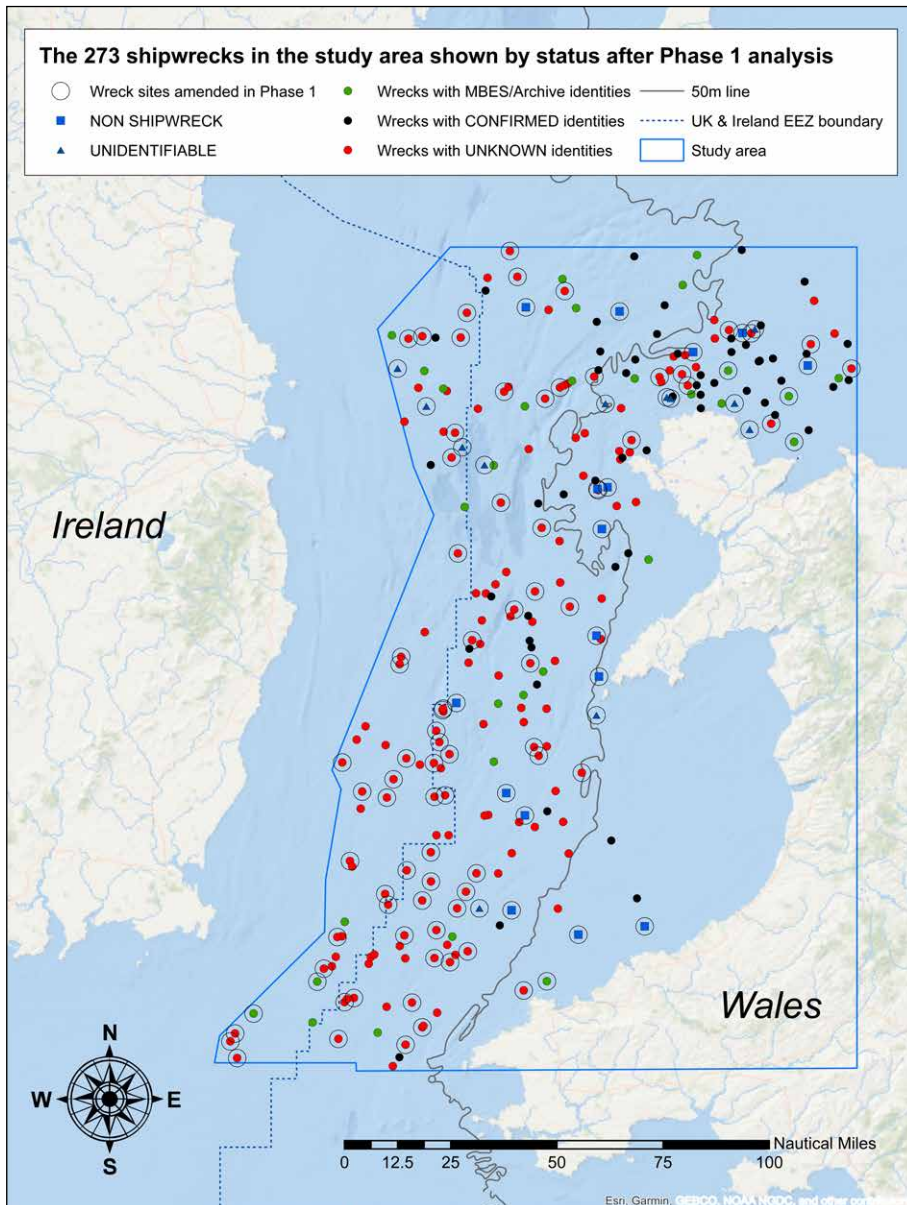
Figure 3.7. The attribution status amendments made during Phase 1 compared to the original UKHO wreck cards. The 110 amendments made are circled (Innes McCartney. Contains public sector information, licenced under Open Government Licence v3.0 from UKHO).

The results of the Phase 1 analysis are shown spatially in Figure 3.7. The wreck sites which had their status changed are circled for ease of comparison to Figure 3.3. It will be noted that the largest cluster of amended sites lies in the central and southern portion of the study area. These are in the most remote and deepest areas of the study. Conversely, the 54 CONFIRMED sites remain concentrated inside the 50m depth contour line, showing the impact recreational divers have had on the accurate identification of shipwrecks. Where the proximity of shallower wreck sites coincides with higher human population densities, a higher preponderance of identified wrecks sites would be expected, as seen here.

The conclusion drawn when looking at Figure 3.7 is that the number of changes which Phase 1 analysis would have made, had it not been for the impact of diver identifications of shipwrecks. It would have been much higher. In effect, by identifying a wreck, the diver will have in most cases already caused the site to have been amended, so that no change would be needed during Phase 1 analysis. Therefore, what the large cluster of UNKNOWN wreck sites in the southern region of the study area represents is probably what the entire UK EEZ would look like if divers had not reported their discoveries to UKHO over the past decades.

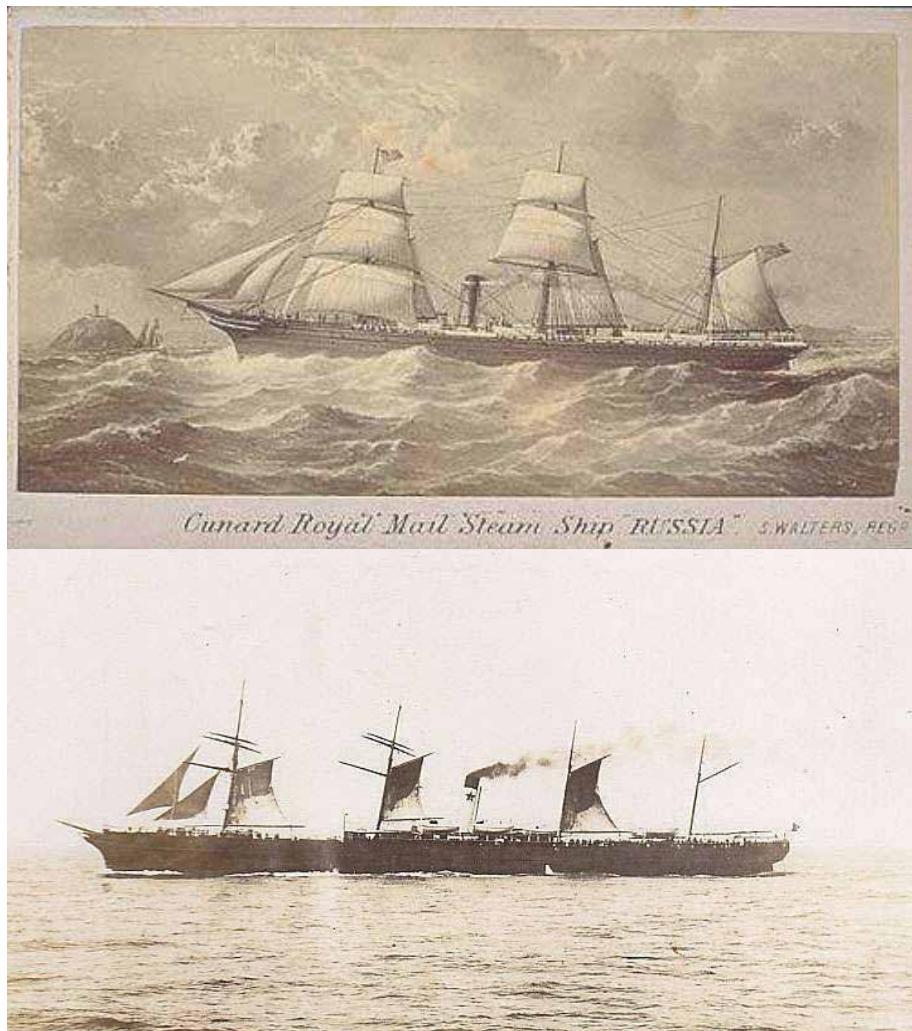
Figure 4.1. SS *Waesland* as originally built for Cunard in 1867 as SS *Russia* (above) and as it appeared around the time it was lost in 1902 (below). Note the difference in length and an additional mast (wrecksite.eu).

The identification of this particular wreck site was not without its pitfalls, which were mainly due to the long history in service during which it had been lengthened. This ship itself was in service for 35 years by the time it was lost. It had originally been built as SS *Russia* for the British & North American Royal Mail Steam Packet Company (renamed The Cunard Steamship Company in 1878) and was the last Cunarder built with a clipper bow. This can be clearly seen in images of the ship. As built, it was 109.1m long (*Lloyd's Register* 1874-75). It remained in service with Cunard until 1880 when it was sold to the Red Star Line of Belgium. Under its new ownership the ship was transformed, being lengthened by 23.5m in 1881 to an overall length of 132.6m (*Lloyd's Register* 1880-81) and then later re-engined from compound to triple-expansion with the introduction of a pair of double-ended boilers (*Lloyd's Register* 1901-02). The change in the ship's appearance during its life can be seen in Figure 4.1.

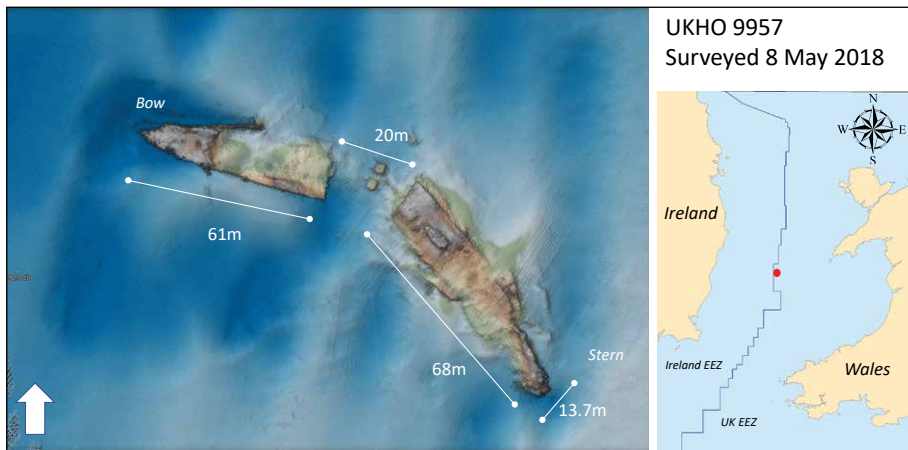
Figure 4.2. The UKHO wreck No 9957 KIRKBY (PROBABLY), amended to UNKNOWN during Phase 1 and attributed during Phase 2 to be SS *Waesland* (MBES/Archive) (Innes McCartney).

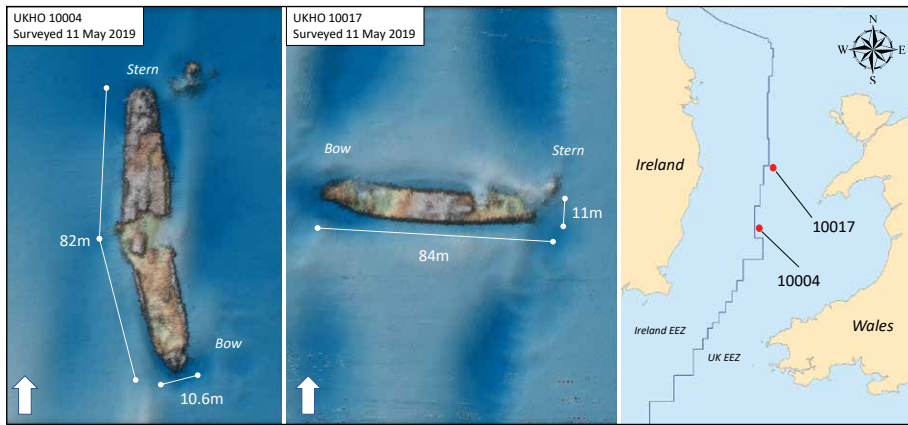
Figure 4.4. The wrecks which are dimensionally, positionally and, archivally consistent with being *Coningbeg* (UKHO 10004, left) and *Formby* (UKHO 10017, right). In both instances the wrecks were listed by UKHO as UNKNOWN. They both manifest damage consistent with the description given in *U62's* KTB (Innes McCartney).

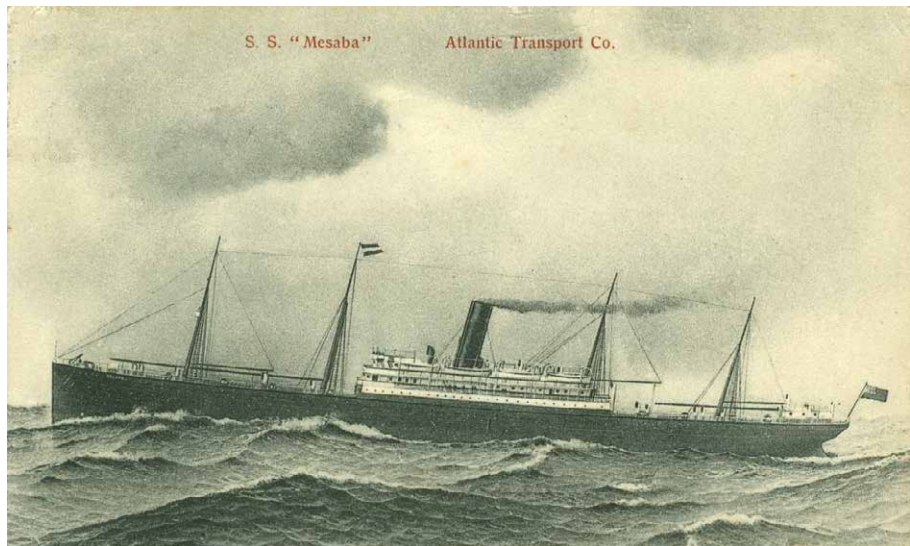
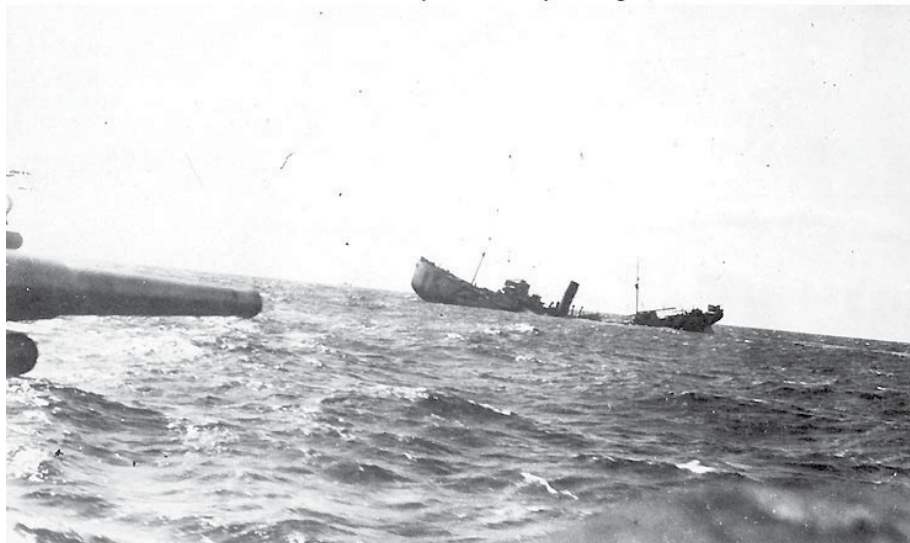
Photo # NH 61498 Torpedoed S.S. City of Glasgow, 1918

Figure 4.5. The steamships SS *Mesaba* (top) and SS *City of Glasgow* (below) were sunk in a convoy attack by *UB118*. In this instance a rare series of photographs showing *City of Glasgow* sinking was taken from one of the escort ships, *USS Beale* (Contemporary postcard & U.S. Naval Historical Centre).

In the case of *City of Glasgow*, the ship was hit on the starboard side amidships. Its back broke but it took an hour to sink. It was photographed by USS *Beale* at this time (see Figure 4.5). Similar to *Mesaba*, this wreck was not difficult to pick out of the survey dataset. Dimensionally and positionally it could only really be UKHO 9913. The wreck lies 5nm south of the position given by *UB118* and 2.75nm south of the position given in *Lloyd's War Losses* (1990). It will be noted that the obvious area of damage seen in the DTM (Figure 4.6) is the same area where ship's back was broken, as seen in the image in Figure 4.5.

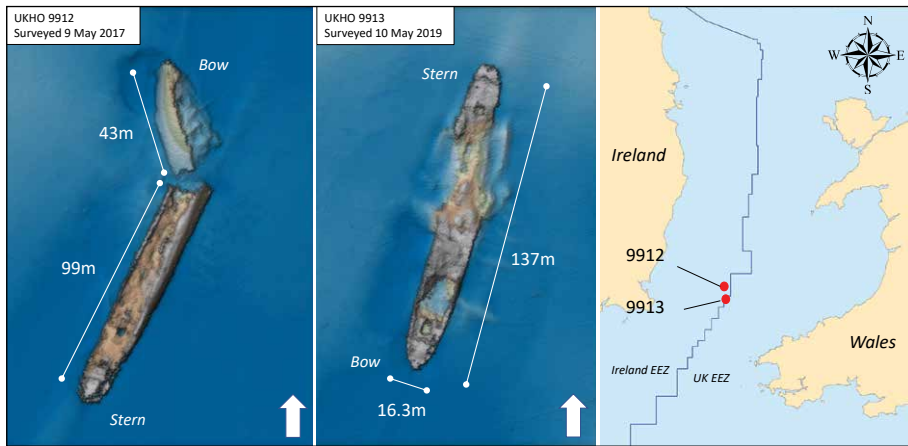
Figure 4.6. The wrecks of *Mesaba* (left) and *City of Glasgow* (right) and their locations. The damage seen on both closely resembles that described and seen in the photograph of *City of Glasgow*. During Phase 1 it was ascertained that the UKHO legacy attributions were in reverse (Innes McCartney).

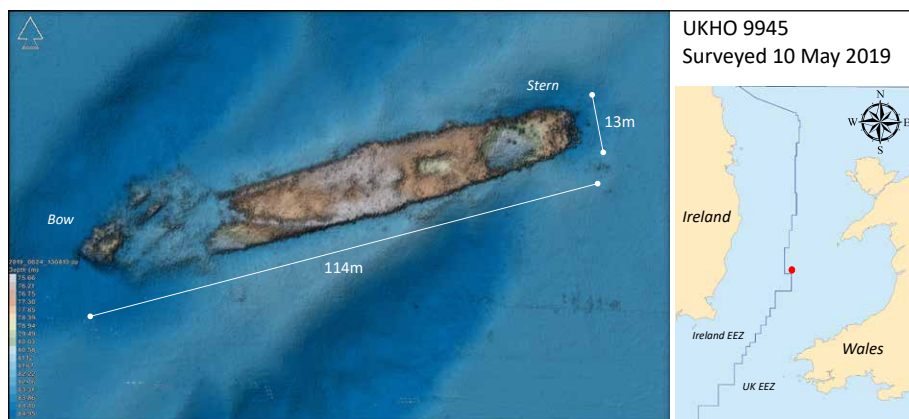
Figure 4.8. The wreck, which is dimensionally, positionally, and archivally the most consistent with *Burutu* turned out to be UKHO 9945. This wreck had been amended to UNKNOWN status during Phase 1 (Innes McCartney).

The wreck which dimensionally, positionally, and archivally was the most consistent with *Burutu* was UKHO 9945, as shown in Figure 4.8. Dimensionally the wreck is consistent on width. Its length is slightly extended, probably due to the damage sustained to the bow during the collision and the sinking. Positionally the wreck plots 1.4nm southwest of the position given in the OL37 record (TNA ADM 137/2618) and 5.3nm south of the HL50 record (TNA ADM 137/2657). Archivally, the damage to the wreck is in the region of the fore holds, as described, and could be interpreted as being a result of being struck on the port side, as described. Further archival evidence emerged by consulting the plans of this ship photographed at the Lloyd's Register Foundation, Heritage & Education Centre. They show that the ship had four holds, two forward and two aft. The after ones are clearly discernible in the DTM.

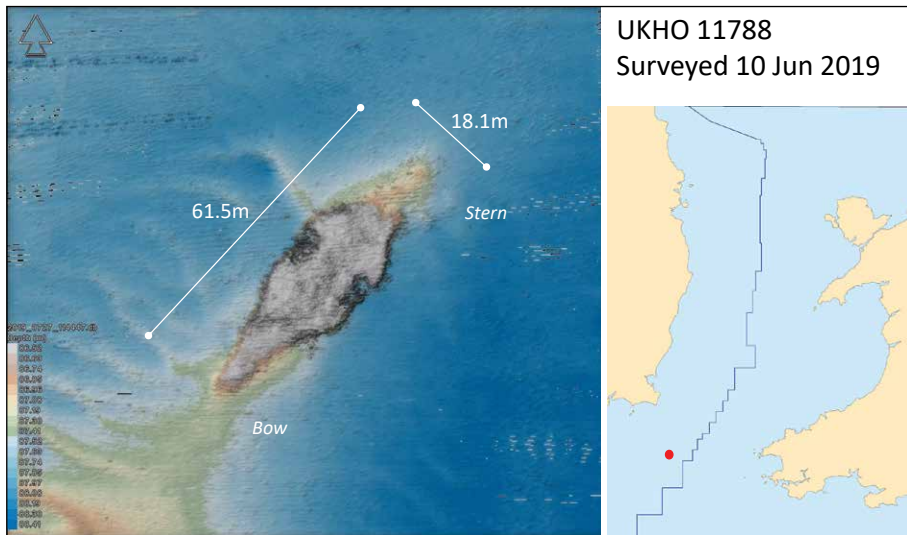
Figure 4.10. The wreck which dimensionally, positionally, and archivally is consistent with HMS *Mercury* as seen in the survey DTM turned out to be UKHO 11788. It had been originally listed as a submarine (Innes McCartney).

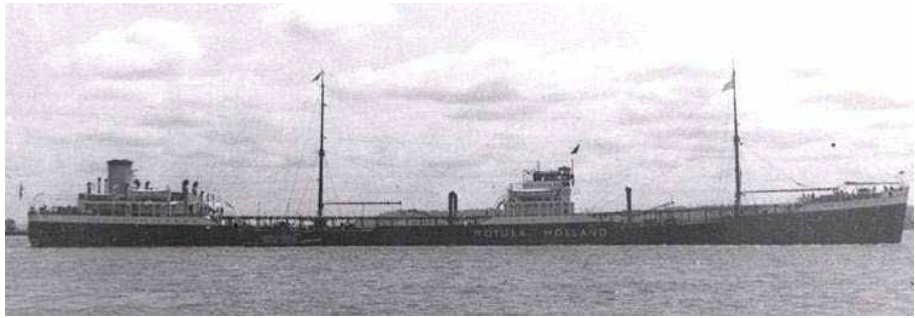
Figure 4.11. MV *Rotula* was the 3rd largest unlocated ship (after Phase 1) in the entire study area. It sank after being bombed, burning for three days before being sunk by gunfire (wrecksite.eu).

The character of the war at sea in the Irish Sea in WW2 is different from WW1. The U-boats only made brief incursions in the last year of the war and for much of the time the area was largely unmolested. However, there were occasional incursions by the German Air Force laying mines, bombing, and torpedoing shipping. One such ship attacked in this manner was the large petrol tanker MV *Rotula*, see Figure 4.11.

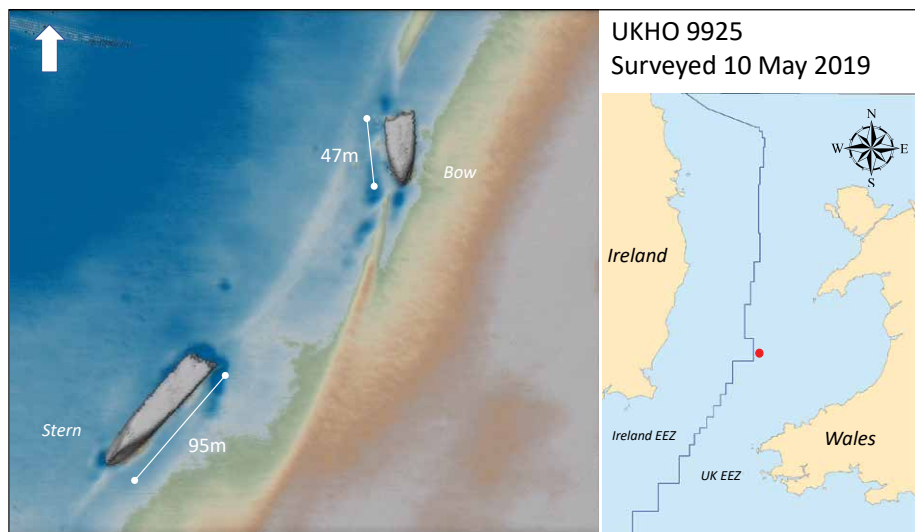
Figure 4.12. The wreck of MV *Rotula* is dimensionally, positionally, and archivally consistent with UKHO 9925. It is broken into two sections along a line 95m from the stern (Innes McCartney).

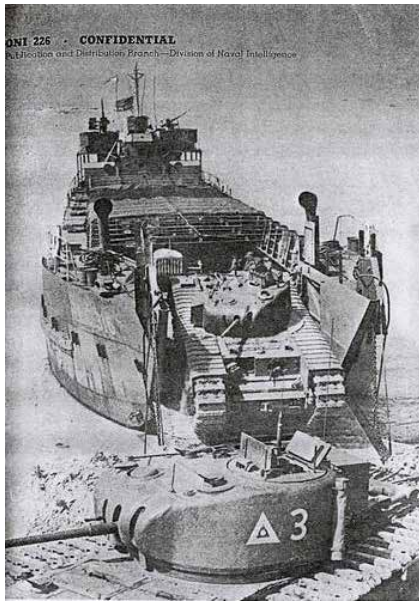
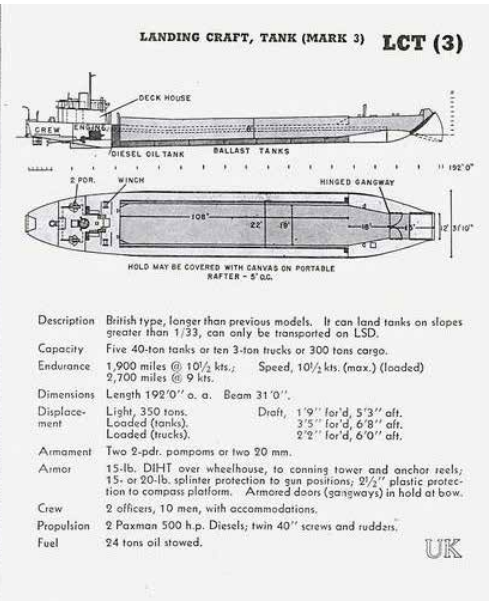
Figure 4.13. The Mk III LCT 326 was of the type seen in this image. The plan of the vessel is similar to the features seen in the DTM in Figure 4.12 (wrecksite.eu).

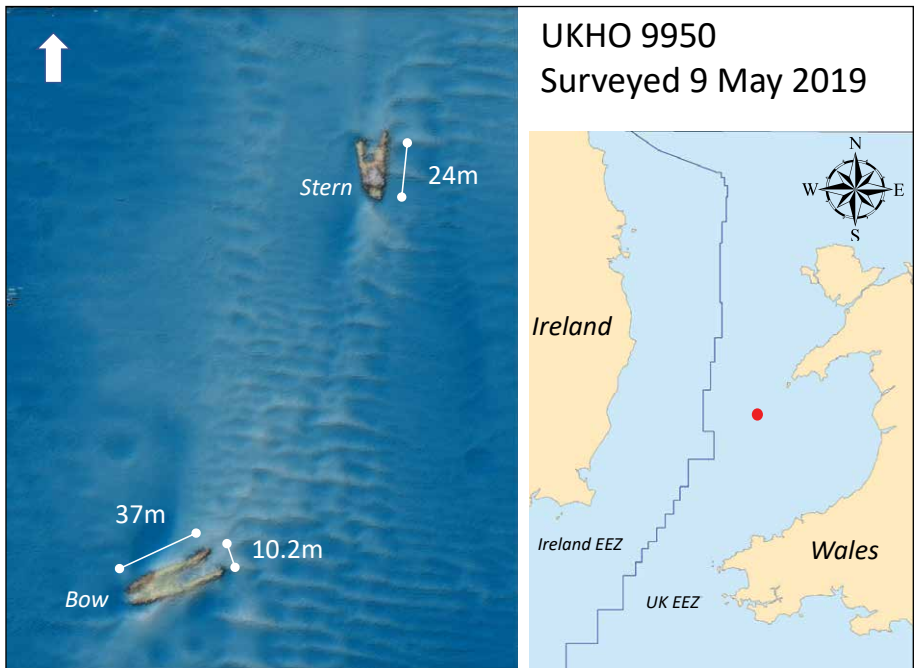
Figure 4.14. The wreck, which is dimensionally, positionally and archivally consistent with LCT 326. It can be seen that it displays features which appear similar to those seen on the plan in Figure 4.13 (wrecksite.eu).
