INNES MCCARTNEY

# ECHOES FROM THE DEEP

*Inventorising shipwrecks at the national  
scale by the application of marine  
geophysics and the historical text*

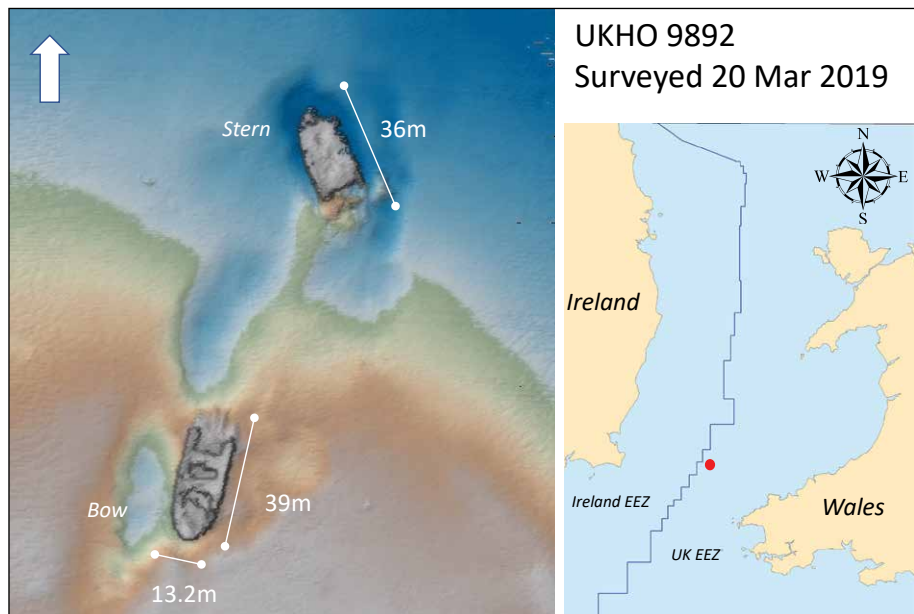
Figure 4.16. The wreck, which is dimensionally, positionally, and archivally consistent with *SS Soreldoc*. The ship broke in two when it was torpedoed. Its original UKHO legacy attribution UKHO 9892 *EMPIRE PANTHER* (PROBABLY) was amended in Phase 1 to UNKNOWN due to this wreck being far too small (Innes McCartney).

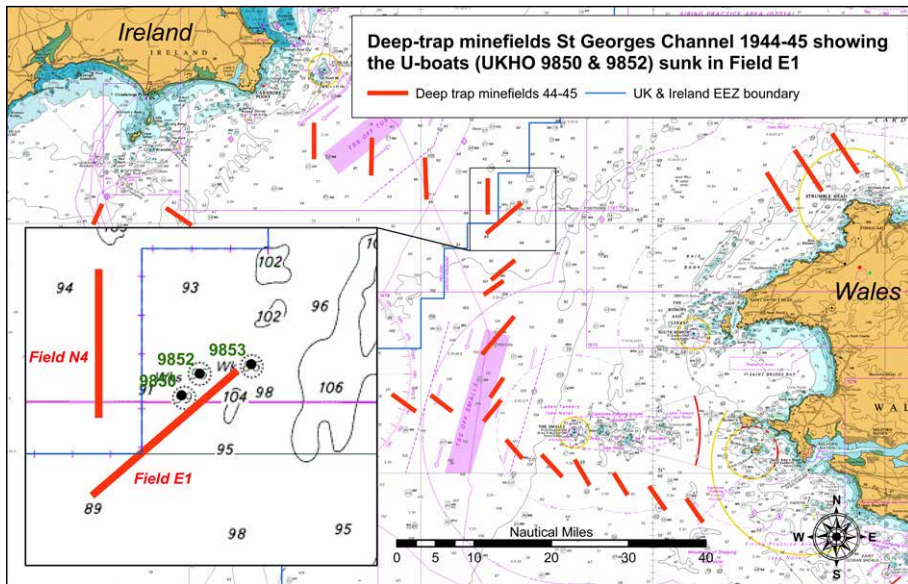
Figure 4.17. The location of the pair of U-boat wrecks (UKHO 9850 and 9852) found to have been lost in deep-trap minefield E1 in the St Georges Channel in 1945. Whereas one U-boat was known to have been sunk in the area, the other was a surprise find (Innes McCartney).

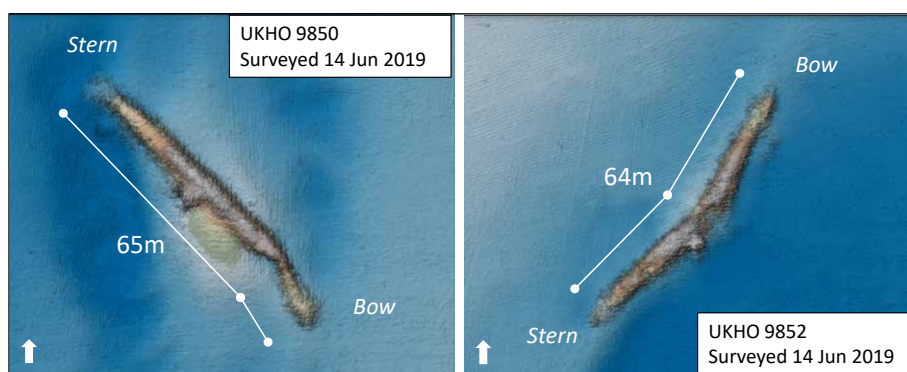
Figure 4.18. The U-boats sunk in Field E1. Both have sustained significant damage consistent with a mine strike. UKHO 9850 can be seen to be heading outbound and UKHO 9852 inbound. They are dimensionally consistent with Inshore Campaign era U-boats (Innes McCartney).

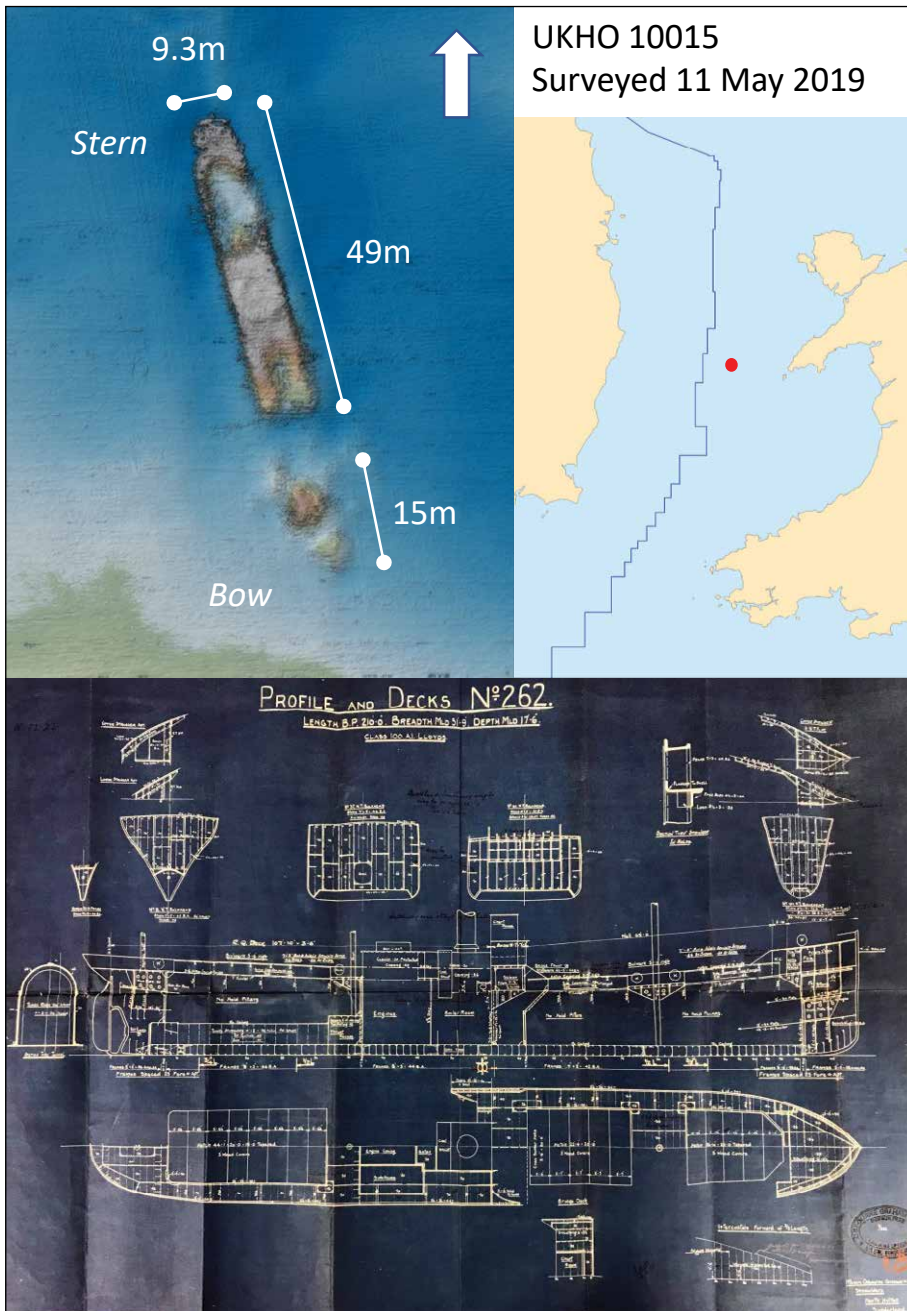
Figure 4.19. UKHO 10015 which by the thinnest of acceptable evidence was given the attribution 10015 GLYNWEN (MBES/Archive). In this instance there is dimensional, positional, and archival consistency, although the positional evidence is weak. The layout of the holds can be seen in the ship plans (Innes McCartney & Lloyd's Register Foundation, Heritage & Education Centre).

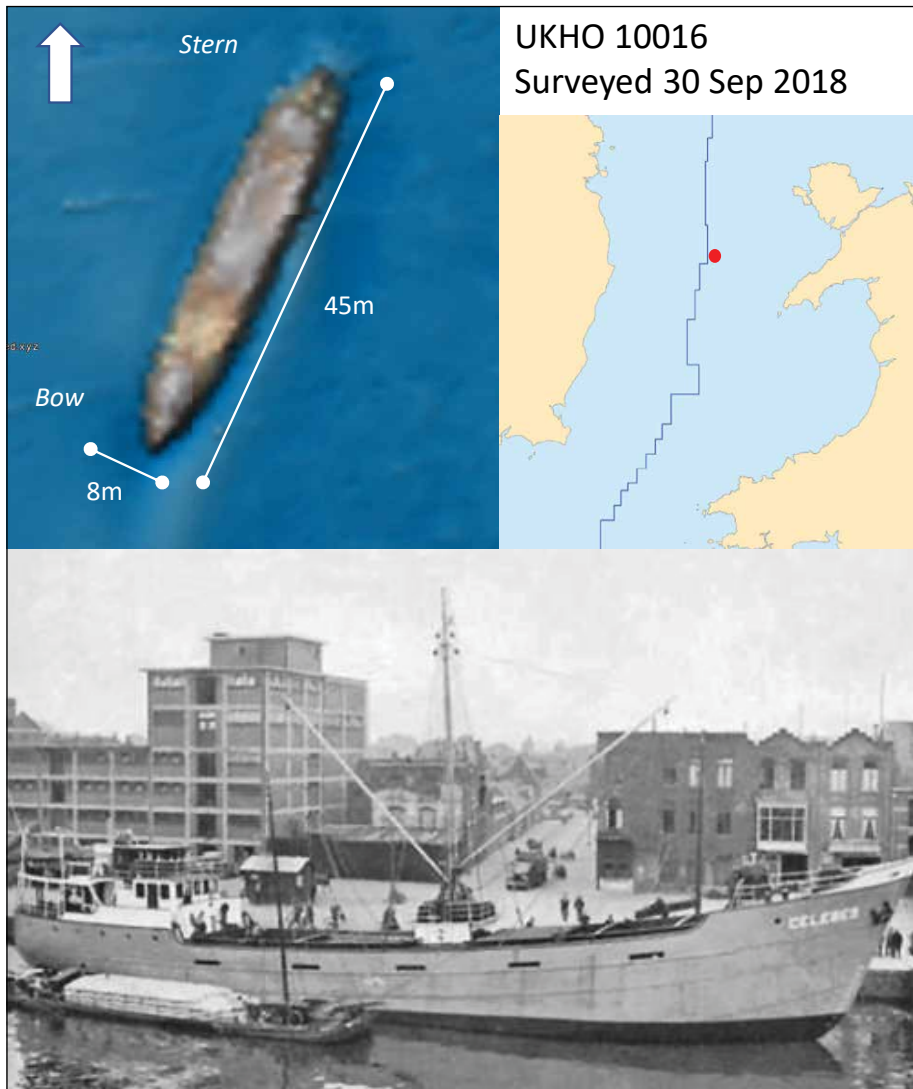
Figure 4.20. The surveyed wreck UKHO 10016 bears some resemblance to the missing MV *Celebes*, but there was not enough evidence available for an (MBES/Archive) attribution to be made. In this case, along with 31 other wrecks, it remains UNKNOWN (Innes McCartney & wrecksite.eu).

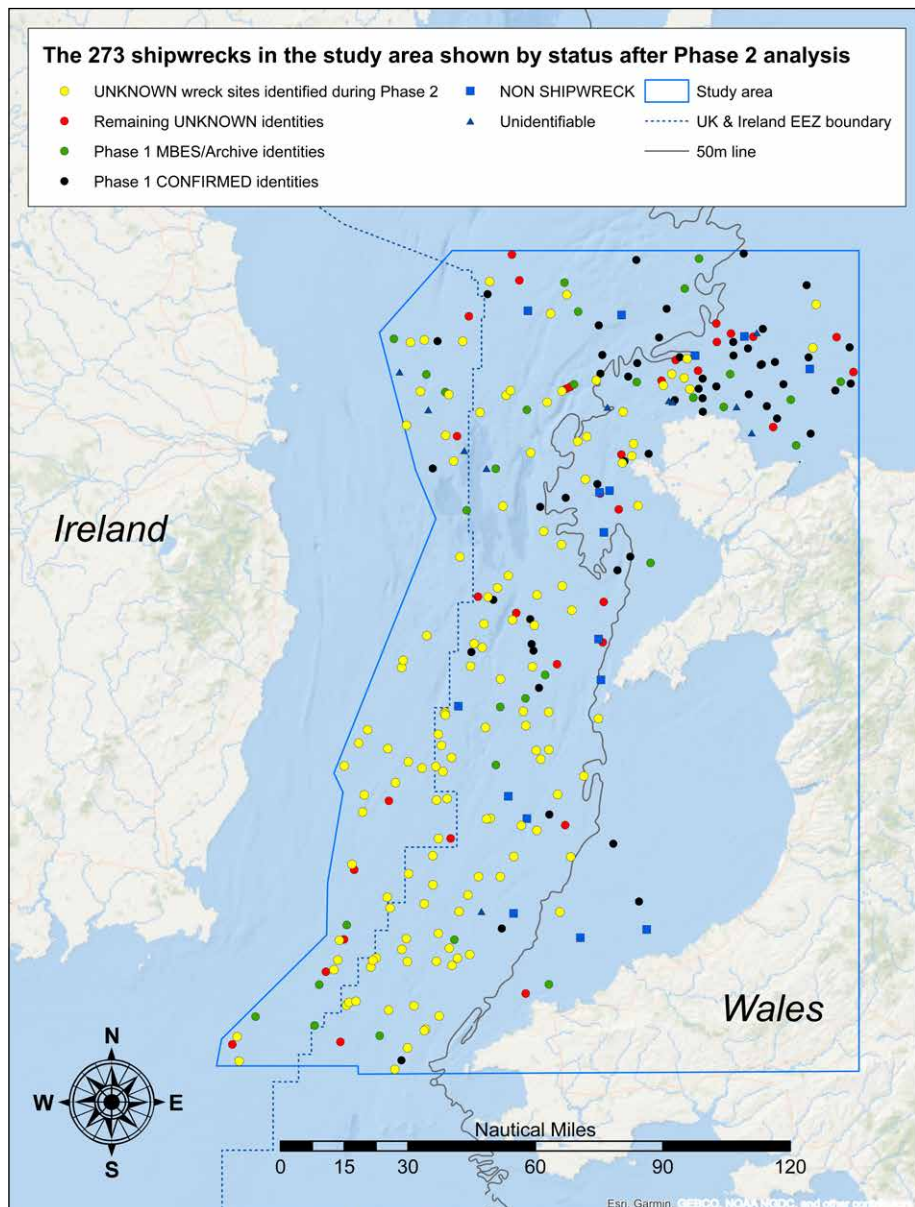
Figure 4.21. The results of Phase 2 on the 273 shipwrecks surveyed. By comparing this map with Figure 3.7, the impact of Phase 2 becomes apparent. It has transformed what is known of these shipwrecks and created a detailed shipwreck inventory (Innes McCartney).

The impact of Phase 2 on the research can be seen in Figure 4.21, which spatially shows the distribution of the UNKNOWN wrecks identified during Phase 2. By comparing this map with the similar one compiled after Phase 1 (see Figure 3.7), the extent to which Phase 2 has transformed our knowledge about these shipwrecks is readily apparent. Phase 2 has placed identities on 80% of all of the 161 UNKNOWN wrecks in the study area.

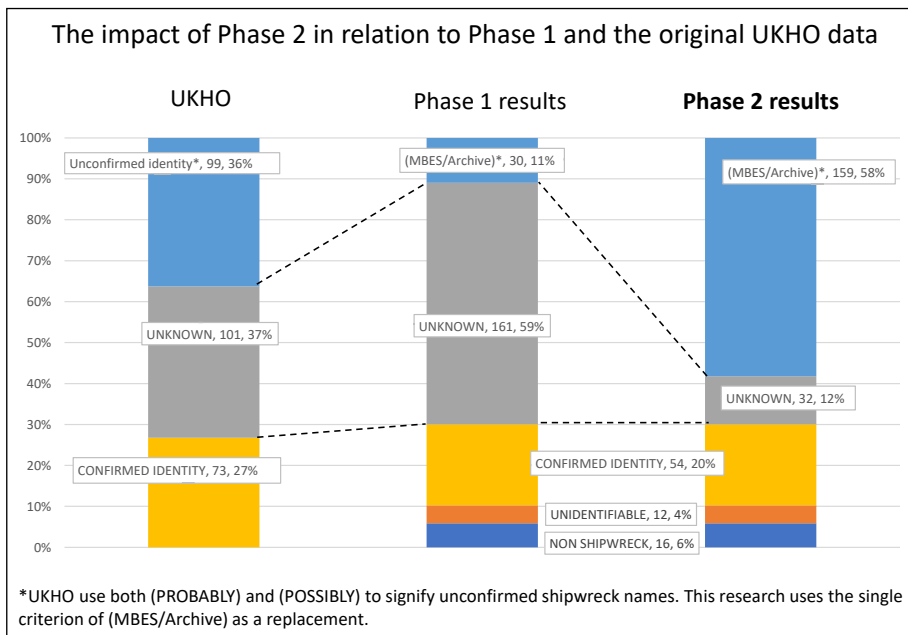
Figure 4.22. The impact of the research through both Phase 1 and Phase 2, showing the reduction of the number of UNKNOWN wrecks in the study area from 59% to 12% (Innes McCartney).

Figure 4.22 statistically shows the impact Phase 2 has had on the overall research. This graph presents the data seen in Figure 3.6 and adds the Phase 2 results to it. The overall percentage of UNKNOWN wrecks has fallen from 59% to 12%. Clearly the numbers of CONFIRMED, NON SHIPWRECK and UNIDENTIFIABLE have not changed since Phase 1. It shows that now completed, the research has established that overall, 78% of the wrecks surveyed have now been identified, based on the strict criteria for a CONFIRMED attribution (Phase 1) or the (MBES/Archive) methodology. When the UNIDENTIFIABLE and NON-SHIPWRECK wreck sites are discounted, because they cannot be identified, the actual overall percentage of identified wrecks is 87% (being 213 of the 245 identifiable

Moreover, Figure 4.22 clearly shows the necessity for the Phase 1 research. By expunging all of the UKHO legacy attributions from the data and correctly deriving the number of UNKNOWN wrecks, it created a level basis upon which to begin Phase 2. It was essential to chronologically process both phases one after the other in order to accurately derive the final results of the research. It is likely that this represents the highest quota of identified shipwrecks in any stretch of water of comparable and size with a similar shipwreck density anywhere in the world.

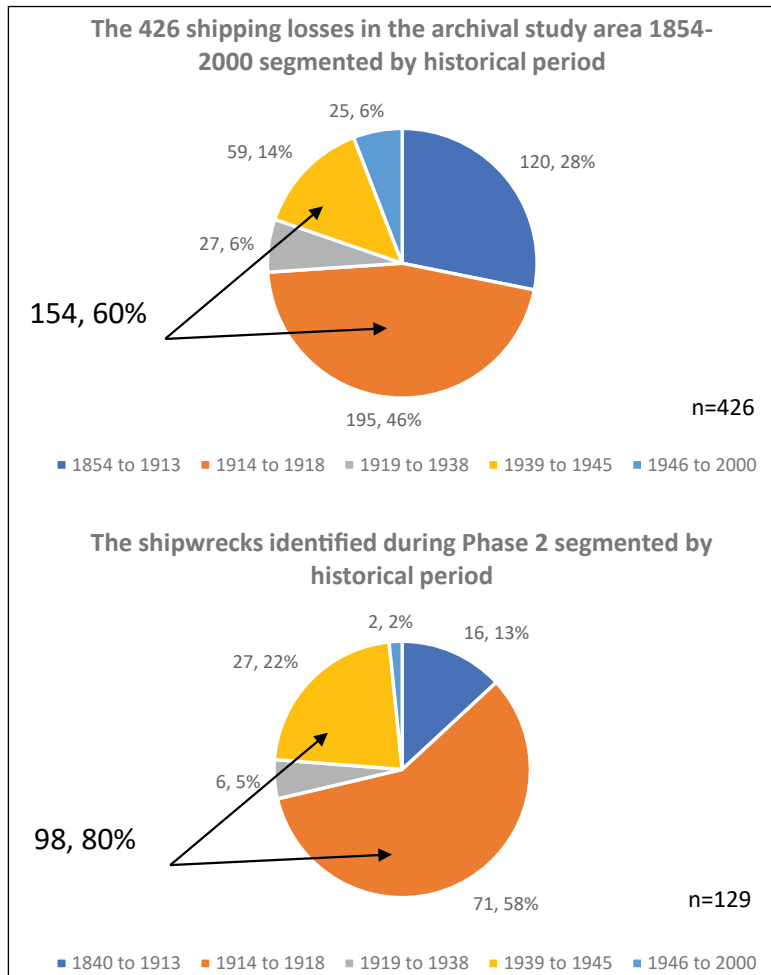
Figure 4.23. The chronological profiles of the historical text (above) and the 129 shipwrecks identified in Phase 2 (below). The world wars remain the dominant feature (Innes McCartney).

In Chapter 2 the chronological profile of the 426 shipwrecks recorded in the historical text as sunk offshore in the archive study area was presented in Figure 2.2. It will be recalled that it showed that 60% of the ships recorded sunk were from the world wars. The pie chart from Figure 2.2 is shown again in Figure 4.23 alongside the pie chart showing the chronological profile of the 129 shipwrecks identified during Phase 2. It can be seen that the percentage of inter-war wrecks is similar in both profiles, however, there are some notable differences between the two.

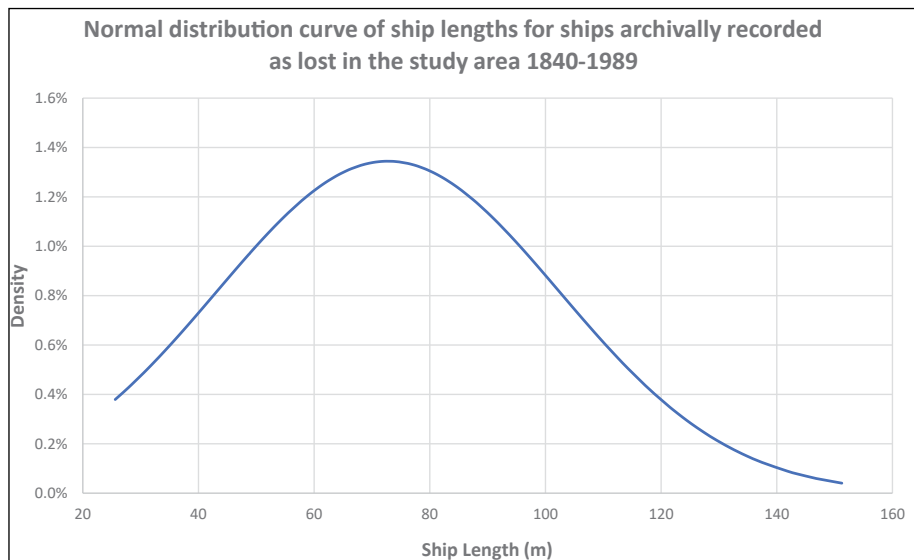
Figure 4.24. The normal distribution curve of the dimensional length of the ships archivally recorded as lost in the study area (Innes McCartney).

Of the three strands of evidence used to make Phase 2 attributions, the accurately recorded dimensions of the shipwreck DTMs were essential in order to reconcile them with the historically recorded shipping losses. Early on during Phase 2 it was recognised that when the historical losses database was sorted by ship's length that there were lower populations of the dimensionally longer and shorter ships. Figure 4.24 shows the normal distribution curve for the ships archivally recorded as lost in the study area by their length.

As seen in the case studies, there was very high confidence that such cases as SS *Mesaba* and MV *Rotula*, were likely to be accurate when resolved. The normal distribution curve shows why this would be the case, because those wrecks are among the most dimensionally rare in the study area. As Phase 2 progressed and relative dimensional rarity fell off, the other strands of evidence became crucial in making the attributions.

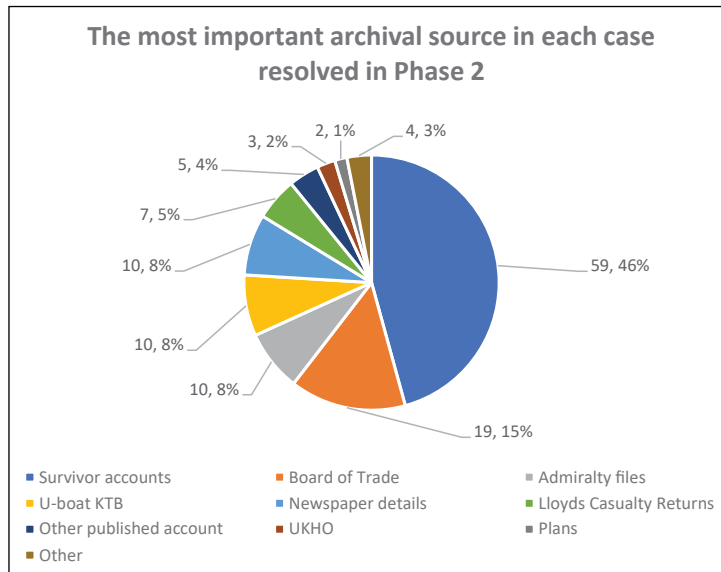
Figure 4.25. The archival evidence considered most important in the resolution of the 129 cases in Phase 2 (Innes McCartney).

The 3rd string of evidence used to make the Phase 2 attributions was based on textual descriptions from archival research. When seeking evidence of this type, any source pertaining to a shipping loss which could potentially bring evidence to each case was collected. Figure 4.25 shows the percentages of the evidence from archive considered to have been the most important in each of the 129 cases resolved during Phase 2.

The decision as to what was the most important evidence in each case is based on what is cited in the datasheets. It is evident that when available, accounts of survivors have proven to yield the types of evidence which is most important in this type of work and of the highest priority to locate archivally. The type of evidence yielded by survivors would include some indication of the damage sustained by the ship and importantly its location in the ship's structure. It could also include a description of how the ship sank, whether it broke into pieces etc. Beyond survivors, other witness accounts would be found in the newspapers, books and, U-boat KTBs.

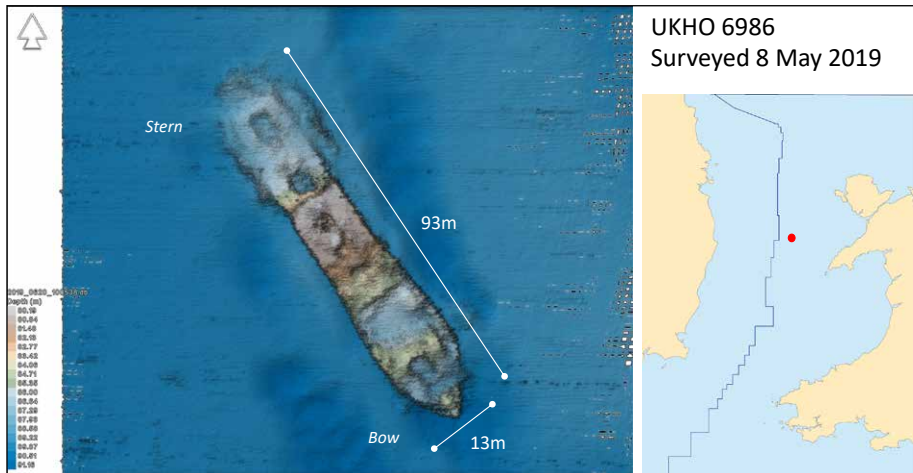
## 6986 CYRENE (MBES/Archive)

UNKNOWN. The wreck is too small to be EARL OF ELGIN.

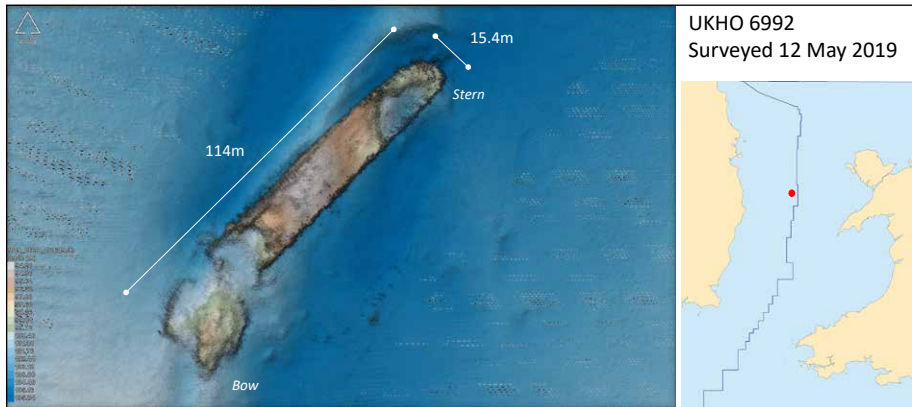
## 6992 MEXICO CITY (MBES/Archive)

UNKNOWN. The width and length of the wreck are too big for TRINIDAD.

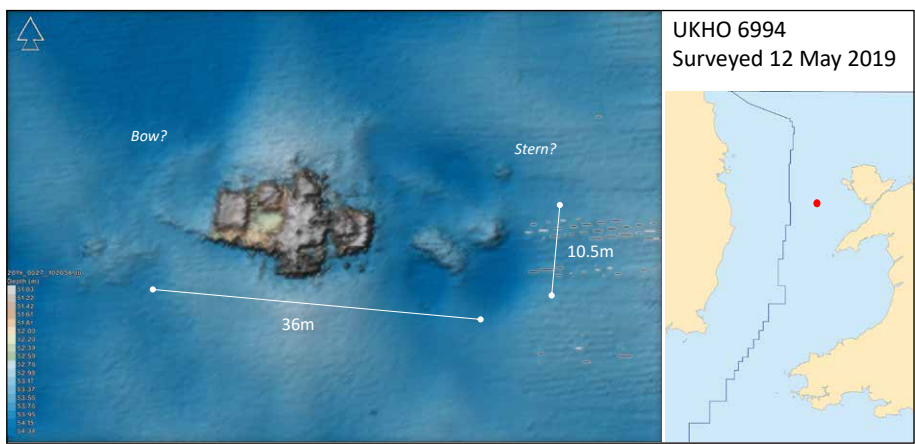
**6994 PSS WILLIAM HUSKISSON/MANCHESTER (MBES/Archive)**

**Phase 1 Conclusion:**  
UNKNOWN. Although this wreck is broadly correct on length for FOSTIMORE (identified at 7418), it appears to be nearly twice the width. The cargo of slag does not show on the pointcloud or DTM.

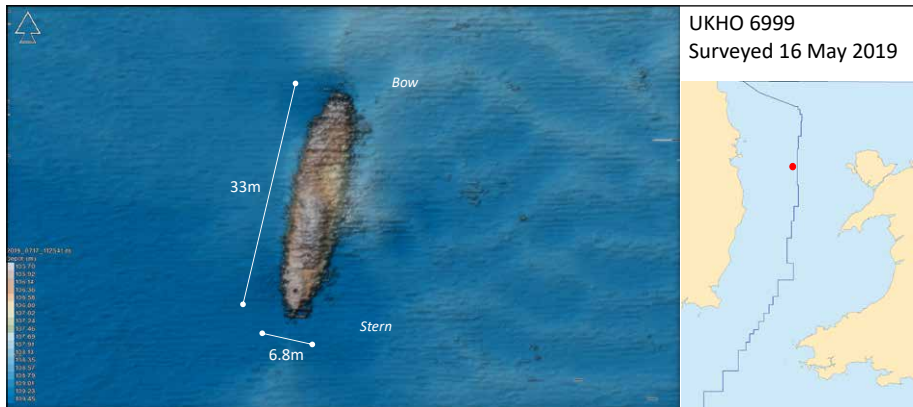
## 6999 ALCAZAR (MBES/Archive)

UNKNOWN. ENERGY was an SV, and this wreck is clearly a steamship.

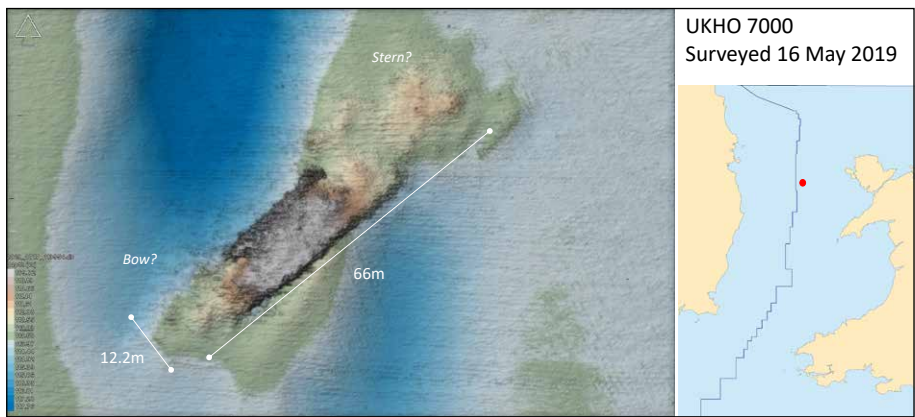
## 7000 ESKMERE (MBES/Archive)

UNKNOWN. The wreck is too small to be MEXICO CITY which was 121m x 14.5m (*Lloyd's Register* 1918-19).

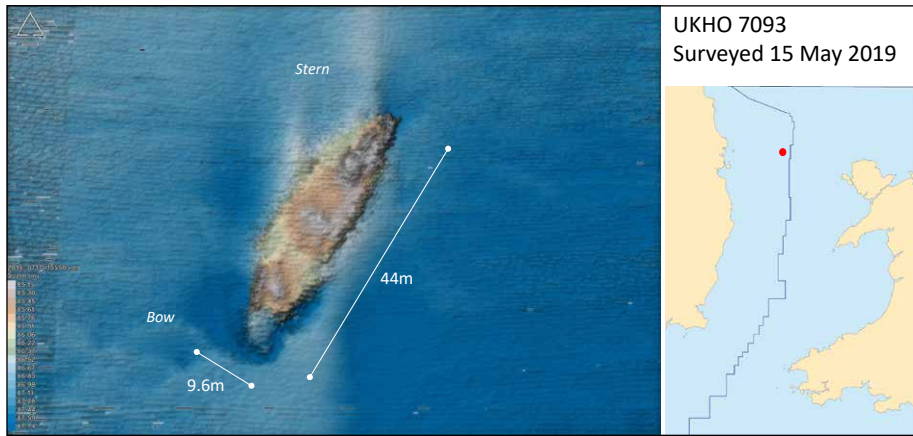
## 7093 THE MARQUIS (MBES/Archive)

**MBES Analysis:**  
Collapsed trawler or small coaster with possibly a motor showing at the stern. 44m x 9.6m.

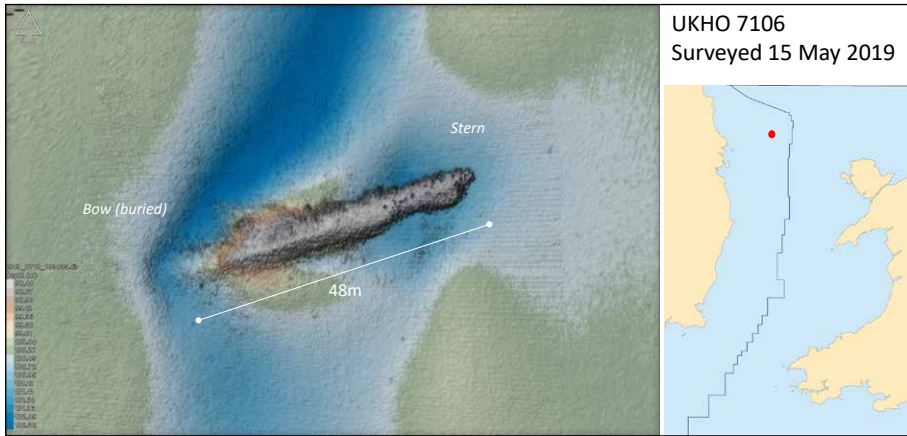
## 7106 U1051 (MBES/Archive)

UNKNOWN. This wreck is not NORMANDIET and is clearly a submarine.

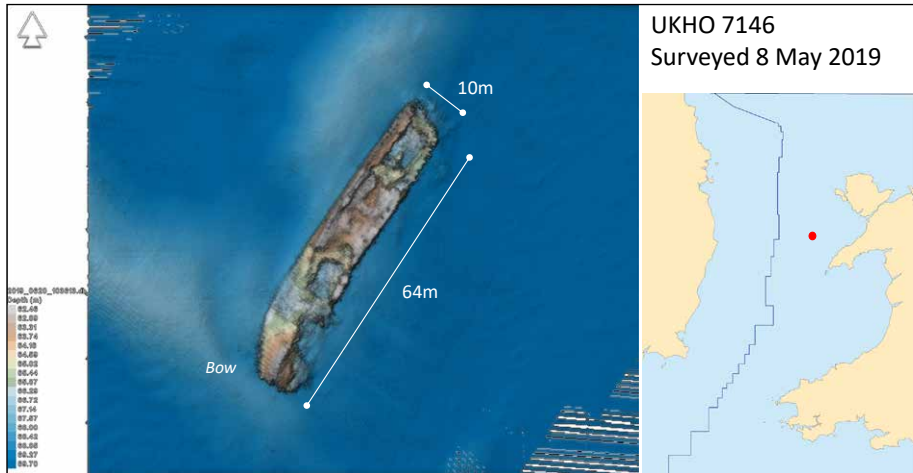
PERSEUS was stuck by an air launched torpedo 12nm north of Bardsey. The explosion blew off the stern, aft of No3 hold. The ship drifted for at least two hours before foundering, sinking by the stern, and leaning to starboard (TNA ADM 199/2136).

Cargo vessel lying upright with lean and collapse to port side. Stern missing. Two holds forward and one aft. Dimensions approx. 64m x 10m.

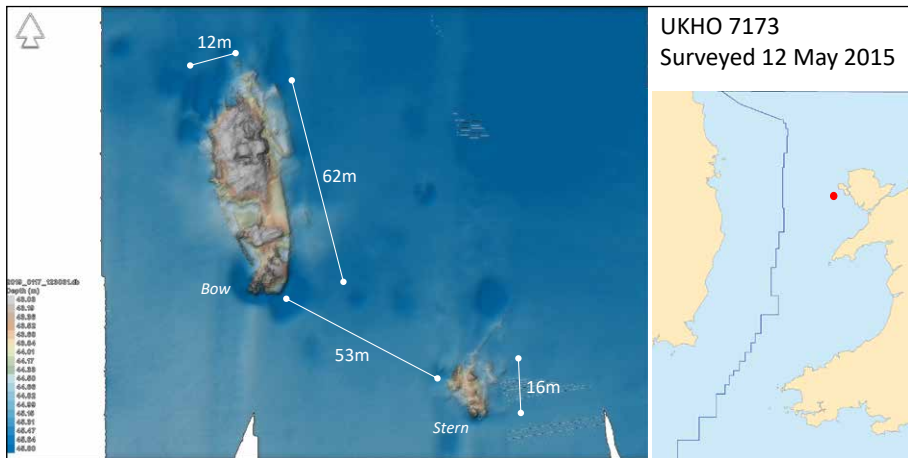
NORMANDY COAST was sunk by U1055 on 11 Jan 1945. Survivor stated ship was hit aft and settled by the stern (TNA ADM 199/2148). It is noted the stern of this wreck is separated from the rest of the wreck. [Wrecksite.eu](http://wrecksite.eu) has updated the UKHO record to show that the wreck is believed to be SS NORMANDY COAST. Means of identification by divers is not given in detail but stated as "100%" certain.

This wreck is broken into two portions. It appears as if the stern section is the smaller part lying 53m SE of the main portion of the wreck. The overall length is approximately 78m and width approx. 12m.

UNKNOWN. This wreck is too short to be SLIEVE BLOOM. It is not known why UKHO considered this wreck CONFIRMED (no suffix).

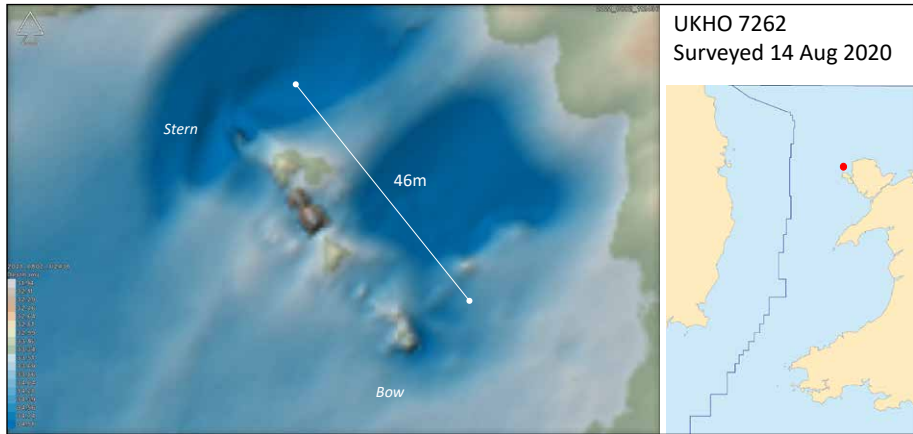
UKHO 7262  
Surveyed 14 Aug 2020

Broken up wreck of a small steamer 46m long and 6m wide.

UNKNOWN. This wreck is not RIVER HUMBER, as it has been identified by the bell elsewhere.

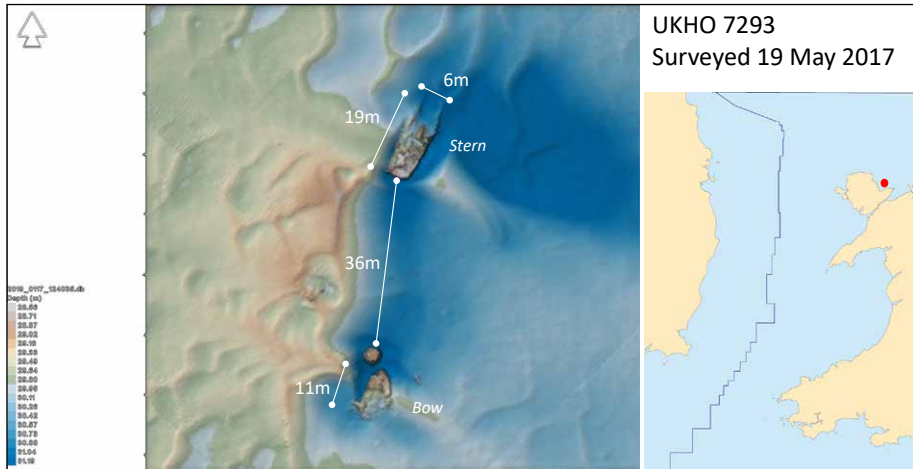
Note that KINKORTH was presumed mined. The damage seen on this site is consistent with a mine hit on a small vessel.

UNKNOWN. This wreck is not likely of wood construction and shows no signs of being burned for its copper.

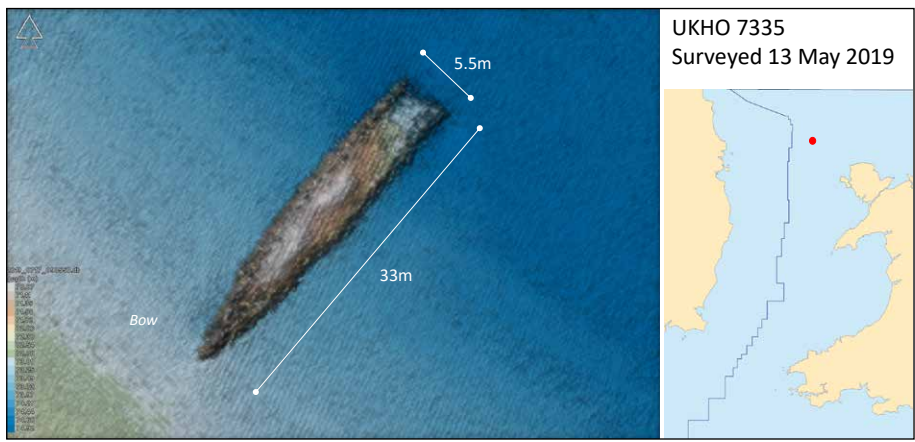
| <p><b>MBES Analysis:</b><br/>MBES scan reveals small wreck of approx. 33m long. Pointcloud shows is upright with stern to the north. The stern appears to be missing and what may be a boiler can be discerned in the centre of the ship.</p> |
| <p><b>Phase 1 Conclusion:</b><br/>UNKNOWN. GLENCONA is ruled out as the identity of this wreck.</p> |

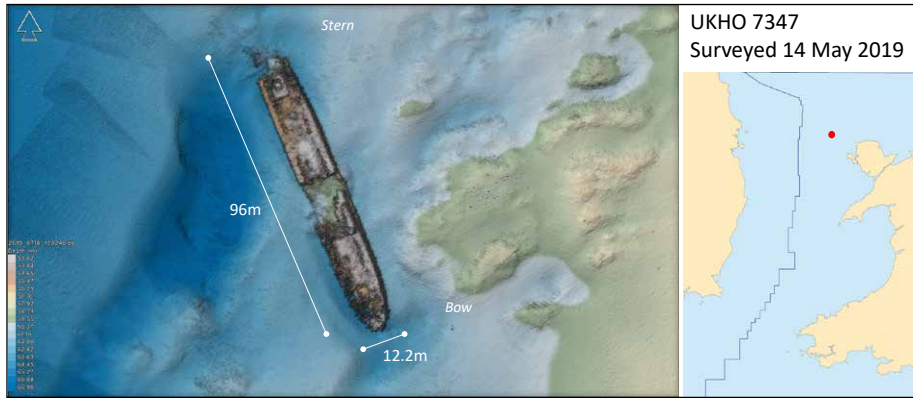
BRITISH VISCOUNT (MBES/Archive). The wreck is consistent with being a tanker, showing what appears to be cylindrical tanks in its structure. It also shows features as described in the text of the sinking (split amidships and damage on starboard side) and in its dimensions.

Steamship, upright with hole amidships and damaged bow. Approximately 96m long and 12.2m wide.

UNKNOWN. The wreck cannot be MANCHESTER as it is far too large. The bell reported coming from GLANWERN clearly was not recovered from this wreck site.

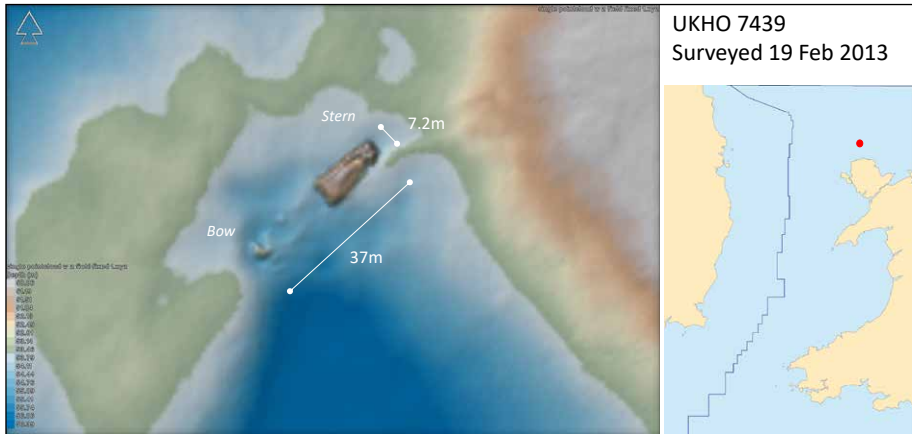
HILDENA was heading SE at the time of the collision. It was hit amidships and sank immediately (*BOT Wreck Report*). It is noted the wreck points SE and is damaged from bow to aft of midships.

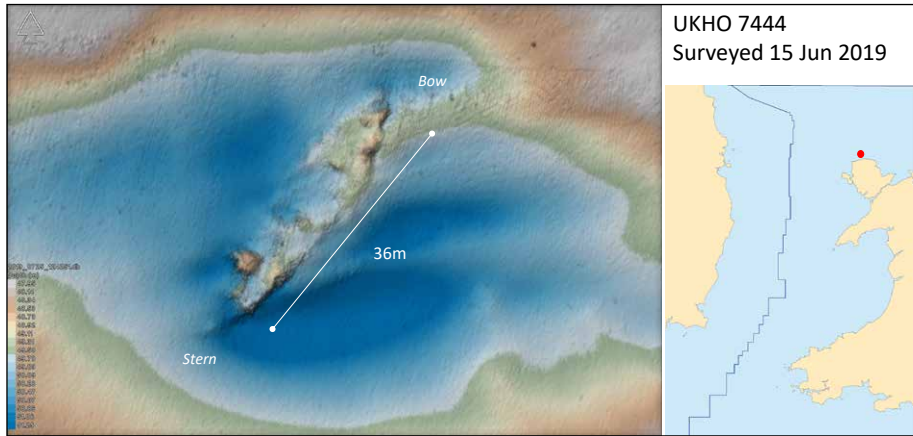
HERBERT foundered with a cargo of clay. No loss of life (BOT 1895-6, p110). No discernible cargo on DTM.

UNKNOWN. Diver suggestion that this might be LEEDS (UKHO) cannot be substantiated from available archival records. Moreover, the MBES scan seems to suggest that the wreck is not a PSS.

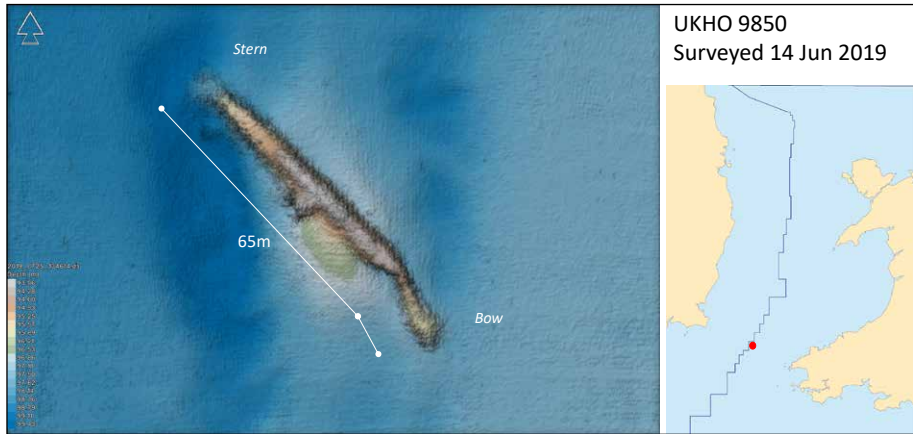
U1172 (MBES/Archive). Evidentially, and only on the balance of probability, this wreck could be U1172, but this is not certain by any means. If a U-boat is ever found off the Arklow Bank, this would need revising.

Wreck of a submarine lying on starboard side beam ends. Damaged forward. Most likely to be a WW2-era U-boat.

UNKNOWN. This wreck is not a steamship.

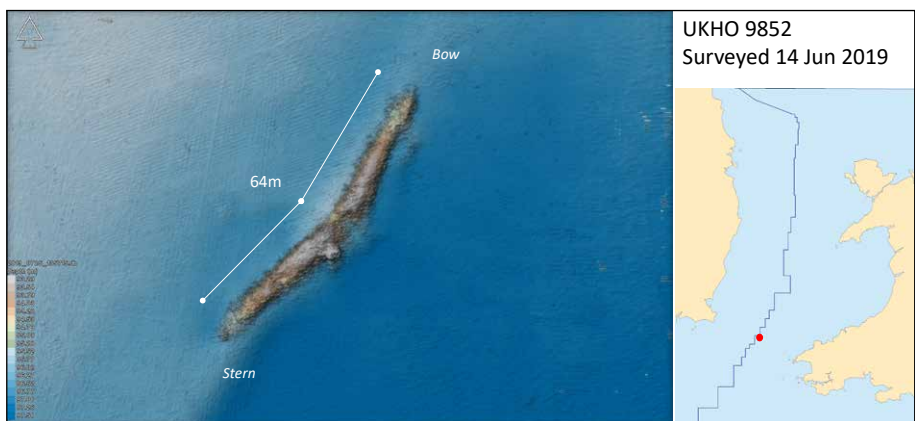
Wreck of a submarine lying on its starboard side, broken almost in half amidships. Dimensionally consistent with a WW2-era submarine.

UNKNOWN. This wreck is a submarine.

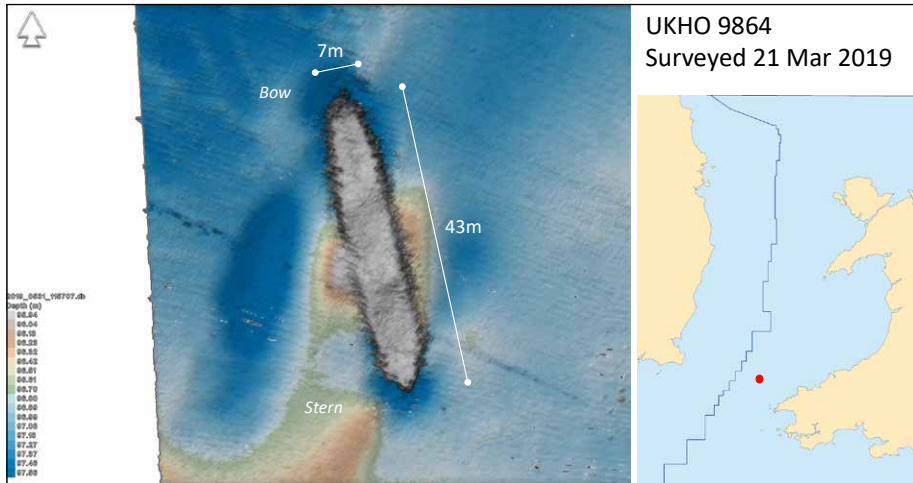
Small coaster/FV possibly upside-down. 43m x 7m, bows to the south. Area of damage midships on starboard side.

UNKNOWN. The wreck is far too small to be ST PATRICK.

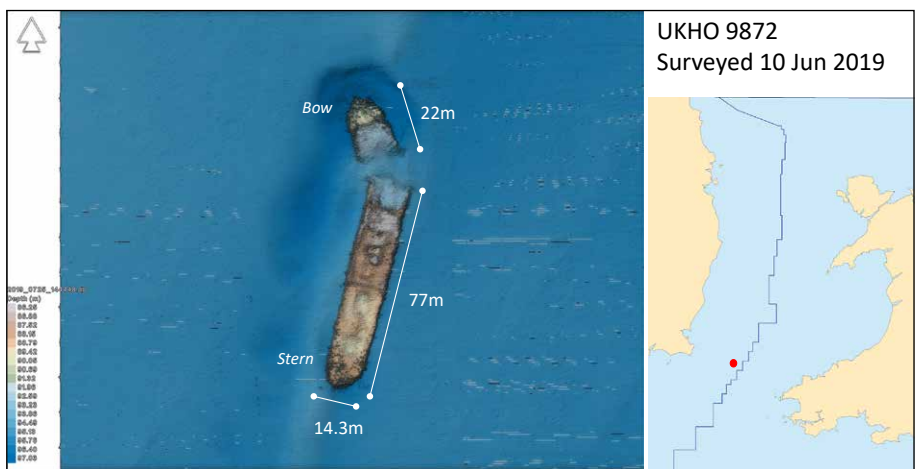
HIGHCLIFFE (MBES/Archive). Positionally, dimensionally, and archivally this wreck is consistent with HIGHCLIFFE. The master's position is very close, and the damage on the wreck is consistent with a torpedo strike as described.

Upright cargo vessel with bows pointing north and broken off. Approx 99m x 14.3m.

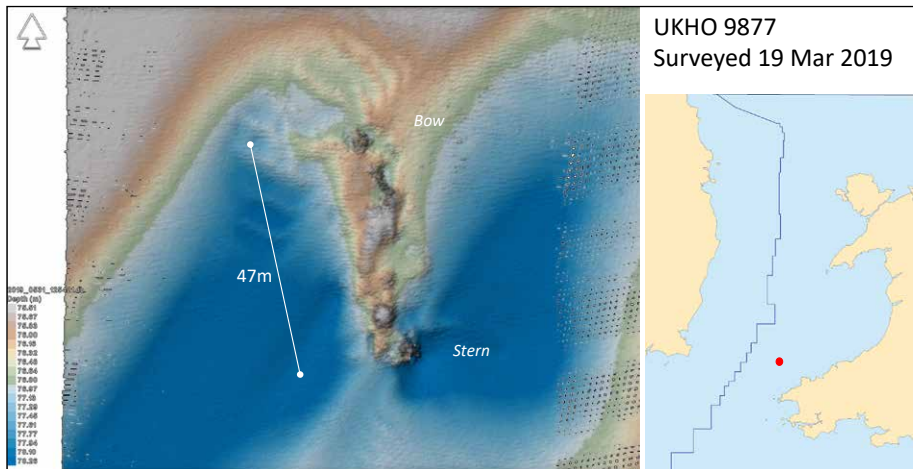
Broken up wreck with possible boiler showing at the southern end. Approx 47m long with boiler at the stern end of the wreck.

UNKNOWN. This wreck is much too small to be EMPIRE GUNNER.

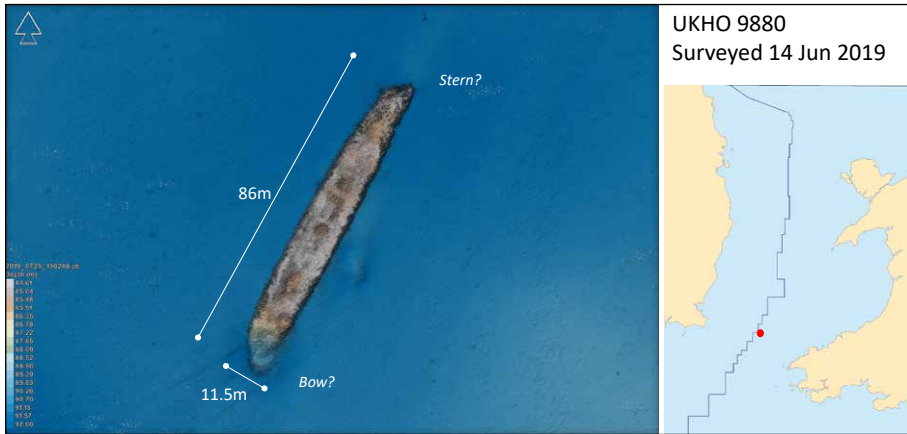
GLENBY (Admiralty Transport No 590) was sunk by gunfire, while the crew were lowering the boat. Two were killed. The U-boat approached the survivors to ask the identity of the vessel and then headed east to attack another (TNA ADM 137/1131). The vessel sank stern first (TNA ADM 137/2959). Bow and stern show damage. Heading of the wreck is difficult to discern.

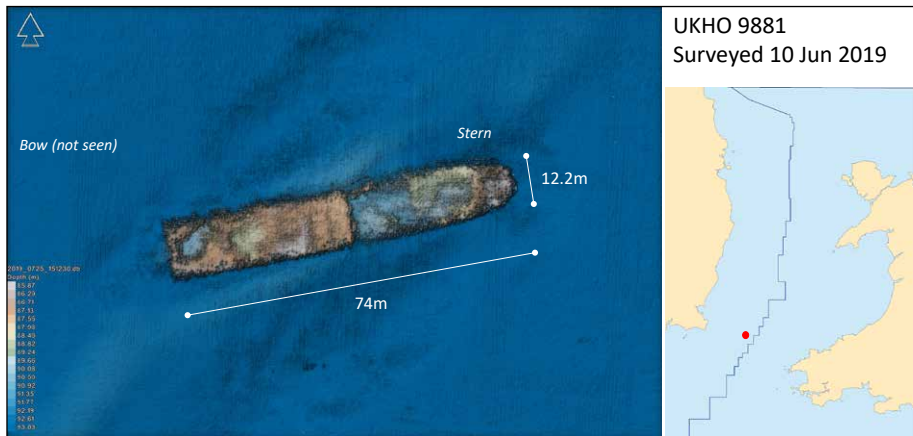
ALU MENDI (MBES/Archive). Positionally, dimensionally (on width), and archivally this is consistent with ALU MENDI. The absence of the fore part of the ship is notable and unexplained, although it should be noted one bomb was placed in No2 hold.

**MBES Analysis:**  
Upright cargo ship with bows missing. 74m x 12.2m. Stern to east.

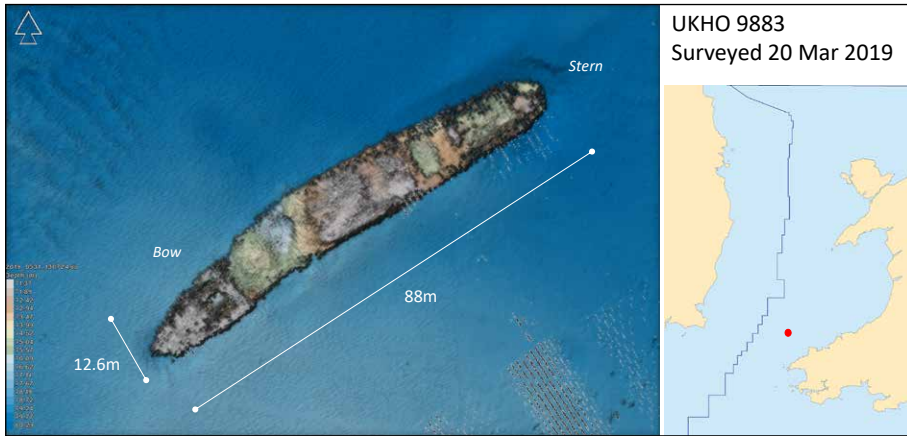
ST PATRICK (MBES/Archive). The wreck is dimensionally, positionally, and archivally consistent with ST PATRICK. Of note is the damage to the wreck, consistent with a vessel which folded as it sank.

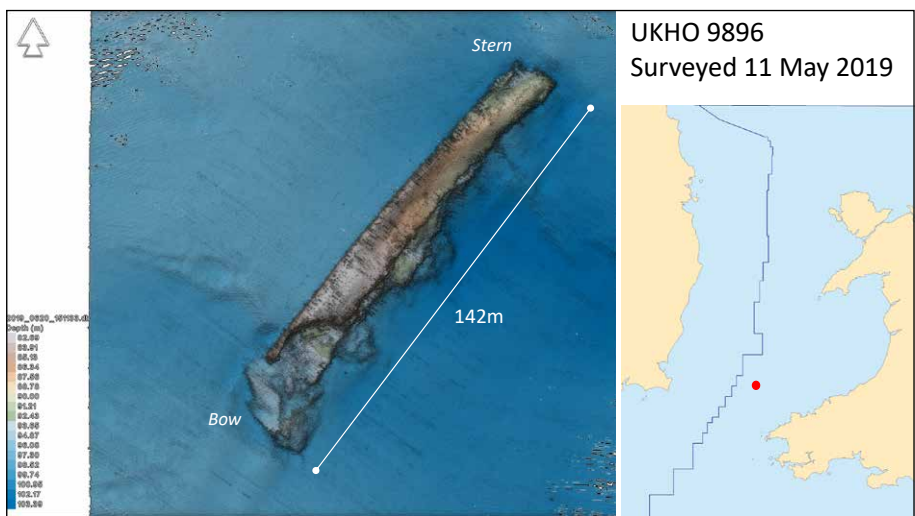
| <b>Phase 2 Conclusion:</b><br>PORT TOWNSVILLE (MBES/Archive). Positionally and archivally this wreck is consistent with PORT TOWNSVILLE. The wreck measures slightly short, but this is explained by the fact that it sank by the head. It can be noted the ship is longer than the sea is deep at this location. The MBES scan shows that the bow seems to have bent upwards on impact. Photos of the ship show it had two islands, both of which can be discerned in the MBES data. |

| <b>Phase 1 Conclusion:</b><br>UNKNOWN. This cannot be STRATHNAIRN based on length. |

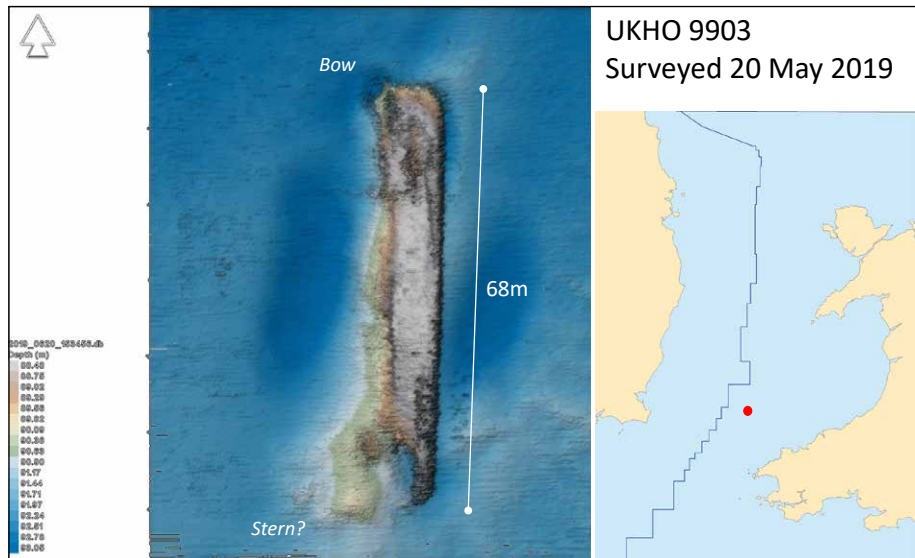
BOSCASTLE (MBES/Archive). This wreck is positionally consistent with BOSCASTLE. It seems from the archival data that the ship broke in half. This MBES scan appears to only represent the fore part of the ship, with the after part not being seen, but the break being exactly as described by U111. It should be noted that the shape of the bow of this vessel is similar in shape to that seen in the drawing of BOSCASTLE in the project archive. The evidence is not conclusive, but this wreck appears to be the best fit. It is just possible that the unidentifiable wreck 9898 could be associated with this one.

UNKNOWN. Too short for GRESHAM.

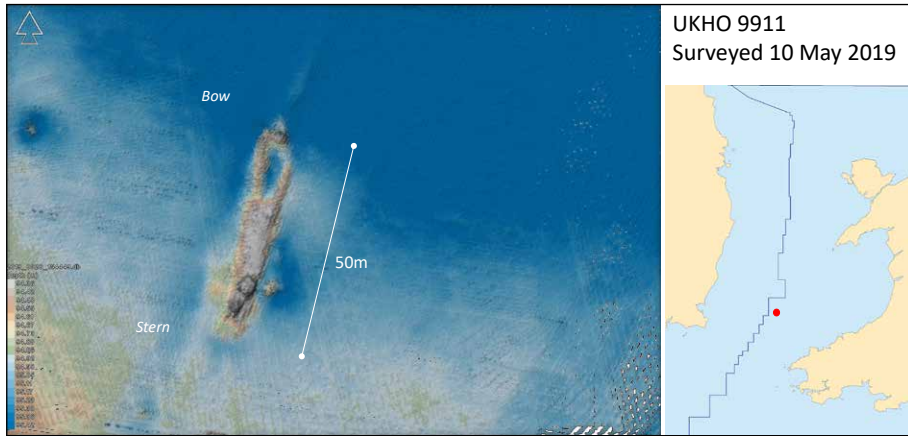
The evidence of destruction included human tissue and the attack was graded "A Known Sunk" in 1945. The attacks on the wreckage were persistent and went on for some time. The wreckage on this site is flattened and this is consistent with heavy depth charge attacks, as seen in the case of U678 (see McCartney 2014, p153-356). It should be noted too that this wreck was located in May 1945 when it gave off oil and wreckage (presumably as a result of being depth-charged previously) (UKHO).

Small broken down wreck, prominent high point at southerly end. Approx. 50m long.

UNKNOWN. The wreck is too short to be SORELDOC.

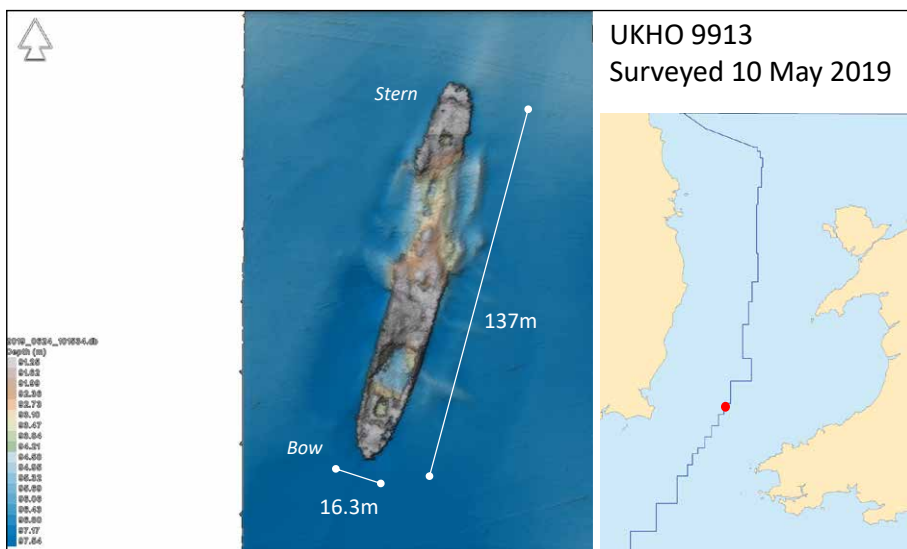
Large upright SS cargo of 137m x 16.3m. Appears to have broken aft of the bridge area.

UNKNOWN. This wreck is too short to be MESABA.

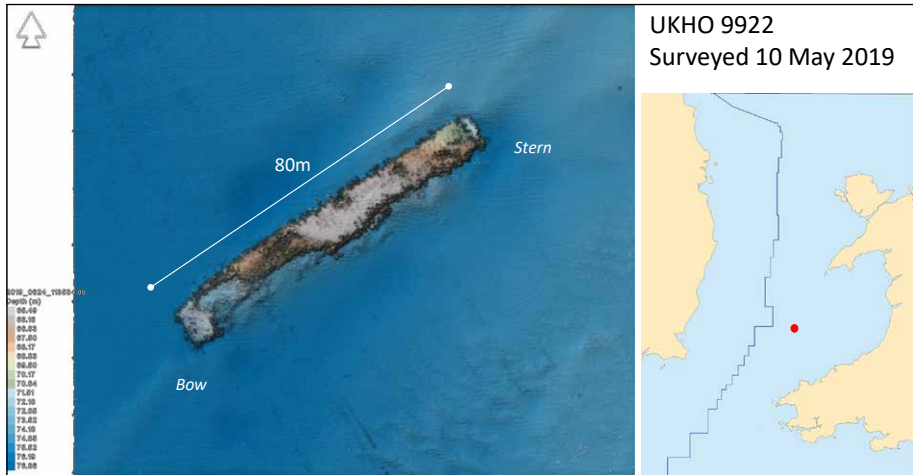
## 9922 GREENLAND (MBES/Archive)

Large wreck lying on port side with noticeable damage in the holds forward of the bridge. 80m long.

GREENLAND (MBES/Archive) Positionally, dimensionally, and archivally, this wreck is consistent with GREENLAND. Due to the vague positional recording by both U-boat and ship, it should be noted that 82347 (currently thought to be DUNSLEY) and 9929 (SERULA) cannot be ruled out as alternative candidates.
