INNES MCCARTNEY

# ECHOES FROM THE DEEP

*Inventorising shipwrecks at the national  
scale by the application of marine  
geophysics and the historical text*

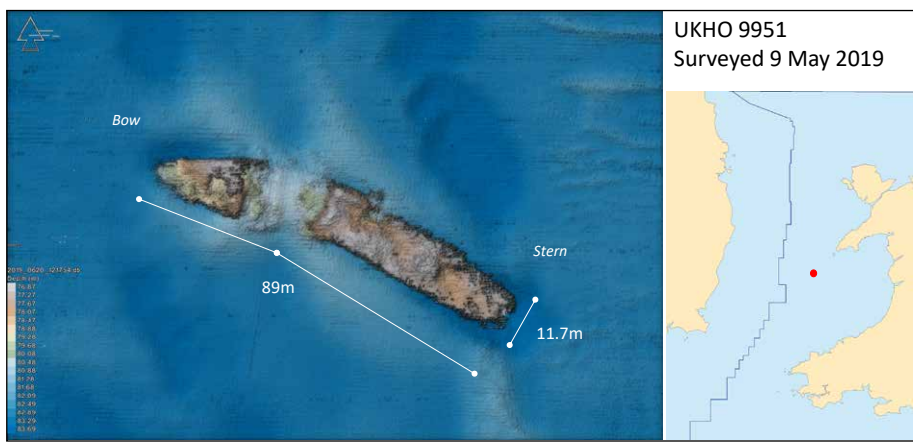
## 9953 BOSCAWEN (MBES/Archive)

The torpedo hit between the forecastle and No1 hold on the port side and the ship immediately sank by the head. It is noted by the Admiralty assessors that the ship was east of its allotted course (TNA ADM 137/1501).

BOSCAWEN (MBES/Archive). Dimensionally and archivally the wreck is consistent with BOSCAWEN. The position is at the extreme end of what one would expect. However, in this case the damage to the wreck and its orientation (on port side) closely match the torpedo hit as described.

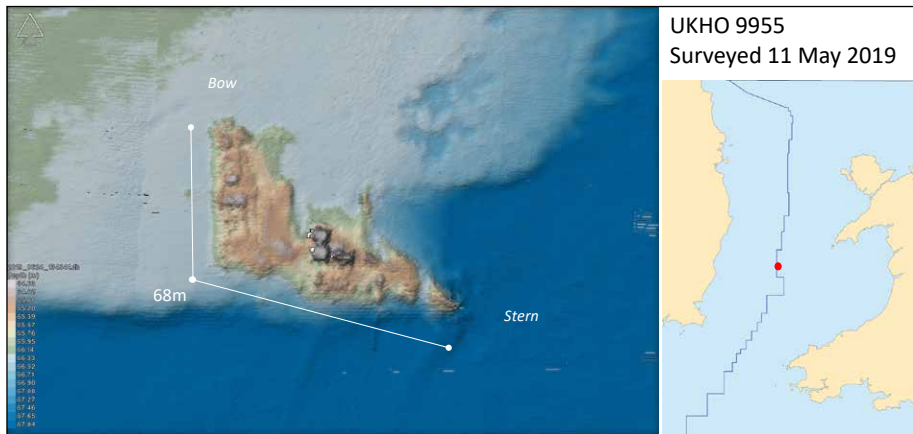
## 9957 WAESLAND (MBES/Archive)

WAESLAND (MBES/Archive). Positionally, dimensionally, and archivally this wreck is consistent with WAESLAND. Of note is the vessel's size and the damage coming from the port side, matching the accounts of the accident. It is also noteworthy that the extension added in 1880 appears to be the area of the ship which gave way and is seen as collapsed on the MBES scan of the wreck.

Steamship with large engine and a pair of boilers visible in the DTM. Broken amidships with a break of 20m length. The combined lengths of the two halves is 129m. Width of the wreck is approx. 13.5m.

Built as SS RUSSIA for Cunard. Sold to the Red Star Line in 1880 and lengthened by 23.5m in the same year (*Lloyd's Register* 1880-81). Had been fitted with a triple expansion engine by 1901 (*Lloyd's Register* 1901-02). It collided with SS HARMONIDES which hit the ship amidships, rebounding into it a second time and WAESLAND was fatally damaged and quickly awash (*The Times* 8 Mar 1902) The collision was on the port side (*The Sphere* 15 Mar 1902).

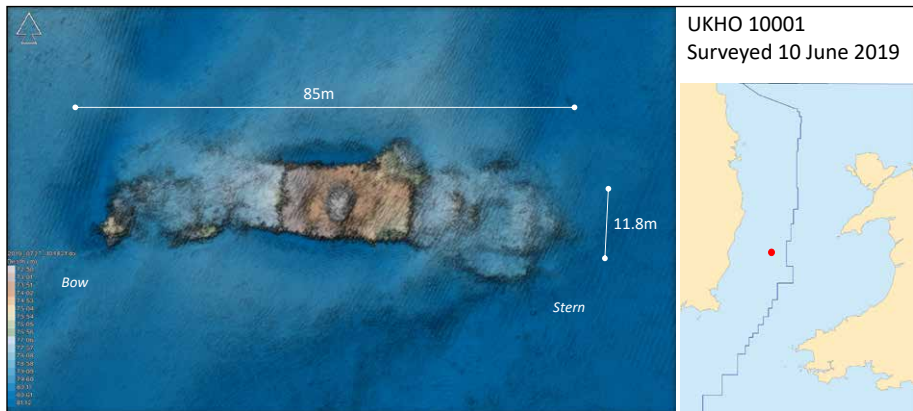
## 10002 POSEIDON (MBES/Archive)

Upright wreck of a cargo ship with bows being the most damaged area. 90m x 12.1m. Holds fore and aft with machinery amidships.

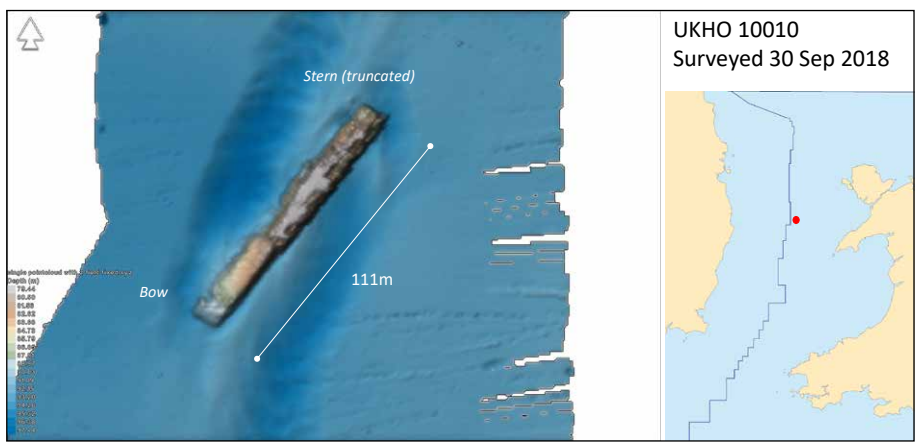
## 10011 ROSE MARIE (MBES/Archive)

Upright steamship possibly pointing north. Bows broken down. High mid-section. Difficult to measure due to collapse but approx. 85-90m long.

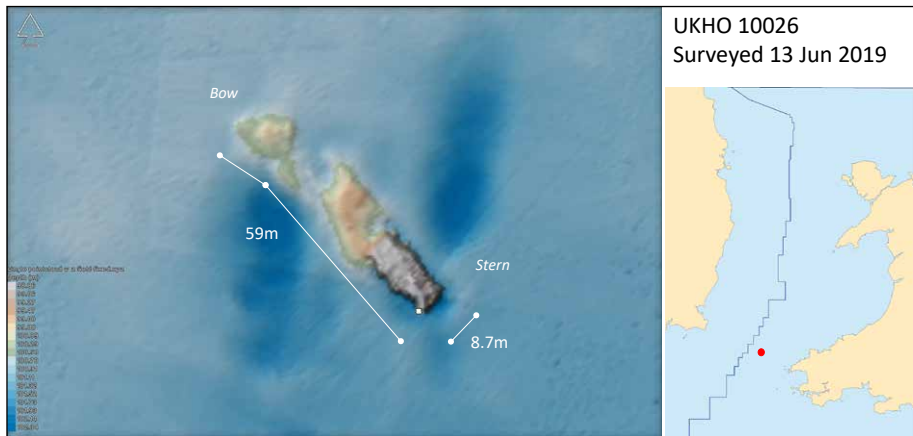
LODANER (MBES/Archive) Positionally, dimensionally, and archivally this wreck is consistent with LODANER. It should be noted that the course of this vessel is correct for a northward bound zig-zagging ship (as described in the KTB). Also, the bridge of this ship was 45.1m long (*Lloyd's Register* 1918-19), matching the length recorded on the MBES scan.

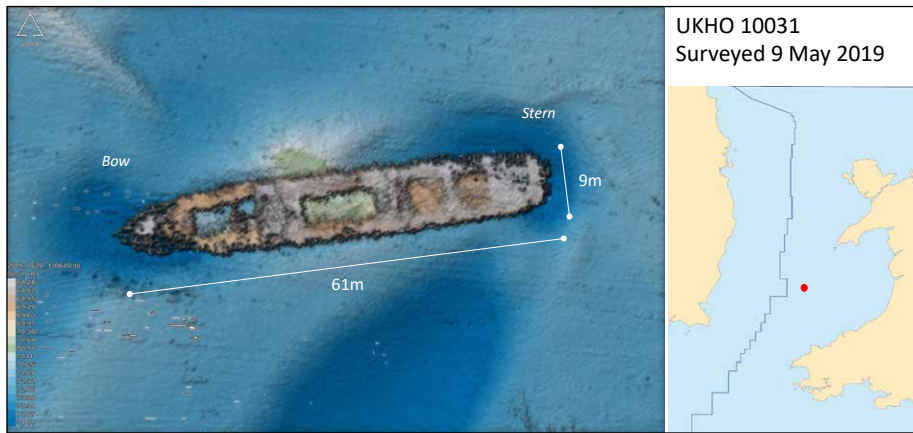
HAVNA (MBES/Archive). Positionally, dimensionally, and archivally this wreck is consistent with HAVNA. Of note is the obvious damage on the wreck, consistent with the account of the sinking.

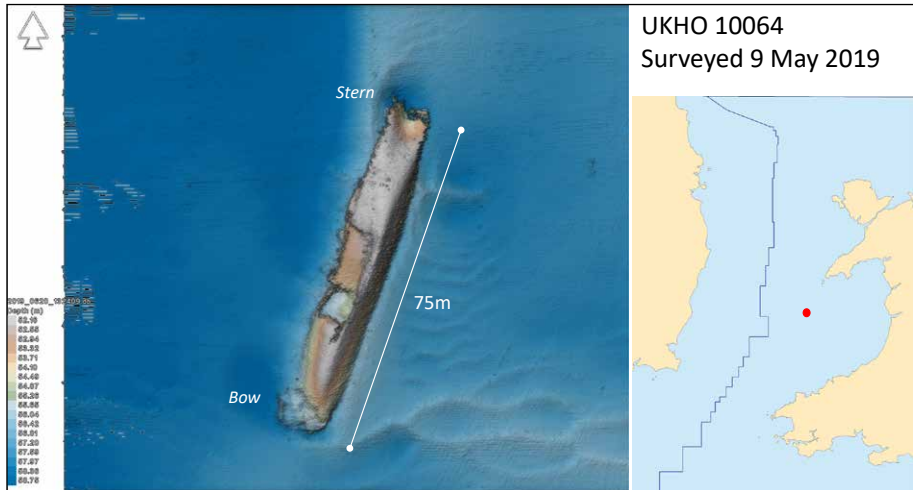
UKHO 10064  
 Surveyed 9 May 2019

EMPIRE PANTHER (MBES/Archive). The evidence in this case is not conclusive due to positional discrepancies and the dimensions of the wreck being shorter than EMPIRE PANTHER. This is a large wreck, and the candidates are limited, this being the best fit and no more. It is possible for the ship to have drifted NE in the prevailing wind and to have foreshortened as it sank, which would be consistent with the way in which the ship is described as being damaged. The width is correct for EMPIRE PANTHER.

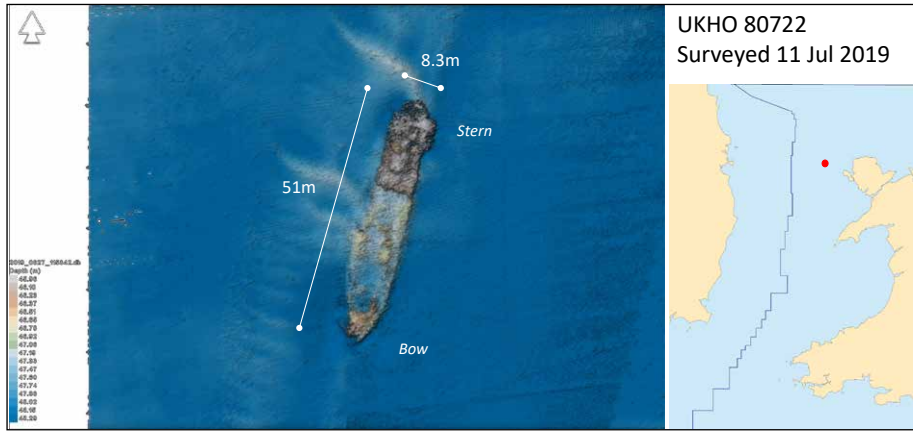
Wreck of a cargo ship with holds fore and aft of central superstructure. Broken into two parts Points NE. Approx. 74m x 10.5m overall.

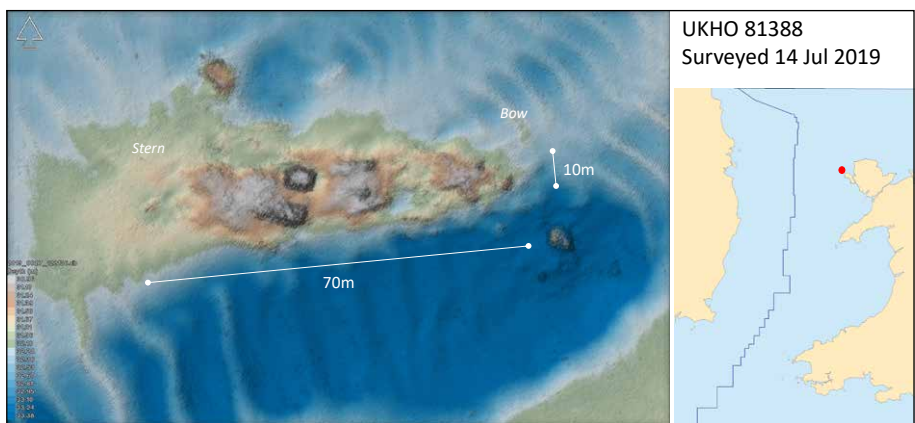
UKHO 81388  
 Surveyed 14 Jul 2019

This wreck plots 1.9nm from the position given as the collision point (BOT 1900-1901, p145). The ship was struck in the engine room and sank immediately. This wreck shows damage aft, where the engine room was situated.

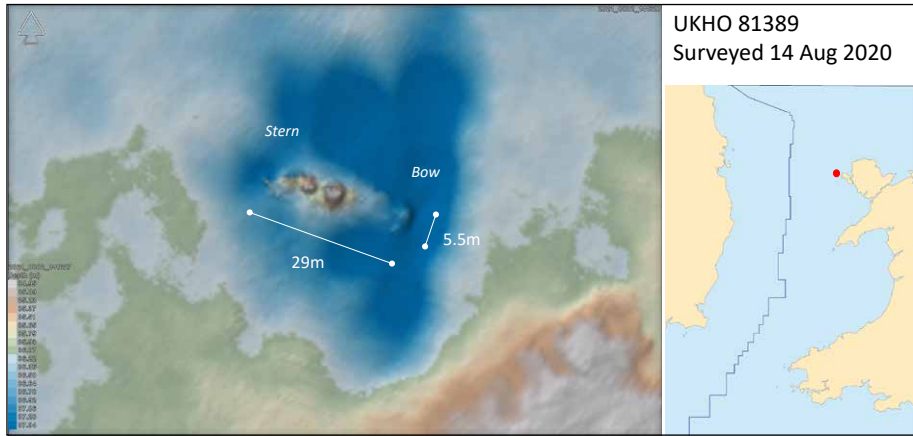
| <b>Archival Analysis:</b><br>Foundered in very heavy weather, with 23 lives lost (BOT 1884-85, p101). Unnamed newspaper accounts on wrecksite.eu suggest the ship sank stern first in plain view of the Holyhead breakwater. |

| <b>MBES Analysis:</b><br>Wreck of steamship, heavily degraded lying E/W. 70m x 10m approx. |
| <b>Additional Evidence:</b><br>Located in 2013 (UKHO). Divers report artefacts of the correct era (wrecksite.eu). |

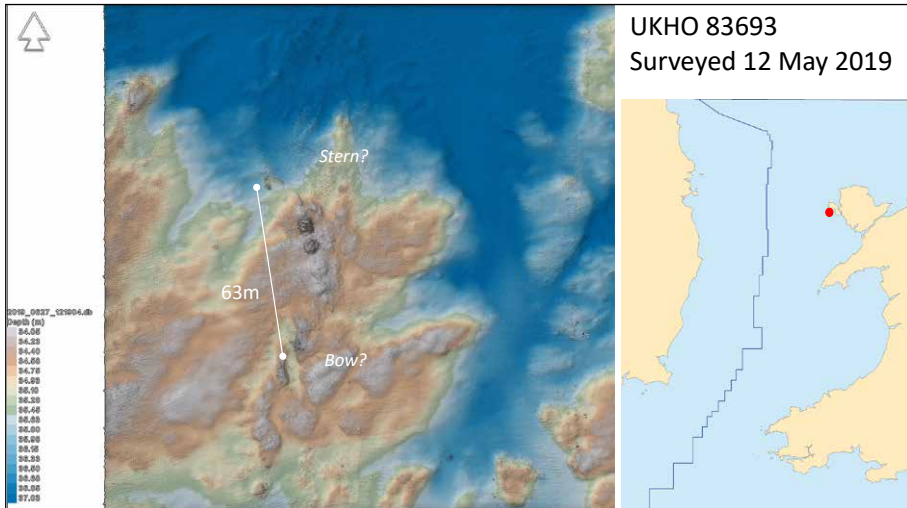
Wreck of SS which has been broken in half in the region of the machinery spaces, spilling the boilers onto the seabed. The wreck has folded back onto itself, so that the bow and stern both point to the SW. Overall length of wreck approx. 100m. Width is difficult to discern with accuracy.
