# ◆ ‘At Pevensey doth a ruin’d Castle stand’: the development of the post-Norman castle

Allan Brodie and  
Mark Bowden

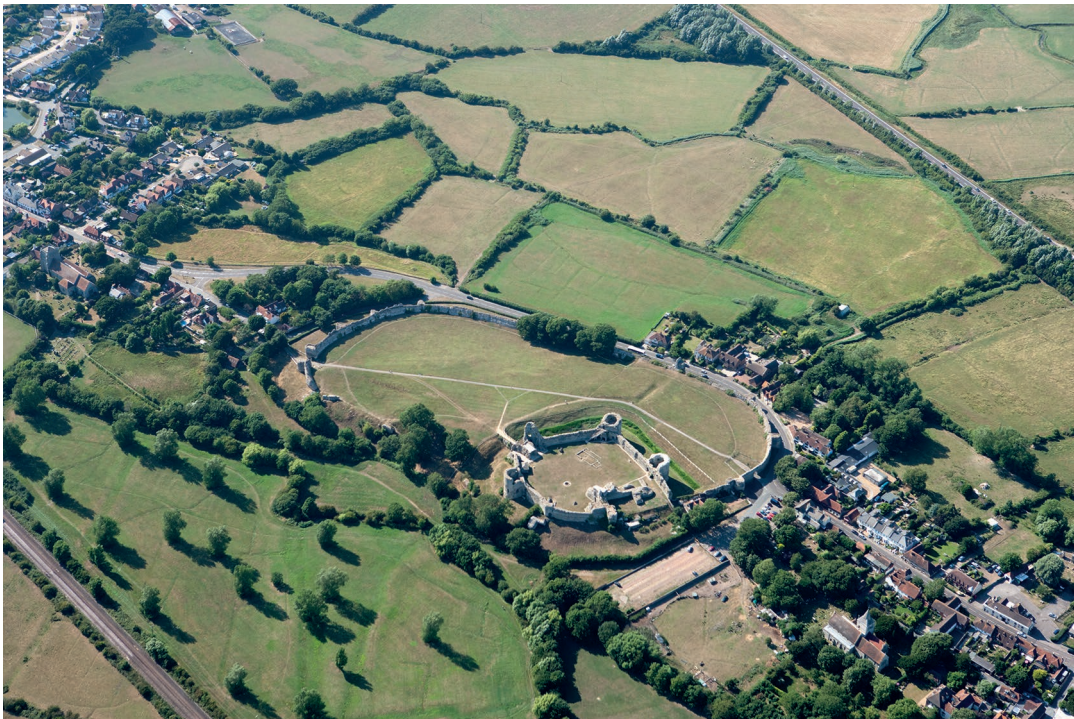
Fig. 1. In this recent aerial photograph of Pevensey Castle, the sea originally lay to the south (left) of the castle, where the original low cliffs on which it stands can be seen. Much of the south wall of the Roman fortification has slid into the sea and mostly been washed away, but one section that may have collapsed in c.1193 can be seen on the slope beneath the medieval castle. Access into Pevensey Haven was to the east (right) of this photograph [26764/026] © Historic England Archive

The Saxon Shore Fort at Pevensey (*Anderitum*) was built soon after AD 293 (Fulford and Tyers 1995, 1011–2; Pearson 2002, 34, 59–60) (Fig. 1). It was first mentioned in the Anglo-Saxon Chronicle in AD 491, but Pevensey does not feature between then and the reign of Edward the Confessor when there are several mentions of its haven or anchorage (Garmonsway 1986, 168–9, 177–8). The reason for its re-emergence in the Chronicle may be due to Edward's greater focus on relations with Normandy than towards more northern European territories.

breach was said to be 40 feet (12.2m) long, implying that the situation had worsened in just over a decade (*ibid.*, 18) (Fig. 1).

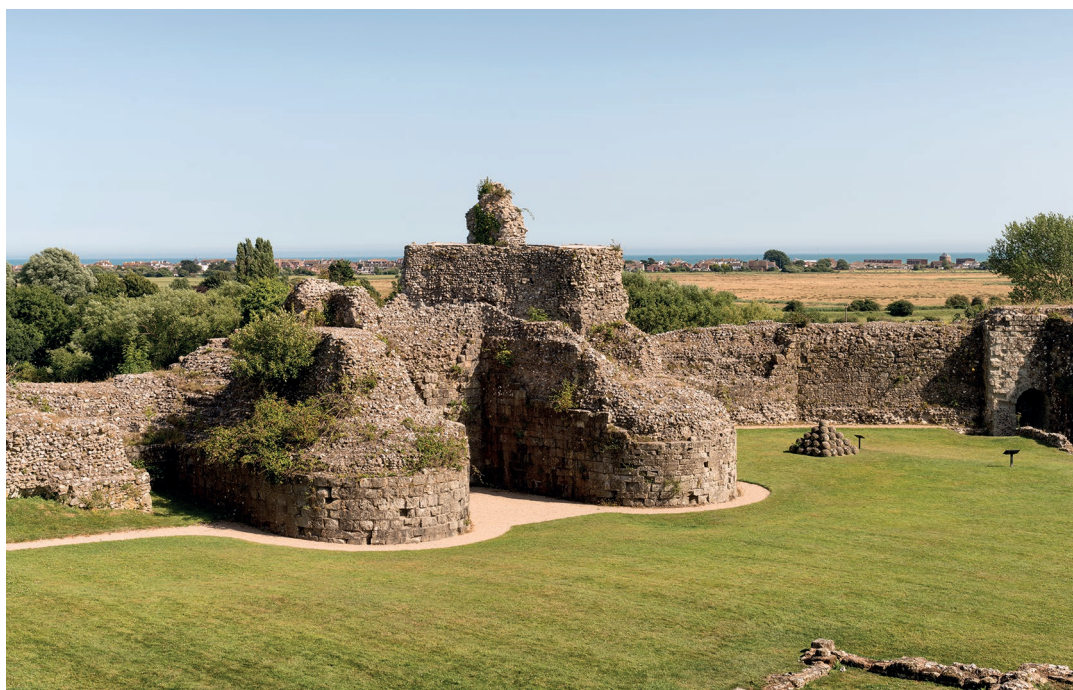
Fig. 2. The undisturbed stonework of the ground floor of the keep is in contrast to the robbed-out rubble core, surviving above. A fragment of wall that may have formed the base of the stair into the keep can be seen on the left of the photograph; to the extreme right is the postern gate, which was probably rebuilt in 1193. [DP236256] © Historic England Archive

A substantial earthwork complex with a strong palisade would have provided an appropriate setting for the monumental stone keep (Fig. 2).

The ashlar of the ground floor of the keep has not been robbed, due to it having been covered by an earth or clay mound. The surviving fabric reveals no openings, and access was apparently at the first-floor level via a bridge, which is referred to in 1289–90 (Salzman 1906, 11). There are two small sections of wall located to the west side of the northern end of the keep that may be the base of this structure. Early French fortified towers were usually entered via a bridge at about 6m above ground level (Thompson 1991, 39), and the castles depicted by the Bayeux Tapestry – Bayeux, Dinan, Dol and Rennes – have bridges up to the entrances of their keeps.

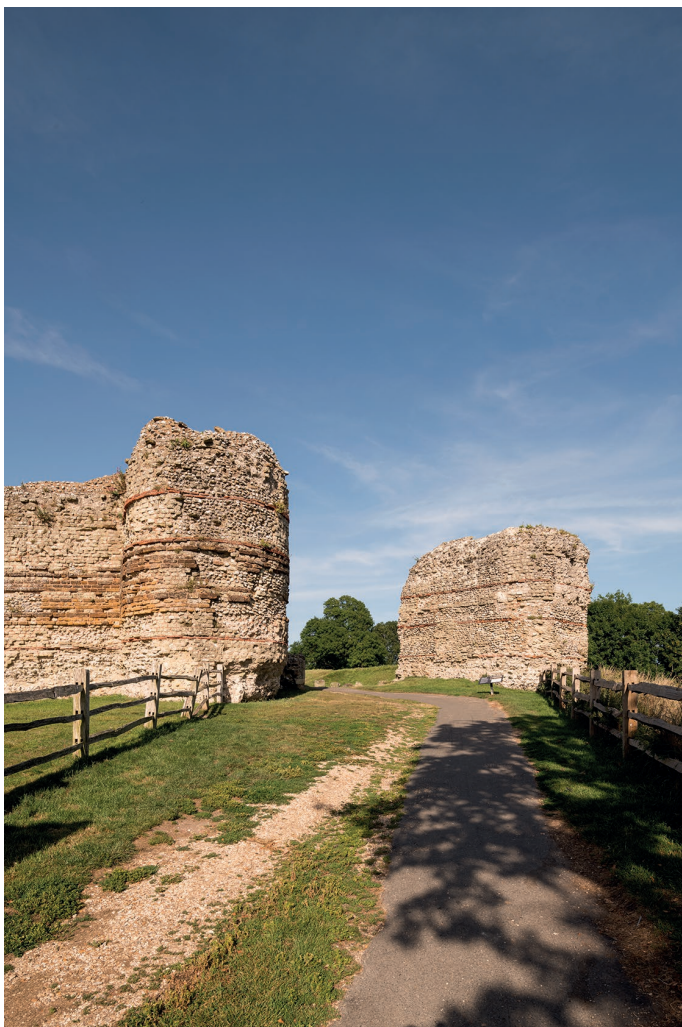
Fig. 3. The West Gate of the Roman fort was flanked by monumental bastions, a formula that almost certainly inspired the design of the Norman keep. [DP236266] © Historic England Archive

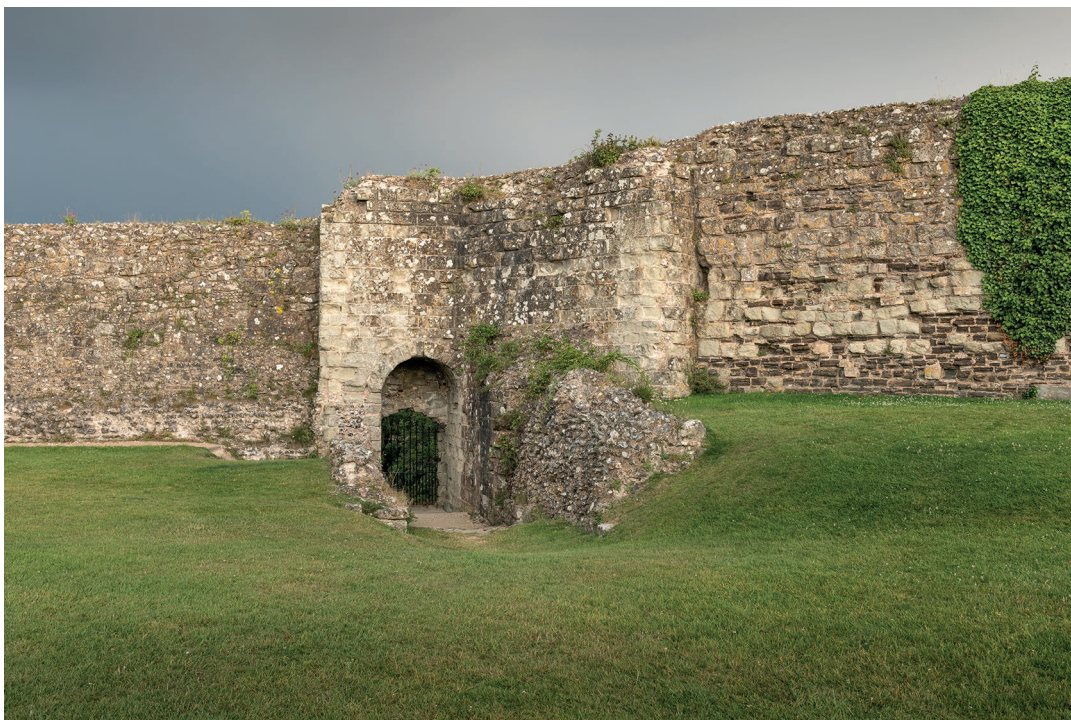
Fig. 4. There are clear joints between the postern gate and the Roman wall to the left, and the mid-13th century castle wall to the right. The wall projecting forwards may have been designed to link with the earlier earth and timber fortification. [DP236364] © Historic England Archive

Bastion 10 of the Roman fortification, on the south side of the castle, has collapsed, but unlike other sections of the south wall it was not washed away, suggesting that this probably occurred when the sea was already in retreat. Therefore, might the expenditure of £57 be a response to that event, creating what is now the postern gate to plug the gap suddenly left in the fortifications? There is architectural evidence that the postern gate predates the stone castle. Inevitably a clear straight joint exists between it and the Roman wall, but equally, there is an obvious joint between the gate and the adjacent south wall of the medieval castle. Therefore, the postern gate predates the existence of the castle, in its current stone form, and its purpose was to secure the integrity of the earth and timber fortification established by the Normans during the previous century and a half. Before the addition of the long wall extending northwards, the western side of the postern gate seems to have been shaped

to be incorporated into the earthwork and palisade fortification, rather than the line of the south wall of the current castle (Fig. 4).

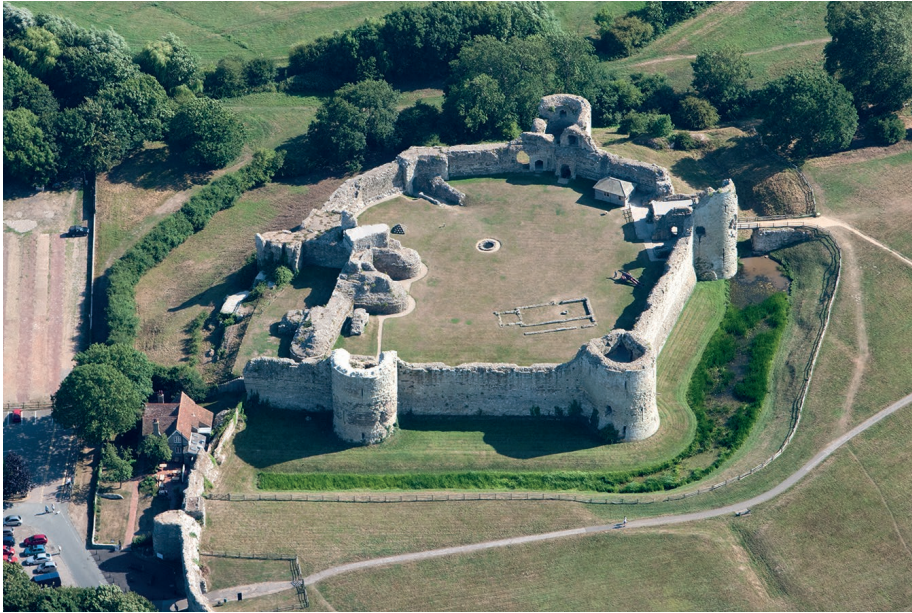
Fig. 5. The postern gate can be seen at the top left of this view with a section of Roman wall to the left of it. The medieval castle appears to have been built clockwise, beginning with its south side (top), then the main gate on the right-hand side, followed by the west and north walls. On the left-hand side, the remains of the keep and the absent, collapsed section of the east wall of the Roman fort can be seen. [26764/031] © Historic England Archive

construction of a circuit of walls running from the c.1193 postern gate clockwise to the east wall of the Roman fortification (Fig. 5). There is a clear joint between the south wall of the castle and the postern gate and another between the south wall and the main gatehouse (Fig. 6). There is no similarly well-defined joint between the north side of the gatehouse and the west wall, although in places there appear to be quoins, suggesting that the west wall may postdate the gatehouse. However, there is a further complication: on the north side of the gatehouse, from moat level upwards, there is a section of fabric that projects out from the surface of the north gatehouse wall. This fabric is incorporated into the gatehouse but is of a slightly cruder quality as if it was a fragment of an earlier structure or an indication of a change of design, the latter perhaps being more plausible due to the neatness of its integration into the building.

bastions fell down, along with a substantial section of the adjacent Roman wall, and were replaced by two new towers; this construction work would have entailed demolishing much of the upper part of the keep (Goodall 1999, 8) (Fig. 5). The dating evidence for this is uncertain; it would be surprising if such a major piece of work was not mentioned in the records at this time, which only specify that the castle was being provisioned (Salzmann 1906, 19). Eighty years later, there appears to be a reference to a very similar programme of work (Salzmann 1906, 23–4), which is perhaps more likely to reflect the date of this reconstruction.

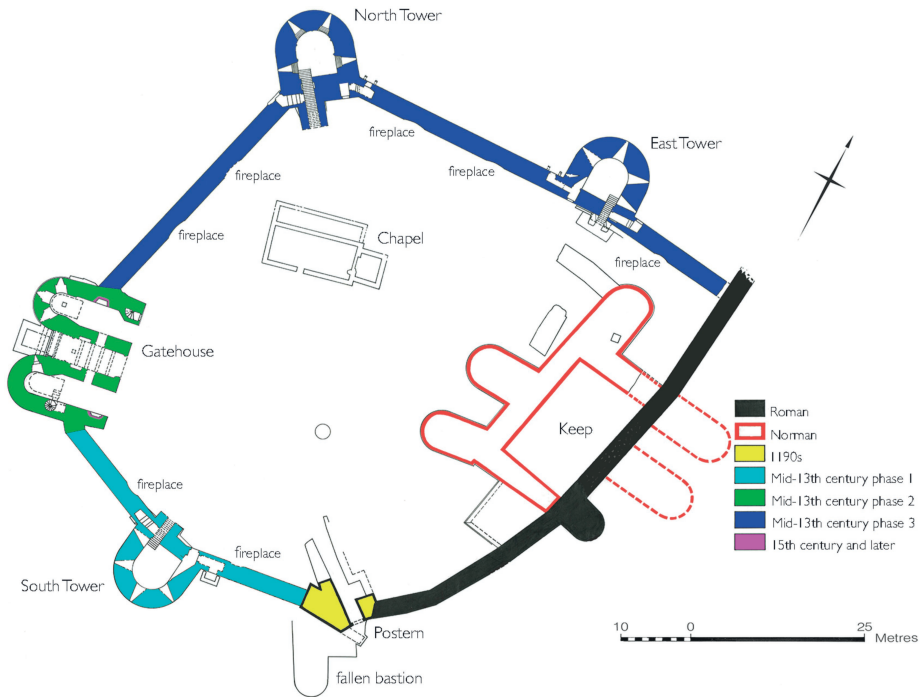
Fig. 6. Phased diagram of the stages in the construction of the medieval castle.

These features provide clear evidence for distinct campaigns of work, but how far apart were these phases (Fig. 6)? Various authors have suggested that the main gatehouse may date from the 1190s or c1220 with the current curtain walls following on in the mid-13th century (Peers 1933, 9–10; Goodall 1999, 5–6; Chapman 2007, 113). It is unlikely that such a substantial stone gate would be constructed in splendid isolation within a century-old earthwork and timber palisade unless there was an intention to replace the earthwork fortification, though this programme might have been delayed. If the gatehouse was as early as the 1190s, what would have been the structure of the castle in 1216, when John is said to have dismantled

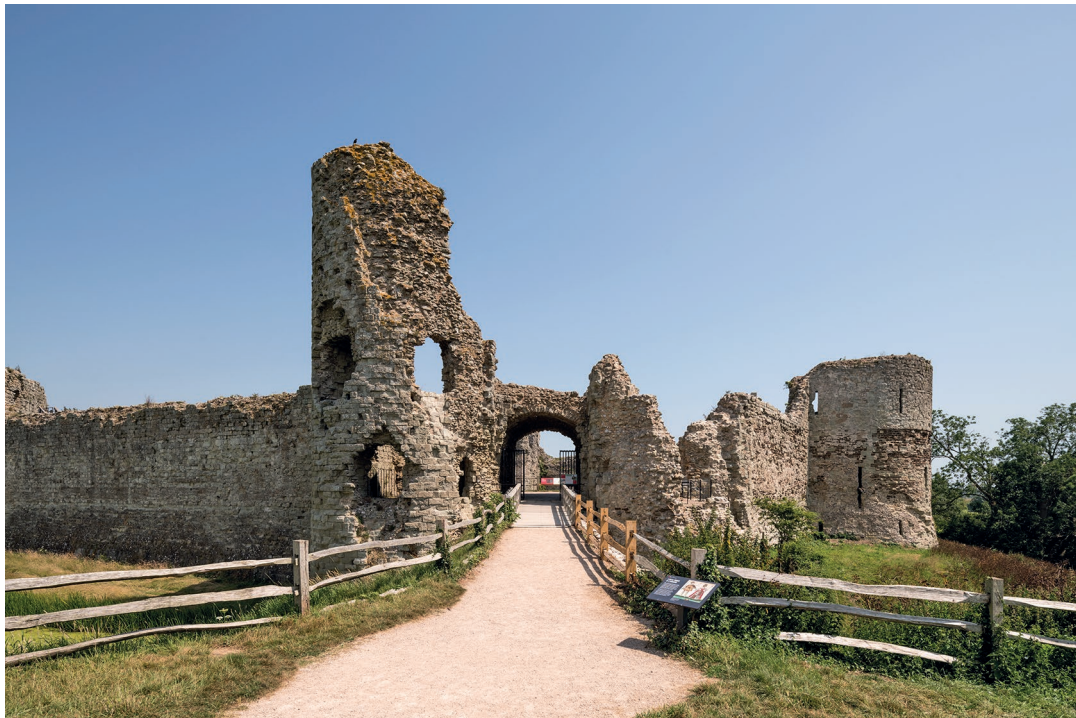
Fig. 7. Fortunately, some of the north turret of the gates survives showing Master Simon's work; unfortunately, much of the south turret does not. It is accordingly difficult to ascertain if there was a significant difference between the fabric of the upper parts of the two turrets. [DP236352] © Historic England Archive

A gate clearly existed by 1264–5 for the fortification to be able to resist the siege, but in 1288–9, a payment was made: 'For wages of 3 men carrying stones and mortar on to the top of the gate on their backs for lack of windlasses, from Michaelmas to All Saints' Day, four weeks and three days, 9s 0d (being 8d a week each)' (Salzmann 1906, 10). The accounts for the following year record that over 4,000 blocks of stone were acquired, and there was a payment of £17 17s. 8d. to Master Simon the Mason for building the north part of the gate (Salzmann 1906, 12). Interestingly, 4,000 blocks of stone appear to equate roughly with the number of stones required for the facing of the north tower,

each course consisting approximately of 50 blocks (Fig. 7).

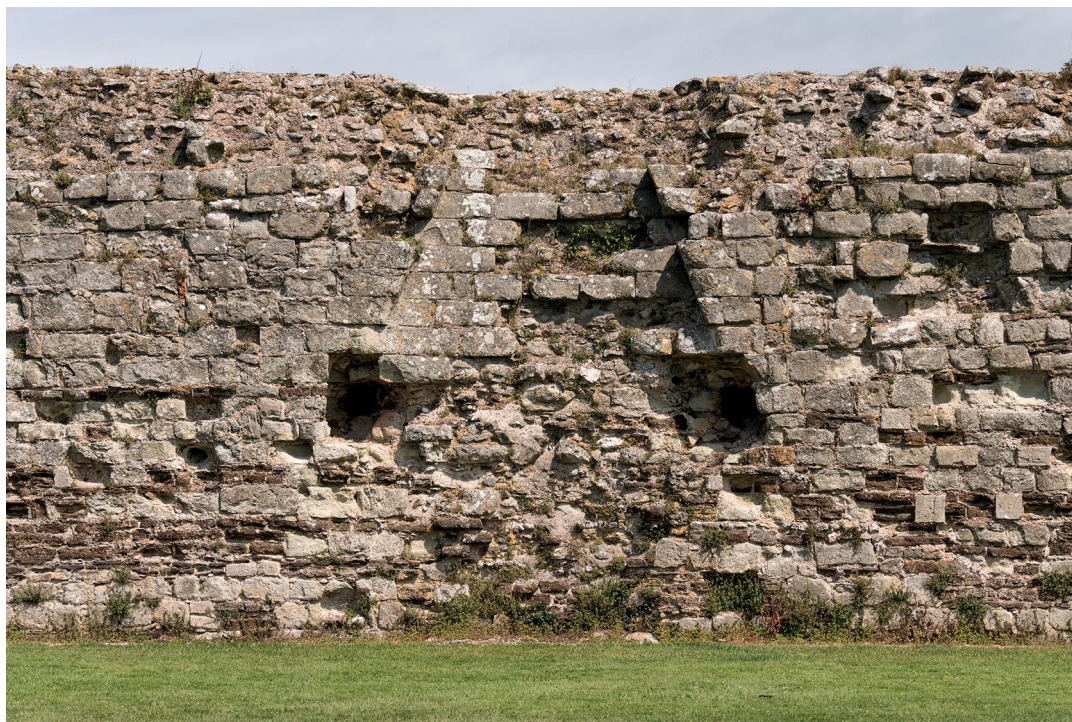
Fig. 9. One of the fireplace positions in the north wall of the medieval castle; the position of the fireplace is marked by the stonework for the back of the flue and the holes on either side where two corbels formerly supported the hood. [DP236430] © Historic England Archive

There is no evidence of any projecting stone canopies where fireplaces are located, but flanking each of the fireplace positions are large holes where stone corbels were once located to support timber and plaster hoods. One corbel that may have been associated with a fireplace may survive in the castle's north wall, amongst the plants adorning the wall beside the east tower. This once-common form of fire hood rarely survives in a building of high status, though it can be found in later, lower-status, vernacular houses (Wood 1985, 262). There are also several corbels set high up in the north and west walls, suggesting that there was a wall-walk around at least some of the perimeter of the inner bailey.

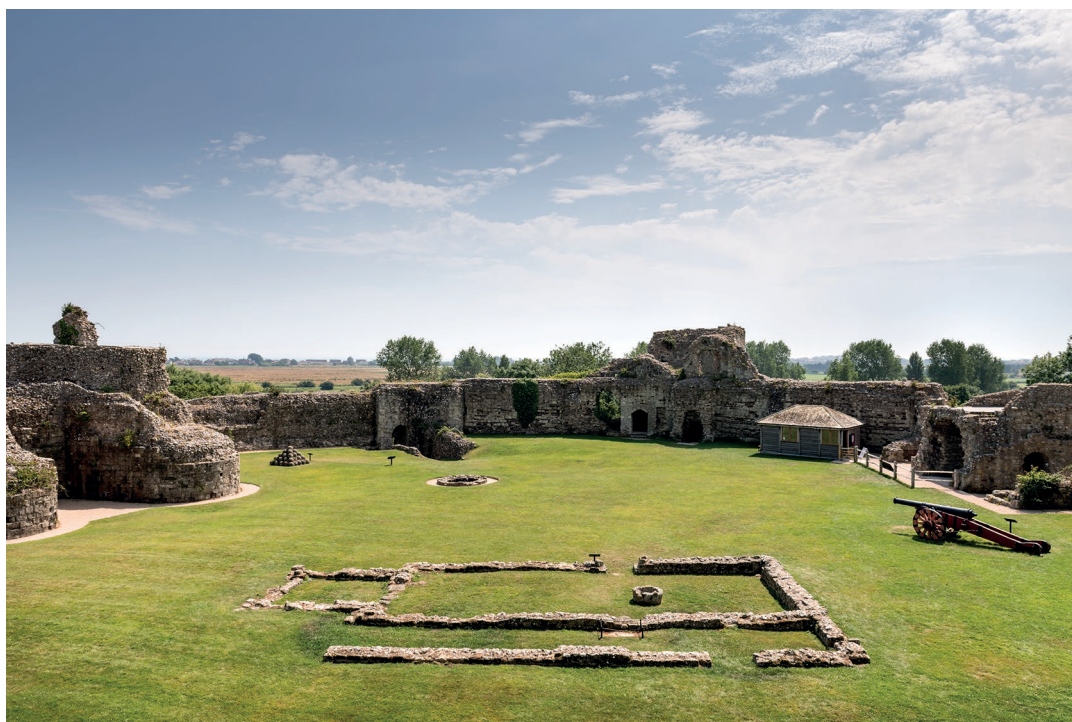
Fig. 10. In the centre of the medieval castle are footings for what may have been the small timber-framed chapel mentioned in 1302, rather than the ancient chapel moved to allow the construction of the castle. [DP236360] © Historic England Archive

The castle also had a chapel. Arnold Taylor has suggested that this chapel may date from before 1066 and that the simple footings in the centre of the castle may be remnants of this building (Taylor 1985, 238–40) (Fig. 10). As mentioned earlier, Peter of Savoy was granted permission by Richard de Wyche, Bishop of Chichester (1245–1253), to move the chapel built near the keep of Pevensey to another suitable site (Peers 1933, 6). The townspeople of Pevensey may have once used this chapel until the creation of the nearby parish church of St Nicholas in the early 13th century. The suggested pre-conquest chapel, said to have been near the keep, perhaps lay to the north, nearer the gate of the Roman fortification and in the way of the castle's development. A chapel is mentioned in 1275, 1276 and again in 1289–90; however, references suggest that this was a building or a room close to the hall or Queen's hall. This is confirmed by the 1306 survey of the fabric of the castle, which mentions repairs required to 'the Queen's chamber with a chapel and other chambers annexed' (Salzmann 1906, 17). However, in 1302, financial records itemise the materials, procedures and workforce employed to create a new timber-framed chapel (*ibid.*, 15). It is plausible that the footings for the chapel in the centre of the castle were associated with this project.

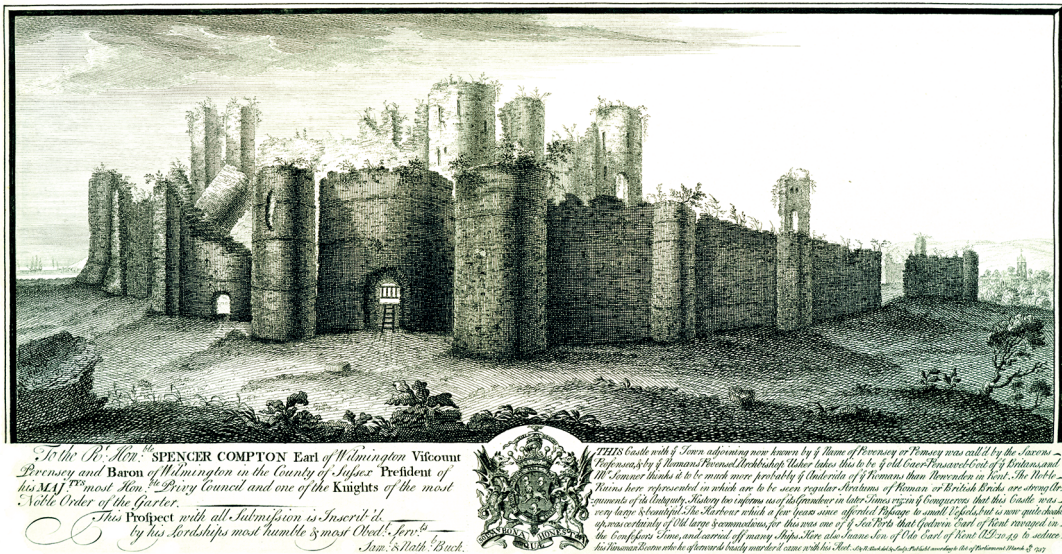
THE NORTH-EAST VIEW OF PEVENSEY-CASTLE, IN THE COUNTY OF SUSSEX.

Fig. 11. This engraving of 1737 by Samuel and Nathaniel Buck depicts Pevensey Castle, with the east gate of the Roman fort in the foreground and the medieval castle and the large earth mound over the base of the keep behind. [PLB\_N070820] © Historic England Archive

During the 18th and 19th centuries, the romantic ruin attracted many antiquaries and artists (Fig. 11). Among the dozens of published images was a bird's eye view based on a watercolour by Samuel Grimm (1733–94), which shows the earth mound covering the keep.
