**Erosion and Rolling Contact Wear Mechanisms in
Silicon Nitride Hybrid Bearings**

**A thesis submitted in partial fulfilment of the requirements of Bournemouth
University for the degree of Doctor of Philosophy**

Bournemouth University
In collaboration with
SKF Engineering and Research centre, The Netherlands.

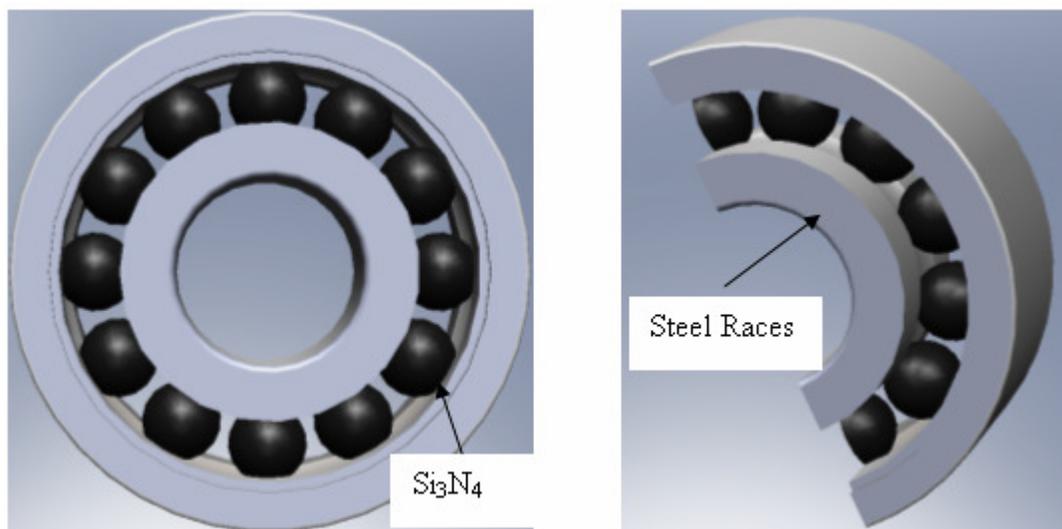
Fig: 1.1 Model of Hybrid bearing with steel races and Si_3N_4 balls.

their physical properties. For example, use of all-steel bearings for high temperature, corrosive and hostile environment, high speed and precision applications is not possible because of unsatisfactory performance. Ceramics and polymers can replace steel components in bearings and offer several advantageous over all-steel bearings. It is often said that “the most significant advance in ball bearings since the invention of bearings is the hybrid bearing”. Hybrid bearings have rings of steel and silicon nitride rolling elements as shown in Figure 1.1

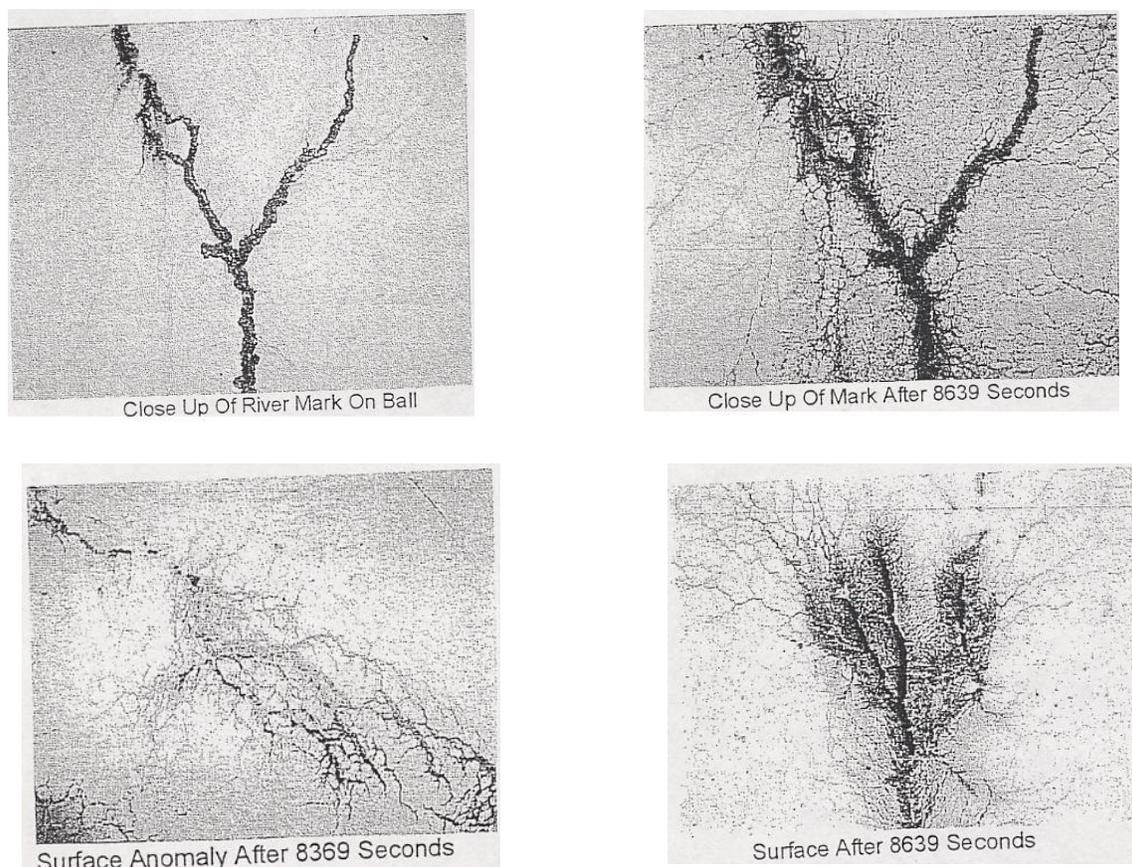
Fig: 1.2 River marks seen on silicon nitride balls and rollers run in cryogenic environments (Gibson 2000).

0.005mm. They ruled out the possibility of fracture as none was noted until then. They also found that river marks did not grow further, rather as smaller tributaries branched out from the main lines. They concluded that the surface anomaly that has been called as river marks exists on some silicon nitride balls and their effect on bearing life needed to be studied.

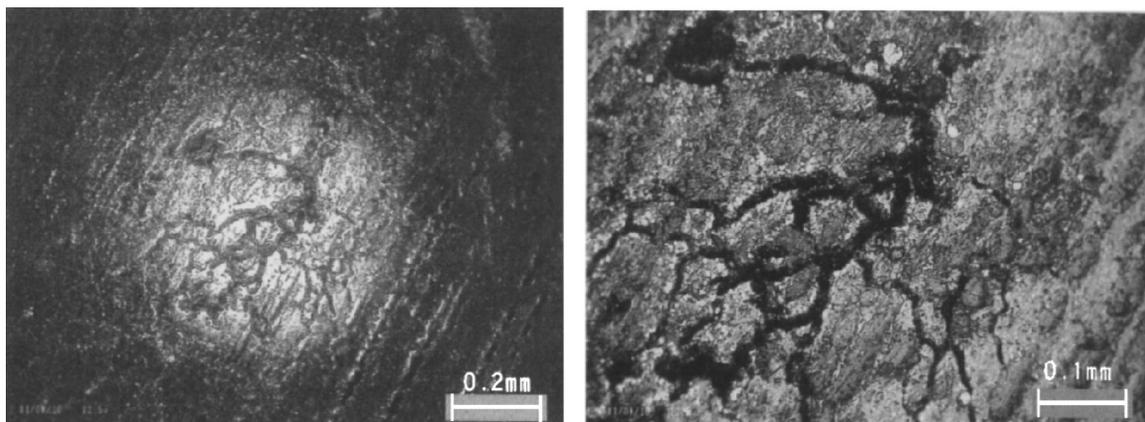
Fig: 1.3. Superficial micro cracks on silicon nitride balls (Nosaka et al 2004)

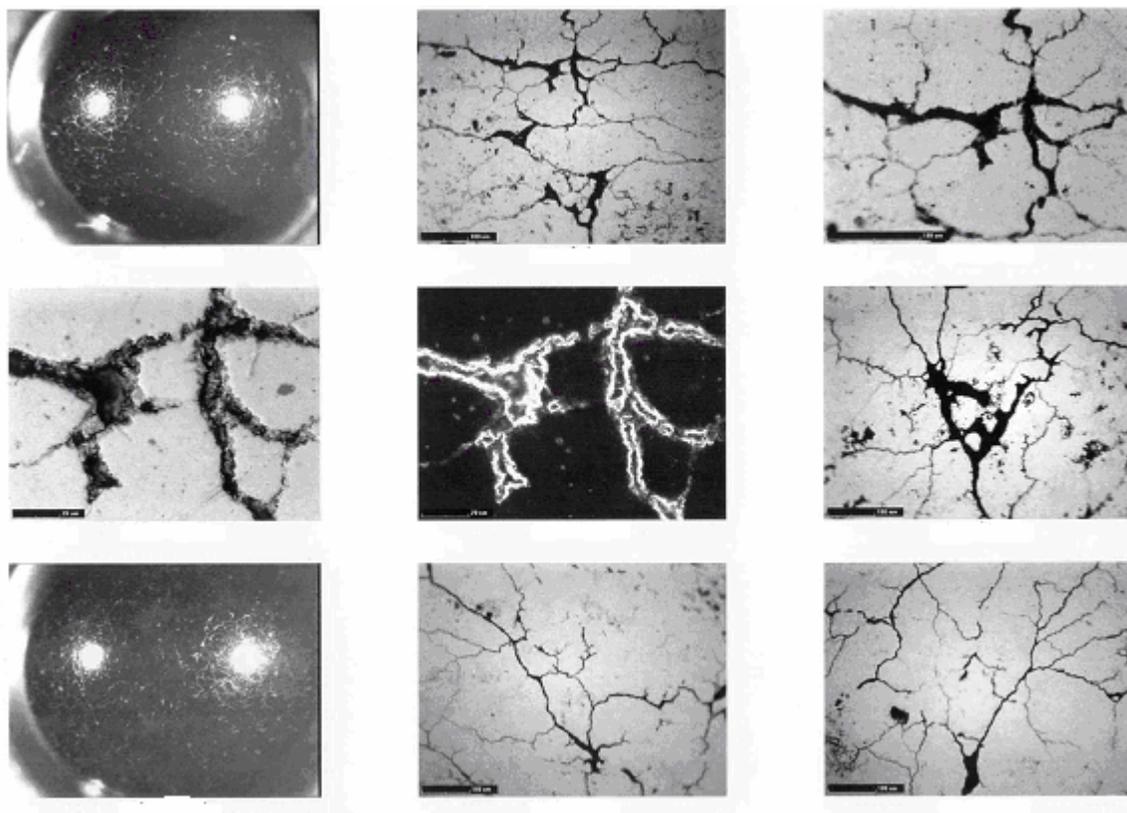
Fig: 1.4. River marks on Silicon nitride balls (SKF)

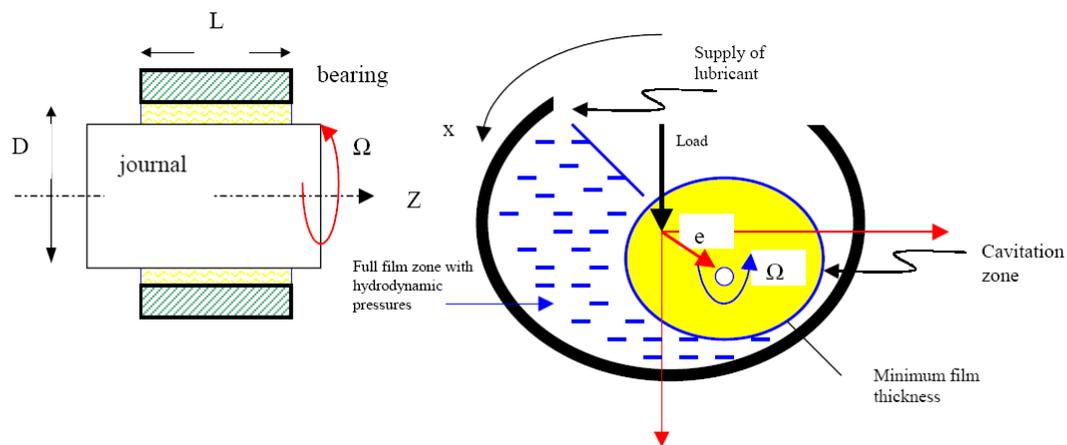
Fig: 1.6. Journal bearing showing lubricant cavitation zone (Andreas 2000).

regions in the bearing. When the film thickness increases locally at certain areas, the fluid pressure may drop below its vapour pressure and lead to release of dissolved gases which results in cavitation. The form of cavitation in bearings is due to the ventilation from the surrounding atmosphere or, as mentioned earlier, due to surface crevices. Figure 1.6 shows a lubricant cavitation in journal bearing. Cavitation in lubricant thin films can not only cause material damage due to erosion but also affect the load carrying capacity of bearings. Thus, cavitation effects on bearings and their stability have been extensively studied and are well documented in literature (Dowson 1974, 1979, Garner 1980, Berthe 1975, Hamrock 1994, Heshmat 1988)

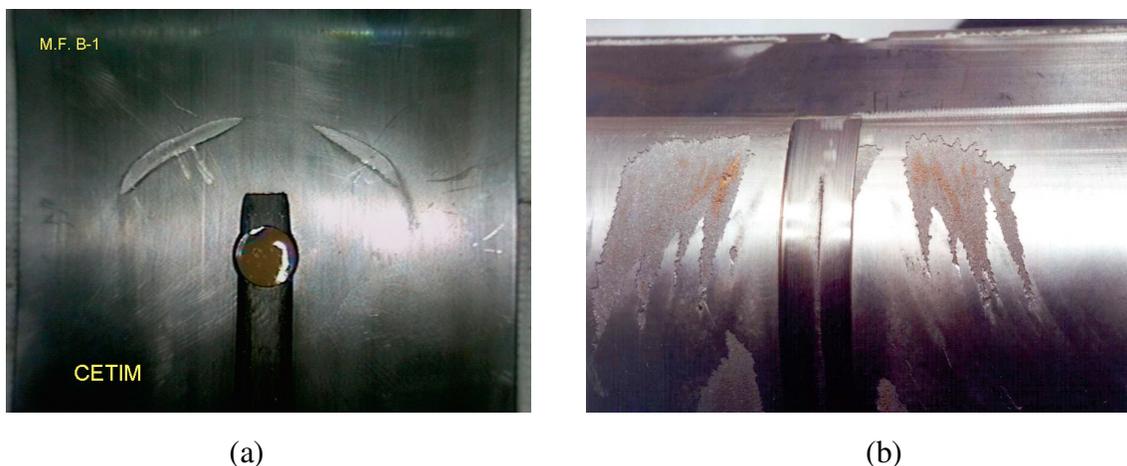
Fig: 1.7. (a) Cavitation erosion of diesel engine main bearing and (b) wear on hydrodynamic bearing surface (Chen 2005).

Gaseous or vaporous cavitation can occur in bearings depending on the steady or dynamic loading bearing conditions. Vapour cavitation in a dynamically loaded journal bearing was first recorded by Hamrock using high speed photography techniques (Jacobson 1983). The effect of shaft frequency on the cavitation formation and damage was also investigated and concluded that the increase in shaft frequency caused a delay in cavitation onset (Brewer 1987). Theoretical studies on cavitation in bearings are extensive and are well documented in literature (Elrod 1974, 1981, Floberg 1961, Zeiden 1989, Feng 1989, Vincent 1996, Rapposelli 2001). Due to variations in the speed, load and designs it is not always easy to identify the exact cause of cavitation. However, cavitation does occur and cause material damage thereby affecting the efficiency of the hydraulic structure. Below Figure 1.7 shows an example of damage caused by cavitation in bearings.

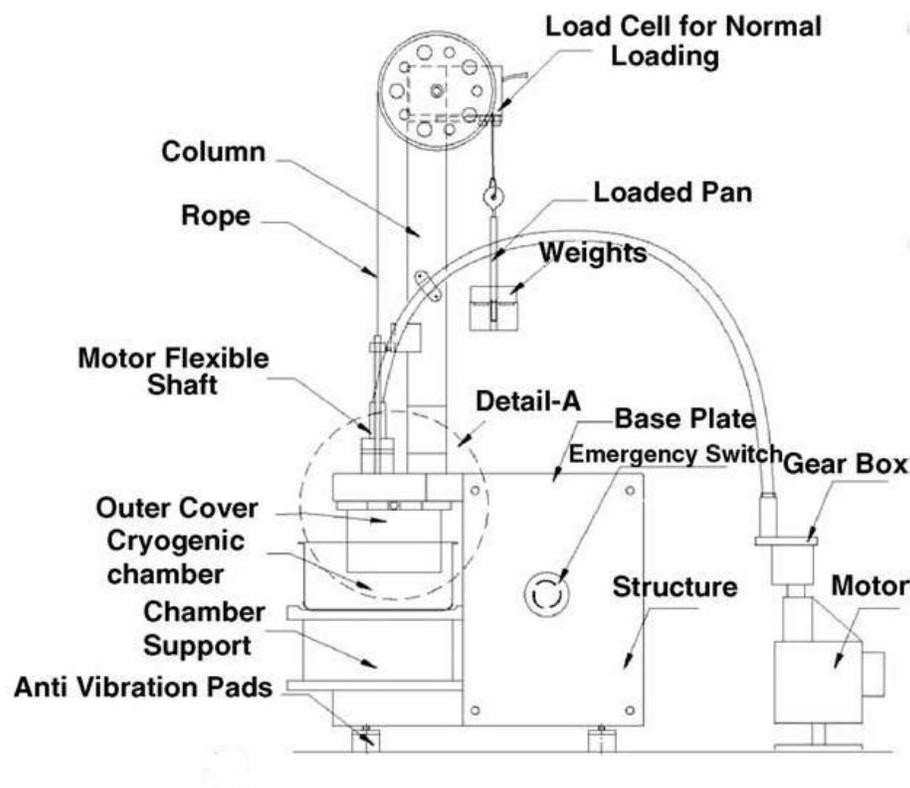
Fig: 1.11 A detailed description of ball-on-disk high speed cryo-tribometer.

notable features of their tribometer is the roller-on-disk and the ball bearing tester submerged in cryogenic fluids. This cryogenic tribometer can only be used to study friction and wear characteristics in sliding contacts and not rolling contacts. Also, their published results did not include ceramic materials but only steel. Tribological testing under these conditions is an important background for this project and hence it is worth reviewing their work. Figure 1.11 below show the design description of this tribometer.

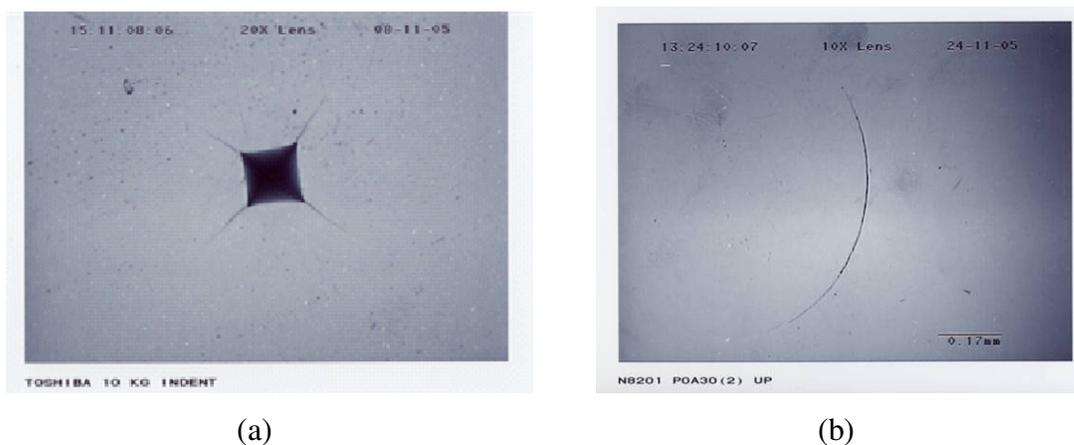
Fig: 2.4 (a) Vickers Indent and (b) Surface crack on test samples

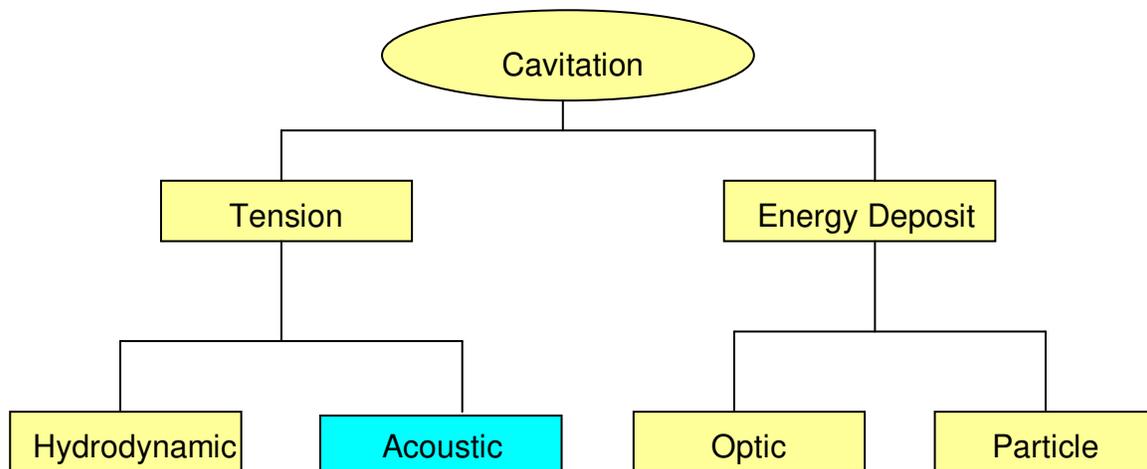
Fig: 2.5 Different Types of Cavitation - Redrawn from Reference (Gong 1999).

This initiation process can be accomplished by either creating tension or by depositing energy into the liquid. Applying tension is broadly classified into hydrodynamic and acoustic cavitation. The first one is the low frequency process and the later is a high frequency phenomena. Figure 2.5 shows the classification of different types of cavitation. The highlighted one in the Figure was used for this project.

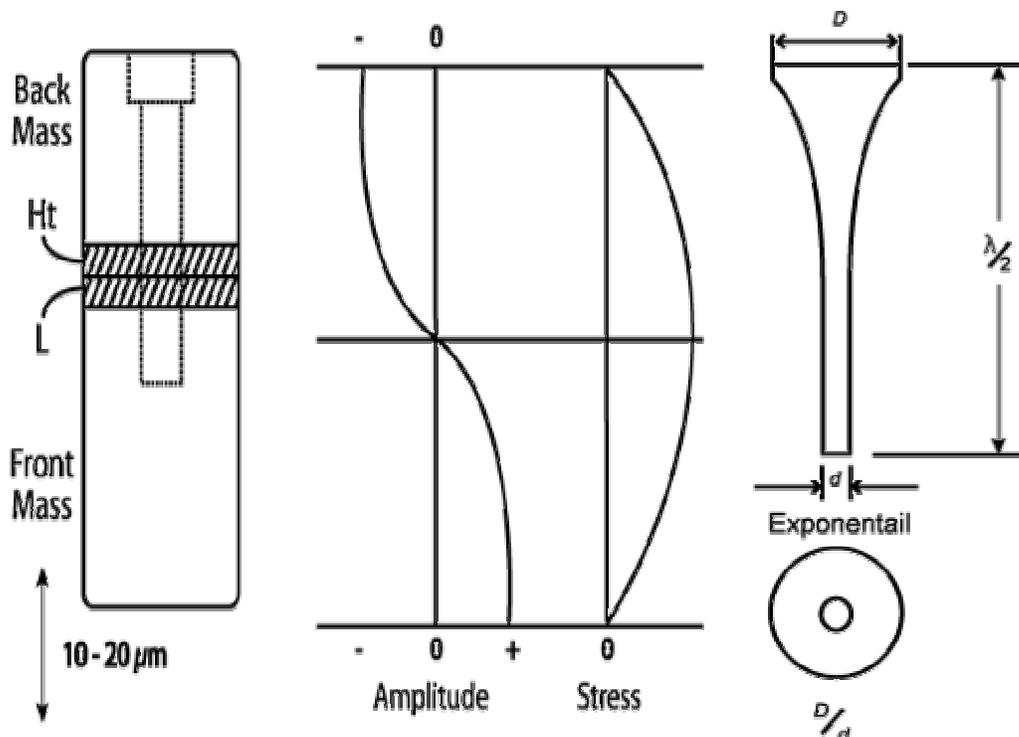
Fig: 2.6. Pre-stressed sandwich transducer - picture reproduced from Equipment supplier for this project (sonic systems, 2005).

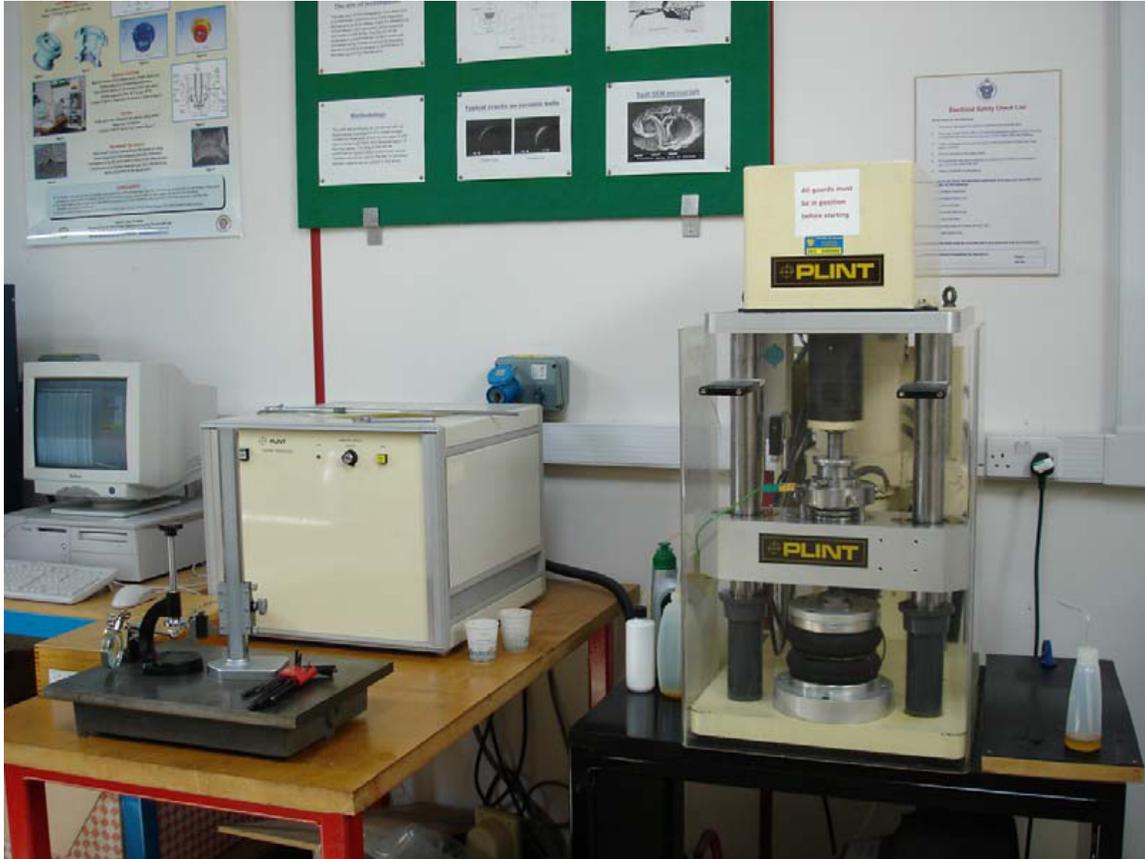
Fig: 2.9. Rolling contact fatigue test facility.

machine is very useful for rolling contact fatigue study of materials under different conditions (Wang 2000).

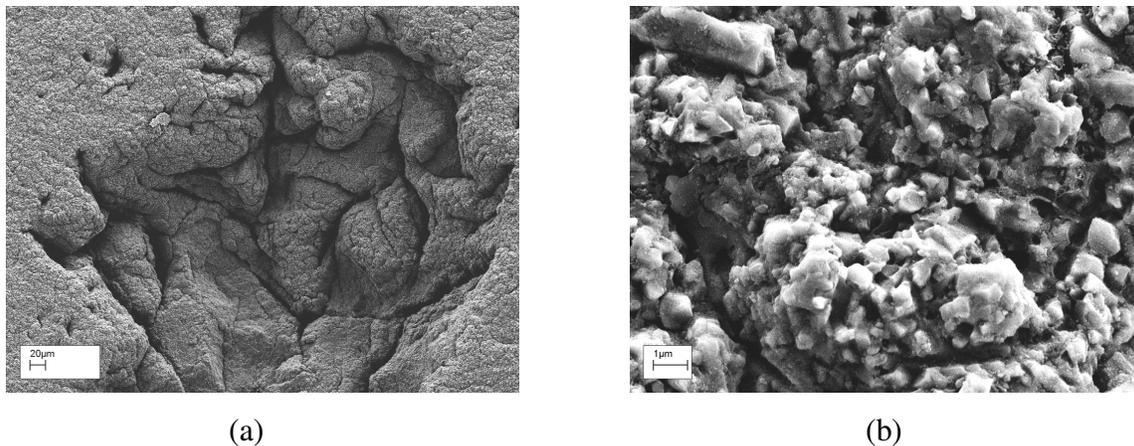
Fig: 2.13 (a) and (b) Scanning Electron Images of silicon nitride balls

Silicon Nitride is a poor conductor of electricity. If a sample of this material is used in SEM, it would result in charge build up in the sample, which will affect both the primary and secondary electrons and thus resulting in a very poor and distorted image. In order to avoid this, non-conductive samples set for SEM study are recommended to coat it with a conductive material. These silicon nitride balls were coated with a thin layer of gold in a sputter coater. Silicon nitride balls were fixed in a metal stud with a conductive adhesive, a silver paint was applied to the top of the ball connecting the metal stud to increase conductivity. This is then placed in the vacuum chamber of sputter coater beneath gold. Vacuum in the order of 0.1 millibar is achieved for a good coating. Argon is introduced into the chamber after 20 seconds along with voltage across gold and silicon nitride. This applied voltage produces argon ions which bombard and remove atoms of gold which then stick to the silicon nitride ball placed beneath it. The time of deposition was selected by experience and found that excellent film thickness is achieved for 5 minutes coating. Figure 2.13 (a) and (b) show images obtained in SEM.

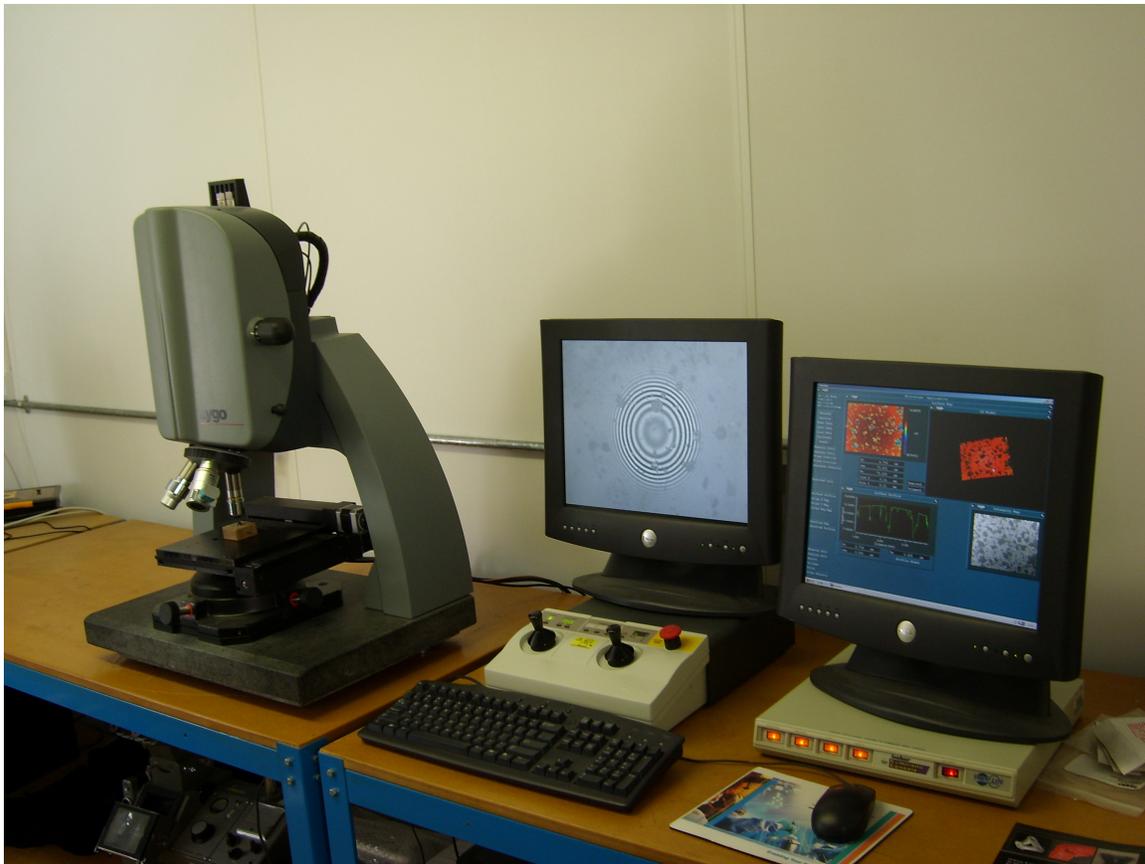
Fig: 2.15 3D Optical Profilometer

Erosion results in severe mechanical degradation of materials. Understanding the surface changes for each test intervals is necessary. A 3-D surface mapping non-contact optical profiler was used to accurately measure the surface roughness, depth of cavitation pits, step heights, angle measurements, and volume loss. This system is based on the principle of white light scanning interferometry, and is capable of mapping ten millimetres wide area in a single measurement with sub-nanometre resolution, providing instantaneous information about surface roughness, shape and waviness. When larger areas need to be measured, a stitching procedure can be employed, in which a number of partially overlapping measurements are combined into one surface profile. This device splits a beam of light into two separate beams and then recombines them to create bright and dark bands called fringes that make up the interferogram. This interferogram carries a wealth of information about the profile of an object under test and its material characteristics. A CCD detector registers this information and forwards it to the computer. A picture of this system is shown in Figure 2.15

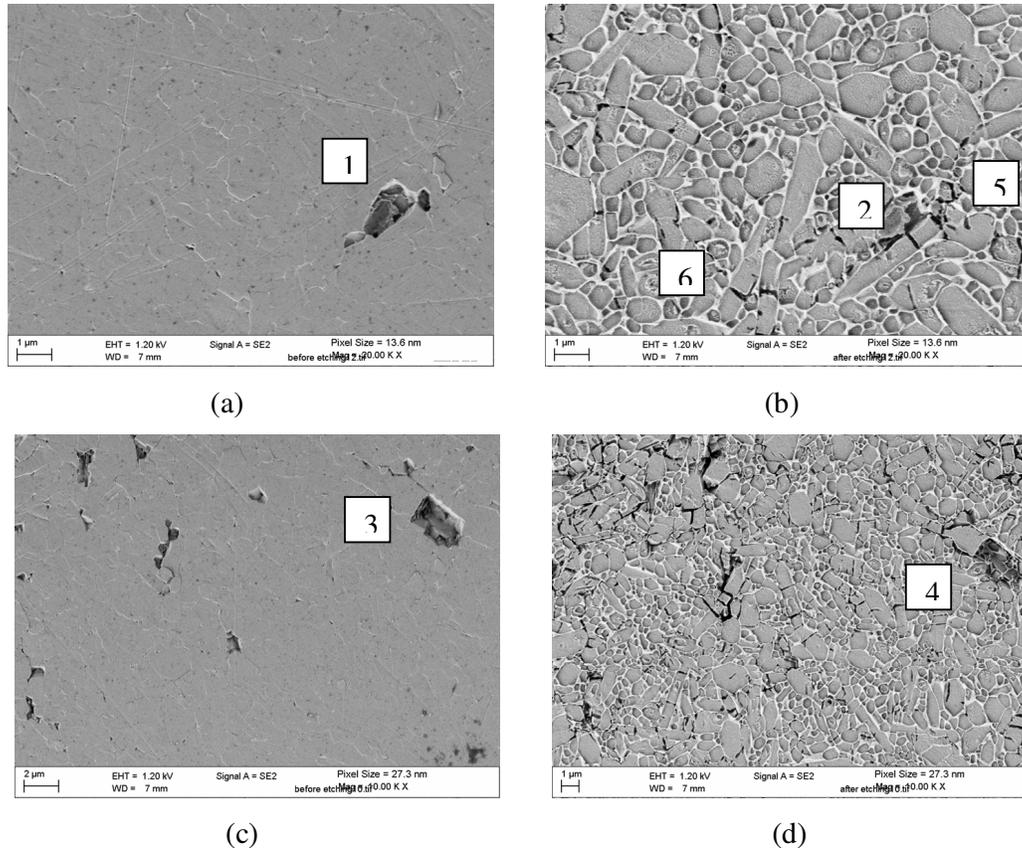
Fig: 3.2 (a) Before etched SEM image of material C showing Transgranular fracture after 10 minutes and (b) after etching (c) Before etched SEM image of material C showing fractured grain after 10 minutes and (d) after etching

Silicon nitride being a strong covalent bonded material undergoes very little plastic deformation. The only way to relieve the imposed stress due to cyclic cavity collapse is by nucleating cracks which is responsible for this irreversible microscopic deformation. The intensity of the cavity collapse must be very high to crack a grain, but at this stage it did not seem to be enough to fracture smaller grains. In material C as shown in Figure 3.2 coarse and elongated grains are the ones which fracture during this stage. The finer grains showed excellent resistance. As marked as 1 and 2 in the Figure 3.2 show an elongated grain been sliced off, clearly showing transgranular fracture.

Figures 3.2 (c) and (d) show half of coarse grain displaced which constitutes that the transgranular fracture did not propagate further in to the grain boundary or to the adjacent grain. This displacement of half grain can be justified by the presence of very fine surrounding grains as marked as number 4 in Figure 3.2 (d). This clarifies that very fine microstructure in silicon nitride can provide high resistance to cavitation especially to grain fracture compared to the microstructure with coarse and elongated grains. The marked areas near numbers 5 and 6 show fracture crack propagating to the adjacent grains. At number 5, two large elongated grains share a common boundary and the fracture initiated and propagated through to the other. Whereas, near the marked number 6 a fine non-elongated grain between the two large elongated grains resist fracturing.

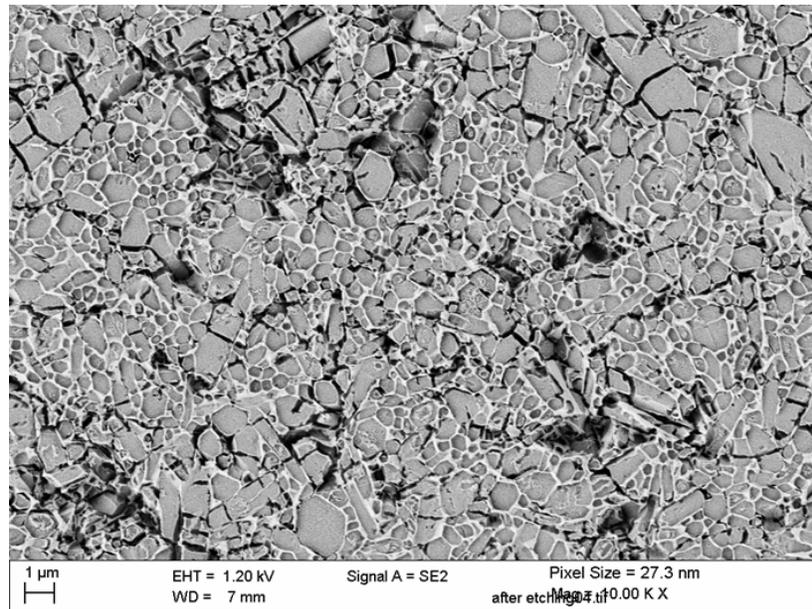
Fig: 3.3 Material B showing advanced stages of Transgranular fracture after 10 minutes of testing

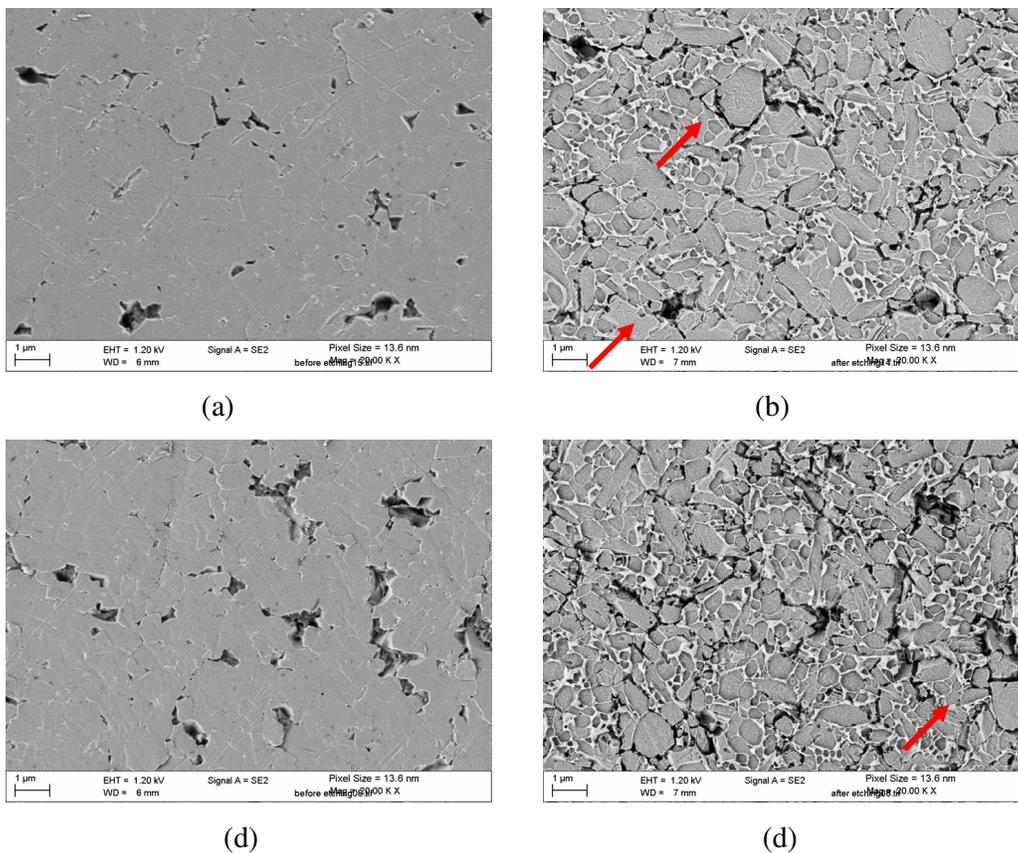
Fig: 3.9 SEM and plasma etched Material B with initial pores next to coarser grains

The intergranular fracture in material B was found predominately near the coarser grains. Grain boundary region adjacent very fine regions showed no damage at this stage as shown in Figure 3.9. As seen in these Figures, the fracture formations are only at the regions where the volume of coarse grains is high. These initially formed fracture zones propagate by linking up and provide home for bubble nuclei, which encourage continued erosion in the formation permanent strain. In many cases, the test samples showed both Trans and intergranular fracture as the beginning stages of erosion. This can be seen in Figure 3.9 (b) where no grain fracture is seen but only fracture at the grain boundaries.

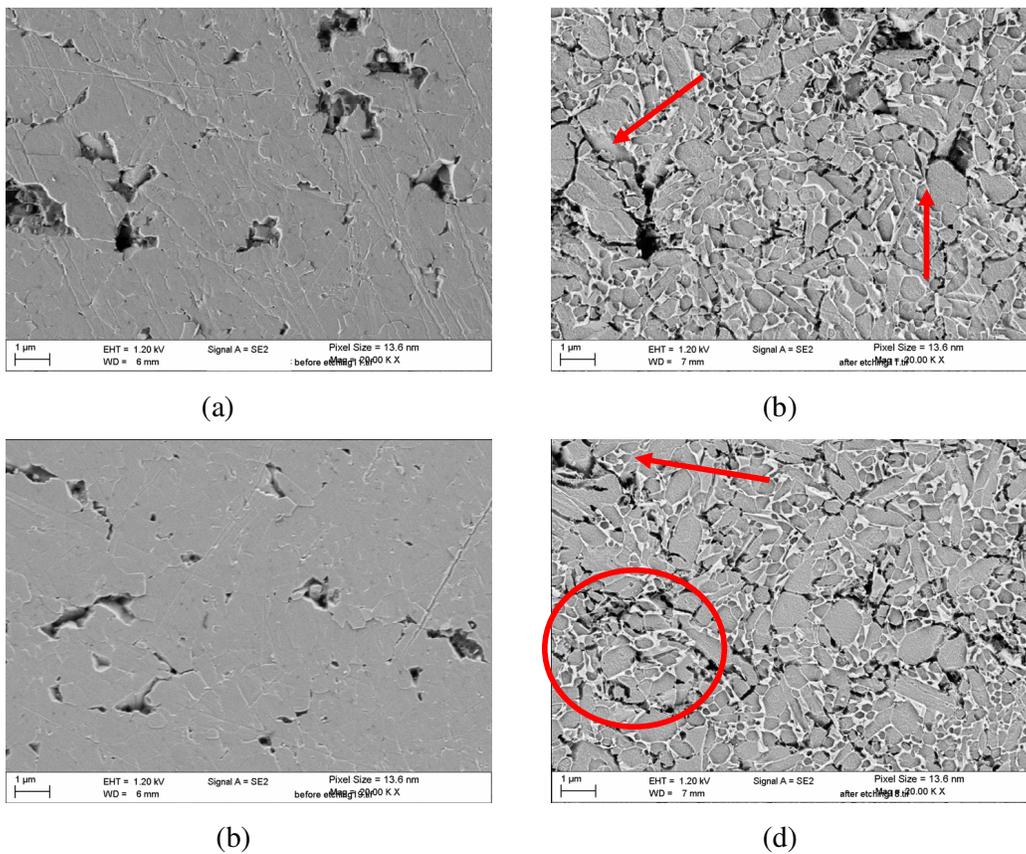
Fig: 3.11 (a) and (b) show SEM an etched image of intergranular fracture surrounding a large grain. (c) and (d) show pore formation circling a bunch of small grains.

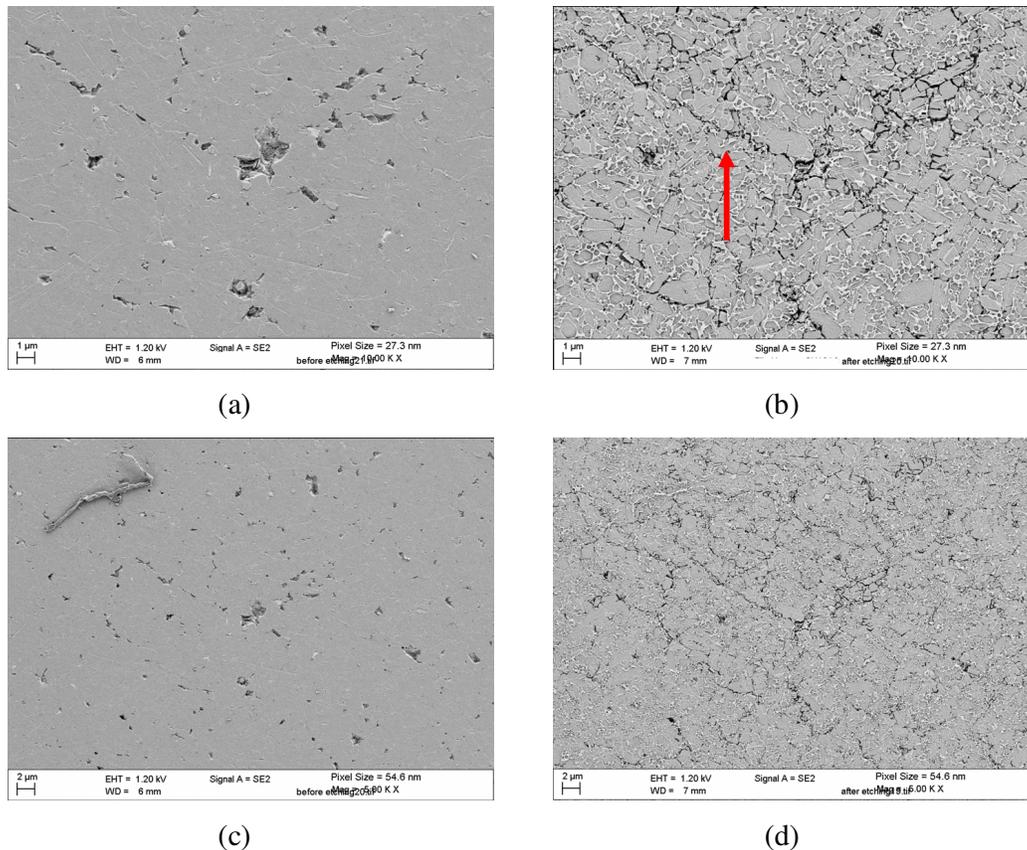
Fig: 3.12 Micro crack formations at microstructure on material B at different scales.

The immediate stage which follows trans and intergranular fracture is the formation of micro cracks with lengths ranging in the order of sub microns to few microns. The main reason for the formation of these micro cracks is linking up pores at the grain boundary region. Cracks opened up along the grain boundary region as a sign of intergranular fracture. It is clear from the pores, that the micro void nucleation due to grain diffusion is the major reason for intergranular fracture. The initial and progression of these micro cracks can only be studied at the microstructure level. Hence it is important to etch the test sample to reveal their microstructure after relevant test intervals. The difficulty in monitoring the propagation or the growth of these cracks is that once the test sample is etched cavitation tests cannot be continued on the sample. Some light polishing techniques must be employed to clear away the coated surface but this will also damage the erosion marks. Due to this difficulty, micro cracks on different samples after different test intervals were considered to understand this mechanism.

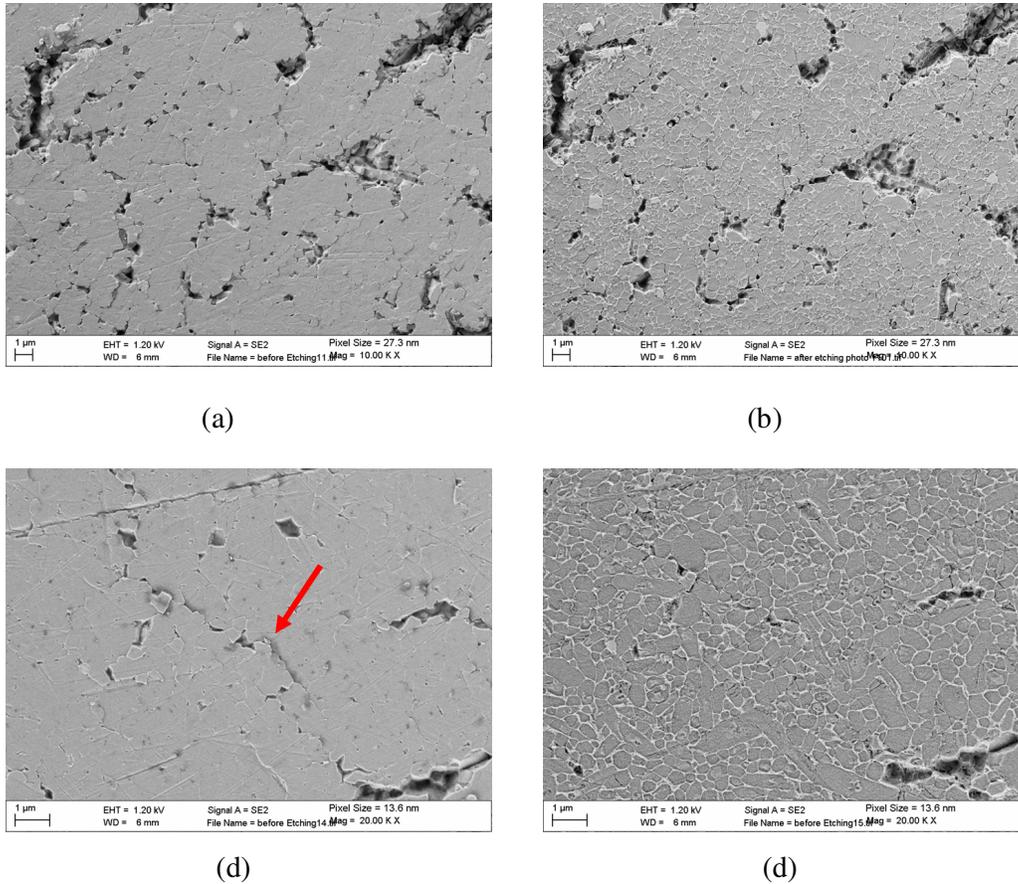
Fig: 3.13 (a) and (b) Broader cracks in material A. (c) and (d) micro cracks propagating in material A

Micro cracks which appeared in all these three materials tested were not similar. This is mainly due to their variation in micro structure and boundary phase composition. Material B shown in the above Figure 3.12 show thin elongated cracks whereas in material A these cracks were also very short but they were broader which is shown in Figure 3.13. Surface investigations on these micro cracks clearly showed that they were not initiated at a single location, but initiated at multiple locations. This is due to the linking of pores. Once a micro void or pore is formed, and upon further exposure to cavitation these pores enlarge and extend to the adjacent pore to link up. Removal of a grain or grains retards the growth of these cracks as shown in Figure 3.13 (a) and (b).

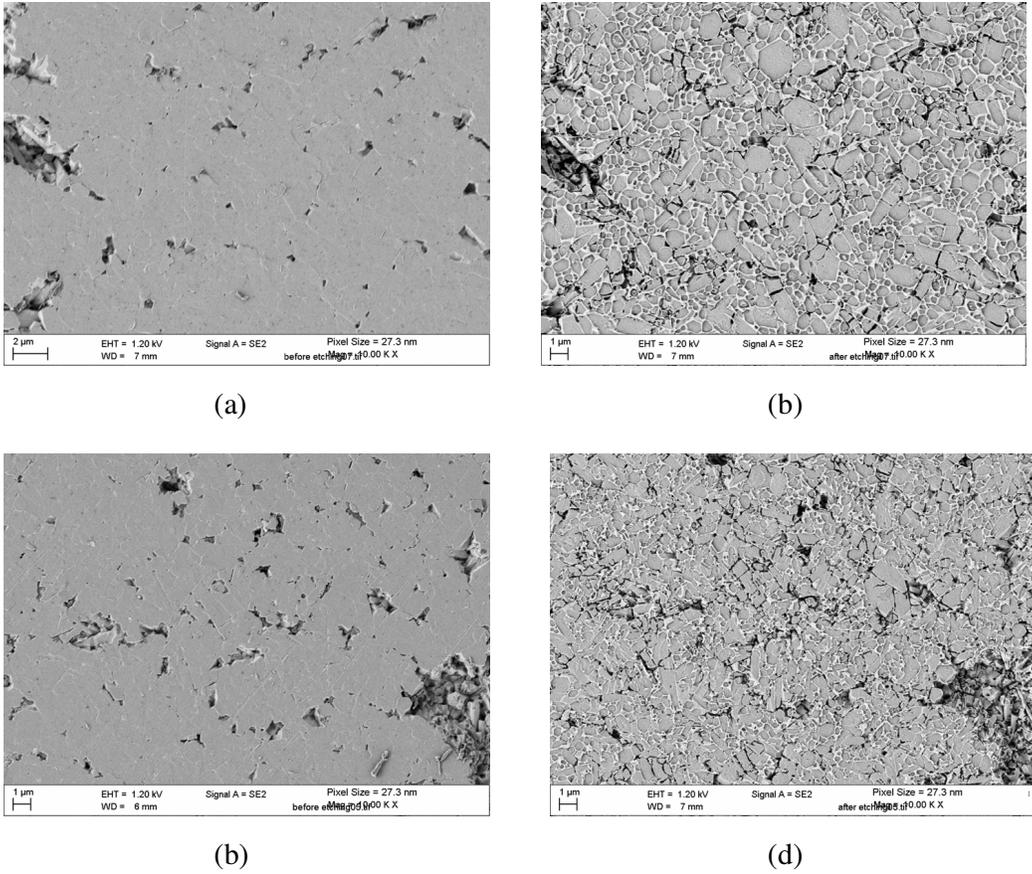
Fig: 3.18 Erosion pit inception in material B

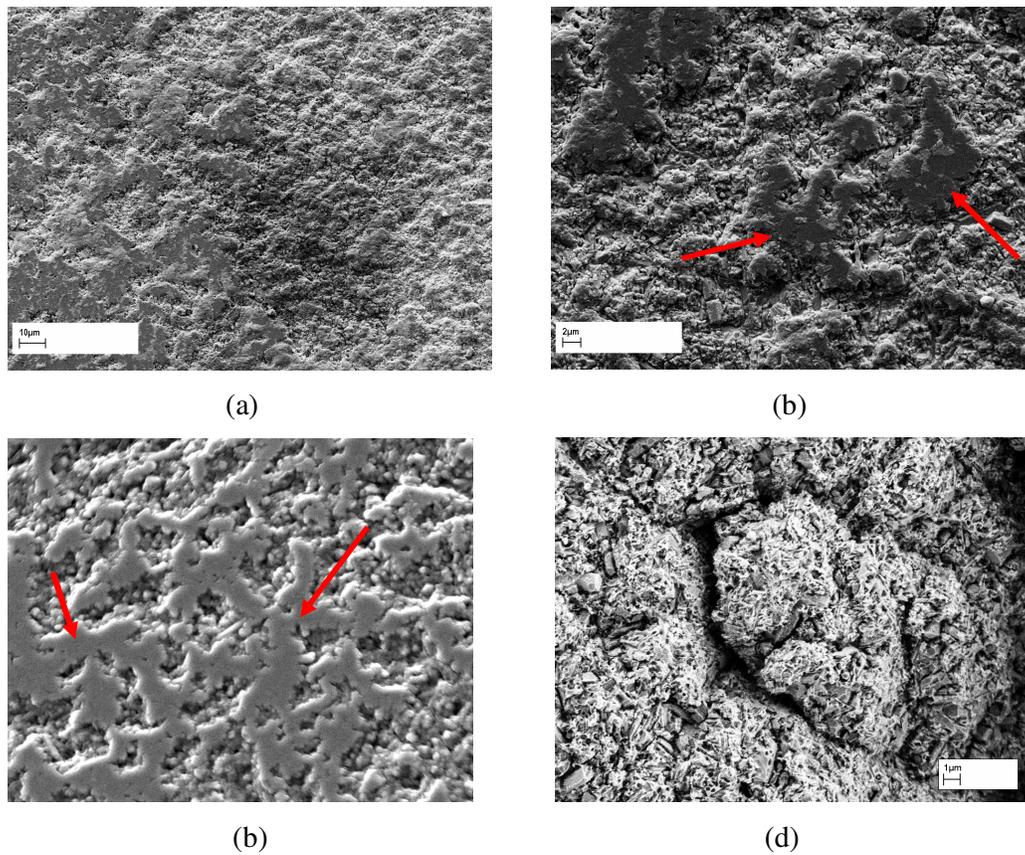
Fig: 3.30 SEM images of final stages of erosion pit growth

Further stages of erosion pit growth showed almost all pits at the centre region of the test specimen were joined together. This showed the severity of the wear and huge material loss was observed until this stage. High magnifications of this advanced stages of erosion pit growth is shown in Figure 3.29 above. As seen in these Figures, it becomes very hard to differentiate the pit from the other wear region. Almost all pits were transformed to a very rough surface. Microscope images during this stage are shown in Figure 3.30. As shown in Figure 3.30 (a) only a rough surface is visible without any notable erosion pits. Further exposure to cavitation resulted in accumulation of surface layers without any pit formation. This stage showed that no more erosion pitting was possible and the material removal was only by means of displacing surface layers from this area. As marked in Figure 3.30 (b) and (c) the surface layer remained at few areas. Some pits were transformed to large craters as shown in Figure 3.30 (d).

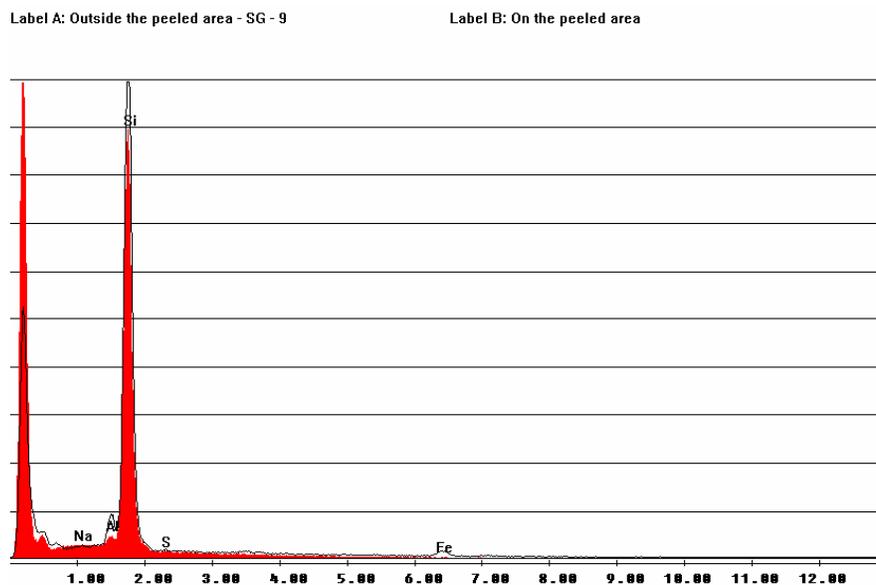
Fig: 3.33 EDAX spectra of wear sheet on material B

Wear sheets lead to a major material loss. EDAX chemical analysis to determine the composition on this wear sheet area was carried out. The result is shown in Figure 3.33. The red area shows the composition inside the wear sheet or the peeled off area and the black line show the composition on the surface outside this wear sheet. Loss of Aluminum and Iron can be seen which are used as sintering additives for this material as Alumina and Iron oxide. This composition change however does not explain the process of wear sheet formation.

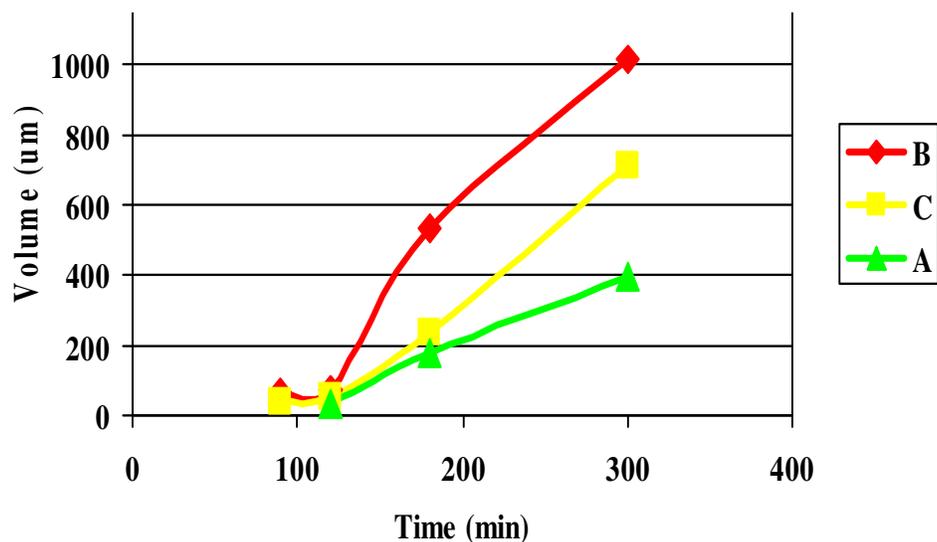
Fig: 3.38 Volume loss measurements over time

The rate of erosion is normally calculated by measuring the mass loss after each test interval. Silicon nitride being a low dense material, a very precise measuring balance with microgram accuracy is required to get accurate mass loss measurements. Another way of calculating the rate of erosion is using volume loss measurements. This was done with the same 3D interferometry technique by calculating the net missing volume, the method which was reported by Miyoshi and Patella (Miyoshi 2003, Patella 2000) and the results are shown in Figure 3.38 which confirms the test material rankings against cavitation.

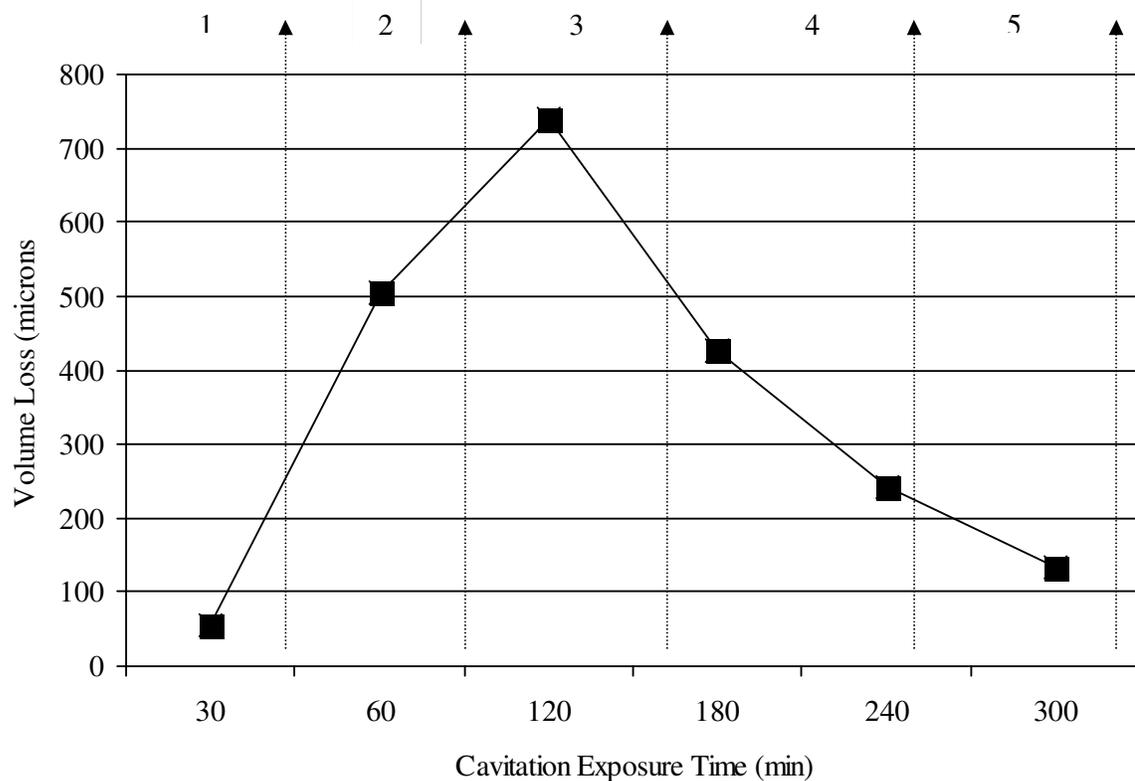
Fig: 3.43. Different stages of cavitation erosion in silicon nitride

Surface investigations on eroded samples revealed the nature of failure to be brittle fracture in silicon nitride as discussed in section 3.1. It was shown that micro cracks generated and propagated during the early stages of erosion. It is well known that brittle fracture requires crack initiation and propagation and thus consumes some time before failure. Also the energy released during cavity collapse is observed by the material. This impact energy absorbing capability of the material is another reason for incubation period during erosion. The testing conditions are one of the primary reasons which vary this incubation period by varying the impact cyclic pressure. This scenario was investigated and is presented in section 3.7.1. Using the high powered transducer with amplitude of vibration 60 microns peak to peak had a very short incubation period of 3 minutes compared to 40 minutes by low powered transducer which operates at amplitude of 16 microns peak to peak. Different stages of erosion as tested with high powered transducer with reduced amplitude of 25 micron peak-peak amplitude are shown in Figure 3.43 below. This power reduction was used for these long run tests mainly to avoid damaging the transducer by cavitation.

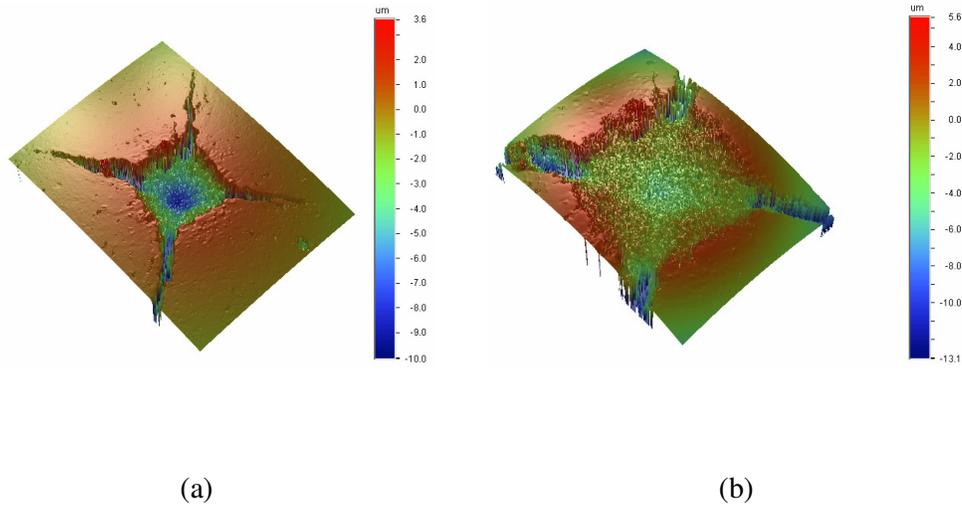
Fig: 3.50. (a) and (b) Eroded Indent after 240 minutes.

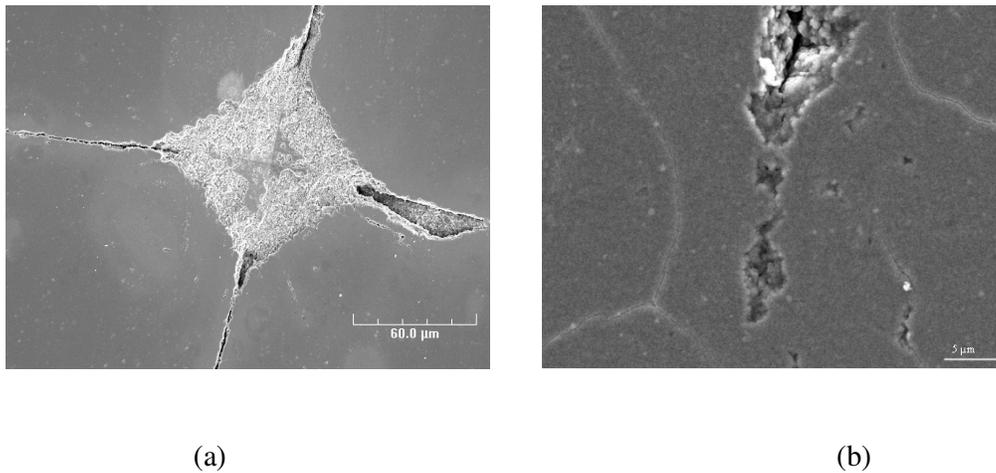
Fig: 3.51 (a) SEM images of Indent eroded after 60 minutes and (b) visible cracks
