**Erosion and Rolling Contact Wear Mechanisms in
Silicon Nitride Hybrid Bearings**

**A thesis submitted in partial fulfilment of the requirements of Bournemouth
University for the degree of Doctor of Philosophy**

Bournemouth University
In collaboration with
SKF Engineering and Research centre, The Netherlands.

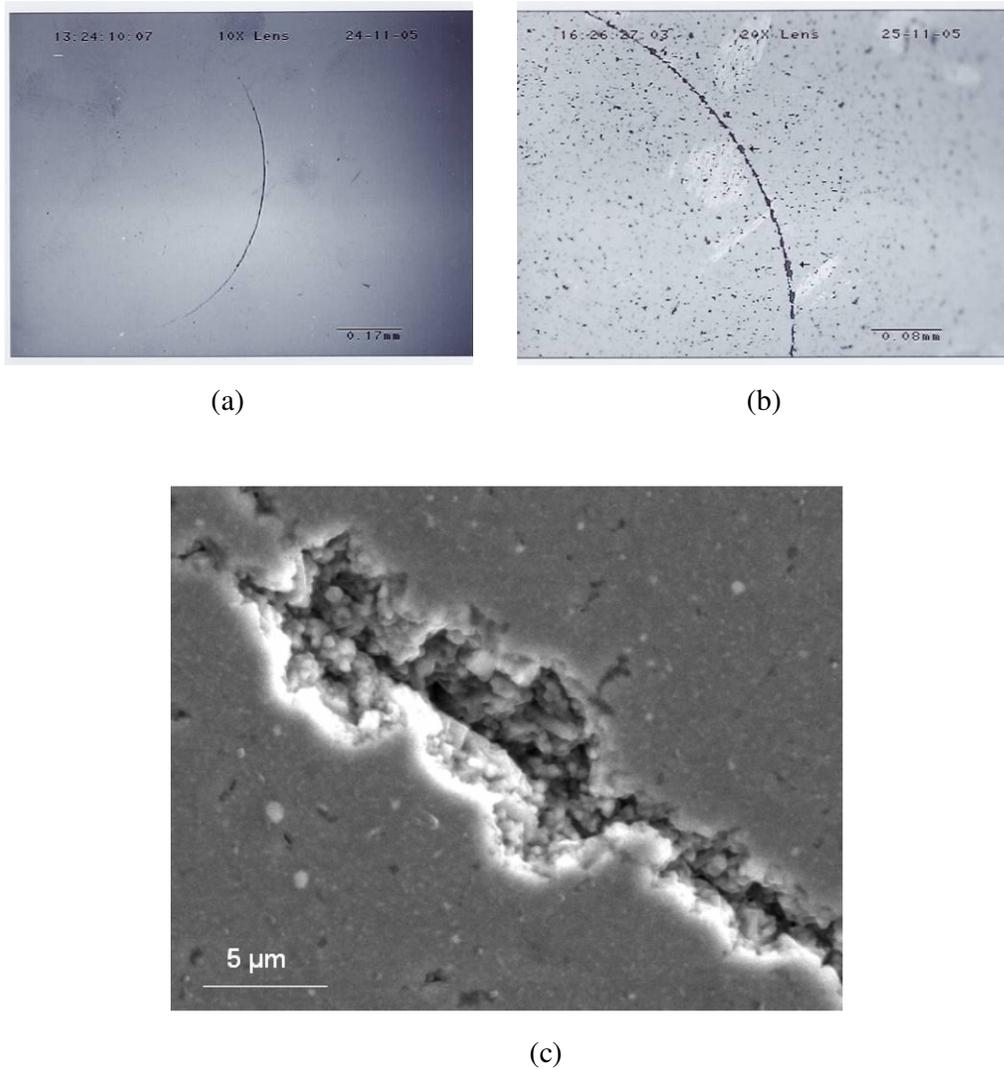
Fig: 3.54 Surface crack (a) Light Microscope image of crack before testing, (b) after 2 hrs of erosion testing and (c) SEM image of eroded crack.

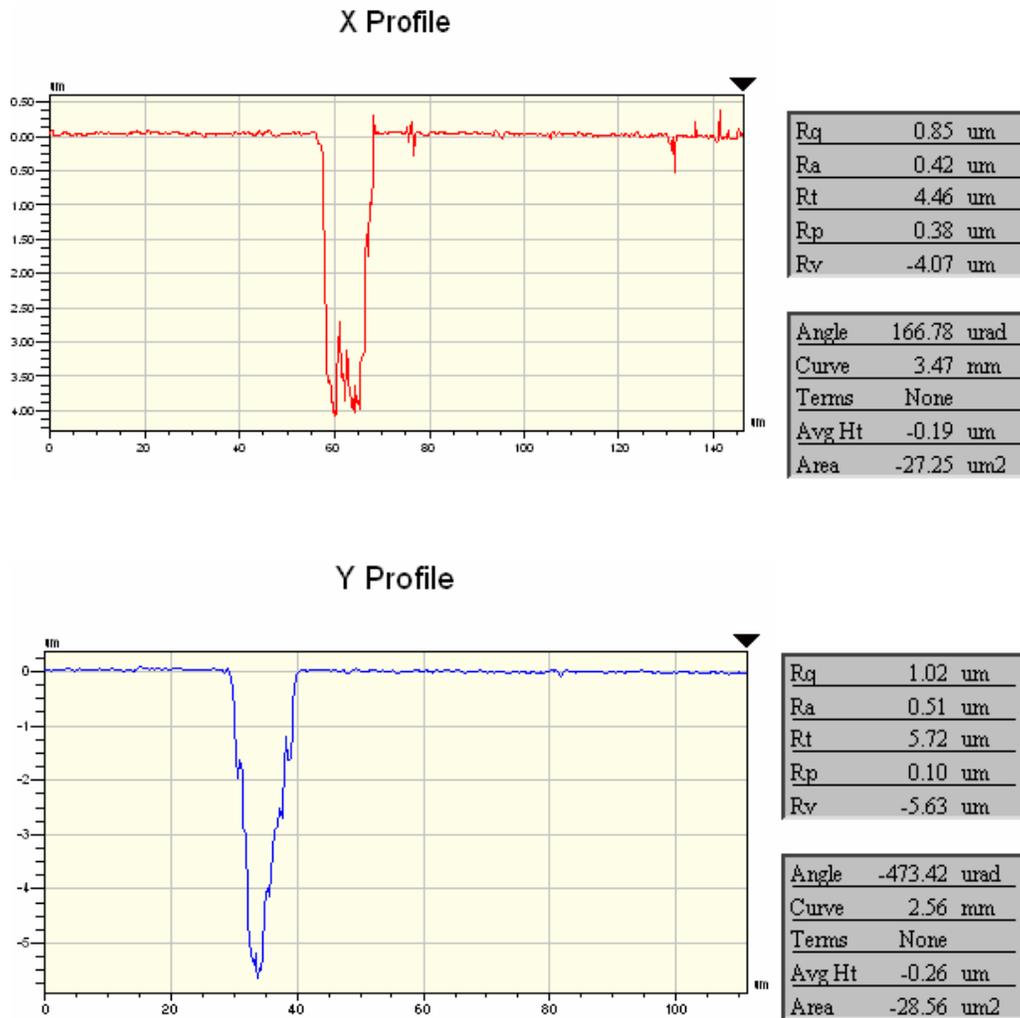
Fig: 3.57. Surface profilometer measurements on the STAR defect.

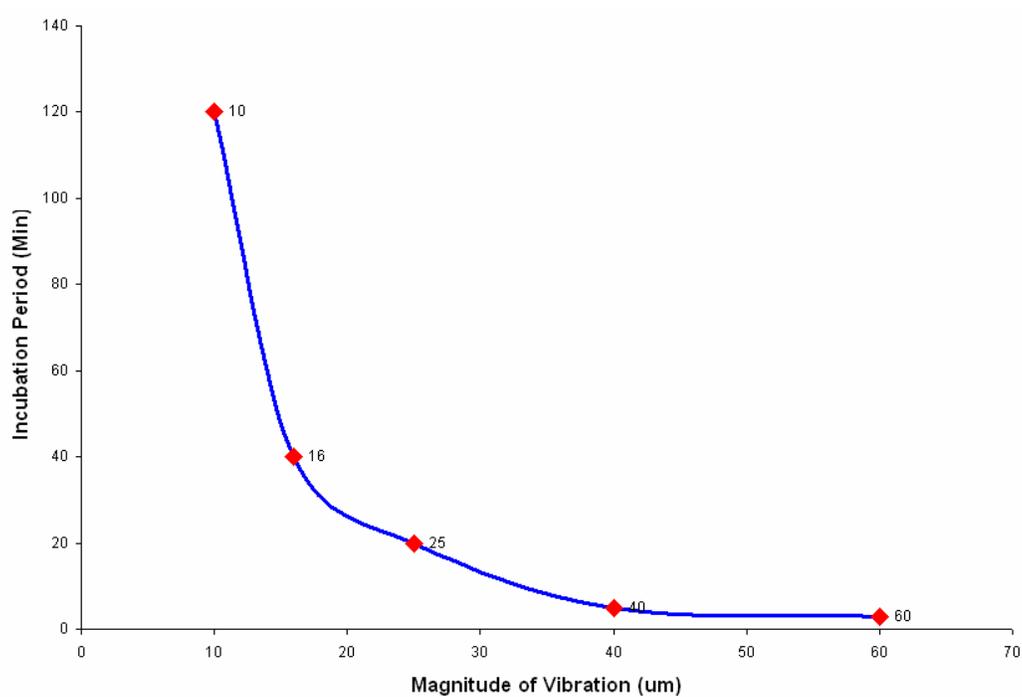
Fig: 3.58. Influence of Vibration amplitude on erosive wear

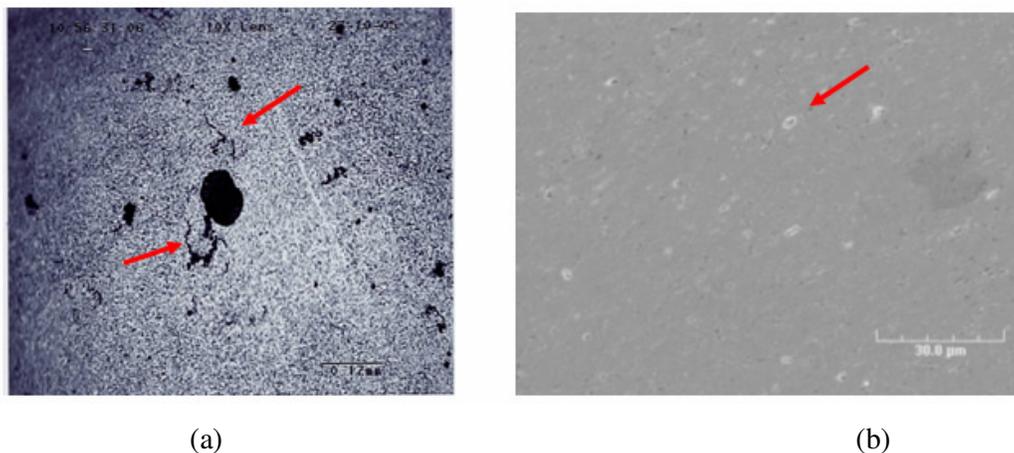
Fig: 3.60 (a) and (b) Light and scanning electron microscope images of erosion initiation in bearing steel.

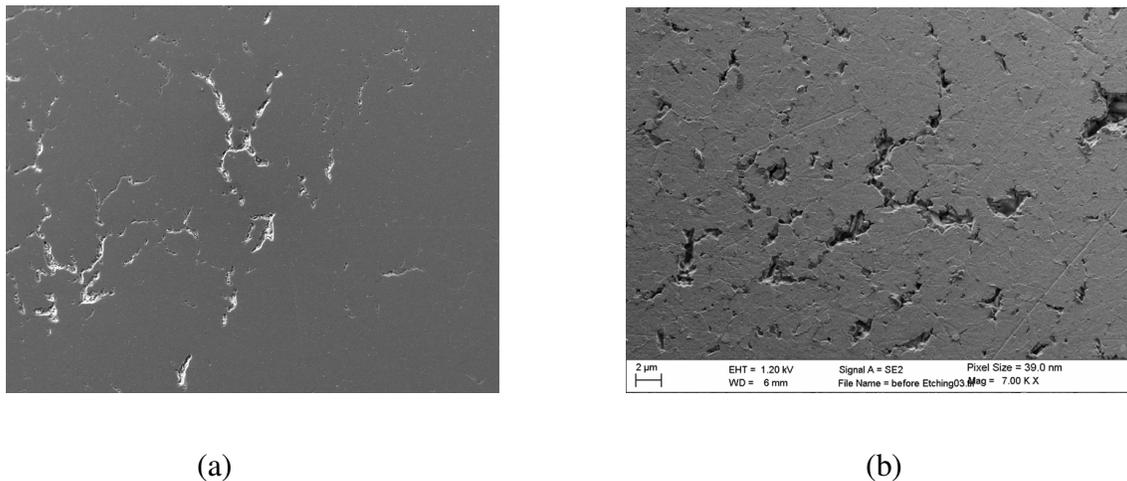
Fig: 4.2 (a) River marks in application balls (SKF Unpublished) and (b) Erosion marks obtained in laboratory.

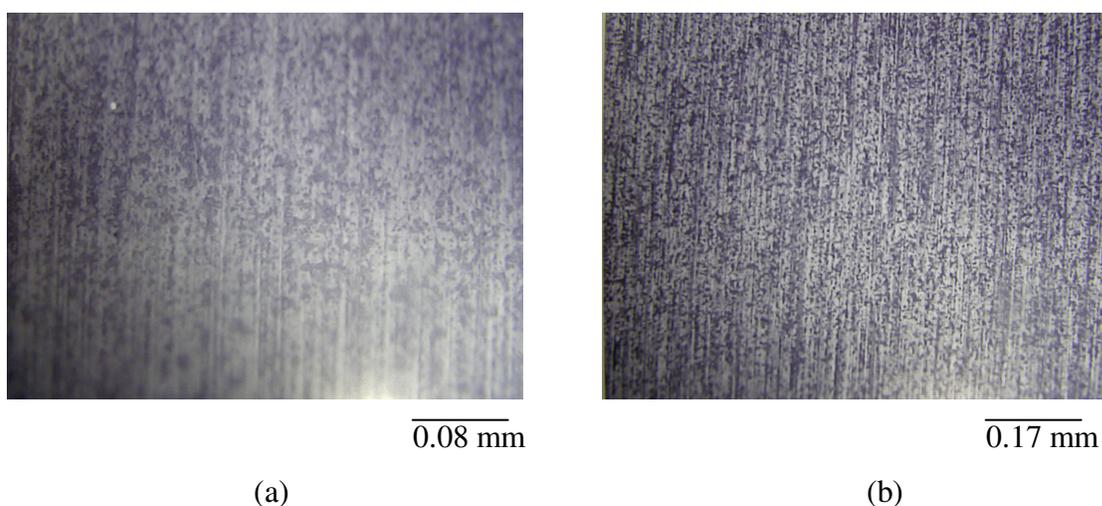
Fig: 4.4 Eroded rotating specimen at various magnifications

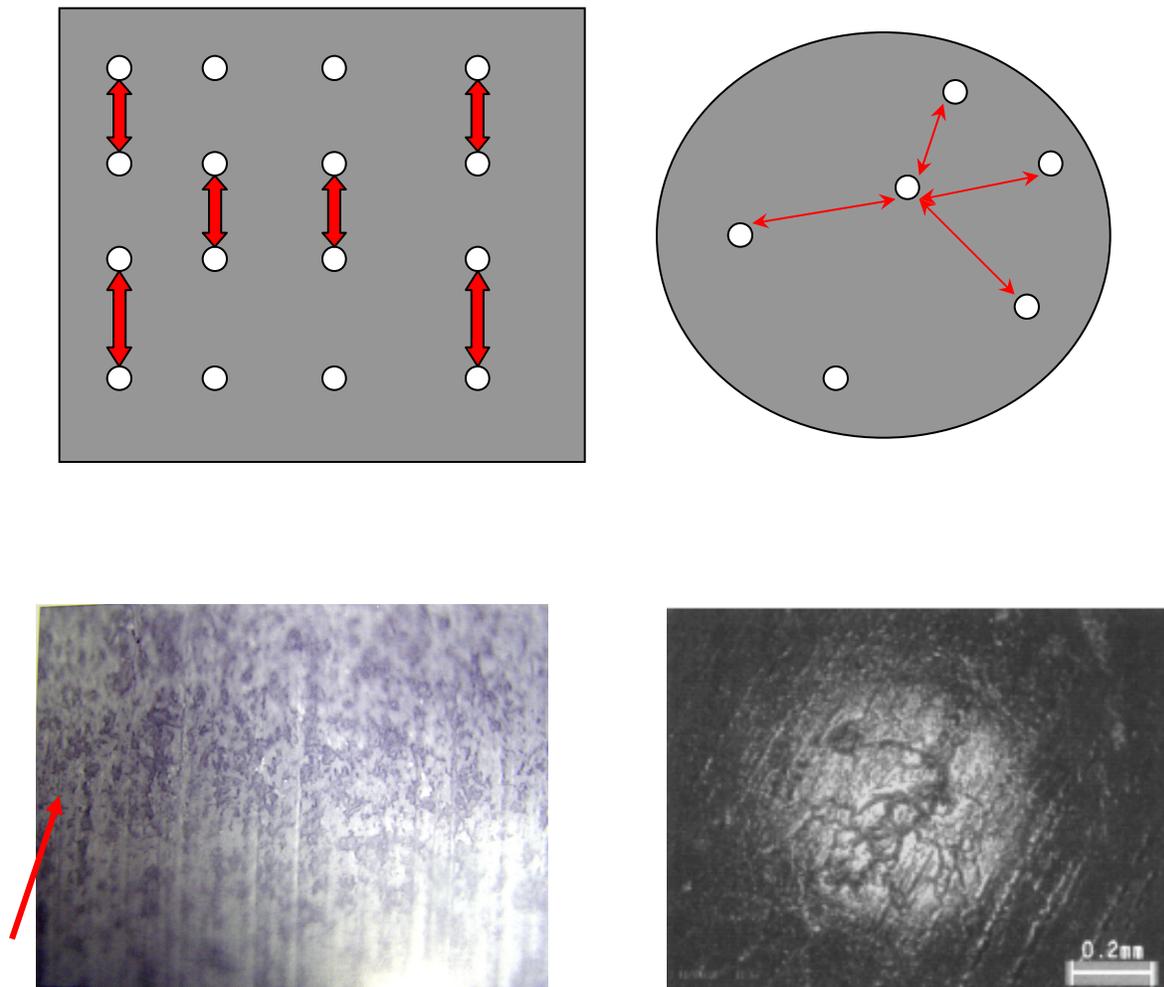
Fig: 4.5. Erosion mark comparison with application rolling elements.

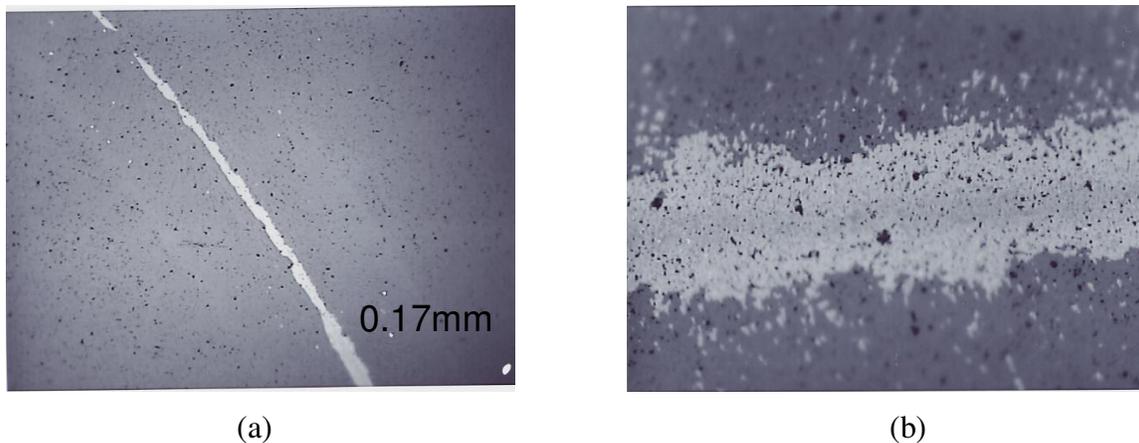
Fig: 4.6 (a) Test specimen after 2 hrs of RCF testing and (b) close up of the contact track

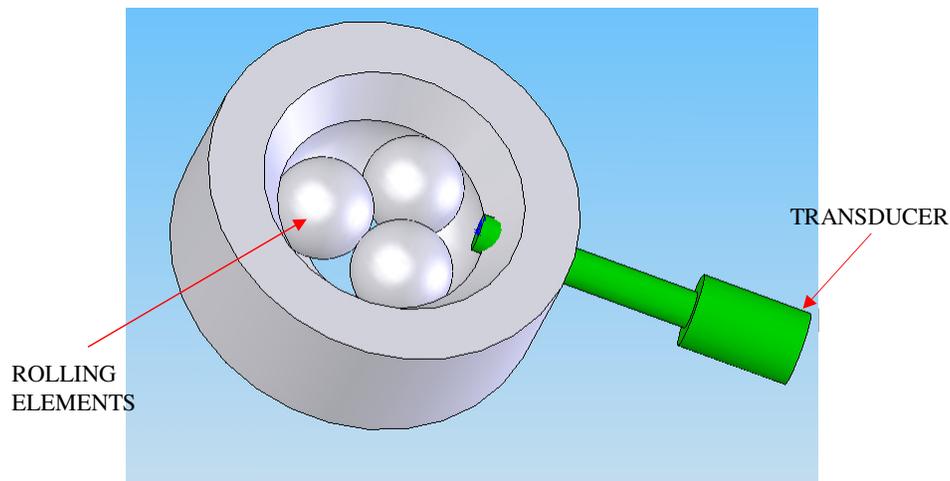
Fig: 4.9. Ultrasonic transducer in RCF test chamber

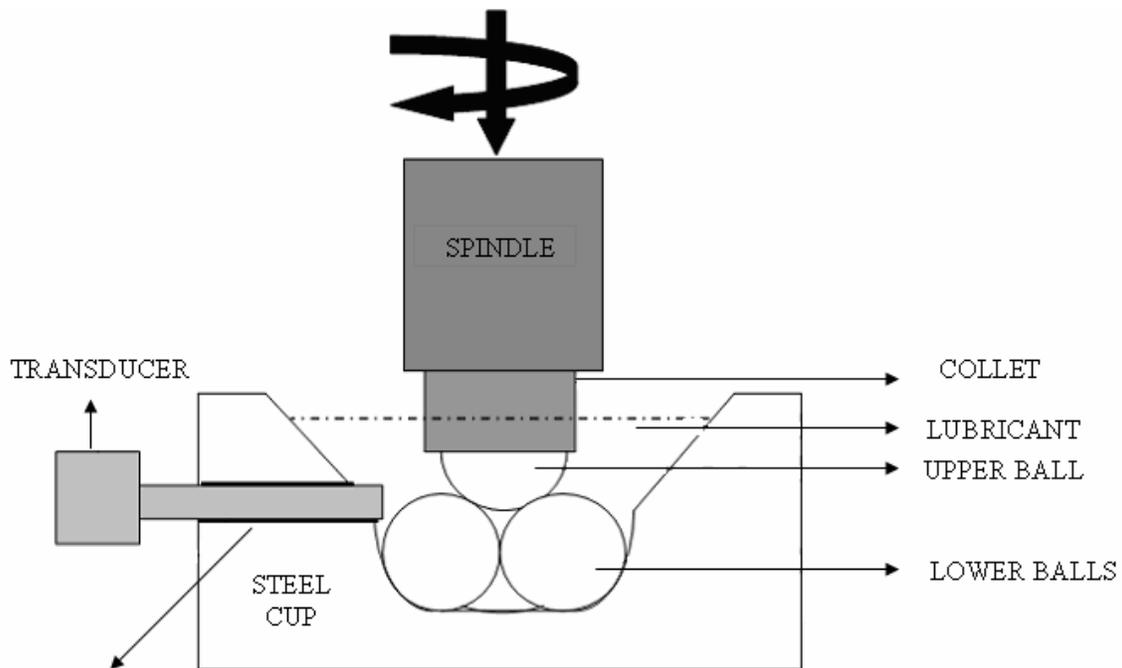
Fig: 4.10 Schematic of Test configuration.

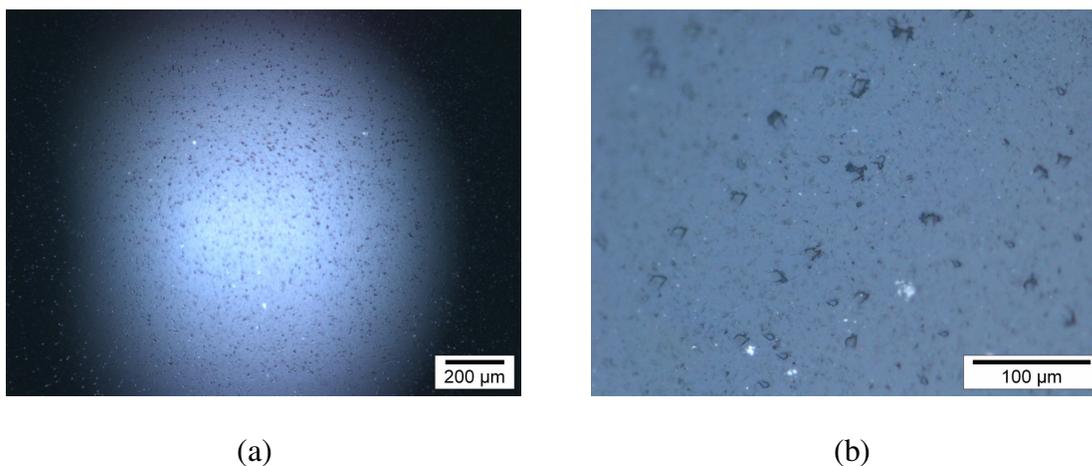
Fig: 4.13 Erosion marks on lower balls of S-1.

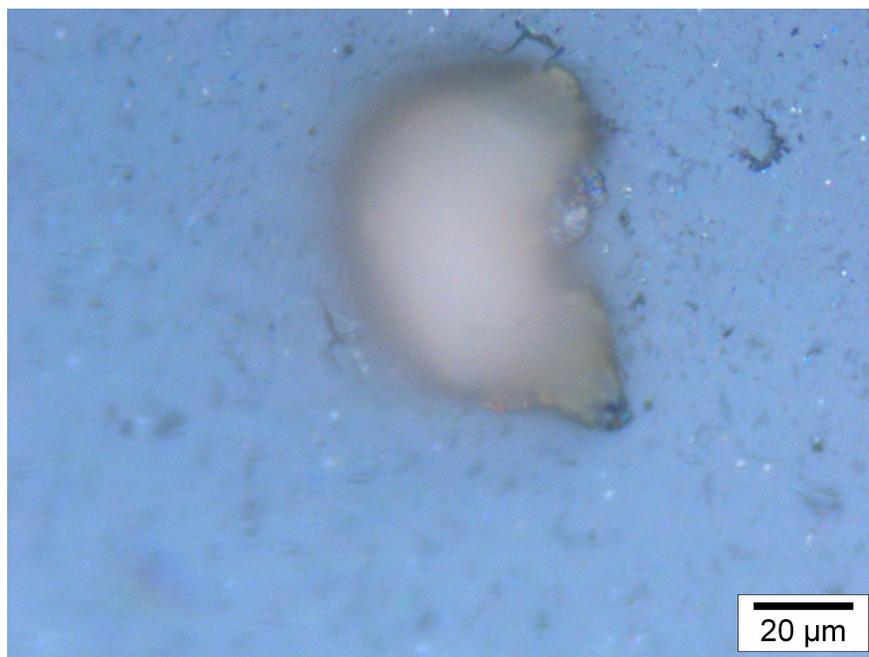
Fig: 4.14 Microscope image of Erosion mark on rolling element.

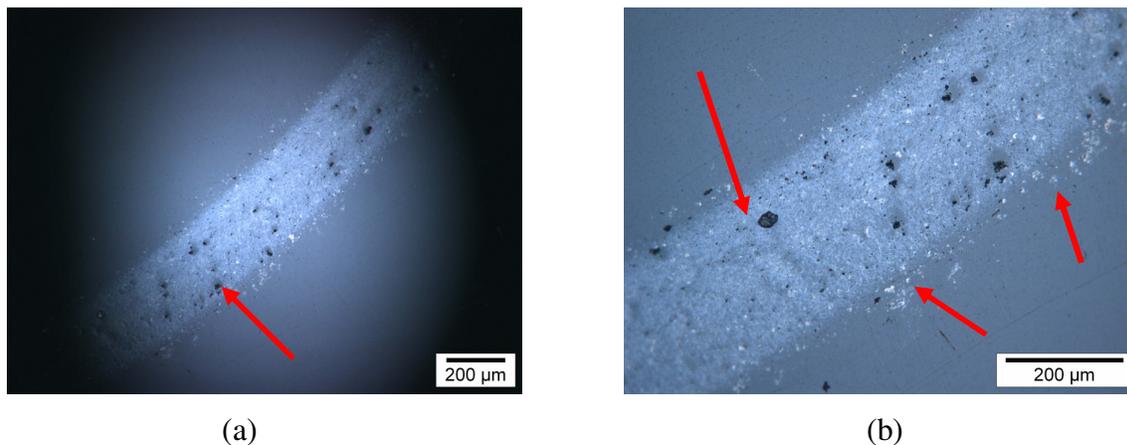
Fig: 4.17 Erosion pits in ceramic to ceramic contact

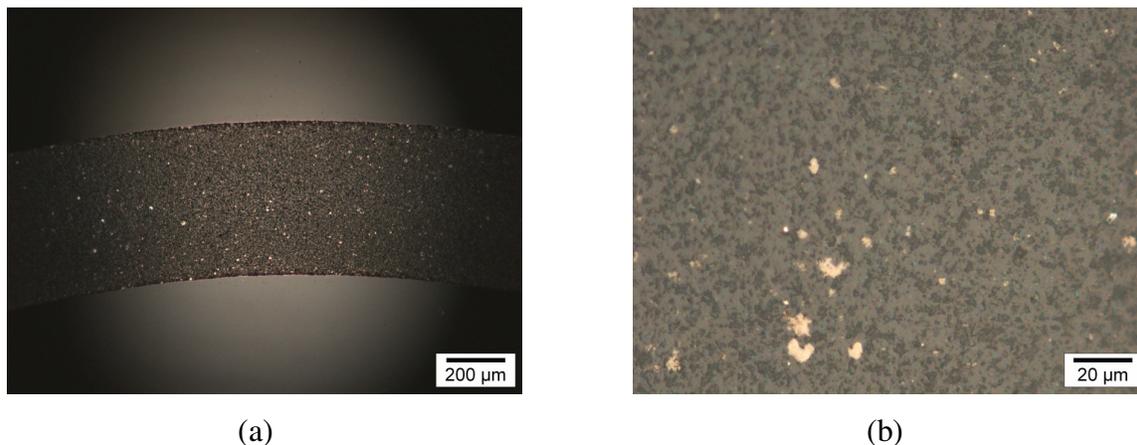
Fig: 4.18 Light microscope images of material C eroded contact track (a) full view of the eroded track and (b) High magnification of the contact track.

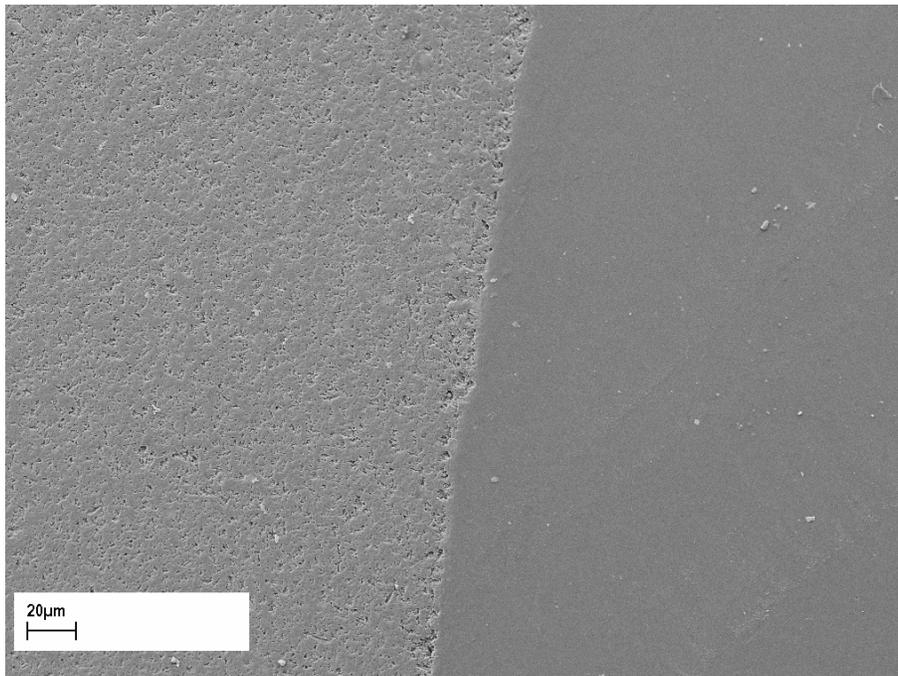
Fig: 4.19.Contact track and adjacent area

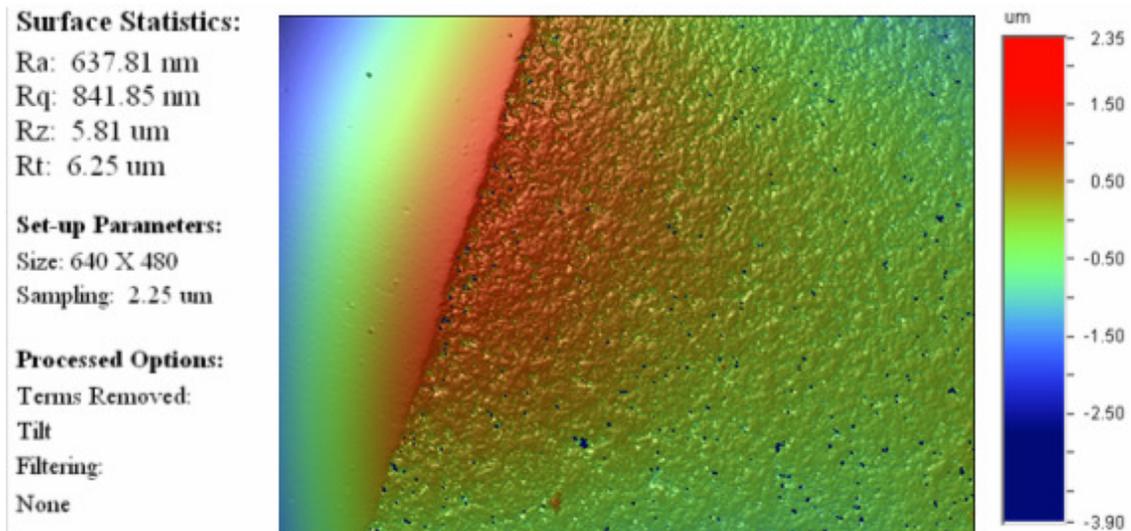
Fig: 4.20 Surface measurements on the contact track region

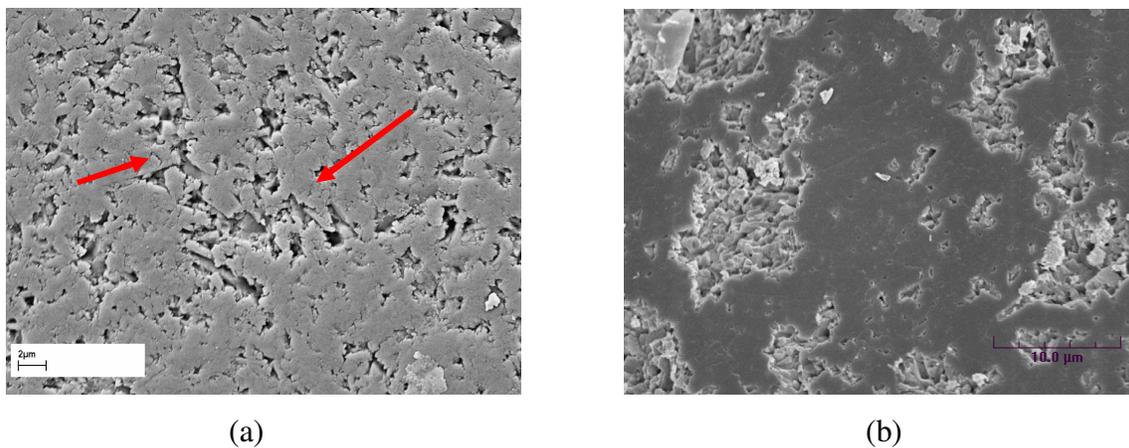
Fig: 4.21 Comparison of erosion pits in rolling contact and bench testing (a) Eroded contact track and (b) erosion pits on stationary specimen.

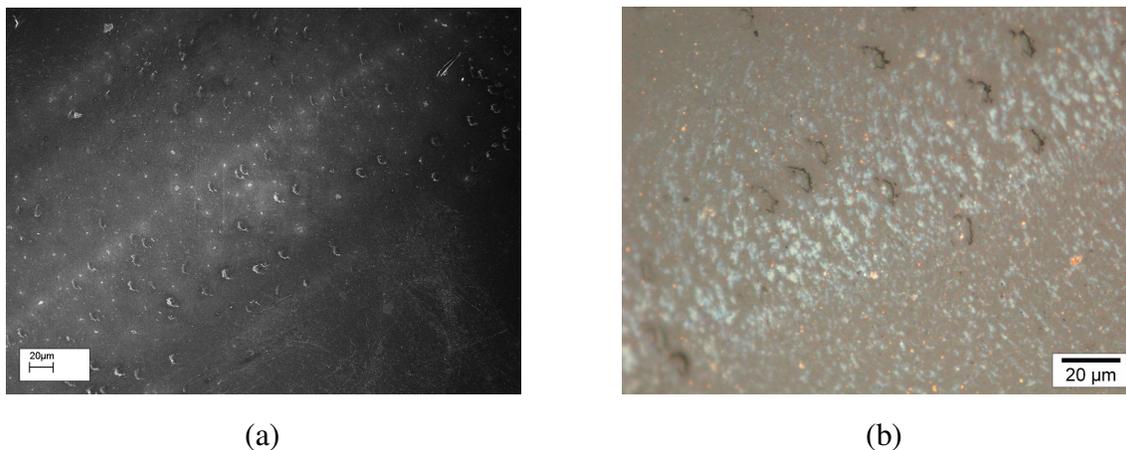
Fig: 4.22 Erosion marks on ceramic rolling element with hybrid contact

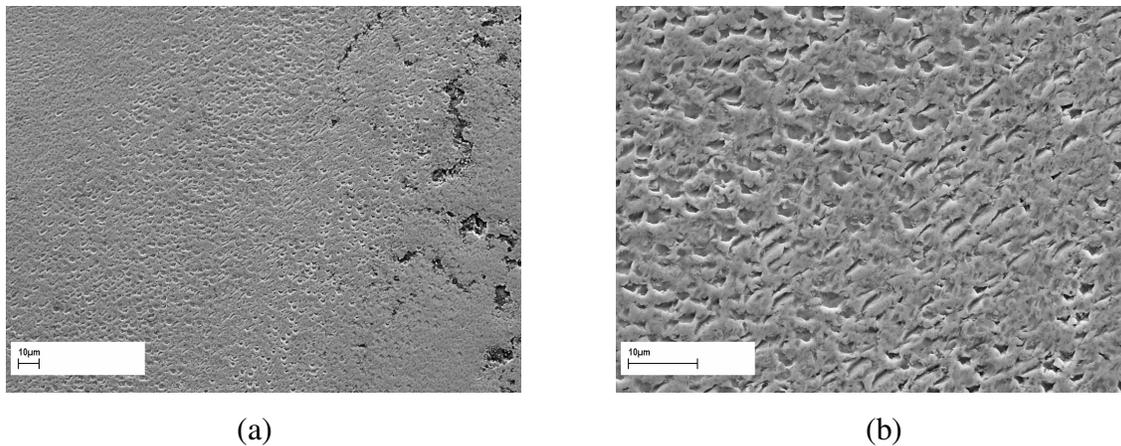
Fig: 4.23 (a) Contact track eroded on steel lower balls and (b) close up

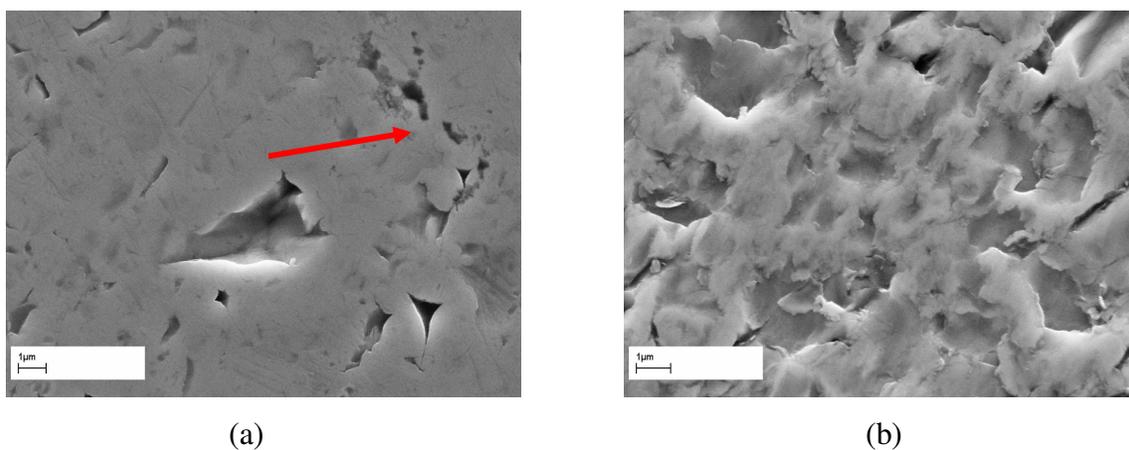
Fig: 4.24 High magnification of steel ball contact track (a) showing sharp erosion pits and (b) high density of erosion marks

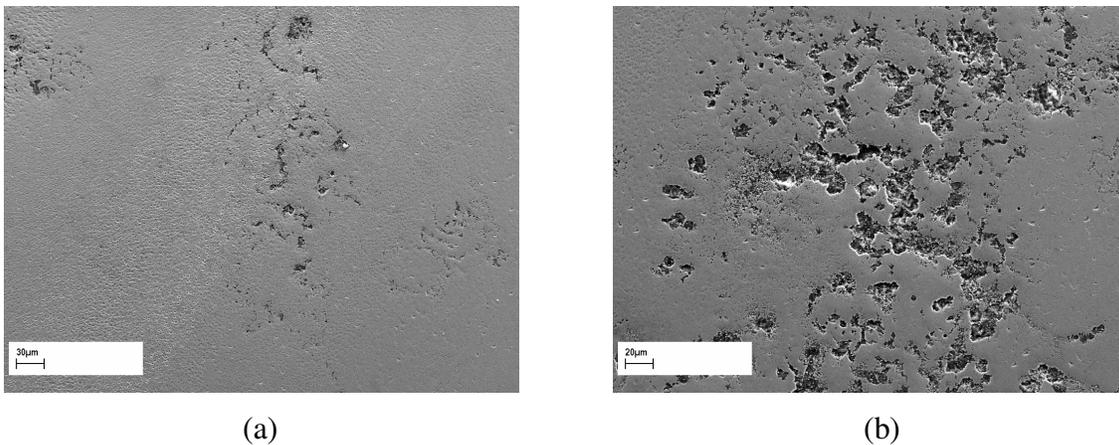
Fig: 4.25 (a) Bird's eye view of contact track of steel lower ball and (b) Area with bunch of erosion pits.

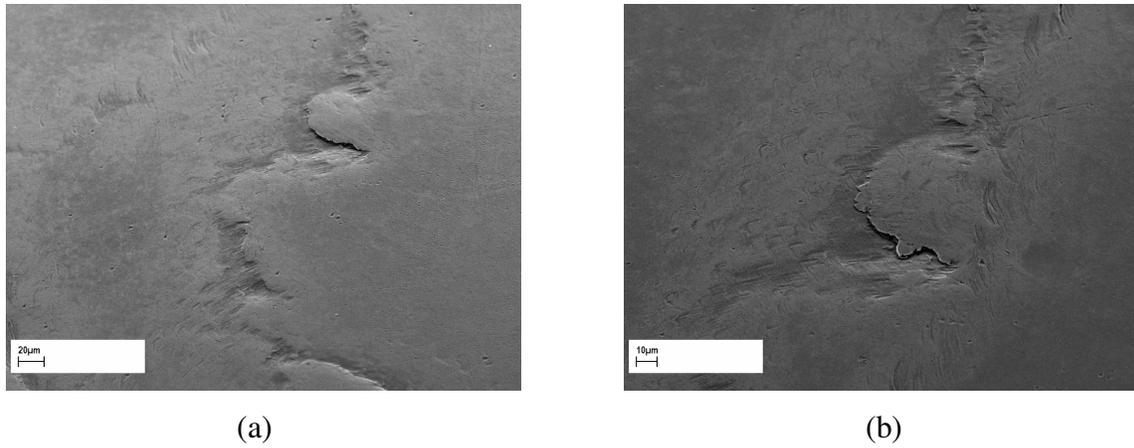
Fig: 4.26 (a) Ring edge of lower steel ball and (b) ring mouth

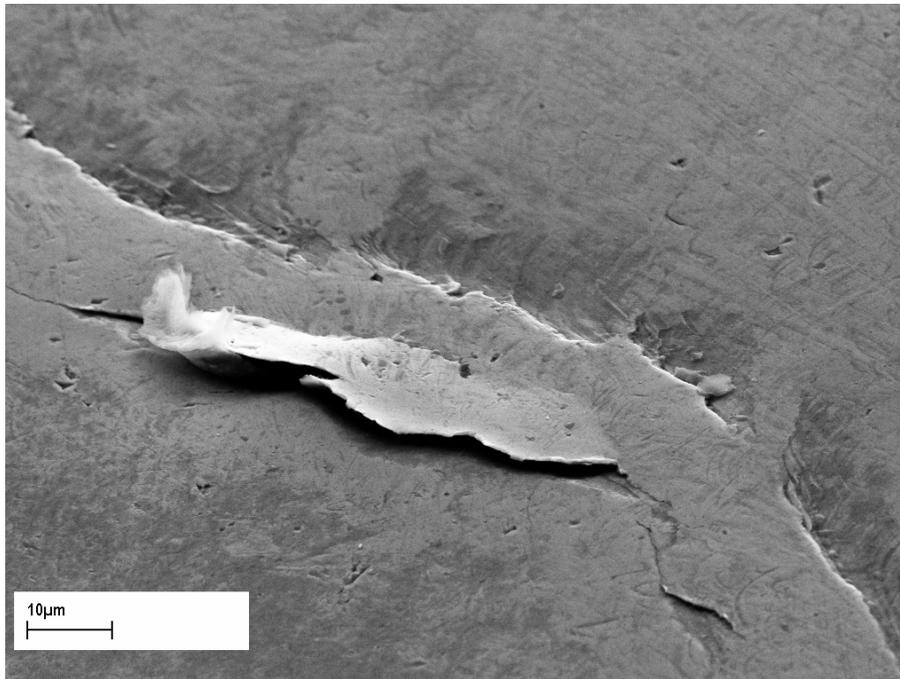
Fig: 4.27 Material flaking at the edge of the ring in bearing steel

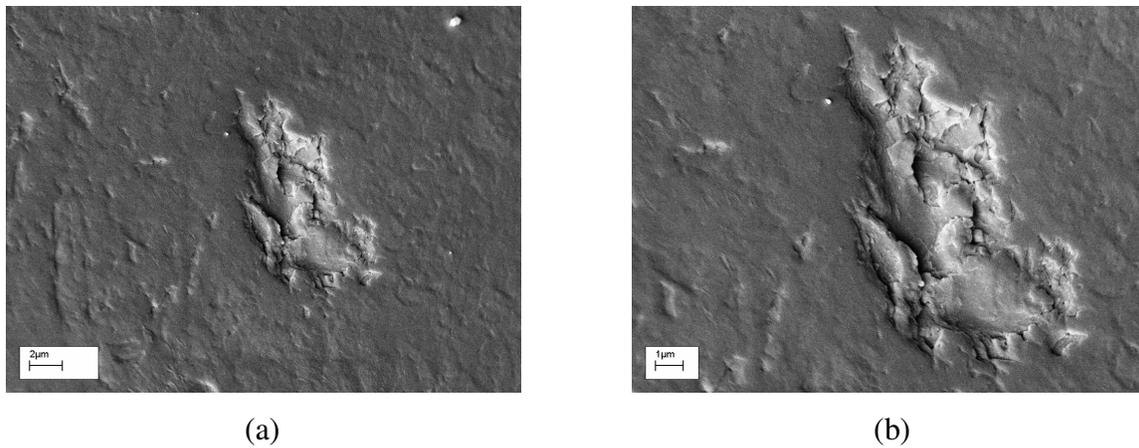
Fig: 4.28. Bubbling out of surface layer in rolling contact

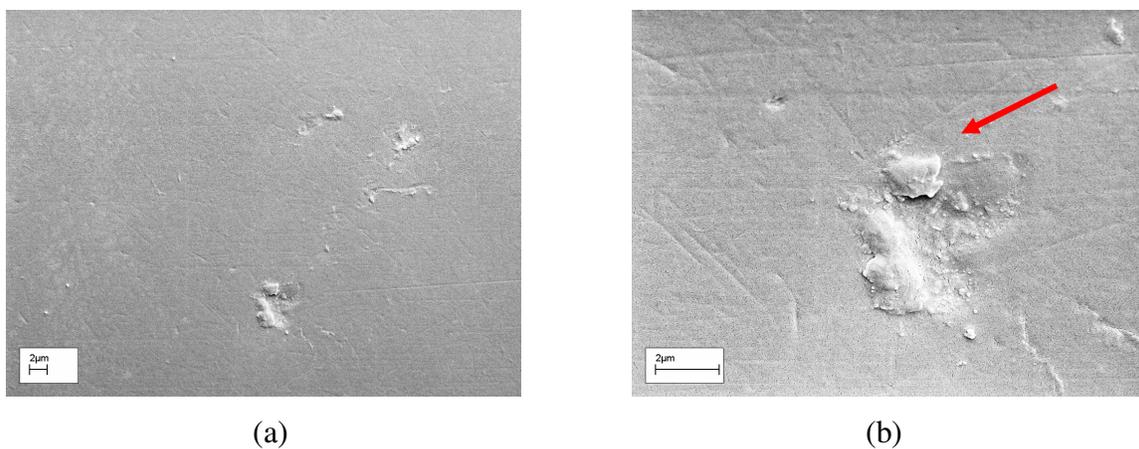
Fig: 4.29 Wear initiations in rolling contact after 40 minutes

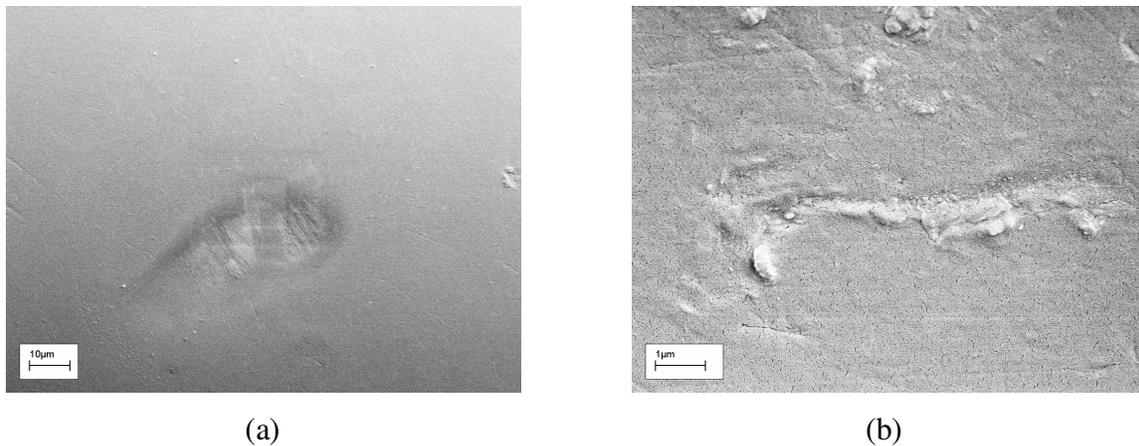
Fig: 4.30 (a) Micro pit formation and (b) C-shaped damage initiation

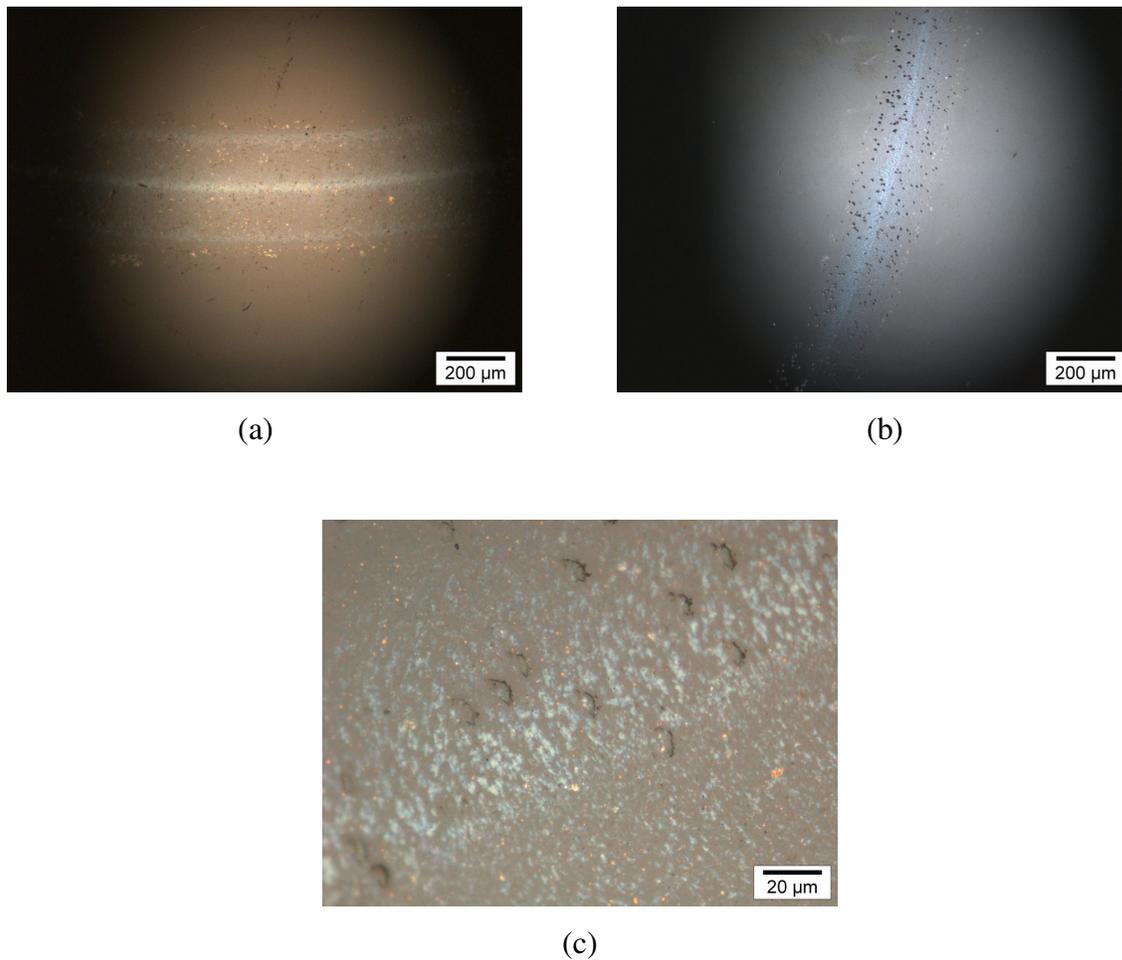
Fig: 4.31 Material A erosion marks (a) after 2 hours (b) after 4 hours and (c) close up of erosion marks

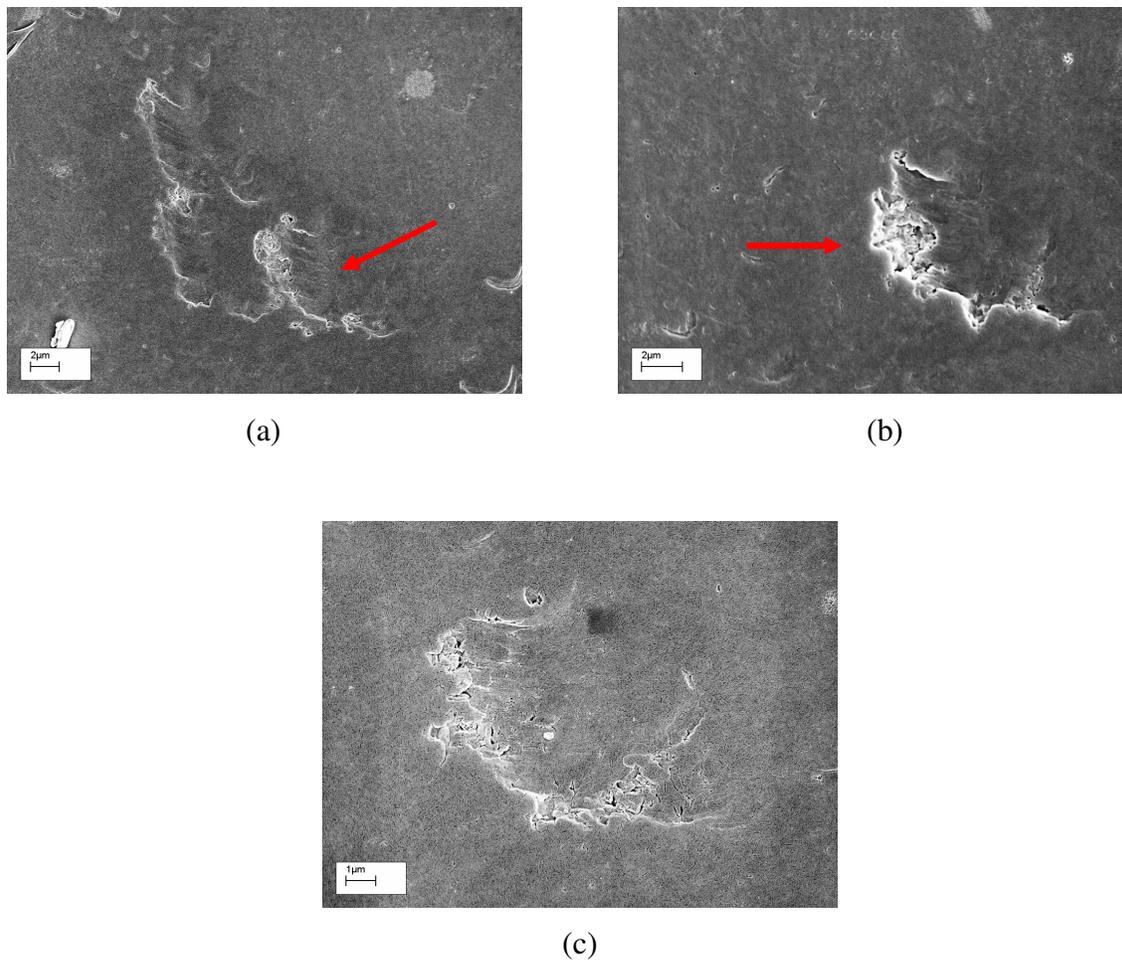
Fig: 4.33 Formation of C-shaped erosion marks on contact track

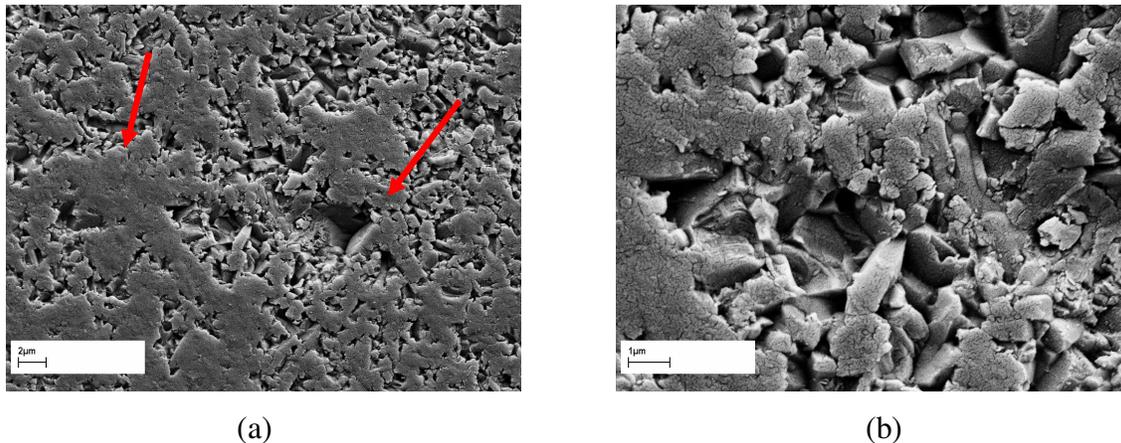
Fig: 4.34 Final stages of material failure showing severe erosion

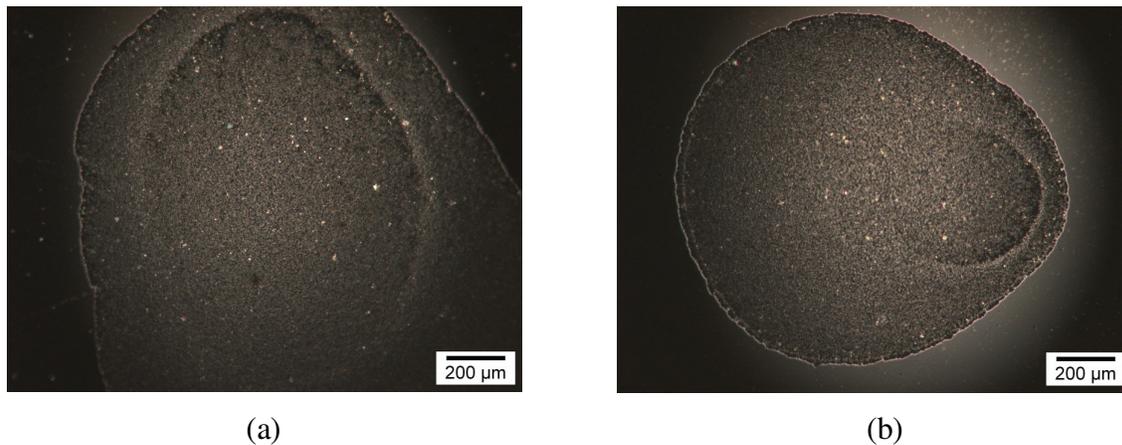
Fig: 4.35 Delamination wear on material C on lower balls

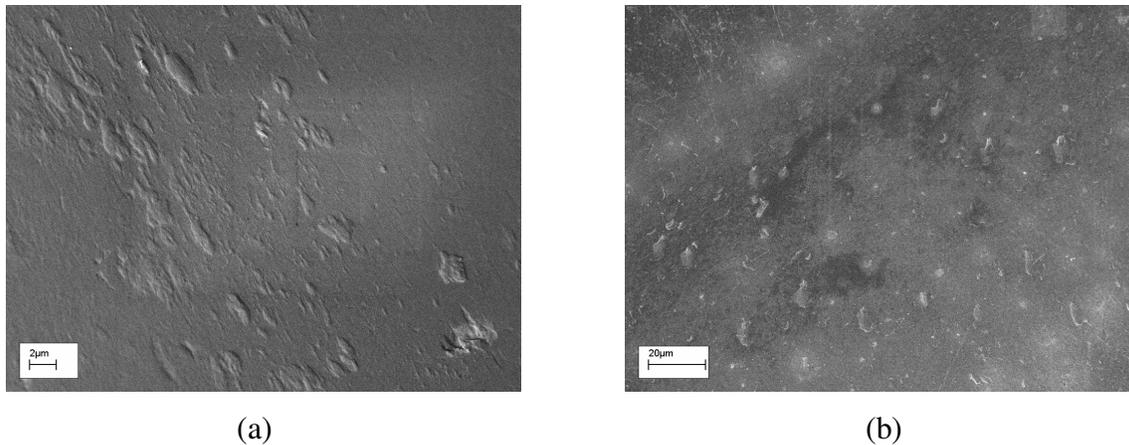
Fig: 4.36 Effect of contact stress (a) contact track at high load of 5.2 GPa and (b) Contact track at low load of 3.5 GPa

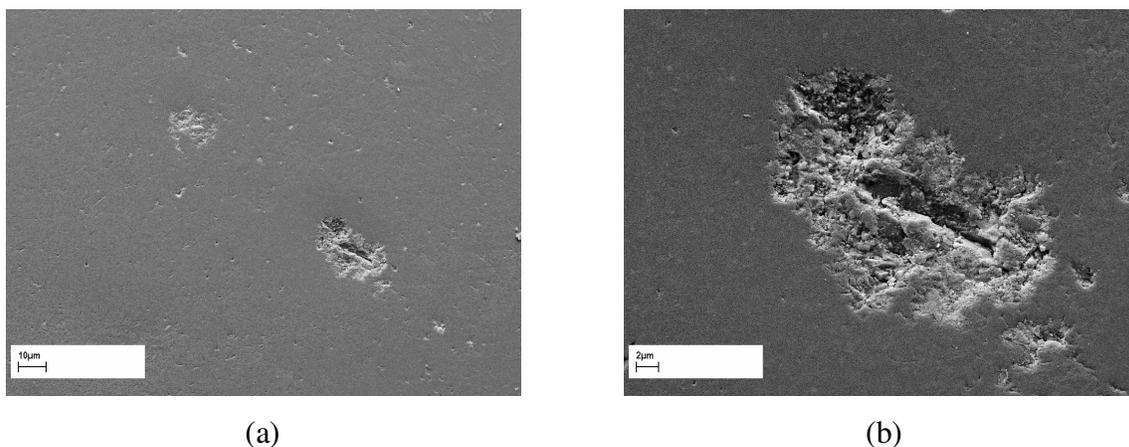
Fig: 4.37 (a) Large pit formation due to high load and (b) Close up of erosion pit

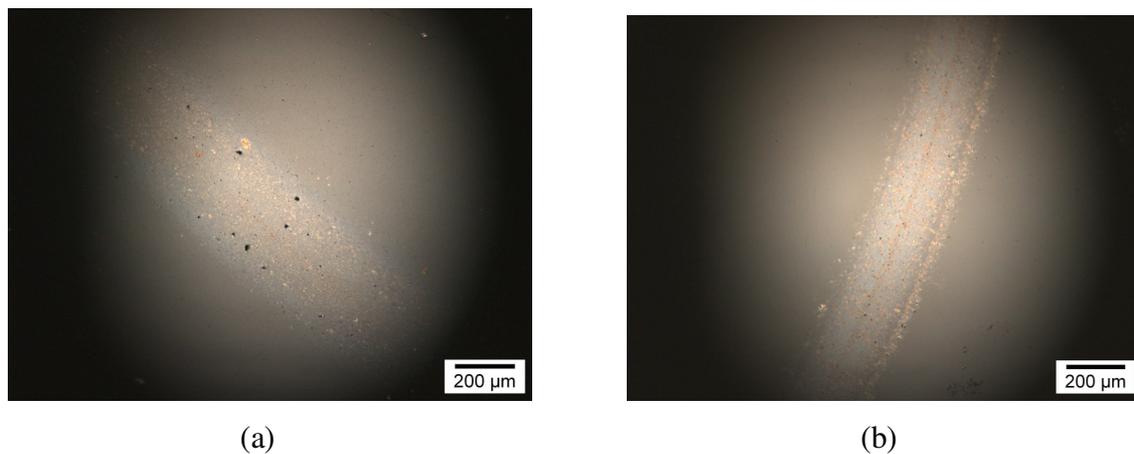
Fig: 4.38 Contact track after 3 hours of testing at speed of (a) 2000 rpm and (b) 3000 rpm

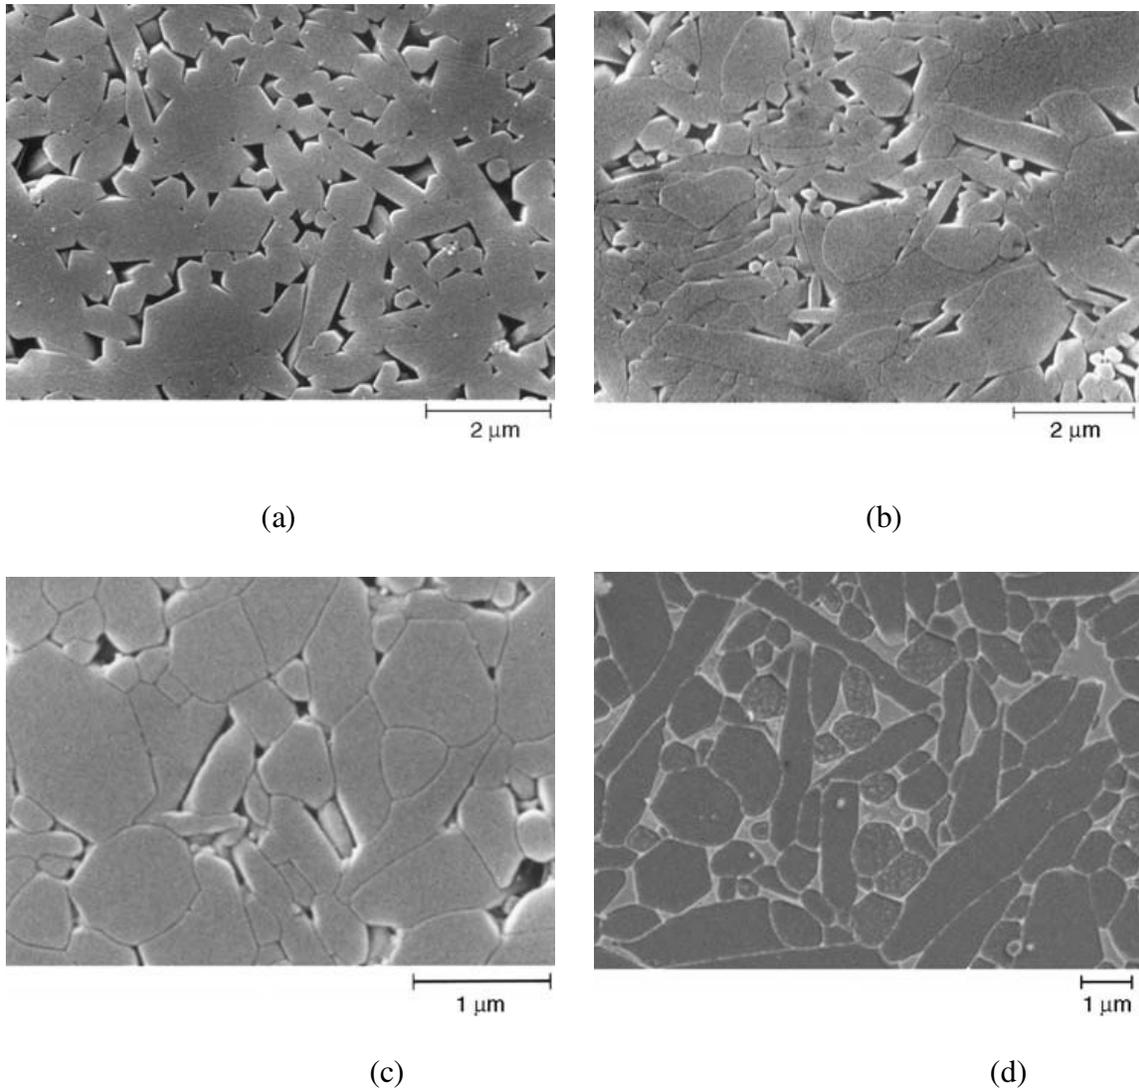
Fig: A1.4. Etched surfaces of different silicon nitride (a) sintered (SSN), (b) Hot pressed (HPSN), (c) Hot isotatically pressed (HIPSN) and (d) Gas pressure sintered (GPSN) (Taeffner 2004).

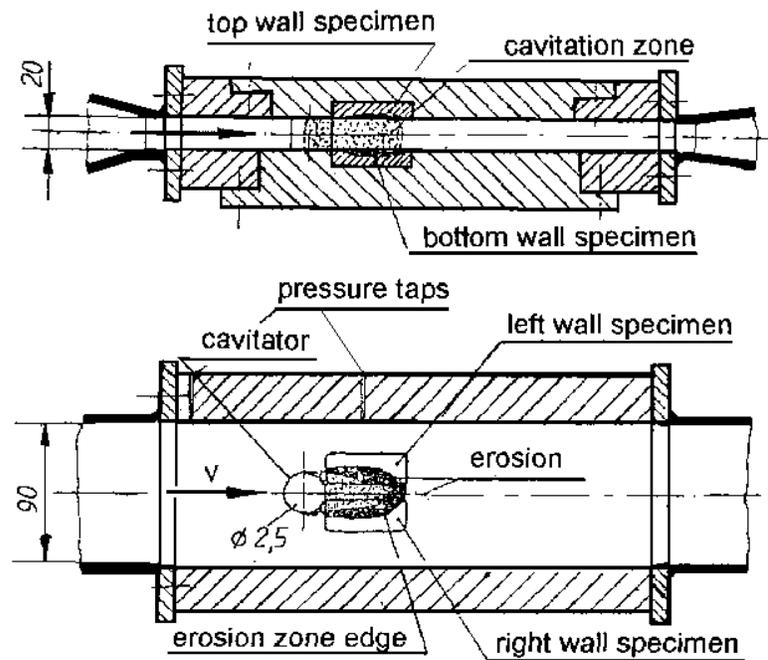
Fig: A2.1. Cavitation tunnel in the Hohenwarte II Pumped-Storage Power Plant in Germany (ICET 1998)
