**Erosion and Rolling Contact Wear Mechanisms in
Silicon Nitride Hybrid Bearings**

**A thesis submitted in partial fulfilment of the requirements of Bournemouth
University for the degree of Doctor of Philosophy**

Bournemouth University
In collaboration with
SKF Engineering and Research centre, The Netherlands.

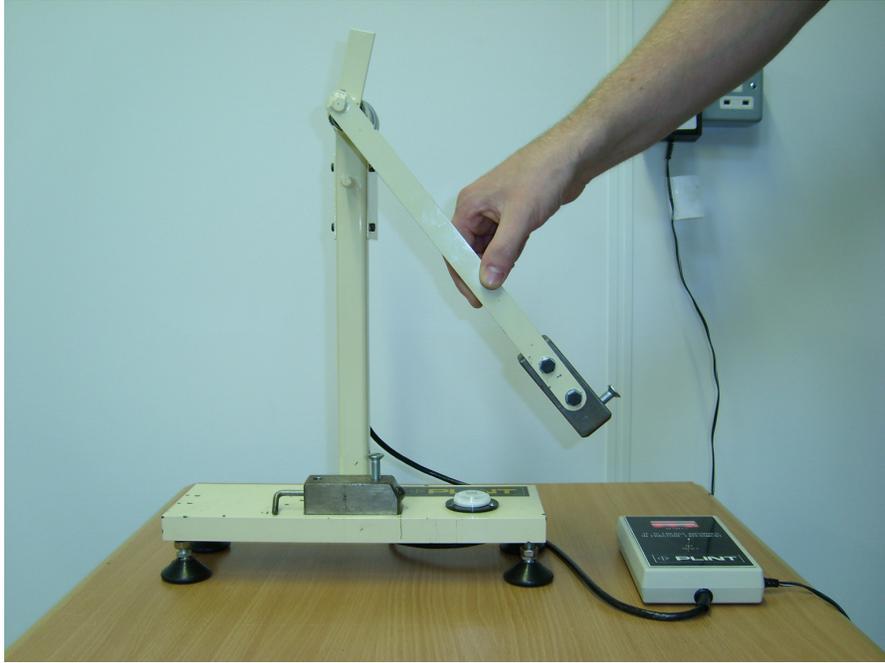
Fig: 3A.13. Crack generating equipment.

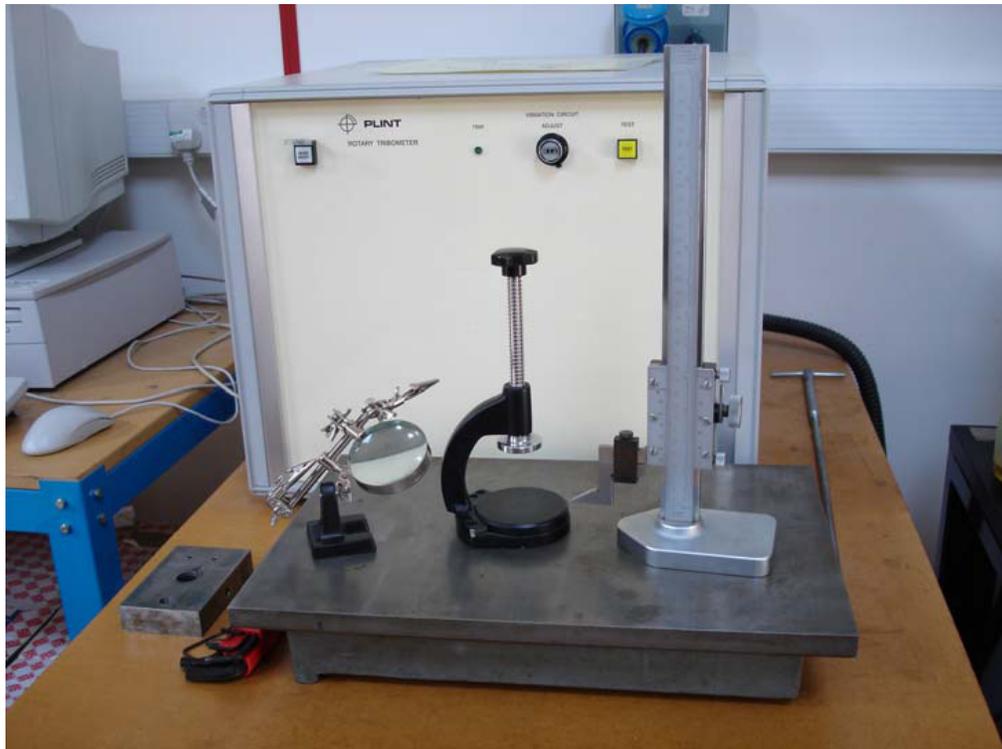
Fig: A3.14. Crack positioning for RCF experiments.

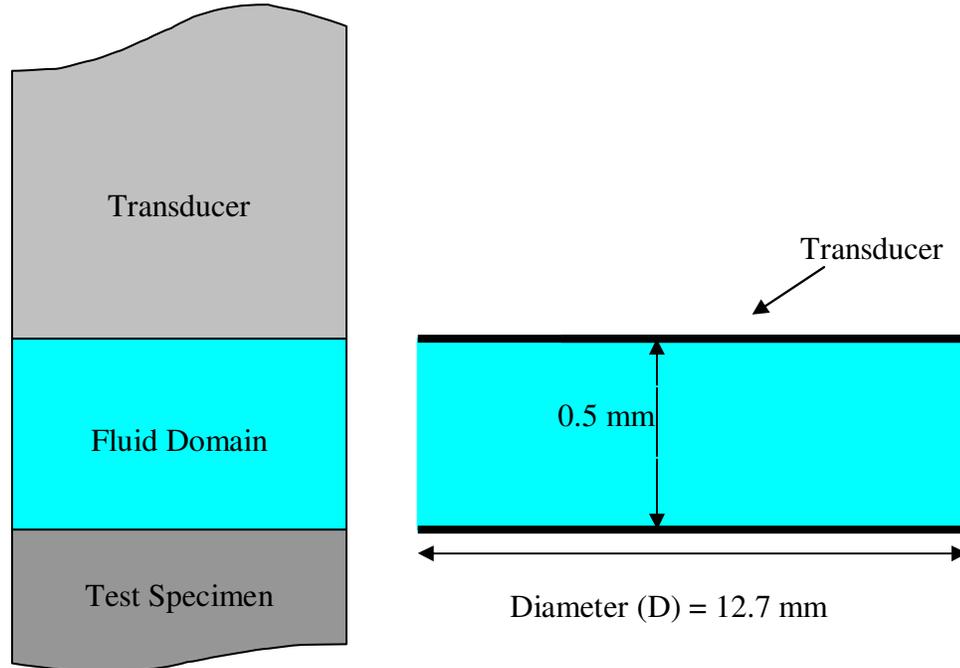
Fig: A.D.2 Schematic of the region of interest.

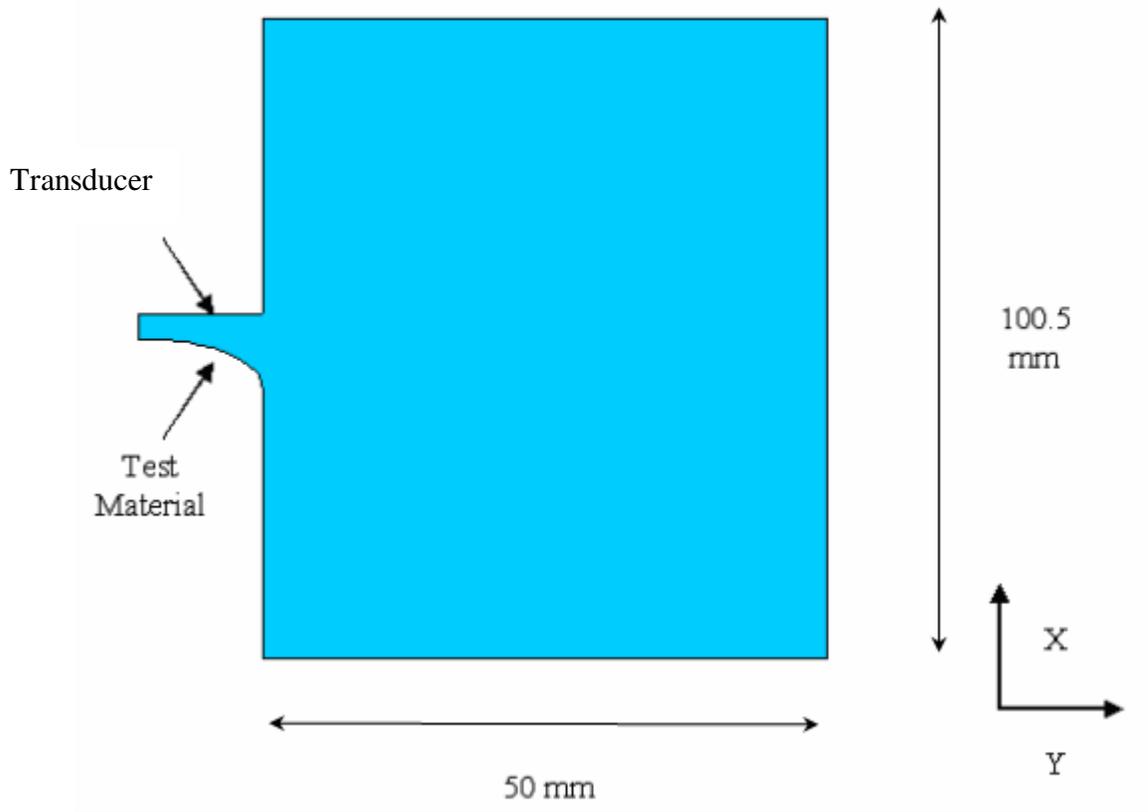
Fig: A.D.3 schematic of the CFD model.

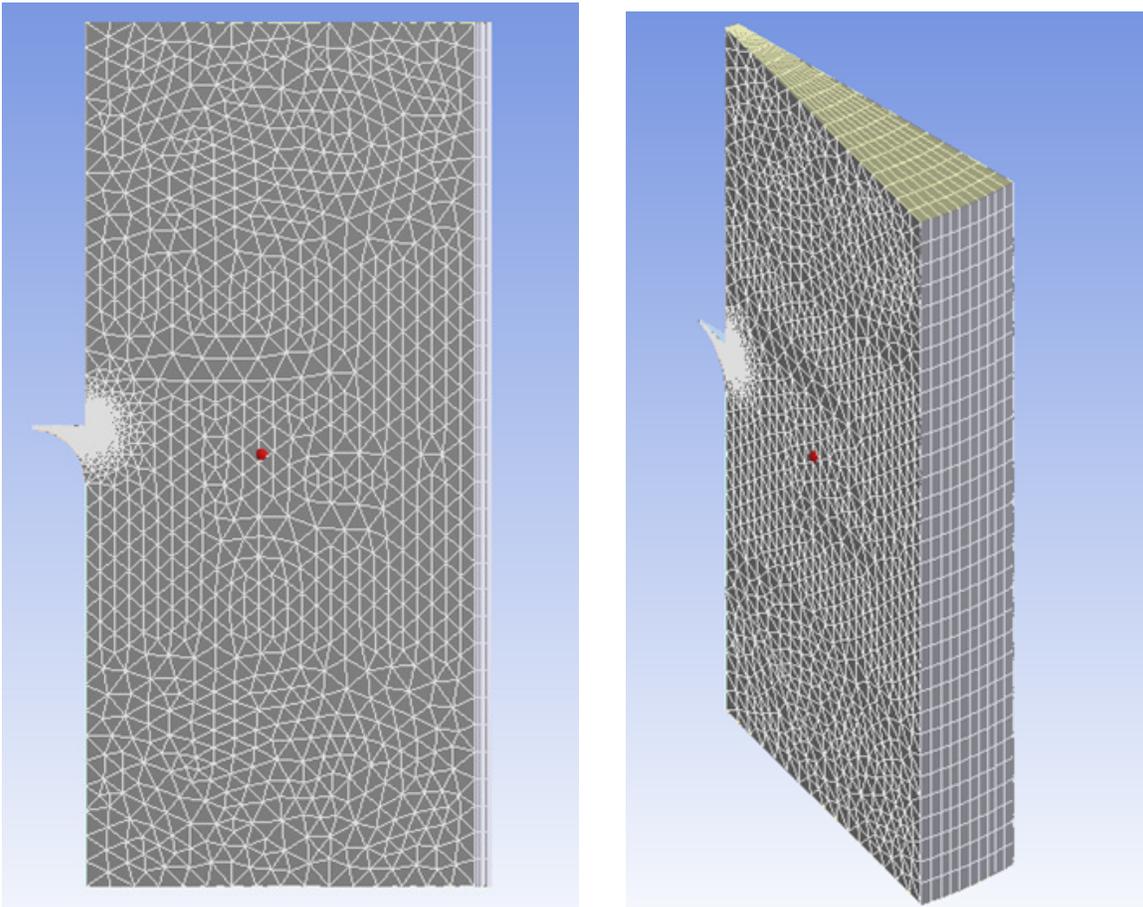
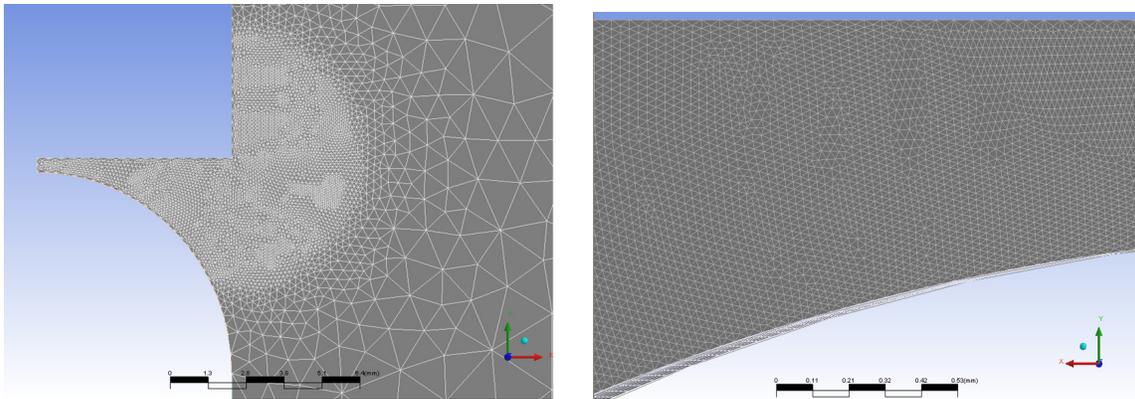
Fig: A.D.4 Meshed structure with refinement at the region of interest

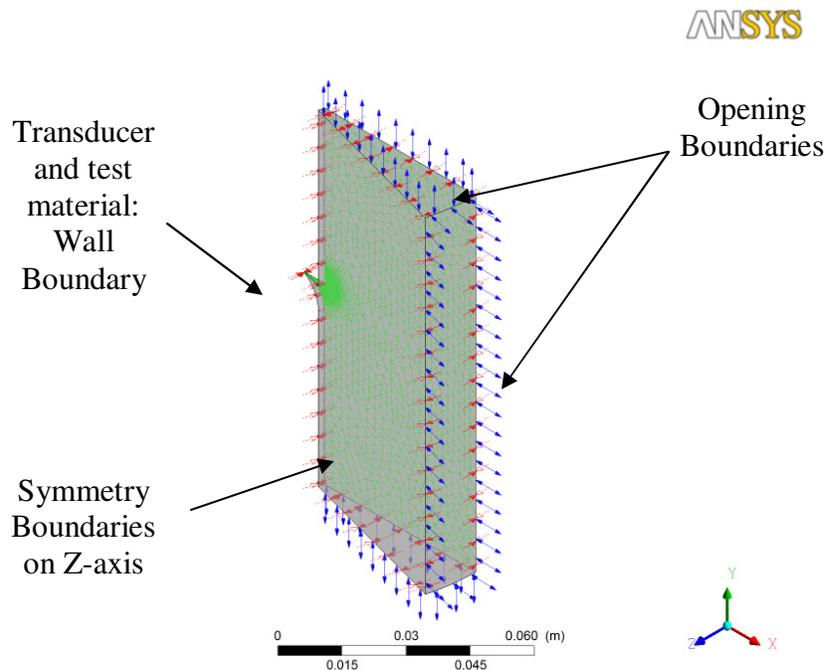
Fig: A.D.5 Boundary conditions for the CFD model

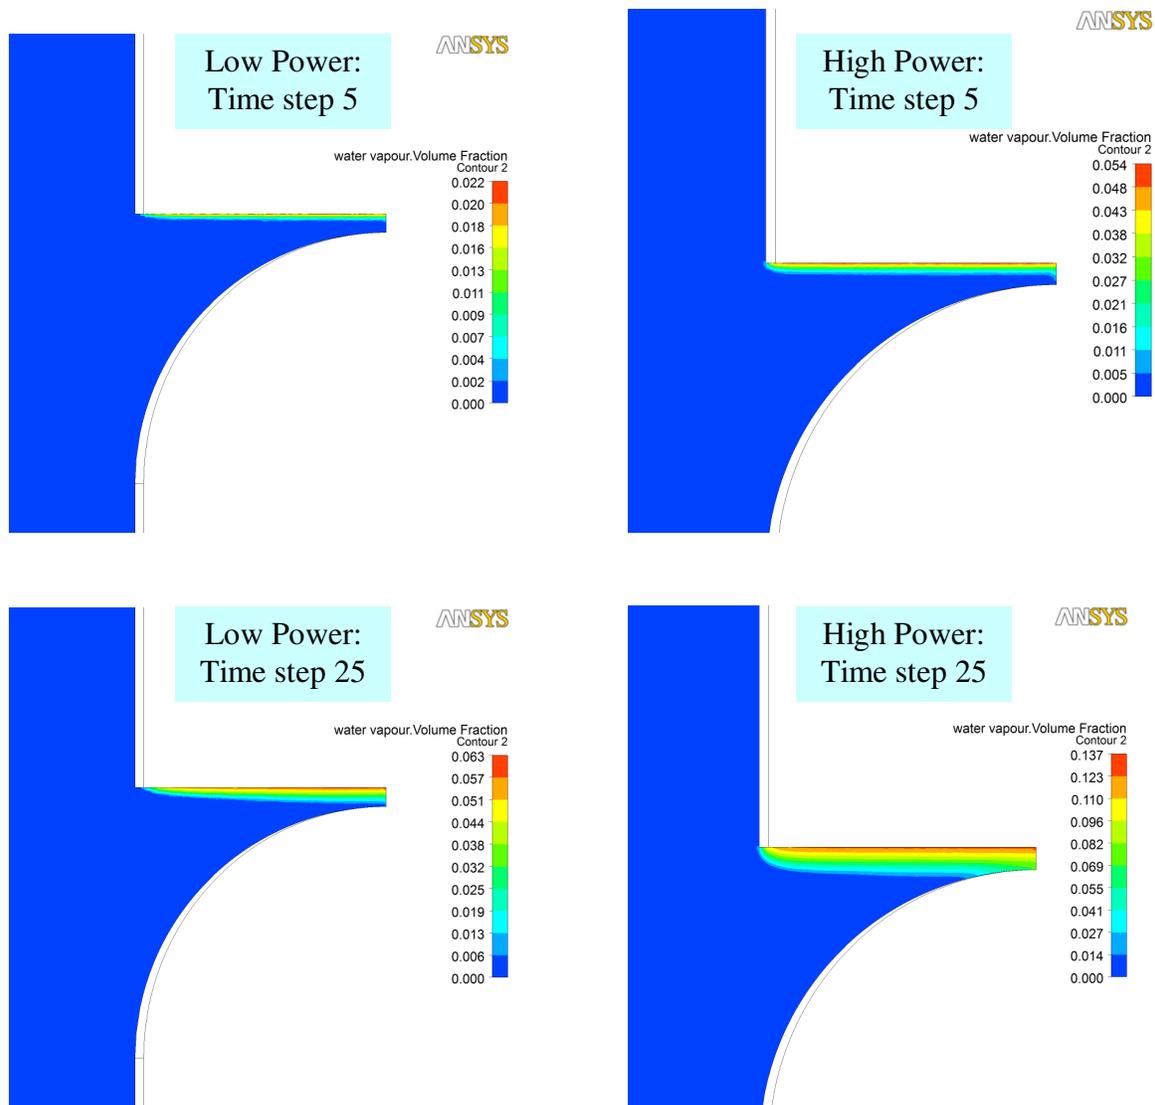
Fig: A.D.12. Water vapour volume fraction contour at different time steps.

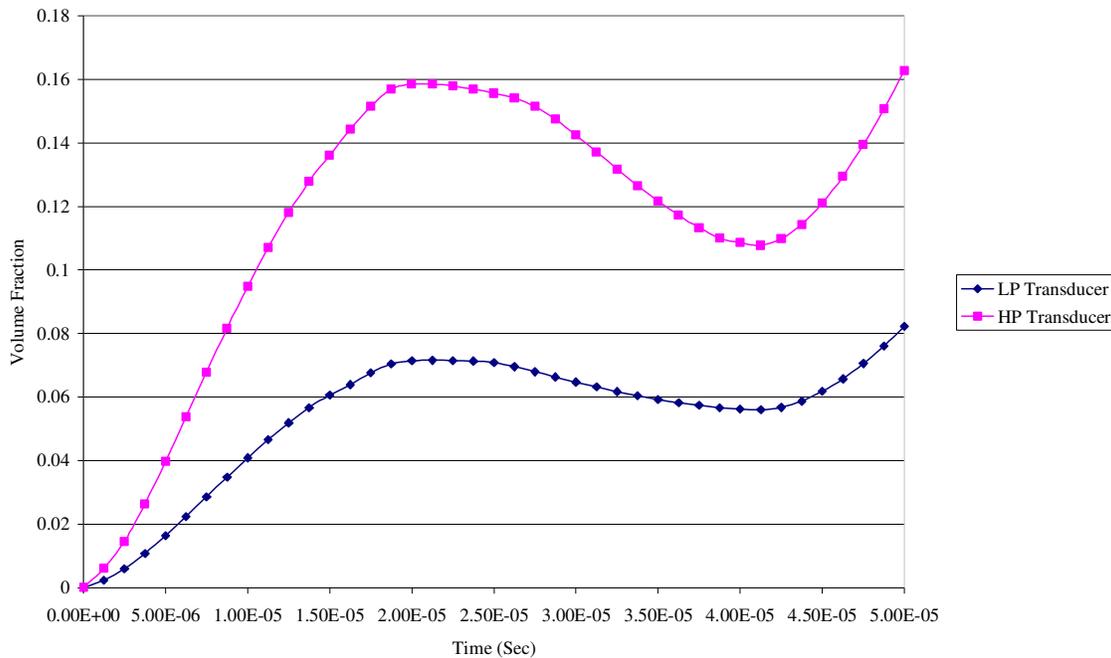
Fig: A.D.13 Volume fraction plot of low and high powered transducer.
