**Sustainable Methodology of Conserving Historic  
Military Vehicles**

**A thesis is submitted in partial fulfilment of the requirements of  
School of Design Engineering and Computing, Bournemouth University  
for the degree of Doctor of Philosophy**

Research was conducted to analyse corrosion and tribological failures in The Tank Museum Bovington military tanks. Due to the age of the exhibits corrosion of vital components has become a significant issue, it is vitally important to preserve these artefacts for future generations and so to do this effectively we need to monitor and reduce this corrosion as far as realistically possible. A case study of the historic military tanks followed by experimental research analyses is presented. Structural degradation through corrosion and engine wear has been identified and analysed. Materials were processed/manufactured during 2<sup>nd</sup> World War, their composition was unknown. Therefore state-of-the-art characterisation techniques were performed on samples collected from the M10, Sherman, Centaur and Tiger 1 to obtain material compositions and to identify nearest standards. A benchmark of material loss due to corrosion so far, has b

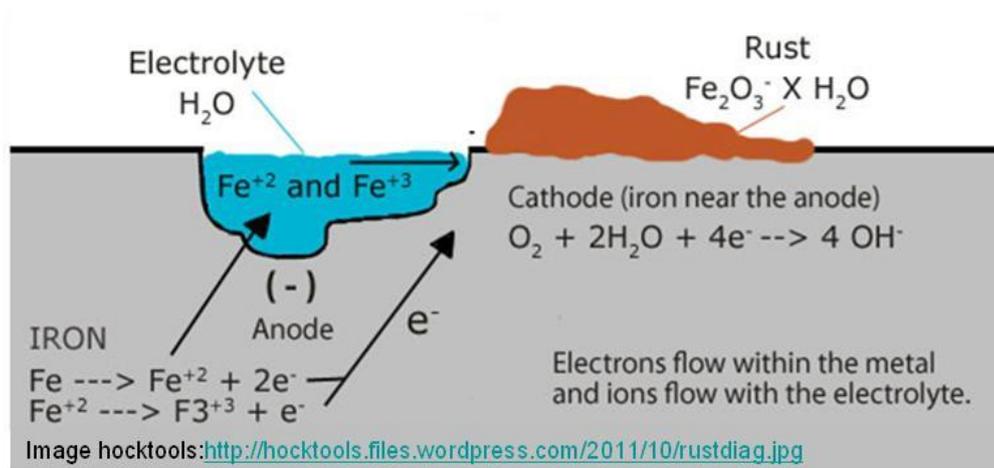
Figure: 2.1 Corrosion Process

The most common example of corrosion is the rusting of Iron (Fe) shown in Figure: 2.1. This is an electrochemical process which involves oxygen, water and electrolyte. Absence of any one of them will result in no rusting of the Fe. Relative humidity above 50% provides necessary amount of water in the air to cause rusting and when relative humidity reaches above 80%, corrosion of bare steel is worse [18, 19]. A droplet of water containing dissolved oxygen on steel surface causes Fe to oxidise. At the edge of the water droplet the oxidising iron provides electrons to reduce oxygen from the air.

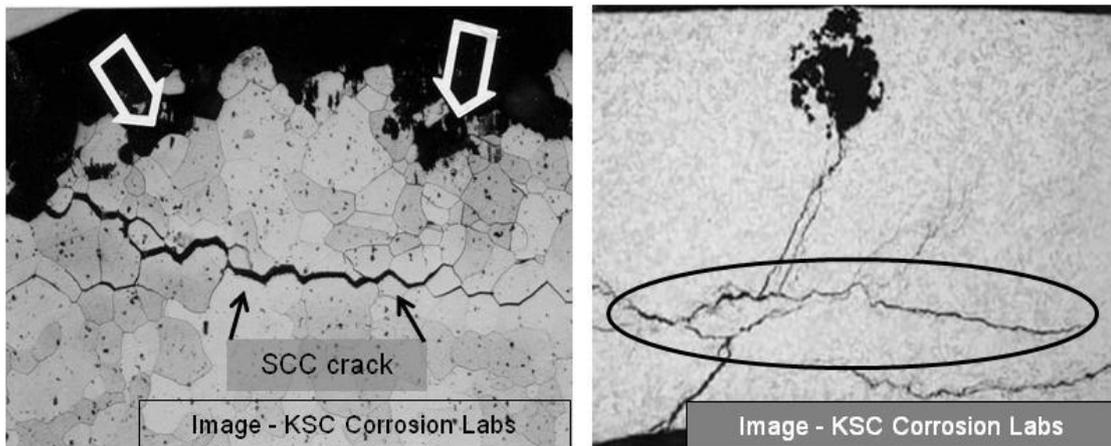
Figure: 2.2 Stress Corrosion Cracking in Aluminium Alloy, Subjected to Residual Stresses and Salts

Corrosion products within small restrained spaces can also generate stresses. Generally most of the surface may look less affected however with inter-granular or a trans-granular morphology illustrated in Figure: 2.2; these cracks penetrate into the surface resulting in fractures. SCC is one of the severe forms of corrosion which is hard to detect and difficult to predict the failures [21, 26].

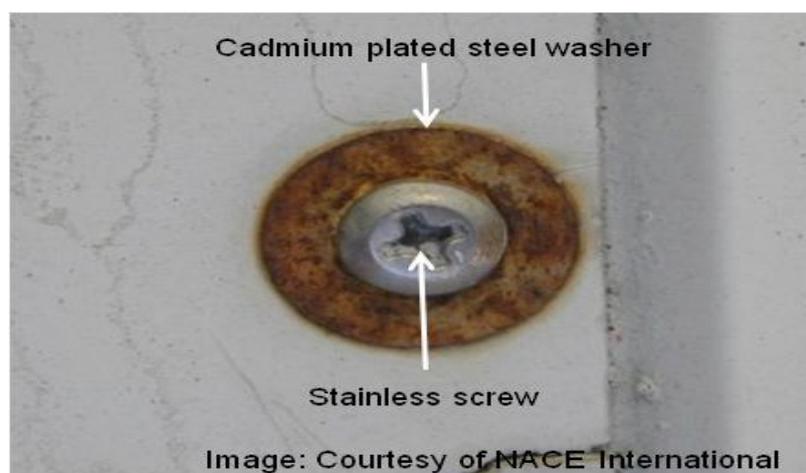
Figure: 2.3 Galvanic Corrosion - Stainless Screw v Cadmium Plated Steel Washer

Galvanic or bimetallic corrosion is an electrochemical reaction between two or more dissimilar metals in the presence of electron conductive path in which one metal corrodes preferentially than the other. The common factors are dissimilar metals, electrical interaction, and a conductive electrolyte. When a conductive path is established flow of electrons takes place from active to noble metal forming a coupling of anode and cathode. One typical example is given in Figure: 2.3 where washer is anodic compared to the stainless screw and rest of the surface. Washer is corroding fast because of the high anode-to-cathode ratio.

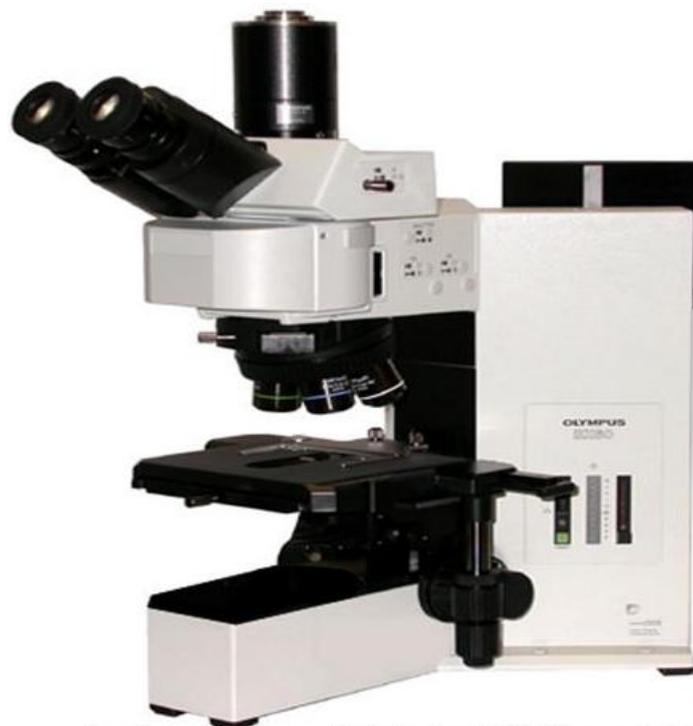
Figure: 3.1 Olympus BX 60 Microscope

Optical Microscopy was conducted using Olympus BX 60 shown in Figure: 3.1. Microscopy method was deployed for the surface analysis of corroded samples and to analyse wear in the pistons and cylinder-liners. Optical microscope uses visible light and a combination of lenses, which can be used for the extensive surface analysis of samples. Microscope is fitted with a digital camera to capture micrographs. The micrographs can be transferred to the computer and can be displayed and effective surface measurements can be obtained through the software.

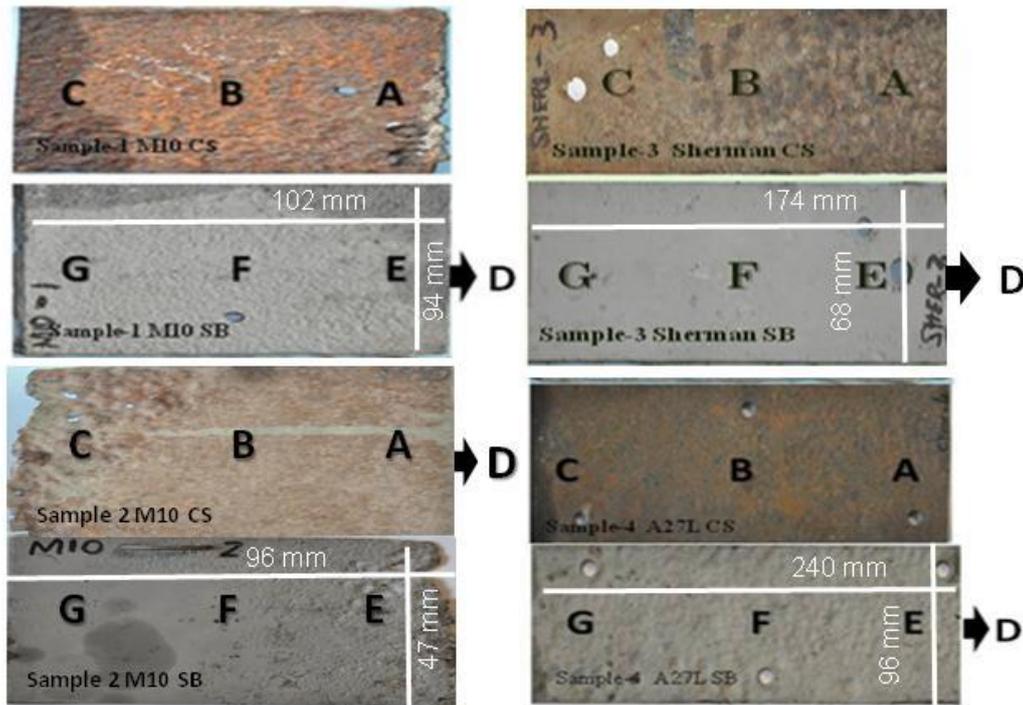
Figure: 3.2 Points Locations for XRF Analysis on the Samples A, B, C are on the Corroded Surface, G, F, E are on the Sandblasted Surface and D is at the Cross Section.

X-ray fluorescence (XRF) was conducted on samples from the M10, Sherman and Centaur. This method was conducted on the same prepared samples discussed in ultrasonic scanning. These samples were corroded on one side; other side however had paint protection. Each sample was scanned for at least 30 seconds at three points on corroded (A, B, C), sand-blasted (G, E, F ) and once on the cross sectioned (D) surfaces as shown in Figure: 3.2.

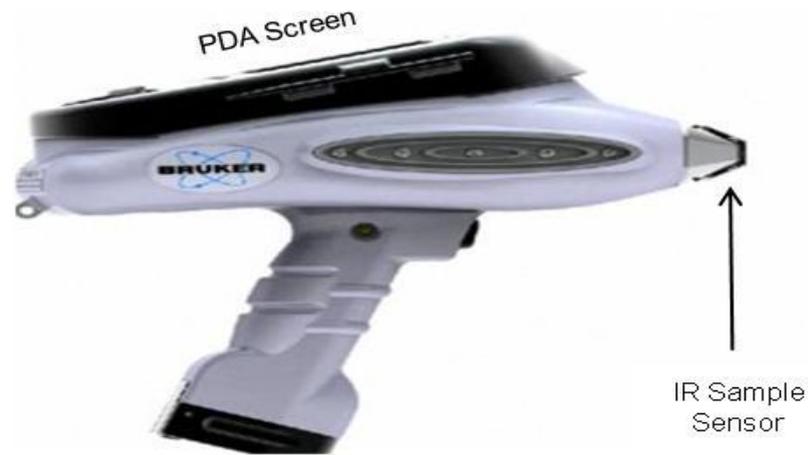
Figure: 3.3 Bruker S1 Turbo XRF Analyser

Bruker S1 Turbo silicon drift detector (SSD) shown in Figure: 3.3 was utilised. The S1 Turbo<sup>SD</sup> can be configured with calibrations that are optimised for a variety of sample materials including a wide range of alloys and various mining and environmental soil samples. S1 technical specifications include a) Detector 10 mm<sup>2</sup> X-Flash SDD, peltier cooled, b) resolution 145 eV at 100,000 cps c) X-ray Tube; Ag target with maximum voltage of 40kV and d) five position motorised filter changer<sup>3</sup>. XRF analysis is a non-destructive method, used for the material characterisation. During this process the samples are bombarded by an intense X-ray beam leading to the emission of fluorescent x-rays. These emitted fluorescent x-rays can then be detected by a wavelength dispersive or energy dispersive detector, which identify elements of materials by measuring the energies of emitted x-rays and counting number of the rays of each energy spectrum. SDD can be used to analyse low alloy steel, stainless steel, tungsten alloys and light elements such as magnesium, aluminium and silicon [65, 66].

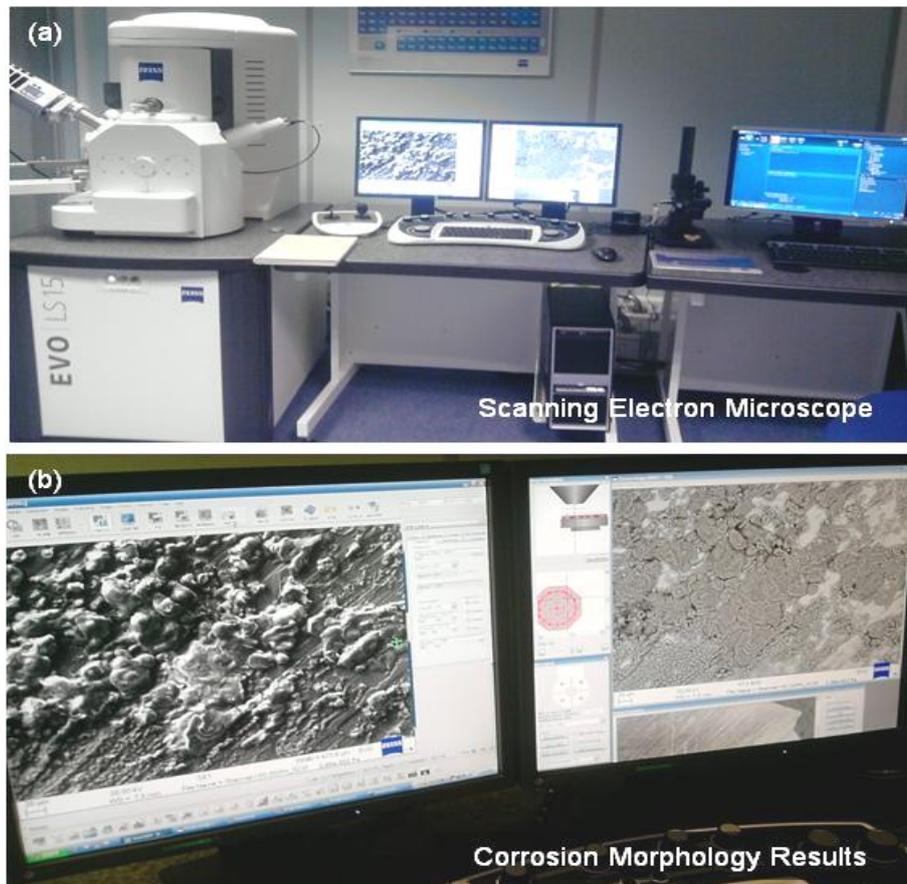
Figure: 3.6 Zeiss EVO LS 15

Emitted x-rays from a sample's surface because of the bombardment of electron beam during SEM are characterised by EDS, to obtain the chemical microanalysis and the elemental composition of the analysed volume. EDS measures the number of emitted x-rays against their energy. Energy of x-ray is the characteristic of the element from which the x-rays were emitted. Elements such as (Be) and (U) atomic numbers 4 and 92 respectively can also be detected and analysed. A qualitative and quantitative determination of the elements is obtained and evaluated from the energy spectrum versus relative counts of the detected x-rays [69-71] .

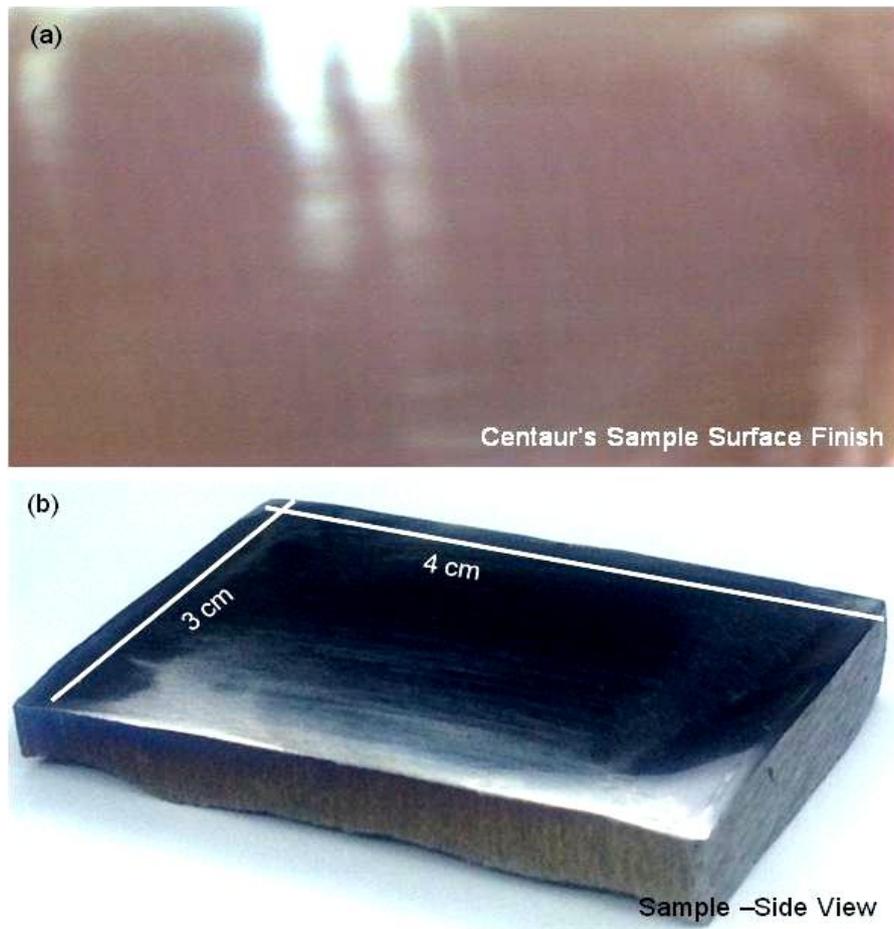
Figure: 3.7 Centaur's Sample Finish for Simulated and Accelerated Corrosion Tests  
 (a) Surface Finish (b) Side View and the dimension of the same sample

uniformity, rinsed with water and no chemicals were utilised during preparation.

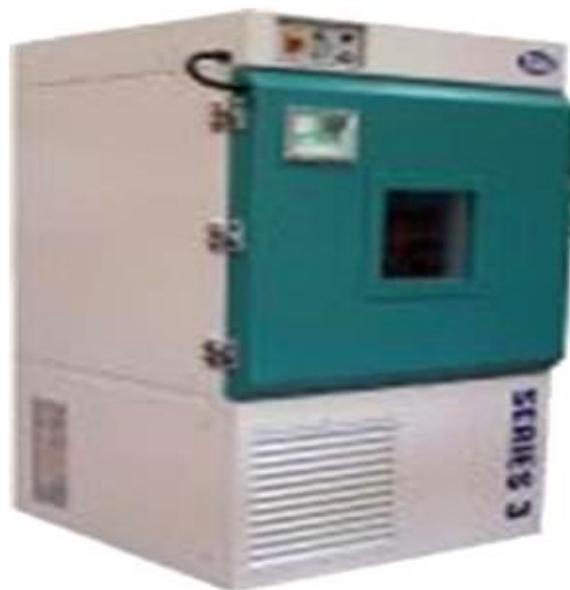
Figure: 3.8 TAS ECO 135 and Series 3 MTCL 600

Simulated environment tests were conducted using environmental chamber TAS LT CL 600 shown in Figure: 3.8.

Each condition shown in Table: 3.4 was operated for 125 hours. In first part of the test, temperature of the chamber was kept constant at 18°C and two values of RH 35% and 55% were used consecutively for 125 hours each. In second part of the environmental test, RH was kept constant at 40% and two temperatures 5°C and 25°C were used consecutively for 125 hours.

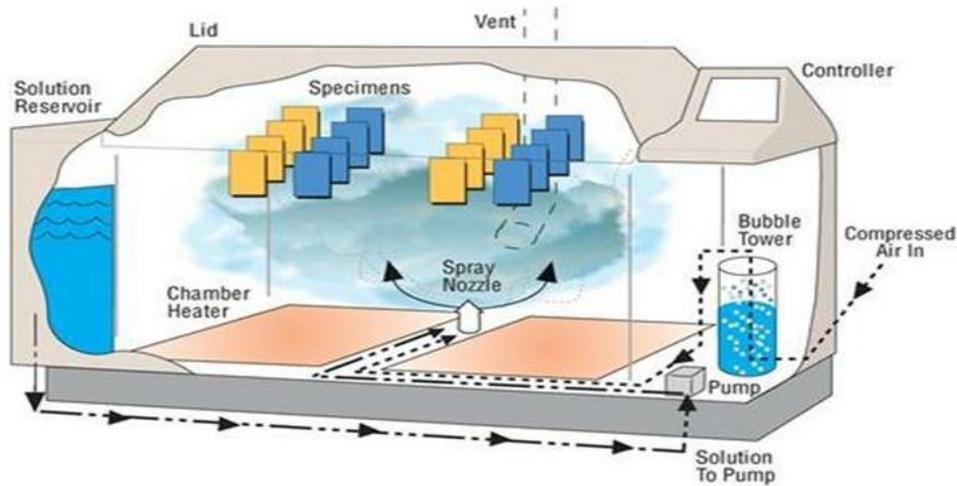
Figure: 3.10 Q FOG Cyclic Corrosion Test Chamber

Samples (23 in total) were inserted in Q FOG<sup>8</sup> cyclic corrosion chamber shown in Figure: 3.10 at the same time, test conditions are provided in Table: 3.5. First set (bare samples) were taken out from the chamber after 48 hours of exposure, the second set at 72 hour while the last was at 264<sup>th</sup> hour.

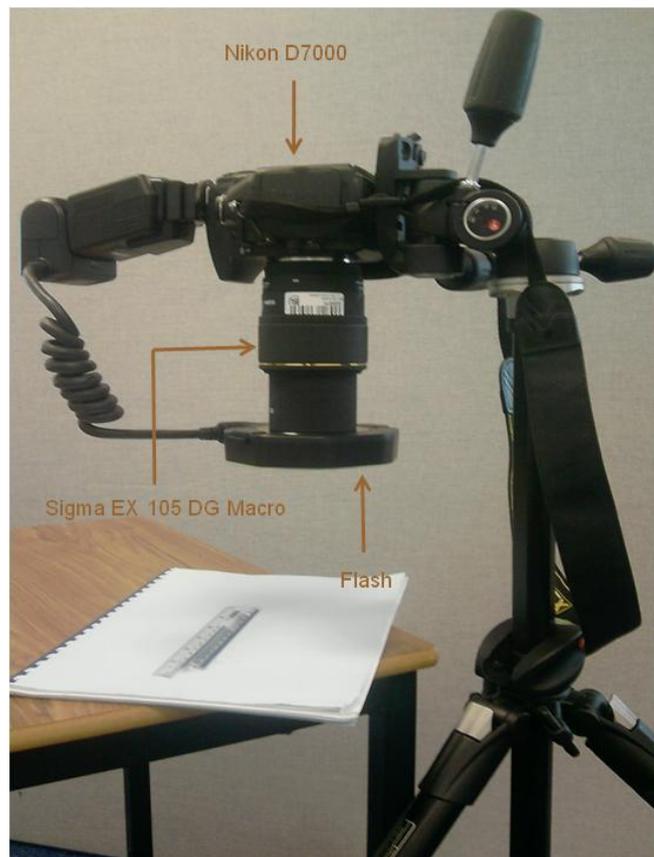
Figure: 3.11 Nikon D7000 Fitted With Sigma EX 105 mm DG Macro

Corrosion was accumulated on the samples after exposure to both simulated environmental and prohesion corrosion tests. Extremely complex morphology was observed in the accumulated corrosion. First high definition images of the samples were taken using Nikon D7000 fitted with Sigma EX 105 mm DG Macro lens shown in Figure: 3.11, secondly these high definition images were analysed through Adobe Photoshop CS5 to quantify corrosion build-up areas.

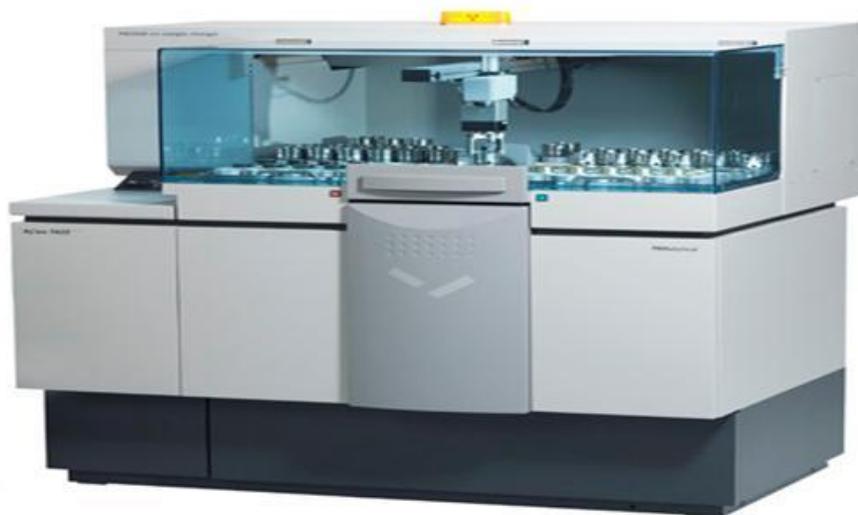
Figure: 3.12 Axios<sup>mAX</sup> X-ray Fluorescence Spectrometer

Material characterisation of the samples was conducted using a PANalytical Axios wavelength dispersive x-ray fluorescence spectrometer illustrated in Figure: 3.12. The measurements were processed using PANalytical's Omnia Standardless Software. WD - XRF is an elemental analysis technique capable of determining the elemental content of various materials including metals, oils, plastics and a variety of powder materials. The standard measurement program takes approximately 20 minutes and contains ten scans to cover the elements from fluorine (F) to uranium (U). All major and trace elements quantitatively analysed.

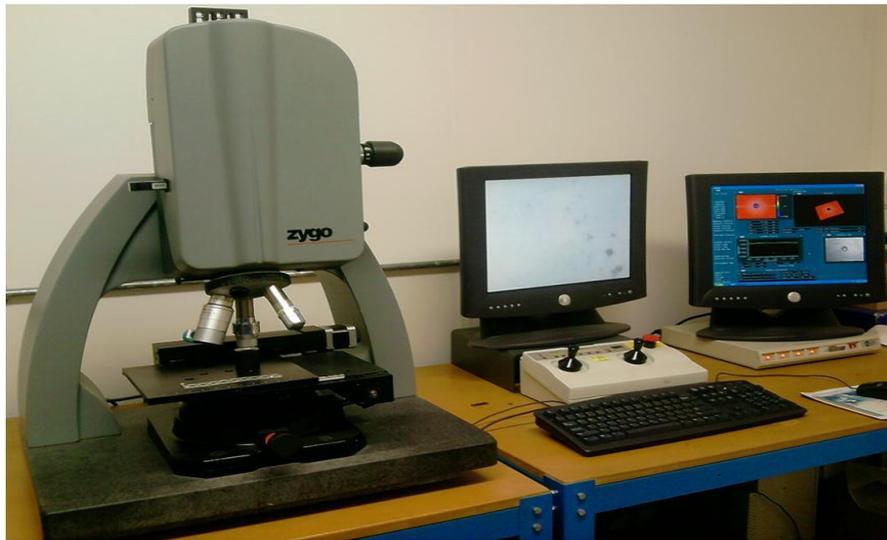
Figure: 3.13 Zygo OMP - 0375G

Surface analyses of the pistons and cylinder-liners were conducted using Zygo OMP – 0375G white light interferometer illustrated in Figure: 3.13. White light interferometry is one of the novel methods to measure surface roughness, shape and waviness of a few millimetres wide sample in a single measurement. Surface roughness, pits and grooves depth, size and periphery of the cracks and the volumes loss can be measured in 3D surface mapping. MetroPro 8.3.3 software was utilised to measure 3D surface defects.

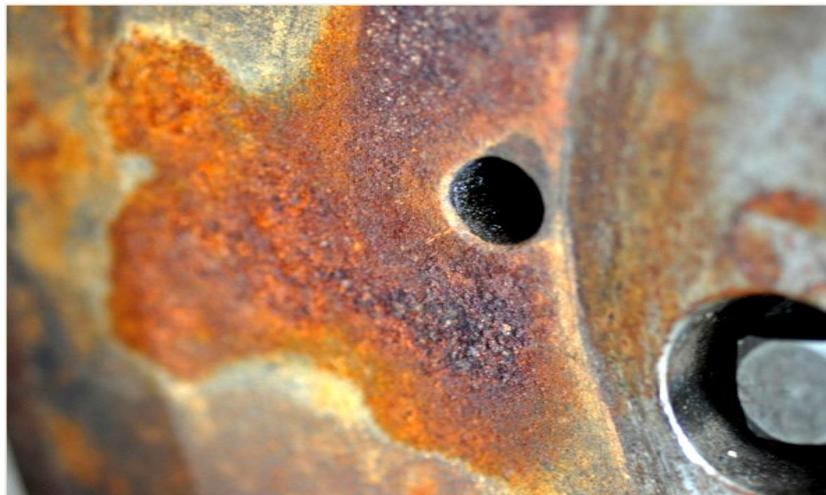
Figure: 4.1 King Tiger's Gear Box Flywheel Showing Signs of Uniform Corrosion

Uniform Corrosion was identified in King Tiger's flywheel Figure: 4.1, Tog II Figure: 4.2 and FT 17 Figure: 4.3. Flywheel of the King Tiger showed the formation and propagation of this type of corrosion. Corrosion was not only confined to flywheel but other gearbox components were also affected. Tog II shown in Figure: 4.2 were amongst the mostly affected tanks with this mode of corrosion. Many part of the Tog II were under attack and the area occupied by corrosion was significant.

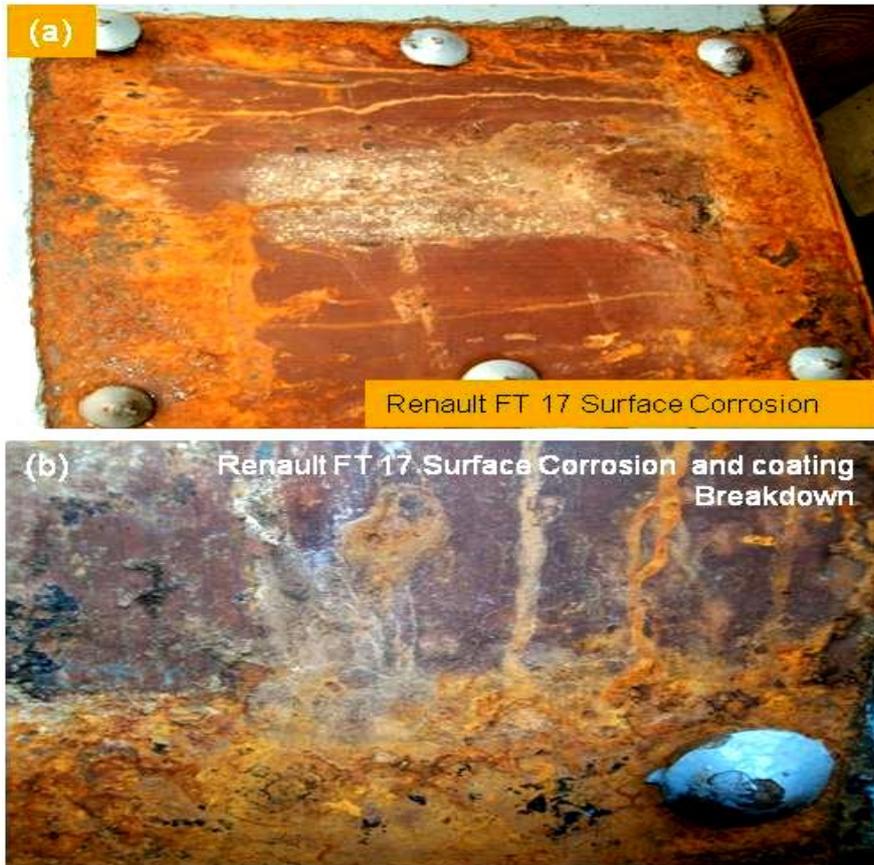
Figure: 4.3 FT 17 Uniform Corrosion

Renault FT 17 shown in Figure: 4.3, was also under the attack of general corrosion. Corrosion on FT 17 is not severe, however if not treated it could result in component degradation [11, 14, 23].

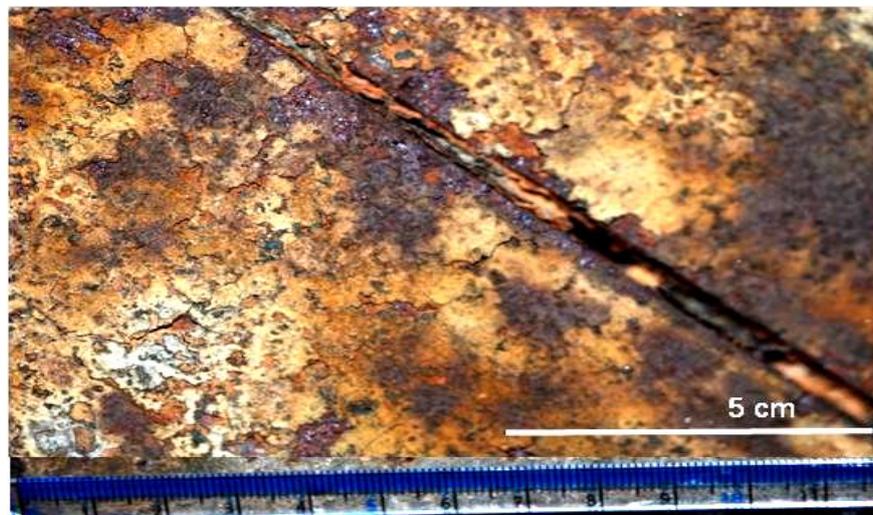
Figure: 4.4 Mark II Uniform Corrosion

Mark II was affected considerably on larger scale through surface corrosion shown in Figure: 4.4. The magnitude of corrosion damage to Mark II structure can be classified as high because majority of the tank structure display accumulation of corrosion.

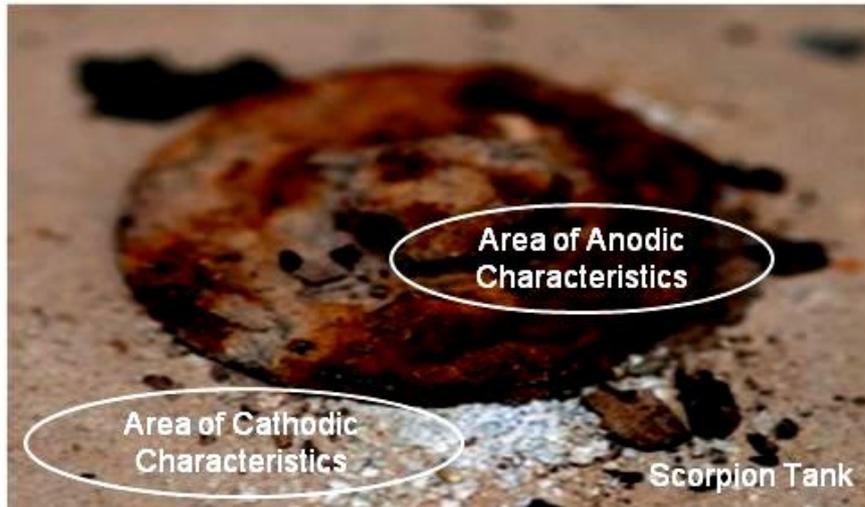
Figure: 4.5 Scorpion Galvanic Corrosion of Washer on the Hull

Galvanic corrosion was observed in the Scorpion shown in Figure: 4.5. The washer and fastener have anodic characteristic and are corroding fast, compare to the rest of the bulk surface.

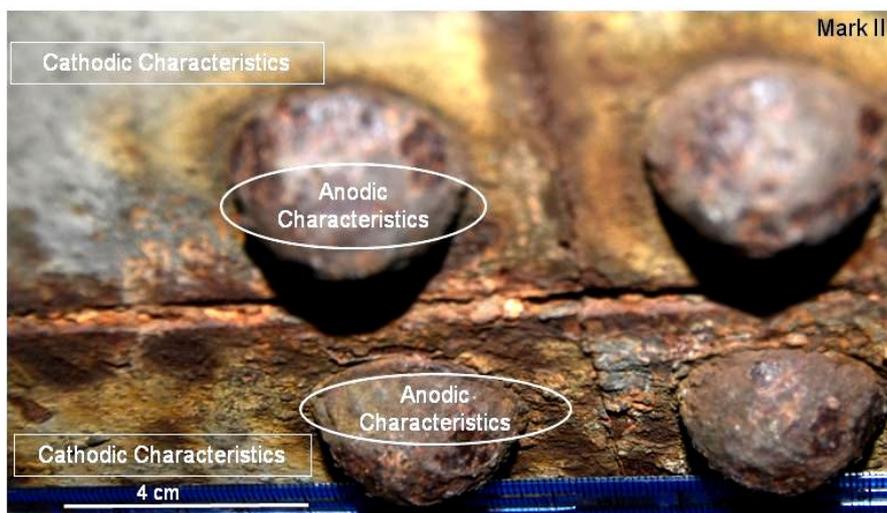
Figure: 4.6 Mark II Glacis Plate Shows Galvanic Corrosion

Mark II Figure: 4.6 also illustrate galvanic corrosion its structure. Bolts' heads show anodic behaviour whereas the rest of the bulk surface could act as cathode. Mark II endures severe corrosion in different forms.

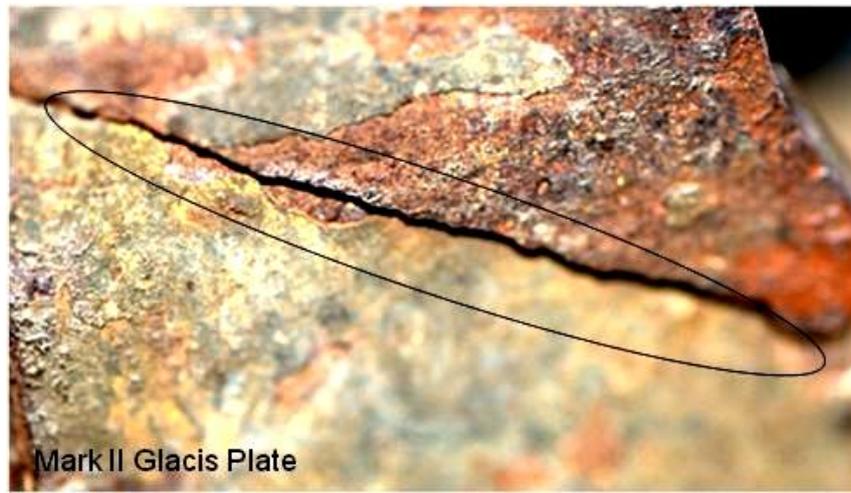
Figure: 4.7 Mark II Stress Corrosion Cracking

Stress corrosion cracking is one of the severe forms of corrosion and their contributions to structures failures are significant. This mode of corrosion was also identified in the tank museum vehicles. Figure: 4.7 from the Mark II glacis plate shows stress corrosion crack penetrating through the surface with no significant material loss on the surface. Also a sub-surface crack was observed in sample collected from the armoured skirt of the Centaur shown in Figure: 4.8. Surface and sub-surface cracks may lead to sudden components failures in both vehicles. High degree of failures leading to catastrophic structural damage may happen unexpectedly [21, 26, 78].

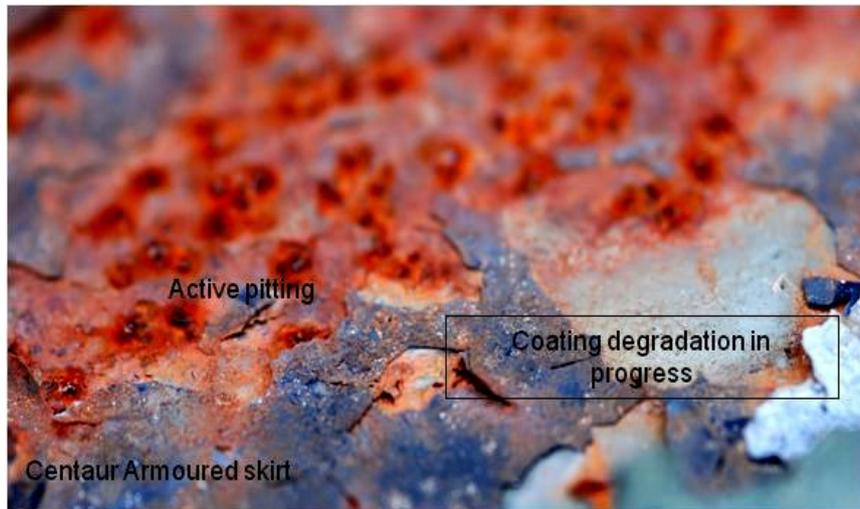
Figure: 4.9 Centaur Pitting in the Armoured Skirt

together. Corrosion mechanism was complex and extreme in the Centaur. Among other forms pitting was also observed in the Centaur shown in Figure: 4.9. Formation of pits were visible on the surfaces, red colour indicate that pitting was progressive. The accumulation of corrosion deposits can be noticed covering the actual pits. This large number of pits will risk the Centaur's integrity [32-35].

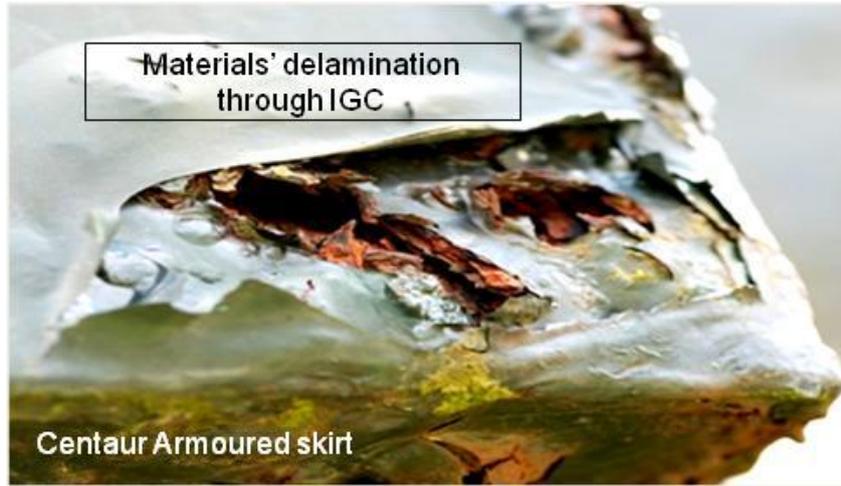
Figure: 4.10 Centaur Signs of Inter-granular Corrosion in the Armoured Skirt

Centaur was badly affected from various corrosion modes. This form of corrosion was also observed in its armoured skirt shown in Figure: 4.10. Inter-granular (IGC) corrosion is a localised corrosion attack on or at the grain boundaries propagating into the material. Anodic dissolution of the grain boundaries is caused by a) regions depleted of alloying elements b) second phase precipitates and/or c) regions with segregated alloying or impurity elements. IGC reduces the toughness of the material at early stage and fracture may occur as a result. Impurities and/or alloying elements at the grain boundaries become galvanic elements due to difference in concentrations. As a result a zone of less noble material in the grain boundaries develops acting as an anode whereas the other parts become cathodic. In  $\text{CuAl}_2$  alloys precipitate at the grain boundaries may become noble than the bulk material causing grain boundary attack [17, 29]. The disintegration of materials through IGC in this form is also referred as leafing or lifting effect. During this process corrosion deposits occupy larger surface area taking the material apart. Figure: 4.11 show the exfoliation of the entire structure leaving behind leaf like structure.

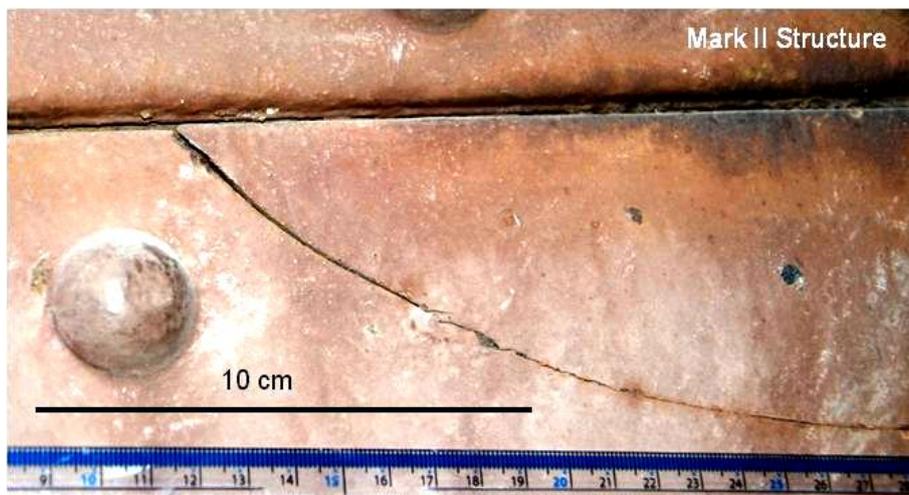
Figure: 4.12 Mark II Corrosion Fatigue

Corrosion fatigue failure was observed in the structure of Mark II shown in Figure: 4.12. This mode of failure is often the result of fatigue accelerated and simulated by corrosion. Fatigue under corrosion may reveal beach marks but usually they may be less visible due to corrosion products on the affected surface [17, 38]. In the Mark II, a long crack with noticeable widening and size was observed. The crack appears to be initiated as a result of “dry fatigue”. There is a lower limit for stresses causing fatigue in structural steels under dry fatigue known as fatigue limit. When corrosion is introduced two effects can be developed a) the number of cycles to fracture decreases and fatigue limit is reduced, and b) the number of cycles to fracture becomes dependent on load frequency. The crack development can be divided into four stages 1) Initiation 2) Crack growth stage I, with crack growth direction about 45° relative to the tensile stress direction 3) Crack growth stage II and 4) Fracture. Figure: 4.12 of the Mark II appear to be a failure. Growth of cracks is expected under corrosive environment and in the presence of cyclic loading [17, 39-41].

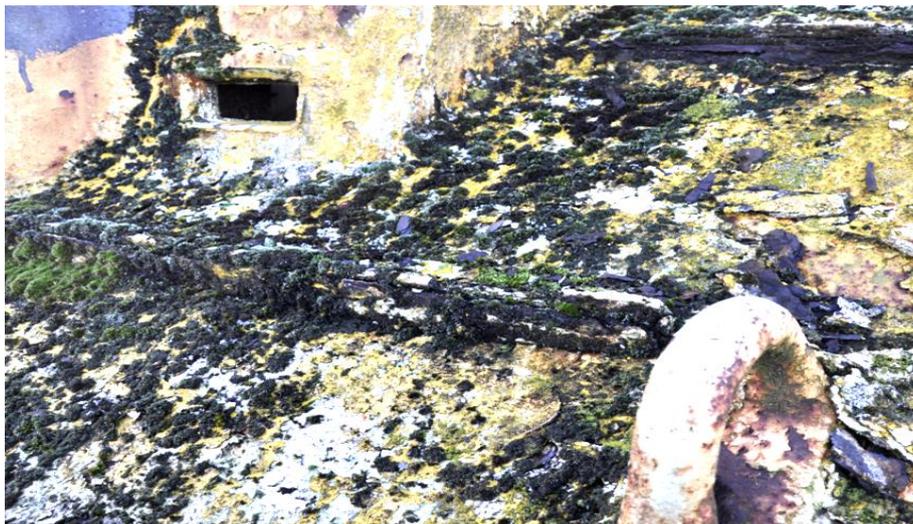
Figure: 4.13 Sherman Target Tank - Accumulation of Moss and Vegetation could result in Microbial Corrosion

Microbial corrosion is referred to the degradation of metals because of the activities of the bio-organisms. Micro and macro organism in various environments, such as industrial, seawater, soils, and natural petroleum products contribute to corrosion. Figure: 4.13 of the Sherman outside the museum in an uncontrolled environment shows accumulation of moss and vegetation on its surfaces. In such environment the growth and multiplication of a wide range of microbial species is possible. This surface condition can be a source of carbon food, nitrogen and phosphorous. Microbes decompose organic and mineral matter and precipitate in the cycle of carbon, nitrogen and sulphur. Many microbes can adapt to temperatures between (-10°C) and 99°C, pH range of 0% to 10.5% and concentration of oxygen between 0% to almost 100%. These species produces mineral and organic acids leading to a corrosive environment on the surfaces [19, 81]. These species also form microbiological surface colonies and establish bio-films. Such bio-films on the surfaces become corrosive and material degrade rapidly [42-44].

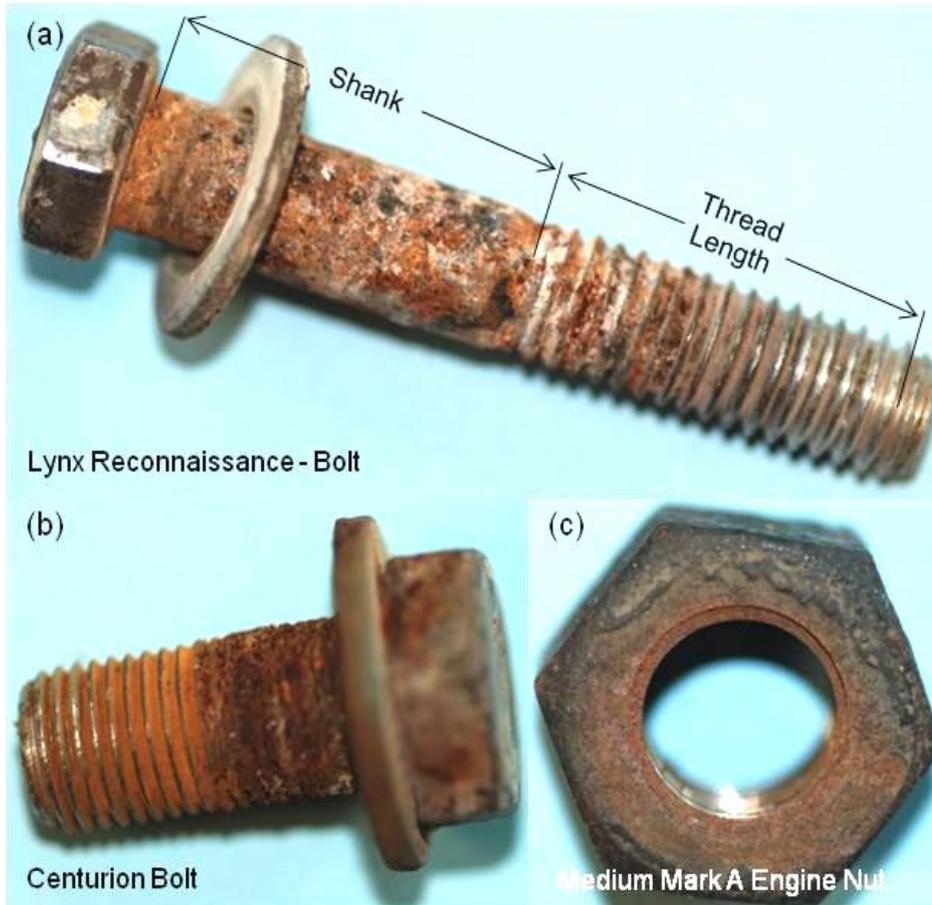
Figure: 4.14 Crevice Corrosion

Crevice corrosion was identified in the Centaur, Centurion, Tiger 1, Comet, Sherman, Renault FT 17, Lynx Reconnaissance and Medium Mark A - Whippet. Figure: 4.14 an example of crevice corrosion in (a) Lynx (b) Centurion and (c) Medium Mark A.

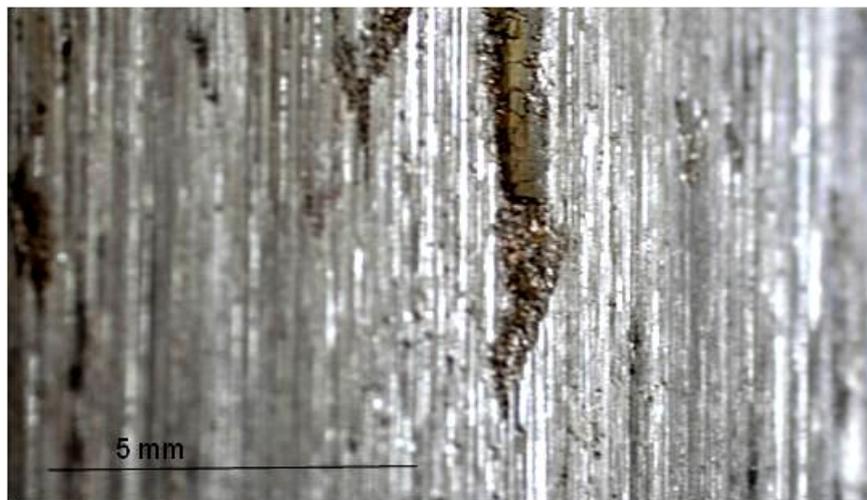
Figure: 4.16 Tiger 1 Piston Skirt Thrust Face

Tiger's engine piston Figure: 4.16 and connecting rod Figure: 4.17 show wear scars due to mechanical surface interactions. Scuffing is visible on the piston's surface and surface integrity has been lost completely [83]. Materials composition, failure in lubricants and elevated temperatures play a vital role in such failures. Wear of Tiger 1 pistons and cylinder-liners has been discussed in more detail in chapter 8.

Wear was also an important factor towards component failures. Tiger 1 engine showed tribological related issues in its various components as shown in Figure: 4.16 and Figure: 4.17. Tiger 1 operates occasionally; when it is stationary there is a possibility of corrosion build-up in the engine, an example is shown in Figure: 4.22 of the Tiger 1 cylinder-liner. Corrosion and wear together will have a detrimental impact on the engine performance. High rate of wear occurs initially when the engine starts to function and/or when engine operates cold or extremely hot. The combined damage of corrosion and wear "corrosive wear" will be significant for the Tiger's engine components [84]. In dry contact conditions when engine starts to function will further facilitate failures.

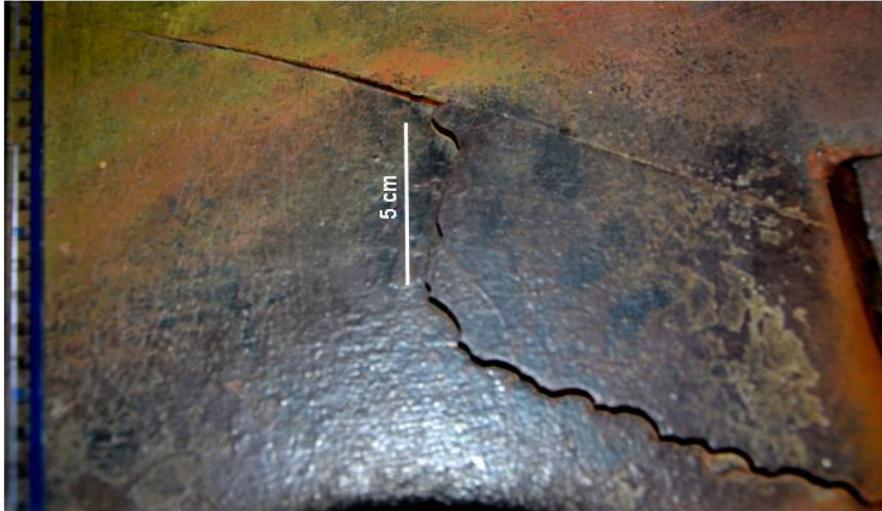
Figure: 4.18 Mark II Fatigue Cracks

Various types of cracks were identified in some vehicles. Mark II glacia plate Figure: 4.18 and Jagdpanzer's armoured skirt Figure: 4.19 were mostly affected by various types of cracks. The cracks are converted into fractures, their sizes are considerably large and would cause rupture in the structures.

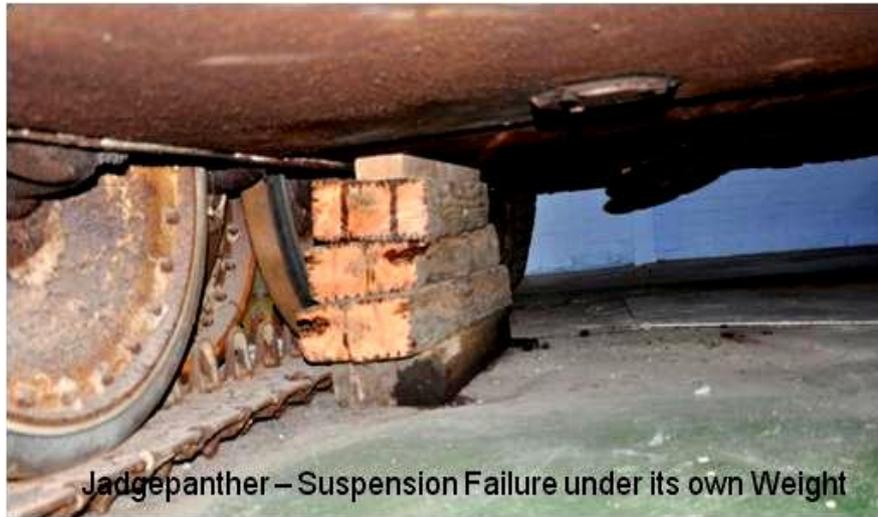
Figure: 4.20 Jadgepanther

Stresses are major contributors to the aging of large metal structures and were noticed in some tanks. Compressive stresses were observed in Jagdepanther (Figure: 4.20) and Challenger 2 (Figure: 4.21). The body weight has causing enormous stress on the suspension of the vehicles. Conventional methods to overcome these issues are in practice.

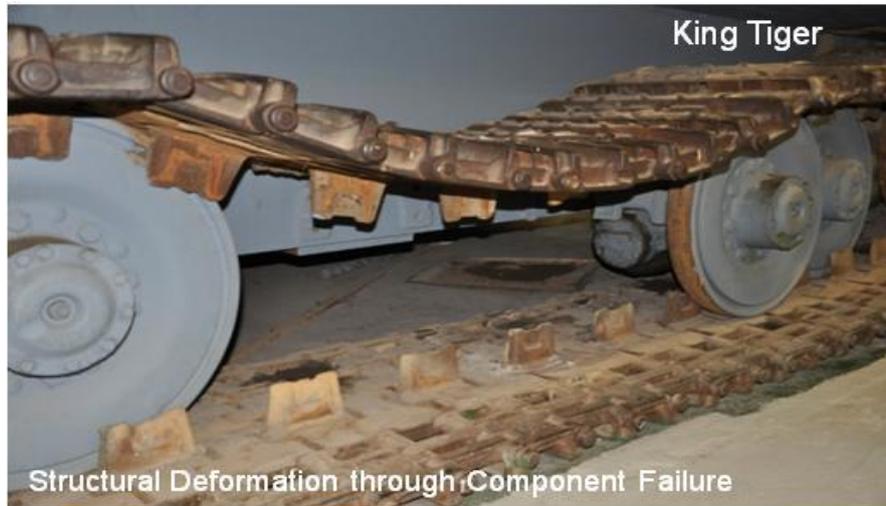
Figure: 4.23 King Tiger - Structural Deformation due to Component Failure

Structural deformation due to component failures was also observed in some vehicles in the museum. The King Tiger shown in Figure: 4.23.

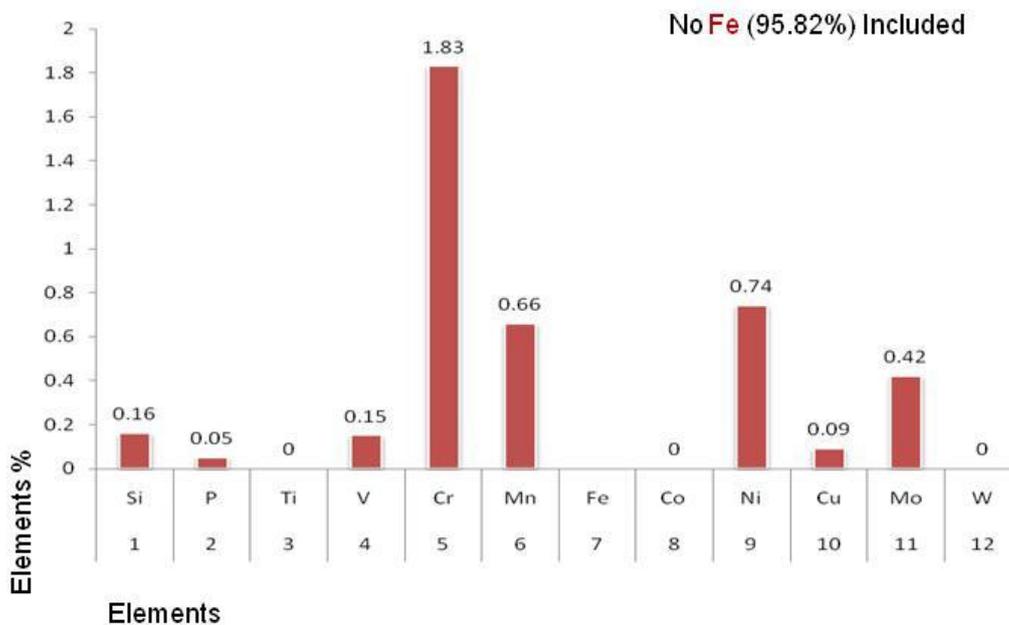
Figure: 5.4 Centaur Sample - 4 XRF of Cross Section at Point D

Figure: 5.4 show XRF of point D at the cross section. Fe (95.82%) was the highest; Cr (1.83%) was the second highest while P (0.05%) was lowest. No traces of Ti, Co and W were found.

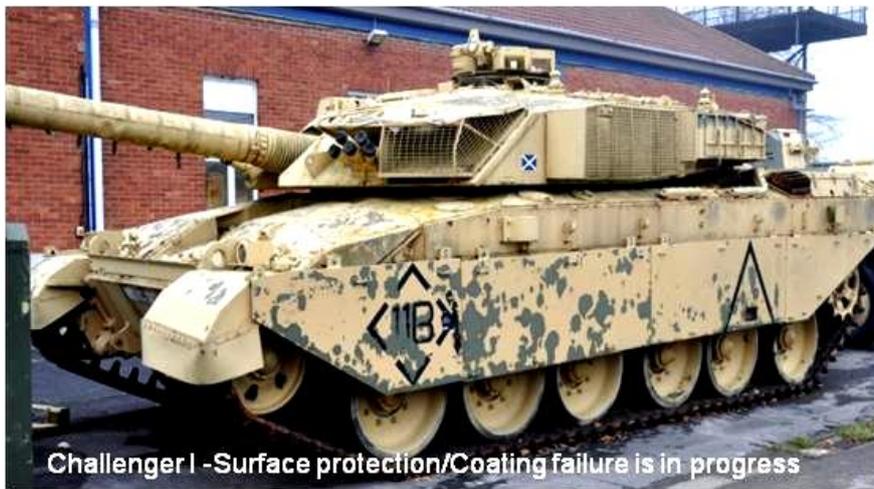
Figure: 7.5 Challenger I Surface Protection Breakdown

Corrosion problems are primarily associated with failures in the surface protection/coating. Failures in the coating were also a common occurrence in the museum vehicles. Figure: 7.5 demonstrate surface protection breakdown in the Challenger I.

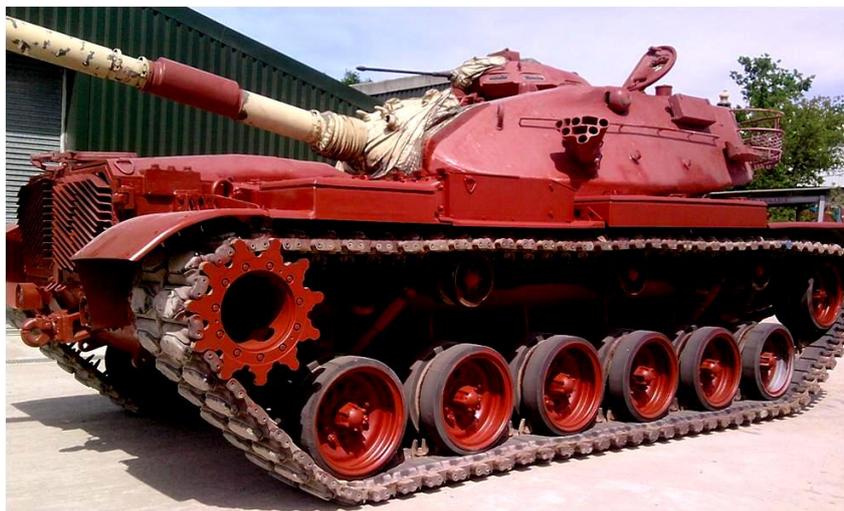
Figure: 7.6 M 60 A3 - Application of Red-Oxide Primer

The Tank Museum deploys Red-oxide (colour red) as primer shown in Figure: 7.6, and Air Drying Alkyd (colour green) as coat on the tanks surfaces.

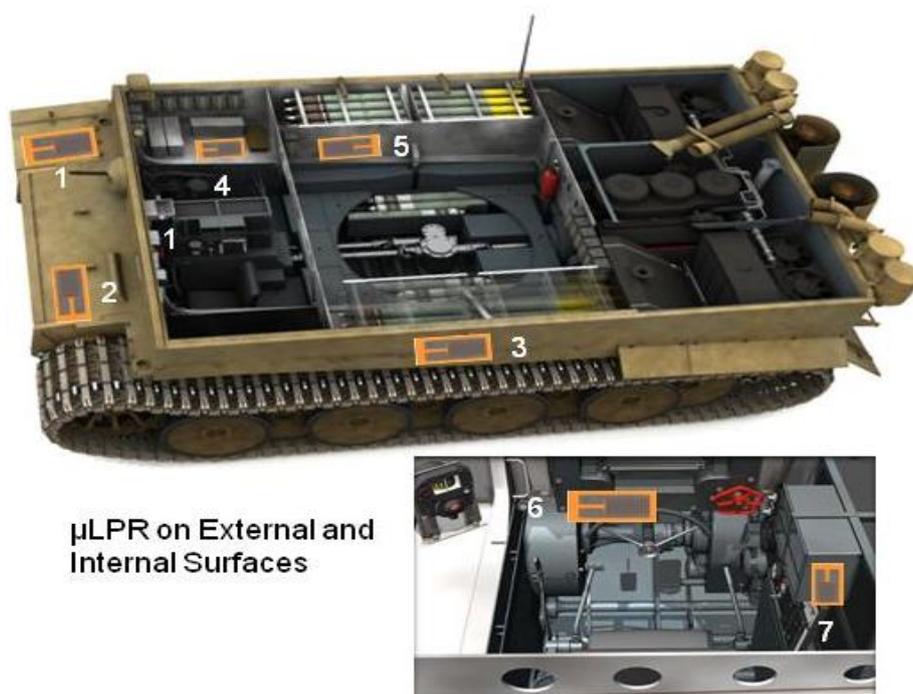
$\mu$ LPR on External and Internal Surfaces

16  $\mu$ LPR corrosion sensors are acquired during this research and are ready to be installed. Also a frame work of in-situ corrosion monitoring, has been designed to install 16  $\mu$ LPR on two high value tanks (8 sensors on each tank). 8 sensors attached to data collection node (Figure: 10.1) will be used to monitor corrosion continuously or at regular intervals. Corrosion data under various environments from the data acquisition node can be transferred to a computer for evaluation. Figure: 10.2 illustrate the proposed model of in-situ corrosion monitoring for the Tiger 1.

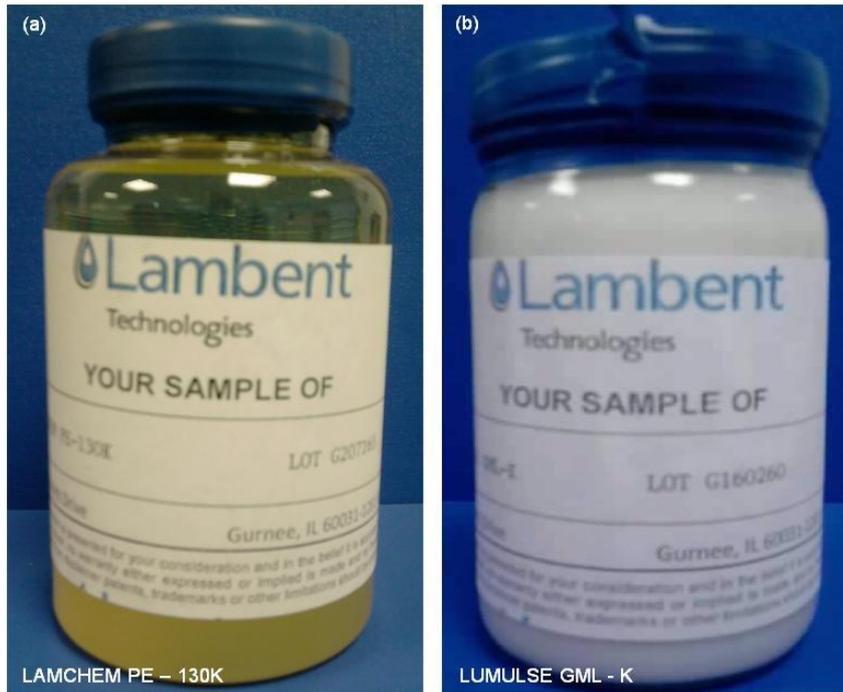
Figure: 10.3 Corrosion Inhibitors

Further research is needed to investigate state-of-the-art corrosion inhibitors. They must be environmentally friendly, robust and their application on the components may not alter the originality of the artefacts. For these purpose novel corrosion inhibitors LAMCHEM™ PE - 130 K and LUMULSE GML K GLYCEROL ESTER shown in Figure: 10.3 are obtained. These corrosion inhibitors can be added around 1% into vegetable or mineral oil and then applied to the corrosion affected surfaces. These inhibitors are useful for the tanks surfaces which still have the original coating, and removal of the original paints is not favoured. Experimental research to evaluate the durability of these corrosion inhibitors under real museum environment is suggested.
