**The Maritime Archaeology of a Modern Conflict:**

**Comparing the Archaeology of German Submarine Wrecks to the Historical Text**

**Innes McCartney**

**PhD by Thesis**

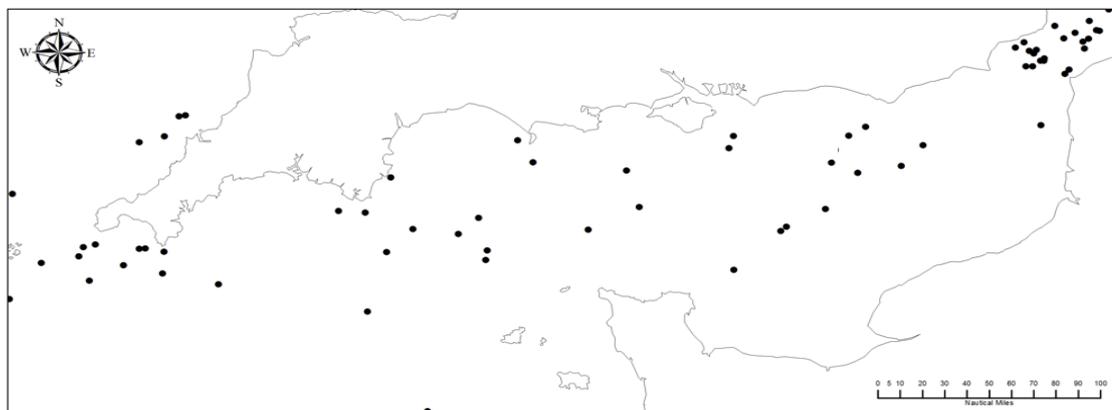
Figure 1.1. The boundaries of the Study Area of this thesis also showing the distribution of the known U-boat wrecks as of July 2013 (Innes McCartney).

With this in mind, the boundaries of the Study Area were set broadly as the English Channel. The actual boundaries were defined as 6 deg 22 min West, 1 deg 55 min East, 49 deg 0 min South, 51 deg 15 min North (see Figure 1.1). These are broadly the boundaries of Chart No. 2675 (Hydrographics Department of the Admiralty, 1999), truncated in the deep waters inaccessible to diving in the far south and west, but with the North Cornwall coast added. These borders therefore constitute an area where all three of the criteria above are satisfactorily met. Over the last decade, the waters along the North Cornwall coast have been surveyed for the first time since the nineteenth century and are included in this study because of the surprising discovery of four U-boat wrecks in an area thought to have no U-boat losses in either war.

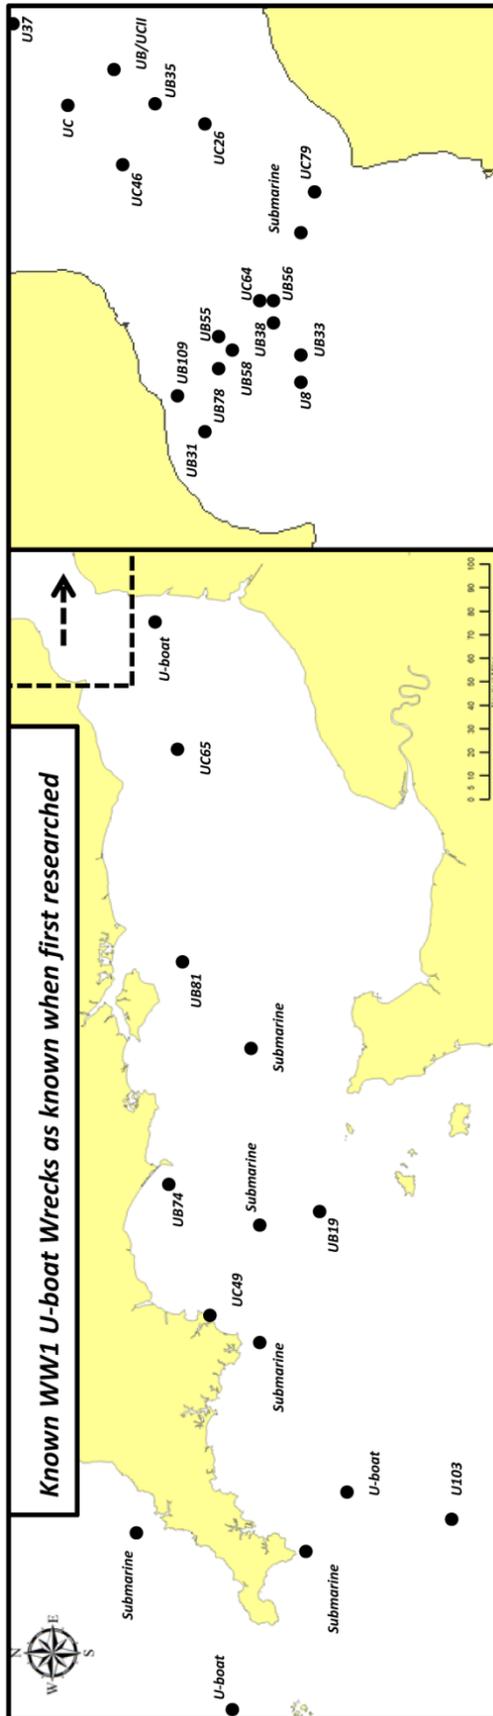
Figure 1.3. The 32 known U-boat wrecks of WW1 in the Study Area with identities of each site as known when initially researched by the author. These form the basis of the archaeology examined in Part Two, WW1 (Innes McCartney GIS base map).

By comparing Figures 1.2 and 1.3 it becomes apparent that there are discrepancies between the two sets of data. There are five fewer wrecks than the 37 listed in 1919. Moreover the pattern of dispersal is different. For instance Figure 1.2 does not show any U-boats lost in the Bristol Channel and Scilly Isles, but Figure 1.3 shows there are known WW1 losses in those areas. It will be noted that Figure 1.2 shows two U-boats sunk very close to the French shore; *UB26* and *UC61*. These were salvaged during the war and therefore are not present on Figure 1.3.

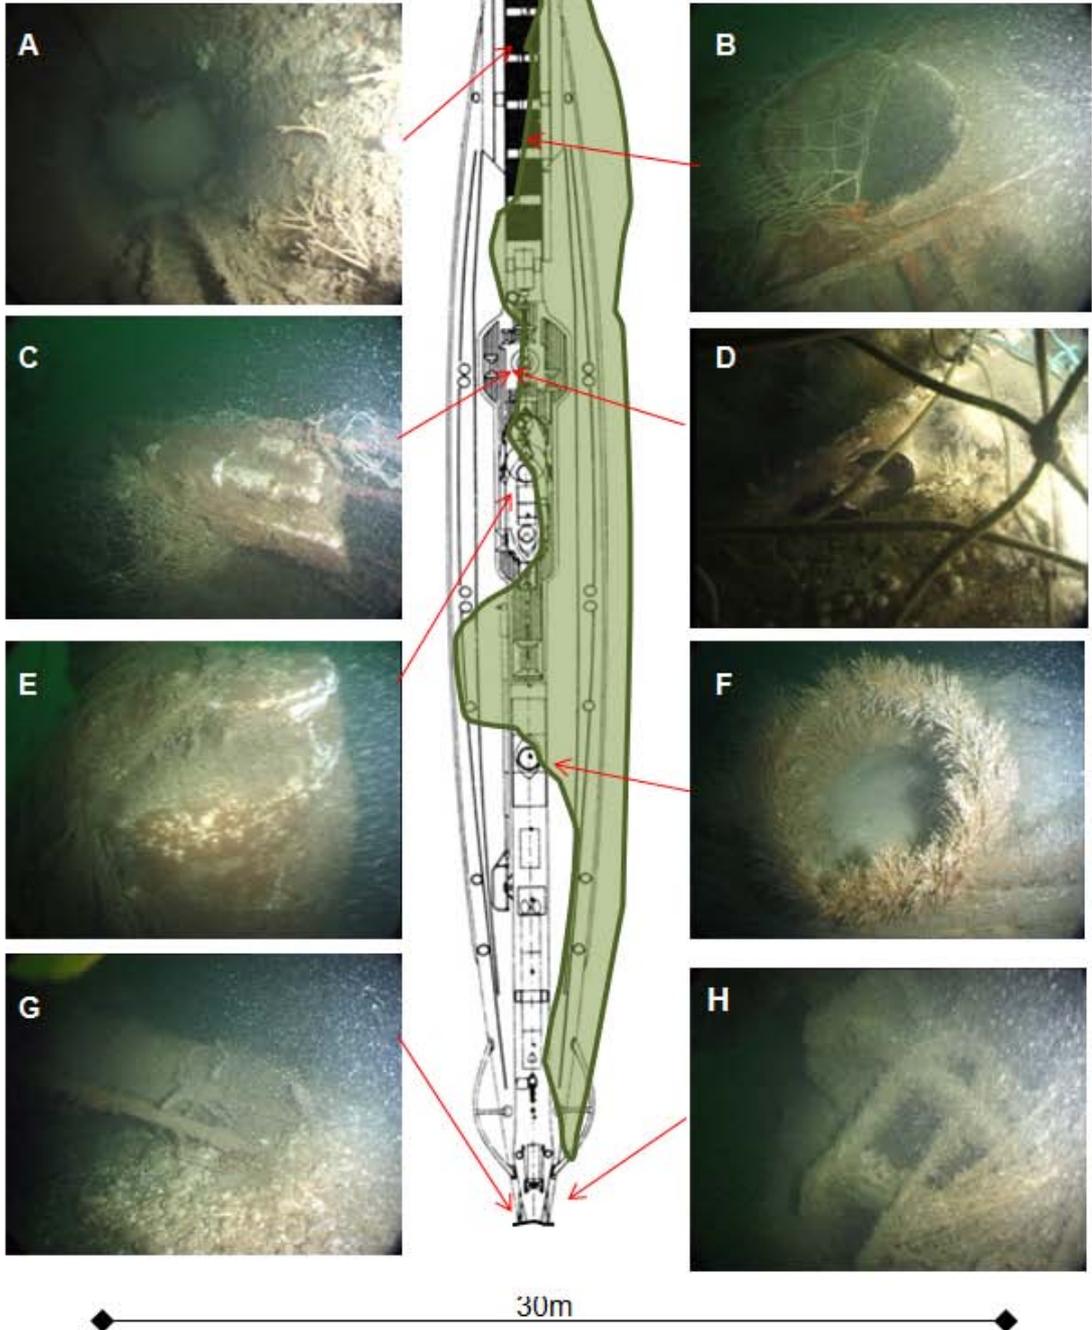
Figure 1.8. Diagram of the wreck of UC46 showing its key features as surveyed and described in the text (Innes McCartney, line diagram adapted from Rössler 1989, 52).

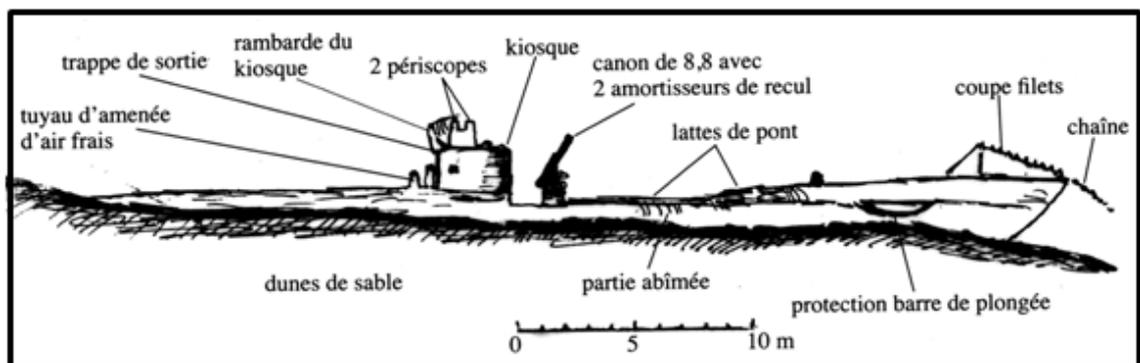
Figure 1.9. Sketch of the wreck of *UB56* showing its key features as seen by Alain Richard (Richard & Lugiez 2010, 169).

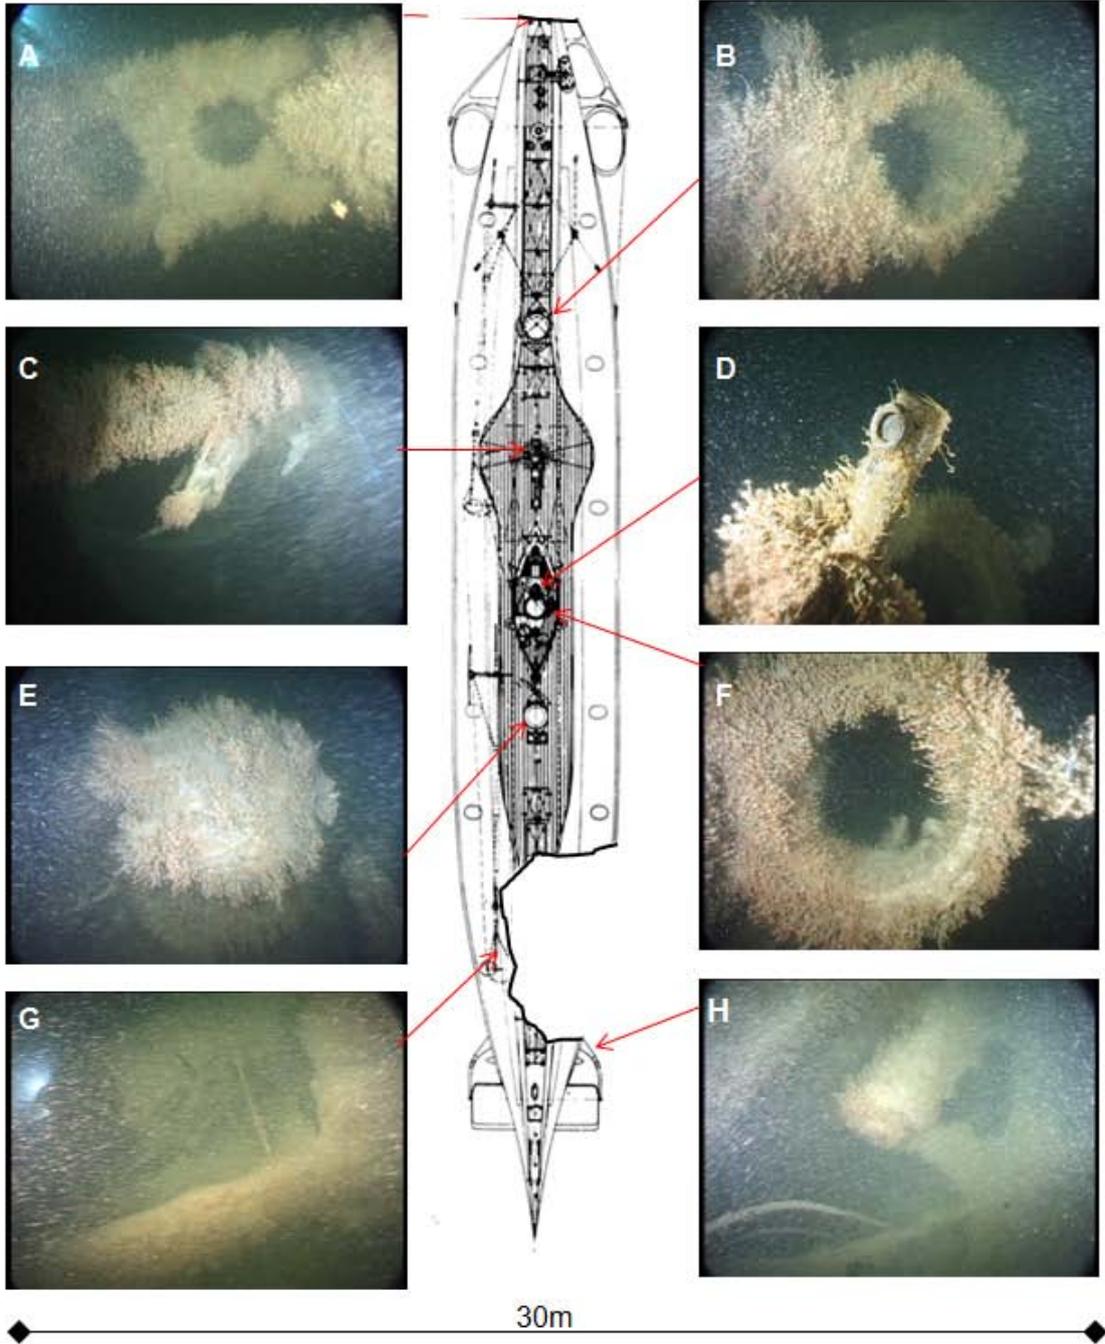
Figure 1.10. Diagram of the wreck of UB38 showing its key features as surveyed and described in the text (Innes McCartney, line diagram adapted from Rössler 1989, 51).

- Image B: The forward hatch is where one would expect to find it. In this instance it is open, probably as a result of corrosion, or possibly it was forced open by the mine explosion;

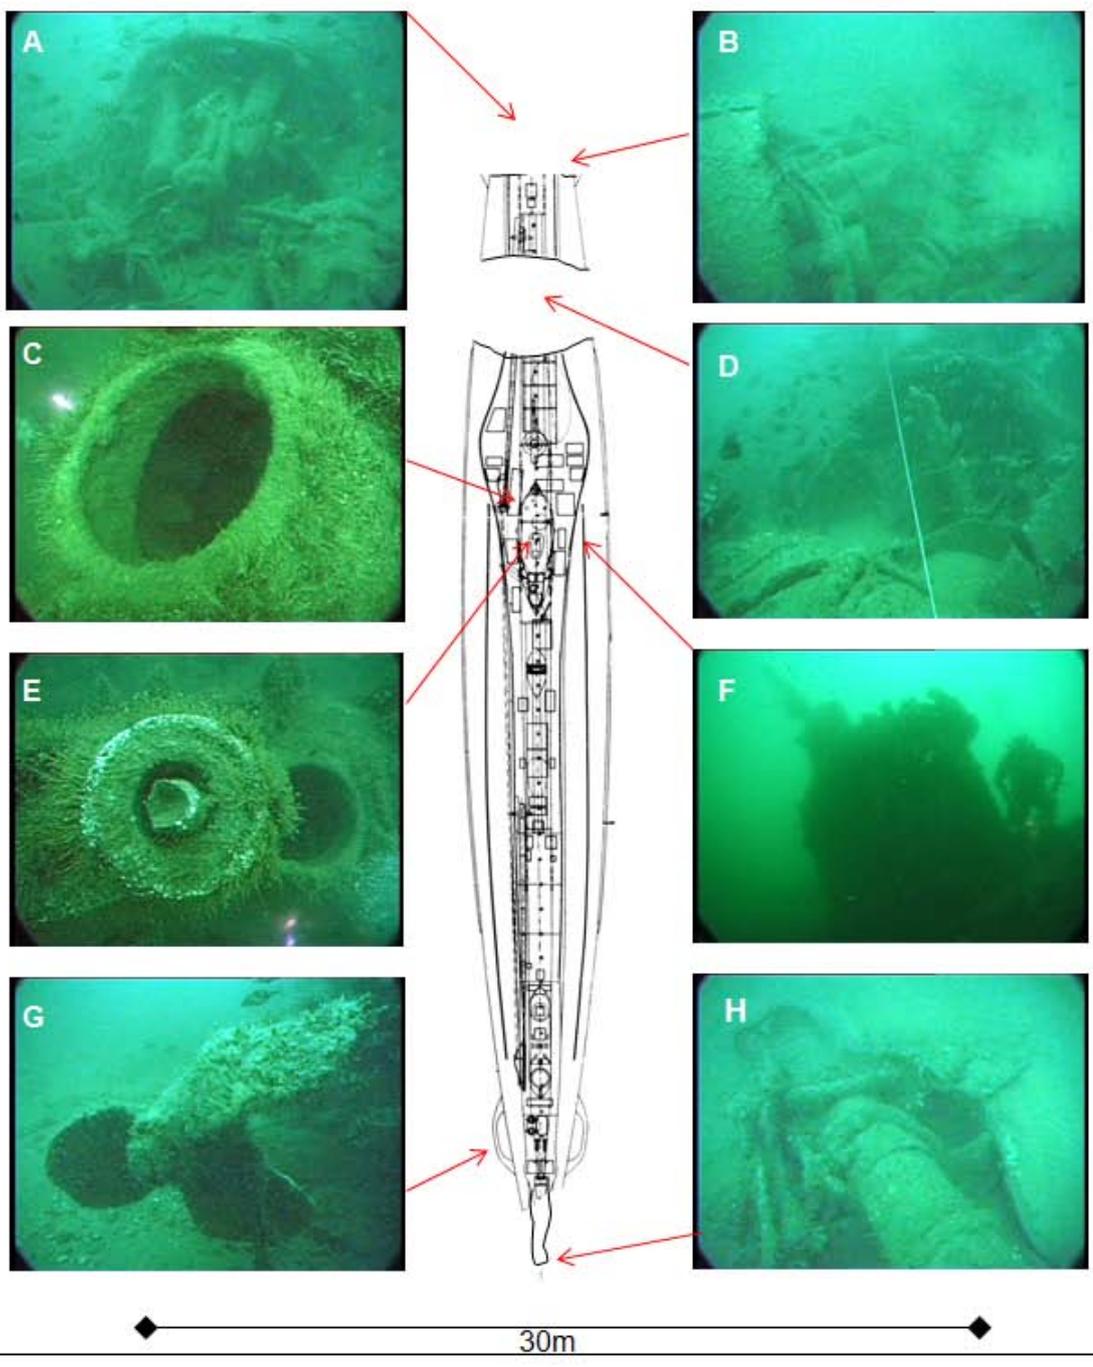
Figure 1.13. Diagram of the wreck of UB55 showing its key features as surveyed and described in the text (Innes McCartney, line diagram adapted from Rössler 1989, 56-57).

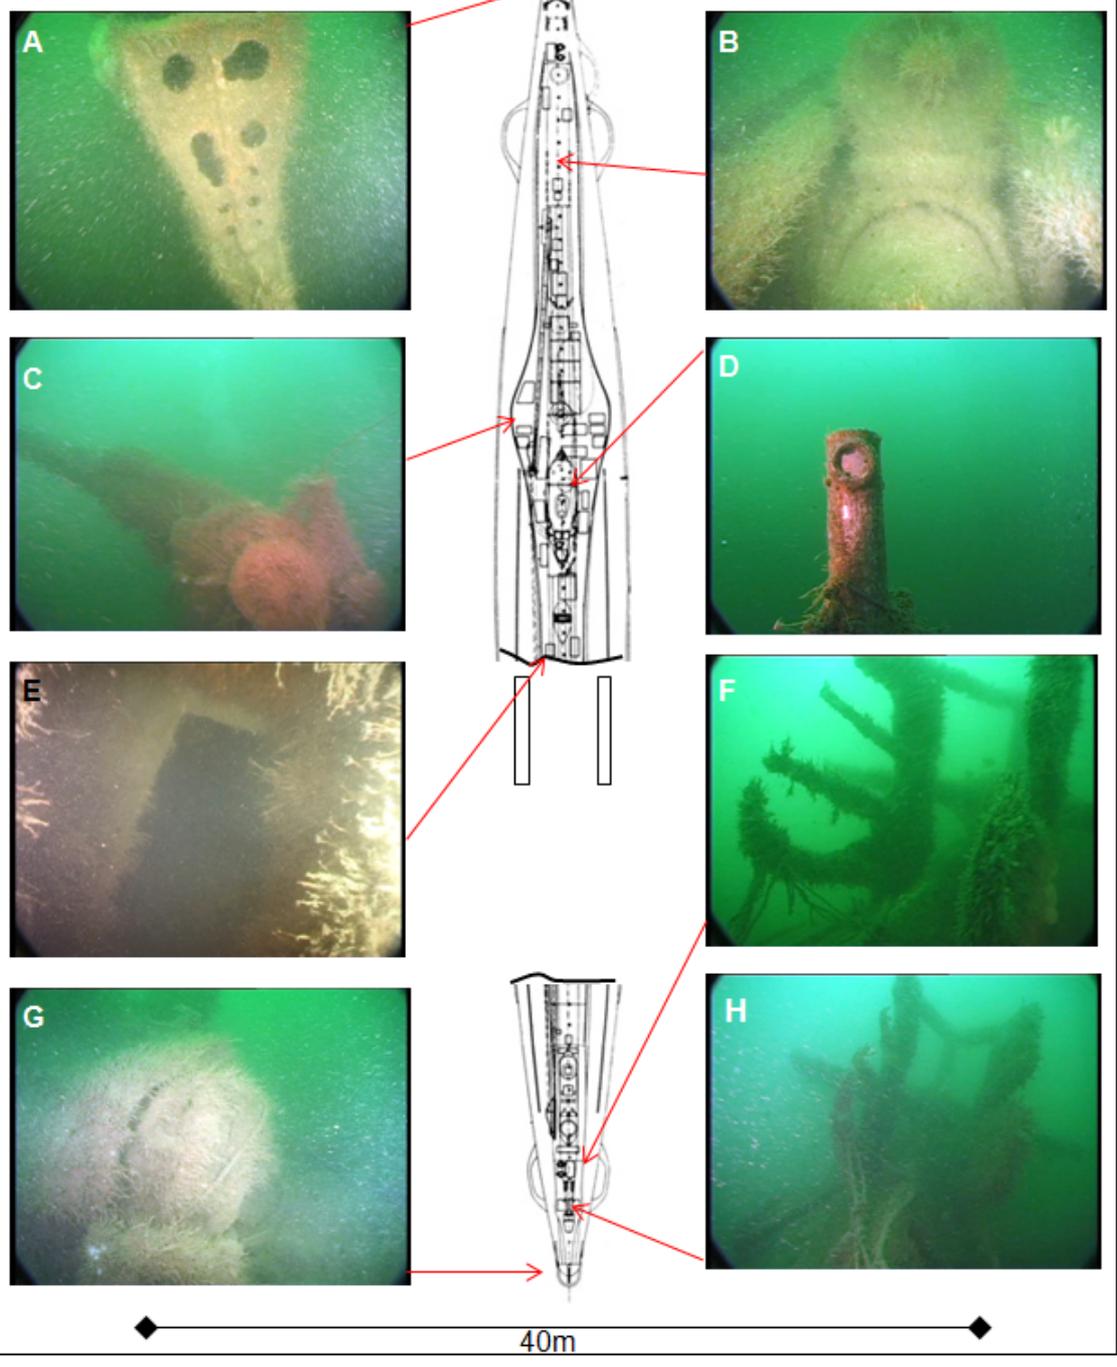
Figure 1.14. Diagram of the wreck of UB109 showing its key features as surveyed and described in the text (Innes McCartney, line diagram adapted from Rössler 1989, 56-57).

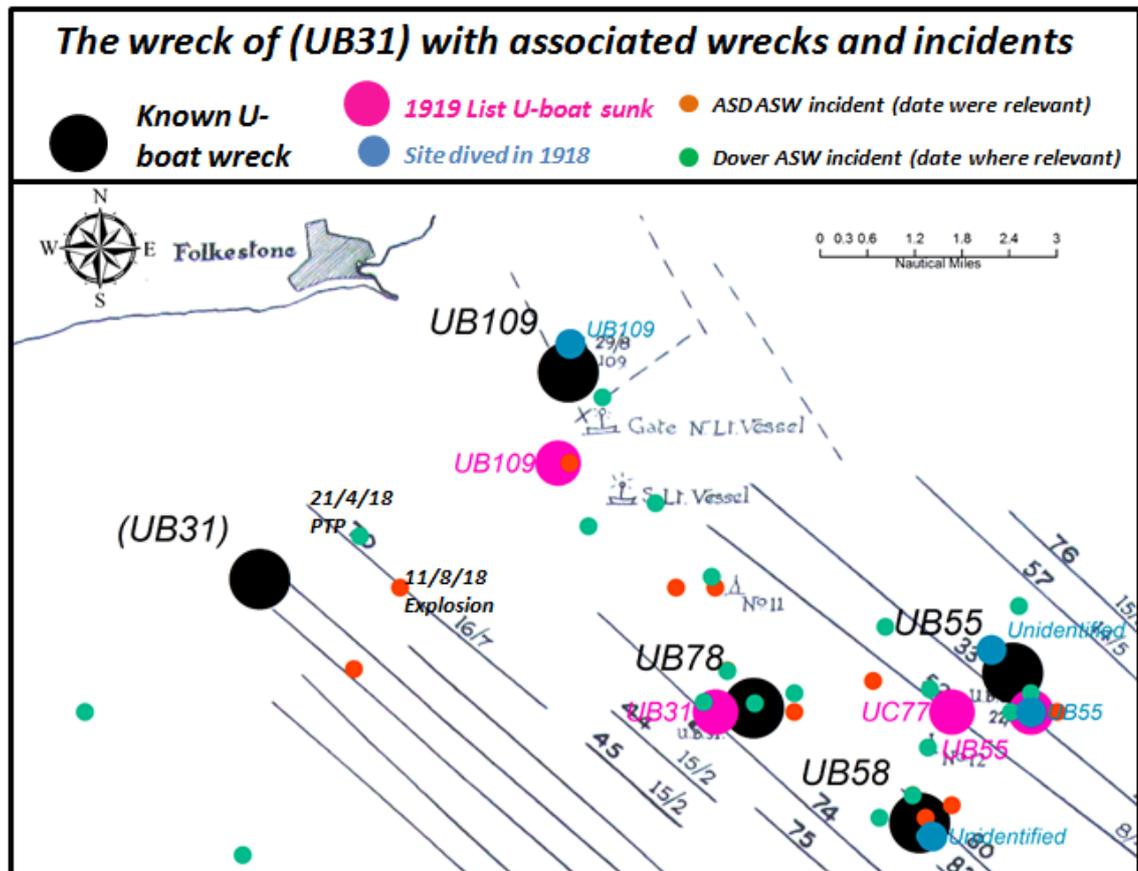
Figure 1.15. Diagram showing the location of the wreck of (UB31) and associated wrecks and incidents as described in the text (Innes McCartney GIS base map data overlaid on Chart No XV of Leith, 1920).

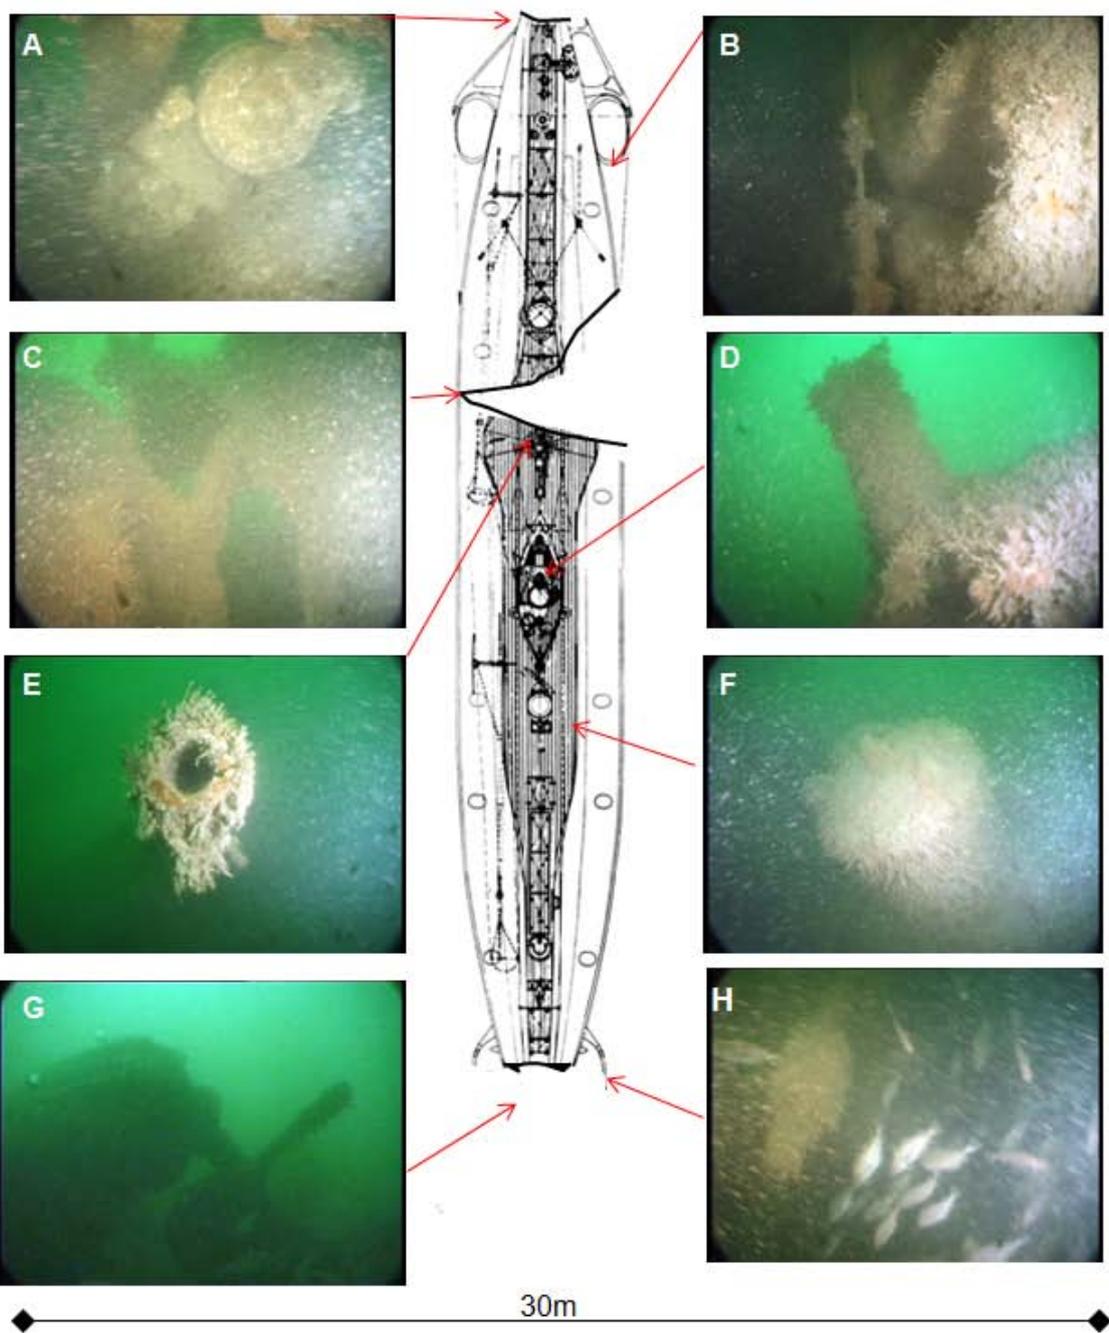
Figure 1.16. Diagram of the wreck of (UB31) showing its key features as surveyed and described in the text (Innes McCartney, line diagram adapted from Rössler 1989, 51).

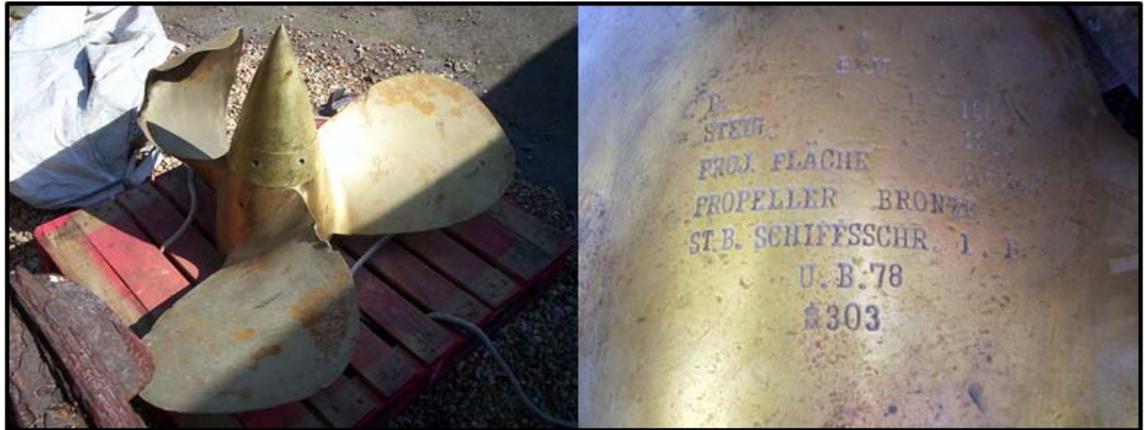
Figure 1.18. One of *UB78*'s propellers prior to being donated to a museum in Germany. The Blohm & Voss shipyard stamp and identity of the U-boat can be clearly seen on the boss (photos: Paul Oliver).

According to the Hydrographic Office record above, the wreck was located by survey in 1977 and confirmed to be a submarine by divers in 1982. Like many of the other U-boats in the shallow waters off Dover, the propellers were removed by divers at some time after its discovery and one of them has now been donated to a museum in Germany. They both revealed that the U-boat was UB78 (see Figure 1.18). This was a surprise because it was listed as being sunk by ramming off Cherbourg on 9 May 1918 (McCartney 2003, 155). We know from the

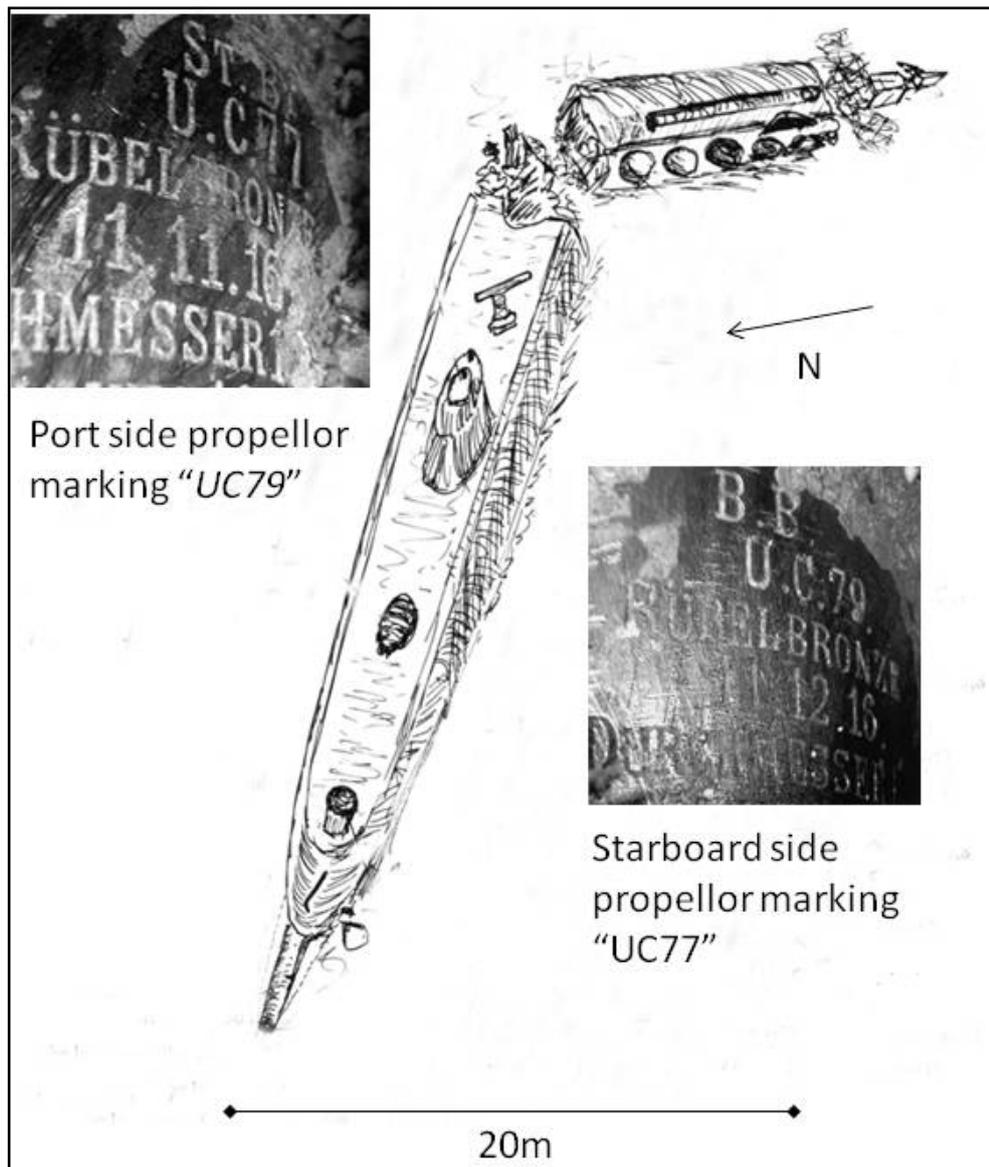
Figure 1.21. Drawing of the wreck of (UC79) with photos of the propeller markings taken from the wreck site (Images from Richard 2007, 157-161).

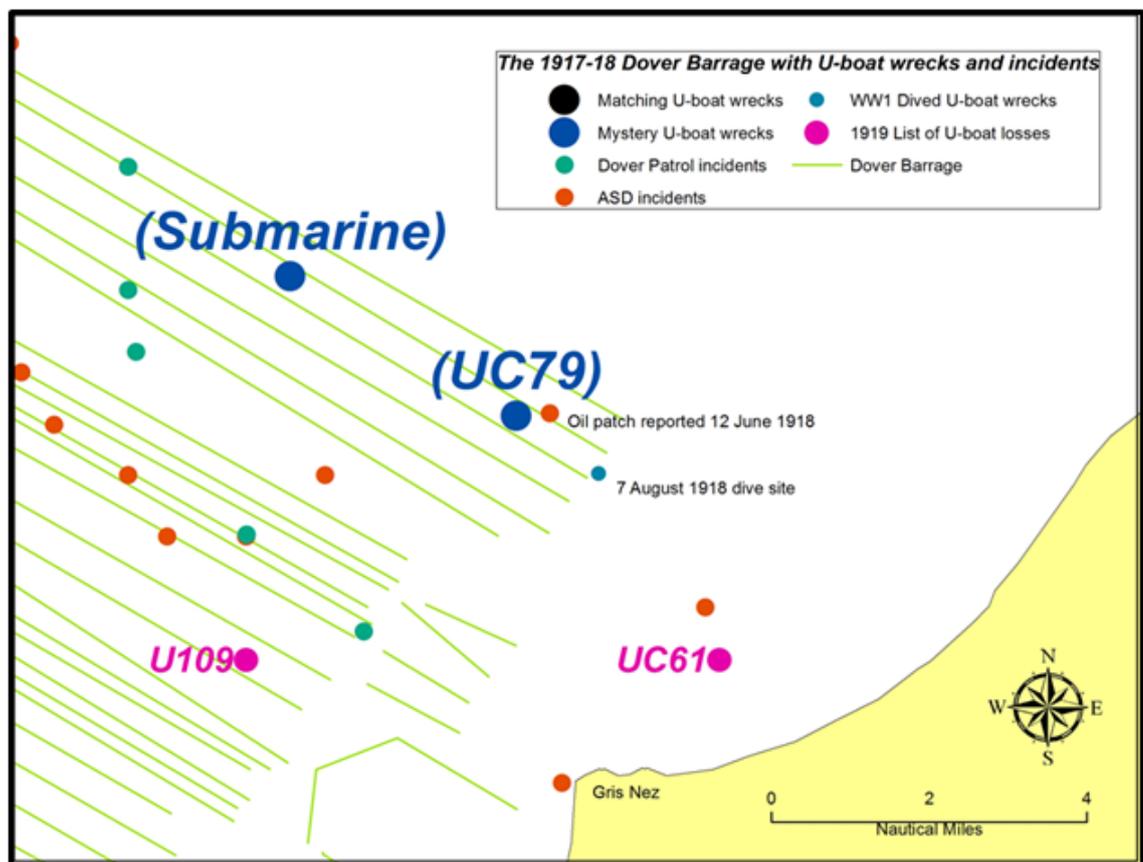
Figure 1.22. Map showing the location of the wreck of *UC79* in the Dover Barrage and the related oil patch and 1918 diving site related to it (Innes McCartney GIS base map).

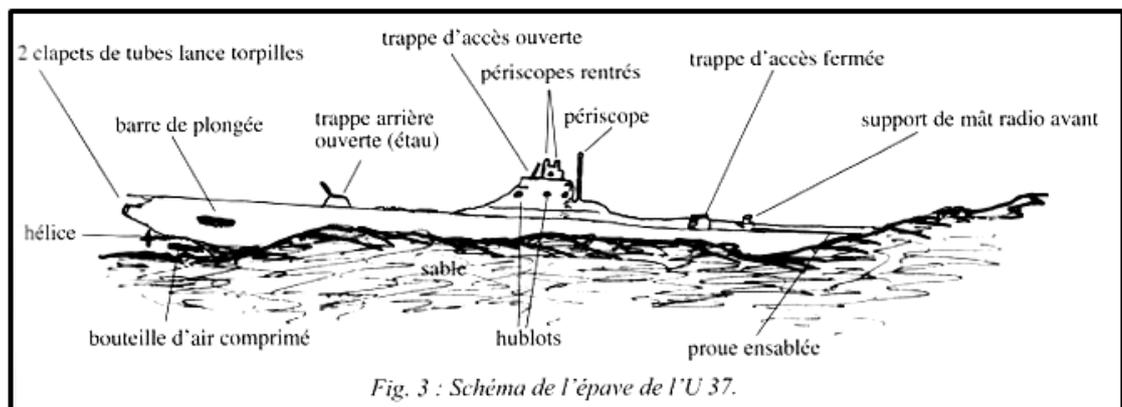
Figure 1.23. Alain Richard's drawing of the wreck of U37 showing its key features. (Richard 2010, 59).

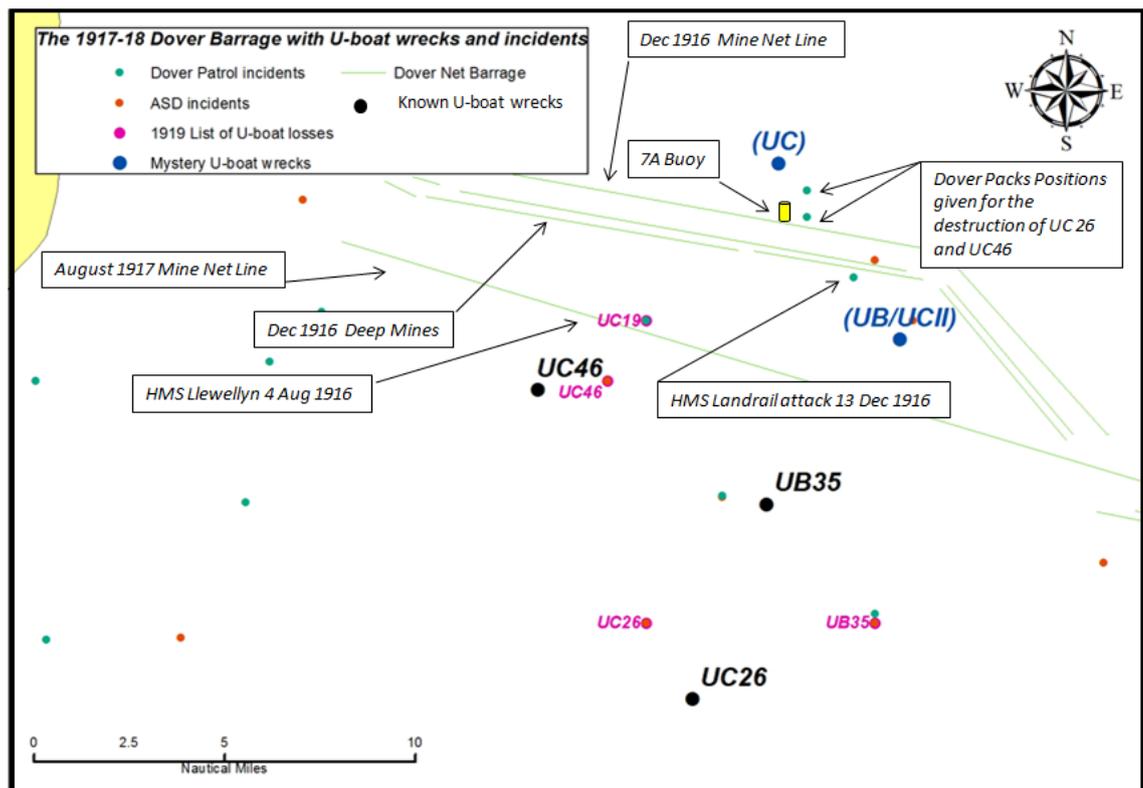
Figure 1.25. The location of the mystery wrecks (UC) and (UB/UCII) shown with the related minefields and incidents in the area. (Innes McCartney GIS base map).

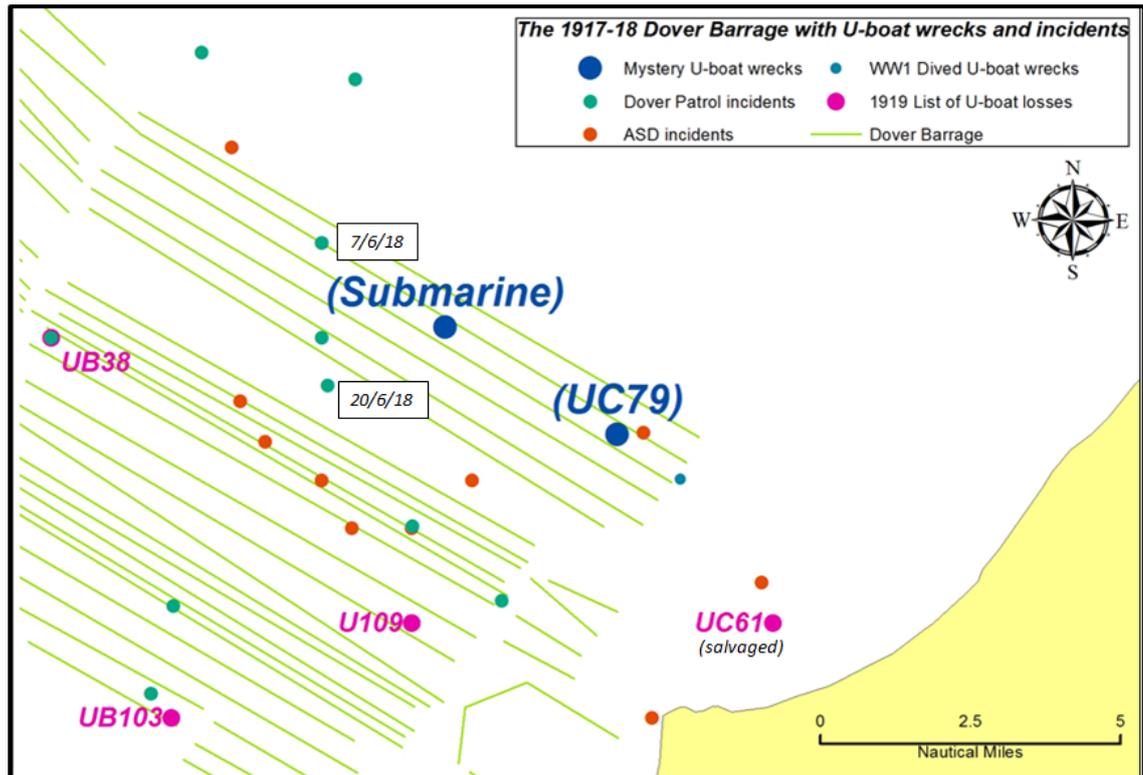
Figure 1.26. The location of the mystery wrecks (UC79) and (Submarine) shown with the related minefields and incidents in the area. (Innes McCartney GIS base map).

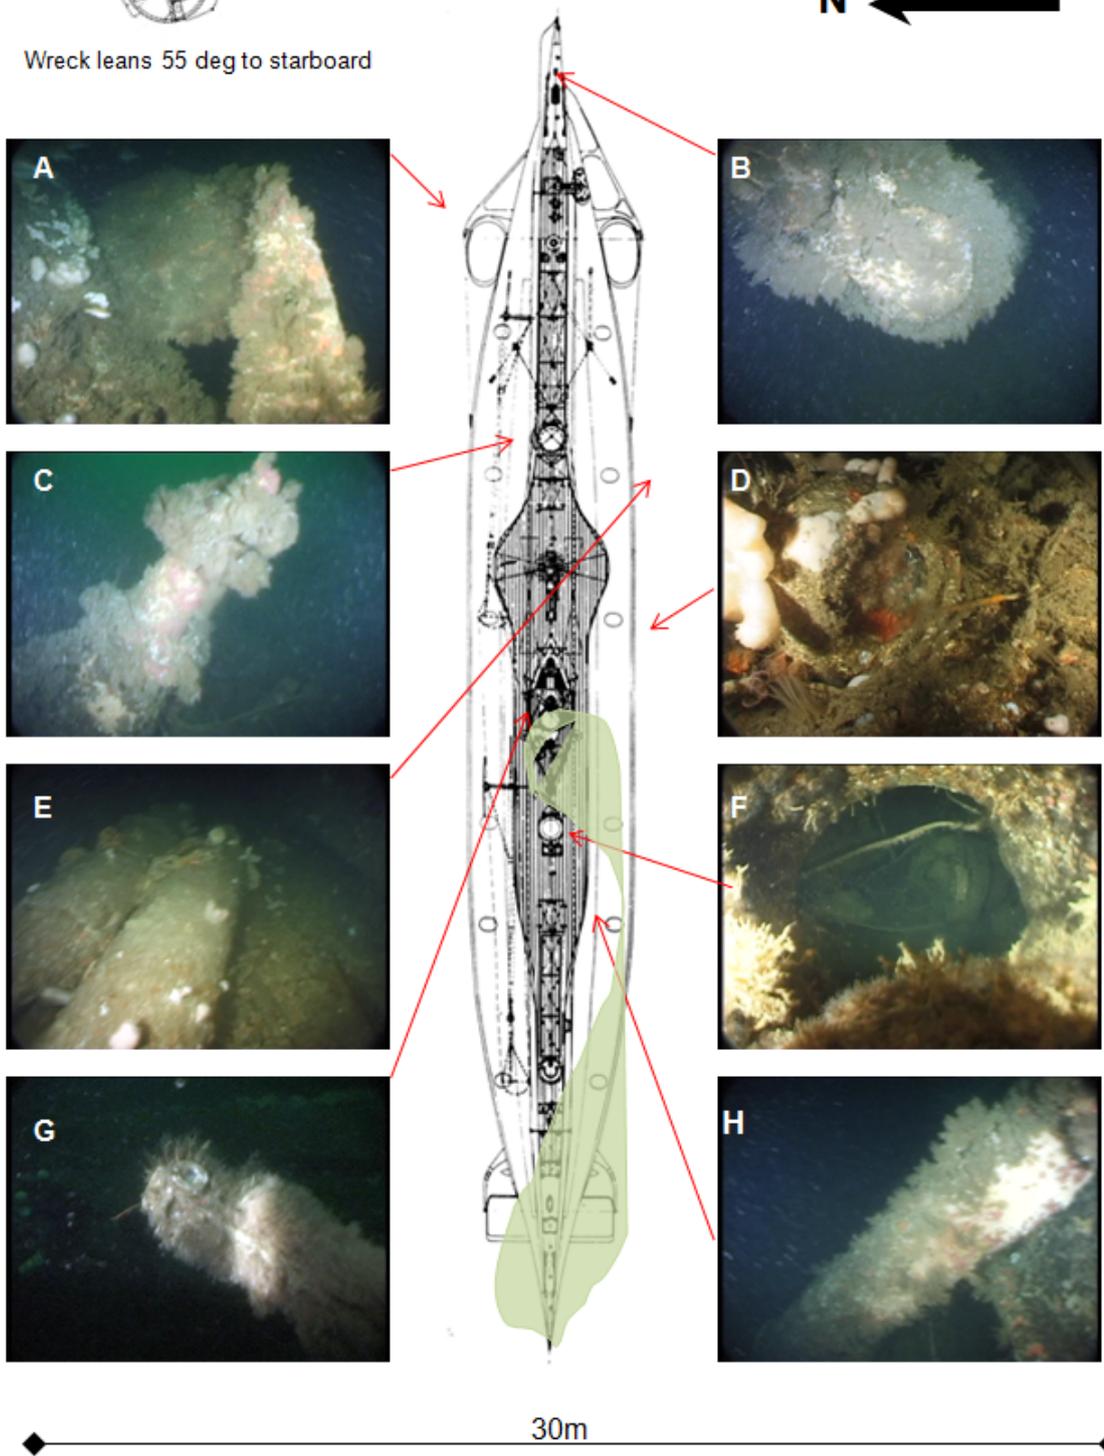
Figure 1.28. Diagram of the wreck of UB19 showing its key features as surveyed and described in the text (Innes McCartney, line diagram adapted from Rössler 1989, 51).

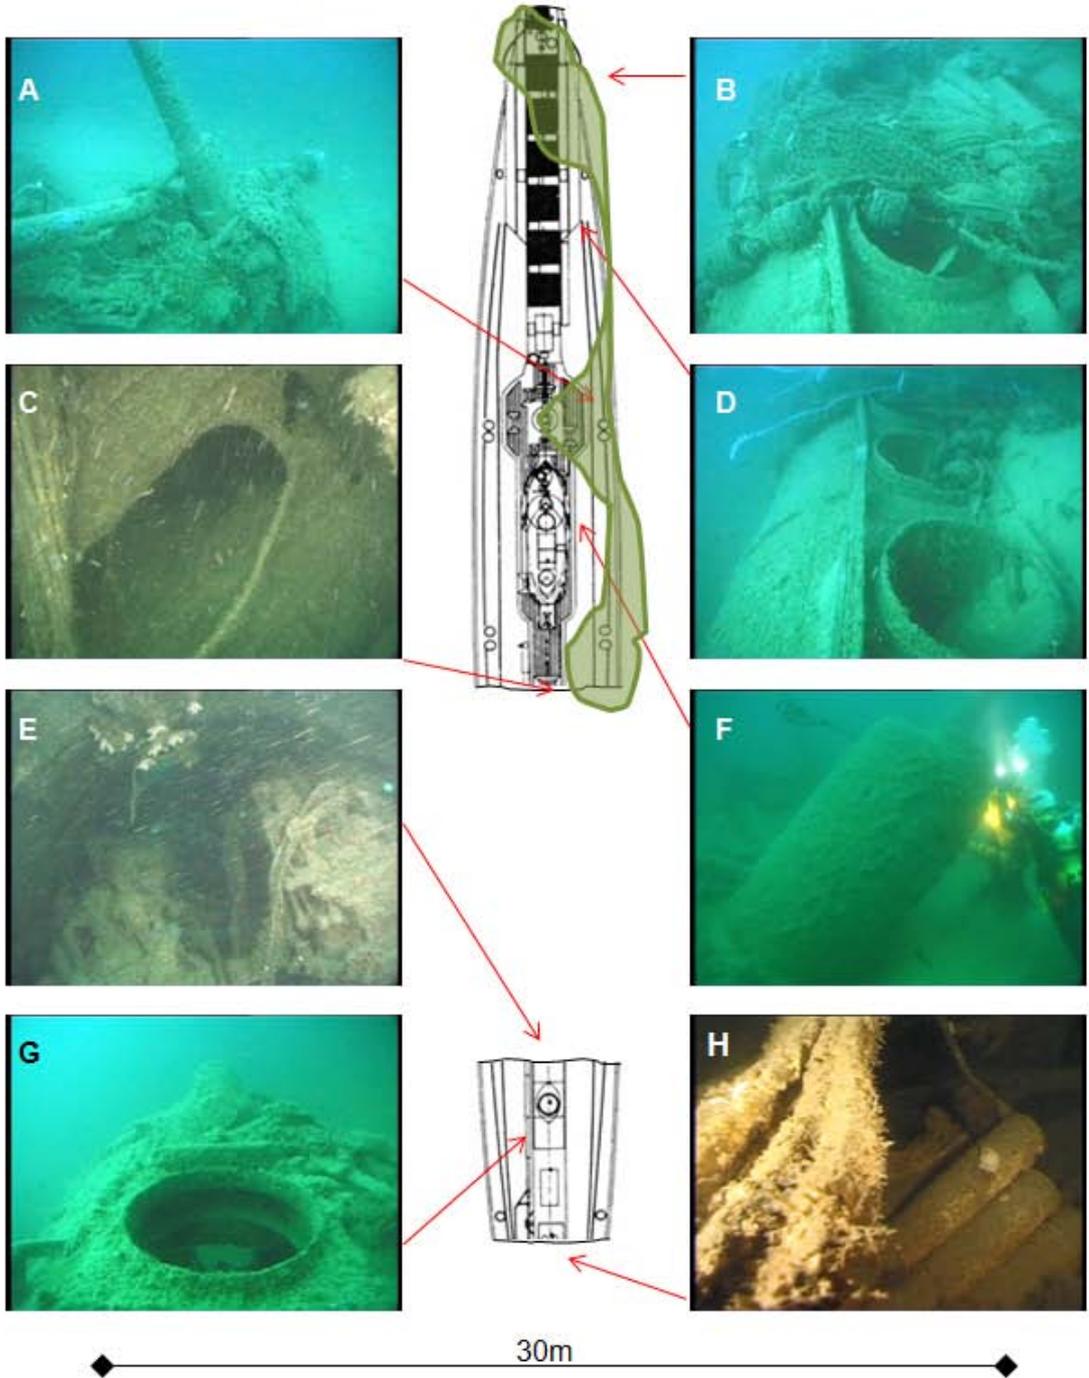
Figure 1.30. Diagram of the wreck of UC65 showing its key features as surveyed and described in the text (Innes McCartney, line diagram adapted from Rössler 1989, 52).

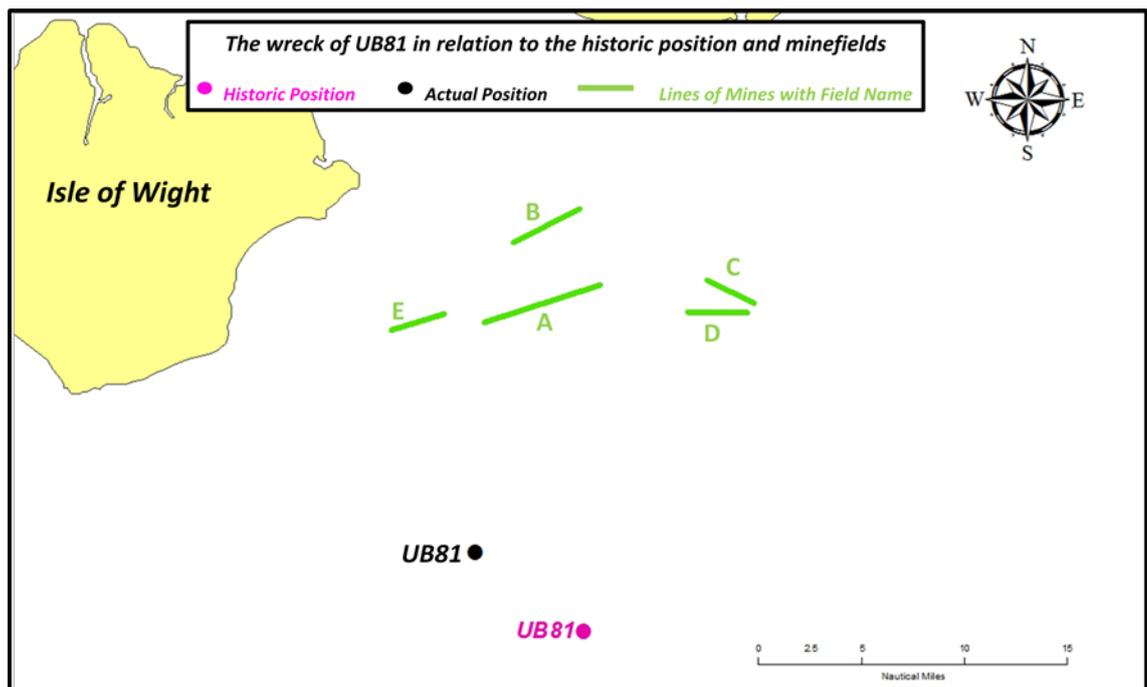
Figure 1.31. Map of the location of the wreck of *UB81*, the historic position given in 1919 and the mines it is attributed with striking (Innes McCartney GIS base map).

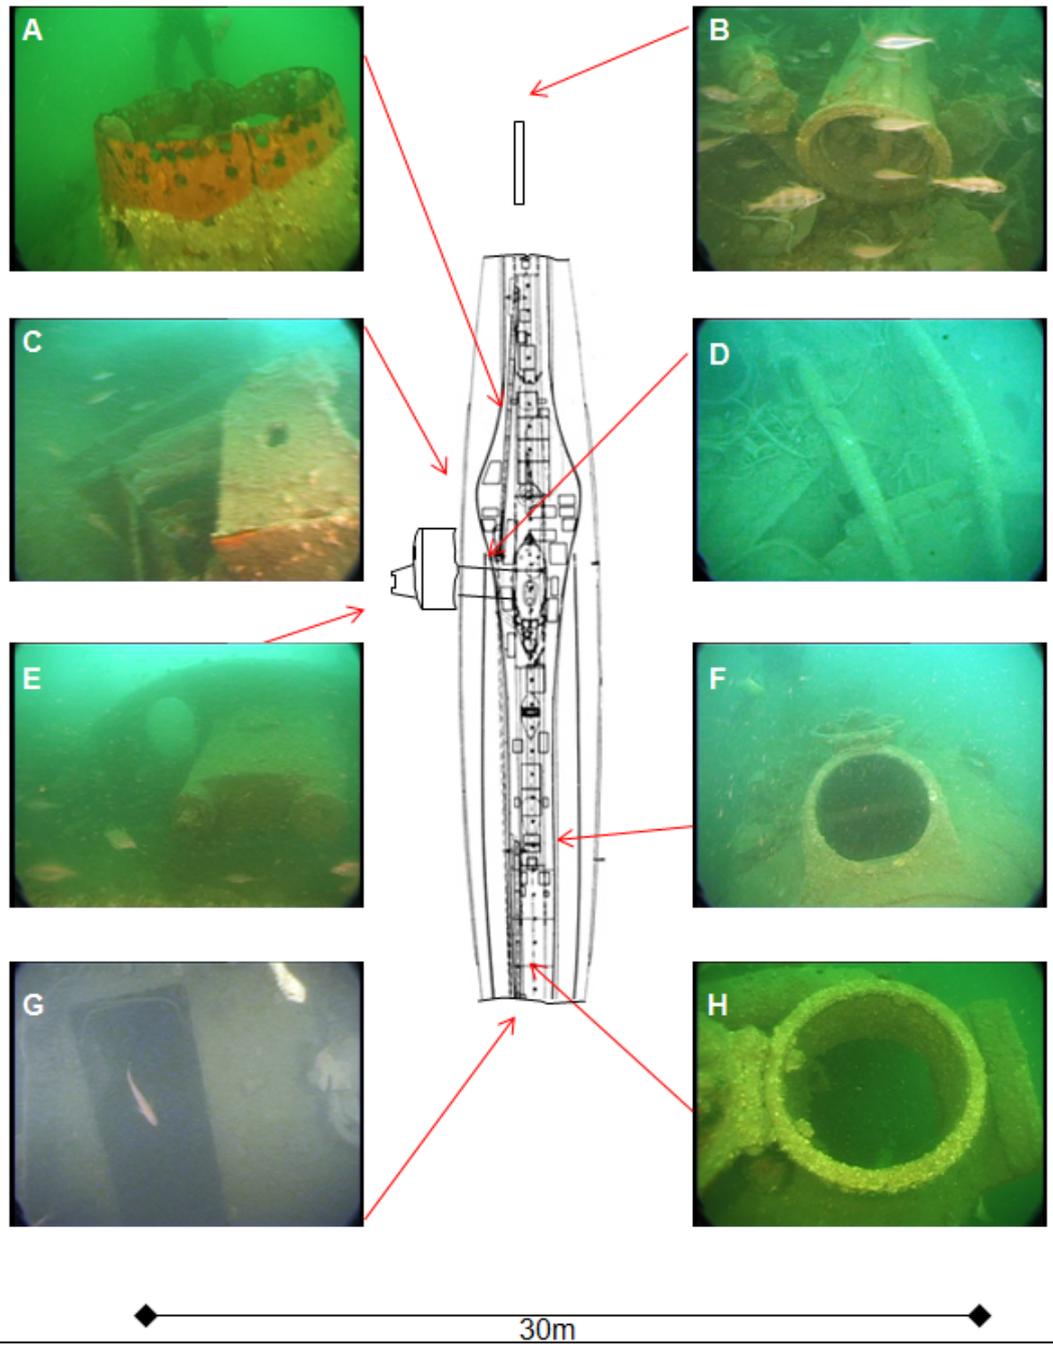
Figure 1.32. Diagram of the wreck of *UB81* showing its key features as surveyed and described in the text (Innes McCartney, line diagram adapted from Rössler 1989, 56-57).
