**The Maritime Archaeology of a Modern Conflict:**

**Comparing the Archaeology of German Submarine Wrecks to the Historical Text**

**Innes McCartney**

**PhD by Thesis**

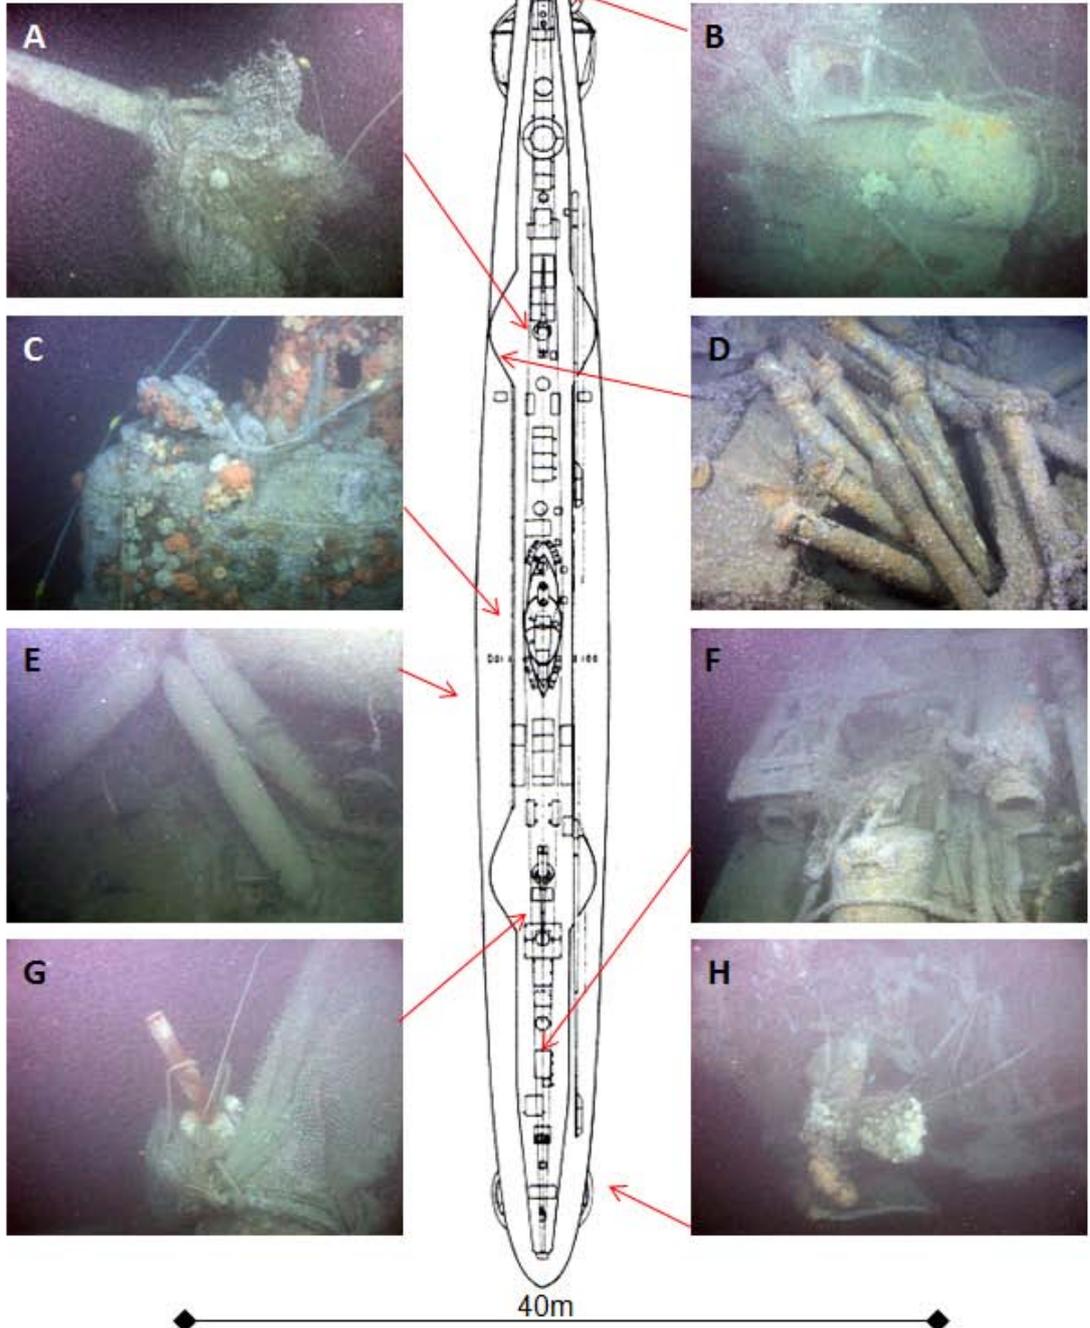
Figure 1.33. Diagram of the wreck of U103 showing its key features as surveyed and described in the text (Innes McCartney, with images courtesy of Odyssey Marine Exploration and line diagram adapted from Rössler 1997, 191).

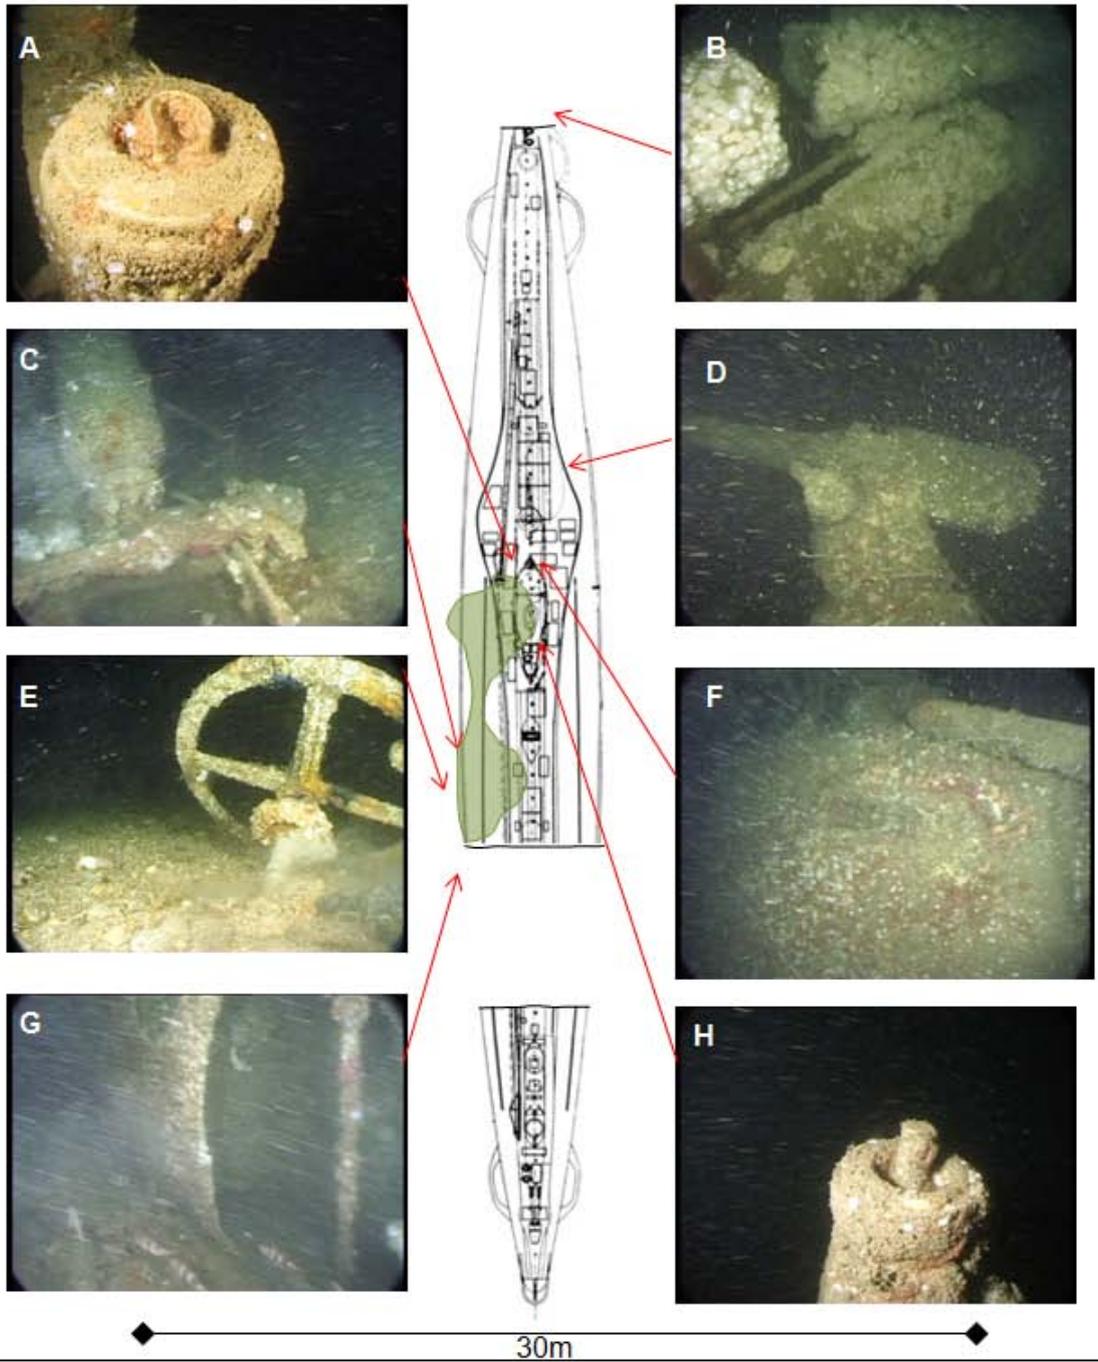
Figure 1.34. Diagram of the wreck of UB72 showing its key features as surveyed and described in the text (Innes McCartney, line diagram adapted from Rössler 1989, 56-57).

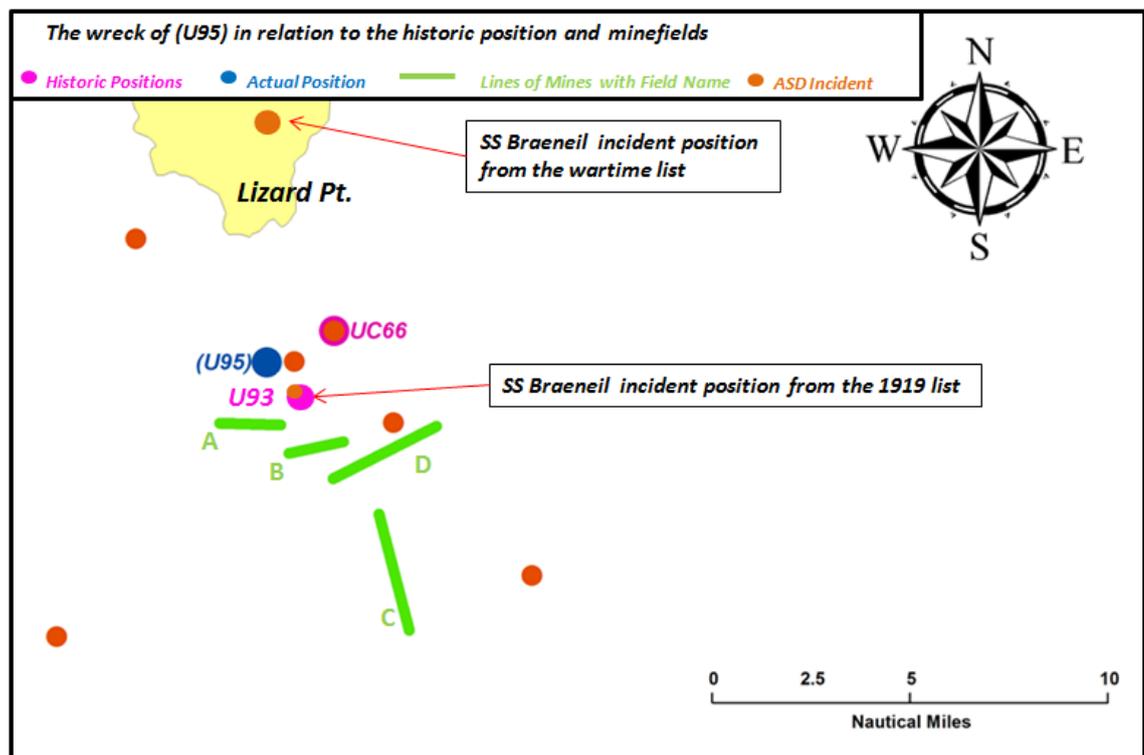
Figure 1.39. Map of the location of the wreck of (U95), the historic position given in 1919 and nearby incidents and minefields (Innes McCartney GIS base map).

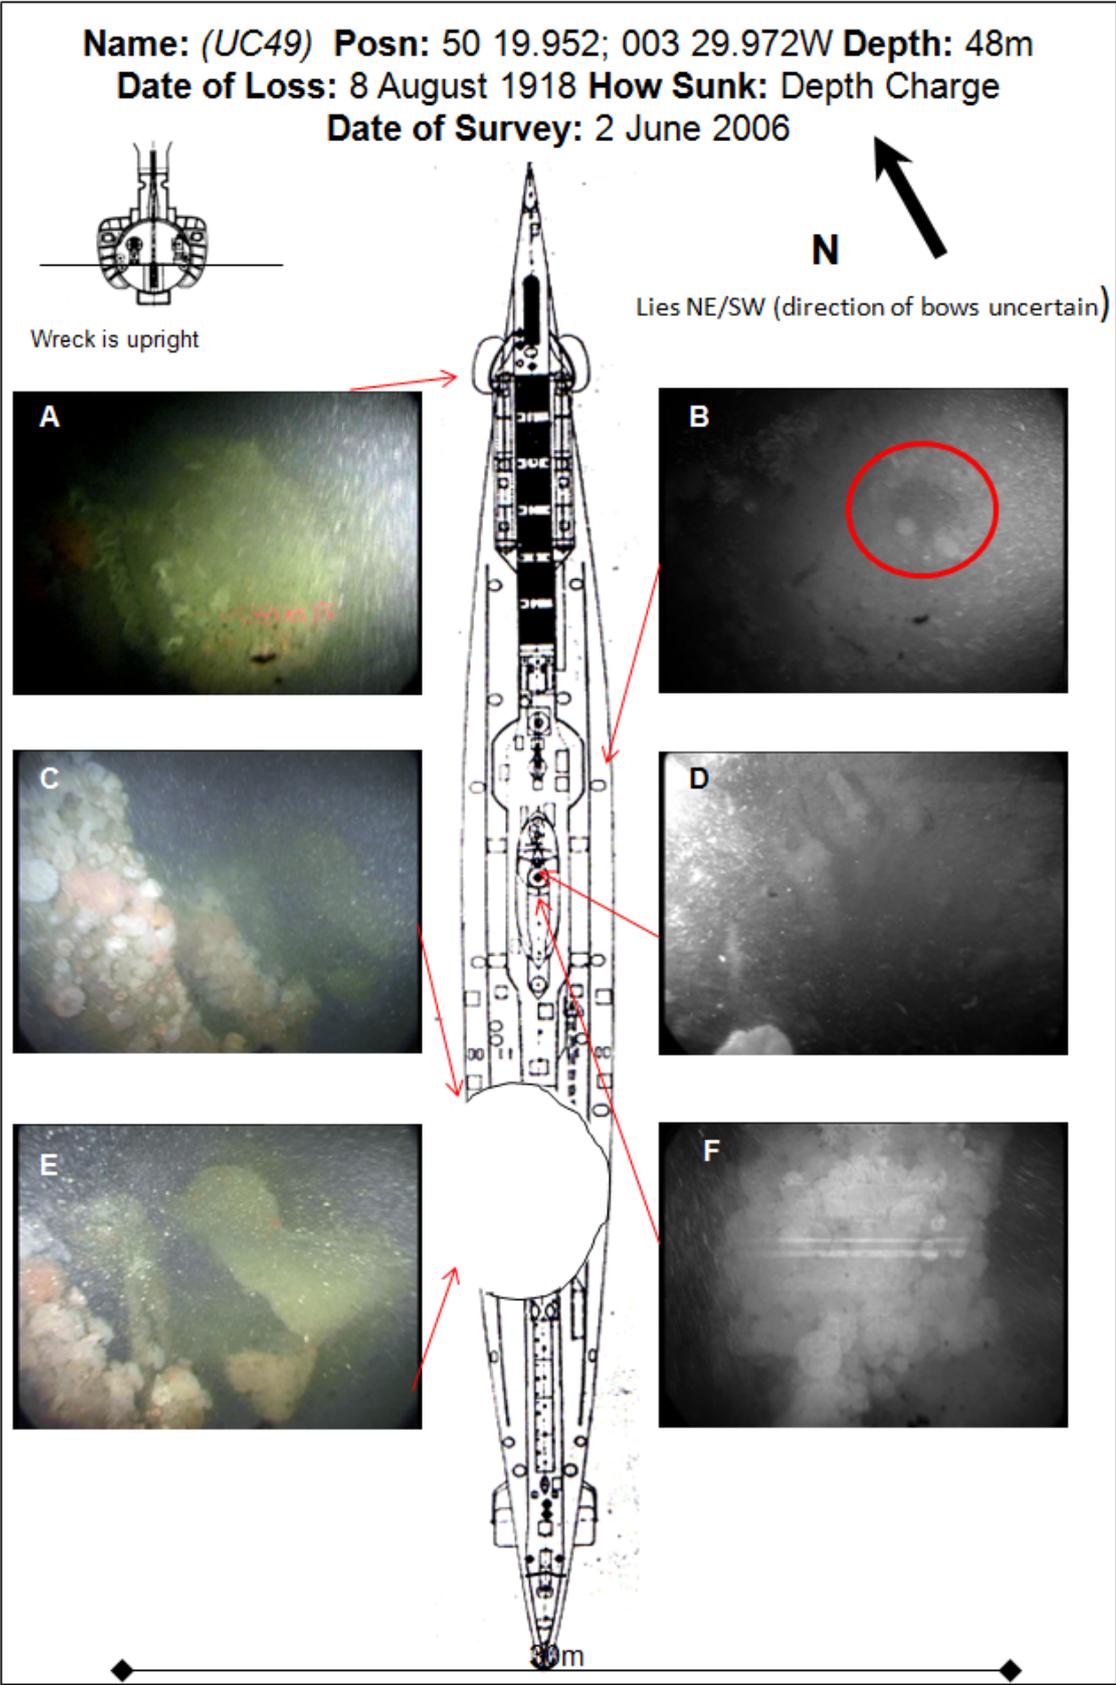
Figure 1.40. Diagram of the wreck of (UC49) showing its key features as surveyed and described in the text (Innes McCartney, line diagram adapted from Rössler 1997, 225).

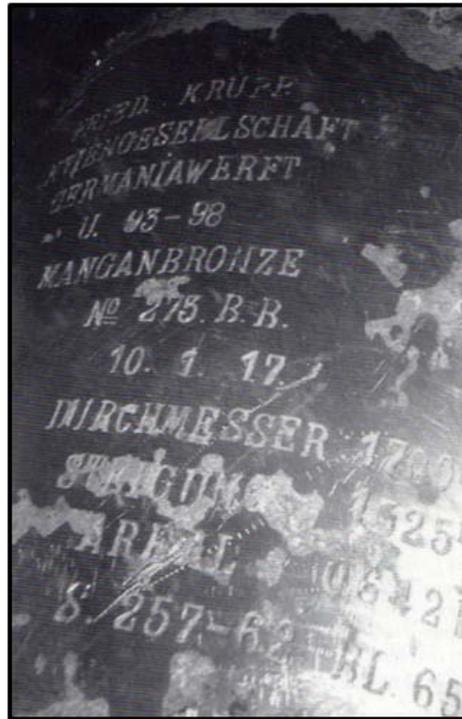
Figure 1.43. Richard's photo of the port side propeller on the wreck of (U93). Manufactured for the Germaniawerft shipyard, it is one of a batch made specifically for the U93-U98 Class of U-boats (Richard 2007, 128).

Close to shore and at the very shallow depth of 20 metres Richard was able to examine this site in detail. While all of the features recorded seemed to show that they could be from any of the three January 1918 losses, the propellers yielded a clue that the wreck was probably not *U109*. Figure 1.43 shows a photograph taken of the port side propellor. It shows that it was made by Krupp for Germaniawerft and that it was specifically made for the batch of U-boats it was building to the same standard, *U93-U98*.

Both propellers also show a serial number and a date of manufacture. The port side propellor was made on 10 January 1917 (see Figure 1.43) and the starboard one was stamped with a

Firstly, the detail stamped on the propeller in Figure 1.43 also displays a three digit number above the manufacturing date; in this instance it is 273. On the starboard propeller it is 274 (Richard 2007, 128). I am grateful to Axel Niestlé for pointing out to me in conversation on 18 April 2013 that these numbers refer to the matched pair of propellers made for each specific U-boat. We would logically expect that the three digit number would be the same on each propeller. Although we can now never know why they are not matched in this case, here we have evidence which suggests that at some time the propellers have been substituted to produce a pair which could be run smoothly together. This seems to suggest that the dates on the propellers should not be used as a means of dating the launch of the U-boat and thence to derive its identity.

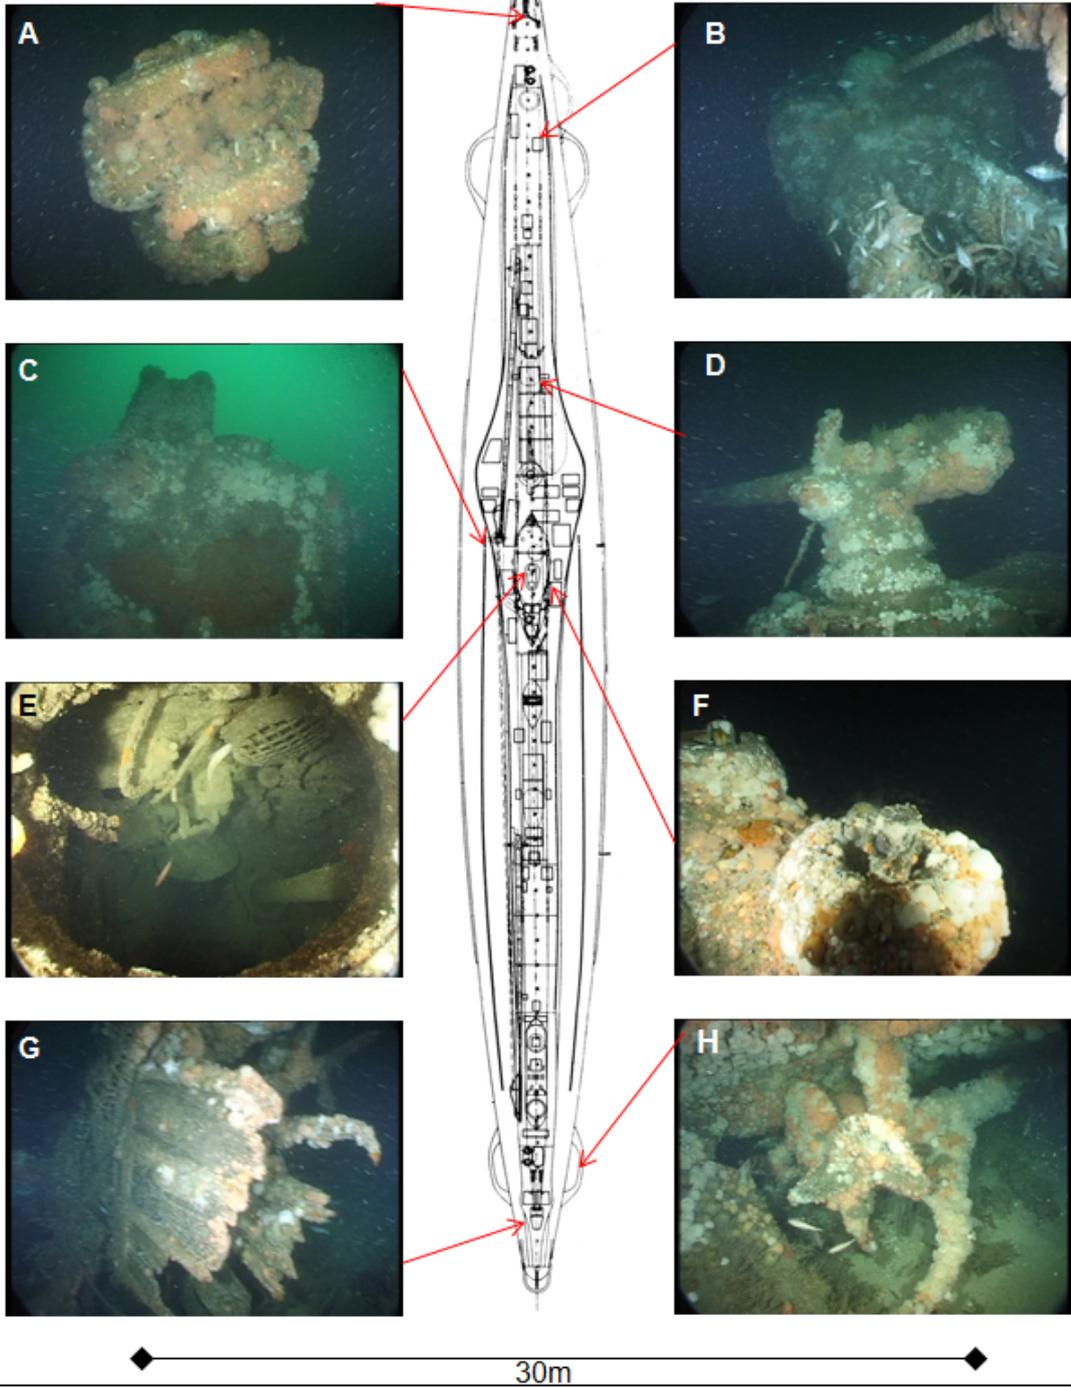
Figure 1.45. Diagram of the wreck of *UB65* showing its key features as surveyed and described in the text (Innes McCartney, line diagram adapted from Rössler 1997, 215).

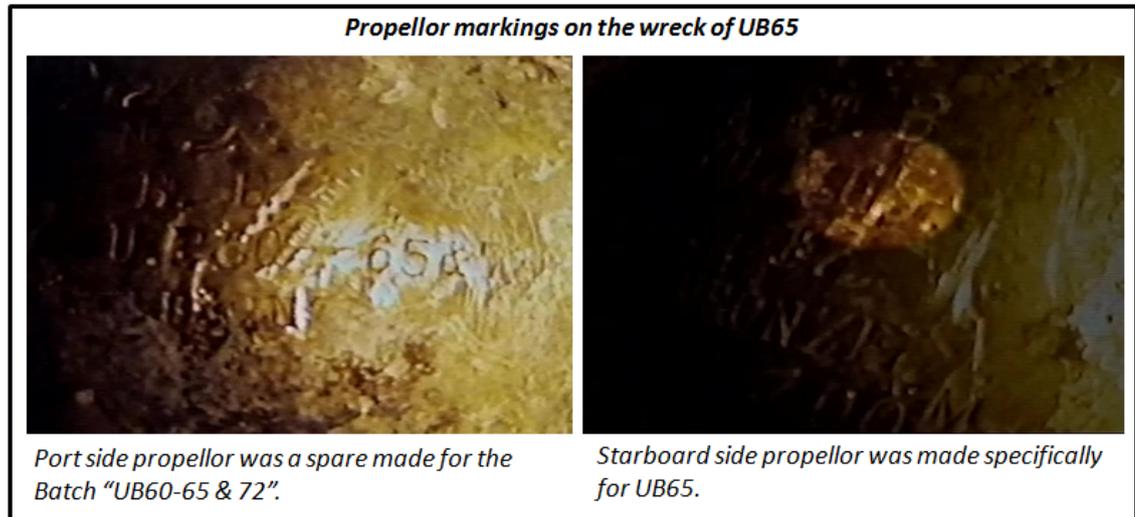
Figure 1.46. Diagram showing the propellor markings on the wreck of UB65. The starboard propellor was specifically manufactured for UB65 and the port was a spare (Innes McCartney/RDF Media).

Figure 1.46 shows the results of the dives, with the images being captured by the author using a small lipstick camera which was connected to the survey ship. The port side propellor was made as a spare for the U-boats which were built to the same specifications, *UB60-UB65* and *UB72*. The U-boats were built by the Vulcan shipyard, Hamburg (Gröner 1991, 26). Interestingly *UB60-65* were of one order and *UB72-74* were of another. The propellor markings seem to suggest a design or process change during manufacture of the second order. Clearly it did not offer a specific identity on its own. However the starboard side propellor was specifically made for *UB65*, and this clearly identified the U-boat.

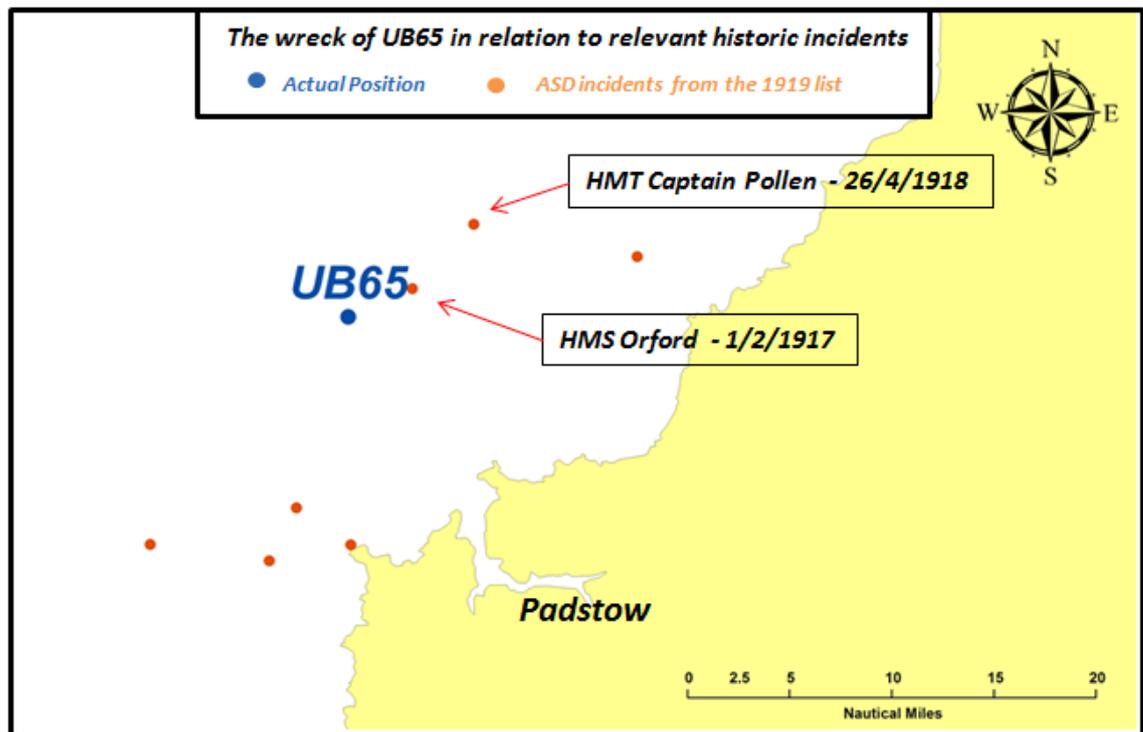
Figure 1.47. Map of the location of the wreck of *UB65* and nearby incidents from the 1919 List. None of the incidents shown on this map occurred in July 1918 when *UB65* was patrolling the area (Innes McCartney GIS base map).

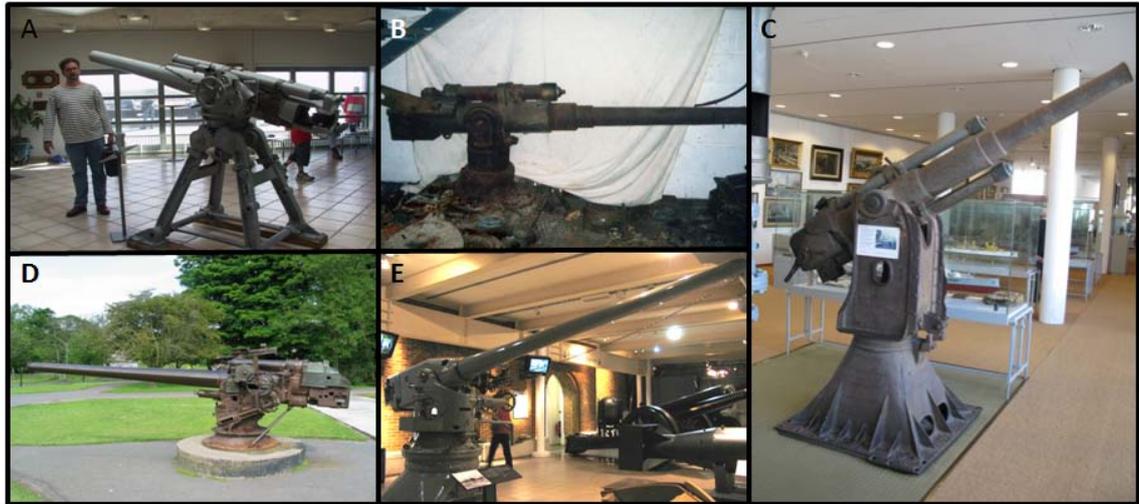
Figure 1.53. Surviving examples of WW1-era U-boat guns: (images A & C Innes McCartney, B Dave Batchelor, D Al Wright, E retrieved from [http://www.flickr.com/photos/carlos\\_seo/121041782/](http://www.flickr.com/photos/carlos_seo/121041782/) on 15/5/2013).

Friedman (2011, 144-147) states that there were up to nine different guns of 50mm, 88mm and 105mm which were manufactured for smaller naval vessels. The two manufacturers were Krupp and RMM. The records Friedman primarily used for his research were those of British intelligence, which by their very nature are unlikely to be fully accurate. Mehl (2002, 115-116) gives details of three types of U-boat specific guns from the period (from examples which exist in museums) but this is not a comprehensive list. He did however, describe the specific types of mounts designed for U-boat use, but again it is far from certain whether this list is comprehensive. Figure 1.53 shows existing examples of some of the guns.

- c) The RMM 105mm UTOF gun is also of a type which is distinguishable from any other type of gun by its shape. Examples are seen on the wrecks of *UB72* and *UB65*. An example of this gun exists in the Imperial War Museum, as seen in Image E of Figure 1.53;

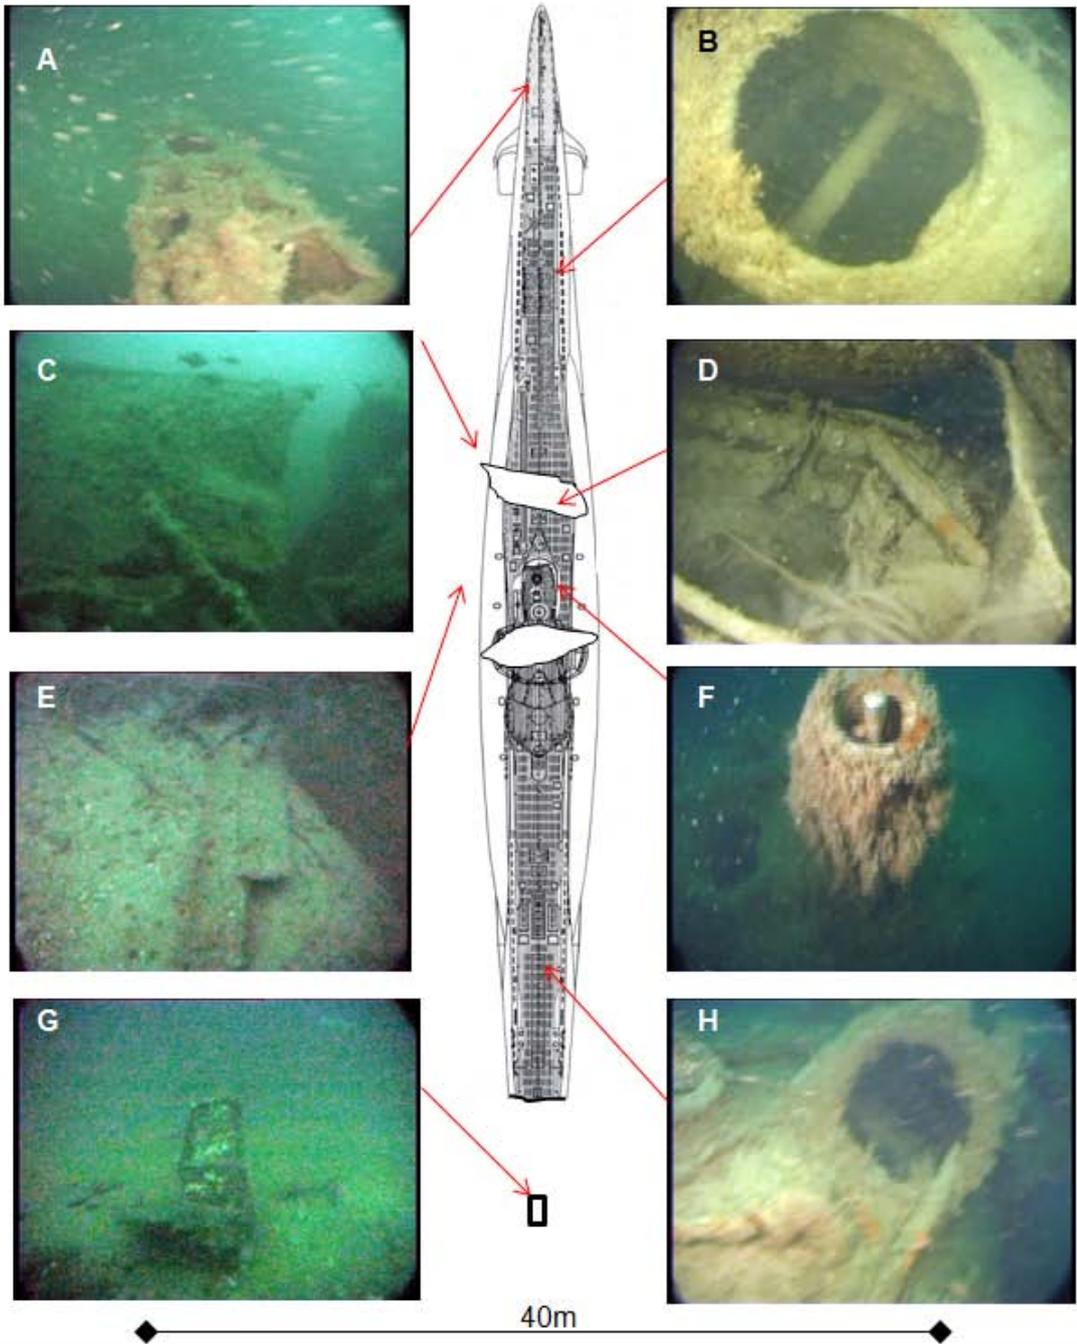
Figure 1.63. Diagram of the wreck of U212 and its key features as surveyed and described in the text. (Innes McCartney, line diagram, adapted from Köhl & Niestlé, 1994, 59).

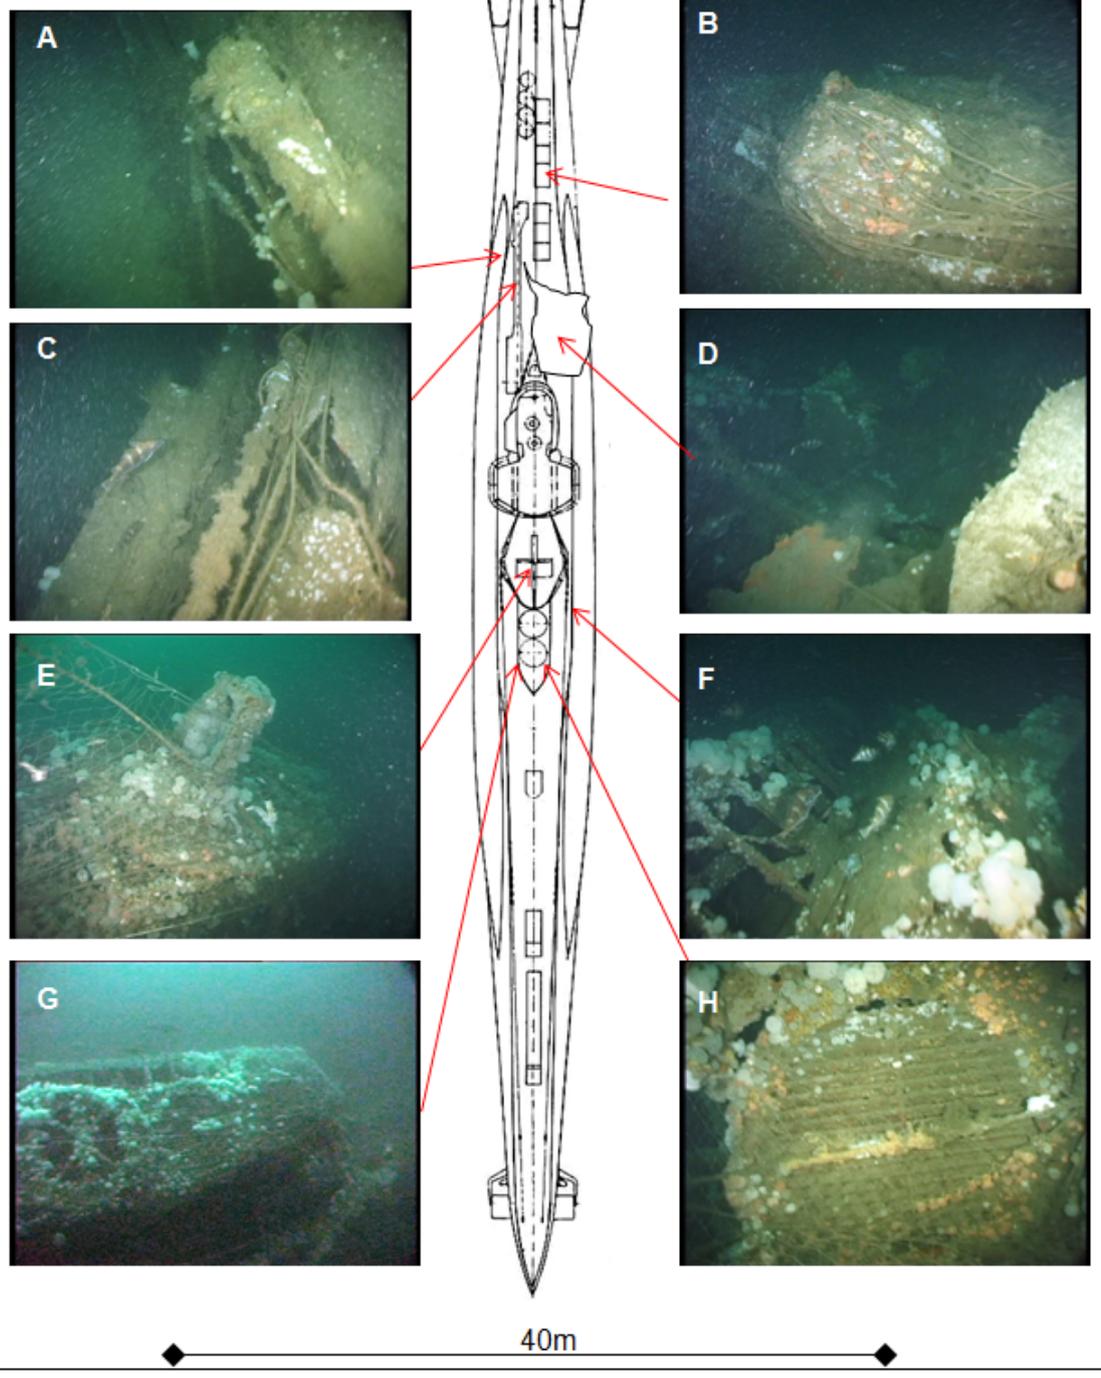
Figure 1.64. Diagram of the wreck of U214 and its key features as surveyed and described in the text. (Innes McCartney, line diagram, adapted from Rössler 1975, 190-191).

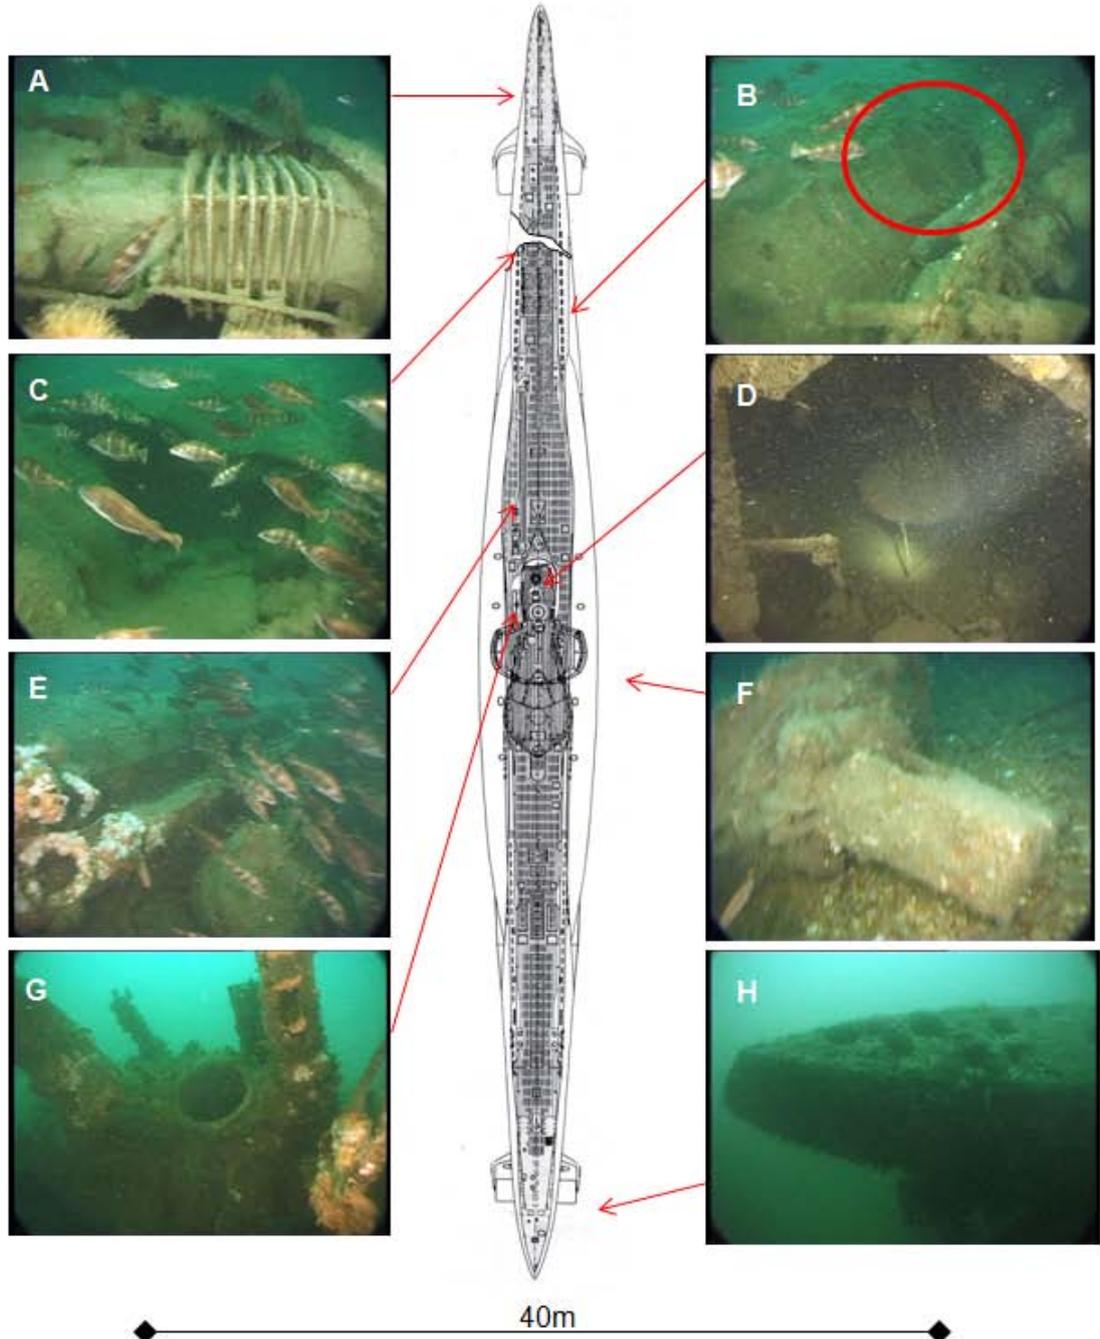
Figure 1.65. Diagram of the wreck of U671 and its key features as surveyed and described in the text. (Innes McCartney, line diagram, adapted from Köhl & Niestlé, 1994, 59).

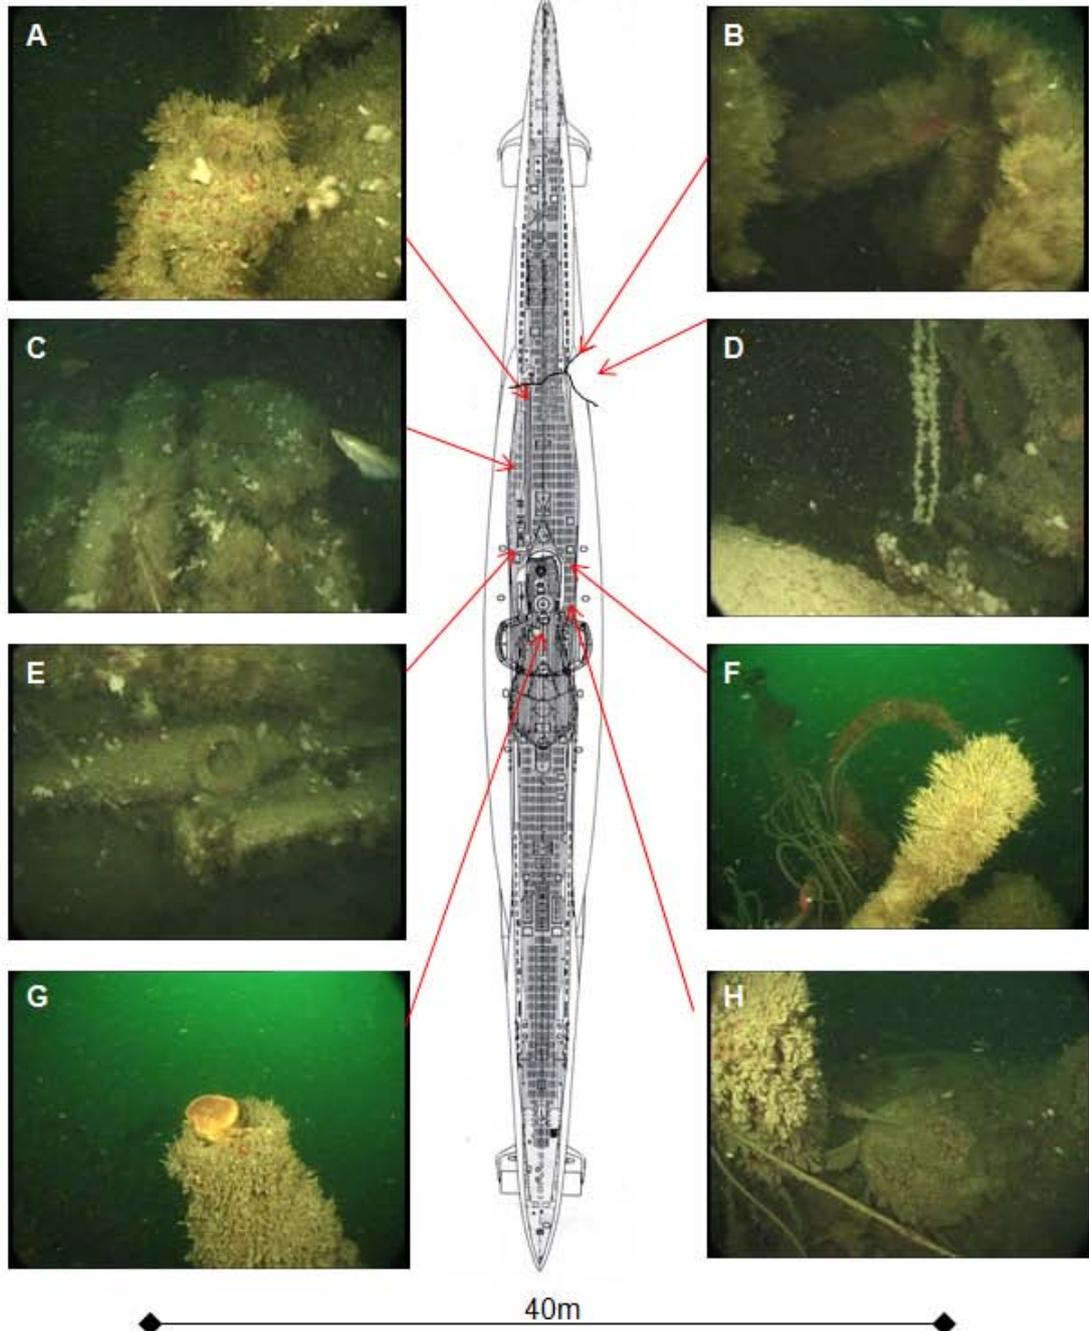
Figure 1.66. Diagram of the wreck of U741 and its key features as surveyed and described in the text. (Innes McCartney, line diagram, adapted from Köhl & Niestlé, 1994, 59).

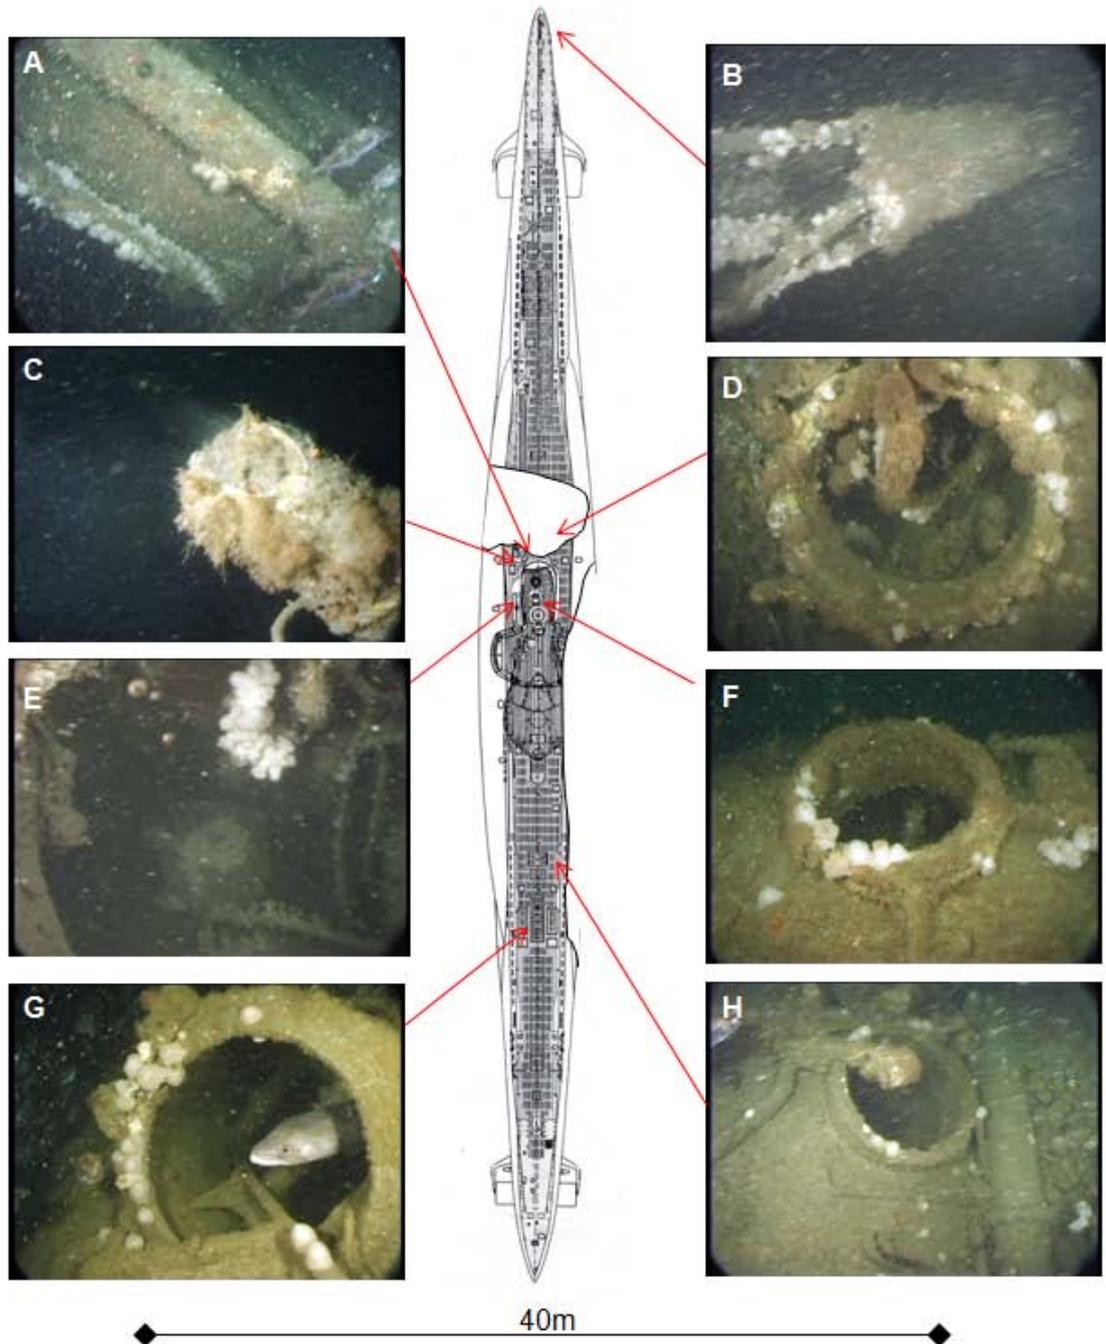
Figure 1.67. Diagram of the wreck of U413 and its key features as surveyed and described in the text. (Innes McCartney, line diagram, adapted from Köhl & Niestlé, 1994, 59).

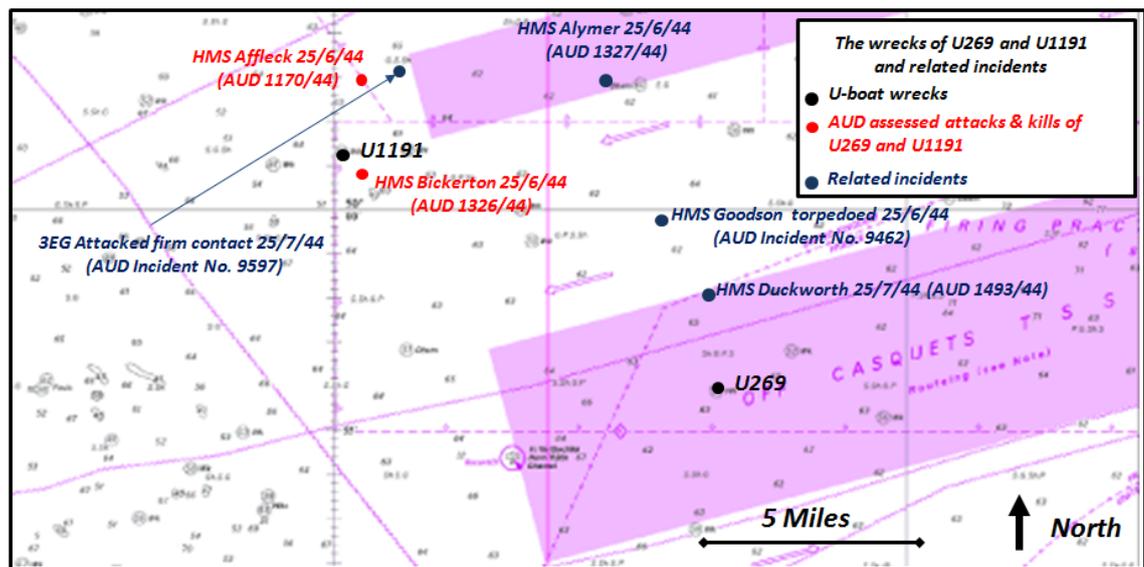
Figure 1.72. Map showing the locations of the wrecks of (*U269*) and (*U1191*) and associated attacks and incidents (Innes McCartney based on Chart No. 2454).

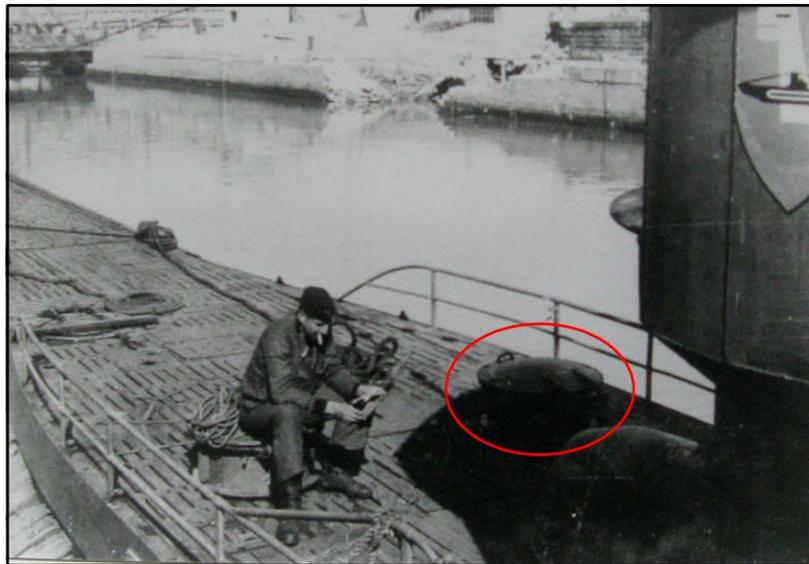
*Figure 1.73. A mysterious non-standard hatched container seen on the foredeck of U228. A similar type feature is seen on the wreck of U1191 (see Figure 76, Image D) and is unexplained. Note the Marcks container on the foredeck behind the crewmember. This would have to be moved or scrapped when the snorkel was fitted, as it lay in a slot cut through the deck on the port side (Uboot Archiv).*

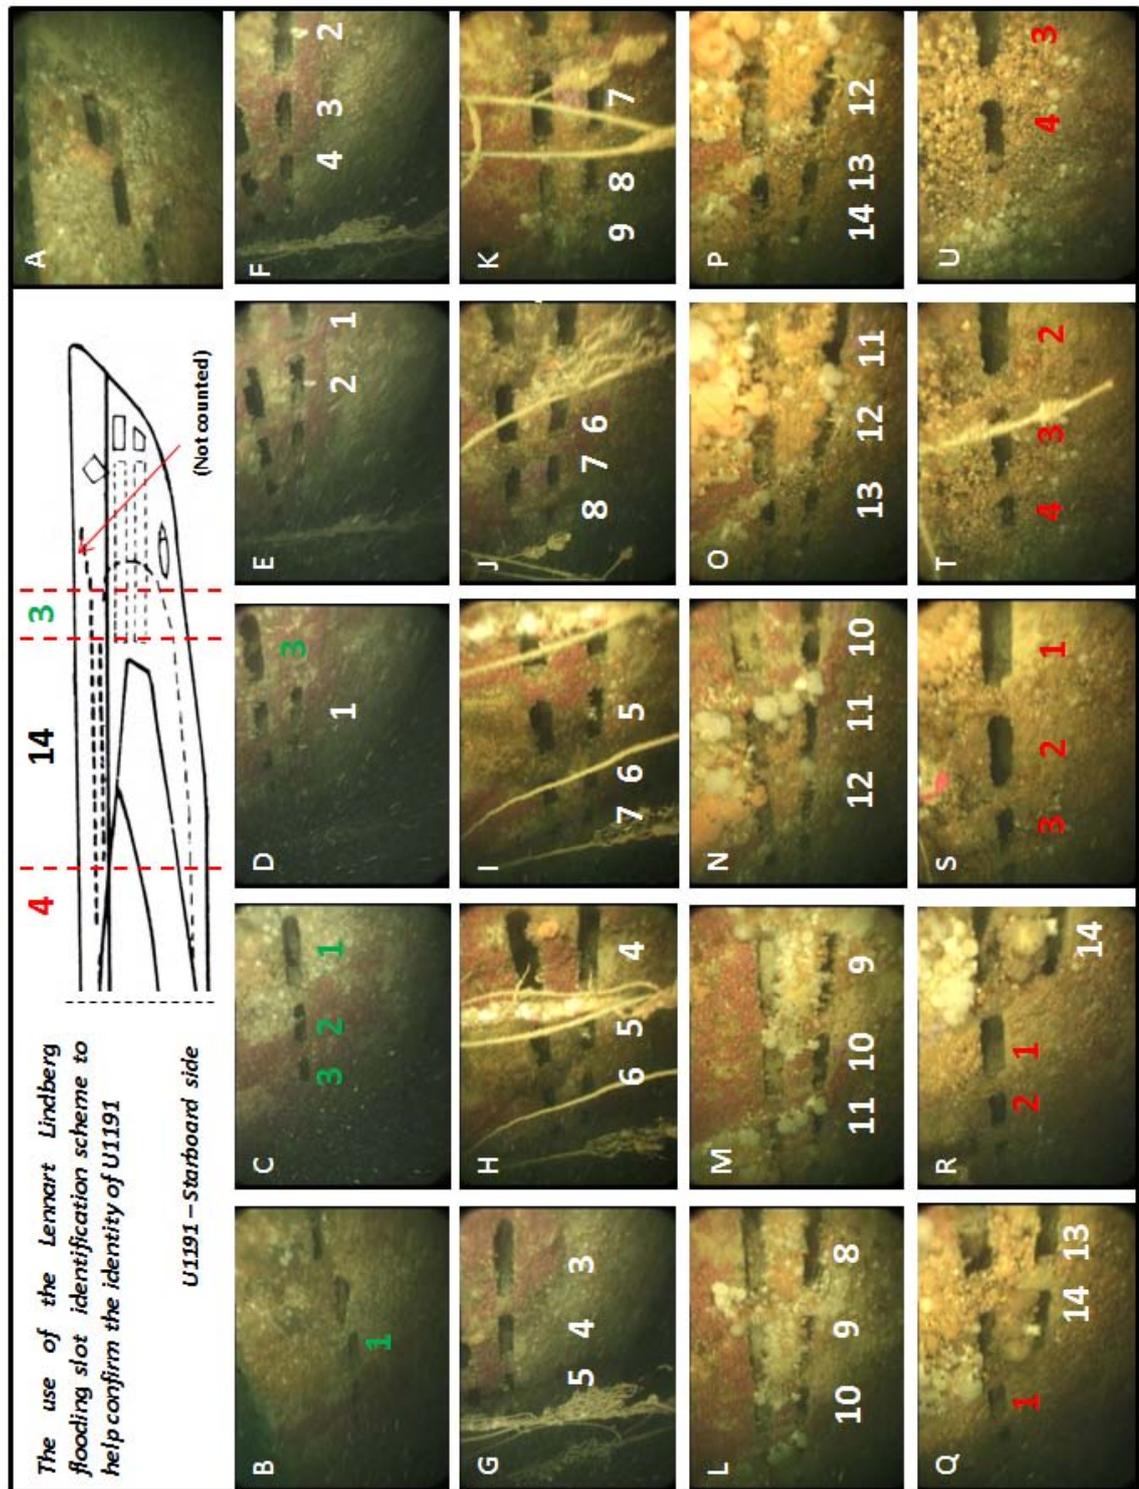
Figure 1.75. The use of the Lennart Lindberg flooding hole scheme to confirm the identity of the wreck of U1191 using video film recorded on the wreck site and counting the slots from bow to stern. (Innes McCartney, with diagram adapted from Gröner, 43).

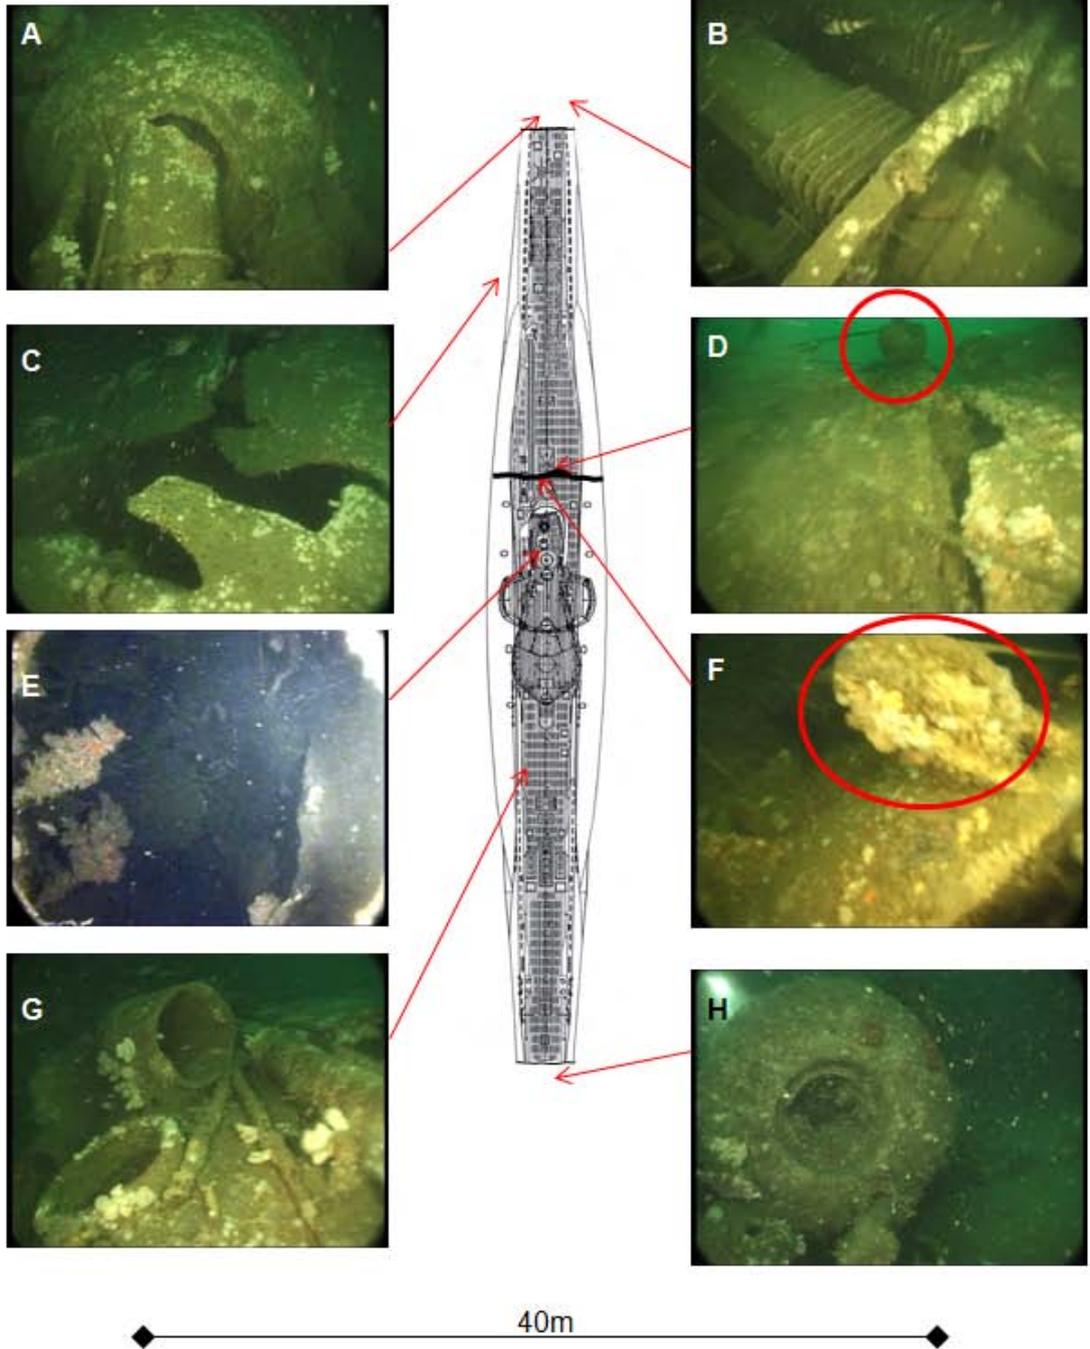
Figure 1.76. Diagram of the wreck of (U269) and its key features as surveyed and described in the text. (All images Innes McCartney except line diagram, adapted from Kóhl & Niestlé, 1994, 59).
