**The Maritime Archaeology of a Modern Conflict:**

**Comparing the Archaeology of German Submarine Wrecks to the Historical Text**

**Innes McCartney**

**PhD by Thesis**

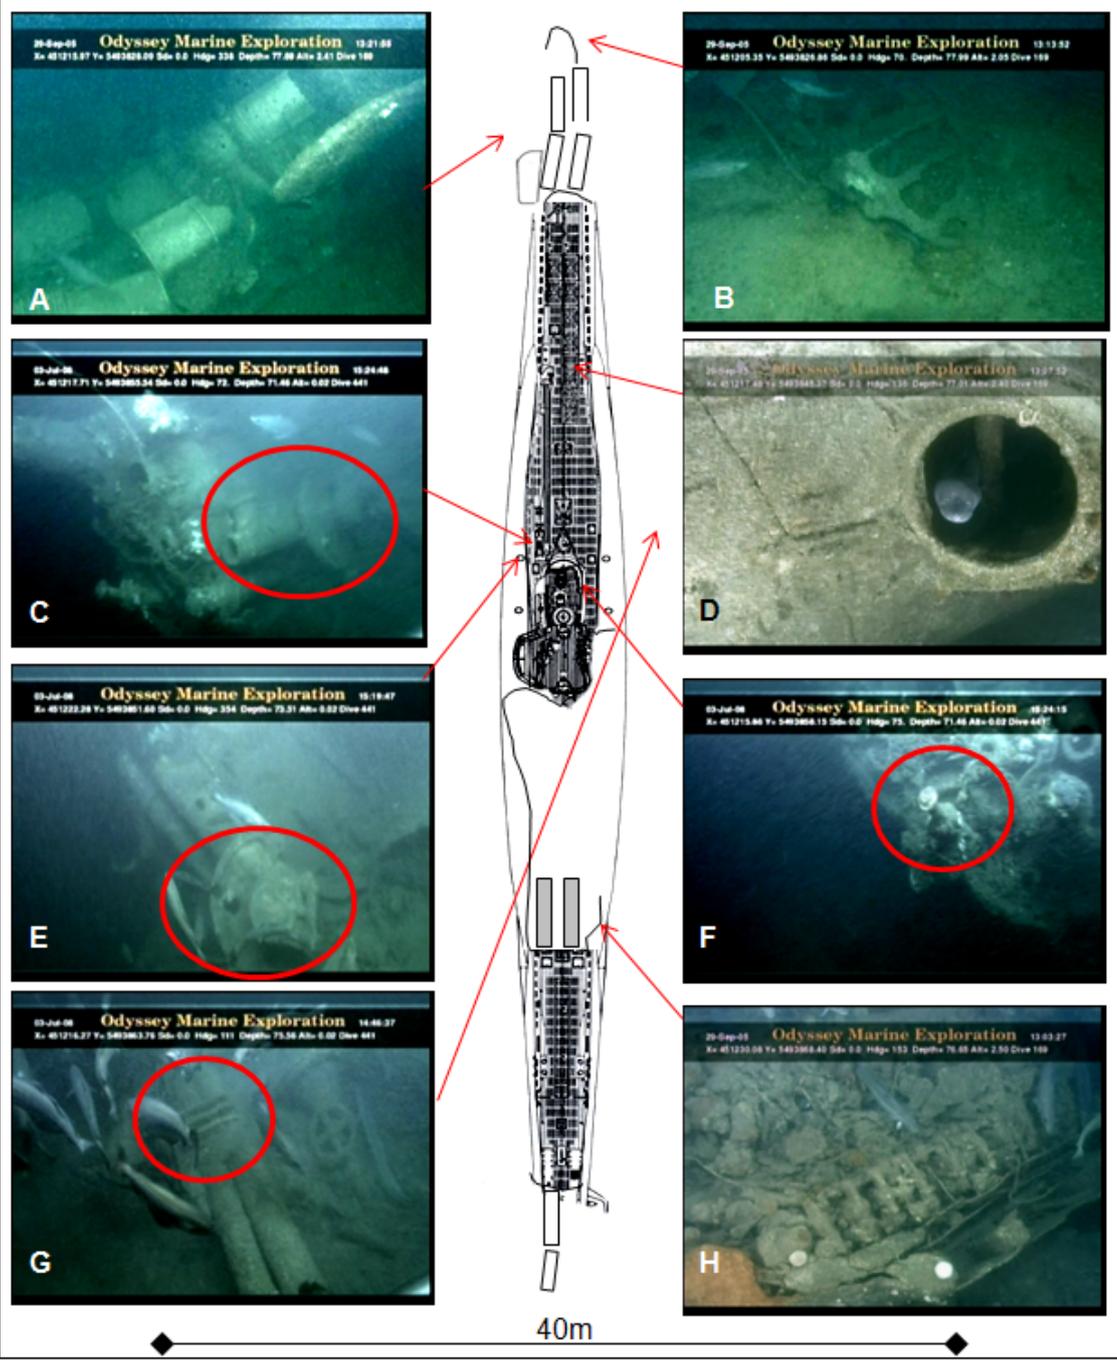
Figure 1.82. Diagram of the wreck of (U441) and its key features as surveyed and described in the text above. (All images from Odyssey International ROV tapes, except line diagram, adapted from Köhl & Niestlé, 1994, 59).

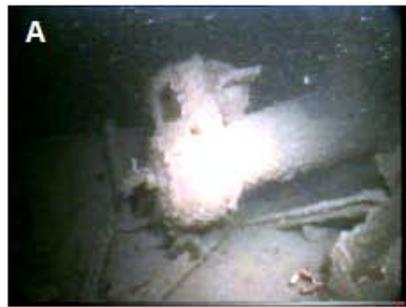
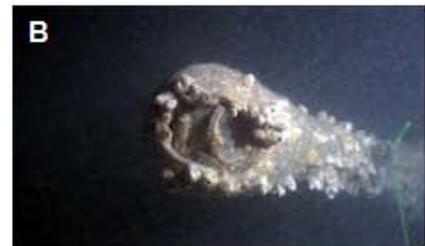
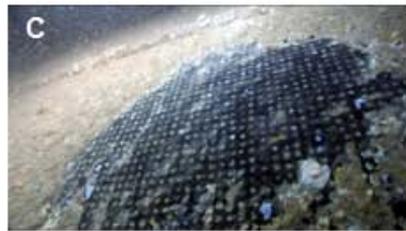
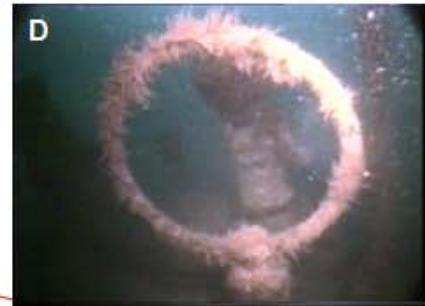
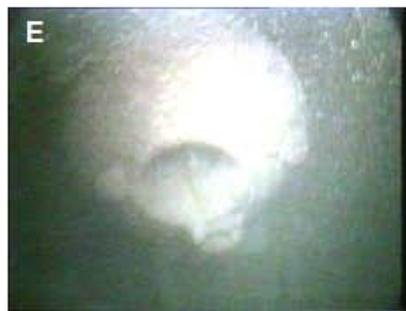
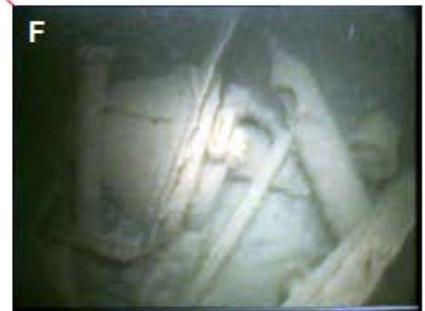
Wreck leans 50° to starboard

Figure 1.86. Diagram depicting the wreck of U480 and its key features as listed below (Innes McCartney, except images B, C, G and H Mallinson Sadler Productions and line diagram adapted by the author from Köhl & Niestlé, 1994, 59).

Figure 1.86 depicts the main features wreck of *U480* as it lies on the seabed. In this particular instance the U-boat is listing to the starboard side. The seabed is of stone, covered in fine mud and the underwater visibility on site can be very poor. Nevertheless, the conditions were good enough on both visits to the site to record its key features, which are described below:

- Image A shows *U480's* snorkel head. It is of an earlier ball-float design which does not seem to be anti-radar coated. The remains of the circular dipole radar warning aerial can be seen on the top. The snorkel is in its retracted position on the port side of the foredeck. The join to the engine trunk is of the very late-war heel connector design (see Figures 1.88 and 1.91);

From an archaeological perspective the Alberich coating may help to explain why some of the features on the wreck seem to be somewhat out of date for a 1945 loss. For example, the absence of the bow life raft containers (see *U1208*) below), rod antenna and anti-radar coating on the snorkel head (see Figure 1.86), which are all upgrades one may look for on such a late-war loss. It is not clear, because the German records are incomplete, whether the upgrades simply were not made due to logistical factors, or because of the problems of bonding Alberich to the surfaces of some of such items. For instance, it is known from the monthly Anti-U-boat reports from 1945 (Anti-U-boat Division 1945c, 25) that Alberich was not bonded to hatch covers, presumably because it was difficult to bond the rubber sheets to a dome-shaped surface.

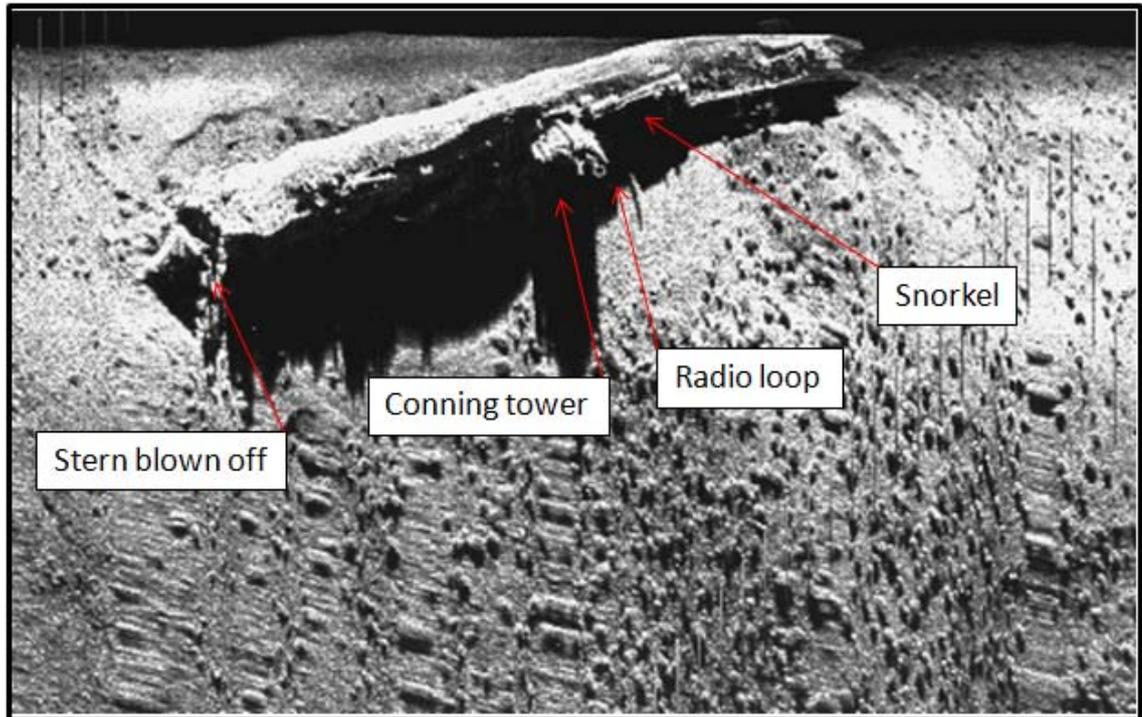
Figure 1.87. Side scan trace of U480 taken in summer 2008. The submarine can be seen leaning over on its starboard side. On this pass the side scan fish was at just the right altitude to capture some of the finer features around the conning tower (Innes McCartney/Mallinson Sadler Productions).

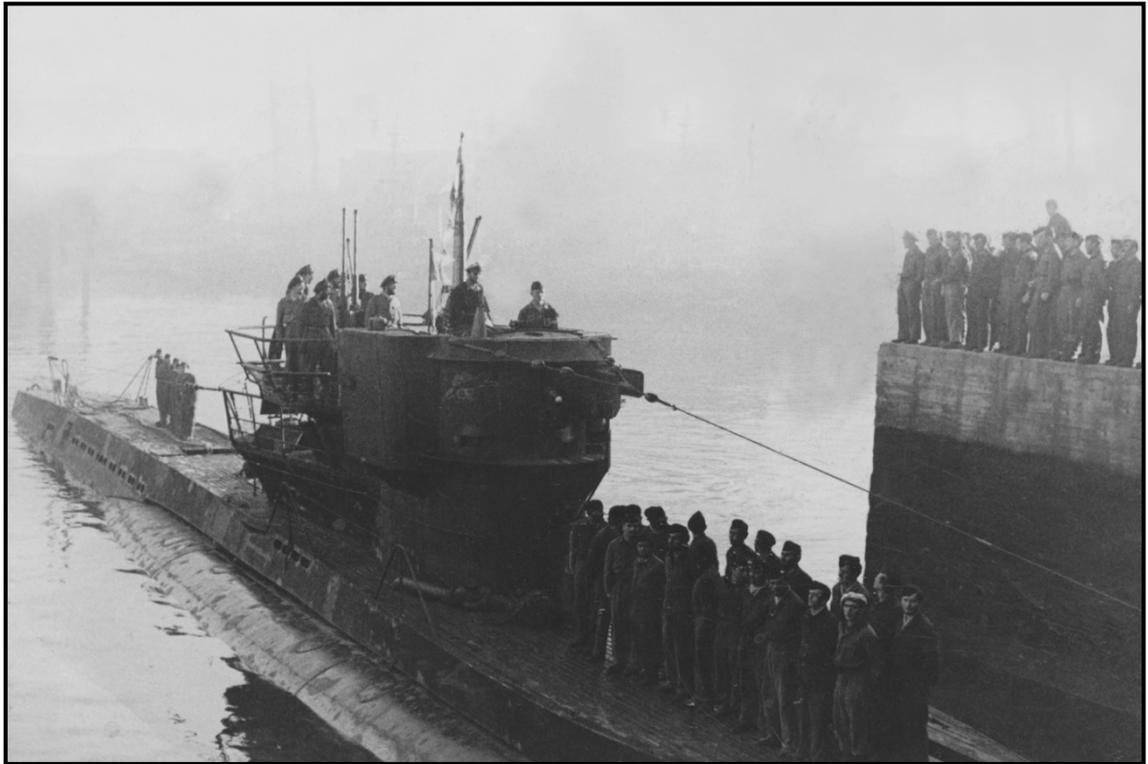
*Figure 1.88. U480 returning to Norway after its second patrol. Note that all the steel surfaces of the submarine are coated in black Alberich rubber, hence the leaping black panther emblem on the conning tower. There is no flange arrangement for the snorkel on the port side of the conning tower, indicating a later heel connector, as corroborated by the archaeology on the wreck site (see also Figure 1.88) (Mallinson Sadler Productions).*

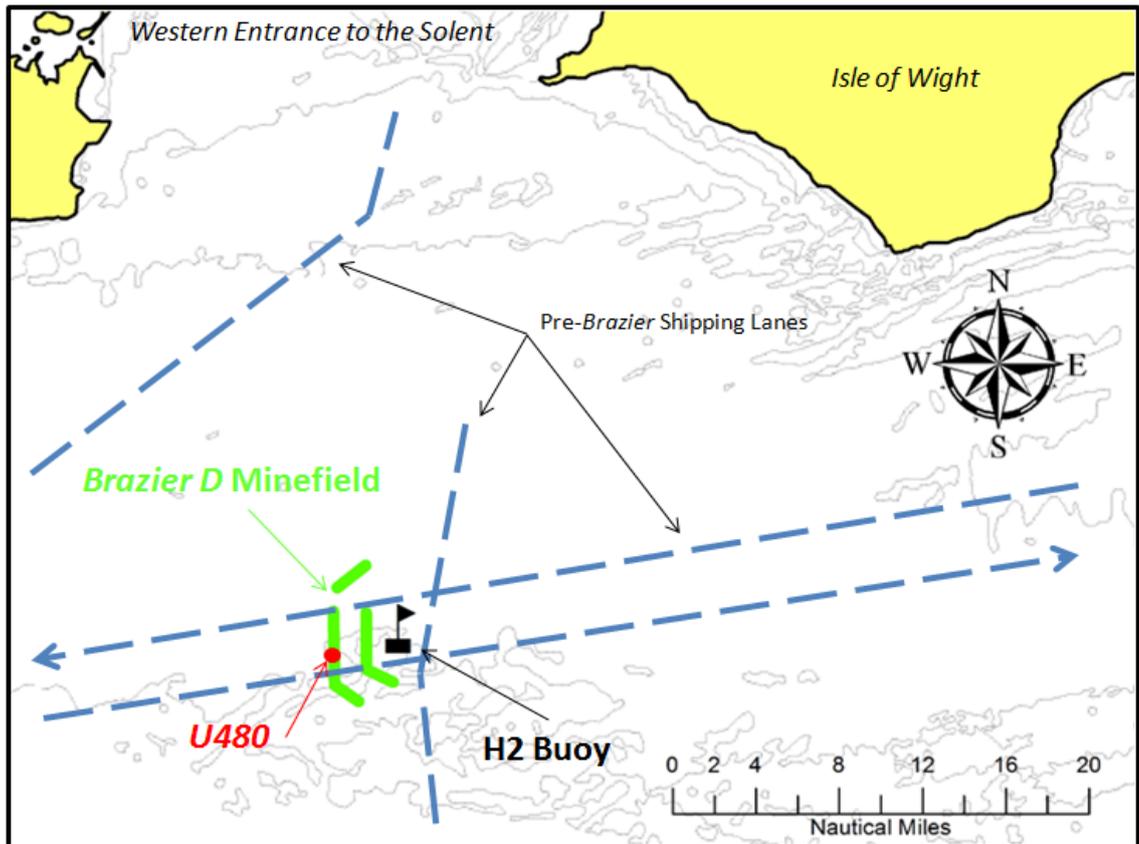
Figure 1.89. The Brazier D minefield, H2 buoy and the wreck of U480 in the second portion (or D2) field. This figure also shows the shipping lanes around which the H2 buoy was a focal point (Innes McCartney).

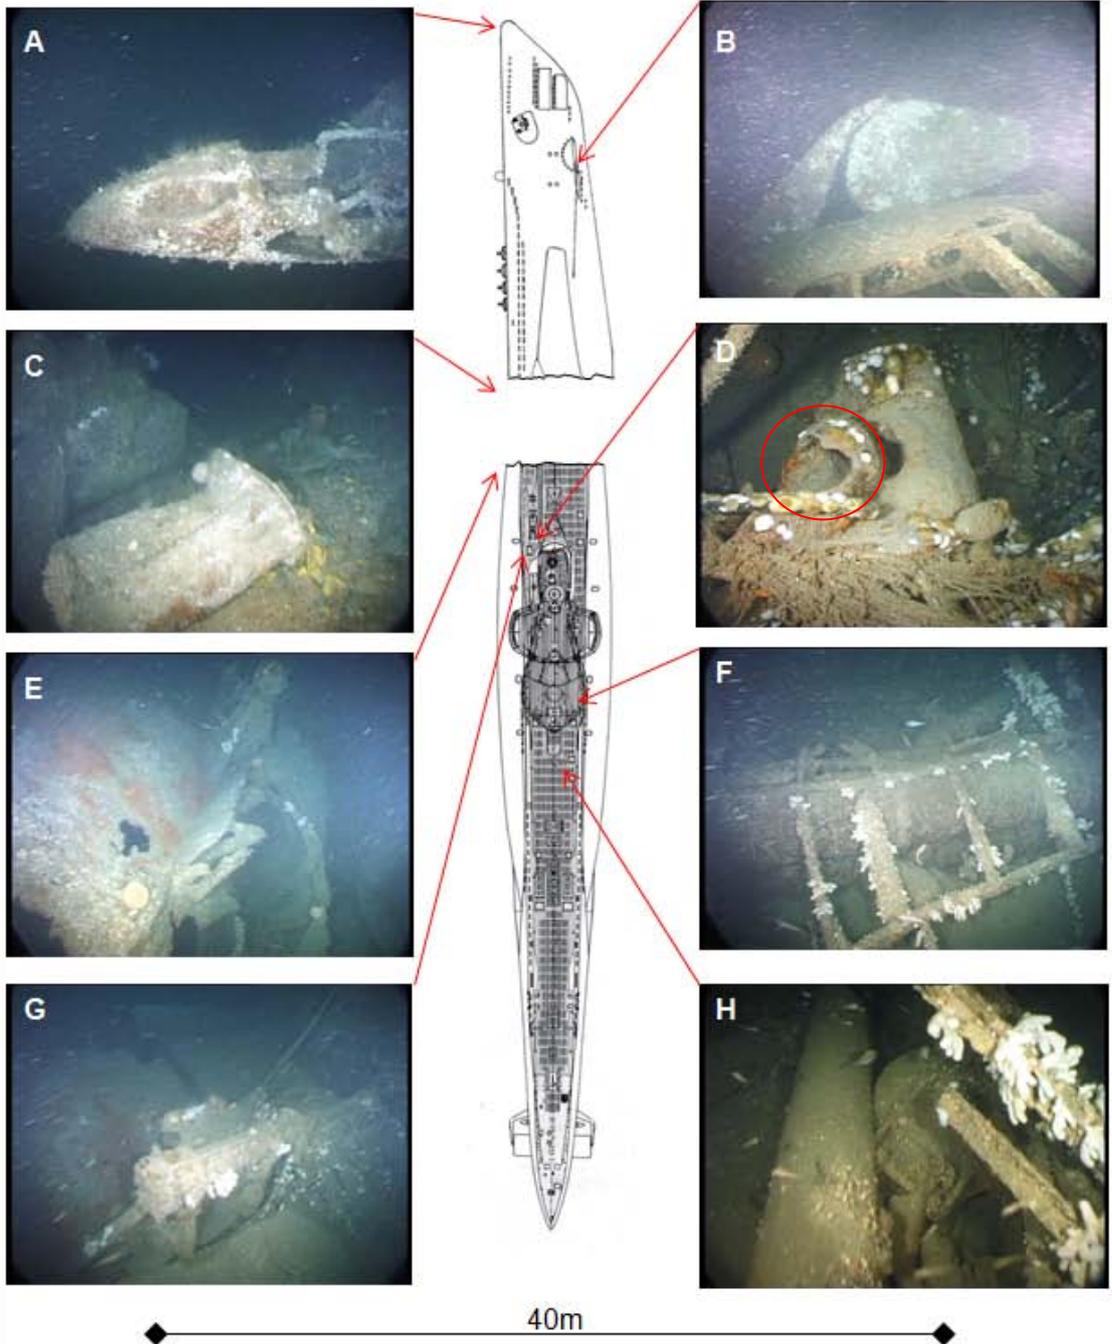
Figure 1.90. Diagram depicting the wreck of (U1208) and its key features as described in the text below (All images Innes McCartney except line diagram, adapted from Köhl & Niestlé, 1994, 59 and Westwood 1983, 33).

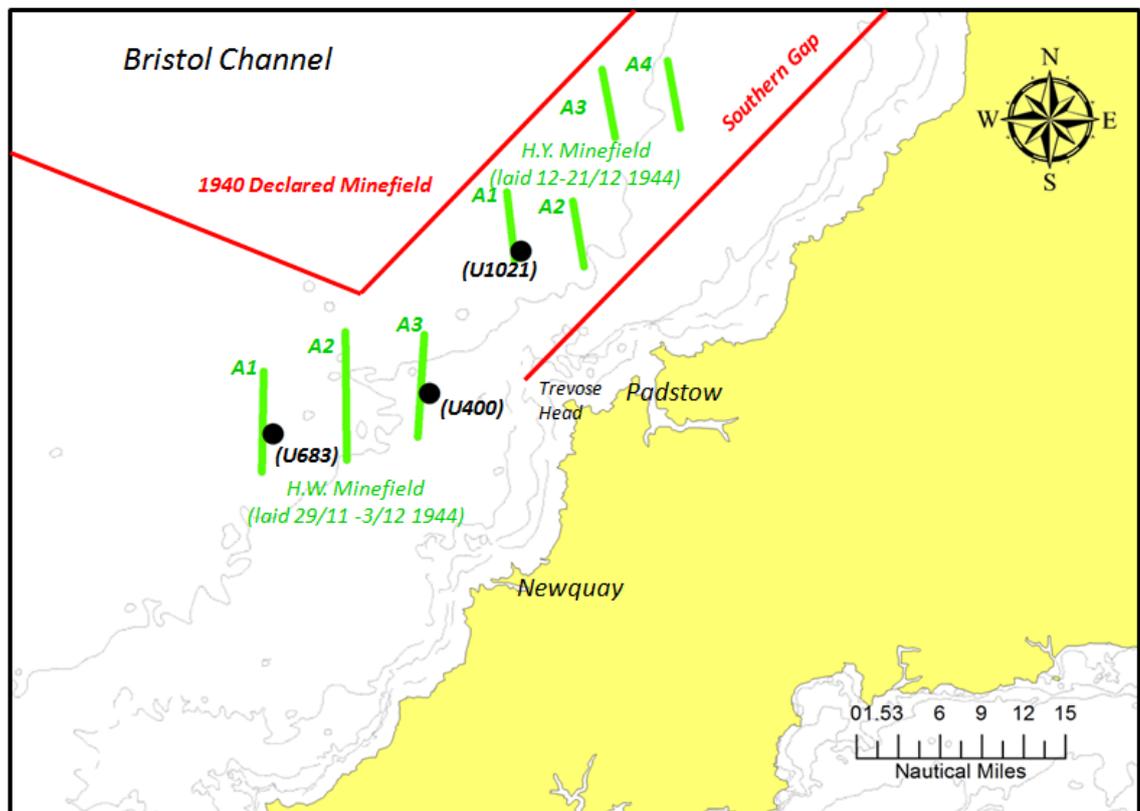
Figure 1.93. Map showing the locations of the wrecks of (*U1021*), (*U400*) and (*U683*) intersected against the minefields which accounted for their destruction (Innes McCartney).

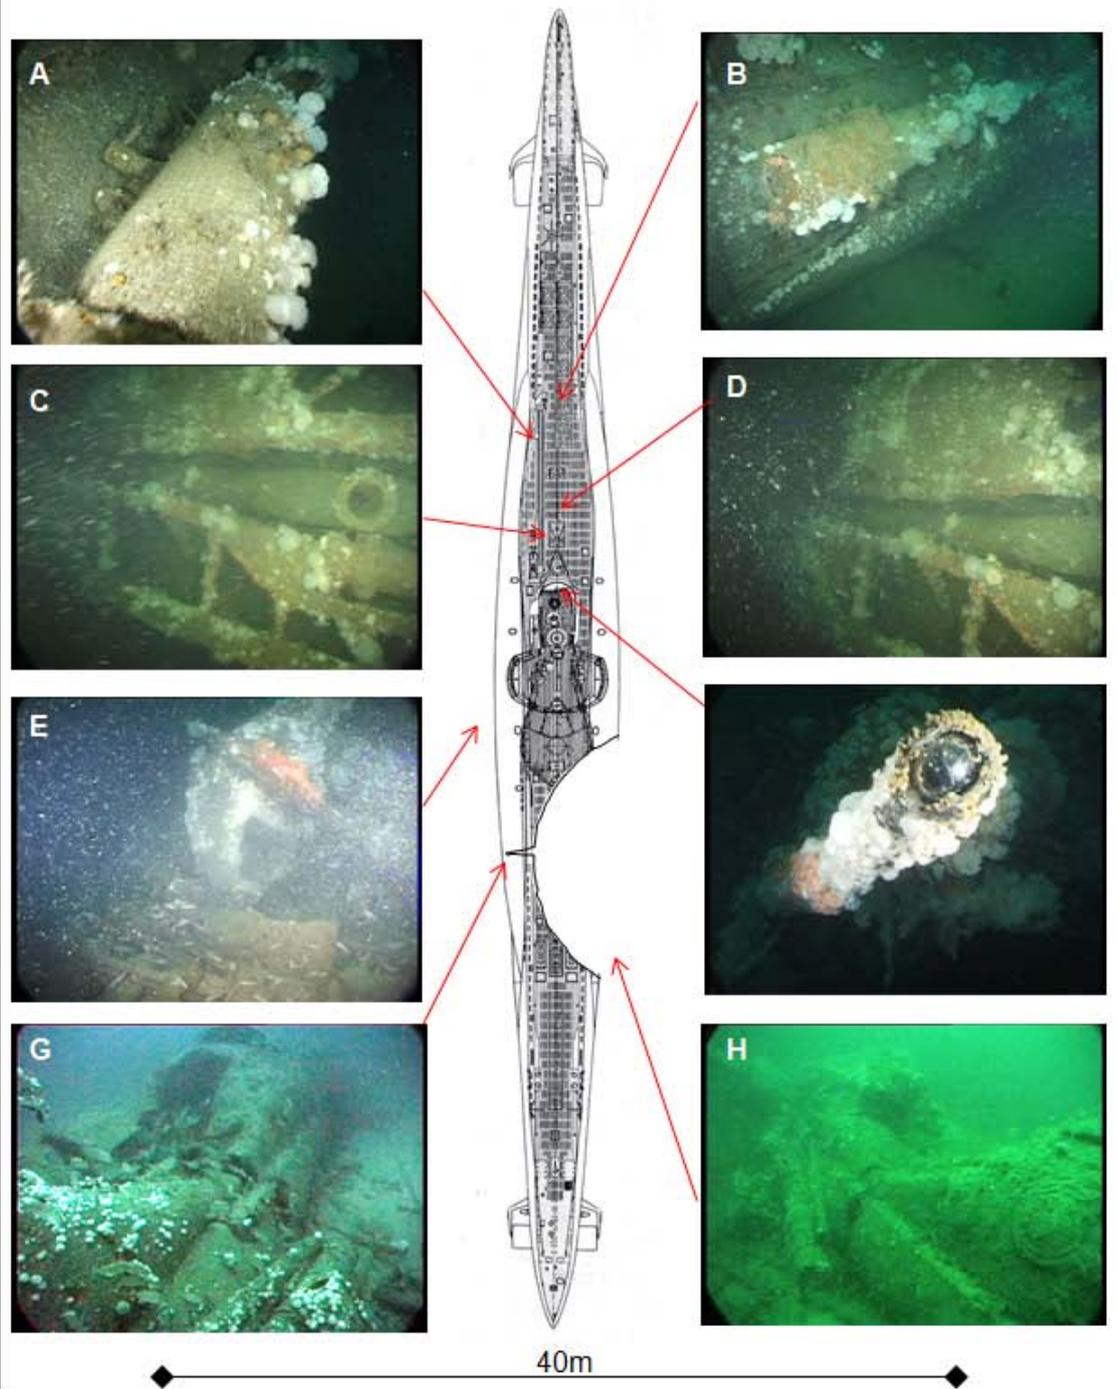
Figure 1.94 Diagram depicting the wreck of (U1021) and its key features as described in the text below. (All images Innes McCartney except the line diagram adapted from Köhl & Niestlé, 1994, 59).

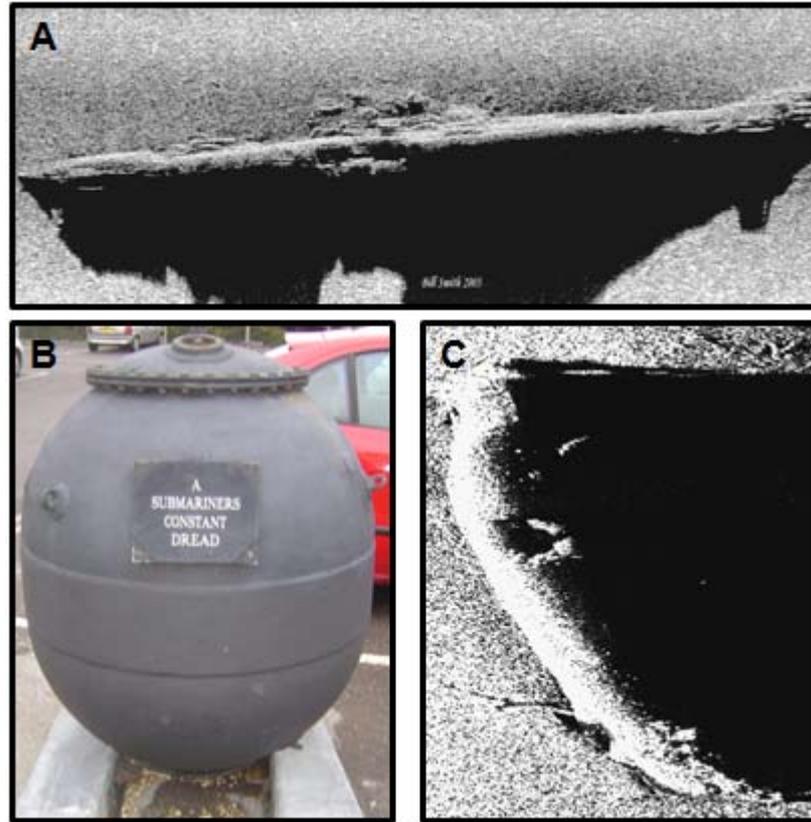
Figure 1.95. The mine damage to (U1021) can clearly be seen in these two side scan images (A&C) of the wreck. The mine used in the deep trap fields of the Inshore Campaign was the Mark XVII anti-shipping mine, as seen in Image B at the Royal Navy Submarine Museum. This mine packed a charge of 500lb, enough to sink a large ship (Images A&C Bill Smith Image B Innes McCartney).

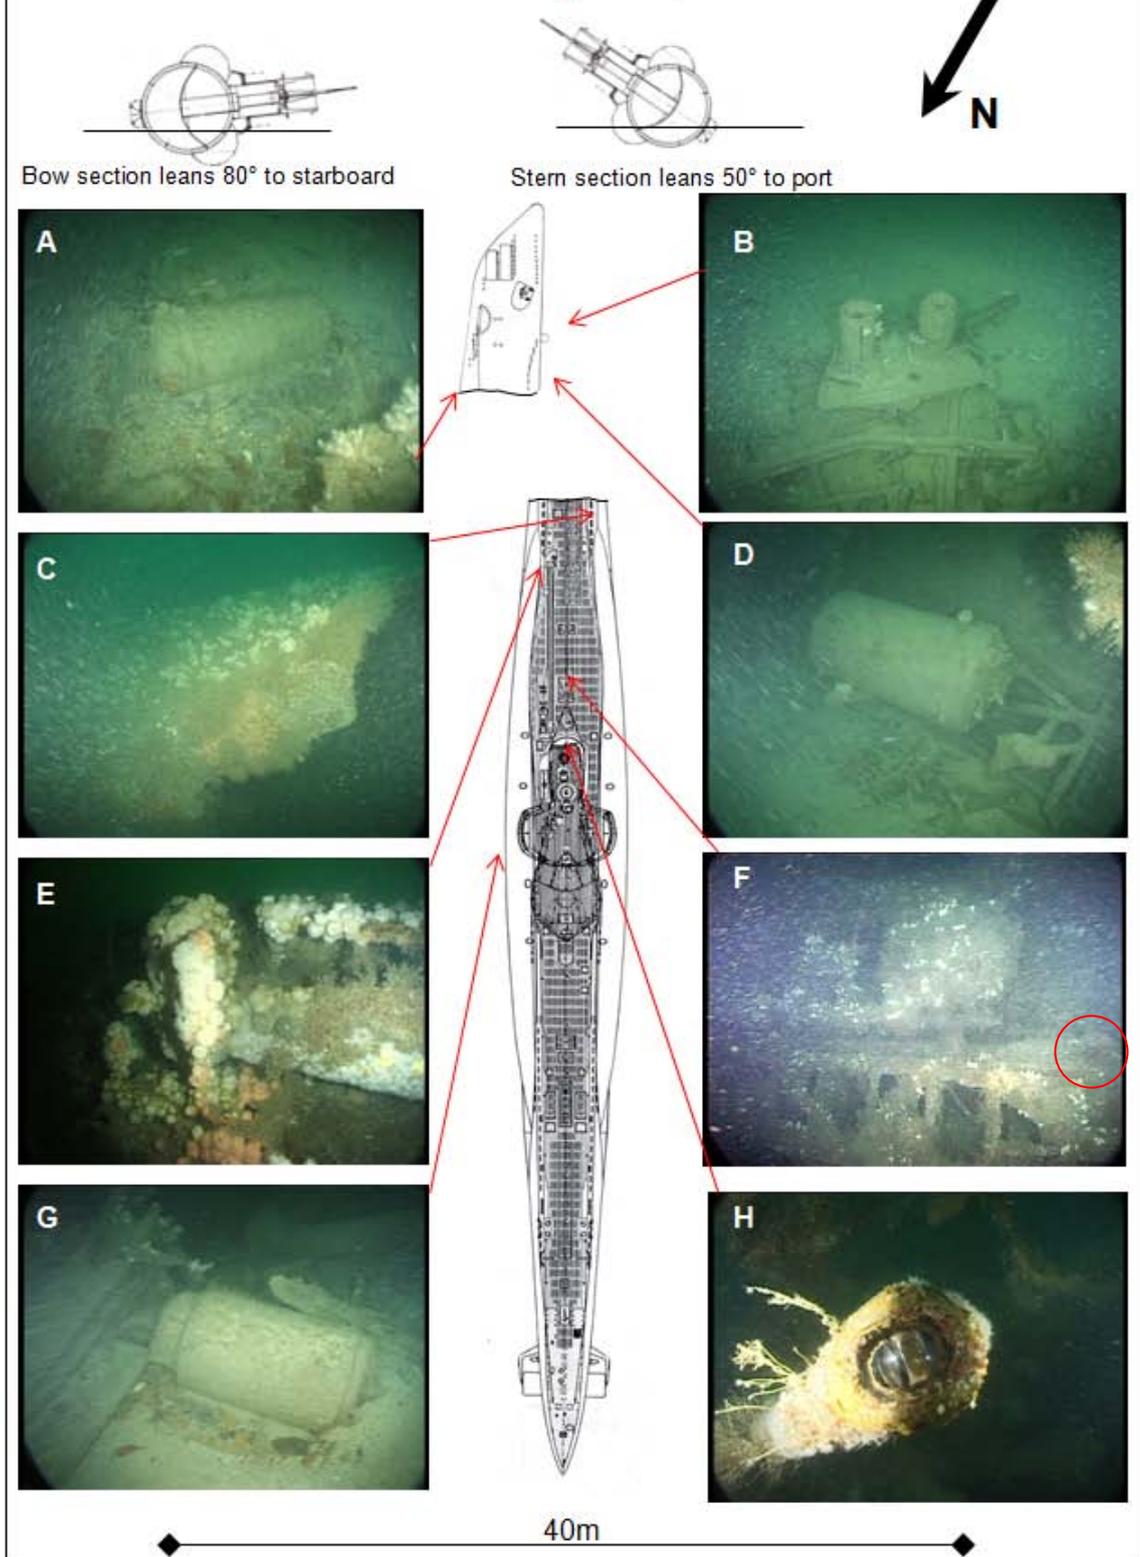
Figure 1.97. Diagram depicting the wreck of (U400) and its key features as described in the text. (All images Innes McCartney except the line diagram adapted from Köhl & Niestlé 1994, 57 and Westwood 1984, 33).

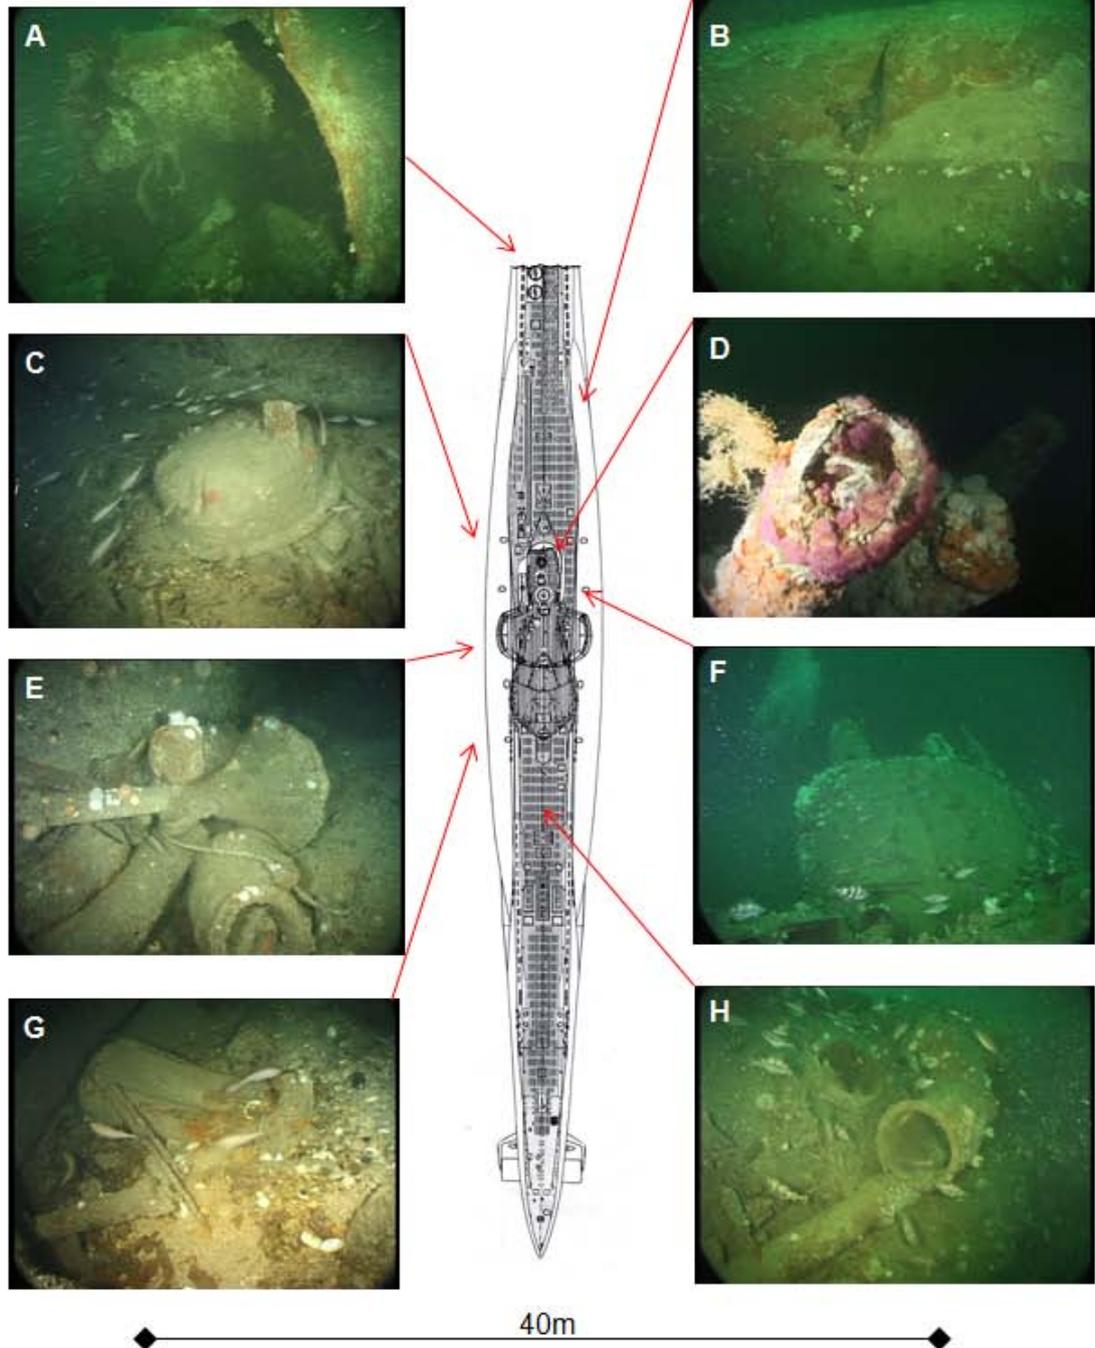
Figure 1.98. Diagram depicting the wreck of (U683) and its key features as described in the text. (All images Innes McCartney except the line diagram adapted from Köhl & Niestlé, 1994, 59).

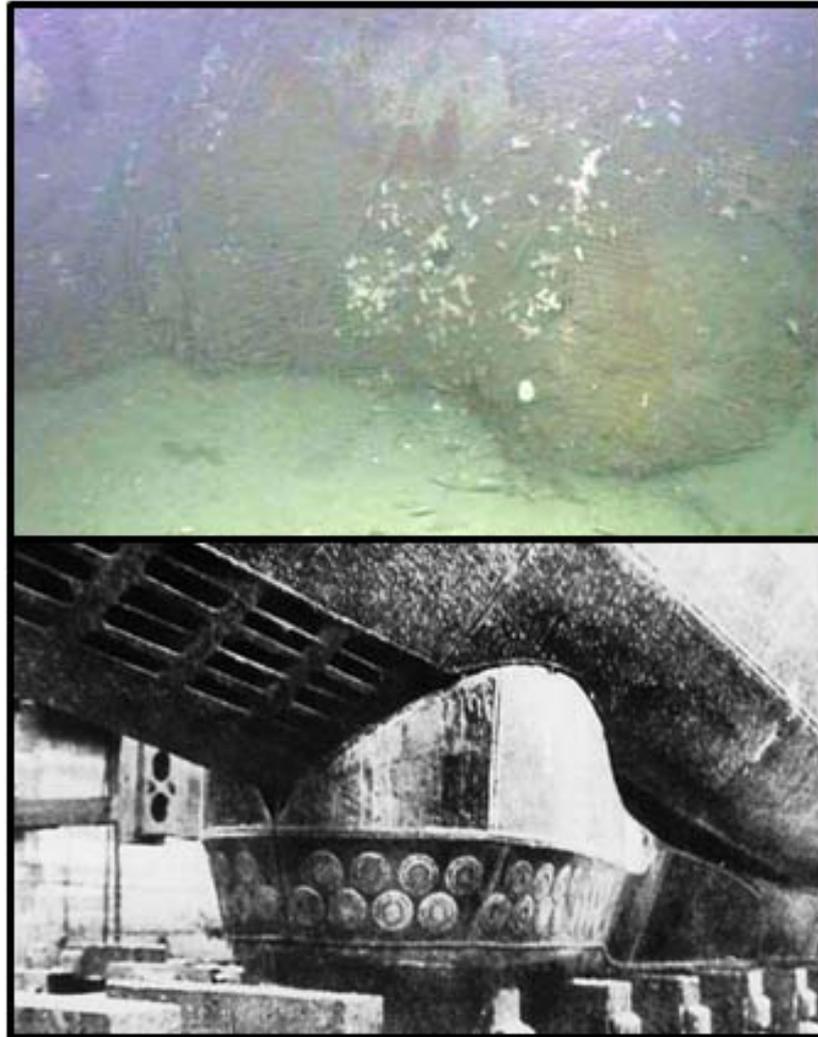
*Figure 1.101. The GHG balcony on the underside of the wreck of (U1279) and as fitted to U1105. (Odyssey Marine Exploration in Niestlé 2009, 4 (top), Kohl and Niestlé 1994, 16 (bottom)).*

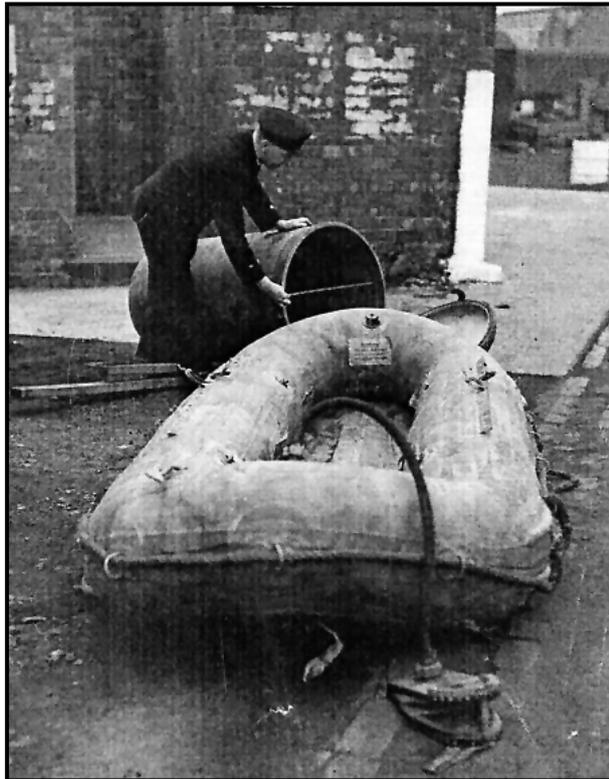
Figure 1.102. The life raft container with its dinghy recovered from the wreckage of (*U1279*) at the time of its sinking. (Imperial War Museum).

- Image G shows one of the ready-use ammunition containers for the 37mm anti-aircraft gun. These features can be confused for the bow-fitted life raft containers, but in this shot it can be seen to be a subtly different shape, without the distinctive narrowing at the bottom end seen on the life raft containers (see Figure 1.102 in Chapter 13);

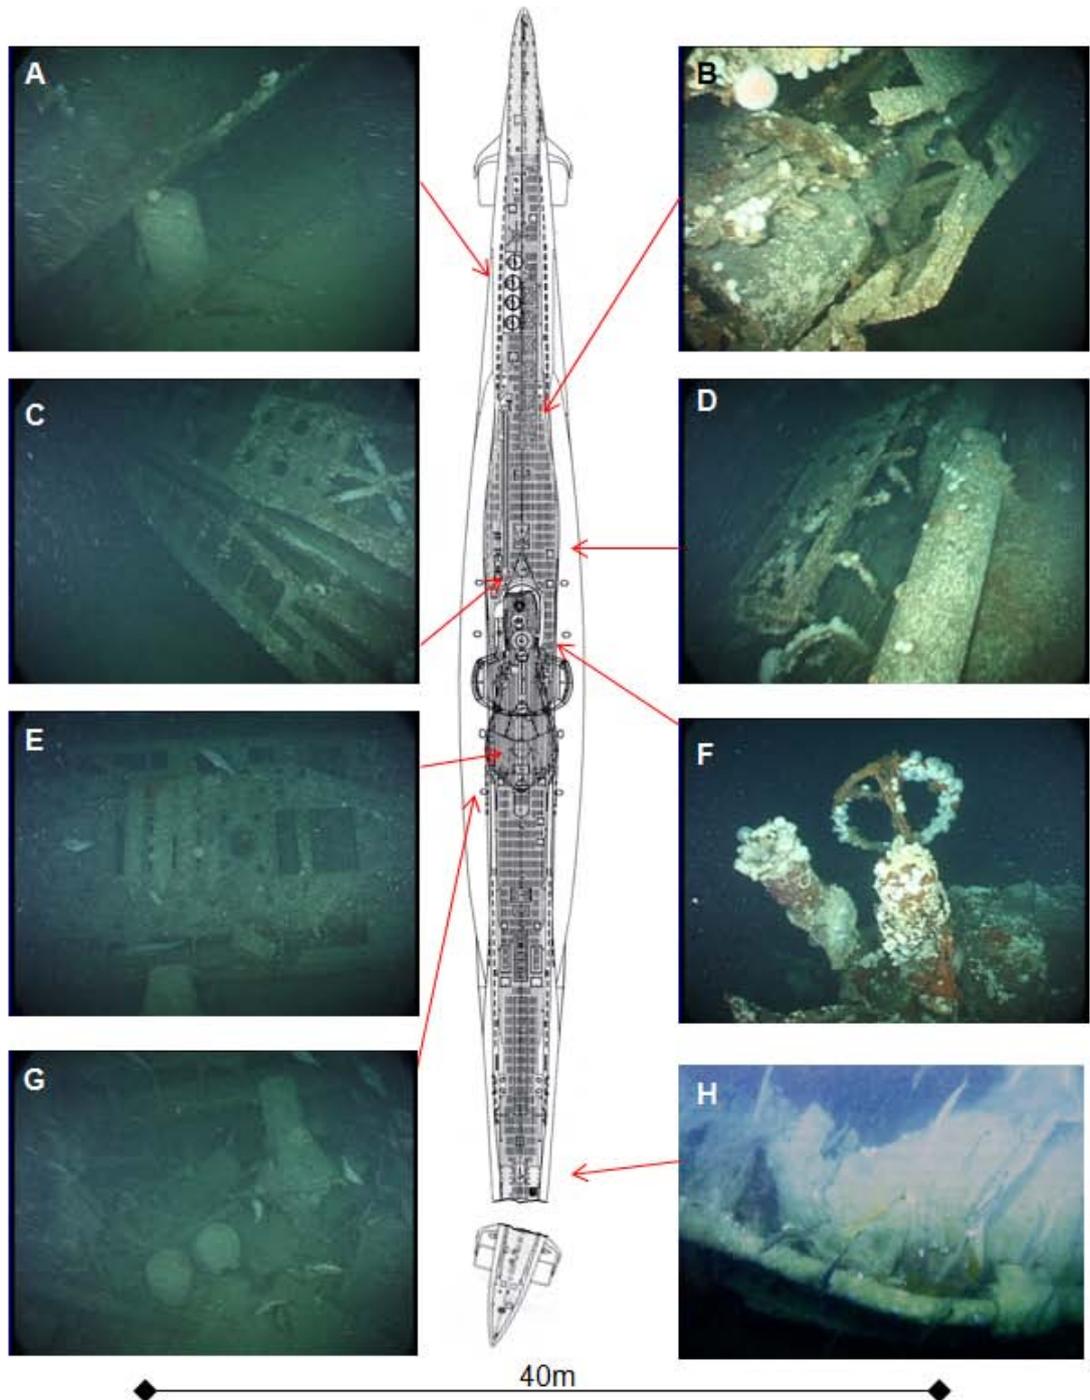
Figure 1.103. Diagram of the wreck of (U325) and its key features as surveyed and described in the text. (All images Innes McCartney except H, Niestlé 2011 and line diagram, adapted from Köhl & Niestlé, 1994, 59).

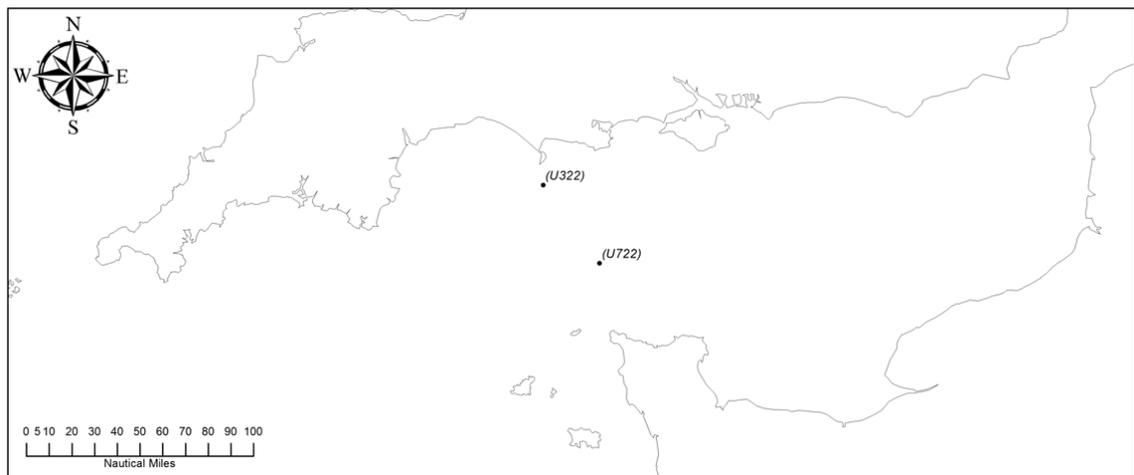
Figure 1.107. Map showing the locations of the wrecks of (U322) and (U772) (Innes McCartney).

This Case Study examines the sinking of two of the earliest losses to occur in the Study Area during the second phase of the Inshore Campaign. According to the 1946 official list of U-boat losses (NA ADM199/1786 Nos. 612 & 628) *U772* was sunk near to where this Case Study suggests it actually lies. However *U322* was considered to have been sunk north of Scotland. Figure 1.107 shows where the wrecks lie within the Study Area.

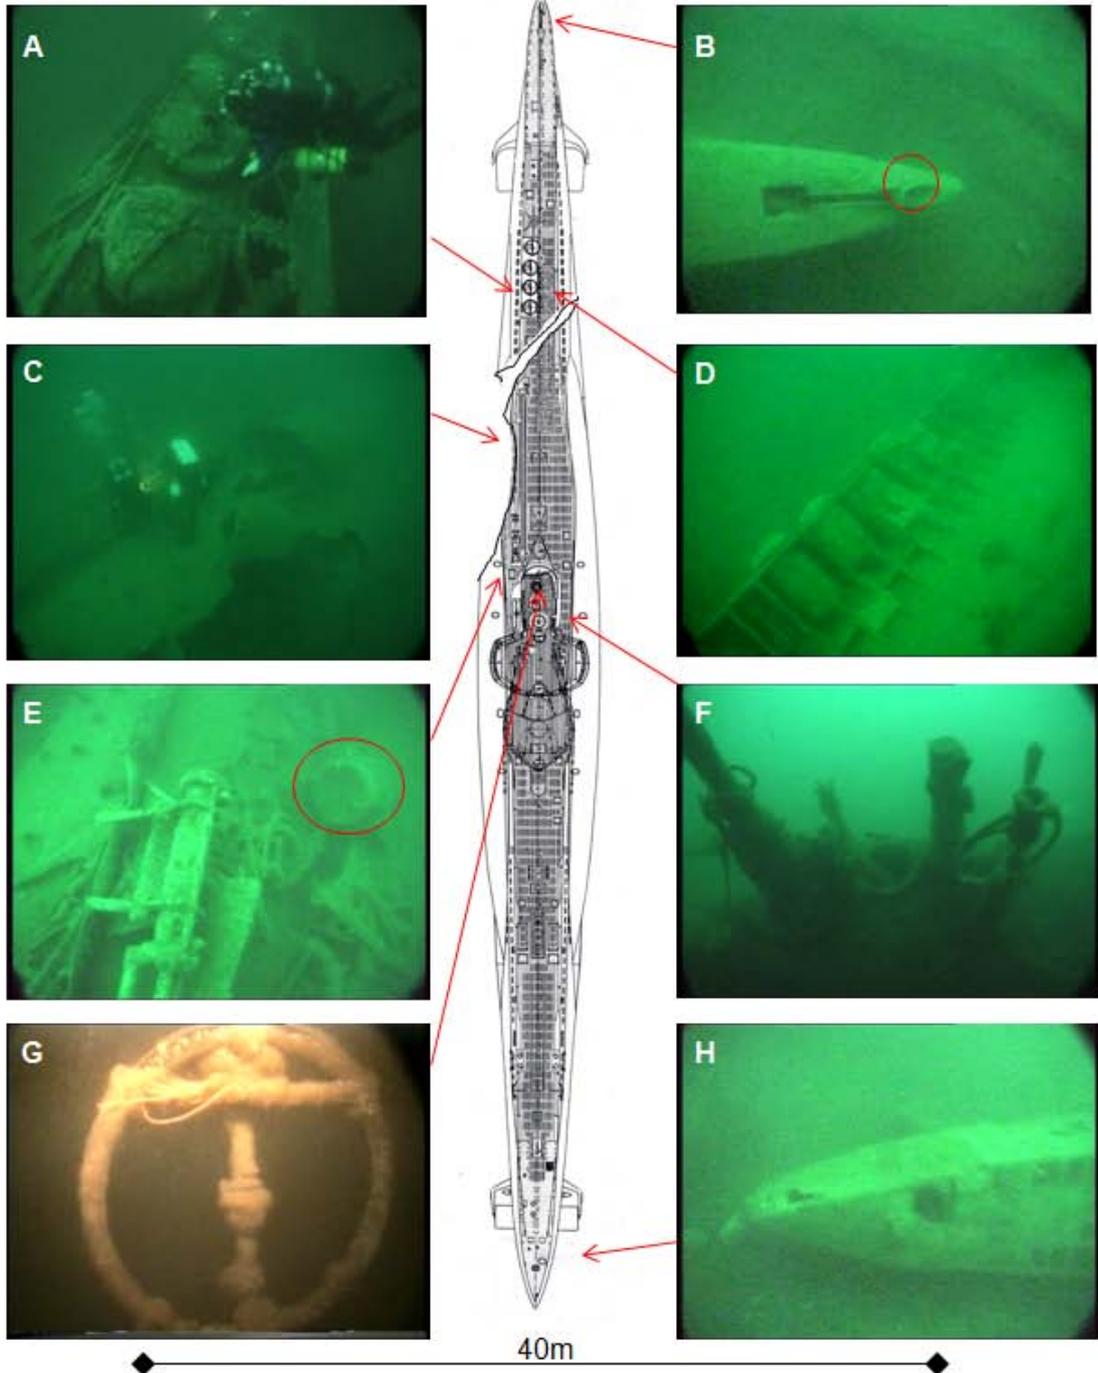
Figure 1.108. Diagram of the wreck of (U322) and its key features as surveyed and described in the text. (All images Innes McCartney except the line diagram, adapted from Köhl & Niestlé, 1994, 59).

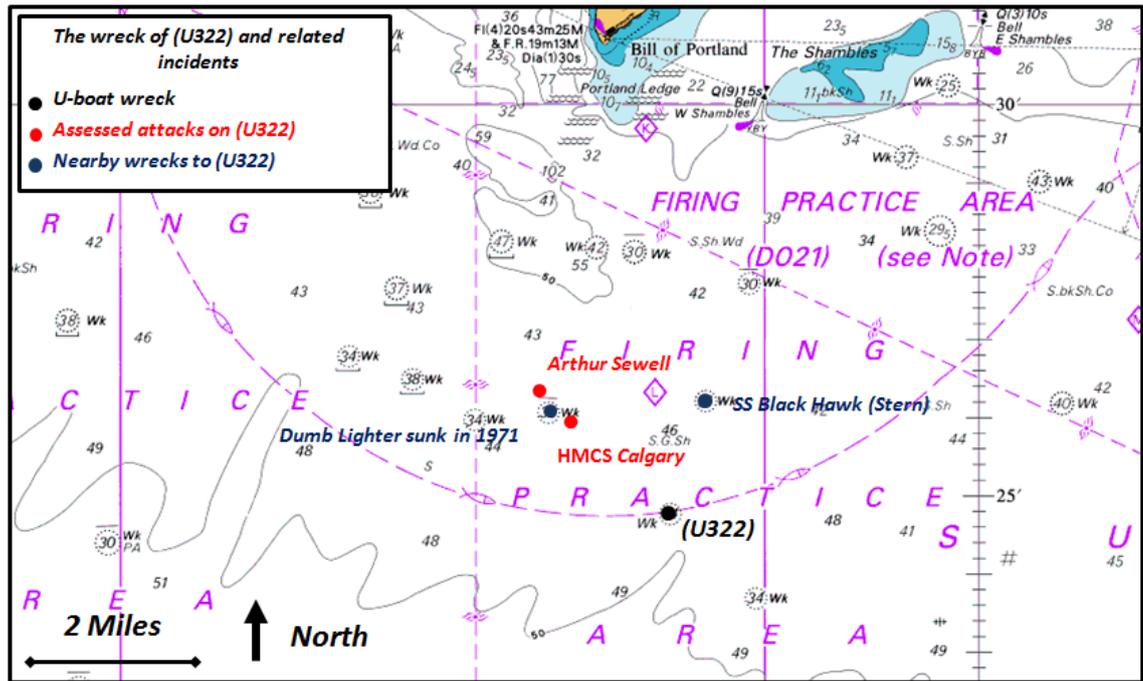
Figure 1.110. Map showing the wreck of (U322) and associated wrecks and incidents (Innes McCartney based on Chart No. 2454).
