**Defect Tolerance Assessment of Silicon Nitride
in Rolling Contact**

A thesis is submitted to Faculty of Science and Technology, Bournemouth University,
in partial fulfilment of the requirements for the degree of Doctor of Philosophy

In collaboration with SKF ERC, the Netherlands

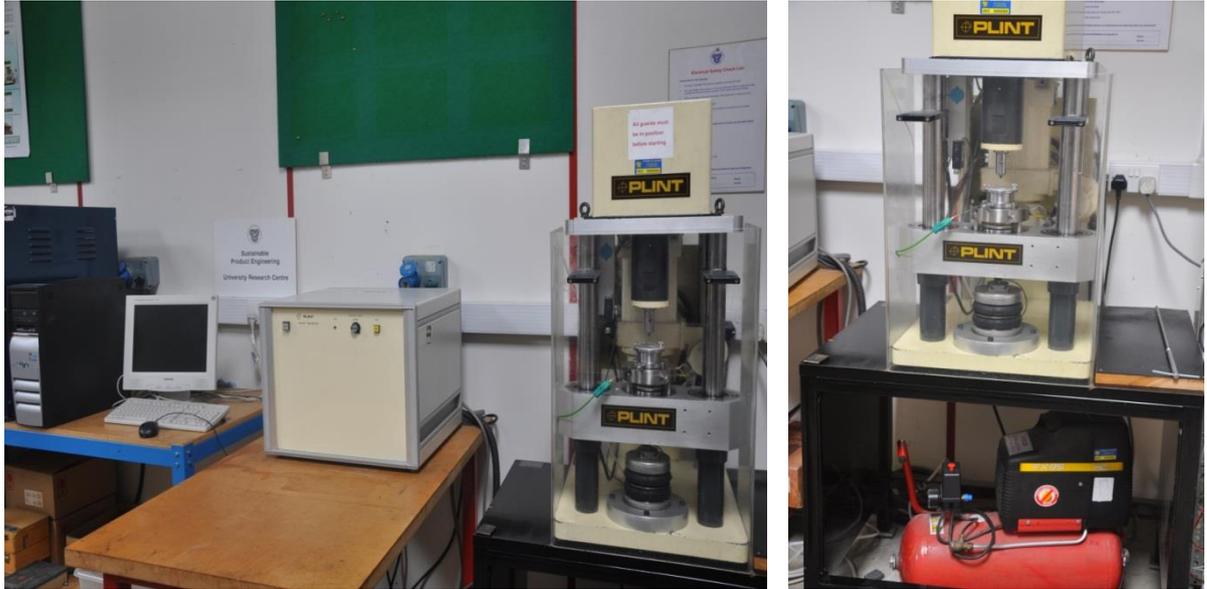
Figure 2.1: Modified four ball machine (a) machine and control unit (b) 4-ball experimenter

The Plint TE92HS microprocessor controlled rotary Tribometer (Fig. 2.1) is widely used for low and high load rolling contact experiments at different speeds and temperatures and can also be operated under controlled environments. The machine used in this study was configured as a modified 4-ball machine according to Institute of Petroleum (UK) IP 300 Rolling Experimental Procedures. It consists of a steel fabricated main body with experiment chamber and thermocouple arrangement.

The upper ball is held in the collet which is rotated by the motor whereas the lower balls are located in a fixed cup and are driven by the upper or test ball. The cup is filled with oil and can be refilled during the experiment through the cover plate. Thermocouple arrangement is made to maintain or control temperature during experiments. The required pressure is applied by the pressure head. The upper ball is subjected to 2.25 stress cycles per spindle revolution as calculated using following formula [Appendix A1, Tourette et al. 1977]. Stress factor is further used to calculate number of stress cycles. Hertz contact theory [Johnson 1985] is used to calculate contact pressure and contact radius. Contact load calculations and Stress factor are detailed in Appendix A (A1 and A2).

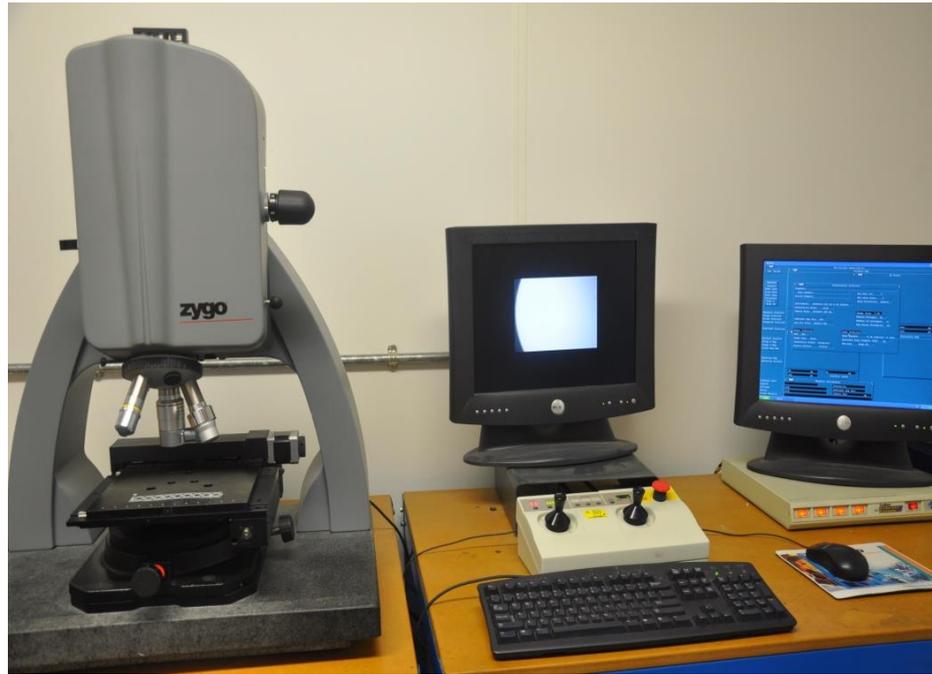
Figure 2.4: White Light Interferometer (Zygo Interferometer)

White light Interferometer (Zygo Interferometer – New View 5000) is used for surface analysis and mapping. The surface finish of the original surface can be measured and compared with the surface morphology after the experiment. The three-dimensional surface mapping profilometer can accurately measure the surface roughness, the size and periphery of the defect, the step heights and the volume loss although there can be some doubt or inaccuracy with features having sharp (vertical) boundaries.

The sample is placed under the main platform and light is focussed and adjusted so that fringes are clearly visible. Volume loss, 3D surface profiling and stitching are the powerful features of this instrument. Figure 2.4 shows white light interferometer used for surface analysis in this research study.

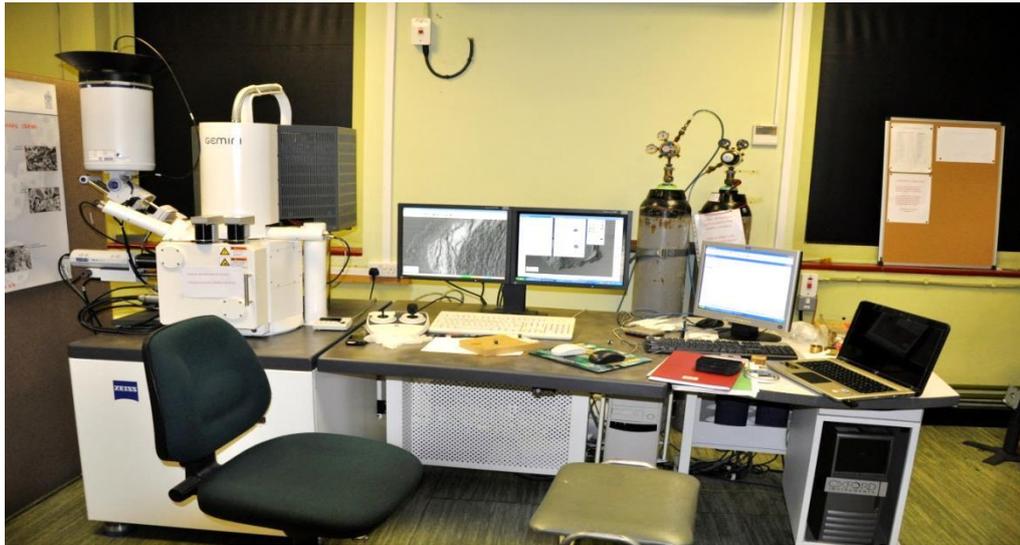
Figure 2.5: Zeiss Supra 35 VP SEM (Courtesy: ETC Brunel University)

SEMs are used for very high magnification and high resolution images and surface analysis and energy dispersive spectroscopy (EDS) for elemental analysis. SEMs are used for magnification normally up to 40,000x and also for some cases are used for magnification up to 1,000,000x. Sample should be electrically conductive in nature and non-conducting samples need to be coated to avoid electrical charging. Cleaned samples are put in the vacuum chamber with appropriate working distance. Parameters such as voltage, current and magnification are controlled through operating console. Higher voltages give better resolution but may lead to more charging problem with non-conductive samples. Generally, biological samples are examined at low voltages and non-biological samples are examined at higher voltages. Figure 2.5 shows the SEM used for this research work.

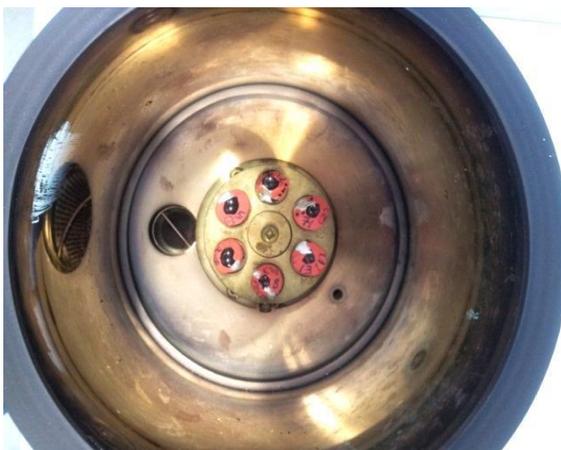
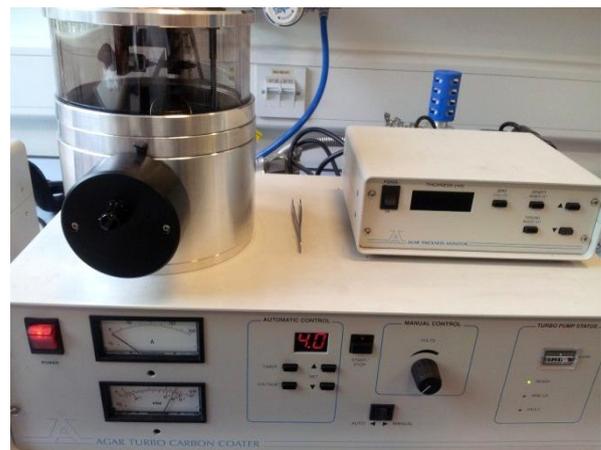
Figure 2.6: (a) Sputter Coater for Gold Coating (b) Agar Turbo Carbon Coater for Carbon Coating

Coating is normally done before using scanning electron microscopy on non-conducting material samples. Gold and carbon coating are commonly employed for this purpose. Sputter coater was used for gold coating whereas Agar Carbon coater is used for carbon coating (Figure 2.6).

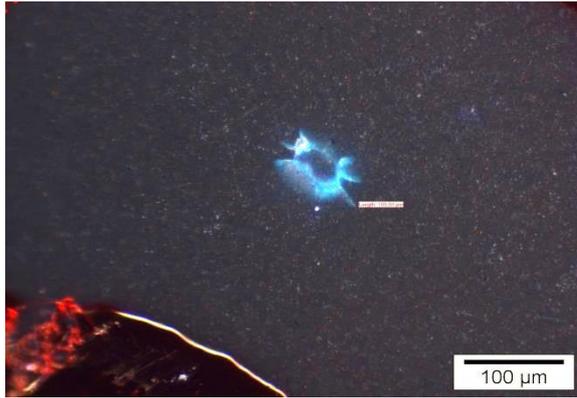
Figure 3.2: Star feature category 2 (a) UV illumination (b) white light illumination

Category 2: Minor missing material (10 μ m to 30 μ m) – Figure 3.2

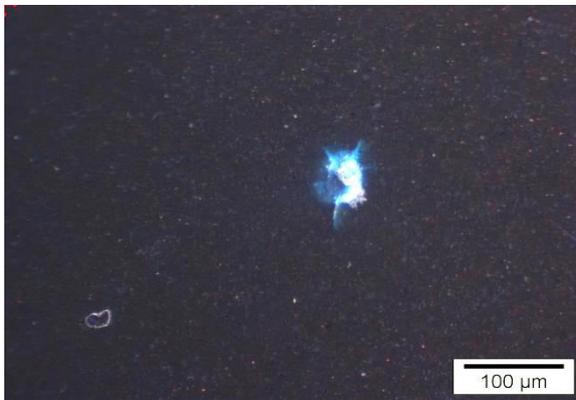
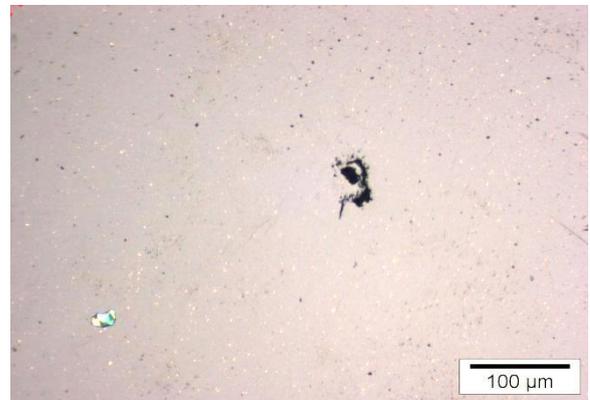
Figure 3.3: Star feature category 3 (a) UV illumination (b) white light illumination

Category 3: Medium missing material (30 μ m to 60 μ m) – Figure 3.3

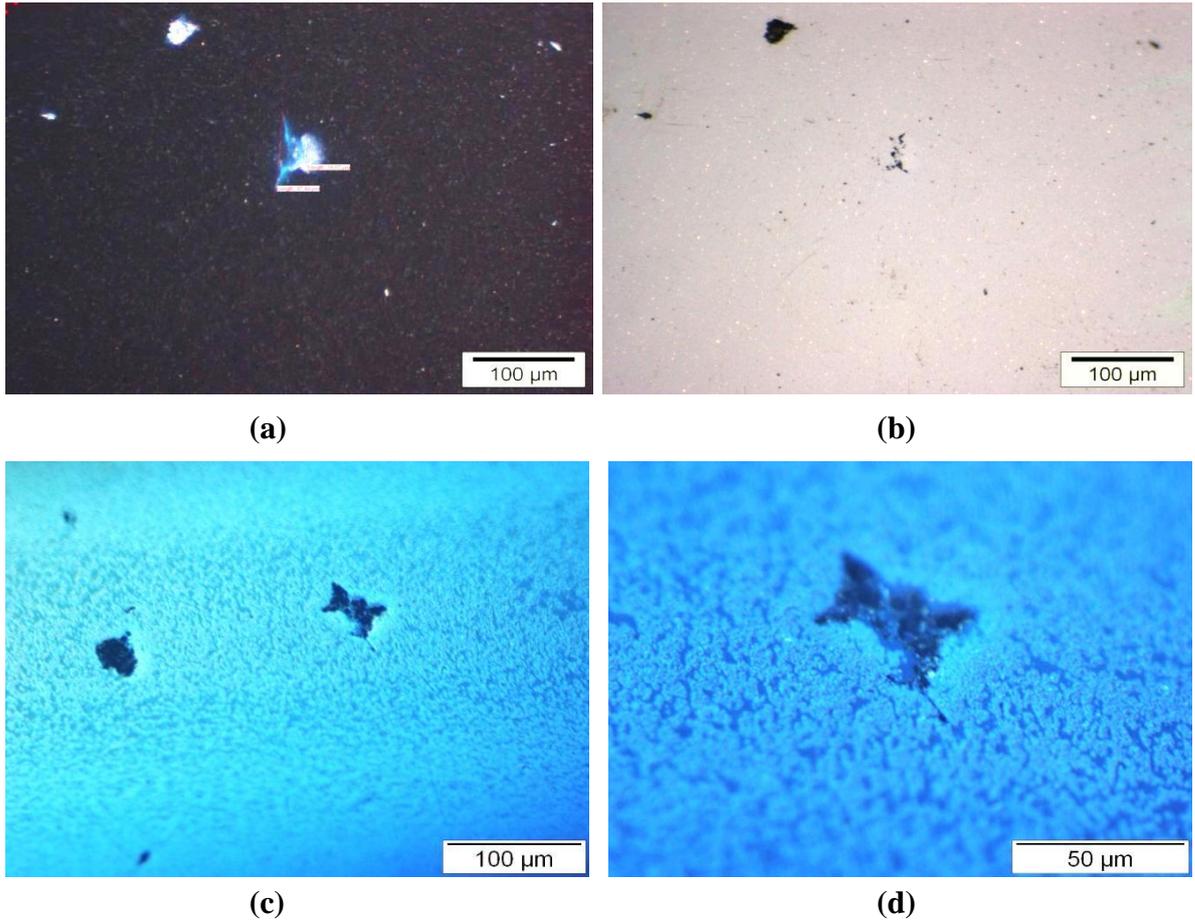
Figure 3.10: Experiment C1TM1 (a) pre-experiment UV illumination (b) pre-experiment white light illumination (c) and (d) post-experiment OM image

In this experiment, material loss within domain of defect was observed along with some crack growth on one side of the defect. Material loss and surface wear observed in mineral oil was more than observed in traction fluid experiments. This may be due to low viscosity of mineral oil (8.81cSt) than traction fluid (28-38cSt) and hence thin film thickness. Film thickness calculation is based on combination of fluid mechanics and material science (Appendix G). SEM post experiment surface analysis is shown in Figure 3.11.

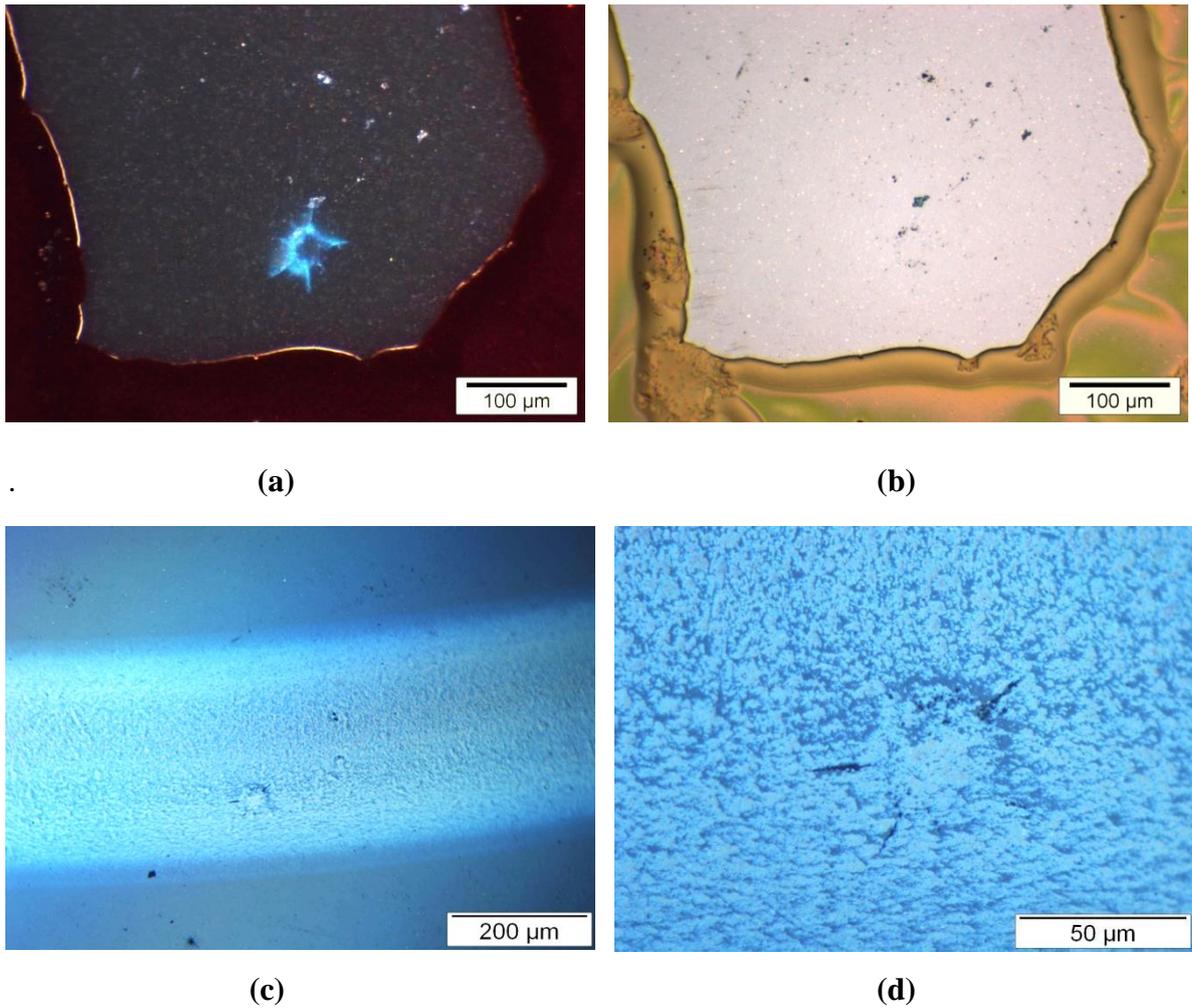
Figure 3.12: Experiment C1TM2 (a) pre-experiment UV illumination (b) pre-experiment white light illumination (c) post-experiment OM image (d) post-experiment OM image at high magnification

In the second experiment (C1TM2), surface wear and uplift was found (Fig. 3.12) after 8 million stress cycles. This uplift mechanism may be due to lubricant penetration of the thin lubricant into the star cracks and then pushing up the top surface by hydrostatic pressure.

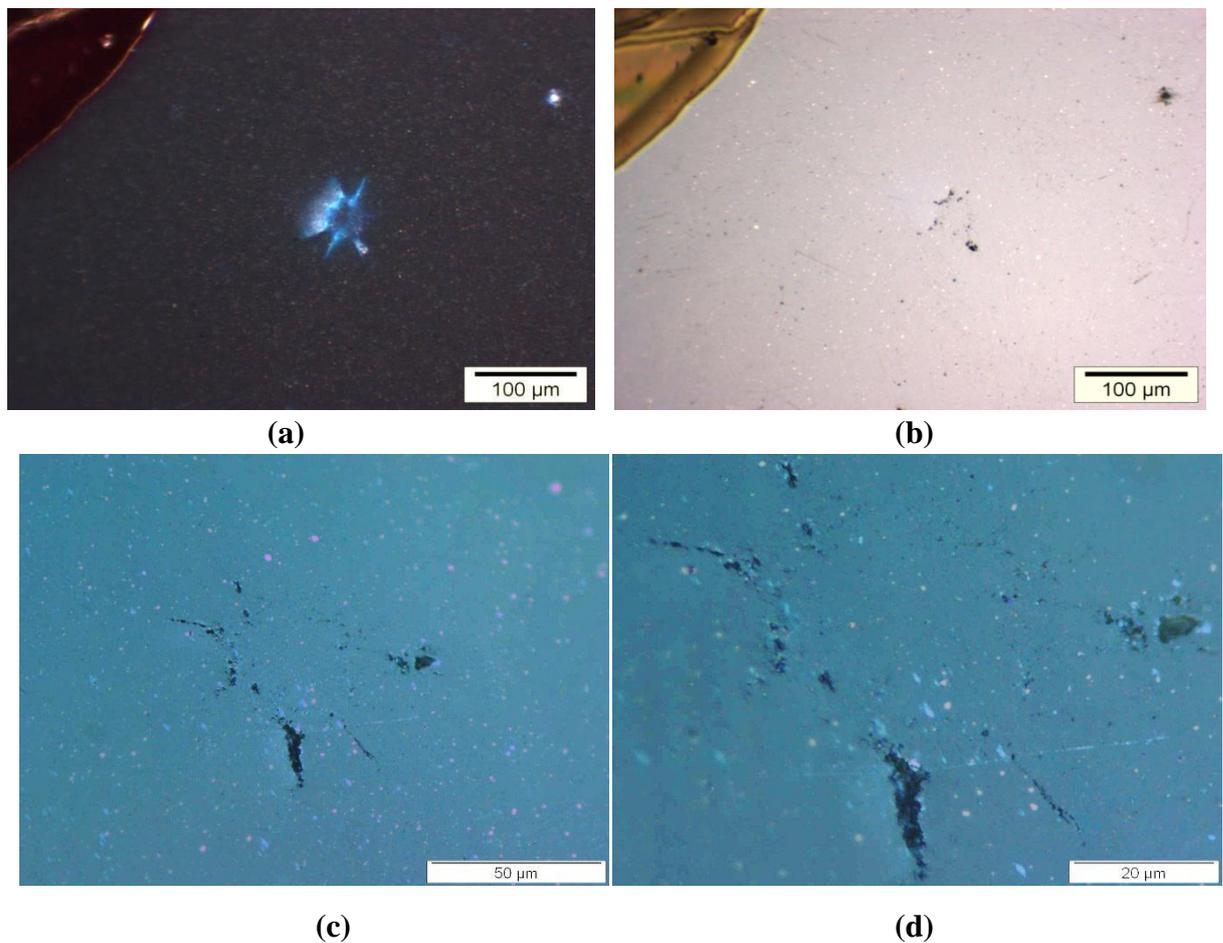
Figure 3.16: Experiment C1Grs1 (a) pre-experiment UV illumination (b) pre-experiment white light illumination (c) and (d) post-experiment OM images

Details of the experiments are given in Table 3.6 and the appearance of the stars before and after testing are shown in Figs. 3.16-3.17.

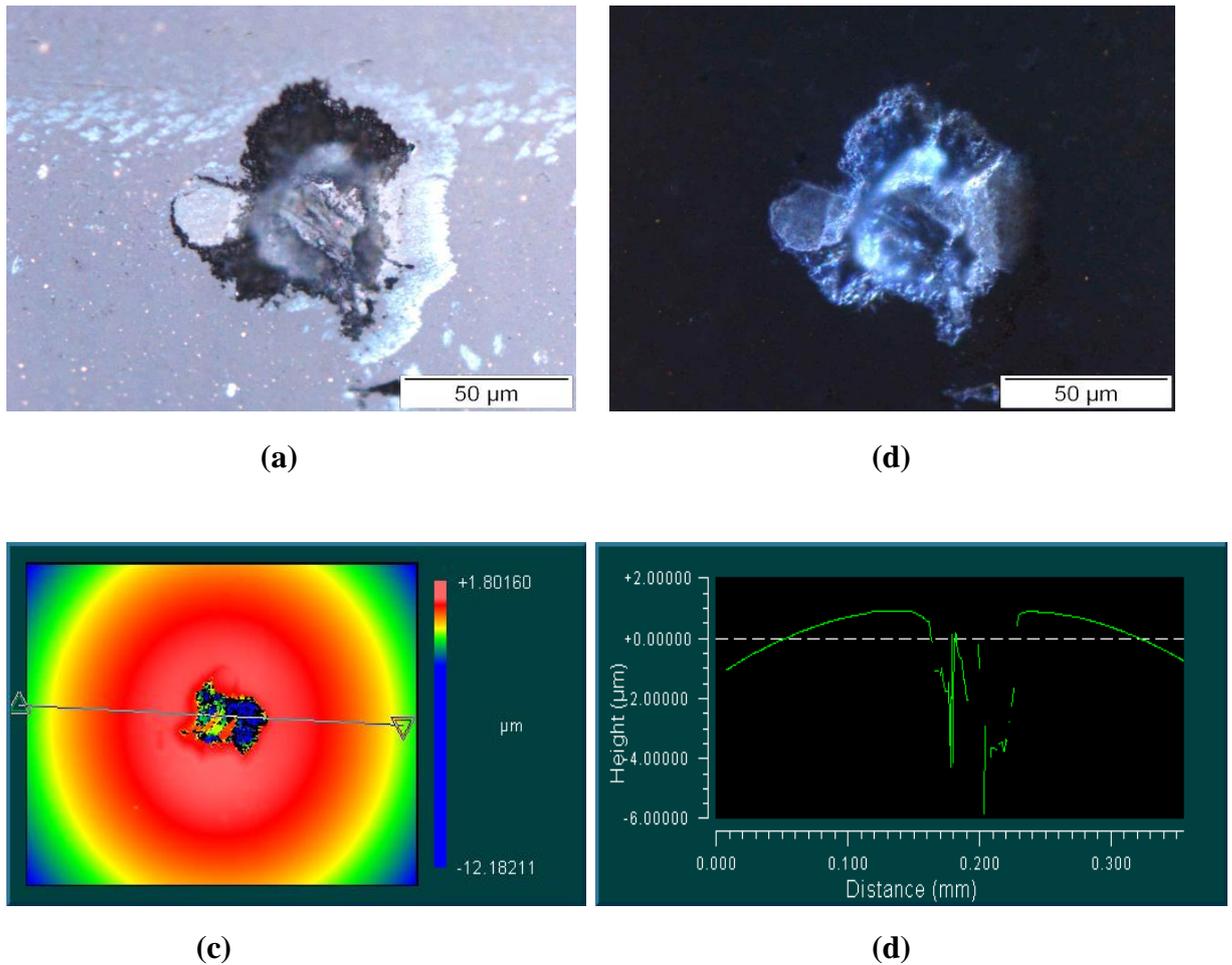
Figure 3.19: Experiment C5TM1 post-test- 100 million cycles (a) white light illumination (b) UV illumination (c) and (d) surface mapping by interferometry

The maximum depth of the feature increased slightly but its extent at the surface was unchanged (apart from the shallow wear areas). Since this first test resulted in little damage and no failure, a higher contact pressure of 4.8 GPa was used in subsequent experiments. In the second experiment (C5TM2), ball rotation or movement inside the collet was observed after 20 million cycles due to the thin lubricant and high friction on the surface. Surface analysis also revealed some small crack growth from the side of the original defect along with surface track wear. Figures 3.20 and 3.21 are showing pre- and post-experiment surface analysis of the sample surface used in the experiment C5TM2.

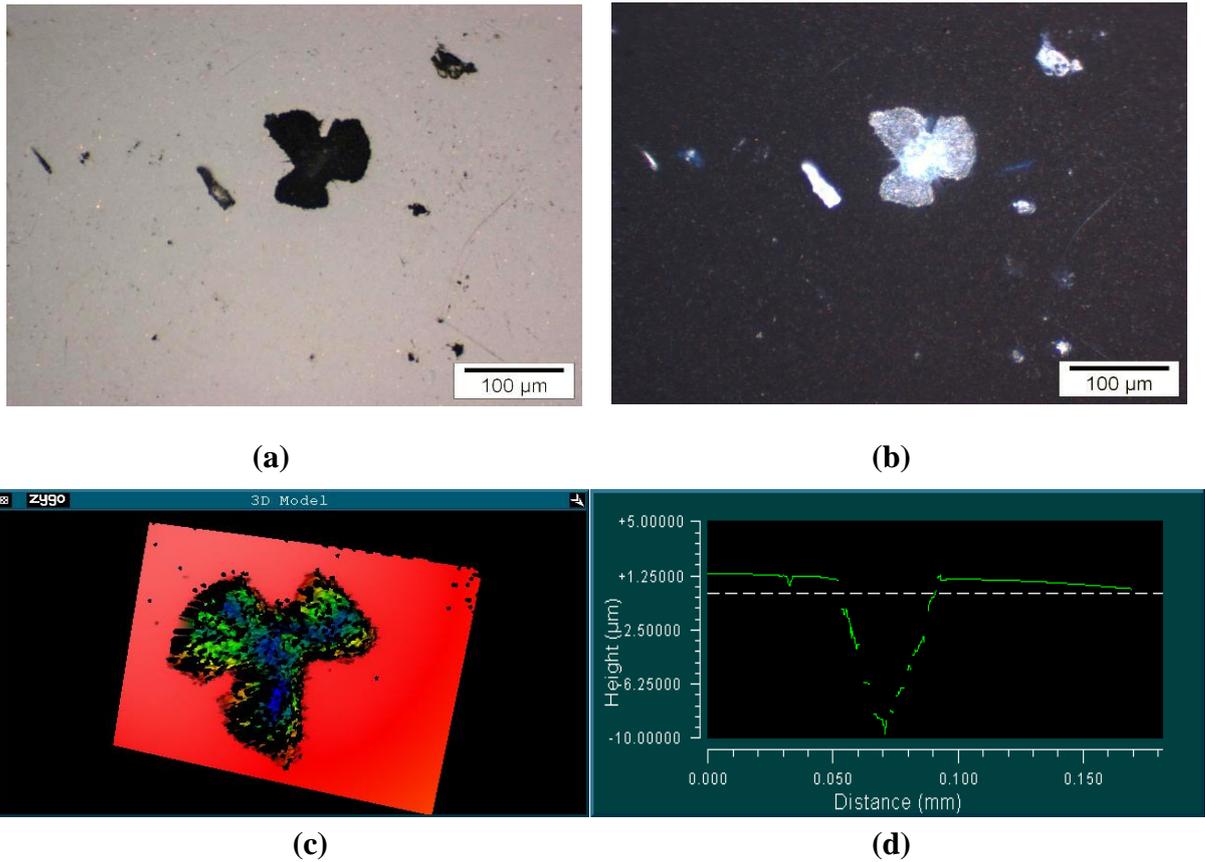
Figure 3.20: Experiment C5TM2 pre-test (a) white light illumination (b) UV illumination (c) and (d) surface mapping by interferometry

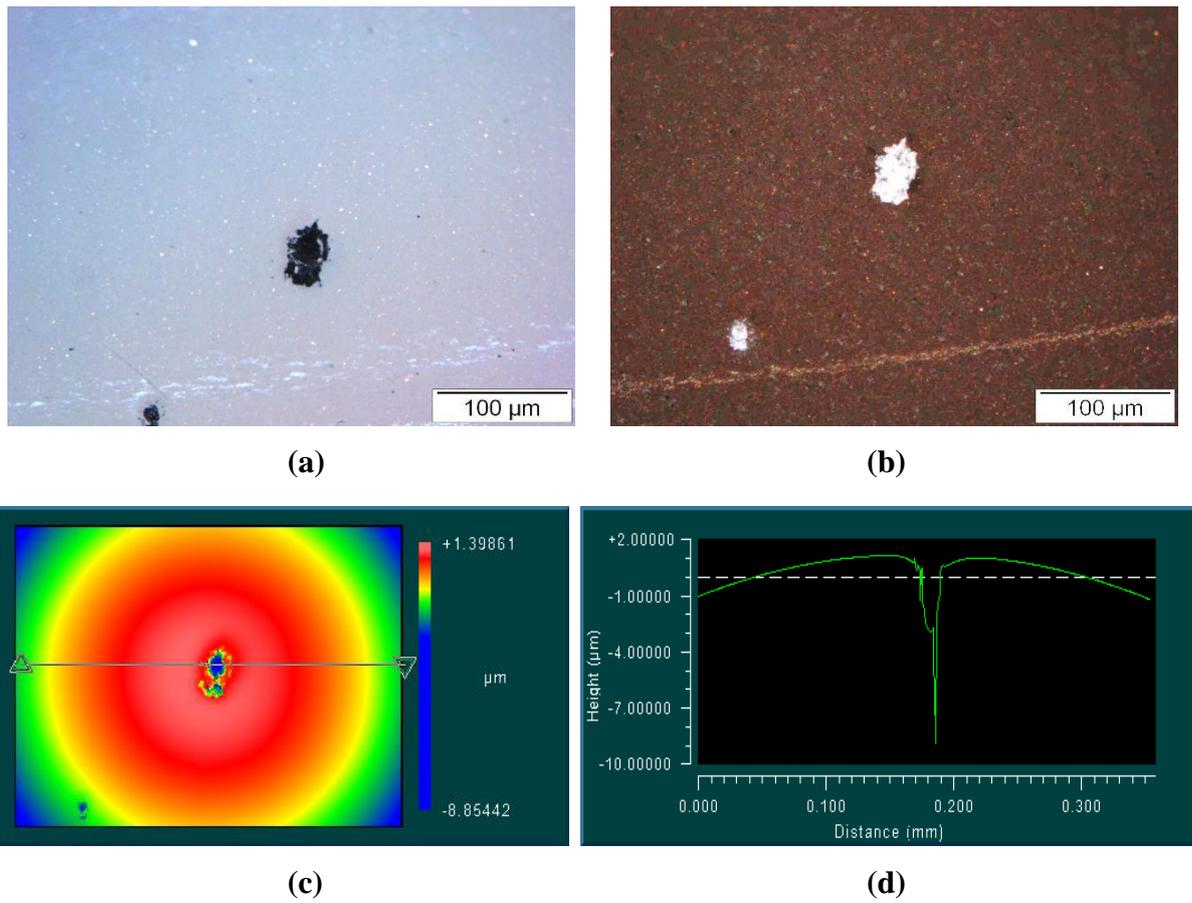
Figure 3.26: Experiment C5TM5 post-test-100 million stress cycles (a) surface analysis using white light illumination (b) Surface mapping by interferometry

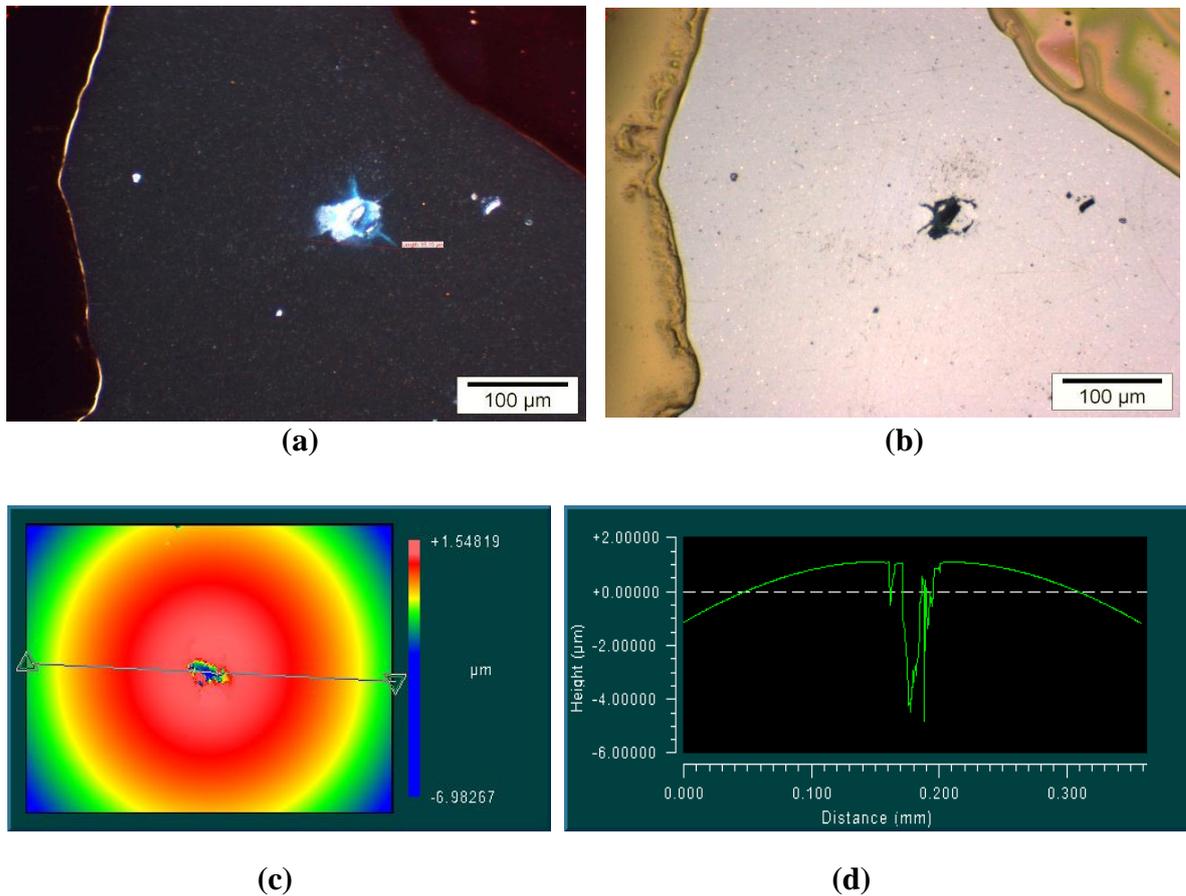
Figure 3.29: Experiment C3TM1 pre-experiment (a) white light illumination (b) UV illumination (c) and (d) surface mapping by interferometry

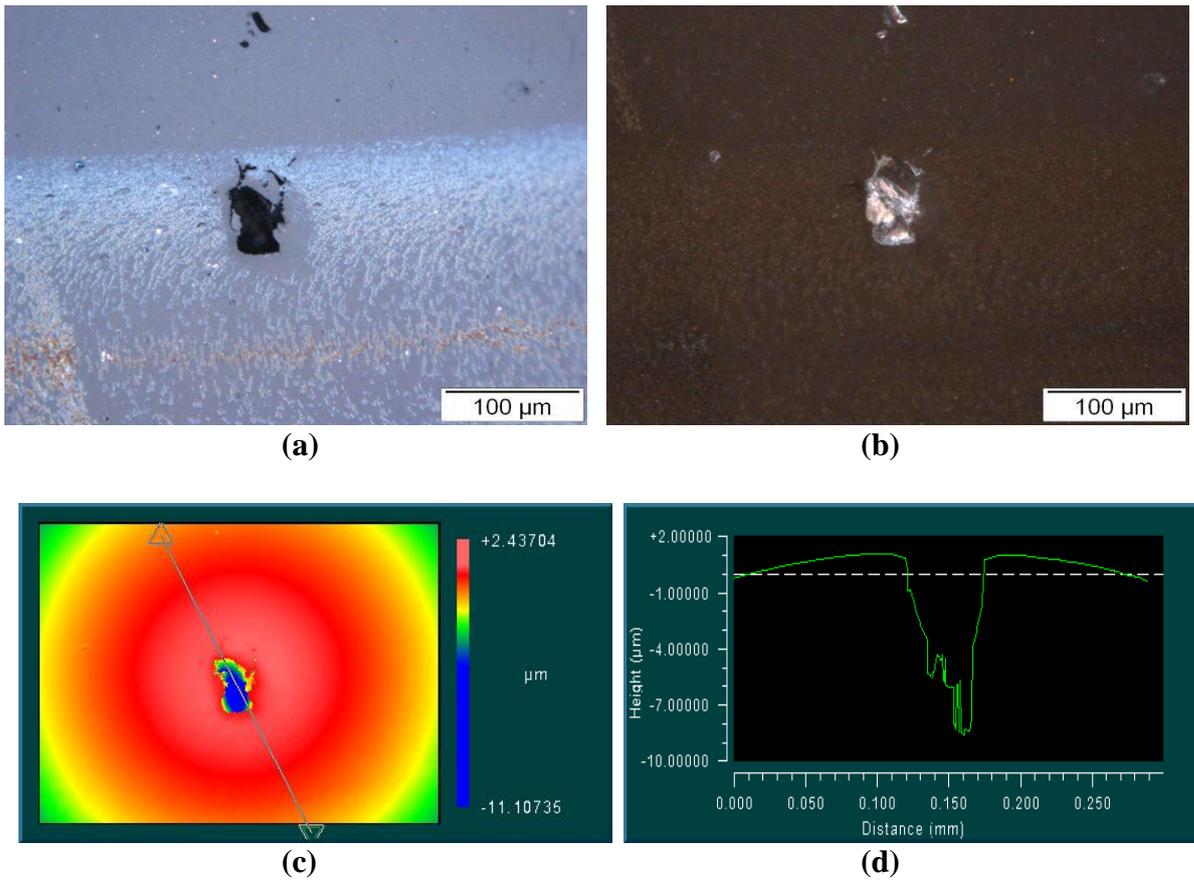
Figure 3.30: Experiment C3TM1 post-experiment (a) white light illumination (b) UV illumination (c) and (d) surface mapping by interferometry

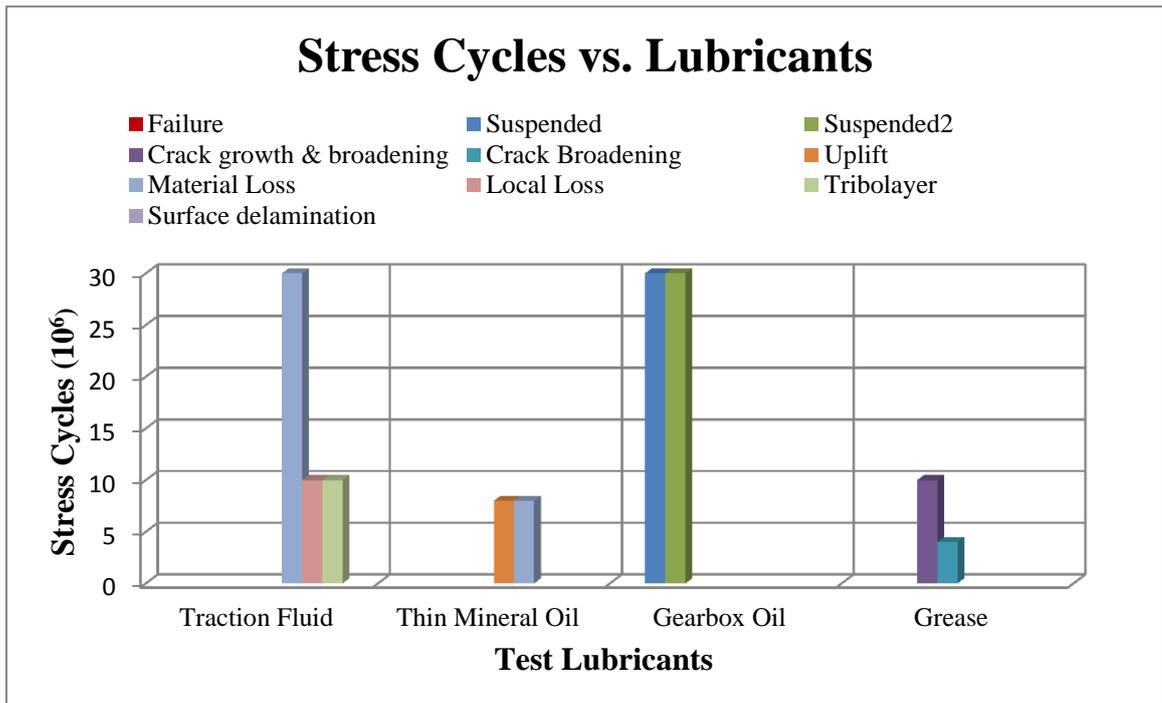
Figure 3.35: Comparison of different lubricants for star features category 1 experiments

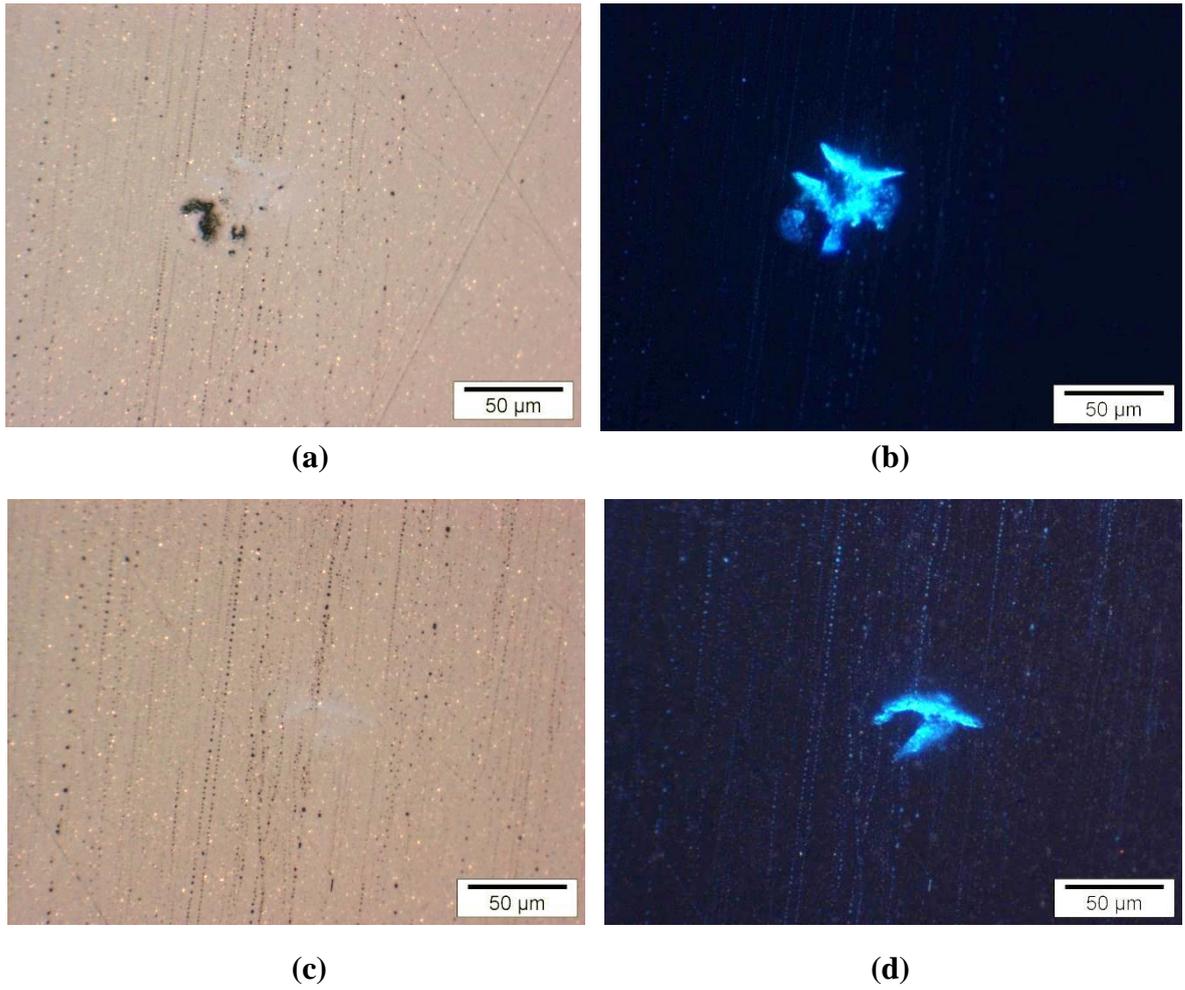
Figure 3.36: Artificial star making using diamond paste (a) and (c) light illumination for sample 1 and 2 (b) and (d) UV illumination for sample 1 and 2 (Work done at ERC)

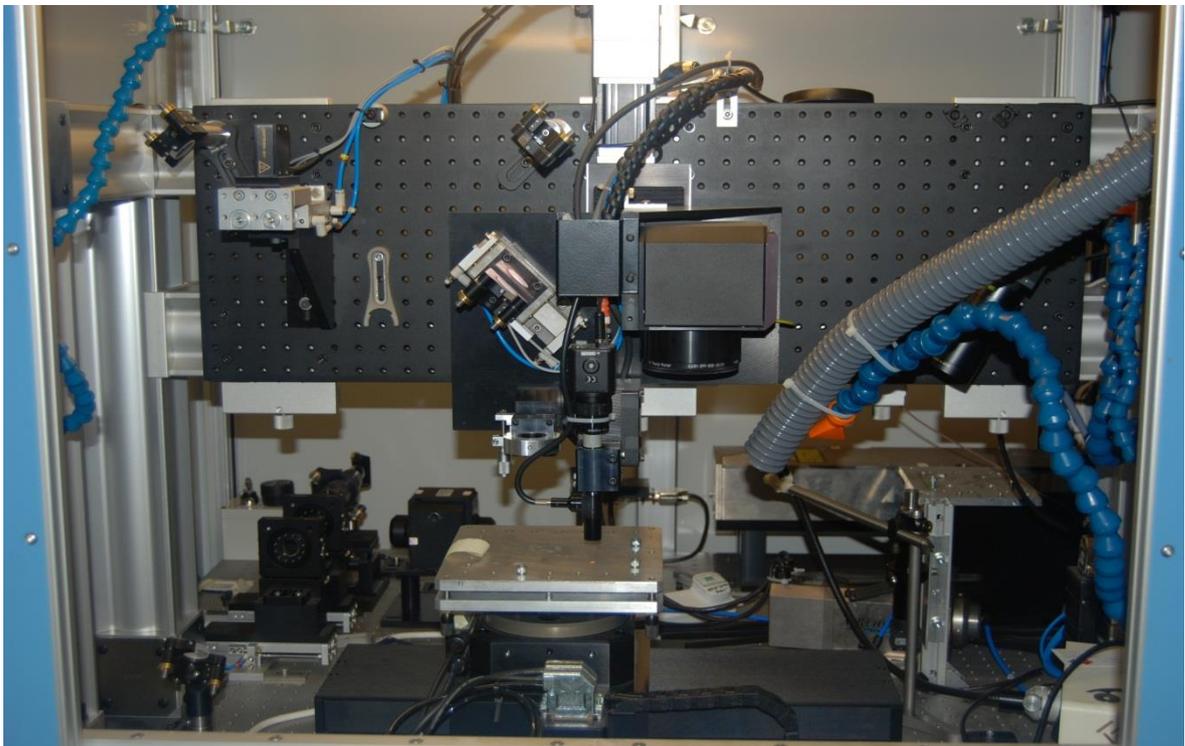
Figure 4.2: Laser Workstation (courtesy: Laser micromachining Limited, UK)

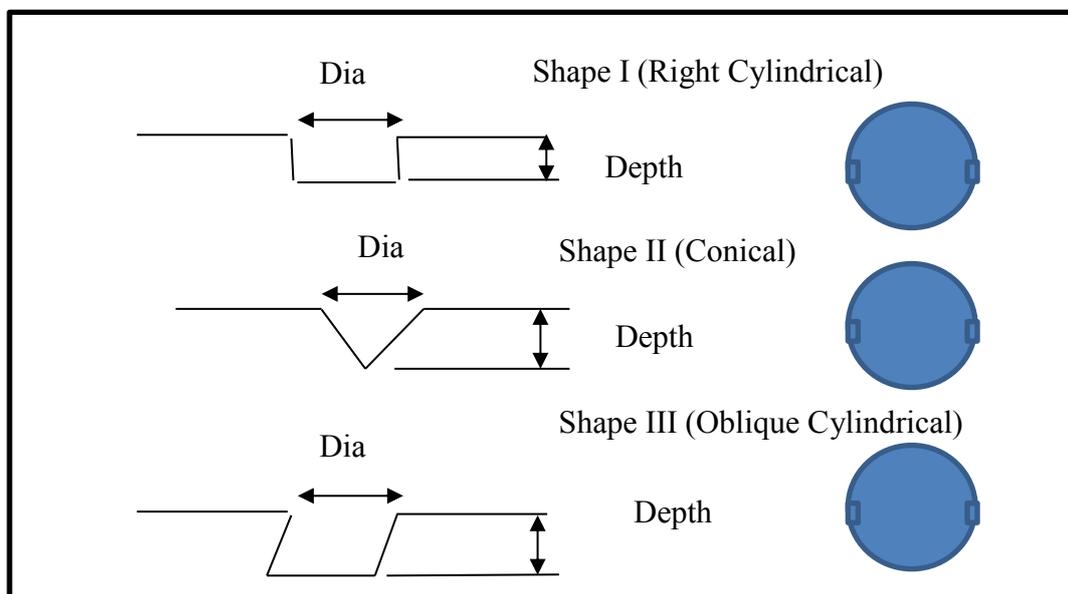
Figure 4.3: Proposed shapes for laser machining

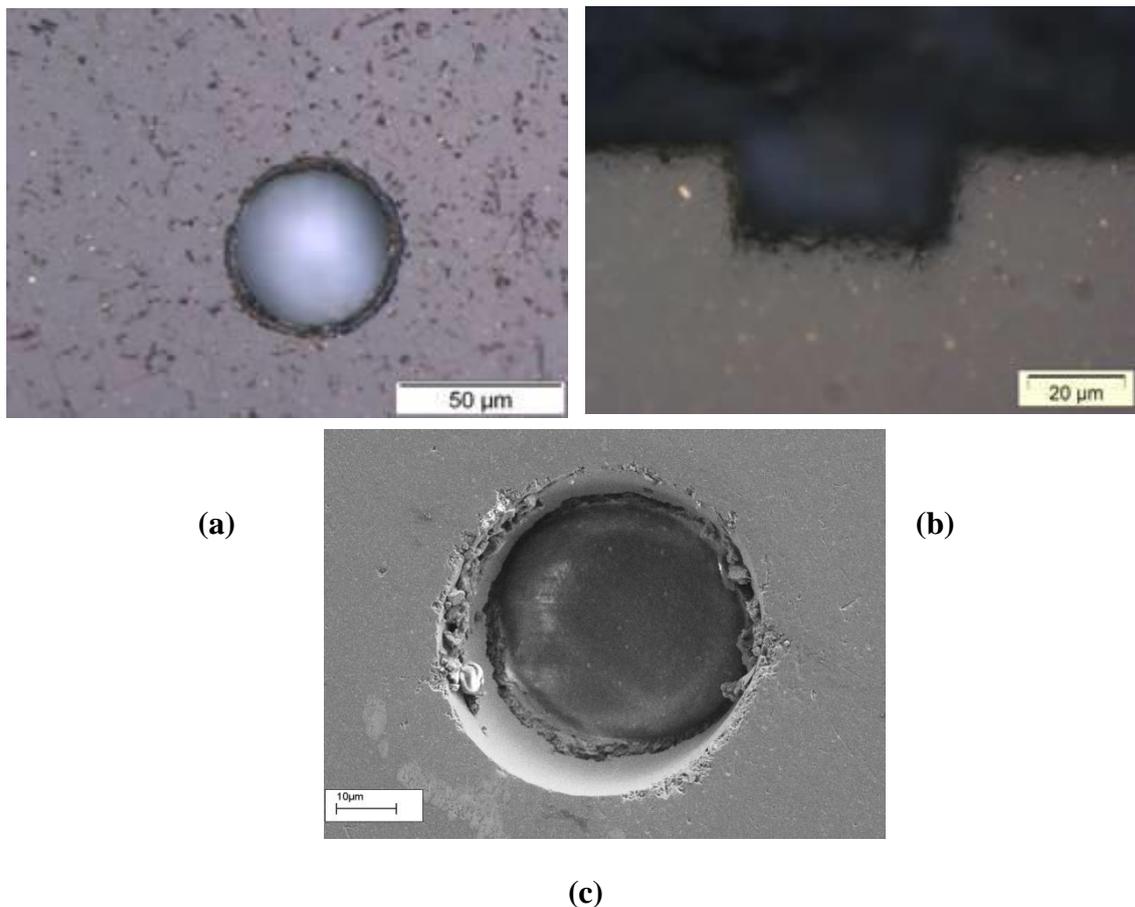
Figure 4.4: Typical laser machined hole (a) Optical microscopy – top view (b) optical microscopy – cross-sectional view (c) Scanning electron microscopy

Shape of typical missing material is shown in the Figure 4.4.

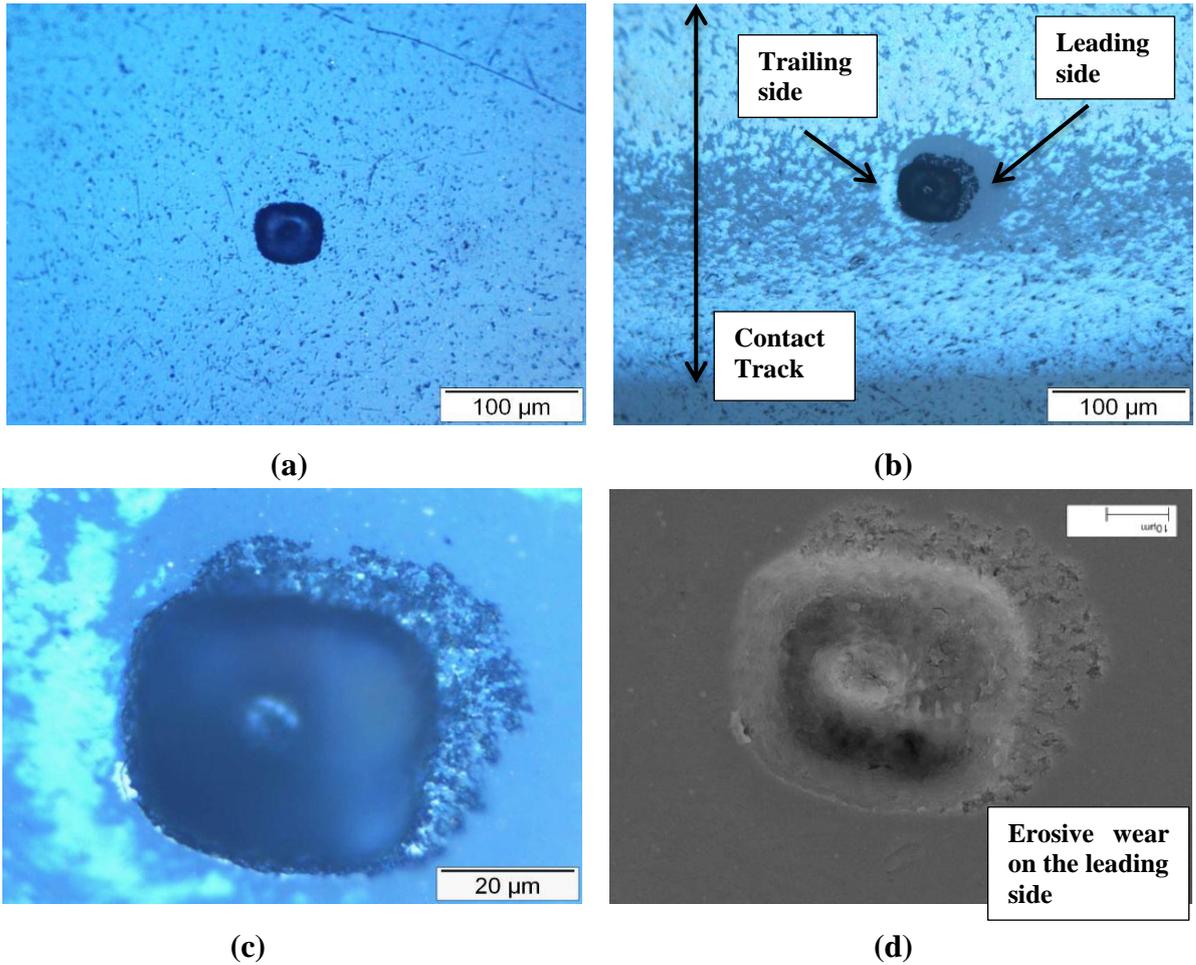
Figure 5.1: Experiment 01 (a) pre-experiment (b) post experiment (120M) (c) post-experiment- higher magnification OM image (d) post experiment SEM image

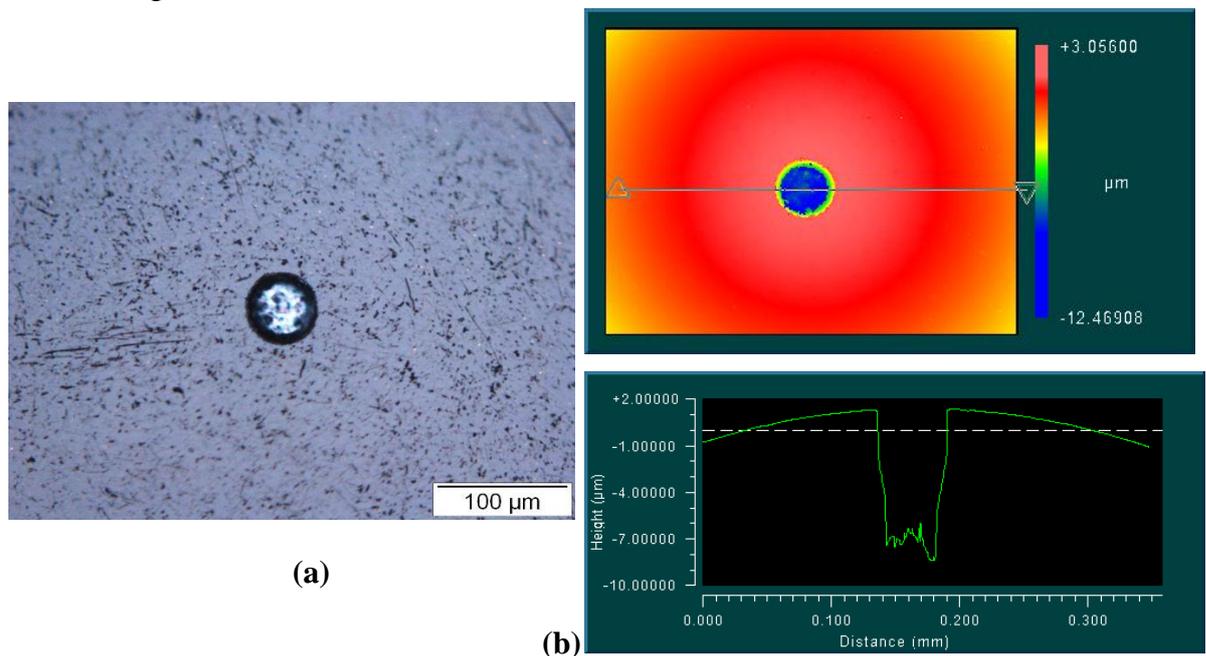
Figure 5.3: Pre-experiment (03) surface analysis using (a) microscopy (b) interferometry

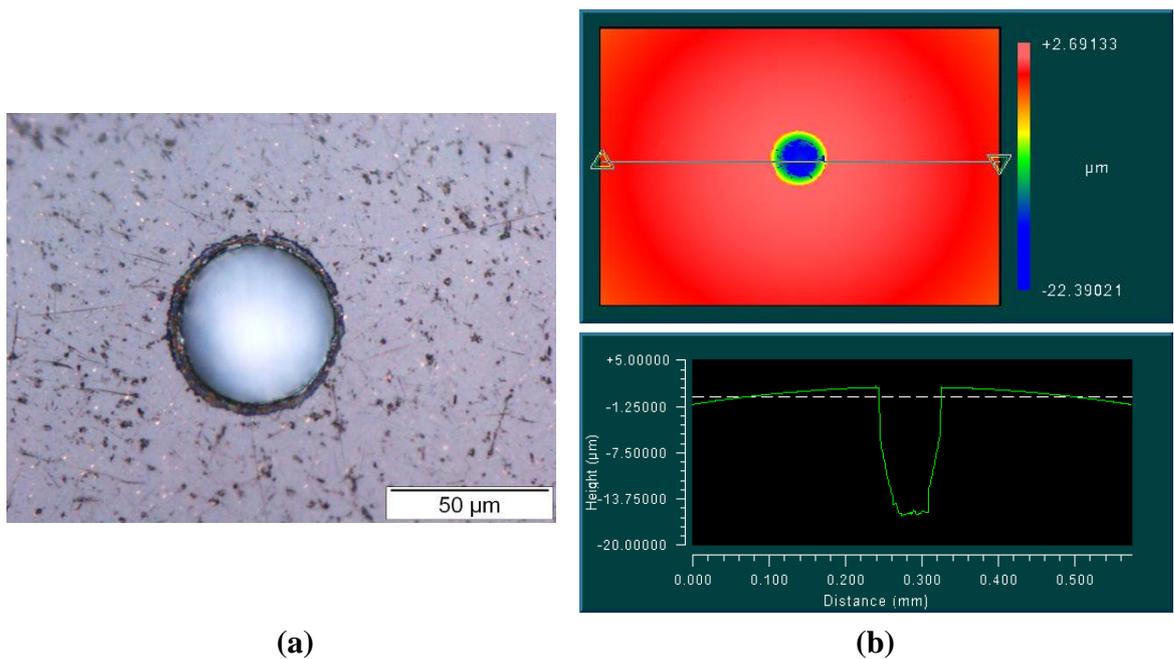
Figure 5.5: Pre-experiment (04) surface analysis using (a) microscopy (b) interferometry

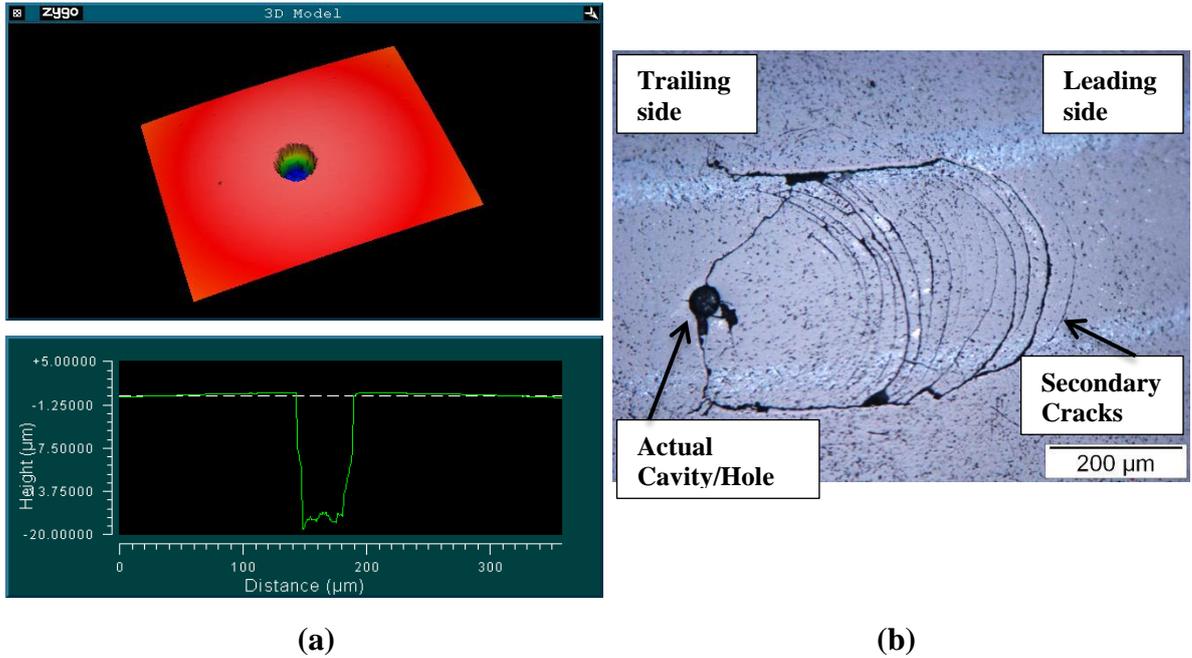
Figure 5.8: Surface analysis (experiment 06) (a) pre-experiment analysis using light interferometry (b) post-experiment analysis using light microscopy
