**Defect Tolerance Assessment of Silicon Nitride
in Rolling Contact**

A thesis is submitted to Faculty of Science and Technology, Bournemouth University,
in partial fulfilment of the requirements for the degree of Doctor of Philosophy

In collaboration with SKF ERC, the Netherlands

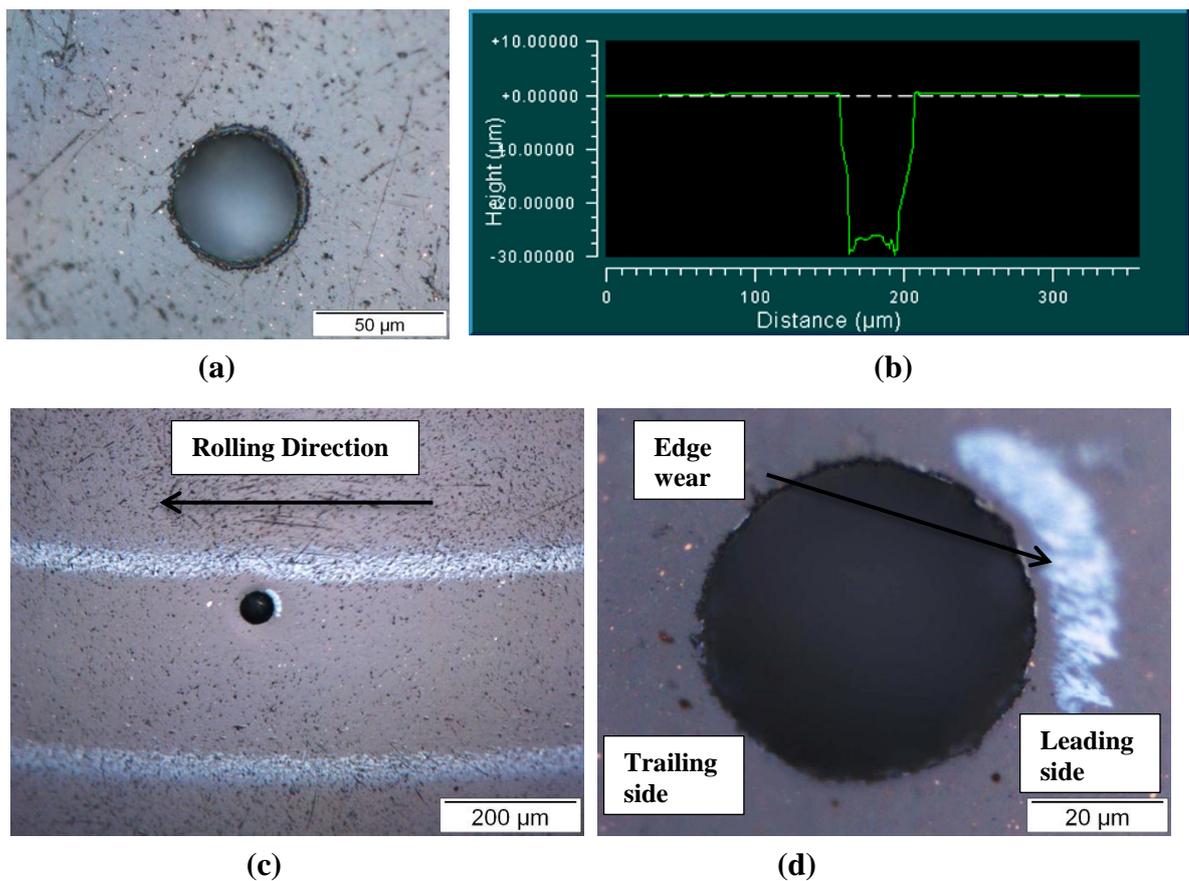
Figure 5.19: Surface analysis/mapping (experiment 14) (a) and (b) pre-experiment using microscopy and interferometry respectively (c) and (d) post-experiment analysis by microscopy

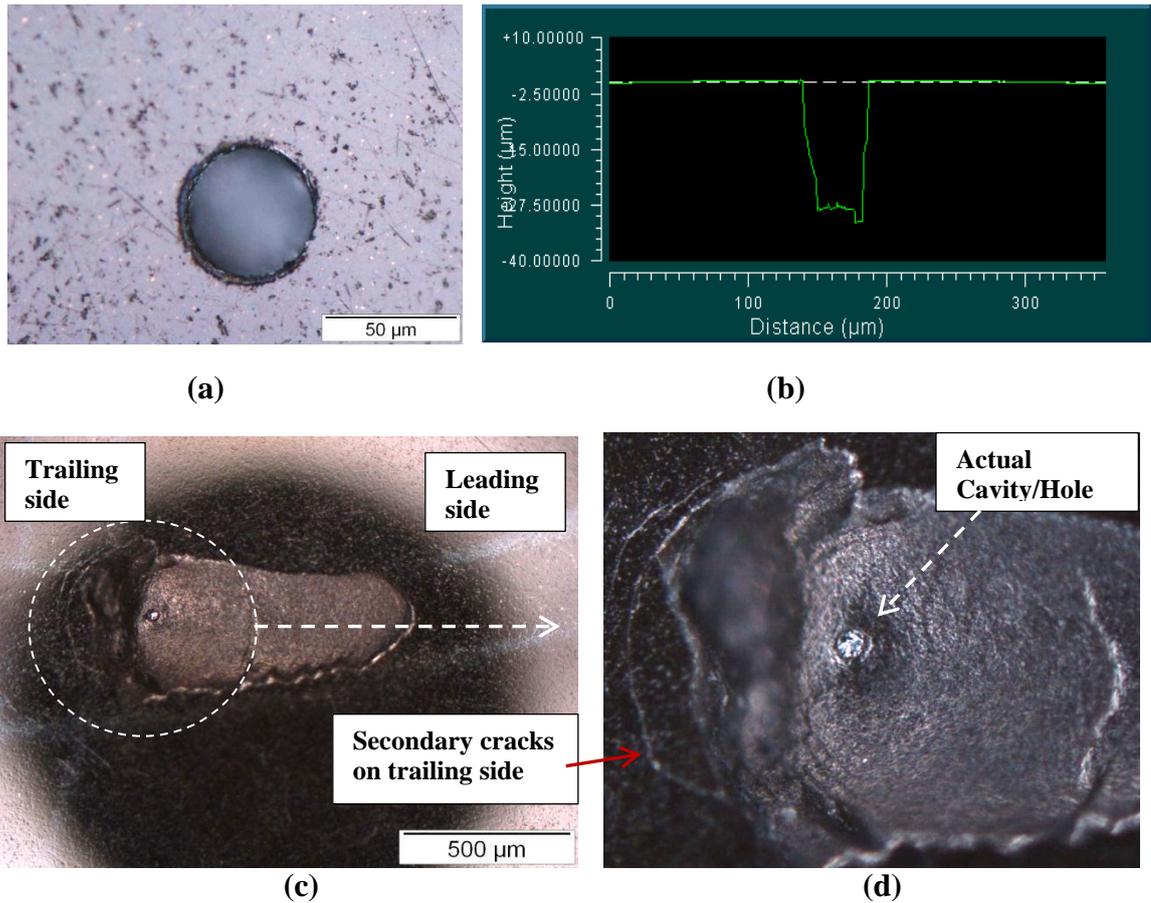
Figure 5.20: Surface analysis/mapping (experiment 15) (a) and (b) pre-experiment using microscopy and interferometry respectively (c) and (d) post-experiment analysis by microscopy

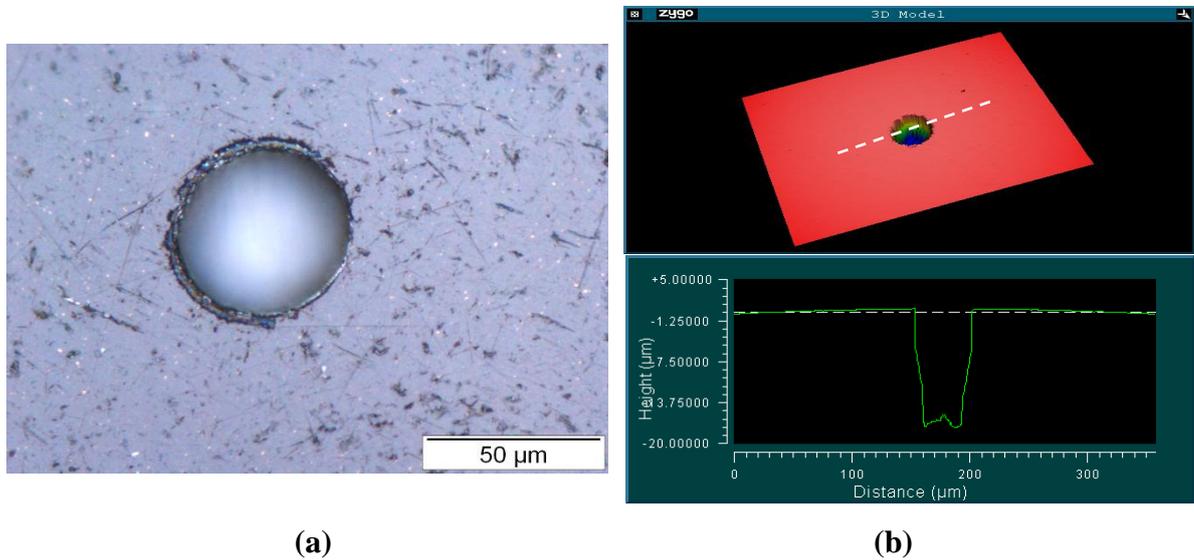
Figure 5.21: Pre-exp. (16) surface analysis/mapping using (a) microscopy (b) interferometry

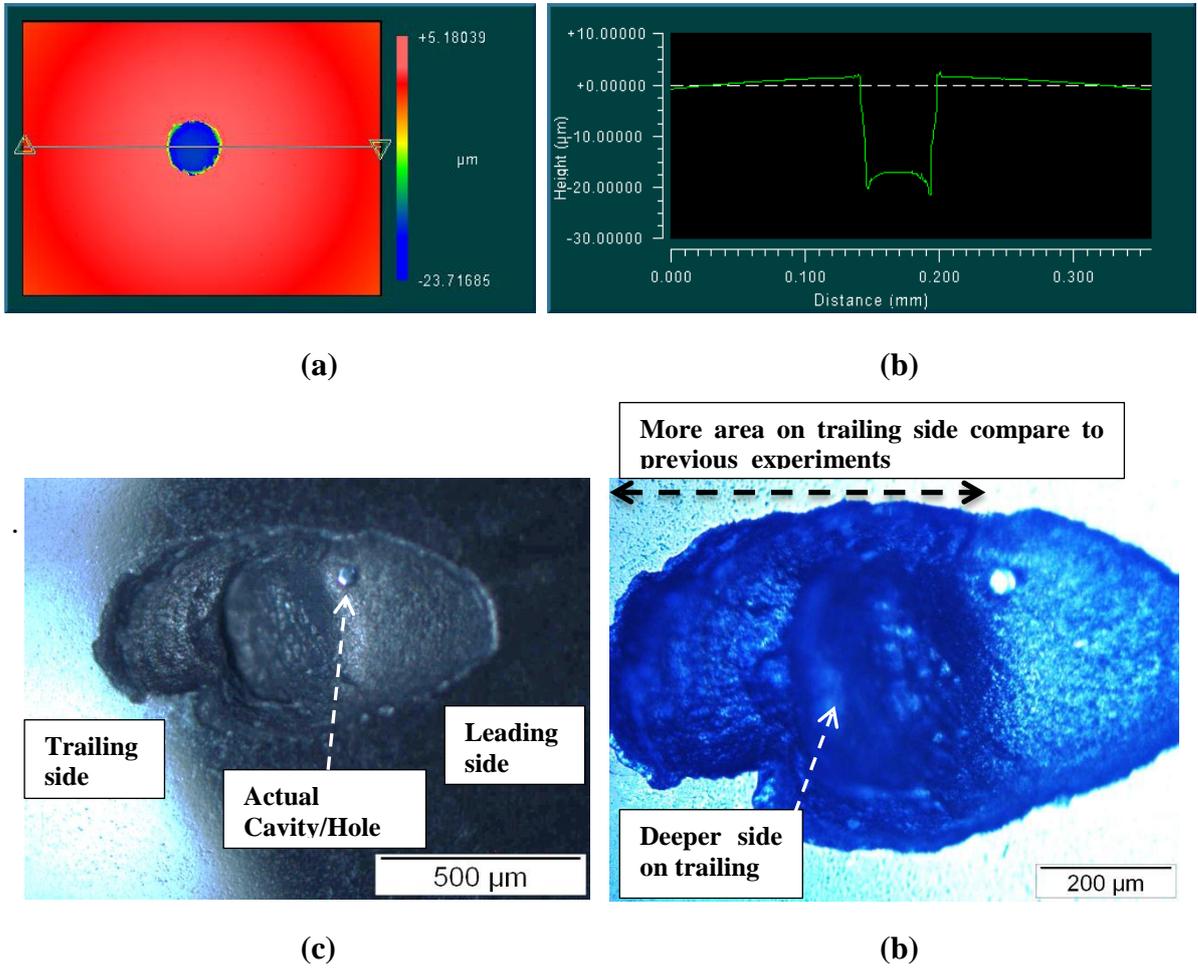
Figure 5.27: Experiment (21) surface analysis (a) and (b) pre-experiment using interferometry (c) and (d) post-experiment microscopy

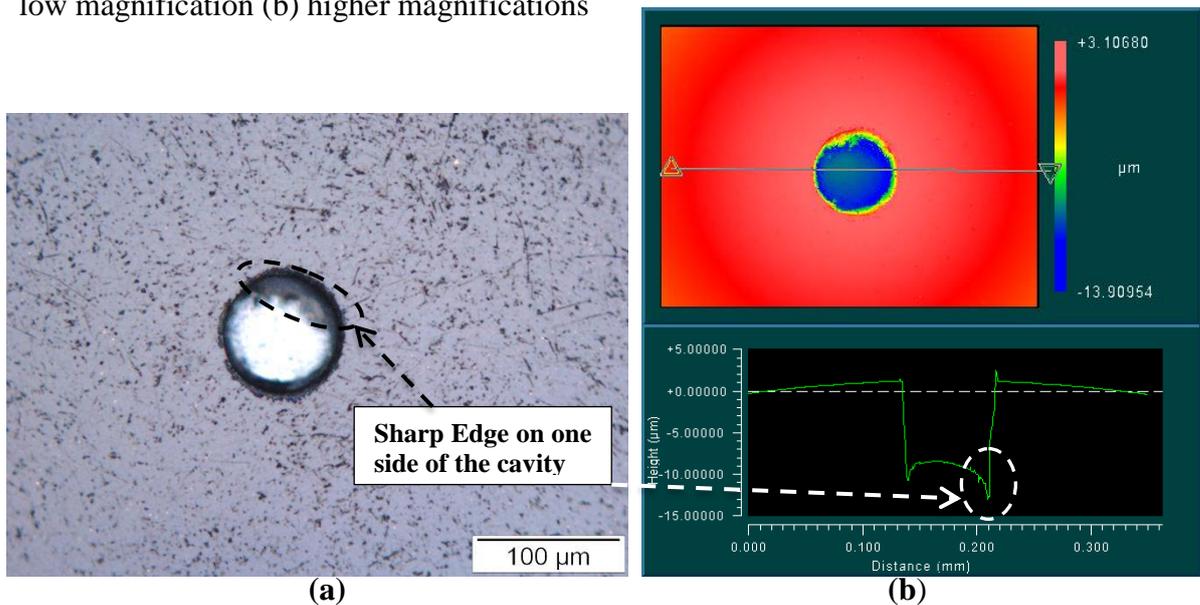
Figure 5.30: Pre-experiment surface analysis/mapping (experiment 24) using (a) microscopy (b) interferometry

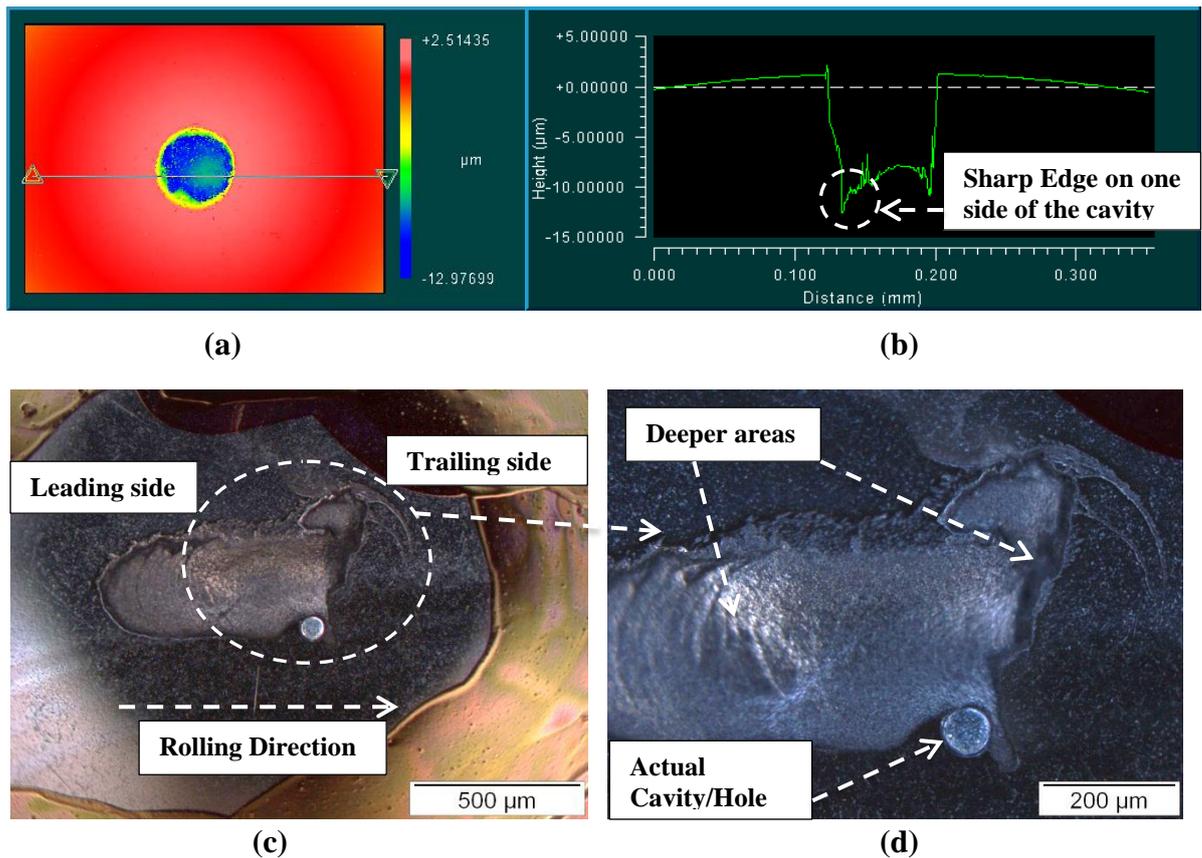
Figure 5.33: Surface analysis/mapping (experiment 26) (a) and (b) pre-experiment using interferometry (c) and (d) post-experiment analysis by microscopy (dark field illumination)

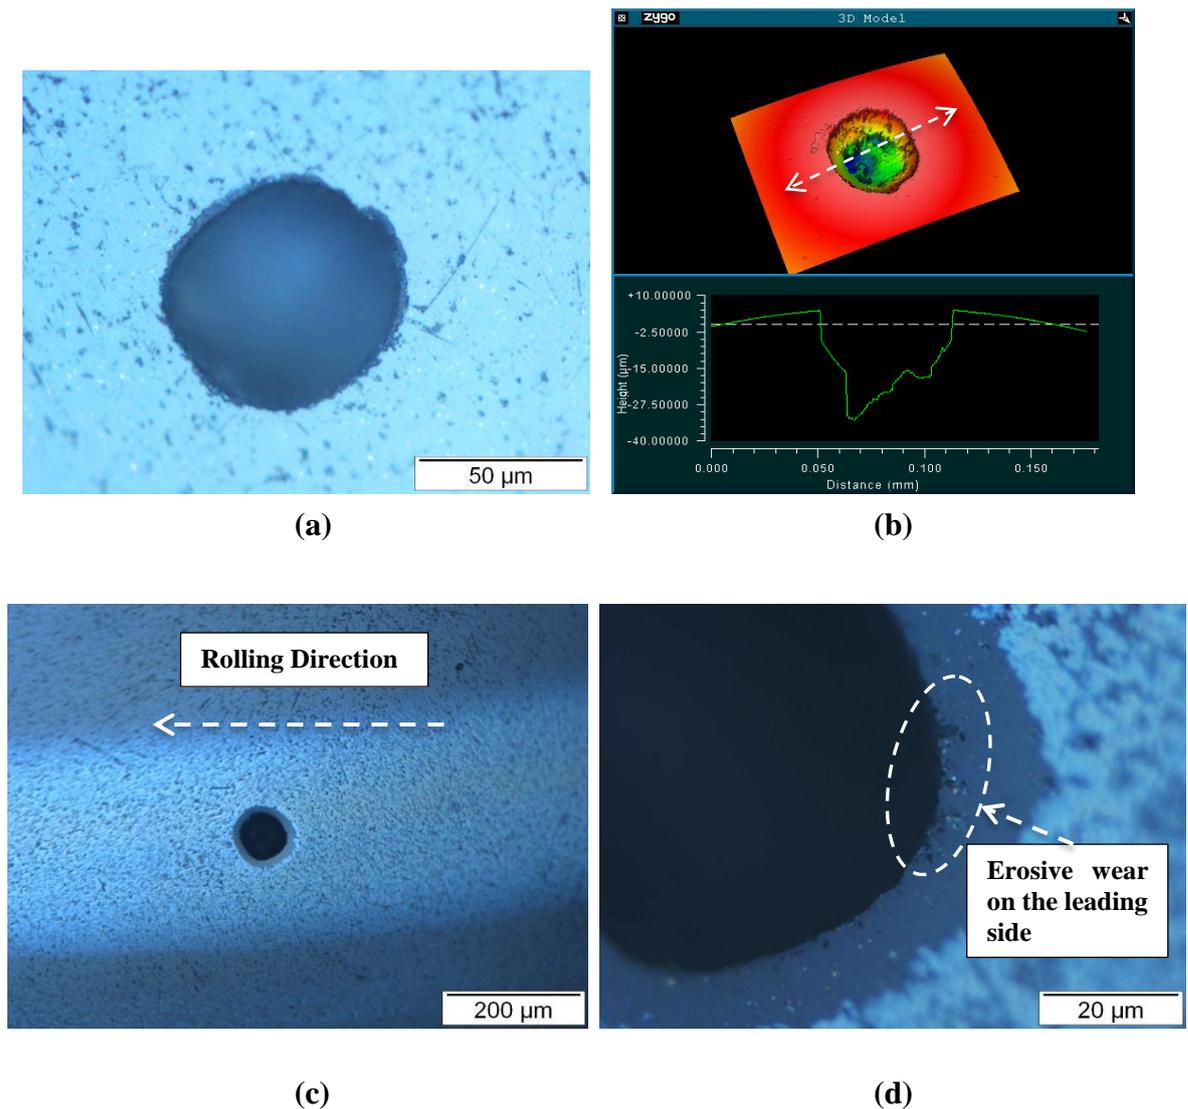
Figure 5.36: Surface analysis/mapping (experiment 29) (a) and (b) pre-experiment using microscopy and interferometry respectively (c) and (d) post-experiment analysis by light microscopy

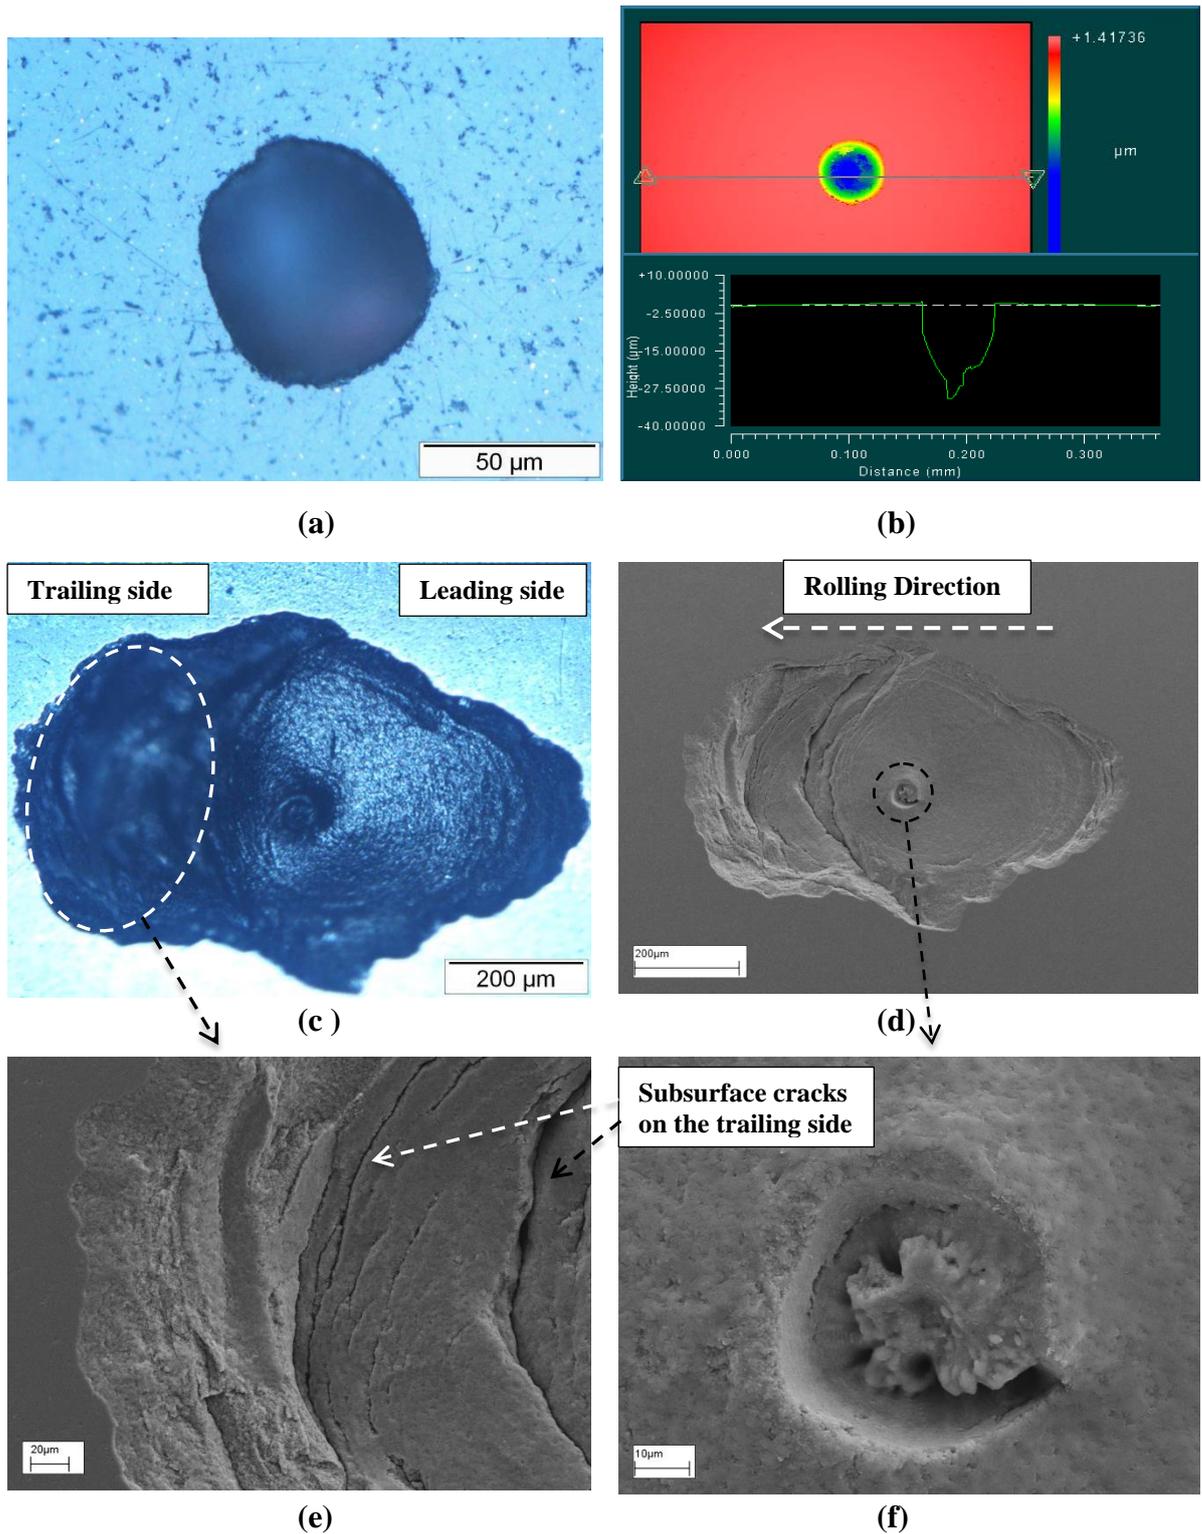
Figure 5.37: Surface analysis/mapping (experiment 30) (a) and (b) pre-experiment using microscopy and interferometry respectively (c) and (d) post-experiment analysis showing spall by microscopy and SEM respectively (e) and (f) SEM images showing cracks on trailing side and base of original cavity

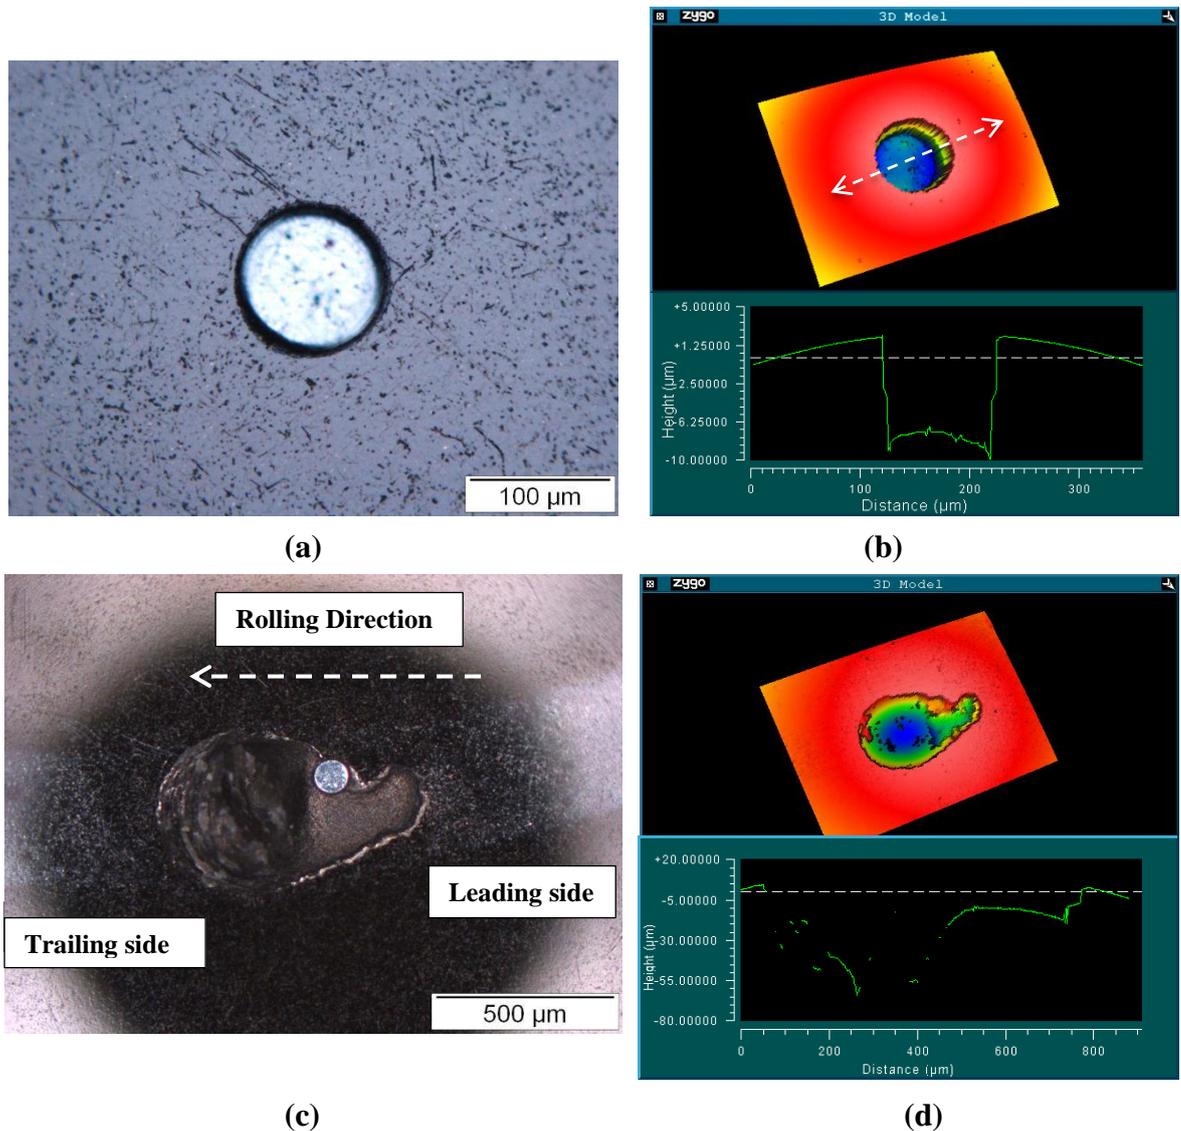
Figure 5.38: Surface analysis/mapping (experiment 31) (a) and (c) pre and post-experiment analysis using microscopy, (b) and (d) pre and post-experiment surface mapping using interferometry

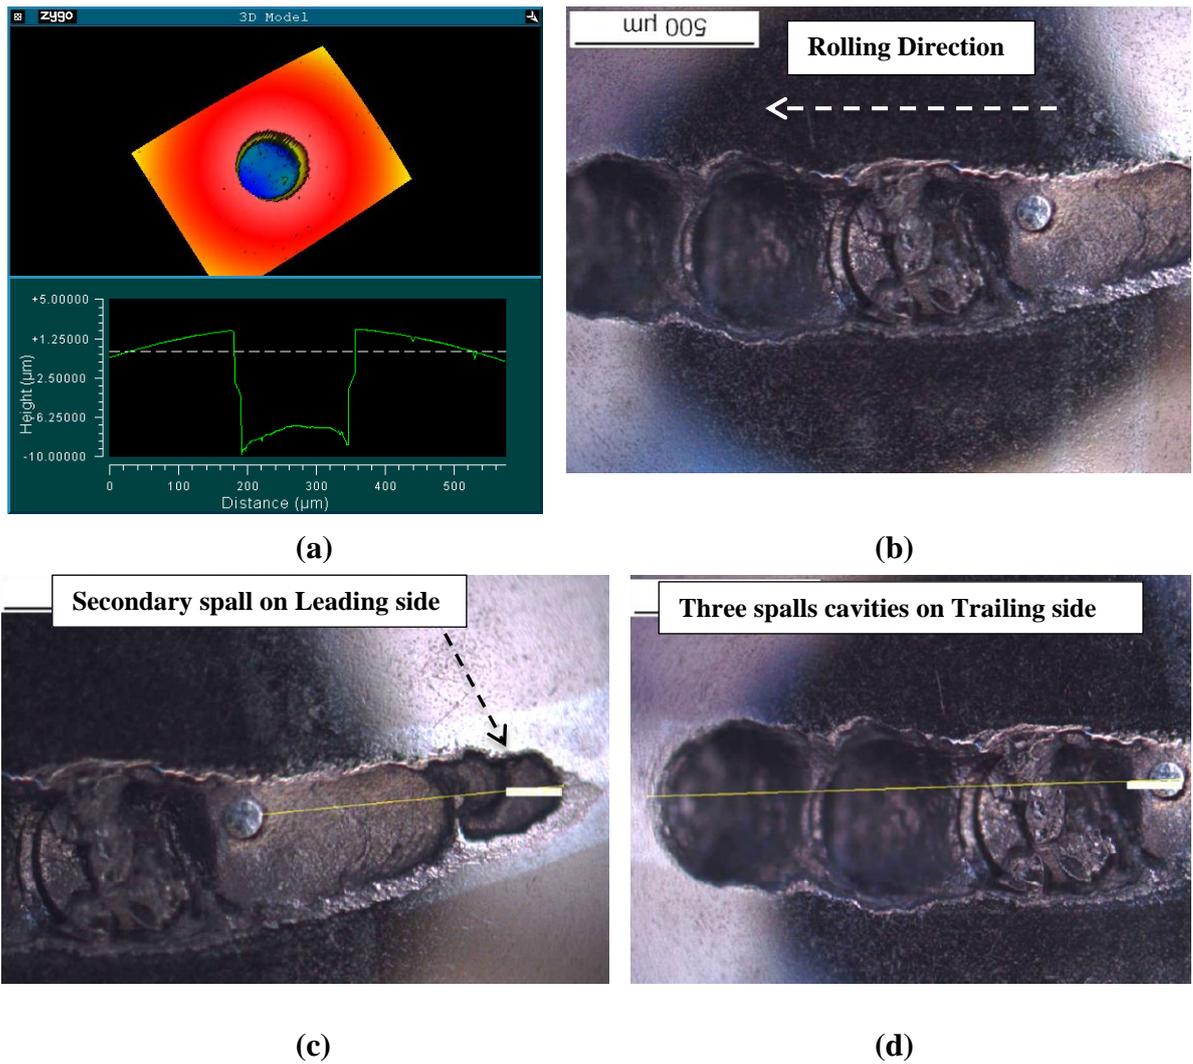
Figure 5.40: Surface analysis/mapping (experiment 33) (a) pre-experiment surface mapping using interferometry (b) post-experiment surface analysis using microscopy (c) and (d) post-experiment analysis using microscopy on leading and trailing side respectively

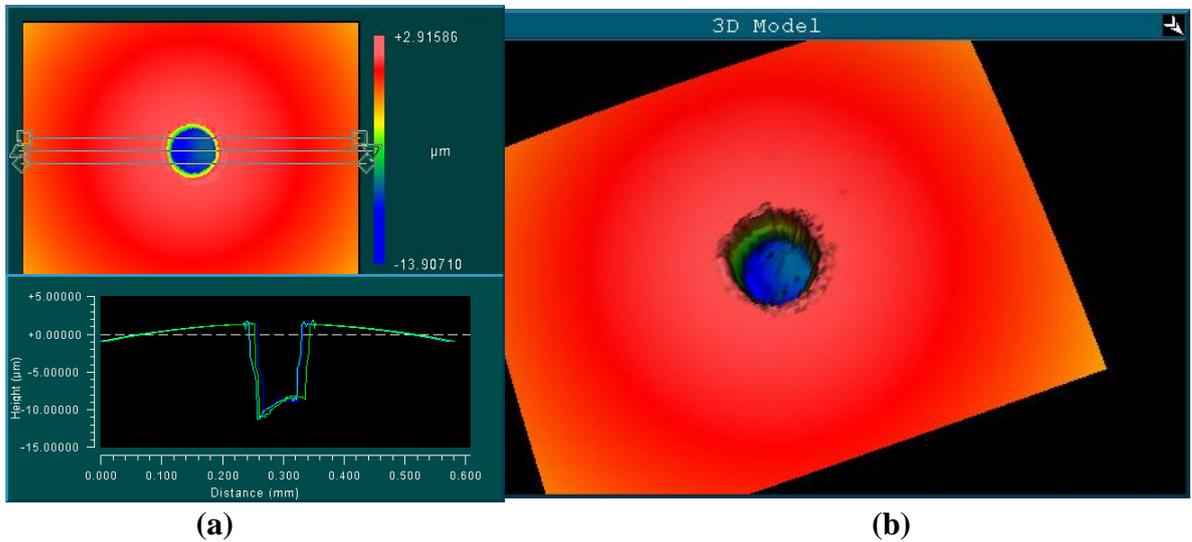
Figure 5.45: Surface analysis/mapping (experiment B1) (a) pre-experiment surface mapping using interferometry (b) 3D cavity profile

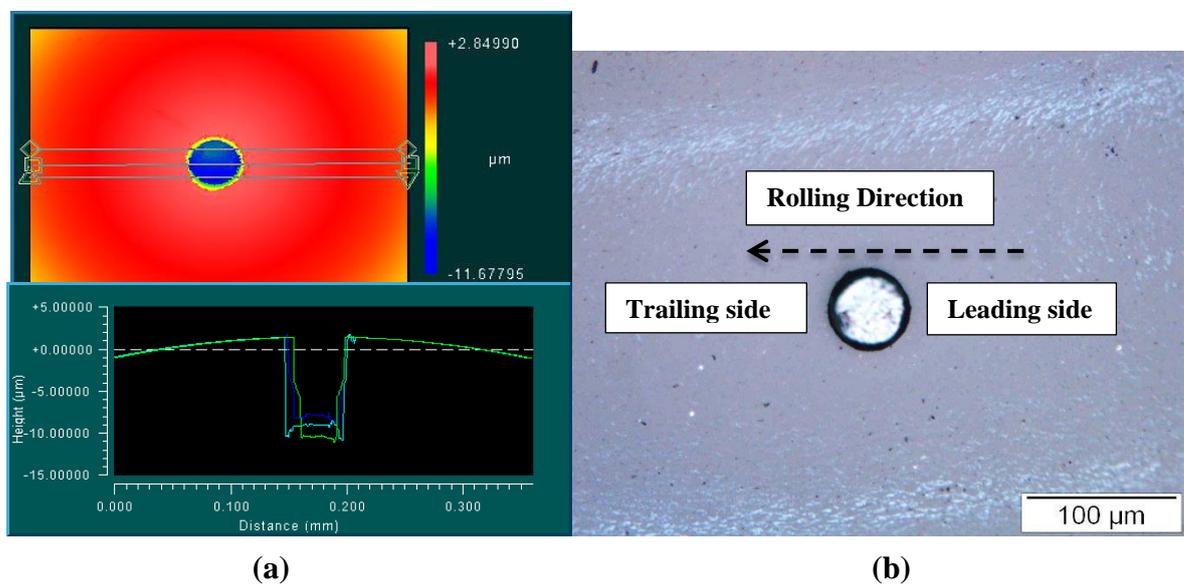
Figure 5.48: Surface analysis/mapping (experiment B3) (a) pre-experiment surface mapping using interferometry (b) post-experiment surface analysis using microscopy

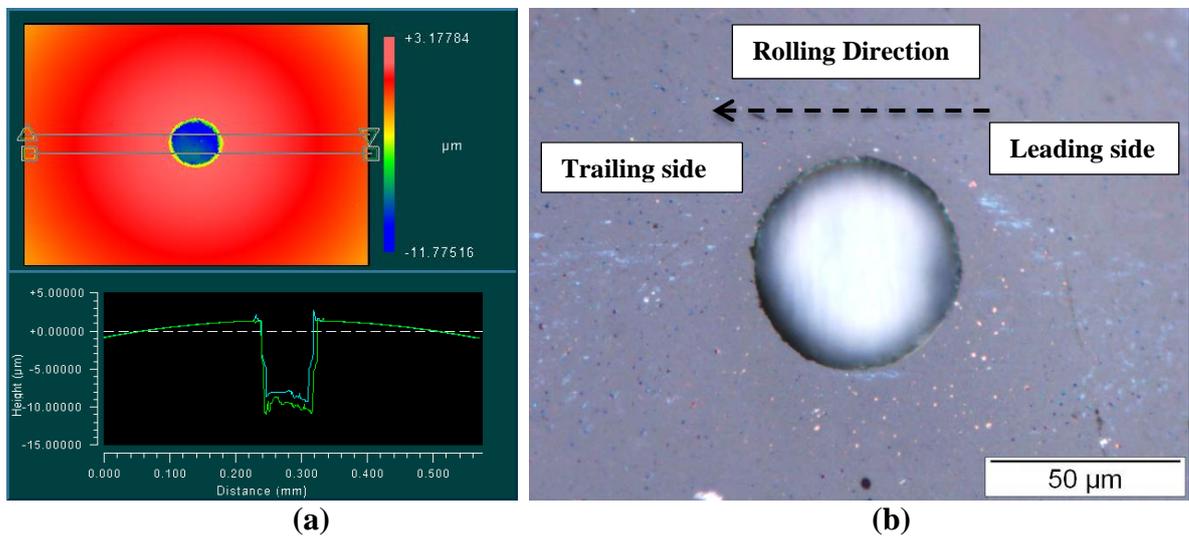
Figure 5.49: Surface analysis/mapping (experiment B4) (a) pre-experiment surface mapping using interferometry (b) post-experiment surface analysis using microscopy

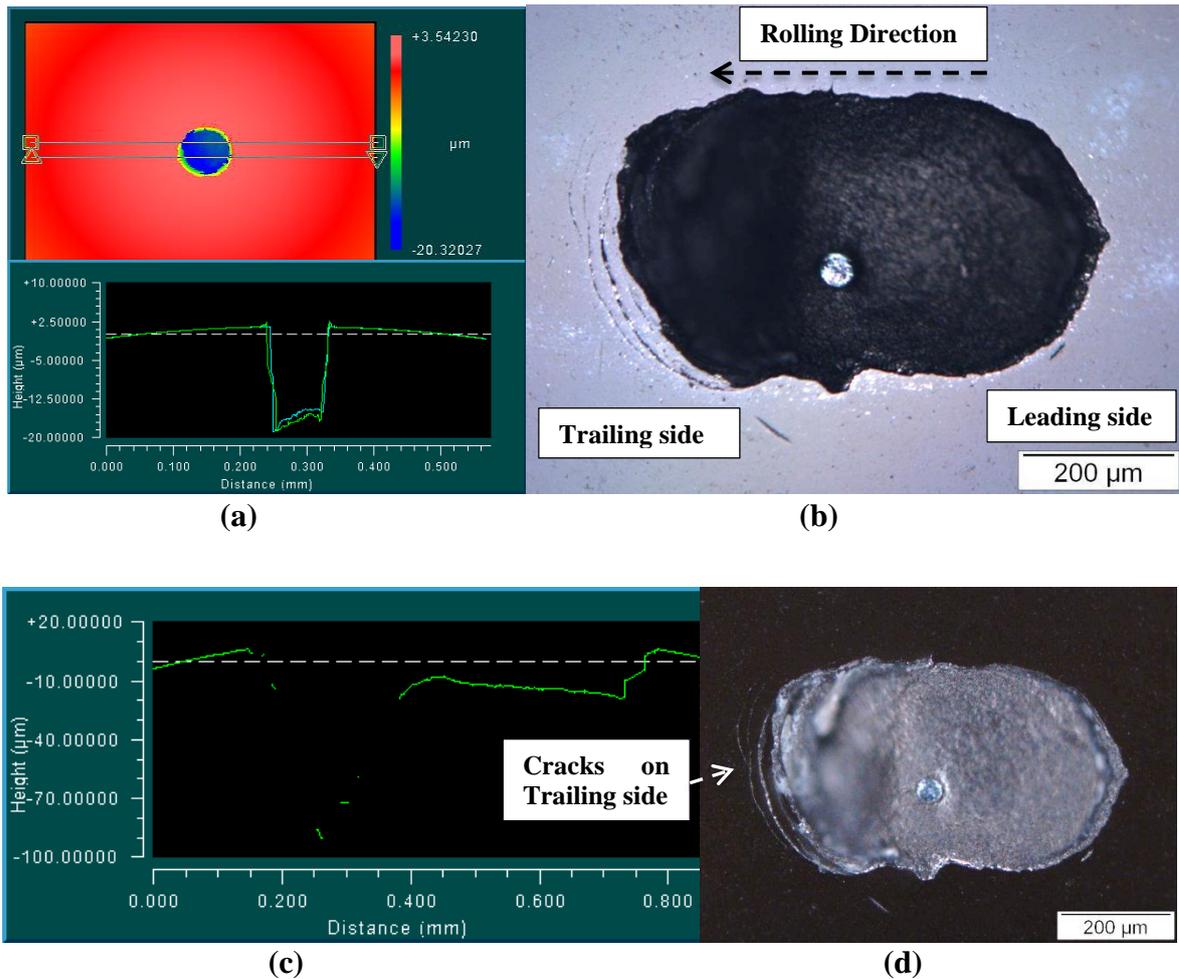
Figure 5.50: Surface analysis/mapping (experiment B5) (a) pre-experiment surface mapping using interferometry (b) post-experiment surface analysis using microscopy (c) spall profilometry (d) spall microscopy - darkfield

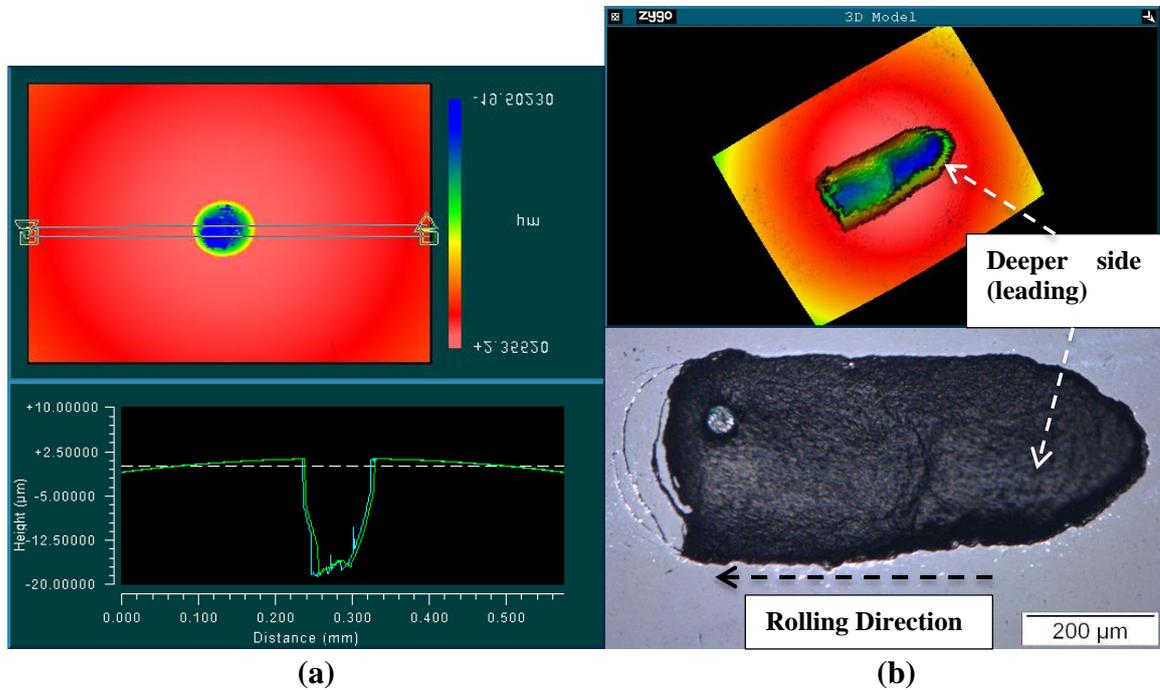
Figure 5.51: Surface analysis/mapping (experiment B6) (a) pre-experiment surface mapping using interferometry (b) post-experiment spall profile using interferometry and microscopy

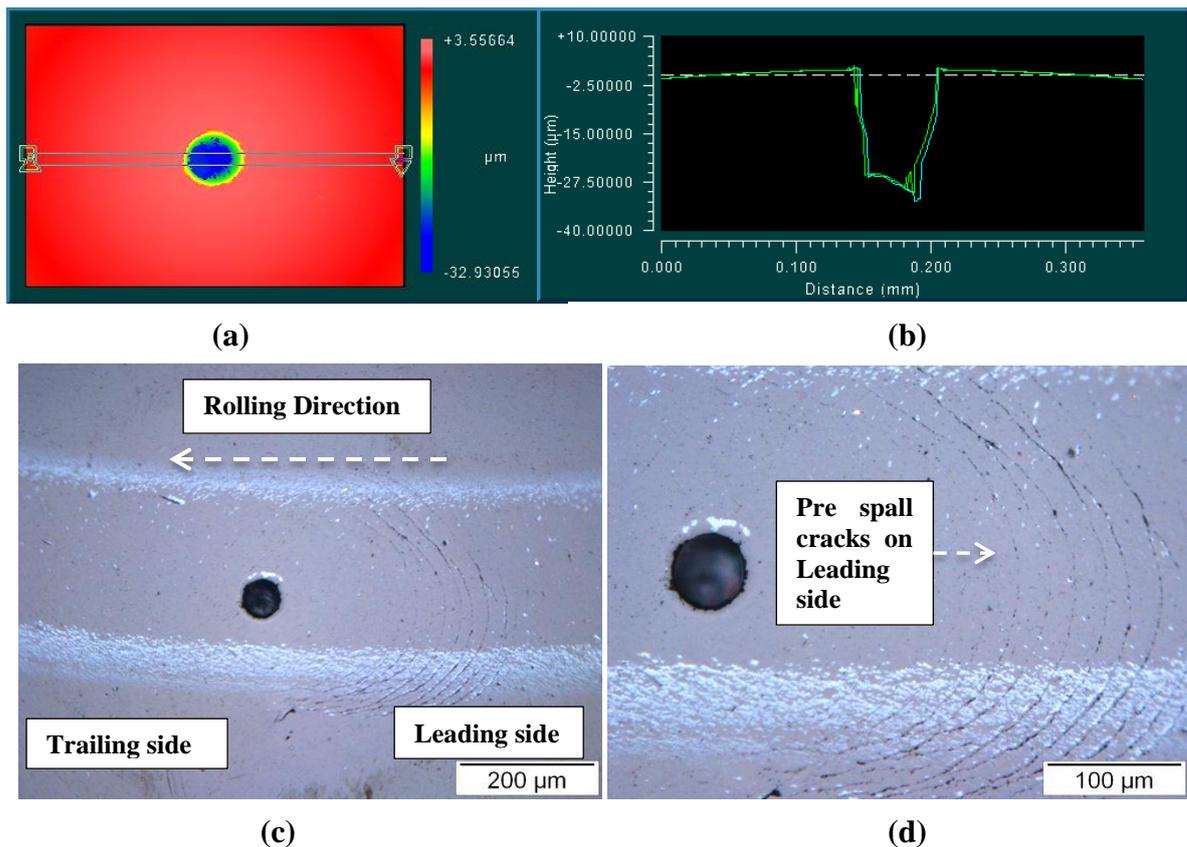
Figure 5.54: Surface analysis/mapping (exp. B8) (a) & (b) pre-experiment surface mapping using interferometry (c) and (d) post-experiment surface analysis using microscopy

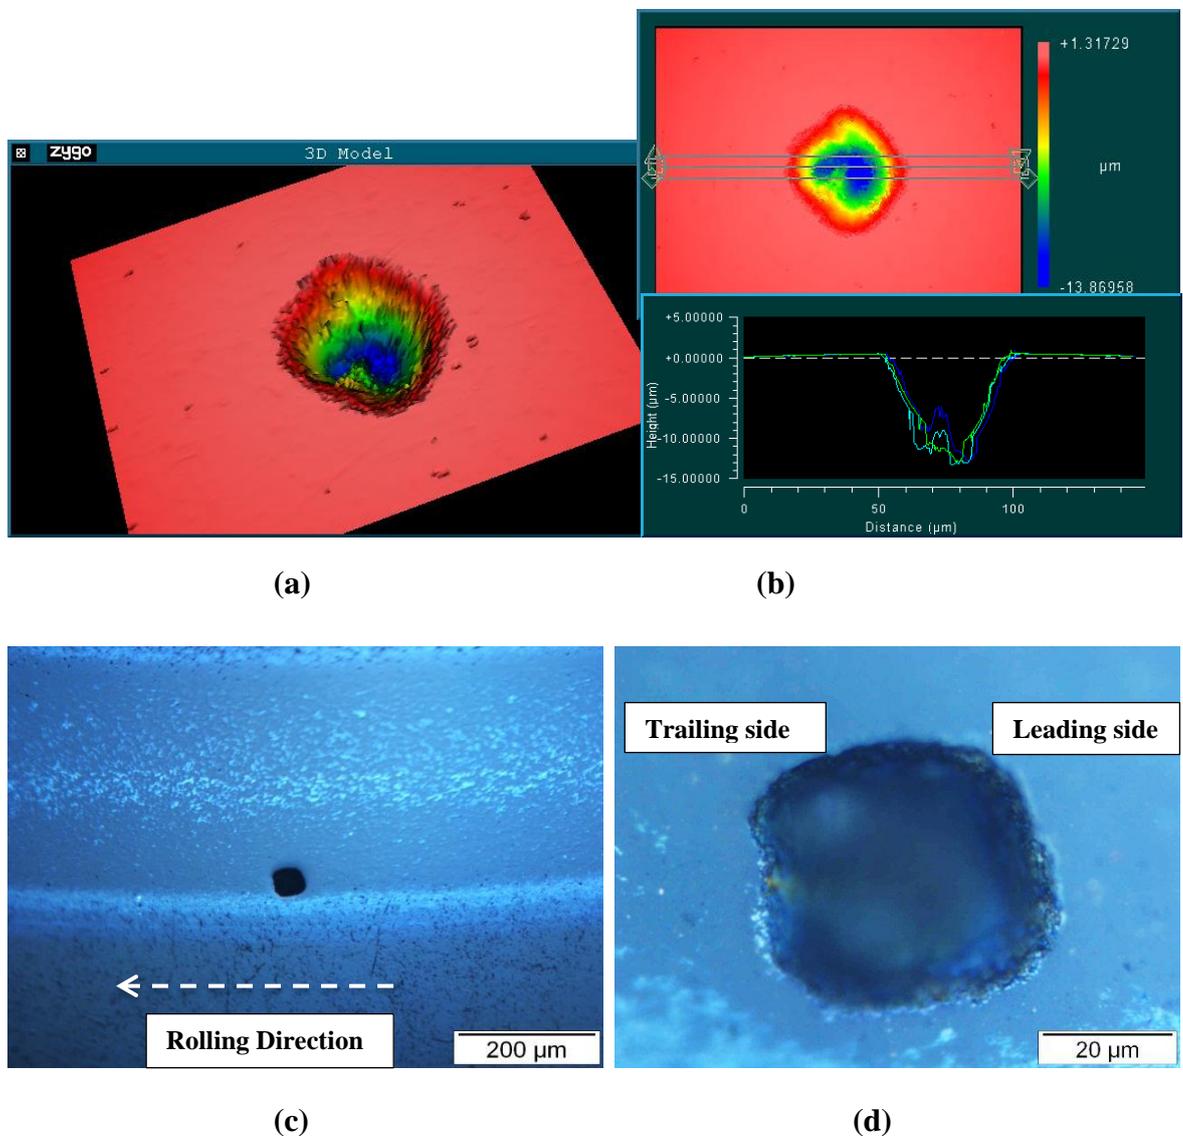
Figure 5.57: Surface analysis/mapping (experiment 39) (a) and (b) pre-experiment surface mapping using interferometry (c) and (d) post-experiment surface analysis using microscopy

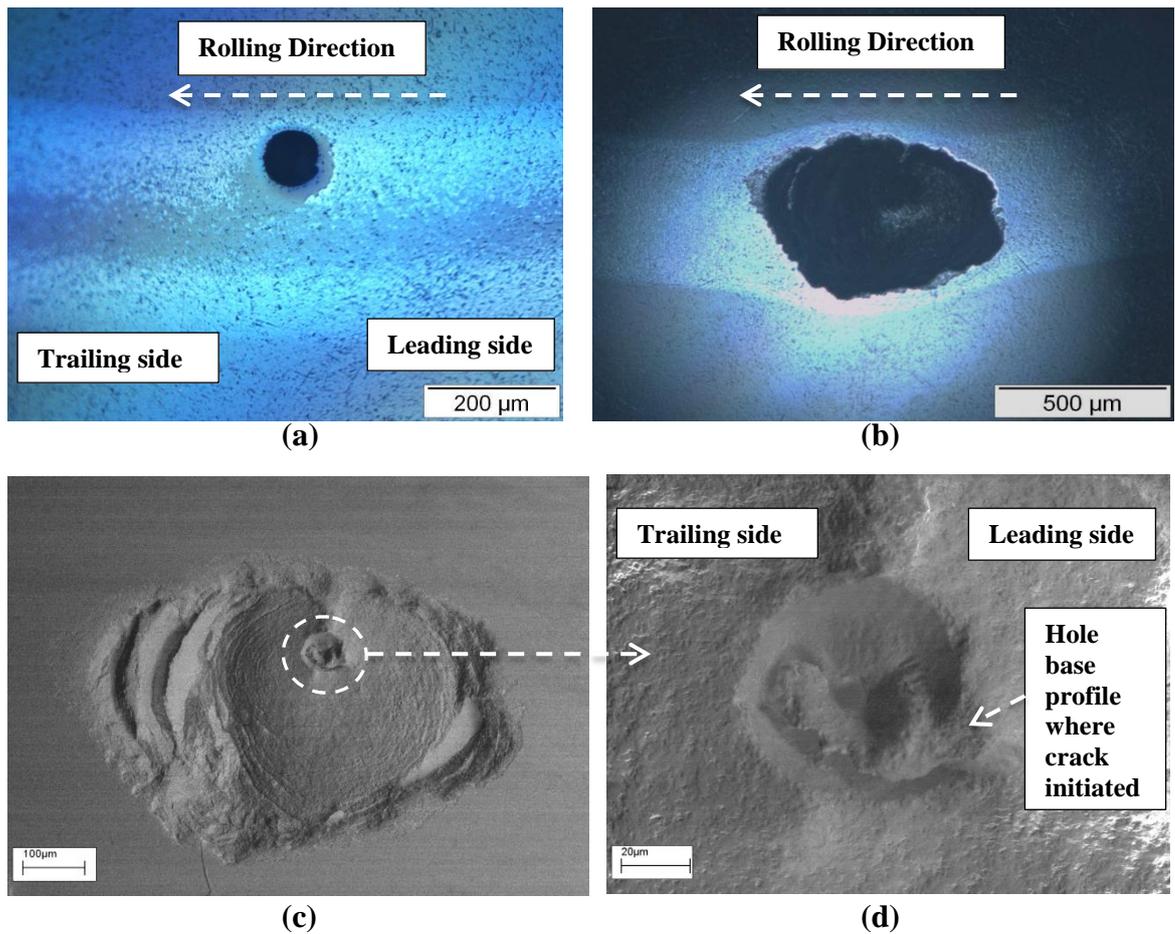
Figure 5.60: Post Experiment (41) surface analysis (a) and (b) post 30 and 35million using light microscopy (c) and (d) post 35million using SEM, showing spall and hole base

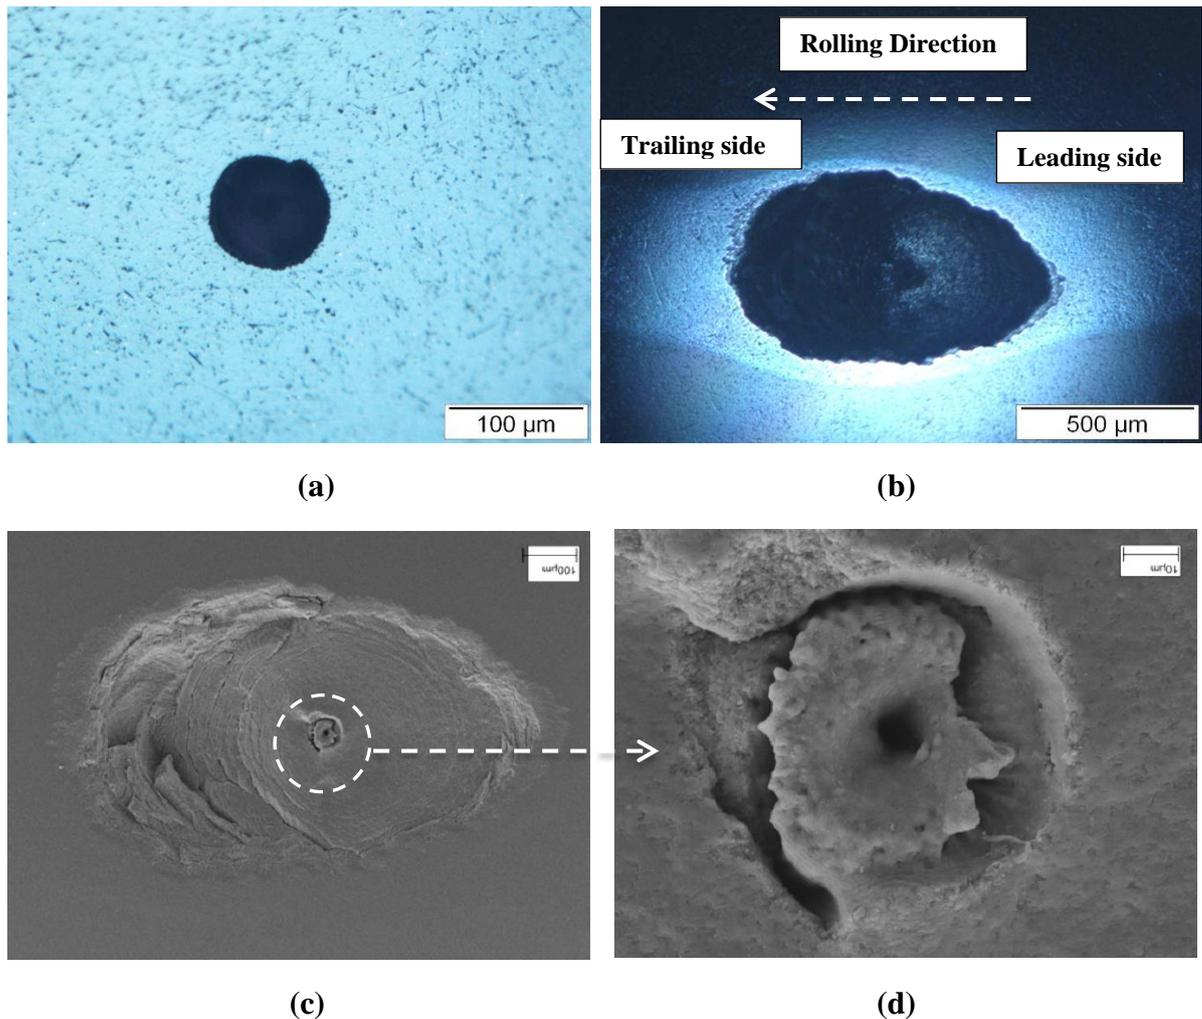
Figure 5.61: Surface analysis (Experiment 42) (a) pre-experiment (b) post 0.15M (c) Spall image - SEM (d) Spall centre (original hole base) - SEM image

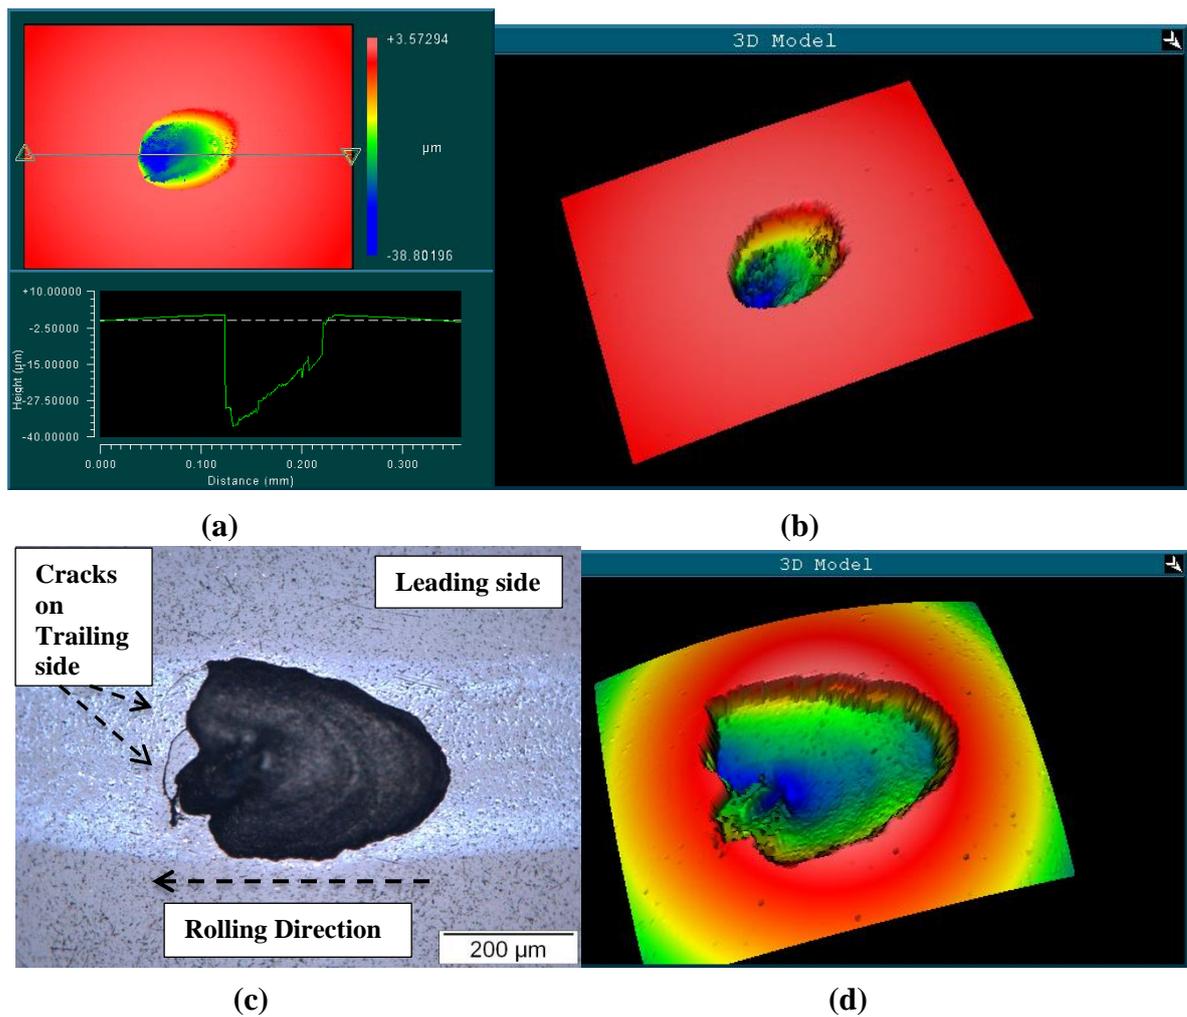
Figure 5.64: Surface analysis/mapping (experiment 45) (a) and (b) pre-experiment surface mapping using interferometry (c) & (d) post-experiment (0.1M) spall profile (OM and WLI)
