**Defect Tolerance Assessment of Silicon Nitride
in Rolling Contact**

A thesis is submitted to Faculty of Science and Technology, Bournemouth University,
in partial fulfilment of the requirements for the degree of Doctor of Philosophy

In collaboration with SKF ERC, the Netherlands

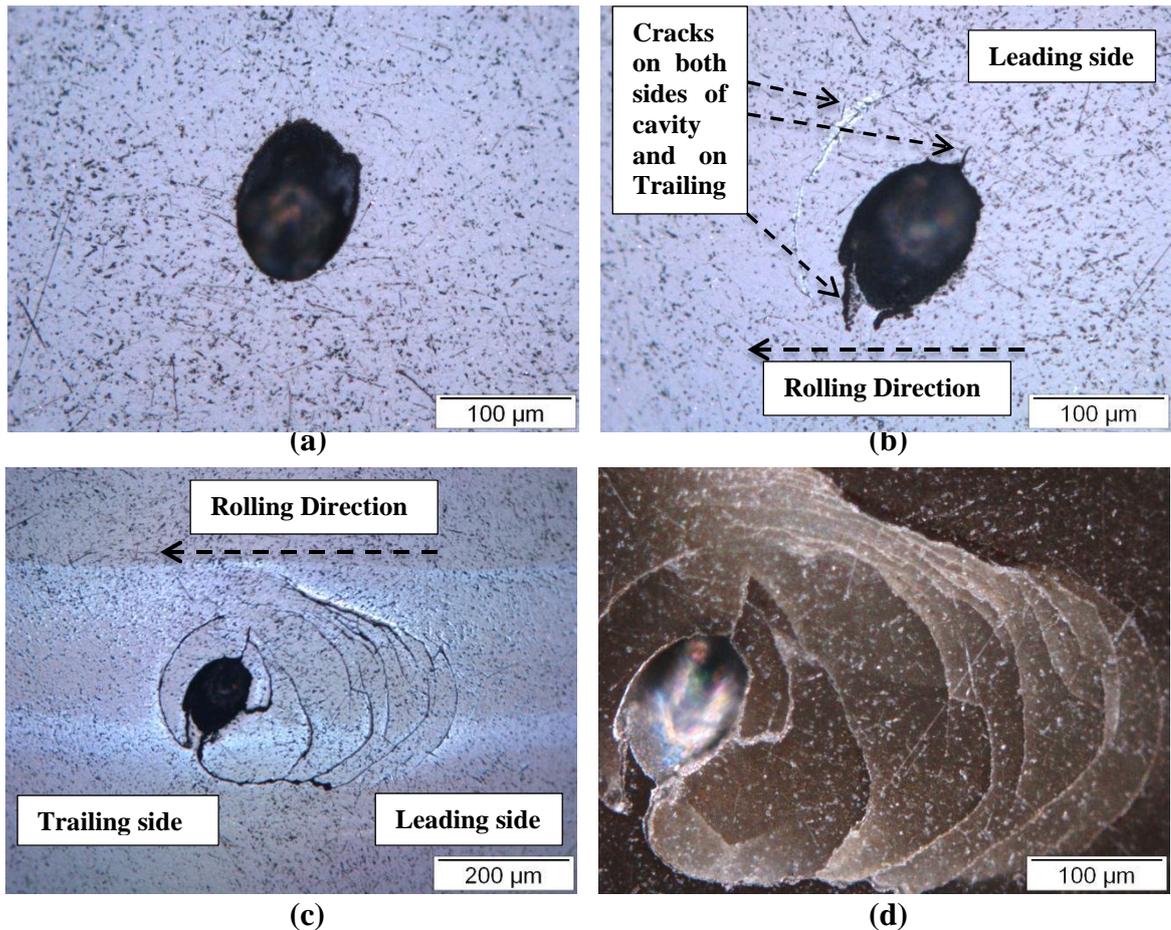
Figure 5.65: Surface analysis (experiment 46) using microscopy (a) Pre experiment (b) post 0.2million (c) and (d) post-experiment (0.45million stress cycles)

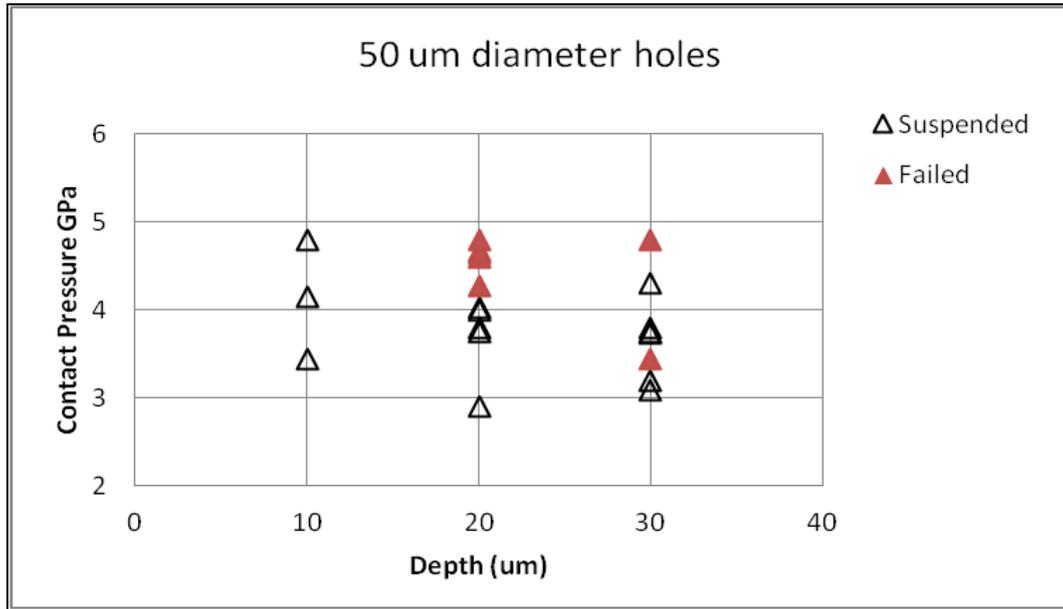
Figure 5.66 Corrected contact pressure vs. hole depth for small diameter holes (50 μ m)

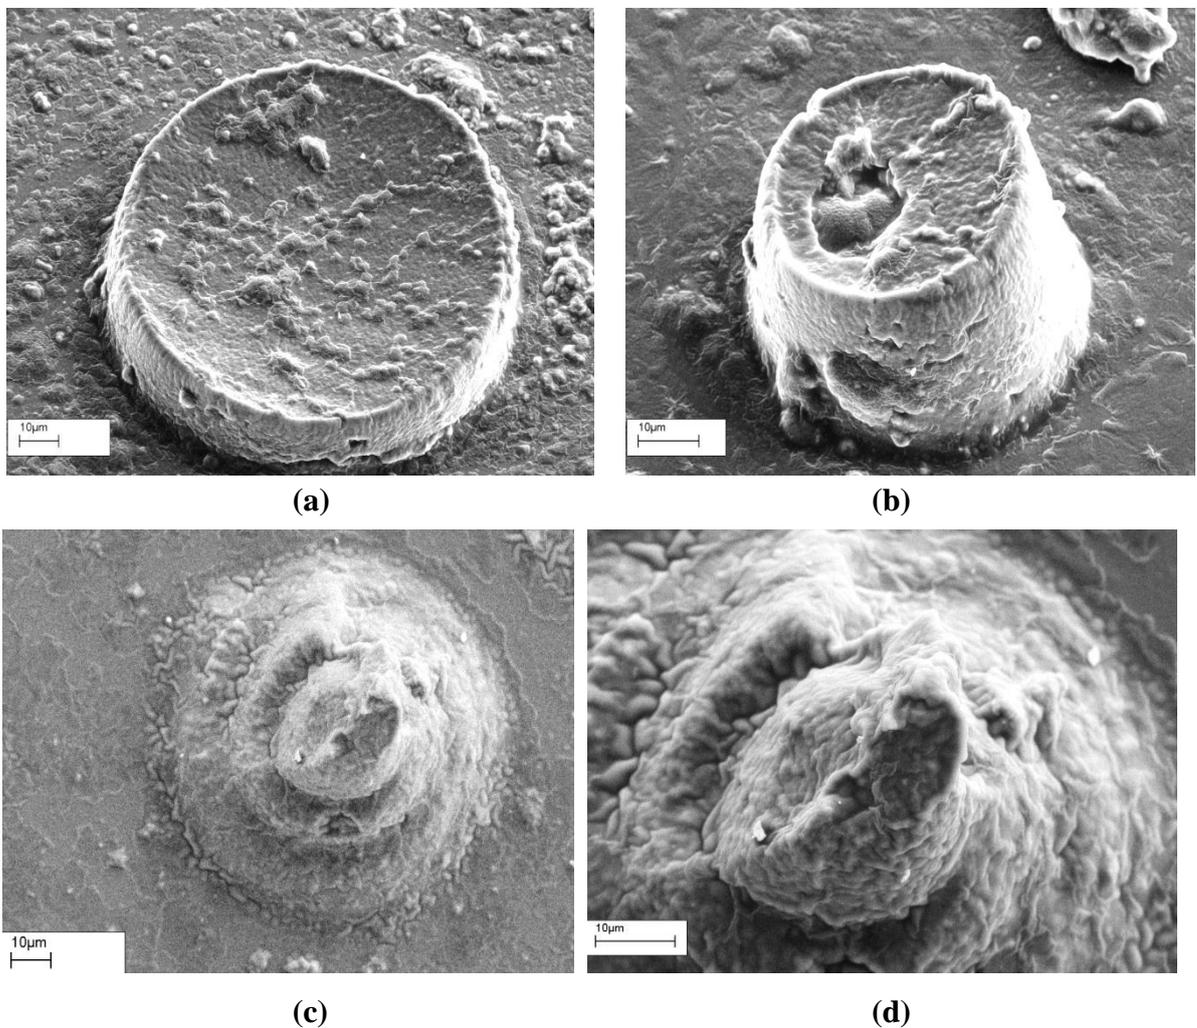
Figure 5.70: Replica cavity profile using SEM (a) and (b) Shape I (c) and (d) Shape II

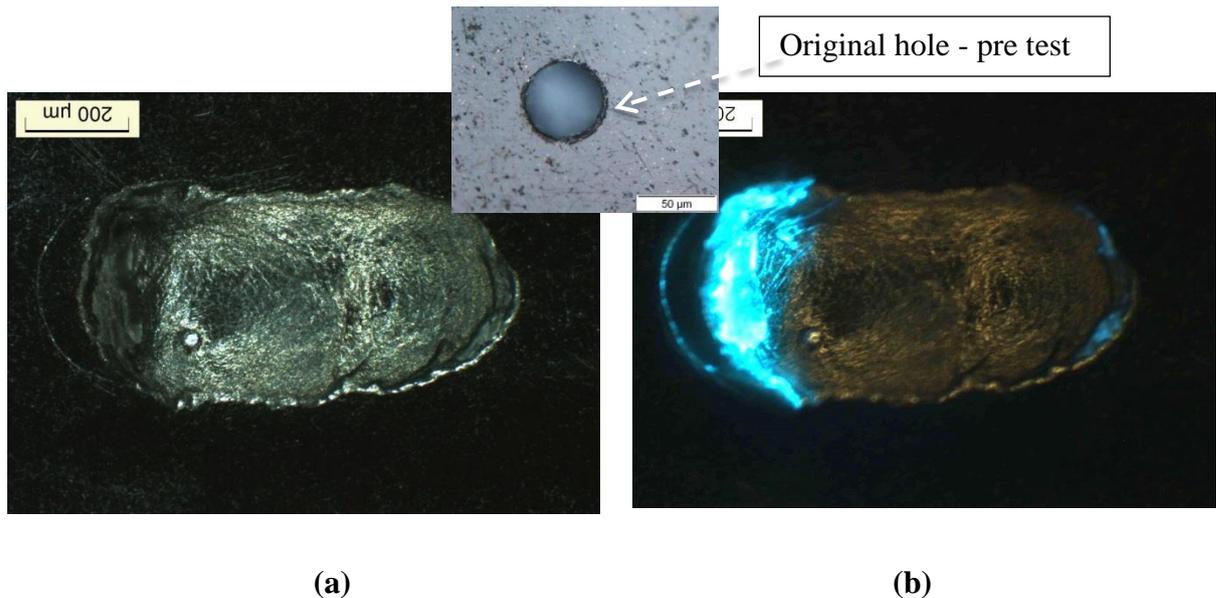
Figure 5.76: Experiment 13 spall profile (original hole : 50 μm diameter and 30 μm depth) (a) dark field illumination (b) UV illumination (original hole also can be seen in the Figure)

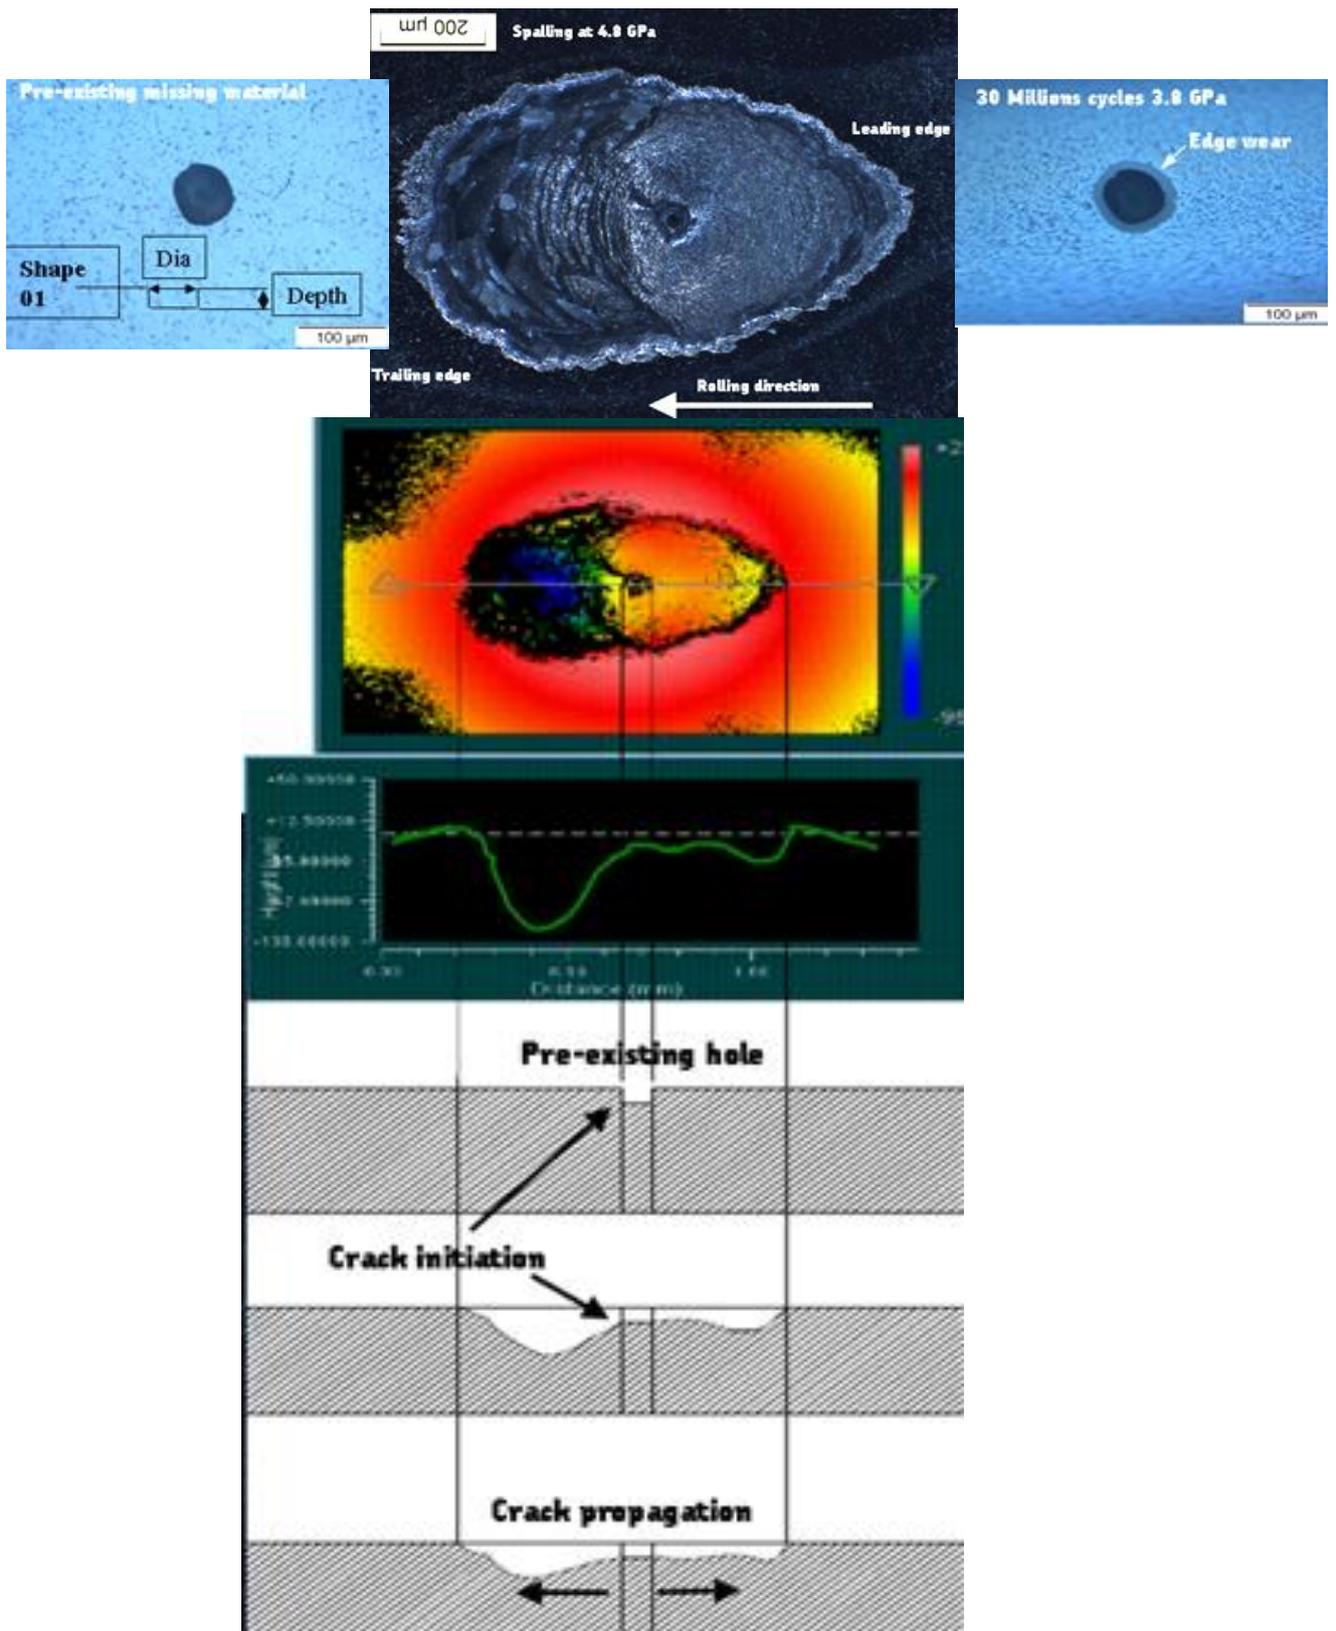
Figure 5.77: Typical spalling mechanism with Shape I profile

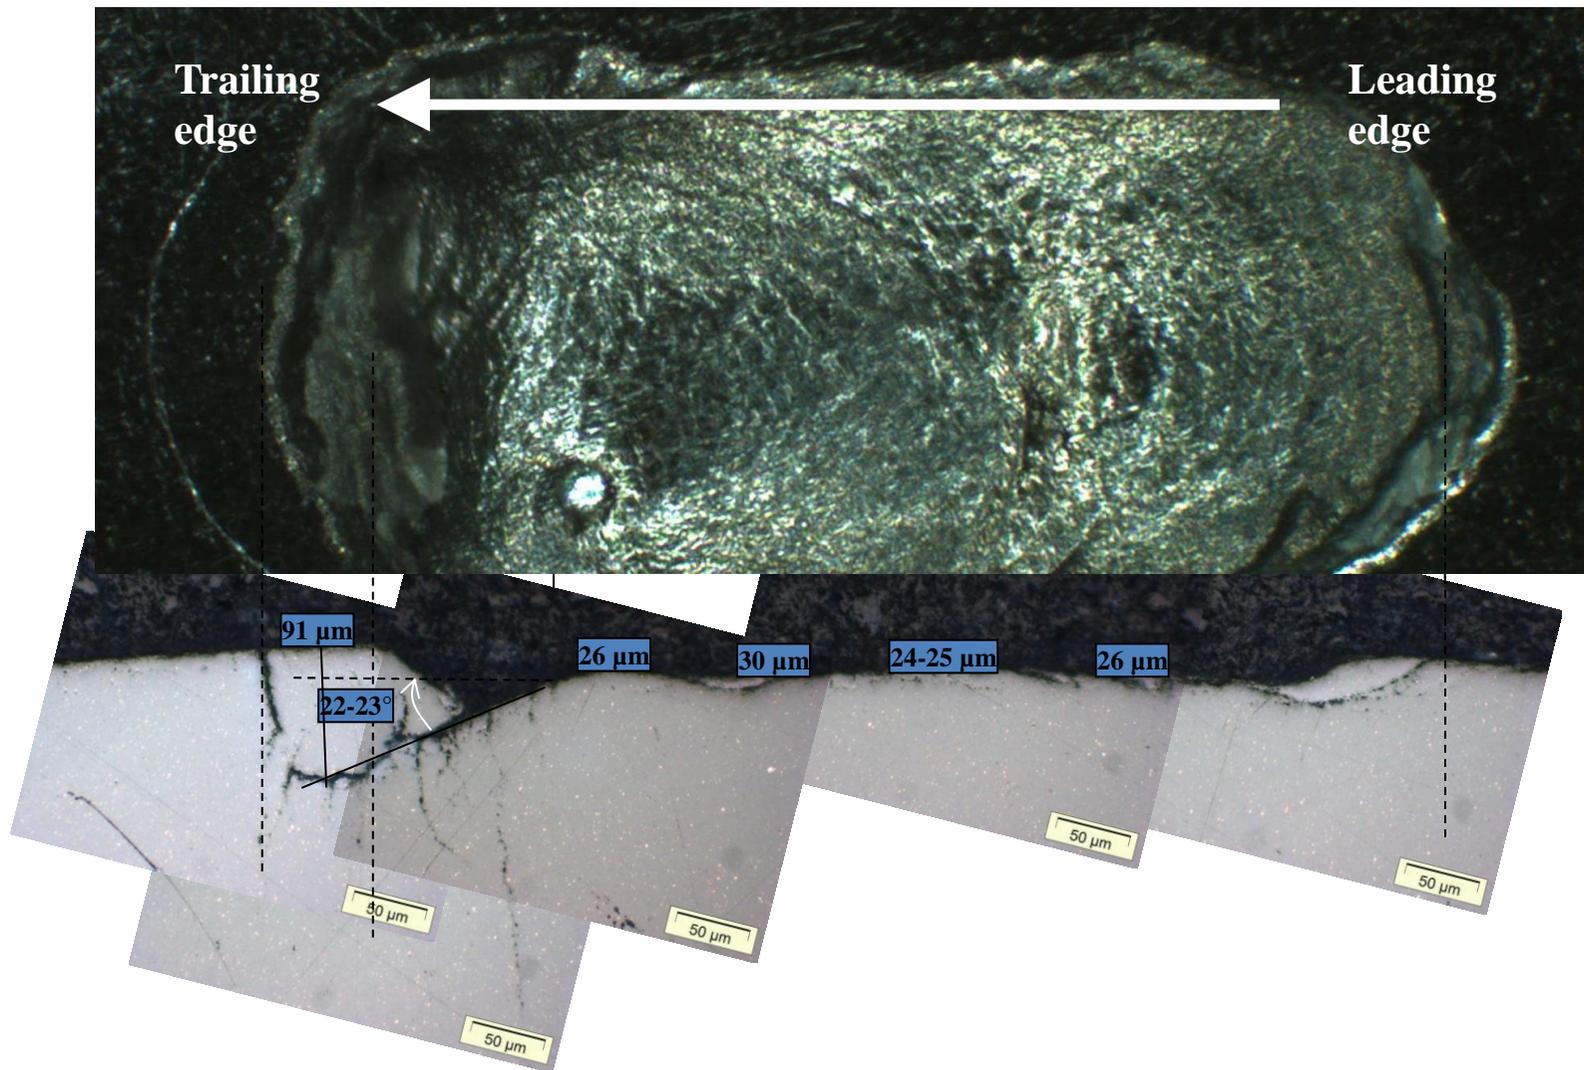
Figure 5.78: Spall analysis (exp. 13, Dia: 50μm, Depth: 30μm) of cross sectioned sample using microscopy (light illumination) - first finishing

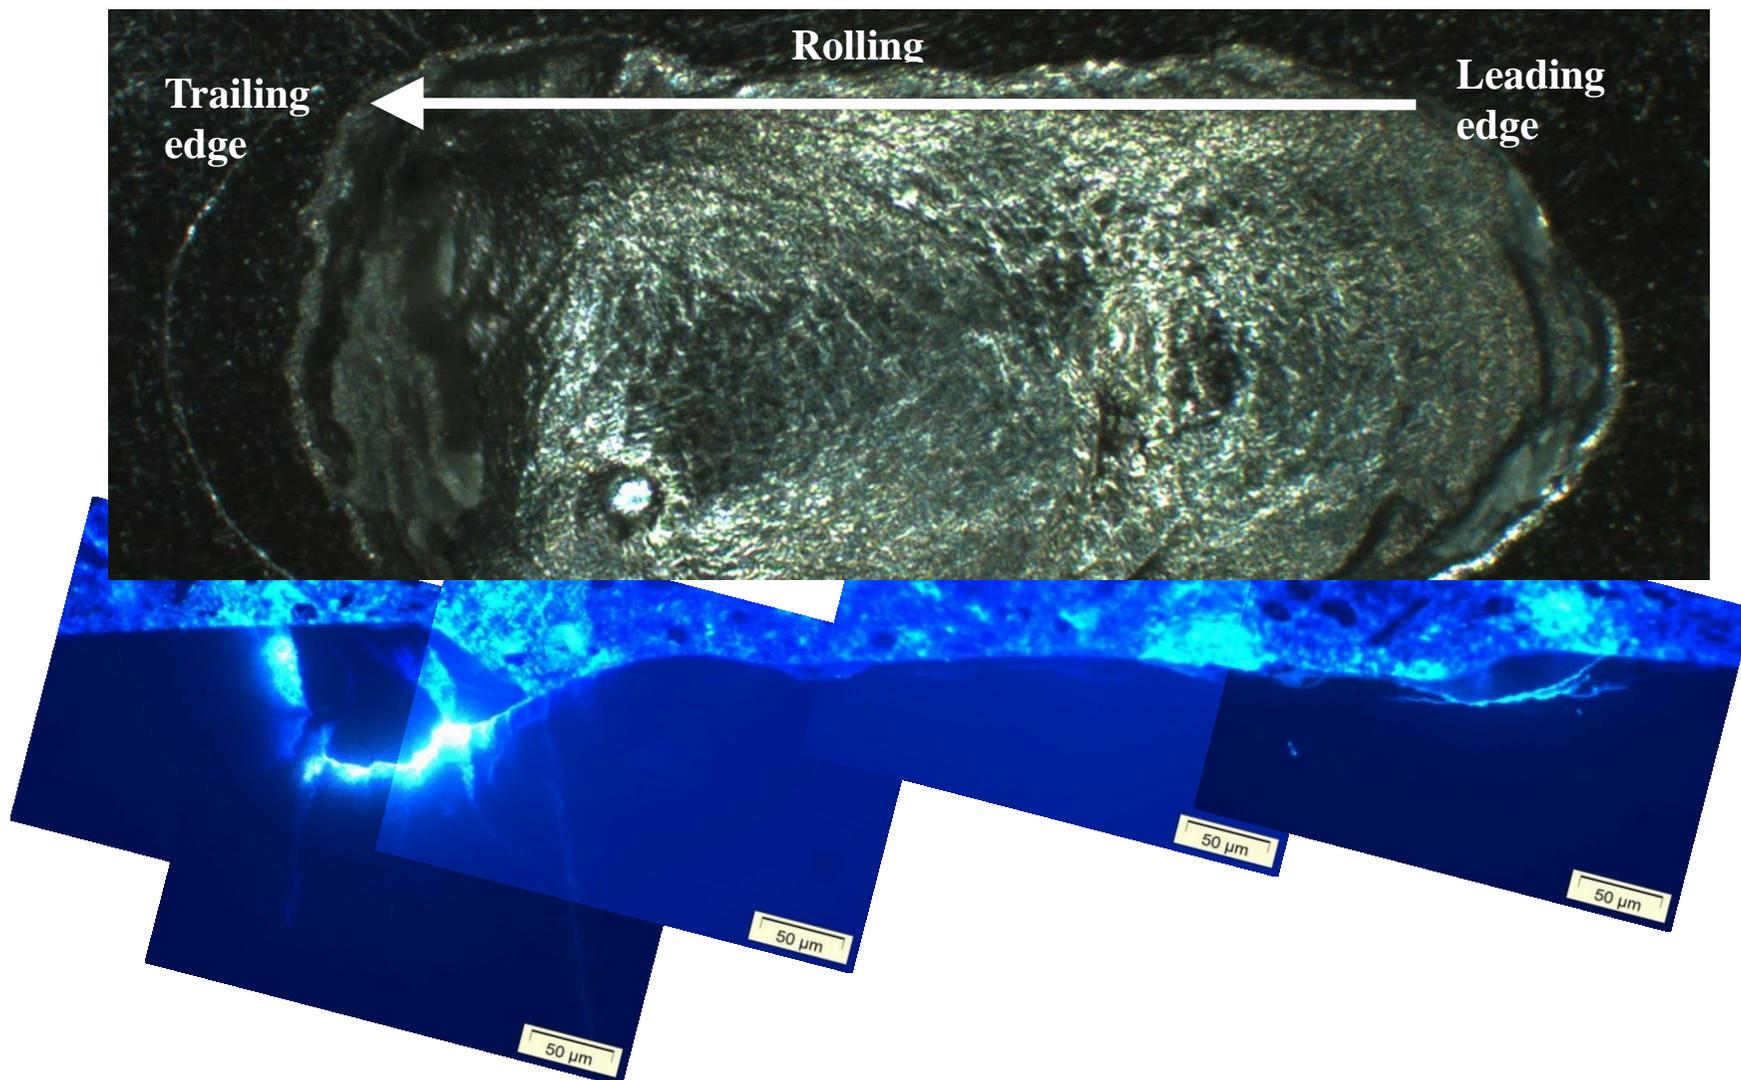
Figure 5.79: Spall analysis (exp.13, Dia: 50μm, Depth: 30μm) of cross sectioned sample using microscopy (UV illumination) - first finishing

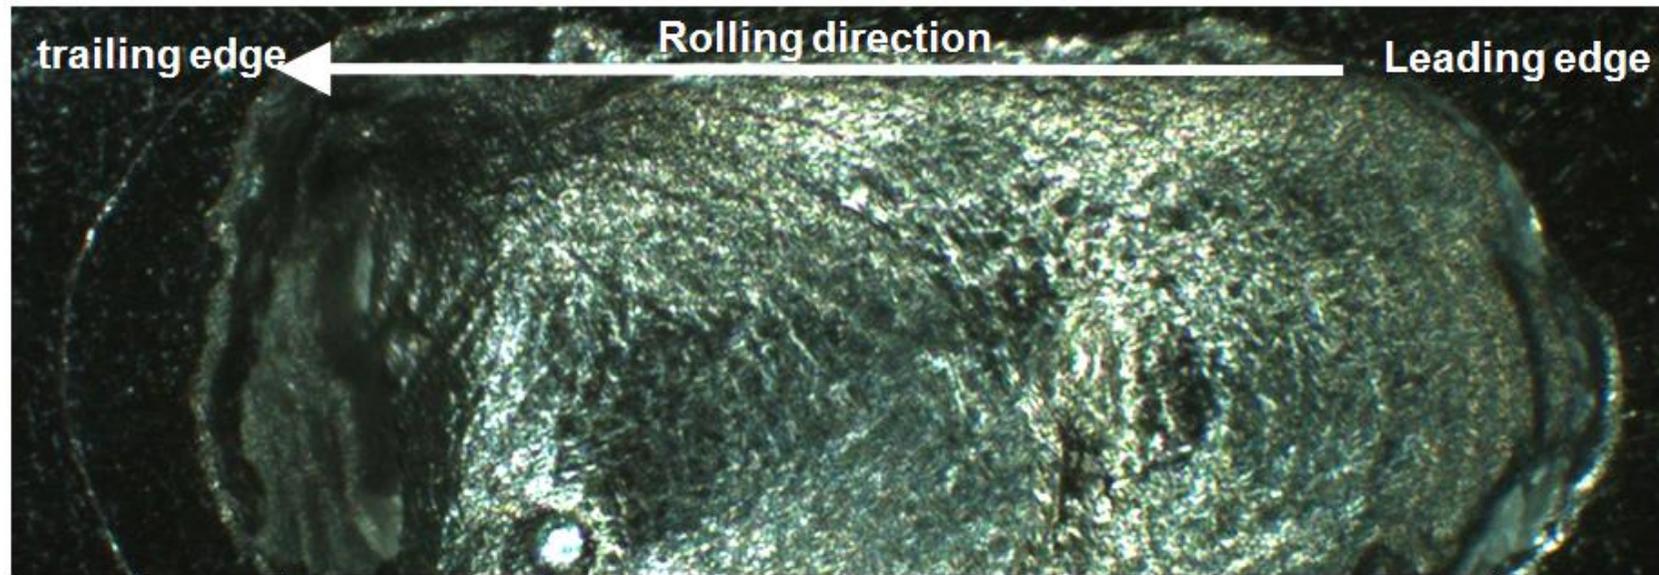
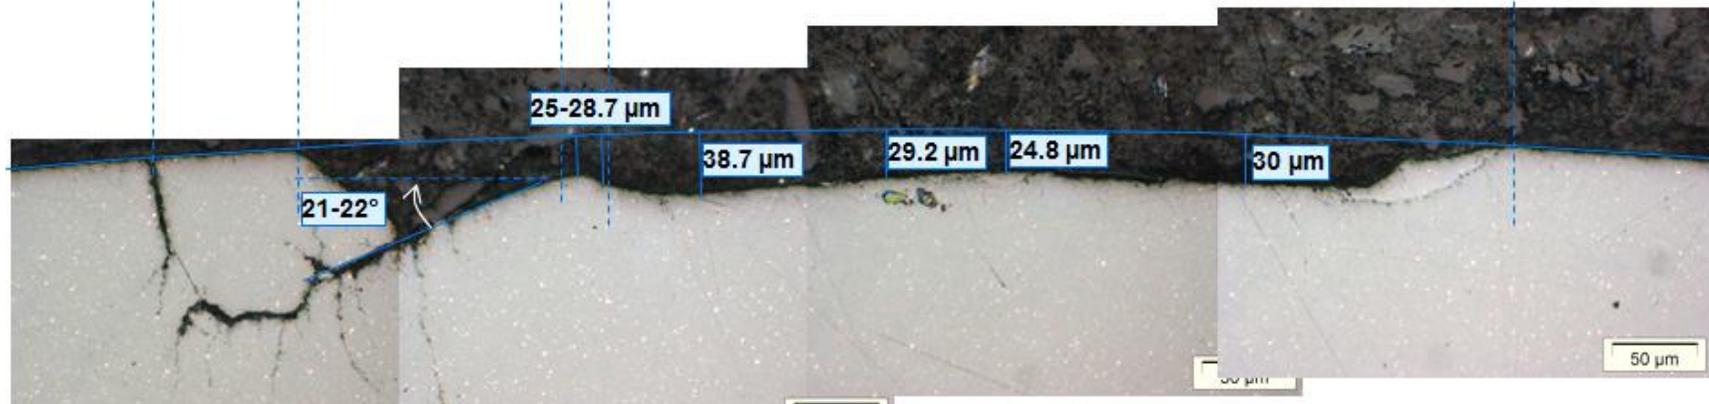
Figure 5.80: Spall analysis (exp.13, Dia: 50μm, Depth: 30μm) of cross sectioned sample using microscopy (light illumination) - second finishing

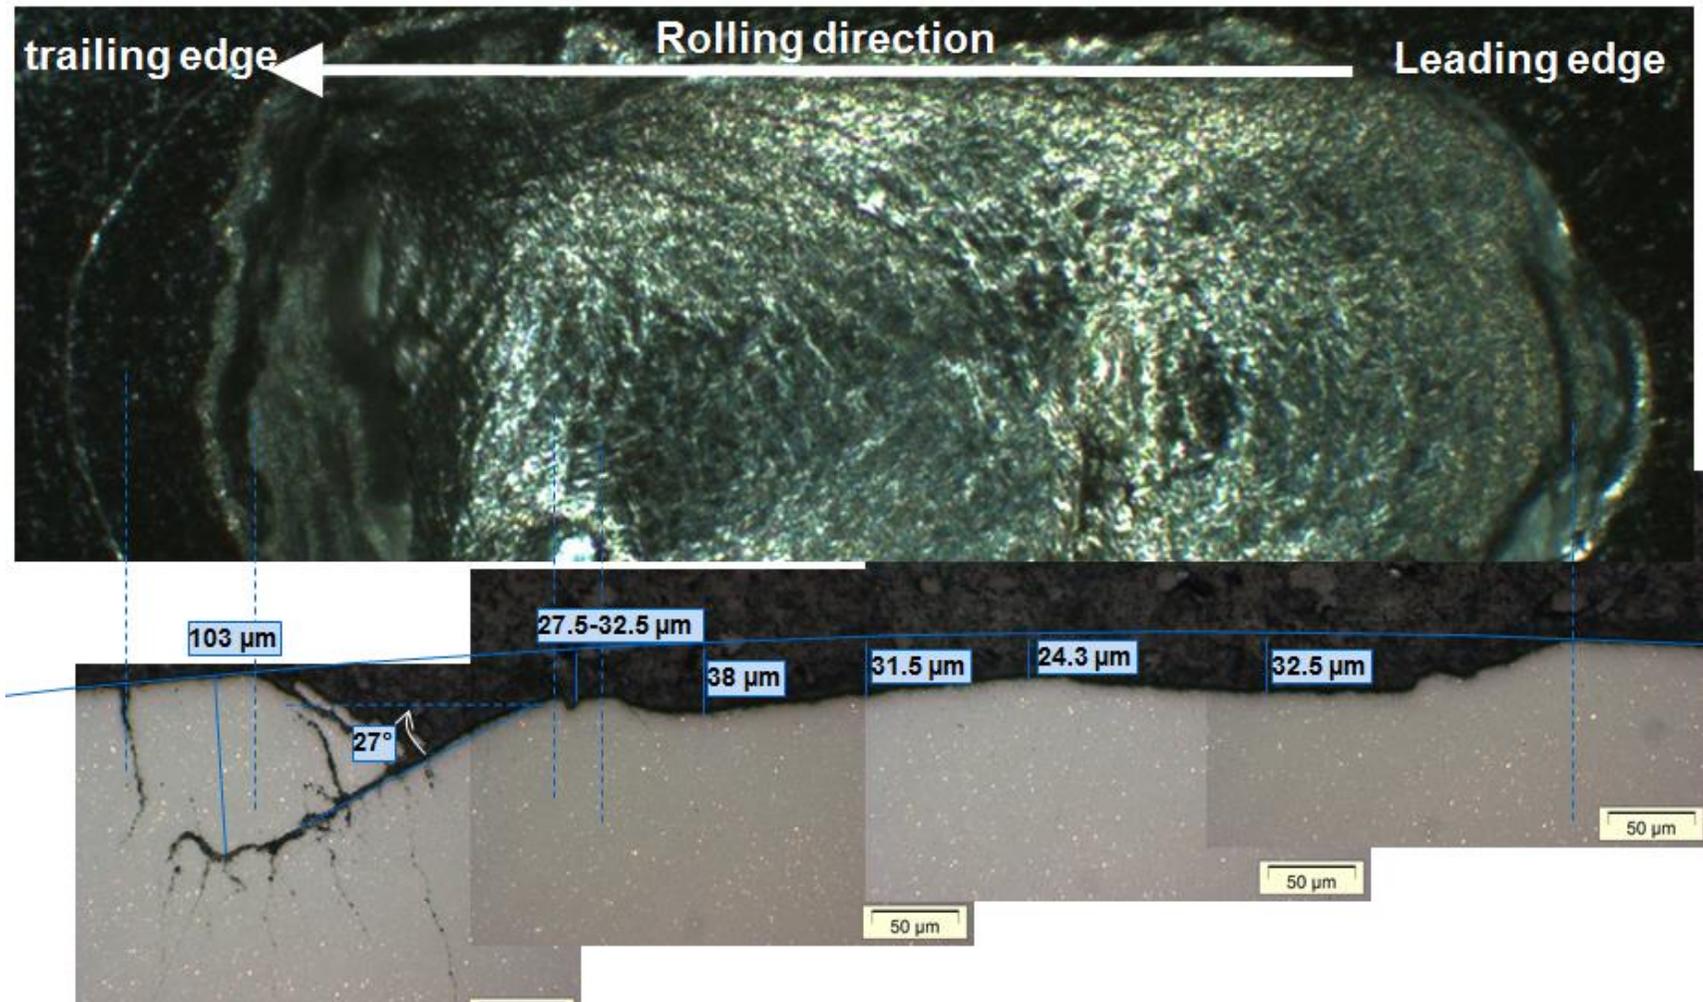
Figure 5.81: Spall analysis (exp.13, Dia: 50μm, Depth: 30μm) of cross sectioned sample using microscopy (light illumination) - 3rd finishing

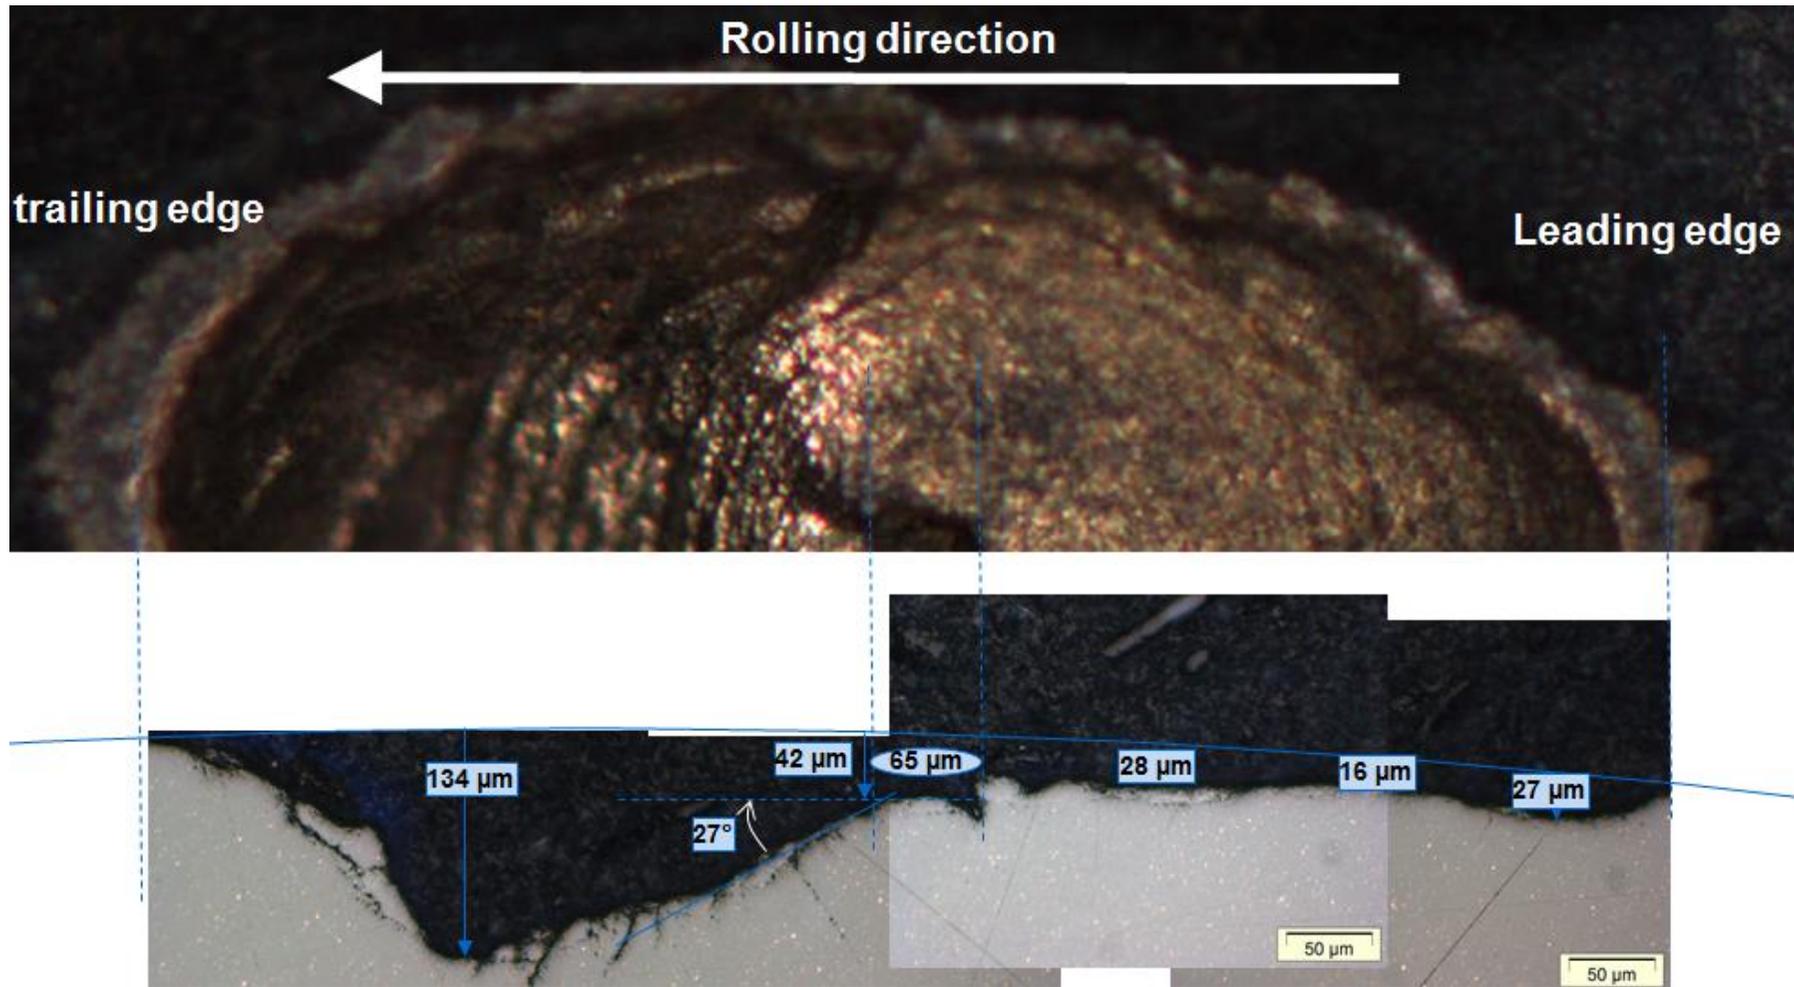
Figure 5.82: Spall analysis (exp.42, Dia: 100 μm , Depth: 50 μm) of cross sectioned sample using microscopy (light illumination) - 3rd finishing

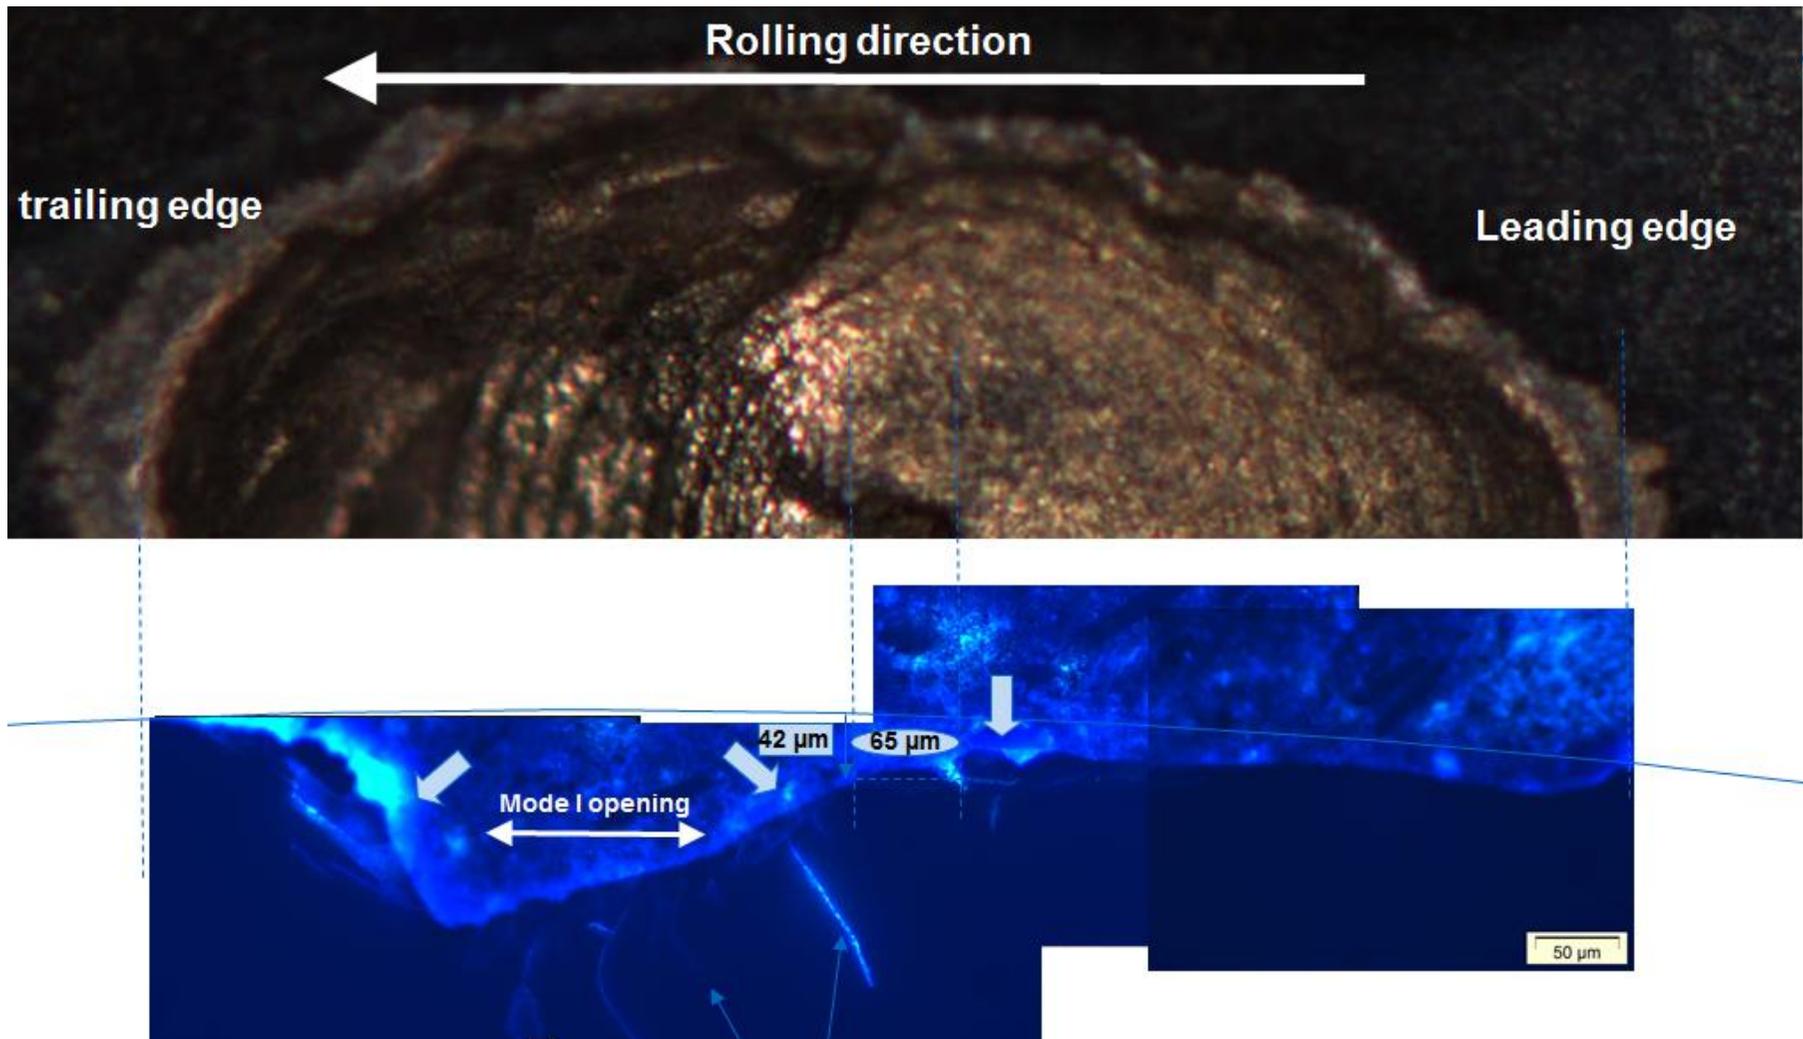
Figure 5.83: Spall analysis (exp.42, Dia: 100μm, Depth: 50μm) of cross sectioned sample using microscopy (UV illumination) - 3rd finishing

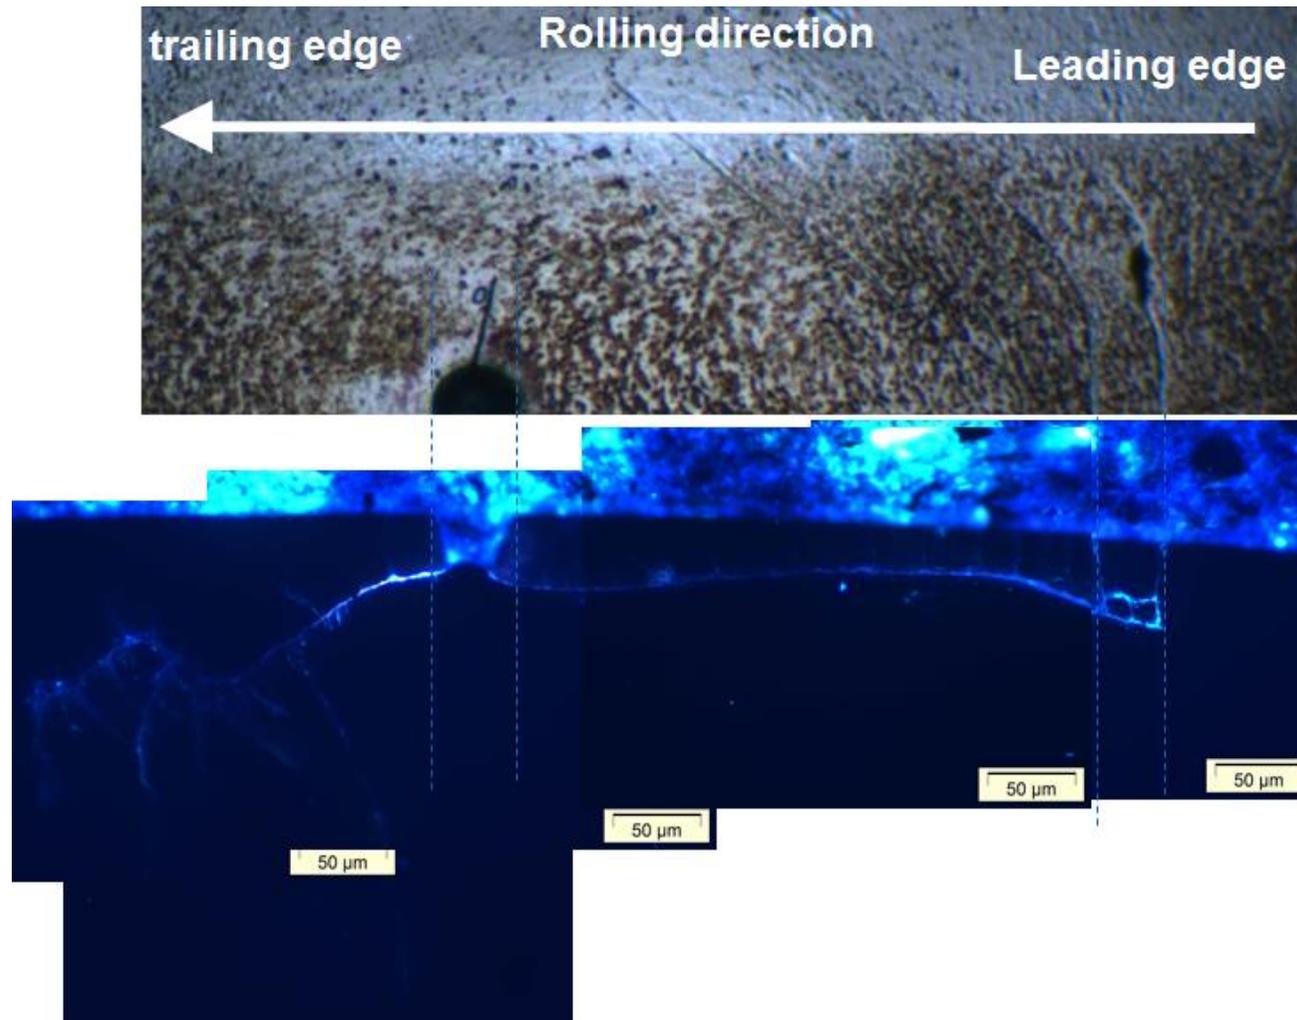
Figure 5.93: Sub-surface analysis (exp.12, Dia: 50μm, Depth: 30 μm) sample using microscopy (UV illumination) - 2nd finishing

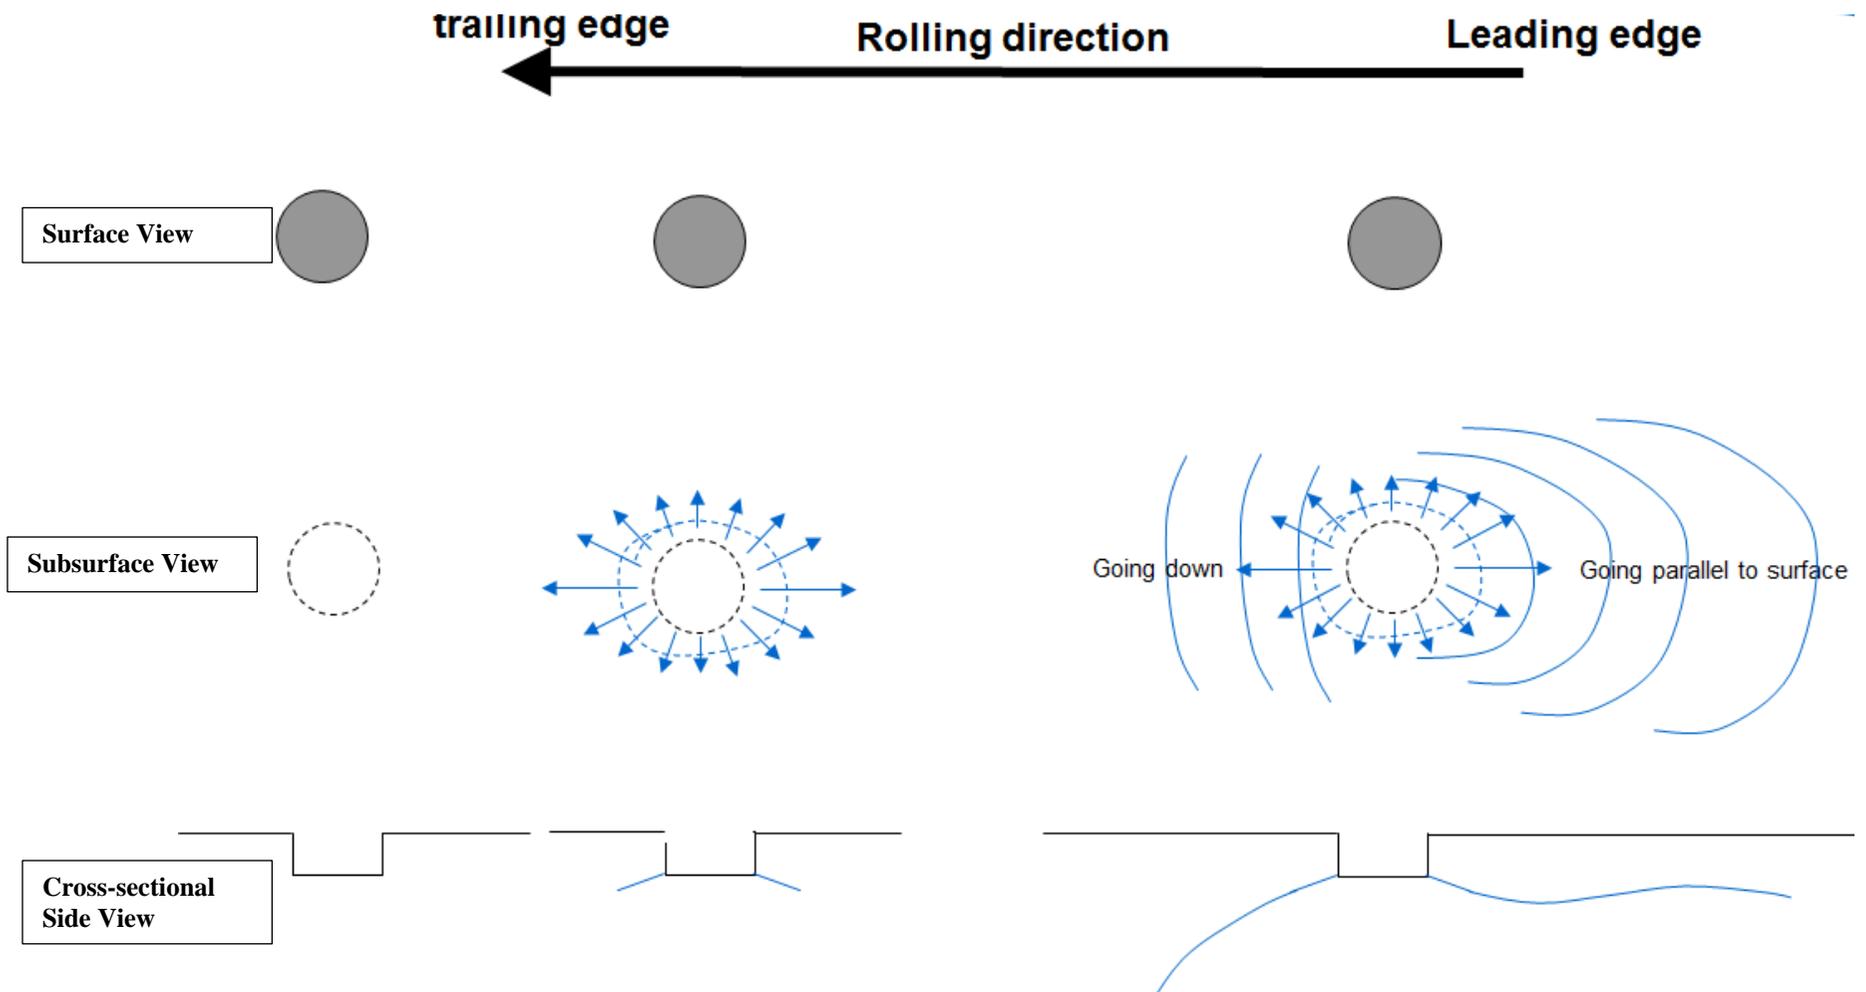
Figure 5.94: Failure mechanism schematic – Step 1 (Concluded from spalled and incipient spall samples)

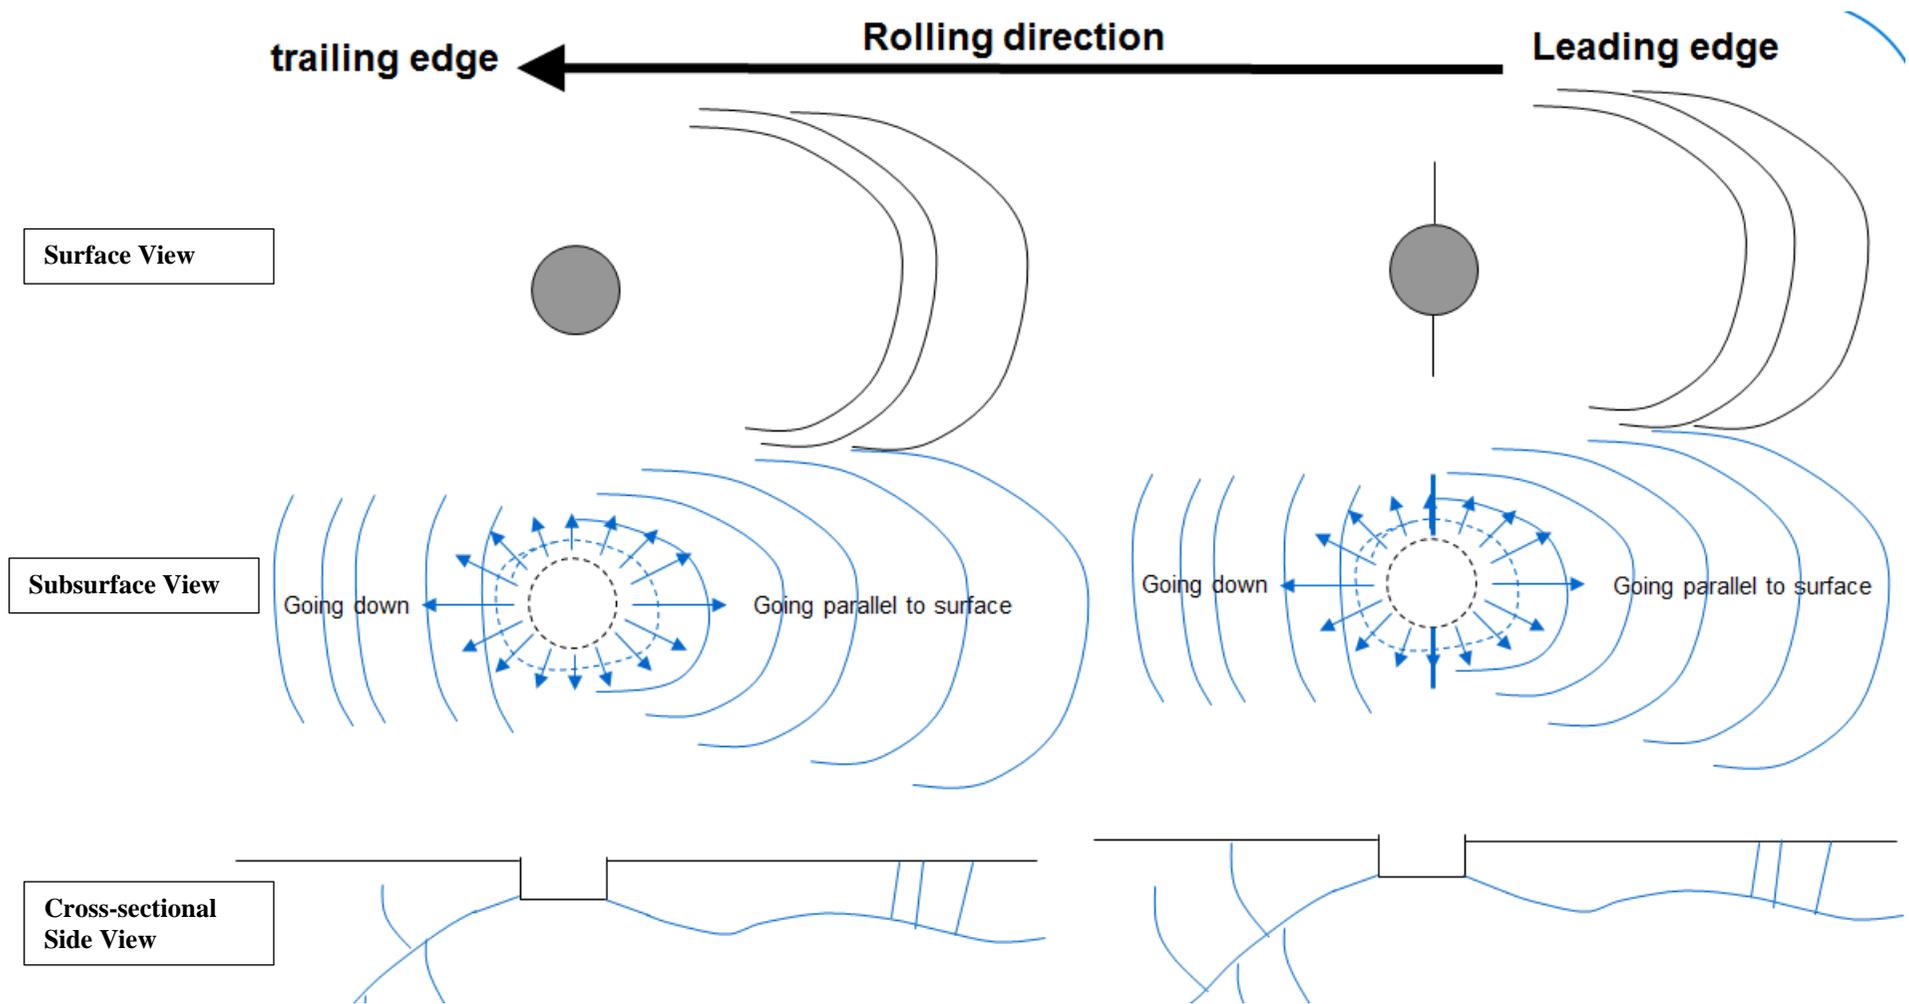
Figure 5.95: Failure mechanism schematic – Step 2
