**Defect Tolerance Assessment of Silicon Nitride
in Rolling Contact**

A thesis is submitted to Faculty of Science and Technology, Bournemouth University,
in partial fulfilment of the requirements for the degree of Doctor of Philosophy

In collaboration with SKF ERC, the Netherlands

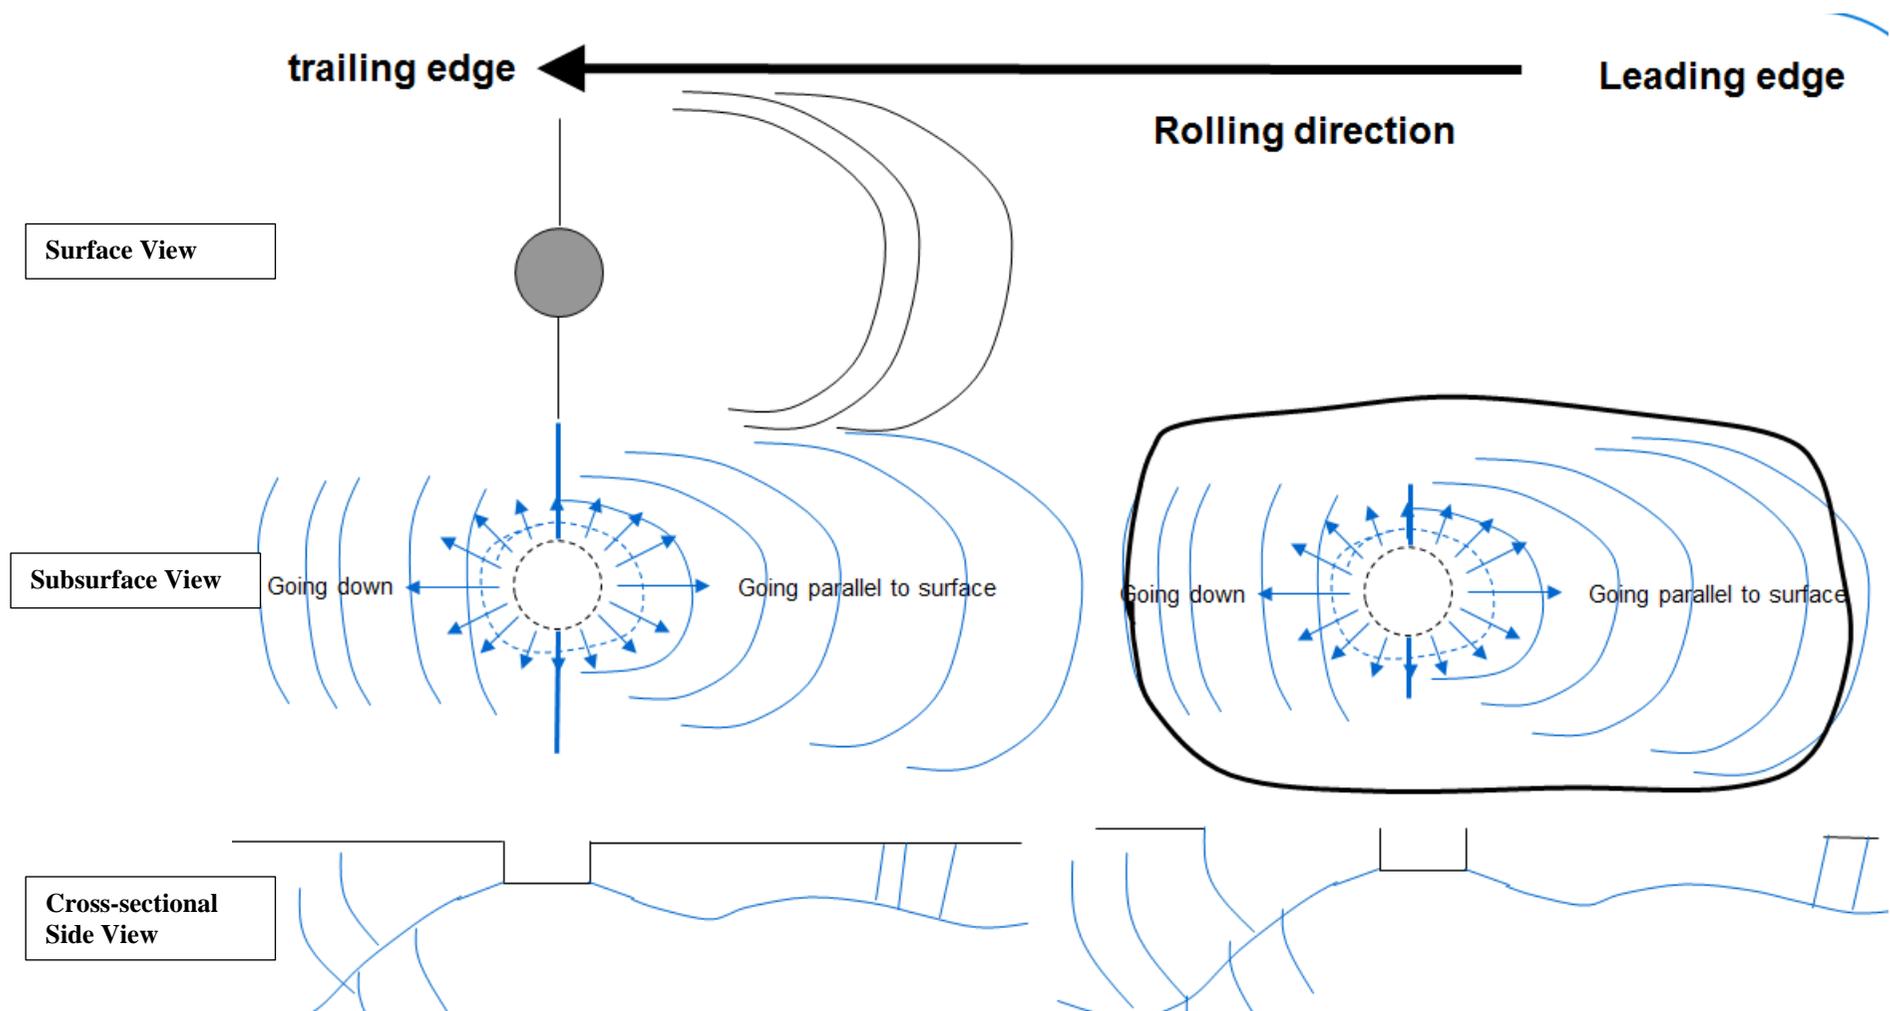
Figure 5.96: Failure mechanism schematic – Step 3

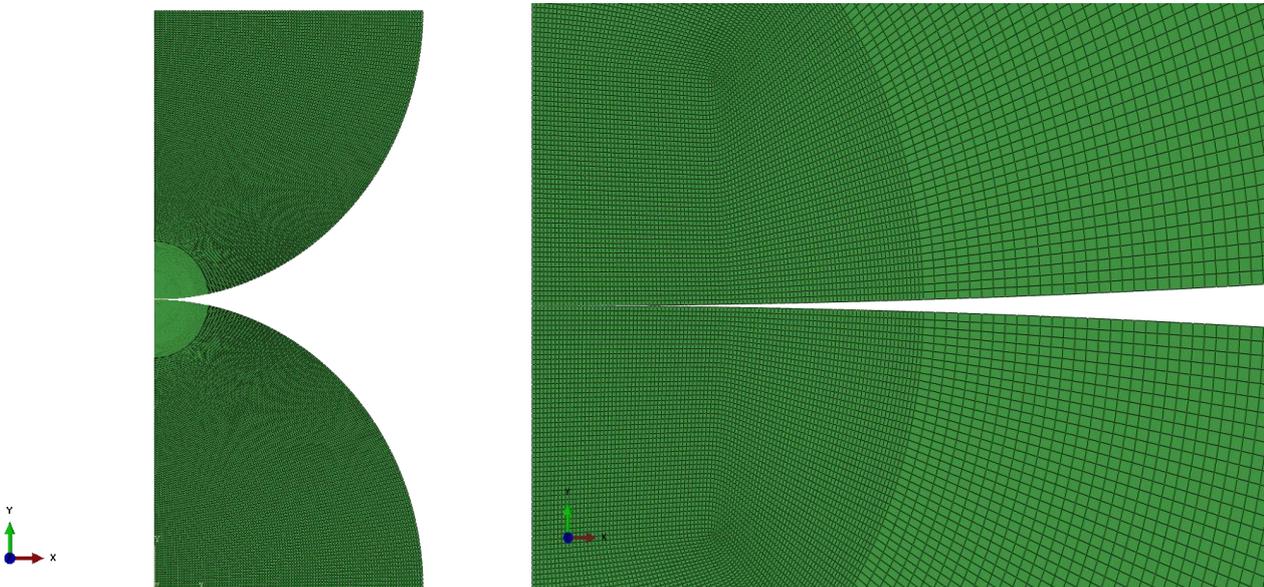
Figure 6.1: 2D Mesh for ball-on-ball (without any hole)

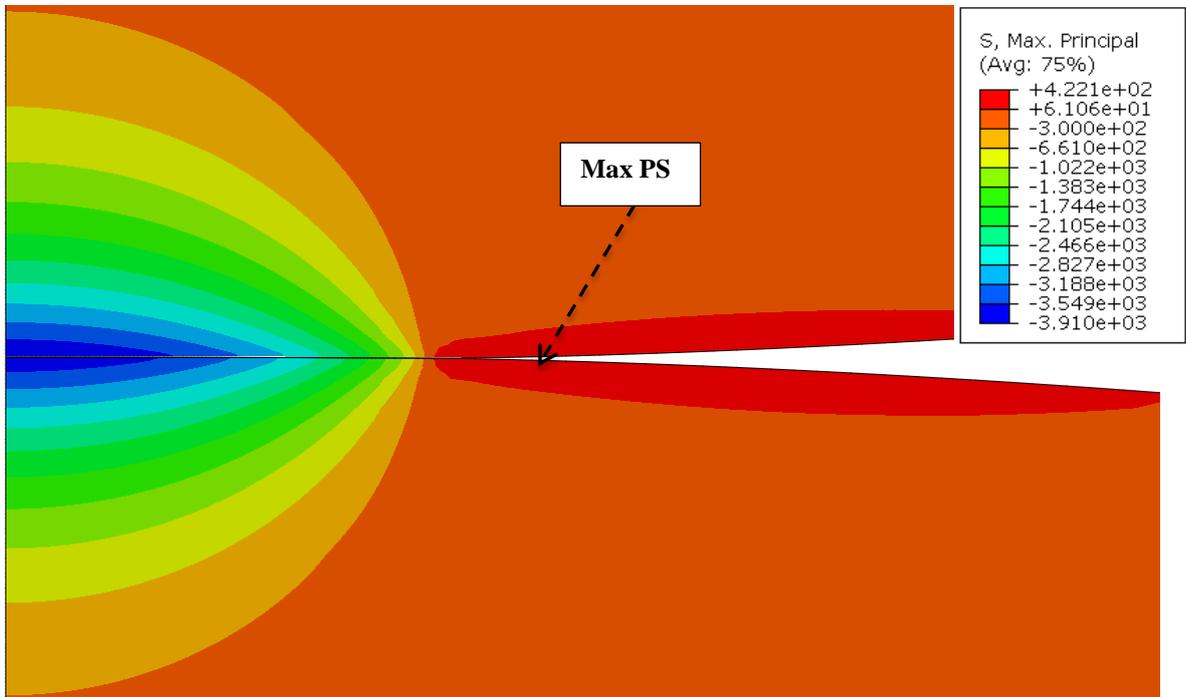
Figure 6.3: Maximum principal stress (MPa) for 2D static model ball on ball (without any hole)

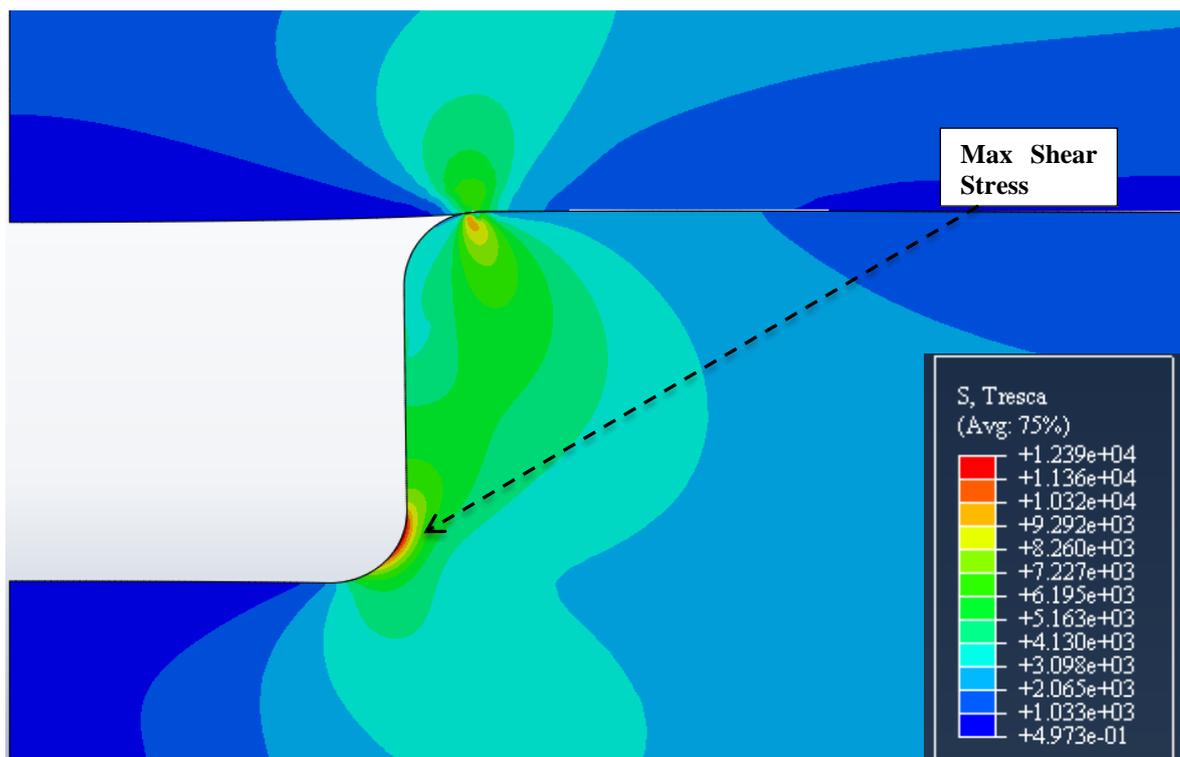
Figure 6.4: Maximum shear stress (MPa) for 2D static model ball- on-ball (with hole)

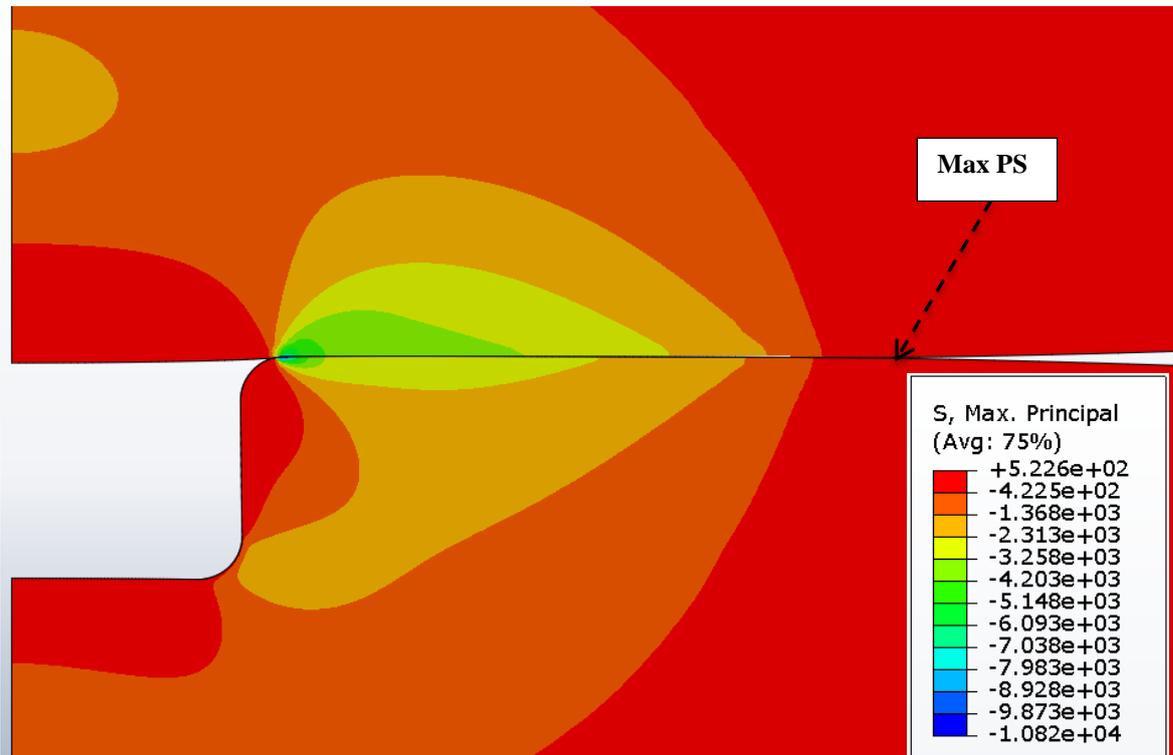
Figure 6.5: Maximum principal stress (MPa) for 2D static model ball on ball (with hole)

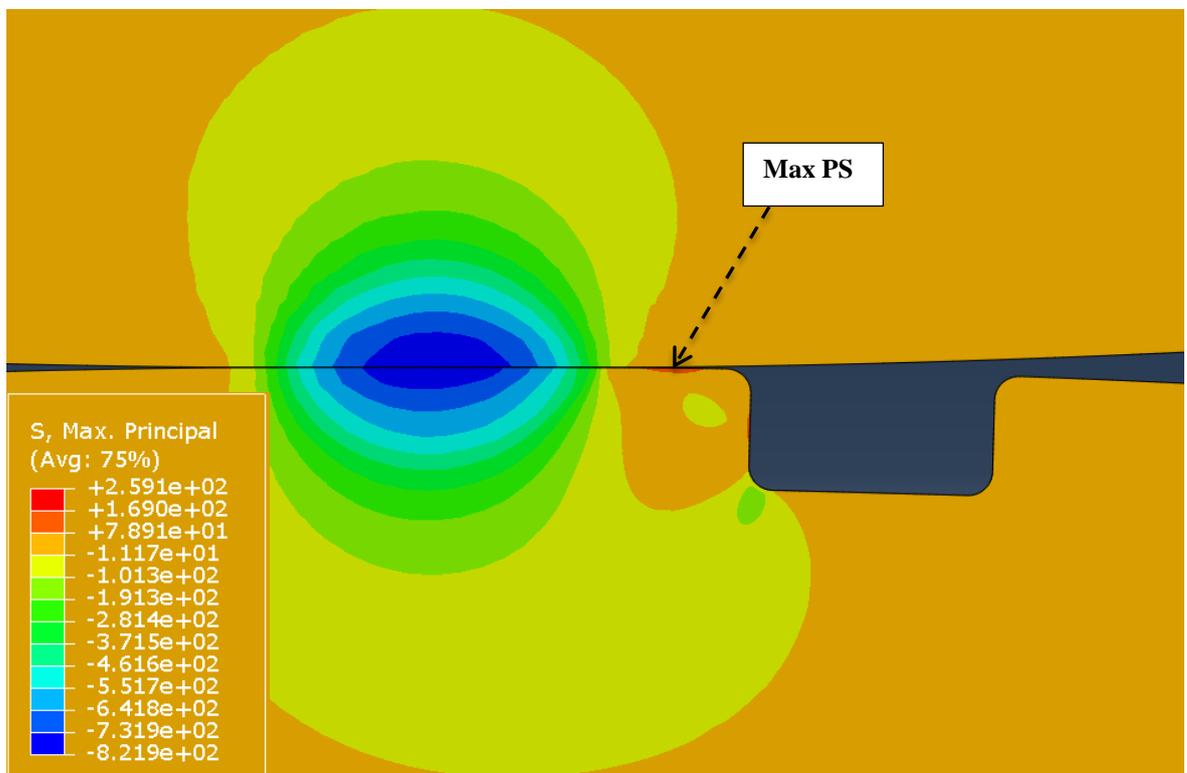
Figure 6.9: Maximum principal stress (MPa) for 2D rolling model ball-on-ball (with hole)
 - at the end of rolling (indent lies outside the contact)

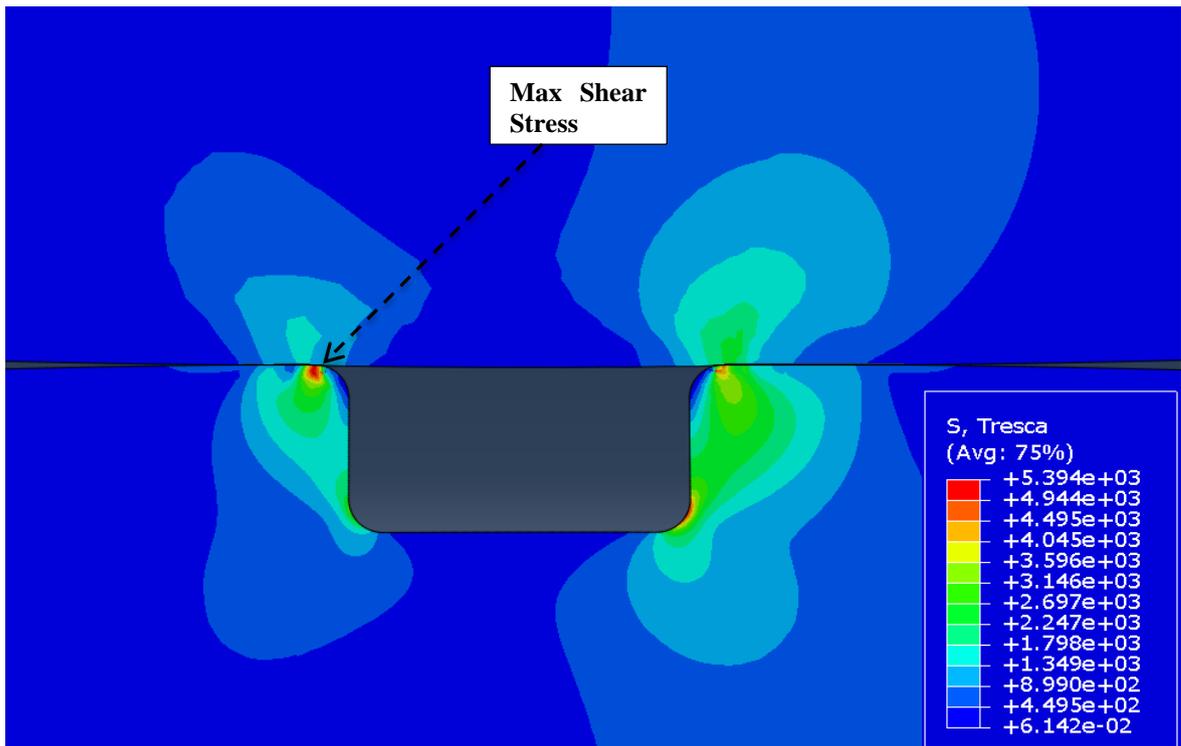
Figure 6.10: Maximum shear stress (MPa) for 2D rolling model ball on ball (with hole) - at the almost centre of contact

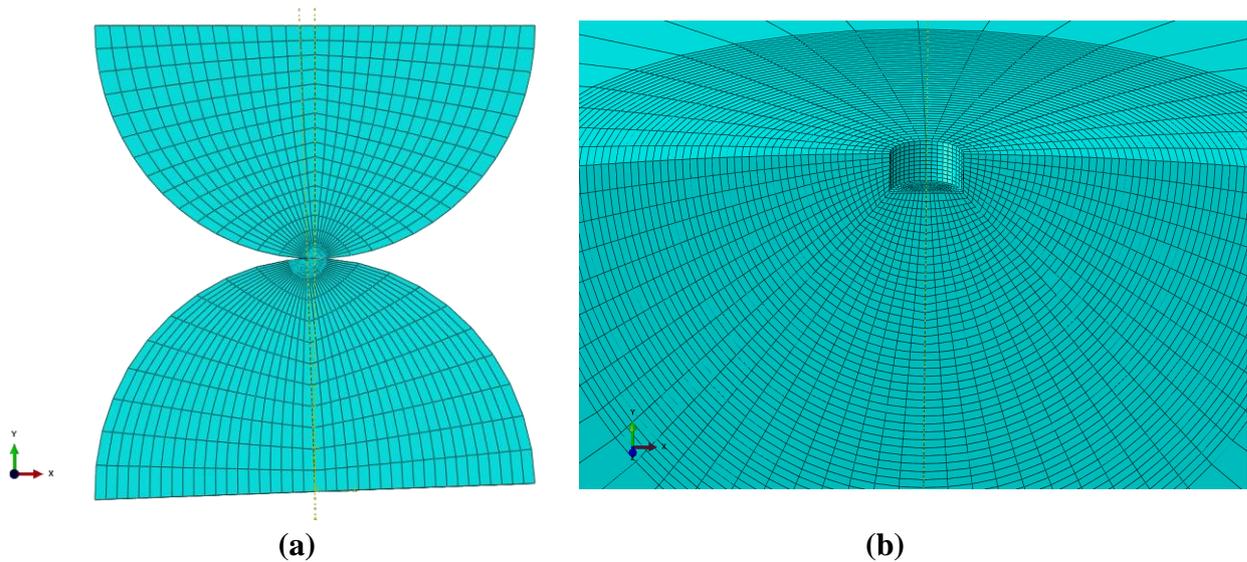
Figure 6.11: 3D Model ball on ball (with hole) (a) 3D Model mesh (b) Closer view of the mesh on the lower ball with hole of 100µm diameter and 50µm depth

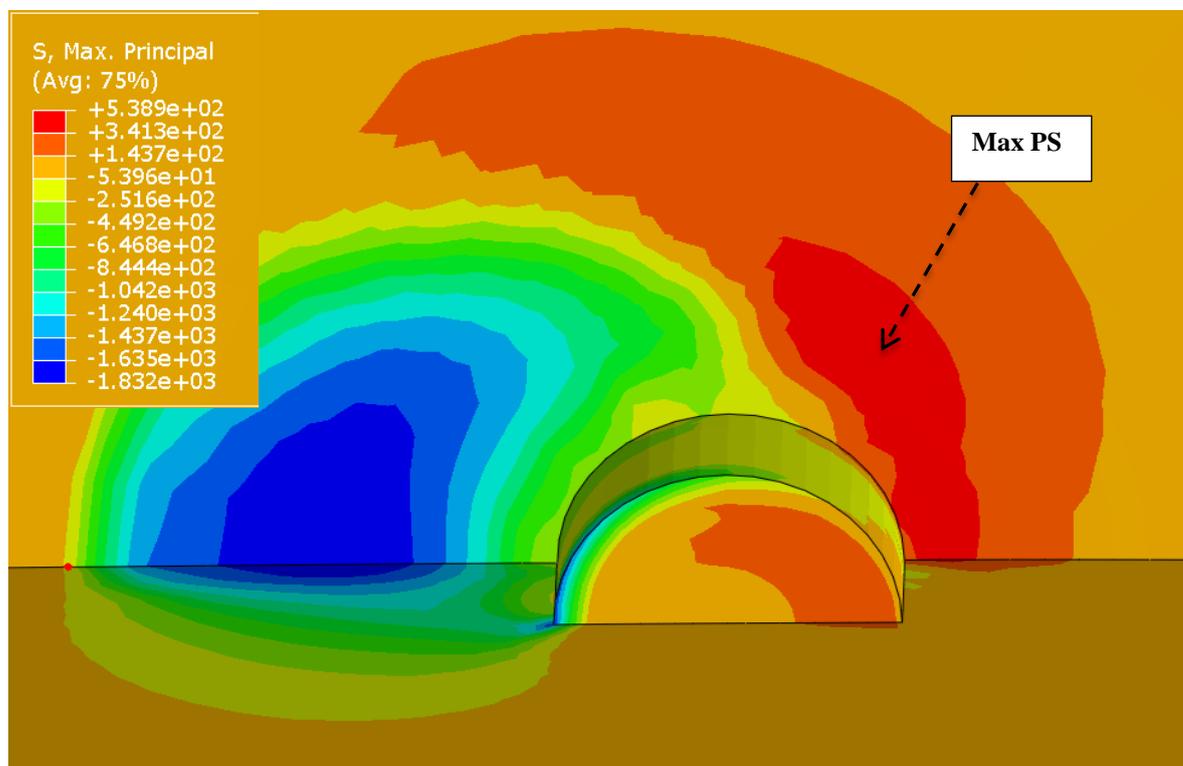
Figure 6.12: Maximum principal stress (MPa) during rolling (located close to leading edge)

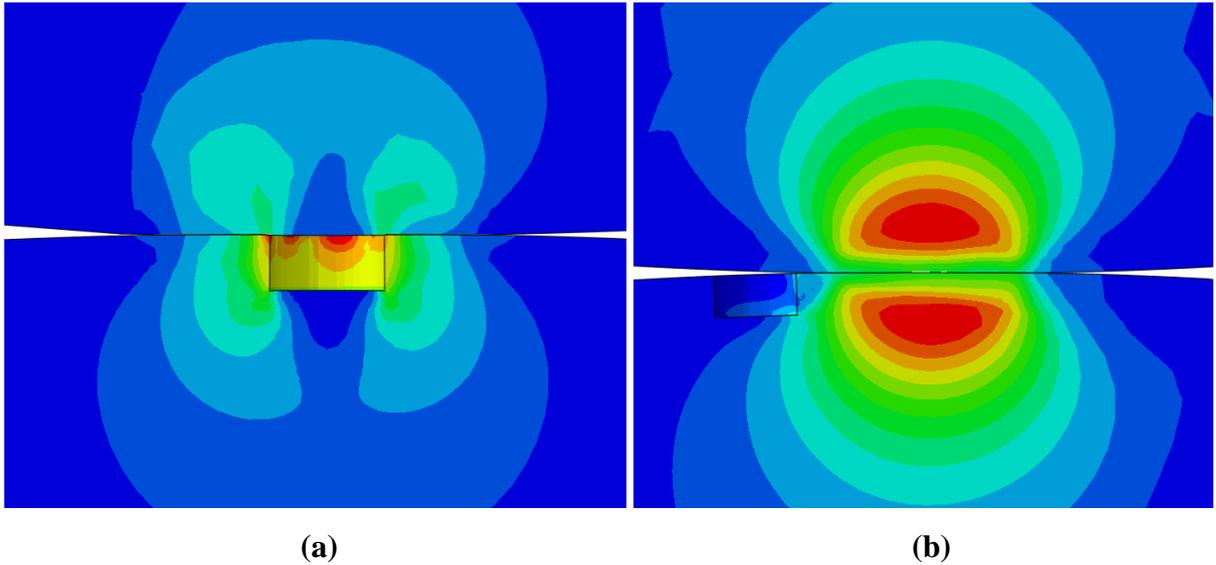
Figure 6.15: Two rolling cases (a) contact centre exactly at hole's centre (b) contact centre far away from hole

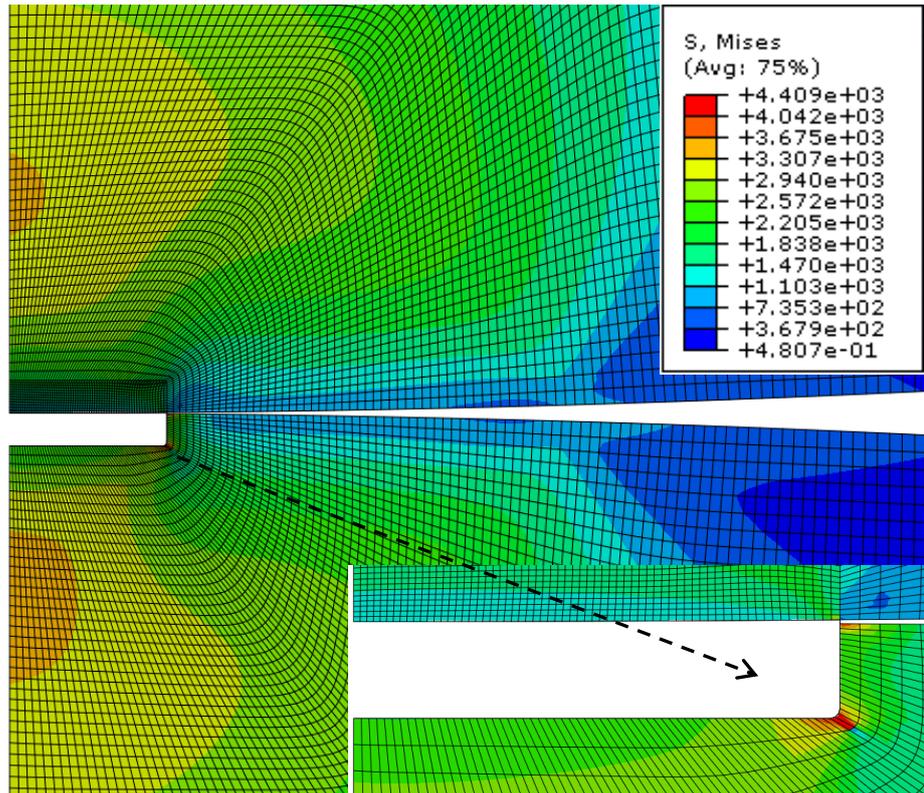
Figure 6.17: Von Mises (MPa) for larger diameter (100µm) and shallow depth (10µm)

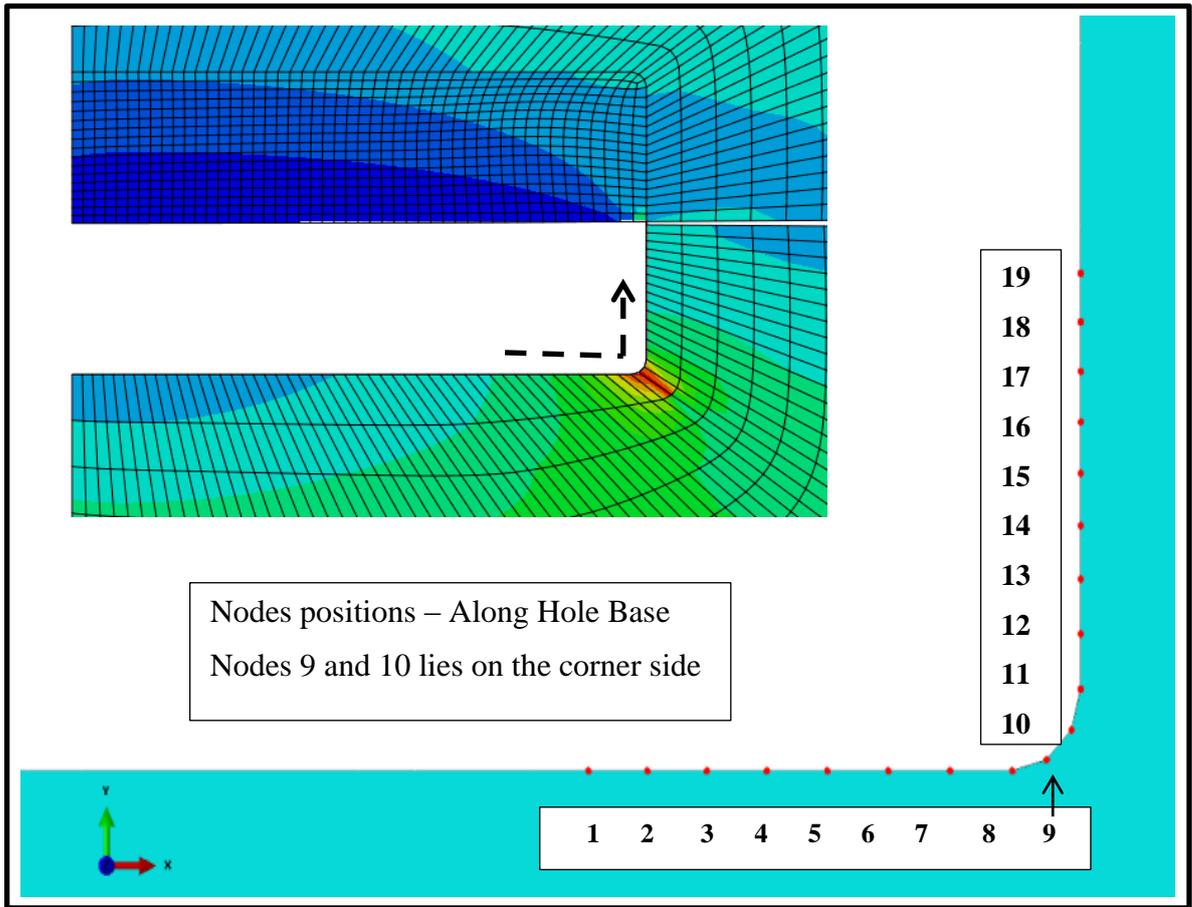
Figure 6.22: Nodal positions - along the hole base

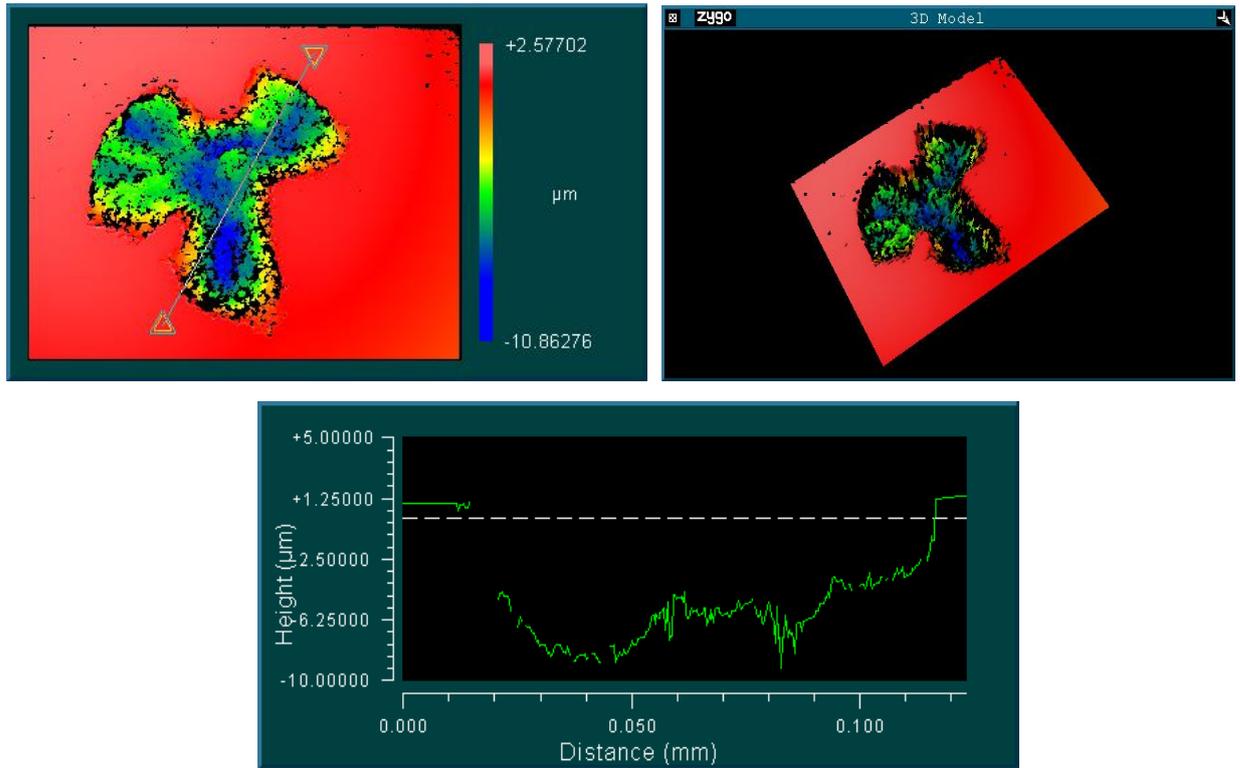
Natural Star with major missing material with depth up to $9\mu\text{m}$ (Cat. 5)

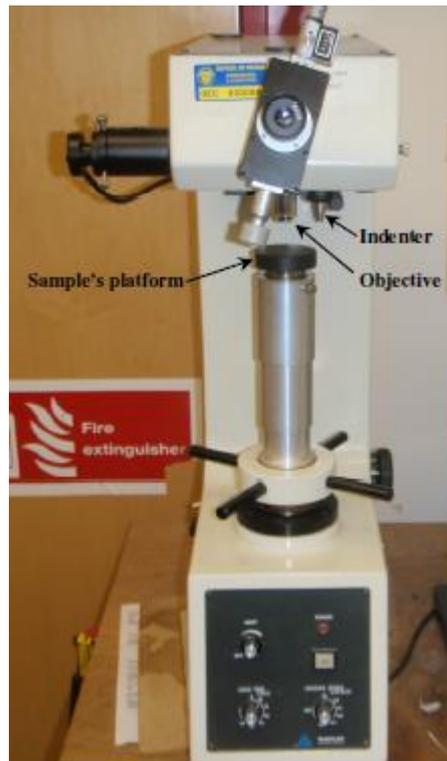
Where b = cross corner distance = 0.074mm (74μm)

h = 0.01056mm = 10.56μm (which was almost upper limit of nature star features)

Vickers indenter used to create indent in the silicon nitride surface
