**Archaeological evidence for the development of Royal Naval
gunnery from 1545 – 1811; analysing change through technology
and culture**

By
Daniel Pascoe

Dissertation submitted in partial fulfilment of the requirements for the degree ‘Doctor of
Philosophy’, awarded by Bournemouth University

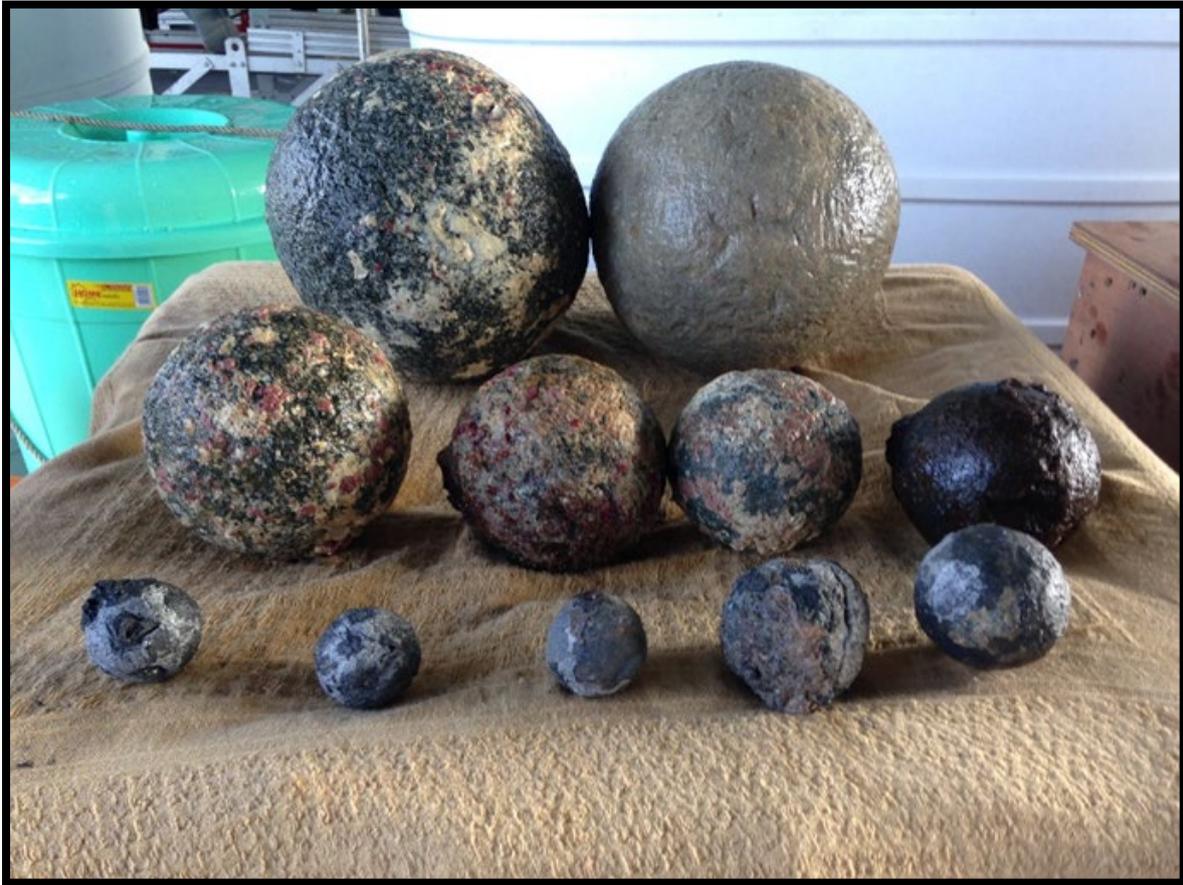
Figure 2.2: Examples of the variety of shot recovered from the Esmeralda. The largest up to 220mm in diameter (Photo by author).

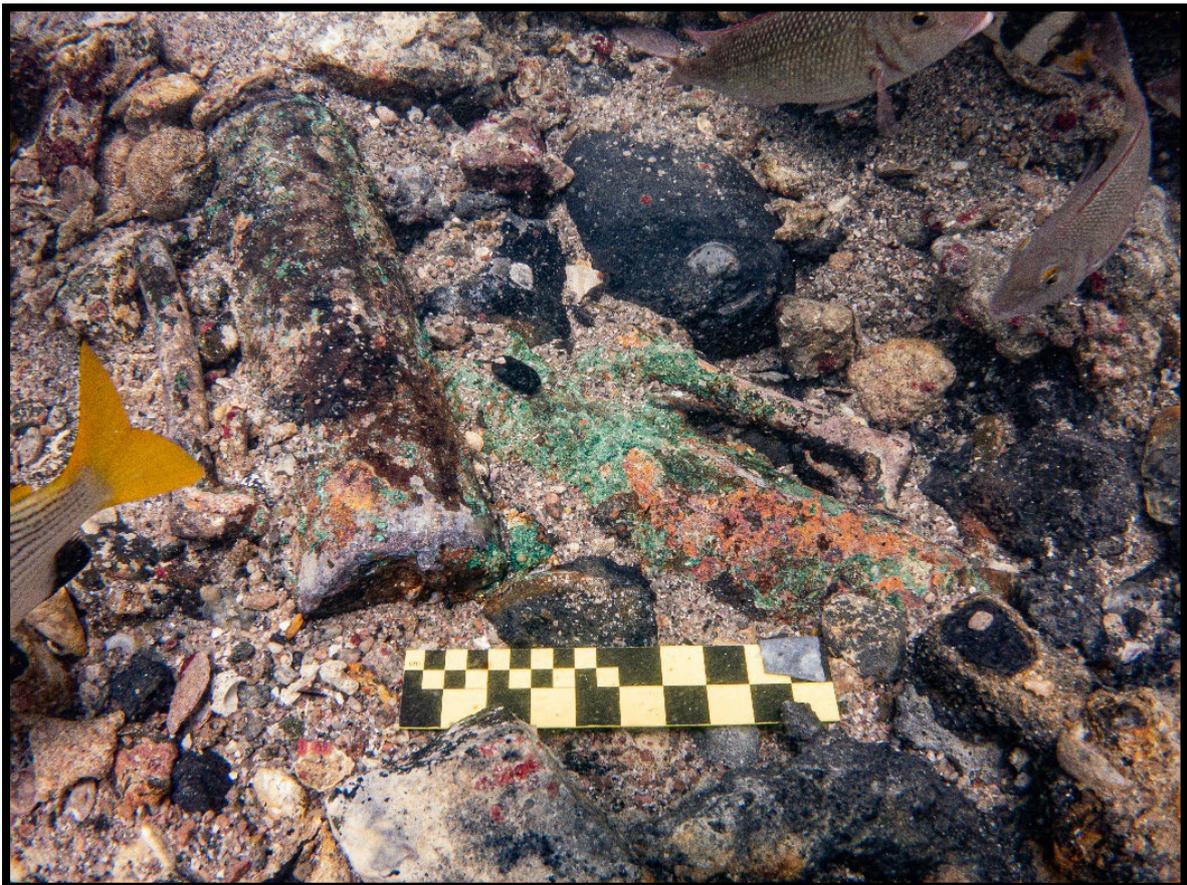
Figure 2.3: Two bronze breech chambers for swivel guns in-situ on the wreck of the *Esmeralda* (Photo by author).

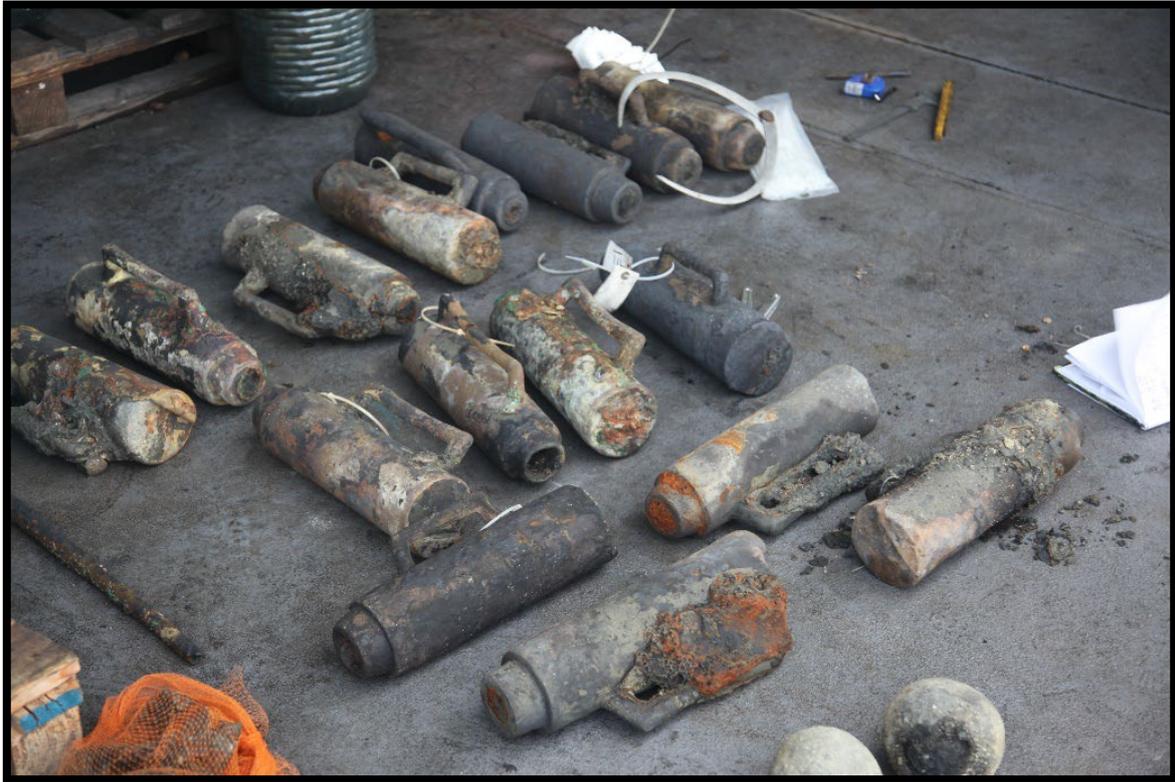
Figure 2.4: Several examples of the breech chambers recovered from the wreck of the *Esmeralda* (Photo by author).

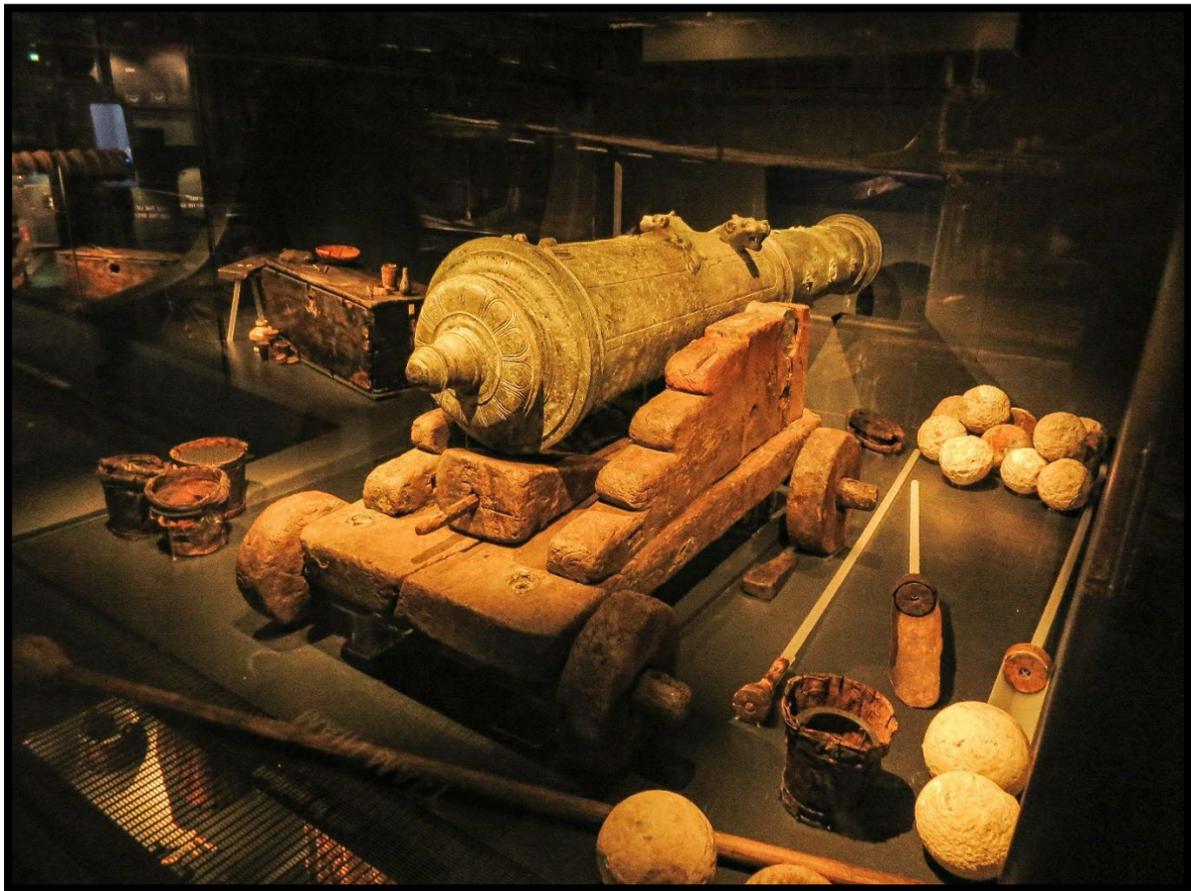
Figure 2.6: The carriage for cannon **81A3003** is more compact and suits the length of the gun (photo by author).

If these carriages were more compact to suit the size of the gun, like the carriage for cannon **81A3003** (Figure 2.6) then there would have been more deck space for the guns to recoil and for the crew to load. The development of the gun carriage was key to improving the performance of the gun and the fighting capabilities of the ship and will be a focus of this research in forthcoming chapters.

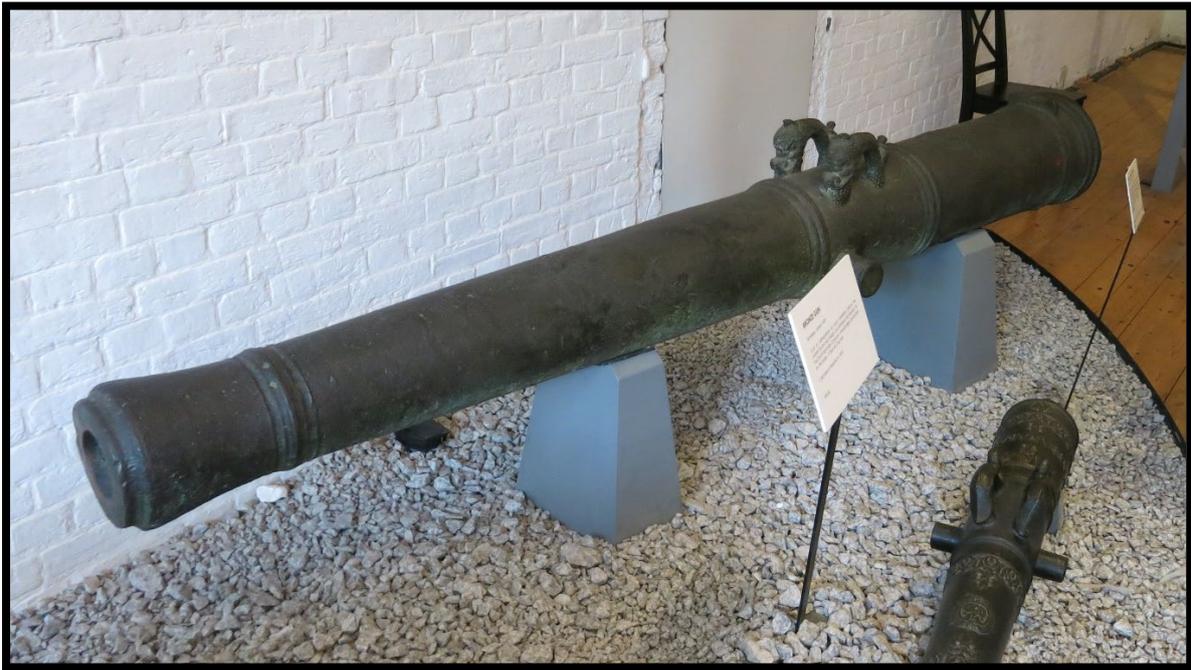
Figure 3.2: The 1636 French demi-culverin recovered from Site 2 in 1961 now on display at Fort Nelson, Portsmouth (Photo by author).

London. The gun was French in origin and dated to 1636, having ended up in English hands following the capture of any number French vessels between 1650 and 1654 (Fox 2011, p. 30). This gun is currently on display at the Royal Armouries Museum and Fort Nelson (Figure 3.2). The discovery of this gun was the first hint that this was the location of one part of the *London*.

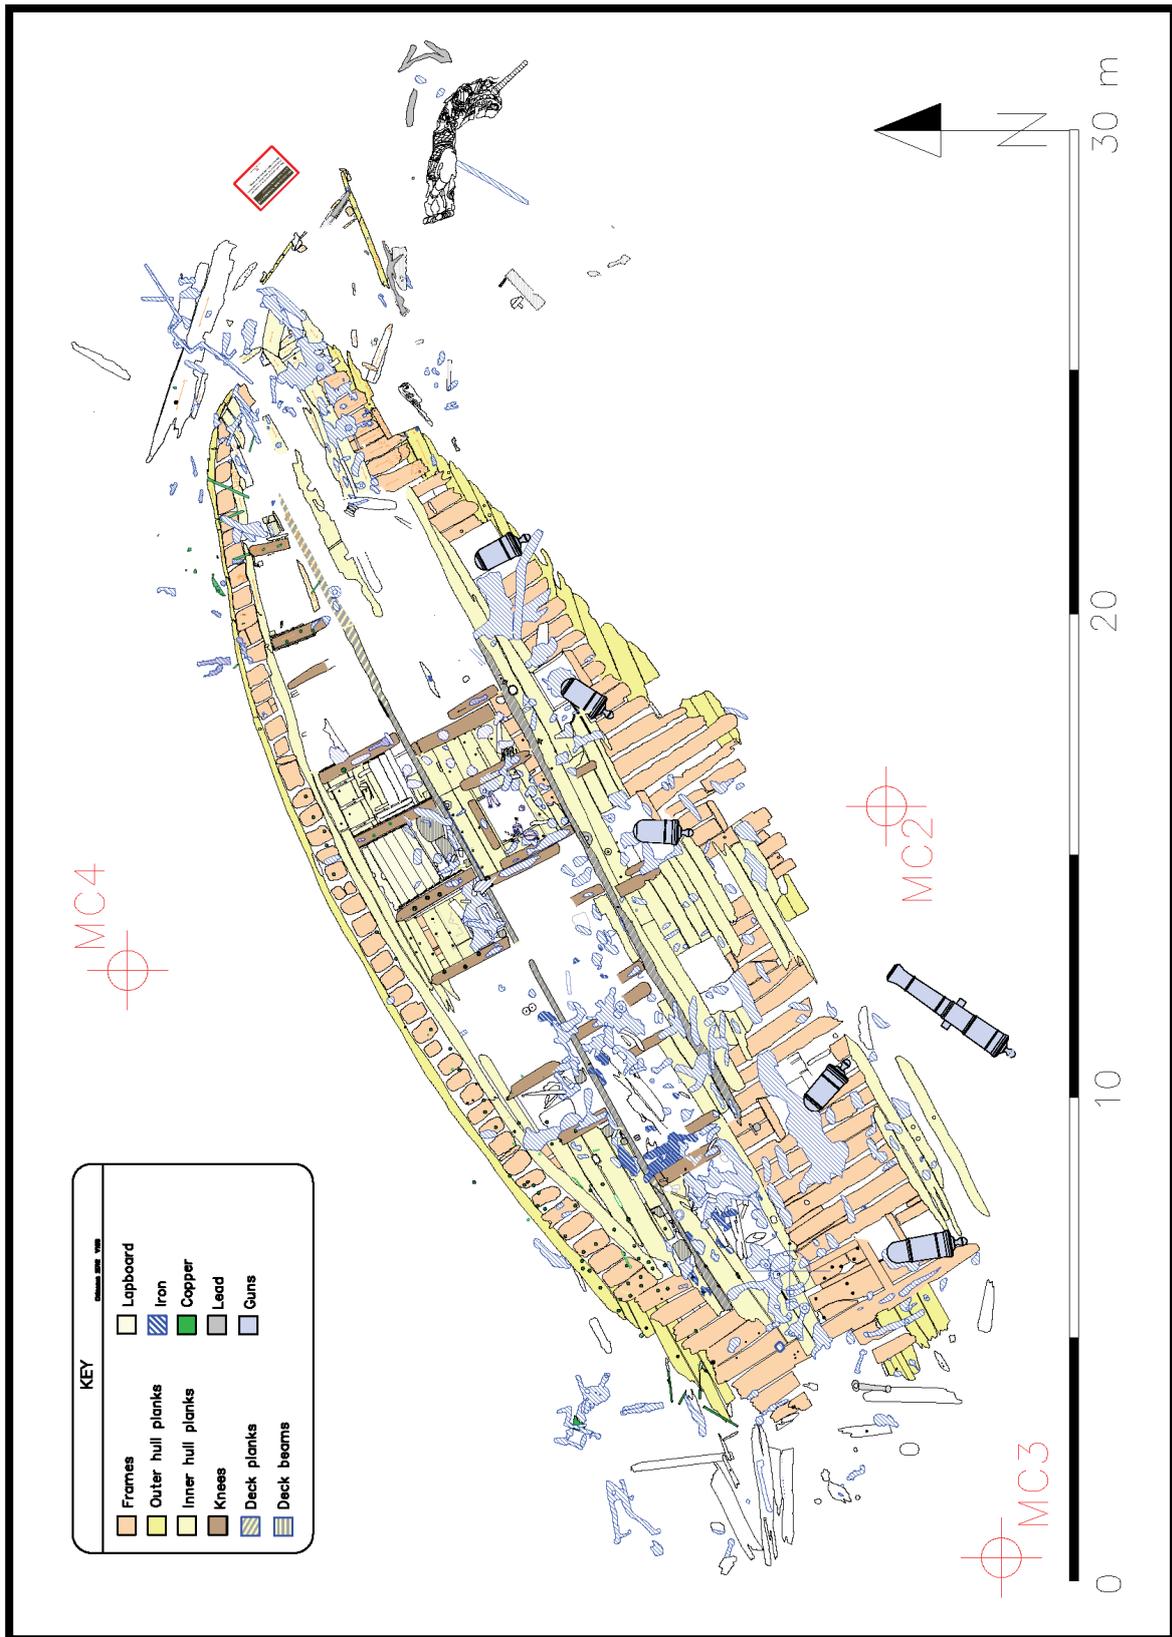
Figure 3.14: The *Colossus* site plan. The stern end at the NE end (Courtesy of K.Camidge and CISMAS).

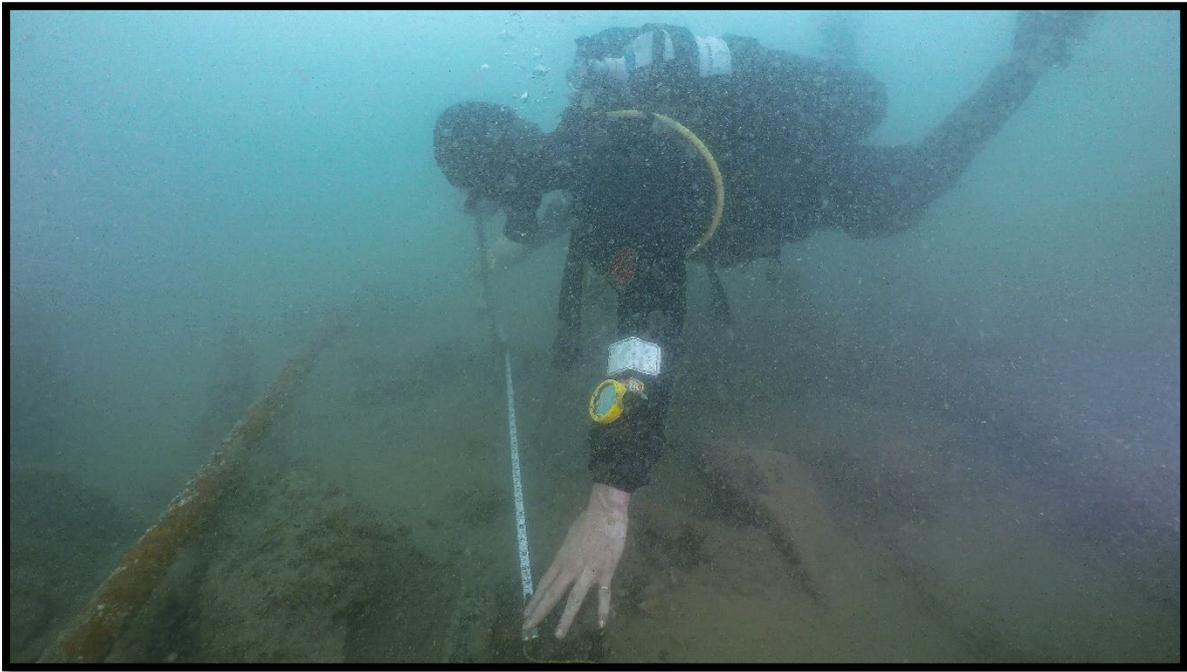
Figure 4.2: Photo showing Dr Rachel Bynoe recording the position of an artefact in relation to one of a network of datum points installed on the site (Photo by author).

The main site of *Hazardous* has a network of datum points installed. Recovered artefacts were positioned through trilateration (Figure 4.2). The whole of the main site was recorded photogrammetrically in 2017 and again in 2019. The results of the surveys have been scaled and georeferenced in ArcGIS in relation to 2014 multibeam bathymetry data. The position of large artefacts and features have therefore been given an exact position in time and space.

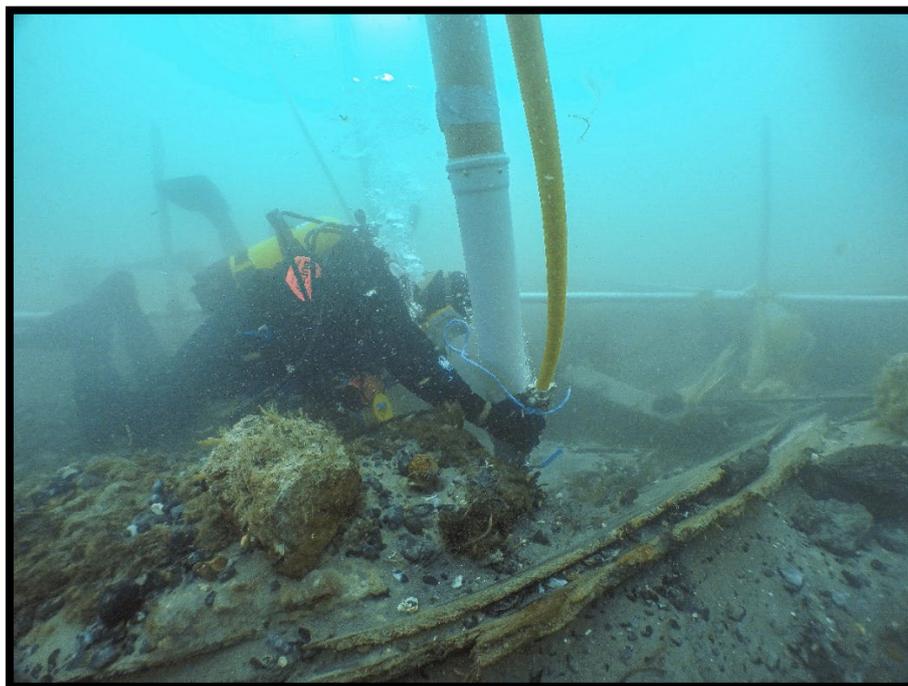
Figure 4.3: Photo showing diver excavating within the scaffold grid using a 4-inch airlift (Photo by author).

Excavation was conducted with the use of a combination of 6-inch and 4-inch airlift powered by a road compressor from the deck of the DSV. The 6-inch airlifts were primarily used to remove overburden and the 4-inch airlifts used when the archaeological layers were encountered. A network of 3 x 3 m scaffolding grids were installed over the excavation areas to enable each diver to excavate within a designated grid or section of a grid (Figure 4.3).

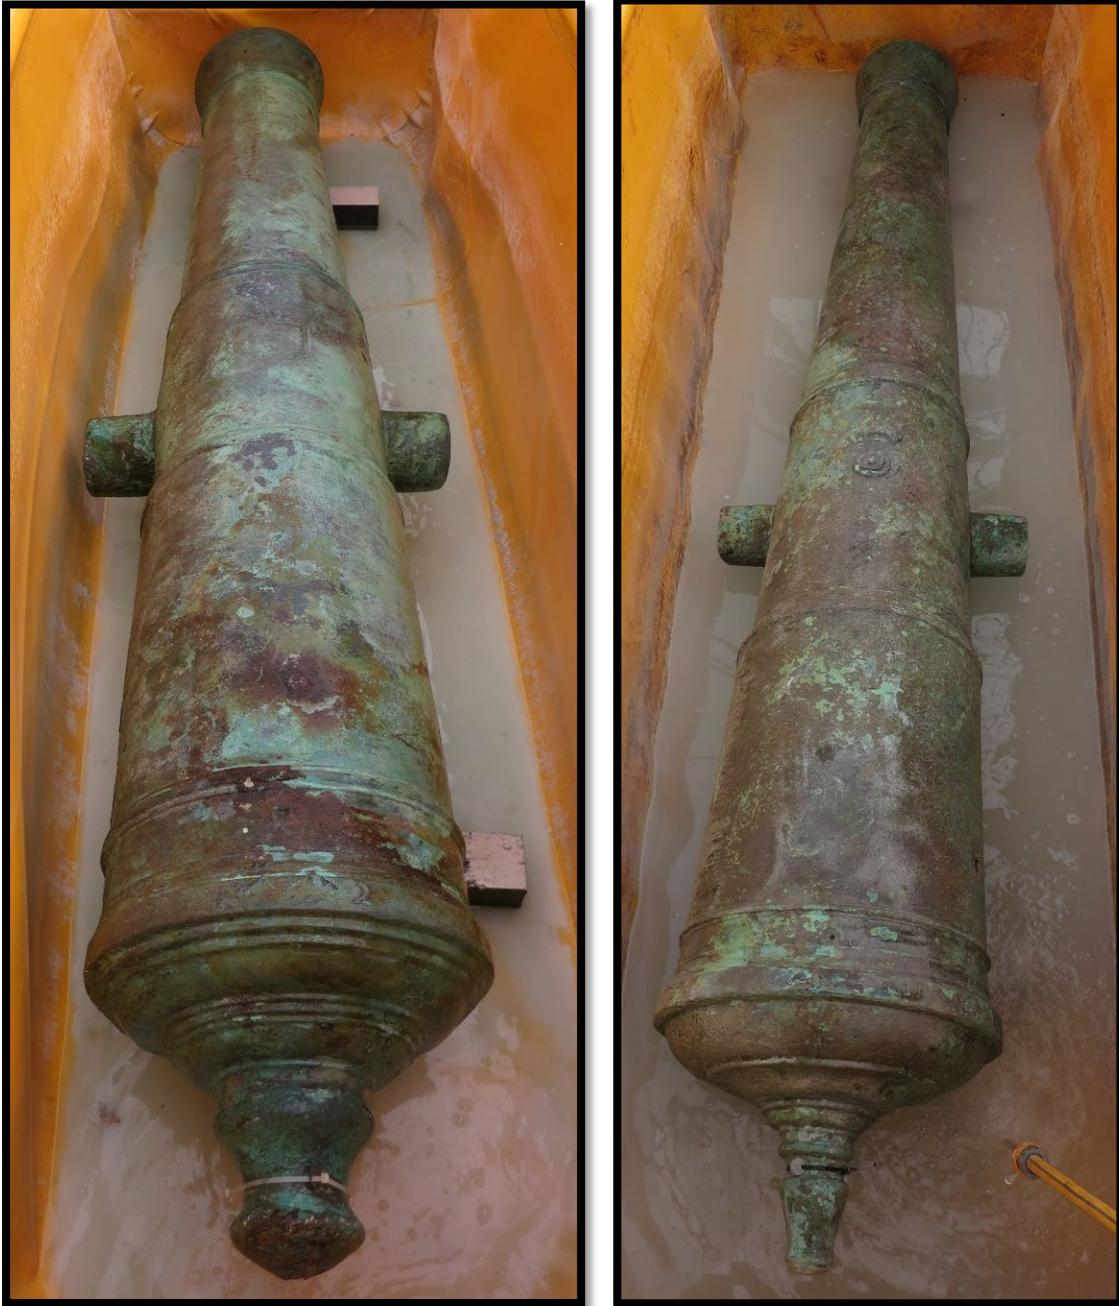
Figure 5.4: On the left the Cromwellian Demi-cannon and on the right the Tudor Culverin bored out to become a 24-pounder.

Despite this wealth of evidence, however, the gun was missing, having been one of five guns illegally salvaged from the site in 2007. Subsequent research by the author has identified the likely candidate as a Dutch 24-pounder cast in 1600 by Conraet Antonis, one of eight issued to the *London* in 1664 (Pascoe 2017a, p. 44). The other guns included a Commonwealth demi-cannon, cast by George Brown in 1656, a Tudor culverin cast by Peter Gill in 1595 and re-bored as a 24-pounder; and two other Dutch 24-pounder cast in 1616 and 1617 respectively by Gerard Koster (Fox 2011, Pascoe 2017a, pp. 43–45). These were all guns from the *London's* main gundeck demonstrating that there was no strict issue of a homogeneous battery on each deck (Figure 5.3 and 5.4).

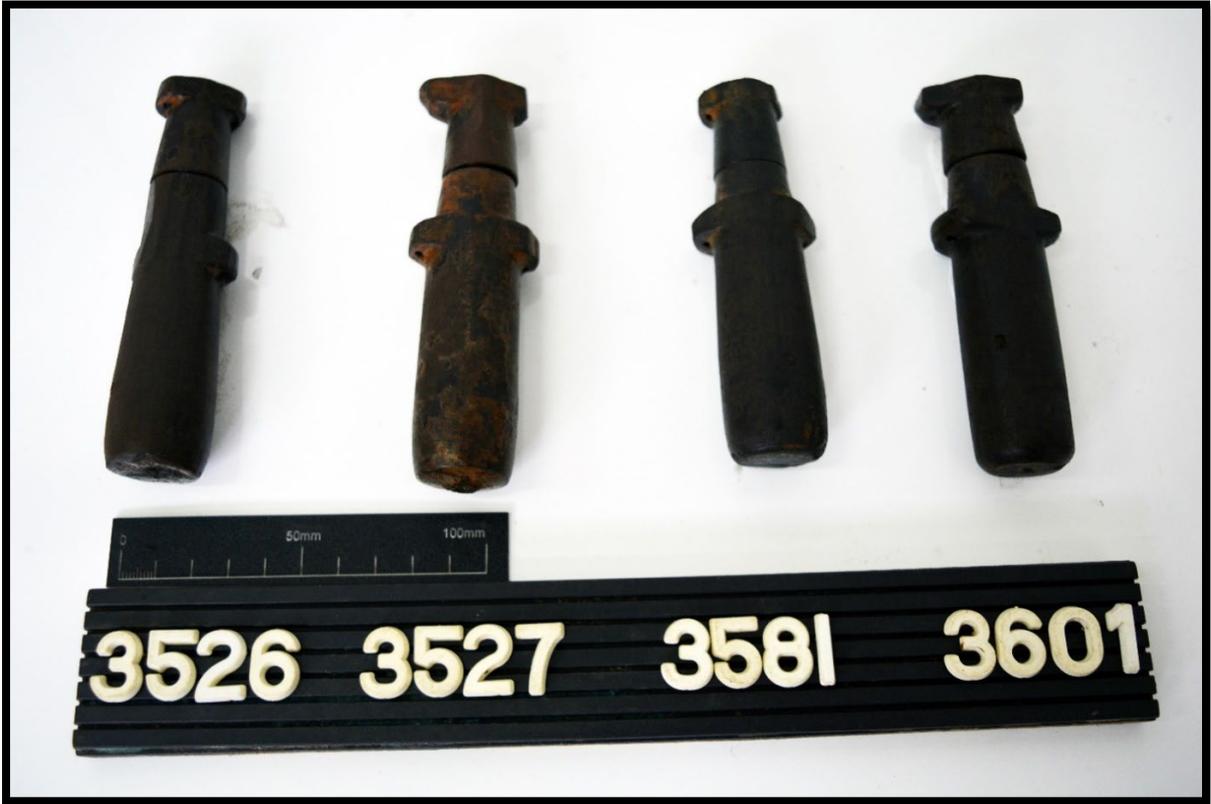
Figure 5.5: A selection of the powder boxes (Photo by author).

As well as the carriage with its associated gun tackle, many different types of gun accessories and equipment were recovered, too many in fact for the use of one gun. There was also a broken chest containing leather bandoliers with powder boxes, containing single charges of powder and priming flasks, with a spout instead of a lid. A total of approximately 90 powder boxes were recovered with many more left within the chest and reburied (Cotswold Archaeology 2016, p. 31). The bandoliers would have been worn across the chest of the ship's musketeers and powder boxes used to load their muskets or pistols with powder (Figures 5.5 and 5.6). The location of all this equipment and munitions at a single gun station was not the normal arrangement on board a warship and an explanation for their presence here will be discussed in section 5.5.

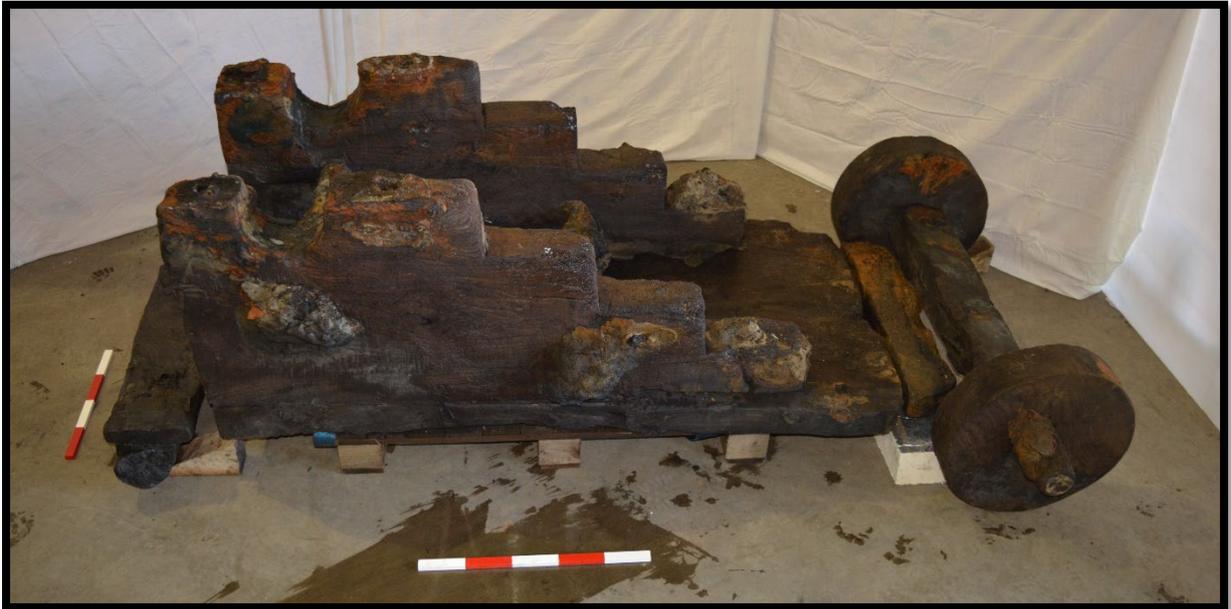
The carriage is commonly known as a truck carriage (Smith 2001, p. 27, McElvogue 2008). It consists of two stepped trunnion support cheeks, each constructed from a single piece of timber with chamfered edges (Figure 5.8). The depth of the chamfers are greater on the horizontal edges along the top of the steps than the vertical edges. They are secured at the rear by means of iron bolts that secure the rear axle to the carriage and at the centre by a single tenon set into mortises cut into the lower edge of the cheek and upper face of the bed and secured in place by two wooden dowels. The cheeks are also secured to each other transversely by two iron through-bolts (Figure 5.10). The cheeks have four steps, used as leverage points for hand crow leavers and crow bars, to elevate or depress the breech of the gun (Figure 5.8). At the front end of the cheeks are deep trunnion recesses and either side of the recess are rectangular bolt holes, which identify where the iron cap squares were attached (Figures 5.8, 5.12 and 5.14). The cap squares were missing, lost when the gun was salvaged, but they would have been hinged at the rear and folded over to secure the trunnions to the

carriage. The partial remains of the iron pins survive in the front holes. They would have protruded above the top of the cheek and had a hole for locating a linchpin that would have secured the cap square in place (Smith 2001, p. 28).

Figure 5.8: Photo of the carriage pre-conservation (Photo by author).

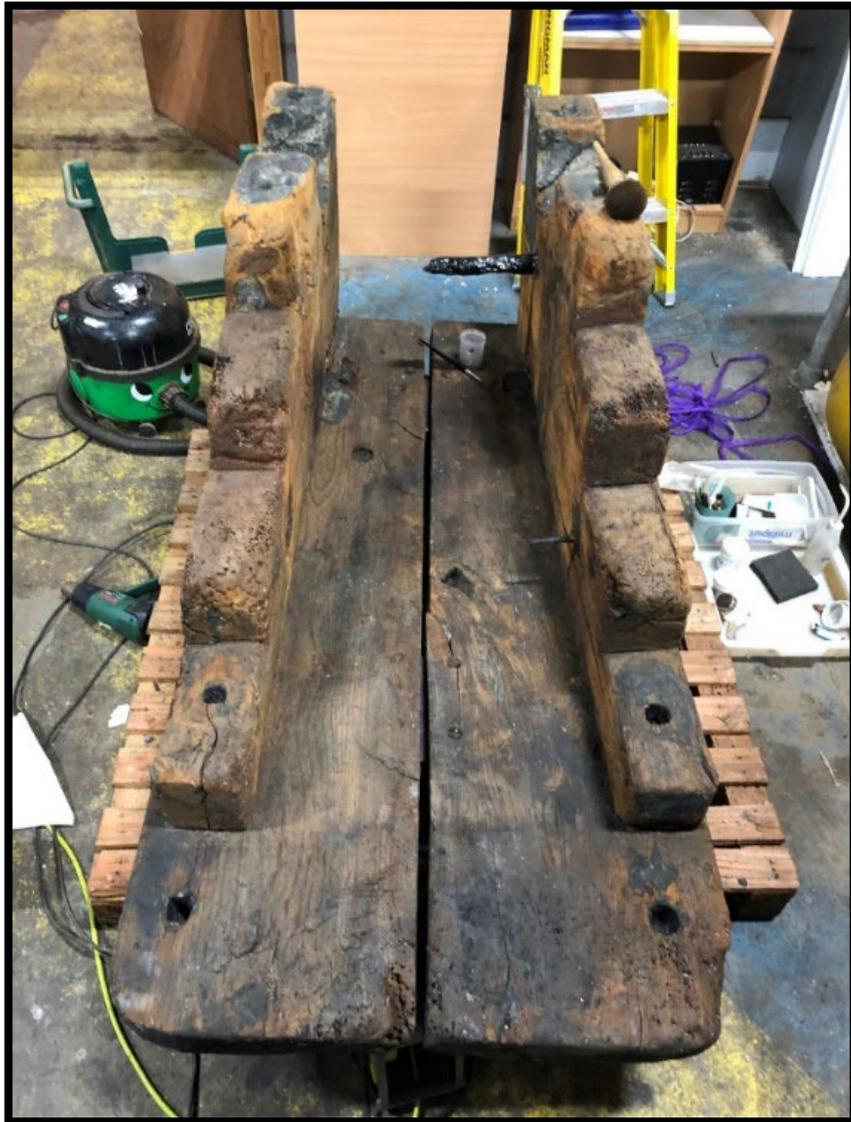
The bed of the carriage consisted of two planks secured together down their length by two tenon and mortise joins, similar to the cheek arrangement (Figure 5.9). The bed has shallow chamfered edges and is wider at the rear, the cheeks follow the taper of the bed. The rear corners of the bed are rounded, whereas the front are square cut.

Figure 5.9: Photo showing the bed made of two planks, taken post-conservation (Photo by author).

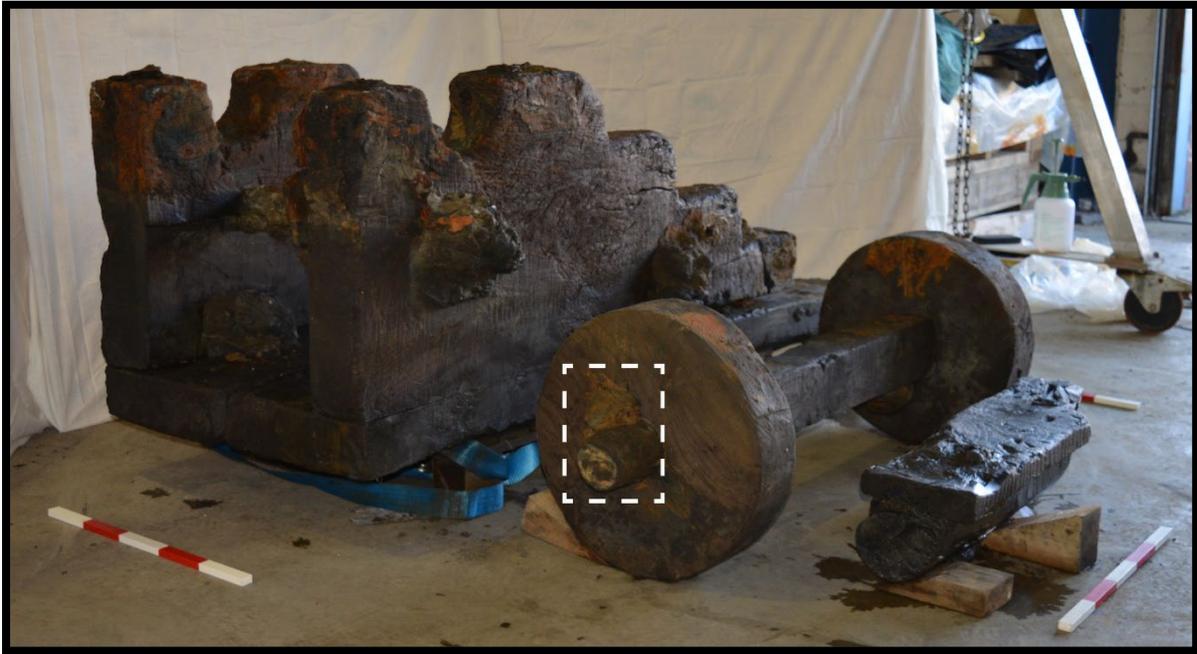
The ends of the front and rear axles are rounded to accommodate the trucks. The trucks were secured in place by iron pegs that passed through holes drilled into the protruding ends of the axles (Figure 5.12). The front trucks are significantly larger than the rear trucks.

Figure 5.12: The rear axle at the centre of the photo showing the concreted remains of an iron pin to secure the truck (Photo by author).

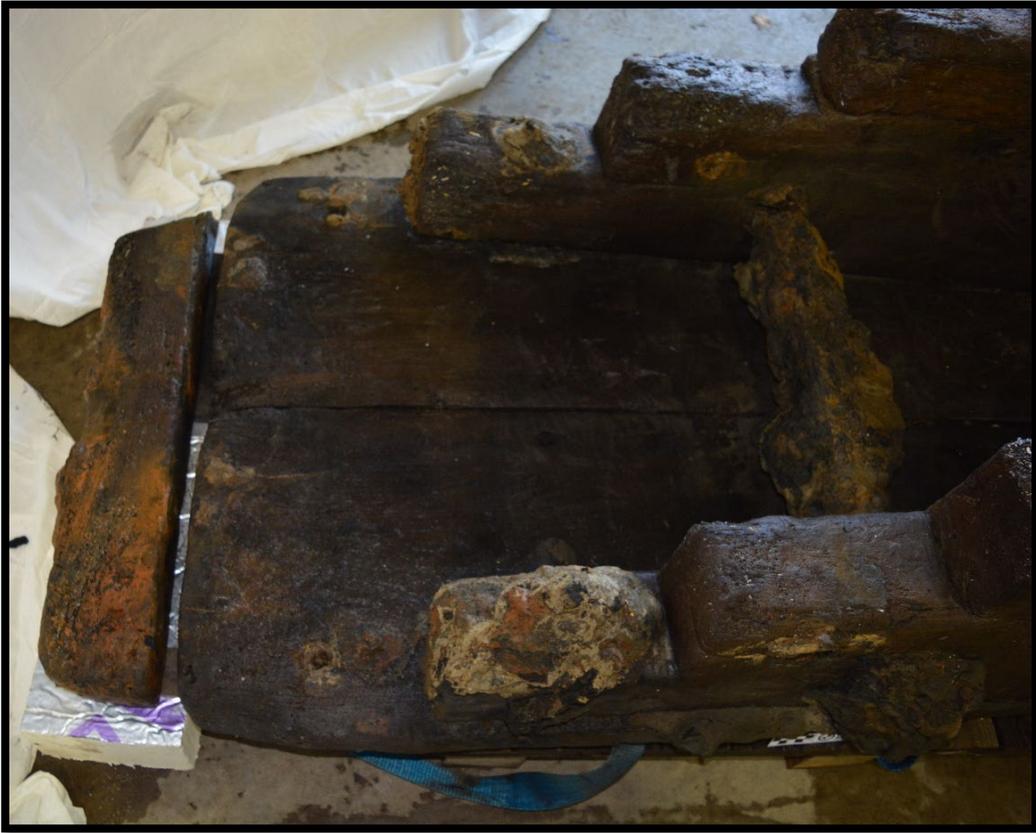
Figure 5.13: Photo showing timber extension at rear of the carriage.

These features are common with other carriages found in terrestrial collections, such as the Windsor Castle carriage and shipwrecks, such as the *Stirling Castle* and Duart Point wreck examples (Smith 2001, McElvogue 2008, Martin 2017). Indeed the fragments of a cheek attached to a gun from the Elizabethan wreck off Alderney is almost identical in form to that of the *London*, demonstrating that this design of carriage was introduced at least as early as the 1590s (Monaghan and Bound 2001, p. 50). However, there are features present on the *London* carriage that indicate modification, making it unique and customised to support a specific gun – not that which it was made for. These alterations include a timber extension piece fastened to the rear of the bed (Figure 5.13), two thin planks of wood attached to the inside of the cheeks and around the trunnion recesses (Figure 5.14), and a timber plank added to the top surface of the front axle (Figure 5.15).

They were therefore used as a packing device to stop the trunnions from jumping around when the gun was fired. The alterations recorded on the *London* carriage identify that it was adapted to support a longer and narrower gun. Of the five main gundeck guns recovered from the site the most likely candidate for the gun was the Dutch 24-pounder cast by Coentraet Antonis in 1600, due to its length and girth (Pascoe 2017a, p. 47) (Figures 5.3 and 5.17). The addition of the plank of wood between the front axle and the bottom of the bed was to raise the position of the gun so it was positioned in relation to the centre of the gunport. There was no evidence of the stool bed or coin, but these could have easily become dislodged during the wrecking event and floated away.

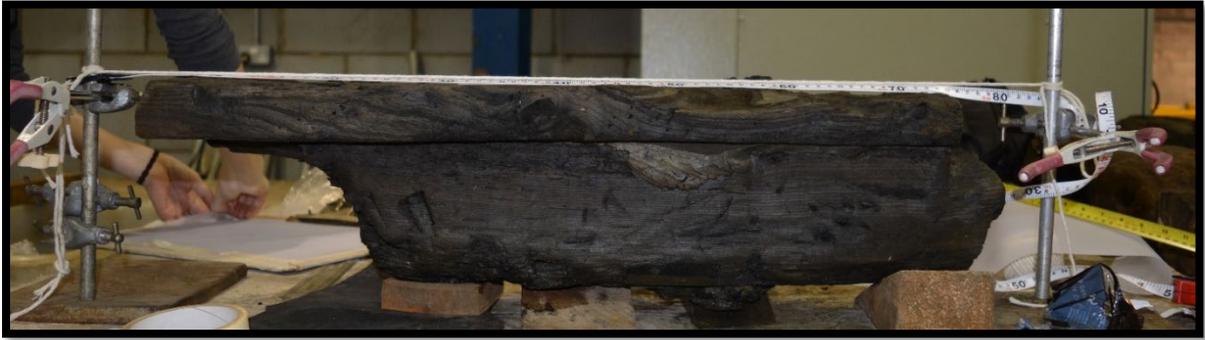
Figure 5.15: Photo showing timber plank above the remains of the front axle.

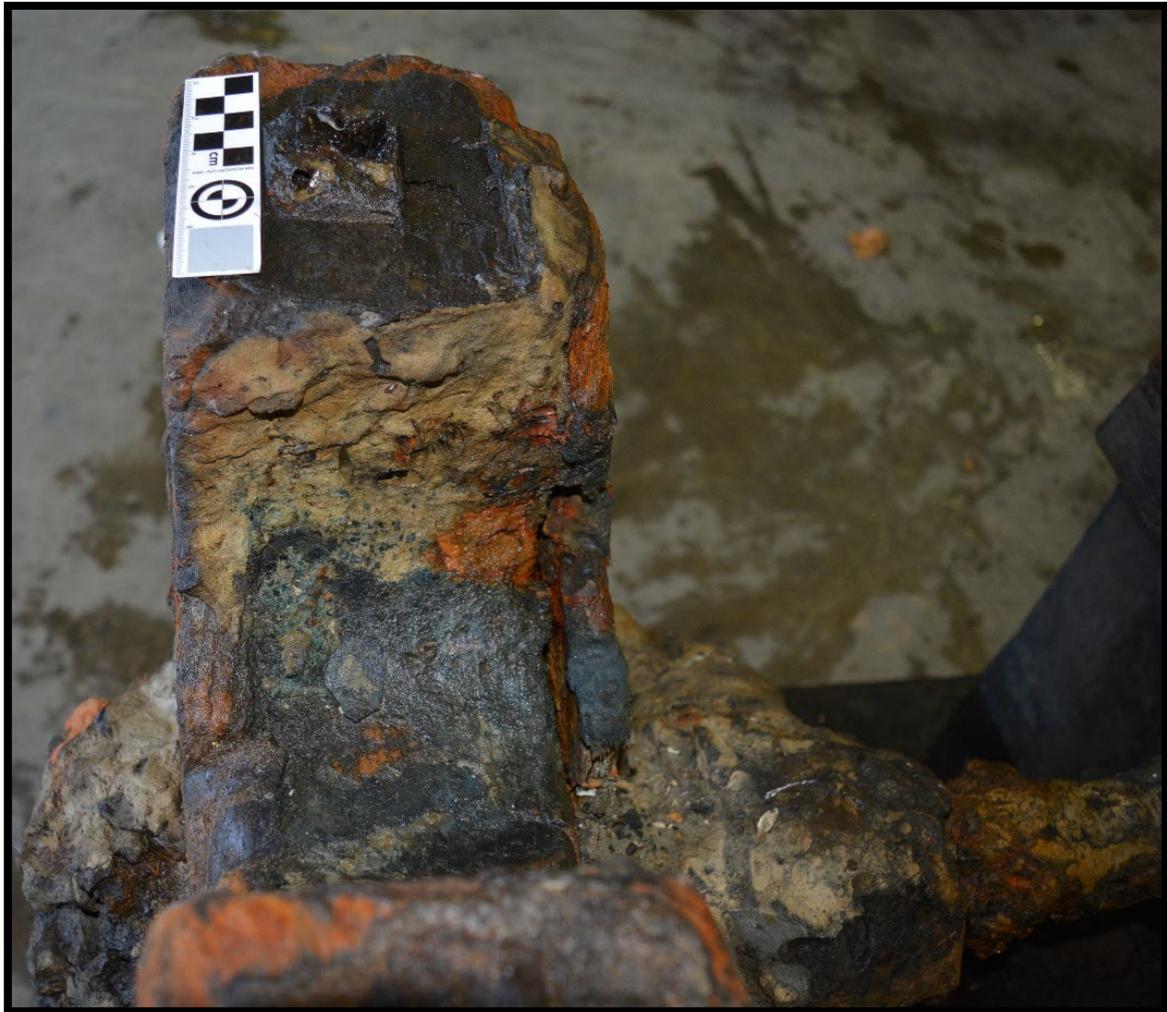
Figure 5.16: Photo showing possible residue on the inside of the trunnion recess.

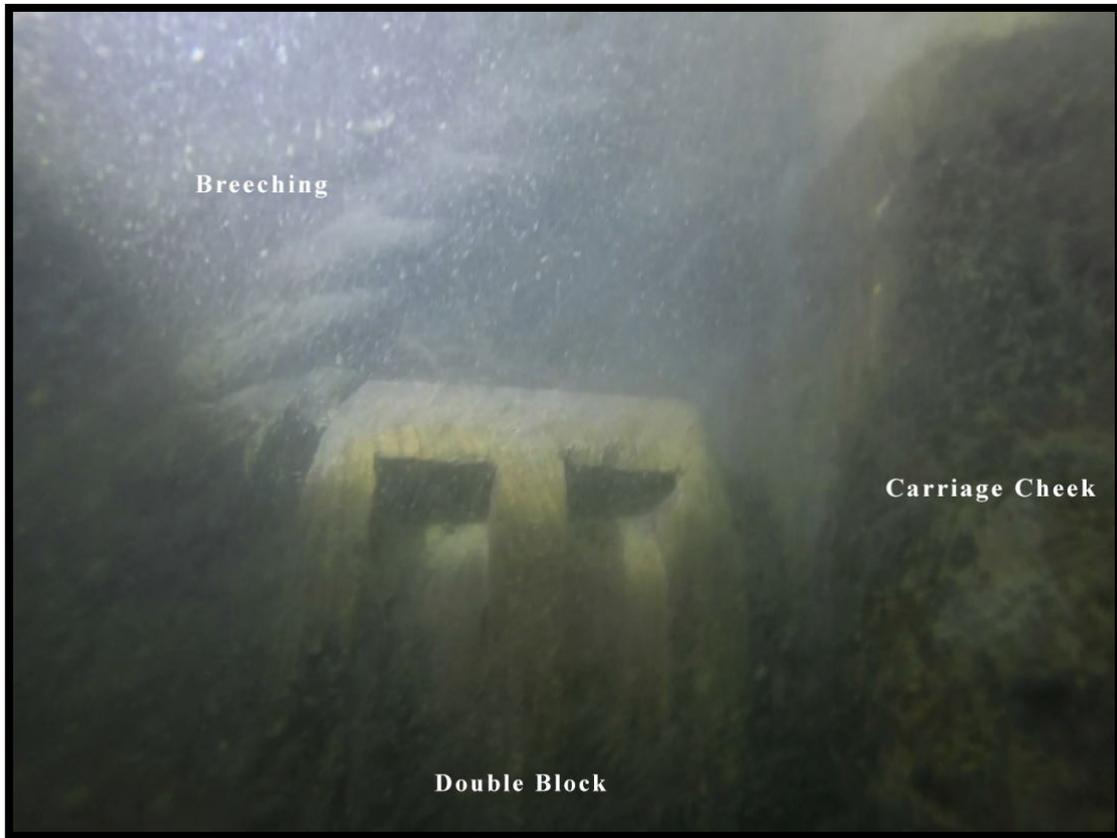
Figure 5.20: A still image taken from GoPro footage showing breaching rope and double block outside the cheek of the carriage.

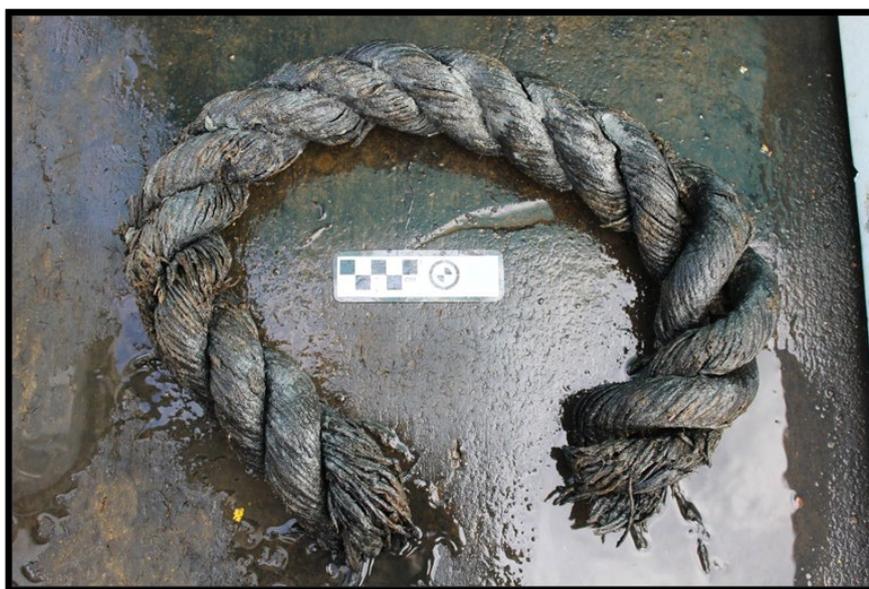
rope (in a Z-twist) with a circumference ranging from 184 – 203mm (7 ¼ - 8 inches) (Figure 5.21). The range in size is probably due to the rope losing its original tightness and form when fragmented.

Figure 5.21: Photo of a section of breaching rope recovered from Trench 3.

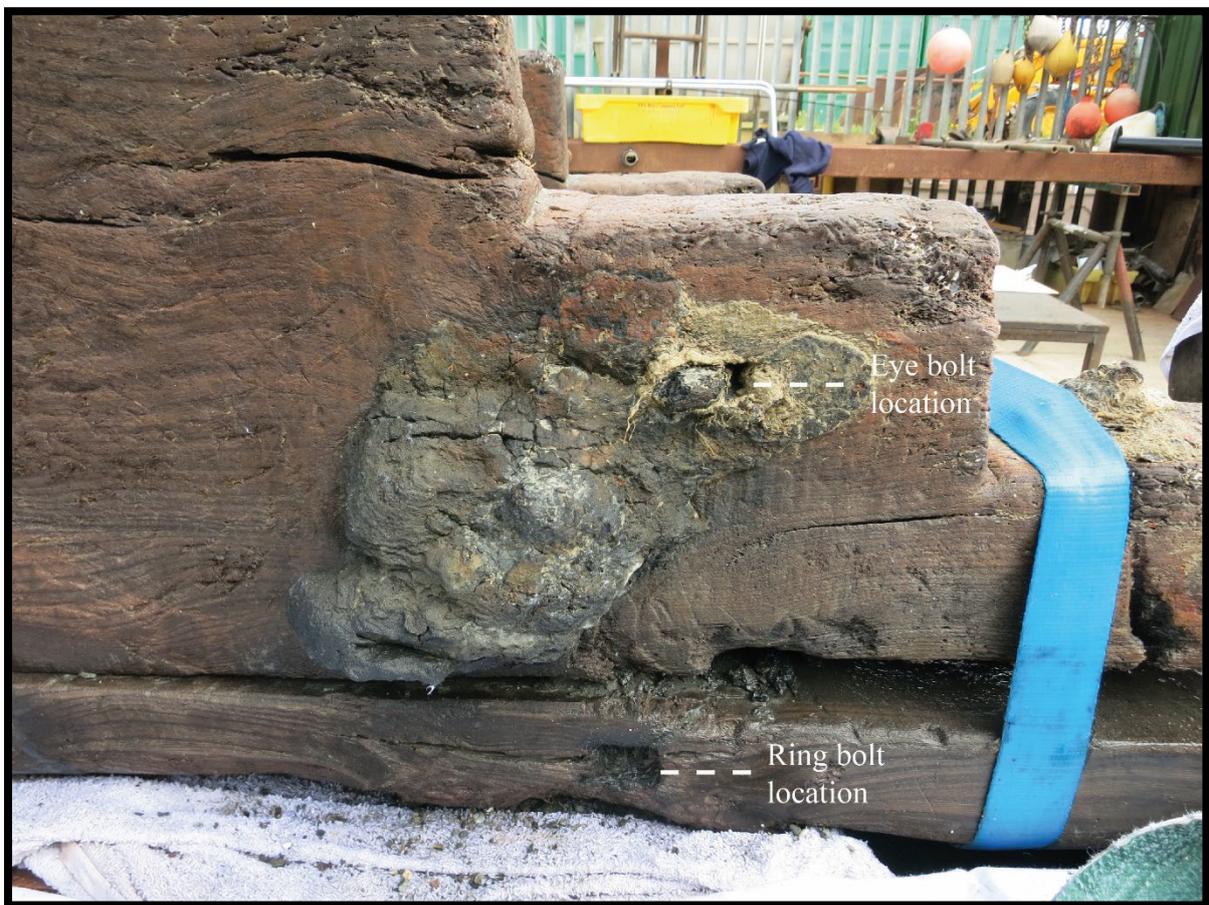
Figure 5.22: Photo showing fixing holes for eye and ring bolts. The breeching rope went through the ring bolt and the gun tackle hooked into the eye bolt (Photo by author).

Following the recovery of the carriage further excavation revealed a single concreted ring bolt on the right side of the gunport, just below the level of the sill (Figures 5.7 and 5.23). Although the left side of the gunport was not excavated to the same extent as the right, it is likely that at least one ring bolt would have been in a similar position. To secure the gun the breeching rope would have been tied onto the ring bolts on the side of the hull, passed through ringbolts on the sides of the carriage and then extended around the breech end of the gun. The ring bolts did not survive attached to the carriage, but the fastening holes for the ring bolts are visible on the side of the bed between the axles (Figure 5.22) and is present on the Windsor Castle carriage (Figure 5.18).

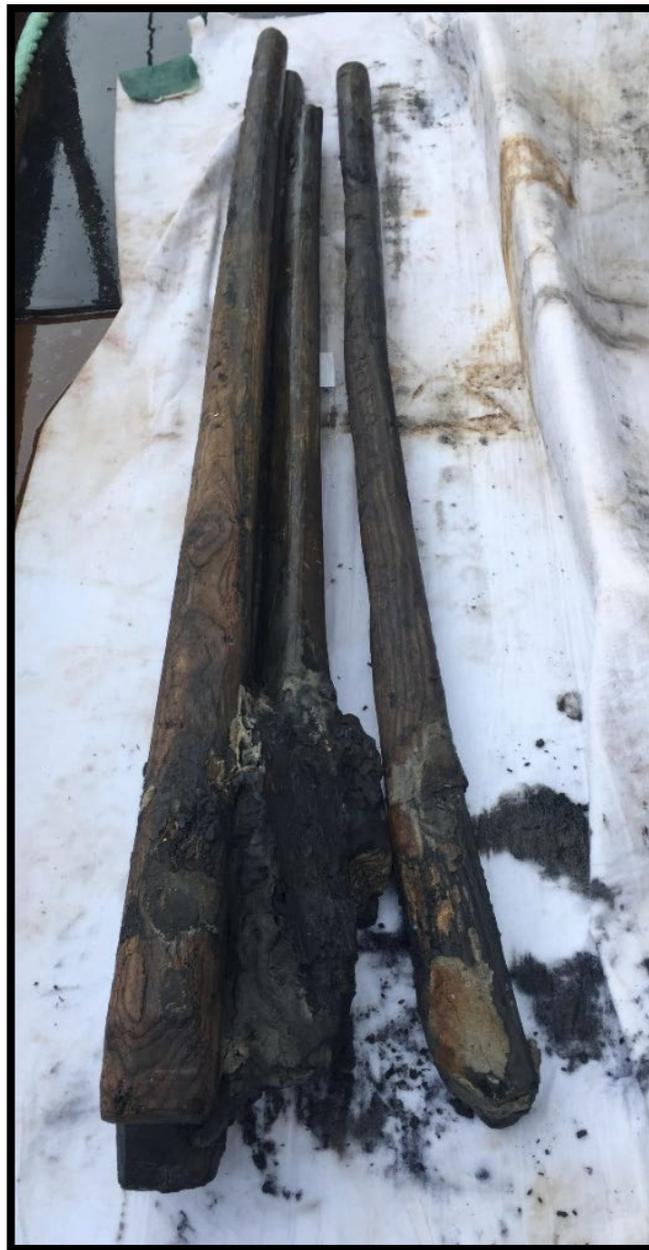
Figure 5.27: Photo showing a group of hand crow leavers concreted together by their iron shoes (Photo by author).

The excavation of Trench 3 recovered fragments relating to at least 20 individual hand crow leavers with four of those complete (Figure 5.27). Several others were left in-situ and re-buried (Figure 5.28). They were found grouped together on either side of the carriage, are all the same shape and design and also have the remains of an iron shoe at the head/lower end. The complete examples were roughly five feet in length and made of a single piece of ash (Hazell and Aitkin 2019, p. 6). Ash is a timber particularly resistant to stress (Gale and Cutler 2000, p. 120) and therefore ideal for dealing with the forces and stresses involved in manoeuvring heavy objects such as the guns.
