**Archaeological evidence for the development of Royal Naval
gunnery from 1545 – 1811; analysing change through technology
and culture**

By
Daniel Pascoe

Dissertation submitted in partial fulfilment of the requirements for the degree ‘Doctor of
Philosophy’, awarded by Bournemouth University

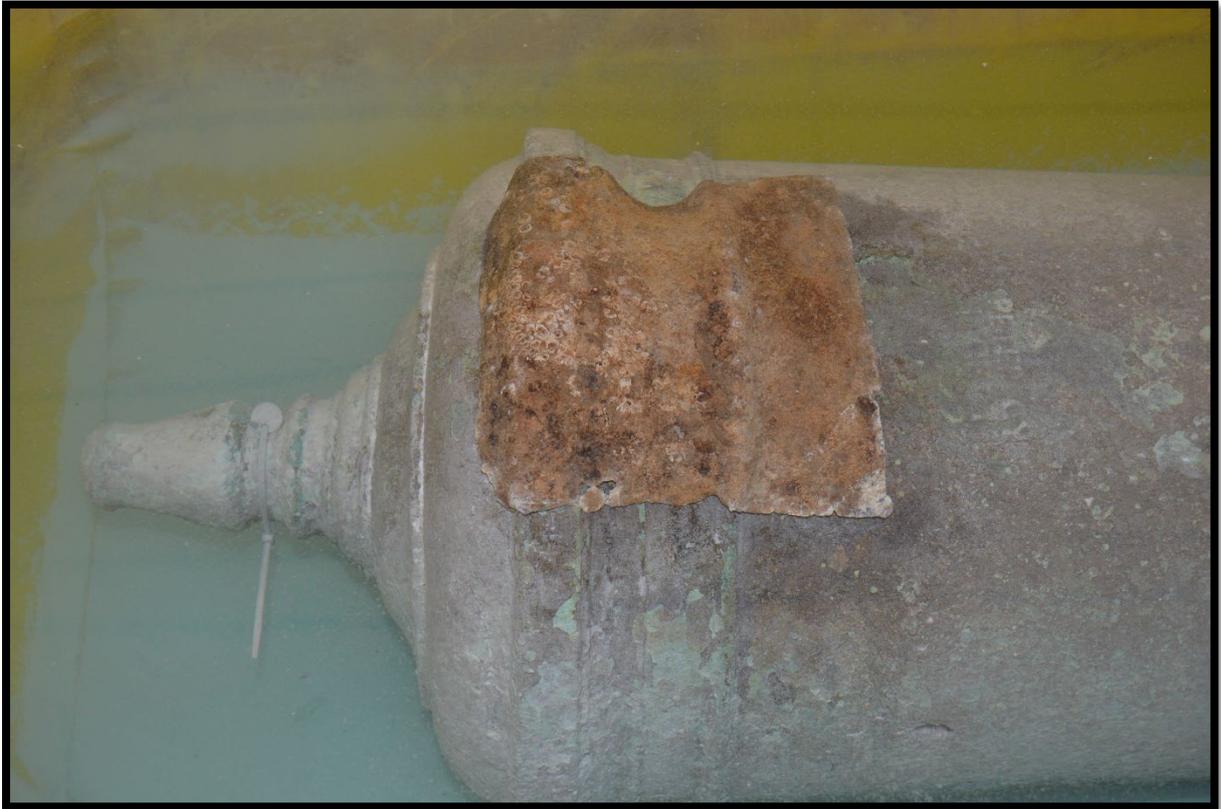
Figure 5.30: Apron 3326 in position over the vent hole of the Tudor 24-pounder (Photo by author).

size of the guns. Table 5.2 shows the dimensions of the recovered apron and the potential gun type they fitted. The author took the aprons to the Royal Armouries at Fort Nelson where three guns from Site 2 are being conserved and where the demi-culverin recovered in 1961 is on display. The shape and indentations of apron **3326** was a good match for the mouldings found on the Tudor Gun cast by Peter Gill in 1595, which was bored from a culverin to the size of a 24-pounder (Figure 5.30). This demonstrated that the apron was a size suitable for at least culverin and 24-pounders. None of the other aprons matched the mouldings of the other guns but apron **3323** was a good size match for the demi-culverin (5.31).

Apron Artefact Number	Length (mm)	Width (mm)	Gun type
3323	145	210	demi-culverin Or smaller
3326	235	260	24-pounder (mouldings match the Peter Gill 24-pounder, which was originally a culverin)
3341	254	237	culverin and above
3350	250	280	demi-cannon

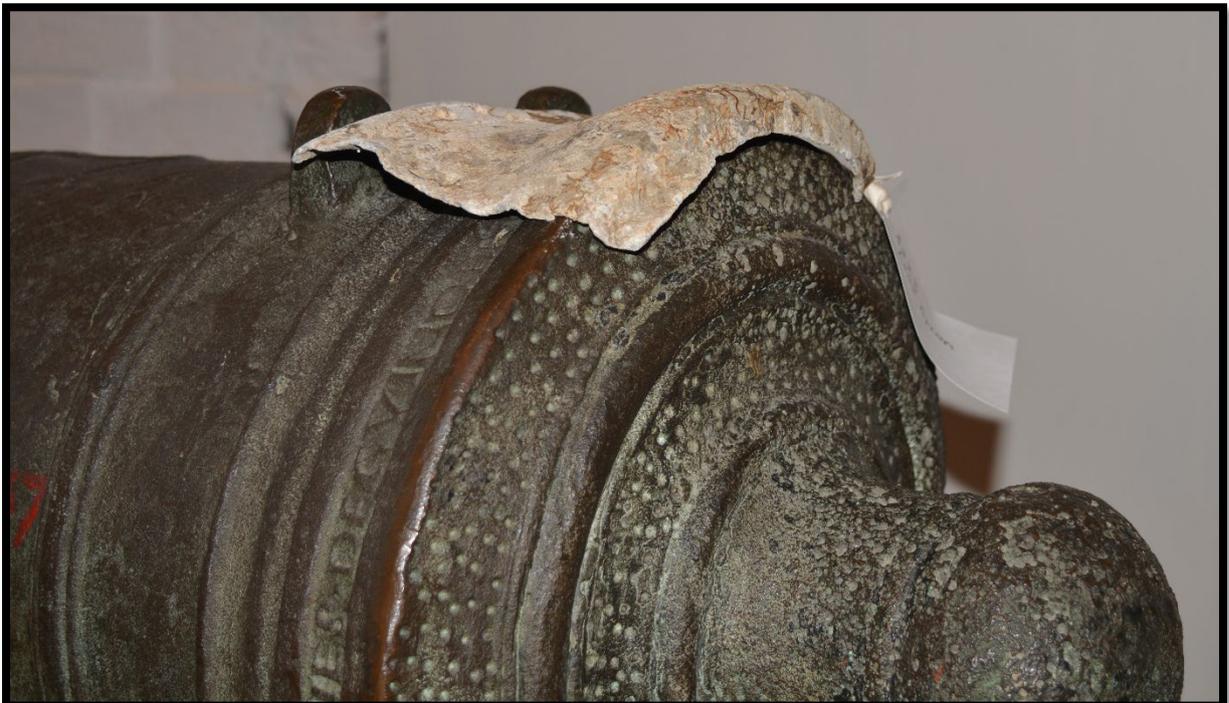
Figure 5.31: Apron 3323 with demi-culverin recovered from the *London* (Photo by author).

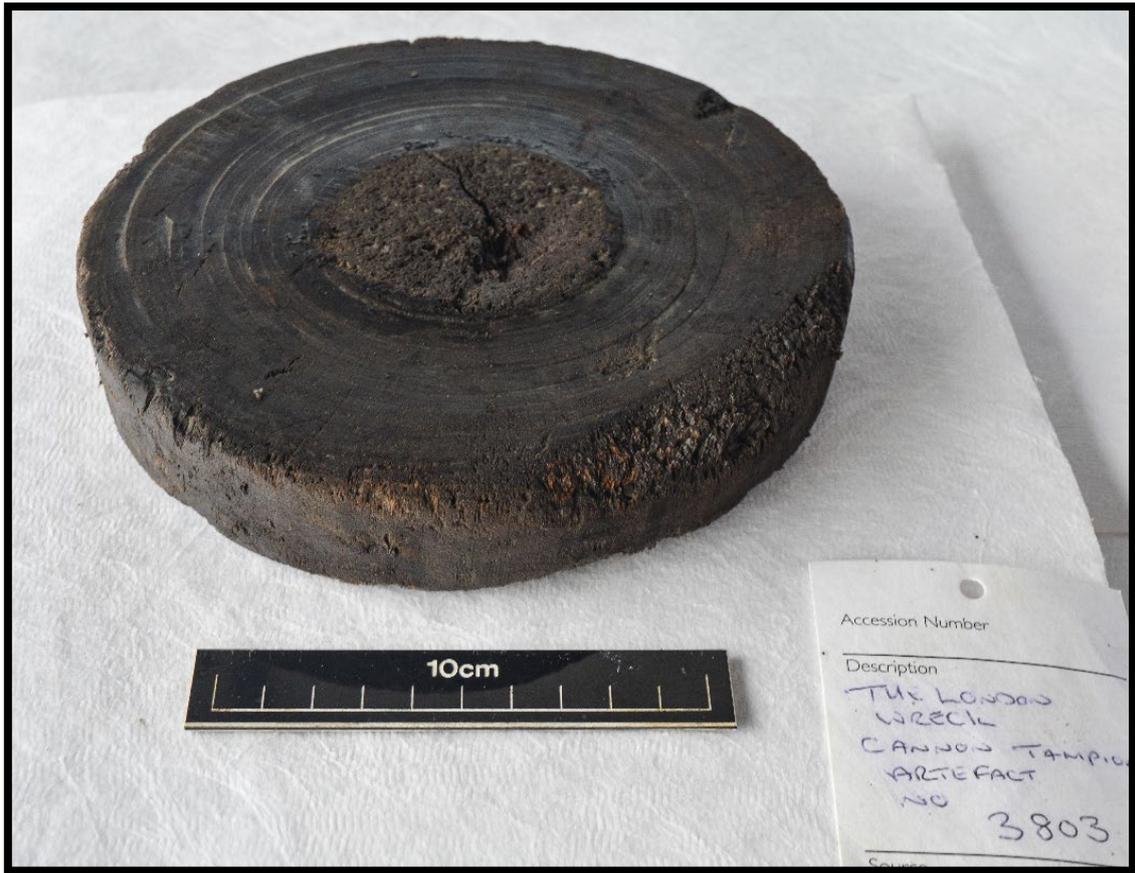
Figure 5.32: Tampion 3803, note the centre core which joined it to the other tampions in the reel (Photo by author).

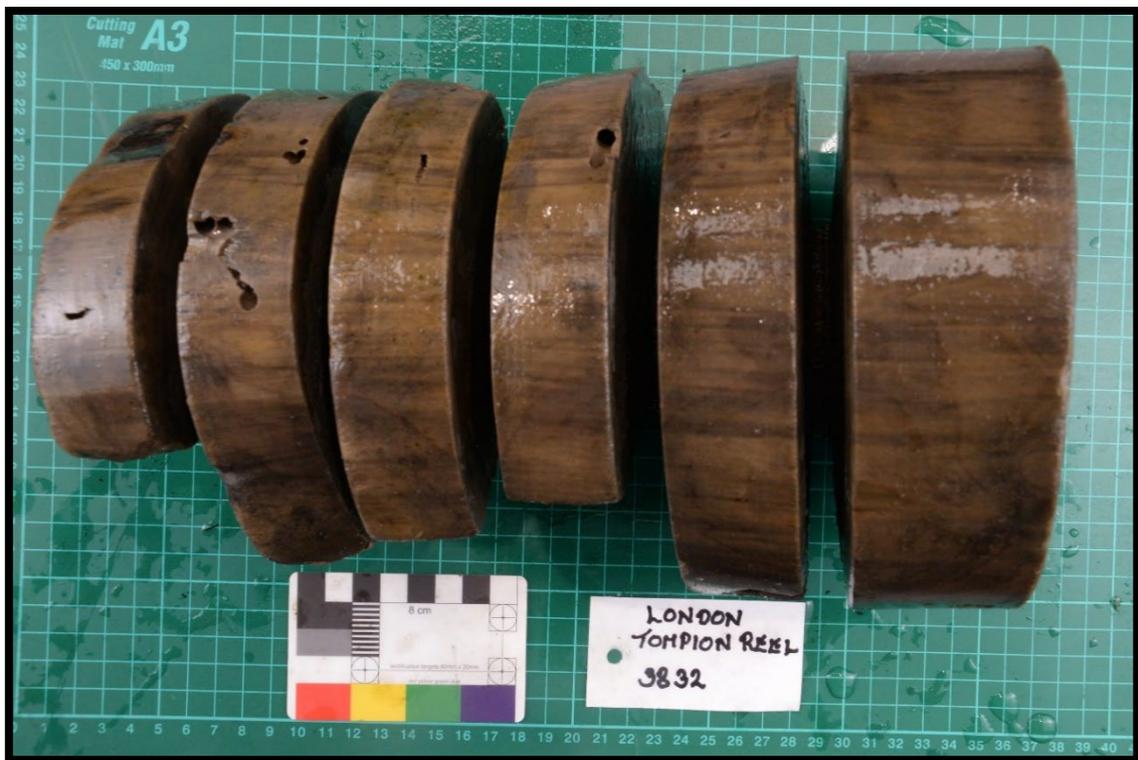
Figure 5.33: A reel of tampions (Photo by author).

In the Chatham ledger they are referred to as tampeons and the *London* was issued with 100 (TNA WO55/1667). In the case of the *London* they have been found individually (Figure 5.32), either loose on the seabed, or in the case of at least one, lodged in the barrel of one of the guns recovered in 2007 (Fox 2011, p. 33), or in their spare form as a reel of six (Figure 5.33). The reel (**3832**) is turned from a single piece of timber and segmented into individual tampions by cutting grooves while on the lathe. The reel is shaped like an hourglass (Figure 5.33) and a core is left joining each segment (Figures 5.32 and 5.33). When needed the end tampion would either be broken or cut from the reel. Tampion **3803** shows evidence of torn fibres at its core suggesting it was snapped off (Figure 5.32). The tampions have a tapered profile with one face wider than the other. When placed into the muzzle of the gun the wider face was facing outwards. The diameter of the outer face of the tampion **3803** was 175mm (6.8 in) and the inner face was 170mm (6.7in). Although on the large size this tampion would be appropriate for the demi-cannon, but one that may have had a degree of wear at the entrance to the muzzle. This would not be surprising considering the age of several of the guns recovered from the site. The maximum diameter of the outer face of the tampions from the reel (**3832**) was 160mm (6.3 inches) and the inner face was 155mm (6.1in). This suggests these tampions were designed for the *London's* demi-cannon. Five of the tampions on reel **3832** are a similar thickness ranging from 32-28mm but the tampion at one end is considerably thicker at 52mm.

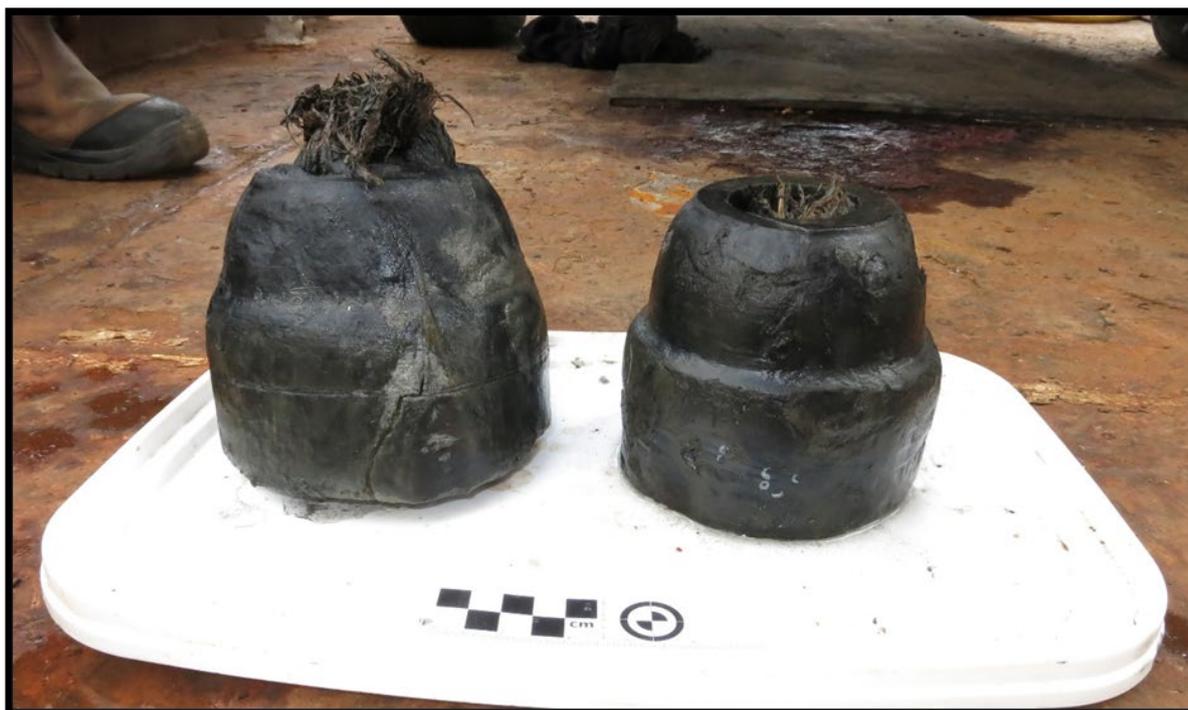
Figure 5.34: Photo of rammer heads **3206** (left of photo) and **3207** (right of photo) (Photo by author).

The heads of both rammers are turned from a single piece of timber into a conical cylinder, tapering from a maximum diameter at the face to form a neck into which the rope was threaded and secured by iron nails. Although they are similar in form, they do have several differences in their construction. Rammer head **3206** was made of poplar or willow (Hazell and Aitkin 2019, p. 33) and has an external diameter at the face of 127mm (5 inches). This size would be appropriate for an ordinary culverin and possible a great culverin (Table 5.3). It has a rope hole with a maximum diameter of 62mm (2.4in). It was fitted with three strand hawser laid rope. X-radiography identified that the hawser had a jaw angle of 52° and that it was secured in place by two iron nails driven horizontally through to counter sunk holes at the shoulder of the neck (Figure 5.35). The counter sunk holes ensured that the heads of the iron nails could not cause a spark if coming into contact with the barrel of the gun.

From Trench 3 two rammer heads and one sponge head, along with partial remains of their rope, were recovered (Figures 5.34, 37 and 41). Two other rammer heads with rope were recovered by the site Licensee in 2018 from a location on the main gundeck within a few metres of Trench 3 (Figures 5.38-41). According to the Licensee there were other rammer heads with their ropes at the location where the later examples were recovered. The examples from the excavation will be described first followed by the later recoveries. Both rammer heads and the sponge head were recovered from the west side of the carriage along with pieces of rope still attached, other detached sections of served rope were also recovered. The analysis of the rope is critical in understanding the makeup of the rope rammers and sponges but first the heads will be described.

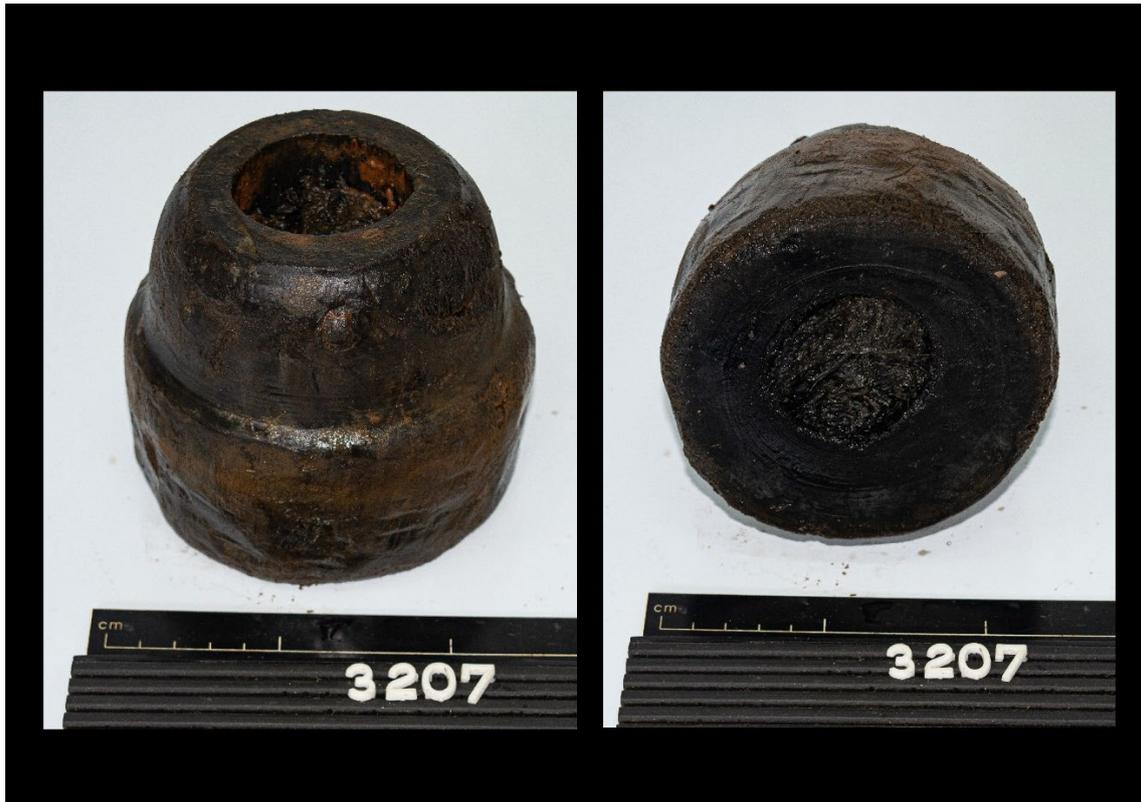
Figure 5.36: Photo showing tool marks around the outer of the rammer (Photo by author).

Rammer head **3207** was made from a solid piece of alder (Hazell and Aitkin 2019, p. 33) and has an external diameter at the pushing face of 115mm (4 ½ inches). It shows subtle evidence of retouch along the outer face at the end nearest the face, suggesting it has been modified to fit a slightly smaller bore (Figure 5.36). This size would be appropriate for an old demi-culverin and possibly a small culverin (Table 5.3). It has a rope hole with a maximum diameter of 50mm (1.9in). X-radiography has identified that it was fitted with three hawser cable laid rope with a jaw angle of 46° (Figure 5.35). This was secured in place by three opposing diagonally penetrating iron nails into counter sunk holes.

3206 and **3207** do not look particularly well used either. Again, there is little wear around the edges of the ramming faces and the cut marks are still fairly clear on the edges of rammer **3207**; this is no surprise if the guns were only fired on average twice in eight months. The combined evidence from the *London* demonstrates that there was little practice in the firing of the guns.

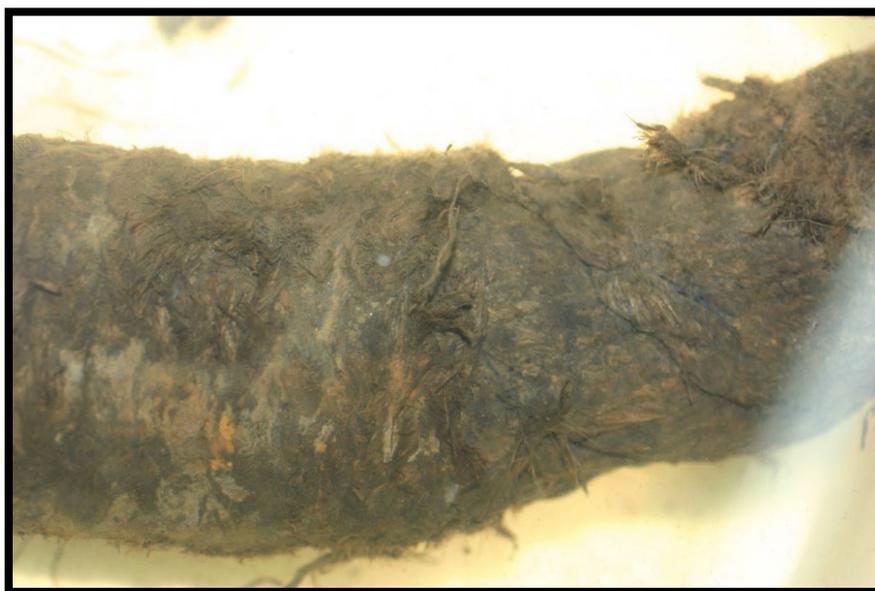
Figure 5.37: A close-up photo of rope **3209** showing the serving and worming (Photo by author).

Two sections of wormed and served, three stranded hawser were recovered from the same location as the two rammers (Figure 5.37). However, as rammer **3207** was fitted with cable laid rope, this is likely to relate to rammer **3206**, although it is not possible to identify the serving in the radiographs. The served ropes **3173**, **3208** and **3209** ranged slightly in size from 56-53mm diameters. They would have all fitted into the rope of hole of rammer **3206**.

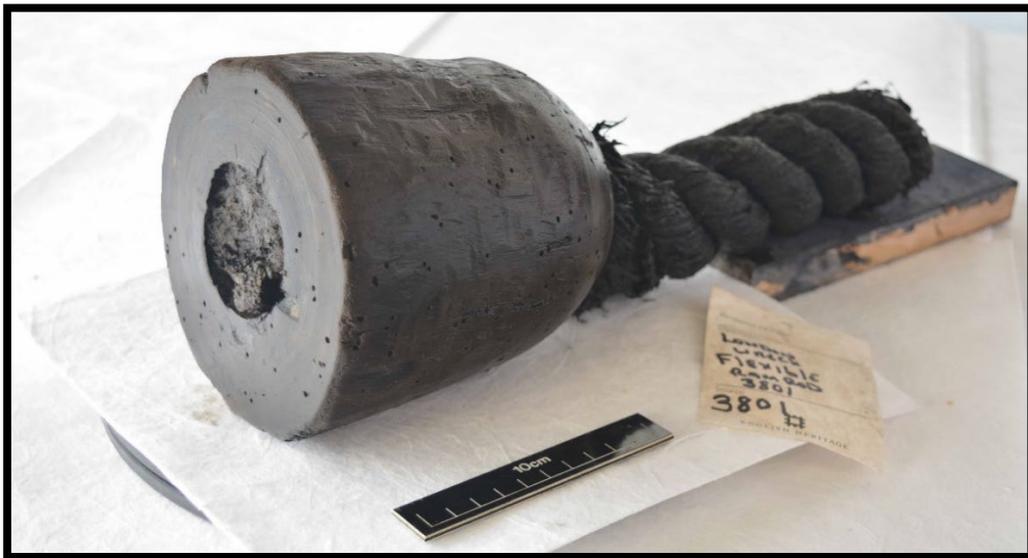
Figure 5.38: Rammer head **3801**, showing tool marks and wood worm damage (Photo by author).

circumference of the head from 40mm (1.6in) below the shoulder down to the bottom edge. The rope hole has a maximum diameter of 57mm (2.2in), which was fitted with three strand hawser laid rope with a jaw angle of 50°. This has been fastened with a single iron nail at the shoulder. In addition, a wooden wedge has been inserted at the rope hole at the pushing face between the rope and the inside of the hole. There was also evidence of terrestrial insect infestation suggesting it was either not being used frequently when on board or it had been sitting around in stores for a prolonged period of time (Figures 5.38 and 39).

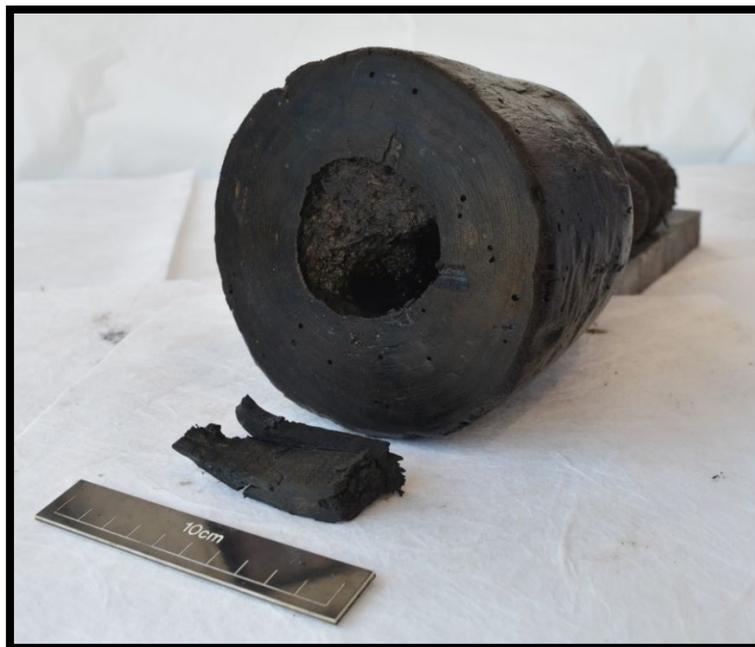
Figure 5.39: Photo showing rammer **3801** with the wooden wedge that was inserted into the rope hole at the ramming face (Photo by author).

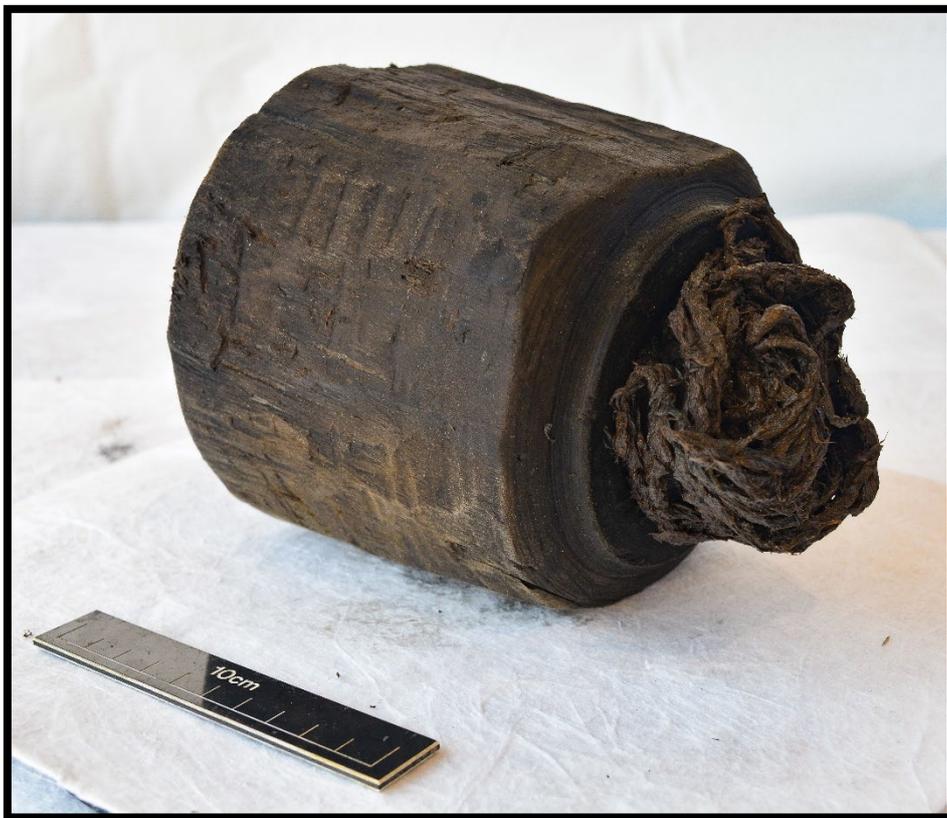
Figure 5.40: Photo of rammer head **3802** showing tool marks (Photo by author).

Rammer **3802** has a maximum external diameter across the face of 142mm (5.6 inches). It has been turned from a single piece of timber, not yet identified to species, and has been crudely reworked with a straight-edged tool from the top of the shoulder to the bottom edge to fit a smaller calibre of gun (Figure 5.40). This size would again be appropriate for a 24-pounder gun. The rope hole is tapered going from a diameter of 62mm (2.4in) at the top to 50mm (1.9in) at the bottom. It has been fitted with three stranded hawser laid rope, with a jaw angle of 50°. This was fastened with one iron nail below the shoulder. The tapering of the rope hole may be another method to help secure the rope inside the hole.

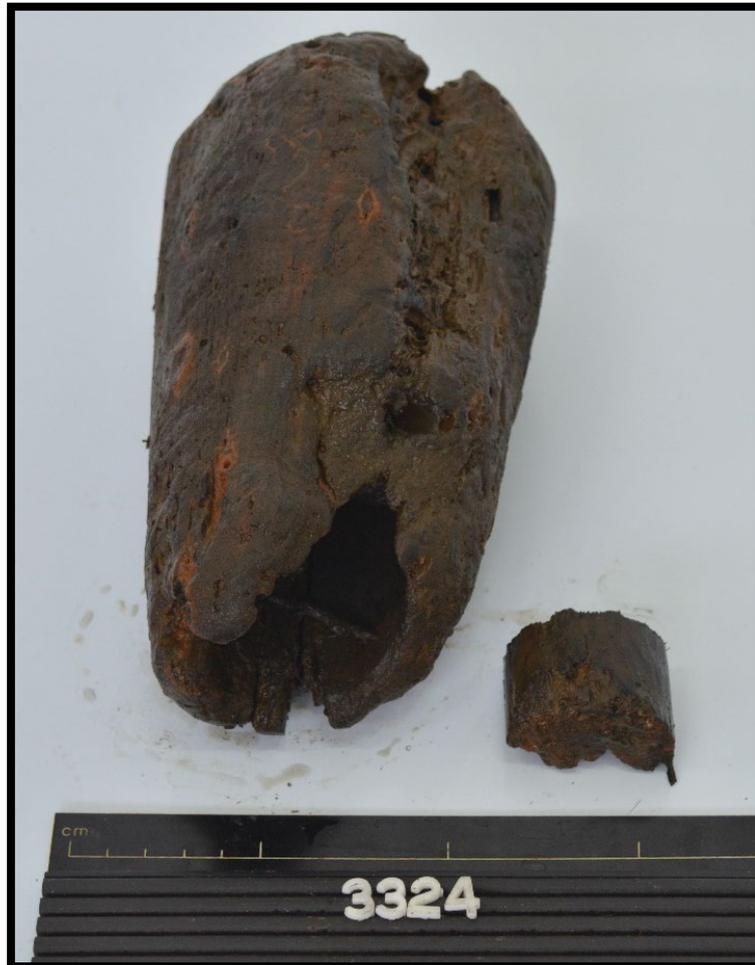
Figure 5.41: Photo of sponge head **3324**, also showing wooden plug, which was inserted into the rope hole (Photo by author).

The sponge head **3324** was located 0.5m to the west of rammer heads **3206** and **3207** at the top of the stratigraphy, which accounts for the biological damage. The sponge head would have originally fitted at the opposing end of the rammer head, but **3324** was found detached. The sponge head is made from alder (Hazell and Aitkin 2019, p. 33) and is cone shaped expanding from a diameter of 80mm (3.1in) at the face to a maximum diameter of 116mm (4 ½ inches) at the shoulder (Figure 5.41), tapering again from the shoulder to the top of the neck. It has a rope hole with a 45mm (1.7in) diameter, fitted with three stranded hawser laid rope with a jaw angle of 40° and with a wooden plug inserted at the bottom. X-radiography

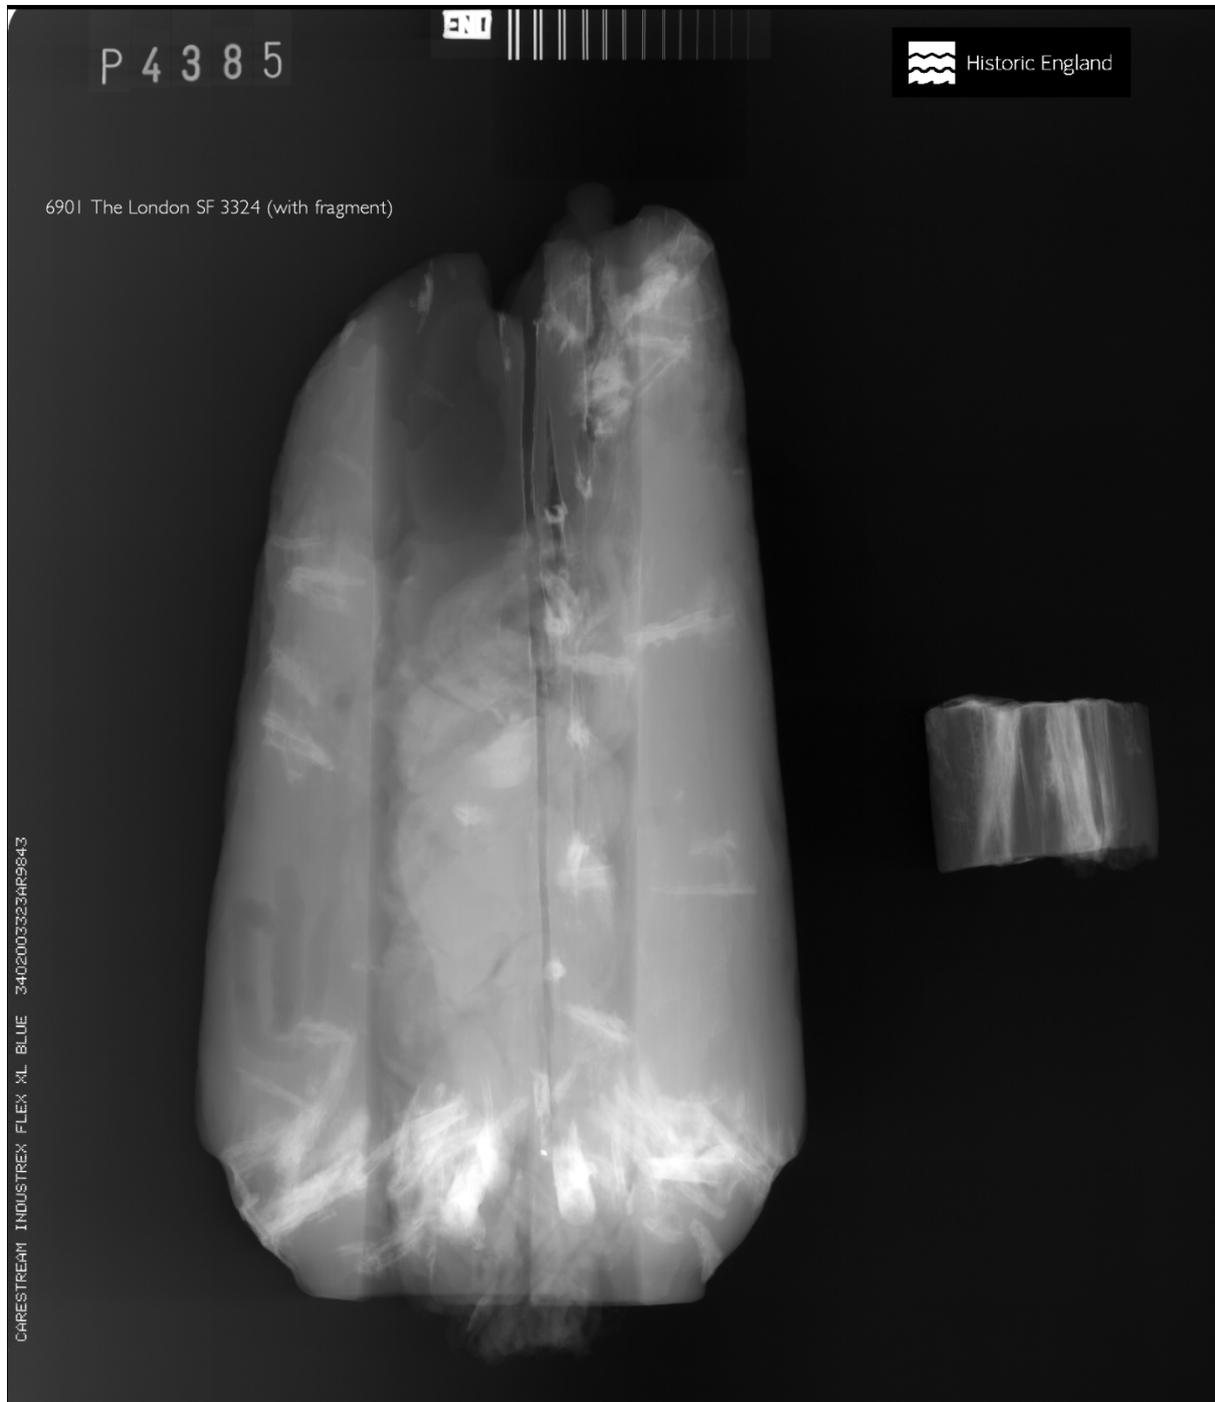
Figure 5.42: Radiograph of sponge head 3324 showing the iron fastenings at shoulder and across the sides of the head (Radiograph courtesy of A. Middleton, HE).

identified at least one iron nail driven in diagonally from above the shoulder down into the core of the rope (Figure 5.42). Several shorter iron nails can be seen on the side of the head. These would have been used for fastening the sheepskin sponge (Figure 5.42).

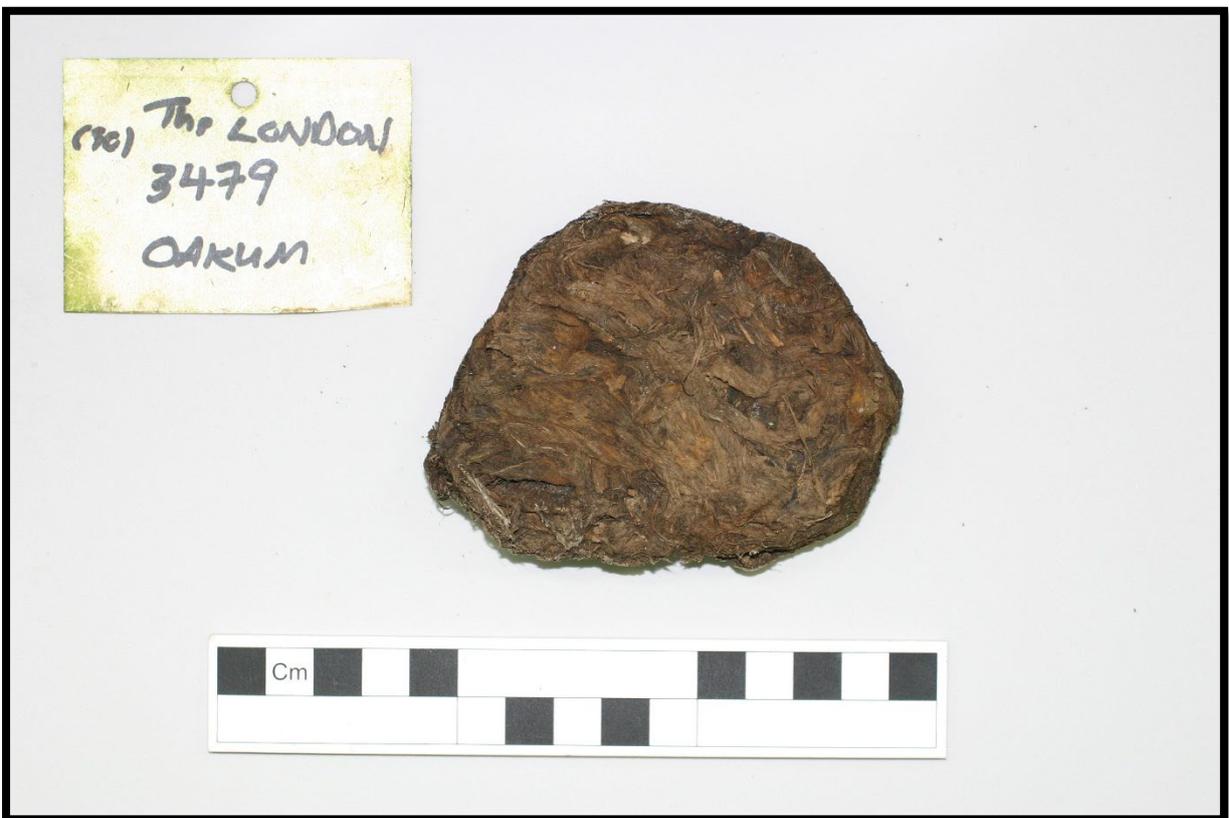
Figure 5.45: Photo of gunwad 3479 (Photo by A. Middleton, HE).

During the initial excavation of Trench 3, in the 2014 season, the edge of a wicker basket with wadding inside was observed near the top of the stratigraphy, on the east side of the carriage (Cotswold Archaeology 2014) (Figures 5.7, 5.43 and 48). This was likely to be the gun's immediate supply of wadding. Unfortunately, this was not seen again during the following seasons suggesting it had been lost due to natural seabed reductions in the intervening period. During the 2016 excavations of Trench 3 a partial gunwad was recovered. It was constructed from yarns of rope folded or wrapped into a tight ball (Figure 5.45).

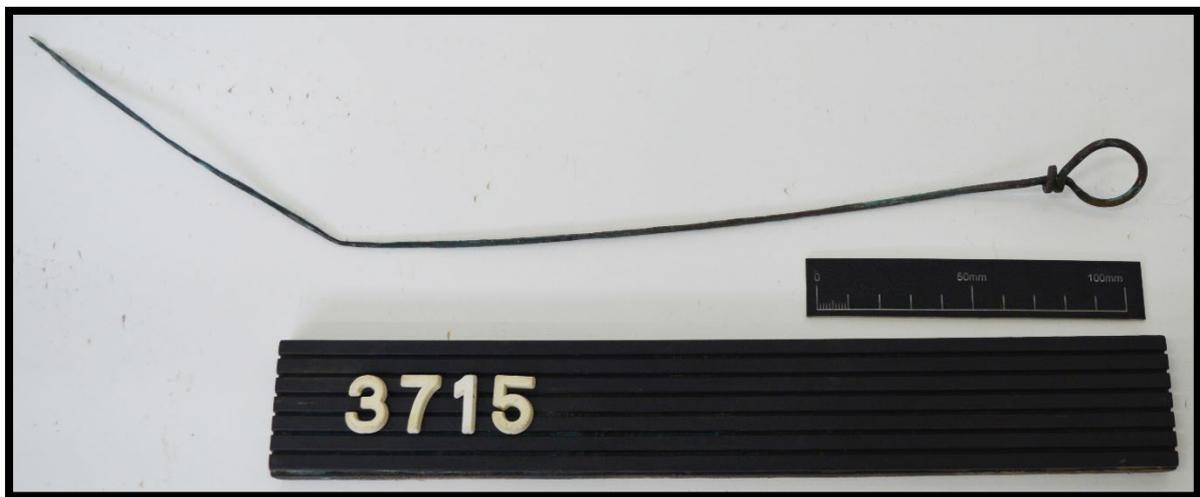
Figure 5.46: Photo of priming wire **3715** (Photo by author).

A single priming wire **3715** was found on the west side of Trench 3, during the 2016 excavation season, in the stratigraphy above the leather bandoliers and wooden powder boxes. It is made of copper alloy and is 400mm (15.7in) long with a diameter of 2-3mm with a loop at the top end, which is twisted back around the shaft, the lower end is pointed (Figure 5.46).

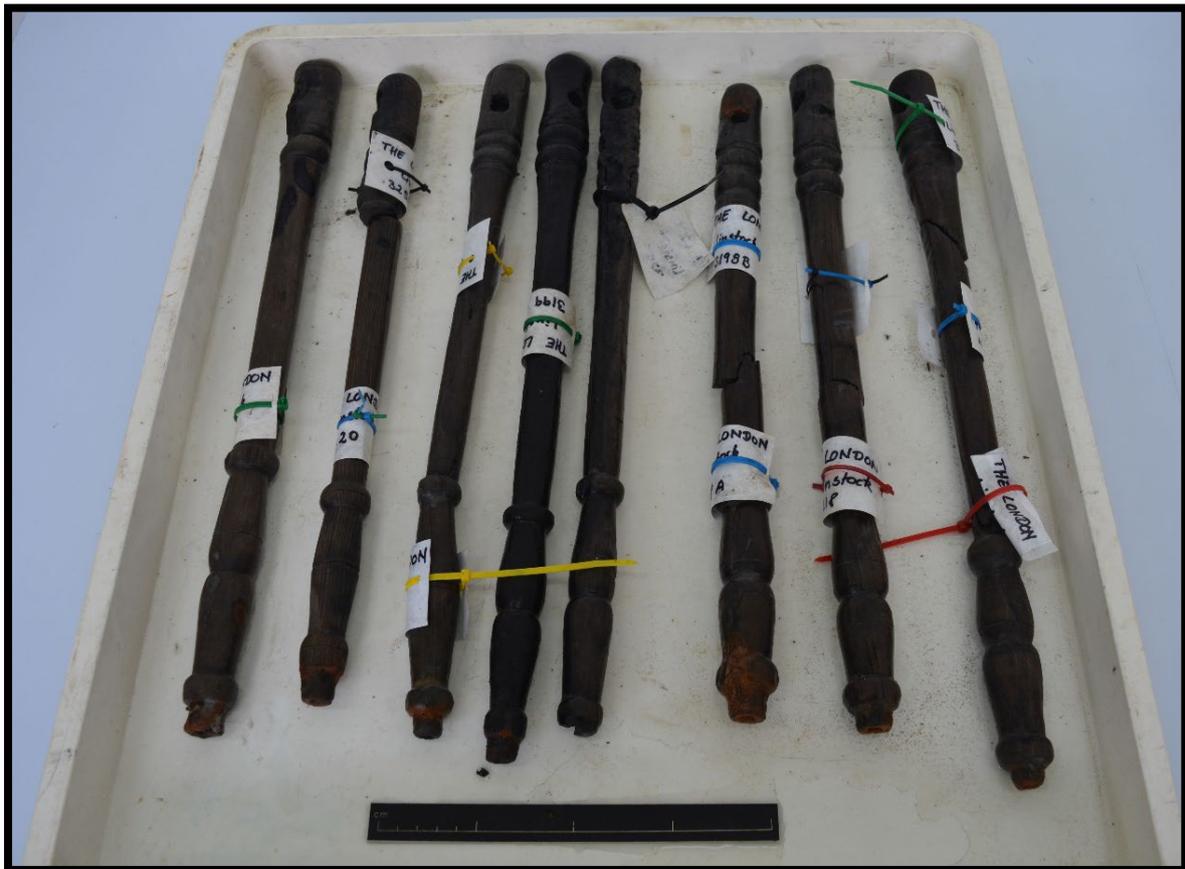
Figure 5.47: Photo of an example of the linstocks recovered from Trench 3 (Photo by author).

During the 2015 excavation season nearly the entire complement of linstocks was recovered from Trench 3. The linstocks were fragile and most were recovered in several pieces. A total of 29 individual linstocks were recovered in the form of: three complete and unbroken, nine complete but in fragments, eight nearly complete, and nine partials. They are similar in form but not identical (Figure 5.47). Bar one (**3310/3213**, which is in two pieces), they have all been turned from a single piece of wood on a lathe, which would have taken a great deal of skill in order to create the narrow shafts. In contrast, **3310/3213** has been carved rather than turned and has a style like those of the *Mary Rose* (Figure 5.48). With the exception of **3310/3213** they all have a hole at the head end for clasping the slow match. The head end is separated from the shaft by a collar. The lower end of the shaft has been turned to include a grip. At the end of the grips were small concretions or rust-stained holes. This was the

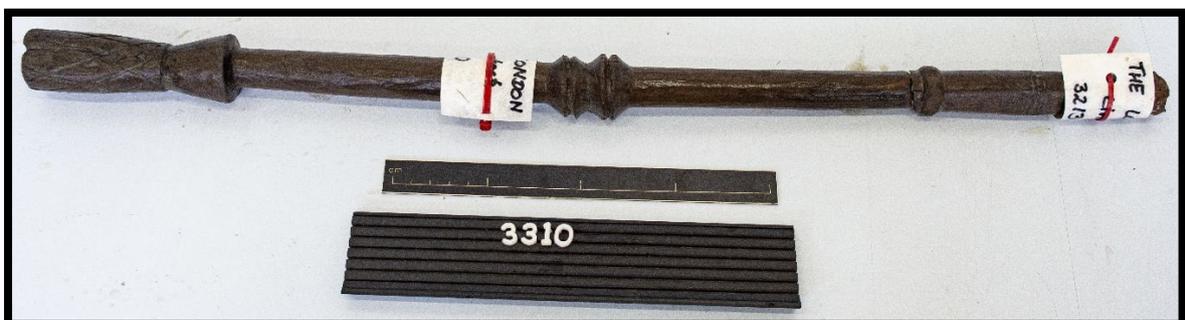
Figure 5.48: Photo of linstock 3310/3213, which is hand carved as opposed to turned on a lathe (Photo by author).

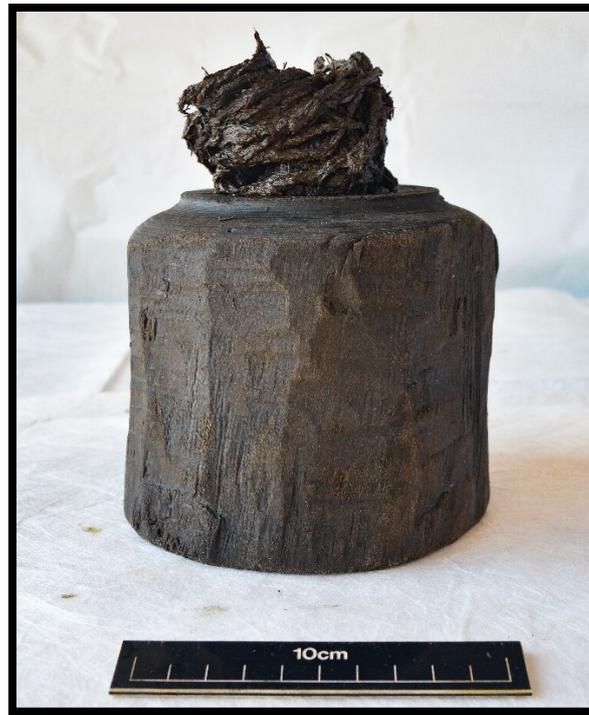
Figure 5.50: Photo of rammer head **3208** showing clearly defined cut marks (Photo by author).

The archaeology recovered from the *London* certainly supports a lack of use of the largest guns. The evidence from the rammers shows little evidence of wear around the ramming face and sides, especially on rammers **3801** and **3802** (Figures 5.50 and 51) - the rammers that were altered to fit the 24-pounders. The cut marks on both rammers look fresh with defined edges, not what one would expect if they were well-used pieces of equipment that were yielded to ram heavy objects down solid bronze barrels. The lack of wear and therefore use corresponds with the ledger that identifies that no 24-pounder round shot was fired. Rammers

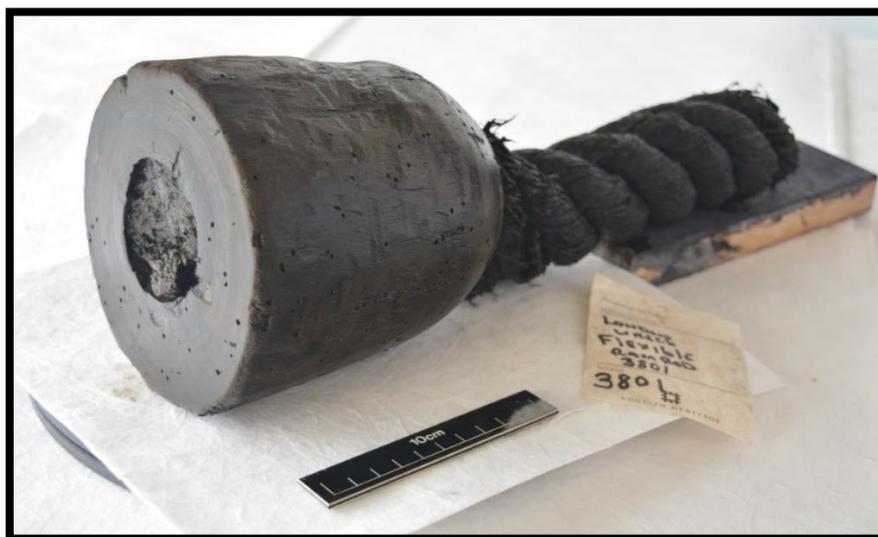
Figure 5.51: Photo of rammer head **3801** showing no signs of wear around edges of the ramming face and also wood worm holes suggesting it was sitting around not being used (Photo by author).

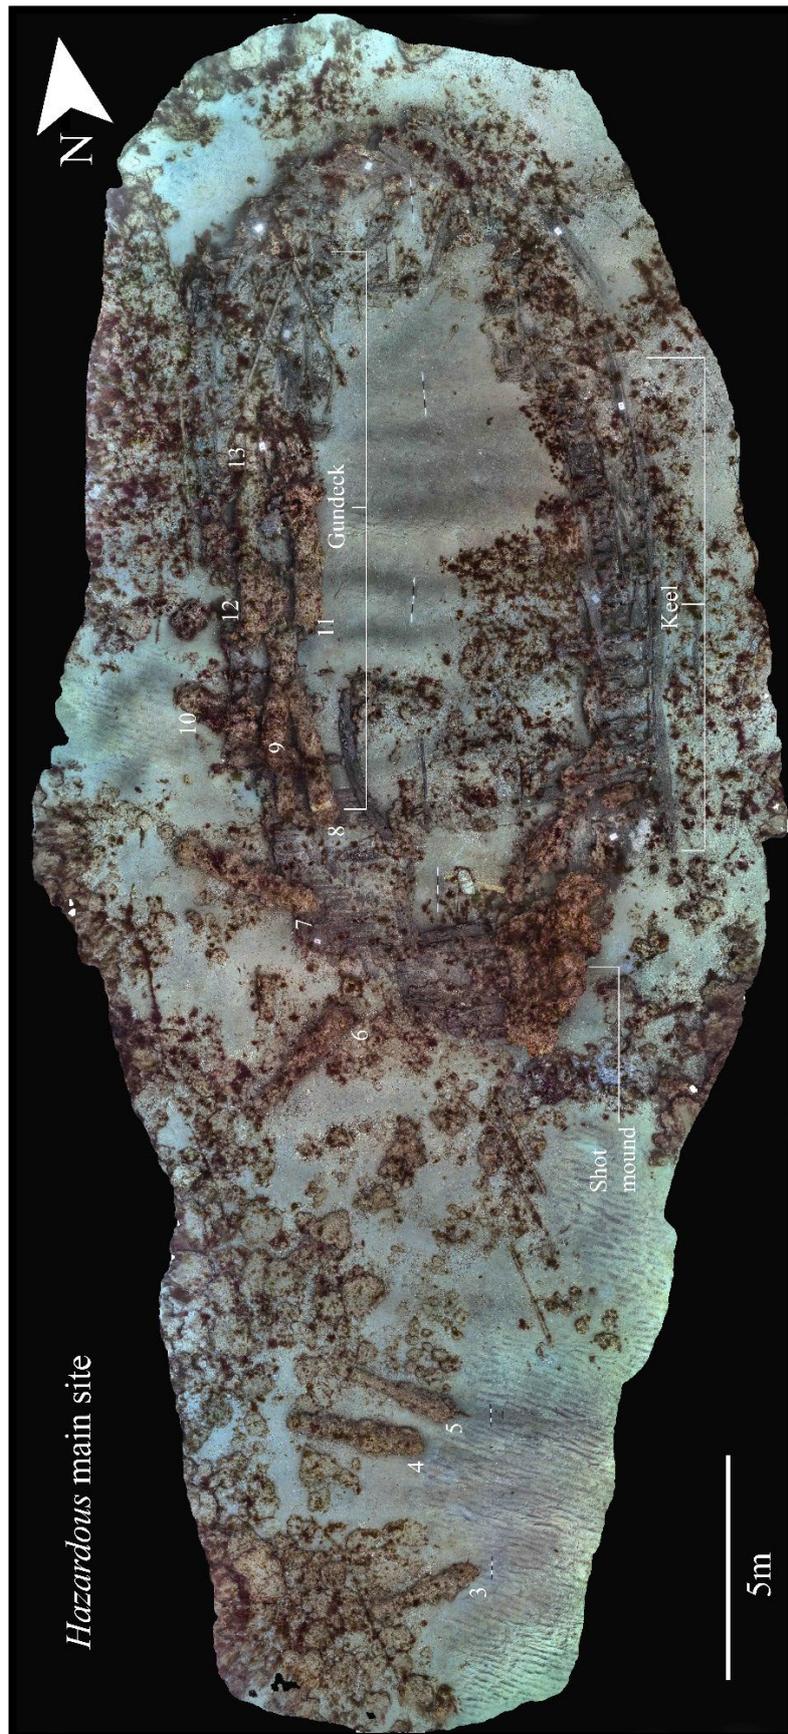
Figure 6.2: An orthophoto mosaic showing the current extent of the main site and the guns are numbered 3-13 (Survey and image produced by author).

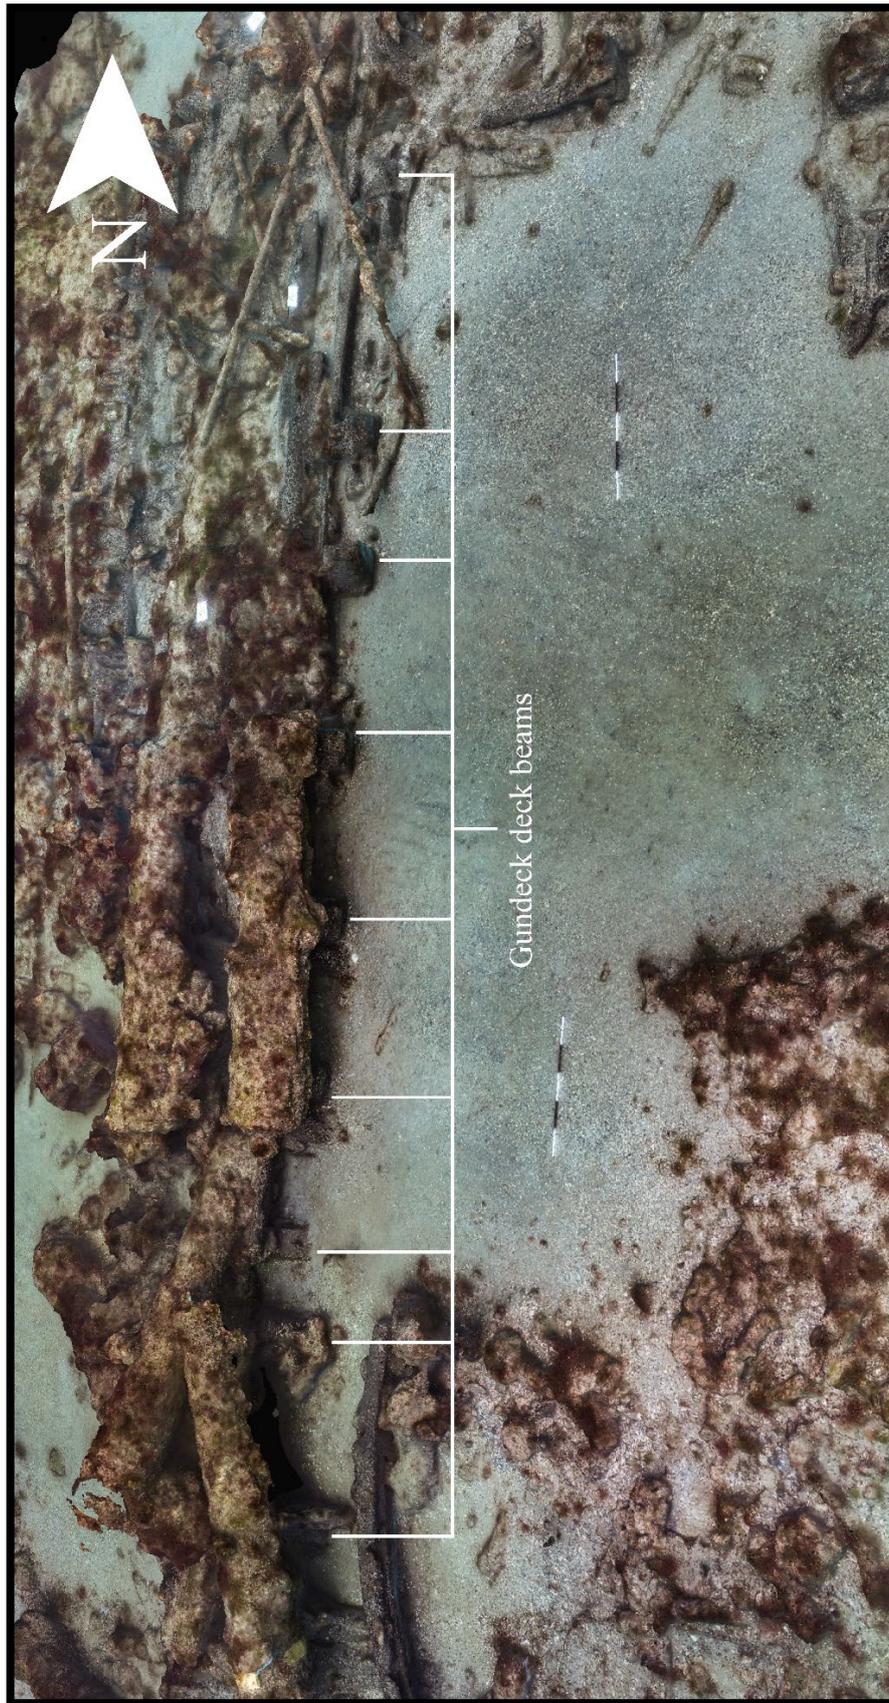
Figure 6.3: 2019 photogrammetry survey model showing protruding gundeck deck beams. The scales in the image are 1m with 20cm increments (Survey, model and image produced by author).

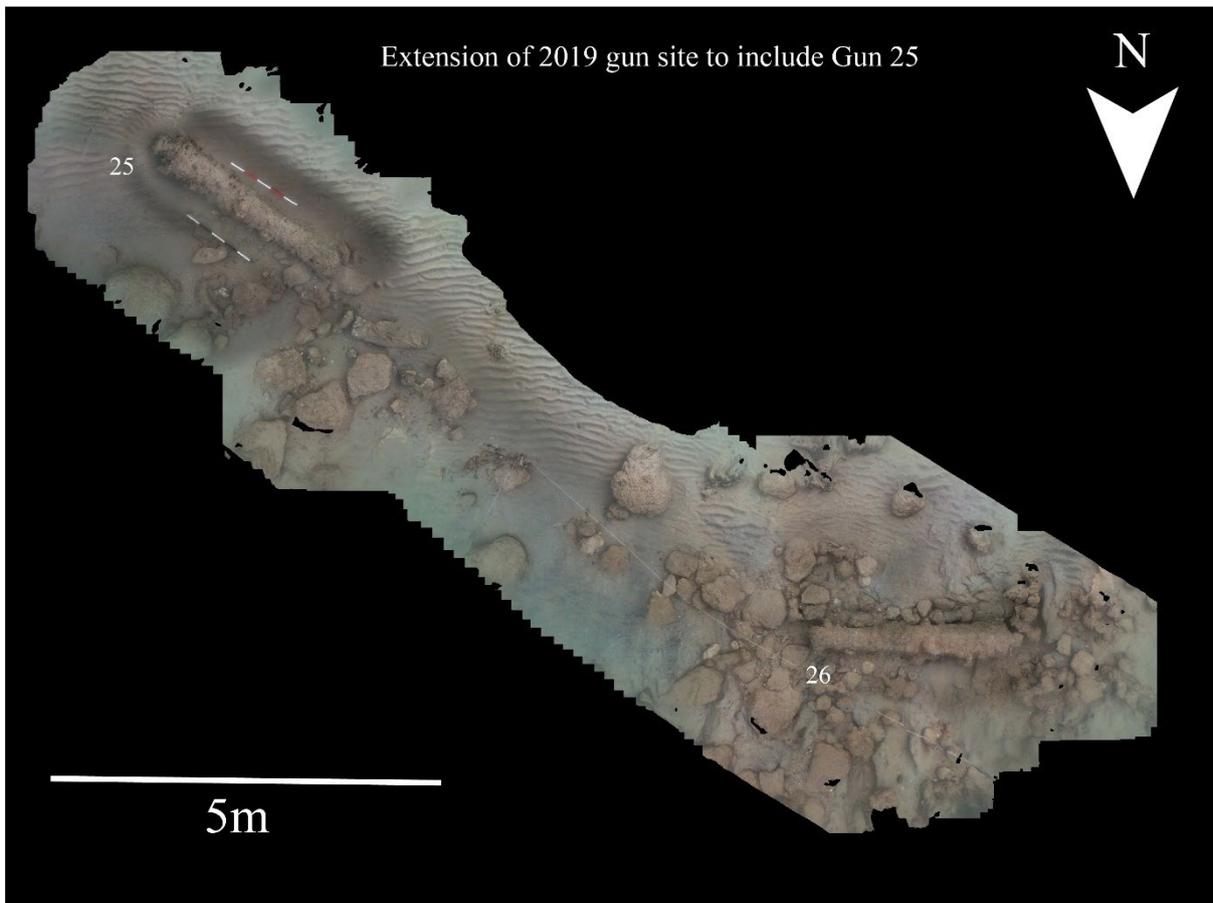
Figure 6.6: Orthophoto mosaic showing guns 25 and 26 of the 2019 gun site (Survey and image produced by author).

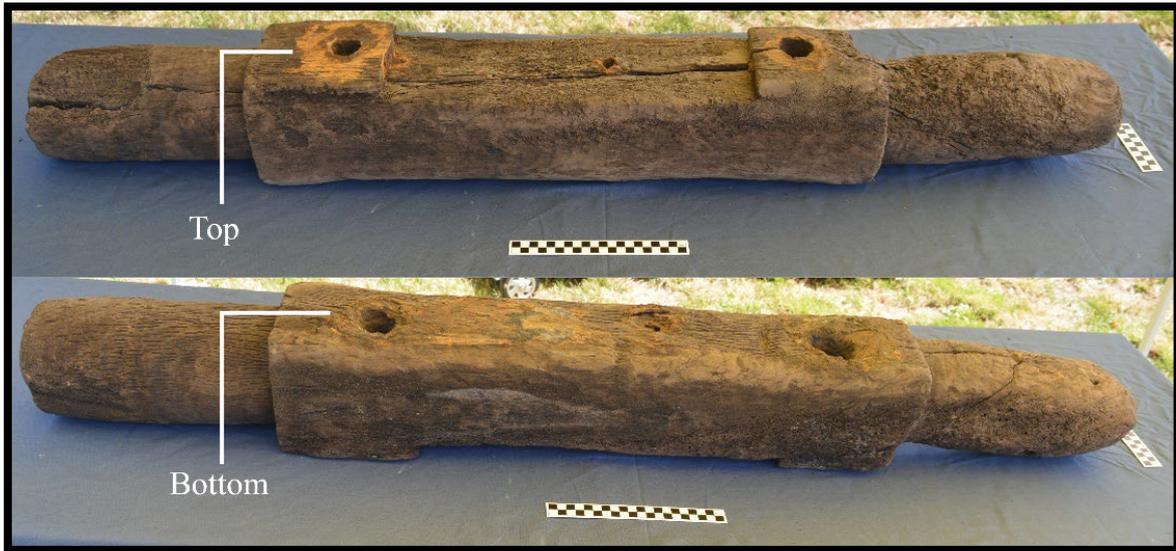
Figure 6.12: Axle HZA003-07. Top photo is the upper face and bottom photo is the underside.

Further evidence of the characteristics of the *Hazardous* carriages derives from three axles, two, **HZA012-14** and **HZA013-14**, found stowed in the hold (Figure 6.10-11) and a third, **HZA003-07**, found outside the structure of the main site (Figures 6.12). Their location and stowage will be discussed in section 6.1.6.3 but relevant to this section is their design and construction. We have seen from English-style carriages recovered from the Duart Point wreck (Martin 2017, p. 152), the *London* (Pascoe 2017a, p. 36), and the carriage at Windsor Castle (Smith 2001, pp. 26–28), that the front axle was secured to the bed by two iron bolts that passed up from the bottom and through the bed on the inside of the cheeks. The location of the holes are different with the *Hazardous* carriages. With the case of the *Hazardous* axles there are bolt holes where the cheeks would line up on top of the bed (Figures 6.10 - 12). On the underside of the axles it is possible to see the impressions left by the bolt heads and
