**Archaeological evidence for the development of Royal Naval
gunnery from 1545 – 1811; analysing change through technology
and culture**

By
Daniel Pascoe

Dissertation submitted in partial fulfilment of the requirements for the degree ‘Doctor of
Philosophy’, awarded by Bournemouth University

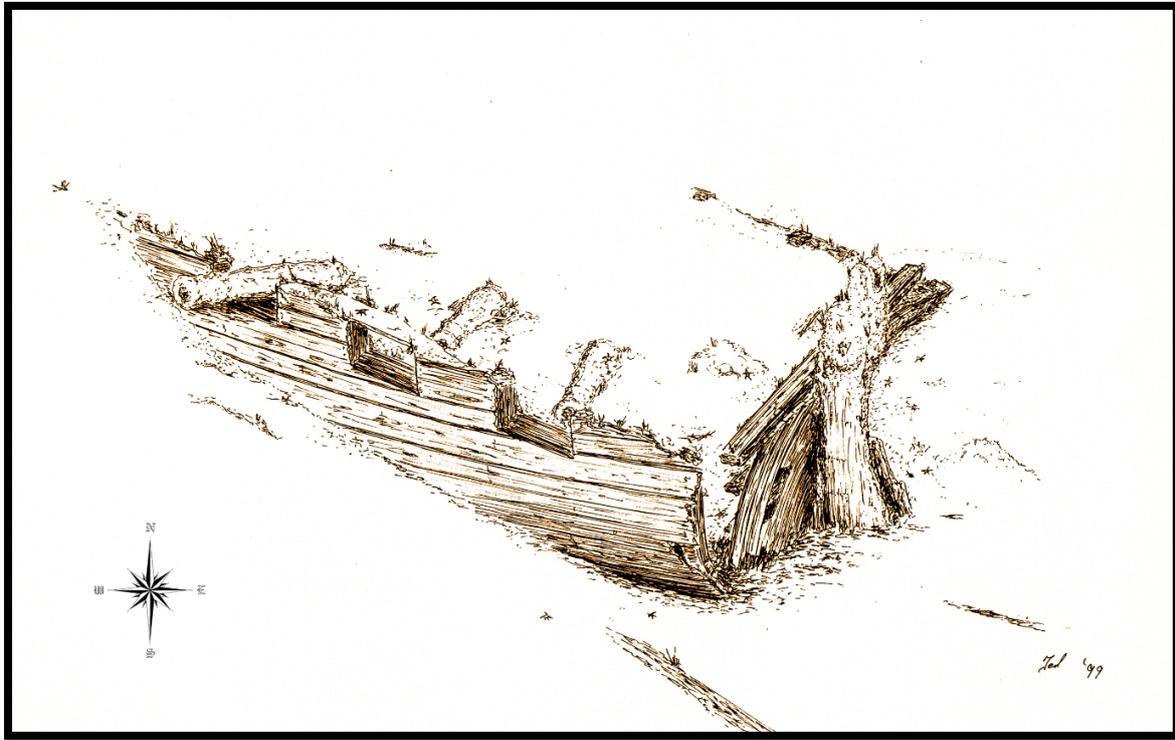
Figure 6.16: A divers sketch showing the exposed guns on the port quarter before the collapse of the hull structure (Drawing by Ted Westhead and courtesy of the Seadive Organisation).

A demi-cannon with carriage and some of its associated gun tackle was recovered in September 2000. It was first seen alongside two other guns on the main gundeck at the port stern quarter, adjacent to its gunport but within a relatively short period of time the wreck began to deteriorate (Figure 6.16). Due to the weight of sand within the ship the side of the

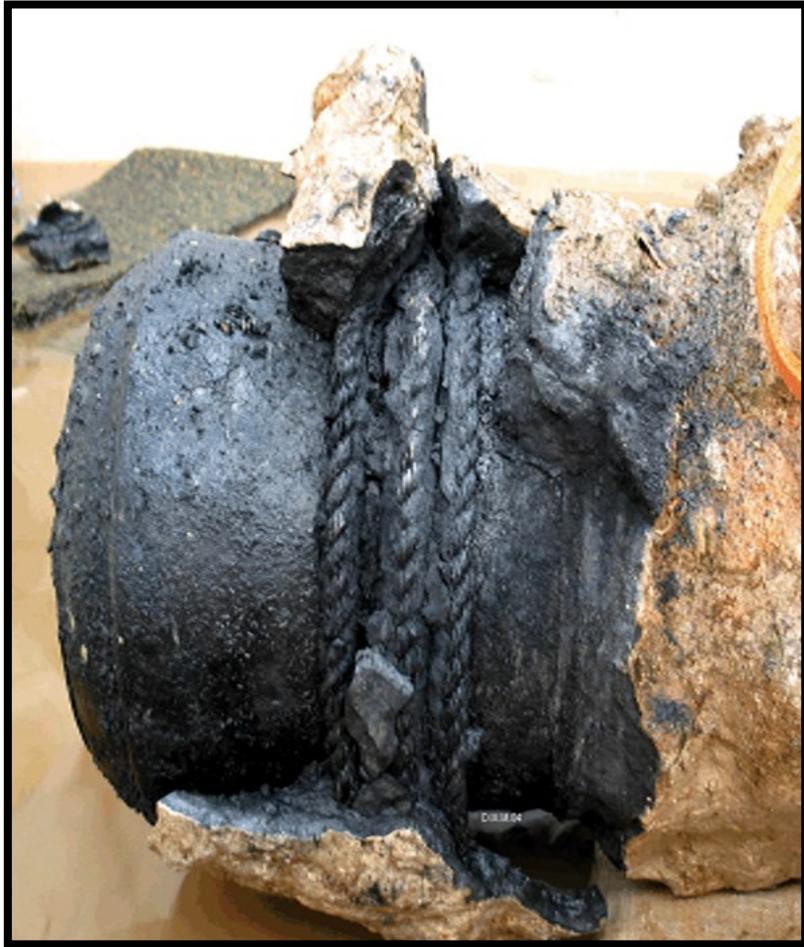
Figure 6.18: Muzzle lashings (Photo by D. McElvogue).

The recovery of the assemblage identified that the gun was positioned in the carriage with the breech end against the rear of the bed and the muzzle fully elevated (Figure 6.17). The de-concreting of the gun revealed hawser laid rope wrapped three times around the muzzle (Figure 6.18). When initially exposed on the site the muzzle was facing the gunport (Figure 6.16). The orientation and elevation of the gun demonstrates that the muzzle was lashed to the side of the hull above the port. The de-concreting of the breech end of the gun and the sides of the carriage revealed two breeching ropes running side by side from the front of the carriage along the side and then around the back of the breech (Figures 6.17 and 6.19). During normal operations, one breeching rope would be necessary, but in this case two separate breeching ropes appear to have been used. The additional breeching rope would seem to be an extra measure of security due to the severity of the storm.

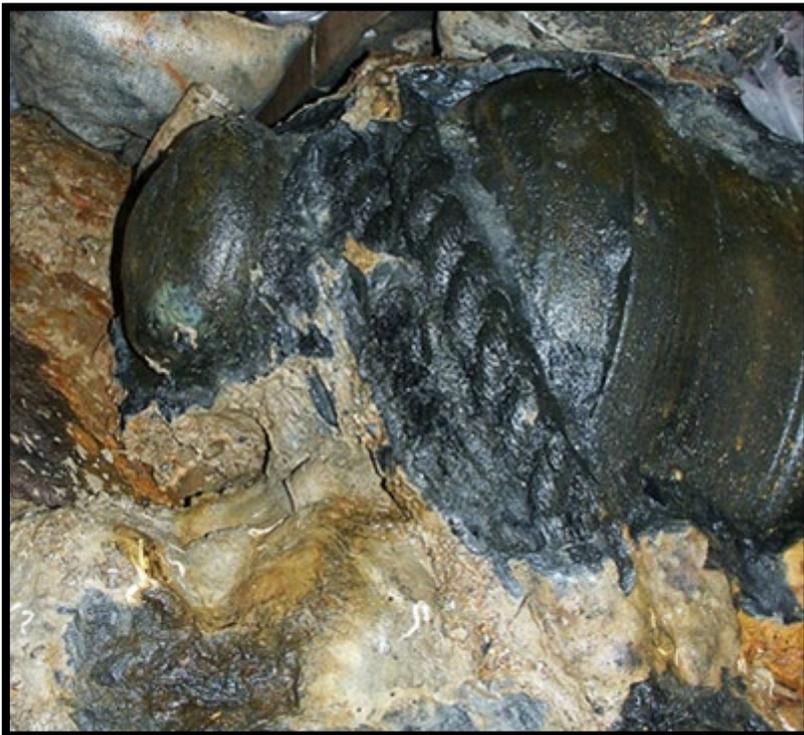
Figure 6.19: Breeching rope around the casabel (Photo by D. McElvogue).

The carriage is a typical truck carriage of the period, but the gun is a more refined Prince Rupert Patent, nealed and turned, demi-cannon (McElvogue 2008). This patent involved a different method of casting to increase quality and performance over the standard rough cast guns (Barter-Bailey 2000). The carriage's construction is similar to the *London's* carriage but it had an additional iron through bolt (three in total) to the support the cheeks and it is without the additional timbers such as the extension piece and planks on the inside of the cheeks (McElvogue 2008, p. 42). Therefore, this carriage was designed for the demi-cannon of 9 ½ feet that it was recovered with. The more interesting features regarding this section were the survival of the gun's breeching rope on the side of the carriage and around the breech end of the gun, and also the muzzle lashings. These identify how the gun was secured and provide evidence of extra security in response to the terrible conditions of the storm (Figures 6.17-19).

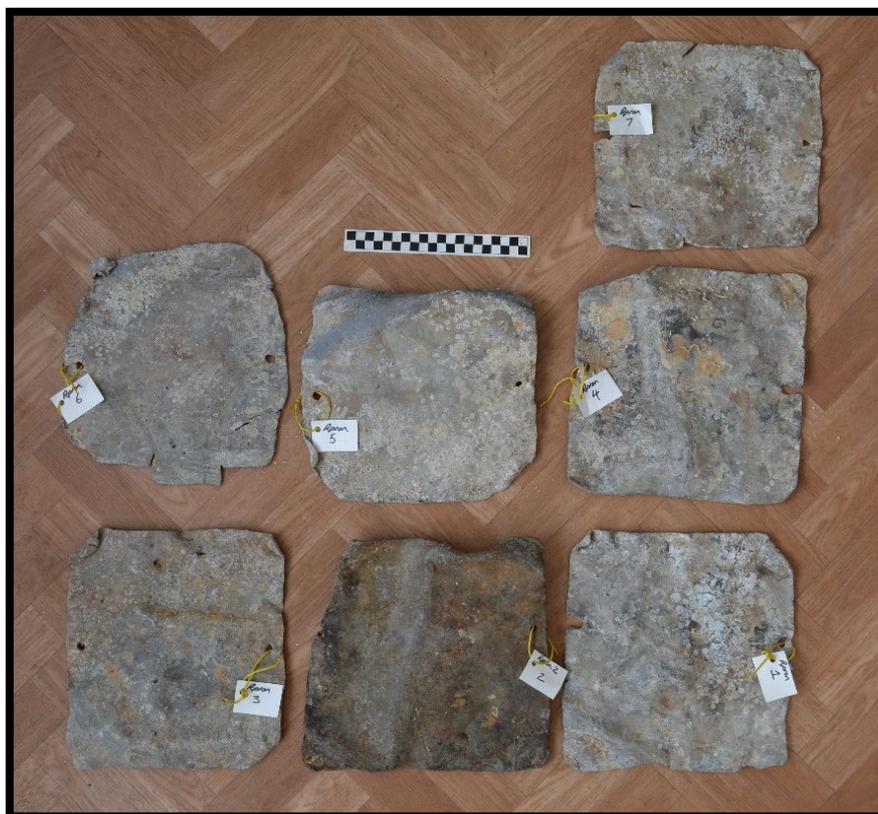
Figure 6.20: Lead aprons recovered from the main site (Photo by author).

According to the 1677-78 inventory a fourth-rate of 54 guns was issued with 56 aprons of lead (TNA WO55/1650). This meant there were two issued as spares. They functioned in the same way as explained in section 5.1.4.3. A total of nine have been recovered from the *Hazardous*, seven from the main site and one each from the 2014 and 2019 gun sites (Figure 6.20). They are rectangular sheets of lead ranging from 260 by 240mm and 2-3mm thick (Table 6.1). They all have one pair of lanyard holes for securing to the gun. Several of them show the shallow impressions of the guns reinforcing rings. They are generally flat except for one, which is moulded at one end, possibly to fit over the base ring of the gun. Although the others are flat, they do have a faint crease mark at the rear suggesting they were moulded. The dynamics of the site is such that large areas of sand periodically move across the site, the weight of which could easily flatten a thin sheet of lead. If the width dimension is viewed as the critical dimension, then the differences between the smallest and the largest aprons is only 20mm (Table 6.1). From this I would suggest these aprons could fit comfortably on any size of gun issued to the *Hazardous*.

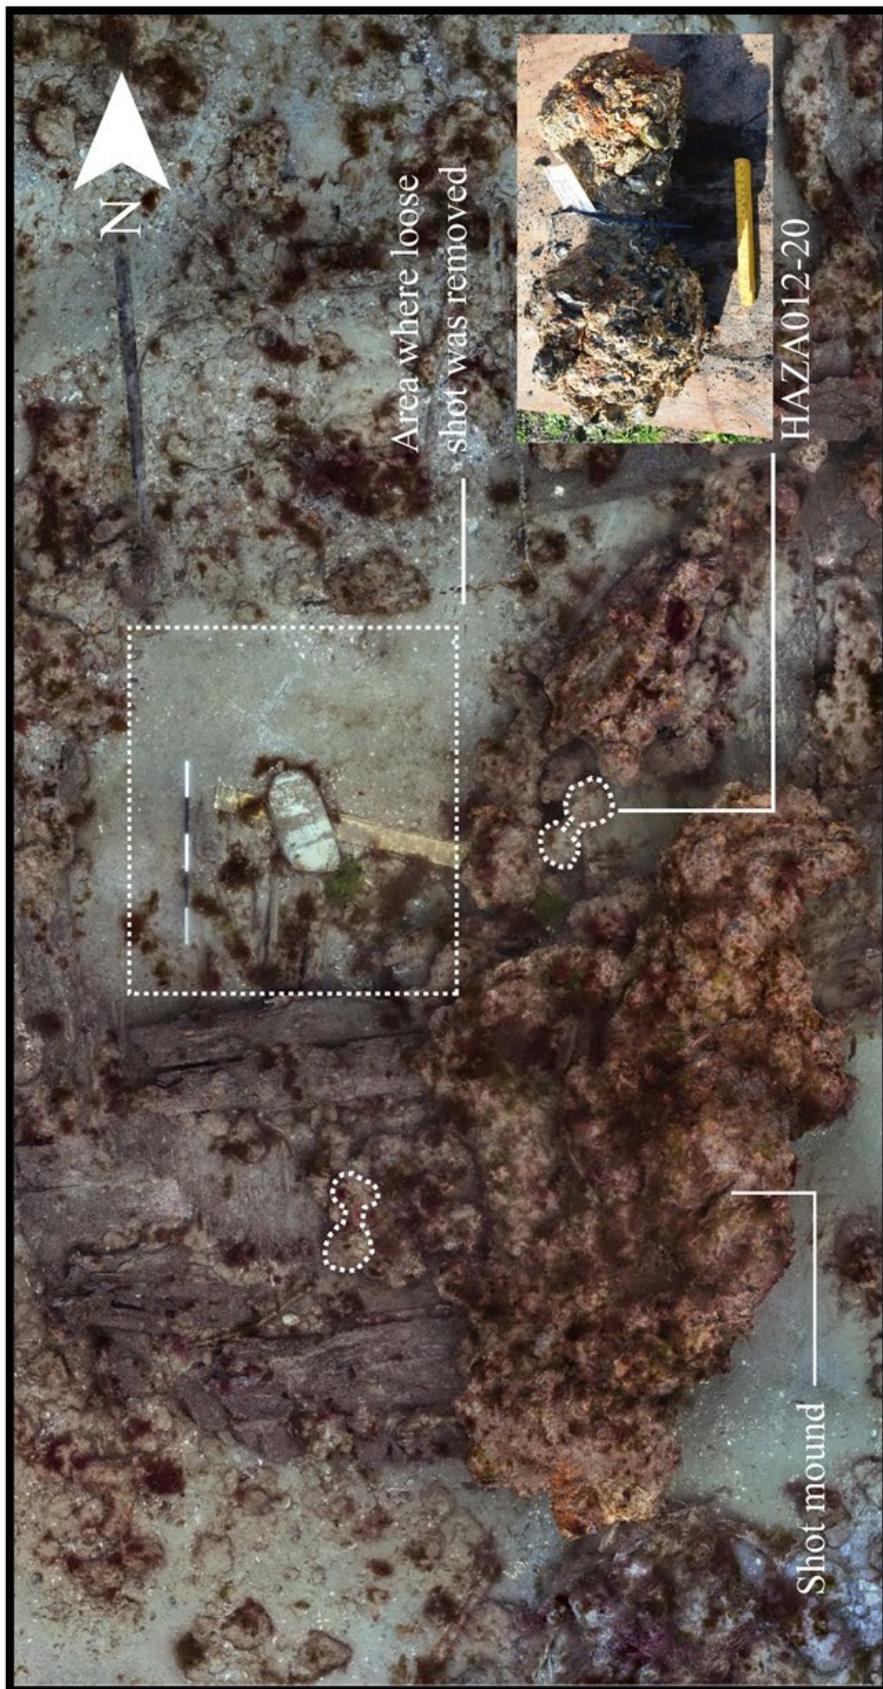
Figure 6.26: Orthophoto mosaic showing shot mound including confirmed double loose headed shot (plus recovered example, **HAZA012-20**) and the area cleared of loose shot for the excavation. The scale in the image is 1m with 20cm increments and the double headed shot are marked by dashed lines (Image produced by author).

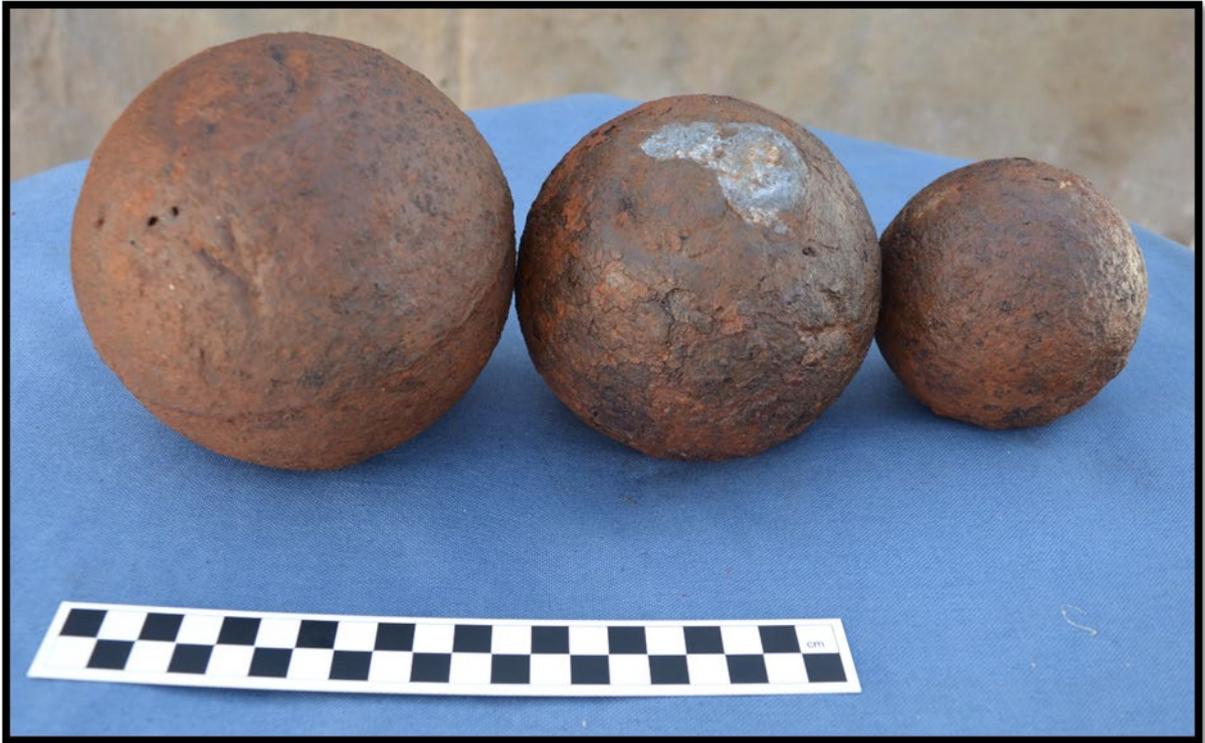
Figure 6.27: In order from the left 18, 12 and 6-pounder round shot. The scale is 20cm with 1 cm increments (Photo by author).

There is one main concentration of shot, concreted to the lower hull on the east side of the main site (Figures 6.2 and 6.26). Inboard of this shot mound are scatters of loose, heavily concreted shot (Figure 6.26). The shot mound is 5.7m long by 2.25m wide by 1.5m high and on inspection the size of concretions forming it suggest it is made up of predominantly the heavier 18 and 12- pounder round shot. This is not surprising as the inventories show that the volume of shot for the larger guns were over double the amount than for the 6-pound shot (Table 6.2). Also, the lighter 6-pounder shot was most probably stored in a higher compartment of the shot locker and therefore more reachable to contemporary salvors. This observation is strengthened by past shot sampling by the HPG which found mainly 18 and 12-pounder shot, with one exception of 6-pound shot and a conglomerate of 1-pound shot (Figures 6.27-28).

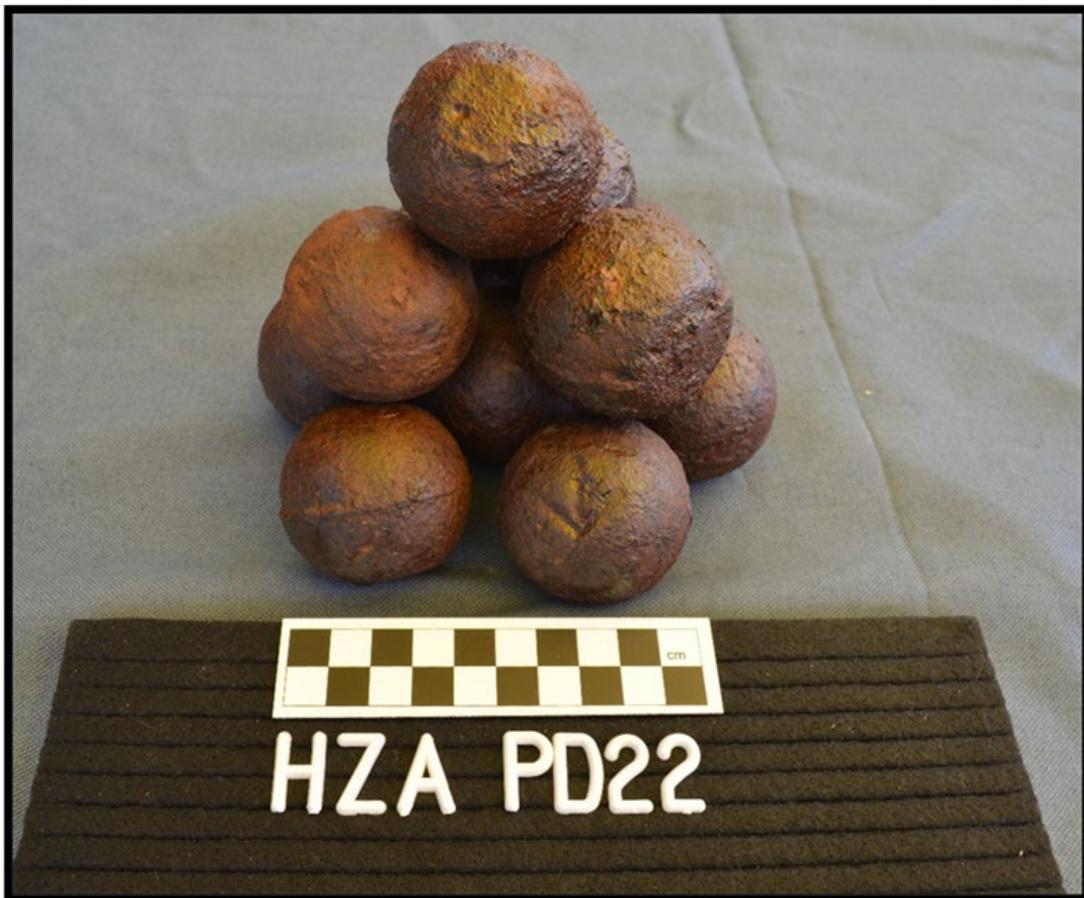
Figure 6.28: A cluster of grape shot recovered from the site (Photo by author).

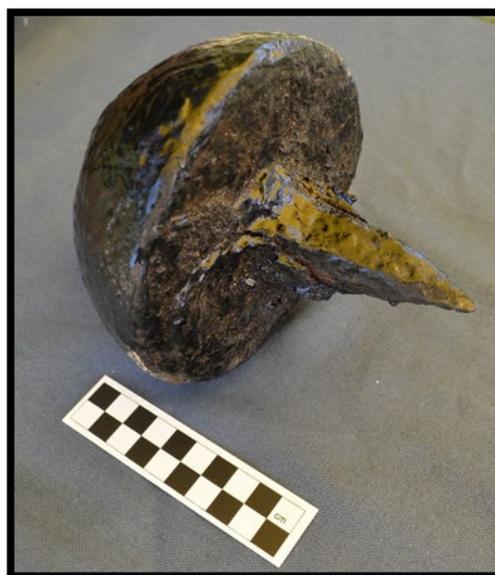
Figure 6.29: Surviving example of one of the cast iron hemispheres from a double headed shot. The scale is 10cm with 1cm increments (Photo by author).

Two examples of double head shot were also found in the past when excavating a recovered concretion. The heads were cast iron hemispheres (Figure 6.29). Only one hemisphere with a small section of the bar has survived. It was coated with several layers of paint and during inspection it wasn't possible to tell whether the remains of the bar was cast or wrought. The current measurements of it should be considered alongside the fact that there has been a degree of expansion since its recovery from the seabed. Its current diameter at the head is 133mm (5.2 inches) and therefore is likely to be appropriate for the 18-pounder guns, if following Povey's description this is an example of the double head cast shot used to target rigging. The inventories show that ships of all rates were no longer issued with double head cast shot from 1677 onwards (TNA WO55/1650). The hemisphere, instead of a solid ball, appears, however, to be French in type, as examples have been recovered from a wreck at Saint Nazaire Harbour in France of French origin (Baron et al 2017, p. 90) and this type is illustrated in a French gunner's companion 'Memoires d'Artillerie' (Surirey de Saint Remy 1697). It is therefore highly possible that the double head cast shot was French.

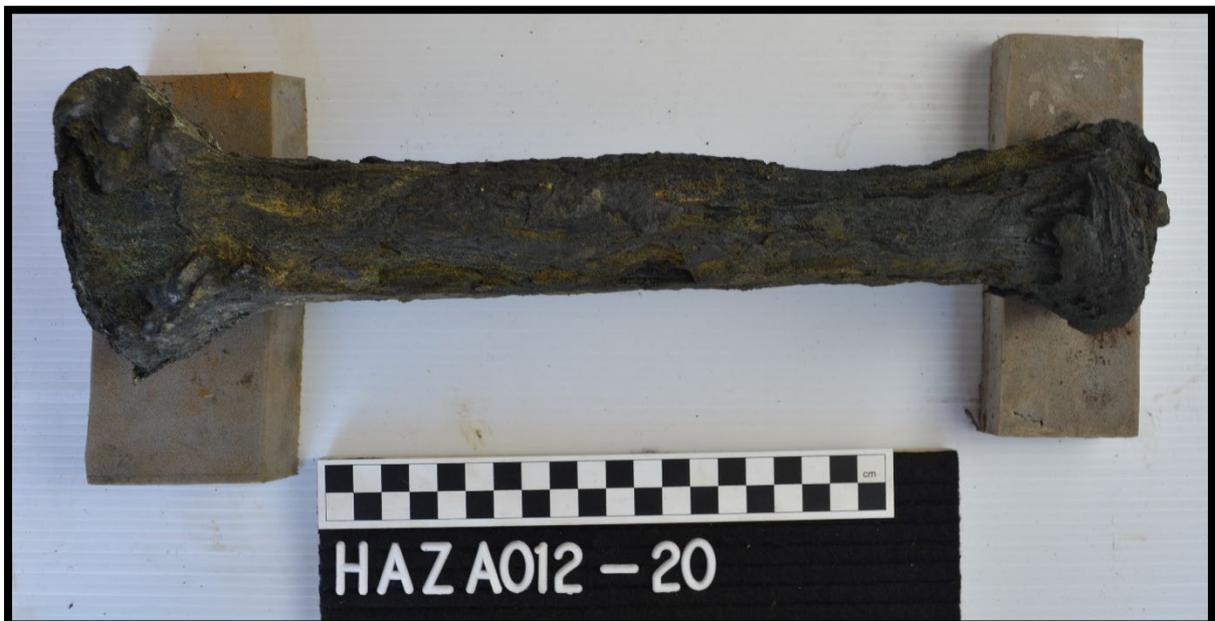
Figure 6.30: Photo of double headed shot **HAZA012-20** recovered from main site in 2020. The scale is 20cm with 1cm increments (Photo by author).

During the current excavations several loose shot were removed from the excavation area and placed outside the south end of the site. One double head shot, **HAZA012-20** was recovered for detailed recording and identification (Figure 6.26 and 30). Following de-concreting it was found to be made of wrought iron. It was 350mm (13.8 inches) long with a maximum diameter at the head of 104mm (4.1 inches) and therefore appropriate for the 12-pounder guns (Figure 6.30 and table 6.2), if following Povey's description this is an example of the double head hammered shot used to target masts and hull structure. The design, construction and form of all the shot will be discussed in more detail in section 6.4.2.

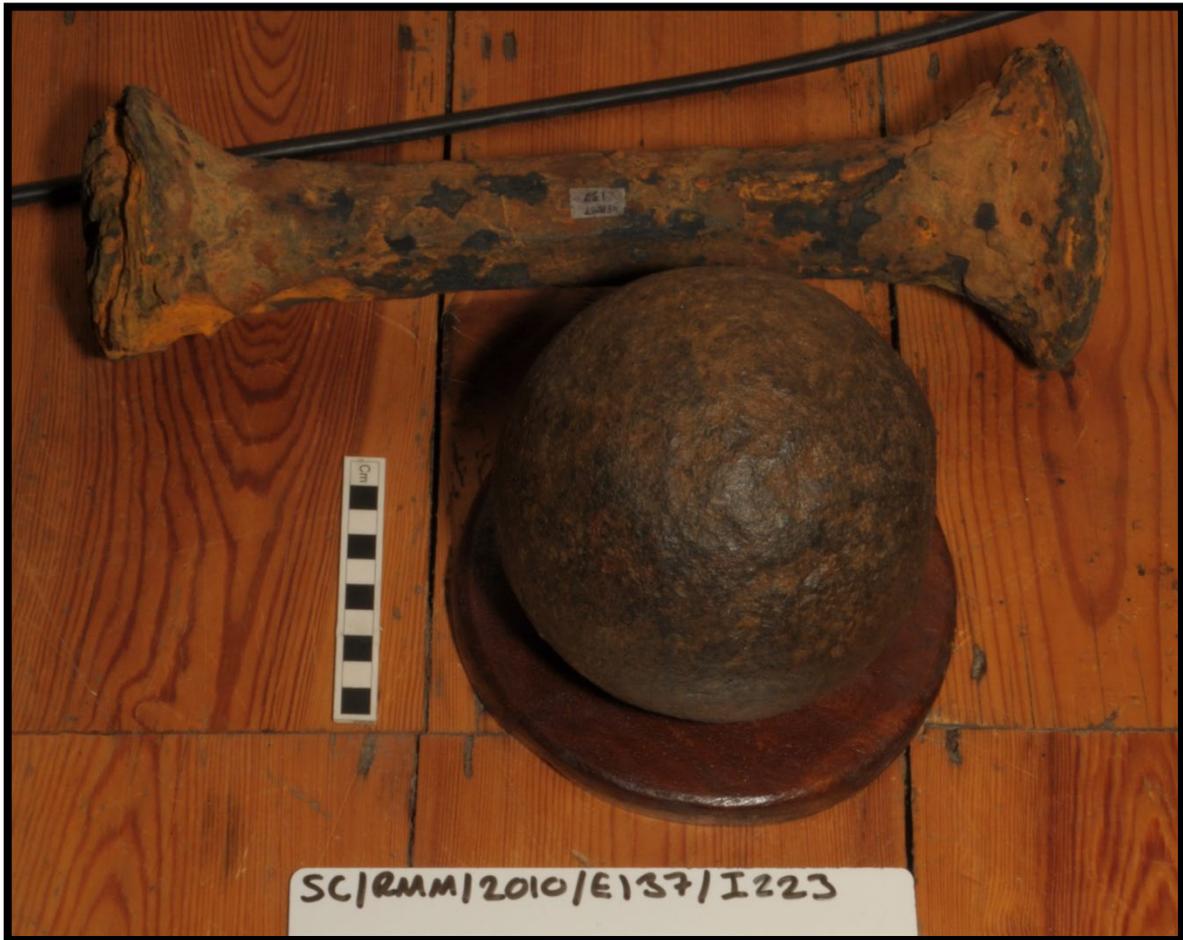
Figure 6.31: Photo showing double head hammered shot at top of image (Photo courtesy of the Maritime Archaeology Trust (MAT)).

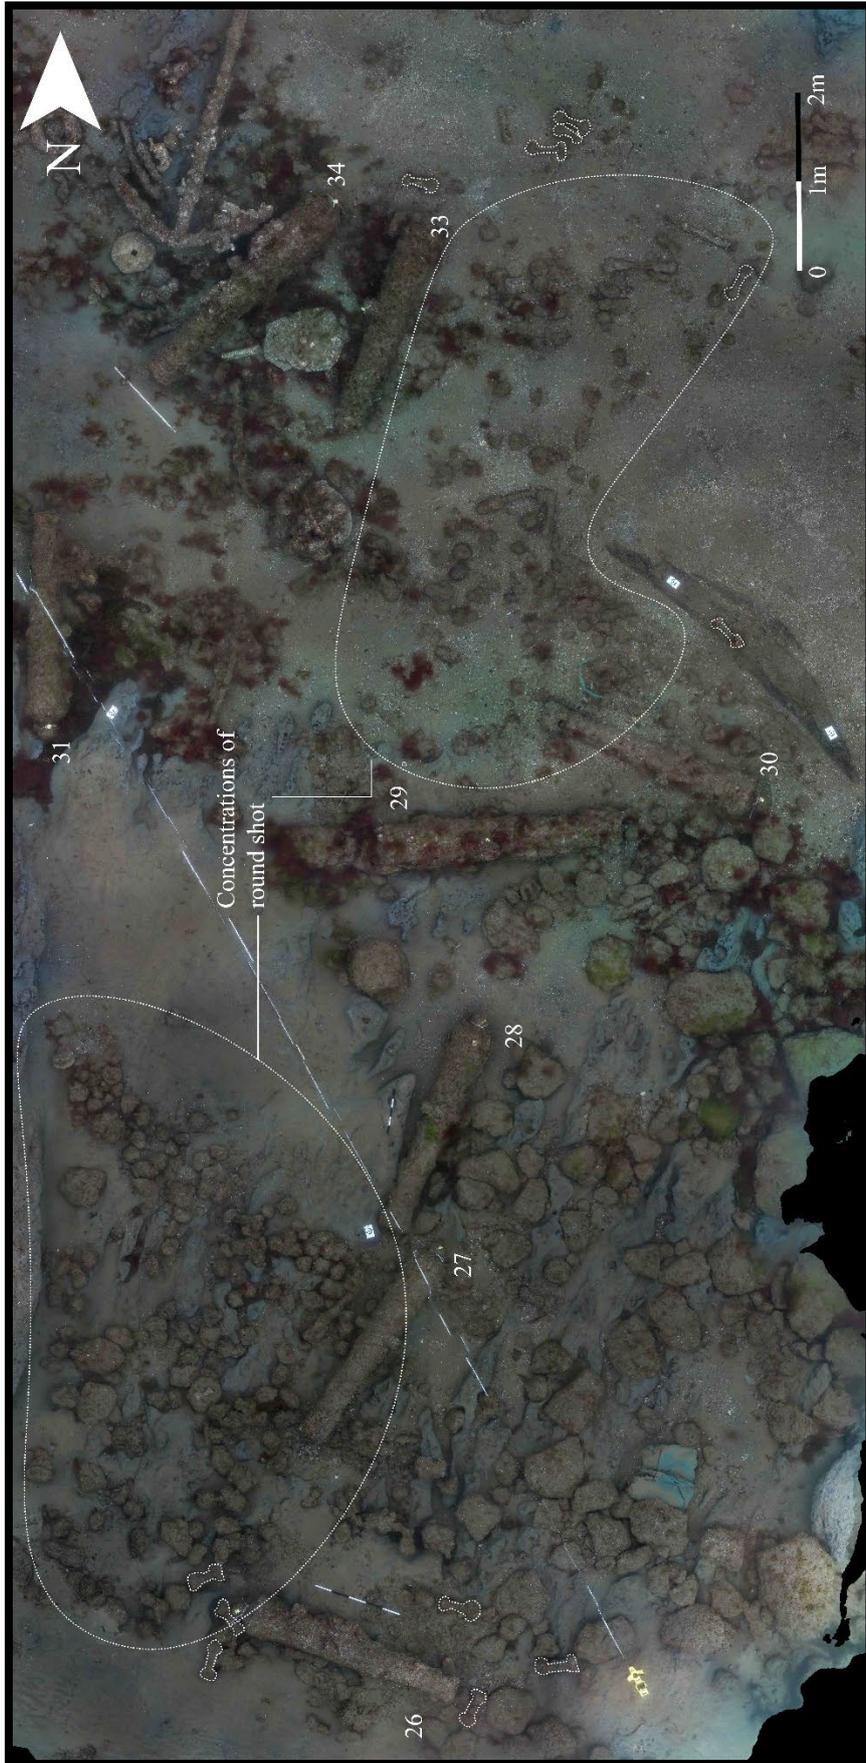
Figure 6.34: An orthophoto mosaic of the 2019 gun site showing the locations of round and double headed shot (outlined traced with dotted lines) (Image produced by author).

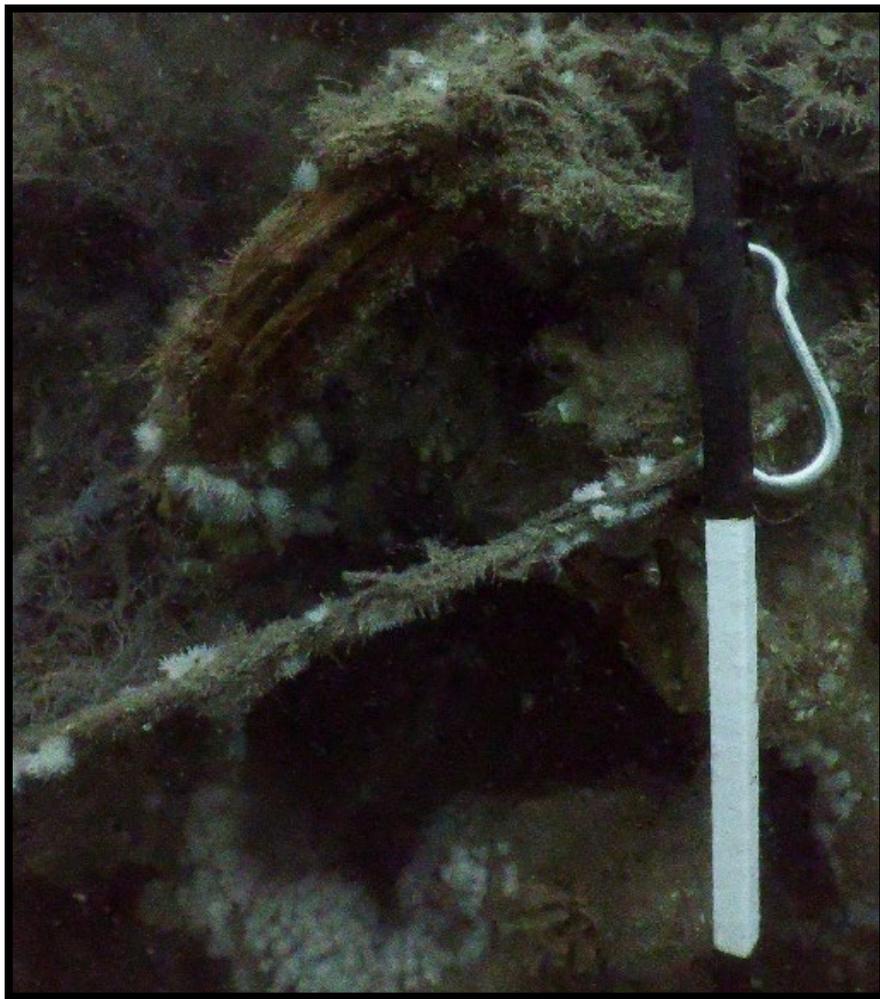
Figure 6.37: Photo showing a de-concreted section of bar that is clearly made of wrought iron. The scale showing is two 20cm increments of a 1m scale. (Photo by author).

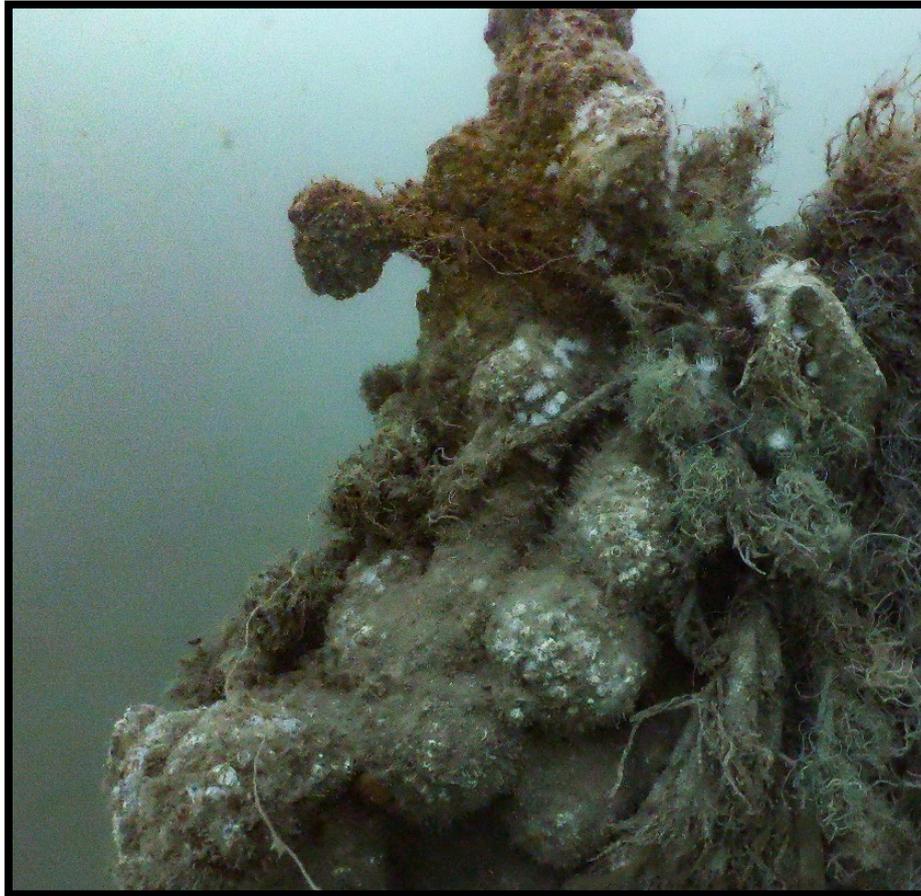
Figure 6.38: A possible group of double headed hammered shot (Photo by author).

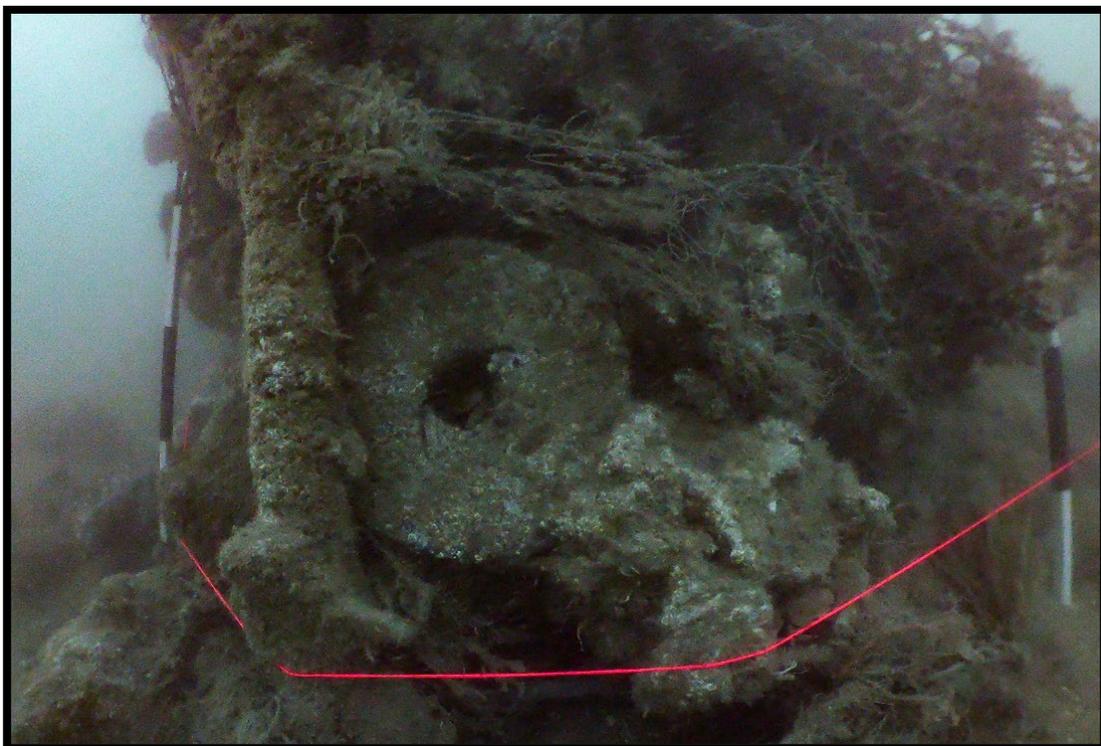
Figure 6.39: A possible concreted bar of iron to the left of a pulley sheave at the foot of the concretion mound. The scales are 1m with 20cm increments (Photo by author).

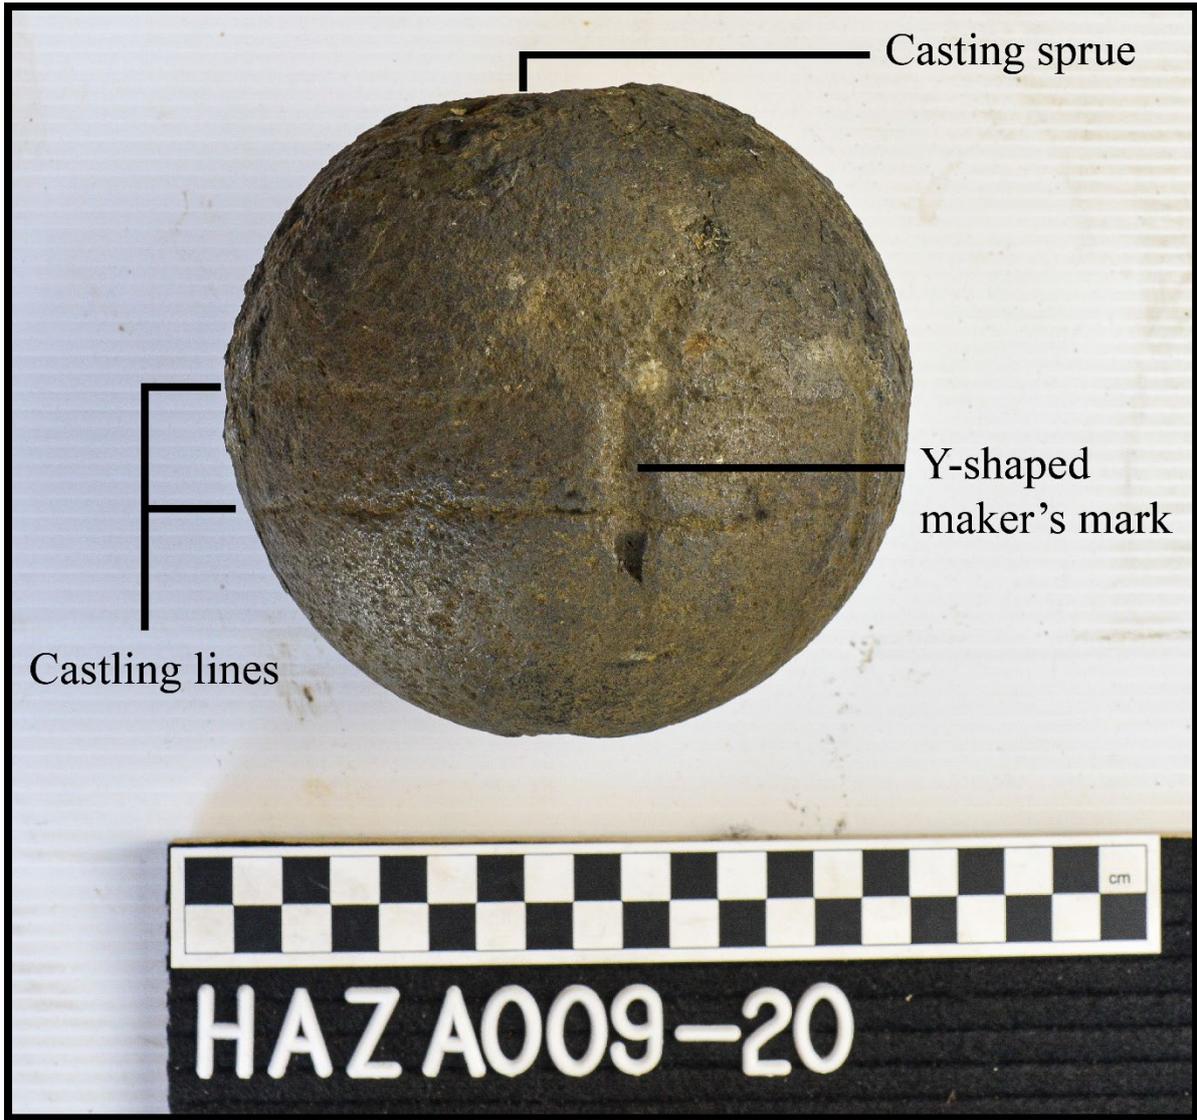
Figure 6.41: 18-pounder round shot HAZA009-20 showing casting lines, casting sprue and makers mark (Photo by author).

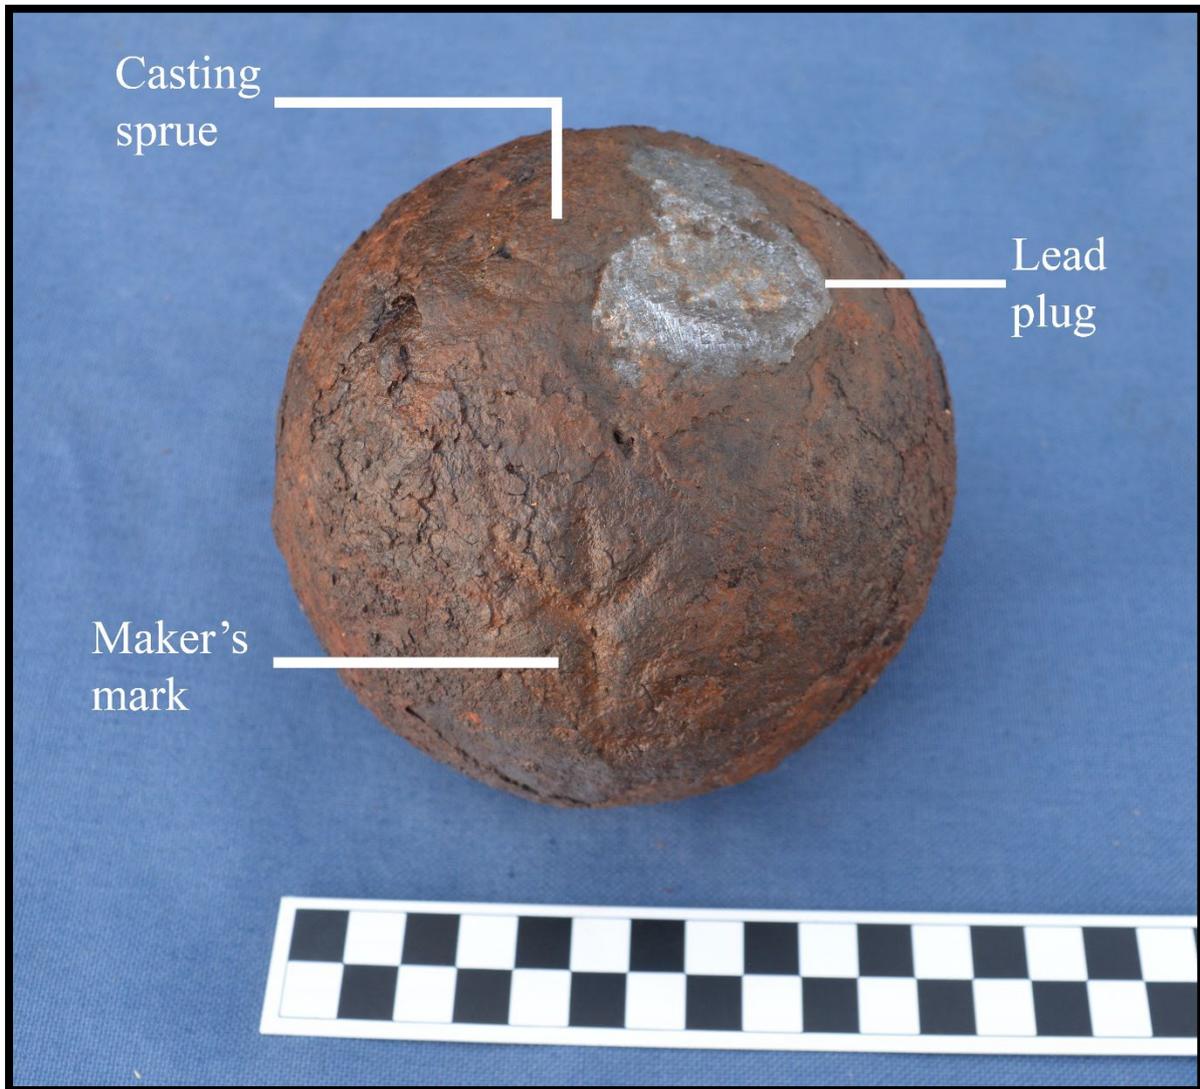
Figure 6.42: 12-pounder shot showing casting sprue, makers mark and lead plug (Photo by author).

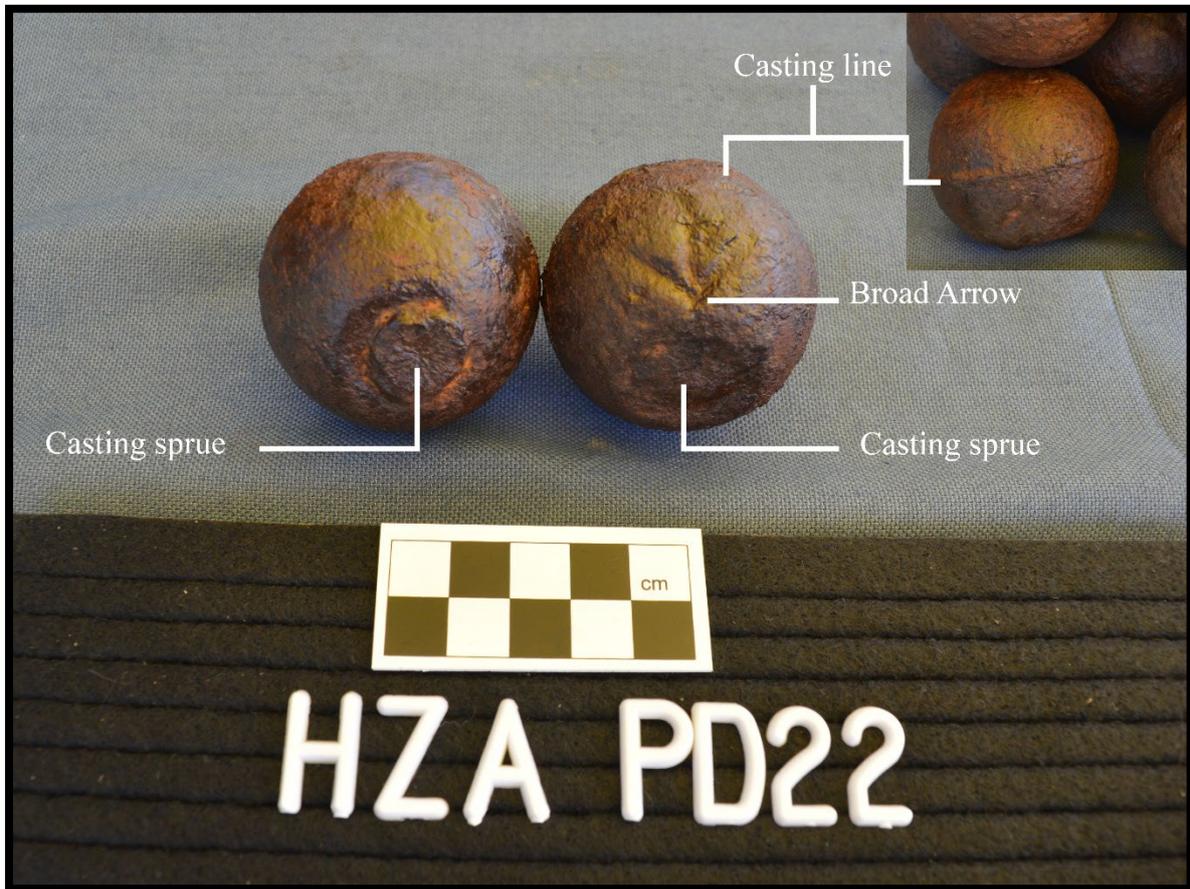
Figure 6.43: Examples of grape shot showing casting, sprue, casting line and broad arrow (Photo by author).

The grape shot range in diameter from 47-49mm (1.9 – 1.93 inches). They have an equatorial raised casting line separate from the casting sprue. The casting sprue has in most cases a raised dimple surrounded by a depression. The position of the cast line suggests a bipartite mould with joint aligned horizontally. In some examples a broad arrow, cut or hammered by an angled blade, such as a chisel, is located between the casting line and the casting sprue (Figure 6.43). The size of the depression around the sprue suggests that the pour of the molten iron into the mould was rapid. The details on both the round and grape shot suggest

they were produced by the same manufacture and the manufacturing process was conducted hastily, which may be a sign of the pressures put on by demand.

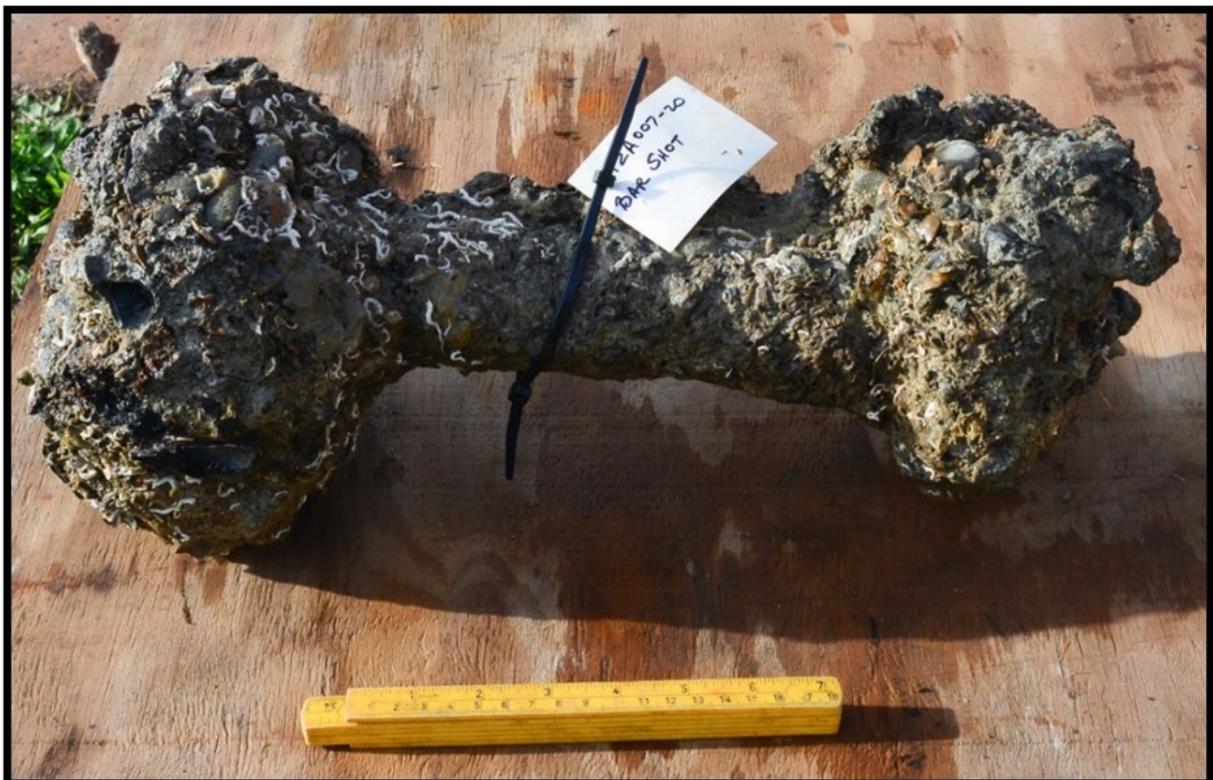
Figure 6.44: HAZA007-20 prior to de-concreting, note one end larger than the other (Photo by author).

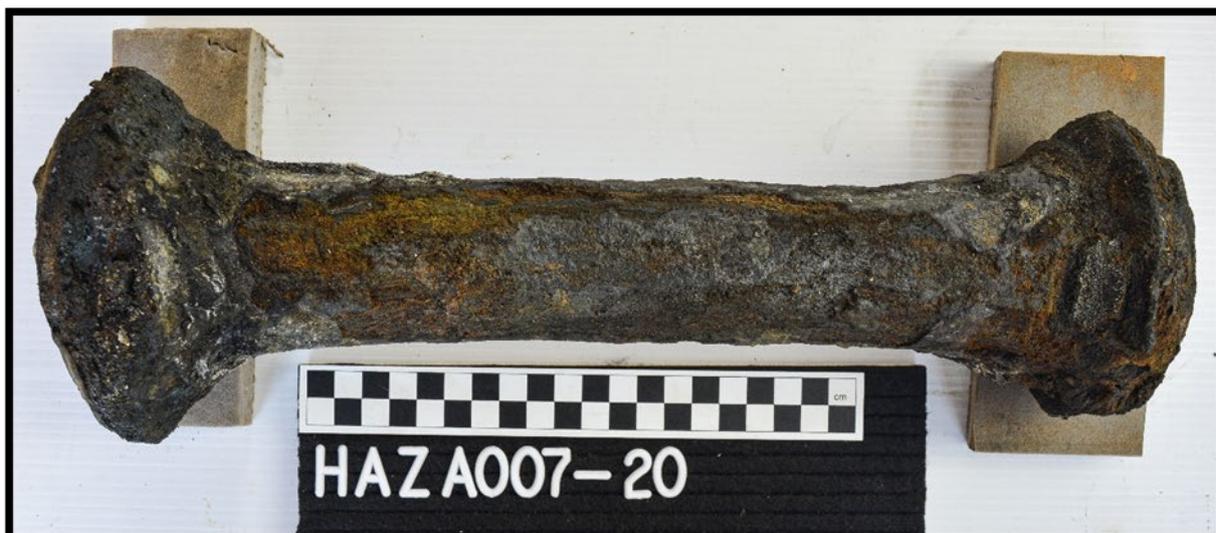
Figure 6.45: **HAZA007-20** following de-concreting. The scale in image is 20cm with 1cm increments (Photo by author).

The seven samples consist of a bar of wrought iron, which can be seen from the obvious grain in the metal, and which has been hammered at each end to form a dome (Figures 6.45 and 46). In at least one example of the de-concreted shot, **HAZA012-20**, an additional wrought iron ring was present (Figure 6.48). This must have been hammer welded (when bar and ring were hot) around the end of the bar to form the domed head. This is apparent from the change in direction of the grain of the metal, which is perpendicular to the bar (Figure 6.48). The reason for this may be that the bar was deemed to be too short to hammer both ends and therefore a ring was added at one end to make up the size of the head. Of the seven recovered four have a dimension at the head suitable for the 18-pounder guns (**HAZA007, 10, 32 and 33**). The length of these 18-pounder shot all differ, ranging from 395-367mm in length. The ranges in the length and diameters of the heads show that the manufacture of this type of shot was not an exact science. The inconsistency in the sizes of the shot of the same calibre can be attributed to the fact that they were all handmade and relied heavily on the eye of the blacksmith. The inconsistencies in size also demonstrates they were made quickly due to large quantities being required to supply the navy. The difference in lengths of the shot, or differences of a few millimetres between the two heads of a single shot, may not have had a significant effect. However, differences of 15mm, as with the case of **HAZA0032-20**, might have cause the shot to rattle down the barrel of the gun, which if repeated by other similar shot may cause damage over time, plus the shot's trajectory on leaving the gun would be affected by the weight discrepancy, sending it off target. According to Povey the heads of the

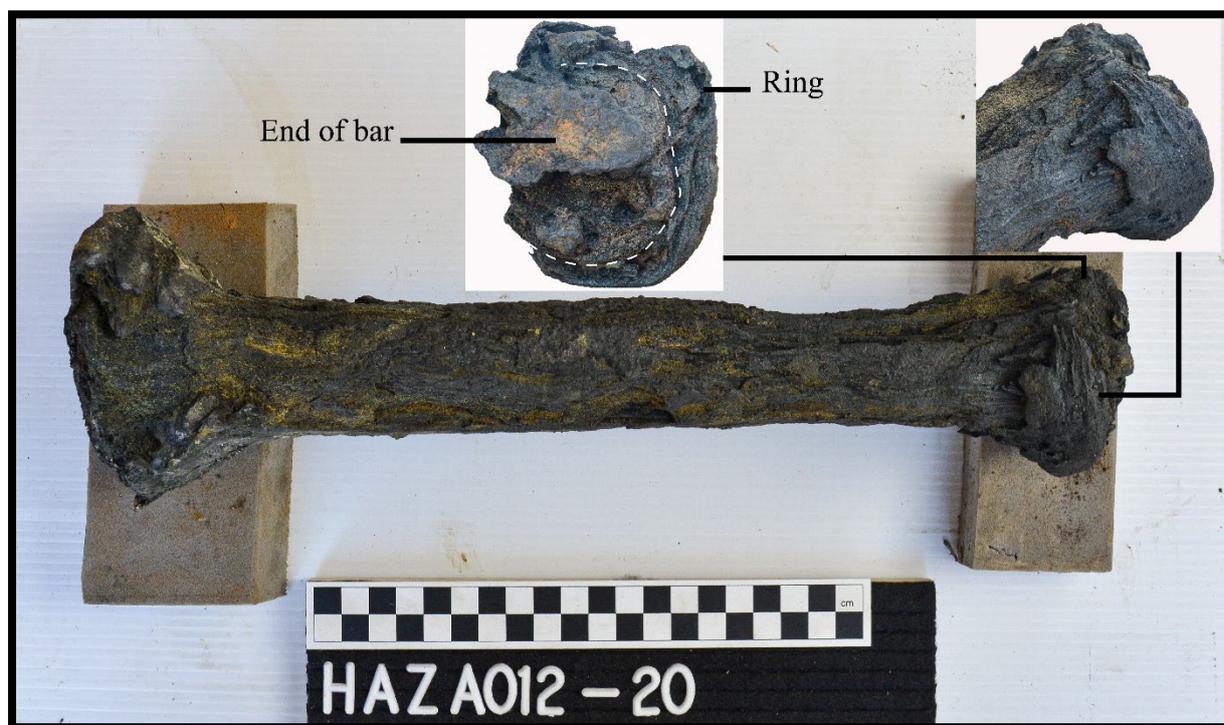
Figure 6.48: HAZA0012-20 double head hammered shot showing the remains of a ring at one end (Photo by author).

double head hammered shot should be equal to the height of the equivalent round shot (Povey 1702, p. 14), so the difference in size was probably a manufacturing error.

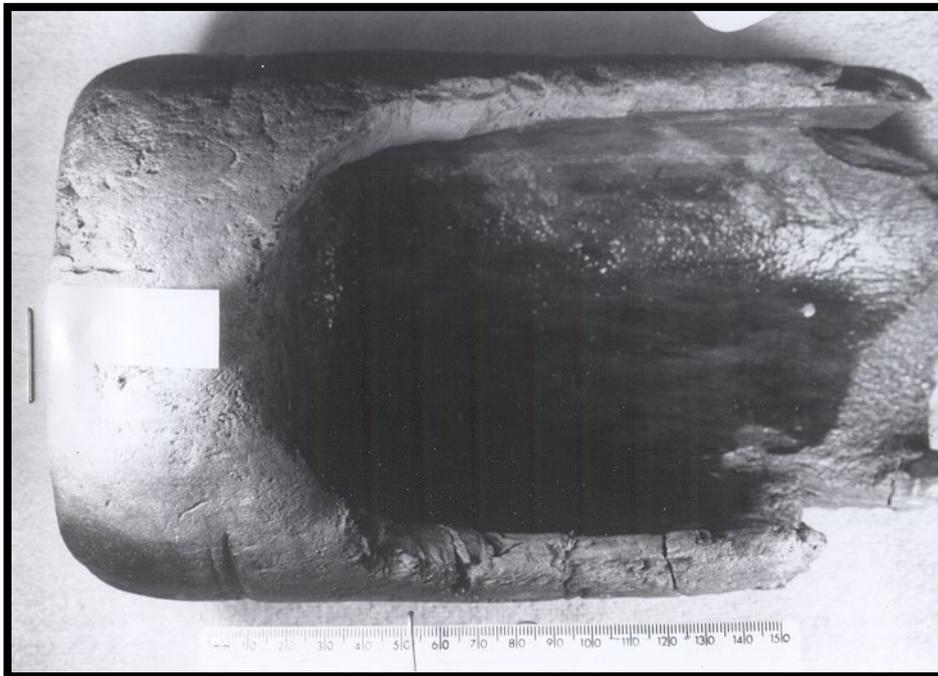
Figure 6.49: Fragment of a powder cartridge case recovered in 1988 (Courtesy of HPG).

the magazine and filling room have survived then they are currently buried, however artefacts associated with these areas have been recorded nearby suggesting the potential for these areas to survive. In 1988 an exploratory trench was excavated across the bow with the intention of better understanding the internal structure of that part of the ship. During the excavation artefacts were encountered including a fragment of a wooden cartridge case (Figure 6.47). A more complete example was found in 2016 (Figure 6.48) a short distance away, lying exposed between two floor timbers in an area consistent with the floor of the magazine or filling room.
