**Archaeological evidence for the development of Royal Naval
gunnery from 1545 – 1811; analysing change through technology
and culture**

By
Daniel Pascoe

Dissertation submitted in partial fulfilment of the requirements for the degree ‘Doctor of
Philosophy’, awarded by Bournemouth University

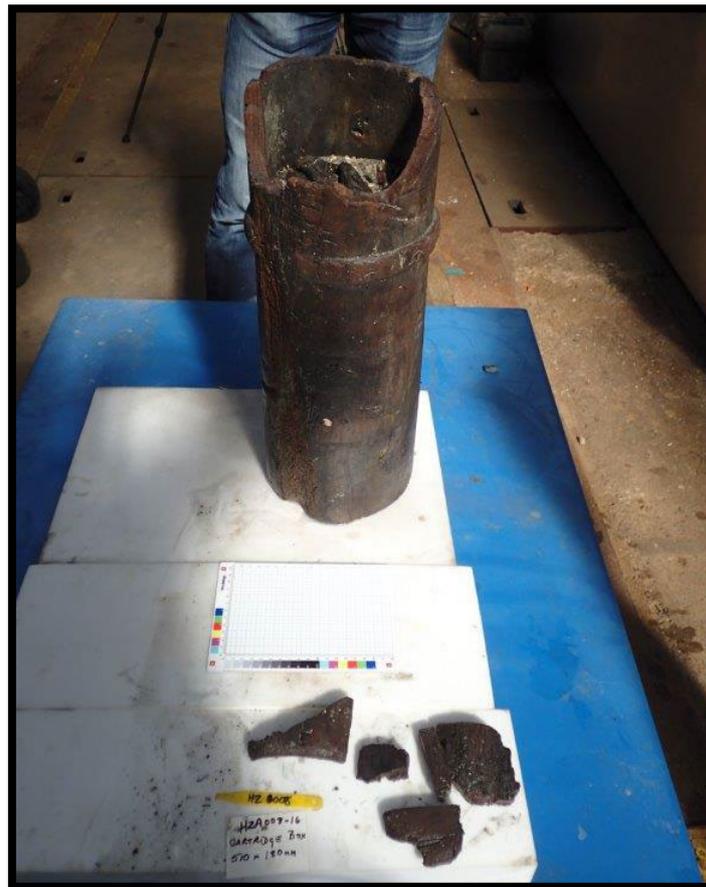
Figure 6.50: Cartridge case **HZA008-16** (Photo by author).

HZA008-16 is a hollow cylindrical container with a solid base, turned from ash (Figure 6.48). Its external diameter is 180mm and its internal is 140mm (5 ½ inches) and its height is 510mm. There is an external collar, semi-circular in section, two thirds of the way to the top (Figure 6.50). The collar has a pair of drilled holes for the attachment of a lanyard. A similar example was found on the Duart Point wreck and dozens were recovered from the later wreck of the *Invincible*. The latter were found with flanged lids, which plugged into the top of their cases and the ones on *Hazardous* would have had the same. The lids had corresponding holes that lined up with the holes at the collar of the case. A looped lanyard would have passed through the holes on both the lid and the case, held in place at the underside of the collar by terminal knots. These cartridge cases, known simply as ‘cases of wood for cartridges’ in

The cases carried a single charge of powder calibre and the internal diameter of the *Hazardous* cartridge case was appropriate for a charge for an 18-pounder gun. The comparison between this one and the example from the Duart Point wreck shows their design had remained the same.

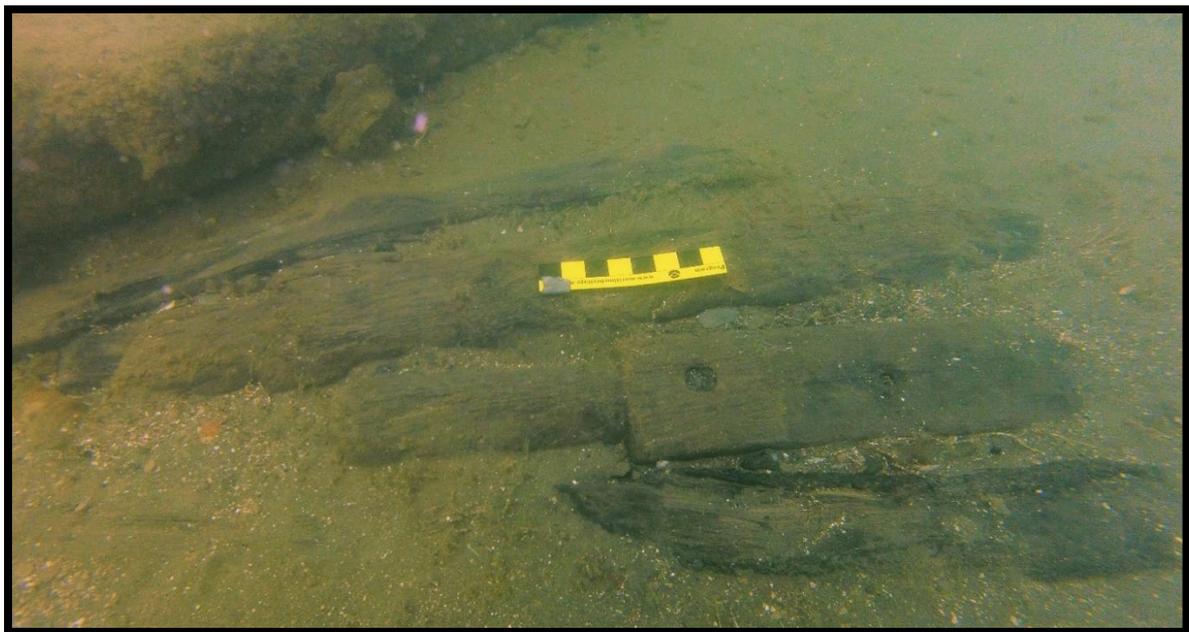
Figure 6.52: Axles **HZA012-14** and **HZA013-14** between two pieces of firewood (Photo by author).

Evidence from the *Hazardous* does identify, however, that spare equipment was used during the ship's last operation and that there was another use for defective components. In 2014 sediments levels inside the main site reduced to an extent that it exposed several timbers. Their location was consistent with the hold and, on close inspection, the timbers were identified as consisting of two gun carriage axles and several medium sized pieces of round wood, still with bark attached (Figure 6.52). The latter were interpreted as logs for fired wood and they were neatly and tightly packed together.

The two axles were recovered, and the logs were left in-situ. During the recording of the axles it was evident that they showed signs of wear and tear. Axle **HZA012-14** was split at one end and the recess on the top side of **HZA013-14** was worn along with its right arm (Figures 6.10 and 11). The condition of both axles and their location alongside firewood in the hold demonstrates first, that there were spare axles to swap out for these defected ones and, second, that the broken ones were going to be recycled for other use, possibly as firewood. The location where they were found was in the forward area of the hold, possibly in a compartment to the port side of the magazine.

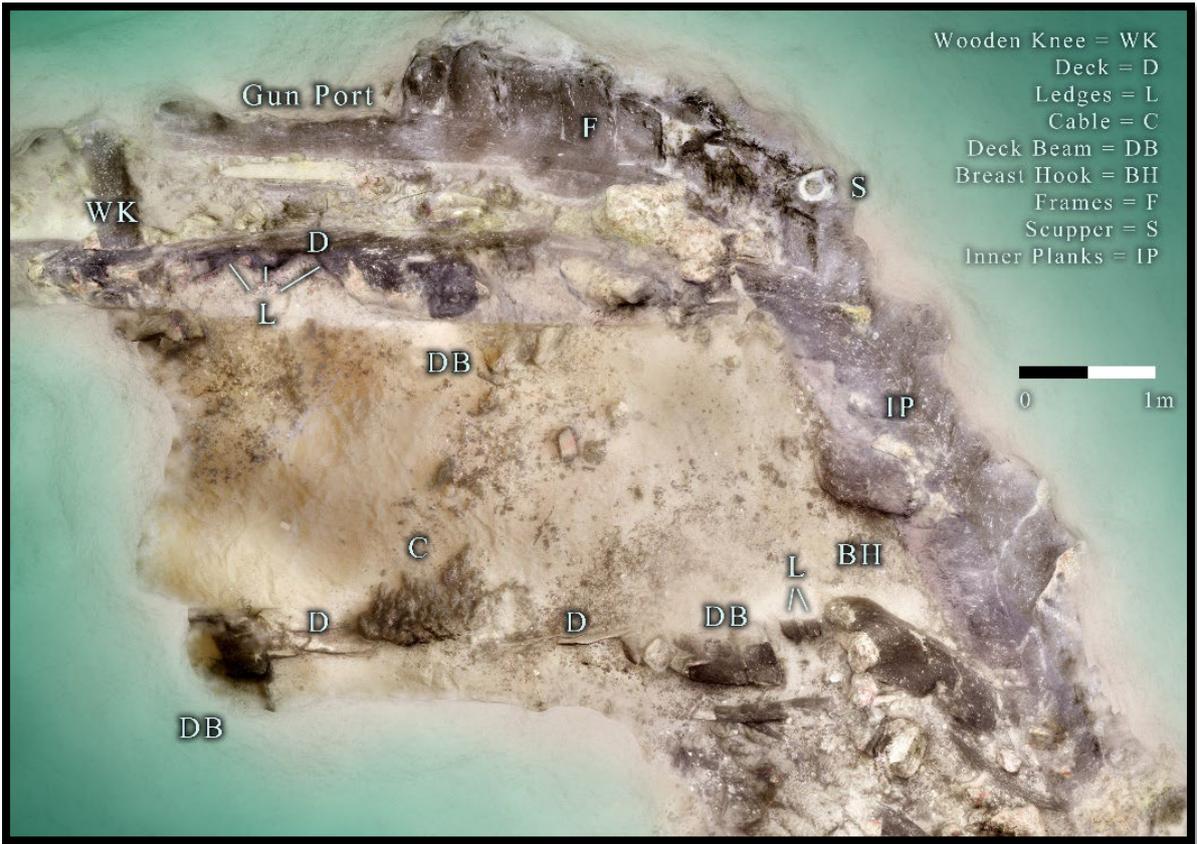
Figure 7.2: The 2016 photogrammetry survey of showing exposed parts of the gundeck, orlop and hold (Image courtesy of Pascoe Archaeology).

A pre-disturbance survey in 2016 had recorded exposed hull structures relating to the main gundeck, orlop and hold (Pascoe Archaeology 2017a) (Figure 7.2). Exposed artefacts on the seabed, along with Bingeman’s 1998 site plan, also indicated that this area had not been fully excavated (Bingeman 2010). The original plans of the *Valiant*, a 74-gunship based on the design of *Invincible*, shows this area of the ship accommodated the forward gun stations on the main gundeck, the gunners store on the orlop and the forward magazine and filling room on a raised floor in the hold (NMM J8137 and J8138). There was, therefore, high potential for finding artefacts and structures relating to gunnery in this location.

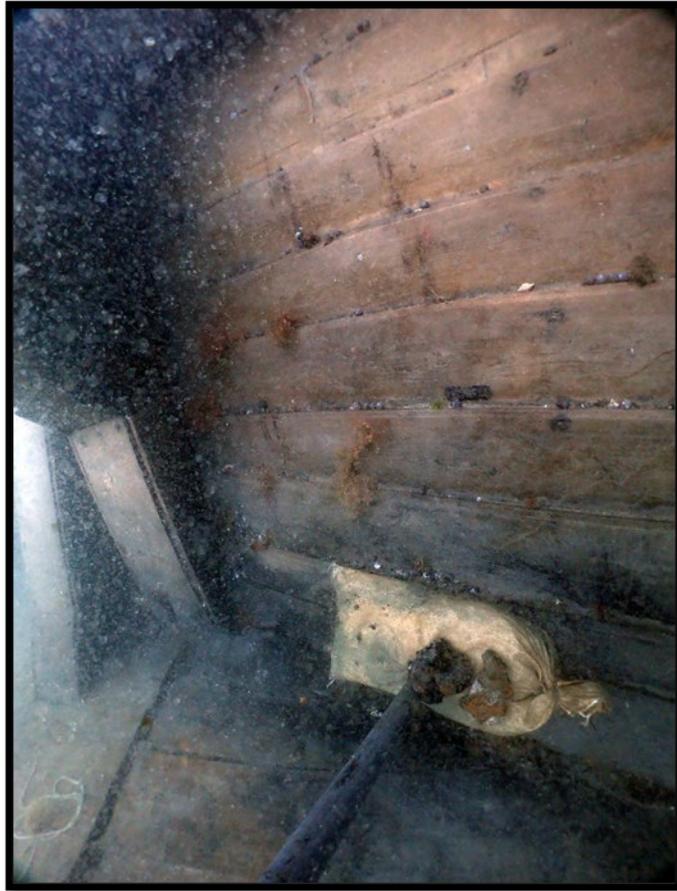
Figure 7.7: Cladding on inside of hull, notice how it is inverted (Photo by author).

has also been used to clad the inside of the hull. This cladding is referred to as deal or slit deal in contemporary building contracts (TNA ADM106/3072) and, from the evidence observed on *Invincible*, is constructed by securing overlapping planks to battens fastened to the inside of the hull (Figures 7.6-7). The three hanging iron knees were also boxed-in using the lighter wood (pine) (Figure 7.8). The remains of a partition, which separate two stores, was also made of the lighter softwood (pine) as well as a series of three boxed shelving units on the inside of the hull (Figure 7.6). Within this section of the orlop are three rising knees. The forward-most rising knee is composite, constructed with two pieces of timber, one on top of the other and fastened into the hull by iron bolts. The rear piece appears to have acted as a packer, shaped to fit the curve of the hull. The next rising knee is 4.11m aft, sandwiched between two iron hanging knees. The rising knee is also clad with the lighter softwood (pine), as was the final surviving rising knee. It was not possible to identify whether the knee behind the cladding was made of wood or iron, although wood is considered most likely given that all other iron knees have been hanging knees. Evidence from *Colossus*, a British 74 gunship wrecked in 1798, similarly identified wooden knees clad with a thin layer of lighter softwood (Camidge 2002, p. 35). Here it is believed that the boarding over of the wooden knees was to keep out dampness caused by the ingress of seawater behind the boarding and therefore keep the stores and compartments dry (Camidge 2002, p. 35).

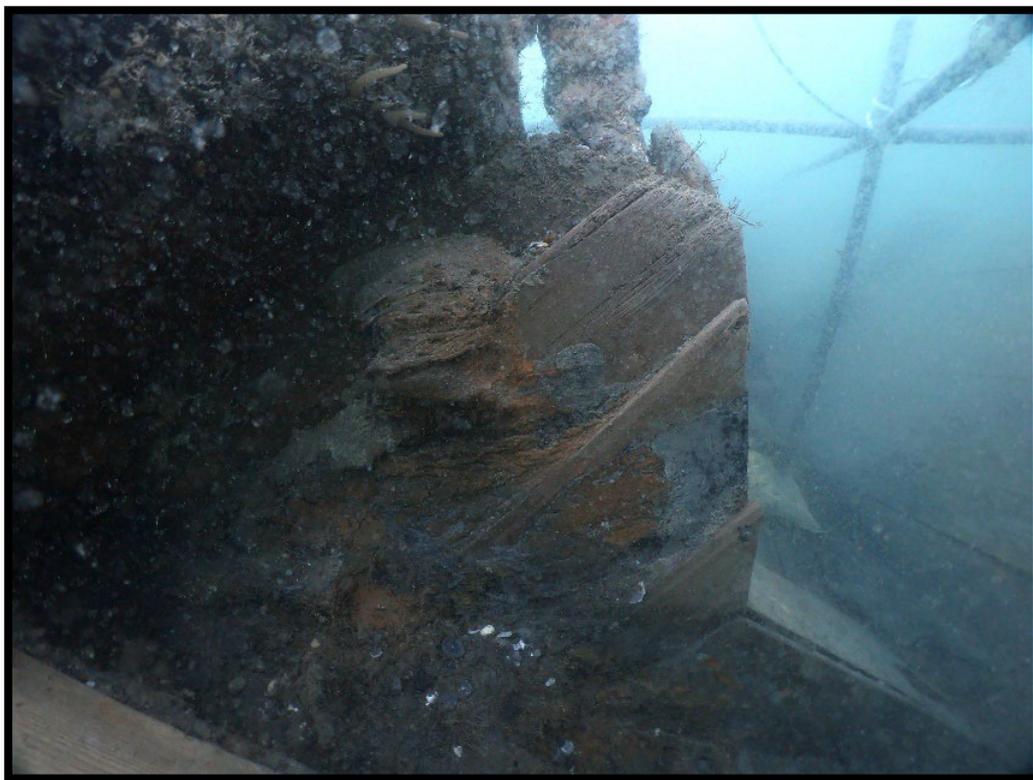
Figure 7.8: Cladding around iron knee along the orlop (Photo by author).

The detailed description above is necessary because this was an area of the ship where the gunner's store was located. The cladding on the inside of the hull and the iron and wooden knees may actually be more relevant than one would initially think. The orlop and the hold are below the water line and water would have leaked through the many seams between the planks, meaning that these parts of the ship would have been quite damp. Keeping the powder dry in the magazine was essential, and will be discussed below, but it would also have been important to keep other stores free from damp to prevent rot. The overlapping cladding would have done just this: creating a thin barrier against the damp inner hull as well acting as a layer of insulation. Further evidence of this function comes from the inversion of the cladding, with the exposed edge of the overlap upside down (Figures 7.7-8). This inversion would have stopped water from coming through to the inside face of the cladding and thus kept the store dry, as well as allowing any condensation created from within the store to run out behind the cladding.

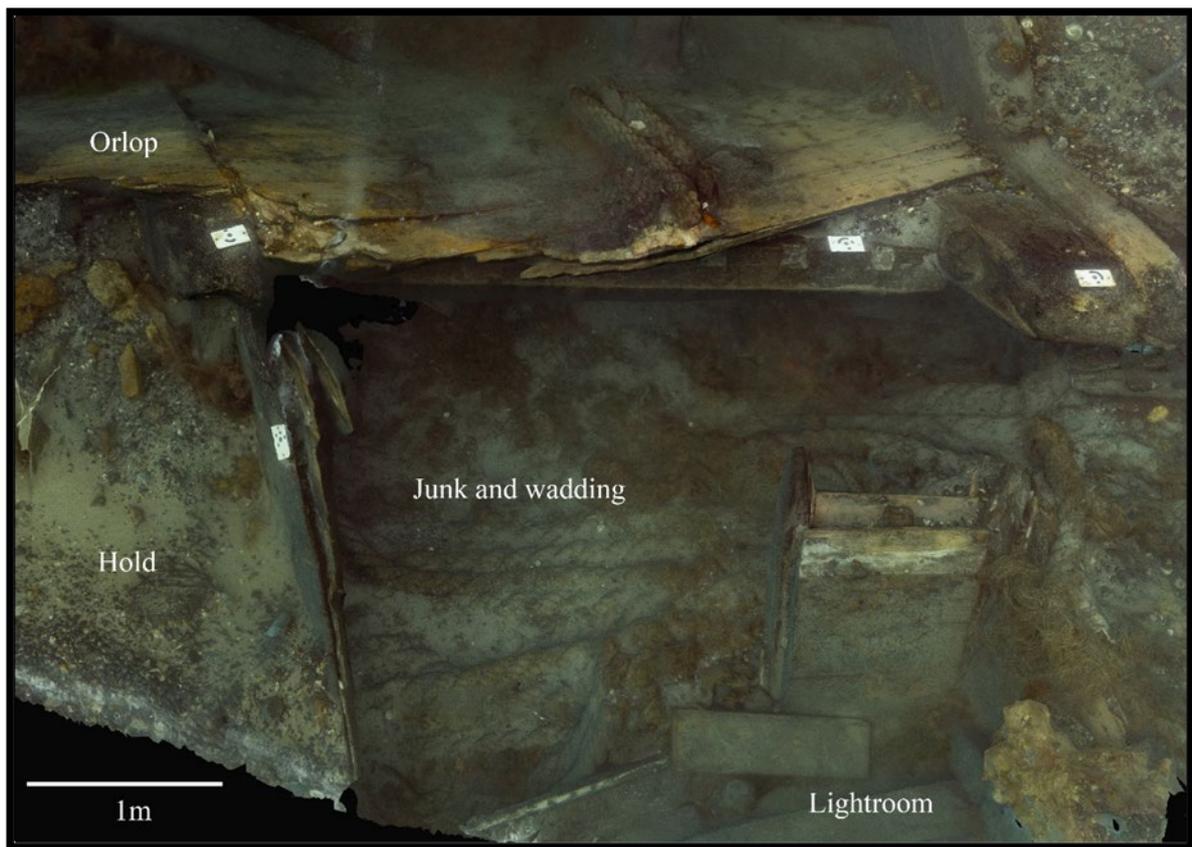
Figure 7.10: A still image from the 2017 photogrammetry model of Trench 1 showing the remains of the lightroom with wadding and junk outside the port side of the room (Survey and model produced by author).

A section of the floor and sections of the forward and port sides of the lightroom survive (Figure 7.10). The internal structures of the lightroom are constructed from a lighter softwood (pine) and the floor is raised over the ceiling planks and breast hooks. This raised floor is supported by oak half beams. Outside the port side of the lightroom was a space between the side hull and roof of the hold. Like the forepeak this was full of junk, but also with hundreds of gun wads, which will be described in more detail in section 7.3.4 (Figure 7.10).

A bulkhead consisting of oak planks and a layer of lighter softwood (pine) separated this area of the hold from the filling room and main magazine (Figures 7.9-10). The softwood was fastened to the oak by iron nails and between the two was a layer of plaster. The contract of a 70-gun warship dated 1755 described how the internal structures and bulkheads above and beside the magazine and filling room were lined and plastered for the security of powder (TNA ADM106/3072). There was no lining over the ceiling planks in the forepeak or the space to the port side of the lightroom.

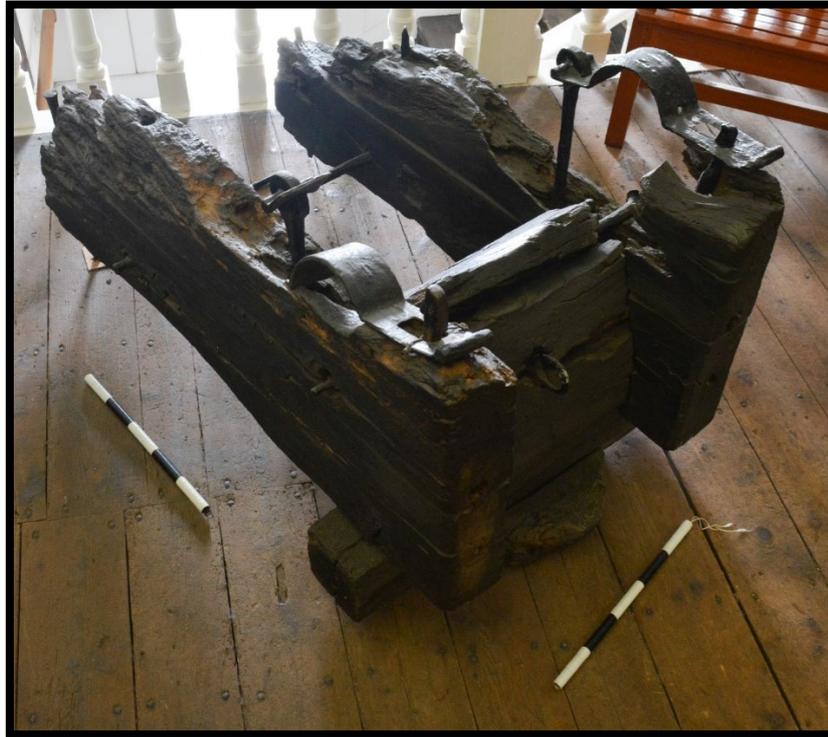
Figure 7.13: Example of a truck and axle carriage recovered from the wreck of the *Royal George* 1782 and now at the NMRN (Photo by author).

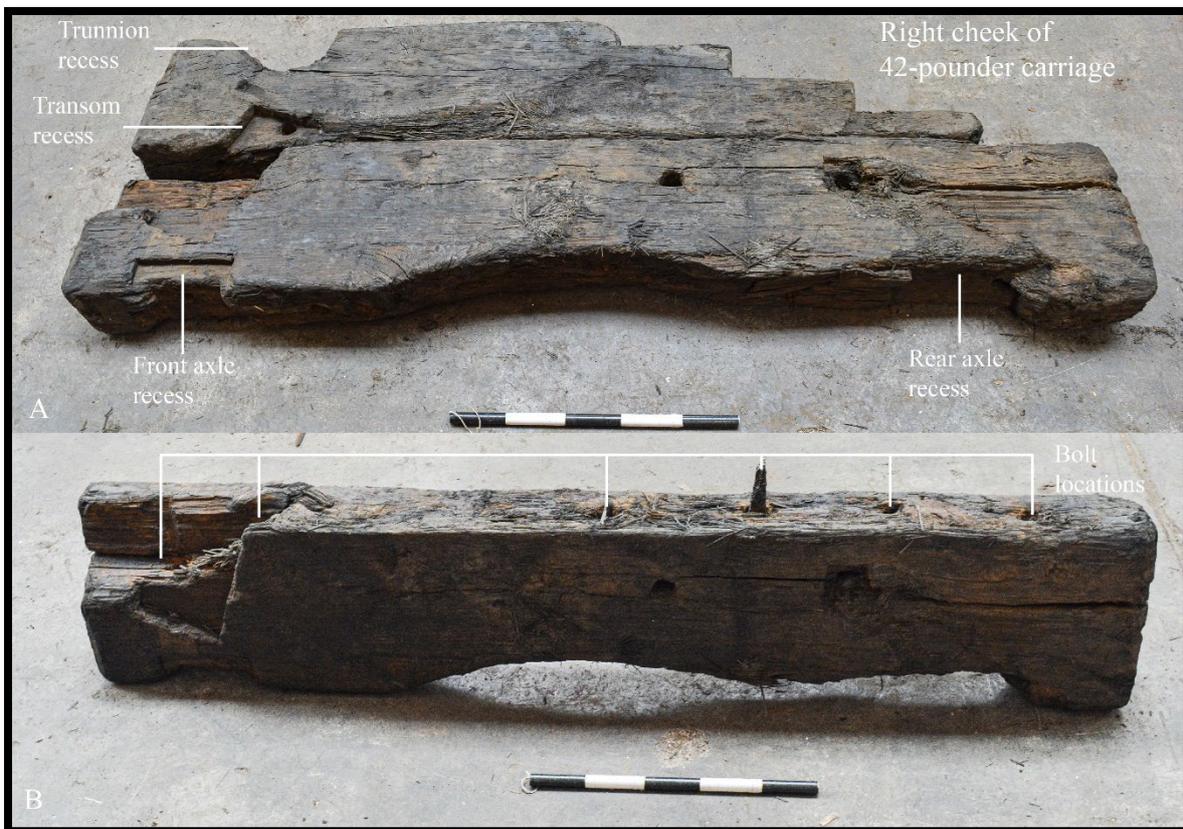
Figure 7.14: The right cheek of a 42-pounder carriage. A) Showing the cheek is made of two separate pieces and B) shows the lower section with location of six bolt holes. This example was recovered from a terrestrial site at Woolwich. The scale is 0.5m with 10cm increments (Photo by author).

The cheeks of bracket and transom carriage were each constructed from two pieces of timber that were secured by iron bolts. These bolts passed down from the top side through the two pieces. It would appear from the archaeological evidence of 18th century carriage parts from Woolwich (Figure 7.14), a recovered gun carriage from the first-rate ship of the line, *Royal George*, wrecked in 1782 (Figure 7.13), along with contemporary illustrations (Caruana 1997), that the cheeks were secured by up to six vertical bolts each. From contemporary illustrations and texts, five bolts would appear to be standard but the evidence surviving on the right cheek of a 42-pounder carriage, recovered from Woolwich, shows six bolt holes (Figures 7.14). This is not unexpected as 42-pounder carriages were the largest and it is no surprise that an extra bolt was needed to secure the two parts of the cheek.

The archaeological evidence from the *Royal George* and from Woolwich identify that a shallow arch was cut into the underside of the cheeks between the axles. This was probably another way of reducing the weight of the carriage without compromising the strength (Figure 7.14). The Woolwich rear axles have an eye bolt attached to the rear face of the rear axle (Figure 7.15). This was known as the after bolt (Mountaine 1747, p. 66). This eye bolt was where the train tackle was connected to the rear of the carriage. The single eye bolt was a change from the two ring bolts located on the rear corners of the old carriage with a solid bed. The obvious advantage with a single attachment point was there was only the need for one train tackle and therefore less tripping hazards across the deck.

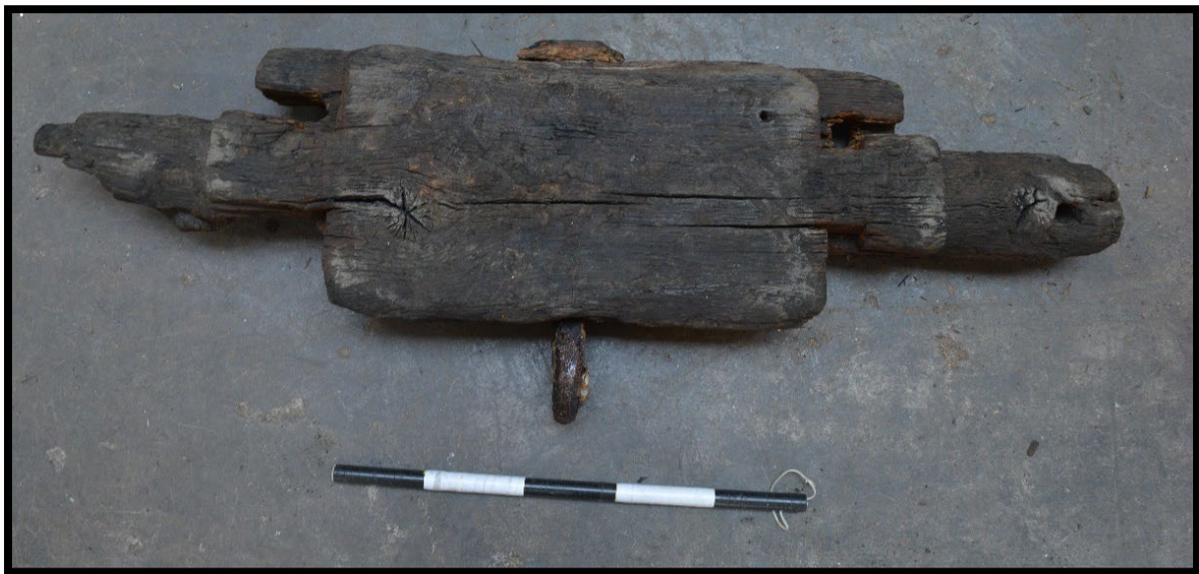
Figure 7.15: An example of a rear axle recovered from Woolwich show the after bolt, which would have been used to attach the train tackle (Photo by author).

The archaeological evidence and contemporary plans identify that the design of the front and rear axles were different (Figures 7.15 and 16). The rear axles have a wider upper surface to support the breech of the gun and provide a platform for the rear end of the stool bed. Recesses were also cut into the rear axle for the cheeks to slot into to form a strong and stable joint. The trucks fitted onto the end of the axles and were secured in place by linchpins (Figure 7.15). Finally an iron hoop was placed at the ends of each axle to prevent splitting (Mountaine 1747, p. 66).

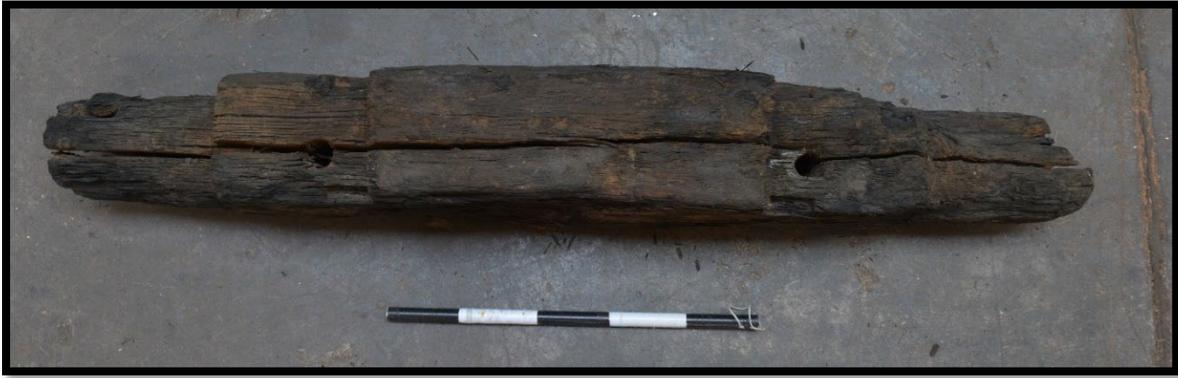
Figure 7.16: Example of a front axle recovered from Woolwich. Note how it is much narrower than the rear axles (Photo by author).

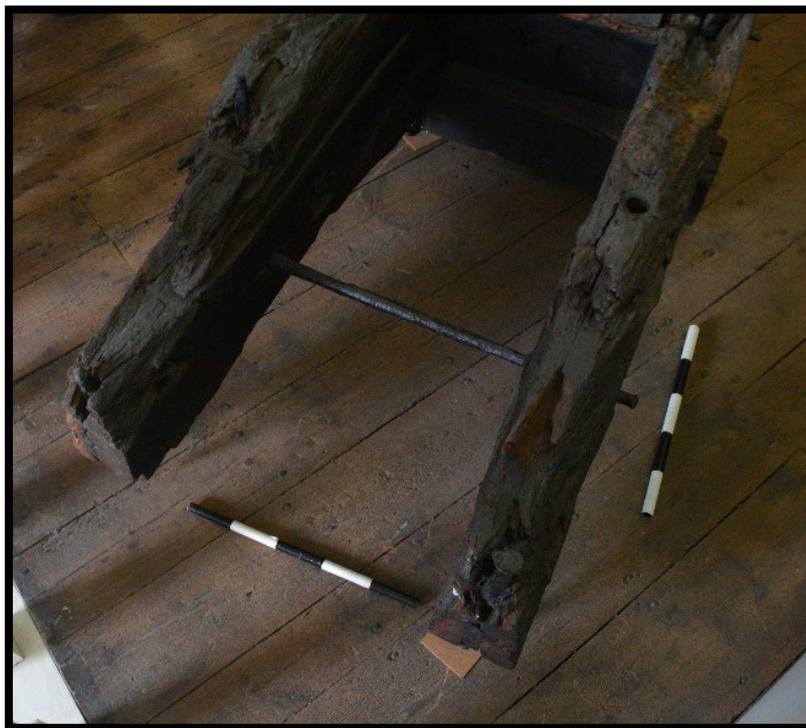
Figure 7.17: Photo showing the bed bolt between the two cheeks of the *Royal George* carriage. Note that the rear section including rear axle was missing from the carriage (Photo by Author).

The iron work on the outer faces of the truck and axle carriage was very similar to that of the older bed carriage. The exception would be the location of the iron through-bolts that provides strength between the two cheeks of the carriage. As the solid bed had been removed the through-bolt between the cheeks was located lower down, so a stool bed and coin could be supported (Figure 7.17). This was known as the bed bolt and it served to secure the cheeks and provide a rest for the fore end of the stool bed (Mountaine 1747, p. 65). The stool beds recovered from the *Invincible* have a notch cut into the underside of the fore end, which would slot over the bed bolt (Figure 7.18).

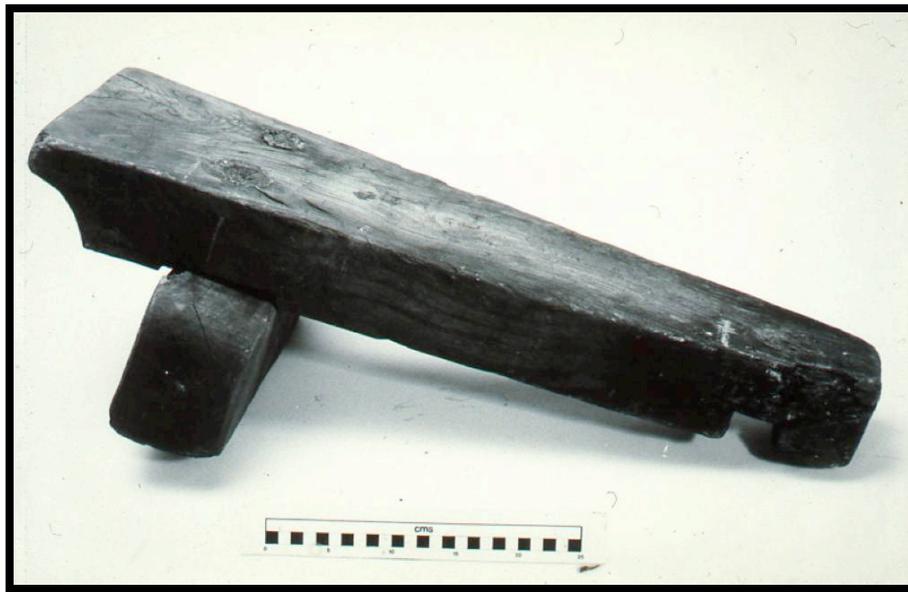
Figure 7.18: Example of a stool bed recovered from *Invincible* (Photo courtesy of J. Bingeman).

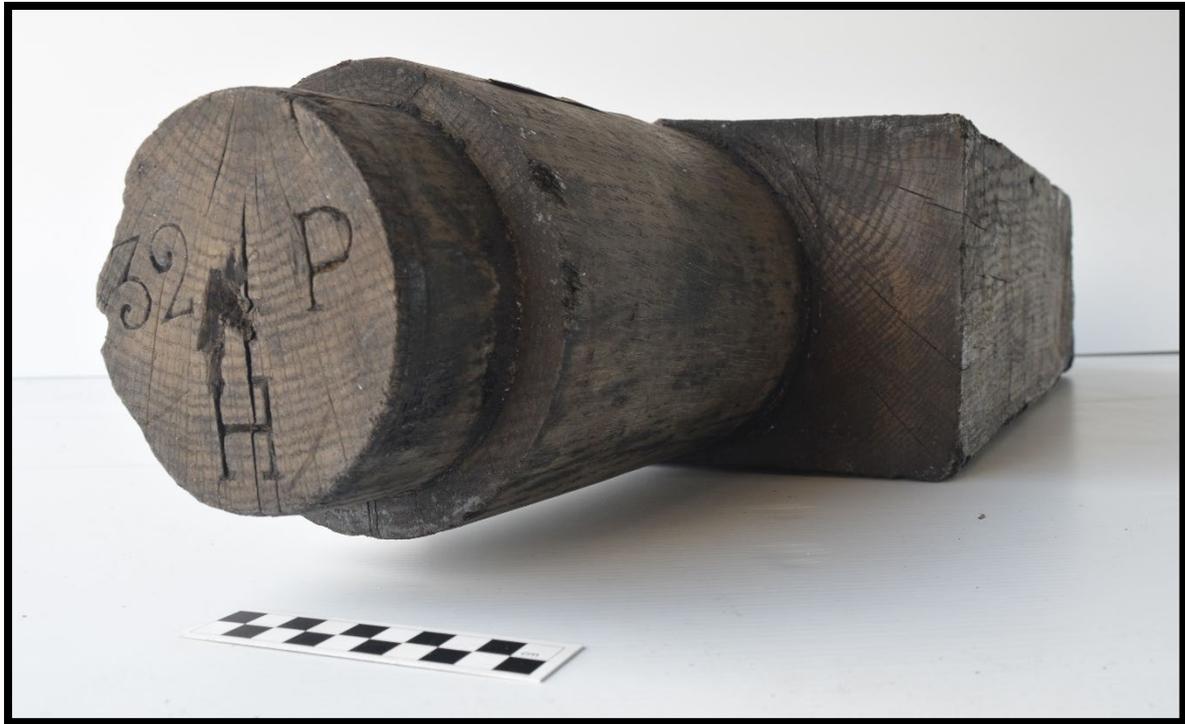
Figure 7.19: Photo of a spare hind axle **Inv18A1448** for a 32-pounder gun carriage (photo by author).

A total of eight spare gun carriage axles were found in Trench 1 sandwiched between two breast hooks in the forepeak. No spare axles were found during the earlier Bingeman excavations. All of the axles had one end of the axle eroded away but the sections of the axles that have survived are in a good state of preservation. Their design is clearly discernible, and the archaeological evidence identifies that the size of the gun and location on the carriage were marked at the ends of the axles (Figure 7.19). Not all of the axles have the markings, which suggest only one end of the axle was marked with the size of gun and locality on the carriage. With the exception of the markings at the end of the axles there were no other inclusions, such as the recesses, to accommodate the cheeks or bolt and linchpin holes to fasten the components of the carriage. This identifies that there would have been minor

differences in sizes and thickness of the various carriage parts, and it was therefore a more sensible practice to make these alterations to the axles specific to the carriage they would be fitted to.

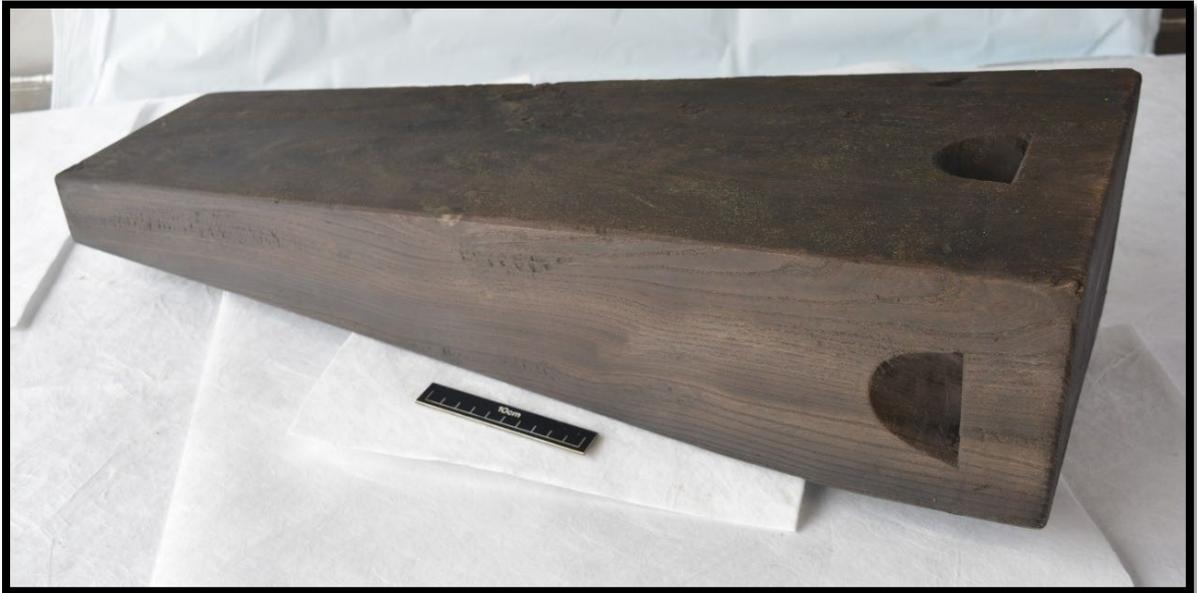
Figure 7.21: 32-pounder coin recovered from *Invincible* (Photo by author).

Stool beds and coins

The design of the 32 and 9-pounder coins are the same. They are wedged-shaped with neat chamfered edges. There are semi-circular finger holes on each side of the coin at the thick end (Figure 7.21), which would have made gripping the coin easier when pulling it from beneath the breech of the gun. There is obviously a considerable size difference between the two coins: the 32-pounder is 690mm long by 280mm wide at the rear end and 172mm at the front end and it is 162mm thick at the rear and 57mm thick at the front; the 9-pounder coin is 544mm long by 200mm wide at the rear end and 130mm at the front and it is 120mm thick at the rear and 36mm at the front. The size of gun each coin was intended for is also clearly marked on the outside face of the wedge (Figure 7.23). A single 32-pounder coin was recovered during the Bingeman excavations, which was marked with *Invincible's* name and the calibre of the gun (Bingeman 2010, p. 131).

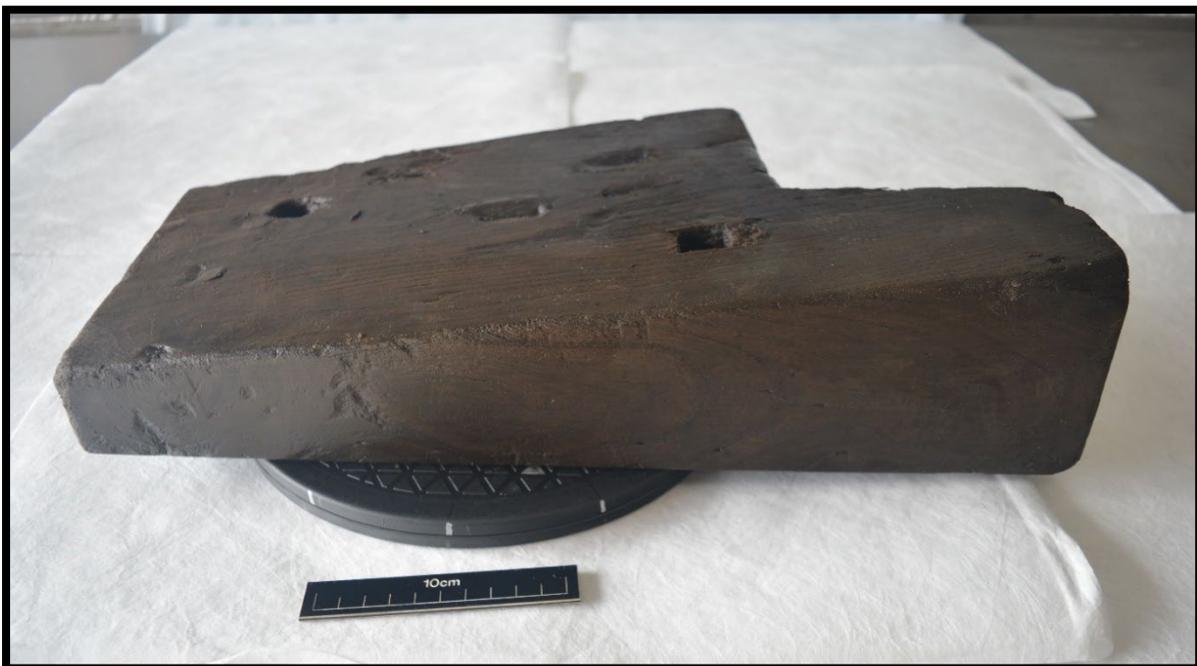
Figure 7.22: New type of coin for coining guns of the new pattern recovered from the *Invincible* (Photo by author).

A total of 14 of the ‘new type’ of coin were found. Eight were found between the raised floor of the lightroom, four were found neatly stacked in the corner of the lightroom and two others were found in Trench 4, within the remains of the starboard side. At least one was recovered during the Bingeman excavations and can be seen in the diver sketch in Figure 7.20. This ‘new type’ of coin is different in design to the regular coins. It is wedged-shaped but with one corner of the thick end cut out. On all but one there are two staggered holes drilled through the broader surface of the wedge. These coins also have neat chamfered edges (Figure 7.22). This type of coin has only been recorded and recovered from one other site, the *St George*, a second rate wrecked in 1811. They are identical in design and were also recovered from the orlop of the *St George*. In both the cases these type of coins came from areas of storage rather than from the carriages on the gundecks, which makes the positioning or attachment of these coins to the carriages currently unclear but hypothesises for their use will be discussed in section 8.4.1 of the next chapter. As all the standard coins are marked with the calibre of the gun, the fact that all the ‘new type’ do not have markings suggest they could be used for all calibres.

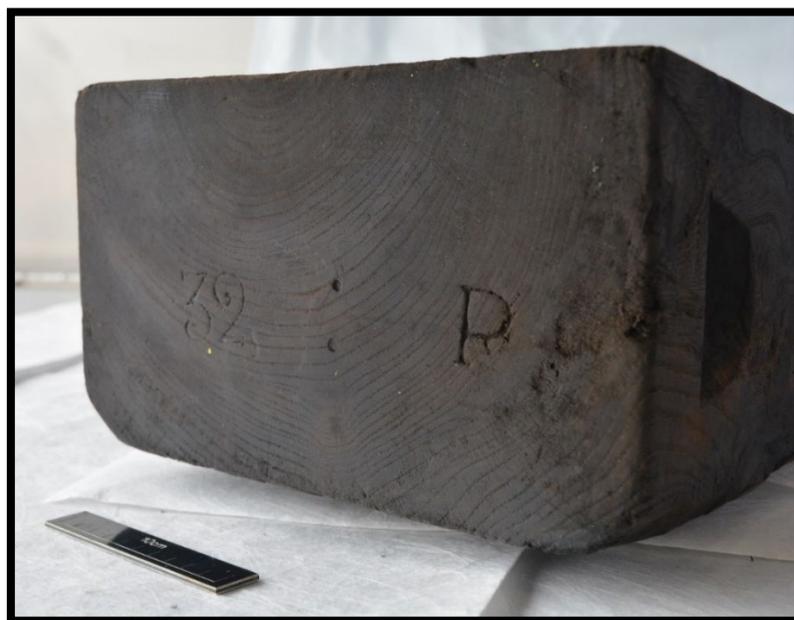
Figure 7.23: 32-pounder coin **Inv18A1082** with size inscribed on the rear face (Photo by author).

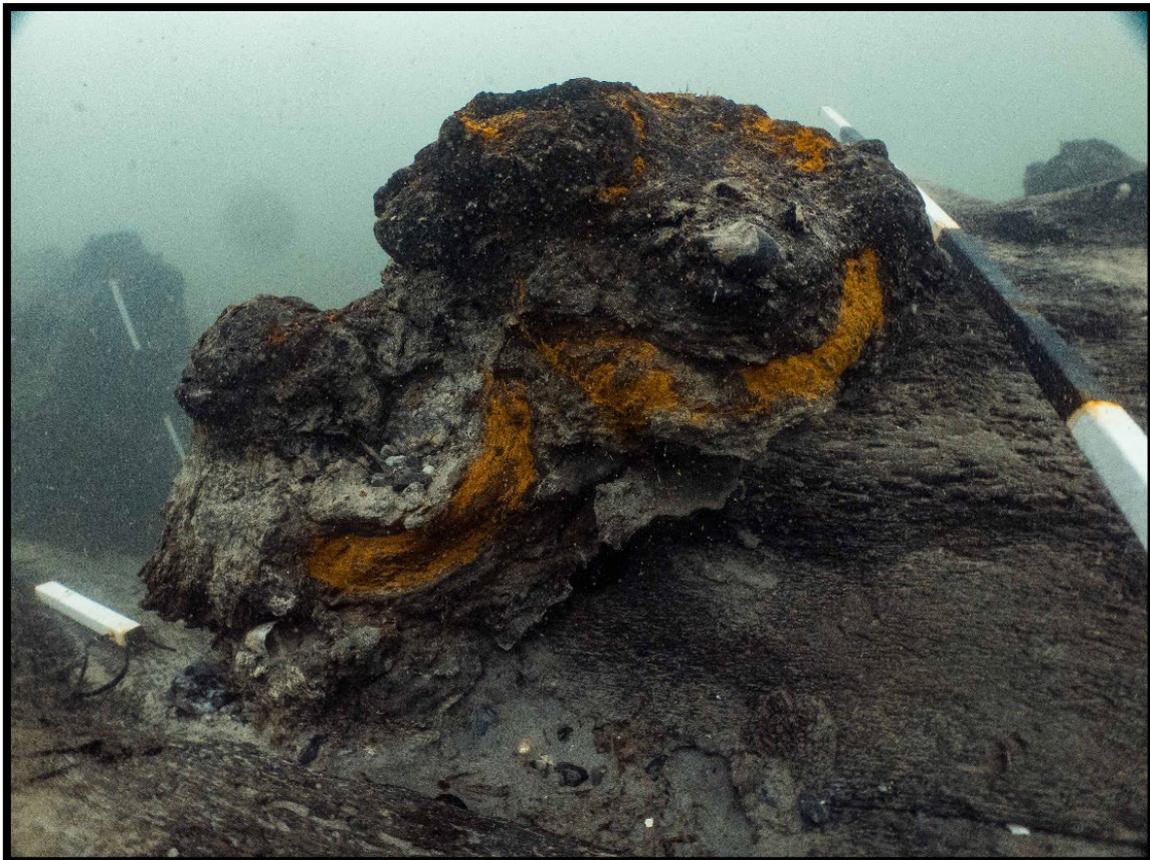
Figure 7.25: The remains of the upper and lower ring bolts on the right side of the gunport (Photo by author).

The evidence for securing the guns from the *Invincible* comes from the main gundeck and the concreted remains of ring bolts on either side of the gunports (Figures 7.24 and 25). The clearest evidence survives on the inside of the hull at the location of the aft most gunport on the port side. There was the evidence of two iron ring bolts fastened to the inside of the hull on either side of the gunport. Supporting evidence can be found in the historical record from a letter dated 15th June 1731 from Captain Romney of the 4th-rate *Romney* to Officers at Portsmouth dockyard. The letter stated that the ship had only one pair of ring bolts to each gunport on the lower deck, and that two pairs were required for securing the guns in bad weather and for convenience in time of action (TNA ADM106/830/233).

On each side of the gunport the ring bolts are in a staggered position one above the other (Figures 7.24 and 25). The upper ring bolt is further away from the side of the gunport than the lower. The bottom of the lower concreted ring bolt on the left side of the gunport is 125mm above the sill and the bottom of the lower one on the right side is 105mm above the sill. The bottom of the upper concreted ring bolt on the left side is 316mm above the sill and the bottom of the upper one on the right is 320mm above the sill. Directly above the lower ring bolts on each side was the evidence of another ferrous fastening. These are possibly the remains of eye bolts.

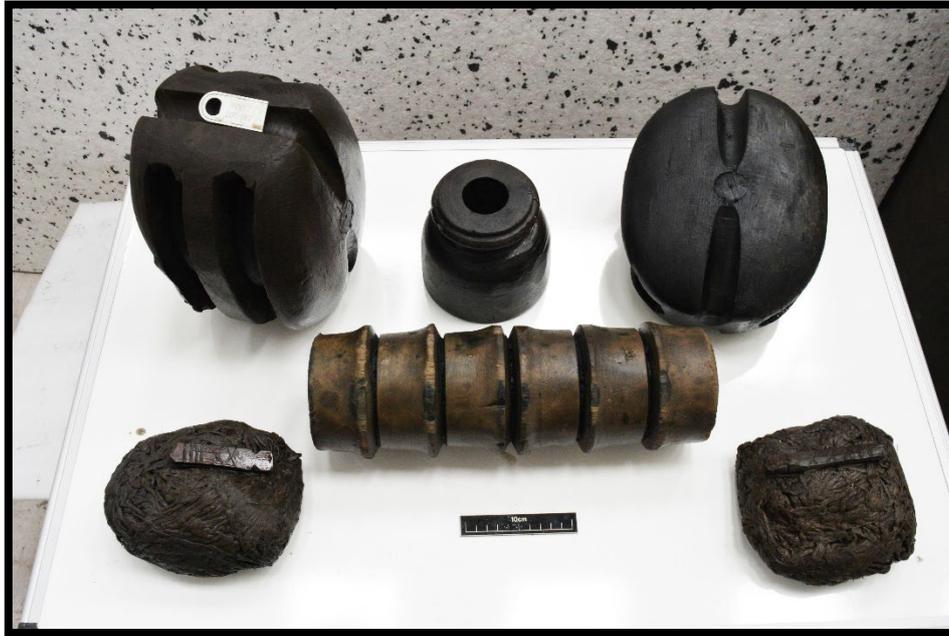
Figure 7.27: Top left a 10 inch double block, top right a ten inch single block at the centre is a reel of six 9-pounder tampions (Photo by author).

To move the guns backwards and forwards gun and train tackle were used (Figure 7.27). Each gun would need two pairs of single and double blocks for the gun tackle and a pair for the train tackle. In addition, 74- gunships like *Invincible* were issued with seven pairs of spare 10 and 8 inch single and double blocks, and seven pairs of spare single 6 ½ inch blocks (NMM RUSI/6). The evidence for these spares comes from single and double blocks found in the remains of the gunner's store on the orlop, in other areas nearby on the orlop and in the hold below. During the current excavations a ten inch single and double block were found lodged under the deck of the orlop in the area of the forepeak. It is highly likely that this pair originated from the gunner's store above.

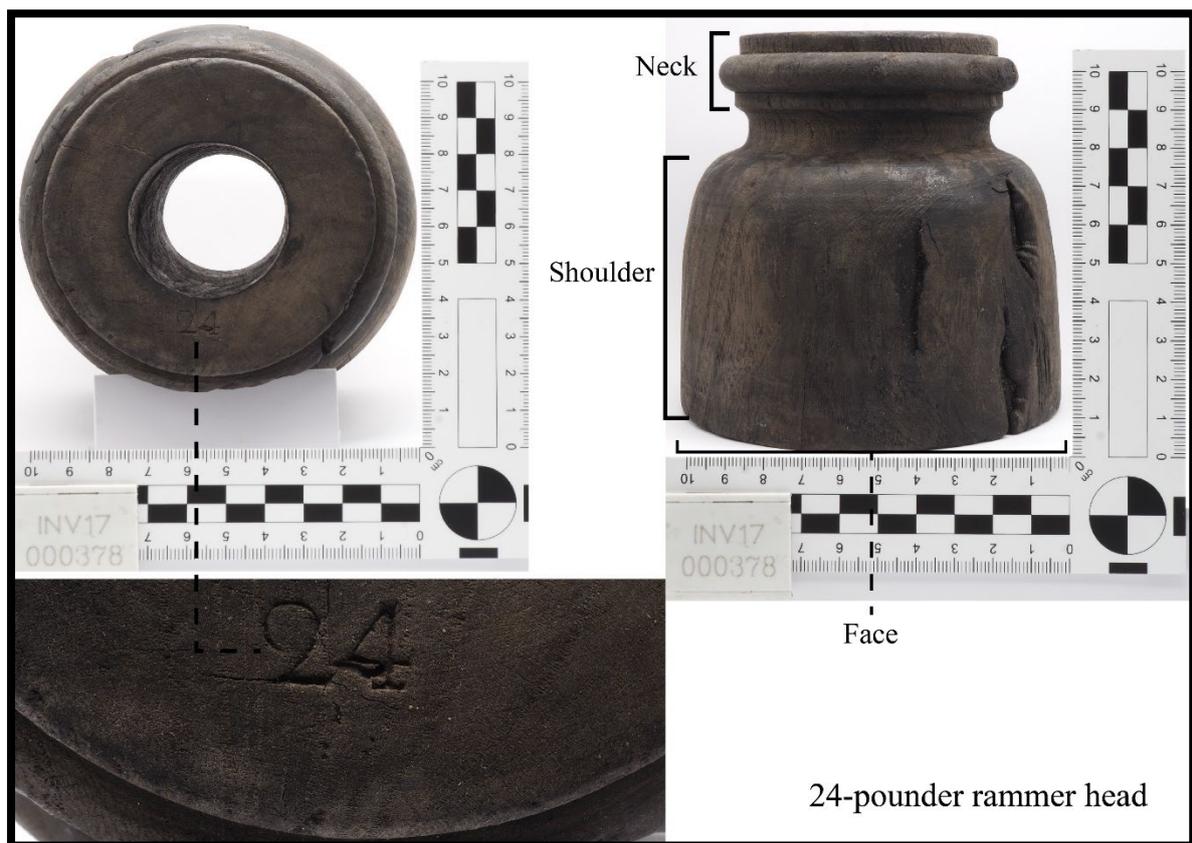
Figure 7.30: A rammer head for a 24-pounder gun (Photos taken by Arantza Novelo and figure produced by author).

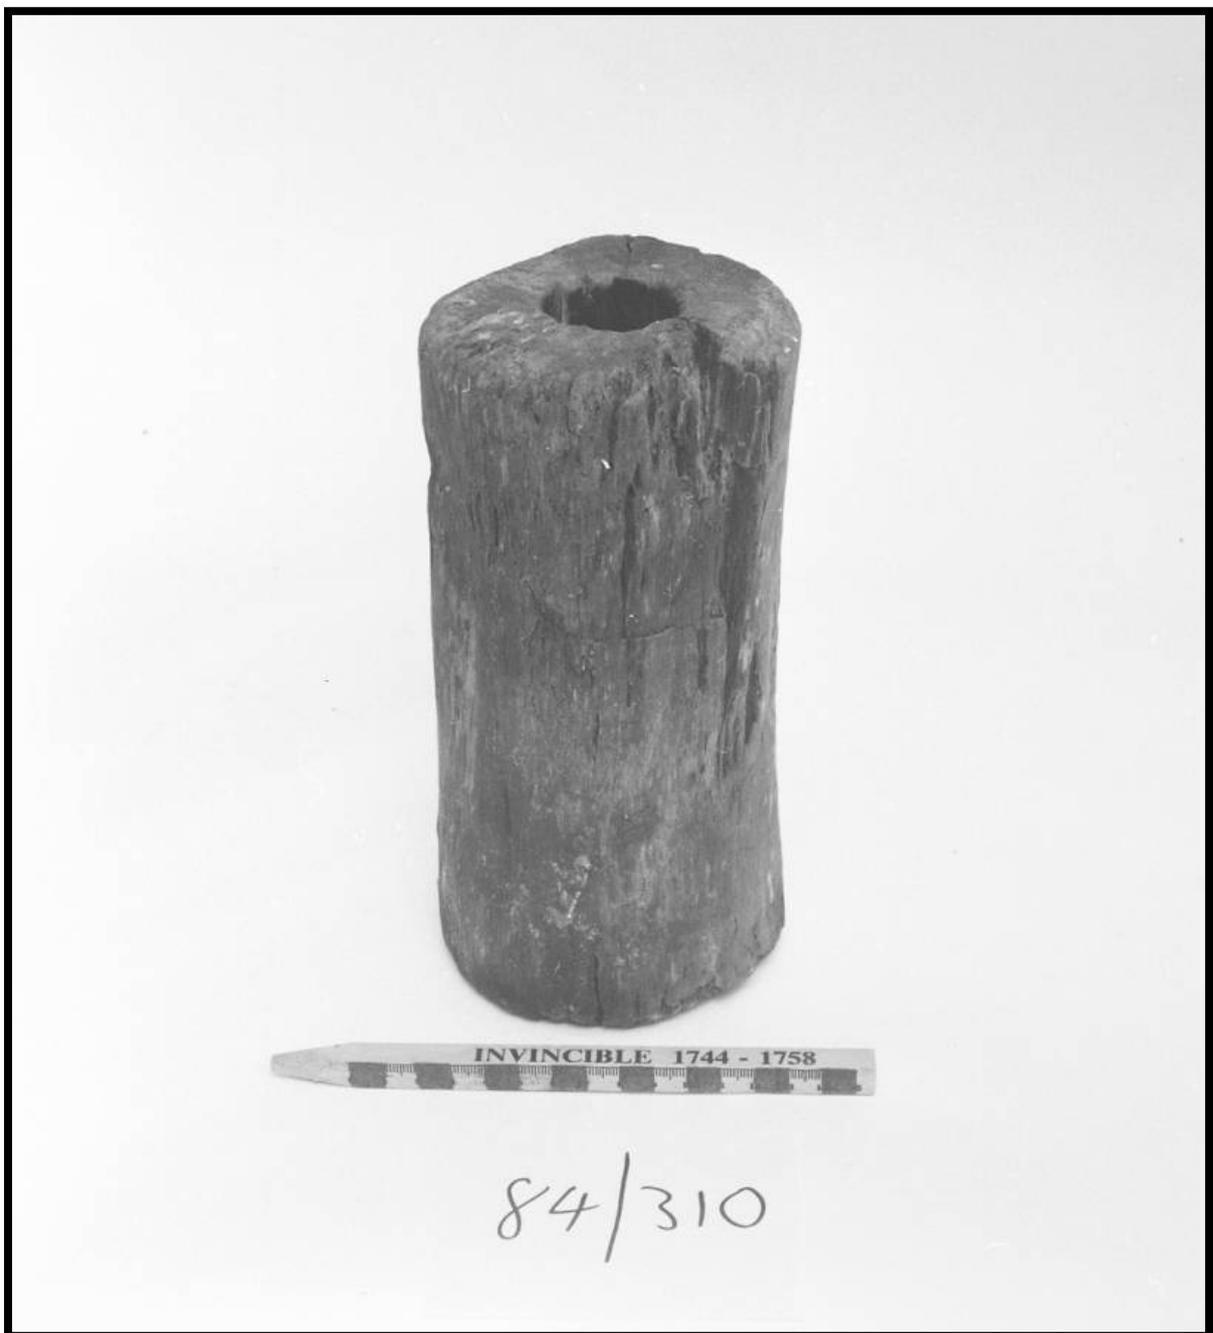
Figure 7.31: A sponge head recovered during the Bingeman excavations (Courtesy J. Bingeman).

All three sizes of sponge cylinders were recovered during the Bingeman excavation, but none were found during the current investigations. A total of 16 sponge heads were recovered, one 9-pounder, eight 24-pounder and seven 32-pounder. Some of the heads were stamped with either 32 or 24 to indicate the calibre of the gun. They are all the same shape: a straight cylinder with a hole running through the centre (Figure 7.31). The 24-pounder head was 225mm long with a diameter of 115mm and the 32-pounder head was 245mm long with a diameter of 125mm.

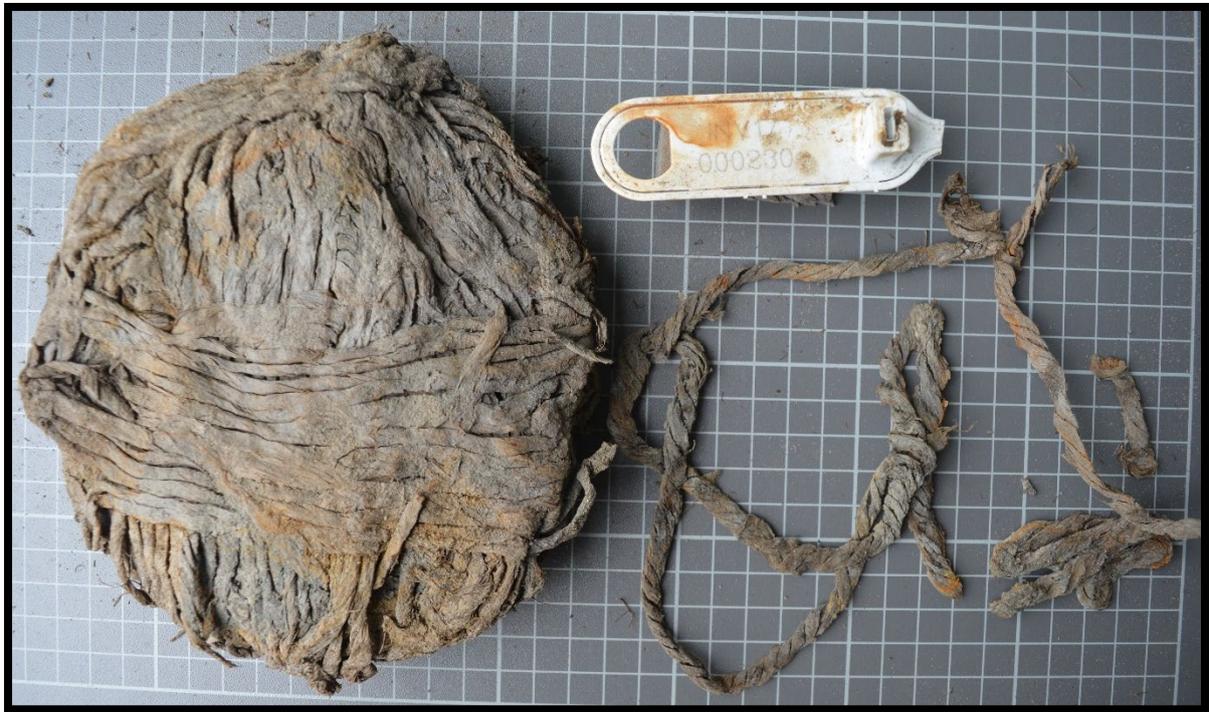
Figure 7.32: Gunwad **Inv17 0230** with fragments of the string bag (Photo by author).

The evidence from *Invincible* shows that there were three sizes of wadding to match the calibre of the guns on board, demonstrated by their string bags containing a wooden tally stick with the calibre of the gun (Figures 7.32,33 and 7.50). The exception being the 9-pounder, which was significantly smaller. It is highly likely that a bag of wads could be picked up and taken to a particular gun station when needed.
