**Archaeological evidence for the development of Royal Naval
gunnery from 1545 – 1811; analysing change through technology
and culture**

By
Daniel Pascoe

Dissertation submitted in partial fulfilment of the requirements for the degree ‘Doctor of
Philosophy’, awarded by Bournemouth University

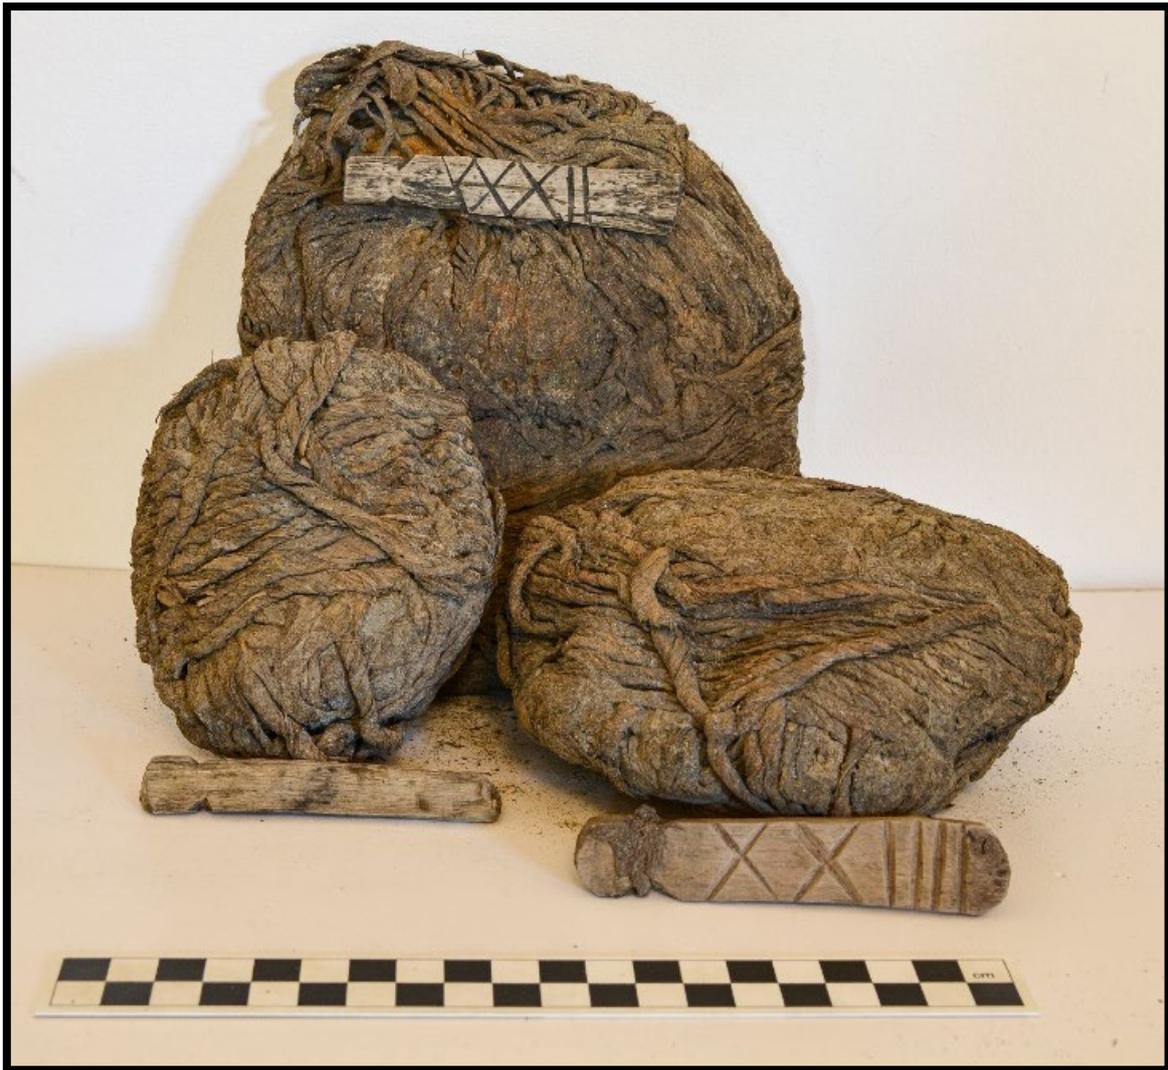
Figure 7.33. Examples of the three sizes of wadding with their associated tally stick indicating the calibre of the gun (Photo by author).

Just aft of the forepeak there was a compartment between the portside wall of the lightroom and the side of the hull. This area was full of wadding, also known as gunwads. Below the wadding were numerous lengths of junk (Figure 7.10). The wadding are balls of yarn and they were piled up in string bags. Only pieces of the bags survived but these showed that the string was made from three yarns twisted together (Figure 7.32). The bags came with a tally stick providing the calibre of the gun they were intended for, which were made of thin strips of wood with the calibre written in Roman numerals: XXXII for 32-pounder and XXIII for 24-pounder. The 9-pounder tally sticks were blank, probably because their size is considerably less, whereas the 32 and 24-pounder wads are a similar size (Figure 7.33).

The evidence from *Invincible* shows that there were three sizes of wadding to match the calibre of the guns on board, demonstrated by their string bags containing a wooden tally stick with the calibre of the gun (Figures 7.32,33 and 7.50). The exception being the 9-pounder, which was significantly smaller. It is highly likely that a bag of wads could be picked up and taken to a particular gun station when needed.

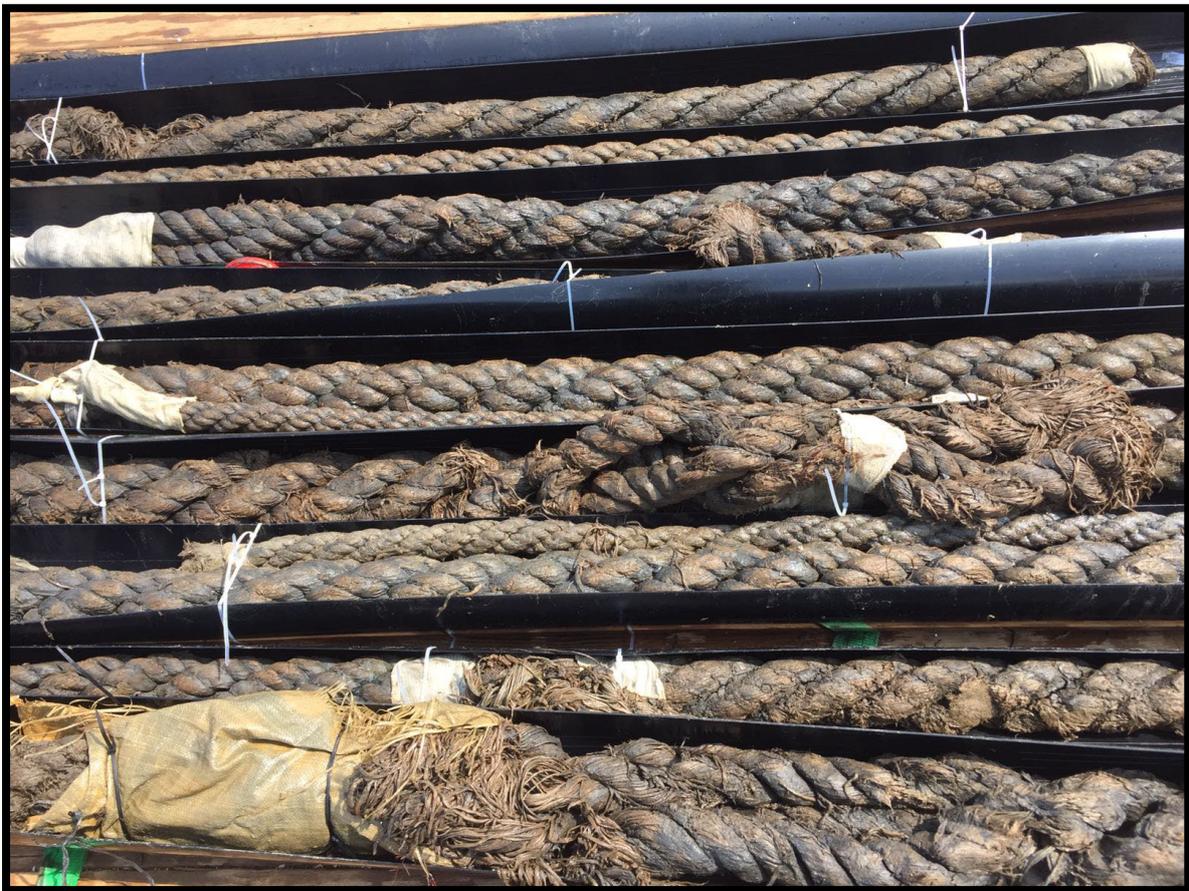
Figure 7.35: Examples of the various sizes of cable laid rope recovered from the junk and wadding store (Photo by author).

During the Bingeman excavations 14 gun wads were recovered (Bingeman 2010, p. 115), with approximately 1000 recovered during the current excavations. Below and around the outside of the wadding was the junk, some of which was also coming from the forepeak. The junk was made up of various sizes of cable-laid rope and hawser-laid rope. It also included large pieces of served cable laid rope (Figure 7.35). Seventy-four gunships during this period were issued with nearly seven ton of junk for foreign service (TNA WO55/1745). This junk was included in the gunner's stores and was used to make wadding.

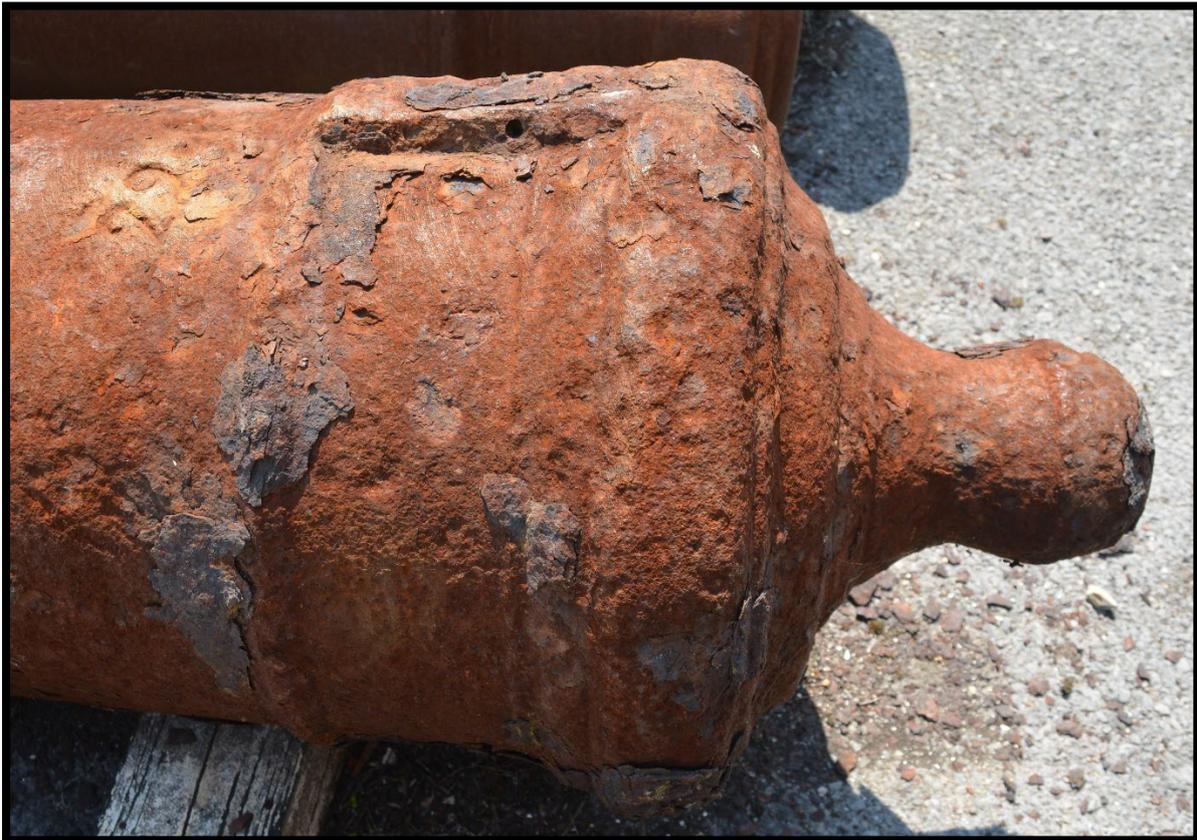
Figure 7.37: A 9-pounder Armstrong pattern gun with raised touch hole and fixing holes for the attachment of a gun lock. This is the same type of gun the *Invincible* was issued in 1755 on her quarter deck (Photo by author).

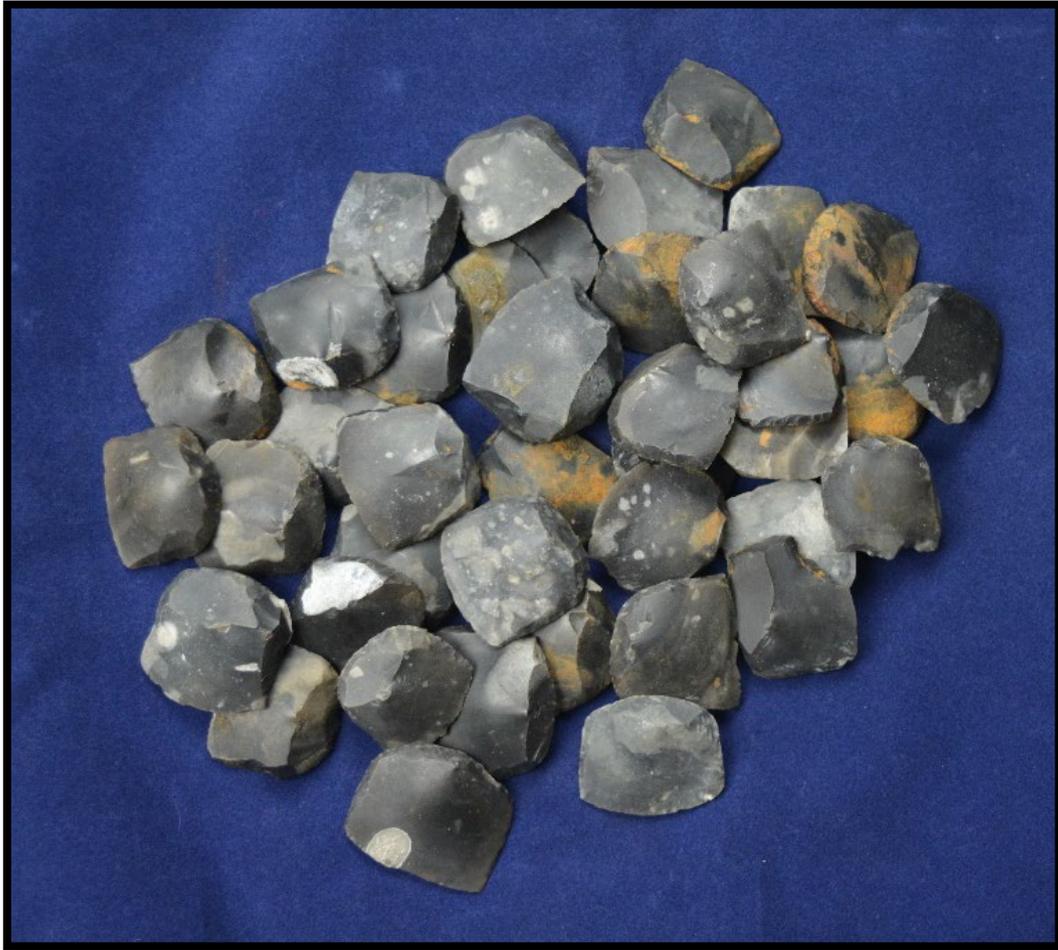
Figure 7.38: A selection of gun flints (Photo by author).

The evidence of this new technology on *Invincible* survives in the form of gun flints only. Hundreds of flints have been recovered from the site during both phases of excavation (Figure 7.38). The flints have all been found in the vicinity of the port side bow and therefore close to the location of the gunner's store. The flints have been carefully knapped into a wedge shape with a thin and sharp striking edge along one side. Not all the flints would have been for use with the 9-pounder guns. *Invincible* was issued with hand weapons, such as pistols and muskets, which were fitted with flint lock firing mechanisms. However, five distinct sizes of flints have been recovered and it is possible that the larger sizes were for use with 9-pounder gun locks.

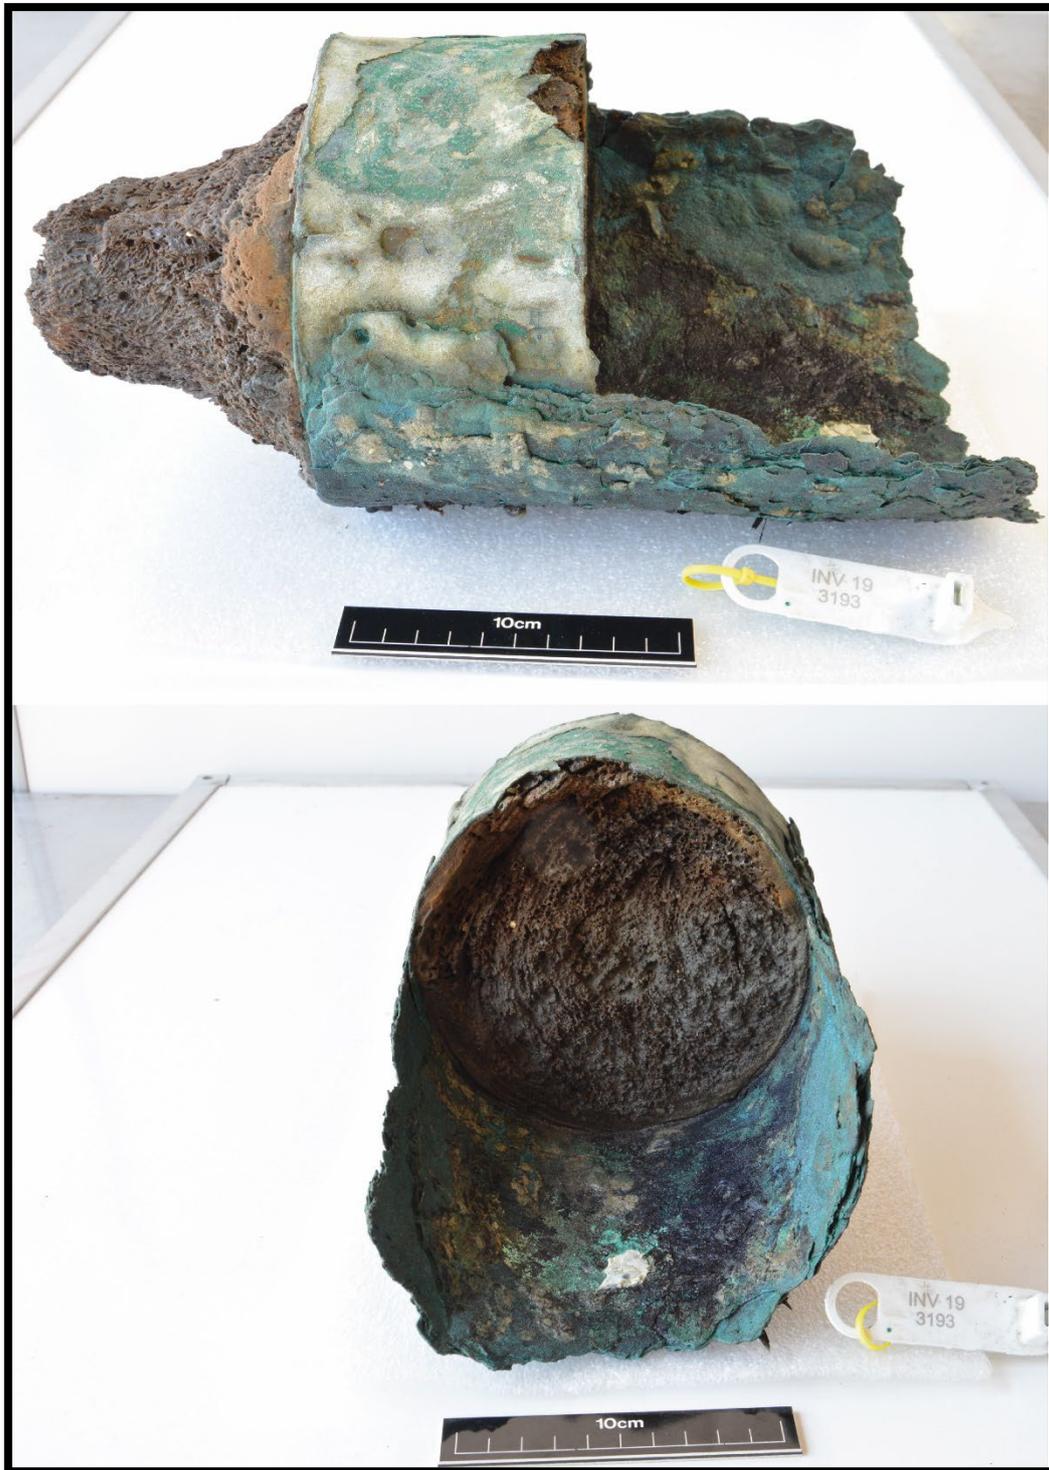
Figure 7.39: The partial remains of a ladle (**Inv19 3193**) for a 32-pounder gun (Photo by author).

A 74-gun ship would have been issued with ten ladles in total, four each for the 32 and 24-pounder guns and two for the 9-pounder guns (TNA WO55/1745). One ladle, **Inv19 3193**, was recovered from Trench 4 in 2019. It is a composite object consisting of a wooden body, similar in design to a rammer head but with a copper scoop attached around the body of the head (Figure 7.39). The diameter of the wooden head is 156mm (6.1in) and the diameter of the copper scoop is 162mm (6.4in). The copper is badly corroded and, as a result, has laminated making the size of its diameter inaccurate. The size of the wooden head is a more reliable measurement and would make the ladle appropriate for the 32-pounder guns.

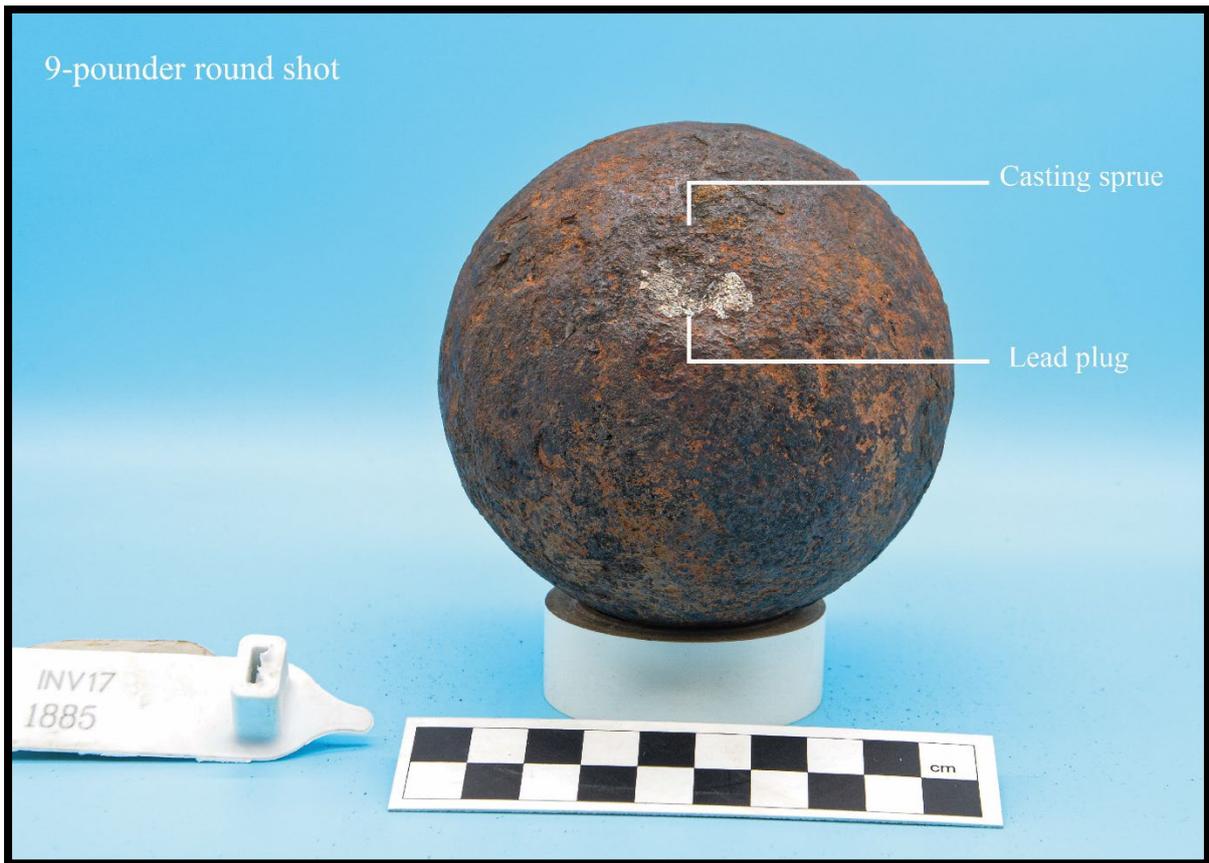
Figure 7.43: A 9-pounder shot with lead plug besides the casting sprue (Photo by author).

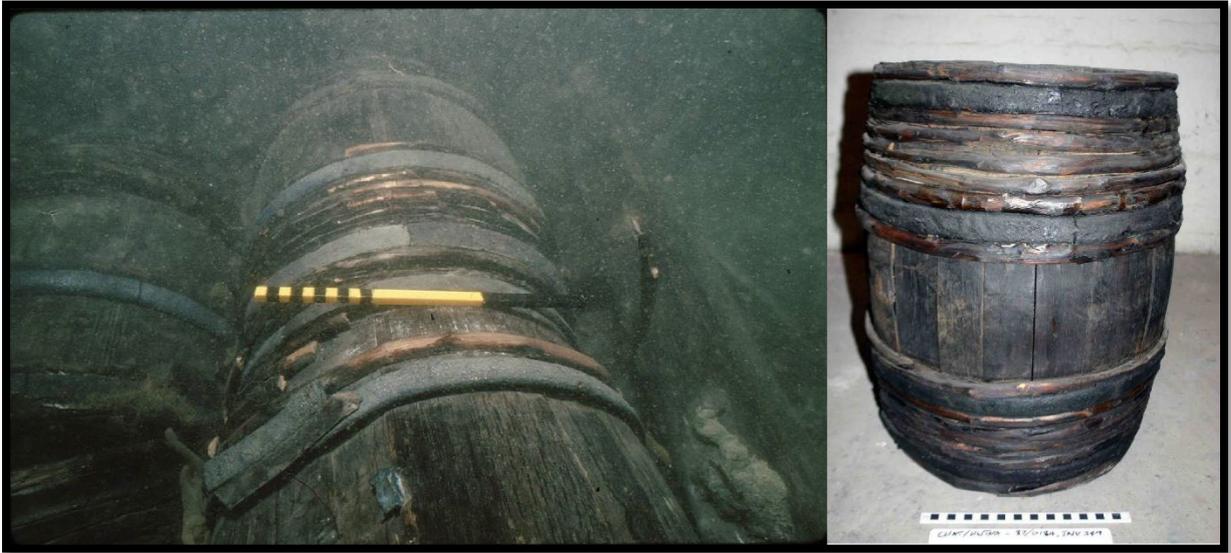
Figure 7.45: Photos of the gunpowder barrels recovered from the *Invincible* (Courtesy J. Bingeman).

The wreck of *Invincible* has yielded the most comprehensive archaeological evidence for the storage of powder and powder charges for the great guns for any Royal Navy ship of the line post *Mary Rose*. The main magazine and the section forward of it, known as the filling room (Figure 7.44), were first excavated during the Bingeman excavations in 1980s. This resulted in 48 barrels of powder being recovered from the magazine and, also, the actual structural compartment and contents of the filling room (Figures 7.45 and 46) (Bingeman 2010, pp. 134–136). The powder barrels were constructed of wooden staves and lids secured tight with a combination of several hazel and four copper bands (Figure 7.45). The barrels were 501mm tall and with lids of 365mm diameter.

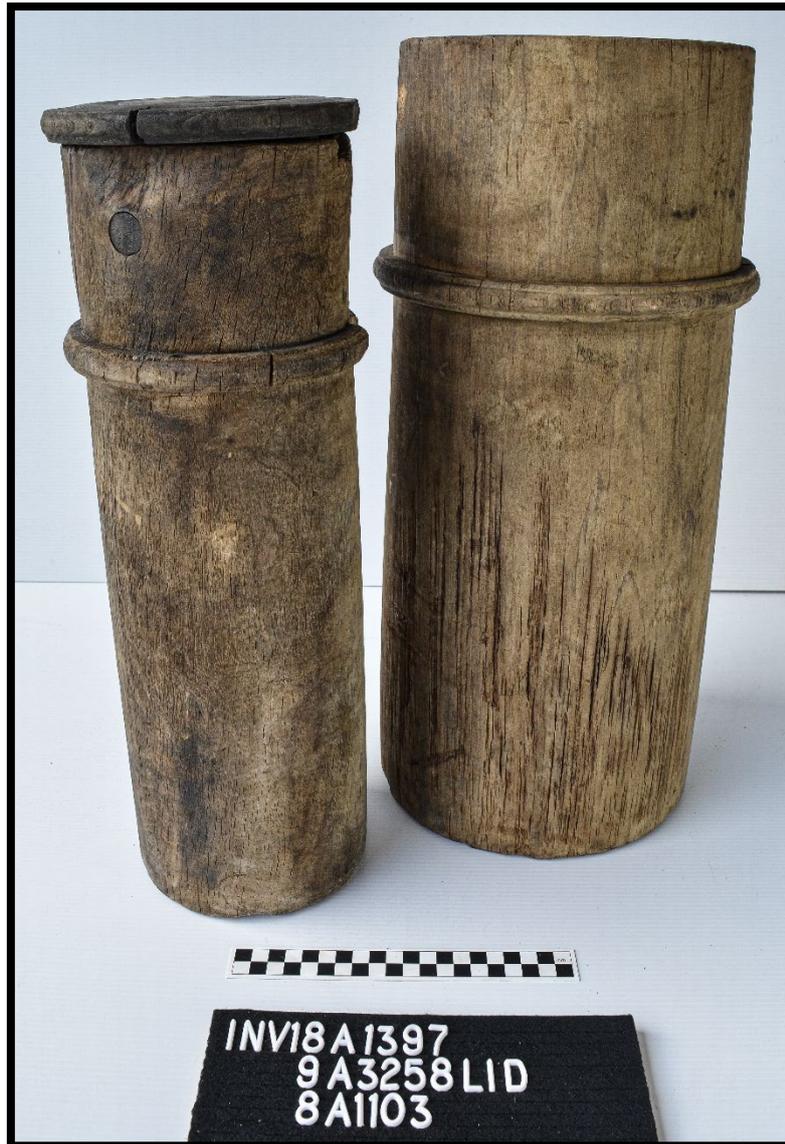
Figure 7.48: A 9-pounder cartridge case with lid alongside a 32-pounder cartridge case (Photo by author).

To transport the powder charges to the gundecks they were placed into wooden cartridge cases, which held a single charge. There were three sizes of cartridge case representing the three calibre of guns. These cases were still referred to as cases of wood in the inventories and the *Invincible* would have been issued with 70 for the 32-pounders, 75 for the 24-pounders and 45 for the 9-pounders (TNA ADM160/150). Over fifty were recovered during the earlier excavations and two complete and several partial ones were recovered during the current excavations. The recent cartridge cases were located between the internal floor timbers beneath the remains of the lightroom, which was immediately forward of the filling room. They were found along with several coins. This position was mostly likely due to the breakup of the ship and subsequent movement of the objects. Many of the cartridge cases during the Bingeman excavations were found just outside the entrance to the filling room in the space between the inside of the hull and the side of the filling room (7.47). The bodies of the cartridge cases were lathe-turned from a single piece of poplar and the cases fitted with a lid. On both the lid and a rim on the case a pair of parallel holes were drilled, through which a thin rope lanyard was threaded to keep the lid and the case together (Figure 7.48).

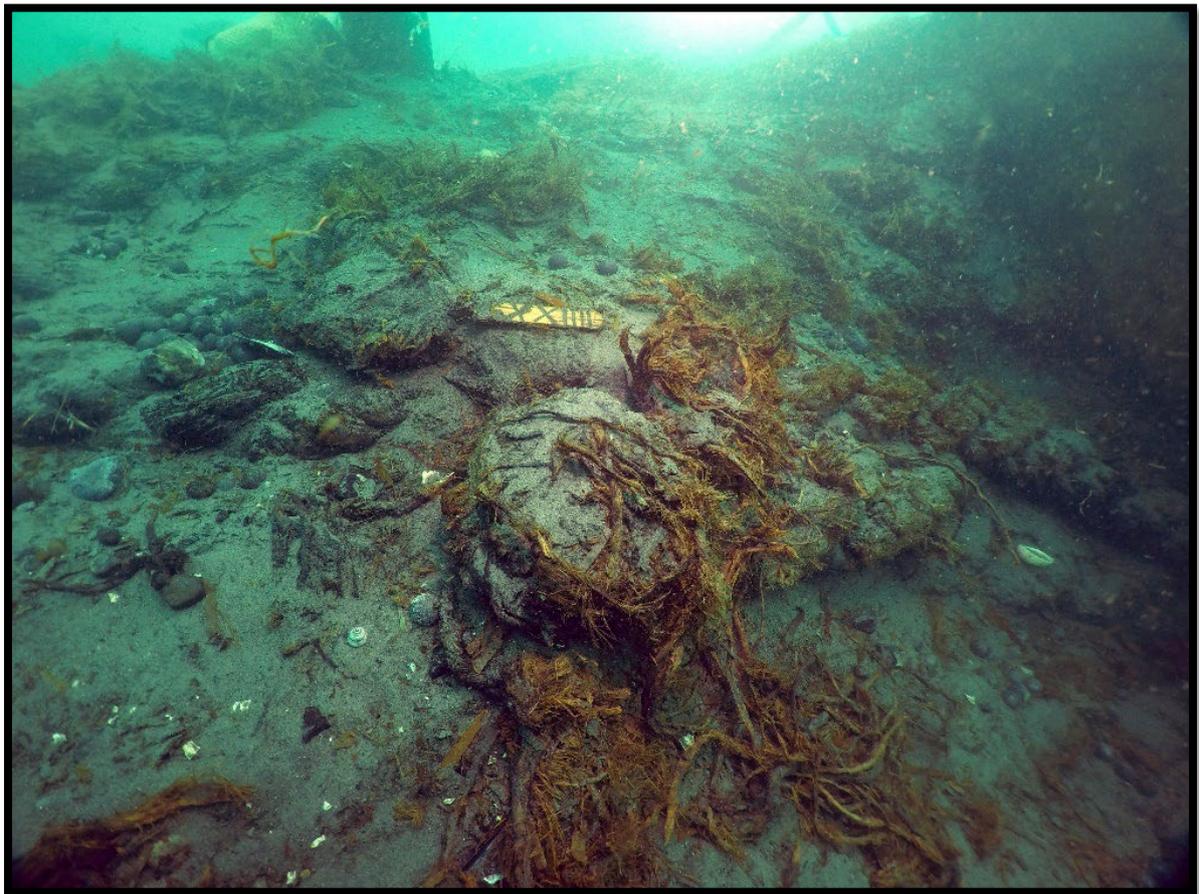
Figure 7.50: 24-pounder gunwad with tally stick nearby. The wadding is resting on top of the junk (Photo by Author).

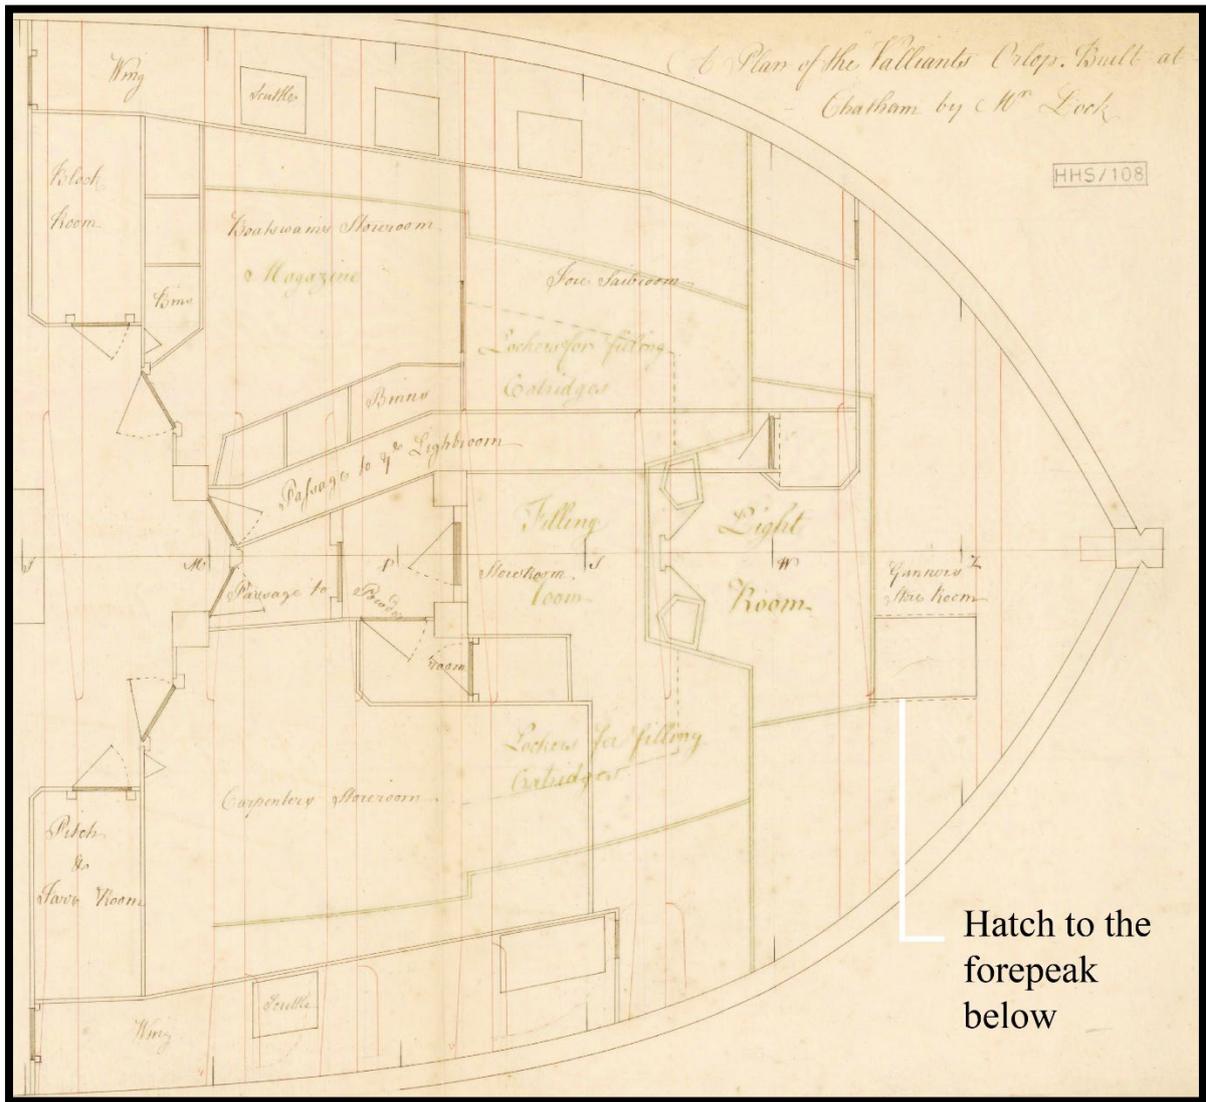
Figure 7.51: Orlop plan of the *Valiant* (based on the lines of *Invincible*) showing a hatch in the gunner's storeroom leading down to the forepeak (Image J8138 © the NMM, Greenwich, London).

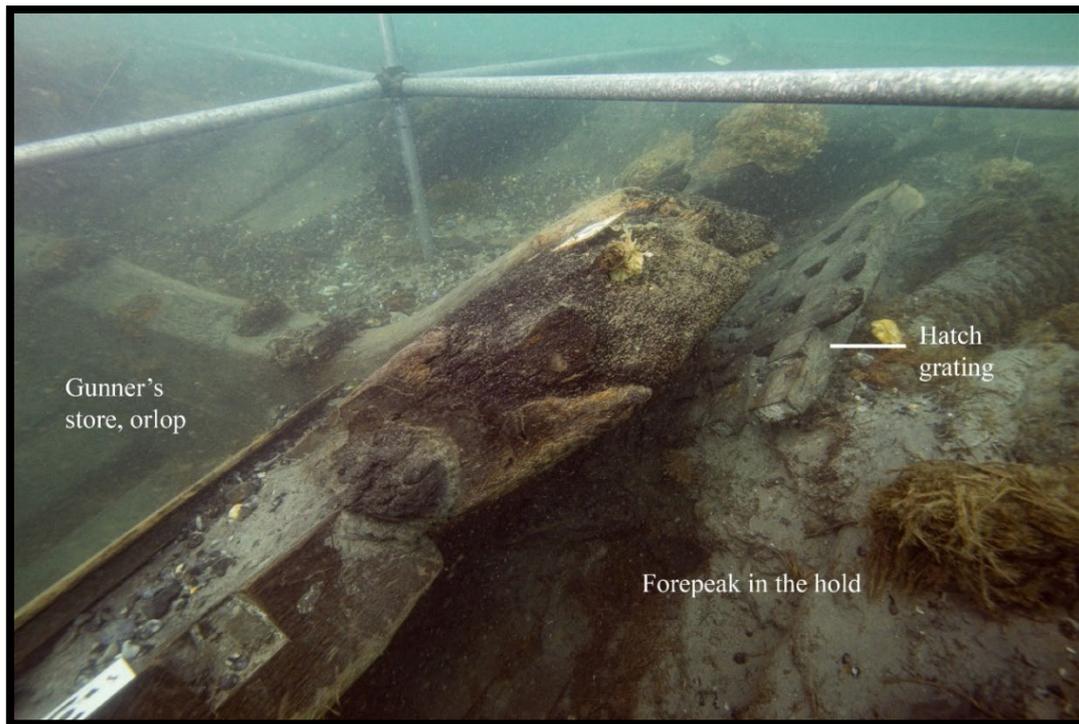
Figure 7.52: Hatching grating found displaced immediately below the floor of the gunner's store on the orlop (Photograph by Michael Pitts).

This store of wadding is immediately below the gunner's store on the orlop. The internal plan of the orlop and hold of the *Valliant* shows a hatch on the starboard side of the gunner's store (Figure 7.51). This hatch enables access to the forepeak and other forward parts of the hold. It is possible that *Invincible* had a hatch here to, but this remains an assumption as this section of the deck in the gunner's store does not survive. However, a hatch grating was found displaced between the forward most surviving section of the orlop and the hold (Figure 7.52), an example of this can be found in a similar location on the forward orlop of HMS *Victory*. The hatch gratings allow light to be directed to areas of the ship below and they are easily removable to enable access. If the *Invincible's* grating was close to its original position, then

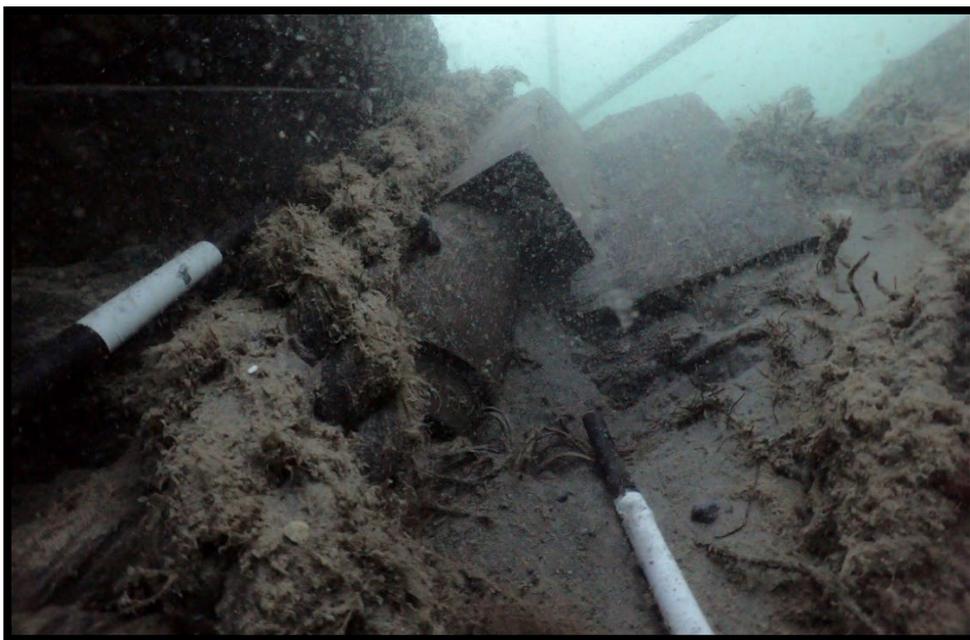
Figure 7.53: Spare gun carriage axles with junk lying on top (Photo by author).

The current excavation revealed that the wadding was piled on top of, and surrounded by, a nest of junk. The junk was laid in relatively short lengths that started at the very front of the forepeak covering a group of eight spare gun carriage axles, which were stacked between two breast hooks (Figure 7.53).

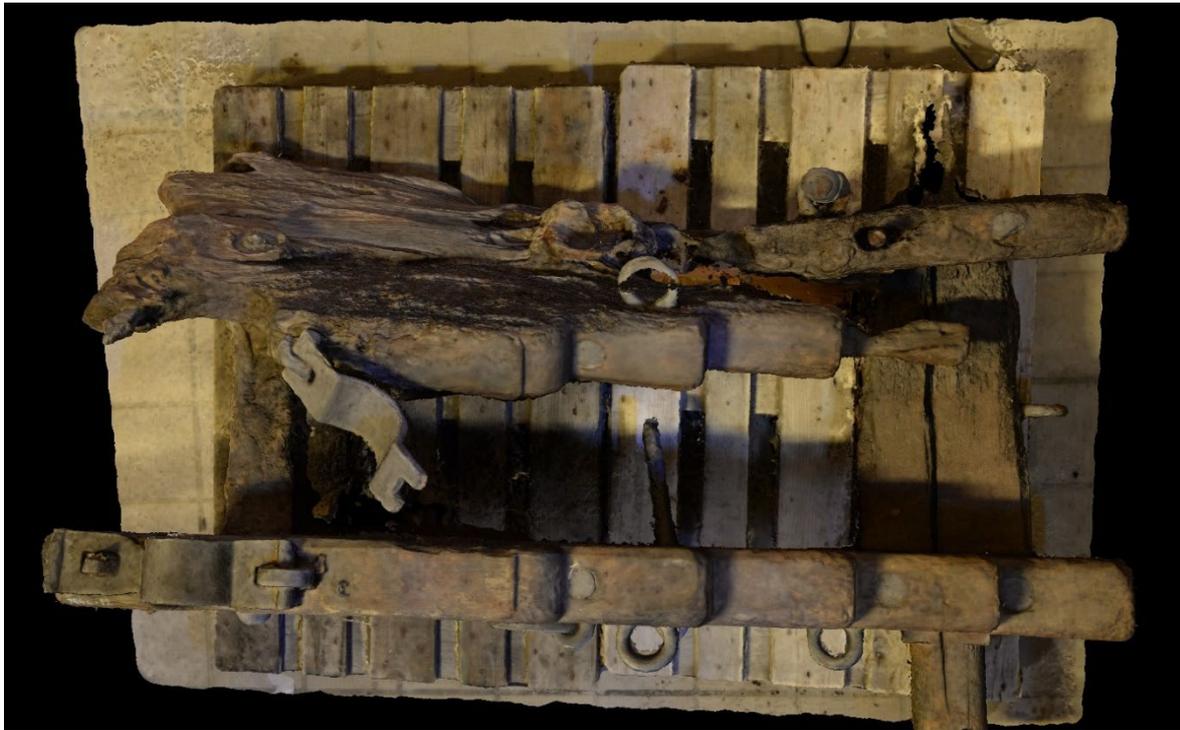
Figure 8.5: Photogrammetry model of carriage 7546-12, showing the counter sunk iron fixings along the top of the cheeks (Model produced by author).

Returning to the front end of the cheek one can see the design of the capsquare has changed little from the time of the 17th century. The capsquare hinges on an eye bolt, which since the development of the transom and axle carriage extends down through the cheek, protrudes from the bottom and is fitted with a washer and forelock (Figures 8.4-5). The top end of the

front capsquare bolt is slotted to allow a locking pin to secure the capsquare when placed over the trunnion of the gun (Figures 8.4-5). The bolt also passes down through the cheek and front axle. The trunnion recesses on these later carriages are significantly shallower than those of the truck and bed carriages and, as a result, the trunnions rest higher above the cheek resulting in the capsquares being more pronounced (Figure 8.4).

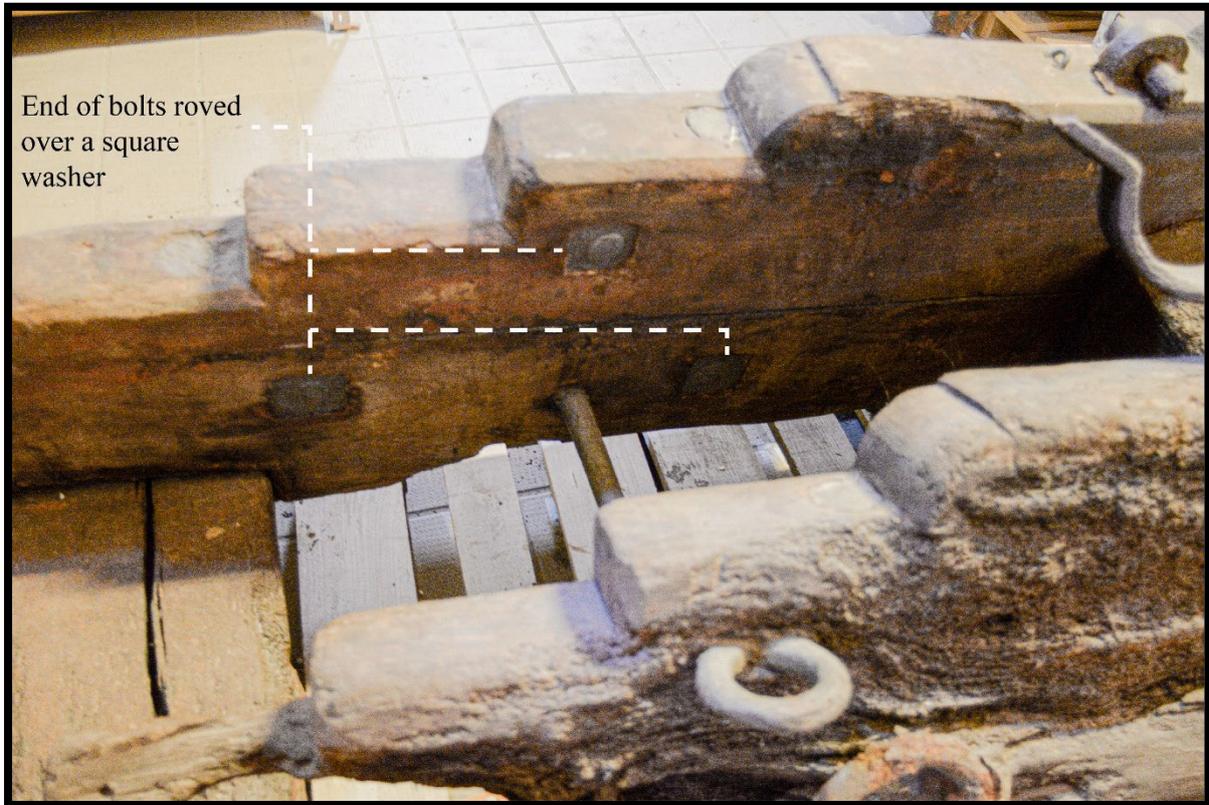
Figure 8.7: View of the inside of cheek showing counter sunk roved over bolts and square washers (photo by author).

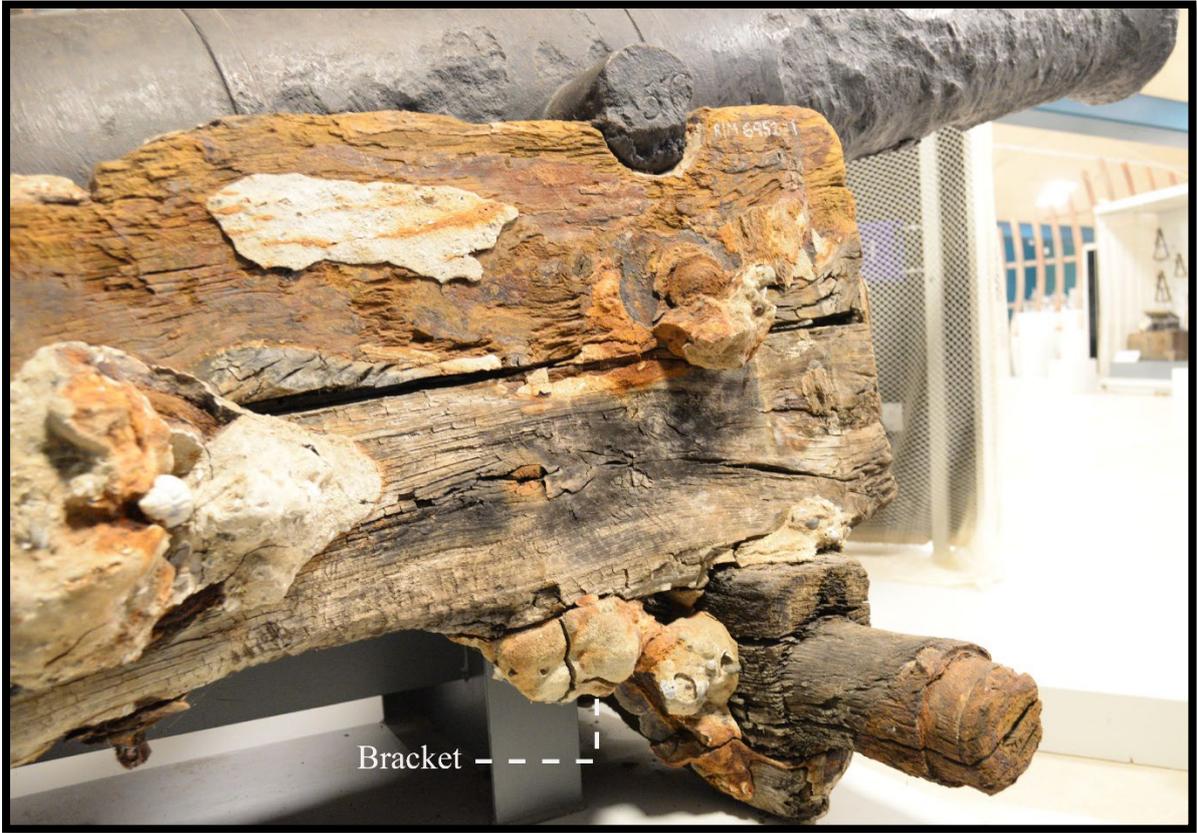
Figure 8.8: Photo showing concreted iron bracket bracing front axle with the bottom of the cheek (Photo by author).

There are additional iron fastenings that are visible on carriage **6952-1**. There is an iron bracket re-enforcing each end of the front axle (Figure 8.8). One end of the bracket fits on to the bottom end of the rear capsquare bolt, the other end attached to the bottom of the axle. This bracket was also present on the carriage from the *Royal George*. On the underside of the corners of the rear axle there are 20mm thick metal plates (Figure 8.9). This was likely to add strength at the rear where there was the force of the weight of the breech of the gun. Caruana suggests this is why the ends of the hand crow levers were shod with an iron shoe for protection (Caruana 1997, p. 396).

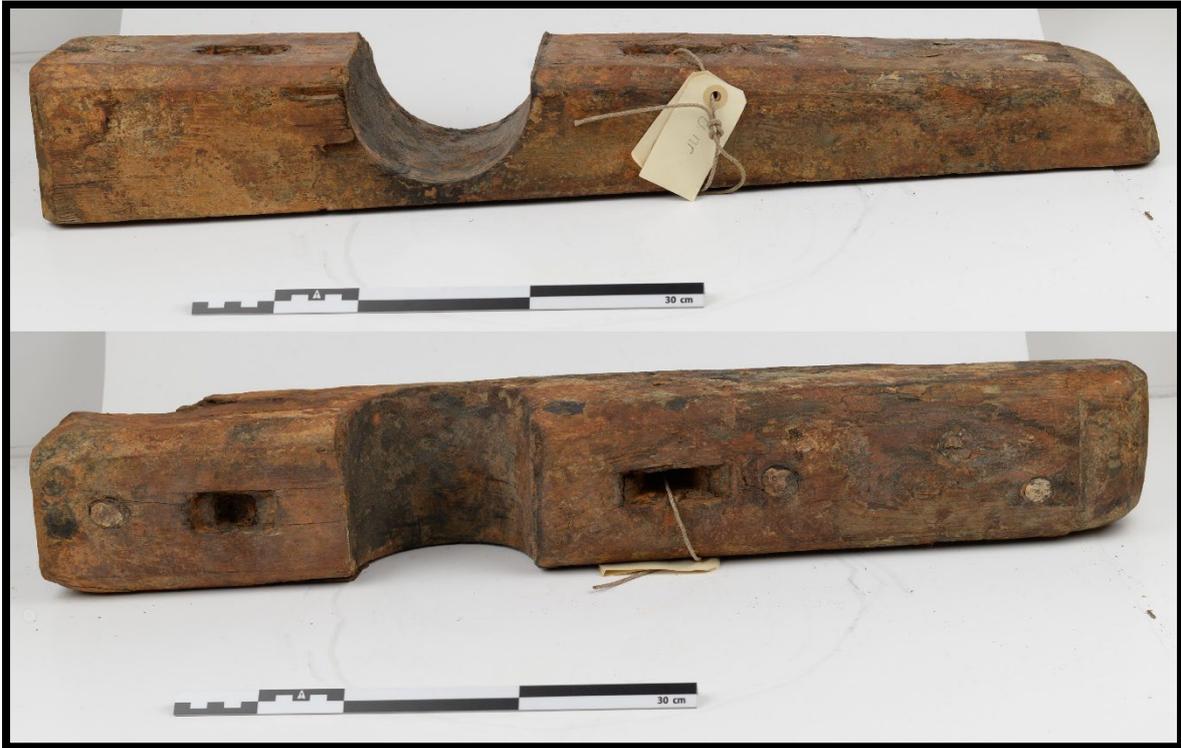
Figure 8.13:Photos showing the top piece of a carriage cheek, probably made as a repair (Photo by author).

In addition to the three carriages a single piece of a carriage cheek was recovered. It is the top piece of a cheek, which includes the trunnion recess and capsquare fixing holes (Figure 8.13). It has been dressed along the top with chamfered edges; the bottom face is a clean cut with undressed edges to sit on top of the lower section of the cheek. There are the remains of iron nails and small pieces of corroded iron within the main capsquare bolts, suggesting this was attached to the rest of the cheek, rather than a spare piece. The inventories of gunner's stores do not list spare carriage cheeks (TNA WO55/1745 and TNA WO55/1749), which would suggest cheeks parts would have to be made-up on board by the carpenter from spare timber. From the evidence of complete transom carriages, each cheek is made of two halves. This piece, consisting of only the top piece above the trunnion recess was, therefore, likely to be a repair.

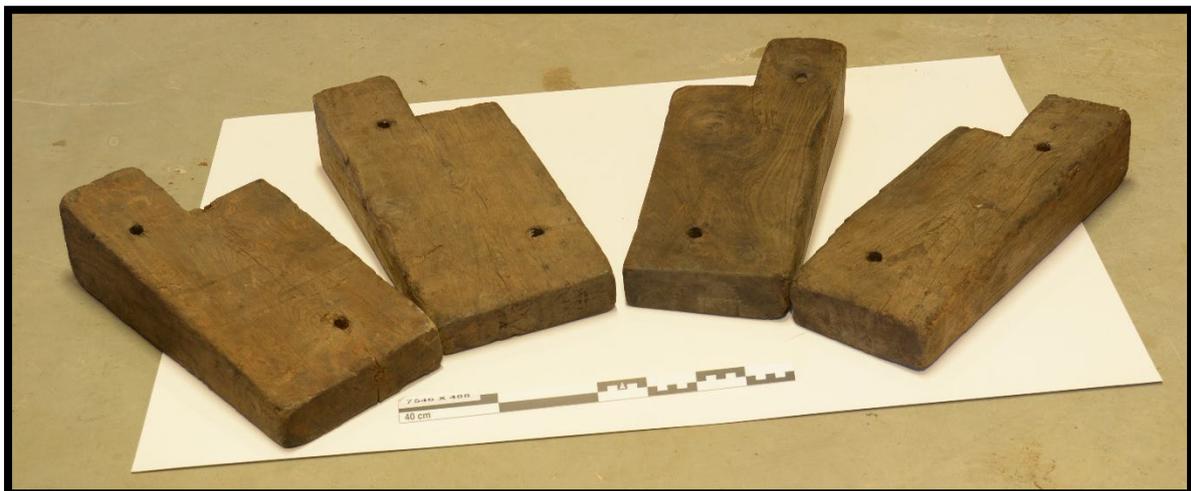
Figure 8.14: Four possible coins for coining guns (Photo by author).

Four almost identical examples to those found on *Invincible* were recovered from the *St George* (Figure 8.14). They are likely to be spares as they were found in the gunner's store. They have several features that stand out, including a square cut-out section, the alignment and distance between the fixing holes, and the angle of the incline, all of which suggest they had a specific function. Logic would suggest the purpose of the cut-out section was to either ensure it did not interfere with part of the carriage, gun, or equipment, or two fit alongside a specific part of the carriage. The bolt holes suggest the coins were fastened to either the carriage, the deck or with another coin. Generally, coins for elevating the guns were moveable pieces of equipment to make quick adjustment to the gun's elevation, so any fixing would have to be quick release to restore the gun to a normal firing position or to change the elevation of the gun. With the exception of the capsquares and linchpins, to secure the trucks on the axles, the fixings on the *St George's* carriages are not quick release and they do not line up with holes on the coins. There are no fixing holes either on any part of the carriages that line up with the holes on the coins. For these reasons it is doubtful that this type of coin was fixed to the carriage.

Fixing these coins to the deck would also create an issue of release and it is therefore equally unlikely that they were fixed to the deck. The fixed alignment of the bolt holes suggests the coins were used in tandem and fastened to one another.

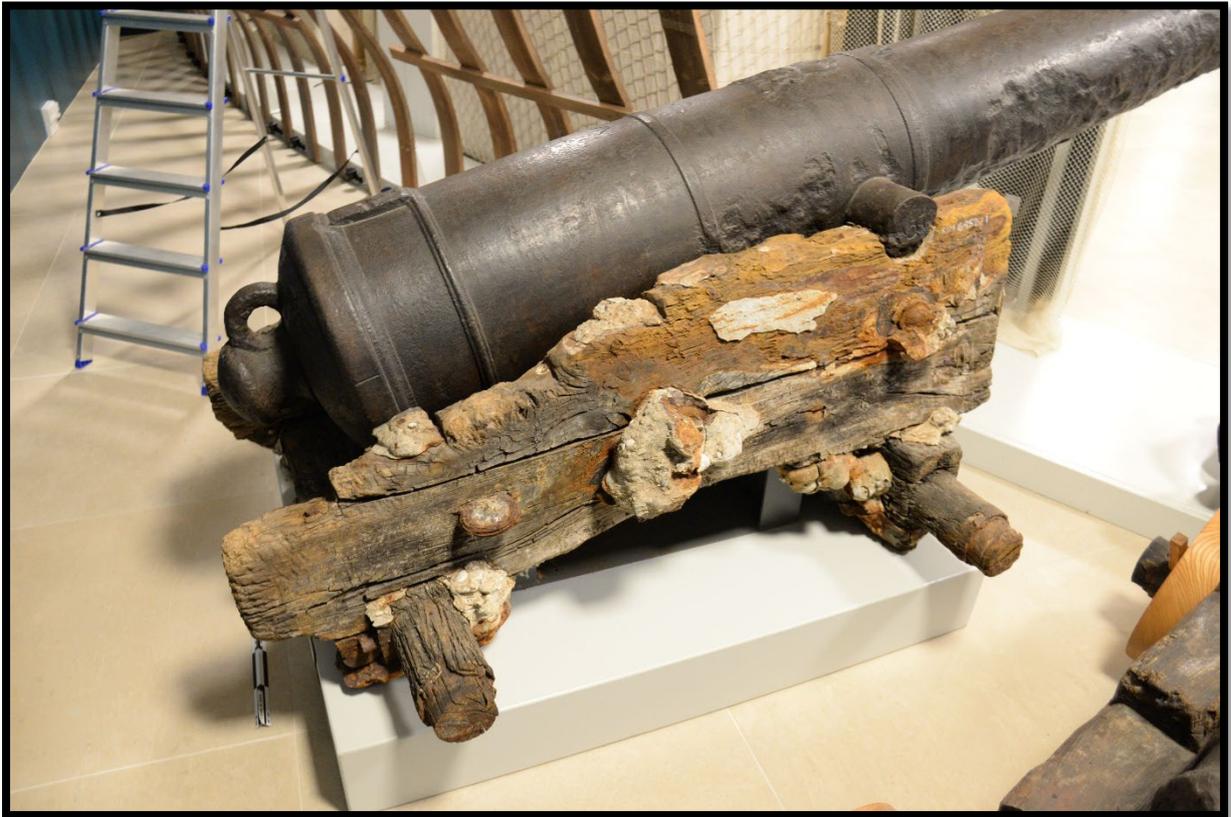
Figure 8.15: Photo showing breeching loop above the button of the 12-pounder Blomefield pattern gun (Photo by author).

Two cast iron long guns and five carronades were recovered from the site, but only the long guns will be included in this section. They are of the Bloomfield pattern, which was first in service from 1787. One of the most noticeable features of this pattern, and relevant to this section, is the breeching loop cast at the top of the button. (Figure 8.15) This simple adaption allowed the breeching rope for the gun to be threaded through and held by the loop at the cascabel without the need to splice the breeching rope around the button to hold it in place. This saves time preparing and securing the gun but it also made operating the gun safer as splices had the potential to slip and jump off the button or even break; the breeching loop took this danger away.

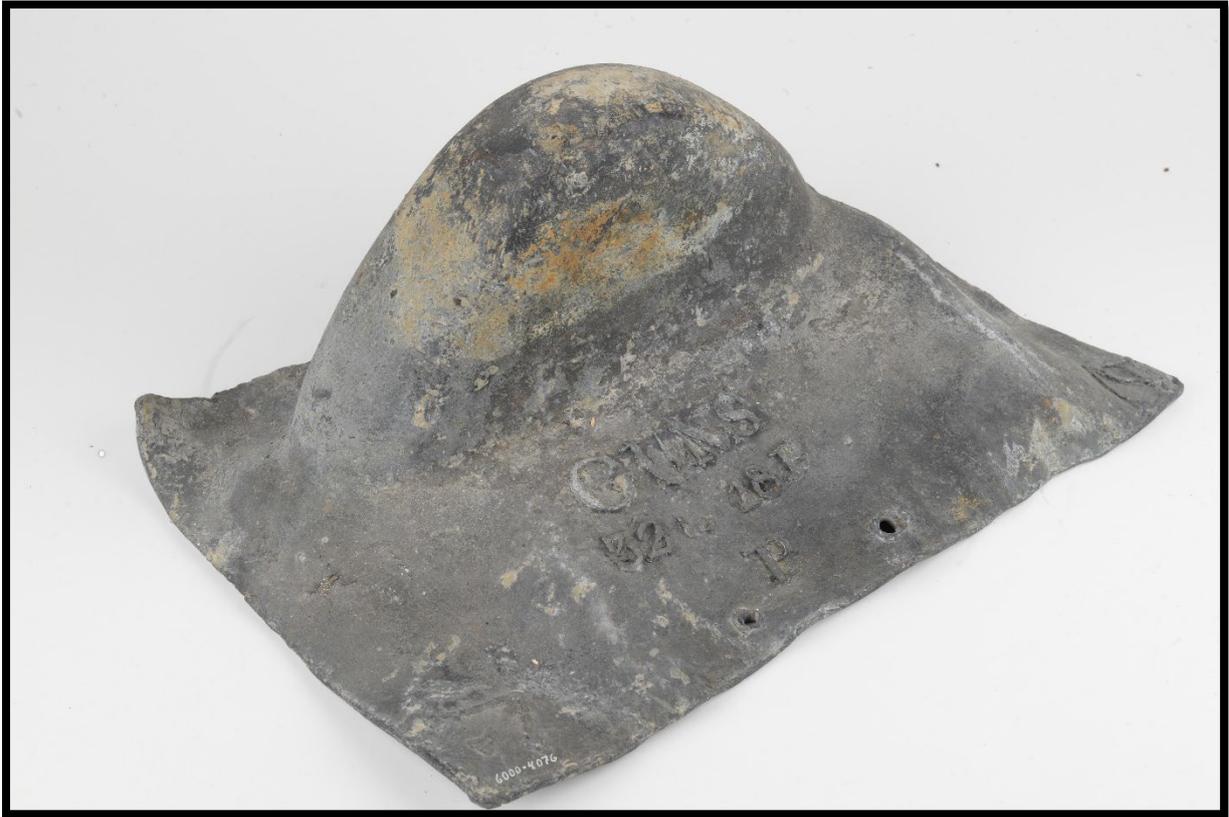
Figure 8.16: Photo showing a lead apron appropriate for 32-18-pounder guns (Photo by author).

All the guns including the carronades were issued with aprons. They had evolved since the period of the *Invincible* to accommodate the cannon lock, which was attached beside the vent hole at the breech end of the gun. The aprons have therefore been designed with an upstanding moulded hump to the right side of the apron, which would sit over the cannon lock, with the other half flat to cover the vent hole. The aprons were embossed with the intended gun calibres as well as two broad arrows in the left corners. The examples studied from the *St George* were for guns of 32 to 18-pounder calibres (Figures 8.16). Similar examples have been found on the wreck of HMS *Pomone*, including ones embossed with carronades 42P, 32P, 24P, 18P and 12P, which shows the apron could fit all sizes of carronade ranging from 42-12 pounders (Bingeman 2010, p. 127, Bingeman et al 2021, p. 26).
