**Archaeological evidence for the development of Royal Naval
gunnery from 1545 – 1811; analysing change through technology
and culture**

By
Daniel Pascoe

Dissertation submitted in partial fulfilment of the requirements for the degree ‘Doctor of
Philosophy’, awarded by Bournemouth University

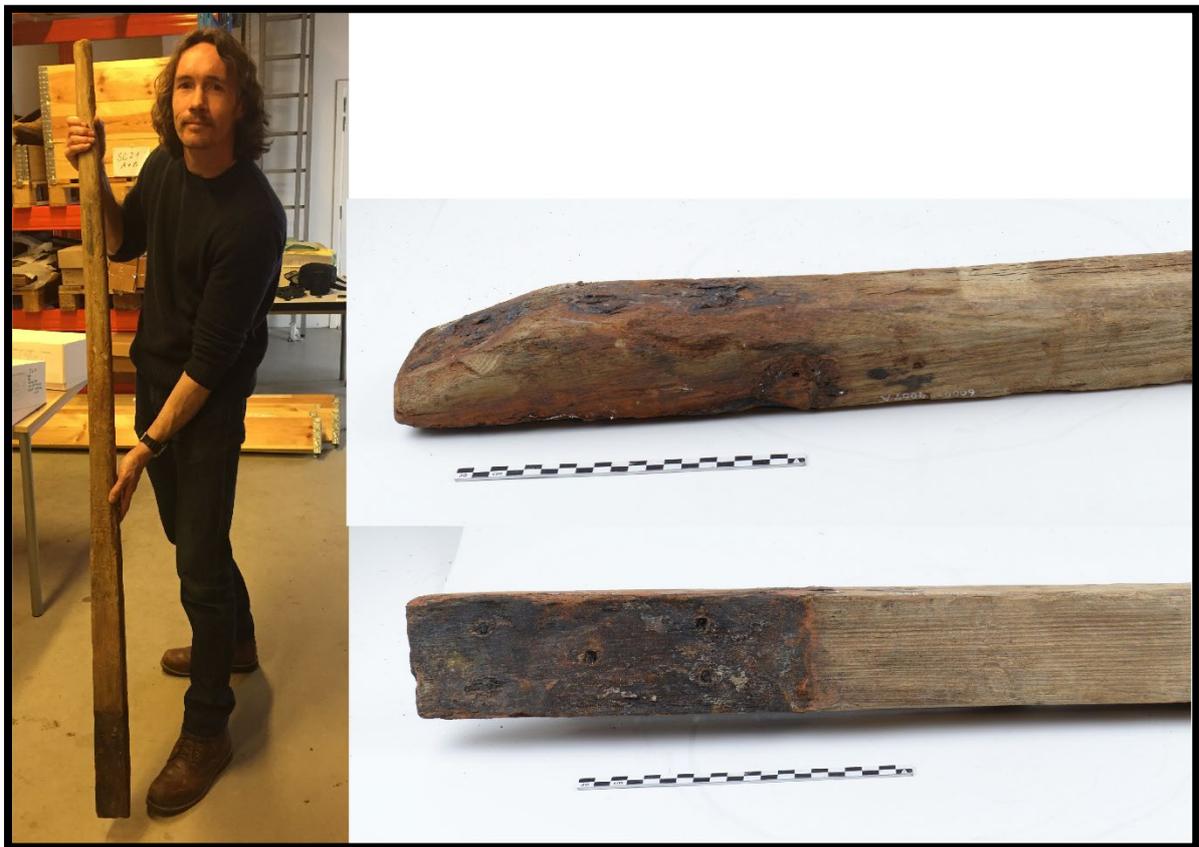
Figure 8.17: Hand crow leaver **6000-4067** shod with iron shoe (Author's photos).

pounder guns and, according to the 1790 proportion of stores, three hand crow leavers were shared between two guns (TNA ADM160/150). Several hand crow leavers were recovered in various states of completeness. Hand crow leaver **6000-4067** was a complete example and will be described in detail (Figure 8.17). It was 1825mm (5.99in) long and can therefore be categorised as one of the six feet long examples. At the head it is rectangular in section with the heel cut at 45 degrees. The inside face of the head is shod with an iron shoe and fastened by five iron nails. The length of the head is 605mm and the shaft is ovoid in section. The design, including the iron shoe, has not changed since the *London*. The thick iron plates under the corners of the rear axles of the *St George's* carriages show why it was necessary to shod the hand crow leavers with iron shoes as, without, the timber would have been easily chewed-up and its working life drastically shortened.

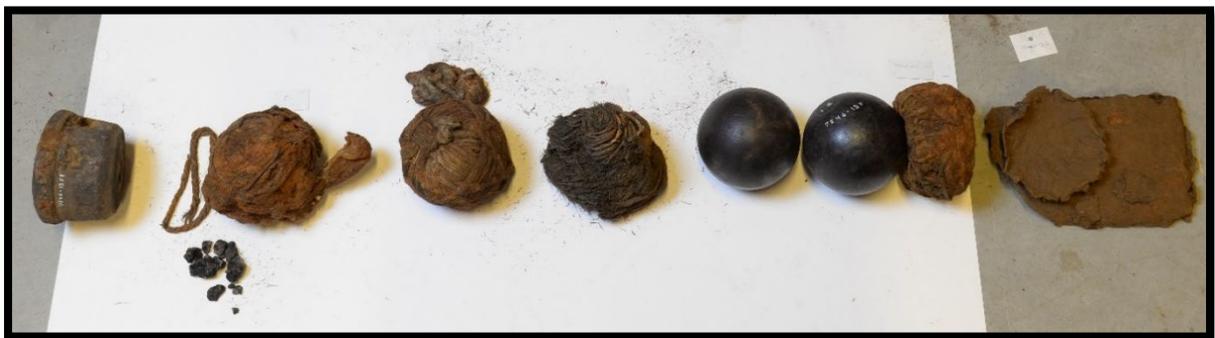
Figure 8.23: Photo showing the contents of the barrel of the 12-pounder gun 7546-13. Note it was double shotted (Photo by author).

The barrel of the 12-pounder gun **7546-13** was excavated and found to be loaded, as one has come to expect, but, perhaps less common, was the fact it was double shotted (Figure 8.23). The contents of the barrel were in an almost perfect state of preservation, due to it being protected from the ingress of seawater by the seal of the tampion at the muzzle end and the wooden plug at the touch hole. The seal between the tampion and the inside of the muzzle was maintained by a wax/tallow sealant and, along with the tight fit of the tampion, it kept

the inside of the barrel dry. The shape of the tampion is the same as those found on the *Invincible*, tapered, so to fit snugly inside the muzzle (figure 8.23). At the centre of the inside face of the tampion was the head of a rusty nail, which was where the first wad was attached by a cord. A second wad was attached to the first by another, thicker cord. The purpose of these wads was to soak up any moisture in the barrel. It is not uncommon to see one wad attached to the tampion as seen from the contents of a barrel of 32-pounder carronade from HMS *Pomone*, wrecked also in 1811 (Bingeman 2010, p. 115, Bingeman et al 2021, p. 24), but to have two could be a first for the current archaeological record. Behind these wads came the charge, which included a wad, two pristine round shot, another wad and then the powder charge within a flannel powder bag (Figure 8.23).

One can see how the wad between the powder charge and the shot has a slightly larger diameter than the shot, which would have succeeded in creating a seal to stop gases escaping around the shot when the charge would have been ignited (Figure 8.23). This would have been especially necessary when double shooting a gun. If using the same charge as one would for a single shot then the velocity of a double shot would have been reduced, which was the intention. Double shooting was for close range tactics to cause maximum damage. High velocity single shots at close range had the potential to pass cleanly through one side of the hull and out through the other. A double shot, on the other hand, would have less velocity but cause more damage by smashing and splintering the hull; large broken off splinters of timbers flying around the decks would cause more fatal injuries than a shot going clean through. Although the intention of double shooting was to reduce velocity, one would not want it to be further reduced by poor wadding, as this may cause the shot to have little impact.

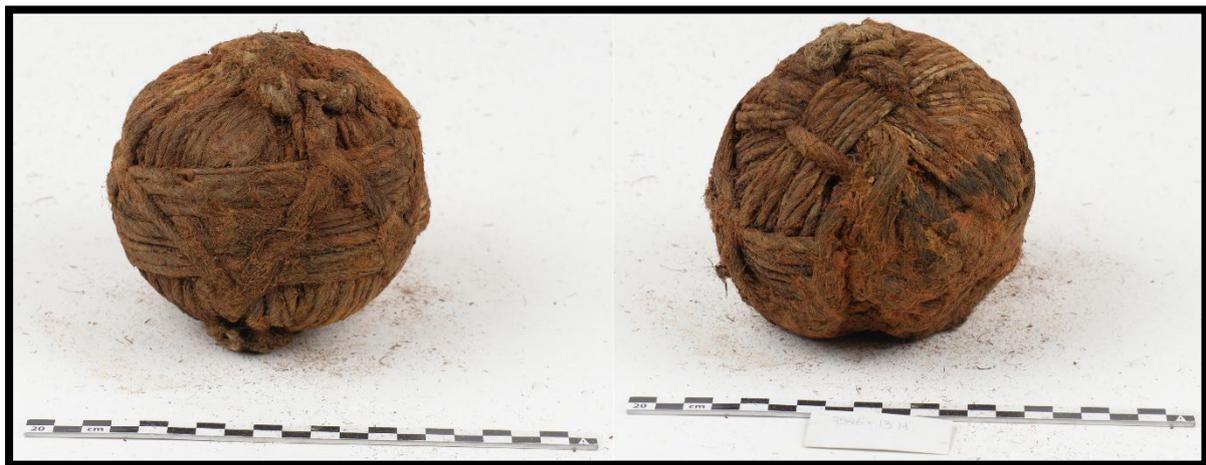
Figure 8.24: Photo of the first wad extracted from the barrel, note the intricate pattern of the wrapping (photo by author).

The wads were all made of handpicked yarns and wrapped in the same style as found on the *Invincible* (Figure 8.24). Three of the wads were in near-perfect condition and show the intricate pattern of the final wrapping around the main body of the wad. Their condition helps demonstrate the importance of the final wrapping as it holds the wad tightly together. It would have taken considerable skill and care to produce wads of this quality and it is more likely that these were manufactured ashore rather than on board.

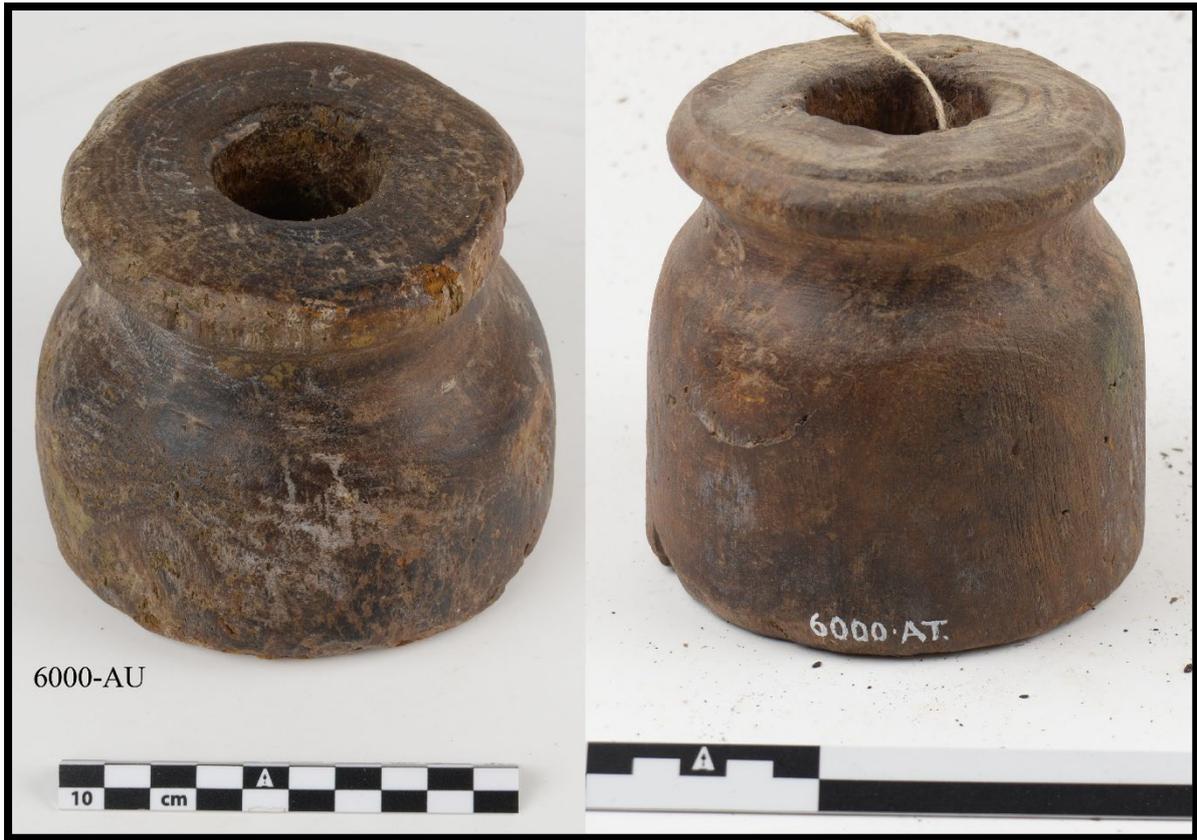
Figure 8.25: Two unused spare rammer heads. On the left rammer **6000-AU** and on the right rammer **6000-AT** (Photo by author).

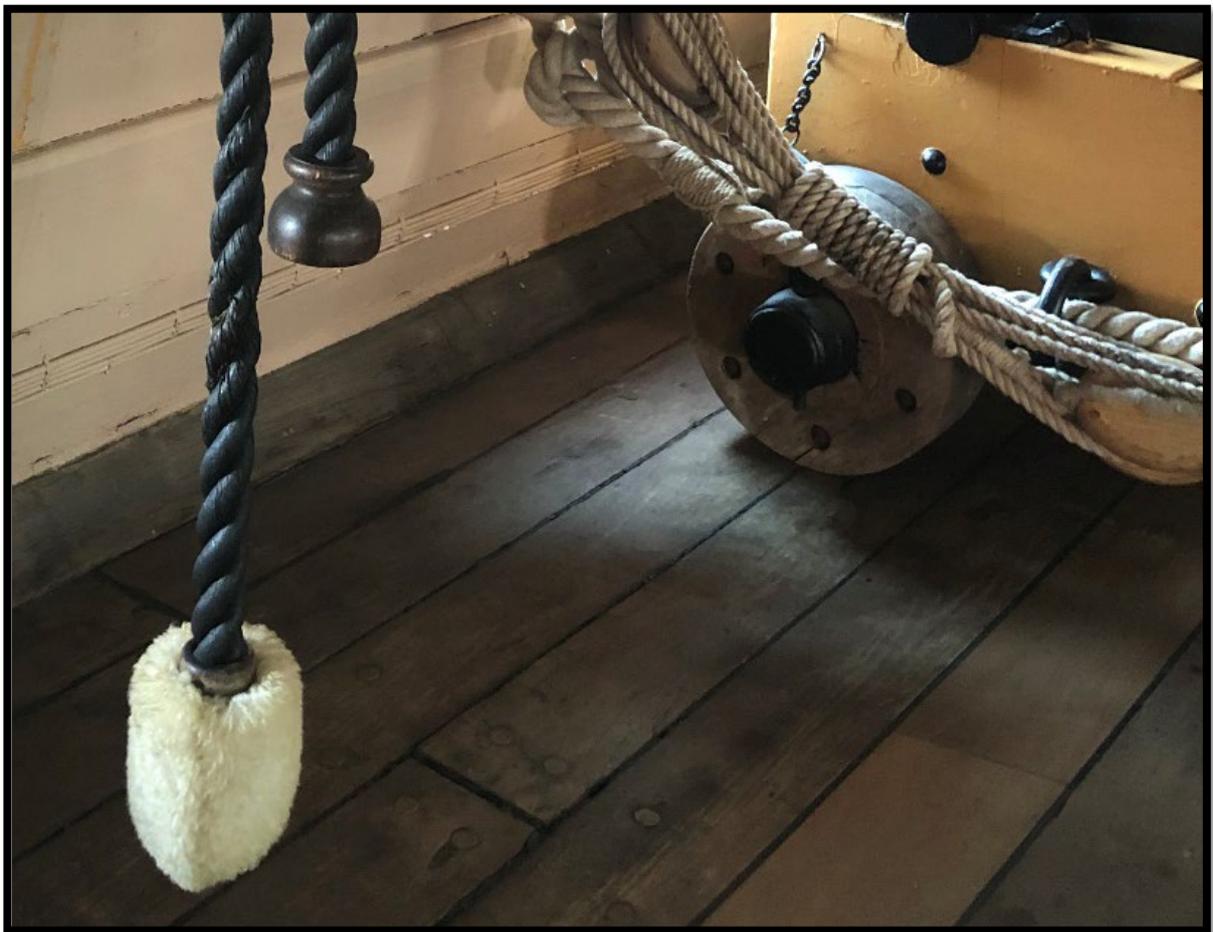
Figure 8.29: Rope sponge on board HMS *Victory* showing similar collared style head to that found on the *St George* (Photo by author).

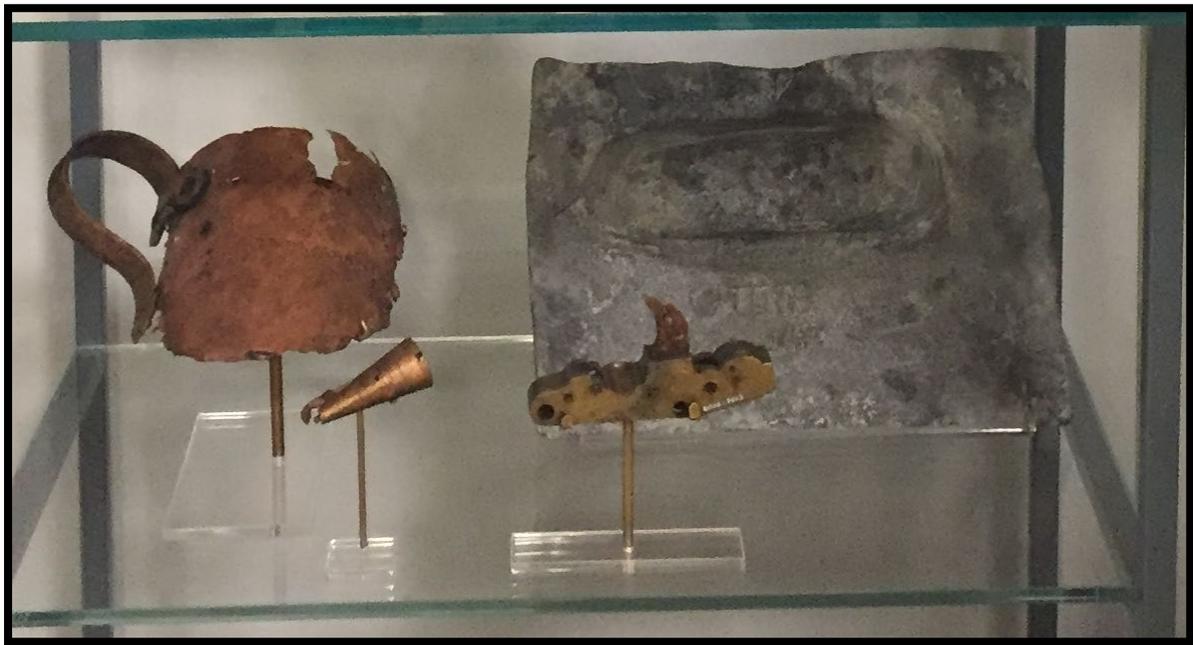
Figure 8.32: Photo showing an example of a cannon lock recovered from the *St George* and currently on display (photo by author).

The cannon locks recovered from the *St George* have a body made of brass with moving parts, such as the trigger, cocking handle and striking plate, made of iron. The archaeological evidence from the wreck of HMS *Pomone*, a 38-gun frigate, wrecked on the Needles, off the Isle of Wight also in 1811, identifies that there are two types of cannon lock in use at that time (Bingeman 2010, p. 128, Bingeman et al 2021, p. 25). One type is inscribed with the name of the manufacturer 'W Dick'. Walter Dick was producing gun locks for the Navy by at least 1787 and in 1791, in partnership with John Knubley, produced a new pattern, which was submitted to Thomas Blomefield for approval. Neither Walter Dick or John Knubley were the main lock producers; that credit goes to Henry knock (Caruana 1997, p. 392). The second type found on HMS *Pomone* is identical to the ones found on HMS *St George*. The main

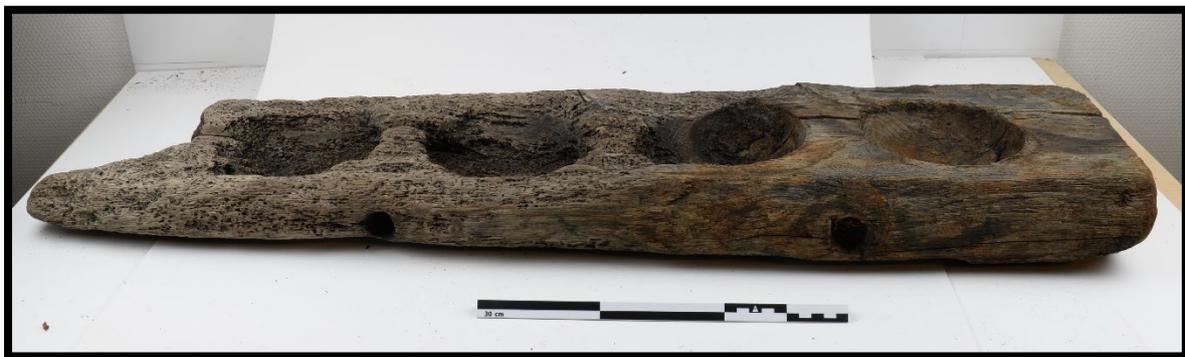
Figure 8.34: Photo of type of shot holder surrounding the hatch coaming along the centre line of the deck (Photo by author).

Divers working on the *St George* observed round shot clustered around the hatchways along the centre line of the gundeck (Jepsen 2019, p. 207). Along with the observations of shot, two types of shot holders were recovered. The first type is constructed from a plank 233mm wide and 70mm deep with four surviving 160mm diameter circular recesses. The diameter of the recesses are appropriate for a 32-pounder round shot (Figure 8.34). The design of this type of holder is consistent with the 1780 order to cut holes around the hatchway coamings (Lavery 1987, p. 150). This type of holder has also been reconstructed and placed along the outside edges of the hatchway hatch coamings on board HMS *Victory*, with the exception of the side at the top of a stair case (Figure 8.35) (McGowan 1999, p. 211).

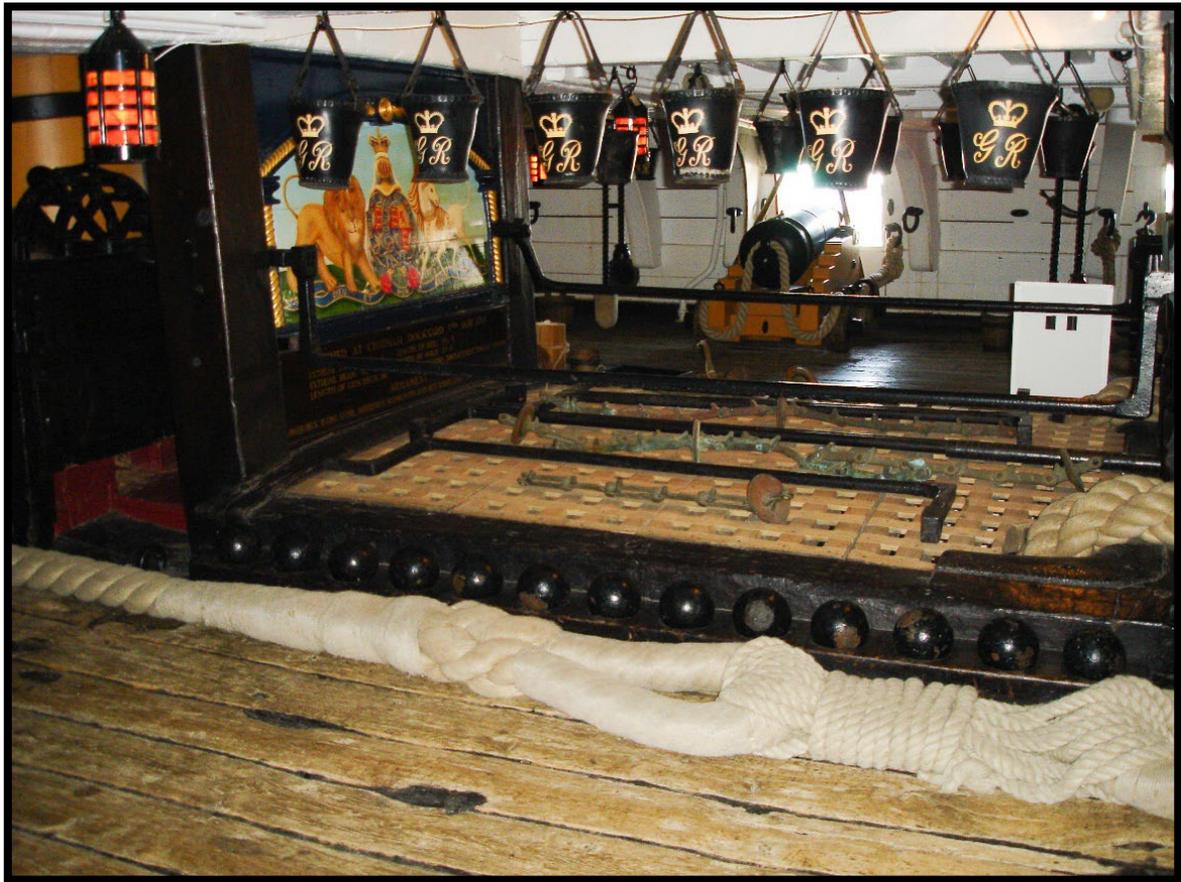
Figure 8.35: Photo showing the reconstructed shot holders along the edge of the main hatch on the main gundeck (Photo by author).

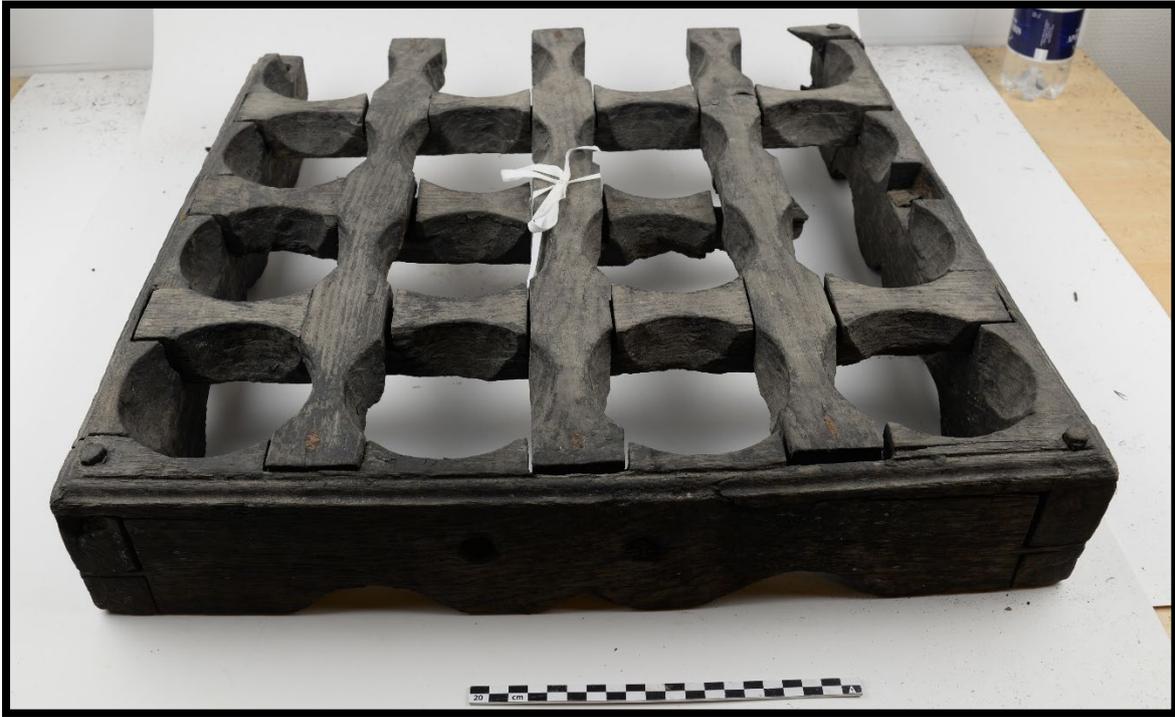
Figure 8.36: Mobile unit for holding shot (Photo by author).

The second type of shot holder is much more of an intricate design consisting of multiple interlocking wooden parts (Figure 8.36). It forms a square of four rows and four columns consisting of 16 circular recesses to hold round shot. This is a mobile unit that could be moved to various locations in the general vicinity of the guns. To avoid interference with the working of the guns it was likely that this was located along the centre-line of the deck, probably in the spaces between the hatchways.

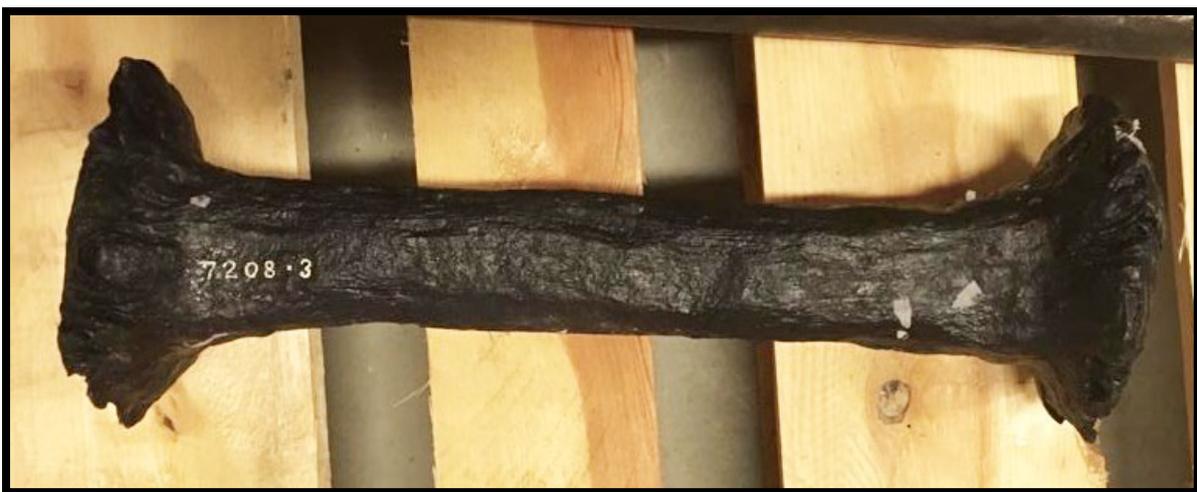
Figure 8.37: Photo of hammered double headed shot 7208-3 (Photo by author).

As well as round shot, double headed hammered shot was found on the gundeck (Figure 8.37). The form is identical to the double headed hammered shot found on the wrecks of the *Stirling Castle* and the *Hazardous* in section 6.4.1 of chapter six. It is made of wrought iron bar hammered at each end to form the diameter of the bore of the gun. This confirms at least two types of shot for immediate use were stored on the gundecks.

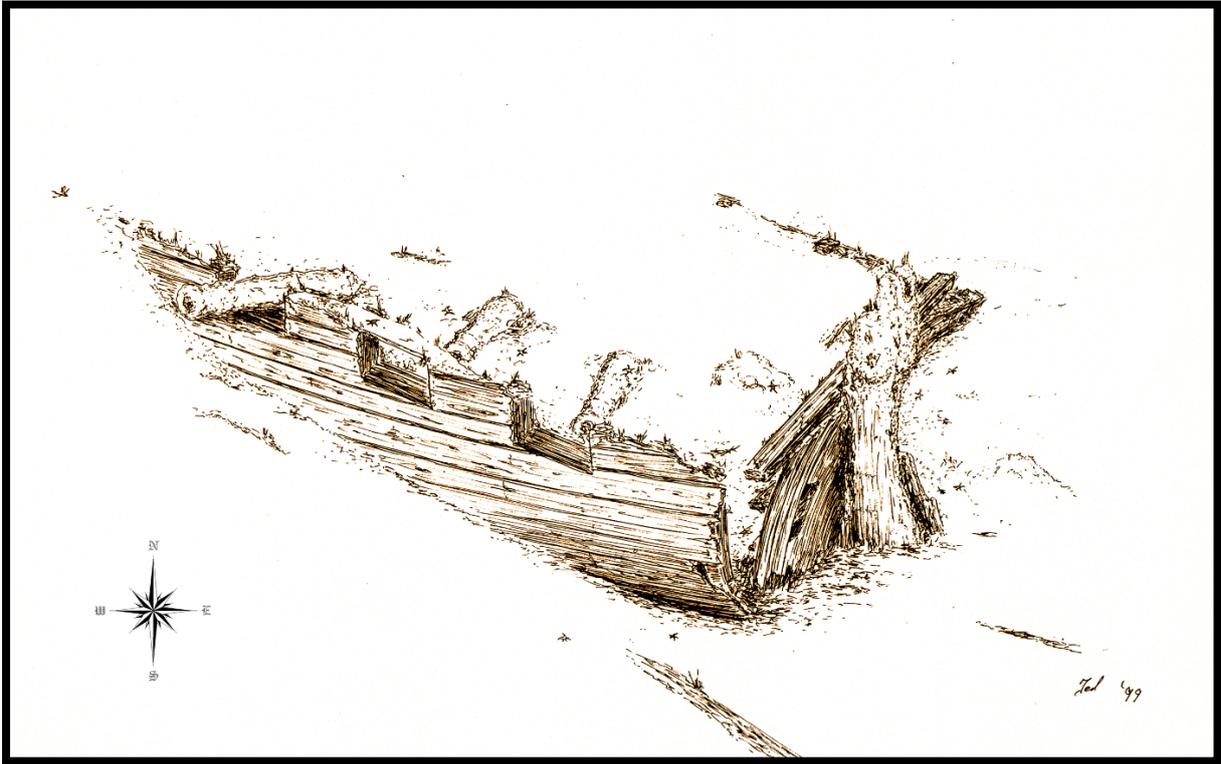
Figure 9.1: Diver's sketch from 1999 showing guns in the broad side position on the port quarter (Sketch by Ted Westhead).

By the last quarter of the 17th Century, we see the end of the need for separate fore and aft armament. New ships were designed to carry all the guns on the broadside but, if the need arose, to fire forward or off the stern, then guns closest could be moved from their broadside positions to the chase ports. Evidence of this can be seen from a diver's sketch of the *Stirling Castle*, which shows that the main gundeck guns on the stern port quarter are all in the broadside position. There are, therefore, two clear advantages of excluding separate chase guns, first it reduces weight, which in turn can improve the ship's sailing abilities, while also ensuring that the lower tier of guns do not lie too close to the waterline. Second, the forward and aft-most guns on the broadside are able to be manoeuvred without interference from the chase guns, which would have improved the overall operation of the guns in those positions.

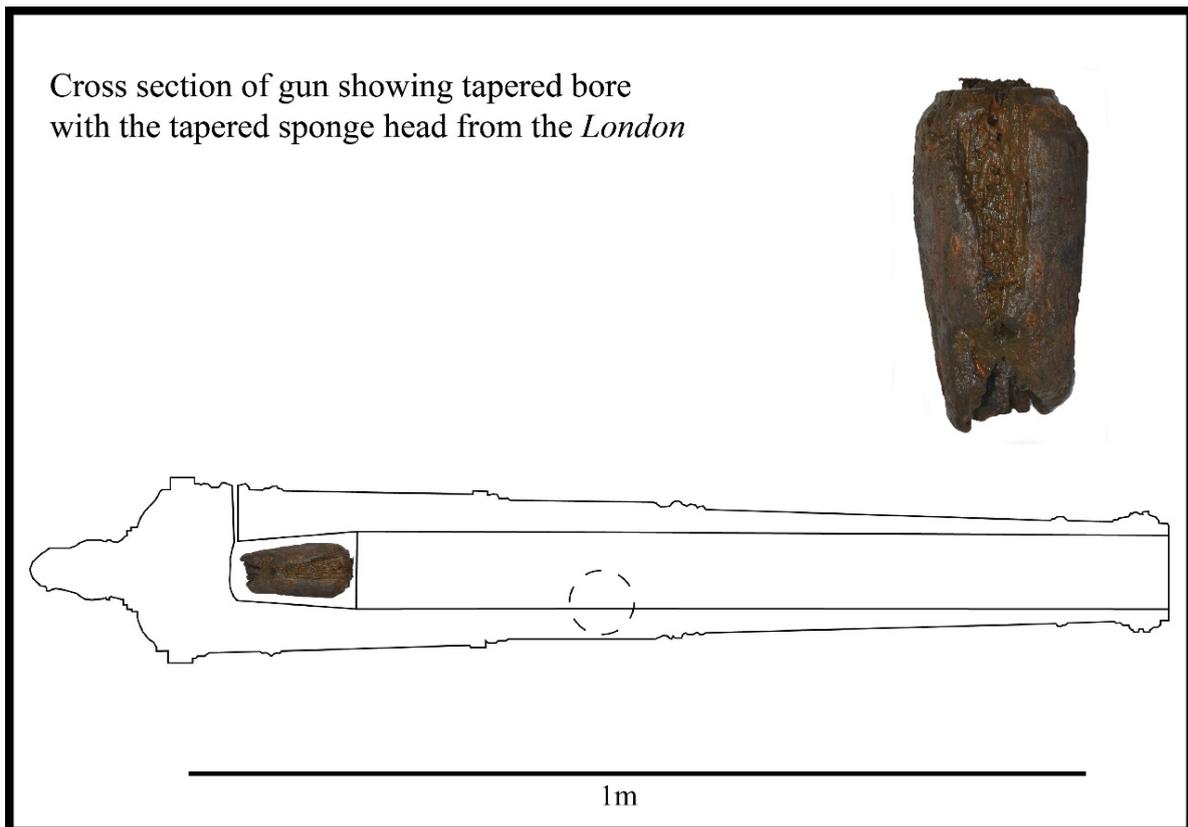
Figure 9.5: Showing cross section of gun with tapered bore and tapered sponge. The gun illustration is based on the minion drake from the Duart Point wreck (Martin 2017, p. 143). (Diagram produced by author).
