Tribology of Sliding Contacts Within Plain Bearing Overlays Subject To Corrosion

A thesis is submitted in partial fulfilment of the requirements of
Faculty of Science and Technology, Department of Design and Engineering,
Bournemouth University for the degree of Doctor of Philosophy

Faculty of Science and Technology, Bournemouth University

Daido Metal Co., Ltd., Ilminster, UK

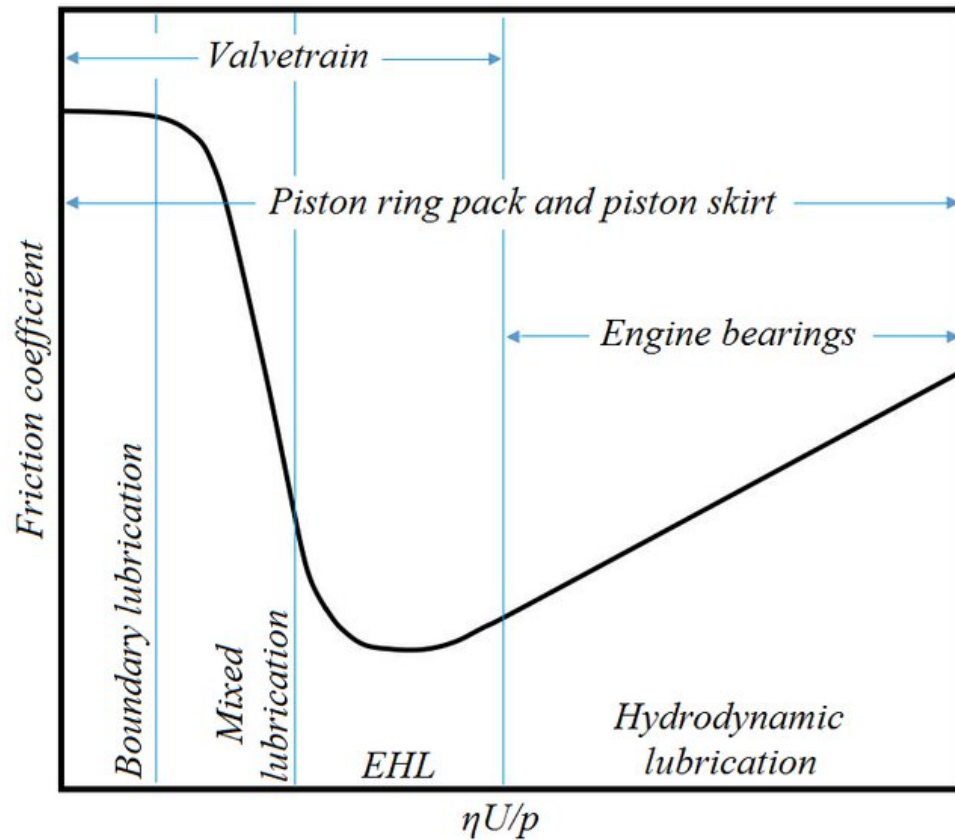
Figure 1.1 Stribeck Curve (Delprete 2020)

The fluid film formation is not adequate to deliver complete wear protection in the time of high load and high-temperature conditions. In such cases, the additives are supportive to form a chemical film on the component surface that protects from wear and corrosion. The chemical film can be removed from the surface during severe engine conditions (Tung 2004). However, depending on the viscosity, speed, surface finish, loads, lubricant and materials, different lubrication regimes prevail as shown in fig.1.1.

The surfaces are completely separated by fluid film, asperity contacts are negligible, and friction and wear should be low.

There is a chance of line or point contact of asperities in this regime. An increase in friction and wear may occur, predominantly if there is increase in load or decrease in sliding speed.

The surfaces are in contact, extreme high load or low sliding speed cause severe surface damage.

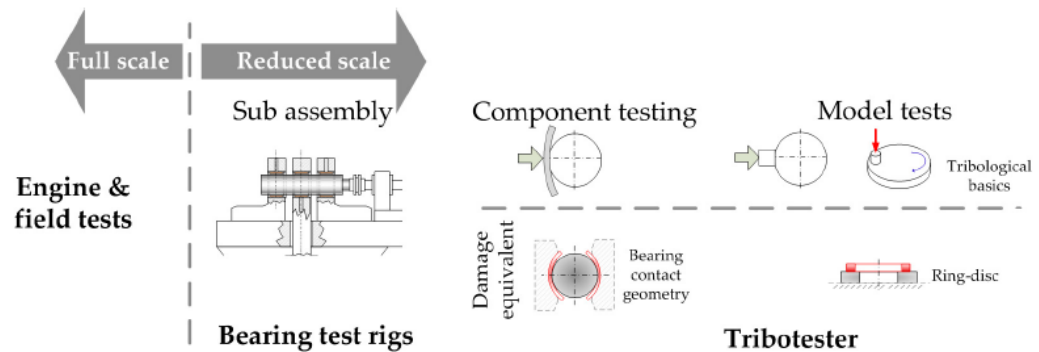
Figure 2.4.1. Test Possibilities of Plain bearings (Summer 2017)

Material design such as bearing materials, shaft materials and lubrication still rely on standard laboratory tests. The test possibilities of journal bearing system from large scale to small scale tests are shown in the Fig.2.4.1.1 (Summer 2017).

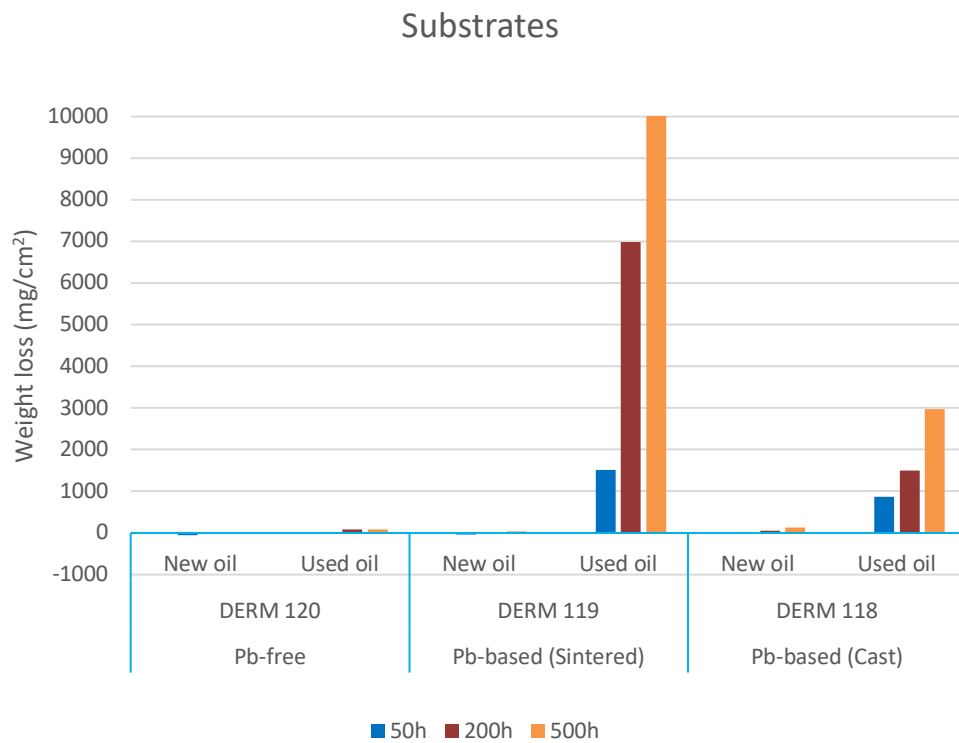
Figure 5.1. Weight loss of different lining materials in both new and used oil

The sample (DERM120) results shown in figure 5.1 indicates the Copper-Tin (Cu-Sn) lining material gained mass. It is comparatively small in both new and used oil, besides there is possibility of oil film formation on the surface during corrosion test. There was significant mass change in case of another lining material (sample DERM119) which is Lead (Pb) a based sintered material within used oil. The mass loss increased as the test duration increased. In addition, lead (Pb) is prone to corrosion within acid nonetheless deteriorated oil contains organic acids. The sample (DERM 118) is a lead (Pb) based cast lining material is also showing a mass loss in case of used oil but not as much compared with sampleDERM119. However, Tin (Sn) weight percentage in sample DERM118 is greater and this can enhance the corrosion resistance of the lead (Pb) phase within the Cu-Pb alloy.

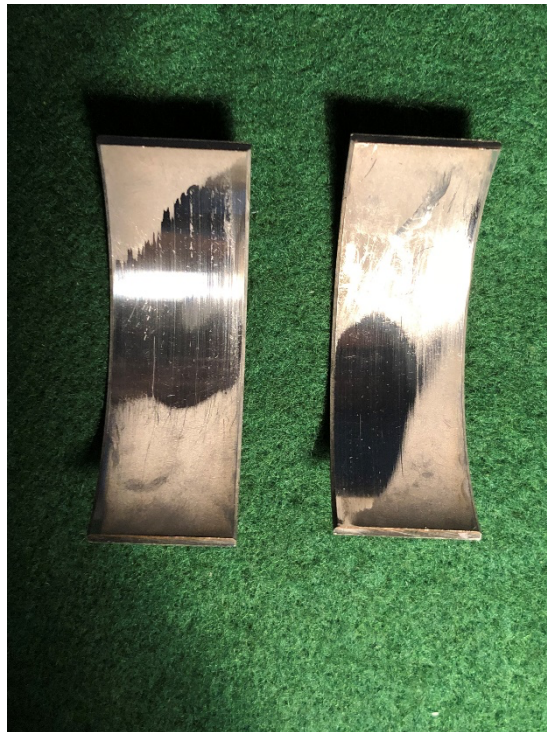
Fig.5.4.2.5. Pb-based bearing overlay material after test
