International Biodeterioration & Biodegradation

Biodeterioration and bioprotection of concrete assets in the coastal environment

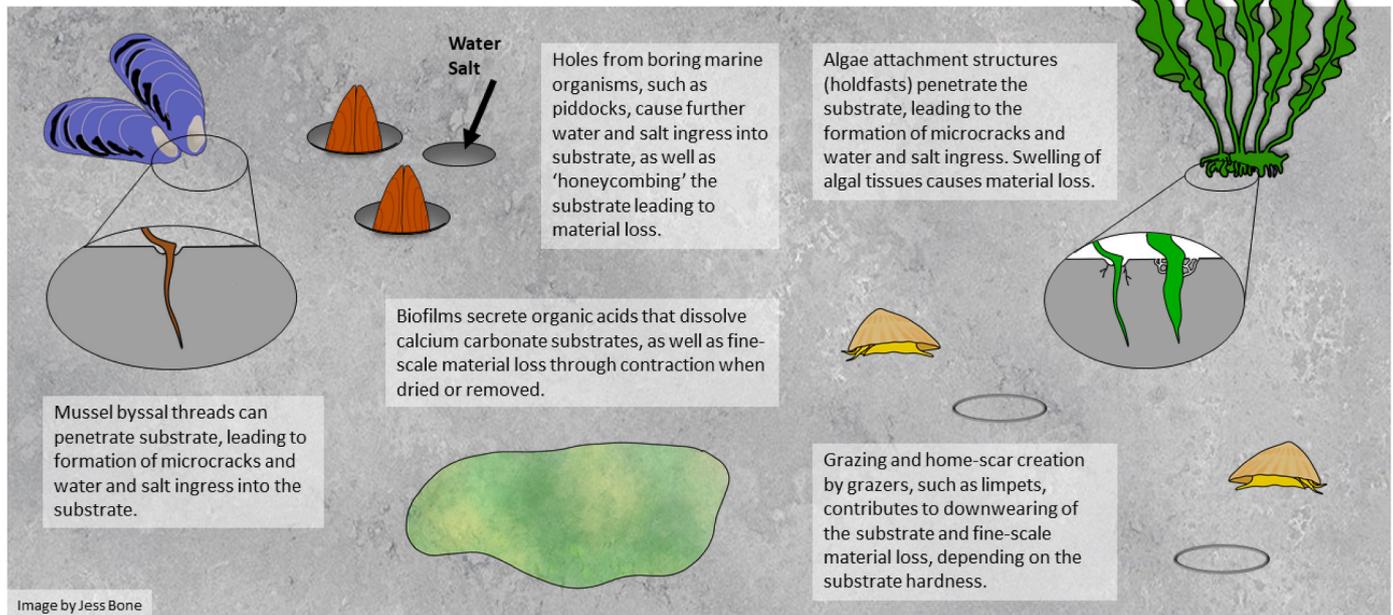
BIODETERIORATIVE MECHANISMS CAUSED BY ROCKY INTERTIDAL ORGANISMS

The biodeteriorative mechanisms caused by marine organisms will act in tandem with erosion and weathering agents, such as wave action, salt cracking, and chemical attack from sulphate and chloride in seawater.

Fig. 1. The biodeteriorative action of rocky intertidal organisms. Note that while substrate is indicative of concrete, the magnitude of biodeteriorative action is dependent on the substrate material and spatiotemporal variations in population size of the organism. Not to scale. See also 'Shore Shapers' (Naylor et al., 2014).

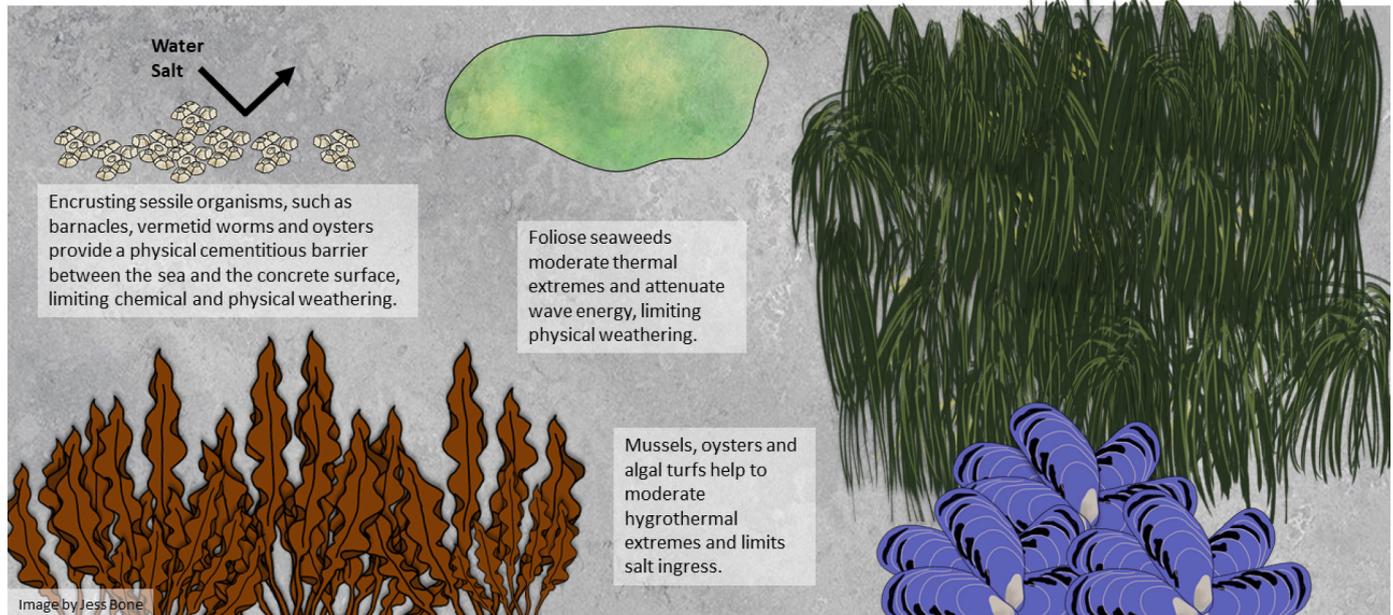
Biofilms provide a protective patina that provides minor protection against salt ingress, and can promote the precipitation of insoluble materials that prevent further water penetration.

Algal turfs and honeycomb worm reefs trap sand and particulate matter, limiting scour and stabilising sediments.

Fig. 2. The bioprotective effects of rocky intertidal organisms. Note that while substrate is indicative of concrete, the magnitude of bioprotective benefits is dependent on substrate material, whether the organism is live, and the spatiotemporal variations in population size and density. See also ‘Shore Shapers’ (Naylor et al., 2014).

Bioprotection can be achieved via three main mechanisms: stabilisation of the substrate, microclimate mediation, and attenuating weathering and other deteriorative effects (Fig. 2). Substrate stabilisation can involve the aggregation of particulate matter within biofilms, the secretion of insoluble precipitates on the substrate surface, such as oxalates, and the retention of sediment in algae. Buffering hydrothermal regimes and reducing the frequency of extreme temperature events can be achieved through the colonisation of sessile and epilithic biota, which

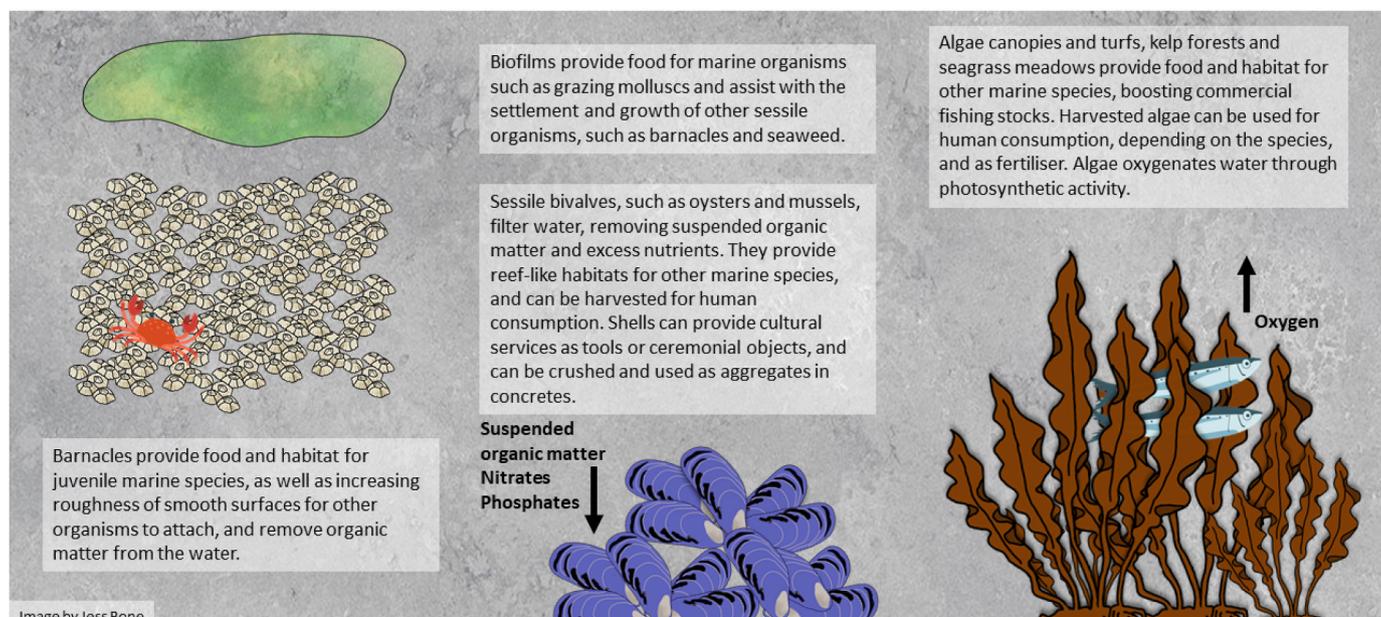
EXAMPLES OF BENEFICIAL ECOSYSTEM SERVICES AND PROCESSES PROVIDED BY ROCKY INTERTIDAL ORGANISMS

In addition to benefits provided by individual morphologies and taxonomic groups below, communities of marine organisms contribute to a 'natural aesthetic' and improve human health and wellbeing by 'greening the grey'. Where eco-engineering is used, there is potential for education, recreation and tourism benefits if the artificial coastal structure is appropriately accessible and signage and interpretation is used.

Fig. 3. Examples of some of the beneficial ecosystem services and processes provided by the rocky intertidal organisms mentioned in this review.

When attempting to determine if a species or assemblage offers a net bioprotective gain or biodeteriorative loss, acknowledgement of the additional ecosystem services offered by it should be considered (Fig. 3). For example, carbon dioxide sequestration and water filtration (Layman et al., 2014), habitat and food provision (Vaughn 2018), contribution to 'natural' aesthetic (Fairchild et al., 2022), and cultural and socio-economic benefits (education, tourism, recreation, fisheries industry) may be provided (Naylor et al. 2014, 2017) and could tip the scales in favour of encouraging or retaining existing colonisation (Coombes and Viles 2021). Ultimately, a bioprotective assemblage is not guaranteed as colonisation of a substrate is dependent on spatiotemporally variable factors, such as latitude, climate, orientation, aspect, substrate material, larval supply, predator-prey dynamics, competition, and habitat and food availability. As noted by Gadd and Dyer (2017) there is no guarantee that target species will colonise or perform in the expected and desired manner. However, promoting a diverse
