## The Warship *Hazardous Prize* – Site Investigations 1992–2022

Daniel Pascoe, Iain Grant & Dave Johnston

**To cite this article:** Daniel Pascoe, Iain Grant & Dave Johnston (2024) The Warship *Hazardous Prize* – Site Investigations 1992–2022, *International Journal of Nautical Archaeology*, 53:1, 74–102, DOI: [10.1080/10572414.2023.2255294](https://doi.org/10.1080/10572414.2023.2255294)

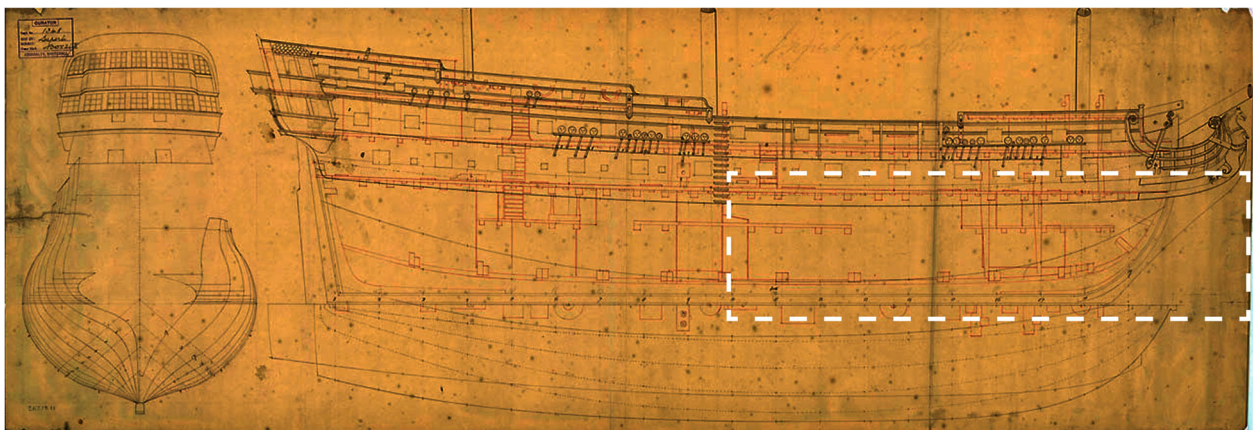
**Figure 8.** Plan of *Superb* showing layout of the internal arrangements of the platform deck. The dotted line represents the surviving section of *Hazardous* (Image ZAZ1811 © National Maritime Museum, Greenwich, London and is reproduced under their fair usage / commitment to support education and scholarship and encourage research, <https://images.rmg.co.uk/price-list/>). Creative Commons Attribution, Non-Commercial No Derivatives (CC BY-NC-ND) licence terms apply.

the Admiralty produced a draft of *Superb* following her capture showing that the orlop was divided into three separate platforms, as described above (Figure 8). The internal layout of store-rooms and compartments on French and British warships differed. For example on French warships the gunner's store, known as the lady's hole, was located at the extreme aft end of the orlop or platform deck and this gave the gunner close access to the main powder room below and to the gunroom above (Boudriot, 1986b, p. 59). Conversely, on a British warship the gunner's store was found at the forward end with access to

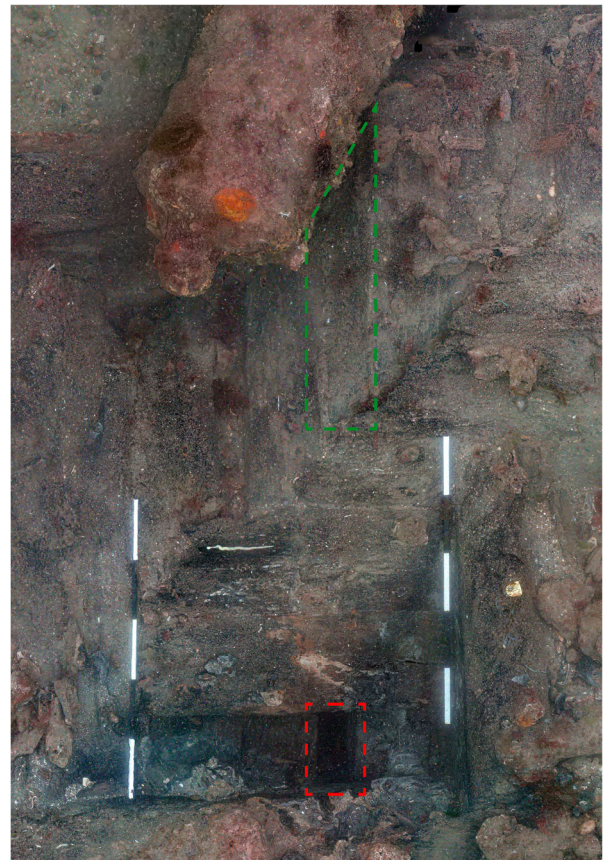
**Figure 10.** The dashed red line showing the space between the frames and the green dashed line showing that space filled by an additional timber, possibly known as a 'filling'. Scales are 1 m with 20 cm increments (survey and model produced by Daniel Pascoe).

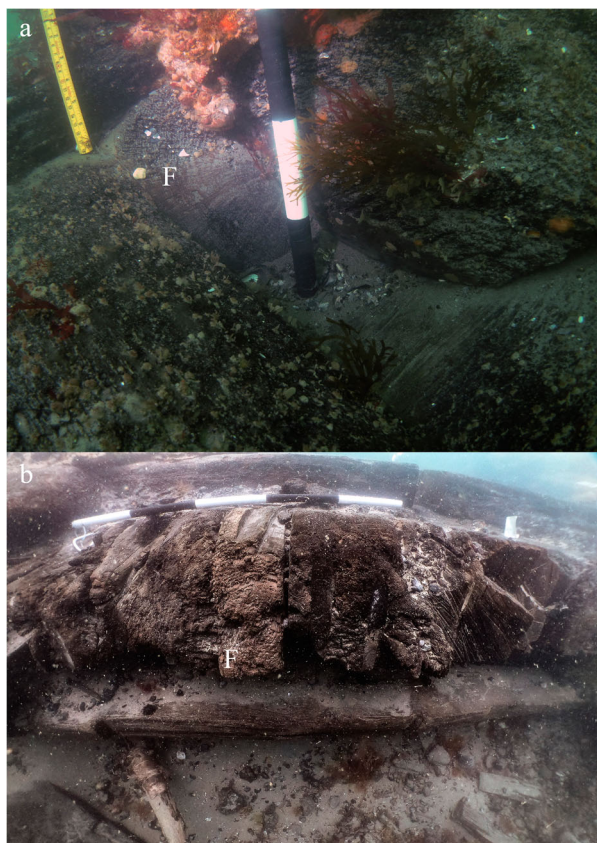
**Figure 11.** Structure from *Invincible* 1758. Photo A) showing filling timber between frame bends from starboard side stern structure from roughly gun deck level, the scale is 50 cm with 10 cm increments. Photo B) shows filling timber at roughly the floor heads on the starboard side amidships, the scale is 1 m with 20 cm increments (photos by Daniel Pascoe).

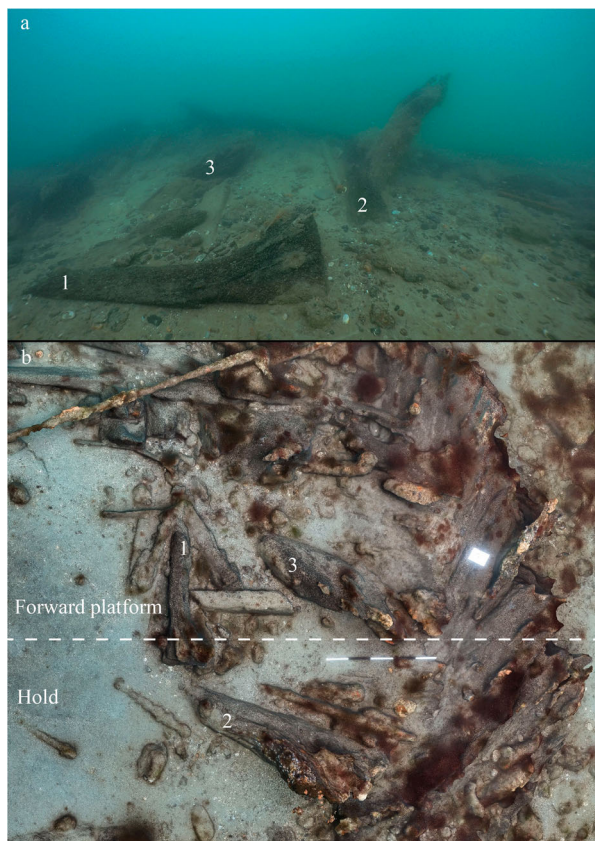
**Figure 13** Image A) is a photograph looking north towards the head. Image B) is a plan view from the 2019 3D textured model. 1 – rising knee, 2 and 3 – breast hooks. The scale is 1 m with 20 cm increments (survey, photo and model produced by Daniel Pascoe).

A second knee relating to the platform deck was located at the forward end, just aft of two breast hooks (Figures 4 and 13). The knee was in a fairly poor condition in 2019 and by 2021 it was gone. From the 2019 recording it appeared to be a rising knee with a vertical arm 1.28 m (4 ft 2 in) long, 250 mm (9.8 in) moulded and 200 mm (7.9 in) sided. As the original surfaces were heavily eroded these dimensions will not relate to the knee's original size.

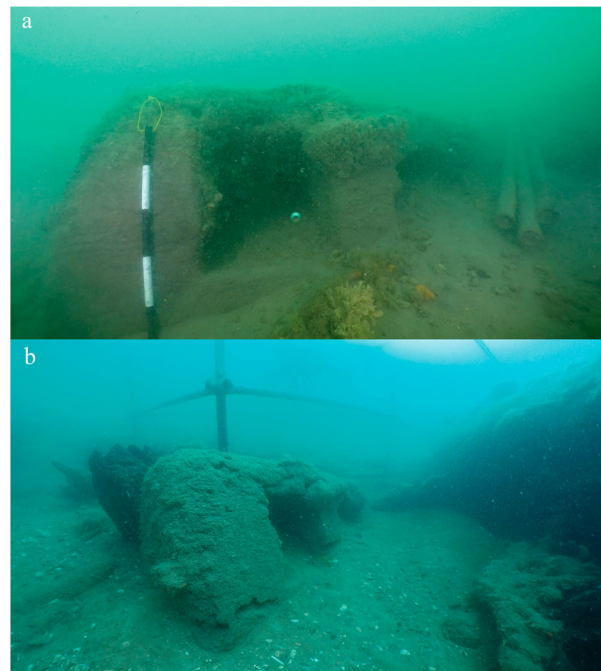
**Figure 20.** Photo A) the mast cap as found in 2016. Image B) mast cap leaning against possible platform beam. Mast caps joined the tops of the lower masts to the upper mast. The square hole slotted onto a square tenon at the top of the lower mast and the upper mast passed through the circular hole. The scale is 50 cm with 10 cm increments (photos by Daniel Pascoe).

The excavation in the area of the forward platform found a carpenter's jack plane and a spare mast-cap two metres further forward, which became exposed naturally (Figure 20). A mast-cap is a rectangular timber with two adjacent holes, one square and one circular, used to secure the upper masts to the lower masts. The tops of the lower masts were cut into a square tenon that slotted into the square hole on the cap, with the end of the upper mast being passed through the circular hole on the cap (Steel, 1796, p. 91). These are the type of artefacts that would be expected to be found in the storerooms on the forward platform.

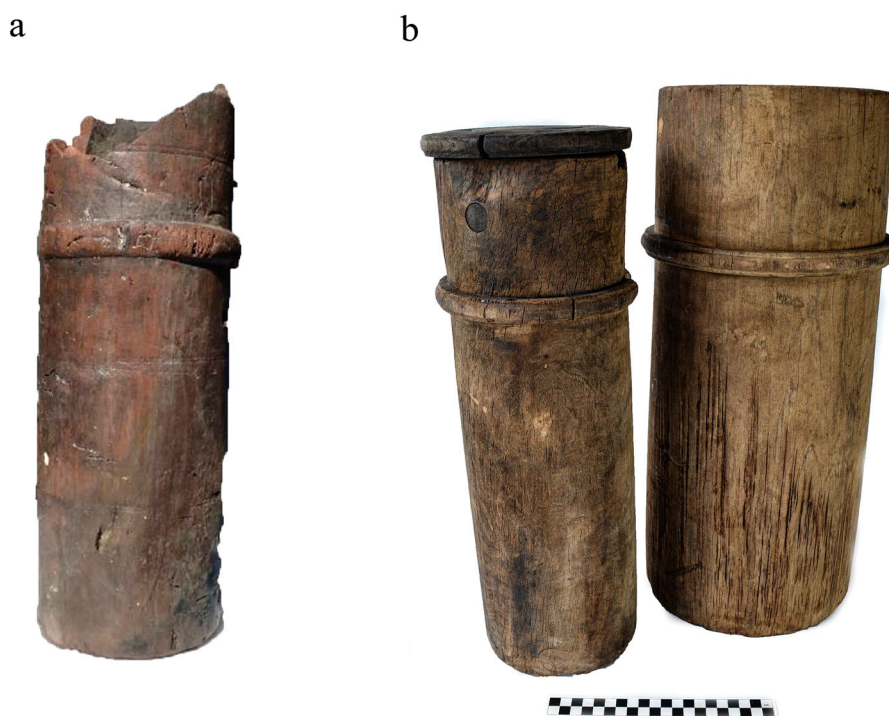
**Figure 22.** Image A) showing cartridge case from *Hazardous*, it has a diameter of 155 mm (6.1 in) and was suitable for the 18-pounder charges. Image B) showing cartridge cases from *Invincible* 1758, scale is 20 cm with 1 cm increments (photos Daniel Pascoe).

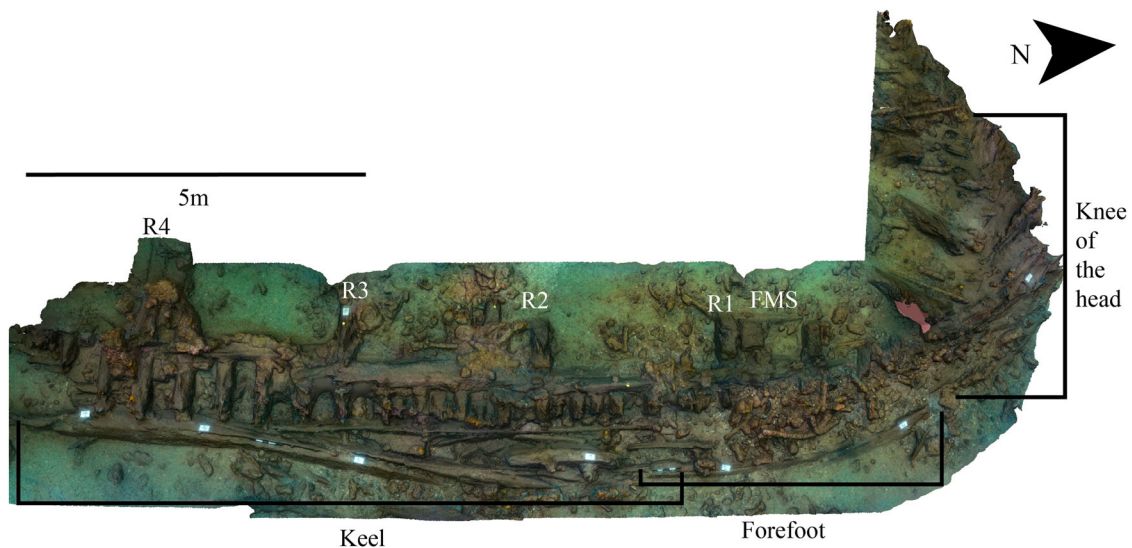
**Figure 23.** A 3D shaded model produced from the 2017 photogrammetry survey of the exposed structure of the lower hull. R1–4 – riders 1–4, F – frames, FMS – fore mast step (survey and model produced by Daniel Pascoe).

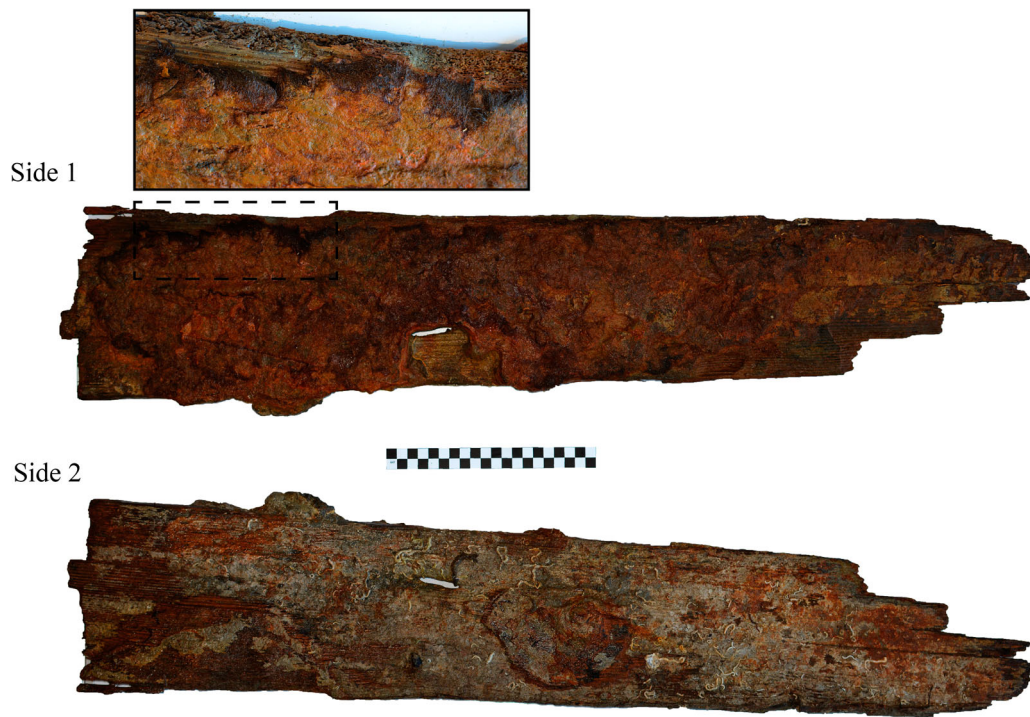
**Figure 26.** The recovered section of outer sheathing. Side 1 is the inside, revealing the layer of tar and hair and side 2 is the outside showing concretion from the iron nail fastenings. The scale is 20 cm (photo by Daniel Pascoe).

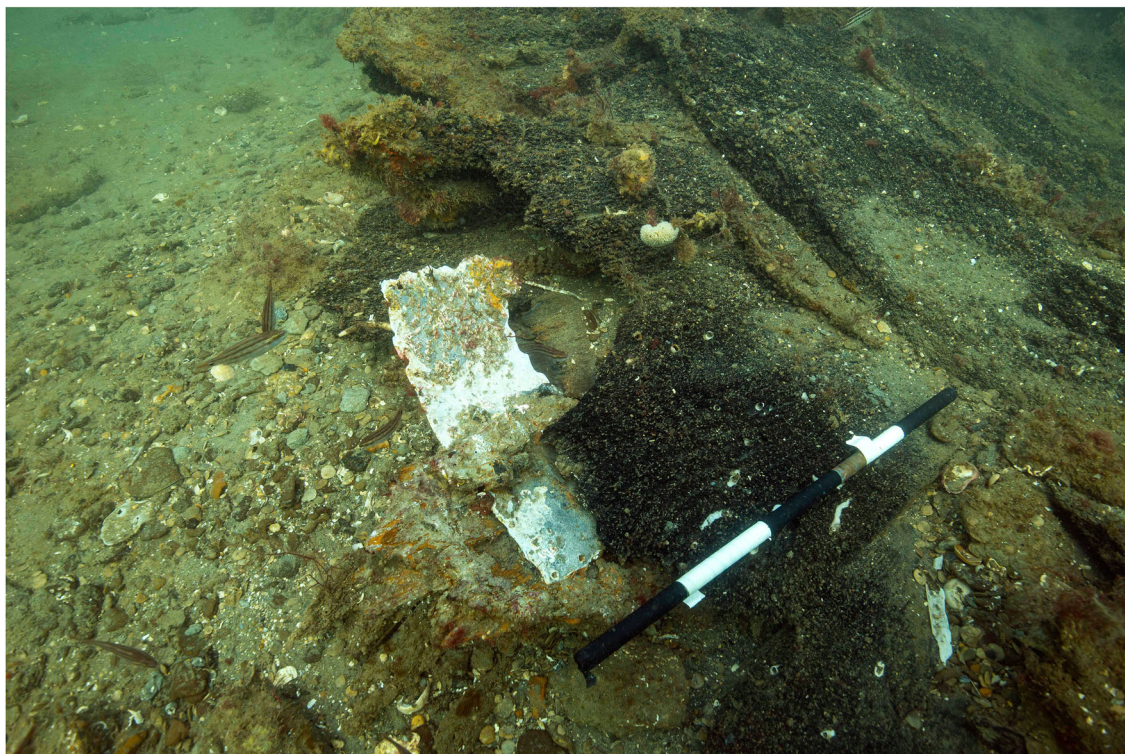
**Figure 27.** Photo showing lead tingle between sheathing and outer planks. Scale in photo is 50 cm with 10 cm increments (photo by Daniel Pascoe).

Another interesting feature on the outside of the hull is the presence of a lead tingle between the outer planking and the sheathing, which suggests the condition of the outer planks may not have been in a good state before the sheathing was added (Figure 27). There is historical evidence to support this as Captain Harris writes to the Admiralty prior to the voyage to Virginia asking that the bottom of the hull should be cleaned as it is very foul. He also states that the carpenters are repairing the doublings, possibly referring to a second layer of planking (TNA, ADM 106/609/106).

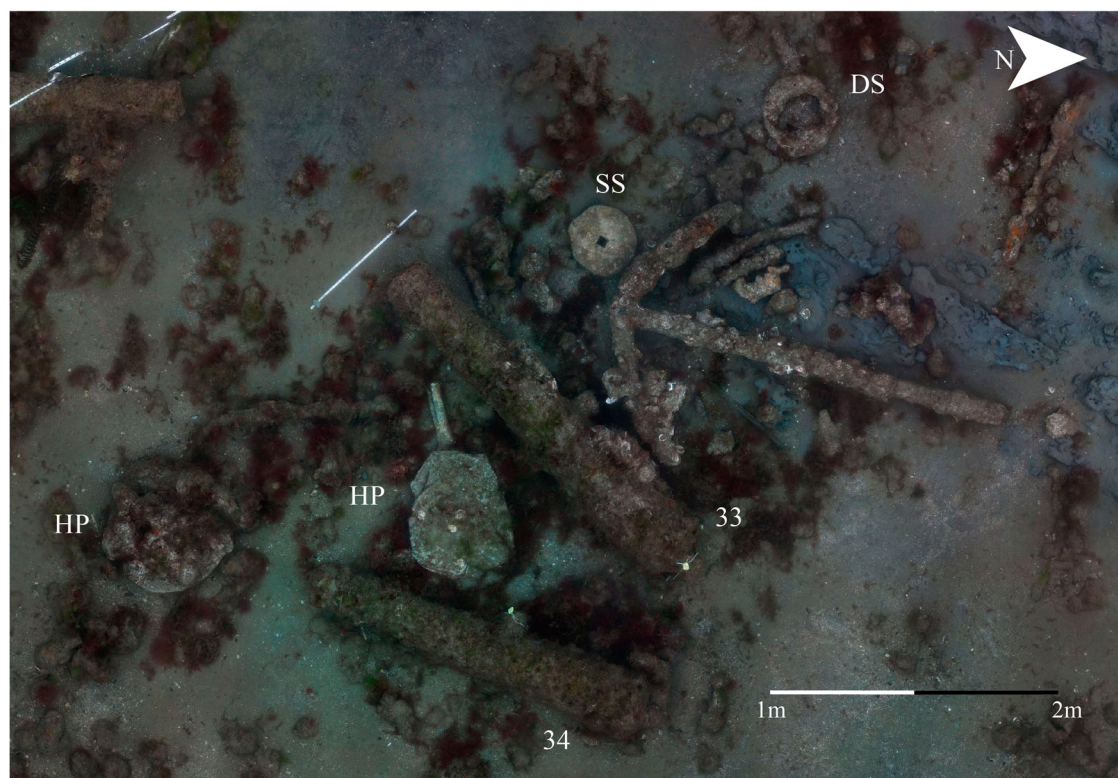
**Figure 31.** Orthophoto mosaic of the anchor next to guns 33 and 34, HP – Hawse-pipes, SS – sharpening stone and DS – deadeye-strap (survey and mosaic produced by Daniel Pascoe).

The anchor found on the 2019 gun site is a relatively small anchor. It has an overall length of 2.82 m (9 ft 3 in), a shank length of 2.65 m (8 ft 8 in), a span of 1.8 m (5 ft 11 in), and the length of the arm is 0.97 m (3 ft 2 in) (Figure 31). The wooden stock and iron ring are missing. According to the contemporary

draftsman, William Keltridge, the shank length is within 2 in of the appropriate length of a kedge anchor for a fourth-rate (Keltridge, 1675, p. 217). The kedge was the smallest anchor carried on board and was small enough to enable it to be carried in the ship's boat. It was used to work a ship up and down a narrow river or inlet or to pull the ship away from shallow water. The anchor would be lowered into the ship's boat attached to a long cable, the boat was rowed out to a suitable depth and the anchor dropped. The cable would then be hauled in by the capstan and the ship drawn to a suitable anchorage. This process is known as kedging (Curryer, 1999, p. 51; Mainwaring & Perrin, 1921, p. 170; Smith, 1627, p. 36).

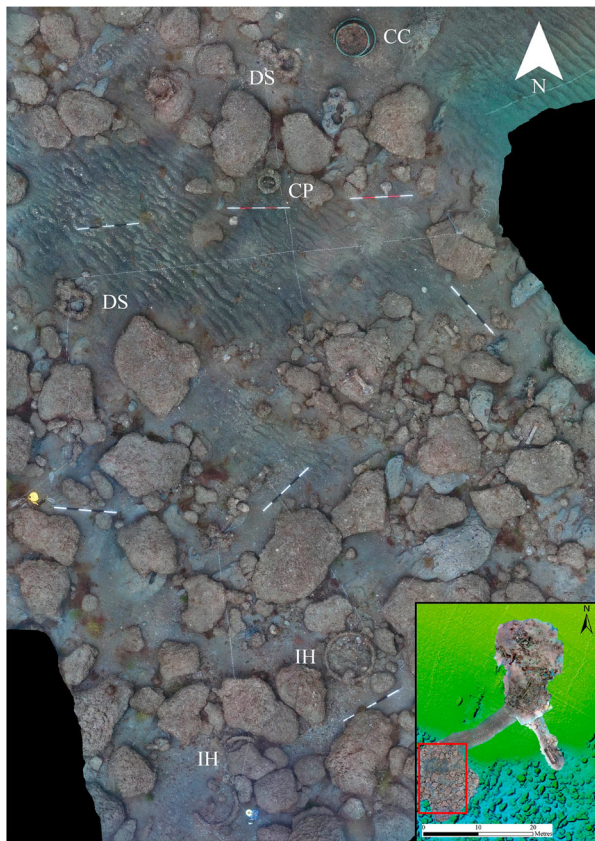
**Figure 32.** Orthophoto mosaic of the extended area of the 2019 gun site showing a large spread and variety of material which include: CC – copper cauldrons, CP – cast iron pot, DS – deadeye straps and IH – iron hoops. Also scattered among these objects are round and double head shot. Scales are 1 m with 20 cm increments (survey and mosaic produced by Daniel Pascoe).

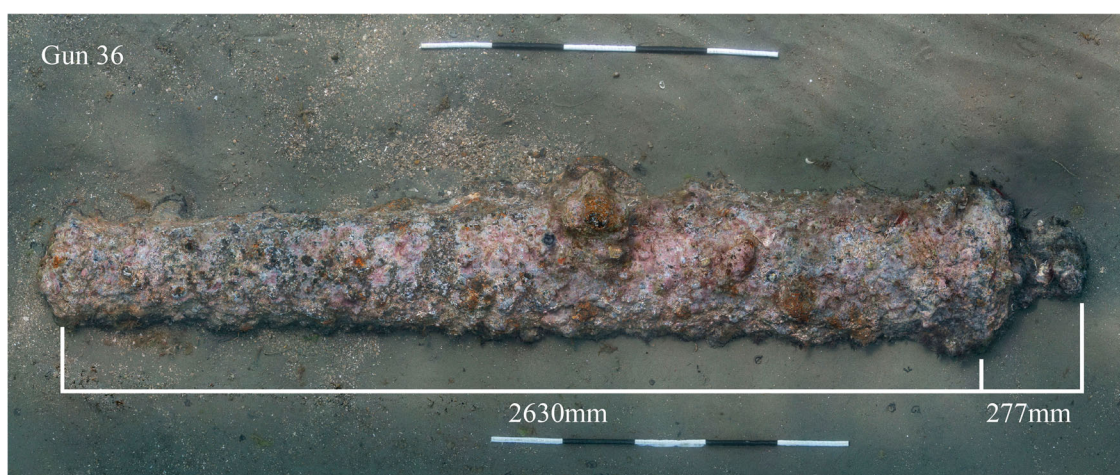
**Figure 33.** Orthophoto mosaics of Gun 36. Scales are 1 m with 20 cm increments (survey and mosaic produced by Daniel Pascoe).

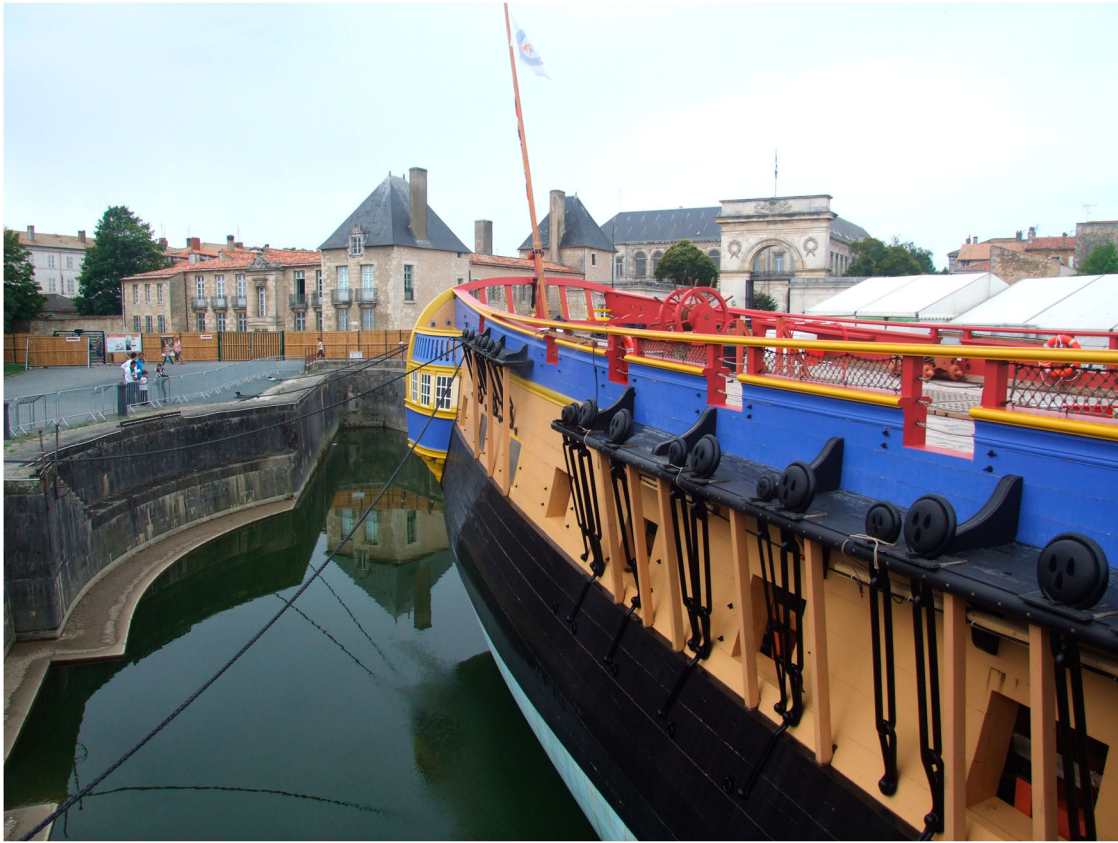
**Figure 35.** Photo of *L' Hermione* showing lower deadeye with shrouds and chain plates. The bottoms of the chain plates are bolted to the outside of the hull and the deadeyes are located along the chainwale (photo by Daniel Pascoe).

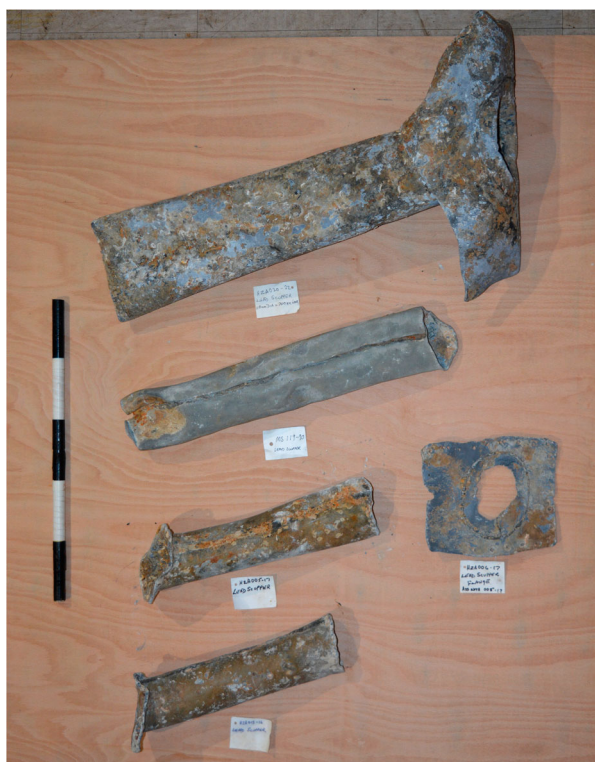
**Figure 37.** Scuppers in order of size from the top down. The scale is 0.5 m with 10 cm increments (photo by Daniel Pascoe).

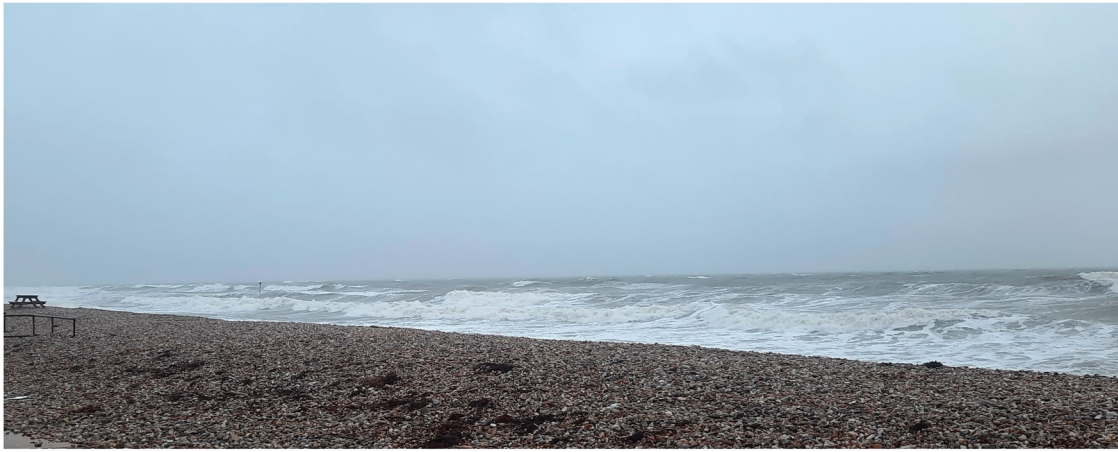
**Figure 38.** View from East Wittering beach looking out towards the site on the 28 December 2022, showing the condition of the sea during a south westerly (photo taken by Iain Grant).

We know from current experience that in Bracklesham Bay calm days and weather from the north are few and far between during autumn and winter months. *Hazardous* would have been lying on her port side in the surf zone and, with any notable weather from a southerly direction, would have been continually battered by wave action (Figure 38). This
