Scuttled in the Morning: the discoveries and surveys of HMS *Warrior* and HMS *Sparrowhawk*, the Battle of Jutland's last missing shipwrecks

Innes McCartney

Due to the circumstances of the loss of HMS *Warrior* and HMS *Sparrowhawk* in 1916, in which subsequent to disablement both had drifted and been towed unknown distances from the Jutland battlefield, they were not located in the 2015 Jutland survey. In August 2016 both ships were located and HMS *Warrior* was revealed to be a pristine warship wreck, the only example in this condition of the 25 ships sunk in the battle. HMS *Sparrowhawk* had a similar pattern of disturbance as seven of the other Battle of Jutland destroyer wrecks. The survey of these wrecks draws to a conclusion a long period of discovery at Jutland and raises questions as to how these important cultural artefacts should be treated in the future.

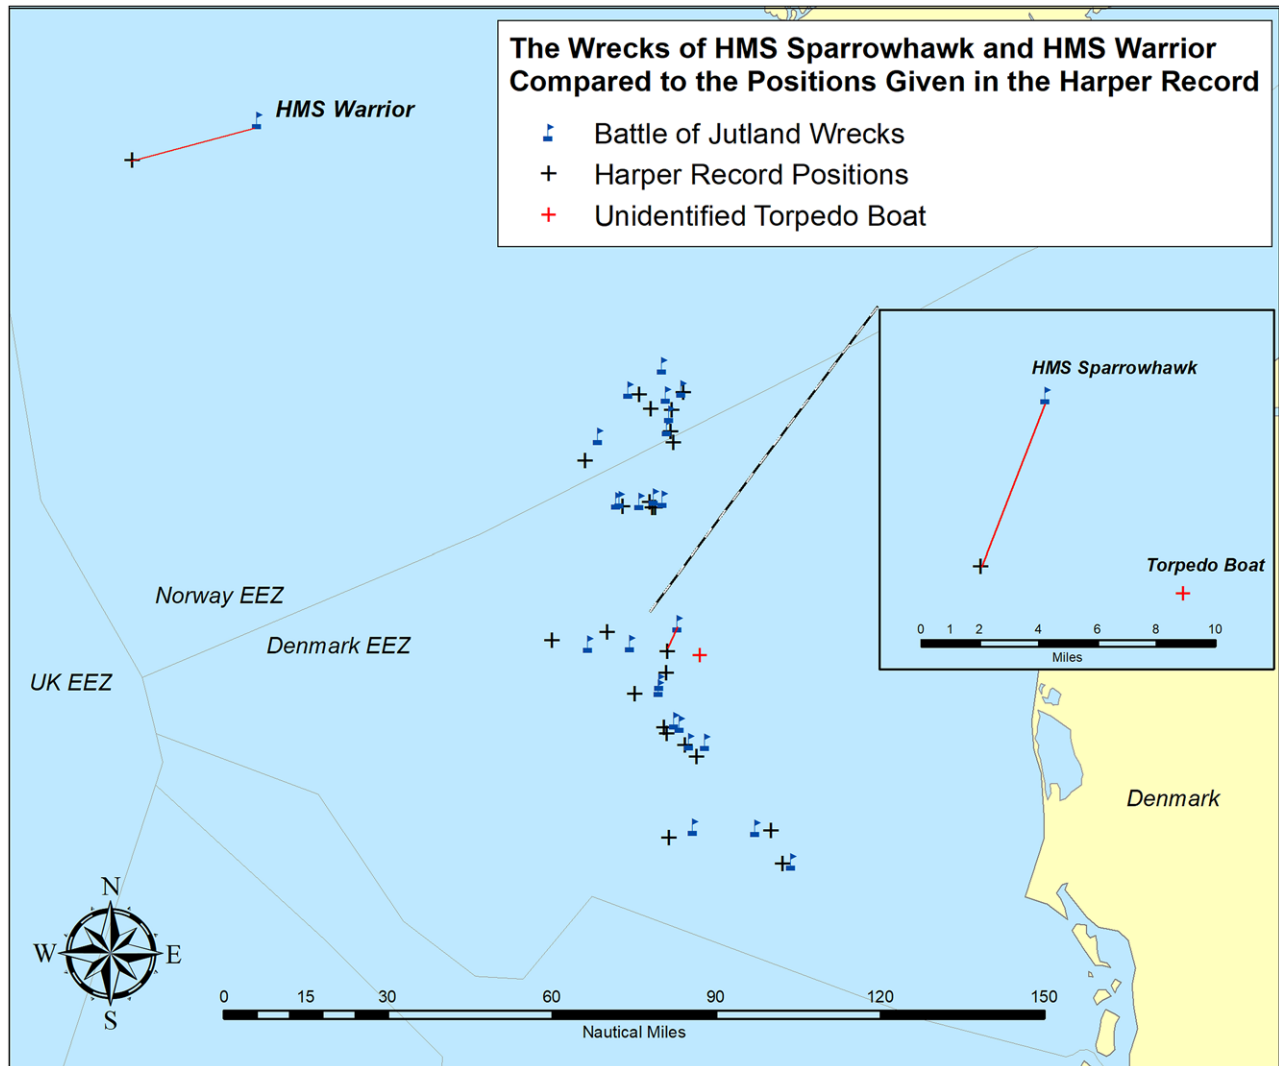
As it turned out, the position given for HMS *Warrior's* loss was the most inaccurate in the entire *Harper Record* by a very considerable margin. The wreck lies 25 miles from the Harper position. Comparison of the Jutland wreck-sites with Harper's estimated positions showed the average discrepancy to be 3.5 nautical miles (McCartney, 2016: 244). *Sparrowhawk* lies six miles from the Harper position (Fig. 1). As described here, an additional destroyer

Figure 1. The locations of the wrecks of HMS *Warrior* and HMS *Sparrowhawk* shown in relation to the other wrecks of the Battle of Jutland and the positions given in the Harper Record. ‘Site B’ wreck, possibly an S138-class German torpedo boat, is marked with a red cross (Innes McCartney).
