FRICTION AND WEAR PERFORMANCE OF LIFEBOAT LAUNCH SLIPWAYS

A thesis submitted in partial fulfilment of the requirements of Bournemouth University for the degree of Doctor of Philosophy

July 2009

Bournemouth University In collaboration with the Engineering and Physical Sciences Research Council and the Royal National Lifeboat Institution

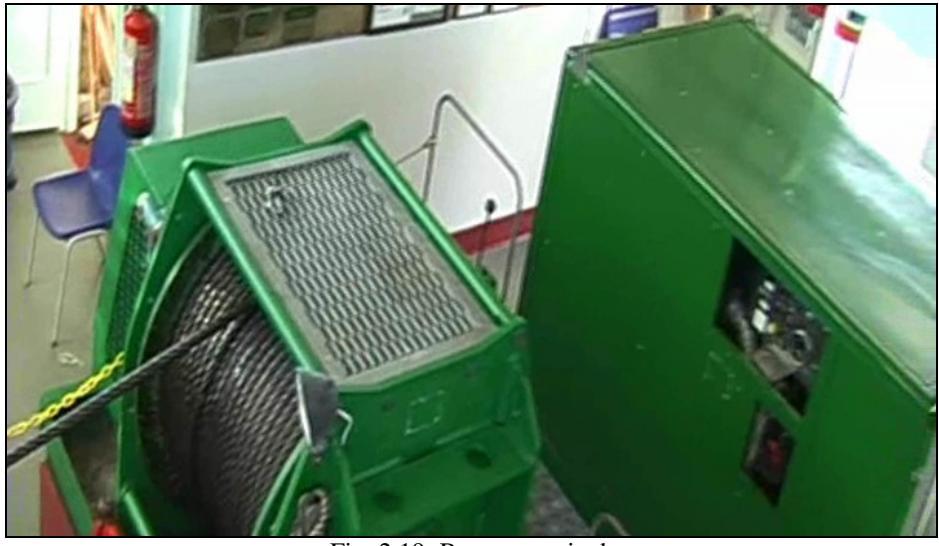
Fig. 2.19: Recovery winch

The recovery winch is rated for a 12 tonne load at a 15m/min line pull speed, high friction incidents on the slipway can cause the load to exceed this and may require the winchman to significantly reduce the line pull speed to maintain acceptable winch loading.

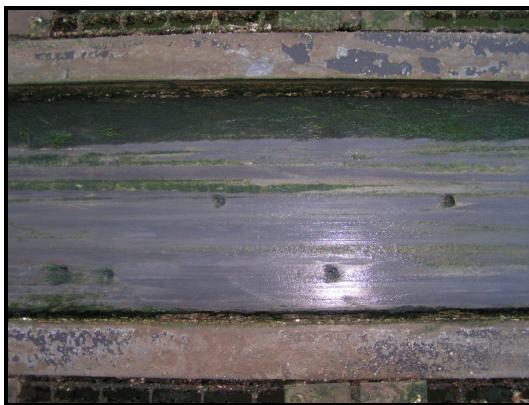
Fig. 3.7: Selsey slipway inspection – algae on panels

Algae was noted to be present on the lower section of the slipway and gouging wear scars were observed. One instance of embedded shell debris (ringed) was noted on the lower section of the slipway.

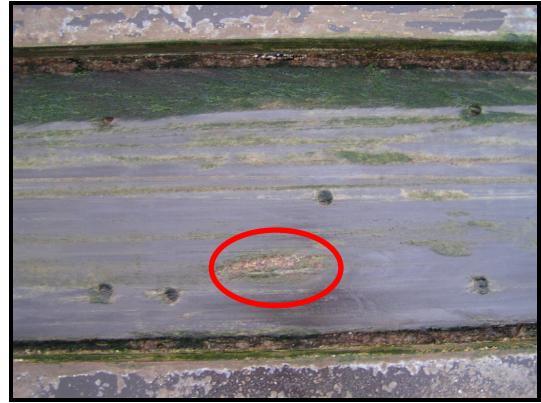
Fig. 3.8: Selsey slipway inspection - embedded debris

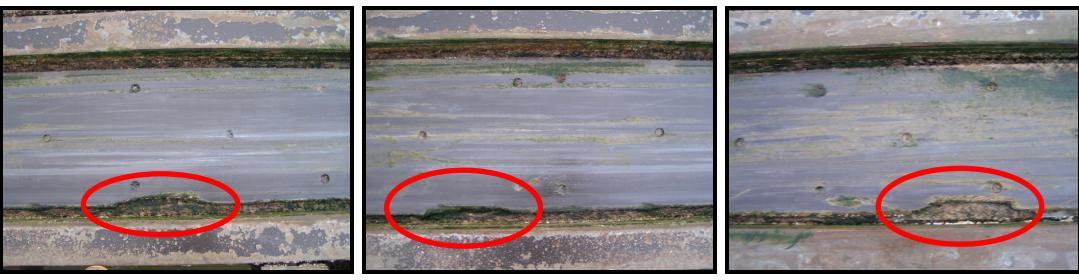
Fig. 3.9: Selsey slipway inspection - Worn panel edges from recovery keel impacts

Further up the slipway, damage to the side of the composite section was observed, this was attributed to keel impacts during recovery as the lifeboat initially mounts the slipway as this damage was only present on the lower section of the slipway where recovery is conducted.

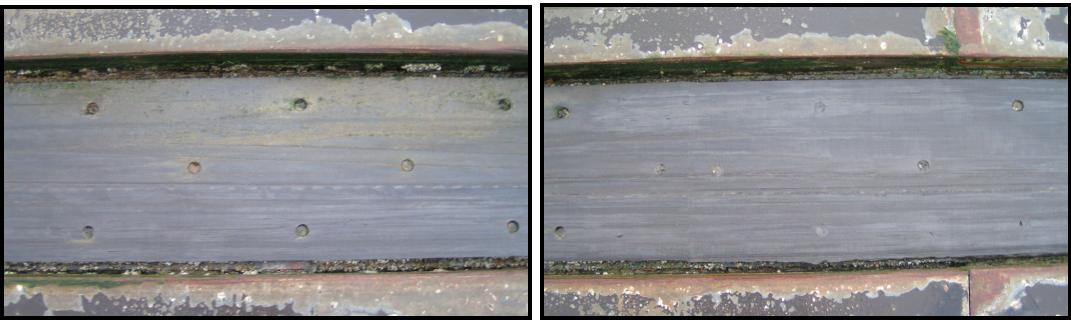
Fig. 3.10: Selsey slipway inspection - Gouging wear scars

Gouging wear was noted along the slipway with shallow wear scars indicating a raised section on the lifeboat keel or trapped 3rd body between the keel and slipway lining.

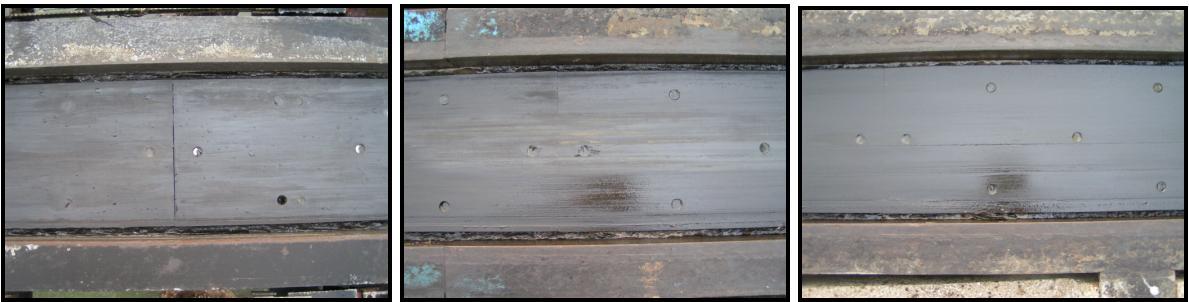
Fig. 3.11: Selsey slipway inspection - light panel end wear

Selsey slipway exhibited very little wear at the ends of the composite panels, whereas this had appeared to be the principal cause of wear at Tenby and Padstow. This may be because Selsey slipway panels are well aligned, with only small gaps between panels and no 'step' effects.

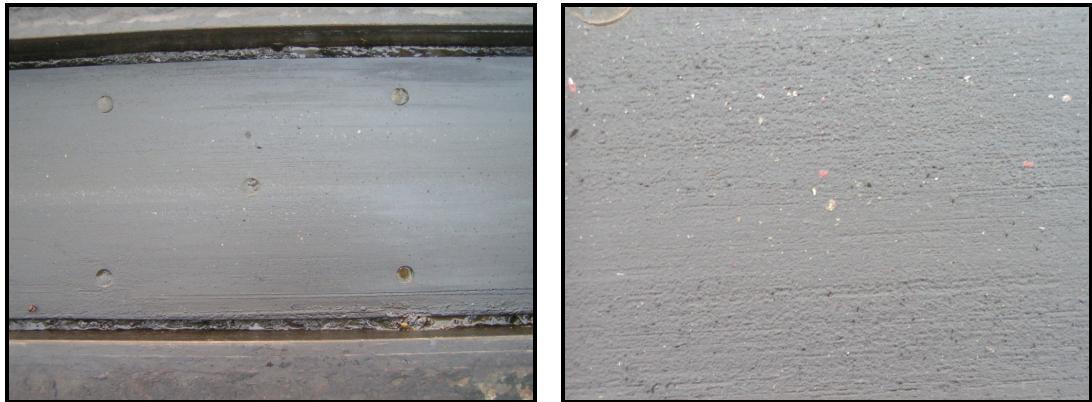
Fig. 3.12: Selsey slipway inspection – embedded shell debris

At the top of the composite slipway section there was another section of embedded debris, the coxswain believed this to be shell fragments as the slipway was used by seagulls to break the shells of hermit crabs and other molluscs [62].

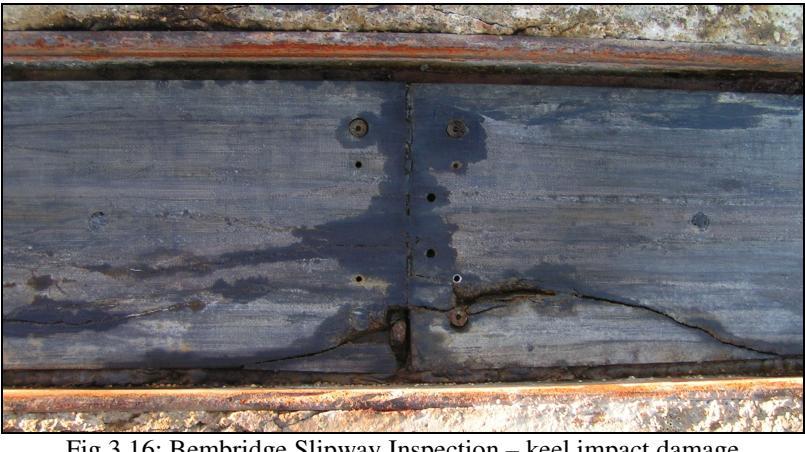
Fig 3.16: Bembridge Slipway Inspection – keel impact damage

Towards the base of the slipway severe cracking damage to the slipway panels it observed, this is reported by the Bembridge coxswain to be due to the impact of the lifeboat keel as the boat mounts the slipway for recovery.

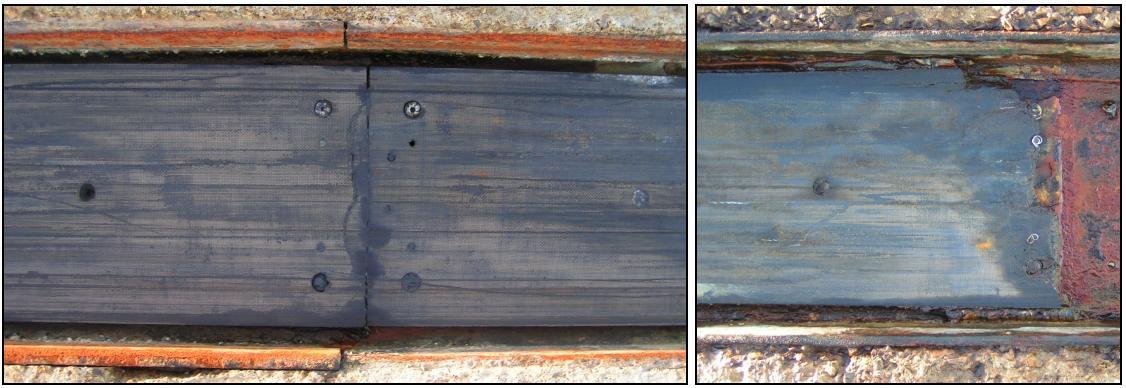
Fig 3.17: Bembridge Slipway Inspection – Panel end damage: a) developing crack, b) cracked sections detached from panel

Panels are observed to be more vertically misaligned than at Selsey and panel end wear was observed at these points. This took the form of cracking, where a cantilever effect on the raised slipway panel results in a horizontal crack developing on the end of the panel. This will eventually progress through the composite until a large end section of the panel breaks away, this is seen on a worn panel at the very base of the slipway (fig. 3.17b).

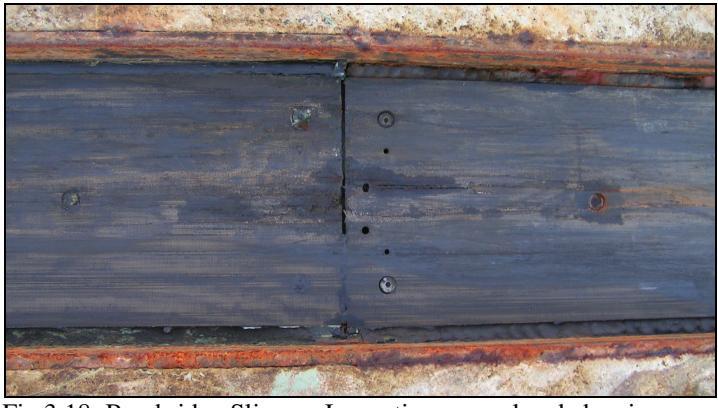
Fig 3.18: Bembridge Slipway Inspection - panel end abrasive wear

If the composite remains adequately supported while still being vertically offset in relation to its neighbour then abrasive wear rather than large sections of cracking becomes dominant as seen in fig. 3.18.

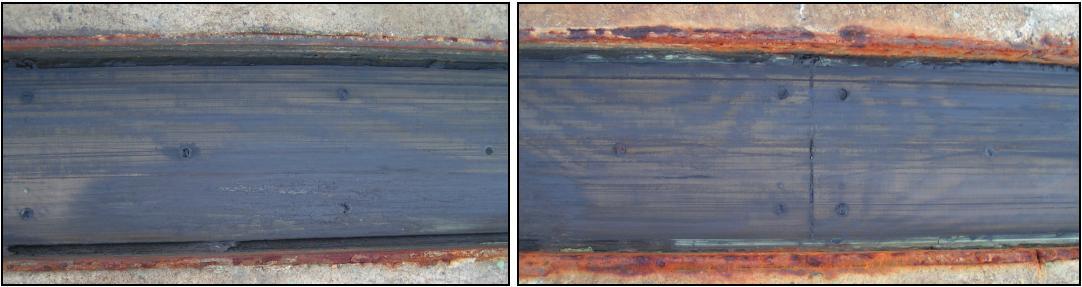
Fig 3.19: Bembridge Slipway Inspection - panel gouging wear

Abrasive gouges in the slipway lining are observed as at Selsey slipway, these are generally shallow grooves formed along the slipway panels by a raised imperfection in the lifeboat keel or by debris trapped between the keel and slipway lining. While contributing to the wear on the slipway panels these are not observed to cause panel failure, which is generally as a result of panel end cracking or abrasive wear on misaligned panels [63].

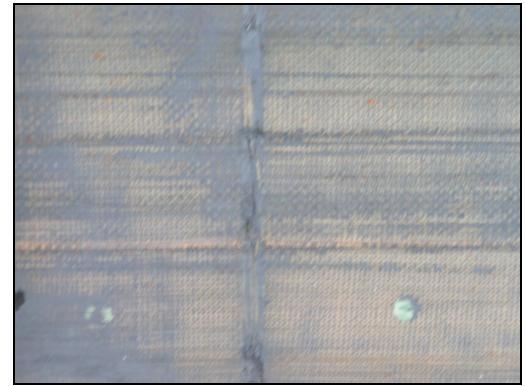
Fig 3.20: Bembridge Slipway Inspection - plane abrasive wear

Smooth abrasive wear was noted on some panels where alignment was good and the keel/slipway contact was plane and conformal, here the phenolic resin had abraded to reveal the underlying jute fibre mesh. This type of wear was observed to be very light and represents the wear that would be expected in the ideally aligned case.

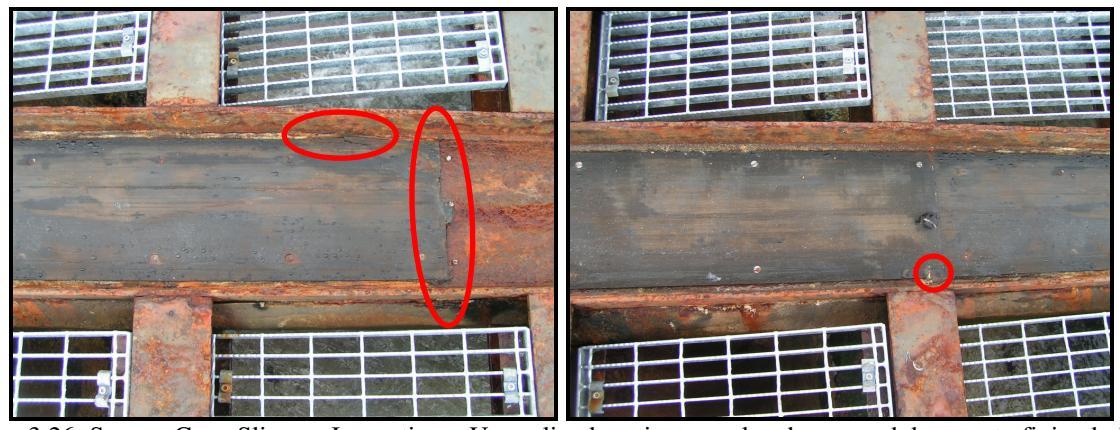
Fig. 3.26: Sennen Cove Slipway Inspection - Upper lined section, panel end wear and damage to fixing bolts

The second stage of slipway lining bears the weight of the lifeboat as it is drawn up the slipway by the winch. Again, this section is in relatively good condition with no prominent wear scar. The start of the slipway lining shows wear where an inclined section intended to smooth the step up from the unlined steel channel has worn away. Without this section the end of the slipway lining is beginning to wear in a similar fashion to the worn slipway panels observed at Selsey and Bembridge. The second slipway panel is almost unscathed with only some damage to one of the fixings observed. Wear on this section from the lifeboat keel is light and evenly distributed with the phenolic resin having worn away evenly in places to reveal the underlying jute fibre mesh in a similar way to the distributed plane sliding wear observed at Bembridge. This wear again represents the ideal case where contact is near planar and there are no stress concentrations present.

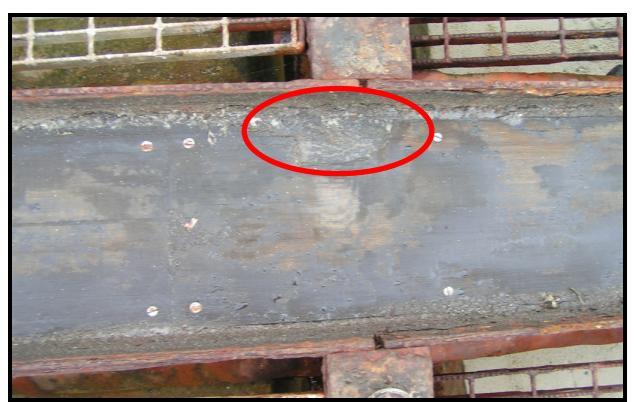
The upper section of the slipway also showed little wear, with some damage along the edges of the panels and wear on the securing screws. Light scoring was also present which is indicative of gouging wear as also found at Selsey and Bembridge. Between the panels and along the edges of the lining a dark slurry comprised of sand and grease has accumulated.

Fig. 3.28: Sennen Cove Slipway Inspection - Upper lined section, grease and sand slurry build-up

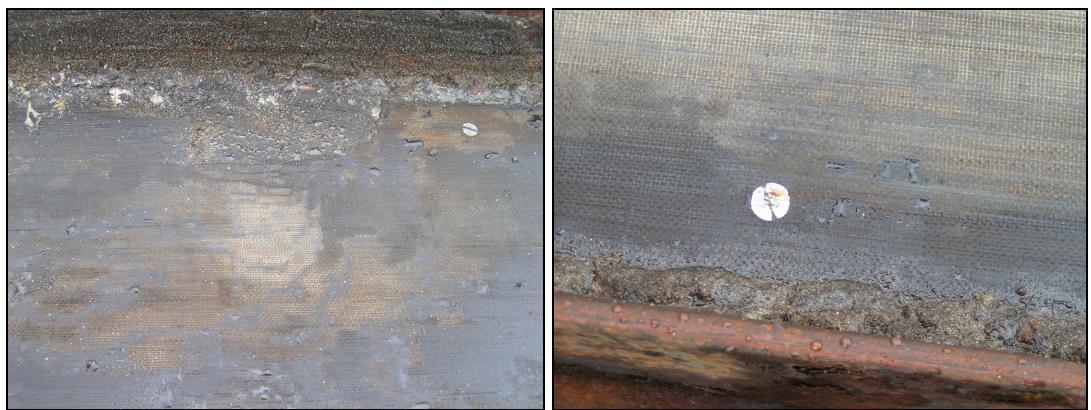
The very top of the slipway lining also exhibited some light wear, though there was one example where the edge of the panel had degraded quite significantly. Wear on this section was primarily the light plane sliding wear associated with smooth, well aligned planar contacts.

Fig. 3.29: Sennen Cove Slipway Inspection - Upper lined section, plane abrasive wear

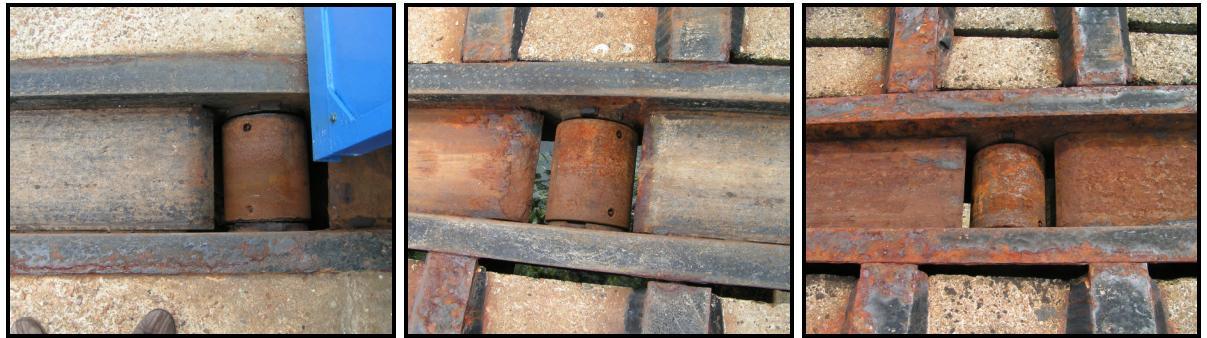
The rollers are observed to be very rusty but no problems have been reported on this section of the slipway.

Fig. 3.33: The Lizard Slipway Inspection: Roller section

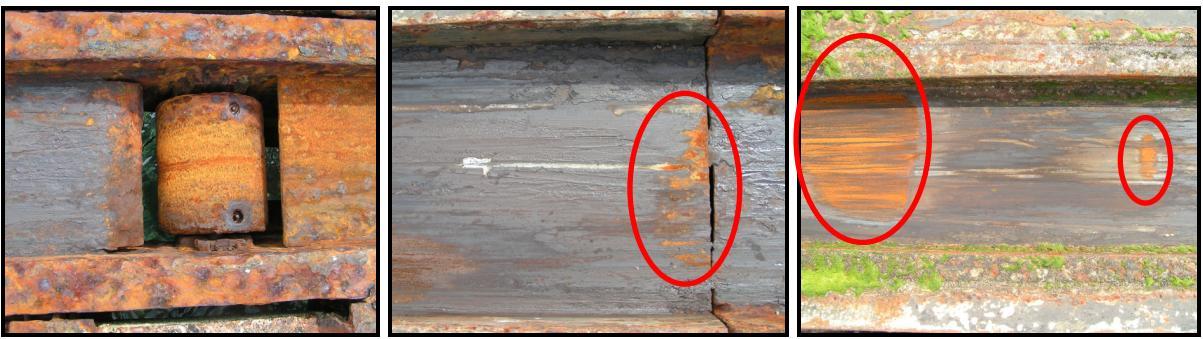
This section features a short length of steel panels which are greased with Marine grease for launch and recovery. These are covered in a sticky residue from the grease used and wear can be seen at the edge of sections and on the last panel, where some bowing appears to have caused the raised areas to wear. From interviewing the lifeboat station staff however, it appears that there is no real friction problem on this section of the slipway [65]. The steel section is treated with hyperchlorate to remove seaweed and algae.

Fig. 3.34: The Lizard Slipway Inspection: Steel panel section

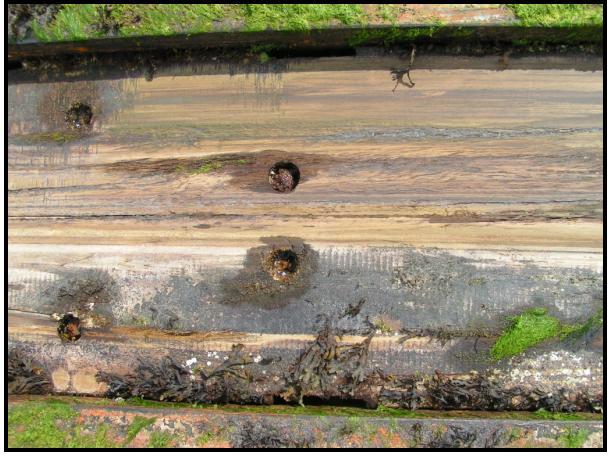
Cracks appear to be longitudinal along the wood panel, and may be caused by swelling/shrinking of the wood as it absorbs water, cracks are more prevalent nearer the waters edge. Other wear seems to indicate gouging due to raised sections on the lifeboat keel or 3rd body particles present in the contact in a similar fashion to other slipway stations surveyed here.

Fig. 3.37: The Lizard Slipway Inspection: Greenheart wood section

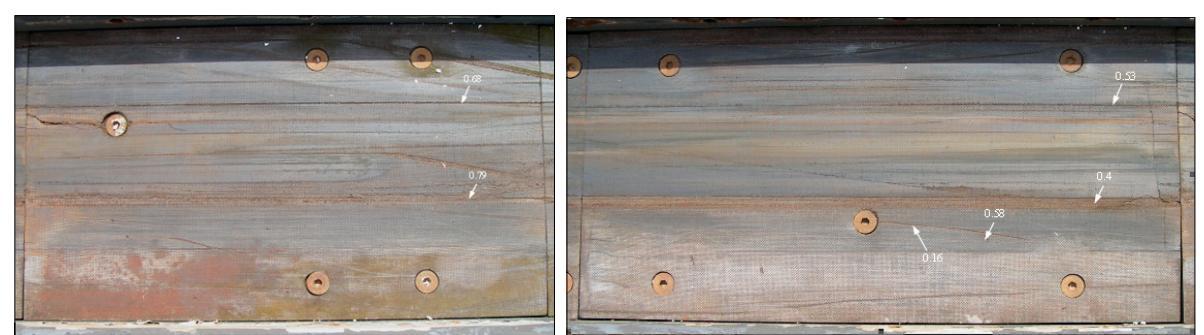
Wear scars from a protruding section of the keel are noted in places. It is known that in early trials the prototype Tamar lifeboat keel featured some sharp protuberances and it is these that have scarred the panels. The majority of the slipway panels used with the damaged prototype keel have now been replaced; hence the gouging scars from this period are not present all the way along the slipway. The gouging scar depth is measured and matches the

gouges on the recovered section, indicating that they are both the result of the damaged prototype keel.

Fig. 3.43: Tenby Slipway Inspection: Gouging Wear

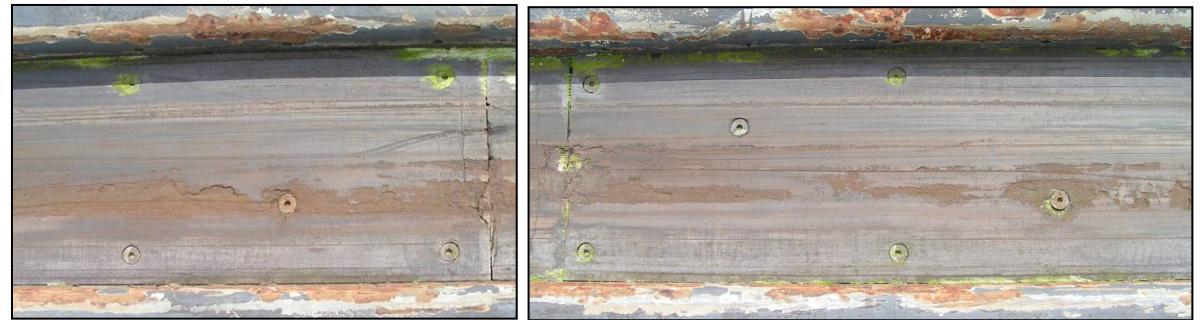
Some delamination wear is seen on the better aligned panels where the load from the keel is more evenly distributed than in the end wear case.

Fig. 3.44: Tenby Slipway Inspection: Delamination Wear

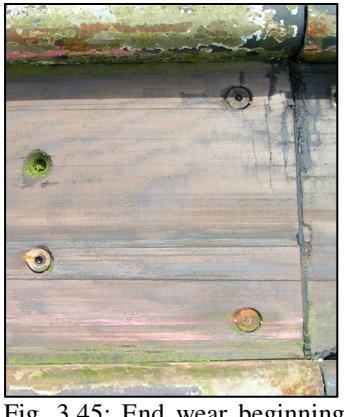
Fig. 3.45: End wear beginning on Tenby misaligned slipway panel

These show that the panel misalignment is present and significant, reaching a peak of 3.52mm height difference between panel 18 and 19. Wear on panel 19 (raised in relation to panel 18) is observed to be primarily end wear with cracking well developed on the panel despite it having been only recently replaced. Overall the slipway shows an average height difference between panels of 0.884mm with a maximum of 3.52mm. From the composite data sheet the compressive yield strain is recorded as 1.9%. on a 19mm thick panel this would correspond to a height of 0.361mm, less than half of the average panel height difference along the slipway. This indicates that compressive deformation of the composite panels is not sufficient to accommodate the panel misalignments present, even at the maximum compressive deformation before failure.

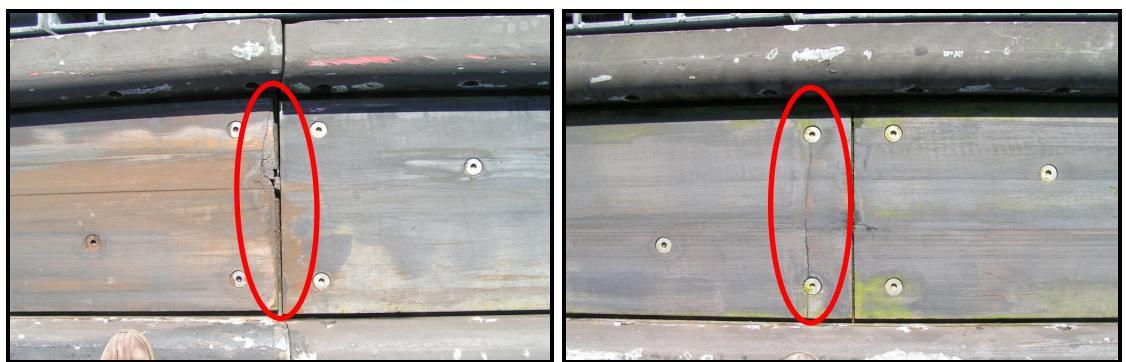
Fig. 3.50: Padstow Slipway Inspection: Panel end wear

In fig. 3.50, a vertical crack perpendicular to the launch/recovery motion is seen at the end of a panel between two fixing points, this would seem to indicate a cantilever effect with the panel sitting higher that the slipway base before cracking. This is similar to effects noted during the Tenby slipway inspection where panels that were observed to be misaligned vertically exhibited more pronounced end wear.

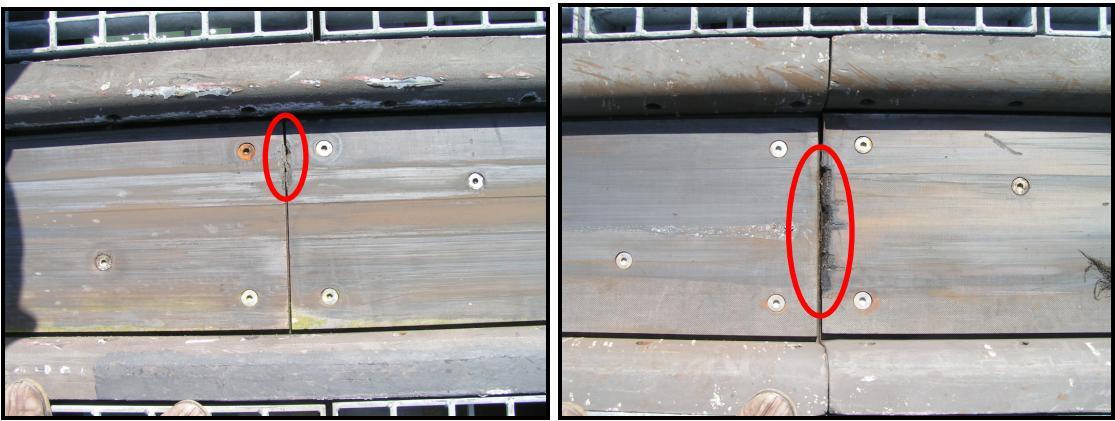
Fig. 3.51: Padstow Slipway Inspection: Panel end wear

Fig. 3.51 again shows wear developing at the panel ends of misaligned panels.

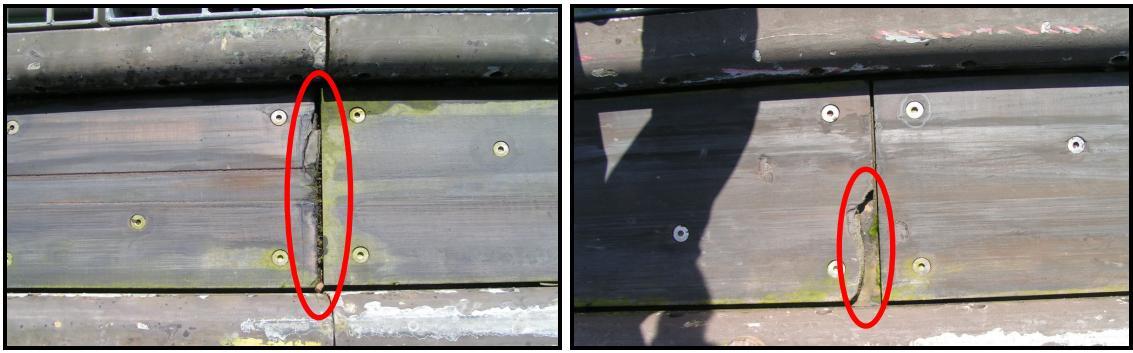
Fig. 3.52: Padstow Slipway Inspection: Panel end wear progression; i.) cracking to form panel 'islands', ii.) panel 'islands' detached from panel

Fig. 3.52 shows a typical progression of wear on the composite slipway panels, initial wear stresses cause the phenolic materials to crack leaving a panel 'island' held in place by the remaining jute fibres, this subsequently detaches reducing the bearing area of the panel.

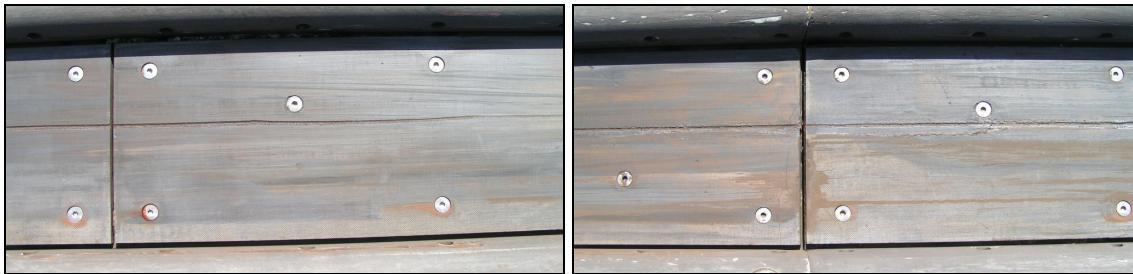
Fig. 3.53: Padstow Slipway Inspection: Gouging wear

Measurements of the gouging wear scar match those recorded at Tenby and are likely to result from keel imperfections on the Tamar prototype used in initial slipway testing as at Tenby.

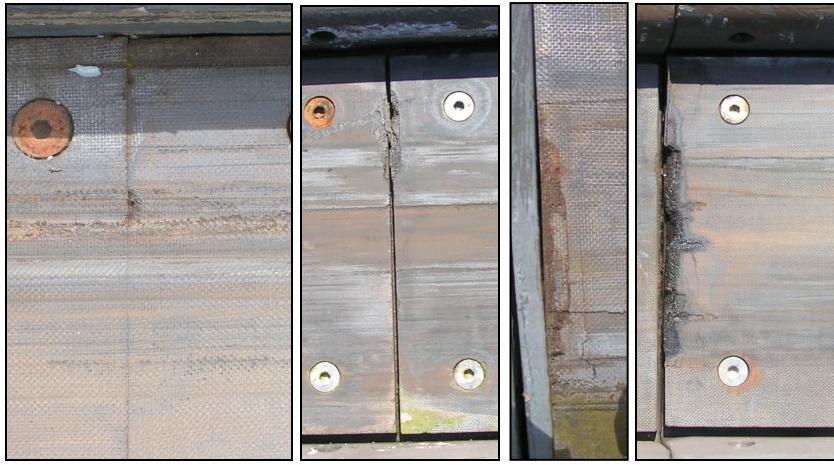
Fig. 3.55: Abrasive panel end wear: wear scar progression

Fig. 3.55 above shows the typical progression of an abrasive wear scar on a misaligned panel. Initially panel end stresses cause a small region of the composite to deteriorate and fail, this initial imperfection develops until it is the width of the lifeboat keel on the panel. Further slipway operation causes this wear scar to progress into the composite panel until it reaches the level of the fixing bolts, at this point the panel is considered to have failed as it is no longer sufficiently attached to the slipway superstructure.

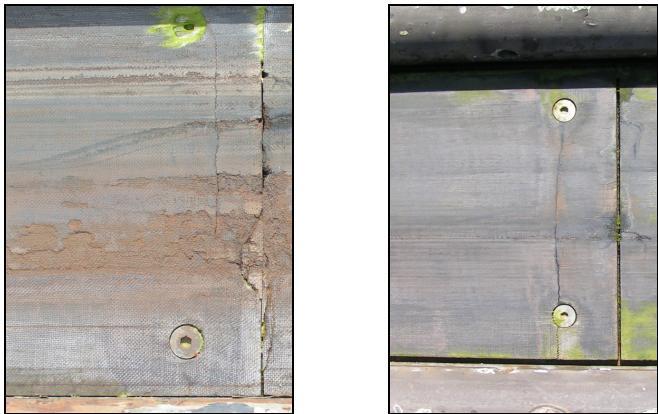
Fig. 3.57: Cracking panel end wear: cracking between fixing bolts

This type of wear is severe as once the cracked section separates from the main panel the holes for the fixing bolts are broken also and the panel can be considered to have failed as it is not adequately fixed to the underlying slipway structure.

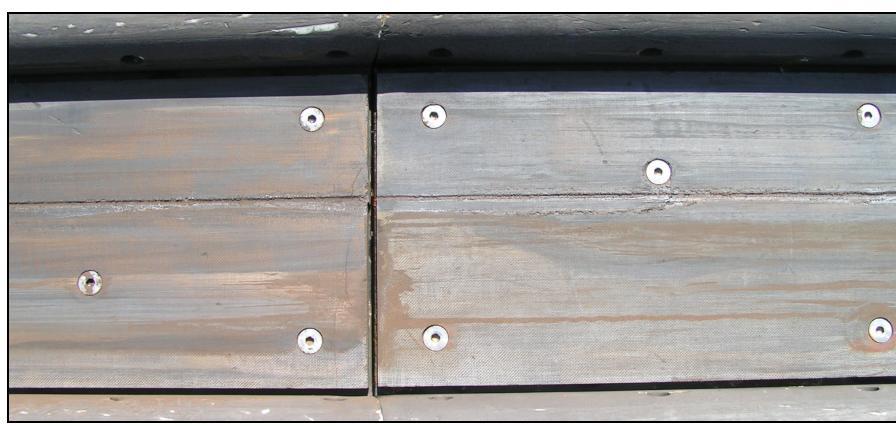
Gouging wear scars along the slipway indicate the presence of raised keel sections or 3^{rd} party wear between keel/slipway lining contact. From inspection of the Tamar lifeboat slipways at Tenby and Padstow and the recovered slipway section from Tenby it is noted that the main gouging wear scars match. This ties in with the observation that the initial Tamar prototype keel was found to have a defect, this defect generated the large gouging wear scars on the Tamar slipways. From inspection of the gouging wear scar the friction coefficient contribution of the keel defect is calculated as $\mu_{gouge} = 0.408$.

Fig. 3.58: Gouging wear from Tamar prototype

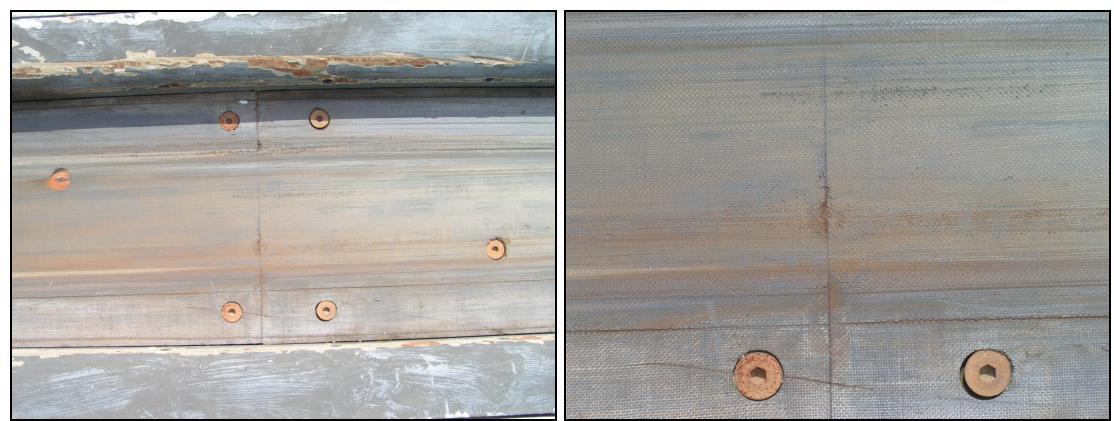
Plane abrasive wear occurs when the slipway panel is well aligned and the contact with the keel is even and planar, in this case the contact pressures are relatively evenly distributed along the panel and the resulting wear is light and even. This typically results in the phenolic bulk of the composite material eroding to expose the underlying jute fibres.

Fig. 3.60: Plane abrasive wear: exposed jute fibres

The incidence of plane abrasive wear on a panel is a sign that the panel is performing well and that the keel contact is well aligned. Under these contact conditions wear will be very light.

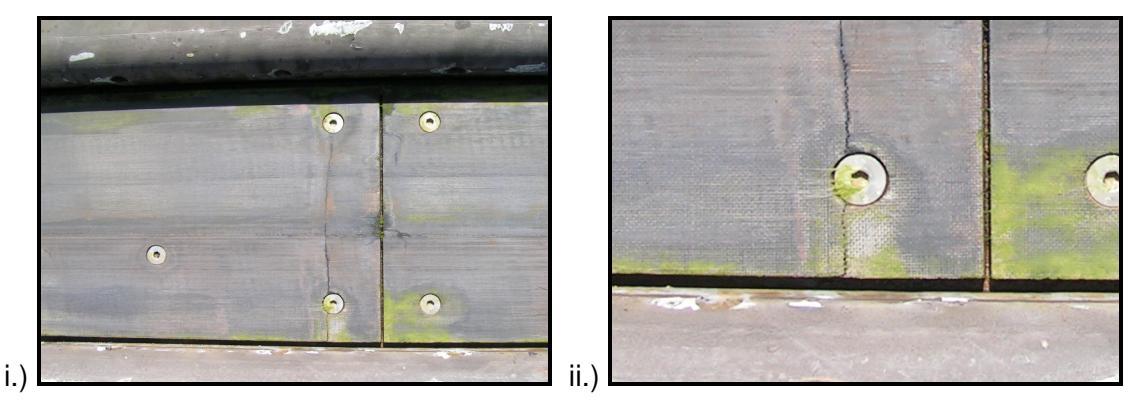
During slipway surveys a number of panels were observed to exhibit cracks around the fixing holes used to attach the panel to the slipway, an example of this is shown below in fig. 92. If the crack is seen to extend from the hole to the panel edge the panel insufficiently secured to the slipway and is in danger of breaking free, thus this condition also constitutes a panel failure.

Fig 9.10: Worn Panel Failure Criteria by cracking around fixing hole area; ii.) shows a detail from image i.) where a crack can be clearly seen to extend from the fixing hole to the panel edge

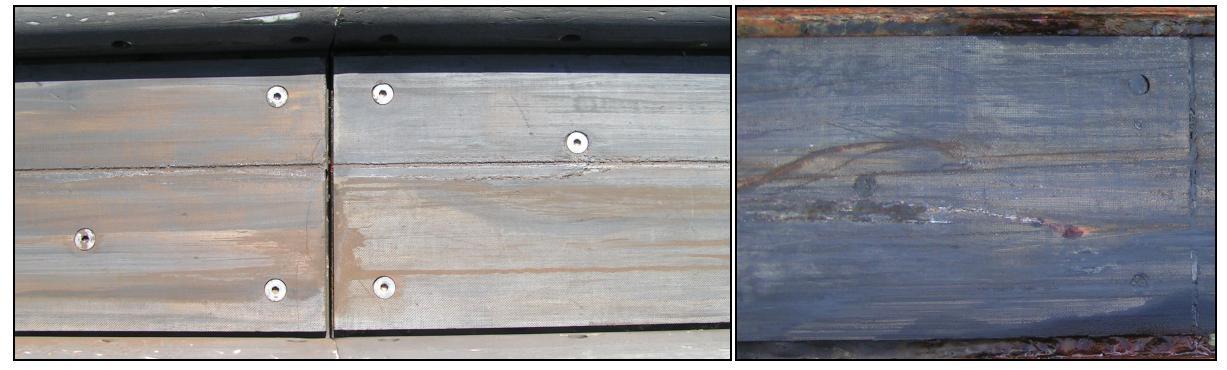
Scoring of the slipway panels as show below in fig. 9.14 indicates the presence of a raised a asperity or hard 3rd body particle in the contact. A straight scar along the slipway length indicates a raised asperity on the lifeboat keel, while a wavy scar indicates a 3rd body particle in the contact region.

Fig 9.14: Worn Panel Failure Criteria – i.) Scoring from raised keel section at Tenby, ii.) 3rd Body wear at Tenby

Scoring of the slipway panels due to raised sections on the lifeboat keel are a cause for immediate concern as repeated slipway launches in this condition will not only

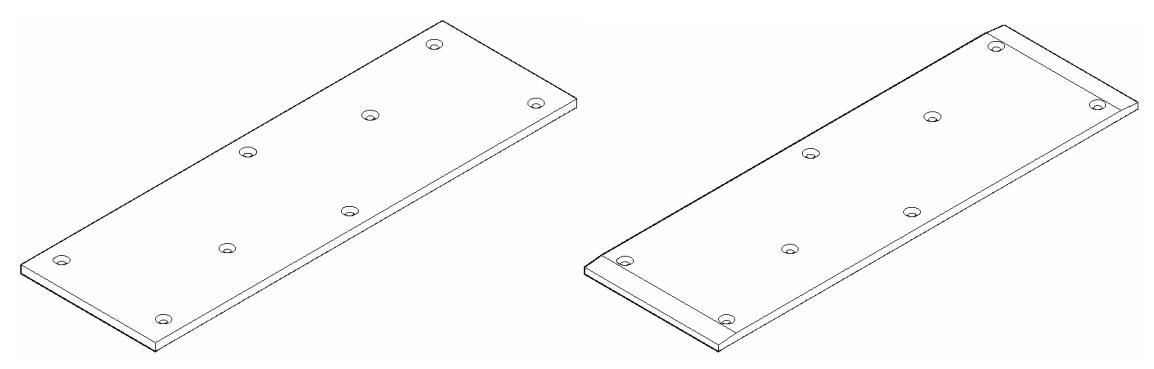
Fig. 11.2: Original (left) and Modified (right) Slipway Panels

Section 8 indicates that the wear on chamfered panels is significantly lower than on the original panels and so the inspection schedule can be relaxed here, it is hoped that by using

these panels slipway inspection will only be necessary as high friction becomes apparent due to high winch loadings during recovery. However, in the initial stages of assessment these panels should be inspected before each recovery in the same way as for standard slipway panels until the slipway performance prompts confidence in relaxing the inspection schedule.
