# The Warship *Hazardous Prize* – Site Investigations 1992–2022

## The Warship Hazardous Prize - Site Investigations 1992-2022

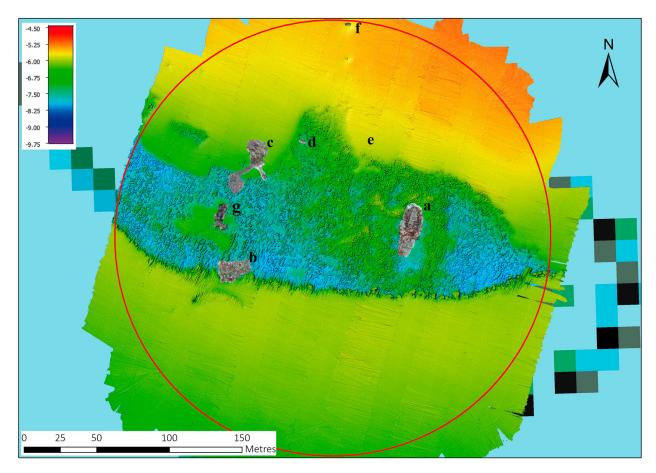
Figure 2. The designated area (150 m radius) with photogrammetric surveys georeferenced onto the 2020 multi-beam bathymetry. A) main site, B) 2014 gun site, C) 2019 gun site, D) gun 35, E) spar site, F) gun 36 and G) 2022 gun site (MBES survey conducted by MSDS Marine and Swathe Services on behalf of Historic England and HPG).

Since Owen's last report the site has changed considerably with new features of the wreck becoming exposed and, unfortunately, parts of it being totally lost to erosion. Incredibly, six completely new and substantial areas of wreck material have been found since 2014, which have included up to a further 25 guns, bringing the grand total of guns confirmed on the seabed to 38. These new areas will be referred to as the 2014, 2019, 2022 gun sites, gun 35, gun 36, and the spar site (Figure 2); all lie within a protected area. With the exception of the spar site, these areas have all been recorded photogrammetrically and

georeferenced onto recent multibeam surveys as shown in Figure 2.

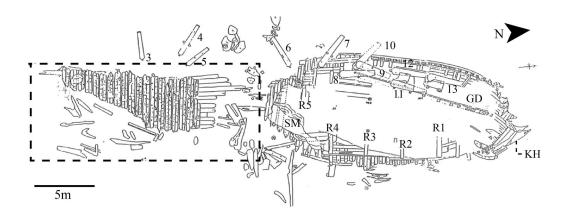
Figure 3. Main site plan adapted from Owen, 1991 plan showing the southern area which was lost in the winter of 1995. Guns are labelled 3-13, GD - Gundeck, R1-5 - Riders 1-5, KH - Knee of the head and SM - shot mound (© HPG).

Since 1992 the character of the site has changed considerably. Over the course of a single winter in 1995 the entire aft section of port side structure was lost (Figure 3), the only evidence of shipwreck remains left in this area being guns 3-5, to the west of this position. A significant proportion of the wreck had disappeared during a single winter, demonstrating, the vulnerability of wooden shipwreck sites when exposed in shallow dynamic environments. After being engulfed by a large sand wave in 2009, the main section of the site remerged again in 2014, remaining uncovered ever since; another demonstration of the mobility and dynamics of the seabed in the locality.

The surviving northern section of the site consists of one coherent 20 m-long section of the port side, inside up, from roughly amidships to the head of the bow and from the main gundeck down to the keel, which lies on the eastern edge and which was not exposed in the 1991 survey (Figures 3 and 4). It has not escaped degradation, as sustained periods of exposure have led to the deterioration of all exposed timber structure through biological, chemical and physical processes. Since Owen's 1992 description of this section of the site it has lost 4 m in length. This is most noticeable at the head of the bow which has radically reduced in size (Figures 3 and 4). In 2017, as surface sediments continued to wash away, the keel emerged for the first time (Figure 4); the continual loss of surface sediments since 2014 has been a clear indication of the impact of wave action in the shallow depth of water.

location of the gundeck remains. The surviving section of gundeck is 14 m long and its maximum depth is approximately 1 m at the location of guns 12 and 13 (Figures 3-5). There are seven guns lying on the surviving deck and hull structure (Figures 3 and 4): guns 7 and 10 are orientated with their chase pointing through the side of the surviving hull structure, which was the probable location of gun ports. Guns 12 and 13 are orientated at right angles to their adjacent gunports with muzzles facing forward. This was probably deliberate because of the reduced space at the forward end of the deck, as it narrows towards the bow. Guns 8, 9 and 11 are lying across guns 10 and 12 and most likely originated from the starboard side, sliding across during the wrecking process. Guns 12 and 13 still have parts of their carriages surviving, although, as noted above, these have deteriorated considerably since exposure.

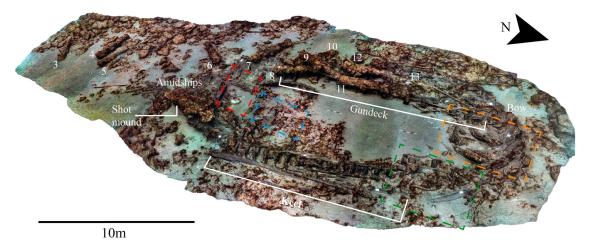
Figure 4. 2019 3D textured model of the main site. Guns are labelled 3–13. The area marked in red denotes the 2018 excavation trench, represented in Figures 9 and 10; the area marked in blue denotes the location of exposed barrels, represented in Figure 19; the area in green denotes the foremast-step and forefoot, represented in Figure 14 and the area in orange denotes the area of the forward platform, represented in Figure 13. All areas were naturally exposed except for the 2018 excavation trench (survey and model produced by Daniel Pascoe).

A second knee relating to the platform deck was located at the forward end, just aft of two breast hooks (Figures 4 and 13). The knee was in a fairly poor condition in 2019 and by 2021 it was gone. From the 2019 recording it appeared to be a rising knee with a vertical arm 1.28 m (4 ft 2 in) long, 250 mm (9.8 in) moulded and 200 mm (7.9 in) sided. As the original surfaces were heavily eroded these dimensions will not relate to the knee's original size.

The keel was only observed in 2017 when sediment levels outside the wreck continued to drop. It extended from just forward of the shot mound to level with the aft end of the foremast-step (Figures 4 and 23). At the point that is level with below the aft end of the foremast-step it joins with the forefoot. The aft end of the forefoot is horizontal, and the forward end is curved where it joins with the lower end of the stem. The stem, however, has become detached. The inclusion of a forefoot appears to be more typical of French construction than English. The English shipwright William Sutherland describes the keel joining directly onto the lower end of the stem (Sutherland, 1717, p. 76) and on the outside an additional timber, known as a gripe, was added (Lavery, 1981, pp. 74-75). On the exterior of the stem, and still attached, is the knee of the head. It is an extension of the stem, consisting of several large flat pieces of timber joined and fastened together by iron bolts. The upper end supported the ship's ornamental figure head (Falconer, 1780, p. 167). The knee of the head has been exposed since the late 1980s and as such its condition has deteriorated considerably. The exposed elements of the head were recorded during the initial exposure

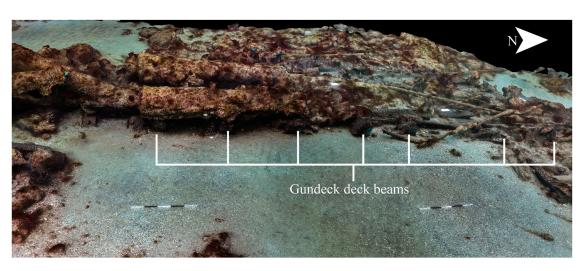
Figure 5. Image from the 2019 textured model, showing position of deck beams. Scales are 1 m with 20 cm increments (survey and model produced by Daniel Pascoe).

From the bow end heading aft are the remains of seven consecutive deck beams. The beams are all 305 mm (12 in) sided and their moulded dimensions are 280 mm (11 in). The spaces between the beams are irregular, ranging from 0.71 m between beams 3 and 4 and up to 1.66 m between beams 2 and 3. This is not unusual as the beams would have had to fit around the masts and hatch ways along the centre line of the deck (Figure 5) (Sutherland, 1717, p. 77).

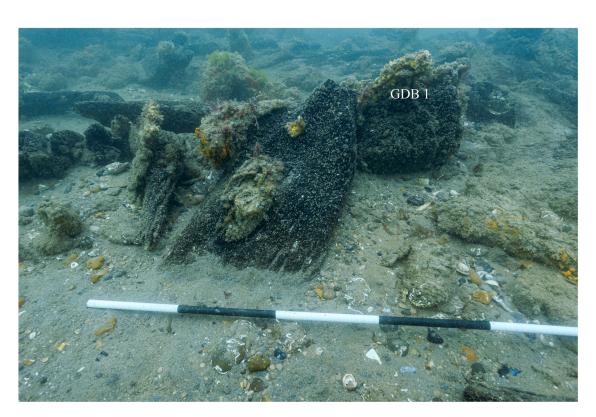
Figure 6. Hanging knee on aft side of gundeck beam 1 (GDB 1). Scale is 1 m with 20 cm increments (photo by Daniel Pascoe).

the deck vertically. Due to the current level of sand, it is not possible to distinguish between hanging and lodging knees at all locations of the deck beams. The exceptions are at beam 1 and beam 3. At beam 1 there is only a hanging knee located on the aft side, which extends diagonally down and aft rather than vertically from the side of the beam (Figure 6). It is substantial in build with a 320 mm (12.6 in) sided dimension. The lack of a lodging knee is likely due to the lack of space at the forward end of the deck. Due to the lack of space between beam 3 and 4 there appears to be only space for a hanging knee on the aft side of beam (Figure 7). Evidence from the later wreck, and larger ship, of Invincible (1744-58) recorded lodging knees on the aft side and iron hanging knees on the forward side of the four most forward deck beams (Bingeman, 2010, p. 52 and personal observations during the 2017-19 excavations). The evidence from Hazardous suggests that where there was insufficient space between beams for lodging knees, hanging knees were used instead.

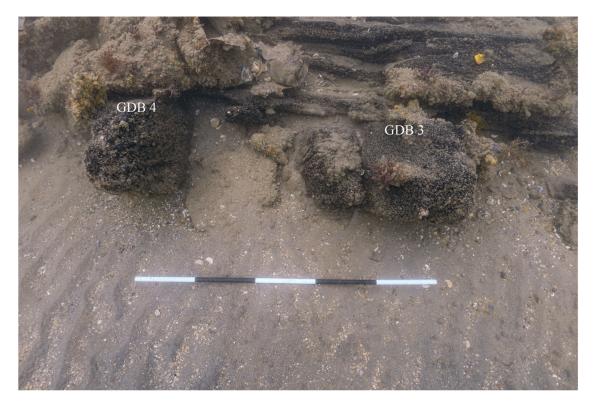
**Figure 7.** Hanging knee fastened on the aft side of gundeck beam 3 (GDB 3). Scale is 1 m with 20 cm increments (photo by Daniel Pascoe).

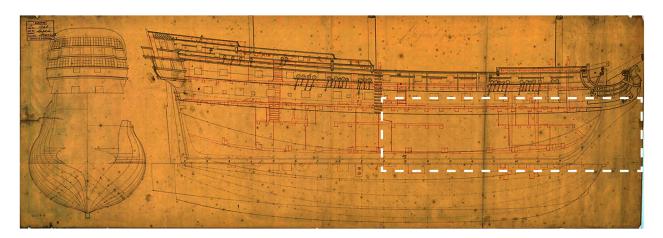
**Figure 8.** Plan of *Superb* showing layout of the internal arrangements of the platform deck. The dotted line represents the surviving section of *Hazardous* (Image ZAZ1811 © National Maritime Museum, Greenwich, London and is reproduced under their fair usage / commitment to support education and scholarship and encourage research, https://images.rmg.co.uk/price-list/). Creative Commons Attribution, Non-Commercial No Derivatives (CC BY-NC-ND) licence terms apply.

the Admiralty produced a draft of *Superb* following her capture showing that the orlop was divided into three separate platforms, as described above (Figure 8). The internal layout of store-rooms and compartments on French and British warships differed. For example on French warships the gunner's store, known as the lady's hole, was located at the extreme aft end of the orlop or platform deck and this gave the gunner close access to the main powder room below and to the gunroom above (Boudriot, 1986b, p. 59). Conversely, on a British warship the gunner's store was found at the forward end with access to

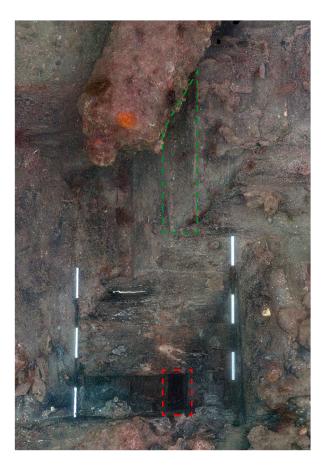
Figure 10. The dashed red line showing the space between the frames and the green dashed line showing that space filled by an additional timber, possibly known as a 'filling'. Scales are 1 m with 20 cm increments (survey and model produced by Daniel Pascoe).

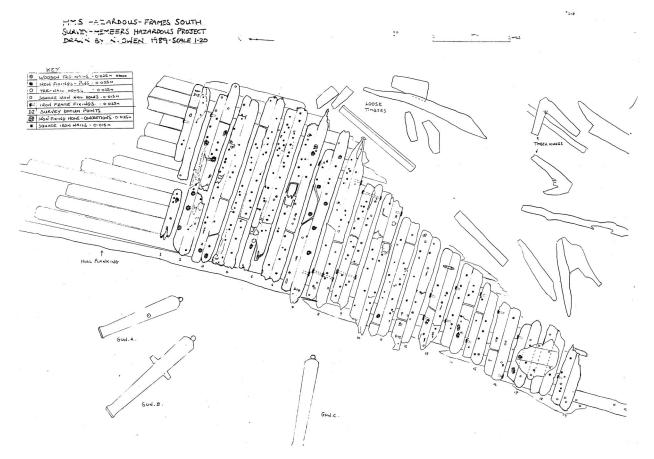
Figure 12. 1989 plan of the southern section of structure which was lost in 1995. It shows the double frame pattern with butt joints and fore and aft fixings but no filling timbers between frame bends (drawing N. Owen, ©HPG).

The plan of the lost southern section of hull does show that the heel and heads of timbers were butt jointed and that the two timbers forming the bend were fastened together, fore and aft, by iron bolts (Figure 12). The combination of double frames laterally fastened adds considerable strength and stiffness to the structure, improving the distribution of force across the hull (Batchvarov, 2002, pp. 154-155). A stiffer hull is also more resistant to the forces caused by the recoil of the guns and, as such, makes a stronger gun platform (Batchvarov, 2002, p. 155)

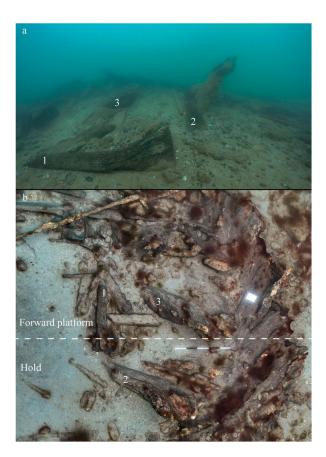
Figure 13 Image A) is a photograph looking north towards the head. Image B) is a plan view from the 2019 3D textured model. 1 - rising knee, 2 and 3 - breast hooks. The scale is 1 m with 20 cm increments (survey, photo and model produced by Daniel Pascoe).

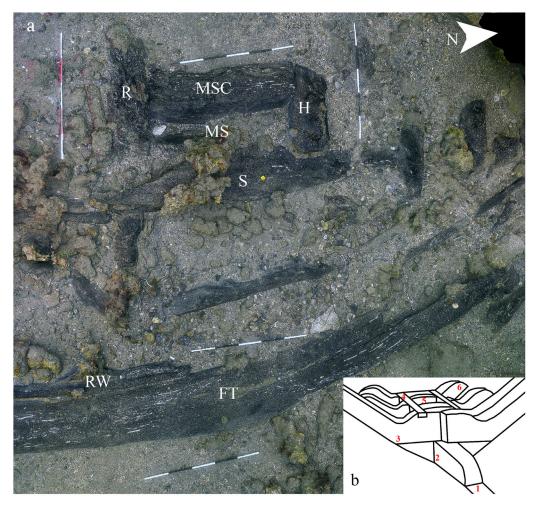
Figure 14. Image A) is a 2022 3D textured model of the remains of the port side of the foremast-step. H – hook, R – rider, MSC – mast-step carling, MS - mast-step, S - stemson, F - forefoot and RS - rising-wood. Image b) is a reconstruction taken from Boudriot's drawing of a foremast-step. 1 – keelson, 2 – stemson, 3 – rider, 4 – mast-step carling, 5 – mast-step and 6 – hook (after Boudriot, 1986a, p. 103). The scales are 1 m with 20 cm increments (survey and model produced by Daniel Pascoe).

Continuing down the centre line the next exposed feature is the foremast-step. What survives is the port side half of the step and currently visible is a cross-sectional view through the centre line (Figure 14). The visible remains show the foremast-step is located over the stemson and consists of a square step, boxed by several transverse and longitudinal timbers. A transverse timber known as a hook makes up the forward end of the step. At the aft end of the step is the forward rider. Running 90° between the hook and the rider is a mast-step carling, which slots into rebates on the upper surface of the hook and rider. Prior to the 2022 survey there was a block that was wedged at the aft end of the step, up against the forward face of the rider (Figures 3 and 4); this must have washed away at some point during the winter following the 2021 season. The block may have represented what Boudriot described as removable wedges, which allowed the position of the heel of the mast to be adjusted (Boudriot, 1986a, p. 105). The heel of the mast would have rested directly on the stemson and been secured within the step by wedges, as described above. The layout and construction of the foremaststep of the 74-gun Invincible is very similar (Figure 15) to Hazardous' and to Boudriot's interpretation,

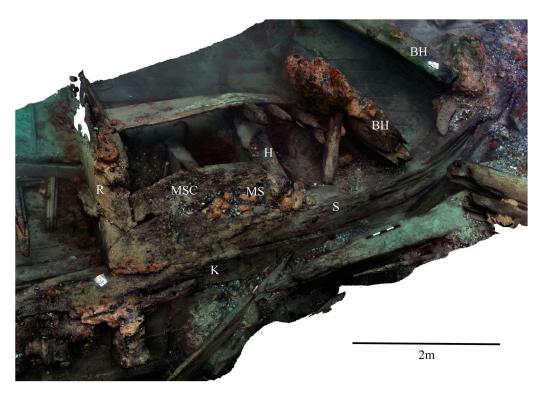
**Figure 15.** 3D textured model of the port side remains of *Invincible's* foremast-step. R – rider, MS – mast-step, MSC – mast-step carling, H – hook, S – stemson, K – keelson and BH – breast hook. The scale is 50 cm with 10 cm increments (survey and model produced by Daniel Pascoe).

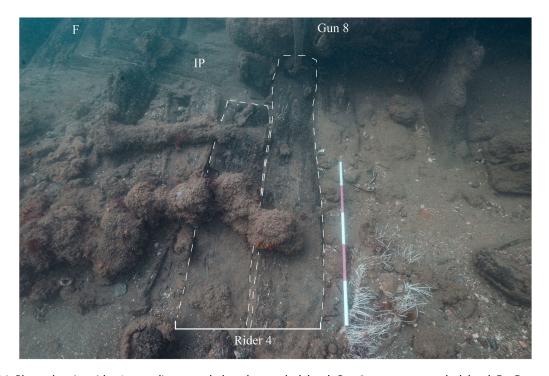
**Figure 16.** Photo showing rider 4 extending up to below the gundeck level. Gun 8 represents gundeck level, F – Frames and IP – inner planking. The scale is 1 m with 20 cm increments (photo by Daniel Pascoe).

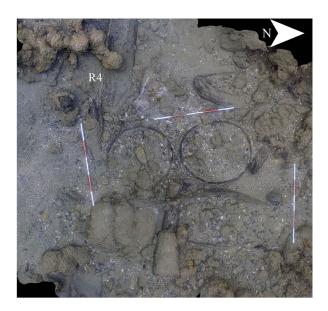
Figure 19. 2022 3D textured model of group of barrels, one of which has been excavated and backfilled with sandbags, between riders 3 and 4. R4 - rider 4. The scales are 1 m with 20 cm increments (survey and model produced by Daniel Pascoe).

and its current location suggests it was originally located in the hold forward of the main mast (Figure 3). Between riders 3-4 and 4-5 is the location of the forward hold. This is the location of several large storage barrels, positioned upright and horizontal (Figure 19). The large quantities of animal bone in this area suggests at least some of these barrels contained butchered meat.

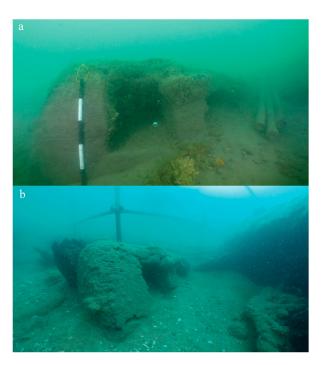
Figure 20. Photo A) the mast cap as found in 2016. Image B) mast cap leaning against possible platform beam. Mast caps joined the tops of the lower masts to the upper mast. The square hole slotted onto a square tenon at the top of the lower mast and the upper mast passed through the circular hole. The scale is 50 cm with 10 cm increments (photos by Daniel Pascoe).

The excavation in the area of the forward platform found a carpenter's jack plane and a spare mast-cap two metres further forward, which became exposed naturally (Figure 20). A mast-cap is a rectangular timber with two adjacent holes, one square and one circular, used to secure the upper masts to the lower masts. The tops of the lower masts were cut into a square tenon that slotted into the square hole on the cap, with the end of the upper mast being passed through the circular hole on the cap (Steel, 1796, p. 91). These are the type of artefacts that would be expected to be found in the storerooms on the forward platform.

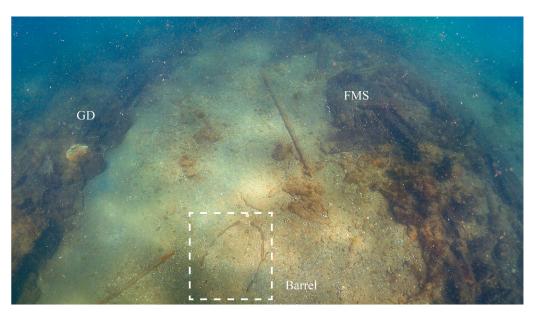
**Figure 21.** Photo showing outline of barrel just aft of the foremast-step. This would have been the location of the main magazine and filling room. GD – gundeck, FMS – foremast- step (photo by Daniel Pascoe).

Between riders 1 and 2 is another partially exposed barrel lying in a horizontal position. This area is where the main magazine containing powder barrels would have been located (Winfield, 2005, p. 73), so it is highly likely that this barrel is a gunpowder barrel and that there could be others just beneath the surface (Figure 21).

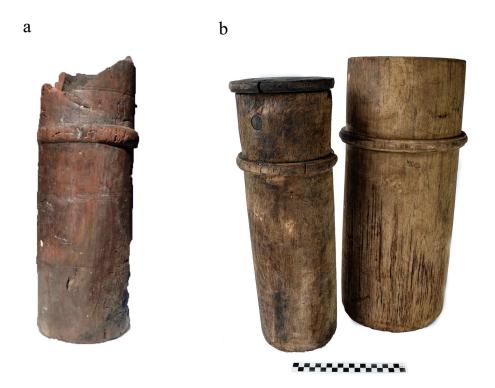
**Figure 22.** Image A) showing cartridge case from *Hazardous*, it has a diameter of 155 mm (6.1 in) and was suitable for the 18-pounder charges. Image B) showing cartridge cases from *Invincible* 1758, scale is 20 cm with 1 cm increments (photos Daniel Pascoe).

uncovered a fragment of a cartridge case. Cartridge cases were turned from a single piece of wood and had a separate lid attached by a lanyard (Figure 22). They were used to transport a single charge of gunpowder from the filling room up to the gundecks. The filling room was located at the forward end of

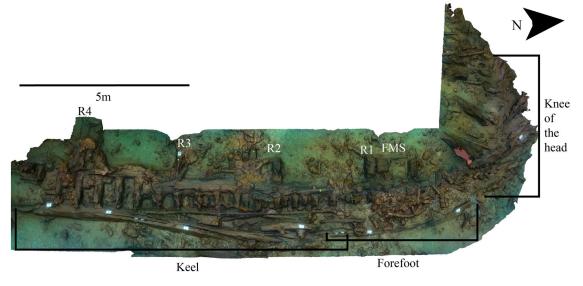
Figure 23. A 3D shaded model produced from the 2017 photogrammetry survey of the exposed structure of the lower hull. R1-4 - riders 1-4, F - frames, FMS - fore mast step (survey and model produced by Daniel Pascoe).

where the keel joins with the forefoot. The risingwood has a maximum depth of 200 mm (7.9 in), however more may be buried. This stops in line with the aft end of the foremast-step (Figure 14 and 23).

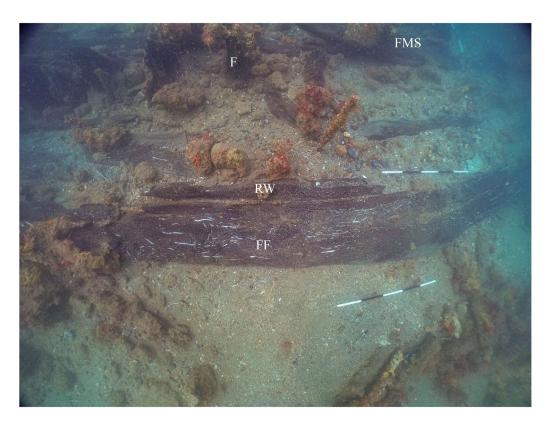
Figure 24. Photo of the forefoot, FF – forefoot, RW – rising-wood, F – frames and FMS foremast-step. The scales in the image are 1 m with 20 cm increments (photo taken in 2022 by Daniel Pascoe).

increases to 585 mm (23 in). At the forward end is a long plane scarph, which is 1.21 m long (4 ft) (Figures 14 and 24). The aft end has the section of rising-wood as described above fastened to the upper surface.

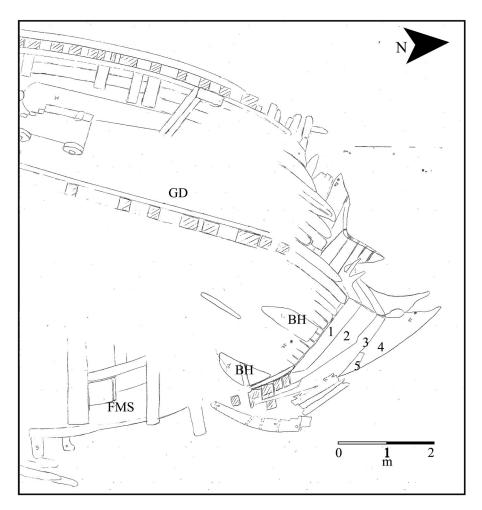
**Figure 25.** The 1991 site plan showing the knee of the head made up of at least five timbers. 1 – stem, 2–3 – chocks and 4–5 – face piece. Other features in plan GD – gundeck, BH – breast hook and FMS – foremast-step (plan © HPG).

It survived from the level of the gundeck and was visible up to 2 m below that point. The 1991 site drawing identified that the exposed section was constructed from five separate timbers, which include the stem on the inside and the face piece on the outside, the latter consisting of two visible timbers. The space between the two are filled by two other substantial timbers with a near vertical join (Figure 25). These may be what Boudriot refers to as 'chocks' (Boudriot, 1986b, p. 8).

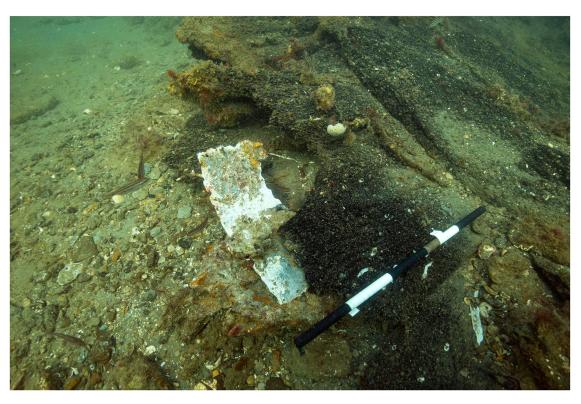
Figure 27. Photo showing lead tingle between sheathing and outer planks. Scale in photo is 50 cm with 10 cm increments (photo by Daniel Pascoe).

Another interesting feature on the outside of the hull is the presence of a lead tingle between the outer planking and the sheathing, which suggests the condition of the outer planks may not have been in a good state before the sheathing was added (Figure 27). There is historical evidence to support this as Captain Harris writes to the Admiralty prior to the voyage to Virginia asking that the bottom of the hull should be cleaned as it is very foul. He also states that the carpenters are repairing the doublings, possibly referring to a second layer of planking (TNA, ADM 106/609/106).

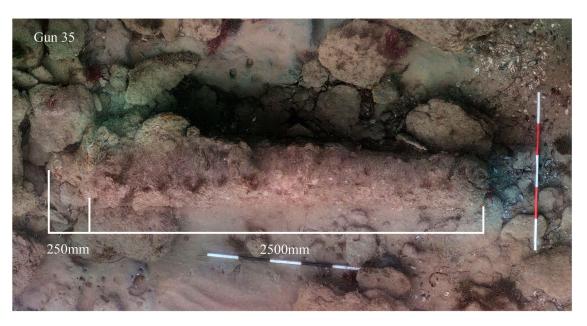
Figure 28. Orthophoto mosaic of gun 35, whose size is consistent with a 12-pounder. Scales are 1 m with 20 cm increments (survey and mosaic produced by Daniel Pascoe).

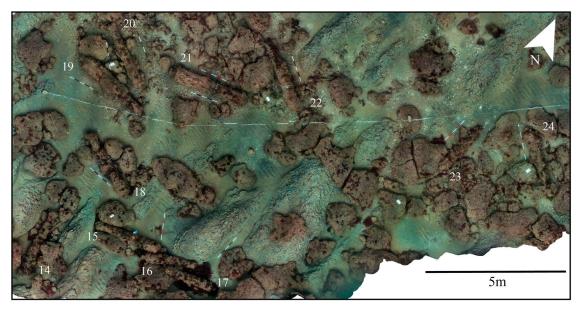
Figure 29. Orthophoto mosaic of the 2014 gun site. Guns numbered 14-24. Scales are 1 m with 20 cm increments (survey and mosaic produced by Daniel Pascoe).

In 2014 the sand had migrated away, uncovering the main site again. This prompted Historic England to contract Wessex Archaeology to conduct geophysical surveys to better understand the full extent of the exposure of the site. The geophysical surveys included multi-beam echo-sounder survey (MBES) over the main site and sidescan sonar and magnetometer surveys over the wider area. The magnetometer survey identified a large magnetic target to the south and the sidescan sonar survey identified several gun-like features within this area (Wessex Archaeology, 2015). Diver ground-truthing by the HPG identified 11 guns, a scattering of shot, as well as two lead scuppers. The size of the guns is consistent with the 12pounders from the upper gundeck and 6-pounders from the quarter and forecastle decks. No wooden structures were found but the presence of lead scuppers suggests structures relating to the side of the vessel did exist at this location at one point. Gun 19 had the partial remains of its carriage, which would suggest these guns were not jettisoned as the carriages would not fit through the gunports. This area of the site was surveyed photogrammetrically in 2019 and is now known as the '2014 gun site' (Figure 29). Its centre is 125 m to the southwest of the centre of the main site, on the boundary between the southern sand bank and the exposed fossil beds (Figure 2).

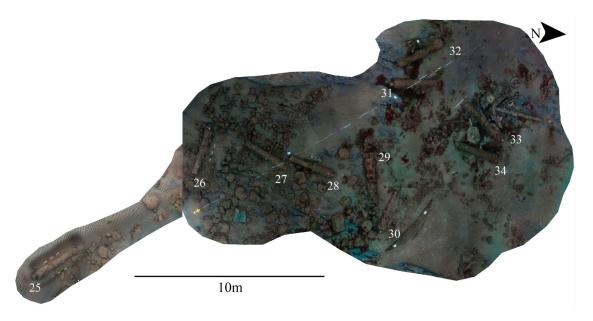
Figure 30. Orthophoto mosaic of the 2019 gun site. The guns are labelled 25-34. Scales are 1 m with 20 cm increments. Note the scatter of round shot west of guns 26-28 (surveys and mosaics produced by Daniel Pascoe).

In 2019 the team found a further concentration of 10 guns, this time 120 m northwest of the main site. Among the guns was a high concentration of shot, along with an anchor and other artefacts associated with the ship's structure, rigging and general shipboard life. The site was surveyed photogrammetrically in 2019, initially nine guns were found and surveyed, followed by a tenth a few weeks later (Figure 30). This area is now referred to as 'the 2019 gun site'. The guns in this area are also of a size consistent with the Hazardous' 12- and 6-pounders.

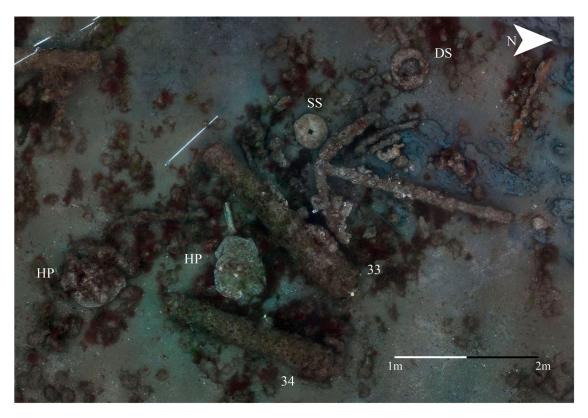
Figure 31. Orthophoto mosaic of the anchor next to guns 33 and 34, HP – Hawse-pipes, SS – sharpening stone and DS – deadeyestrap (survey and mosaic produced by Daniel Pascoe).

The anchor found on the 2019 gun site is a relatively small anchor. It has an overall length of 2.82 m (9 ft 3 in), a shank length of 2.65 m (8 ft 8 in), a span of 1.8 m (5 ft 11in), and the length of the arm is 0.97 m (3 ft 2 in) (Figure 31). The wooden stock and iron ring are missing. According to the contemporary

Lying within a few metres of the anchor are two hawse pipes (Figure 31). The hawse pipes are made of lead and they would have fitted into the hawse-holes, which were cylindrical holes cut through the bow on each side to allow the anchor cables to pass (Falconer, 1780, p. 146; Mainwaring & Perrin, 1921, p. 161). The draft of Superb identifies that there were two hawseholes on each side, at the level of the gunports of the lower gundeck. The lead pipes would ensure the cable would not chafe against the edges of the hull. Both pipes have been squashed but the one situated between guns 33 and 34 is the more discernible of the two, showing the two flanges at either end of a flattened pipe. The outer dimeter of the upper flange is 700 mm (27.6 in) and the inner diameter of the tube is 482 mm (19 in). When captured Hazardous had three sizes of cable 20, 18.5 and 12 in (the circumference determines the size of the cable) (TNA, ADM 106/594/45). As such, a cable with a circumference of 20 in has a diameter of 6.4 in, so there was plenty of room to work the cables in and out of the hawse-pipes.

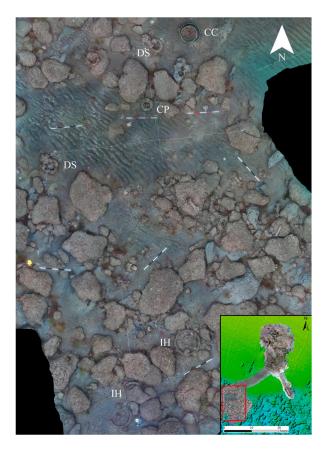
Figure 32. Orthophoto mosaic of the extended area of the 2019 gun site showing a large spread and variety of material which include: CC - copper cauldrons, CP - cast iron pot, DS deadeye straps and IH - iron hoops. Also scattered among these objects are round and double head shot. Scales are 1 m with 20 cm increments (survey and mosaic produced by Daniel Pascoe).

In 2020 further migration of sand occurred around the 2019 gun site leading to the burial of eight guns (guns 27-34) and the anchor but exposure of a wider scatter of artefacts west, east and south of gun 26 (Figure 32). The spread of material included a wide range of artefacts relating to the different aspects

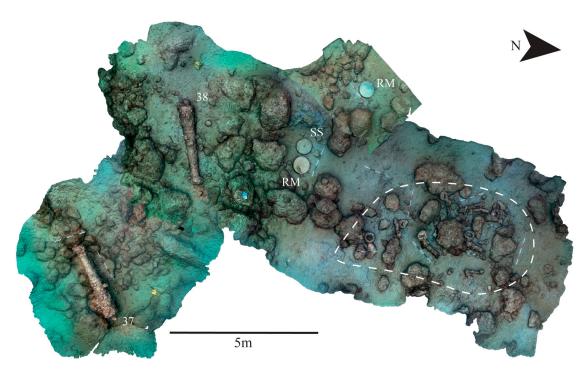
**Figure 34.** Showing a 3D shaded model of the 2022 gun site, also showing the cluster of dead eye shrouds and chain plates plus other objects. RM – rotary hand mill, SS – sharpening stone and deadeye shrouds and chain plates within the dashed area. Scales are 1 m with 20 cm increments and 50 cm with 10 cm increments (surveys and models produced by Daniel Pascoe).

This site lies between the 2014 and 2019 gun sites and consists of a smaller concentration of objects, which had spilled from the ship as it broke up and drifted northwards (Figure 34). Objects include two probable 6-pounder guns; two halves of a rotary hand mill, used for grinding grain to make bread; and a large circular sharpening stone. A similar and complete rotary hand mill was found on the small Cromwellian shipwreck at Duart Point, within the galley debris, at the port edge of the forward ballast mound. It was suggested that it fell from the forecastle deck where the galley was originally located (Martin, 2017, p. 123). The layout of fourth-rates ships also shows that the galley was found in the forecastle, at the forward end of the upper deck (Endsor, 2020, p. 273; Winfield, 2005, p. 73). As such, the rotary hand mill stones at the 2022 gun site are an indicator of galley material from the forecastle, suggesting the two 6-pounder guns probably originated from the forecastle deck. There is also a jumble of concreted dead eye straps and chain plates and at least two lead scuppers. The dead eye shrouds and chain plates secured the lower end of the mast shrouds, probably the forward mast shrouds, to the outer hull and the scuppers were set into the sides of the hull. Their presence is a good indicator that a fragment of the side of the forward hull broke away from the ship and ended up on the seabed with the guns and other objects. In addition, a trail of iron round and double headed shot litters the seabed between the northwest corner of the 2014 gun site

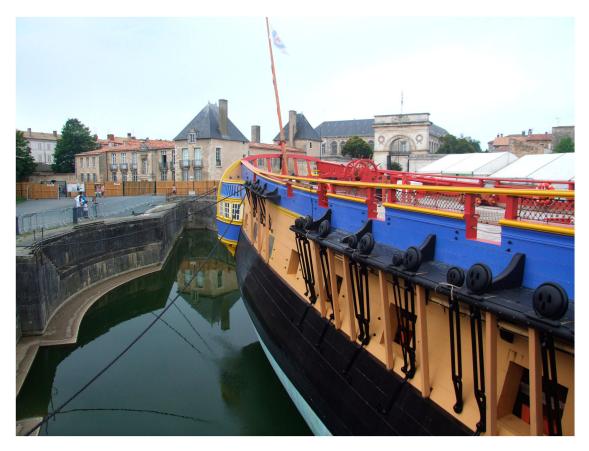
Figure 35. Photo of L' Hermione showing lower deadeye with shrouds and chain plates. The bottoms of the chain plates are bolted to the outside of the hull and the deadeyes are located along the chainwale (photo by Daniel Pascoe).

By far the greatest concentration of lower dead eye straps and chain plates have been identified at the 2022 gun site. Dead eye straps were wrought iron bands which were moulded around the lower dead eyes. The lower end of the strap was made into an eye which connected to an iron plate, known as the chain plate or simply the chains (Mainwaring & Perrin, 1921, p. 122). Similar examples have been recovered from La Belle (Bruseth et al., 2017, pp. 210-13). Chain links were used as an alternative to solid plates as seen on the replica French Frigate L'Hermione. The lower end of the chain plate was fastened to the side of the hull and the upper end was set into the chainwale or channel. The chainwale was a broad timber located on the outside of the ship that acted to spread out the shrouds which were fastened round the upper dead eyes (Figure 35). The shrouds acted as transverse support for the masts.

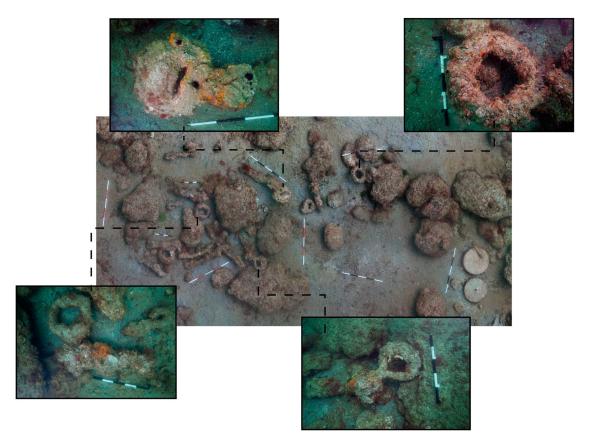
**Figure 36.** Orthophoto mosaic showing the cluster of deadeye shrouds and chain plates alongside photographs of individual deadeye shrouds and chain plates. Scales are 1 m with 20 cm increments and 50 cm with 10 cm increments (survey, photographs and mosaic produced by Daniel Pascoe).

The lower dead eye straps and chain plates are concentrated in a roughly 6 m by 3 m rectangular area and as such probably originated from one side and one mast location (Figure 36). There appears to be at least three sizes of dead eye strap 400 mm (16 in), 280 mm (11 in) and 150 mm (6 in) (Figure 36). The shape of the concretions would suggest the chain plate is of the solid plate variety like those found on *La Belle* (Bruseth et al., 2017, pp. 210–211).

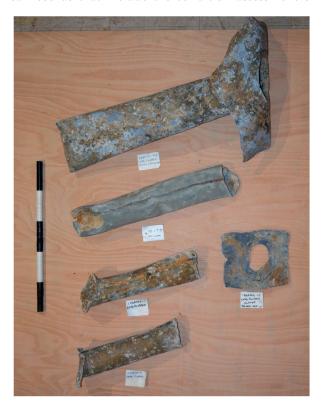
**Figure 37.** Scuppers in order of size from the top down. The scale is 0.5 m with 10 cm increments (photo by Daniel Pascoe).

Lead scuppers allowed water to drain through the sides of the hull from the waterways along the sides of the decks. Several scuppers have been found from across the wreck area and, so far, four have been recovered (Figure 37). There are variations in their form, and they are all different sizes. Their lengths are a good indicator of the thickness of the hull and can determine which deck above the waterline they were from. The longest scupper (HZ A020-22) has a length of 700 mm (27.6 in), which suggests it most likely passed through inner planking, frame and wale. The wales were located in pairs below and above the main gundeck. Scupper MS-250-99 is 570 mm (22.4 in), which suggests it passed through at main gundeck level but through regular outer planking instead of a wale. Scupper HZ A005-17 is 400 mm (15.7 in) and scupper HZ A013-16 is 365 mm (14.4 in), which suggests locations from the upper gundeck and possibly higher.

The most common form of scupper from Hazardous consists of a pipe with a soldered joint running along its length with a circular flange at one end (Figure 37). Following the evidence from the scuppers recorded from the wreck of the fifth-rate Dartmouth, the soldered joint is located along the upper side of the pipe and the circular flange was located on the

outboard side of the hull. The inboard end was fitted with an L-shaped apron, edge-nailed to the waterway and inside of the hull (Martin, 1978, p. 52). A detached apron, HZ A006-17, associated with scupper HZ A005-17, shows that the inboard ends were also fitted with an apron, which was originally soldered onto the end of the pipe. It is rectangular rather than L- shaped showing that it was fastened to the side of the hull only (Figure 37). The scuppers are angled downwards to the outboard flange to allow the free flow of water and leather flapper valves would have been attached to the top of the outer flange to prevent ingress of sea water when the ship rolled or waves struck the hull (Martin, 1978, p. 52). The outboard flanges from Hazardous all have nail holes around their circumference showing they were fastened securely to the outer hull planking. The exception is HZ A0020-22, where the inboard apron has no iron nail holes and it appears that it did not have an outboard flange (Figure 37).

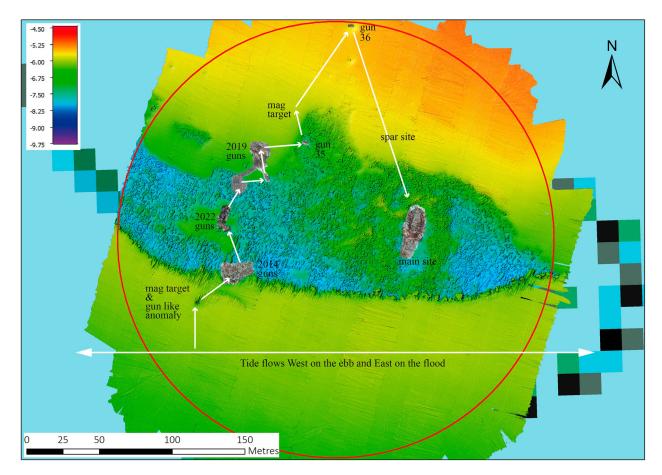
Figure 39. A plot of all the sites georeferenced onto the 2020 bathymetry, showing the suggested direction of travel as the ship breaks up and the direction of the tides in Bracklesham Bay (MBES survey conducted by MSDS Marine and Swathe Services).

Based on the above archival research and the positioning of archaeology on the seabed, the following is an interpretation of the wrecking process of Hazardous: the likely position of the original condition assessment, as well as the initial recovery of guns and anchors, was likely made close to a location 150 m southwest of the main site and 25 m south-southwest of the 2014 gun site, where a gun like feature, and corresponding magnetic signal, is visible on the bathymetry (Figure 39). Sometime shortly after 24 January Hazardous started to break up and zig-zagged north with wind and tide, 220 m up to the location of gun 36 - the tide in Bracklesham Bay flows west on the ebb and east on the flood, hence the ship zig zagging east and west as it drifts northwards (Figure 39). On the way, the upper parts of the hull broke away and spilled guns and equipment from the upper, quarter and forecastle decks; the evidence of which being the 2014, 2019 and 2022 gun sites. Following each loss of heavy objects, the ship would have lightened enough to allow it to be moved with the surf, tide and wind. At the point when the ship reaches the location of gun 36 there was a change in conditions, possibly wind direction coming from the north combined with a flood tide, which moved the surviving part of the ship 130 m southeast, where it comes to rest at the location of the main site (Figure 39). The current location is most likely the final position of the wreck and where the majority of the salvage took place.
